**Project Information Report
PL 109-148 Rehabilitation of Damaged
Hurricane/Shore Protection Projects**

GRAND ISLE AND VICINITY, LOUISIANA

JEFFERSON PARISH, LA

**U.S. Army Corps of Engineers
New Orleans District
New Orleans, LA**

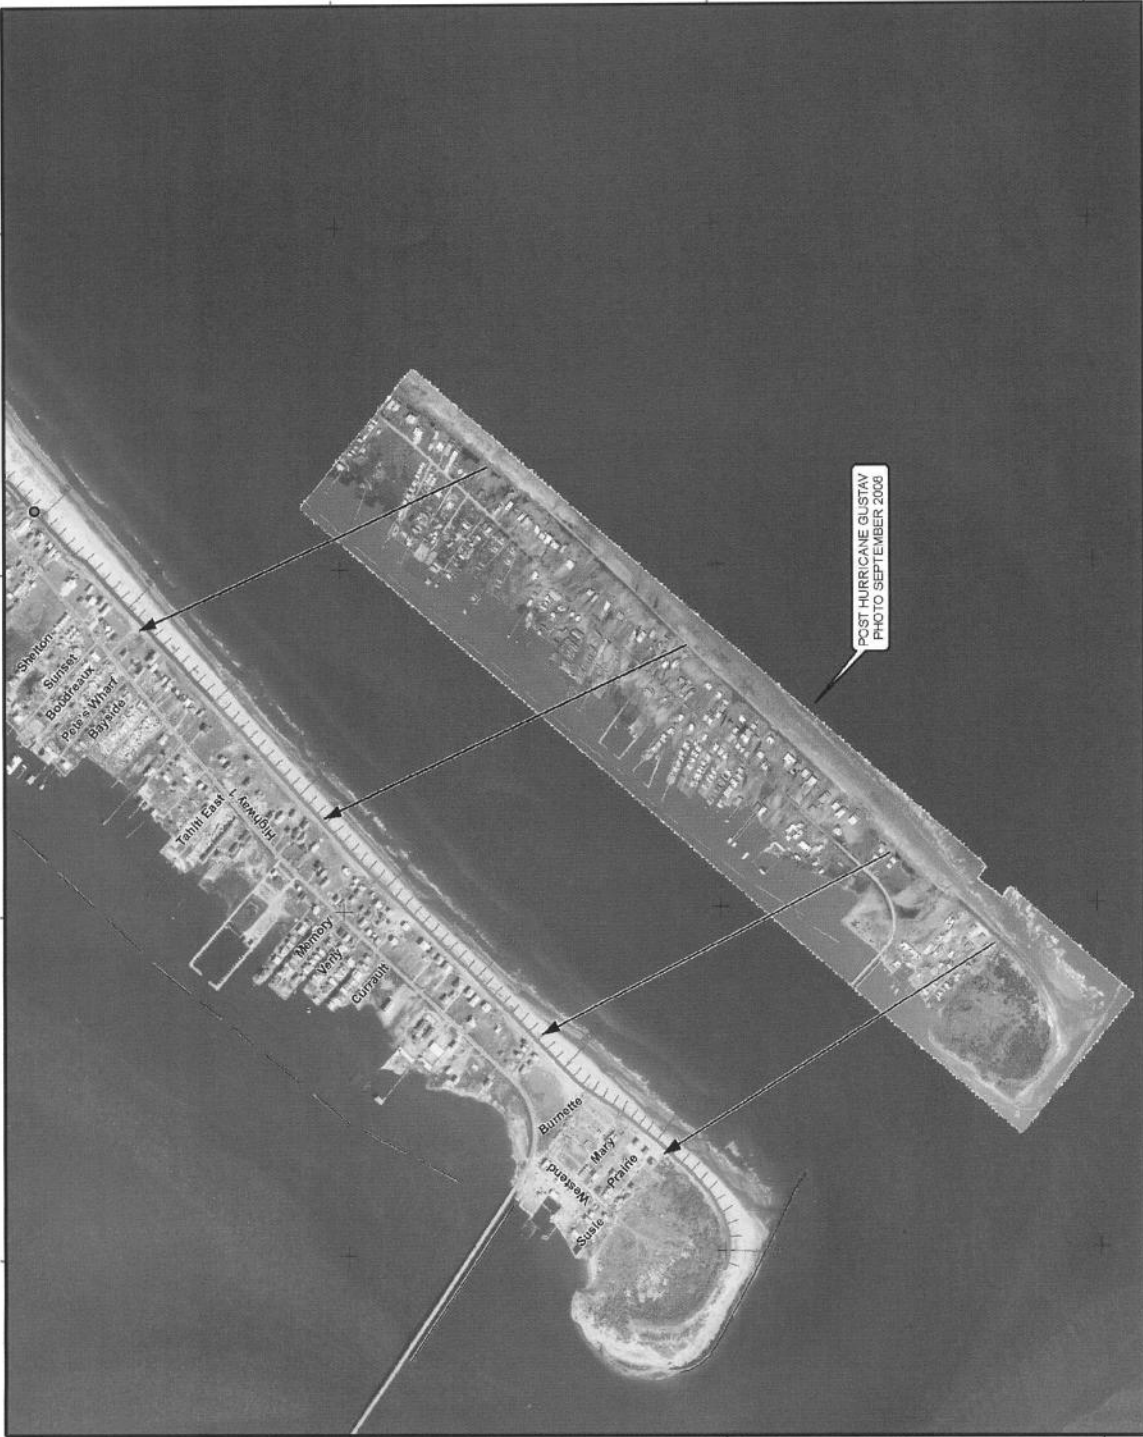
PLATE 2

MVS HURRICANE GUSTAV RECOVERY MAP: GRAND ISLE DAMAGE MAP NO.1

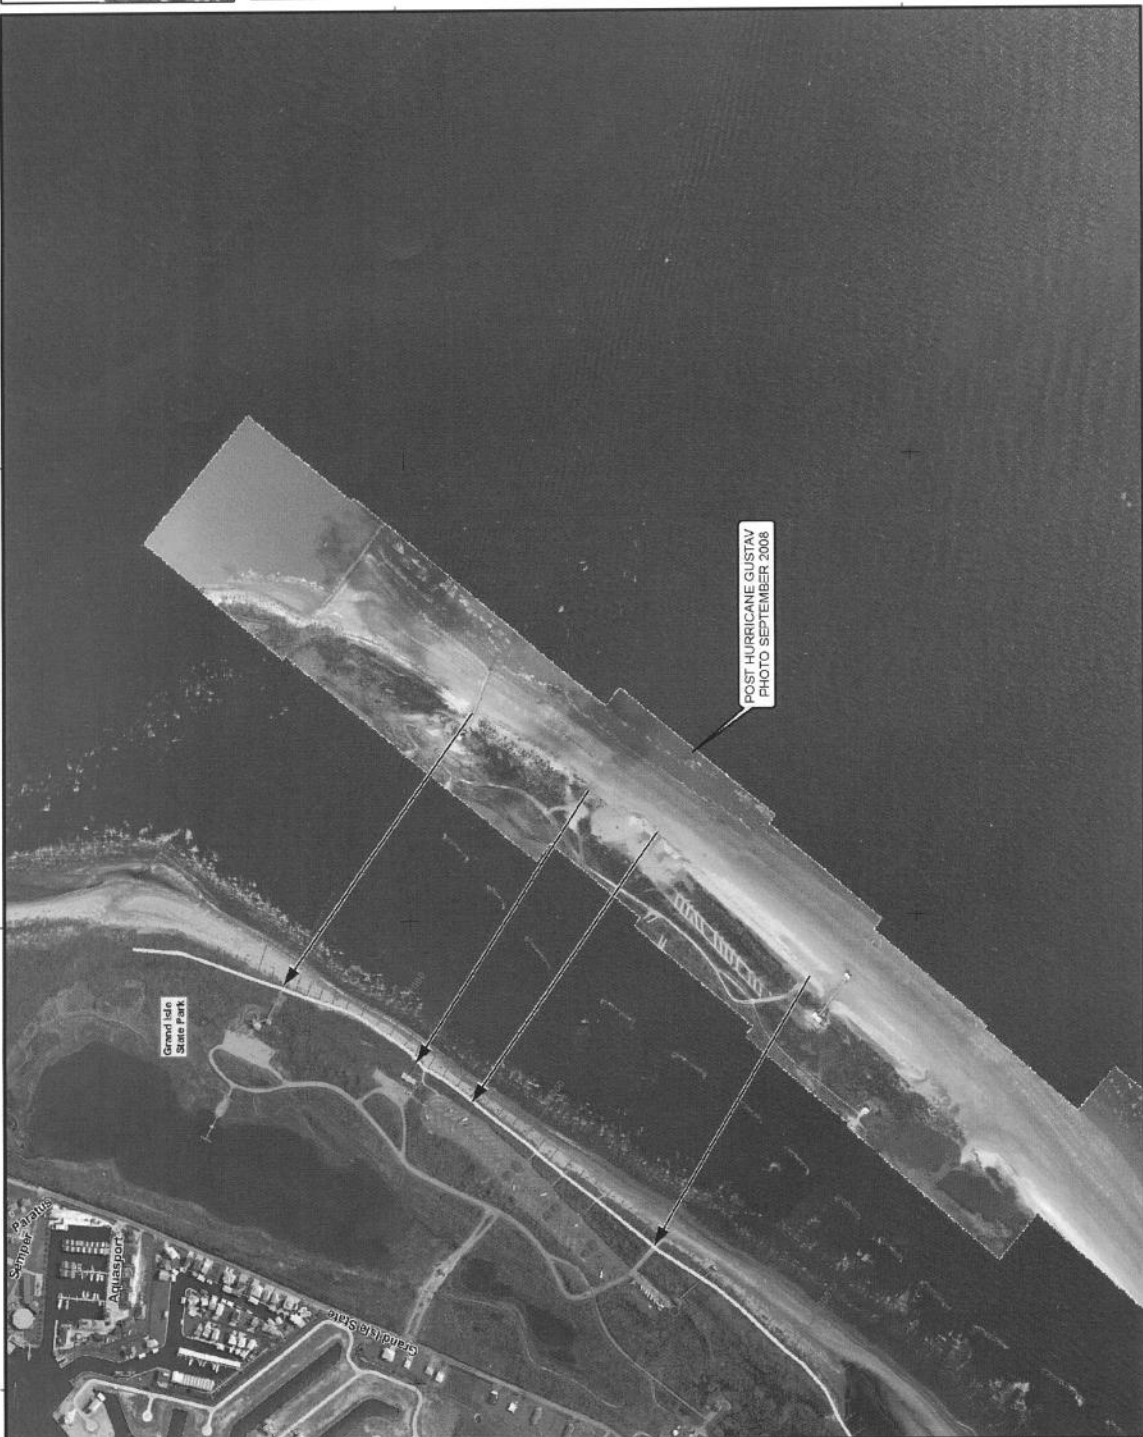
MVS HURRICANE GUSTAV RECOVERY MAP: GRAND ISLE DAMAGE MAP NO. 4

Feature: Cr-01
 Area: Grand Isle
 Block: Eroded and damaged areas shown
 within 100 feet of the shoreline. This
 information is for informational purposes
 only.

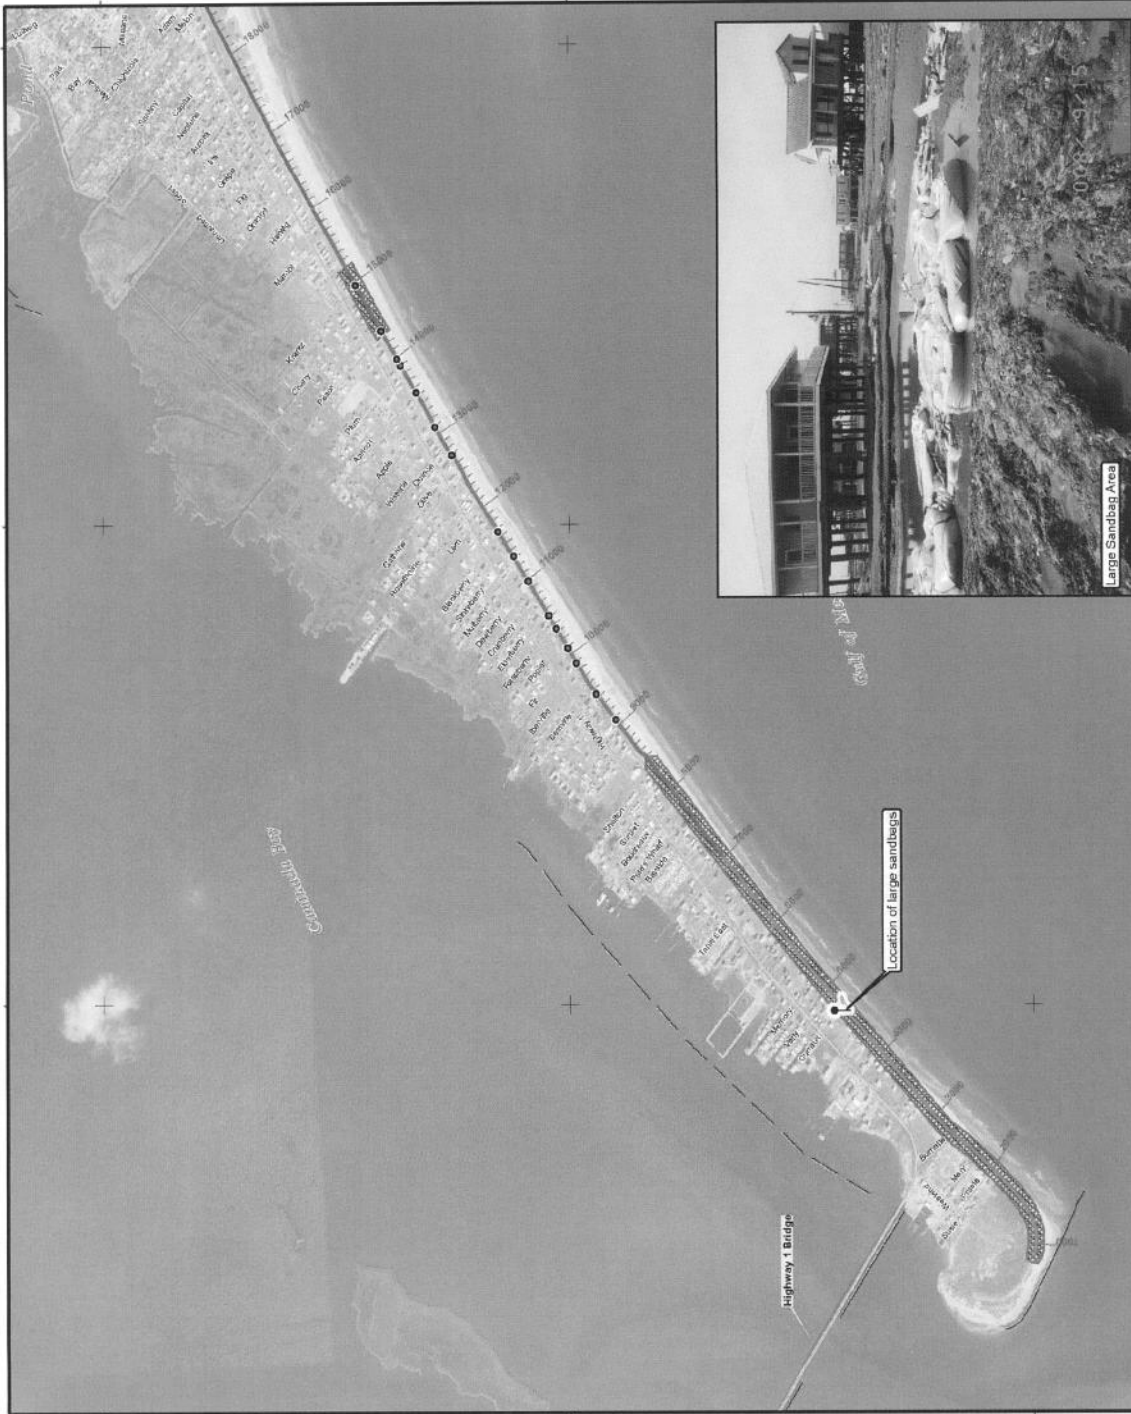
PLATE 6

MVS HURRICANE GUSTAV RECOVERY MAP: GRAND ISLE LARGE SANDBAG AREA

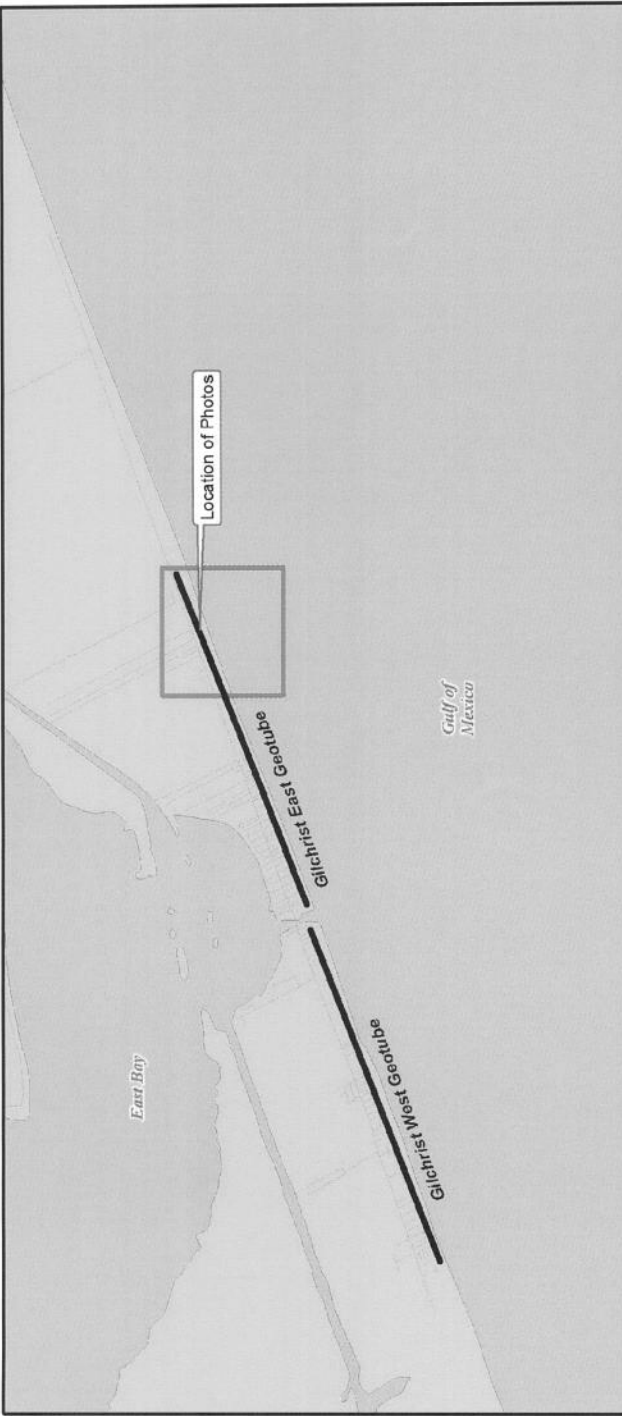
Upon arriving at the eastern end of the geotube line, the team immediately noticed that all sand cover was removed by the storm. The geotube was left exposed to the elements. Most of the UV protection was still in place, but was damaged in several areas. Broad scour depressions (~50'-75' in width) were noted immediately inland of the geotube line. The ground was littered with a cover of small, brittle shells with sharp edges. Very little debris was seen at the eastern end of the geotubes. The team

Most of the geotube line had not moved laterally. However, some breaches of varying lengths were noted. The breaches appeared to have been caused by rips or tears in the geotubes. In all cases, the broken geotubes were pointed out toward the gulf. Geotube connection points did not appear to have been more vulnerable to failure than midlength sections. It was also noted that no breaches in the geotube were oriented inland of the original geotube line. This led the team to suspect that the surge wave flow back toward the gulf from the bay was strong and could possibly have been the ultimate cause of several or all geotube failure points. Further evidence of strong gulfward return flow from the bay was that all grass was laid down in the direction of the gulf.

MVS HURRICANE GUSTAV RECOVERY MAP: GEOTUBE IN GILCHRIST, TEXAS
