MEMORANDUM FOR Chief, Regional and Environmental Planning Division-South
(CEMVN-REPD/Troy Constance)

SUBJECT: IHNC Lock Replacement General Re-evaluation Report, Engineering
Assessment of the Existing Lock Structure

Enclosure 1 – Pictures of Structural Deficiencies

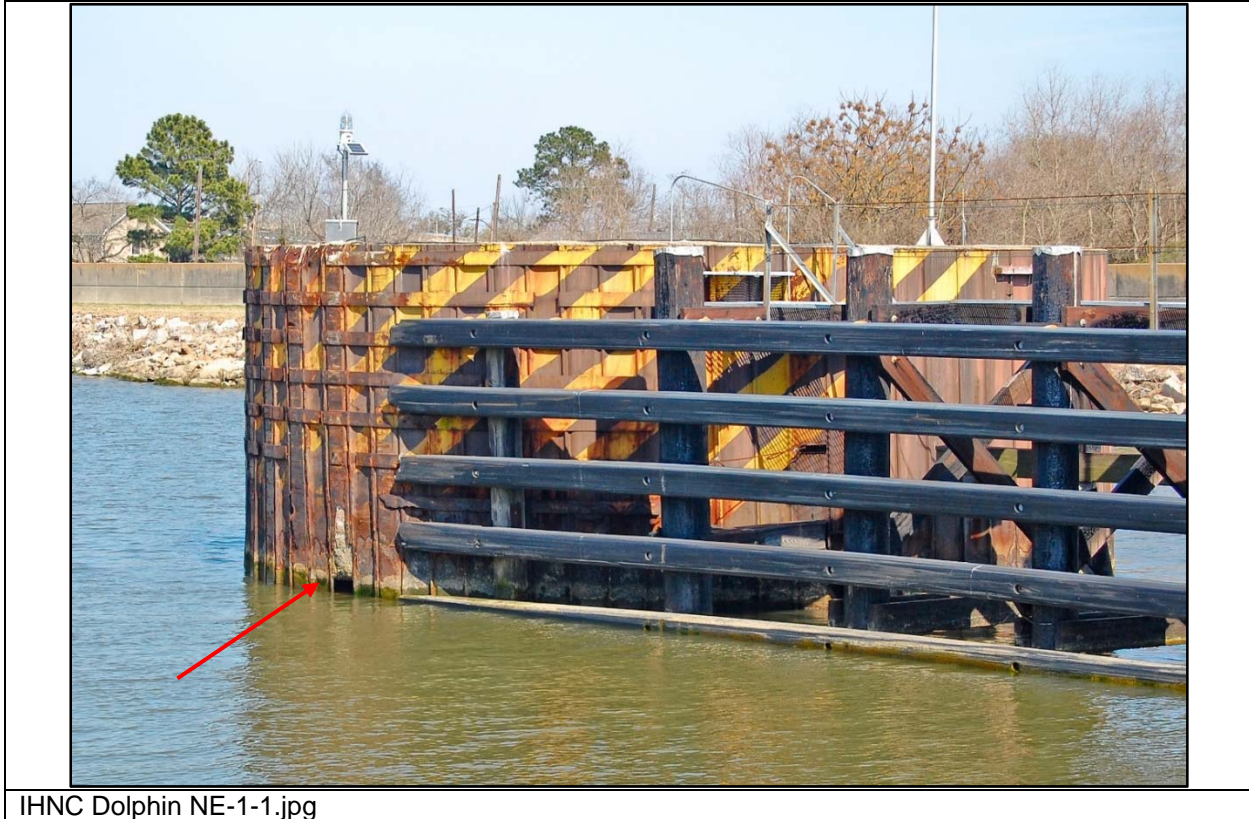
- Lock/Lock Structure/Lock Walls & Other Lock Structures/Nose Pier Downstream
Auxiliary/Deterioration, Stability, and Structural (Foundation is not visible being below
the water line.)

Loss of fill that is the center of the stability of the structure. 100% section loss of interlock metal (sheetpile) mainly in the splash zone going down below the water surface.

The component exhibits a clear mode of failure: The corroded sheet pile below the pile supported concrete inner wall is allowing the stability fill to spill out into the water. The result is loss of impact resistance.

The component has already failed. With the loss of stability fill through the corroded sheetpile, it will not sustain impact. If it sustains a vessel impact, it will fail and crumble into the channel. Failure of the nose pier will expose the guard wall to head on vessel impacts, which it is not designed for. Because of the narrow width of the lock chamber (74') and the maximum width of barge tows that travel through the lock (70'), it's highly likely a vessel impact will occur in the future.

Rating: **F**

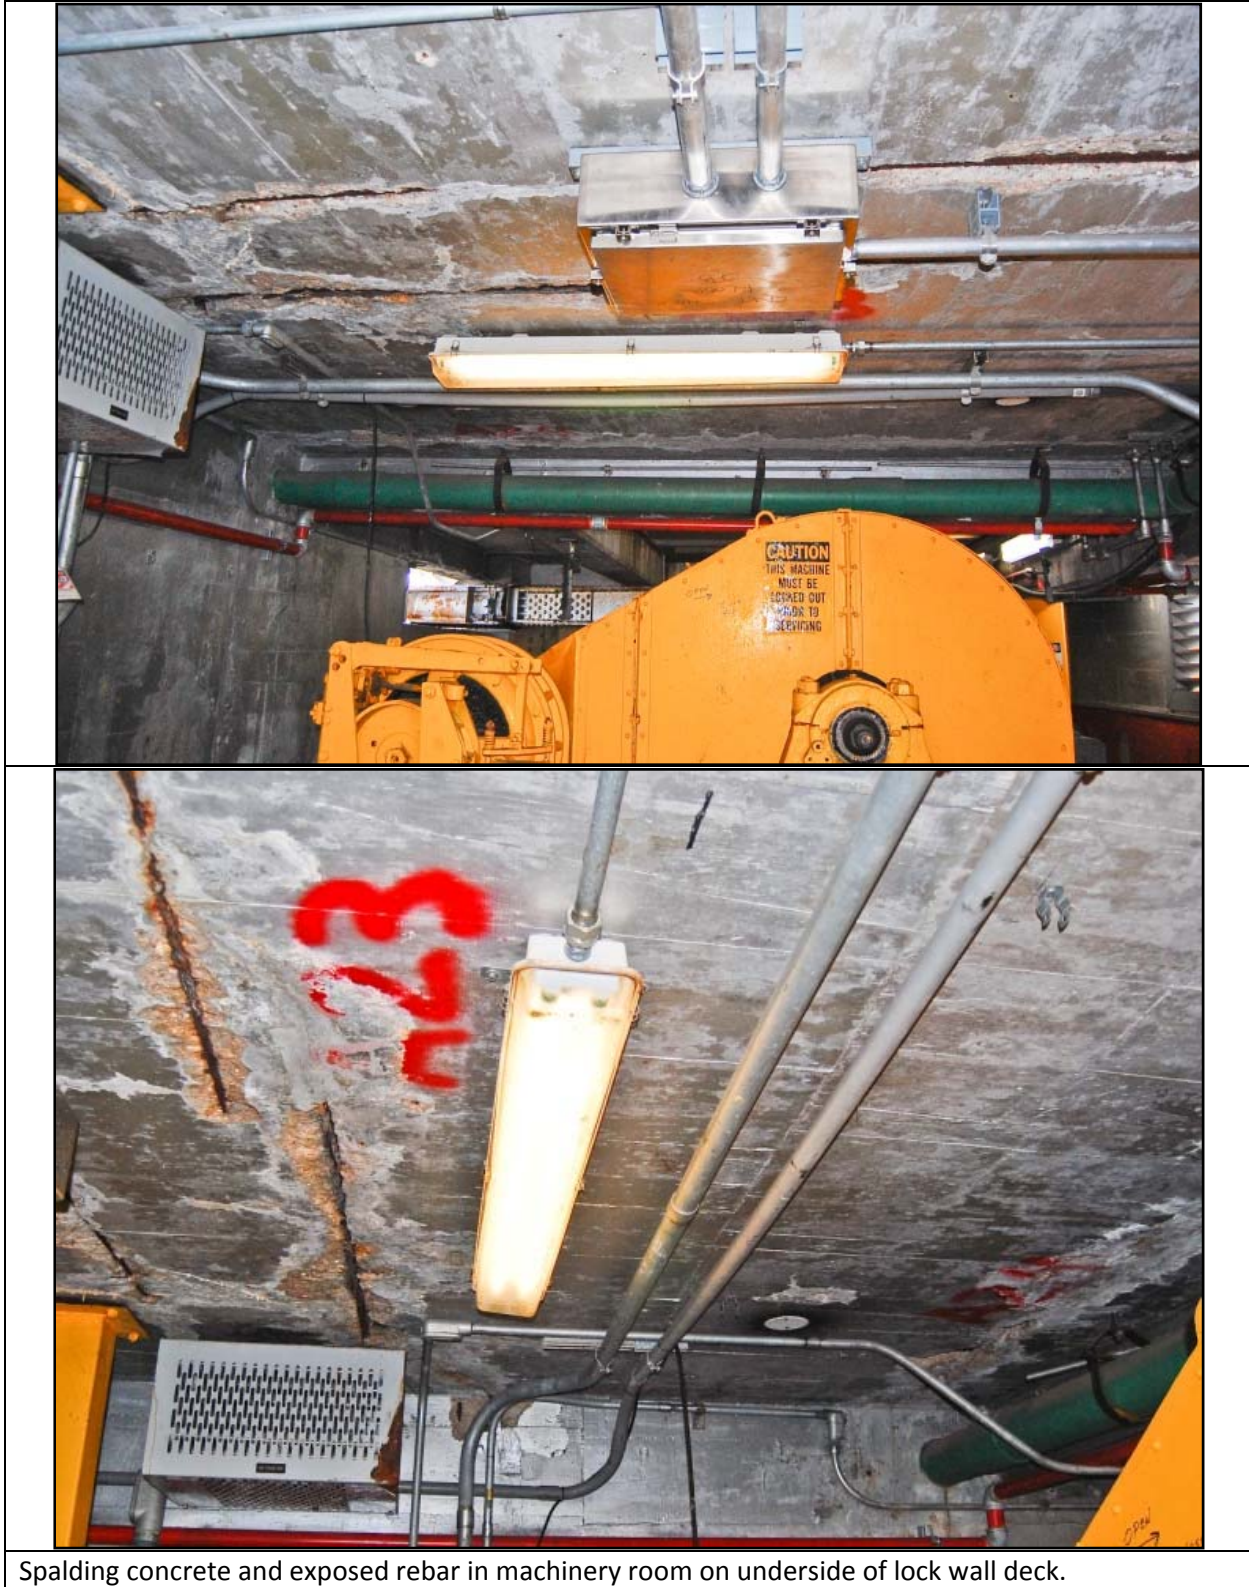
Spalling concrete and exposed rebar in machinery room on underside of lock's west wall deck.

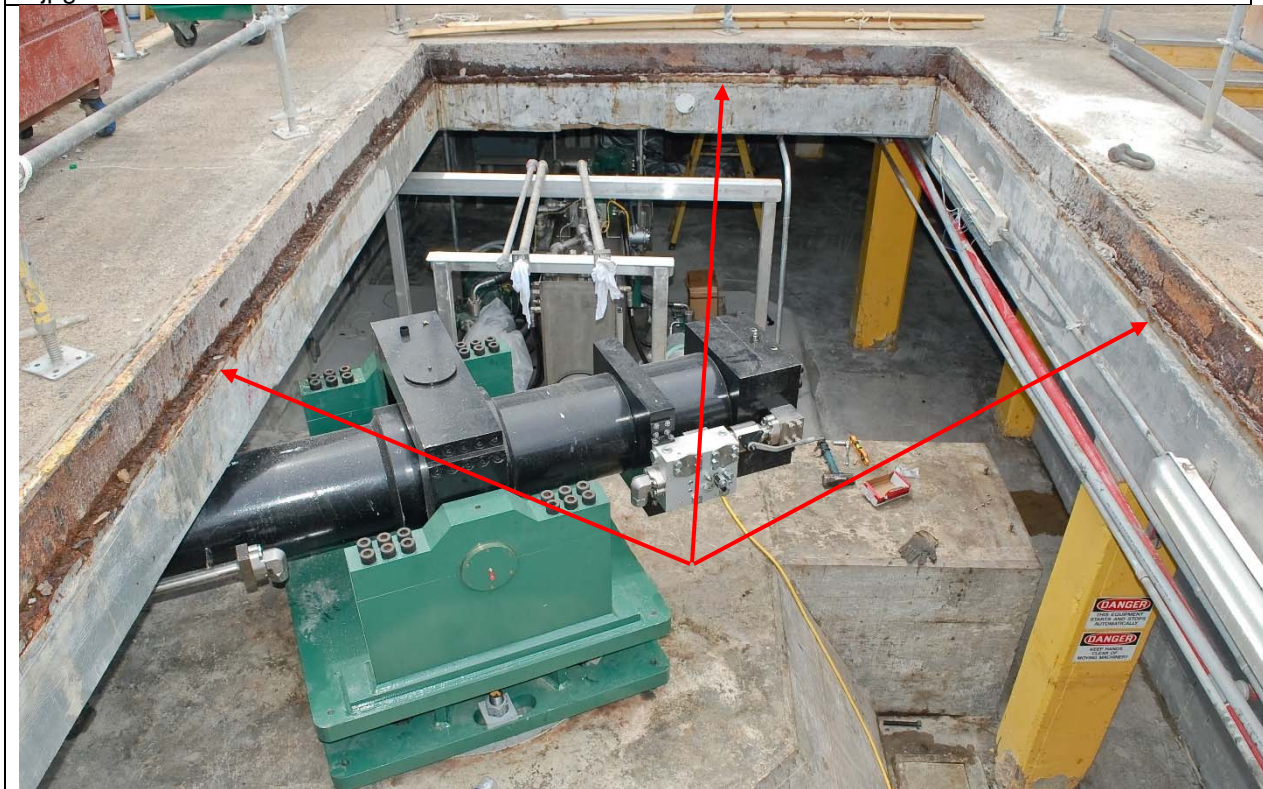
Machinery opening showing steel frame with rusted out water diverting lip gone from the opening recess. IHNC 24 Aug 16 Dewater Gate 7 Cylinder New-7-7.jpg

Cracked and spalled concrete hatch covers, rusted out steel frames with significant and missing section loss.

The component exhibits a clear mode of failure: The cracked covers and leaking frames is leading to increased section loss of frames and increasing risk of cave-in.

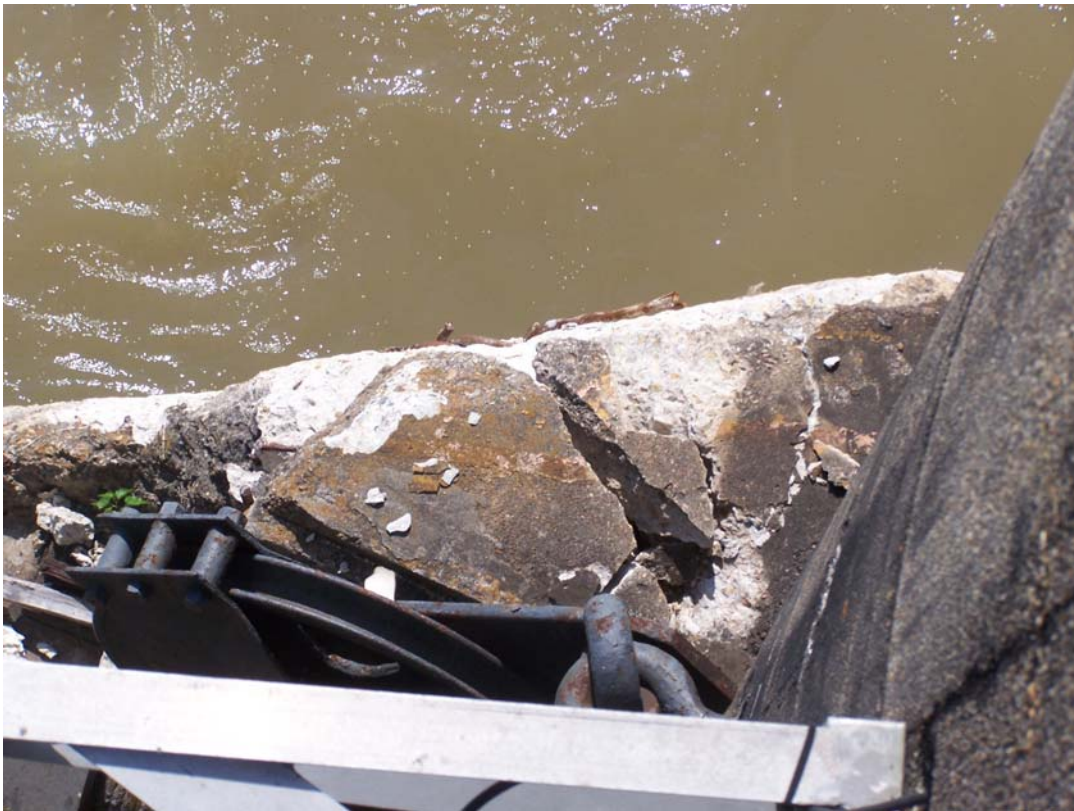
Photo 6 Large spalls and cracked concrete with exposed steel on the northwest side near hinge for gate 9.

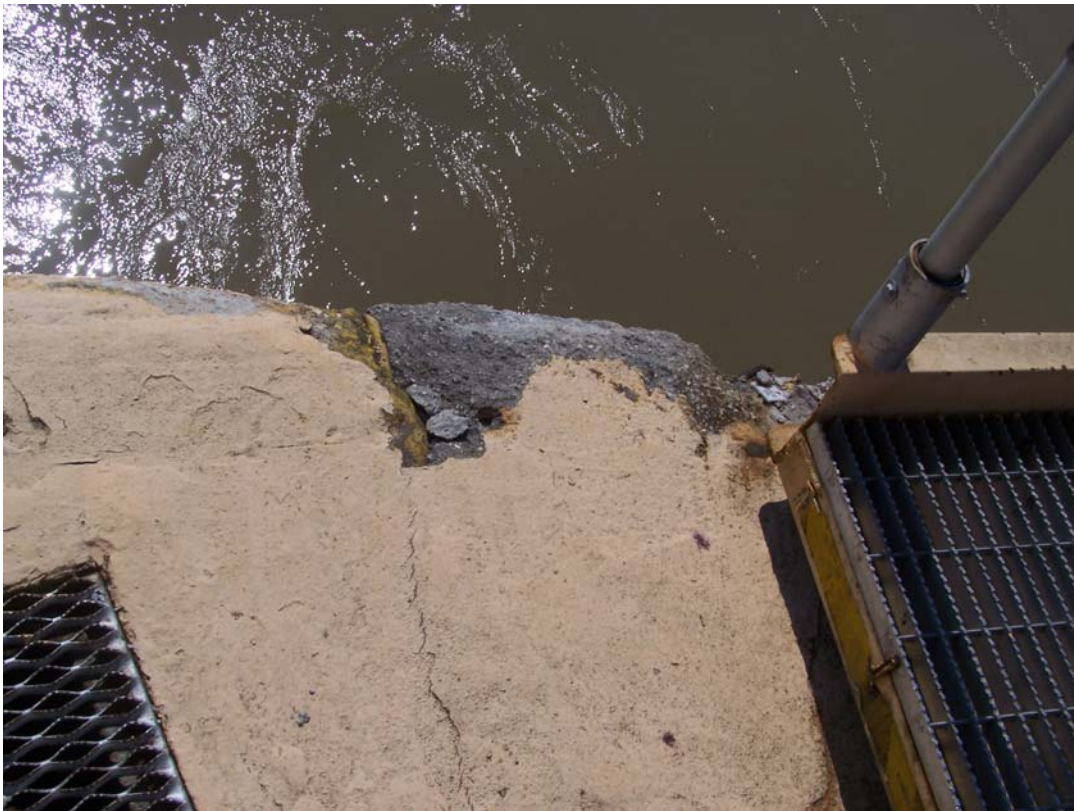
Photo 28 Spall in top of west wall near the hinge for the river side gate.

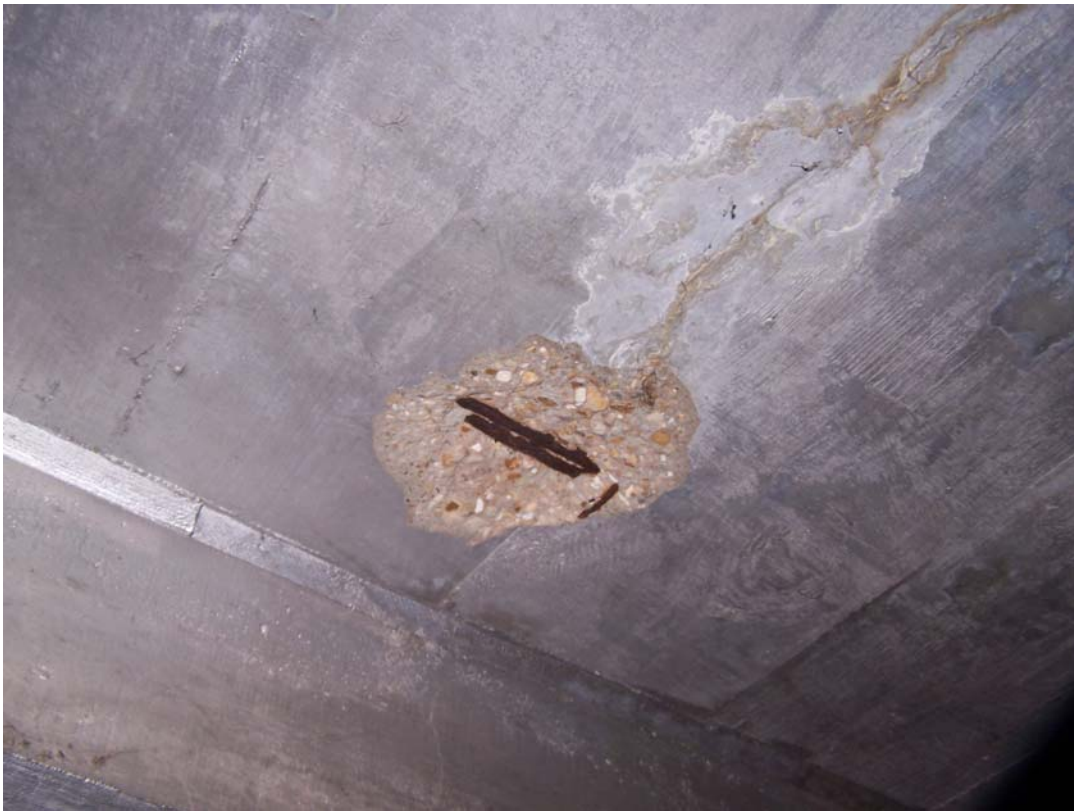
Photo 46 Popout in ceiling near valve 11 caused by corroding steel.

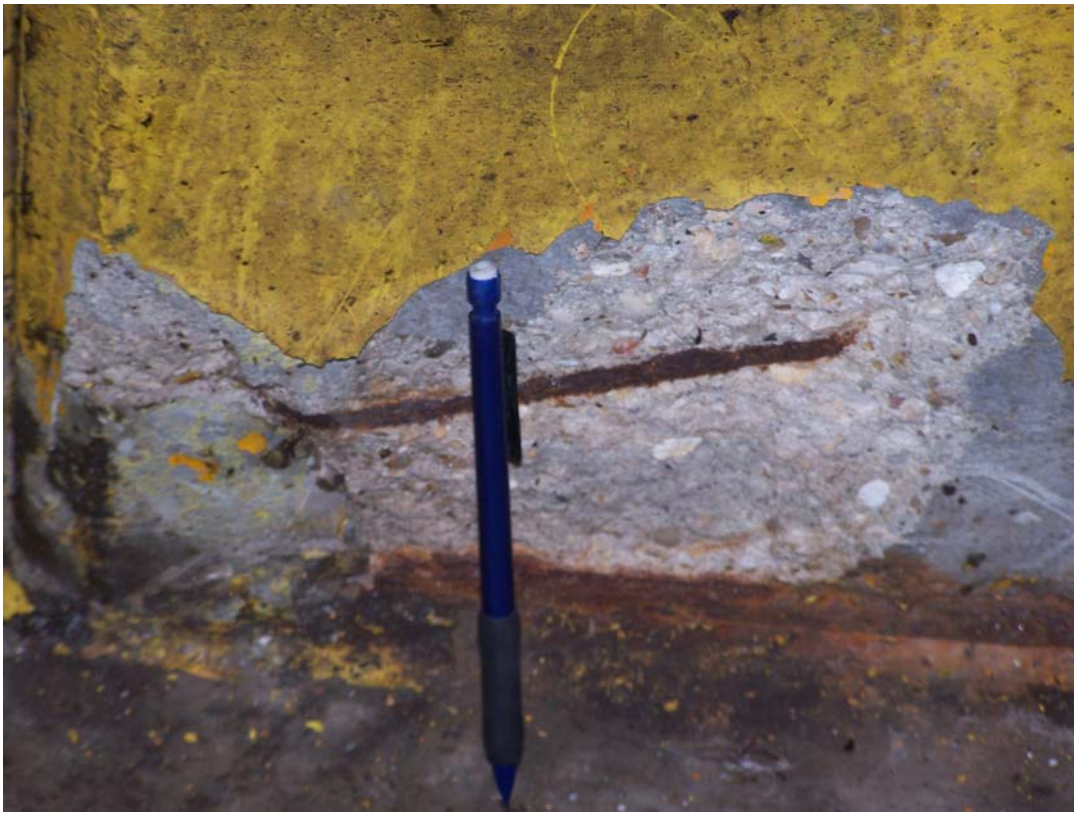
Photo 50 Spalls and delaminations at bottom of columns on both sides of hinge for gate 1.

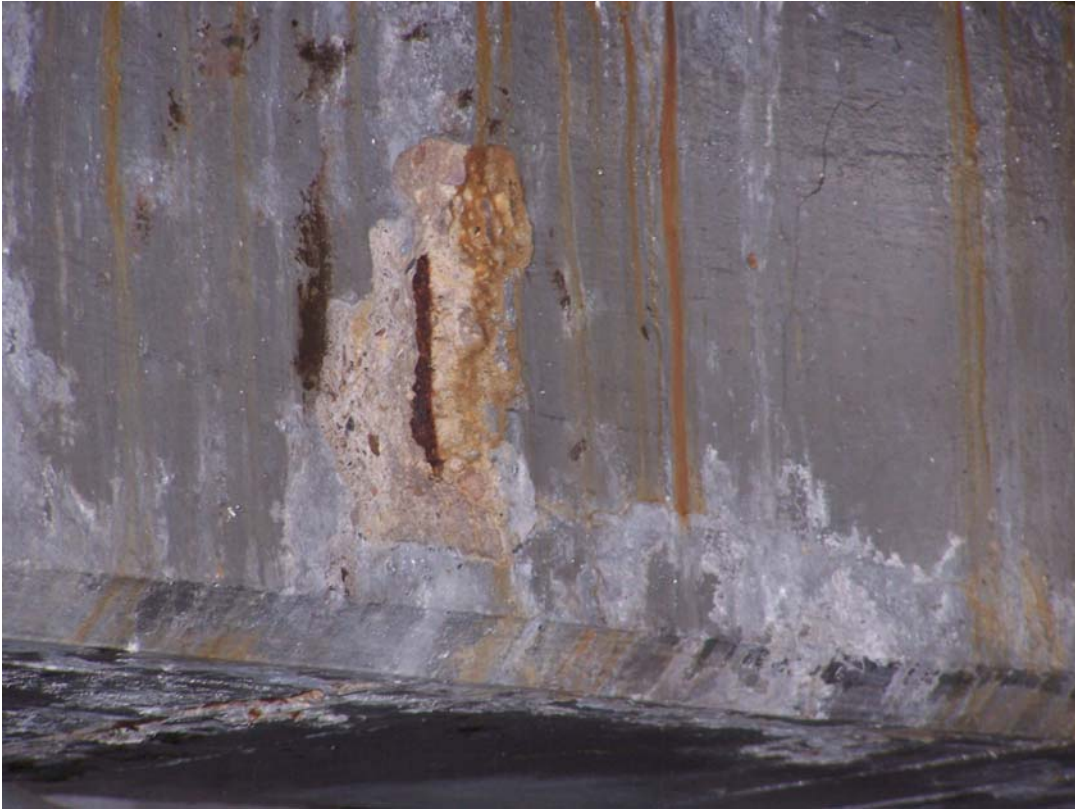
Photo 51 Popout in beam over gate 1 hinge.

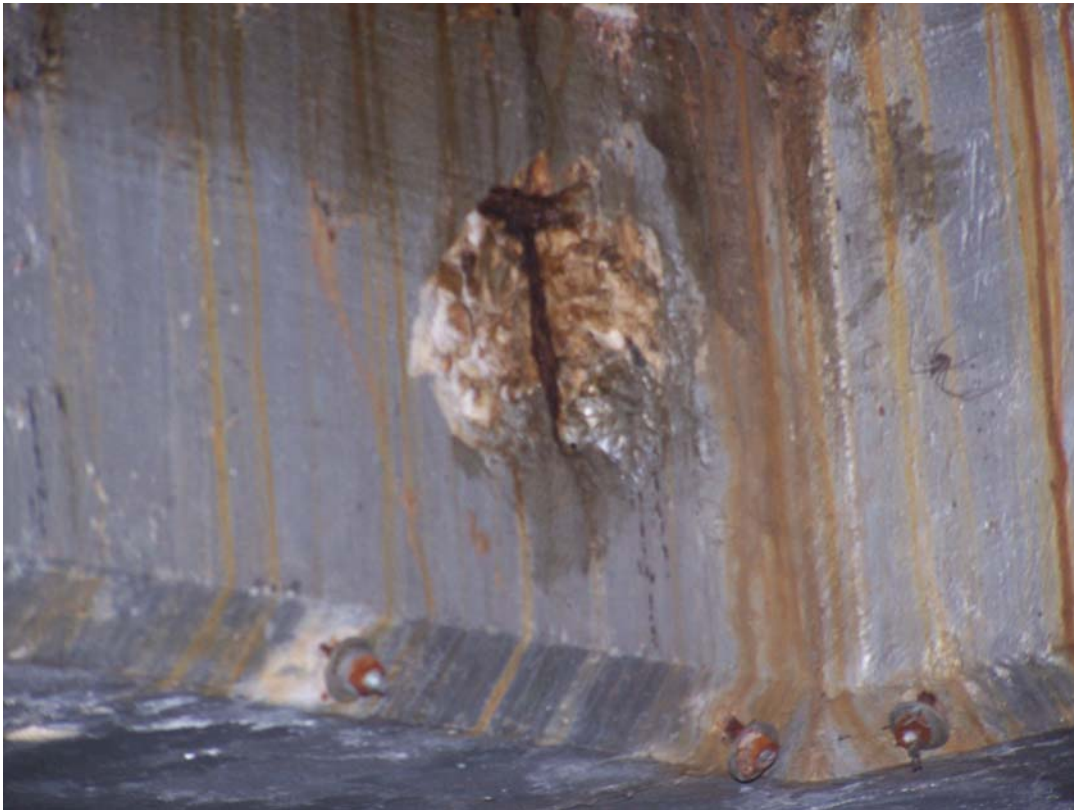
Photo 53 Popout in beam over valve 12 caused by corroding steel.

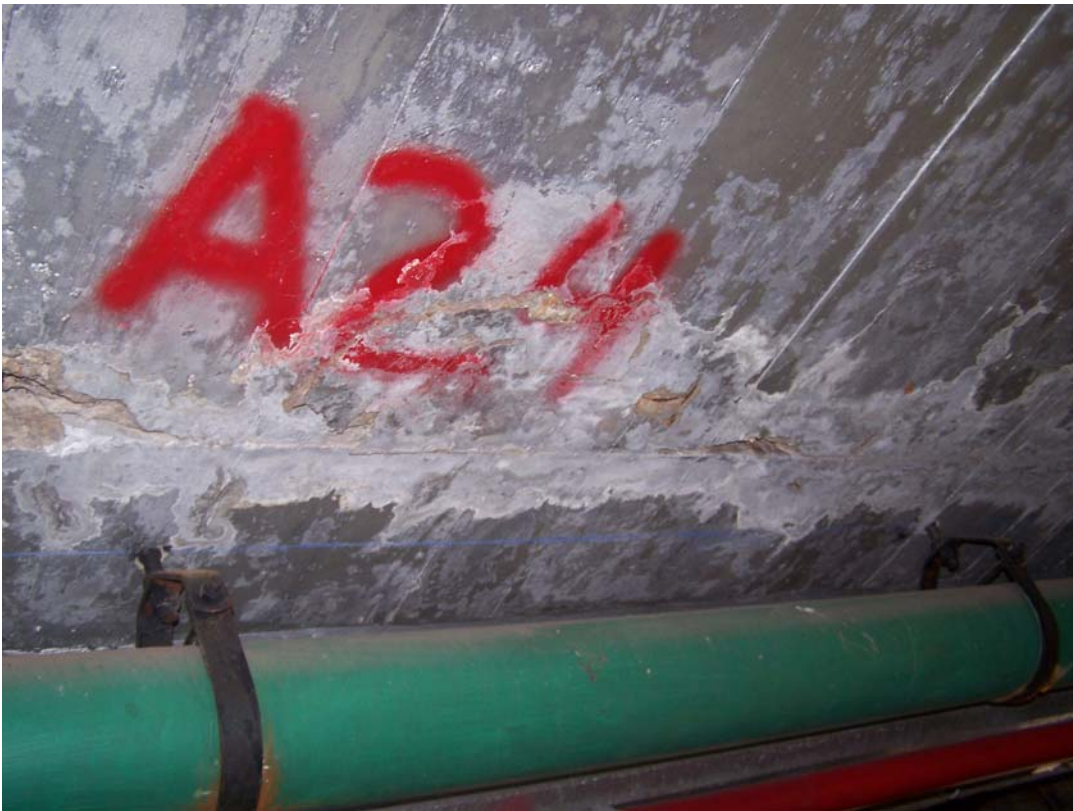
Photo 56 Spalling with corroded steel in ceiling over gate 3 machinery.

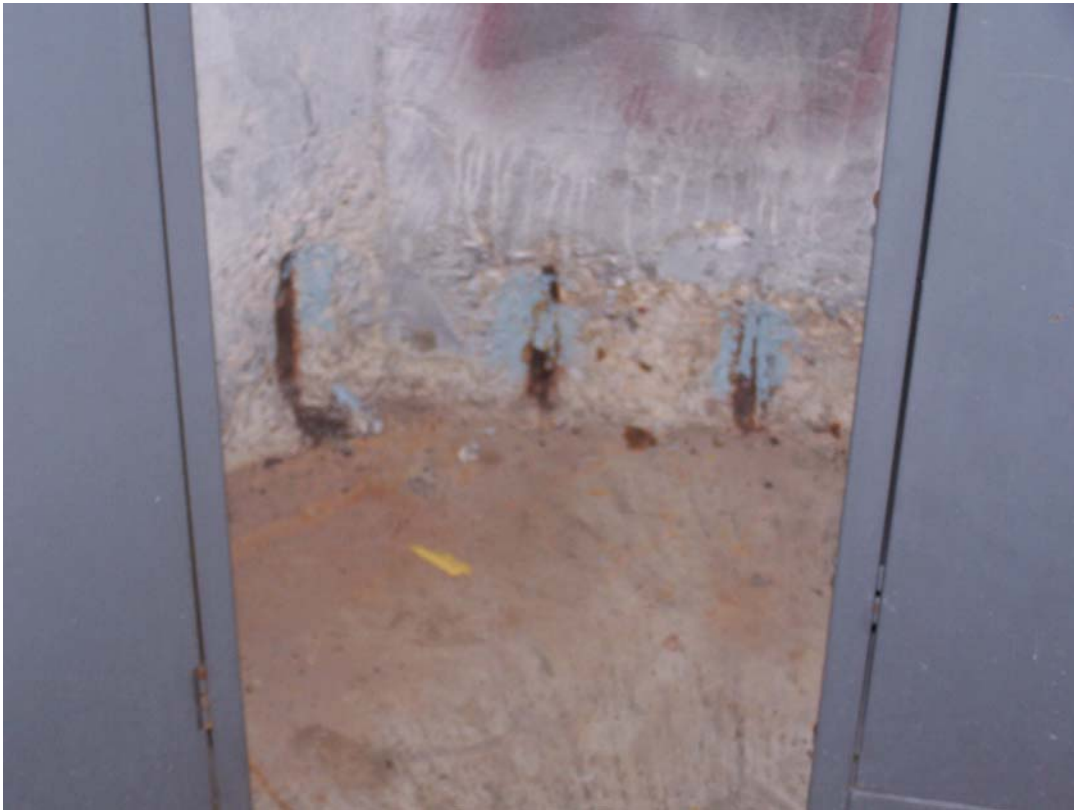
Photo 65 Popouts at the bottom of the wall in room 3.

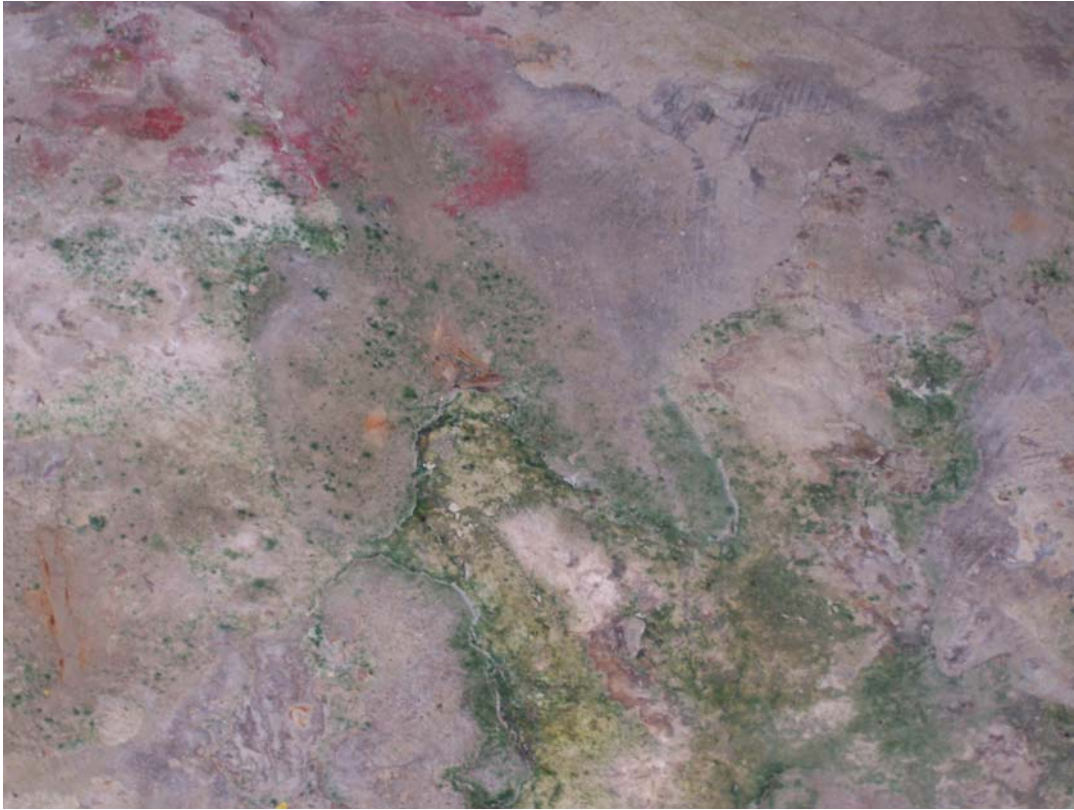
Photo 85 Failed patch in the floor of room 5.

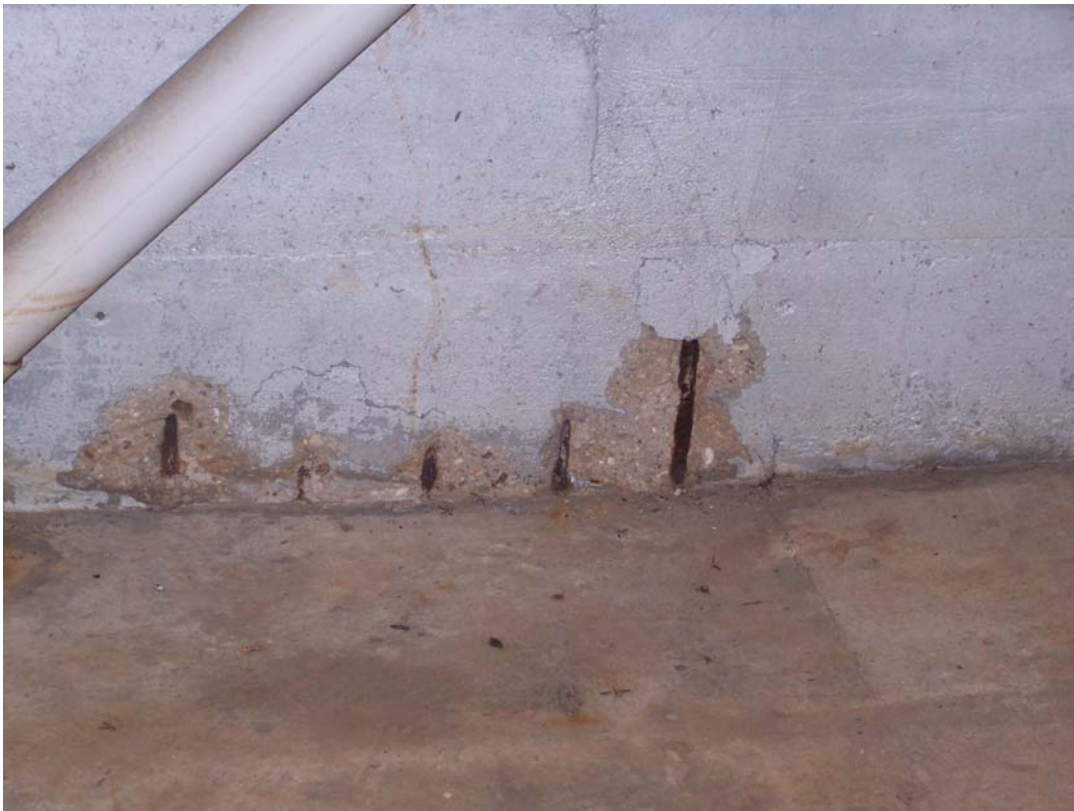
Photo 86 Popouts at the bottom of the wall in room 5.

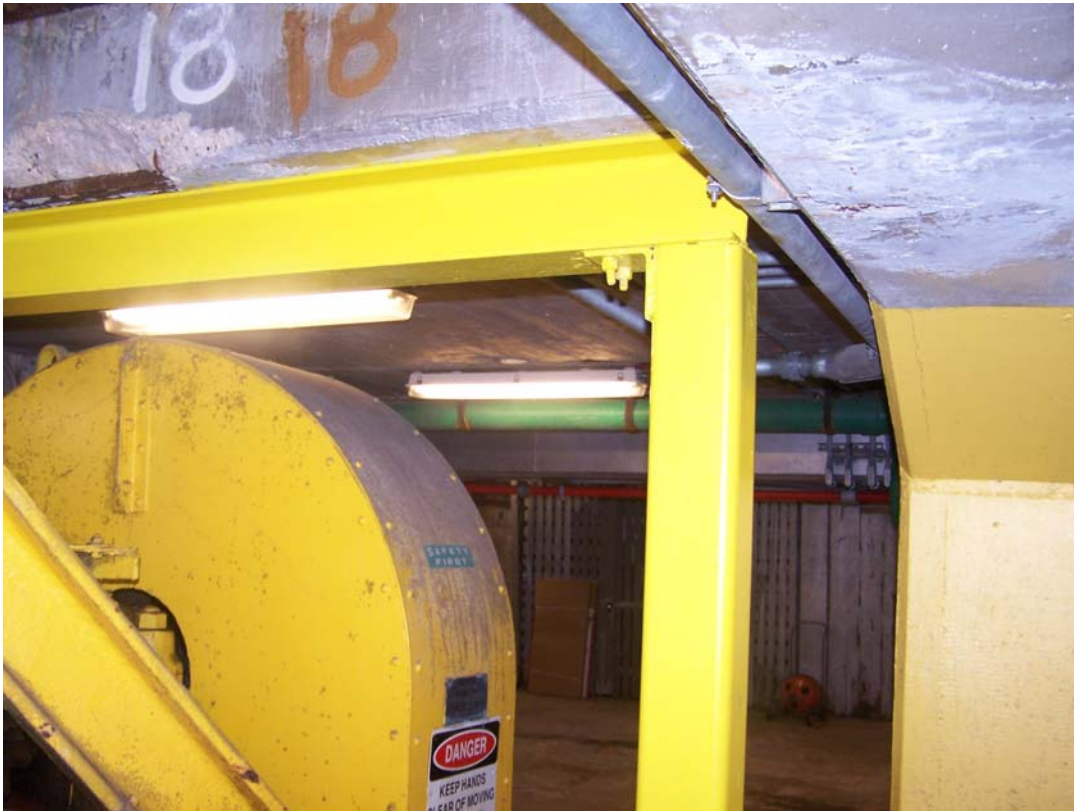
Photo 95 Spalls and corroded steel in beams over machinery in room 5. Note steel beam and columns added to support these beams.

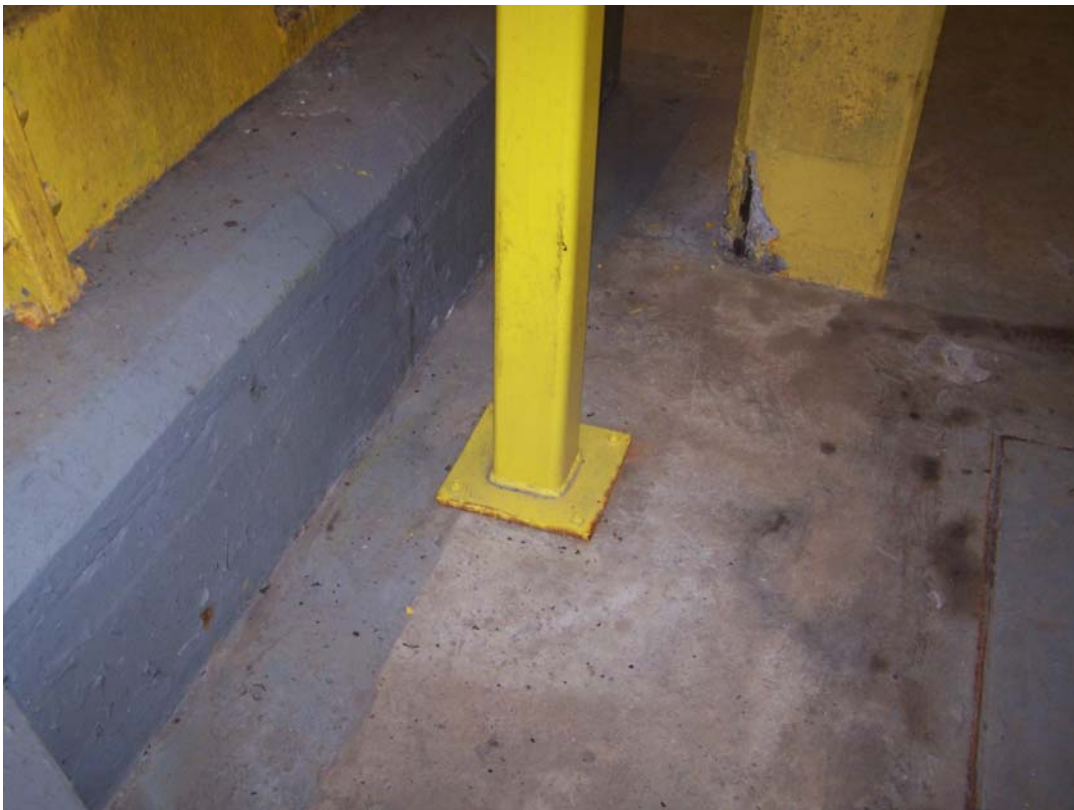
Photo 96 Spall at bottom of column and steel column added to support deteriorated concrete beams and columns.

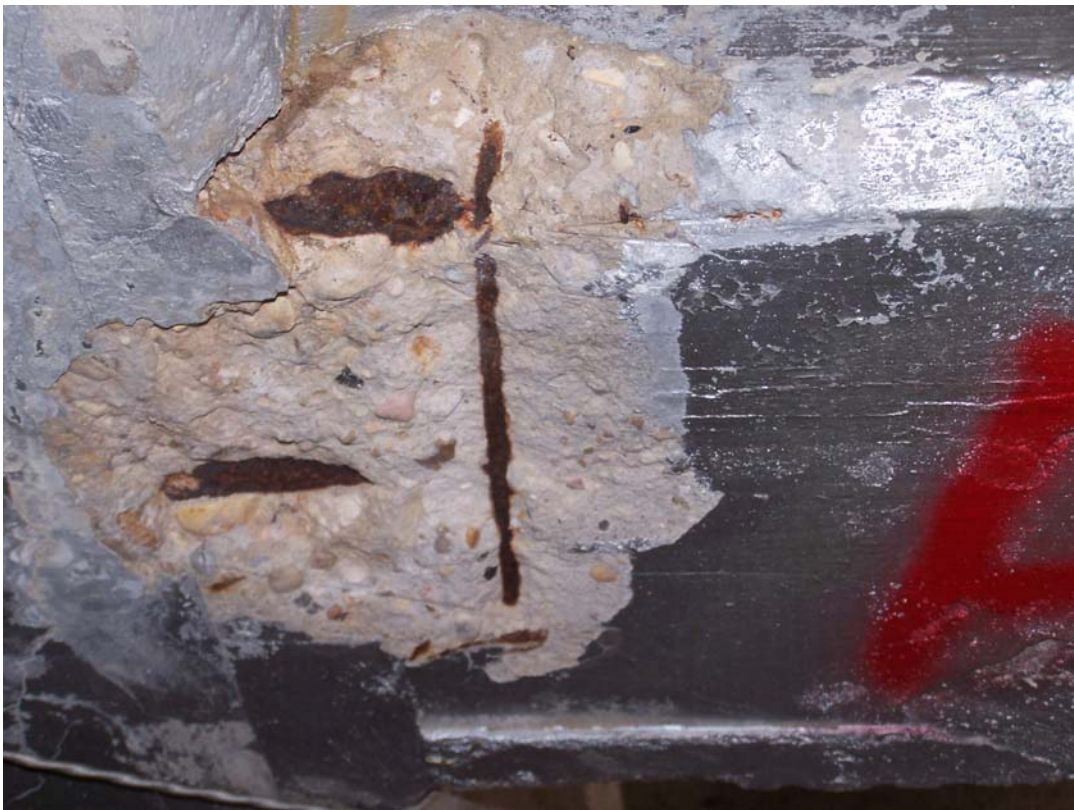
Photo 98 Spall with corroded steel in beam over machinery in room 5.

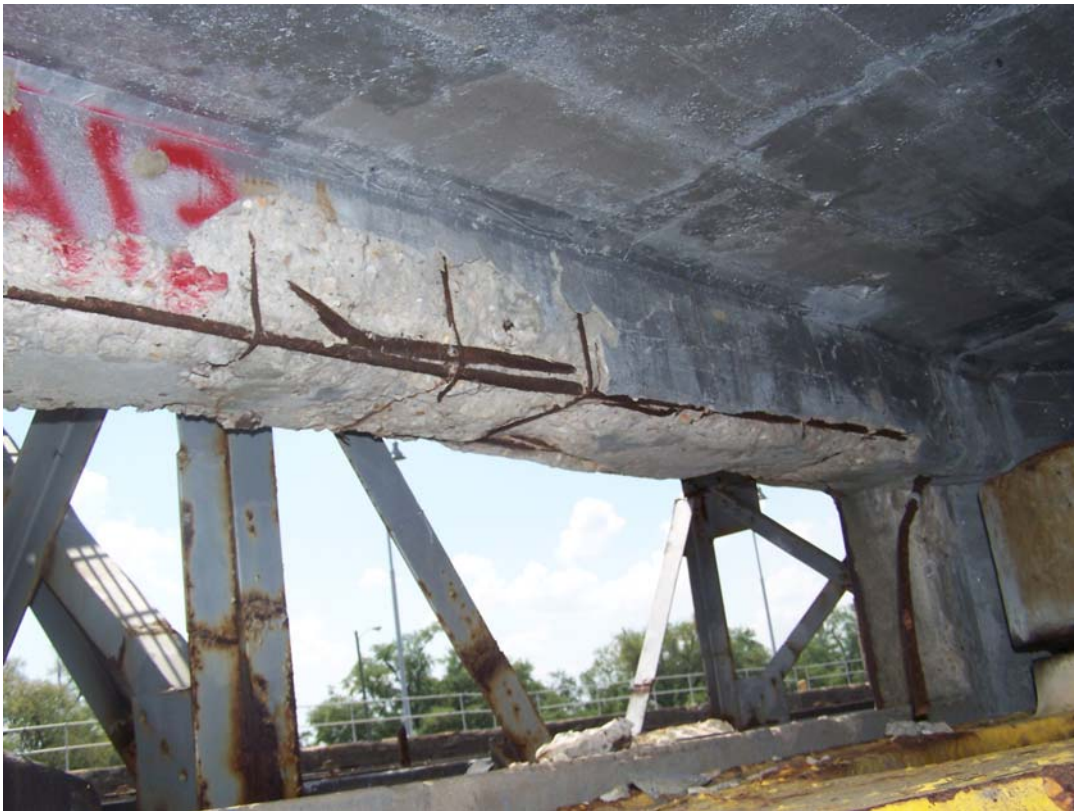
Photo 100 Spalled beam with corroded reinforcing over opening for gate 7.

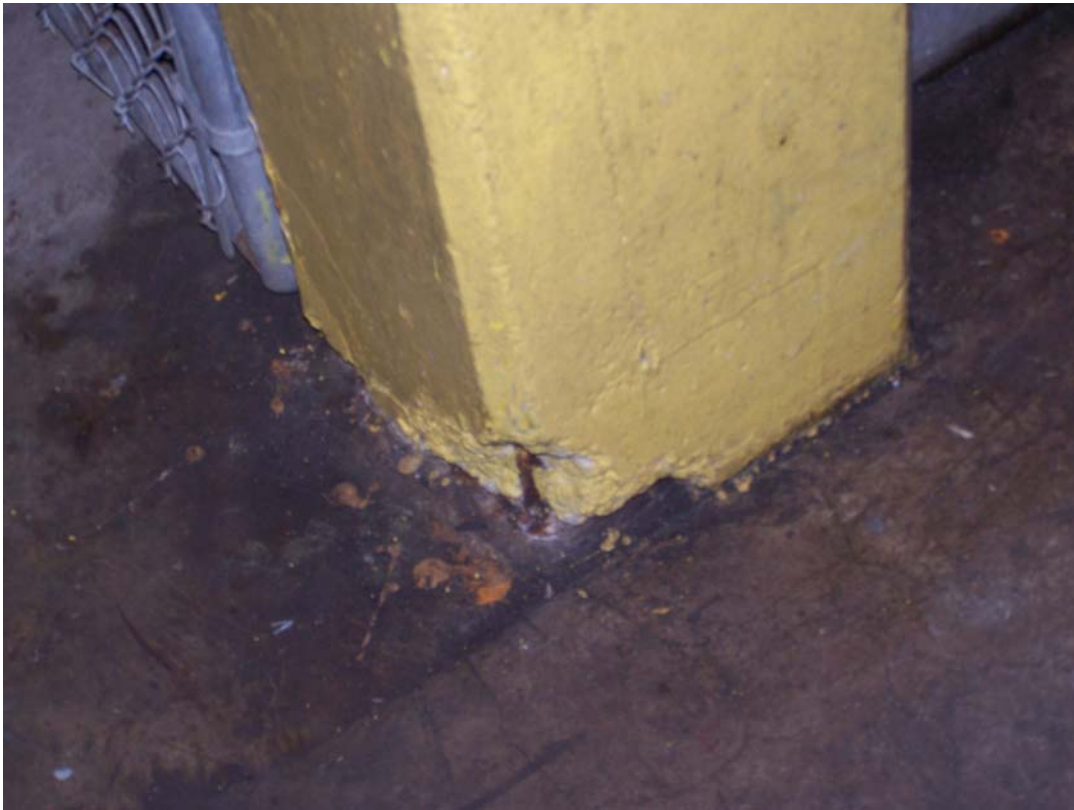
Photo 109 Spall at the bottom of the column by the gate under the stairway.

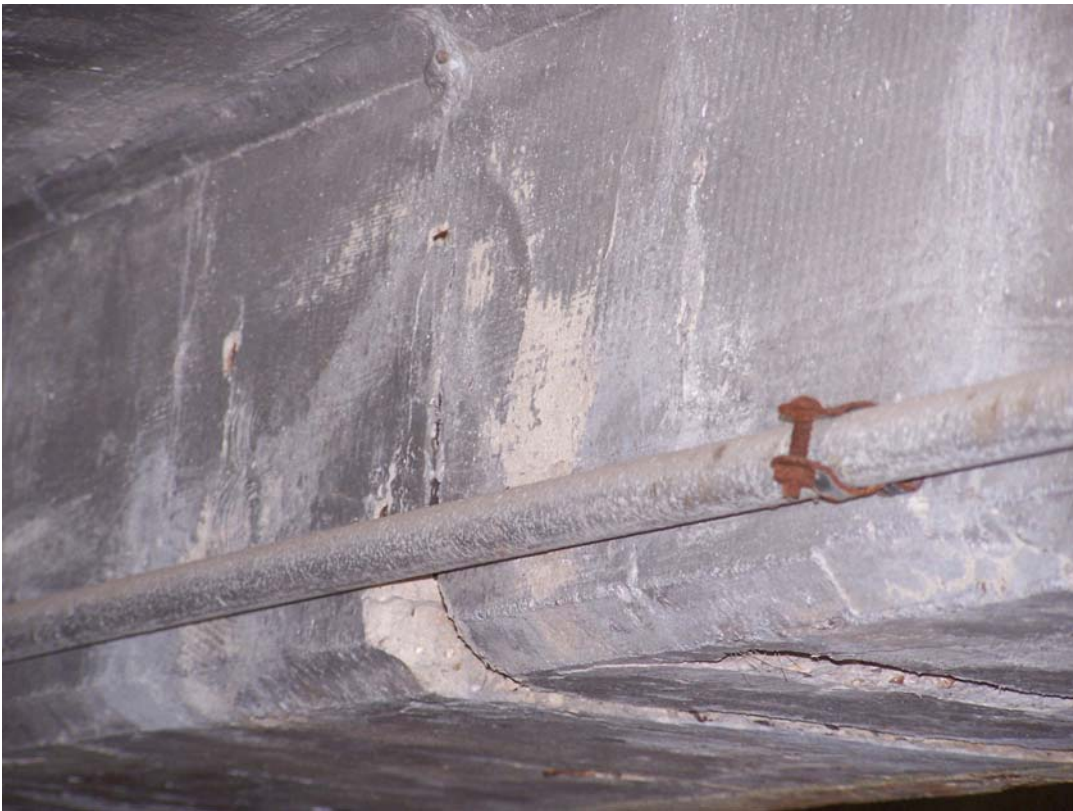
Photo 126 Spalls in beam over Gate 5 machinery. About mid span of beam.

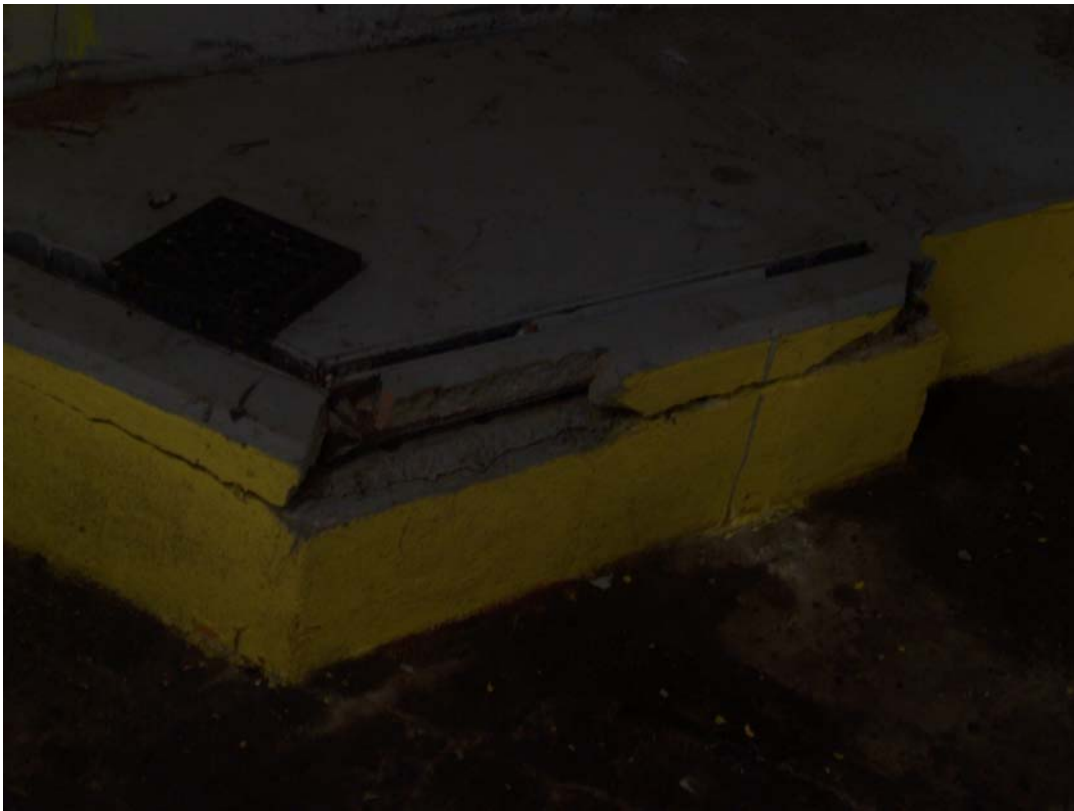
Photo 152 Spalled/delaminated concrete in Room 2. Has increased since last inspection.

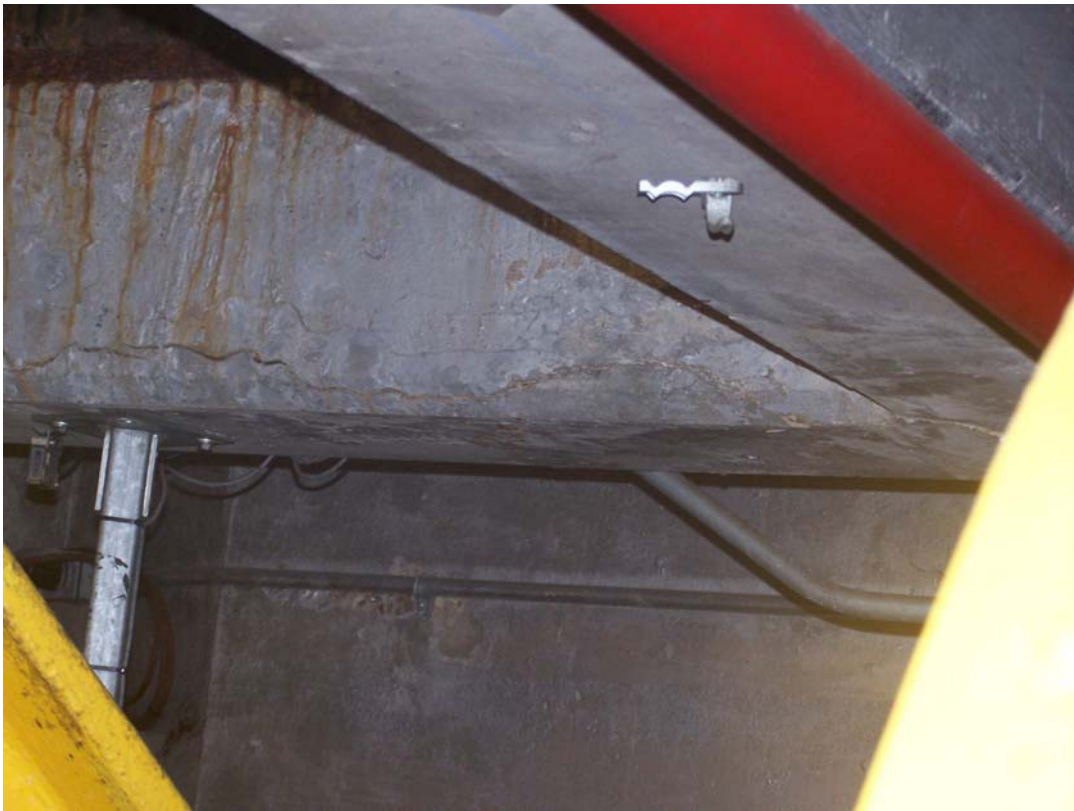
Photo 162 Crack in beam over Gate 4.

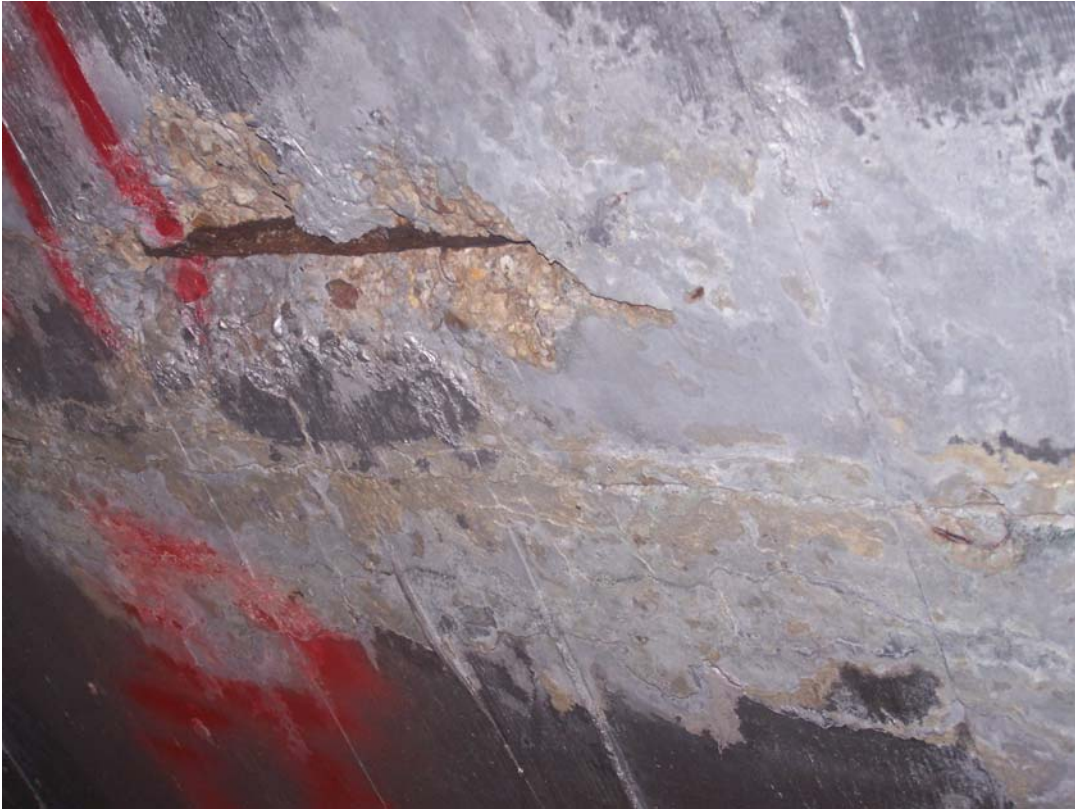
Photo 171 Spalling and exposed steel in ceiling of room 6.

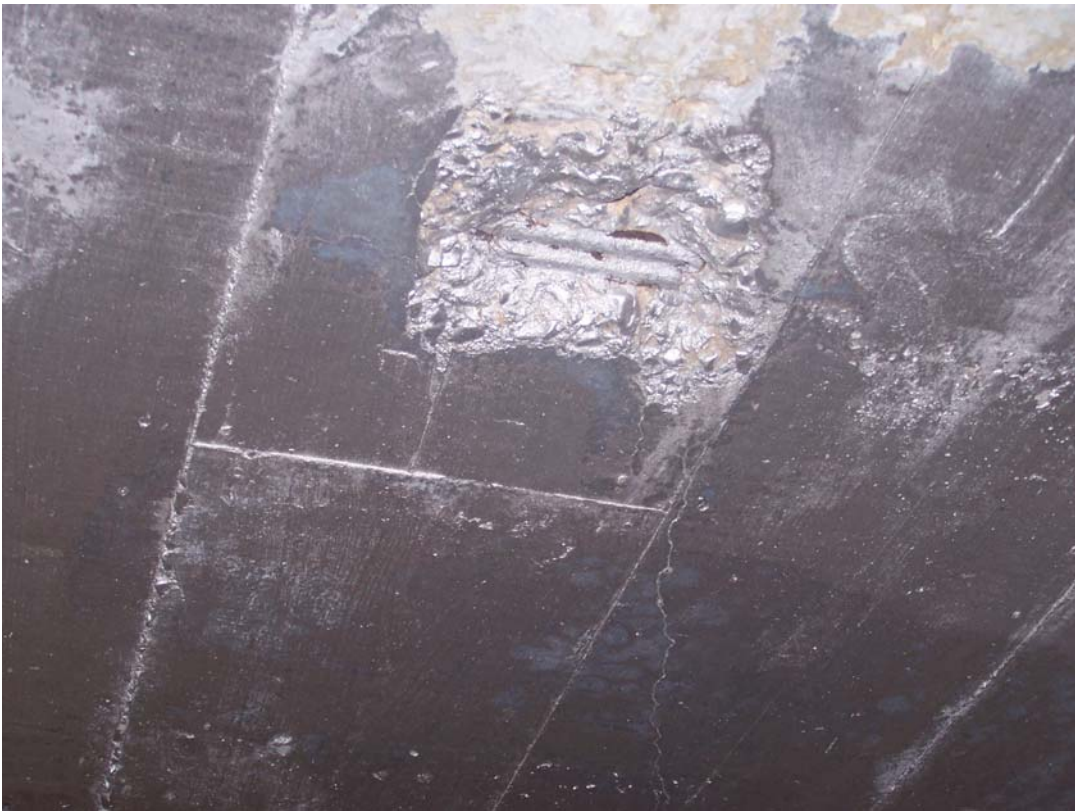
Photo 172 Painted spall in ceiling of room 6.

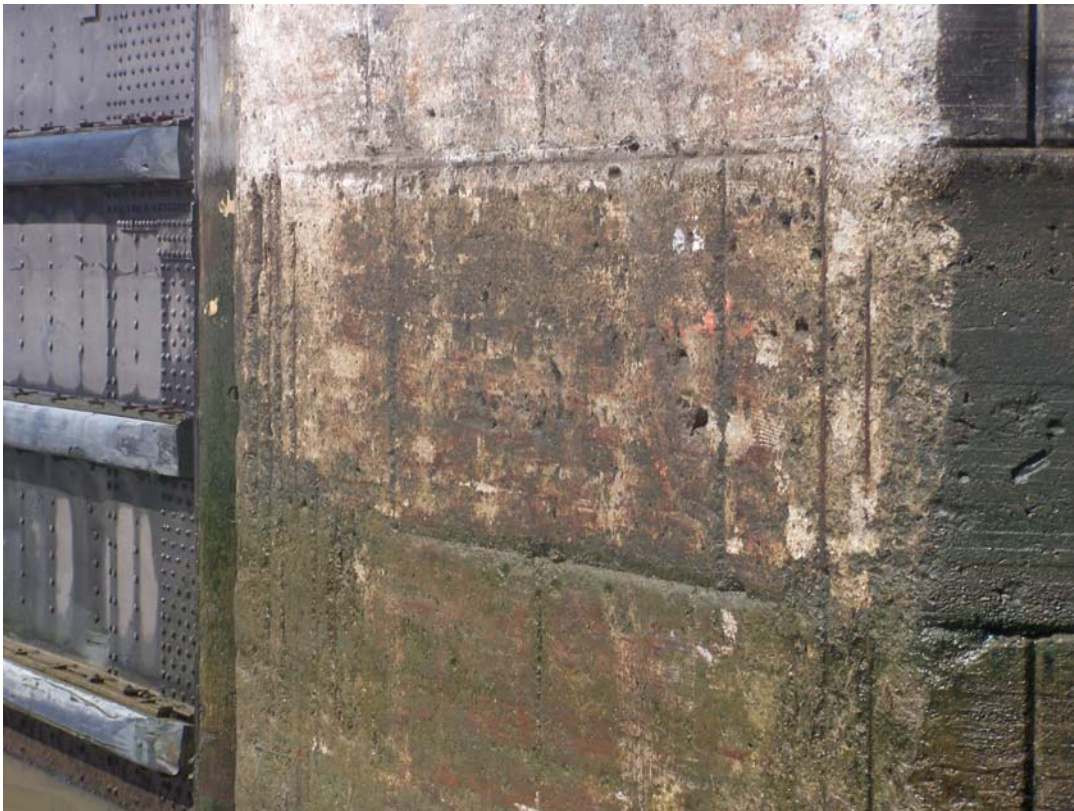
Photo 188 Northwest gatebay wall between the gates.
