MEMORANDUM FOR Chief, Regional and Environmental Planning Division-South
(CEMVN-REPD/Troy Constance)

SUBJECT: IHNC Lock Replacement General Re-evaluation Report, Engineering
Assessment of the Existing Lock Structure

Enclosure 1 – Pictures of Structural Deficiencies

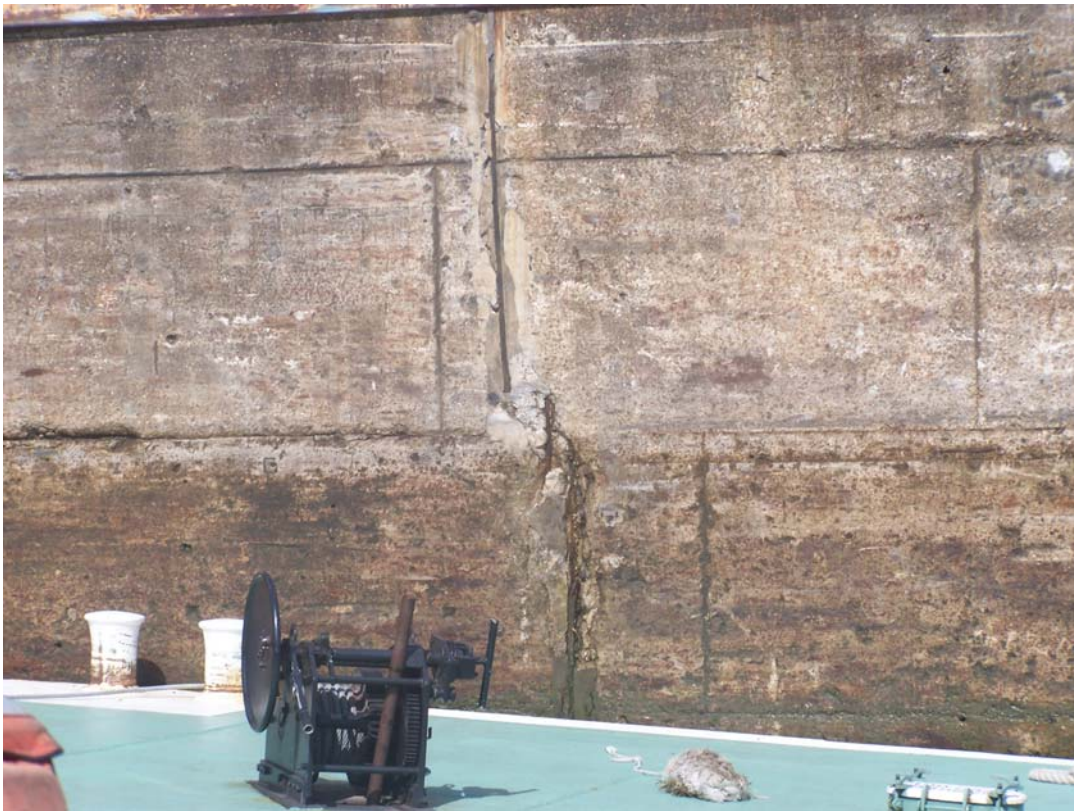
Photo 190 Spalls with exposed steel in the west chamber wall on river side.
