**Mississippi River, Baton Rouge to the Gulf of Mexico, LA  
Interagency Field Trip to Southwest Pass Beneficial Use Sites**

**CEMVN-OD-T  
June 2012 Trip Report**

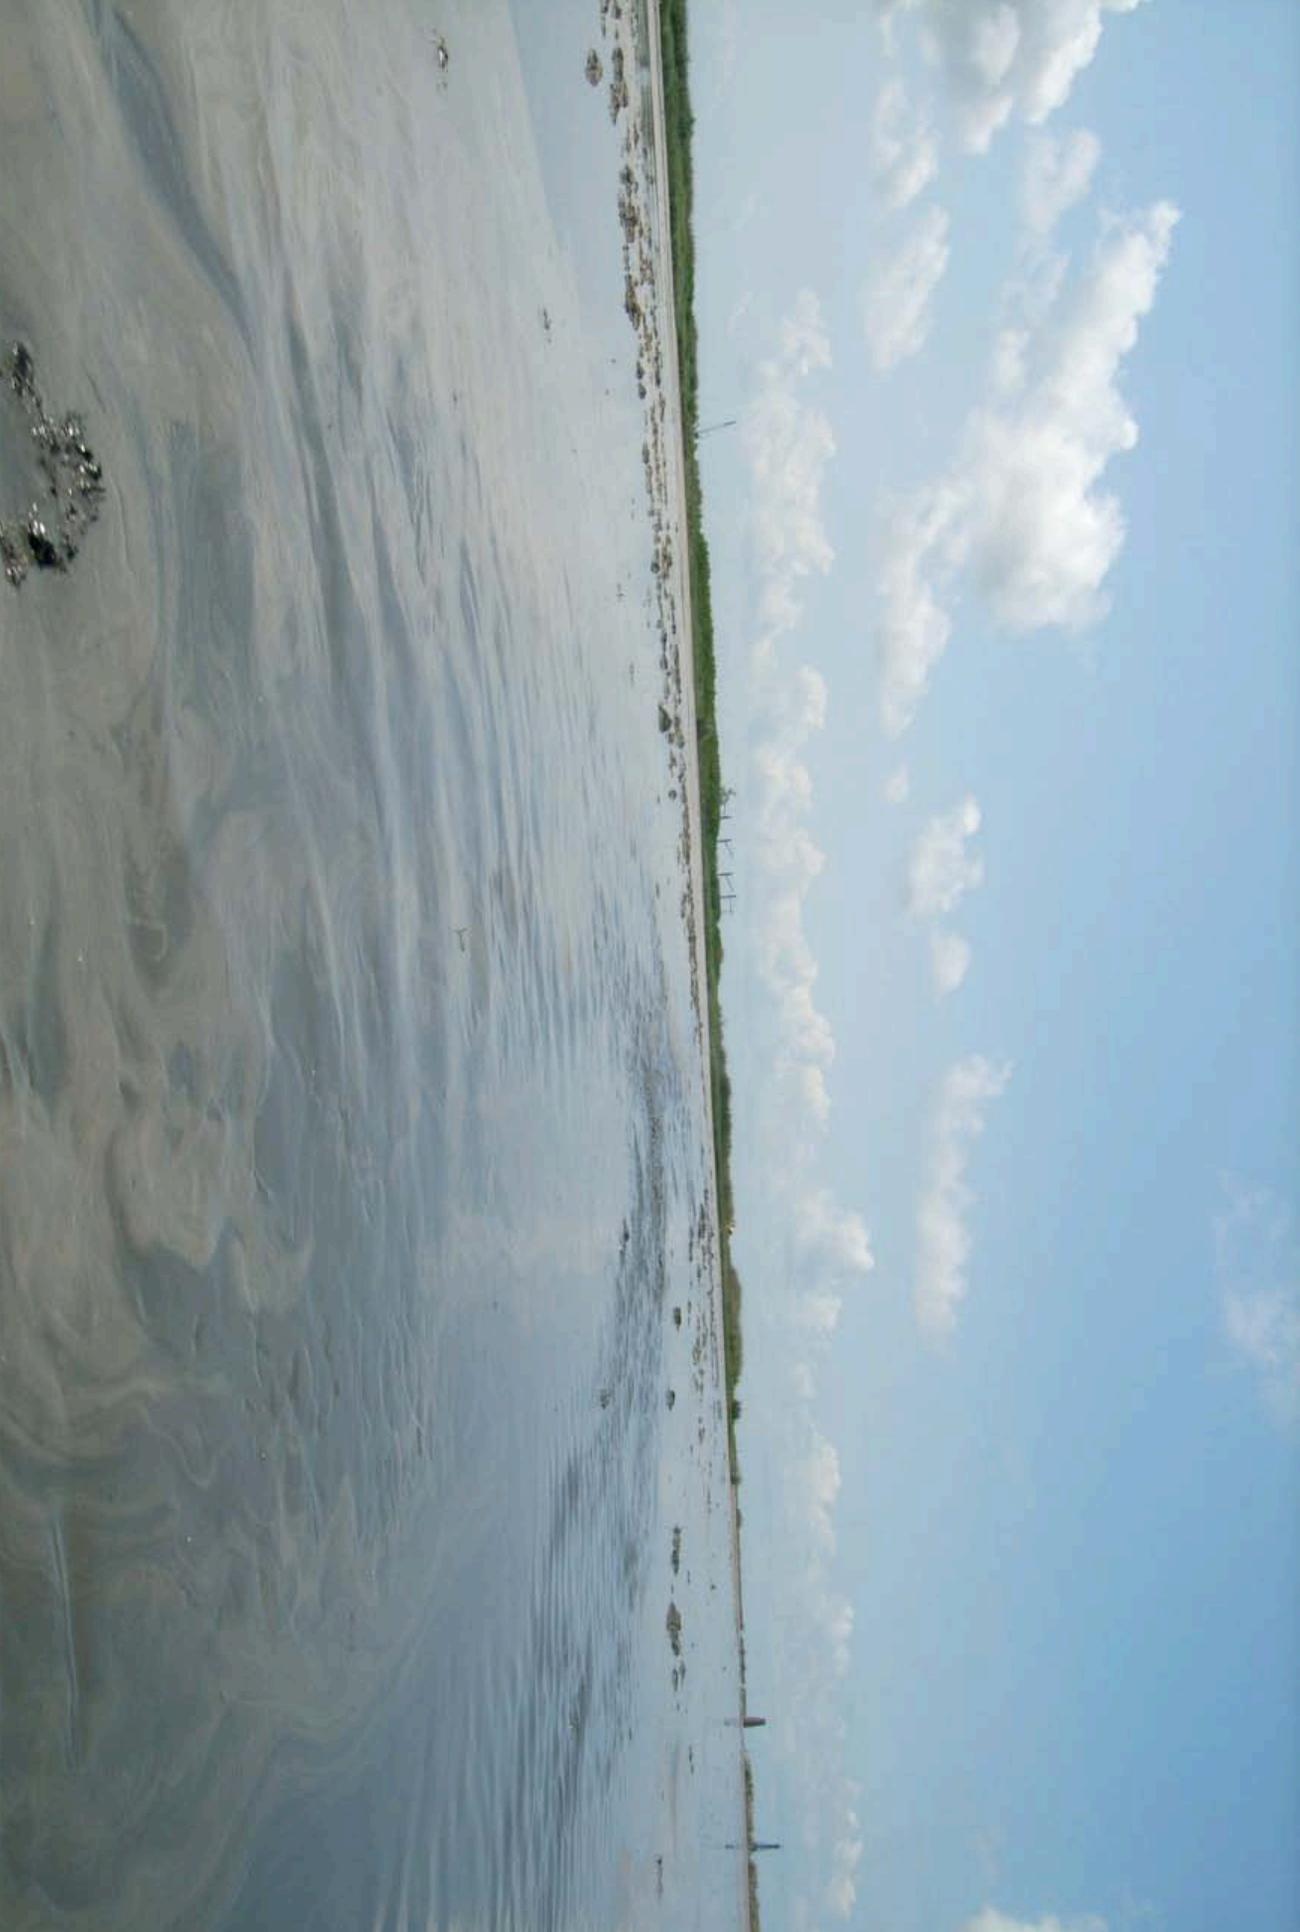
Picture 1. Upper boundary of Placement Area #1, looking towards the right-descending bank of Southwest Pass. The dredge CALIFORNIA was actively pumping into this beneficial use placement area, & flowing dredged material slurry generated the surface ripples visible in this photo.

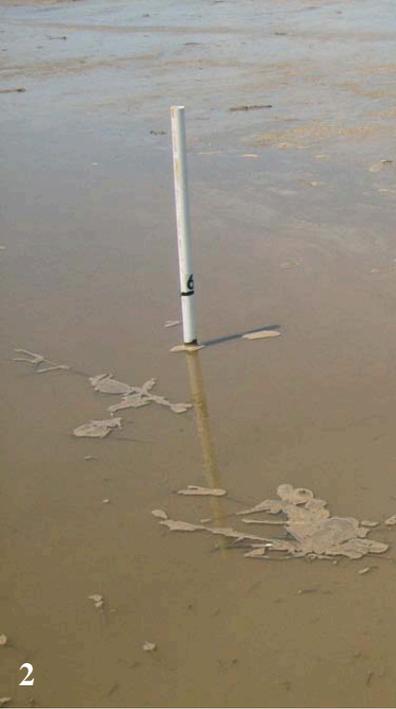
2

Pictures 2-3. Elevation marker denoting target slurry elevation of 5.5' (left). The CALAFORNIA was working near river mile 14 BHP (top). Other equipment was nearly obstructed by marsh grass within the placement area (below).

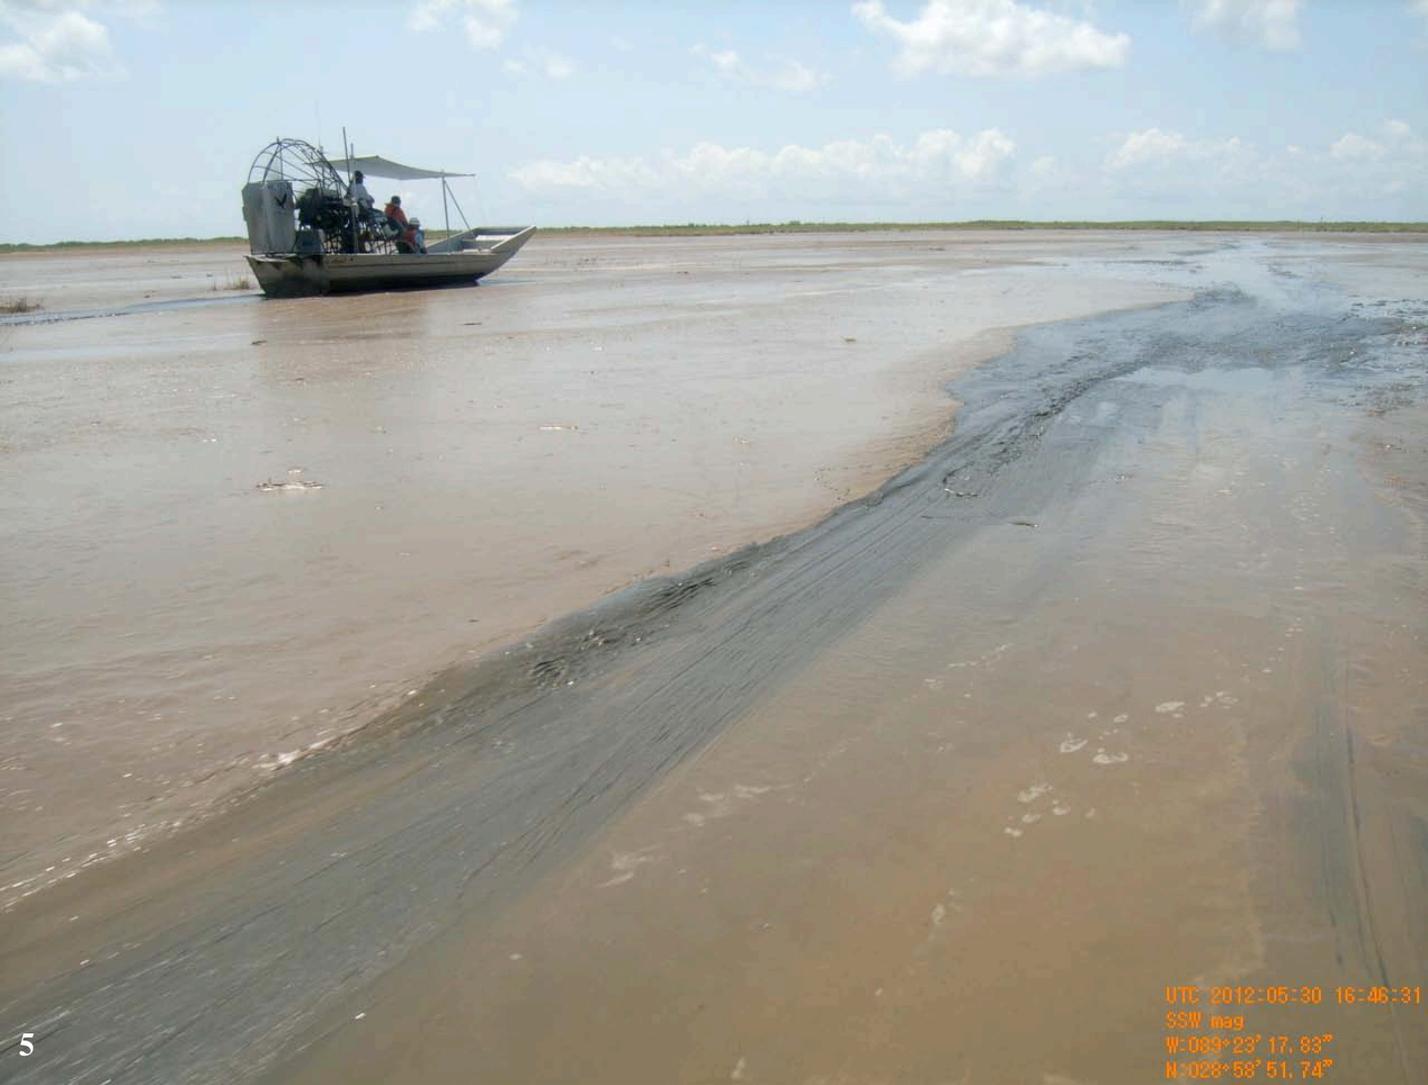
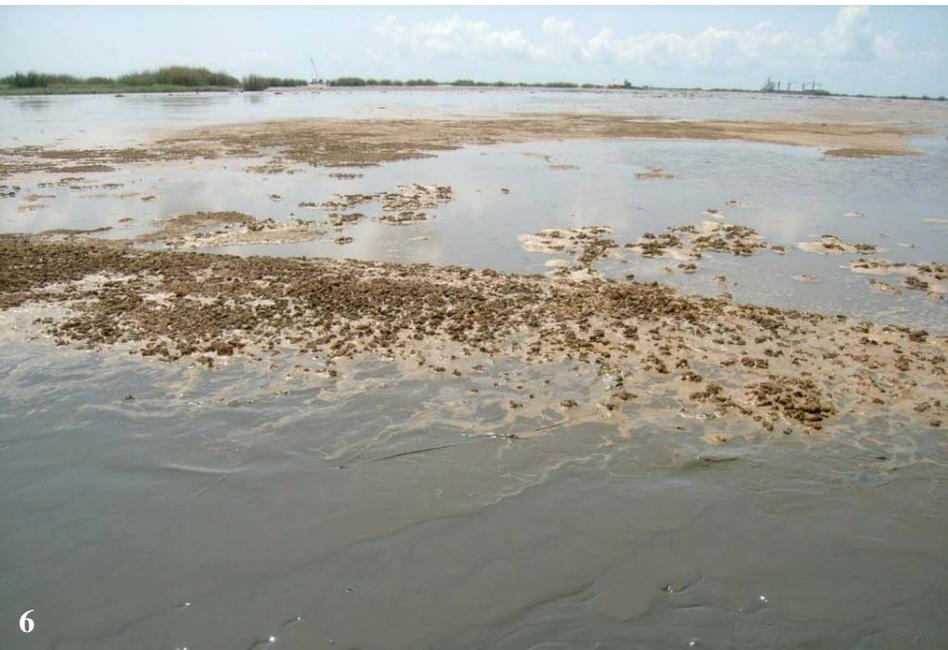
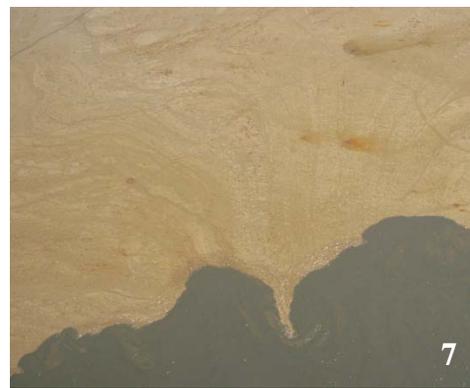
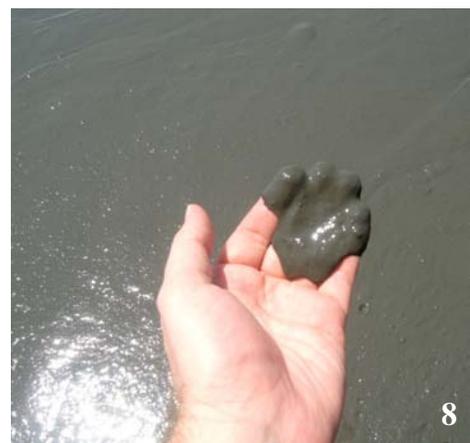
Pictures 5-8. Dredged material discharged into Placement Area #1 was predominantly fine-grained sediments mixed with organic material. Trail made by the leading airboat exposed its pudding-like consistency (above). Organic foam was scattered throughout the site (below).

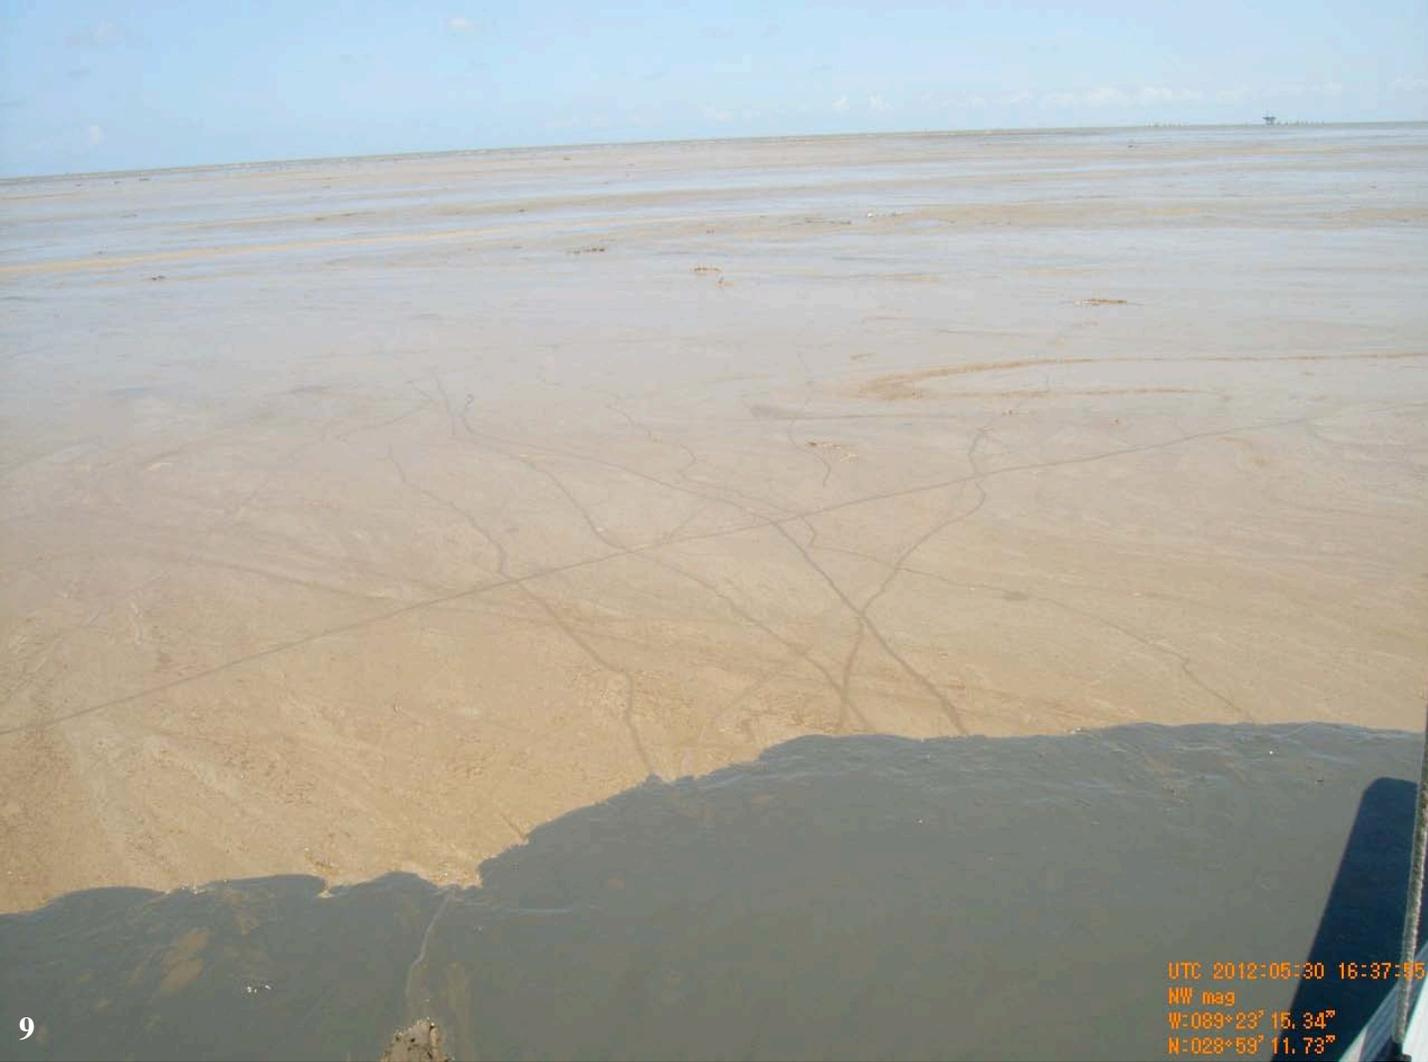
Pictures 9 & 10. Crab & bird tracks on the surface of partially dewatered dredged slurry.

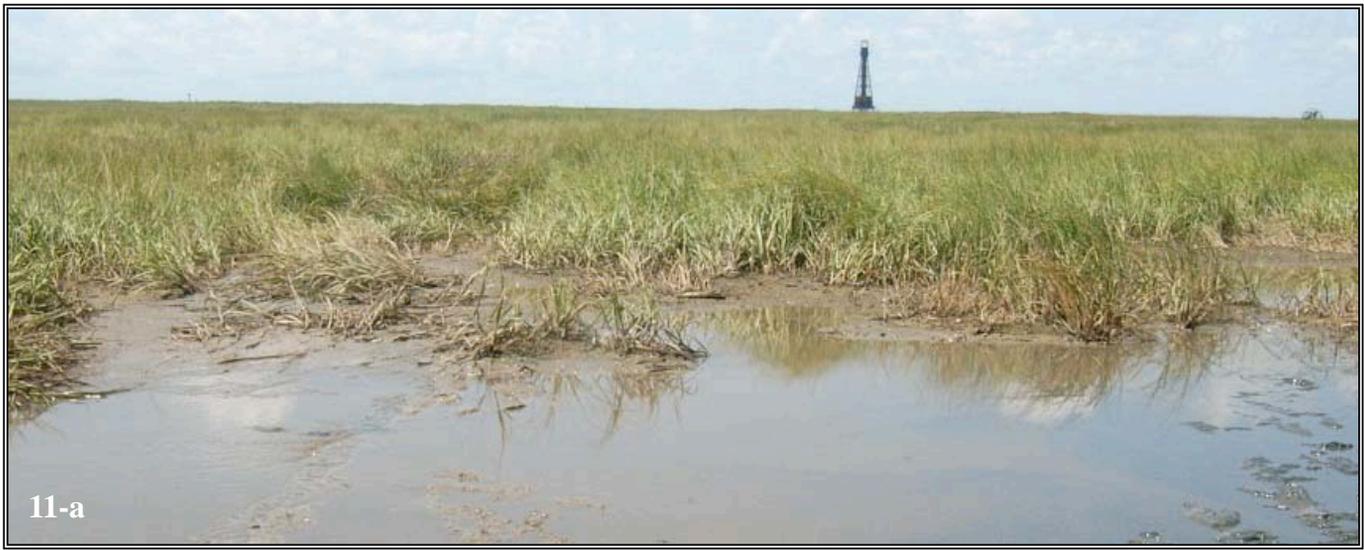
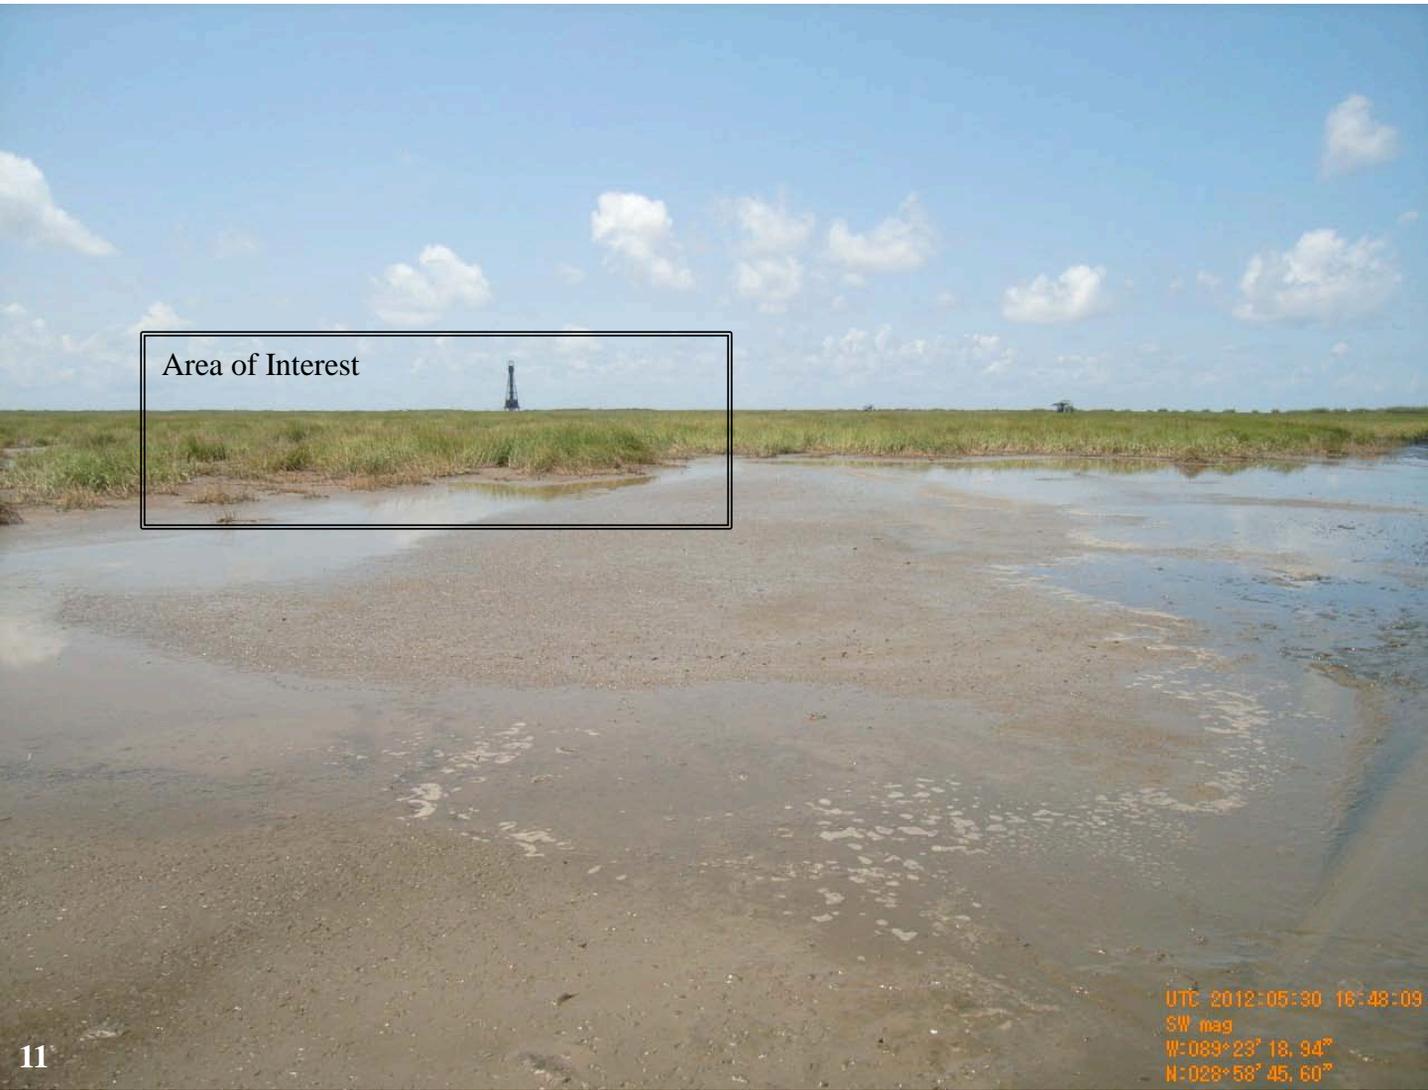
Picture 11 & Area of Interest 11-a. Dredged material was effectively semi-confined by marsh grass within Placement Area #1, without smothering the grass stands.

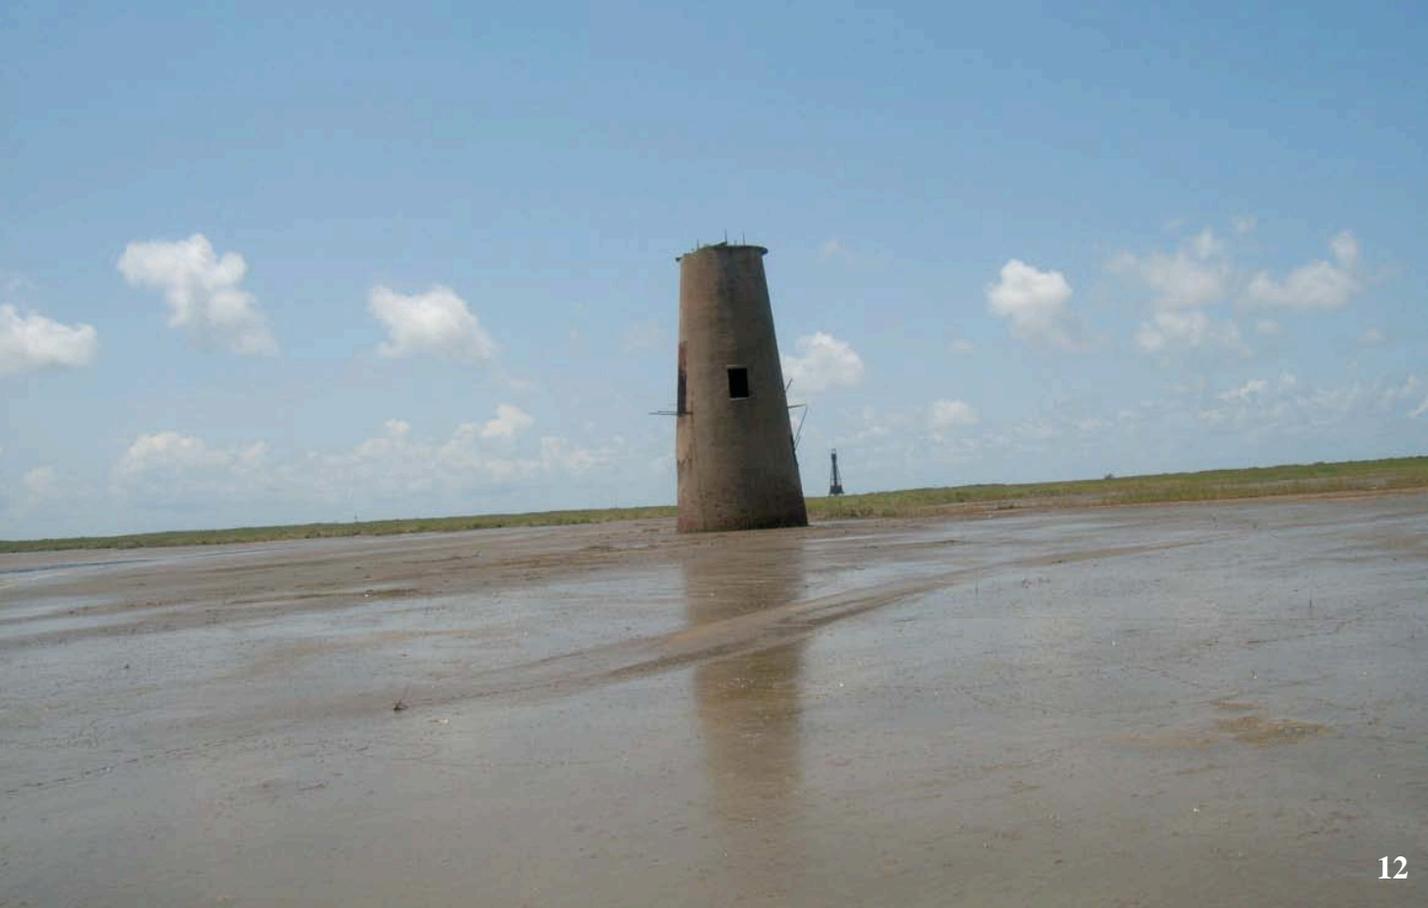
Picture 12 & BUMP Aerial Photography. A relic lighthouse about 1 mile west-northwest of the opening to Burrwood Bayou from Southwest Pass serves as a convenient waypoint for locating Placement Area #1.

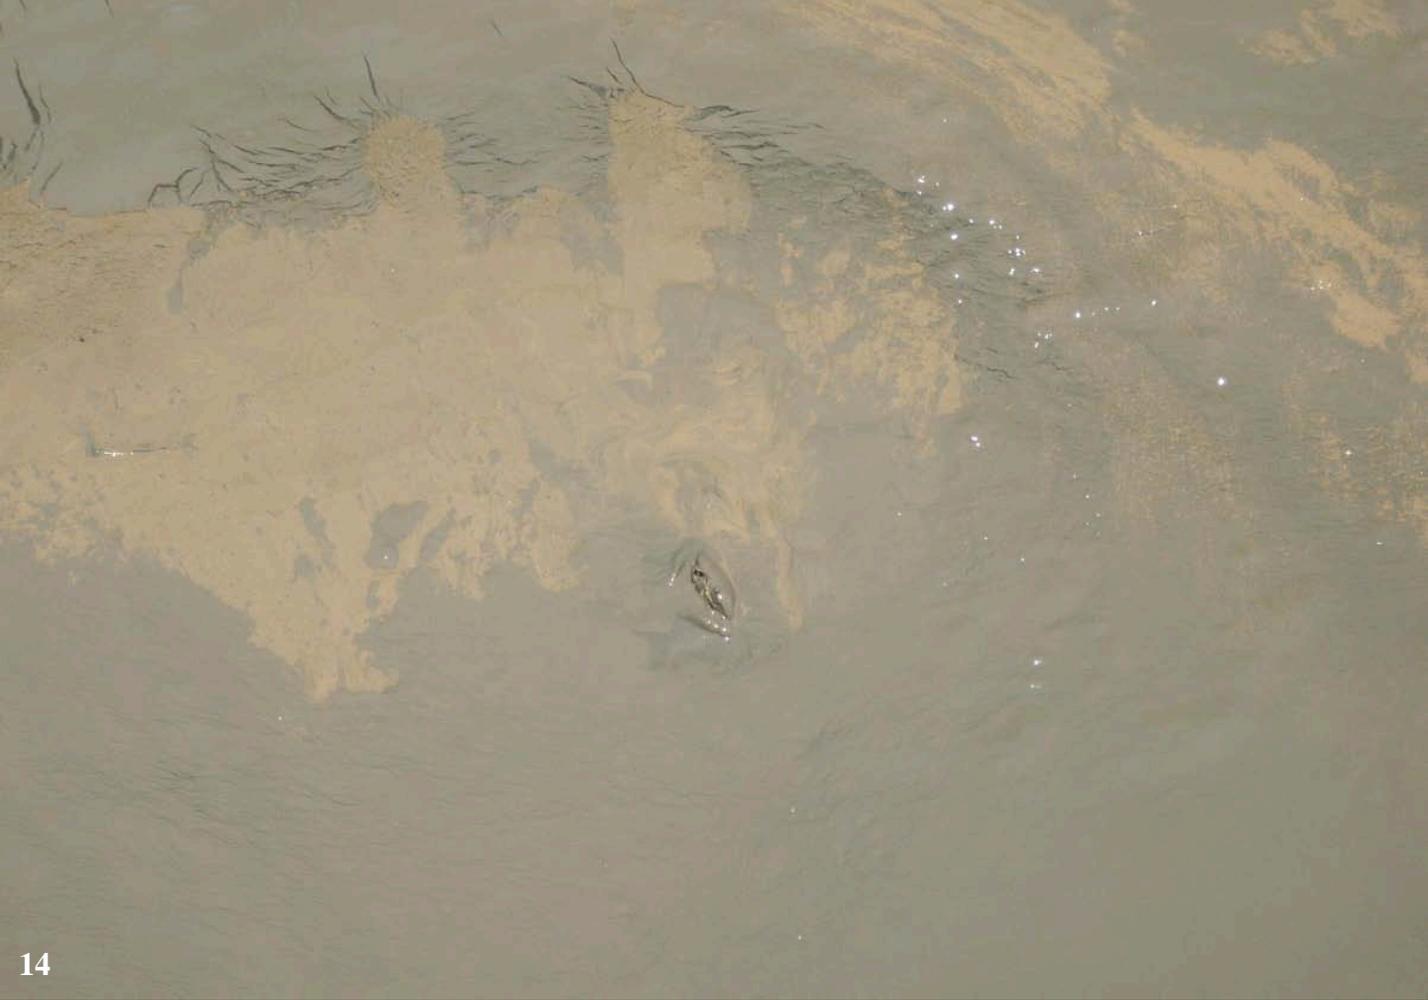
14

Pictures 14-16. Dredged material within the upper boundary of Placement Area #2 was predominantly fine-grained sediments mixed with organic material.

A blue crab hiding in the muck (top). Fiddler crabs were abundant along the perimeter marsh (right).

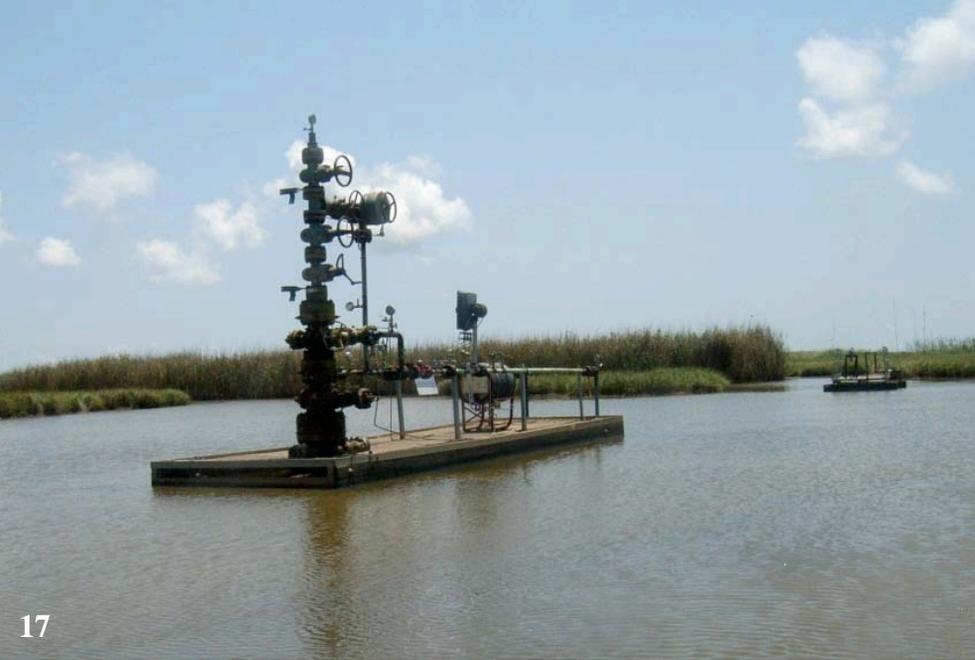
Pictures 17 & 18. Natural gas platform adjacent to the upper boundary of Placement Area #2 (left).

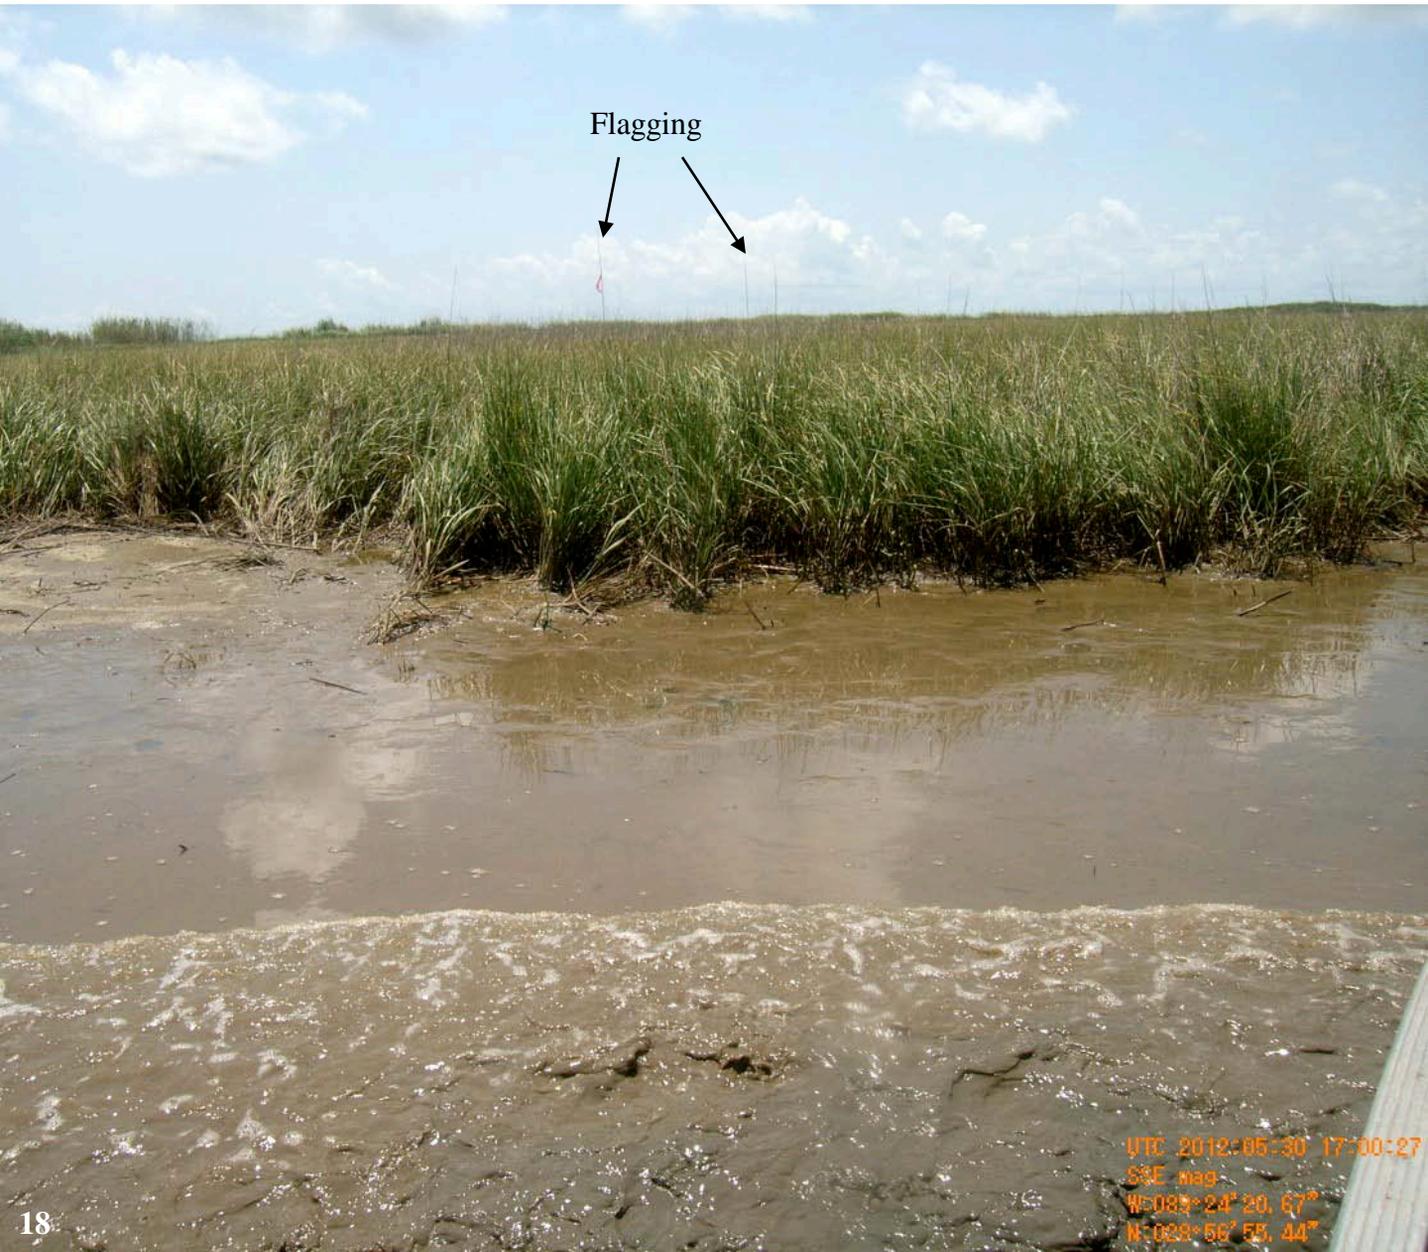
18

Survey flags within the disposal area, possibly marking one of the many pipelines crisscrossing thru the marsh alongside Southwest Pass (below).
