## NON CONCURRENCE STATEMENT

- Tiger Team members have diligently worked for many months to complete their mission of investigating, evaluating, then reporting their activities regarding construction of the WBV-14c.2 levee in Jefferson Parish, Louisiana
- In an effort to complete and otherwise finalize, then publish the report of its mission the Tiger Team members have been in almost continuous conference for several weeks
- Unfortunately, several serious differences in the opinion and findings of the members remain and now appear irreconcilable
- Following deep and honest discussion of these differences the Tiger Team has concluded our best course of action is to allow the report to be issued but, containing statements of non-concurrence in those chapters of the report remaining unresolved

## **Tiger Team Update for SLFPA-W Technical, Operations and Maintenance (TOM) Committee:**

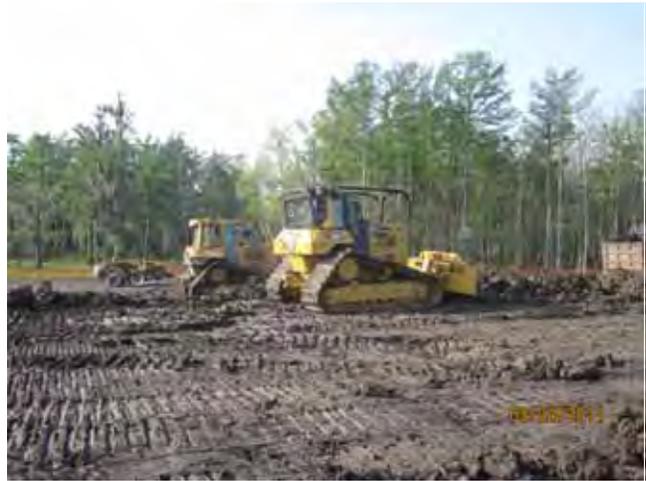
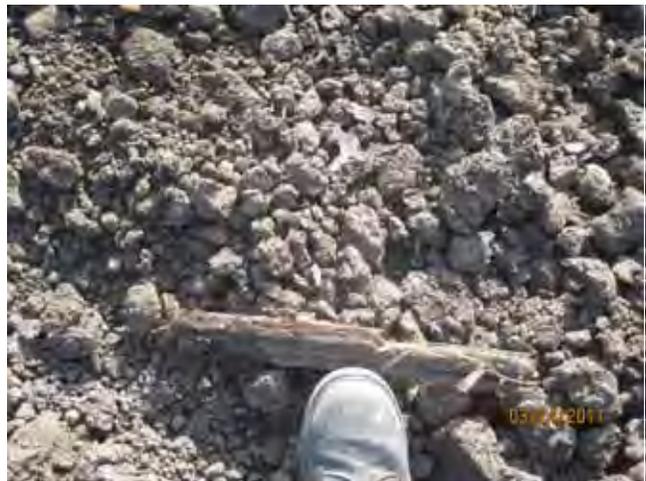
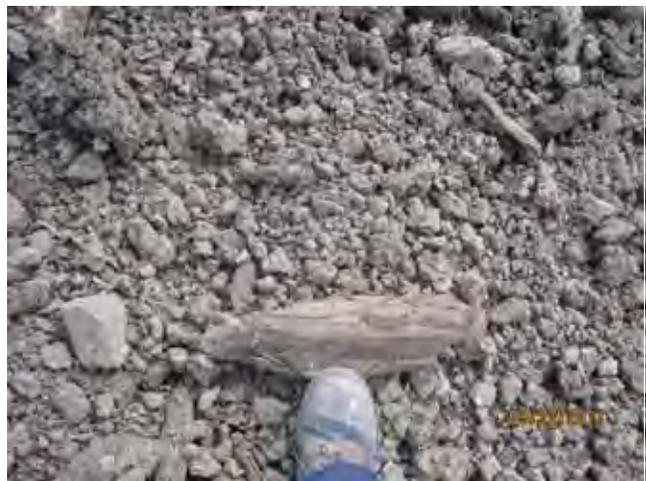
- 
3. An abundant amount of small wood chips (within spec size) are being found in the levee section from Sta.55+00 to Sta.25+00. SLFPAW representatives are concerned that the amount of wood chips in this area would be beyond the 1% of organics allowed in the material, but would like USACE Geotech to determine this. SLFPAW representatives met with Wade Wright (USACE) at the WBV-14e.2 site visit later that day. He informed SLFPAW that he will be making a visit to the WBV-14c.2 jobsite today (3/24/2011), and also to the River Birch pit to investigate the debris problem. GPS Coord: N29 53" 20.82" W090 09' 14.90"

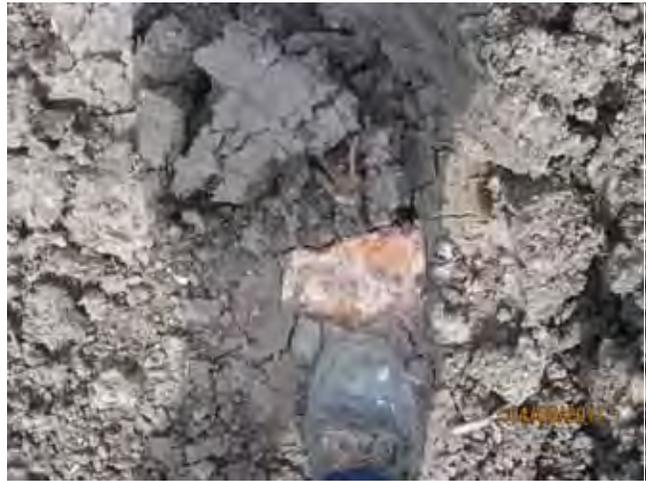
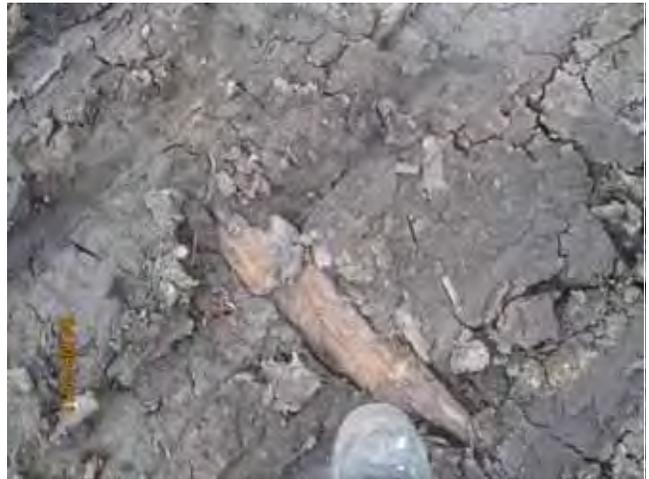
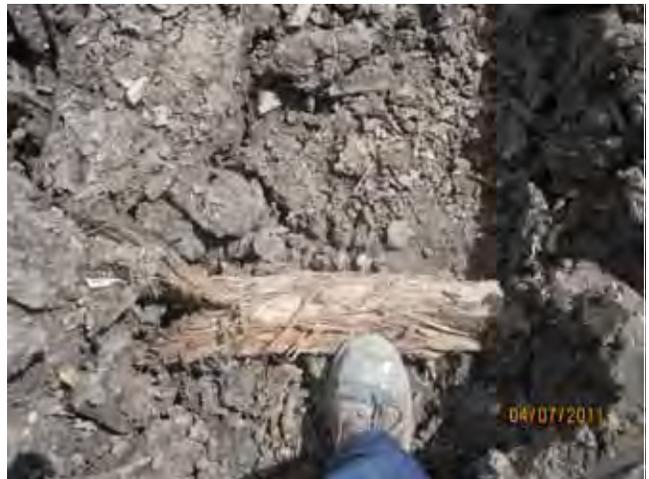
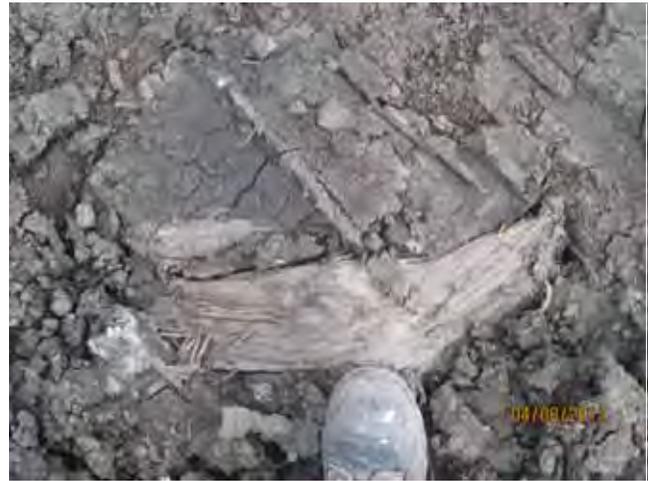
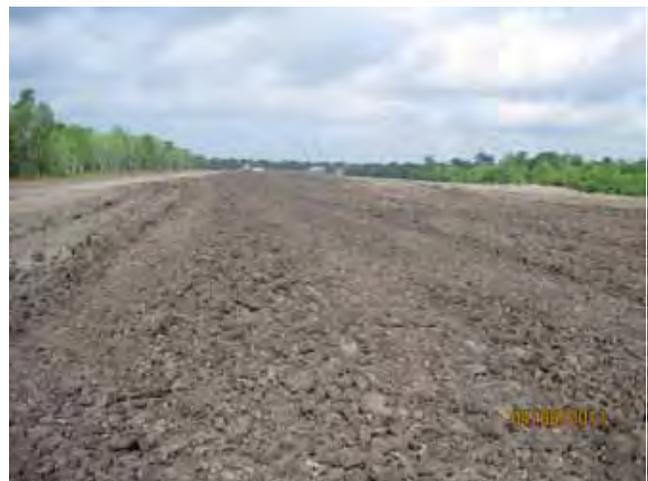
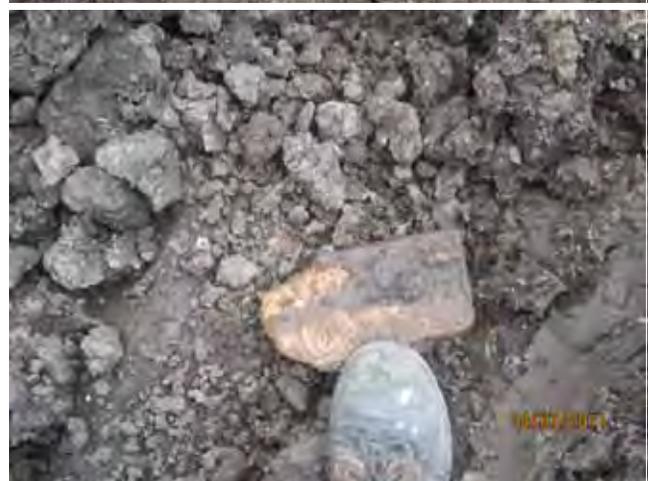
- No active work is currently going on between Sta.65+00 to Sta.107+00, but some debris was found on the floodside of the levee and noted. This area is at elev.+13.0'.

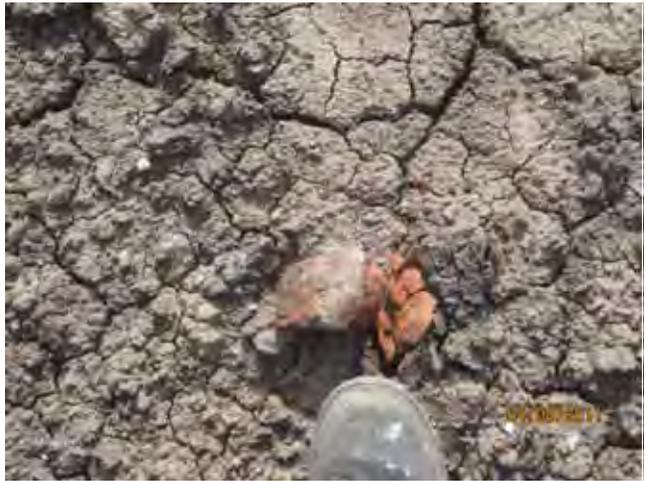
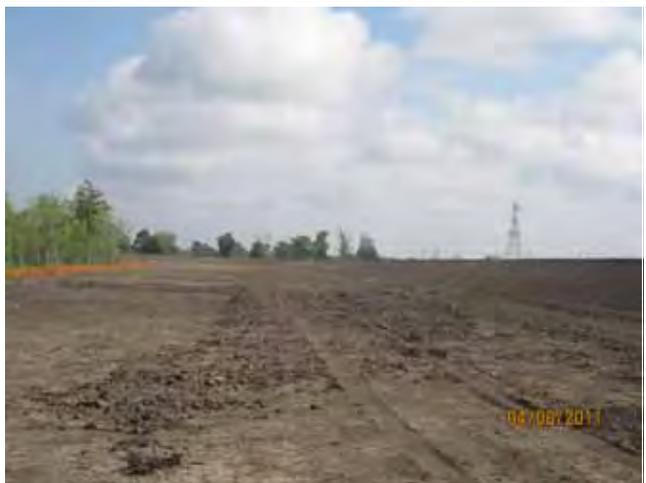
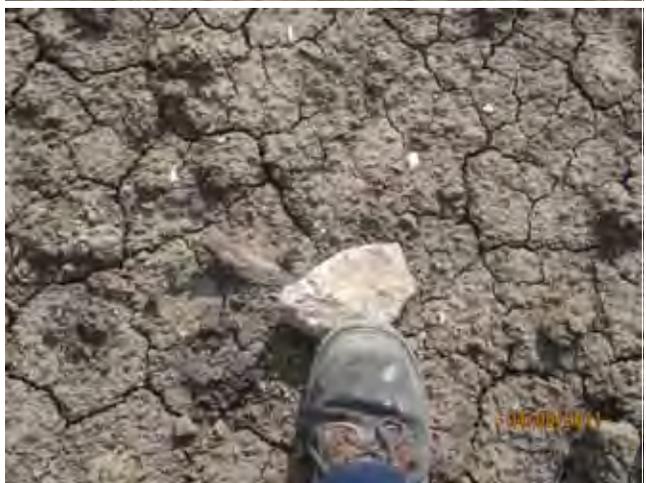
- 
3. Sta.65+00 to 107+00 (floodside).  
- No active work was going on during time of site visit but some debris was found and noted.  
- Area is currently at elev.+13.0'. GPS Coord: N29 53' 13.19" W090 08' 41.57"

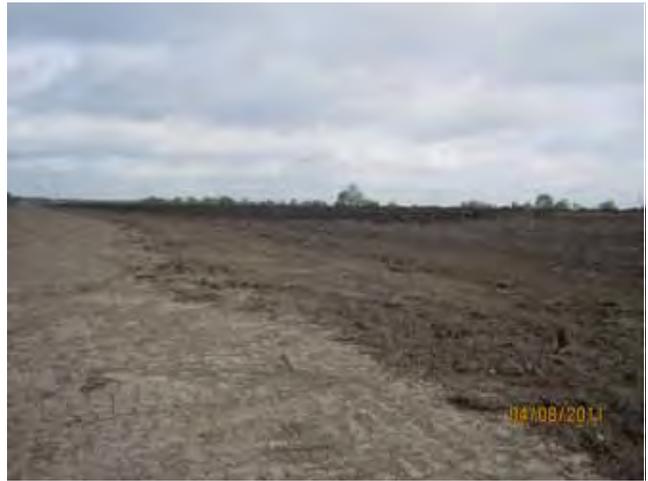
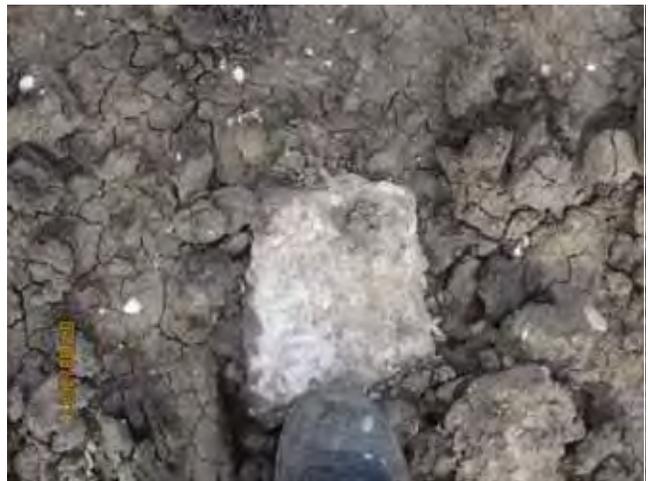
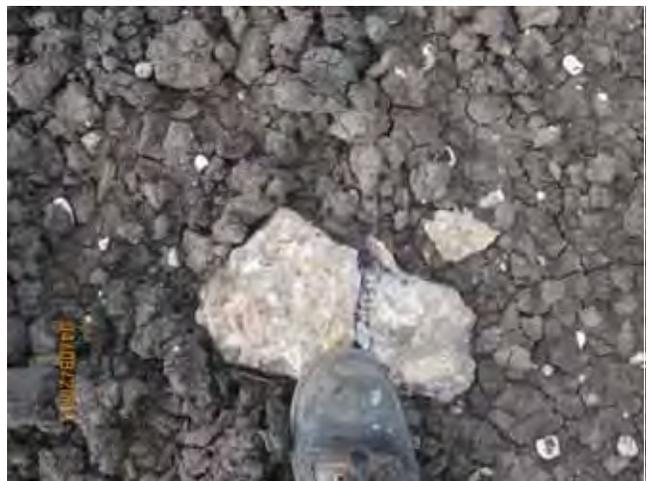
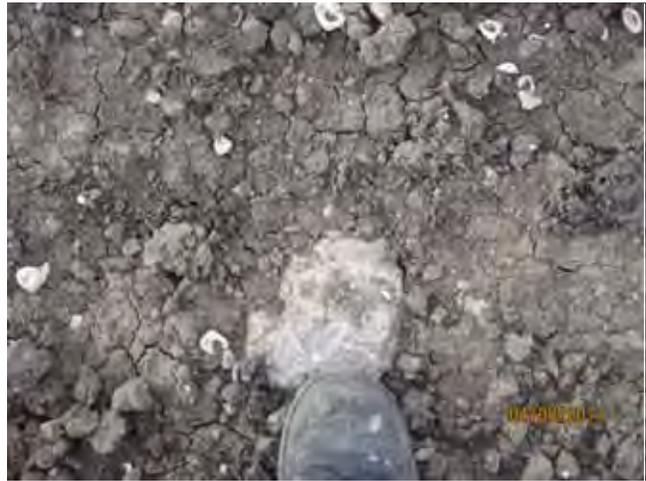
4. Sta.124+00 to Sta.175+00.

- Area where material is being placed is currently at elev.+10.0'. GPS Coord: N29 52' 34.73" W090 08' 17.09"

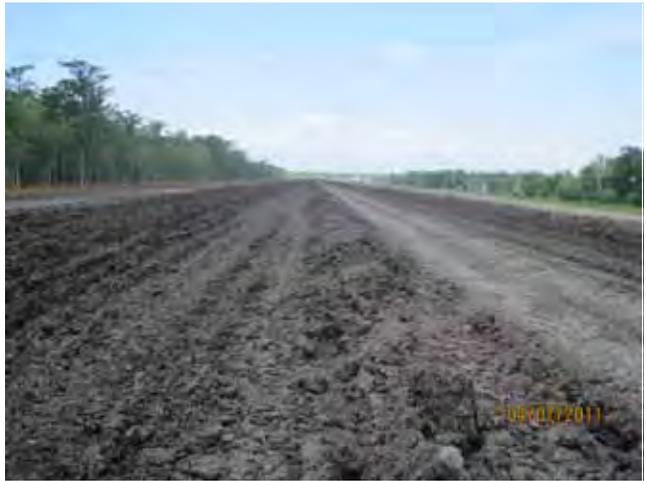
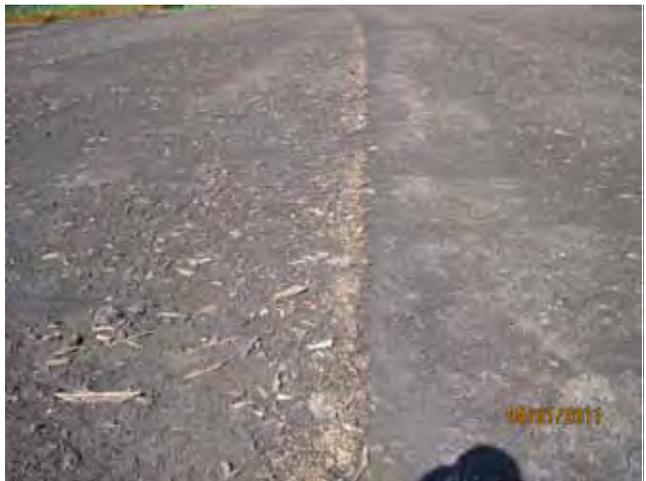
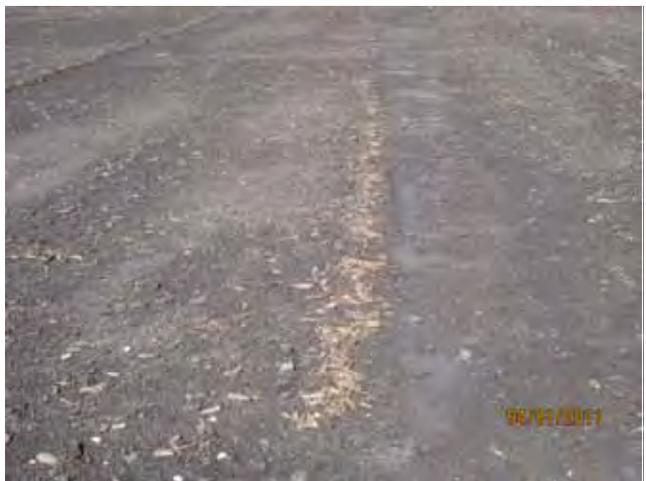
5. An abundant amount of small wood chips (within spec size) is being found in the levee section from Sta.0+44 to Sta.55+00. USACE stopped hauling of material from Sta.0+44 to Sta.55+00 to investigate problem with wood chips and smaller debris. Levee lifts were being placed on top of these wood chips. GPS Coord: N29 53" 20.82" W090 09' 14.90"

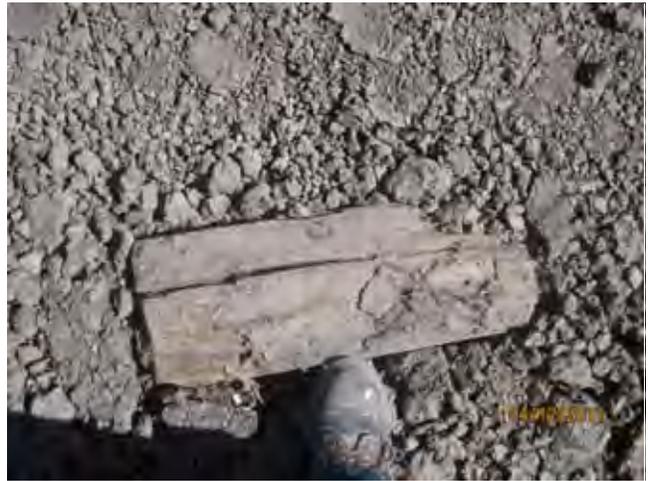
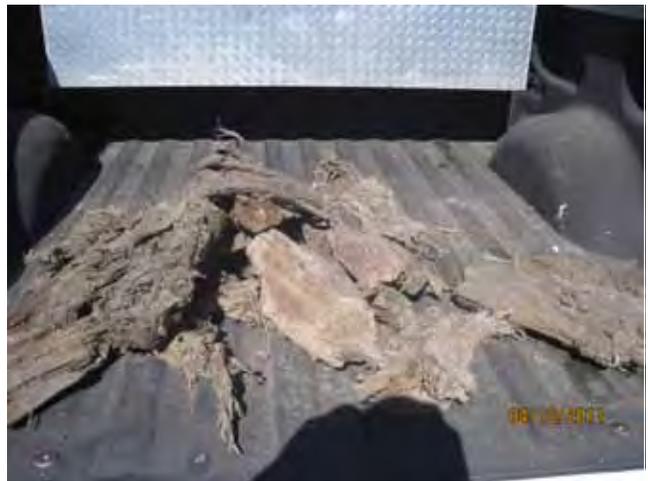
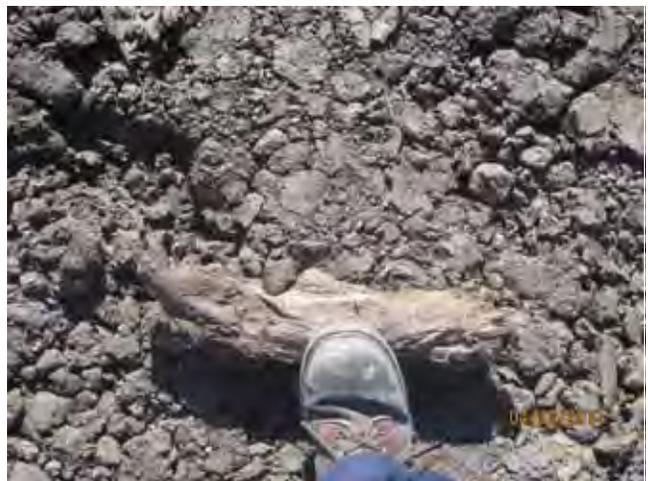
- A considerable amount of large debris, stones, and smaller wood chips was found in the levee section in this area (not berms). Contractor informed SLFPAW reps that the area had been sealed due to expecting rains earlier in the week. This area needs to be picked before more material is placed. GPS Coord: N29 52' 34.73" W090 08' 17.09"

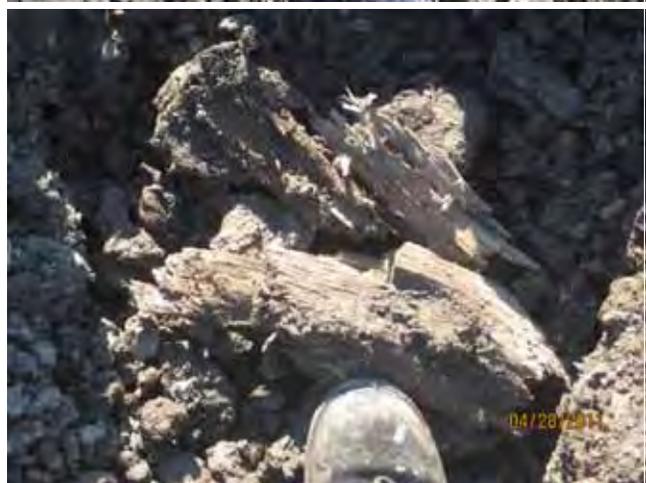
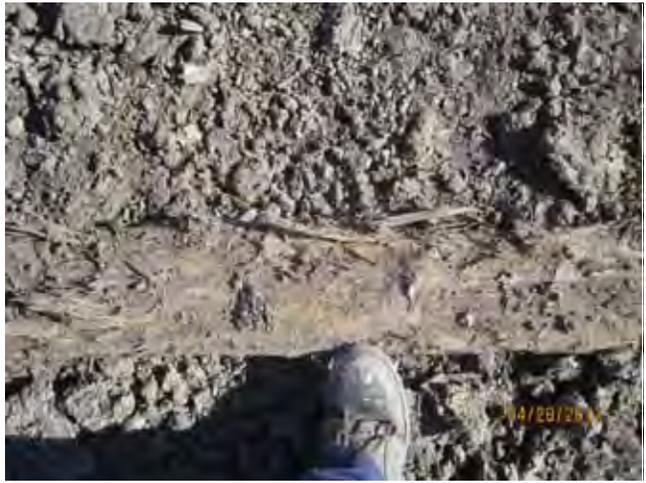
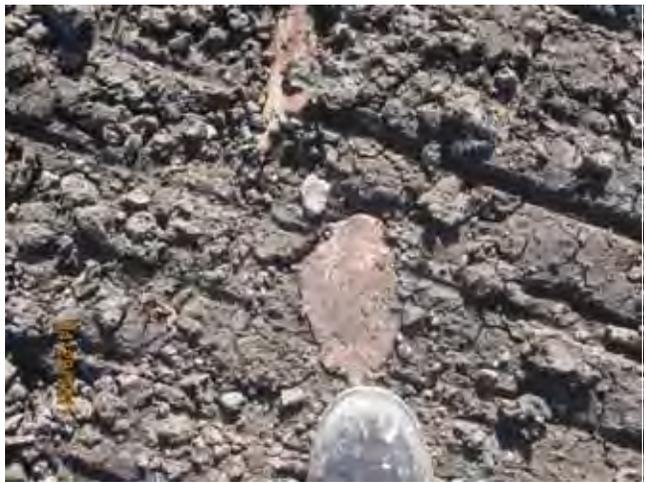
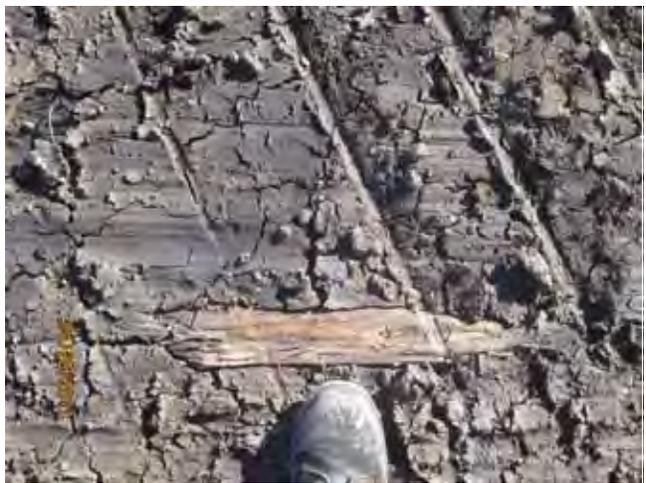
2. Sta.0+44 to Sta.55+00.

- Material has been hauled in to this area earlier in the week. A considerable amount of large debris, stones, and smaller wood chips was found in this area. Pickers were at approx Sta.45+00 during site visit. GPS Coord: N29 53" 20.82" W090 09' 14.90"

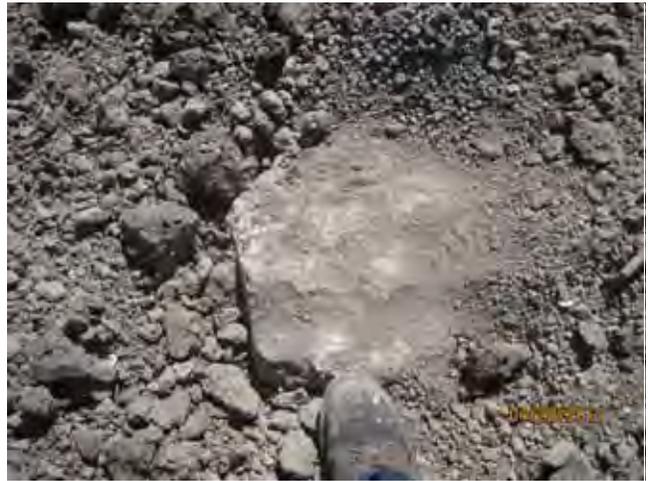
6. On the east end of the job (Sta.119+00 to Sta.182+00) debris is being found within the levee section and on the protected side berm. GPS Coord: N29 52' 34.73" W090 08' 17.09"

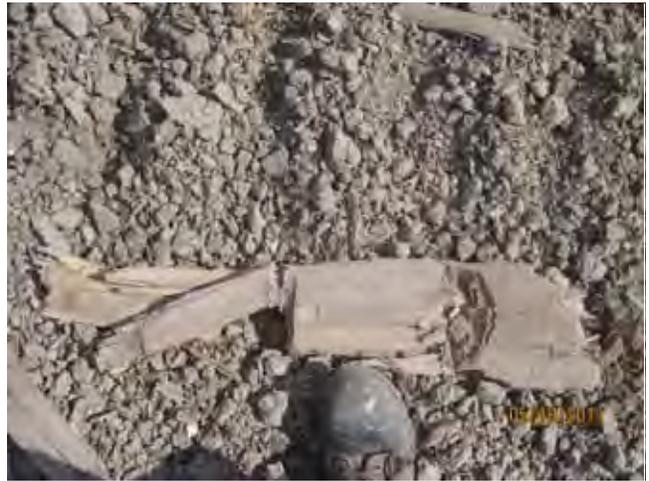
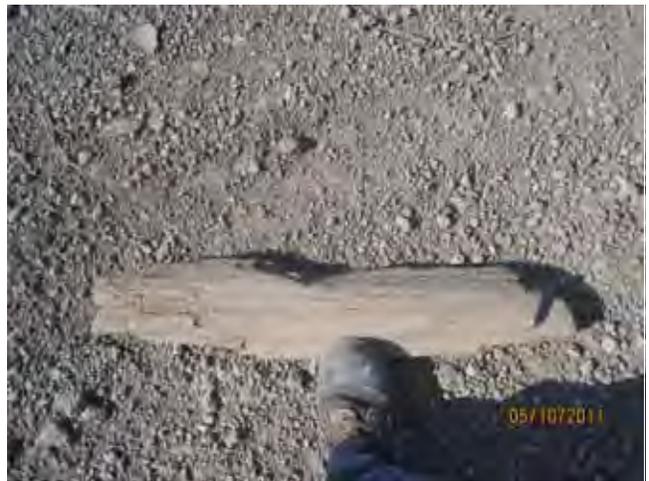
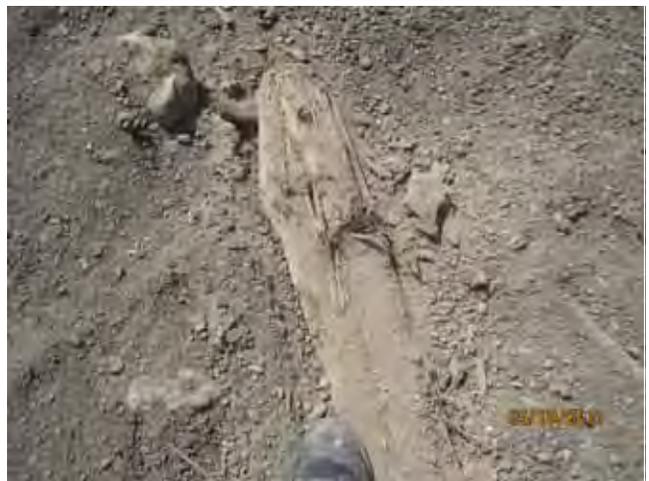
- 
4. East end of the job (Sta.119+00 to Sta.182+00). No active work was being performed on this end of the job, but some unsuitables were found on the protected side berm. GPS Coord: N29 52' 34.73" W090 08' 17.09"

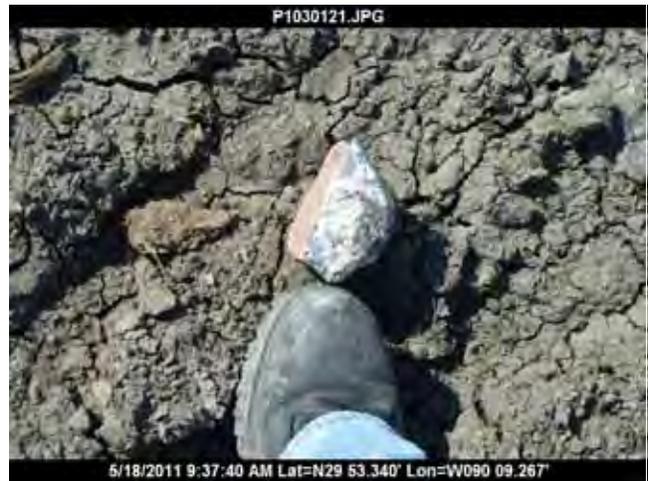
6. Issue:  
 West end of project (Sta.0+44 to Sta.55+00):  
 SLFPA-W reviewed top of new levee ahead of placement operation and noted some debris. GPS Coord: Noted on photos

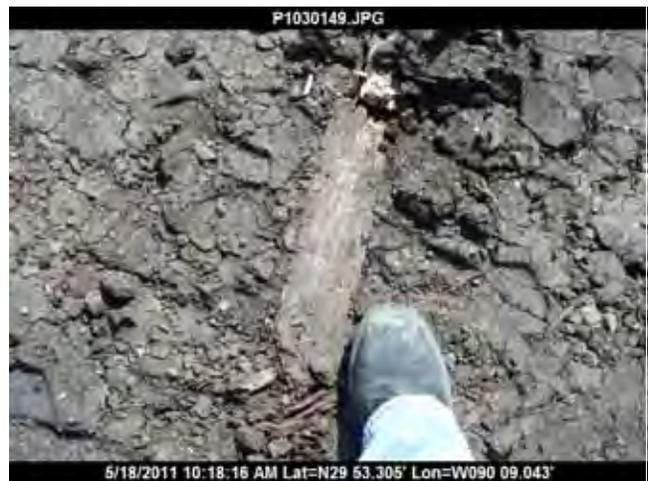
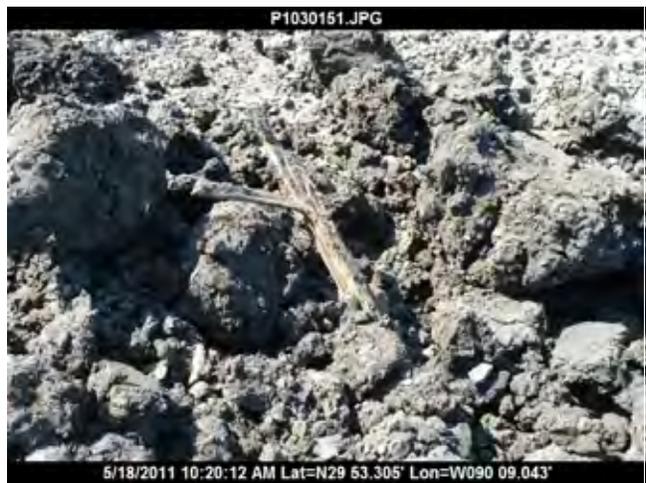
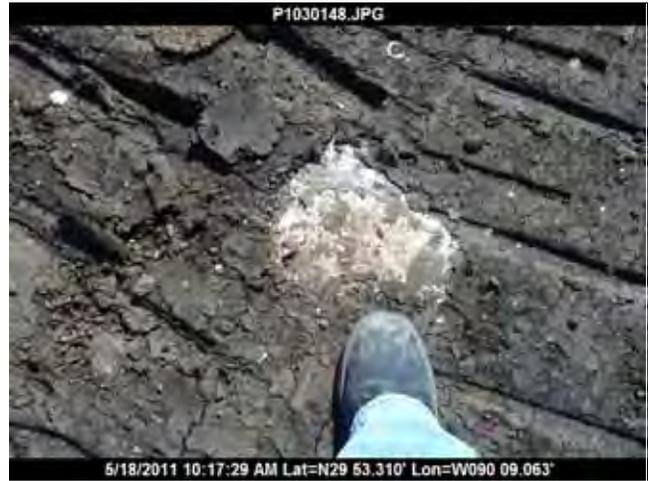
7. Issue:

West end of project (Sta.0+44 to Sta.55+00):

Material from degraded levee contains concrete, bricks and wood debris. Material is to be disked and debris removed before next lift (see previous issue). GPS Coord:

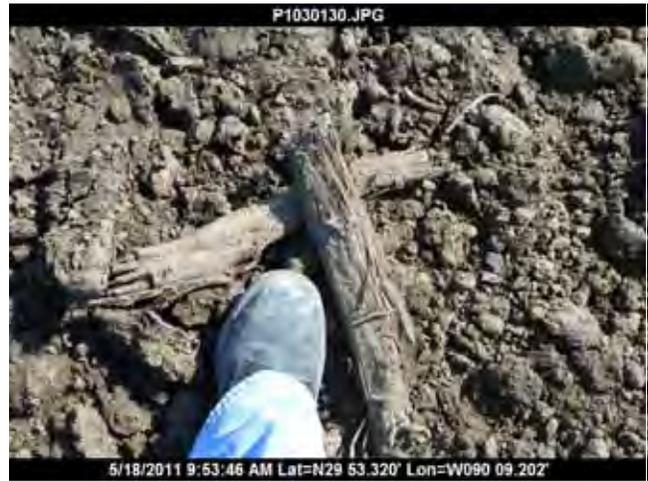
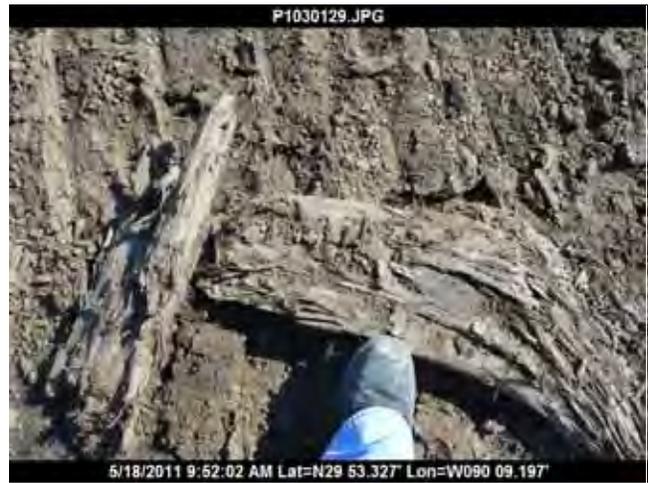
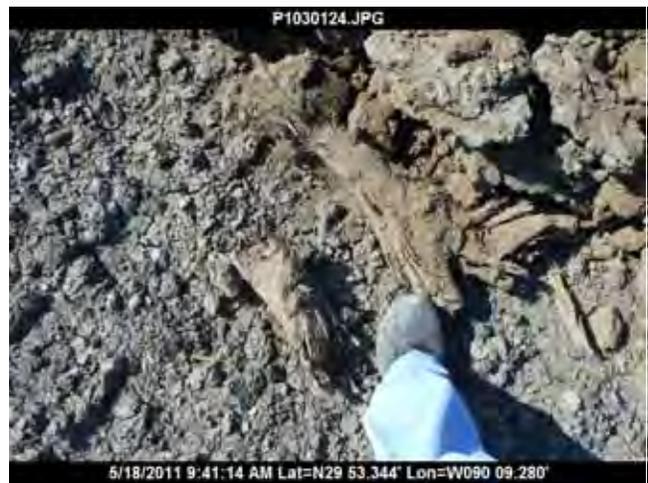
8. Issue:

Approximately a 1' lift has been placed on the flood side berm between approximate stations 0+44 and 10+00. Material appears not to have been disked, cleaned of debris or graded to final grade; contains debris. GPS Coord: Noted on photos

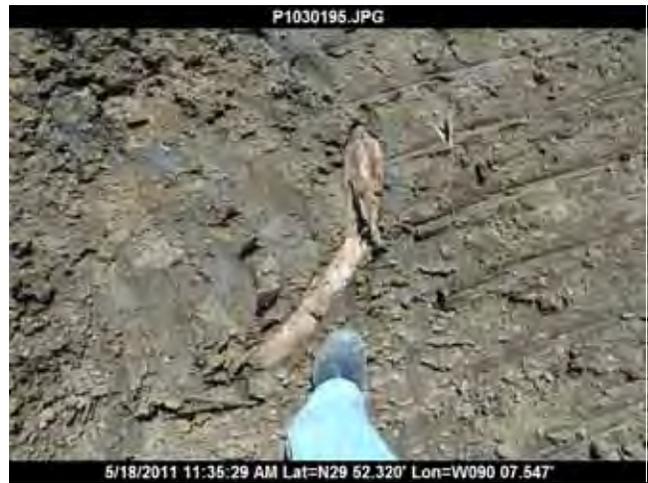
East end of the project (Sta.119+00 to Sta.182+00):

Contractor placing material along the protected side berm. SLFPA-W reviewed several areas and noted that the debris found was large in size but not as abundant as previous material. USACE inspector stated that debris will be removed during diking operation before final grading. GPS Coord: Noted on photos

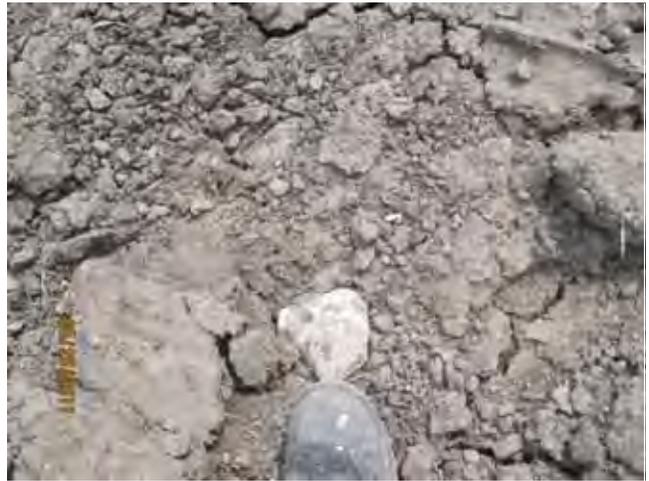
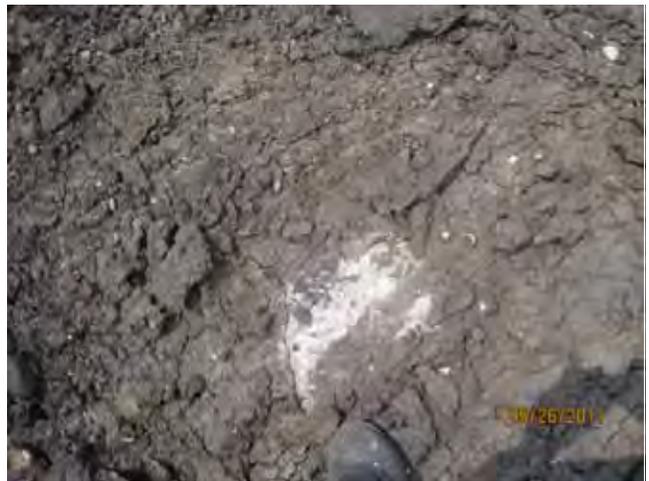
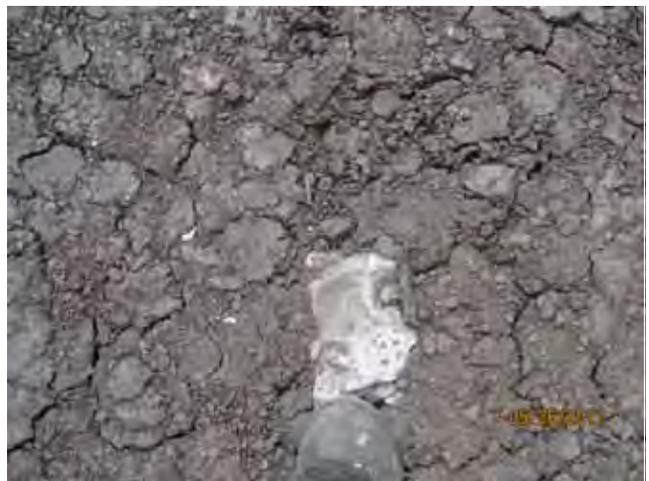
The new levee is up to elevation 11.0' in this area and the degrading of the existing levee is complete. Material from degraded levee contains concrete, bricks, and wood debris. Material needs to be disked and picked before another lift is placed in this area. GPS Coord: N29 53.306' W090 09.053'

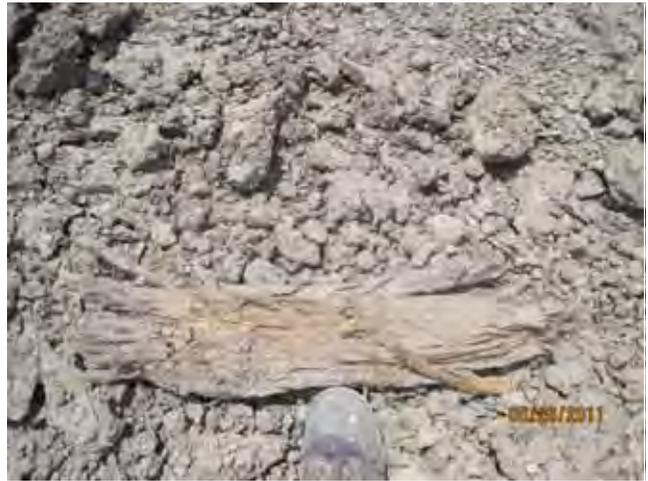
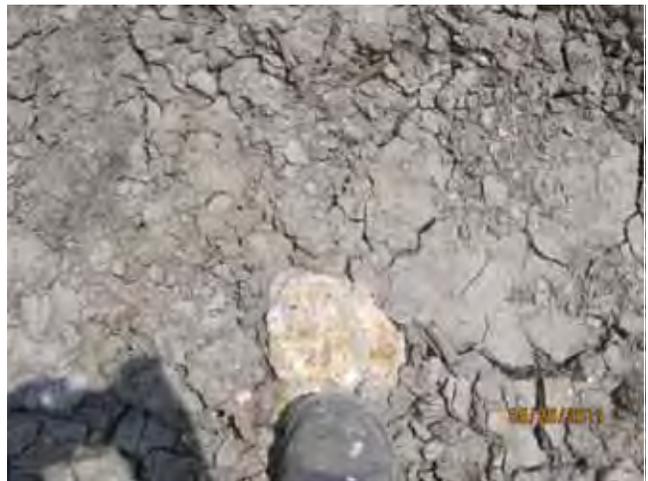
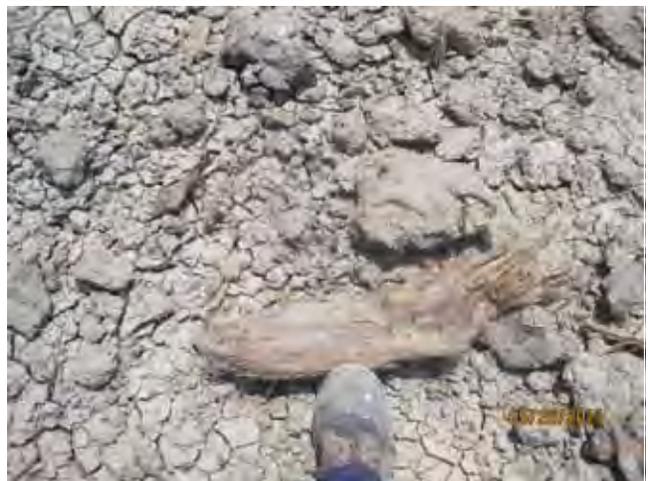
- 
5. East end of the project (Sta.119+00 to Sta.182+00):  
Contractor is placing material along the protected side berm at approx Sta.170+00.  
Throughout the levee and berm of this area concrete and wood debris was found.  
GPS Coord: N29 53.320' W090 09.202'

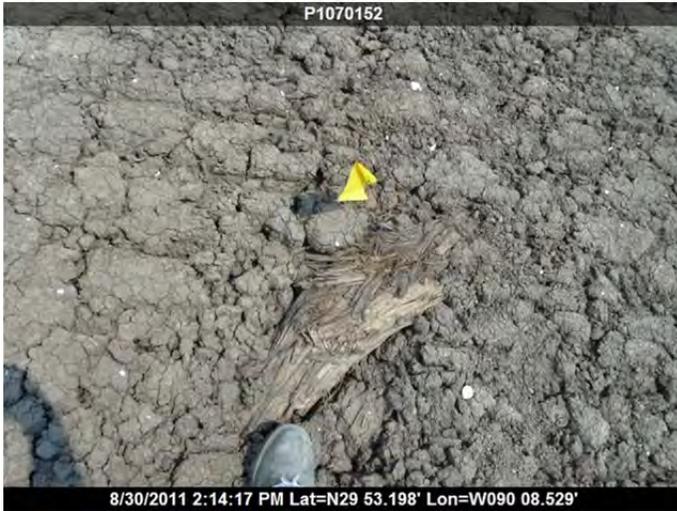
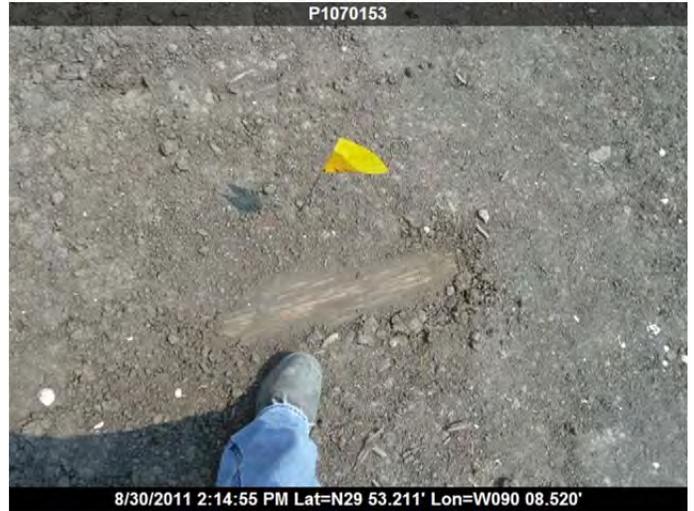
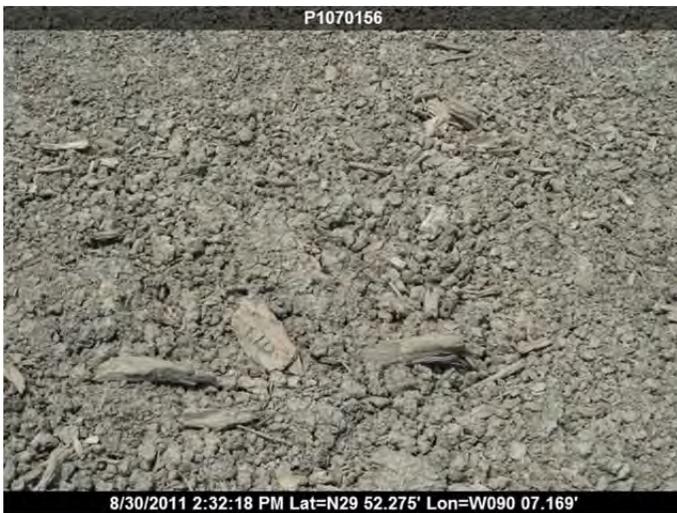
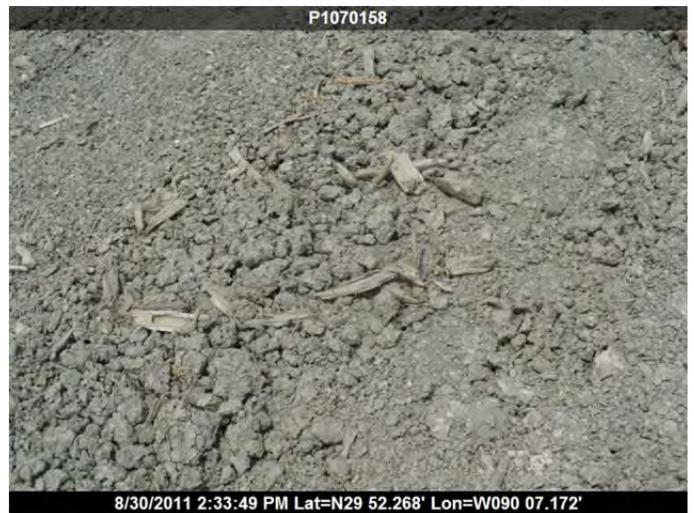
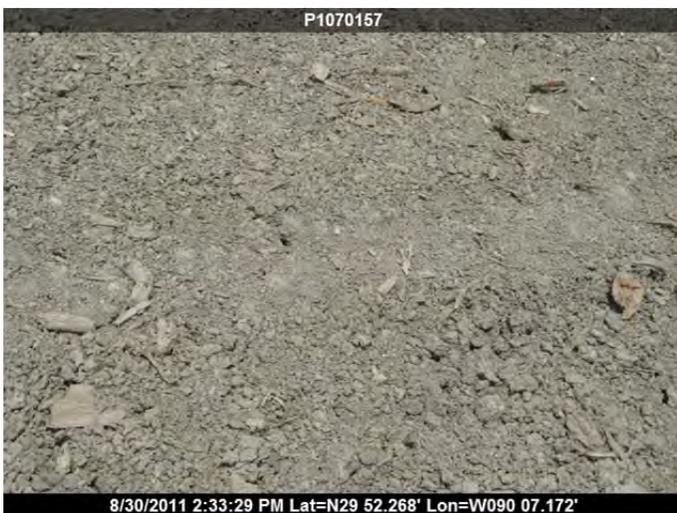
SLFPA-W noted the USACE QAR and CPRA flagging debris during site visit. Debris was noted along the west end levee section (crown).

Debris noted along the east end levee section was a lot of small pieces of wood in the approximate last 1,000 ft.
