South Central Coast Louisiana

Appendix L – Wet Floodproofing Methodology Refinement

May 2022

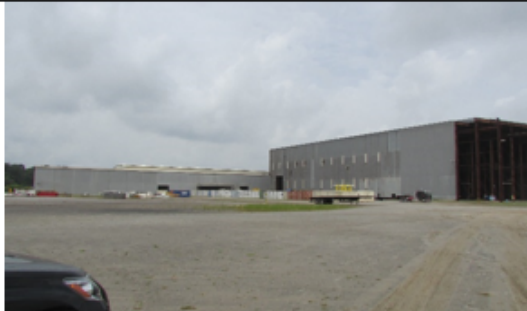
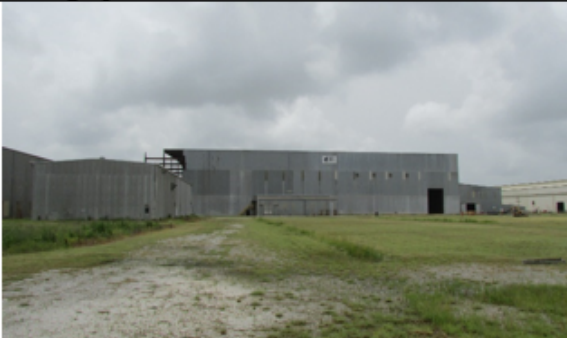
STRUCTURE ASSESSMENT SHEET	
Structure ID	Structure Address
#1	1216 Unifab Rd Bldg B
Structure Photographs

Front	Rear
Structure Characteristics	
Characteristic	Description
Occupancy -	Commercial – service and repair, being converted to storage.
Configuration -	One story with one wing 125,000 sq ft and the other 40,000 sq ft.
Construction -	Concrete slab foundation. Steel framing with steel siding and roof.
Condition -	Good
Other -	The east west main section of the building has a large opening at one end, which is scheduled to be closed in. There are no flood vents in the building walls
Site Visit Observations	
<p>General: The large site features the large 90' high main section and 60' high north south oriented building. A relatively smaller, second wing of the building is oriented north/south. The site is relatively flat and has 2 slips. The building is not occupied at this time, however a lease has been finalized. There are several other buildings on the site.</p> <p>Site: The structure is situated on an industrial port site and free standing on the property. The area around the structure is limestone. The grade at the front of the structure slopes slightly downward toward the access road. The grade at the sides of the structure slopes down from the building. The grade at the rear slopes down away from the structure.</p> <p>Structure: The building needs flood vents in order to be wet flood proofed. The former administration office spaces are going to be converted to conditioned storage. Some minor repairs are needed to the exterior steel siding. The building has a new tenant and is scheduled to have the open end closed in and a large door installed.</p> <p>Systems/Utilities: Systems and utilities are located below the DFE. Air conditioners need elevation to DFE. Electric service needs relocation to DFE. Toilet line needs back flow preventer.</p>

STRUCTURE DATA SHEET (CONTINUED)						
Structure ID	Structure Address					
#1	1216 Unifab Rd Bldg B					
Structure and Flood Elevations						
FF	LAG	B	BFE	Δ BFE-FF	Δ BFE-LAG	Δ BFE-B

5.6 ft	5ft	n/a	AE-11	6.6ft	6ft	n/a
ABBREVIATIONS: FF – First Floor Elevation; LAG – Low Adjacent Grade Elevation; B – Basement Floor Elevation; CS – Crawl Space Ground Elevation; BFE – Base Flood Elevation; Δ – Delta (Elevation Difference); NA – Not Applicable; * - Estimated						
Flood Risk						
Flood Risk: The first floor is approximately 6.6ft feet below the base flood elevation (BFE). The structure's construction, finishes, systems, utilities, storage and contents would incur substantial damage in a flood event. If wet flood proofed, the building would be subject to less damage due to letting the water in and out of the interior.						
Recommendation						
Based on the structure characteristics, site visit observations, structure / flood elevation data and the flood risk, the following mitigations are recommended: <ol style="list-style-type: none"> 1. Relocate the building utilities / systems to upper level above the DFE if applicable. 2. Elevate the exterior HVAC equipment onto platform(s), above the BFE. 3. Remove water damagable construction material and finishes and replace with water resistant construction and finishes. 4. Wet flood proof the structure according to FEMA Technical Bulletin 7. Install engineered flood vents in the existing walls. 5. Plan for evacuation of moveable equipment and structure contents prior to flood event when adequate warning is given. 6. Evacuate the structure during a flood event to prevent loss of life.

Notes: <ol style="list-style-type: none"> 1. The property owner indicated the structure experienced flooding on the first floor during past flood events. When a flood warning is given the property owner evacuates the structure contents and stores it off site. Interior finish materials need to be replaced with approved flood resistant construction materials 2. Loose equipment, containers and debris on the site will easily float away during a flood event, being lost or causing environmental hazard. <p>Note: The building qualifies as “functionally dependent” under CFR 59.1. FEMA/NFIP local ordinance requires a variance be provided for this work.</p>

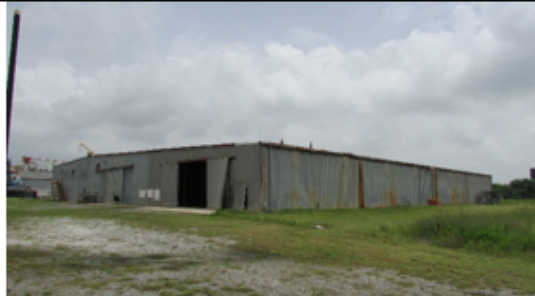
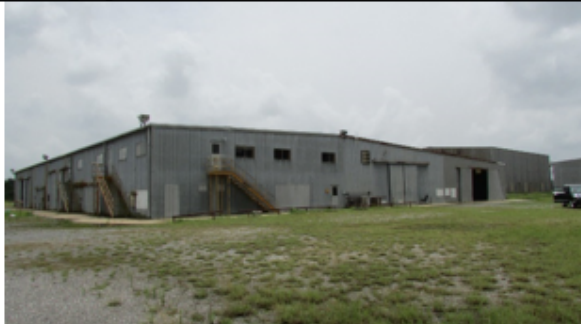
STRUCTURE ASSESSMENT SHEET	
Structure ID	Structure Address
#2	1216 Unifab Rd Building E
Structure Photographs

Front	Rear
Structure Characteristics	
Characteristic	Description
Occupancy -	Commercial storage.
Configuration -	The building measures 200' X 200' = 40,000 sq ft and 20' high. There is an elevated office space in the rear approximately 8ft above grade.
Construction -	Concrete slab foundation. Steel interior frame, steel siding and roof.
Condition -	Good. The building has a few loose steel panels. The roof above the office spaces is relatively new.
Other -	Structure sited above the level of the access road. There are multiple door openings in the sides of the building. There are no flood vents in the walls.
Site Visit Observations	
<p>General: The site is relatively flat. There is a slip just north of the building.</p> <p>Site: Industrial port site. The structure is situated on an industrial port site and free standing on the property. Interior finish materials need to be replaced with approved flood resistant construction materials. The grade at the front of the structure slopes slightly downward toward the access road. The grade at the sides of the structure slopes down from the building. The grade at the rear slopes down away from the structure.</p> <p>Structure: The building needs flood vents in order to be wet flood proofed. Some minor repairs are needed to the exterior steel siding.</p> <p>Systems/Utilities: Air conditioners for the upper level offices need to be elevated on stands to the DFE.</p>

STRUCTURE DATA SHEET (CONTINUED)						
Structure ID	Structure Address					
#2	1216 Unifab Rd Building E					
Structure and Flood Elevations						
FF	LAG	B	BFE	Δ BFE-FF	Δ BFE-LAG	Δ BFE-B

5.6ft	5ft	n/a	AE-11	5.4ft	6ft	n/a
<p>ABBREVIATIONS: FF – First Floor Elevation; LAG – Low Adjacent Grade Elevation; B – Basement Floor Elevation; CS – Crawl Space Ground Elevation; BFE – Base Flood Elevation; Δ – Delta (Elevation Difference); NA – Not Applicable; * - Estimated</p>						
Flood Risk						
<p>Flood Risk: The first floor is approximately 5.4 feet below the base flood elevation (BFE). Structure's construction, finishes, systems, utilities, storage and contents/furnishings at the finished floor level (below the BFE) would incur substantial damage.</p>						
Recommendation						
<p>Based on the structure characteristics, site visit observations, structure / flood elevation data and the flood risk, the following mitigations are recommended:</p> <ol style="list-style-type: none"> 1. Relocate the building utilities / systems / storage to upper level above BFE if applicable. 2. Elevate the exterior HVAC equipment onto platform or onto the roof, above the BFE. 3. Remove water damagable construction material and finishes and replace with water resistant construction and finishes. 4. Wet flood proof the structure according to FEMA Technical Bulletin 7. Install engineered flood vents in the existing walls. 5. Plan for evacuation of moveable equipment and structure contents prior to flood event when adequate warning is given. 6. Evacuate the structure during a flood event to prevent loss of life. <p>Notes:</p> <ol style="list-style-type: none"> 7. The property owner indicated the structure experienced flooding on the first floor during past flood events and incurred extensive damages. When a flood warning is given the property owner evacuates the structure contents and stores it off site. Interior finish have been replace after previous flood event with easily removable water resistant construction in the showroom / office area. Some equipment is stored on mobile racks to facilitate evacuation. 8. Loose equipment, containers and debris on the site will easily float away during a flood event, being lost or causing environmental hazard. <p>Note: The building qualifies as "functionally dependent" under CFR 59.1. FEMA/NFIP local ordinance requires a variance be provided for this work.</p>

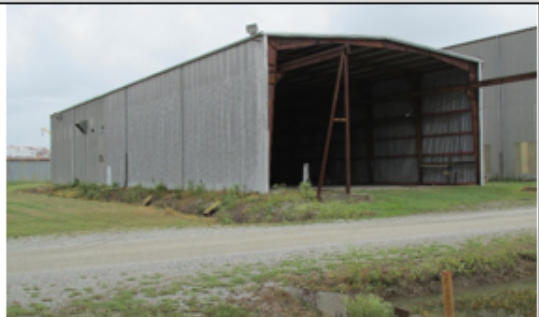
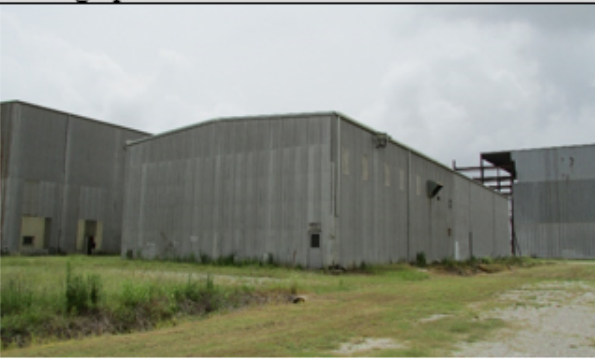
STRUCTURE ASSESSMENT SHEET	
Structure ID	Structure Address
#3	1216 Unifab Rd Building D
Structure Photographs

Front	Rear
Structure Characteristics	
Characteristic	Description
Occupancy -	Commercial – storage.
Configuration -	The building is a rectangular one story, gable roof that measures 180ft X 60ft = 10,800 sq ft. One end of the building is open.
Construction -	Concrete slab foundation. Roof and siding are steel.
Condition -	The siding and roof appear to be in good condition.
Other -	Structure sited above the level of the access road. There are 2 egress door openings in the sides of the building. There are no flood vents in the walls.
Site Visit Observations	
<p>General: The structure was viewed from the exterior and interior. The structure was not occupied and in good condition.</p> <p>Site: - Industrial port site. The structure is situated on an industrial port site and free standing on the property. The area around the structure is Limestone. The grade at the front of the structure slopes slightly downward toward the access road. The grade at the sides of the structure slopes down from the building. The grade at the rear slopes down away from the structure.</p> <p>Structure: The structure is steel framed with a steel siding and roof. The first floor is a concrete slab on grade. The exterior walls and roof have steel siding.</p> <p>Systems/Utilities: The utilities are located below BFE.</p>

STRUCTURE DATA SHEET (CONTINUED)						
Structure ID	Structure Address					
#3	1216 Unifab Rd Building D					
Structure and Flood Elevations						
FF	LAG	B	BFE	Δ BFE-FF	Δ BFE-LAG	Δ BFE-B

5.6ft	5ft	n/a	AE-11	5.4ft	6ft	n/a
<p>ABBREVIATIONS: FF – First Floor Elevation; LAG – Low Adjacent Grade Elevation; B – Basement Floor Elevation; CS – Crawl Space Ground Elevation; BFE – Base Flood Elevation; Δ – Delta (Elevation Difference); NA – Not Applicable; * - Estimated</p>						
Flood Risk						
<p>Flood Risk: The first floor is approximately 5.4 feet below the base flood elevation (BFE). Structure's construction, finishes, systems, utilities, storage and contents/furnishings at the finished floor level (below the BFE) would incur substantial damage.</p>						
Recommendation						
<p>Based on the structure characteristics, site visit observations, structure / flood elevation data and the flood risk, the following mitigations are recommended:</p> <ol style="list-style-type: none"> 1. Relocate the building utilities / systems above BFE if applicable. 2. Elevate the exterior HVAC equipment onto platform or onto the roof, above the BFE. 3. Remove water damagable construction material and finishes and replace with water resistant construction and finishes. 4. Wet flood proof the structure according to FEMA Technical Bulletin 7. Install engineered flood vents in the existing walls. 5. Plan for evacuation of moveable equipment and structure contents prior to flood event when adequate warning is given. 6. Evacuate the structure during a flood event to prevent loss of life.

Notes:						
<ol style="list-style-type: none"> 7. The property owner indicated the structure experienced flooding on the first floor during past flood events and incurred extensive damages. When a flood warning is given the property owner evacuates the structure contents and stores it off site. Interior finish have been replace after previous flood event with easily removable water resistant construction in the showroom / office area. Some equipment is stored on mobile racks to facilitate evacuation. 8. Loose equipment, containers and debris on the site will easily float away during a flood event, being lost or causing environmental hazard. 						
<p>Note: The building qualifies as "functionally dependent" under CFR 59.1. FEMA/NFIP local ordinance requires a variance be provided for this work.</p>

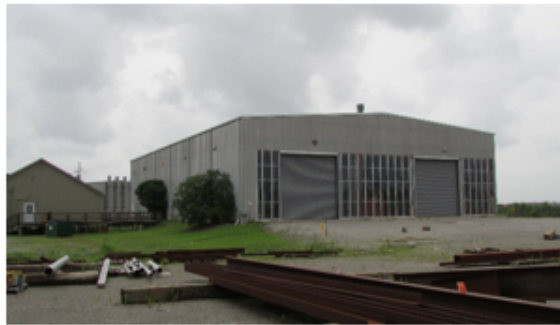
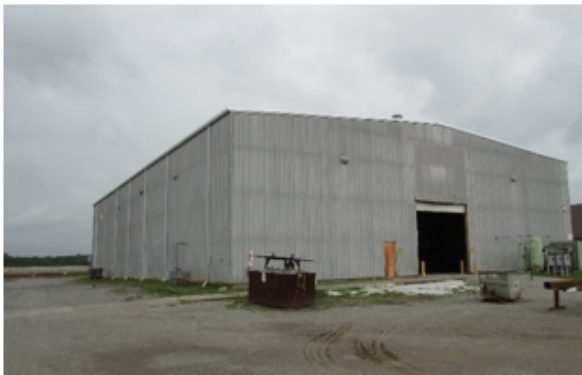
STRUCTURE ASSESSMENT SHEET	
Structure ID	Structure Address
#4	5314 C.P Voorhies Rd Building C
Structure Photographs

Front	Rear
Structure Characteristics	
Characteristic	Description
Occupancy -	Commercial – storage.
Configuration -	One story, concrete slab on grade, gable end steel roof. 16,000 sq ft.
Construction –	Masonry exterior walls with metal framed roof. Wood framed interior.
Condition -	Good. Several steel siding panels on the front of the building have been replaced with clear acrylic panels.
Other -	Structure sited above the level of the access road. There are 2 egress door openings in the sides of the building. There are no flood vents in the walls.
Site Visit Observations	
<p>General: The structure was viewed from the exterior. The structure was not occupied and in good condition.</p> <p>Site: Industrial port site. The structure is situated on an industrial port site and free standing on the property. The area around the structure is sand and gravel. The grade at the front of the structure slopes downward toward the access road. The grade at the sides of the structure slopes down from the building. The grade at the rear slopes down away from the structure.</p> <p>Structure: The gable end structure is steel framed with a steel siding and roof. The first floor is a concrete slab on grade. The exterior walls and roof have steel siding.</p> <p>Systems/Utilities: The utilities and equipment is located at the rear and below DFE</p>

STRUCTURE DATA SHEET (CONTINUED)						
Structure ID	Structure Address					
#4	5314 C.P Voorhies Rd Building C					
Structure and Flood Elevations						
FF	LAG	B	BFE	Δ BFE-FF	Δ BFE-LAG	Δ BFE-B
7ft	6.5ft	n/a	AE-11	4ft	4.5ft	n/a
<p>ABBREVIATIONS: FF – First Floor Elevation; LAG – Low Adjacent Grade Elevation; B – Basement Floor Elevation; CS – Crawl Space Ground Elevation; BFE – Base Flood Elevation; Δ – Delta (Elevation Difference); NA – Not Applicable; * - Estimated</p>						
Flood Risk						
<p>Flood Risk: The first floor is approximately 4ft feet below the base flood elevation (BFE). The structure's construction, finishes, systems, utilities, storage and contents / furnishings at the first-floor elevation area are substantially below the BFE and will incur significant damage.</p>						
Recommendation						
<p>Based on the structure characteristics, site visit observations, structure / flood elevation data and the flood risk, the following mitigations are recommended:</p> <ol style="list-style-type: none"> 1. Relocate the building utilities / systems / storage to above DFE. 2. Remove water damagable construction material and finishes and replace with water resistant construction and finishes. 3. Wet flood proof the structure according to FEMA Technical Bulletin 7. Install engineered flood vents in the existing walls. 4. Plan for evacuation of moveable equipment and structure contents prior to flood event when adequate warning is given. 5. Evacuate the structure during a flood event to prevent loss of life. <p>Notes:</p> <ol style="list-style-type: none"> 6. The property owner indicated the structure experienced flooding on the first floor during past flood events and incurred extensive damages. When a flood warning is given the property owner evacuates the structure contents and stores it off site. 7. Loose equipment, containers and debris on the site will easily float away during a flood event, being lost or causing environmental hazard.

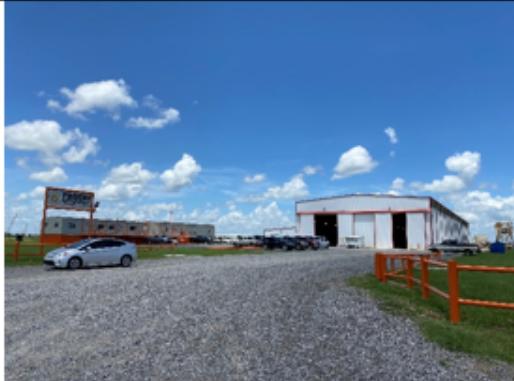
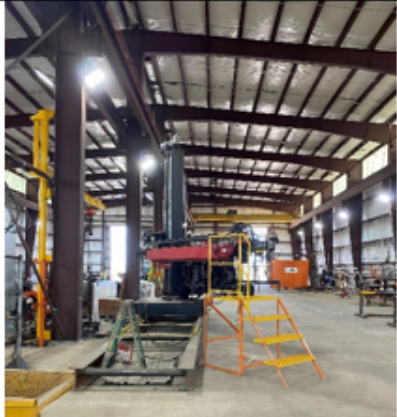
OCCUPIED STRUCTURE ASSESSMENT SHEET	
Structure ID	Structure Address
#5	3705 Earl B Wilson Dr, New Iberia, LA
Structure Photographs

Front	Interior
Structure Characteristics	
Characteristic	Description
Occupancy -	Commercial – Fabrication, service and repair
Configuration -	One story 35,700 sq ft
Construction -	Concrete slab foundation. Steel framing with steel siding and roof.
Condition -	Good
Other -	The building has 2 rolling door openings at either end. There are multiple non-engineered vents in the building walls. The building owner is gradually flood proofing the building. The electric transformer is at BFE. The interior electric needs elevating. The owner has an evac plan to get portable equipment into a shipping container and elevate with existing overhead crane.
Site Visit Observations	
<p>General: The large site features two double wide modular office modular buildings on an elevated structural steel frame. The fabrication building measures 357ft X 100ft X 50ft high.</p> <p>Site: The fabrication building is situated on an industrial port site and free standing on the property. The area around the structure is limestone. The grade at the front of the structure slopes slightly downward toward the access road. The grade at the sides of the structure slopes down from the building. The grade at the rear slopes down away from the structure.</p> <p>Structure: The building needs an engineered flood vent retro fit to be compliant with minimum square ft coverages required by FEMA/NFIP to be wet flood proofed. The administration office spaces are elevated to BFE +1FT. Some minor repairs are needed to the exterior steel siding.</p> <p>Systems/Utilities: The site power transformer is elevated to BFE+1ft. The power distribution system inside the building needs to be elevated. Sanitary waste line needs back flow preventer.</p>

OCCUPIED STRUCTURE DATA SHEET (CONTINUED)						
Structure ID	Structure Address					
#5	3705 Earl B Wilson Dr, New Iberia, LA					
Structure and Flood Elevations						
FF	LAG	B	BFE	Δ BFE-FF	Δ BFE-LAG	Δ BFE-B

5.9 ft	5ft	n/a	AE-11	6ft	7ft	n/a
<p>ABBREVIATIONS: FF – First Floor Elevation; LAG – Low Adjacent Grade Elevation; B – Basement Floor Elevation; CS – Crawl Space Ground Elevation; BFE – Base Flood Elevation; Δ – Delta (Elevation Difference); NA – Not Applicable; * - Estimated</p>						
Flood Risk						
<p>Flood Risk: The first floor is approximately 6ft feet below the base flood elevation (BFE). The structure's construction, finishes, systems, utilities, storage and contents would incur substantial damage in a flood event. If wet flood proofed, the building would be subject to less damage due to letting the water in and out of the interior.</p>						
Recommendation						
<p>Based on the structure characteristics, site visit observations, structure / flood elevation data and the flood risk, the following mitigations are recommended:</p> <ol style="list-style-type: none"> 1. Relocate the building utilities / systems to upper level above the DFE if applicable. 2. Elevate the exterior HVAC equipment onto platform(s), above the BFE. 3. Remove water damagable construction material and finishes and replace with water resistant construction and finishes. 4. Wet flood proof the structure according to FEMA Technical Bulletin 7. Install engineered flood vents in the existing walls. 5. Plan for evacuation of moveable equipment and structure contents prior to flood event when adequate warning is given. 6. Evacuate the structure during a flood event to prevent loss of life. <p>Notes:</p> <ol style="list-style-type: none"> 1. The property owner indicated the structure experienced flooding on the first floor during past flood events. When a flood warning is given the property owner elevates the structure contents. Interior finish materials need to be replaced with approved flood resistant construction materials 2. Loose equipment, containers and debris on the site will easily float away during a flood event, being lost or causing environmental hazard. <p>Note: The building qualifies as "functionally dependent" under CFR 59.1. FEMA/NFIP local ordinance requires a variance be provided for this work.</p>

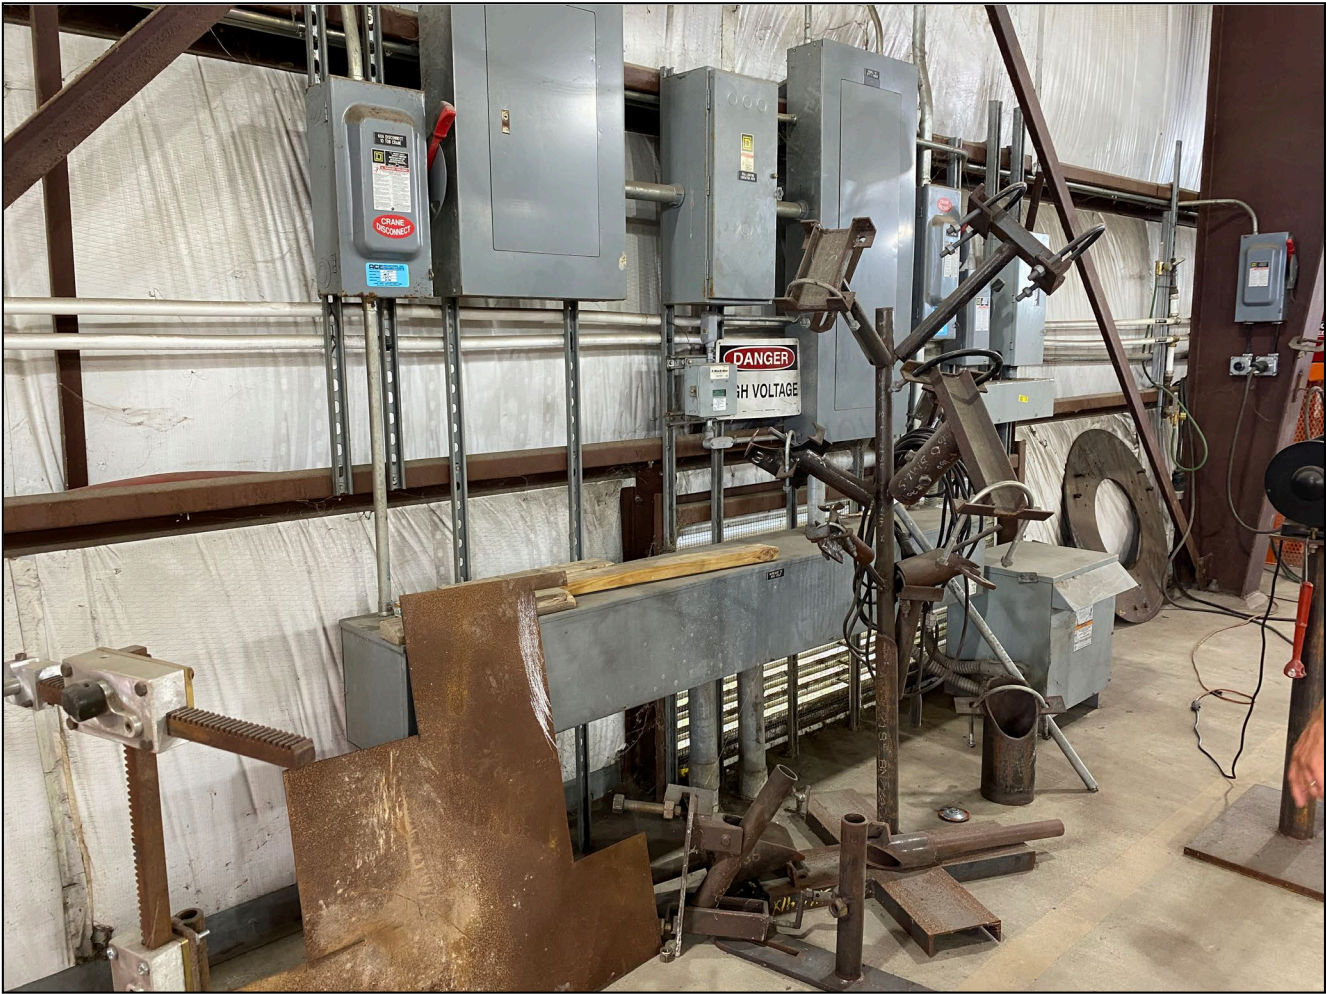
Figure L:2-1. Example of Significant Electrical Infrastructure Requiring Elevation

The USACE refined the wet floodproofing mitigation methods based on the types of structures and its associated operations that were surveyed within the Port of Iberia. Following screening of mitigation methods, structure were sorted into two types: general purpose warehouse structures and fabrication warehouses. The only significance difference as it relates to scope and cost of the cost estimate is that fabrication buildings require significantly more work to elevate as they tend to require large scale hoists and associated utilities as indicated in Figure L:2-1.
