**Mississippi River, Baton Rouge to the Gulf of Mexico, LA
Interagency Field Trip to Southwest Pass Beneficial Use Sites**

**CEMVN-OD-T
June 2012 Trip Report**

Overview – The CEMVN conducted an interagency field trip to two beneficial use sites along the right-descending bank of Southwest Pass on May 30, 2012. The cutterhead dredge CALIFORNIA was performing maintenance of Southwest Pass near river mile 14 BHP during the site visit (contract 12C0021). Prior to the field trip, the CALIFORNIA had placed approximately 1.4 million cubic yards of material in Placement Area #1 and about 900,000 cubic yards of material in Placement Area #2. The CALIFORNIA was discharging into Placement Area #1 during this field trip.

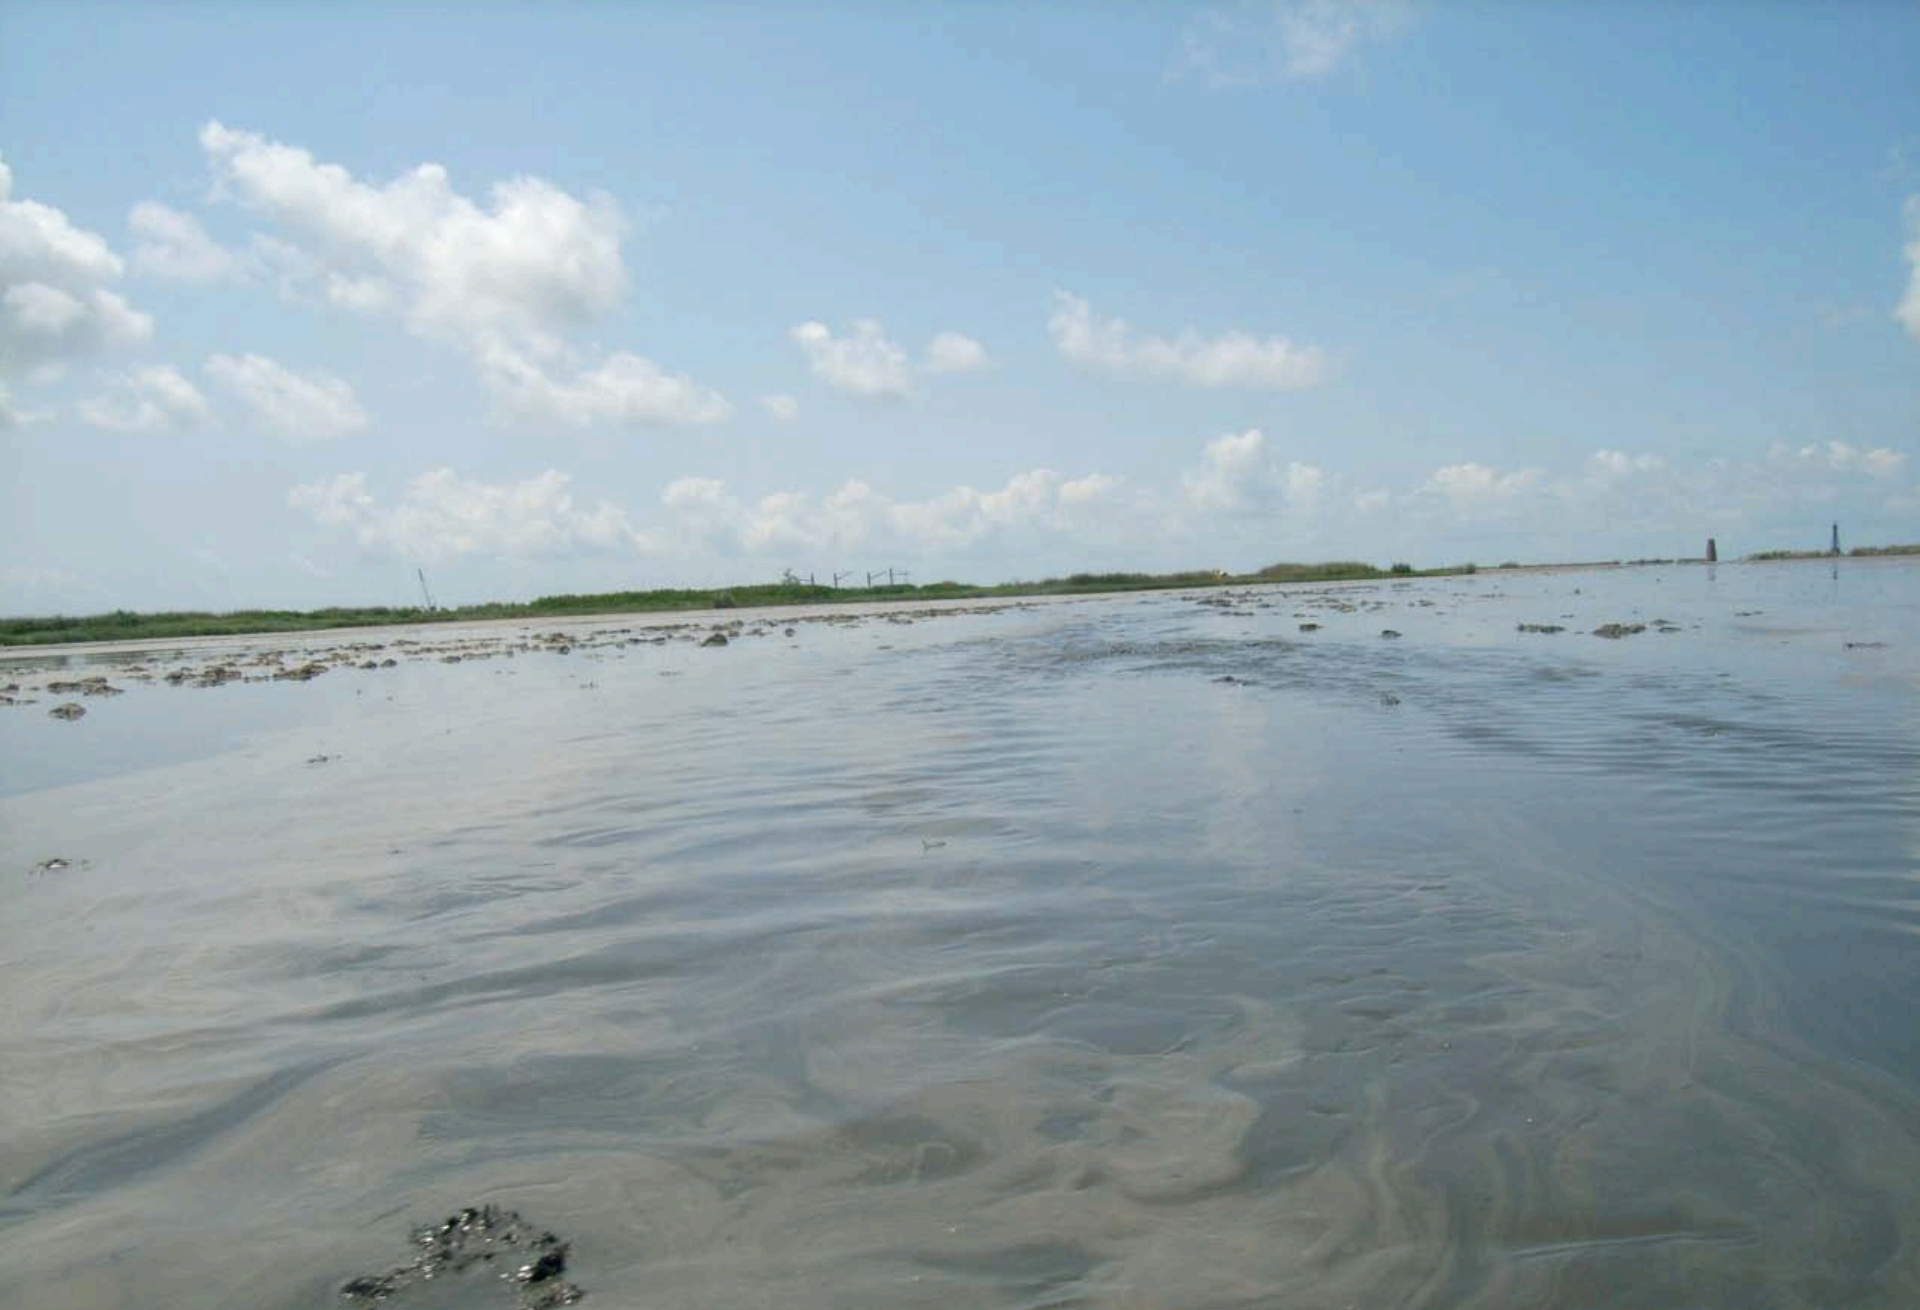
Picture 1. Upper boundary of Placement Area #1, looking towards the right-descending bank of Southwest Pass. The dredge CALIFORNIA was actively pumping into this beneficial use placement area, & flowing dredged material slurry generated the surface ripples visible in this photo.

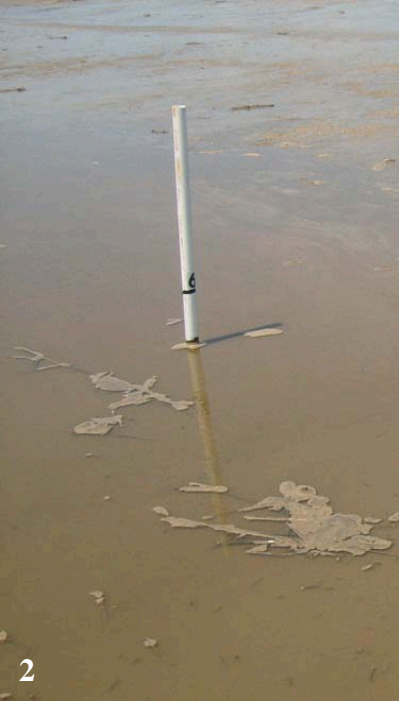
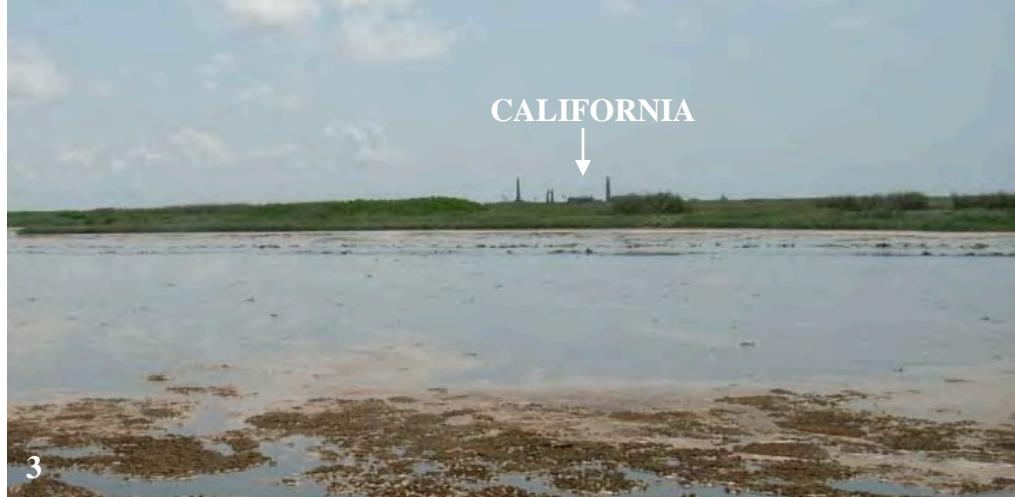
Pictures 2-3. Elevation marker denoting target slurry elevation of 5.5' (left). The CALAFORNIA was working near river mile 14 BHP (top). Other equipment was nearly obstructed by marsh grass within the placement area (below).

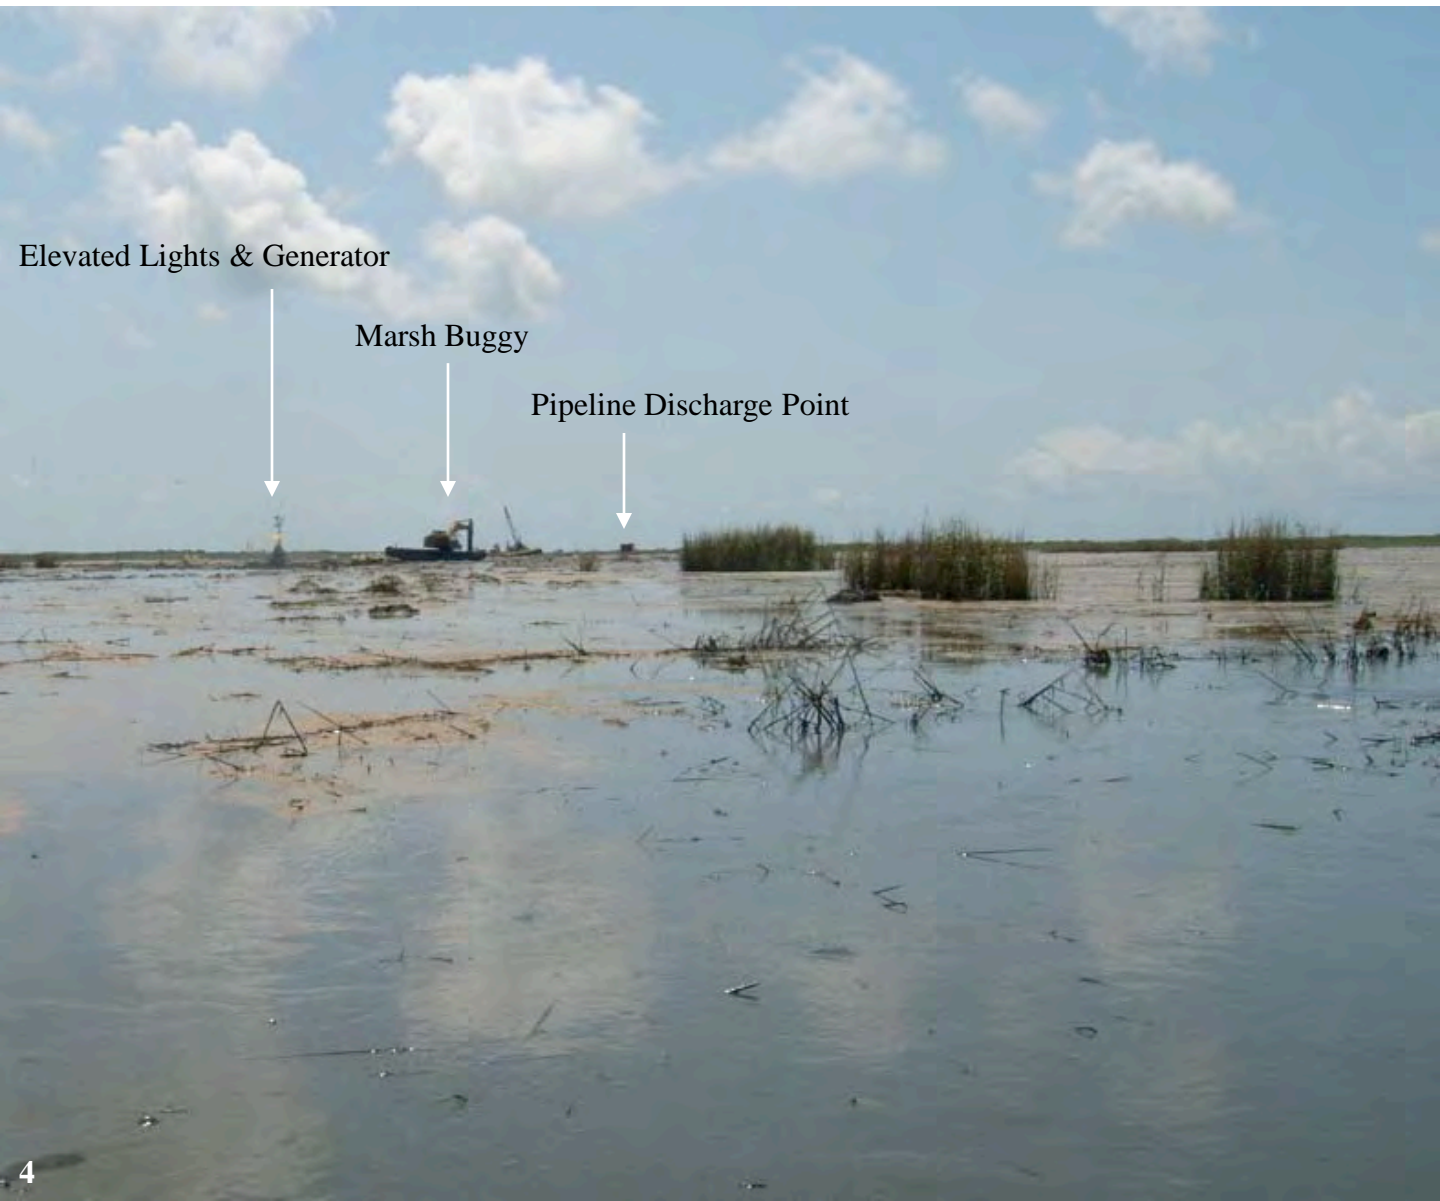
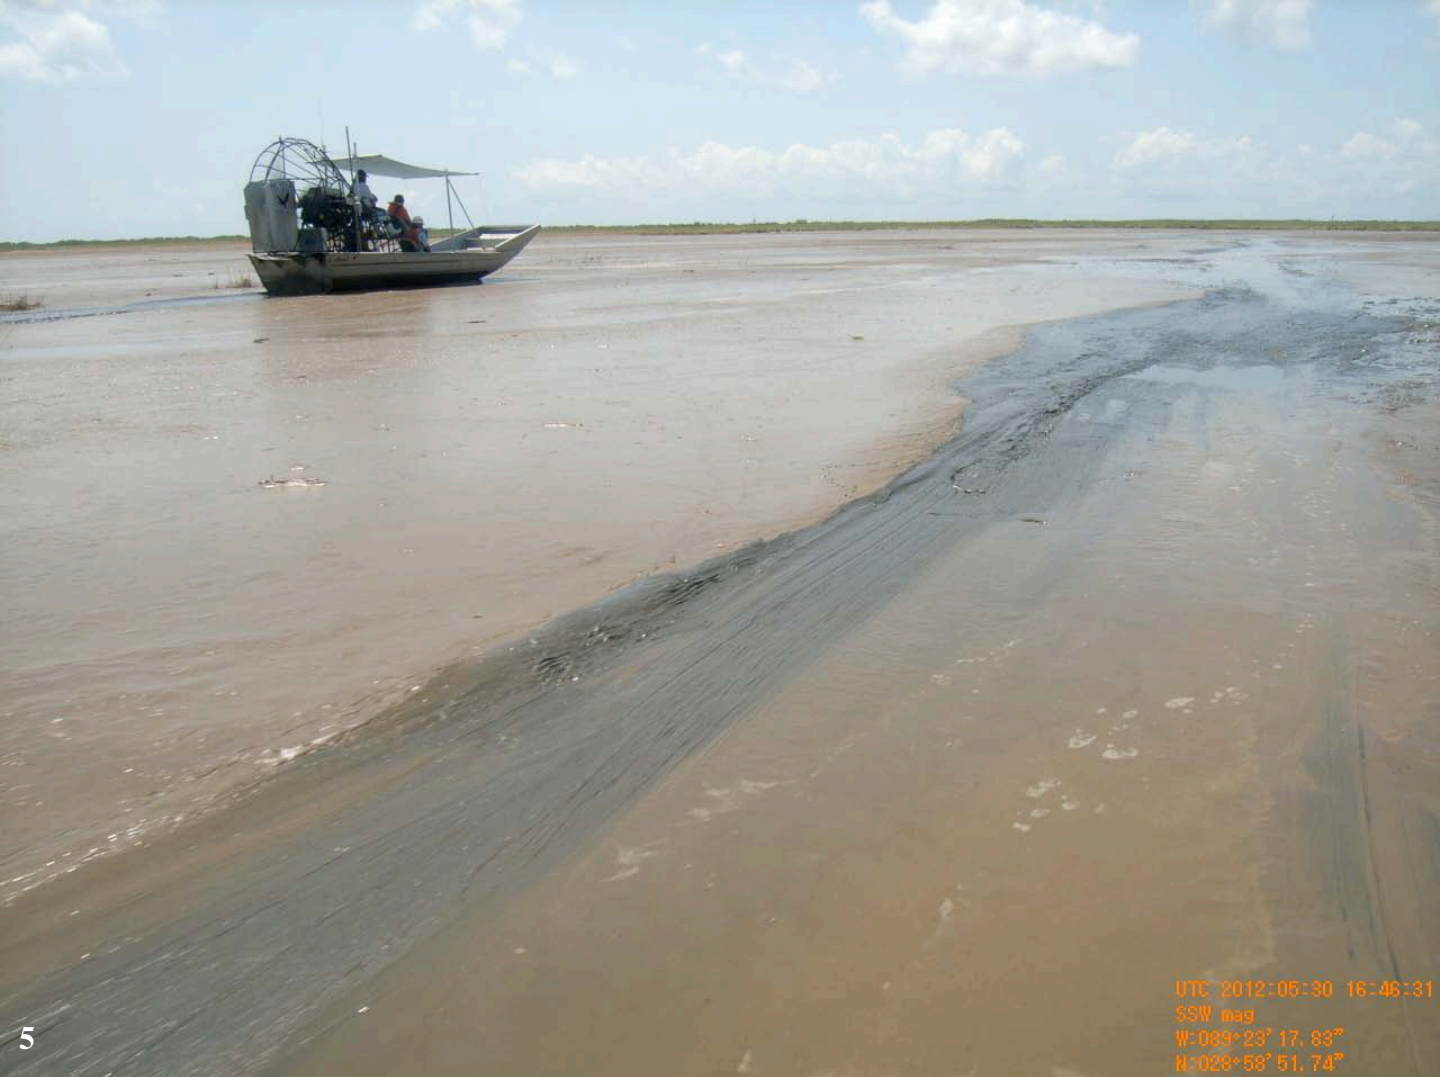
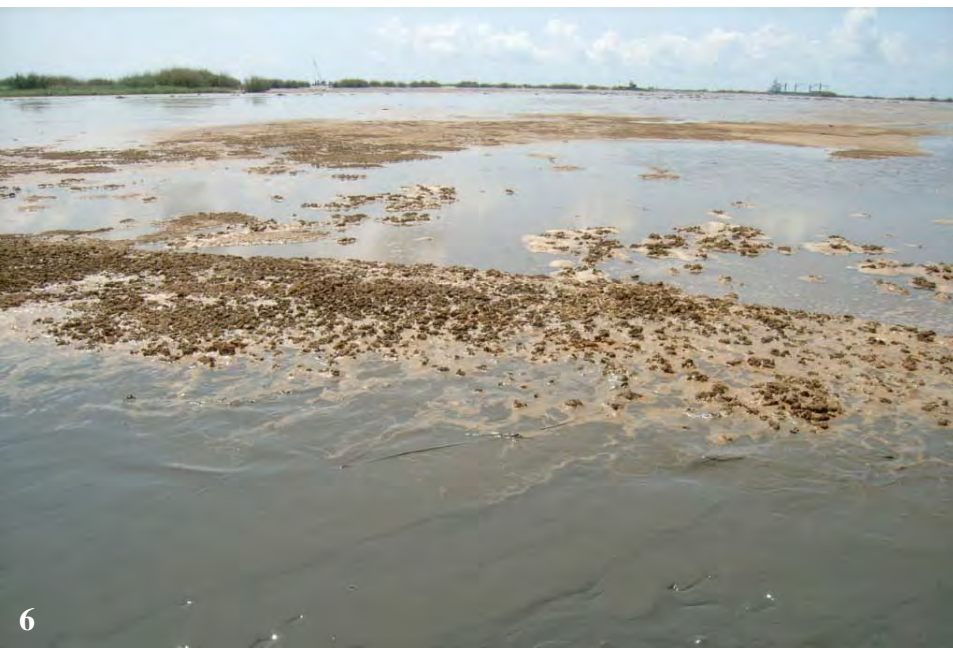
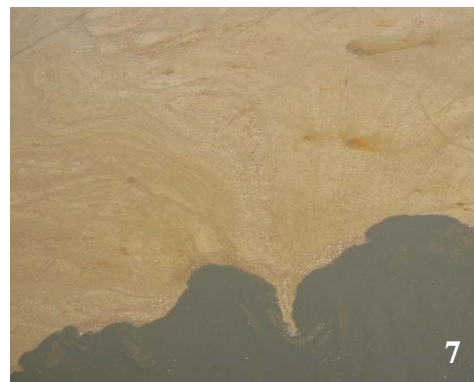
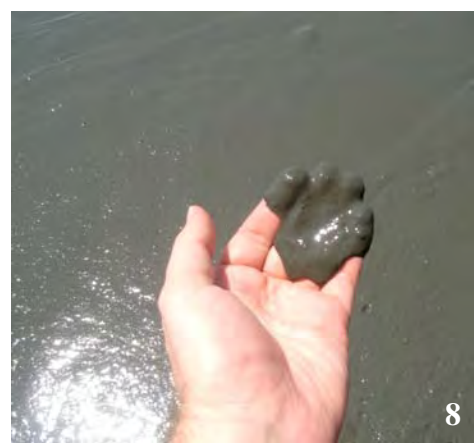
Pictures 5-8. Dredged material discharged into Placement Area #1 was predominantly fine-grained sediments mixed with organic material. Trail made by the leading airboat exposed its pudding-like consistency (above). Organic foam was scattered throughout the site (below).

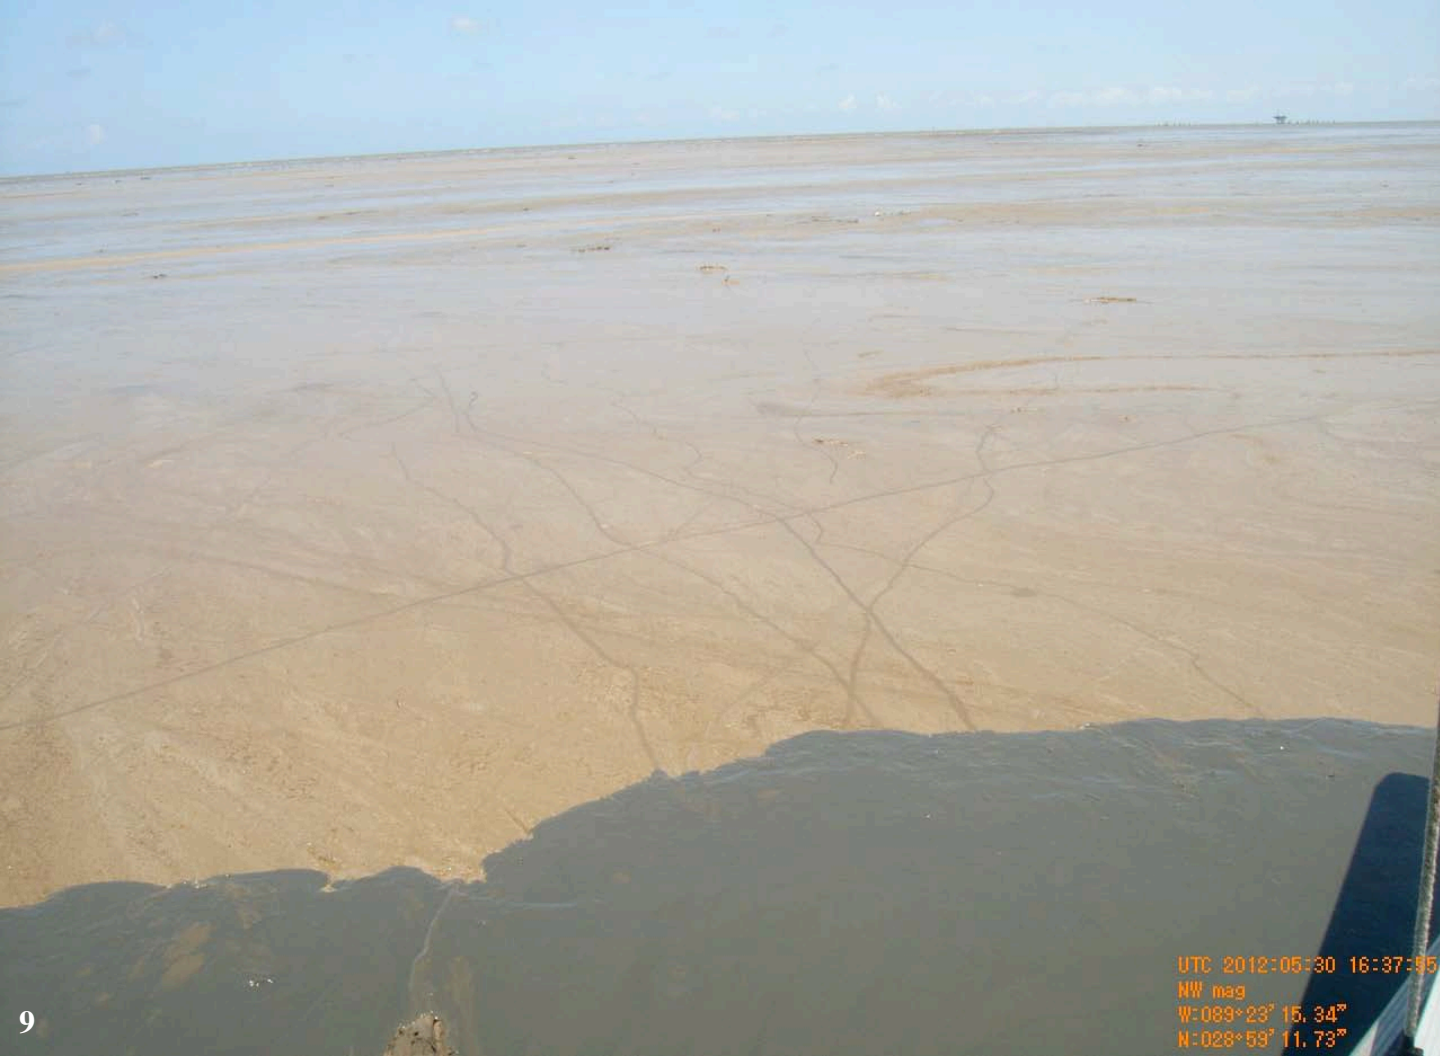
Pictures 9 & 10. Crab & bird tracks on the surface of partially dewatered dredged slurry.

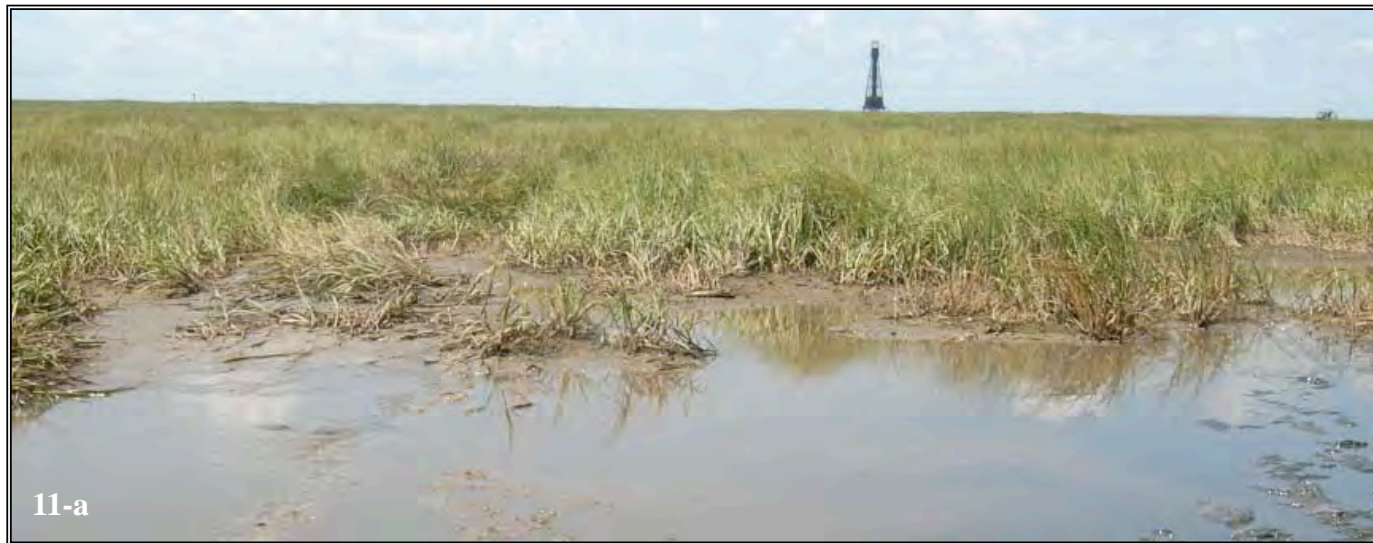
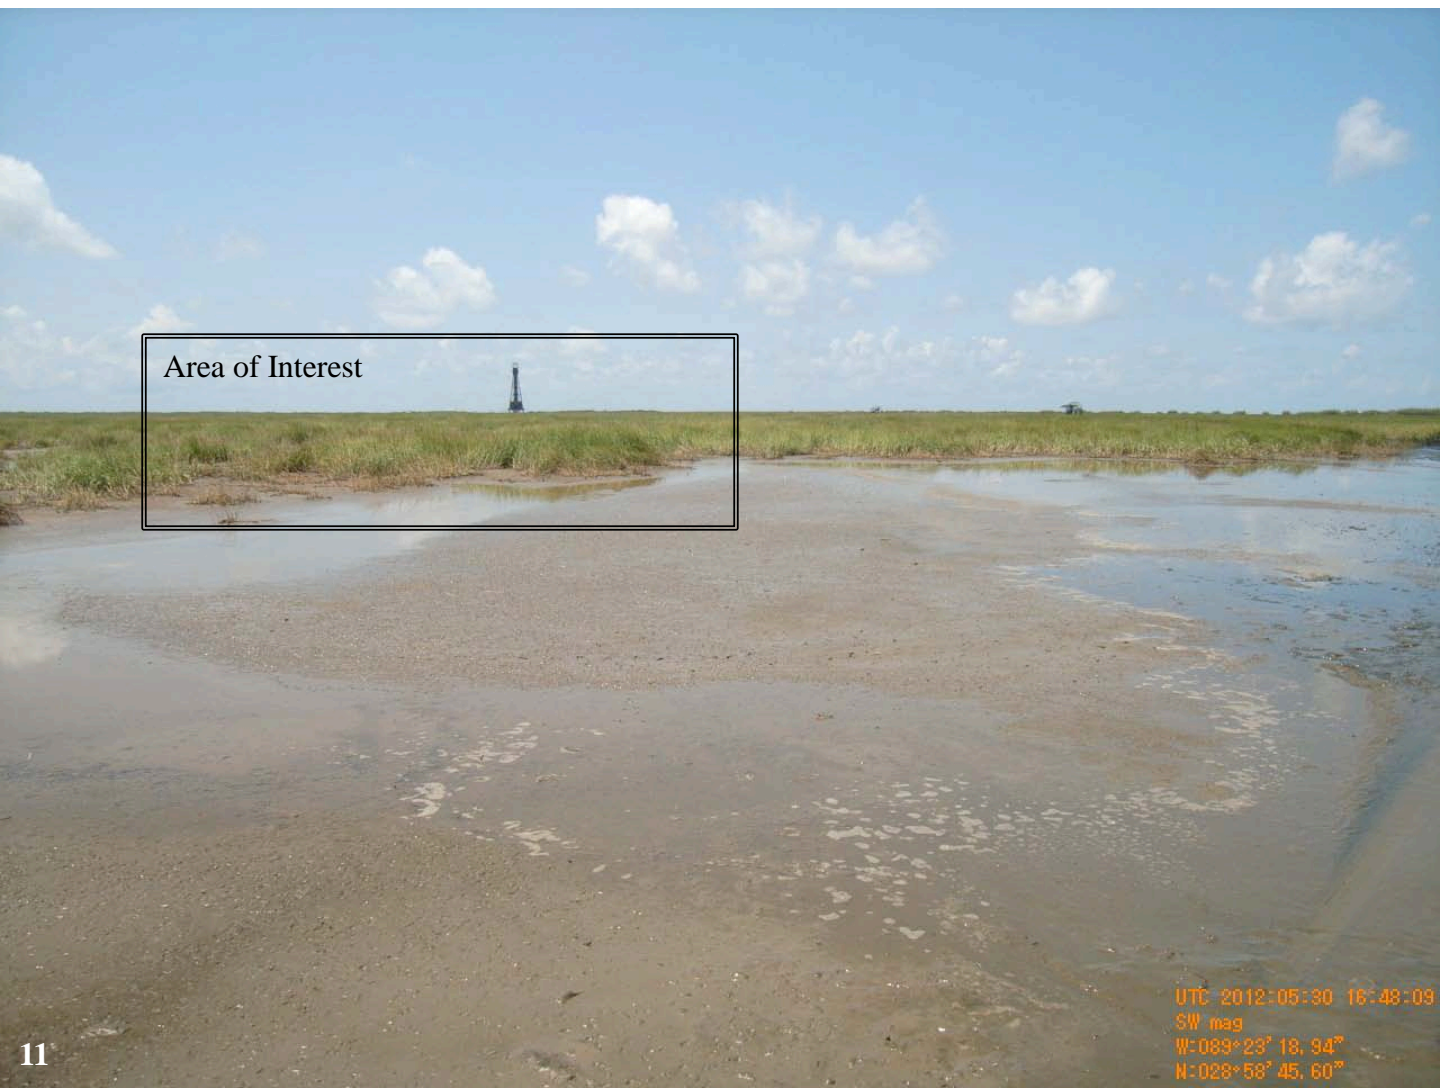
Picture 11 & Area of Interest 11-a. Dredged material was effectively semi-confined by marsh grass within Placement Area #1, without smothering the grass stands.

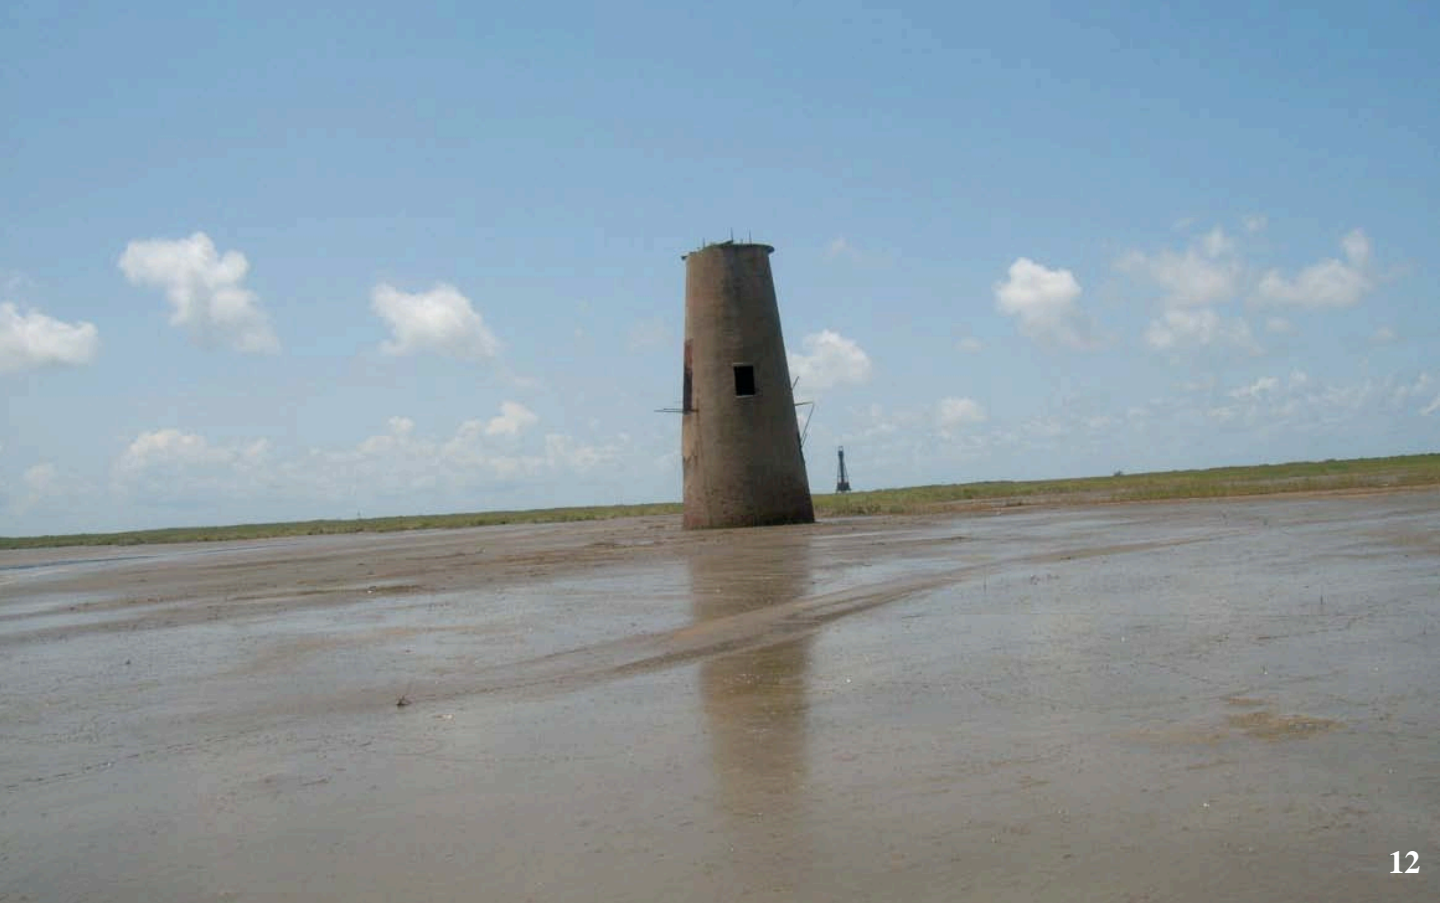
Picture 12 & BUMP Aerial Photography. A relic lighthouse about 1 mile west-northwest of the opening to Burrwood Bayou from Southwest Pass serves as a convenient waypoint for locating Placement Area #1.

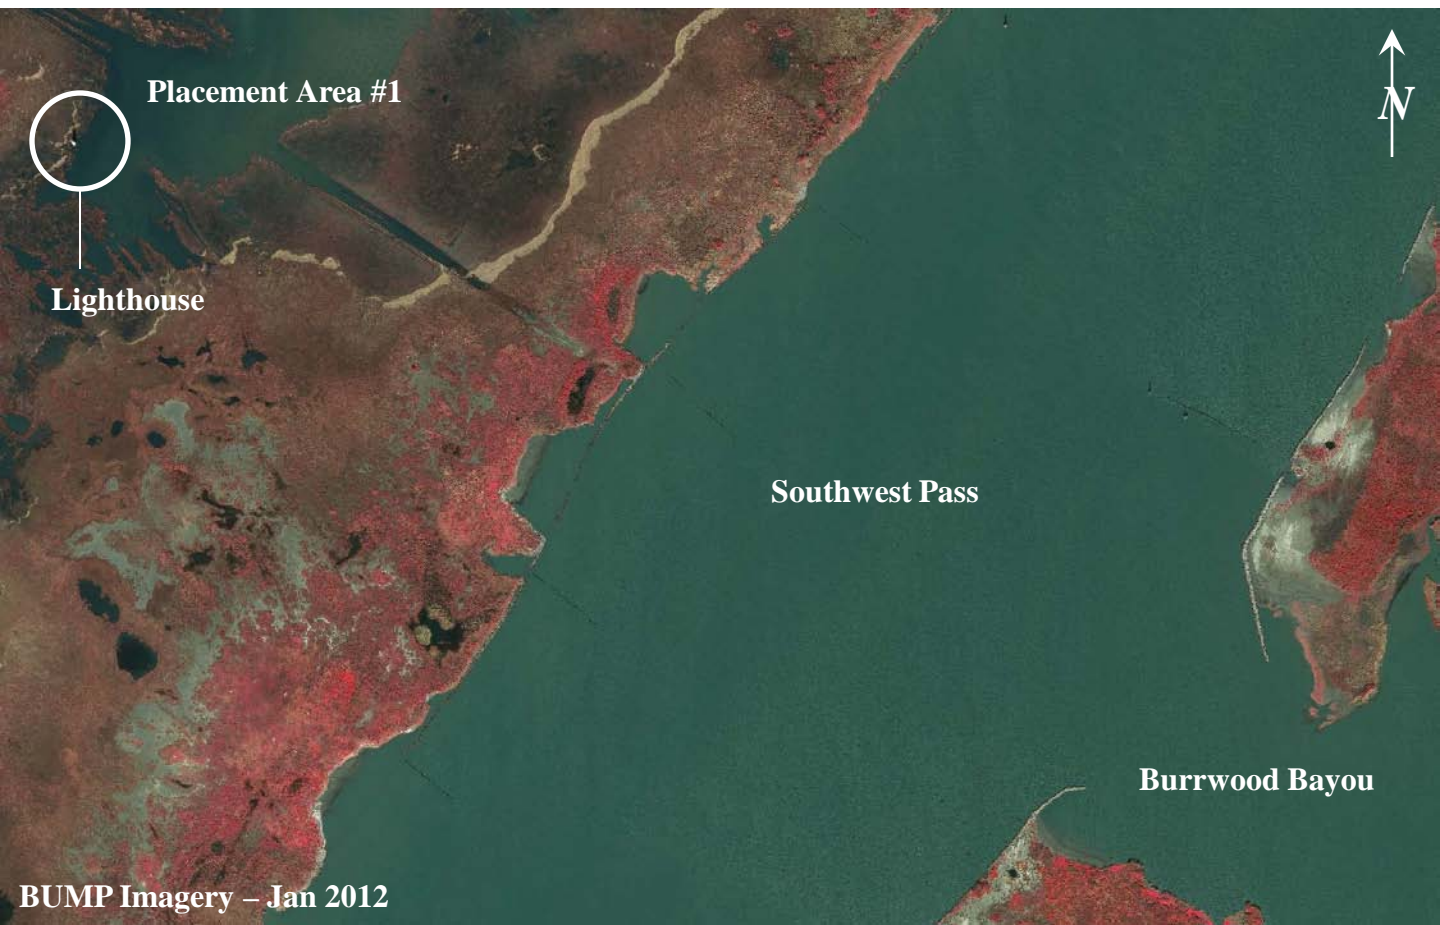
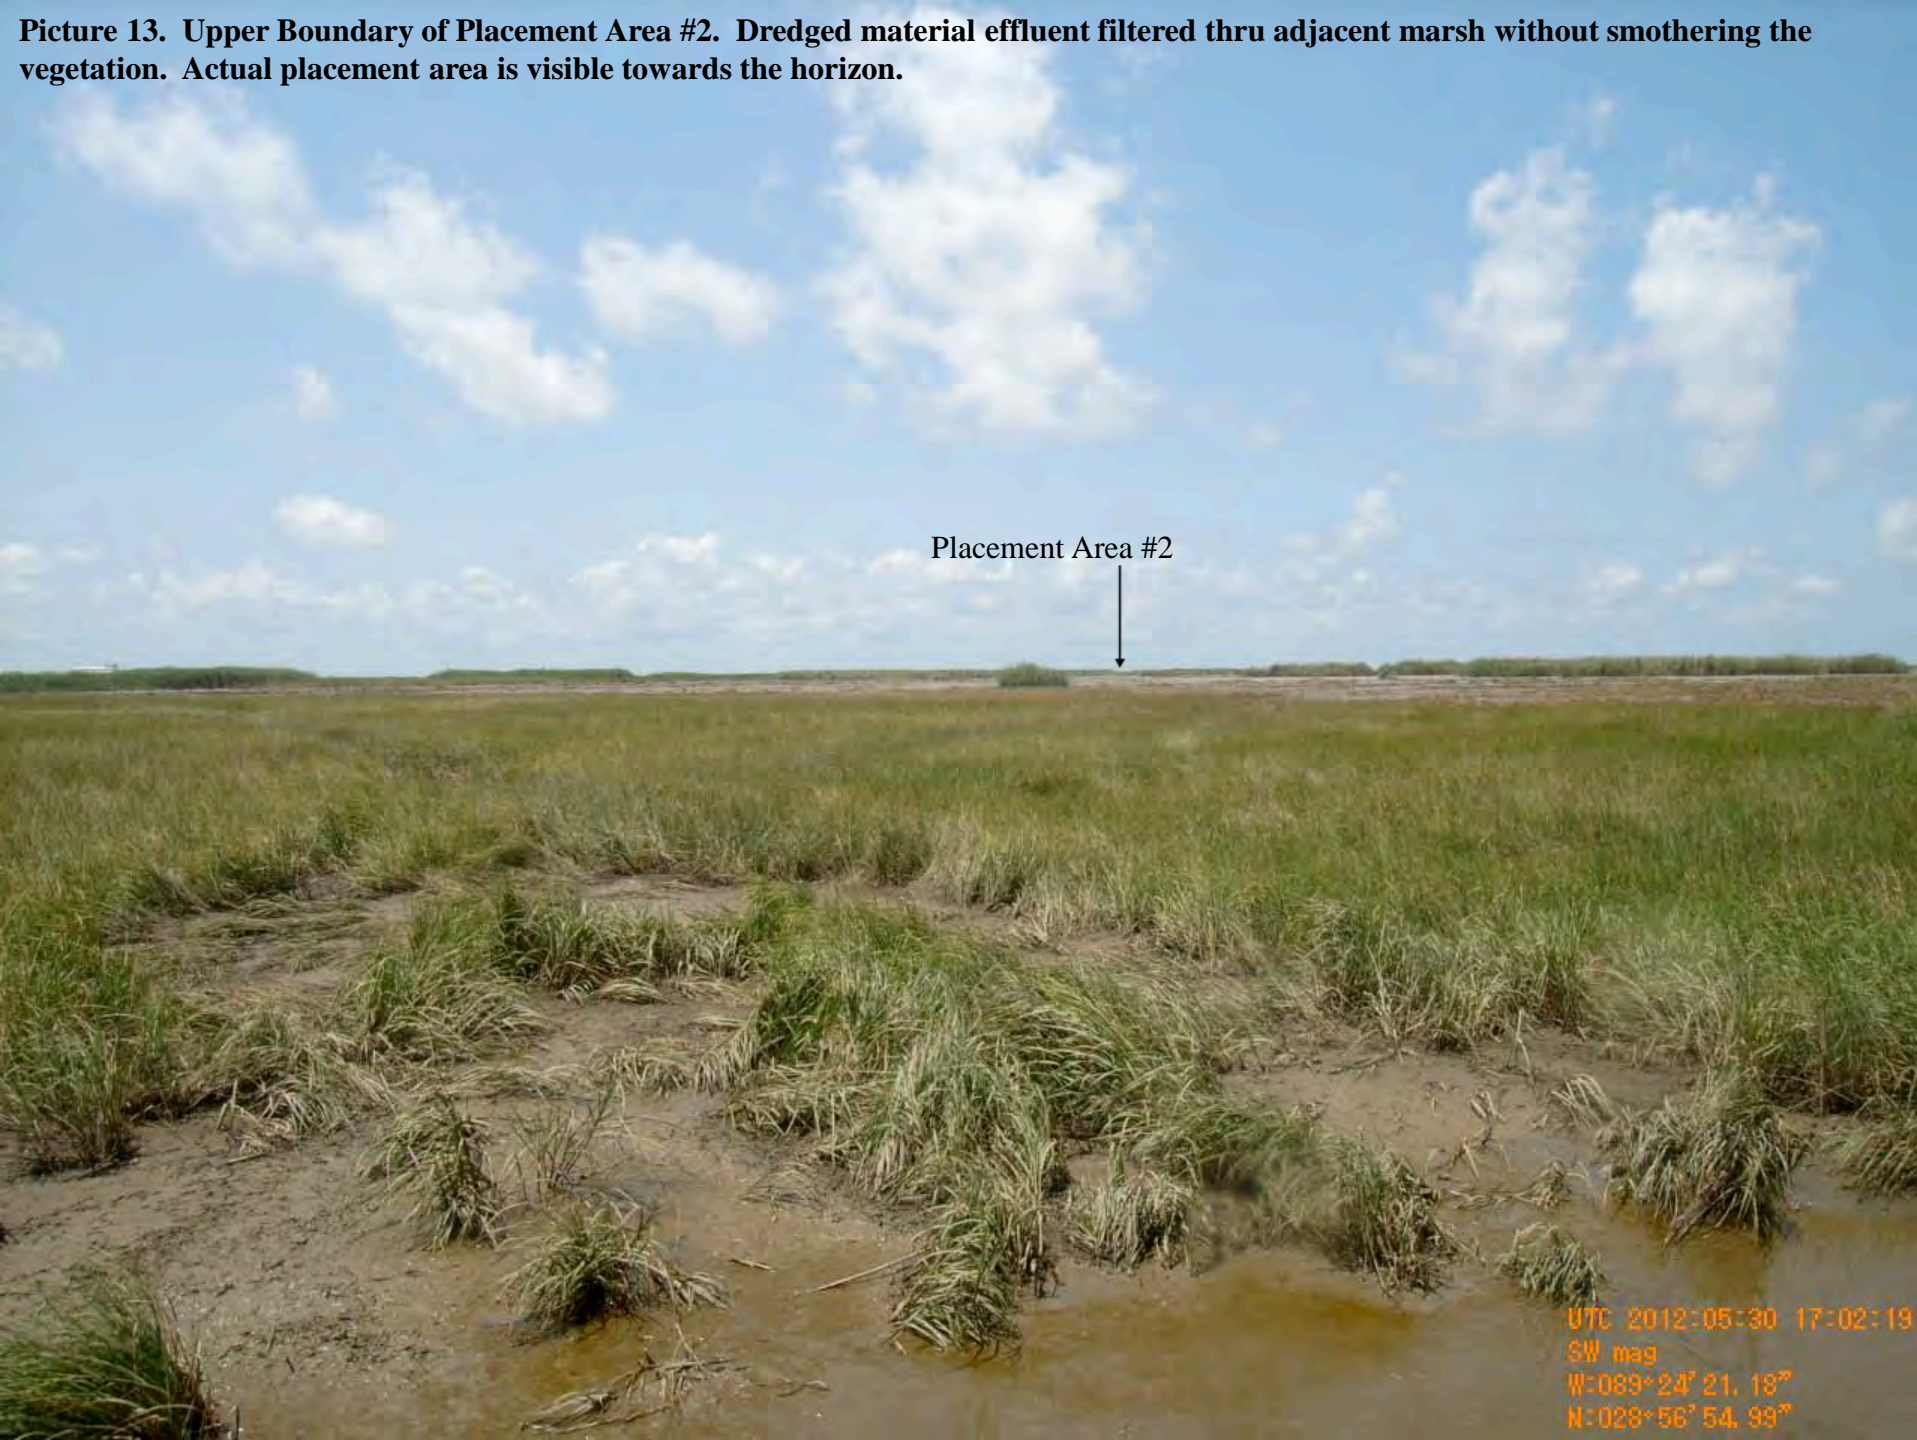
Picture 13. Upper Boundary of Placement Area #2. Dredged material effluent filtered thru adjacent marsh without smothering the vegetation. Actual placement area is visible towards the horizon.

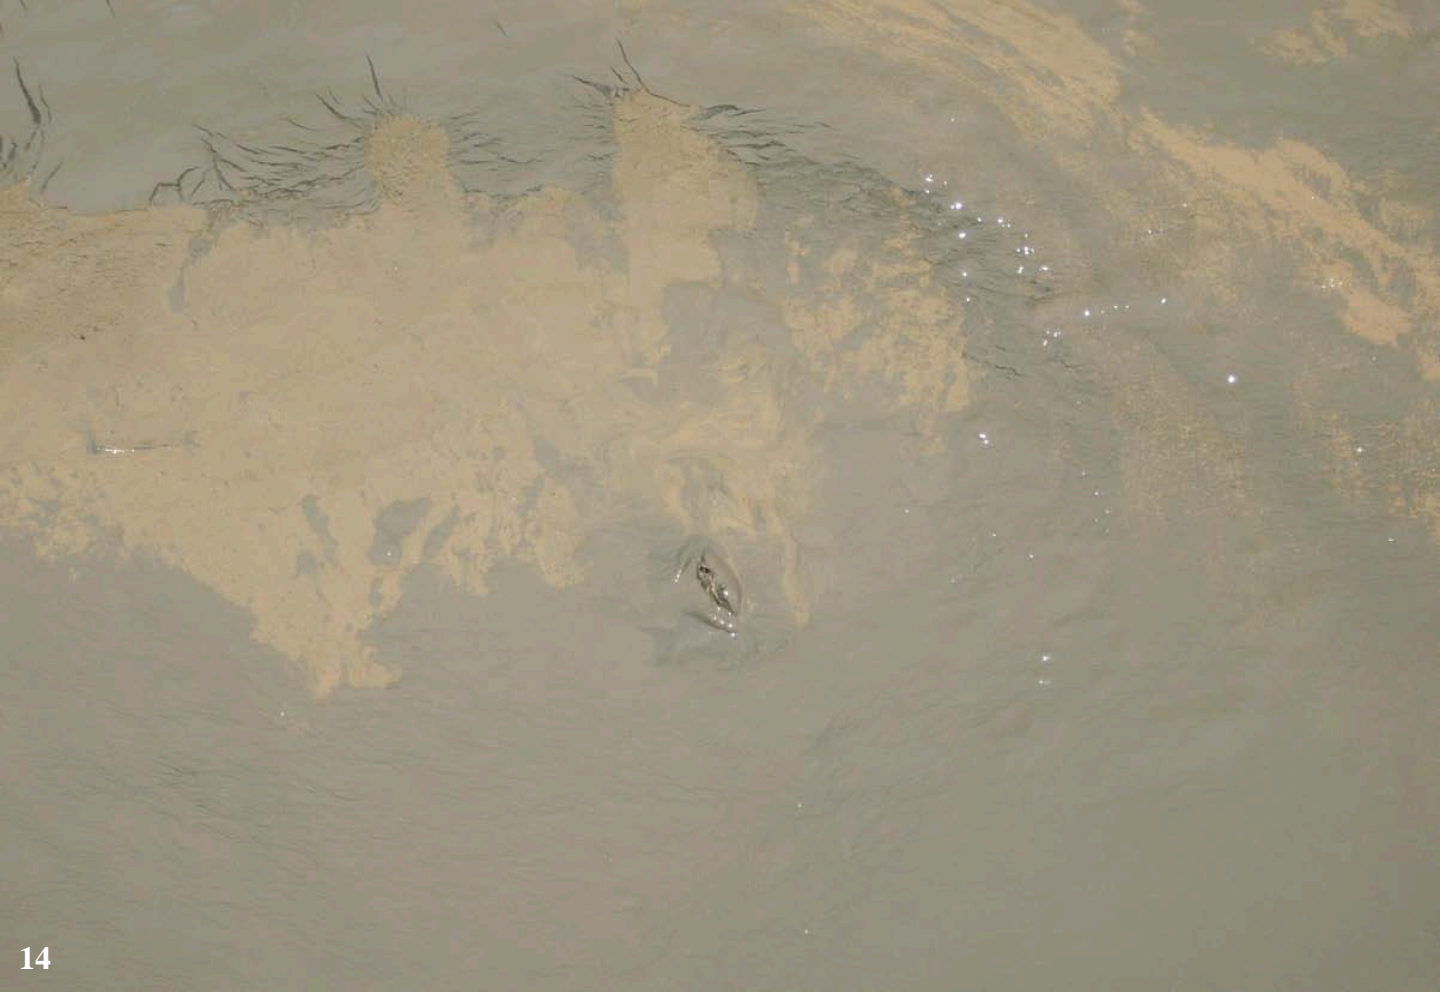
14

Pictures 14-16. Dredged material within the upper boundary of Placement Area #2 was predominantly fine-grained sediments mixed with organic material.

A blue crab hiding in the muck (top). Fiddler crabs were abundant along the perimeter marsh (right).

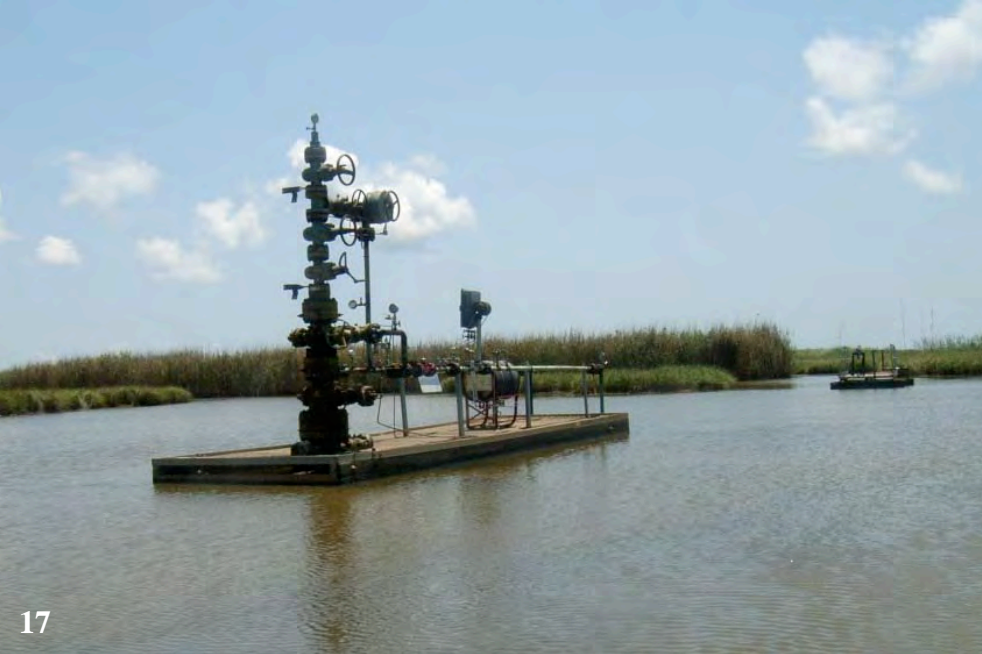
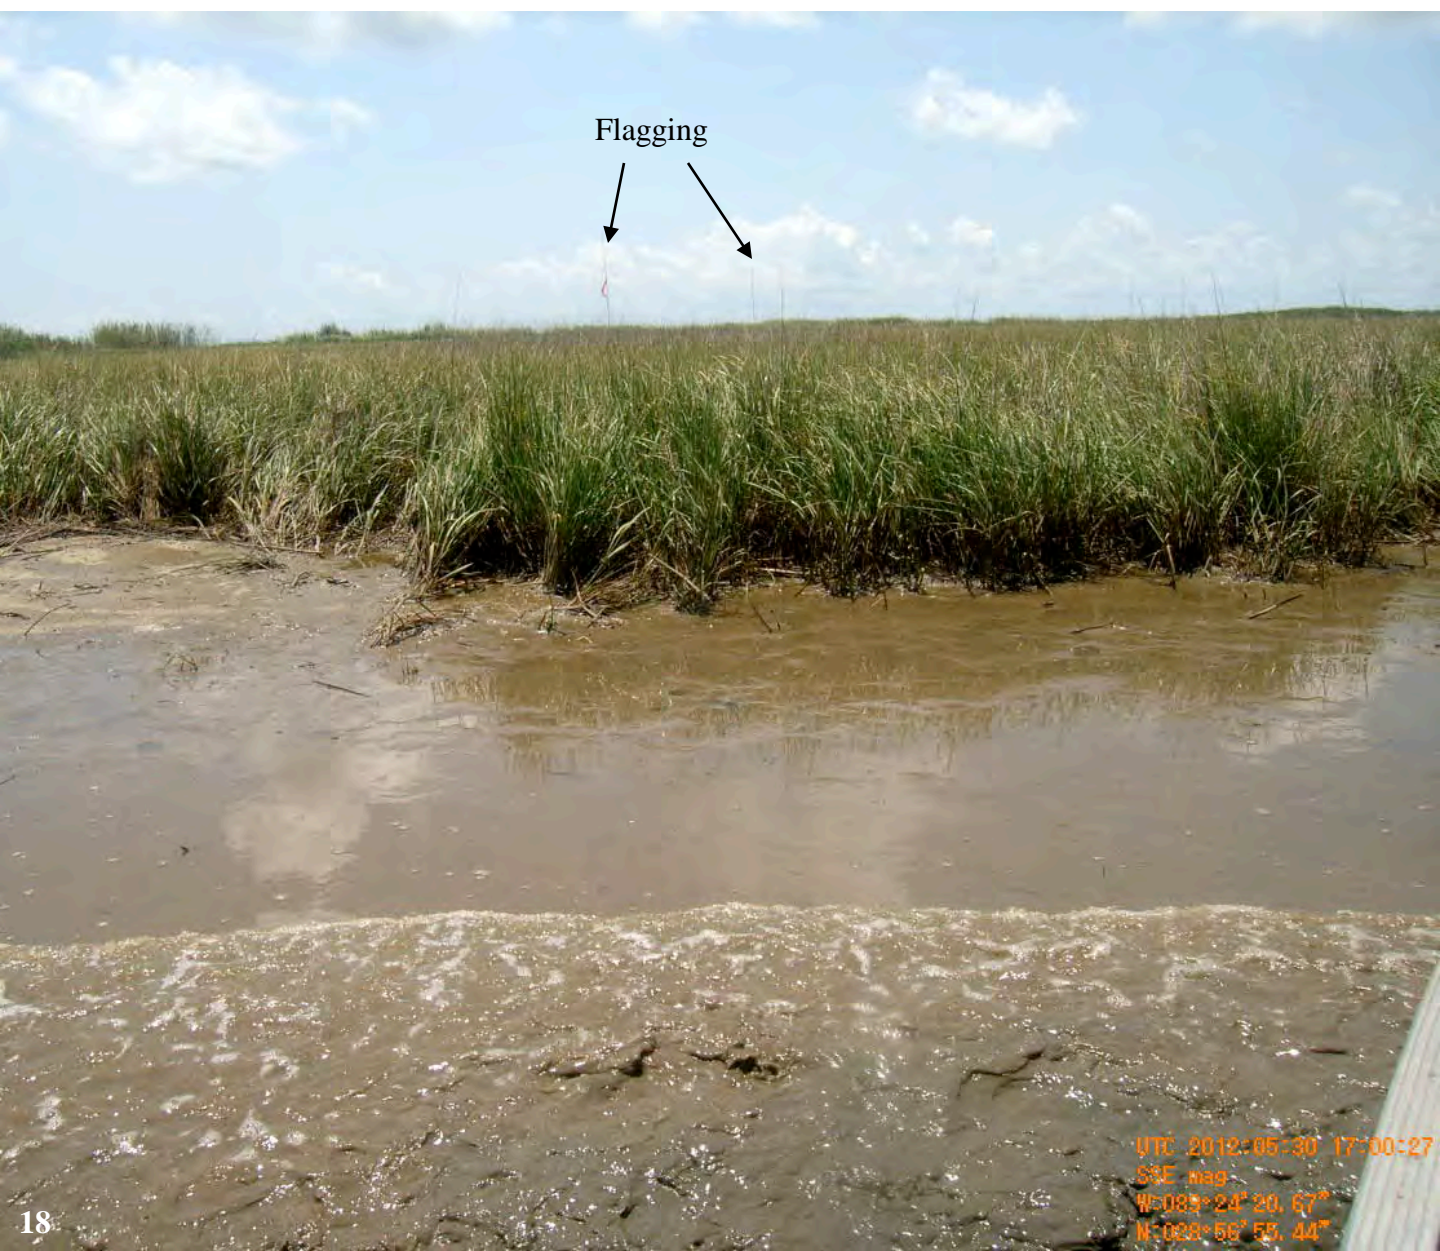
Pictures 17 & 18. Natural gas platform adjacent to the upper boundary of Placement Area #2 (left).

Survey flags within the disposal area, possibly marking one of the many pipelines crisscrossing thru the marsh alongside Southwest Pass (below).
