SUBJECT: IHNC Lock Replacement General Re-evaluation Report, Engineering  
Assessment of the Existing Lock Structure

## **Enclosure 1 – Pictures of Structural Deficiencies**

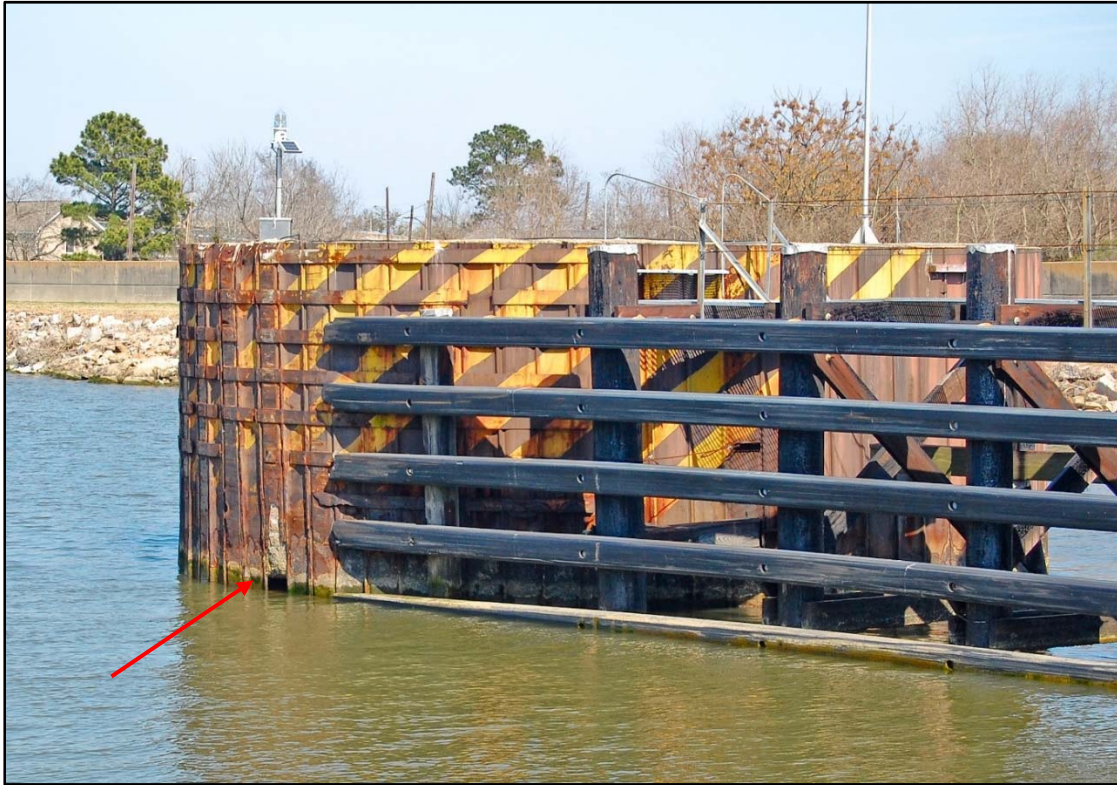
IHNC Dolphin NE-1-1.jpg

**The component exhibits a clear mode of failure:** The corroded sheet pile below the pile supported concrete inner wall is allowing the stability fill to spill out into the water. The result is loss of impact resistance.

The component has already failed. With the loss of stability fill through the corroded sheetpile, it will not sustain impact. If it sustains a vessel impact, it will fail and crumble into the channel. Failure of the nose pier will expose the guard wall to head on vessel impacts, which it is not designed for. Because of the narrow width of the lock chamber (74') and the maximum width of barge tows that travel through the lock (70'), it's highly likely a vessel impact will occur in the future.

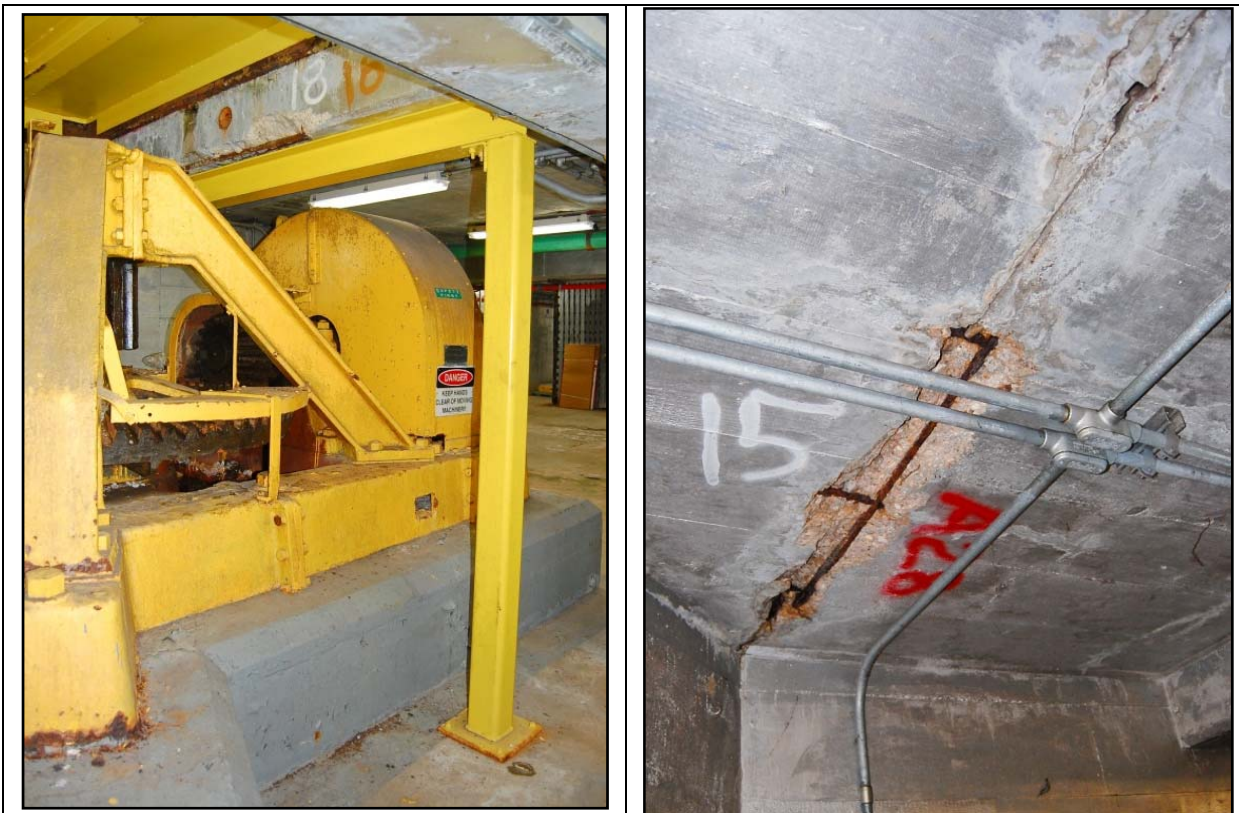
Pictured are main gate and reverse head gate strut arm openings on NW side of chamber that support the edge of the lock wall deck. These two pictures are typical for all eight machinery room/strut arm openings and show severe spalling exposing the rebar support system.

Steel beam and steel support column placed to reinforce failing concrete deck beam.

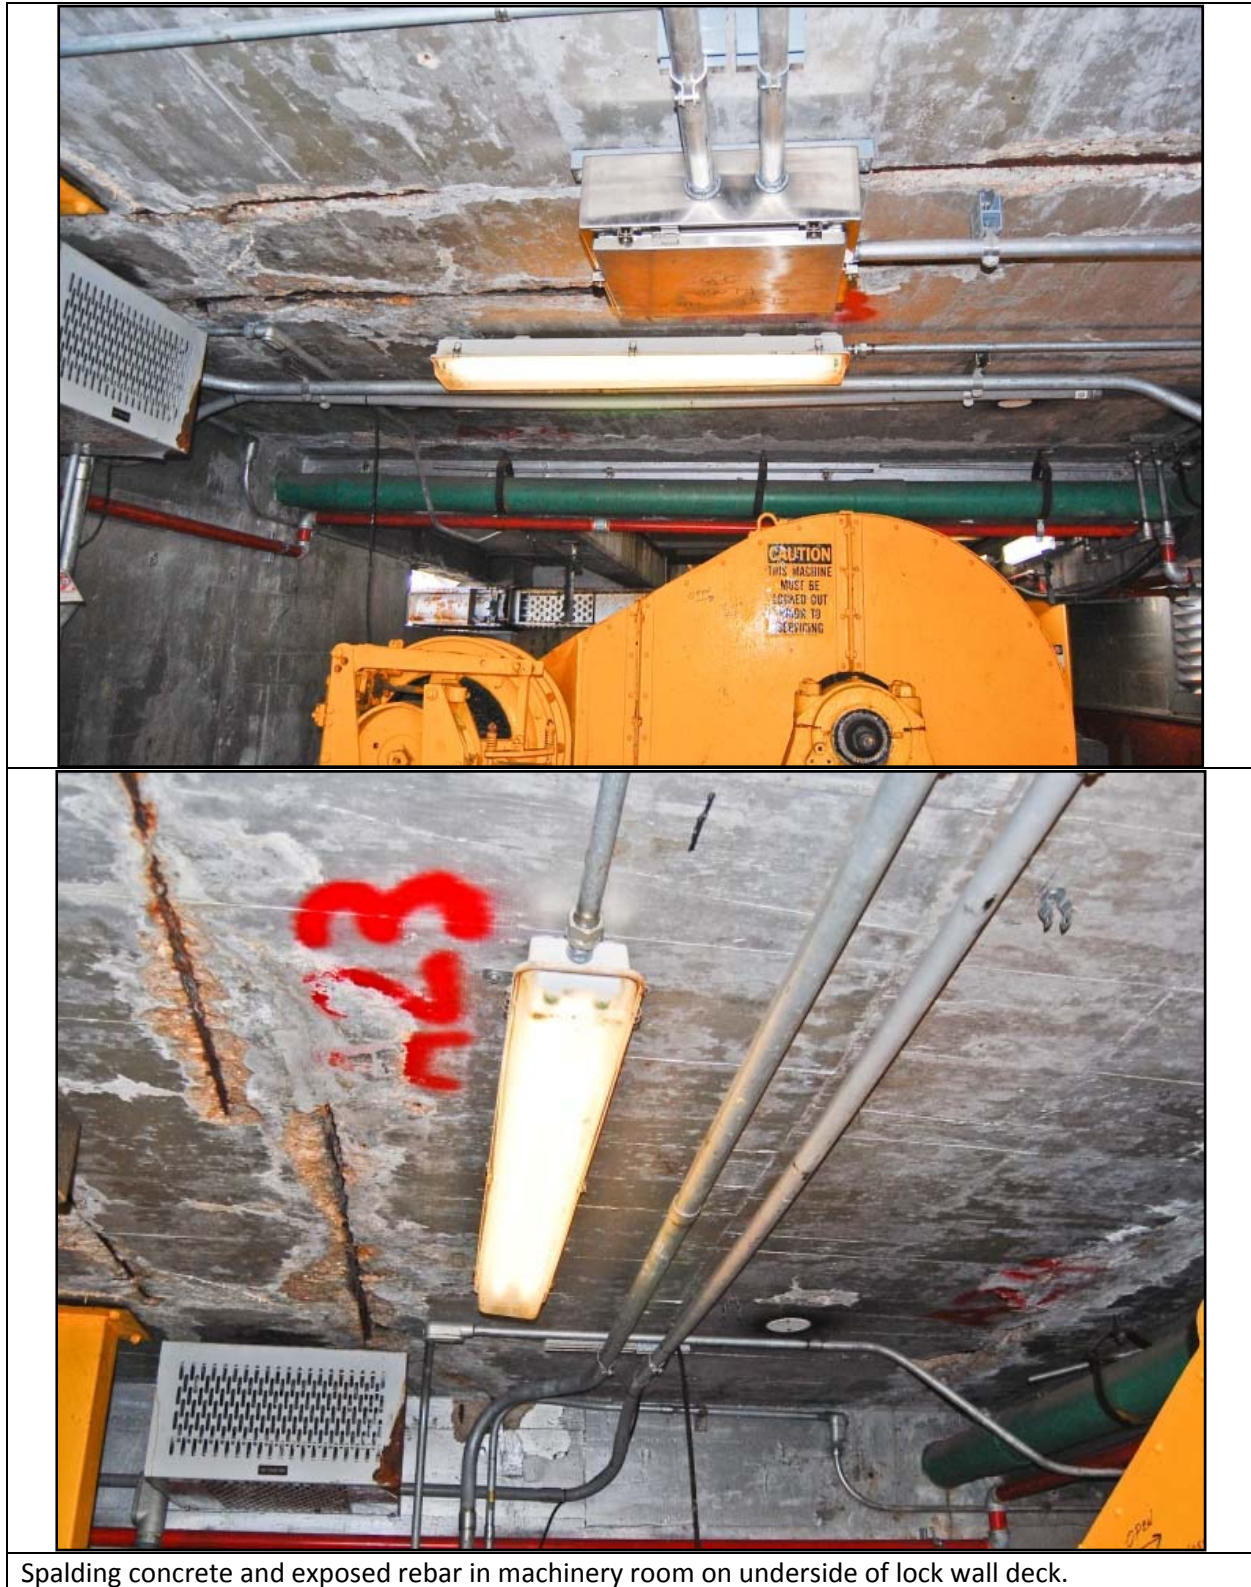
Spalling concrete and exposed rebar in machinery room on underside of lock's west wall deck.

Spalling concrete and exposed rebar in machinery room on underside of lock wall deck.

Columns and beams in each of the machinery rooms exhibit severe spalling of concrete to point of exposing rebar. The steel reinforcing is severely corroded exhibiting significant section loss and some locations the rebar is completely corroded and missing. Additionally, spalling and corrosion is also present in walls, floor and ceilings of the tunnels and machinery rooms.

**The component exhibits a clear mode of failure:** Reinforcing steel in columns and beams is severely corroded exhibiting significant section loss and some locations the rebar is completely corroded and missing. As a result, the capacity of these components is reduced. If the columns or beams were to fail, the result would be damage to the operating machinery causing a shutdown of the lock. Due to the reduced capacity, operational restrictions have been put into effect at the lock to prevent significant live loading above the machinery rooms.

**Safety Concern:** If one of these beams fail while someone is in the machinery room or walking on the lock wall above the failed area, severe injury or death could occur.

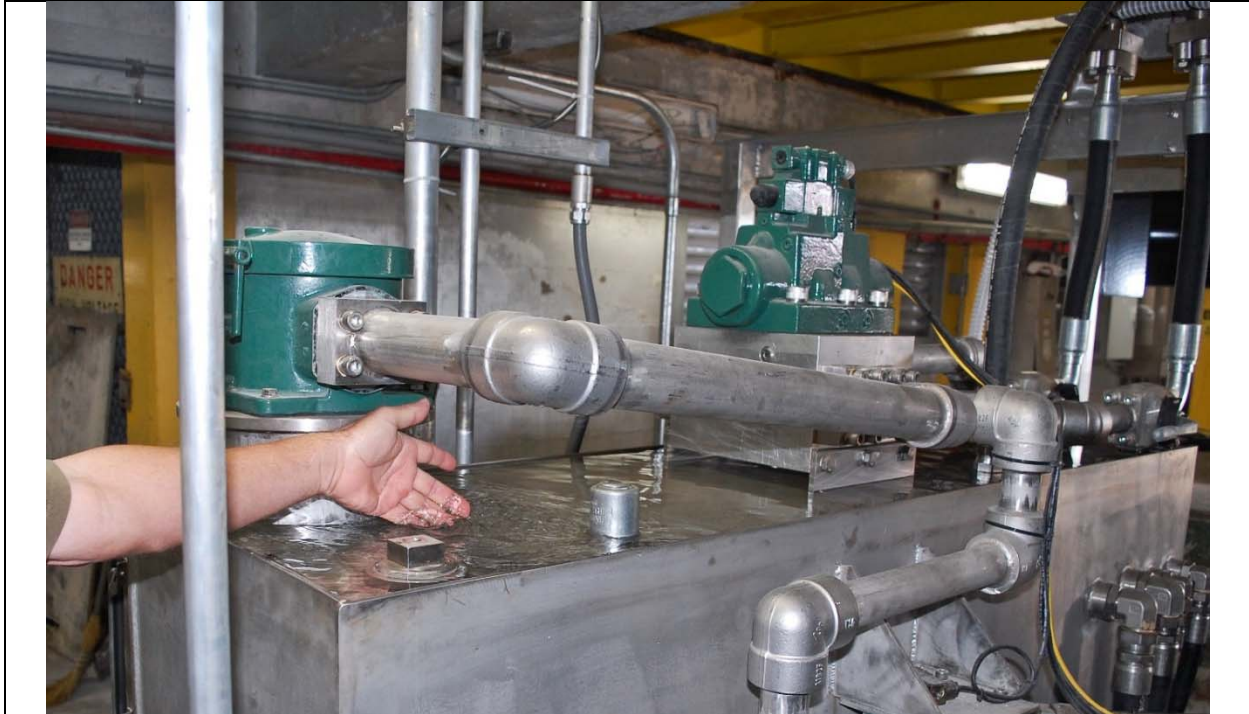
Leaking water collecting in oil retention basin. IHNC 09 Sep 16 Dewater Machinery New Flooded-2-4.jpg

Cracked and spalled concrete hatch covers, rusted out steel frames with significant and missing section loss.

**The component exhibits a clear mode of failure:** The cracked covers and leaking frames is leading to increased section loss of frames and increasing risk of cave-in.

**Project Functionality Affected:** There is water leaking in through all of the deficient hatch covers creating maintenance issues such as having to manually clean out oil containment basins under the machinery.

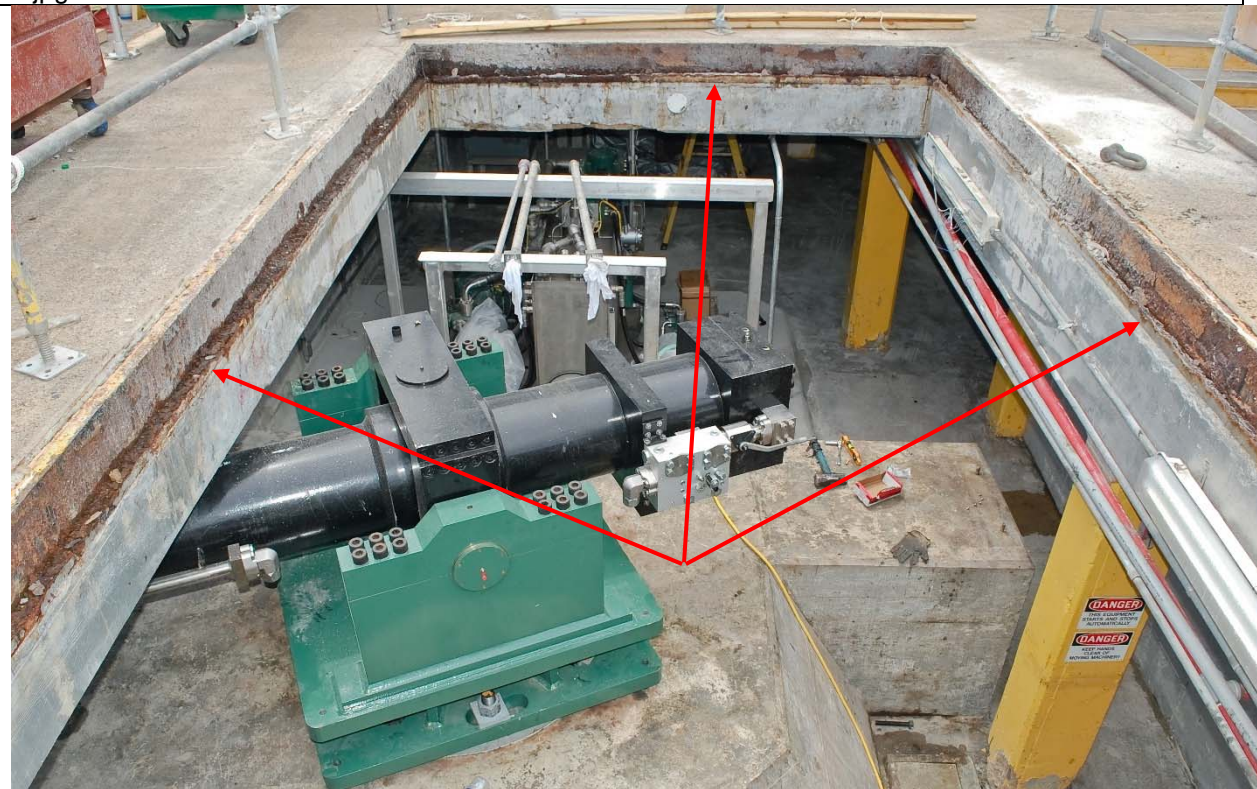
Machinery opening showing steel frame with rusted out water diverting lip gone from the opening recess. IHNC 24 Aug 16 Dewater Gate 7 Cylinder New-7-7.jpg

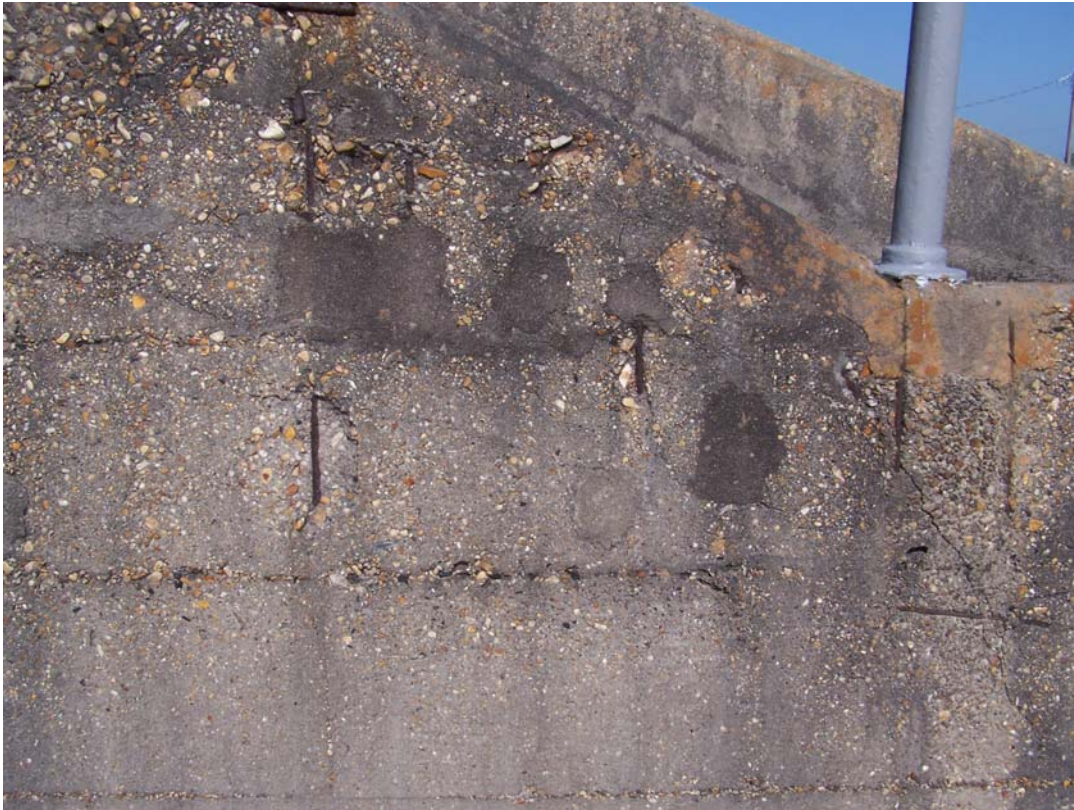
**Photo 3** Spalling, cracks, and exposed steel in the wall below stairs between gates 7 and 9 on northwest side of lock.

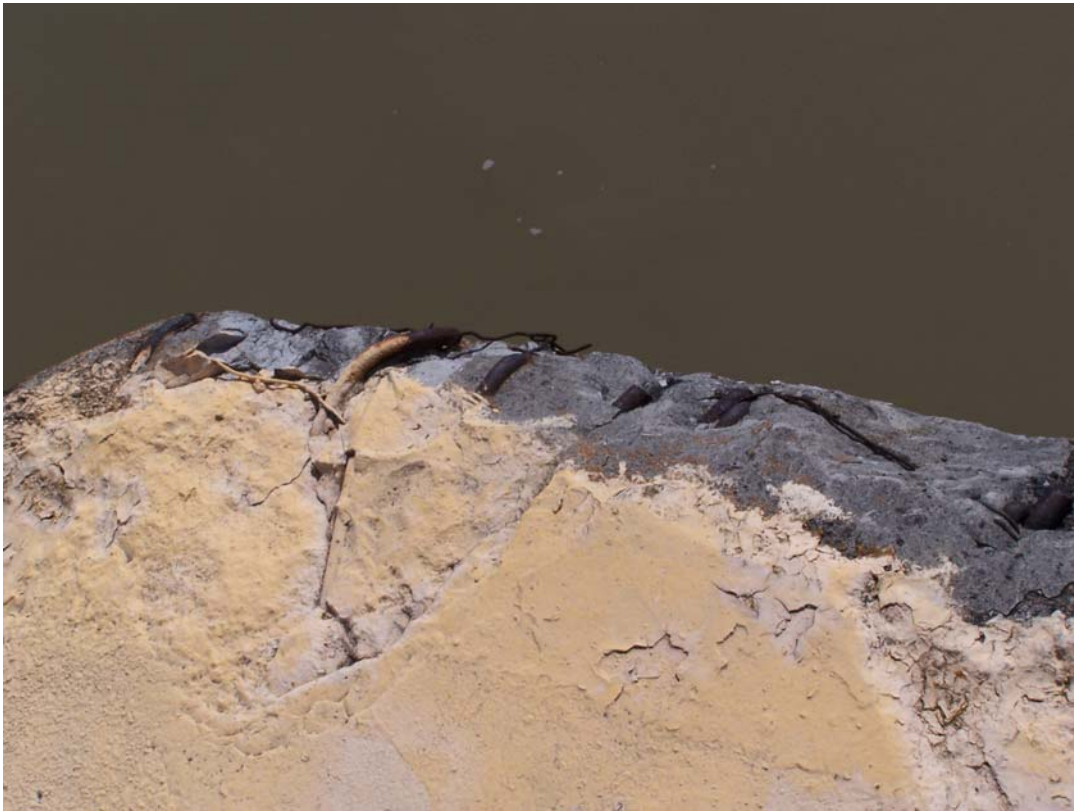
**Photo 7** Spalls in the northeast corner of the northwest gatebay

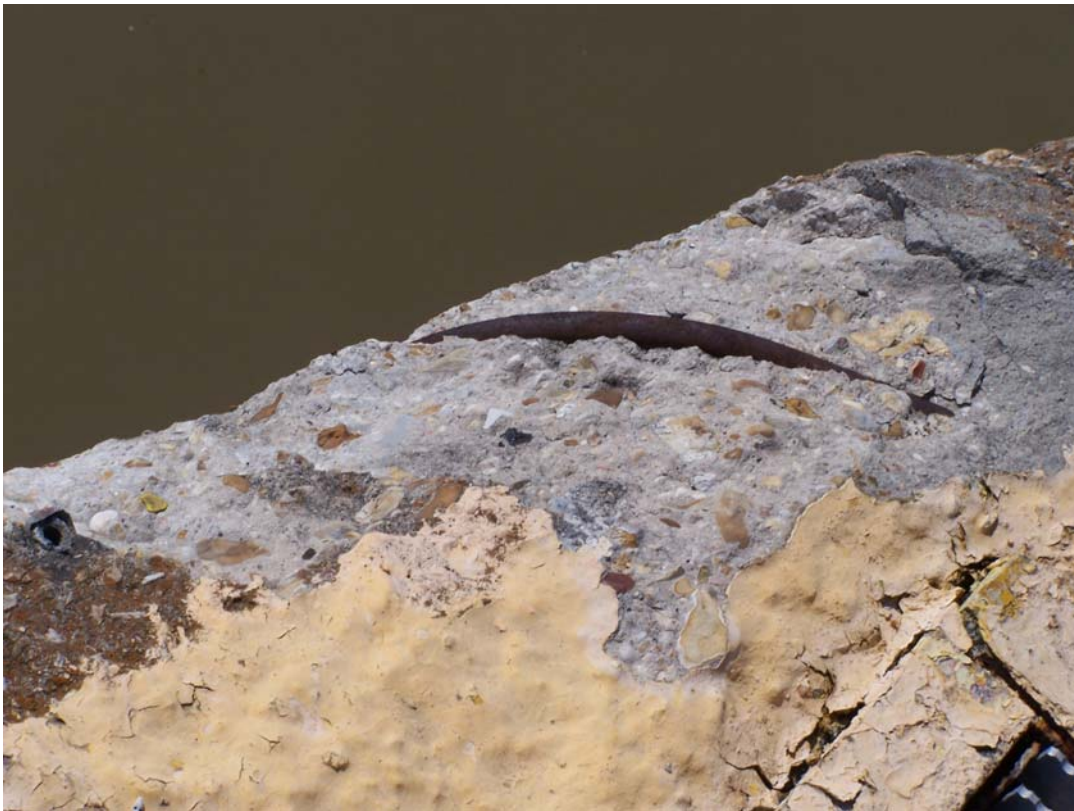
**Photo 8** Spalls in the northeast corner of the northwest gatebay. Appears to be new.

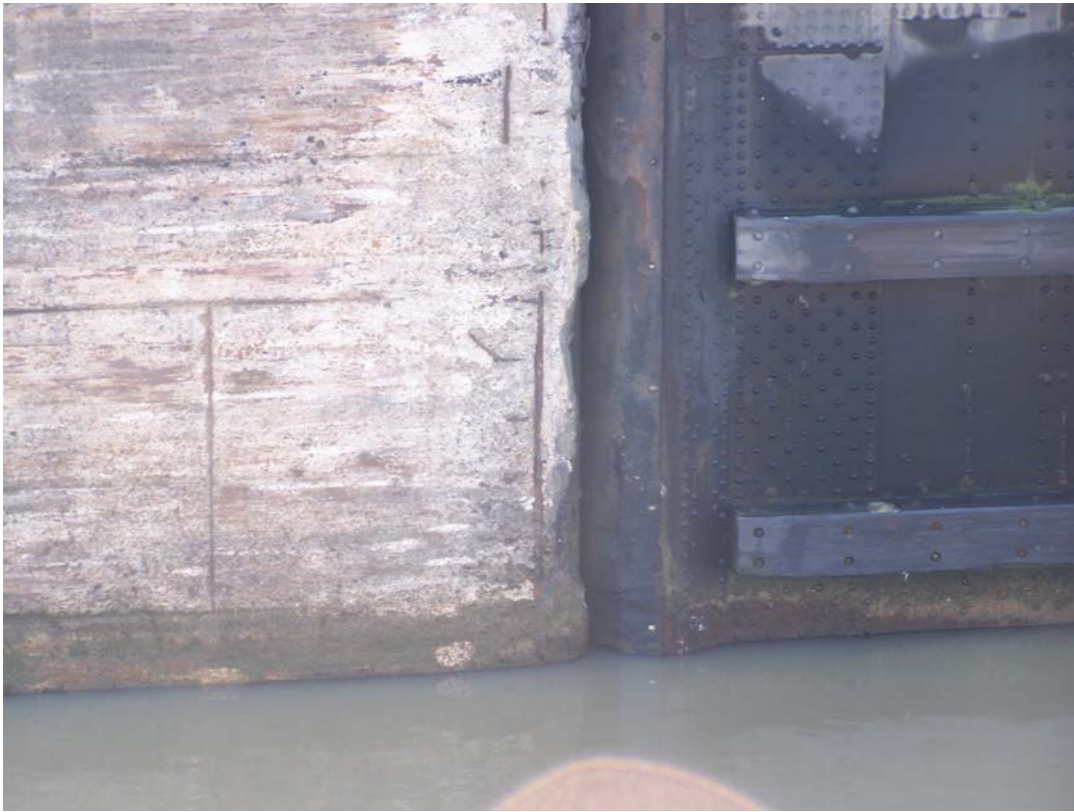
**Photo 9** Spalling with exposed steel in the northeast gatebay near the hinge

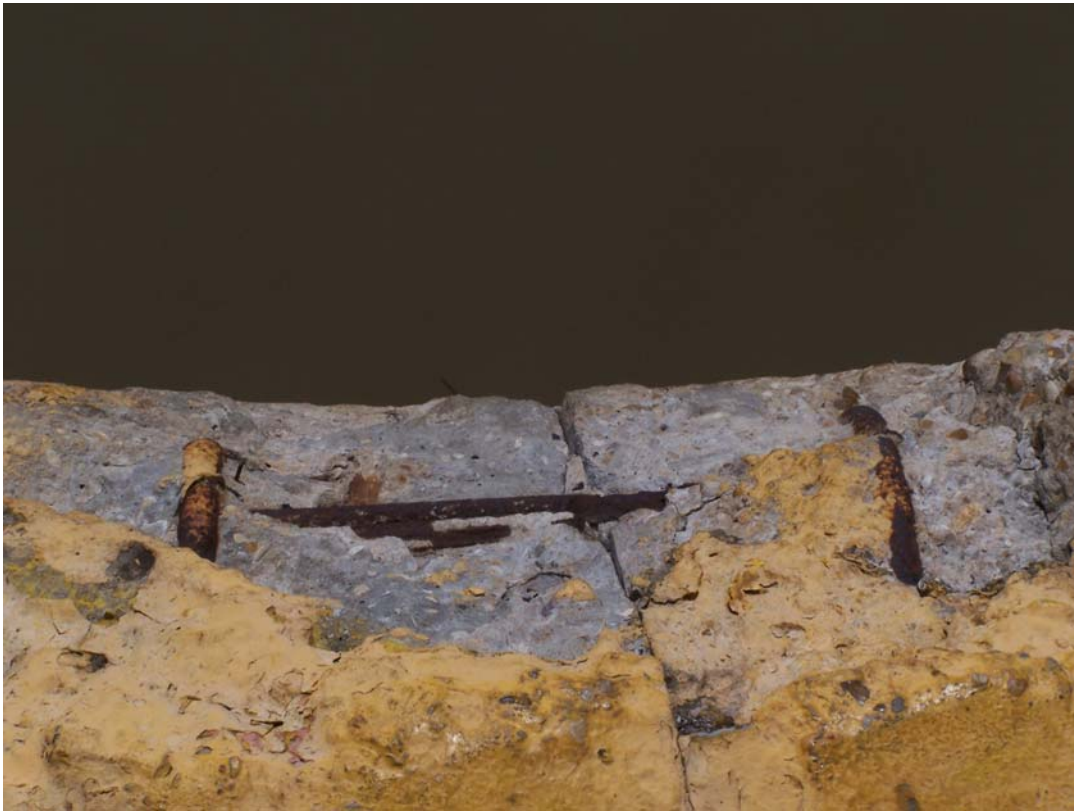
**Photo 15** New spall with exposed steel in top of west chamber wall.

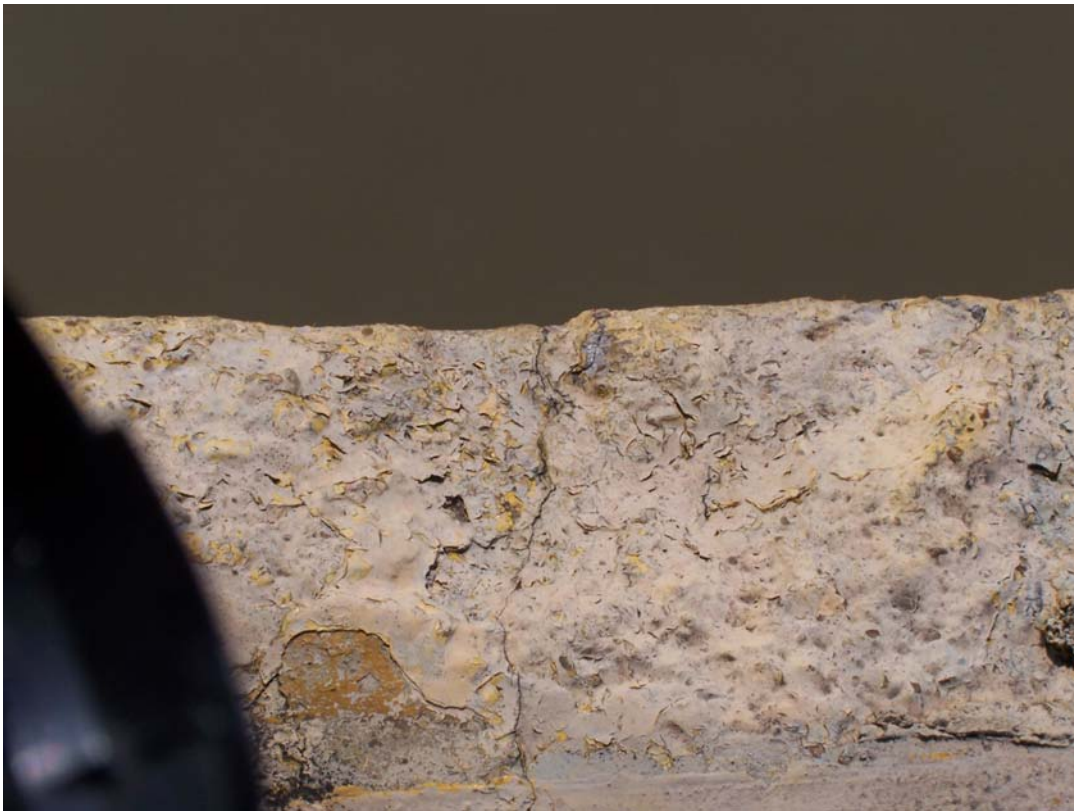
**Photo 16** Spall in top of west chamber wall near light pole number 9.

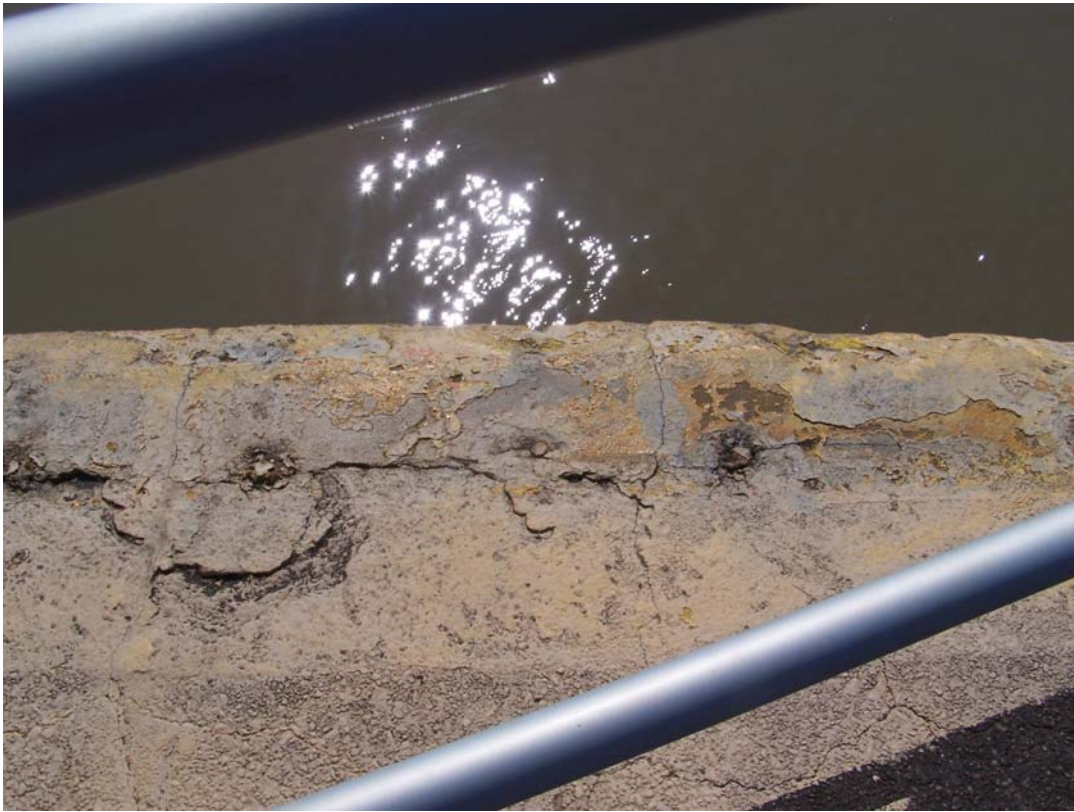
**Photo 21** Delamination (2'x1') along edge of west chamber wall.

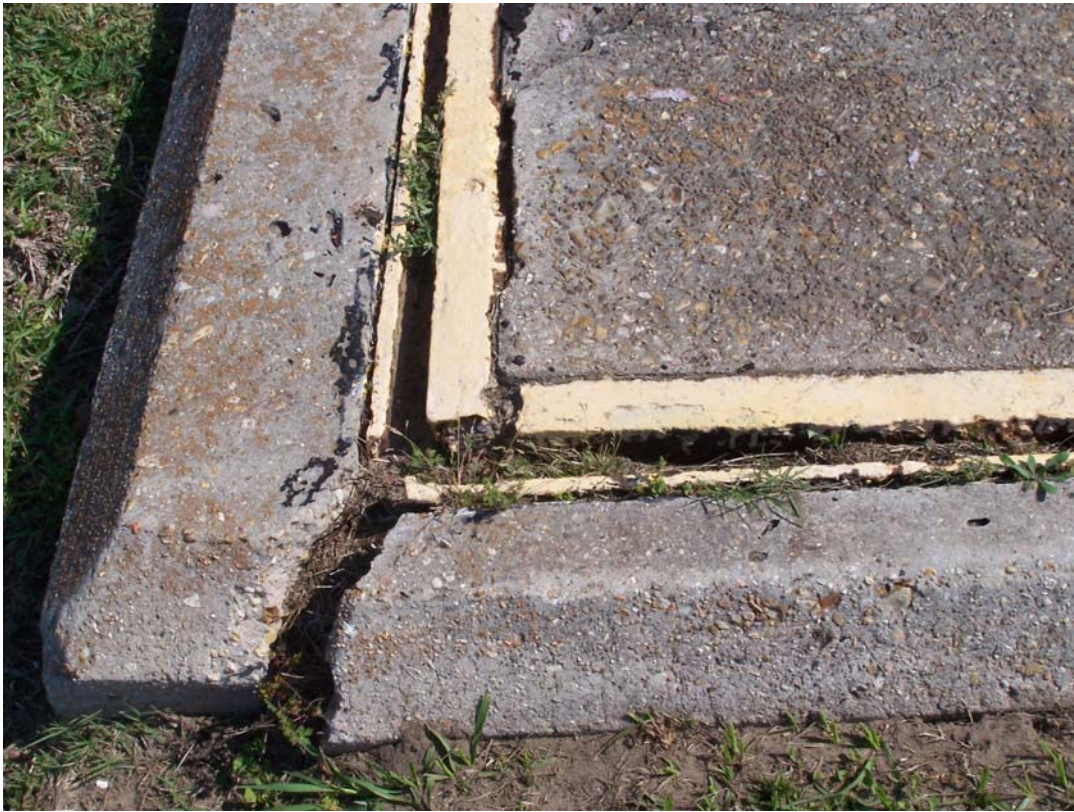
**Photo 23** Hatch cover behind the west chamber wall near reference marker 8W.

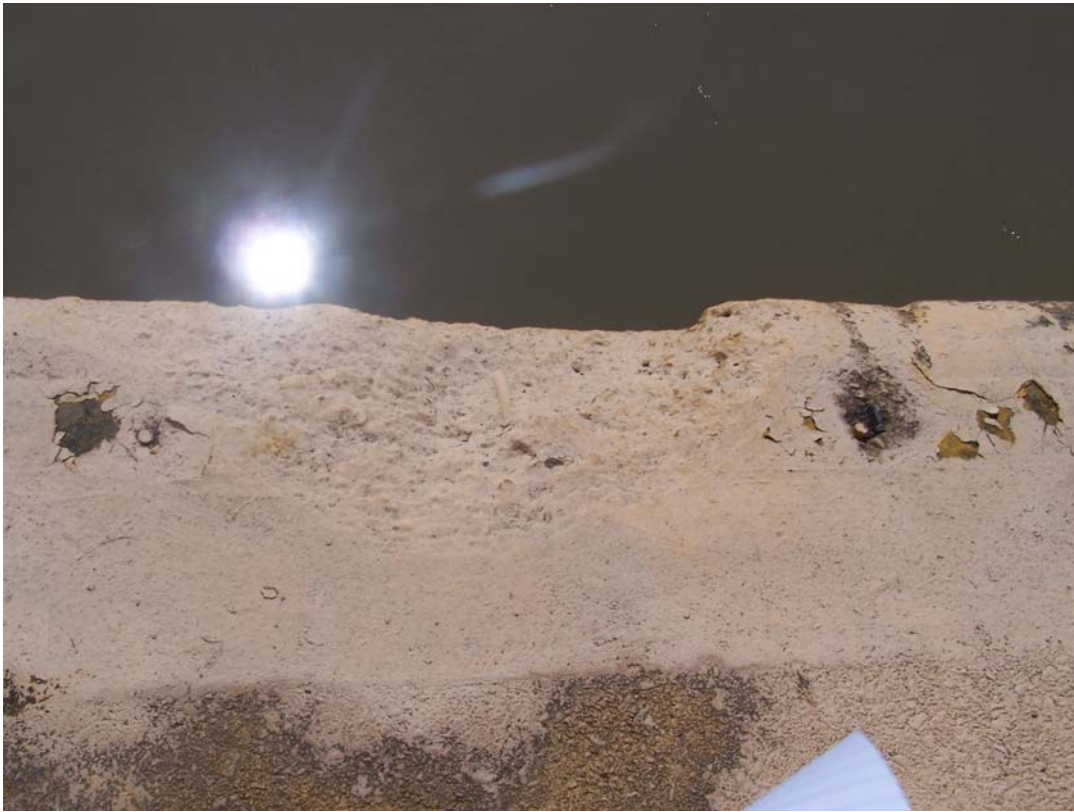
**Photo 27** Spall in top of west wall near the hinge for the river side gate.

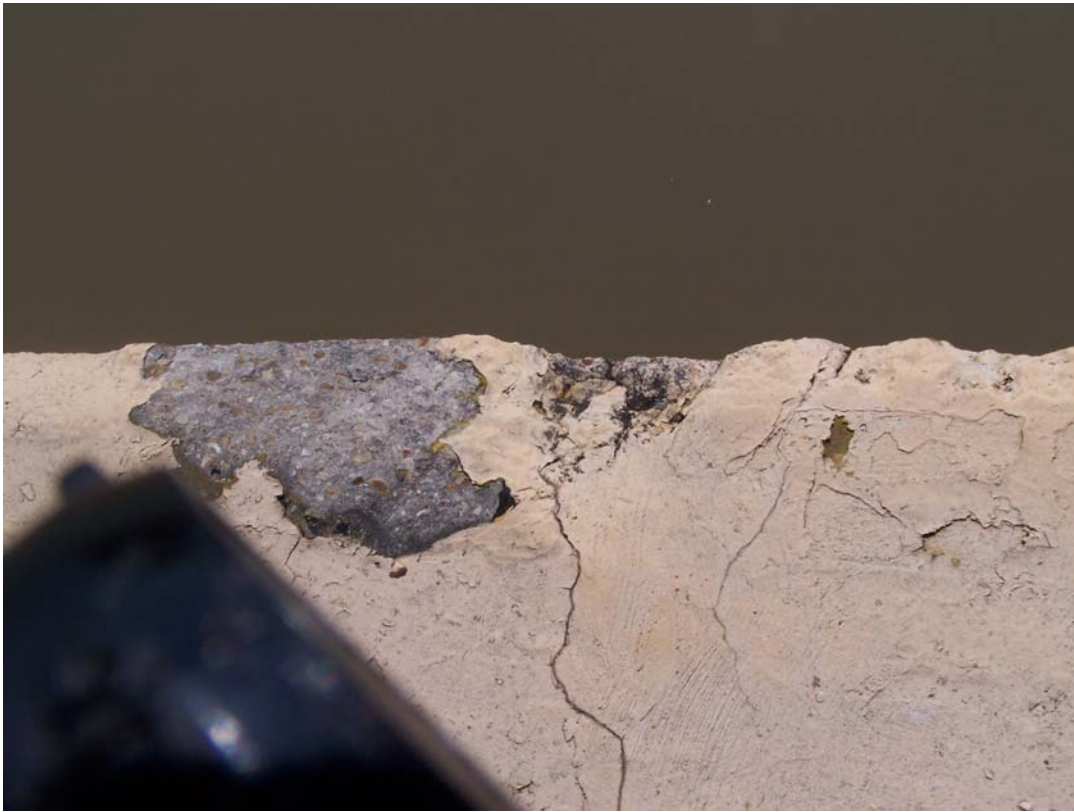
**Photo 31** Spalls in west river side gatebay.

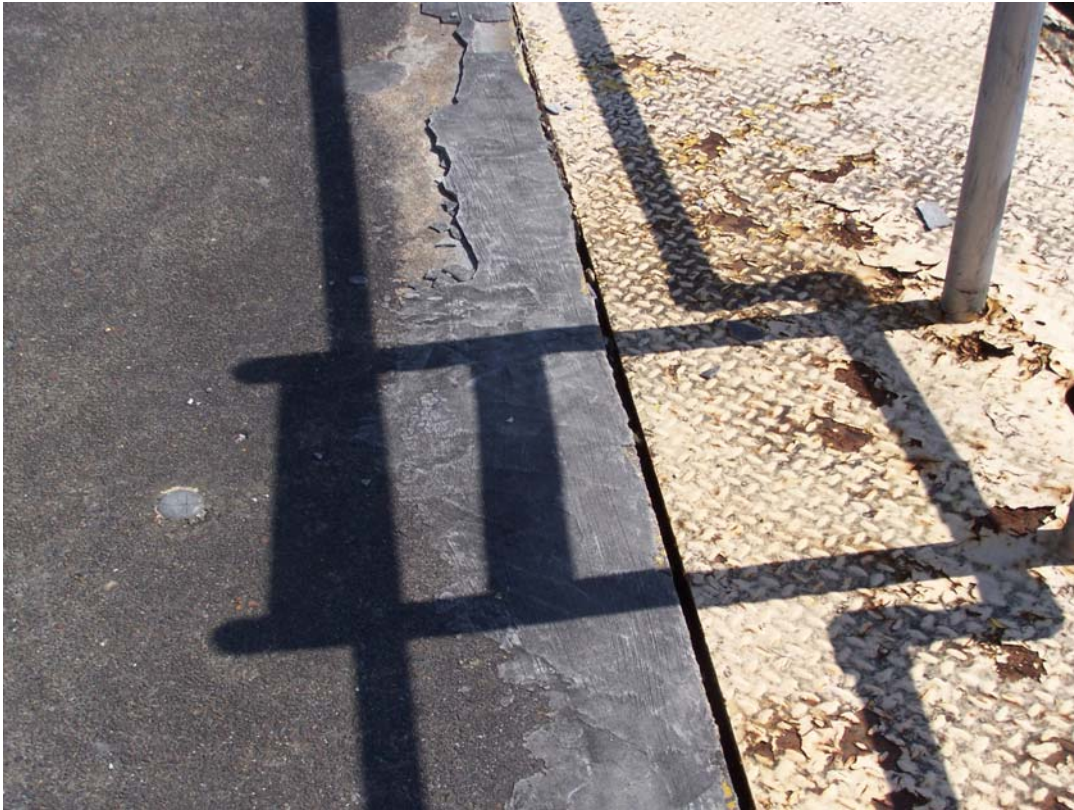
**Photo 33** Failing patch material around the steel plate over the bulkhead recess on the west river side.

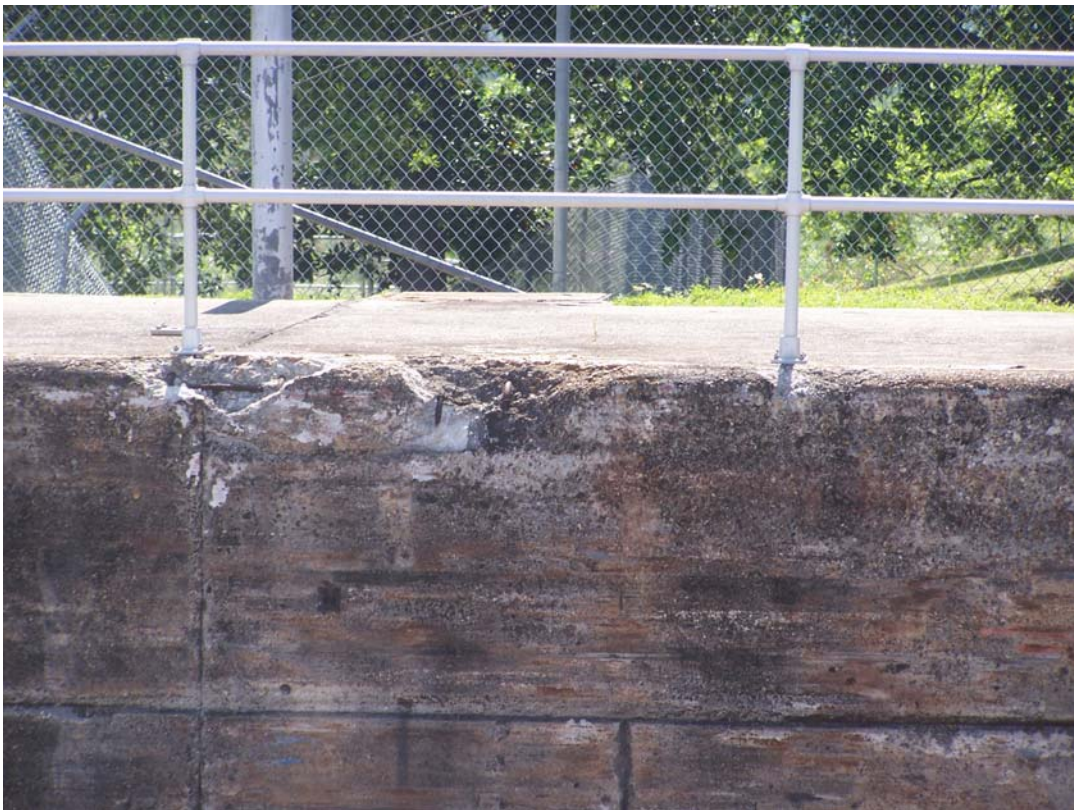
**Photo 34** Spalls with exposed steel on the east wall on river side near the gate for the bridge.

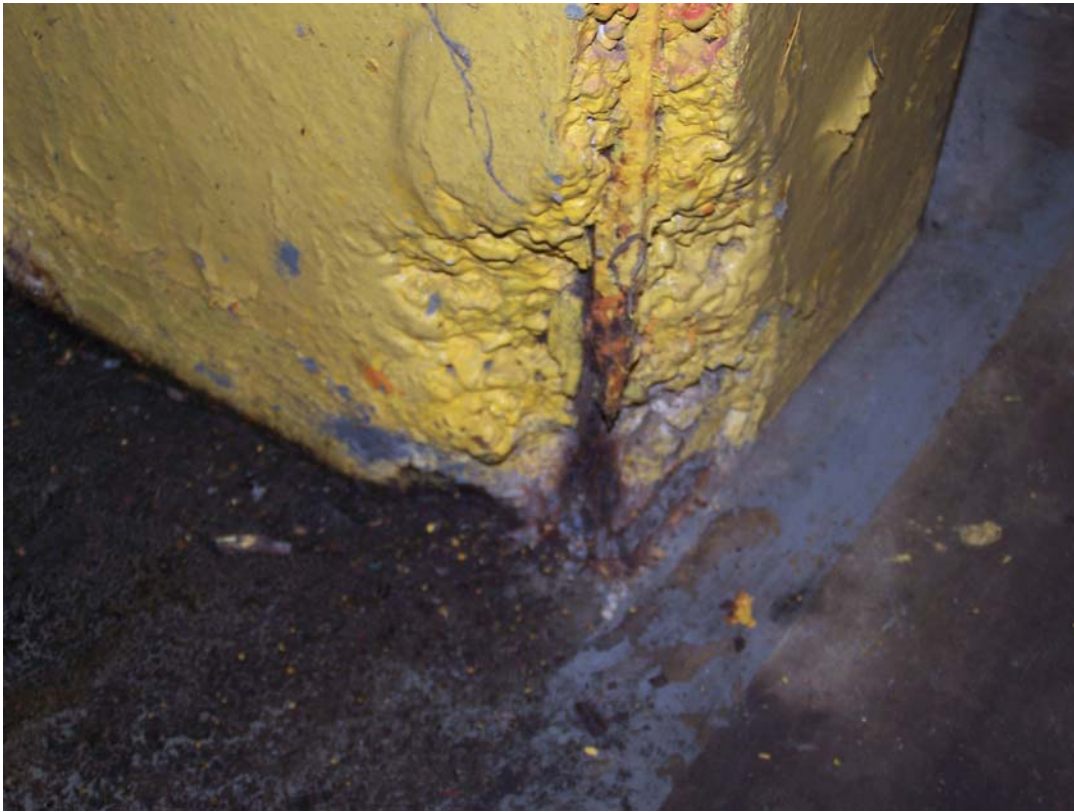
**Photo 37** Spall with corroded steel at the bottom of a column in machinery room #3.

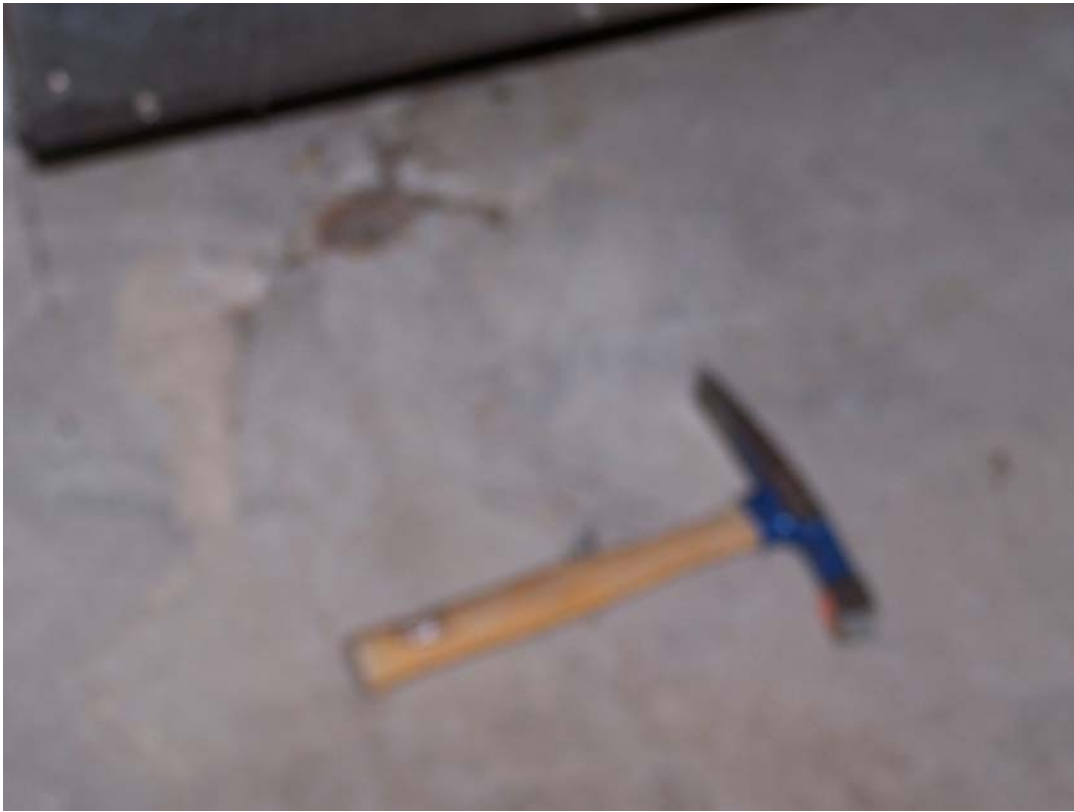
**Photo 39** 2'x2' delamination in the floor under the 480V distribution panel near Gate 3 hinge.

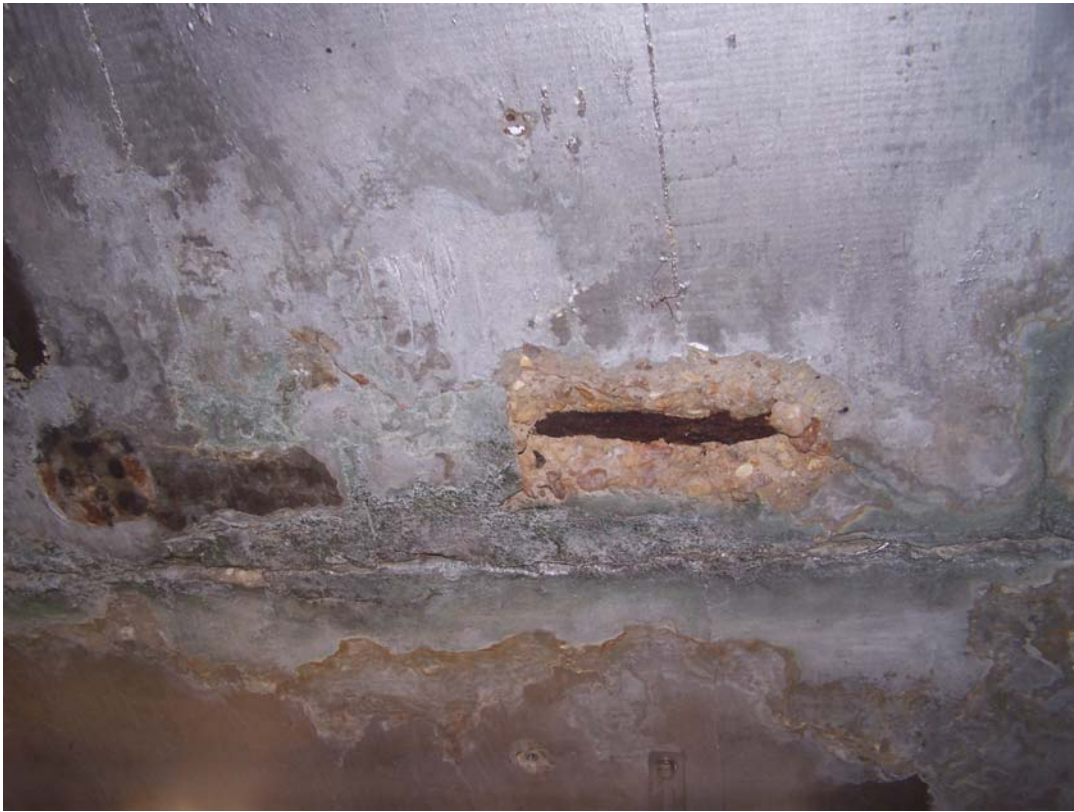
**Photo 43** Popout in ceiling near valve 11 caused by corroding steel.

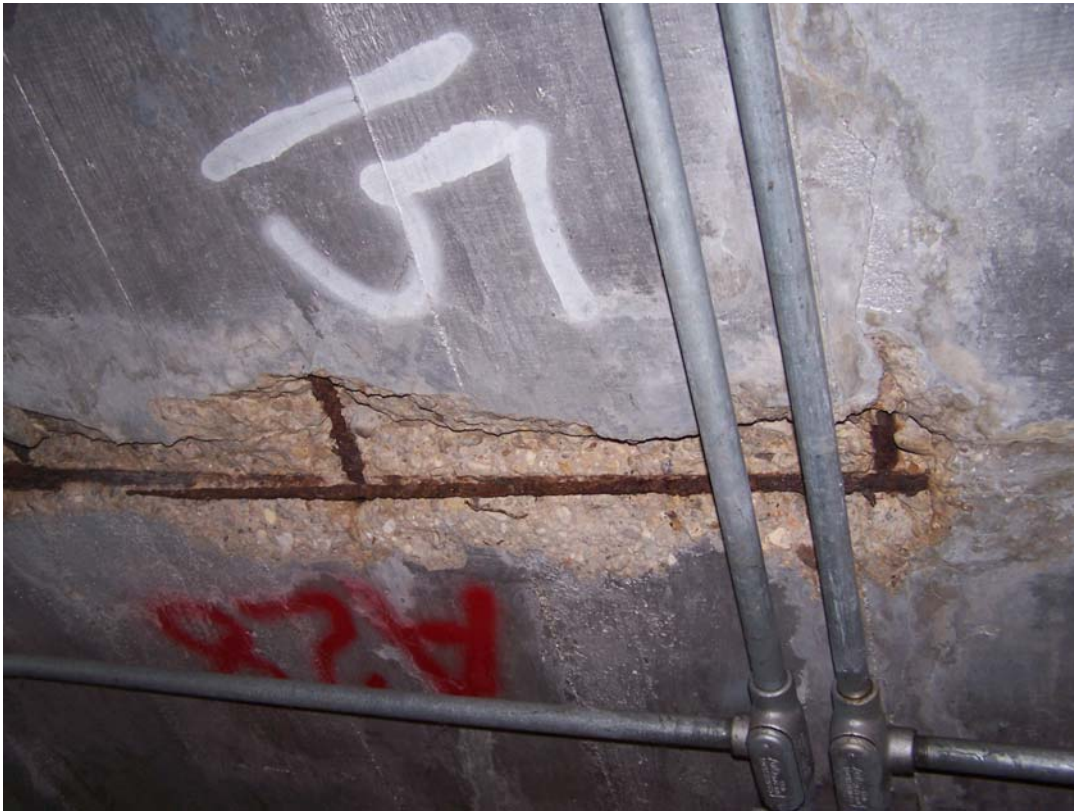
**Photo 45** Spalls in ceiling near valve 11 caused by corroding steel. Further deterioration since last inspection.

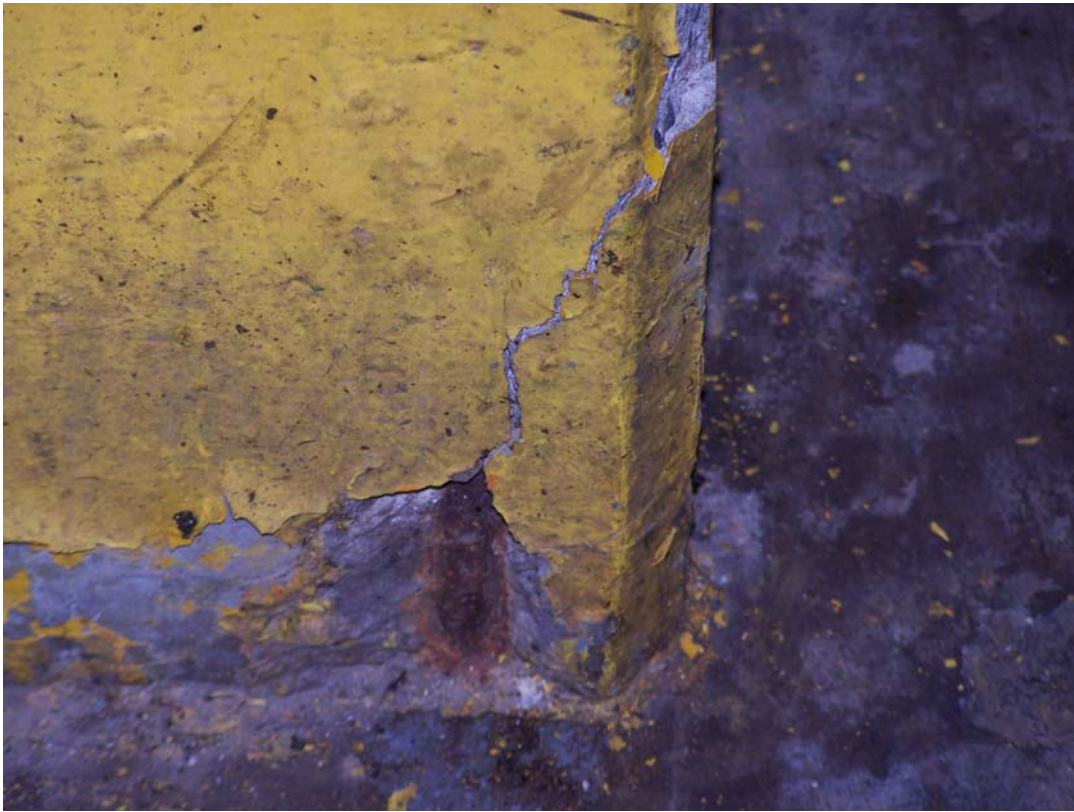
**Photo 49** Spalls and delaminations at bottom of columns on both sides of hinge for gate 1.

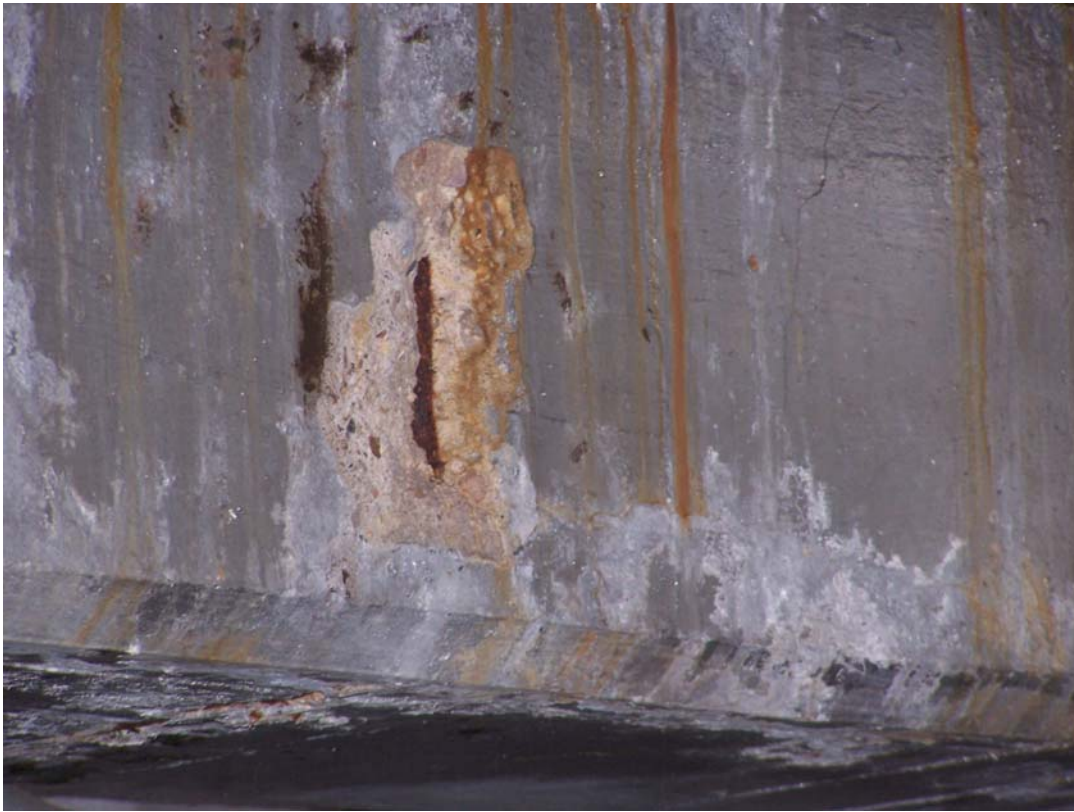
**Photo 51** Popout in beam over gate 1 hinge.
