SUBJECT: IHNC Lock Replacement General Re-evaluation Report, Engineering  
Assessment of the Existing Lock Structure

## **Enclosure 1 – Pictures of Structural Deficiencies**

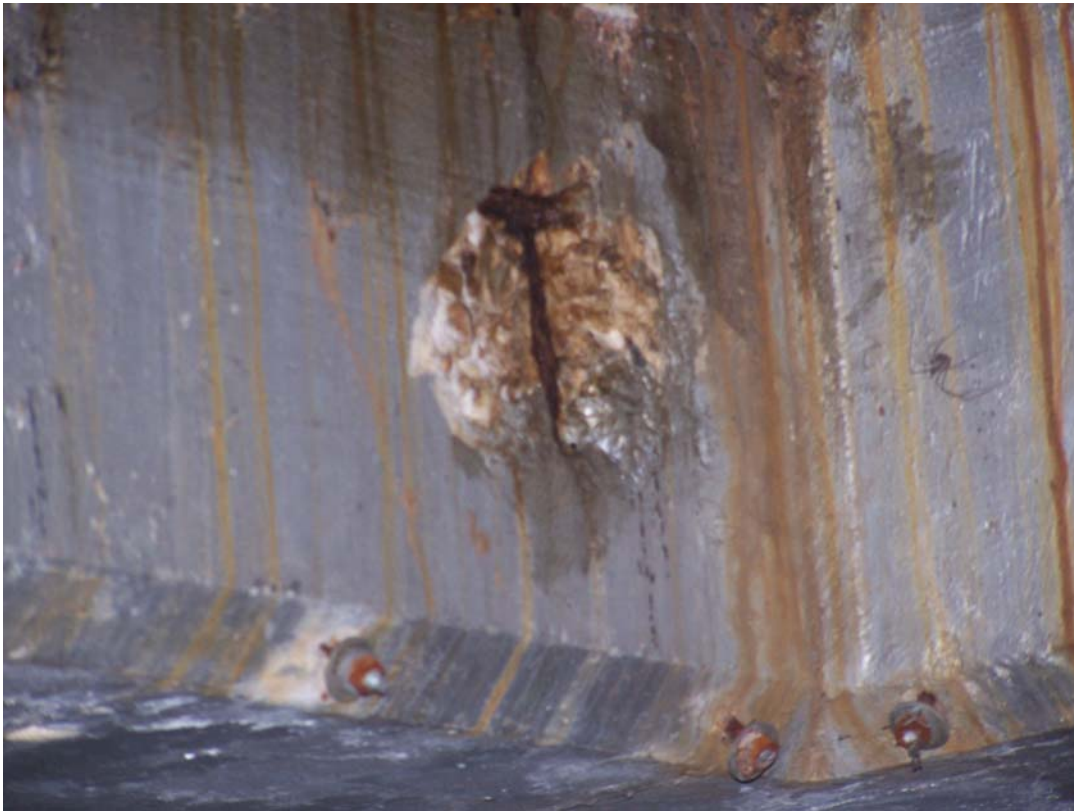
**Photo 53** Popout in beam over valve 12 caused by corroding steel.

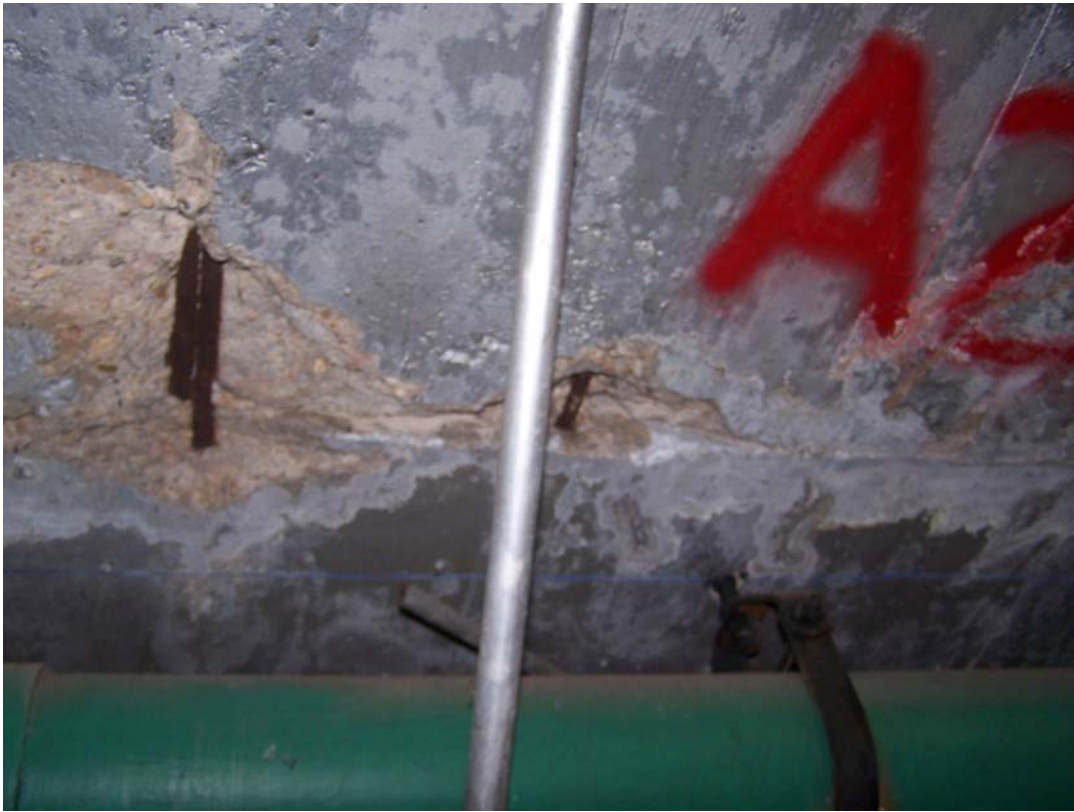
**Photo 55** Spalling with corroded steel in ceiling over gate 3 machinery.

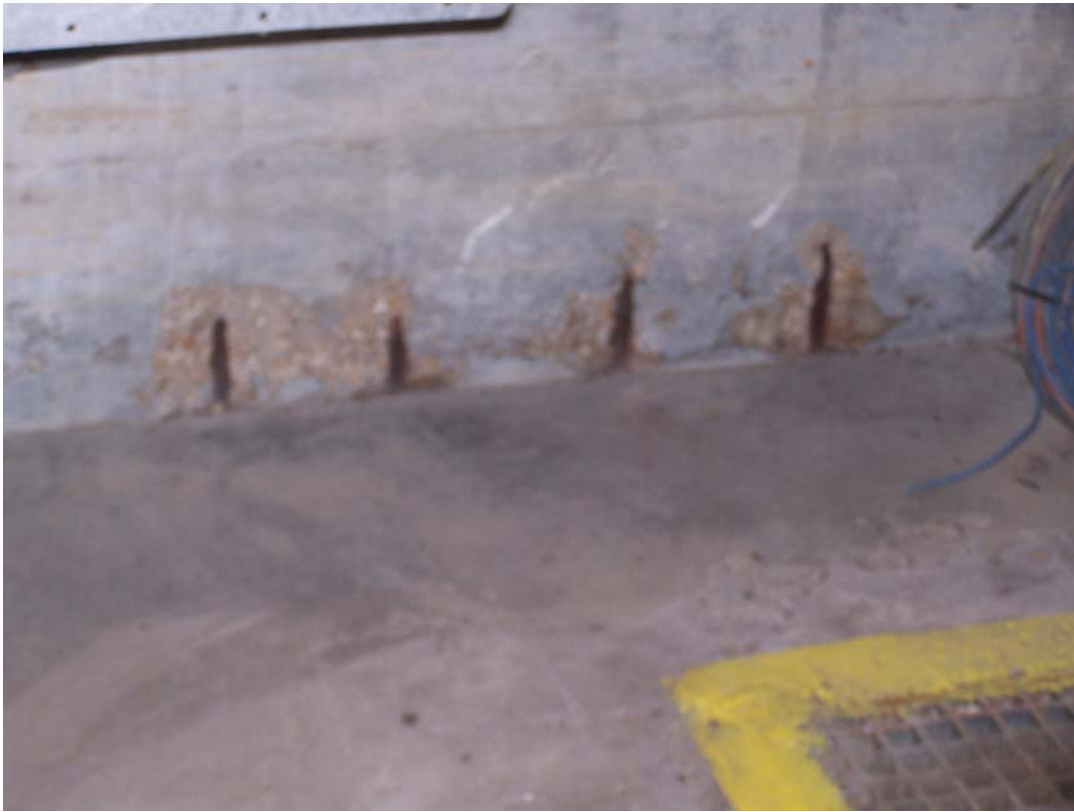
**Photo 57** Spalls caused by corrosion of steel at the bottom of the wall in room 3.

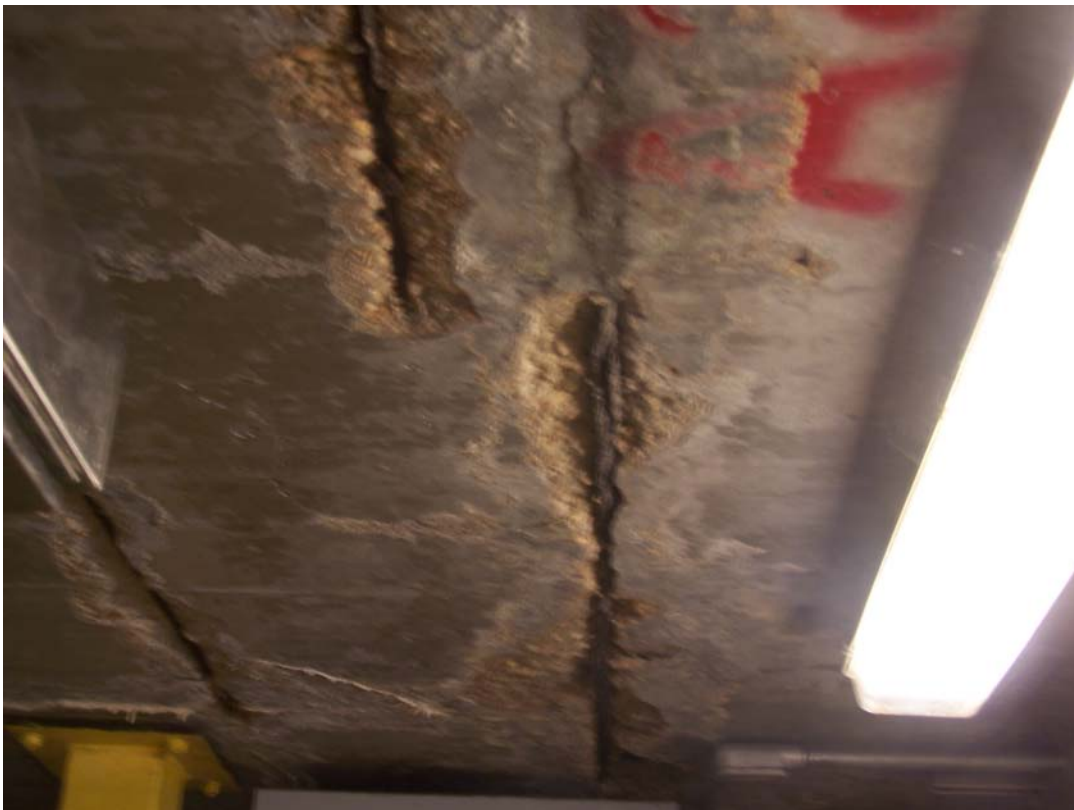
**Photo 58** Spalls and popouts in the ceiling of room 3.

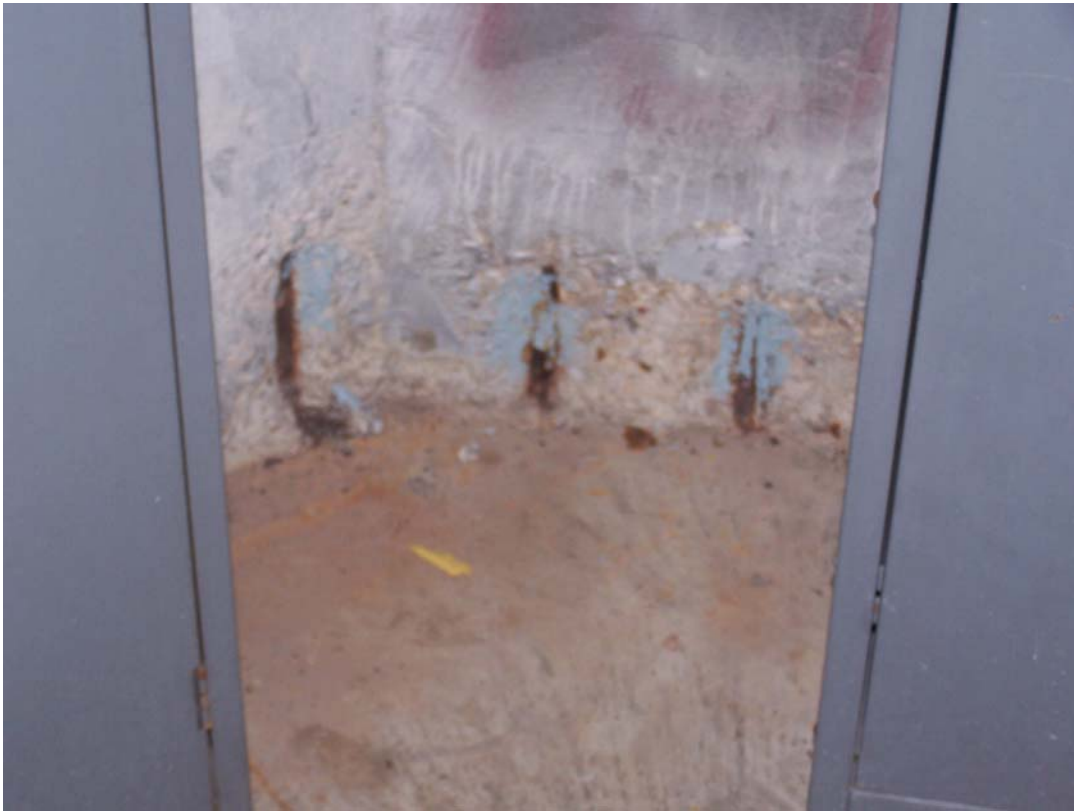
**Photo 65** Popouts at the bottom of the wall in room 3.

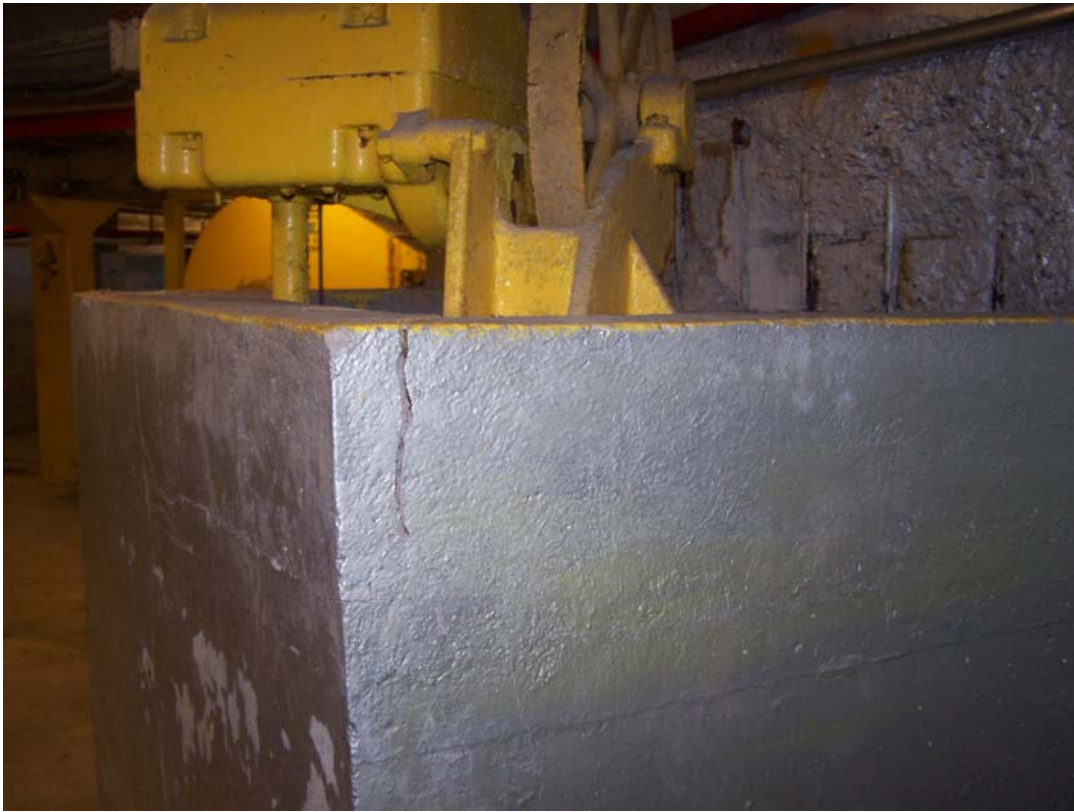
**Photo 83** Cracks in top of wall around sump pump in room 5.

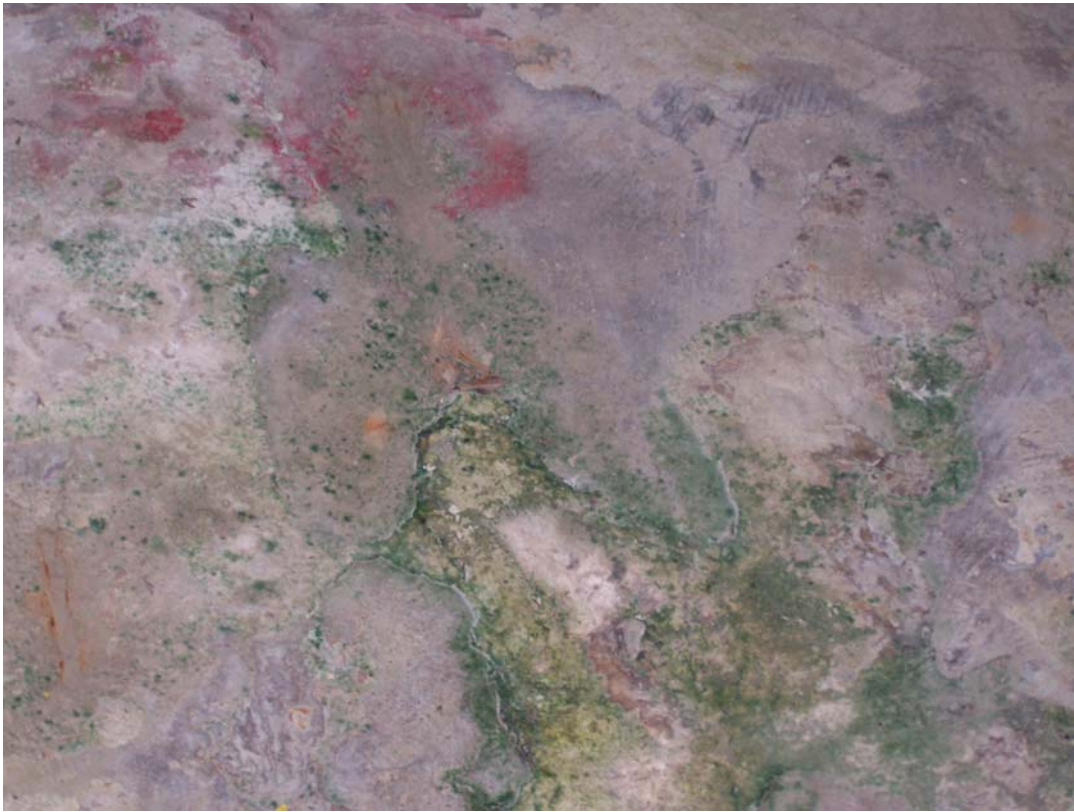
**Photo 85** Failed patch in the floor of room 5.

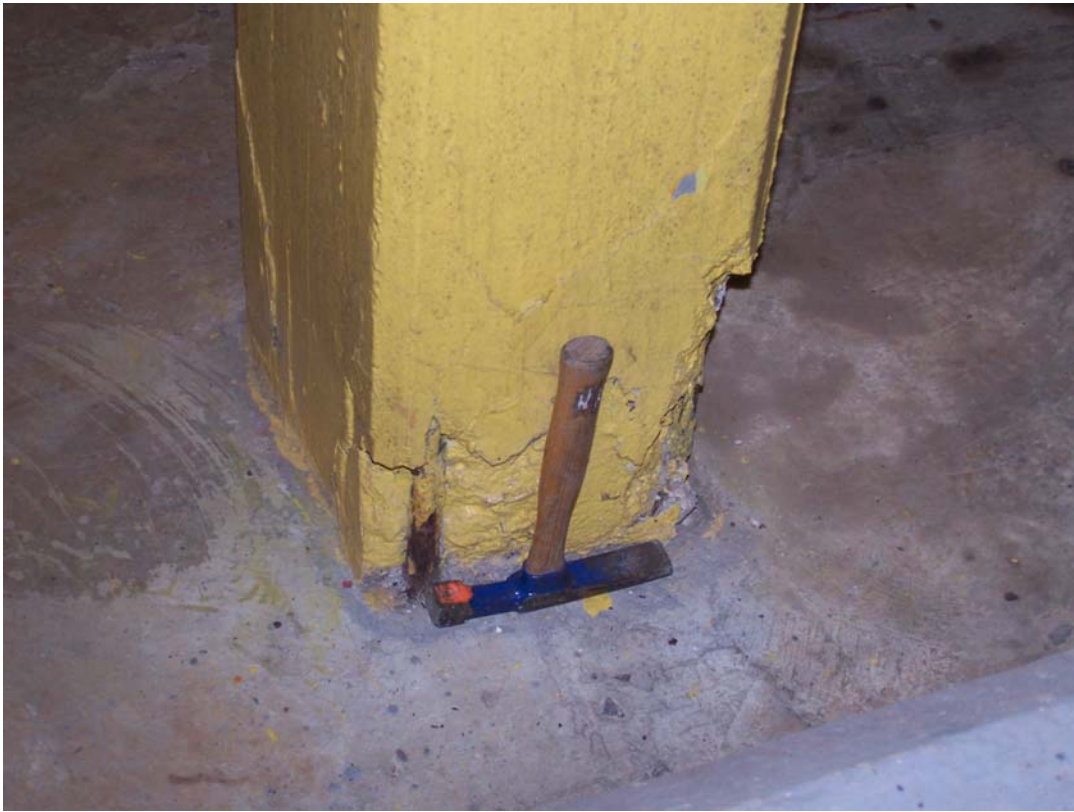
**Photo 89** Spall at the bottom of column in Room 5. Delamination continues about 19" up.

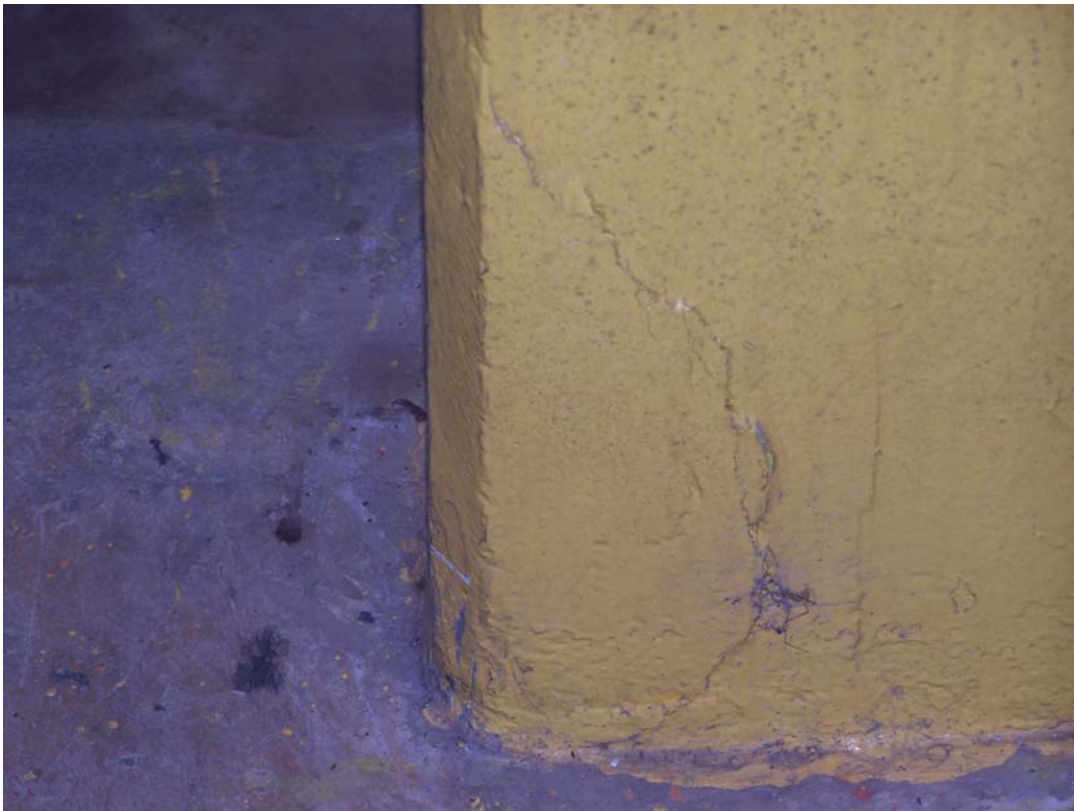
**Photo 90** Corner of column in Room 5.

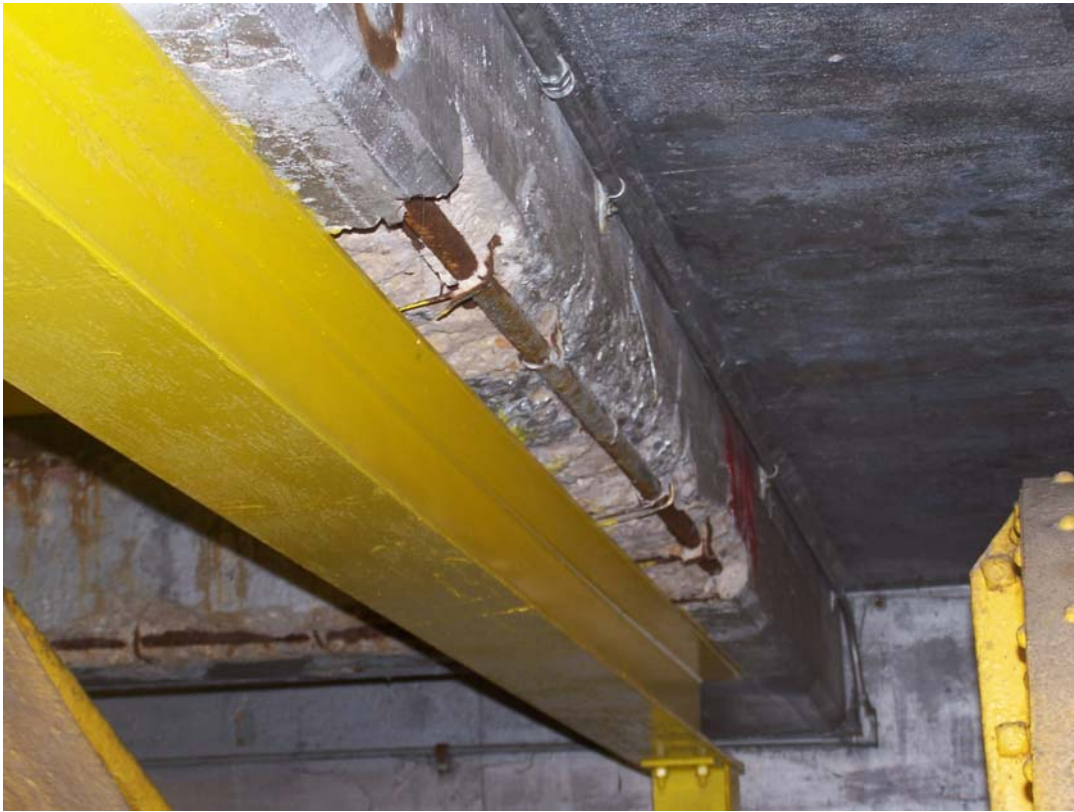
**Photo 93** Spalls and corroded steel in beams over machinery in room 5. Note steel beam and columns added to support these beams.

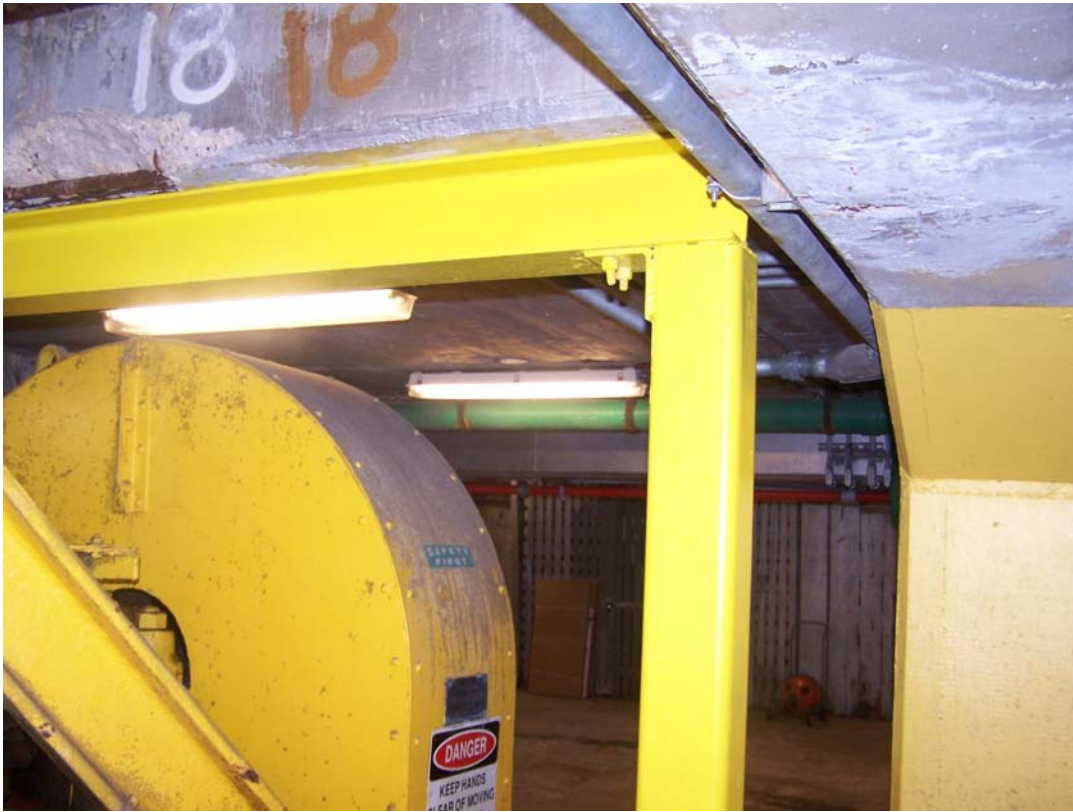
**Photo 95** Spalls and corroded steel in beams over machinery in room 5. Note steel beam and columns added to support these beams.

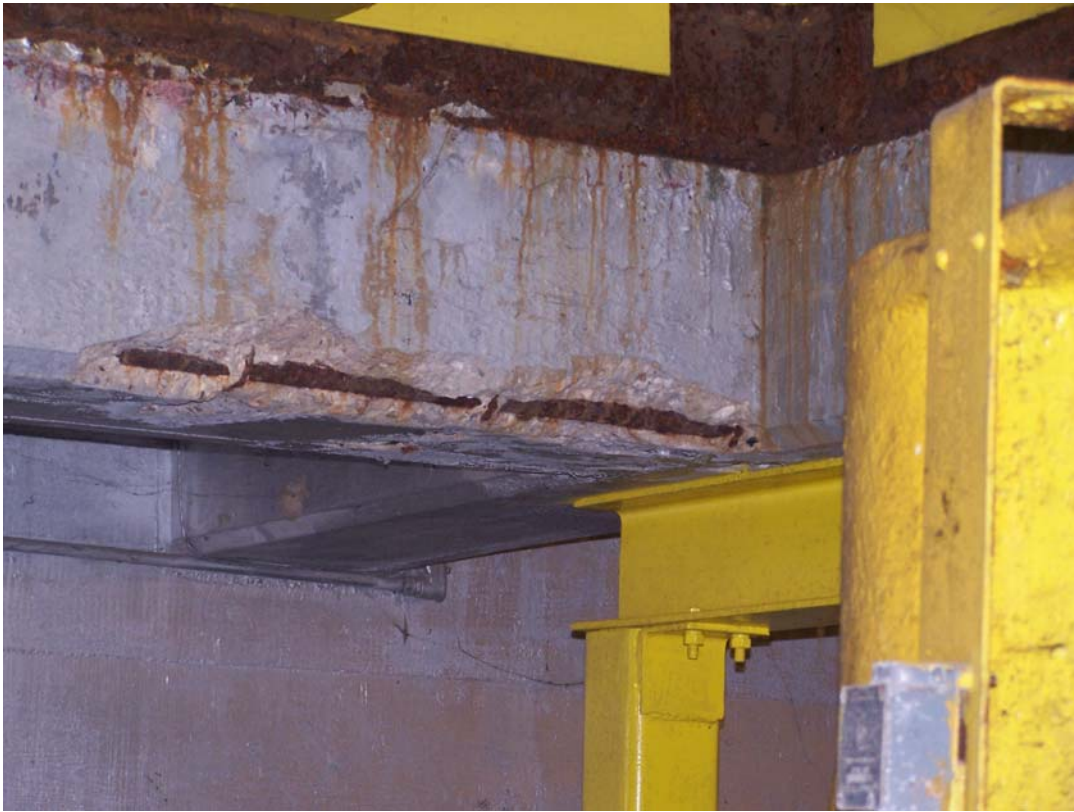
**Photo 97** Spalls and corroded steel in beams over machinery in room 5. Note steel beam and columns added to support these beams.

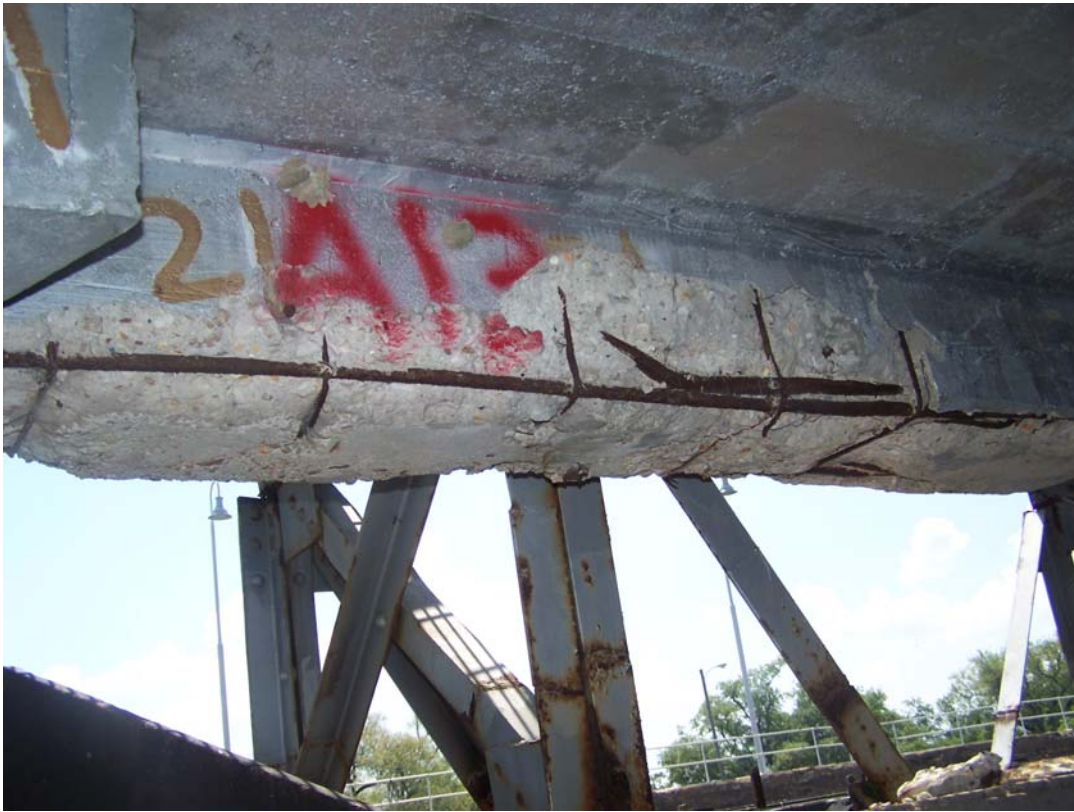
**Photo 99** Spalled beam with corroded reinforcing over opening for gate 7.

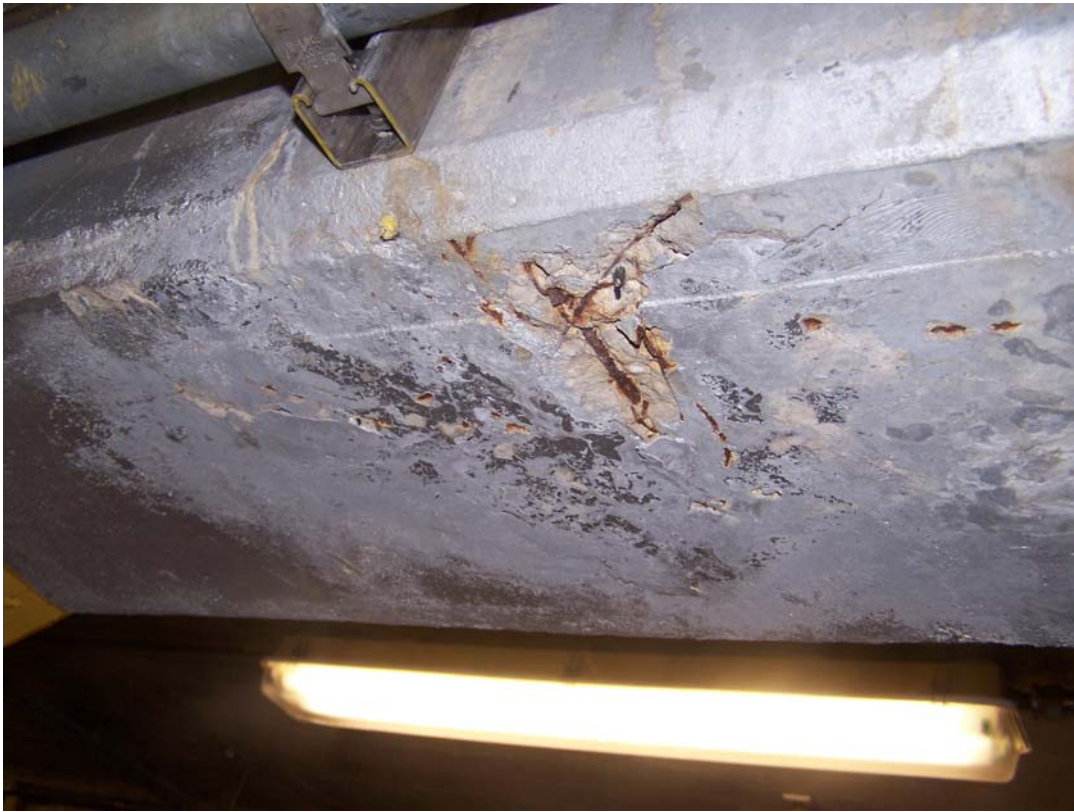
**Photo 103** Crack and spall in the bottom of beam in room 7.

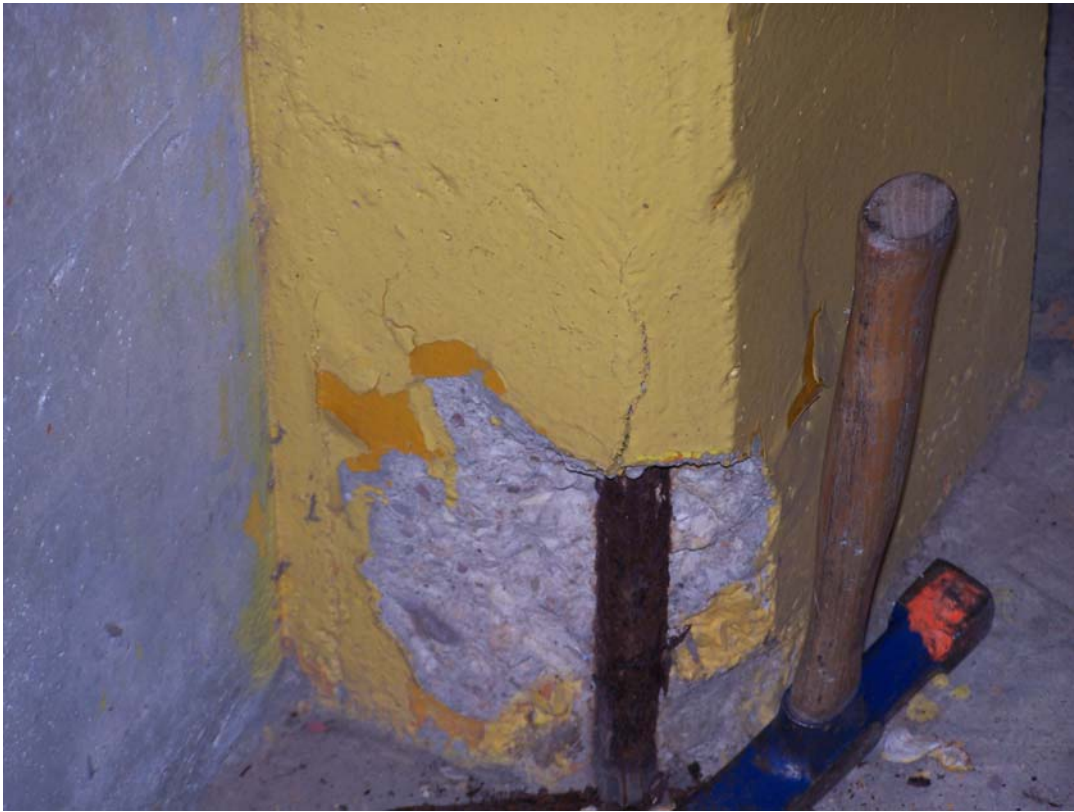
**Photo 105** Bottom of column in the wall in room 5. Delamination continues up the column.

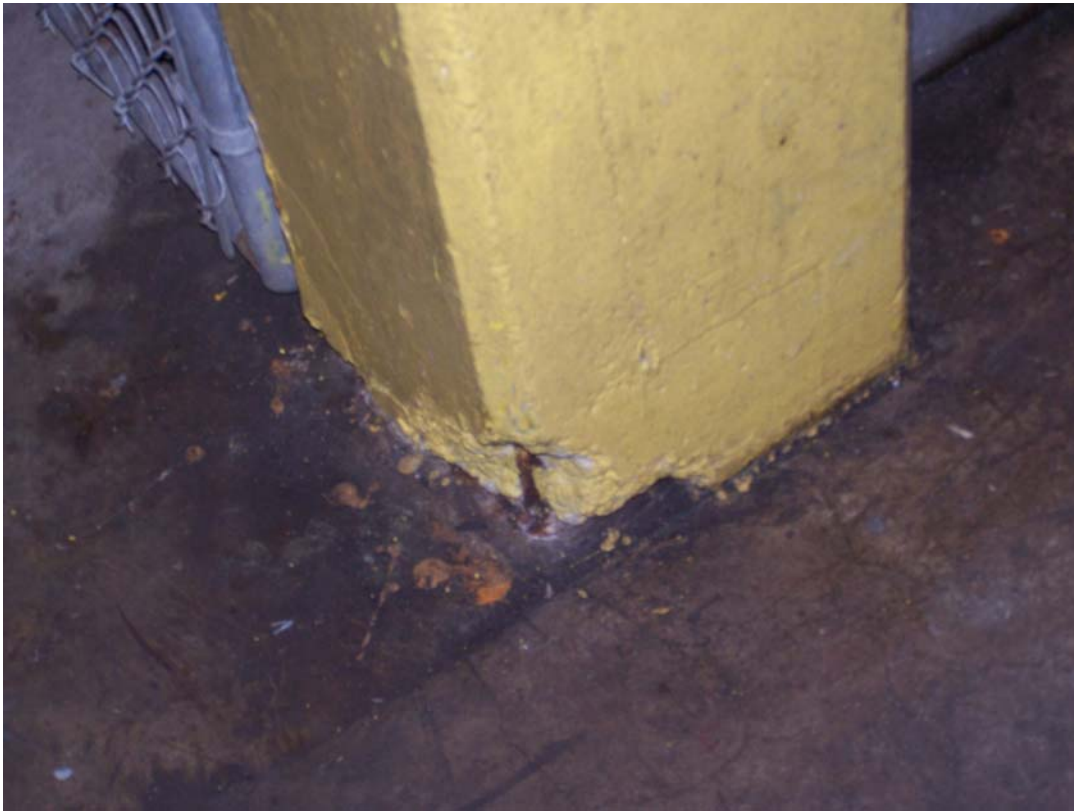
**Photo 109** Spall at the bottom of the column by the gate under the stairway.

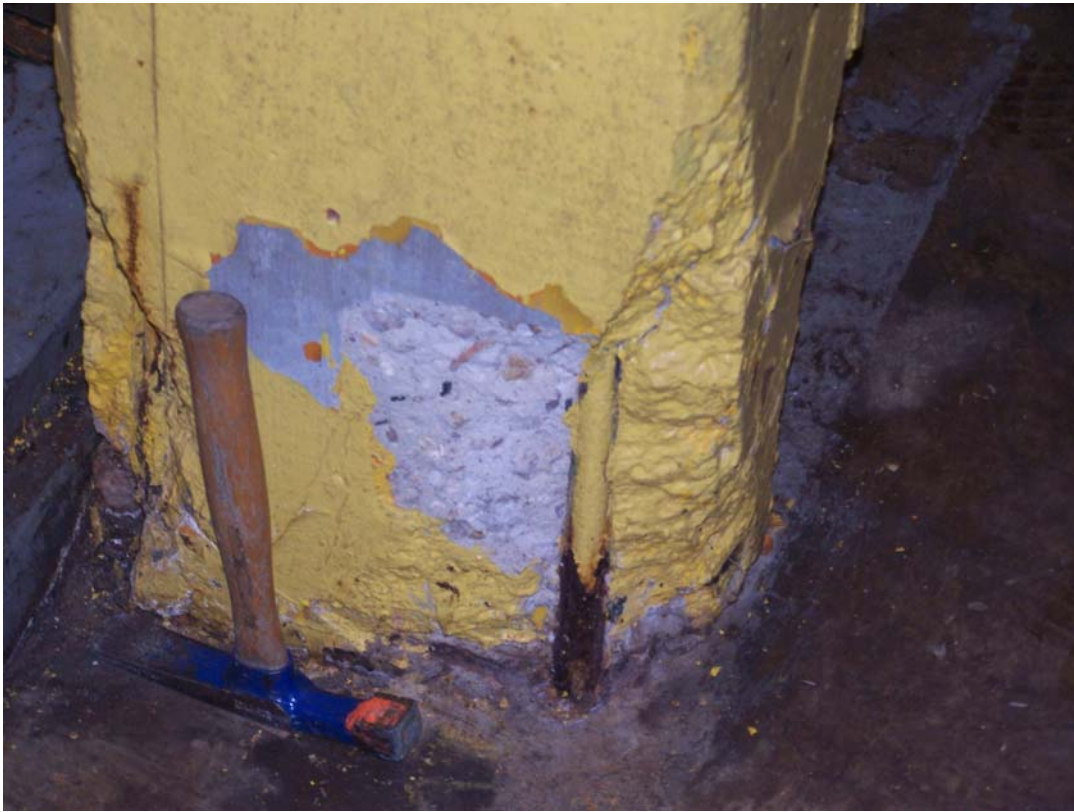
**Photo 111** Spalling and corroded steel at the bottom of the column near the louvers by the hinge of gate 5.  
Damage to about 20" up from floor.

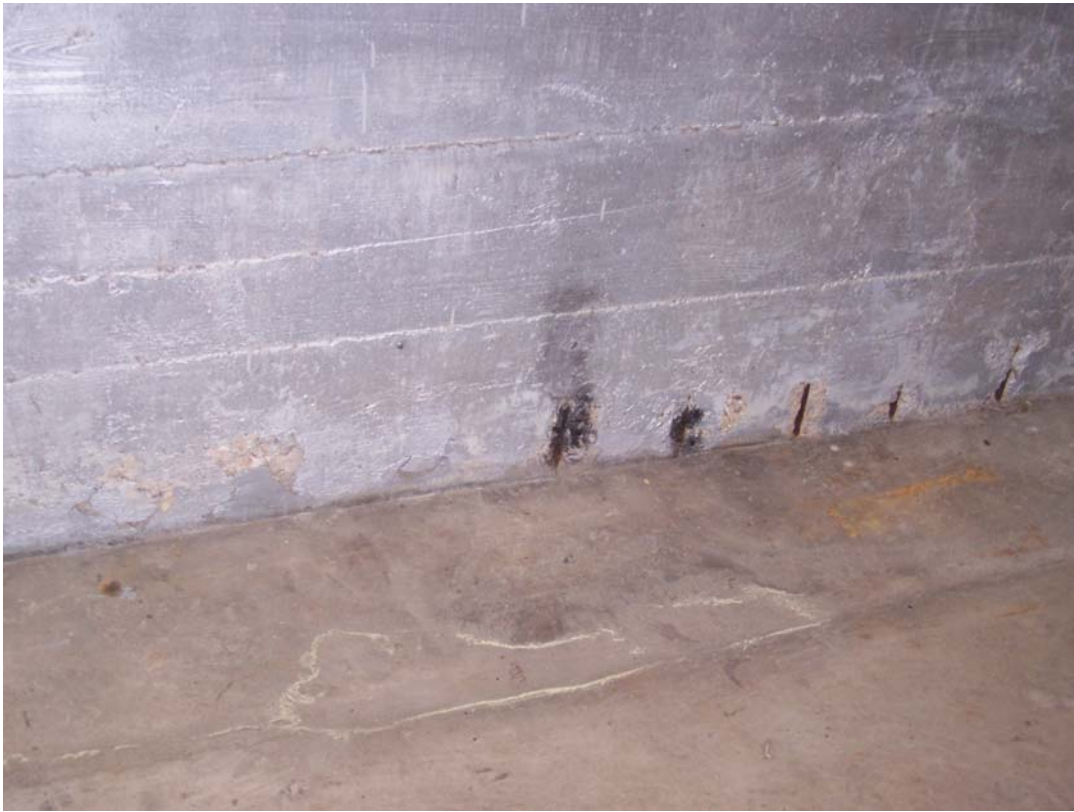
**Photo 117** Popouts along the bottom of the wall near valves 15 and 16.

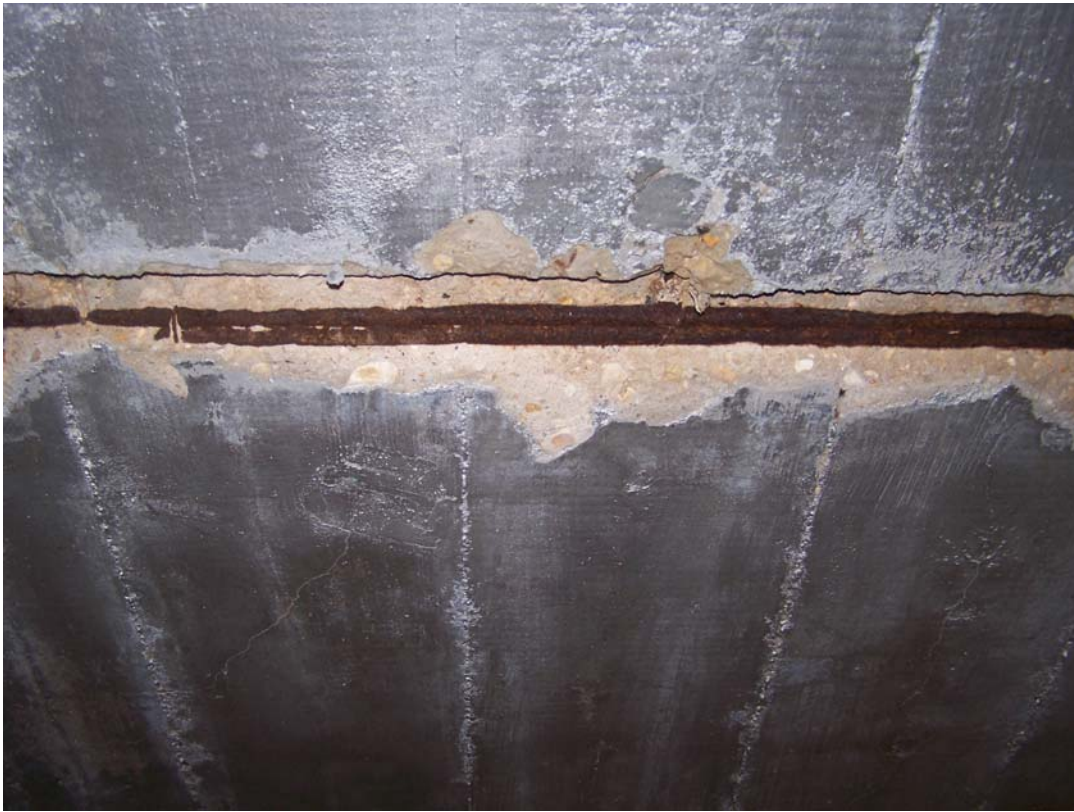
**Photo 119** Spalls in ceiling near gate 5.

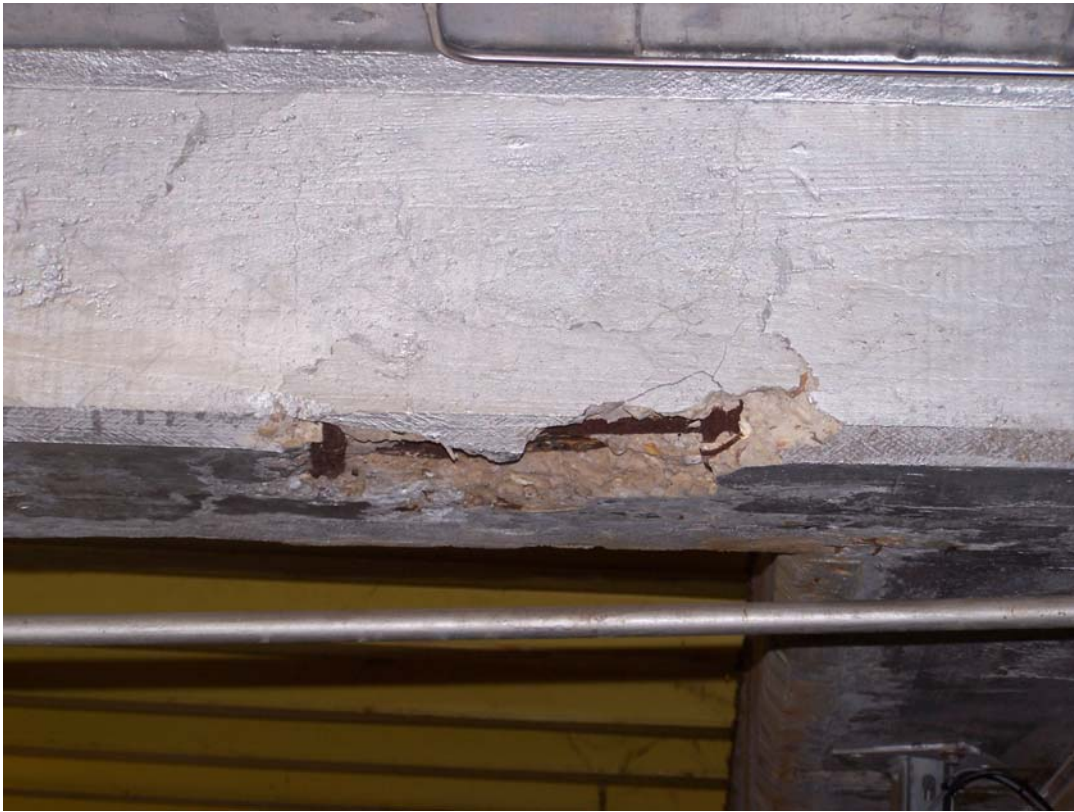
**Photo 121** Spall and corroded steel in beam over gate 5 machinery.

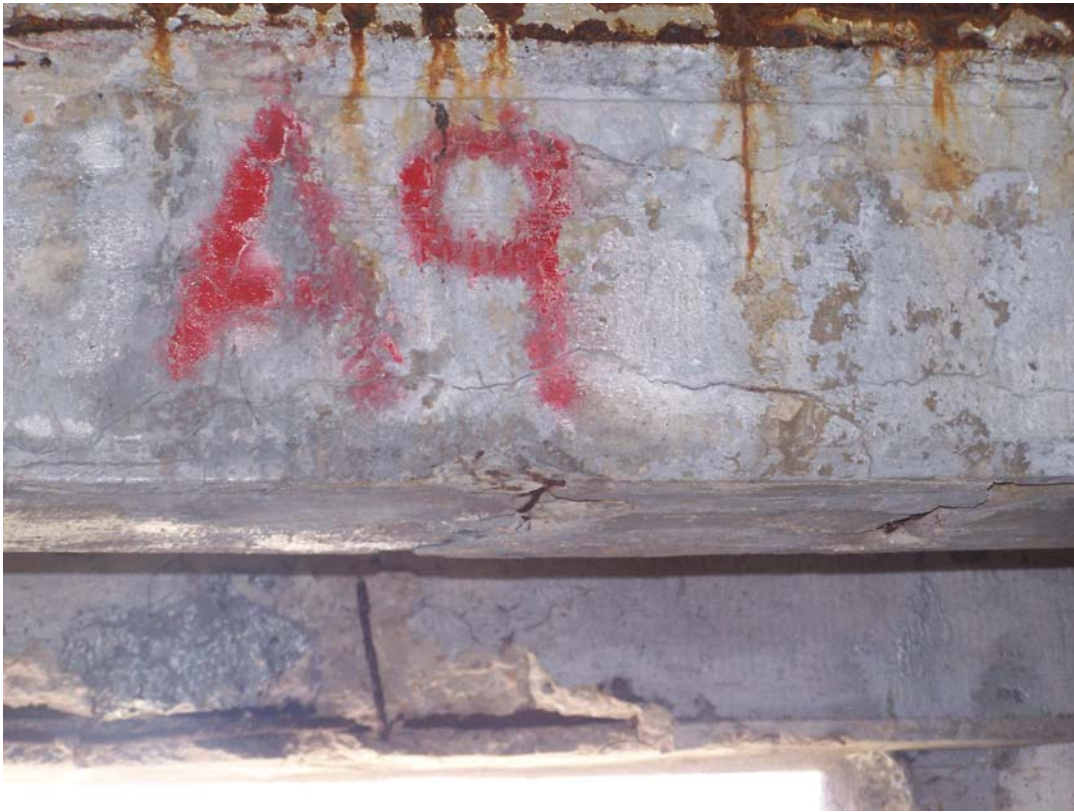
**Photo 125** Cracks and spalls in beam over Gate 5 machinery.

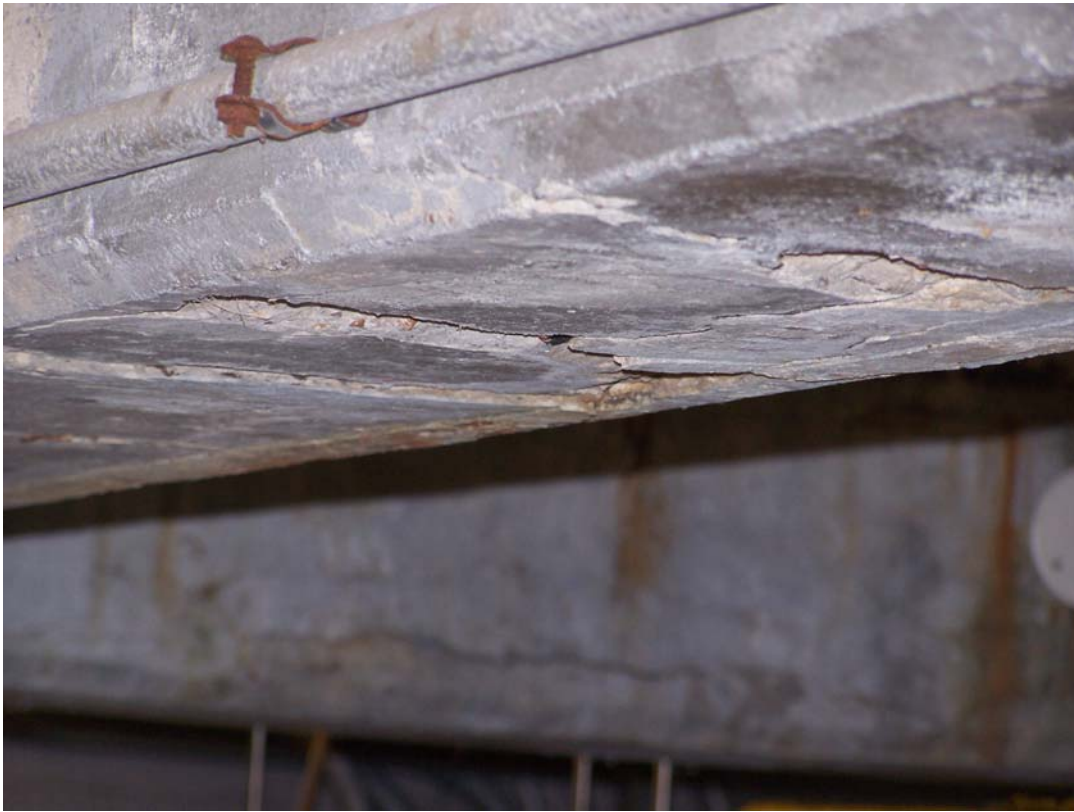
**Photo 127** Spalls in beam over Gate 5 machinery. About mid span of beam.

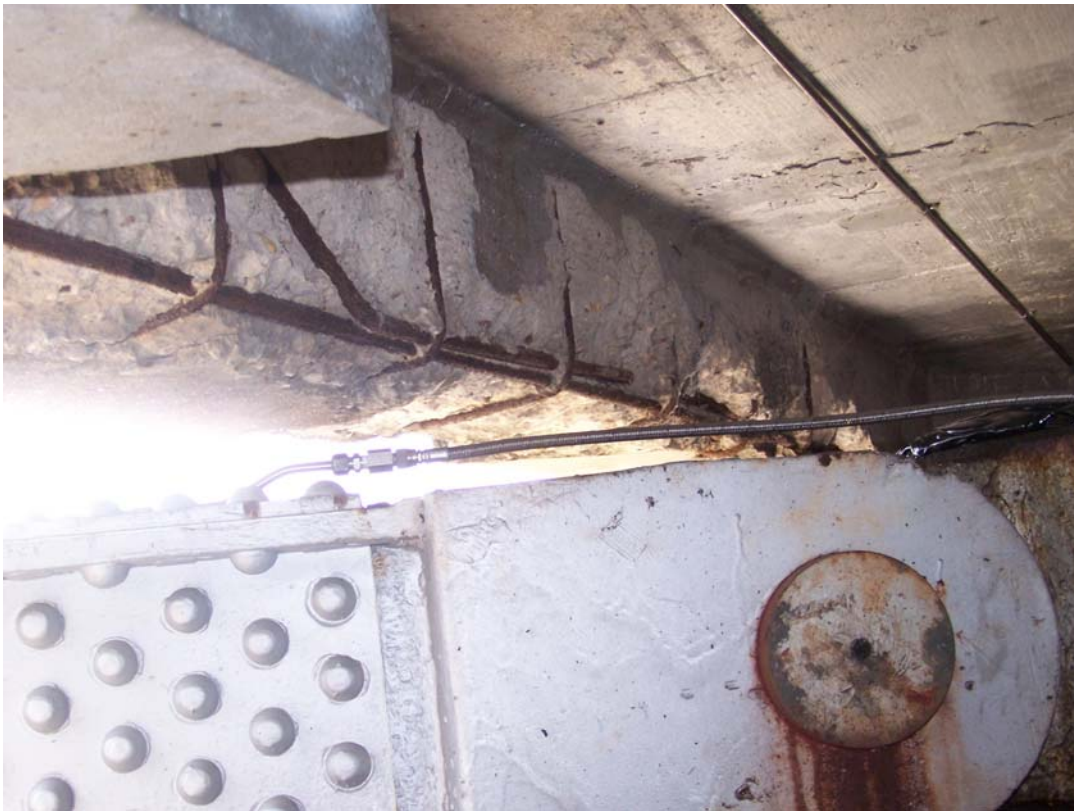
**Photo 128** Deteriorated beam over opening for Gate 5.

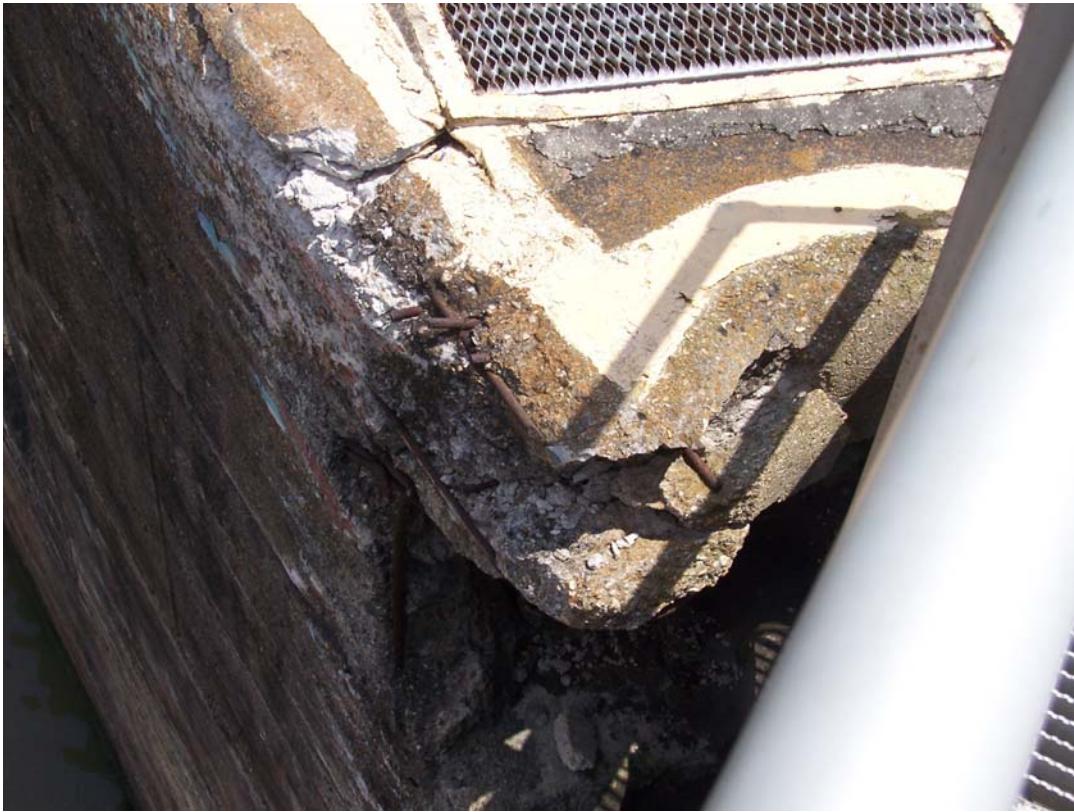
**Photo 133** Spalled concrete and exposed steel near hinge of northeast gatebay.

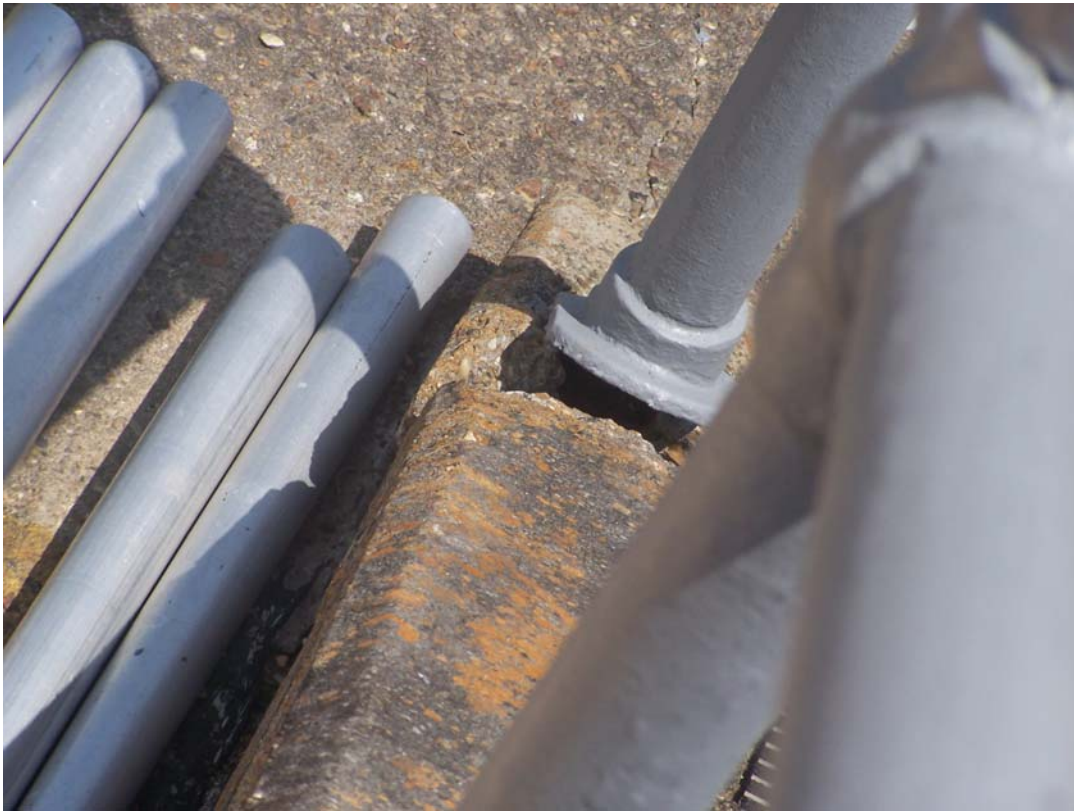
**Photo 141** Spall where handrail post embeds in stairway wall. Handrail is loose.

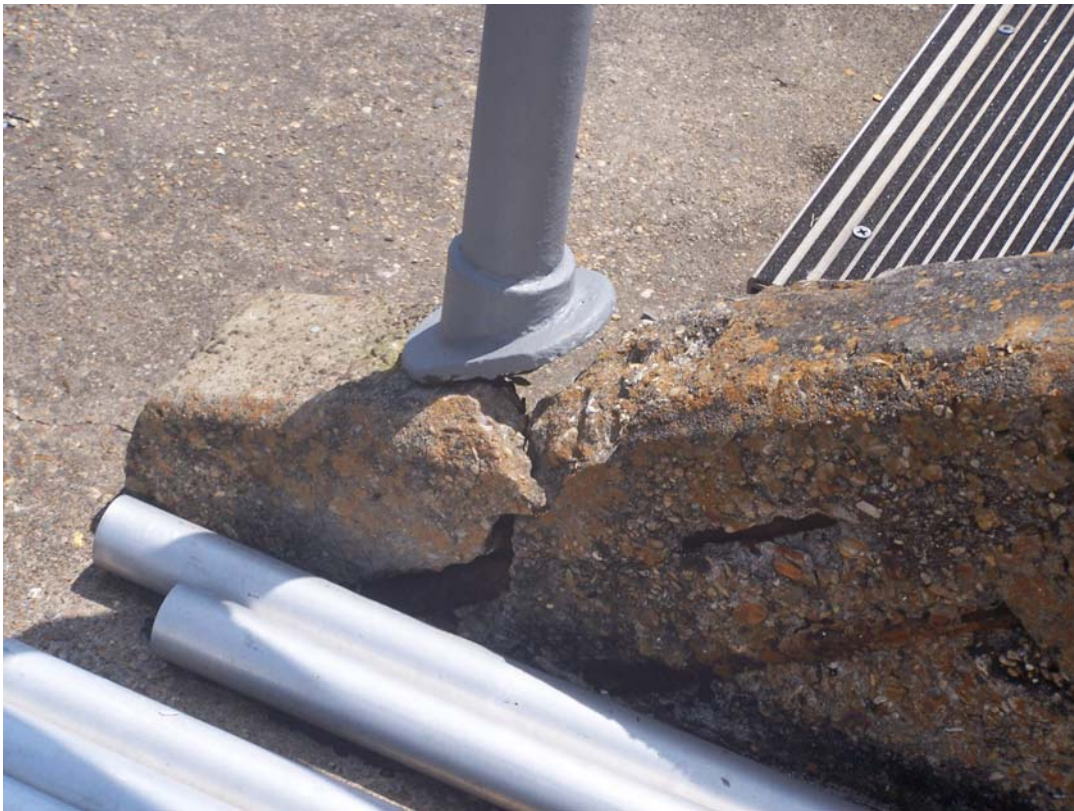
**Photo 142** Spall where handrail post embeds in stairway wall. Handrail is loose
