SUBJECT: IHNC Lock Replacement General Re-evaluation Report, Engineering  
Assessment of the Existing Lock Structure

## **Enclosure 1 – Pictures of Structural Deficiencies**

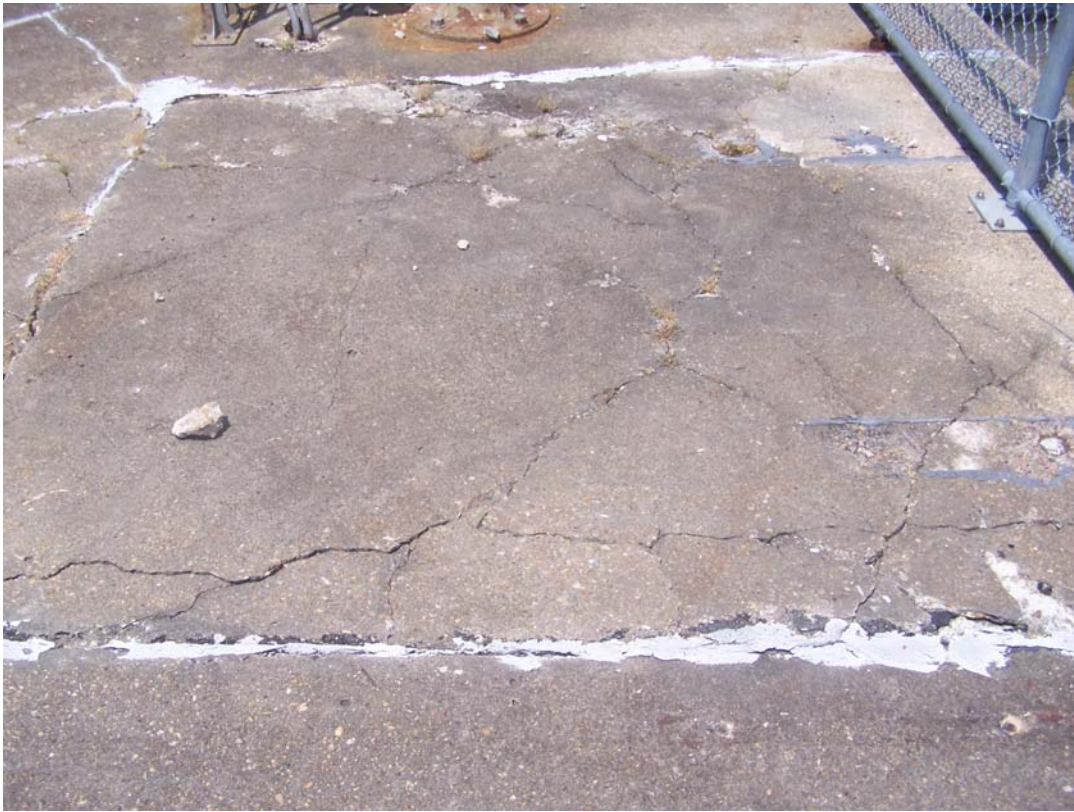
**Photo 143** Large area of cracked and spalling concrete behind northeast retaining wall. The whole area sounded hollow underneath.

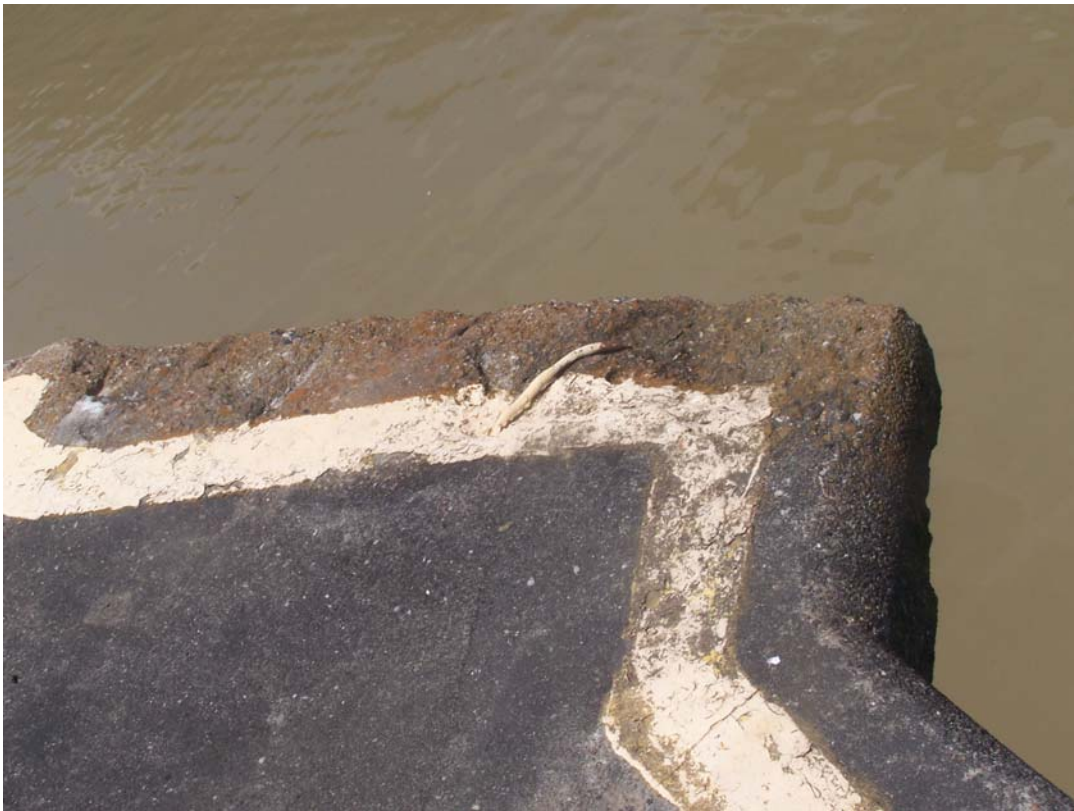
**Photo 145** Spalls in north gatebay.

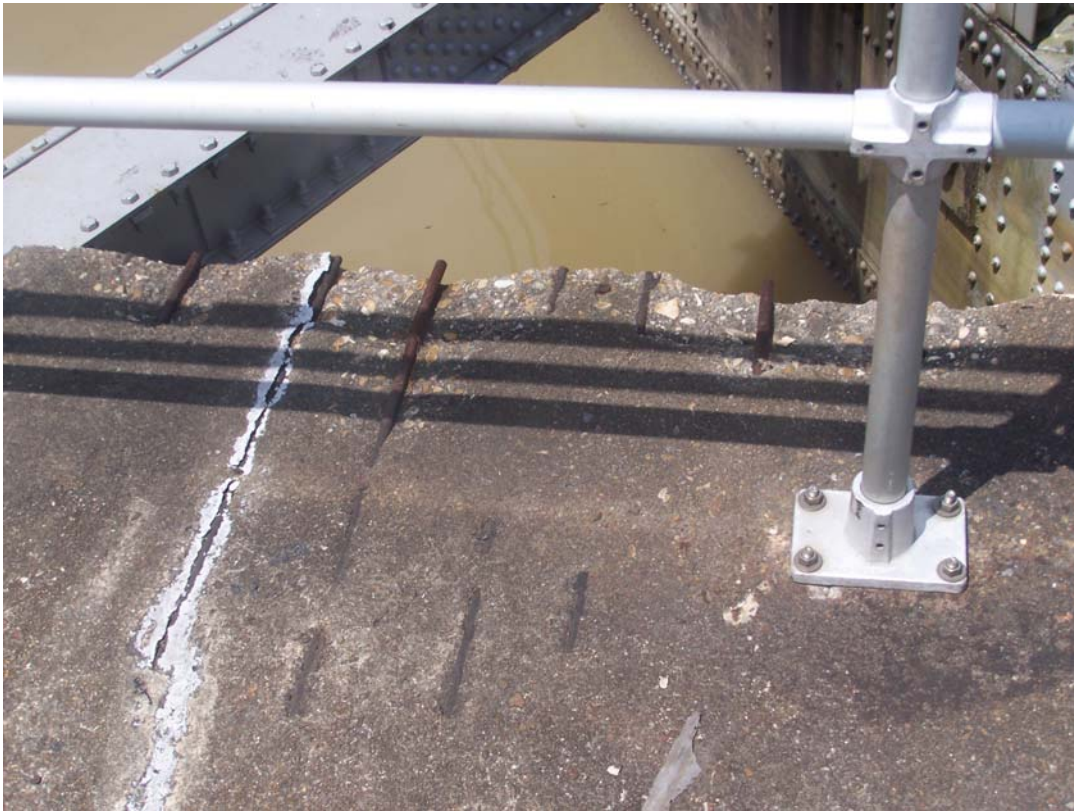
**Photo 151** Spalling with exposed steel near the river side gate hinge.

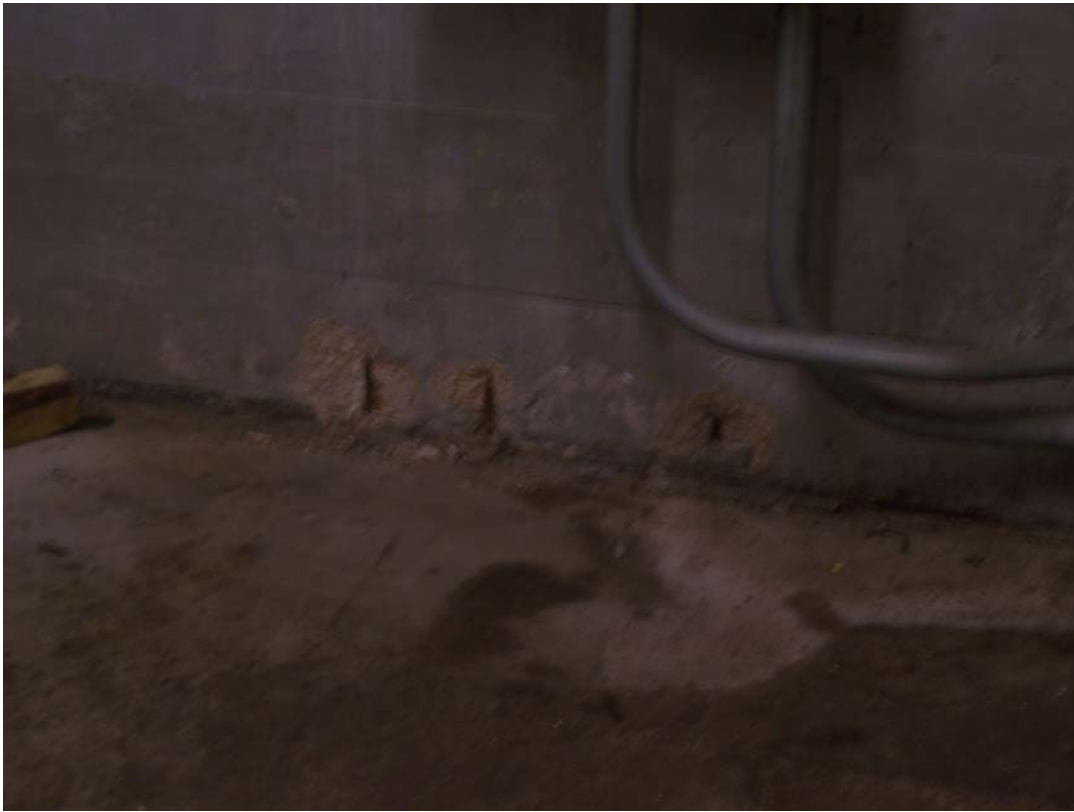
**Photo 153** Popouts in Room 2 caused by corroding steel.

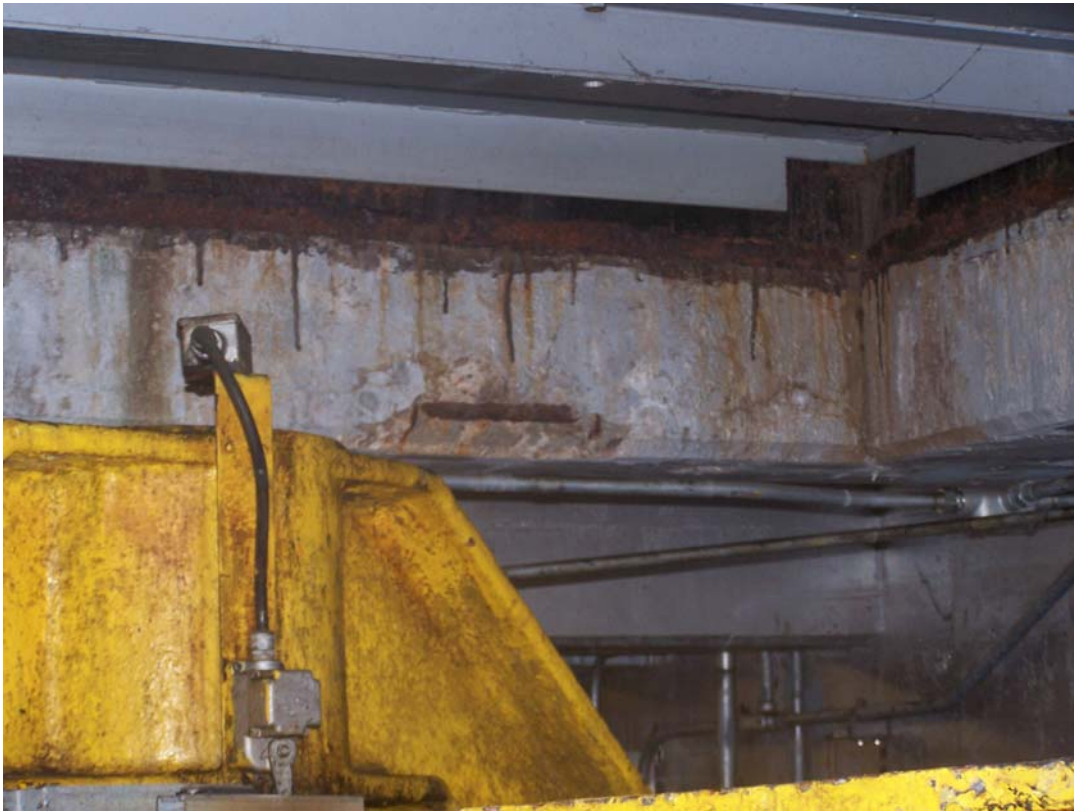
**Photo 155** Spall with corroded steel in beam in over machinery for Gate 2.

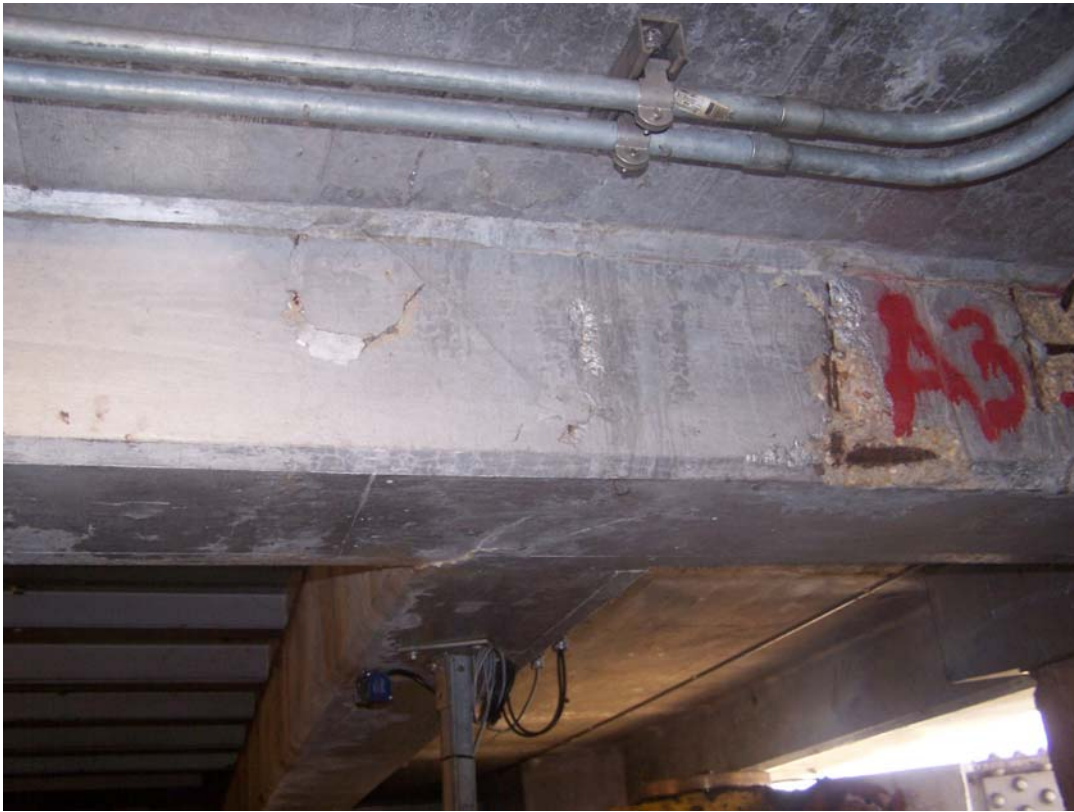
**Photo 159** Spalling and corroding steel in beam in Room 2.

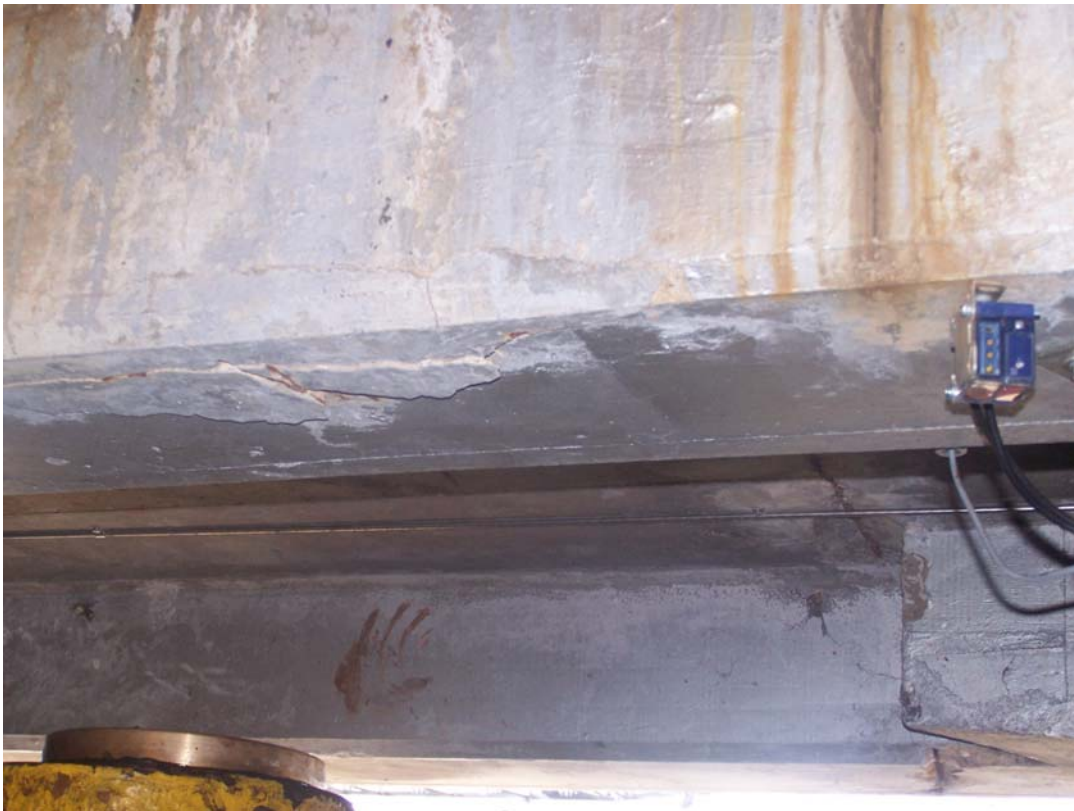
**Photo 160** Crack in beam in Room 2.

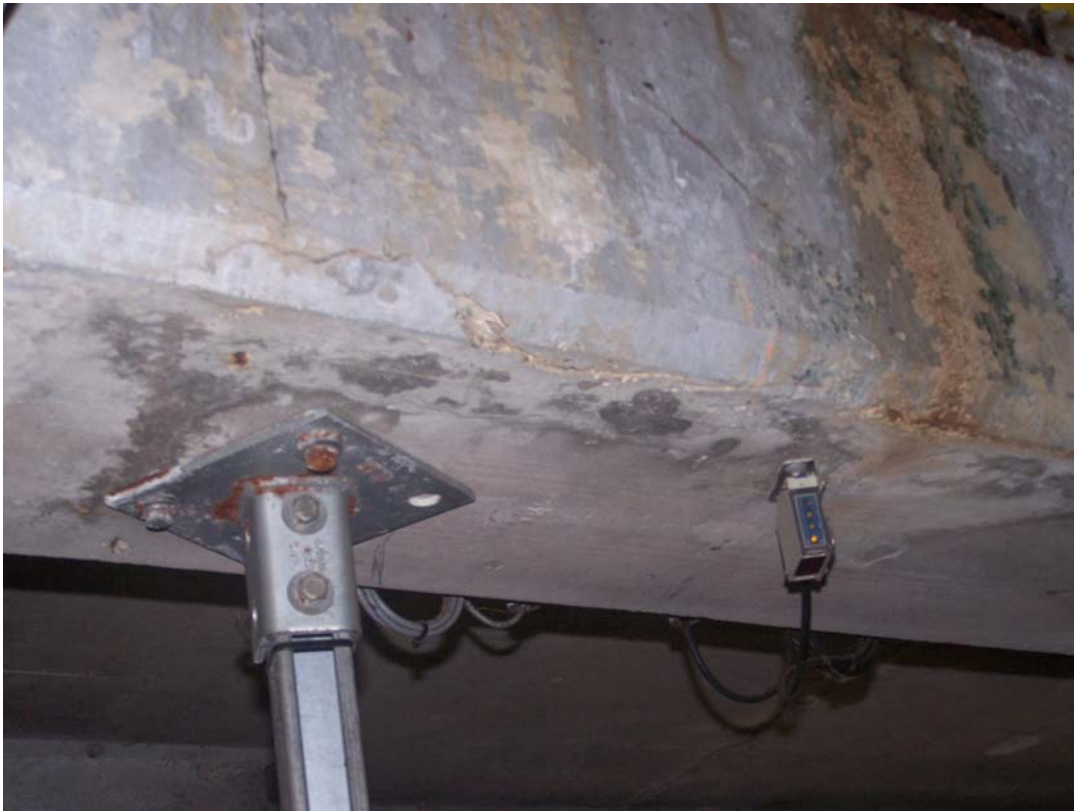
**Photo 161** Crack in beam over Gate hinge.

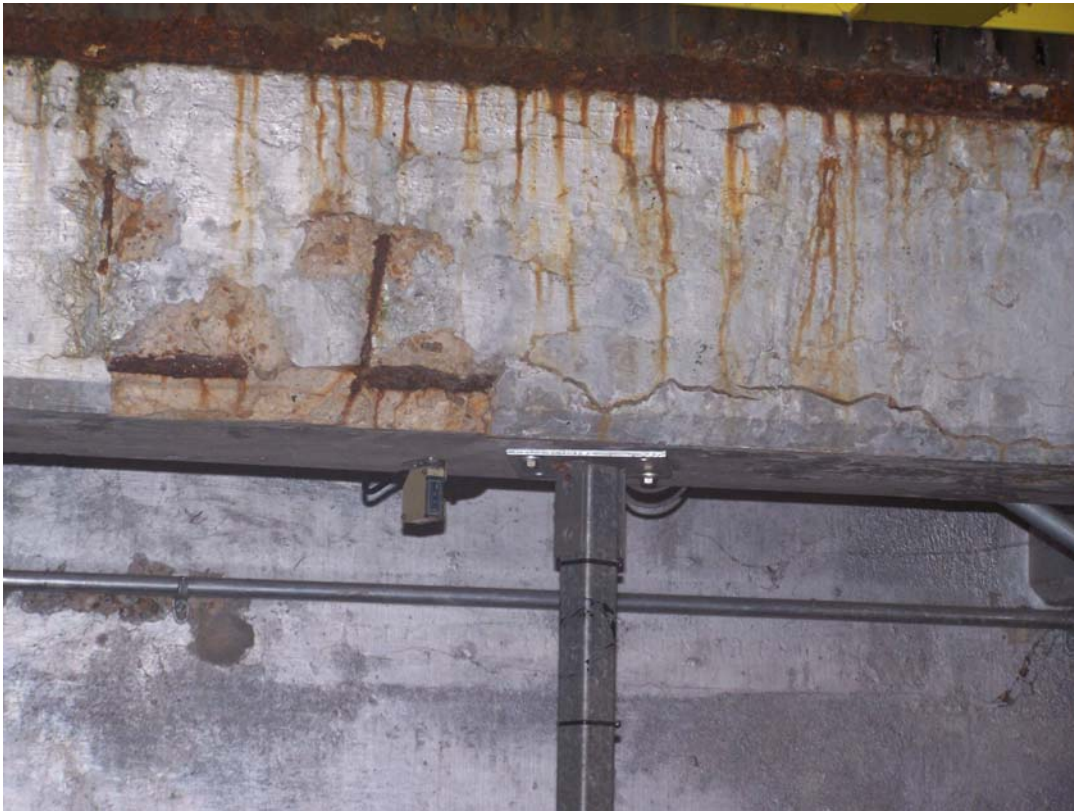
**Photo 163** Spall with corroded steel and crack in beam over gate 4.

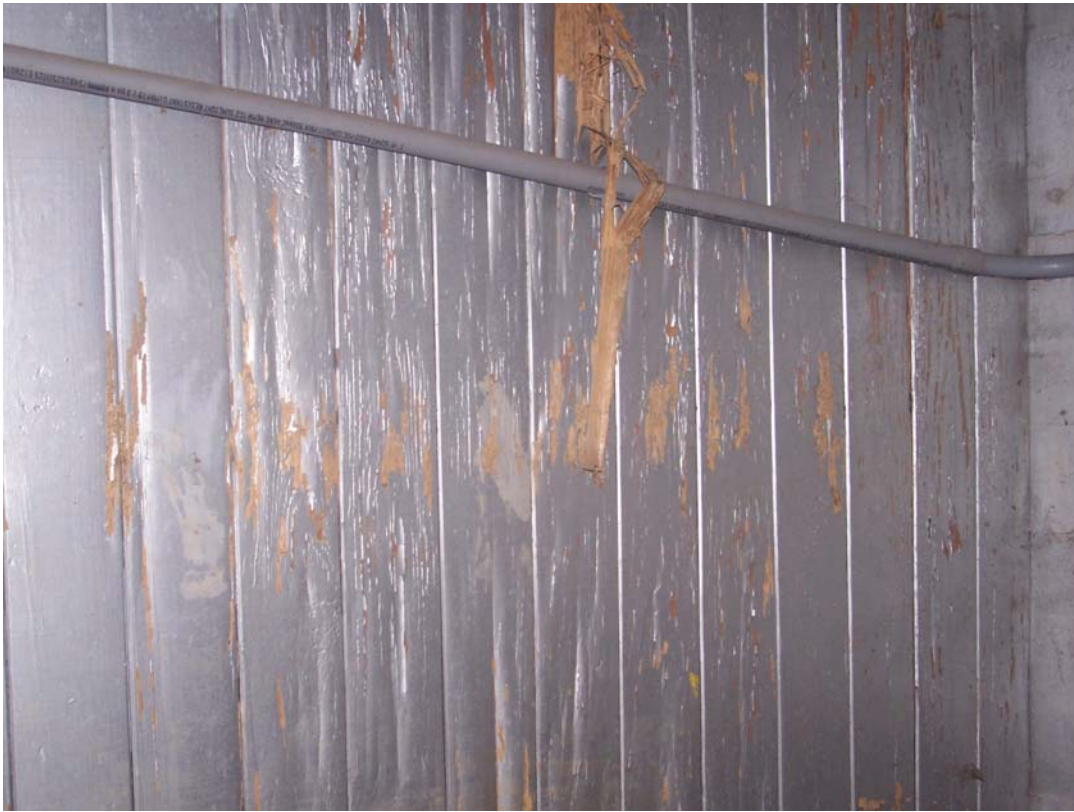
**Photo 165** Termite damage in walls of storage area in Room 2.

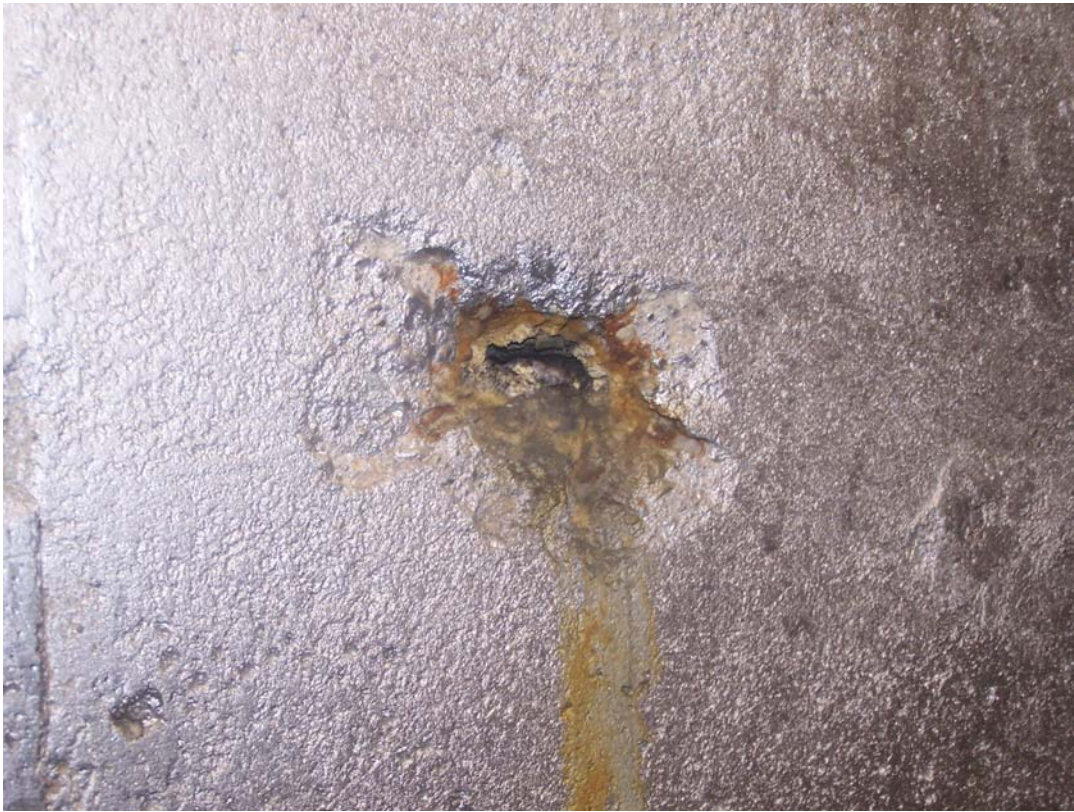
**Photo 167** Small popout due to clay in east tunnel.

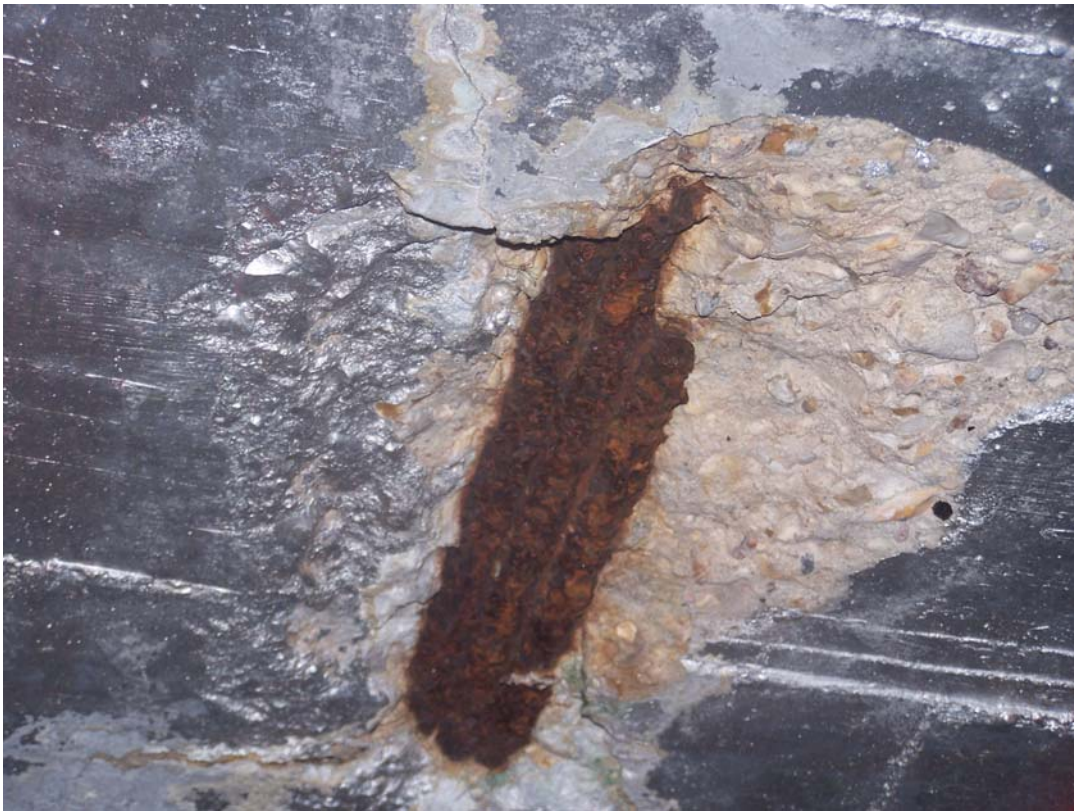
**Photo 168** Large spall caused by corroding reinforcing in ceiling of machinery room 6.

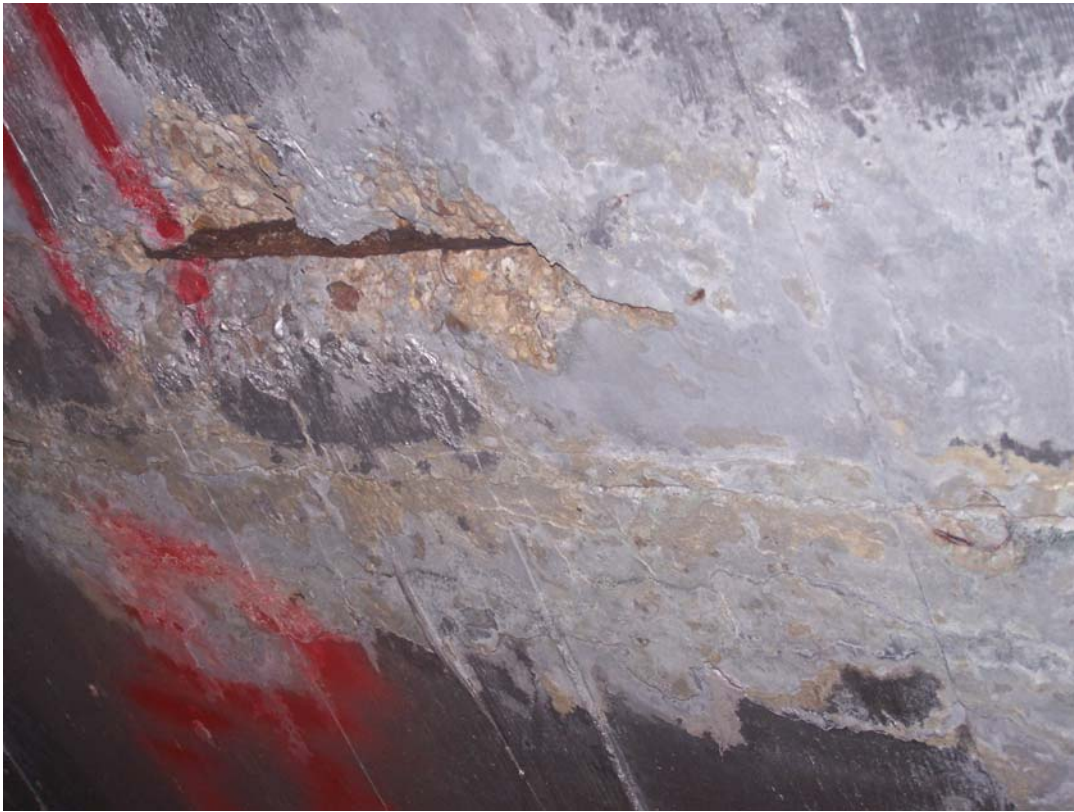
**Photo 171** Spalling and exposed steel in ceiling of room 6.

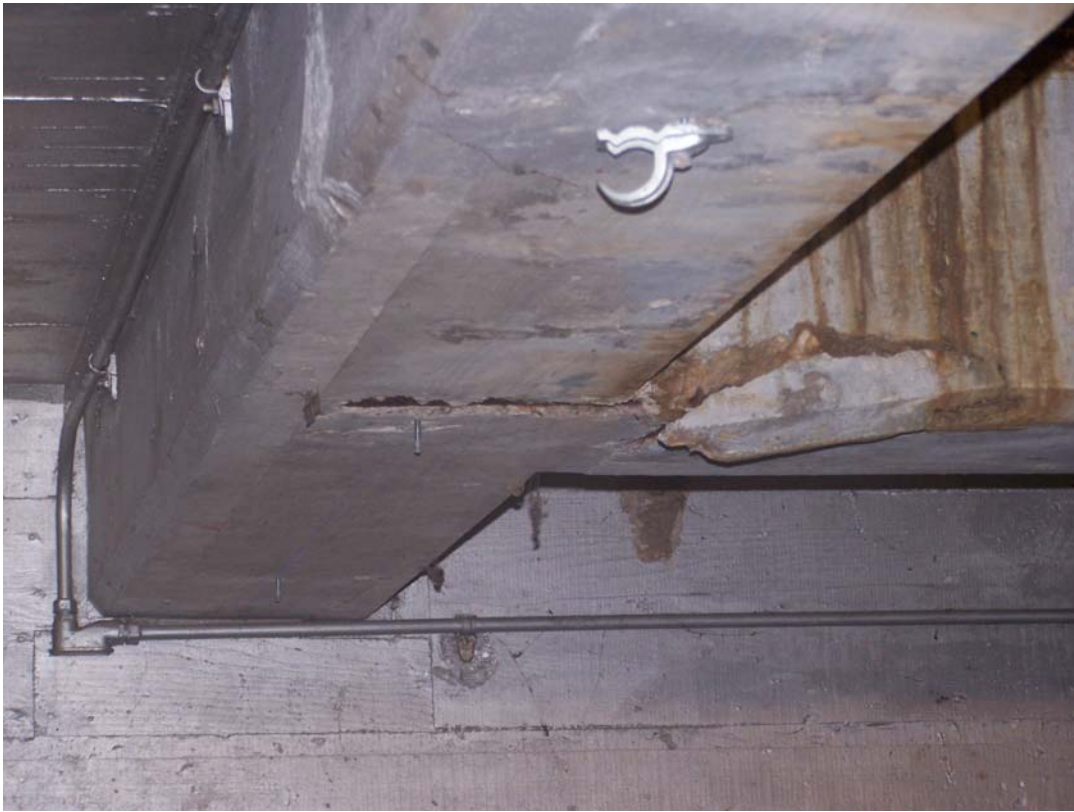
**Photo 173** Spalls and corroded steel in beams over machinery in Room 6.

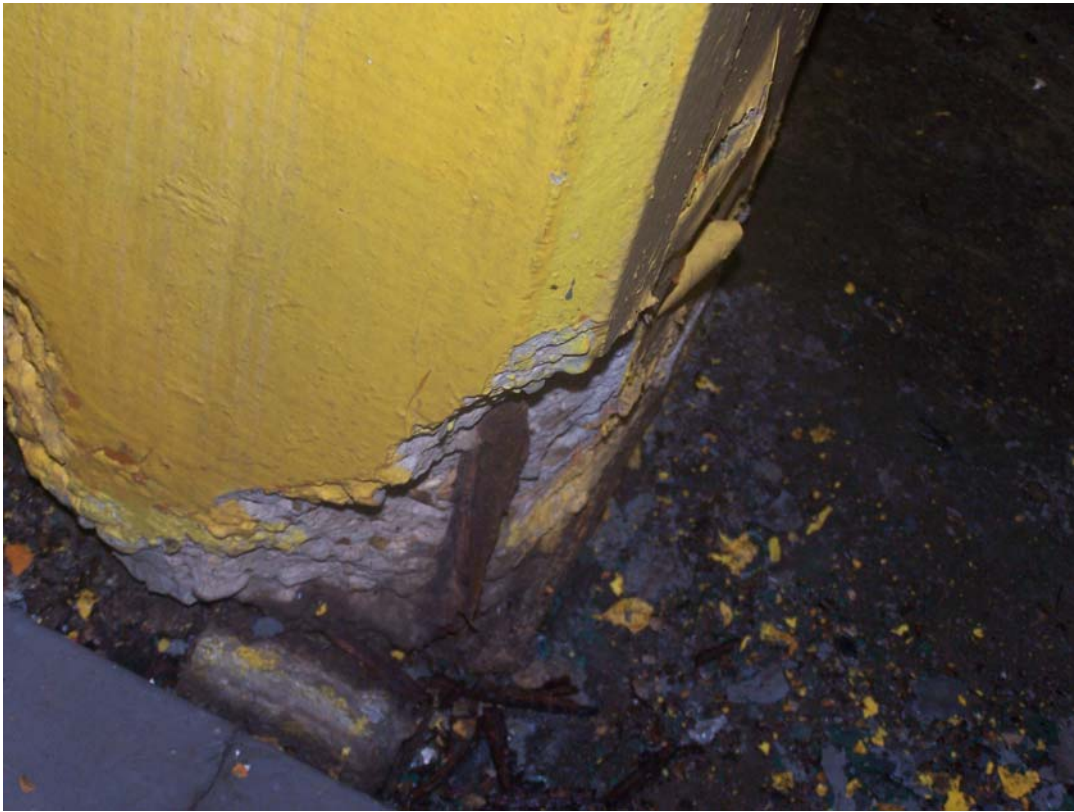
**Photo 175** Large spalls with corroded steel in the bottom of the column near the hinge in Room 6.

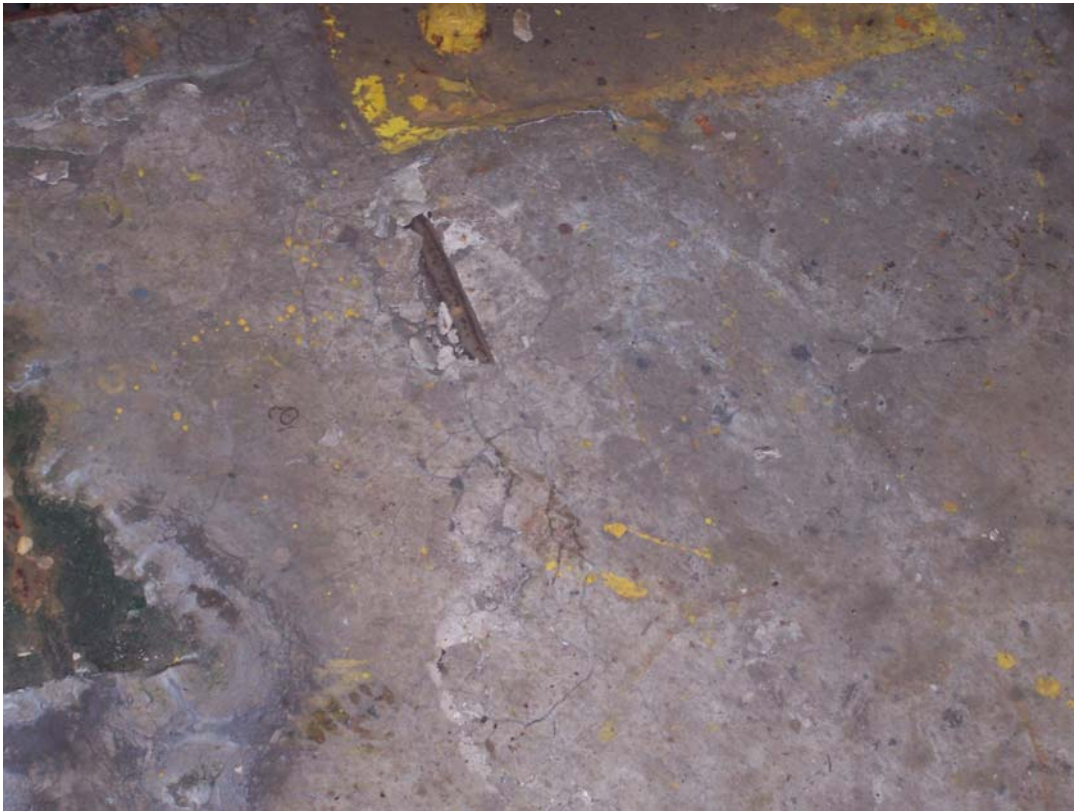
**Photo 179** 1' x 1' delamination in floor near valve between Rooms 6 and 8.

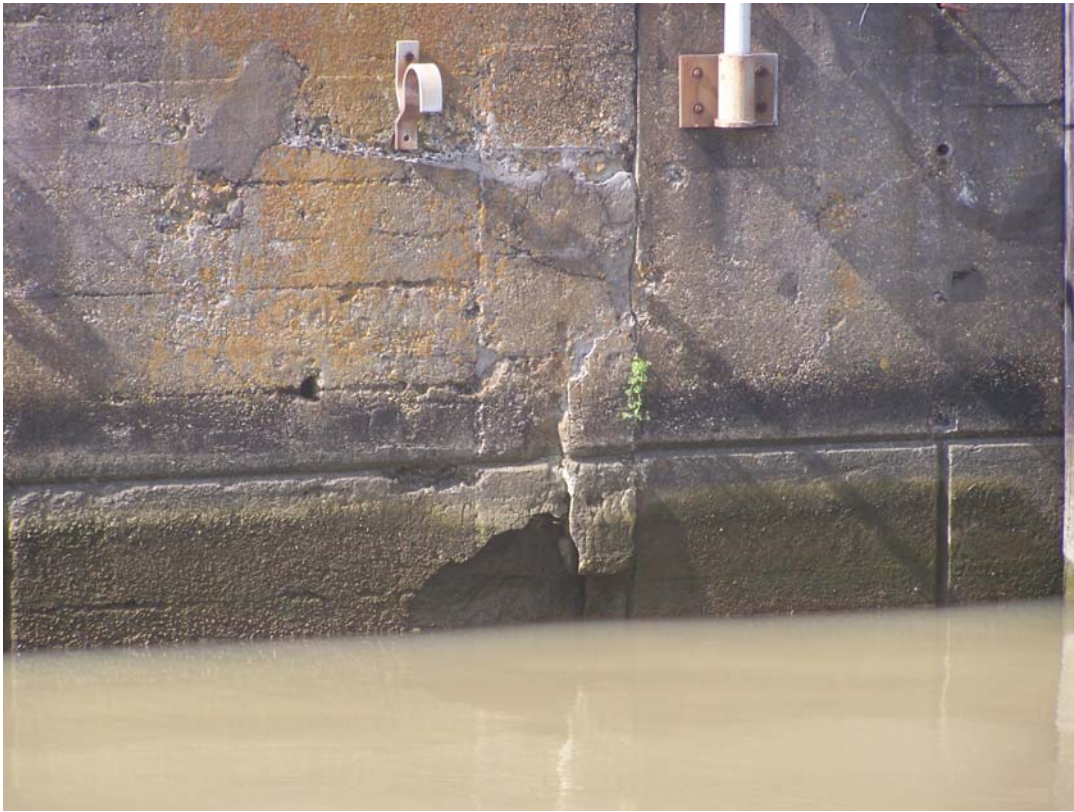
**Photo 183** Cracks and spalling in the retaining wall on the northeast side.

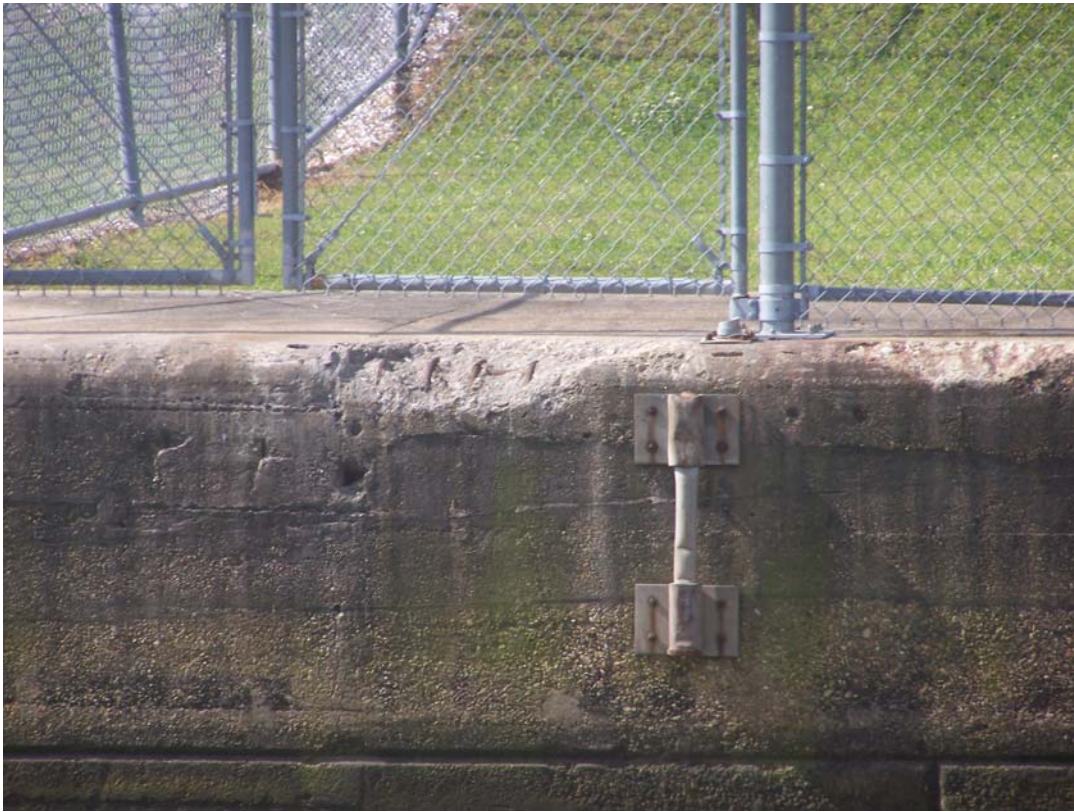
**Photo 185** Cracks and spalling in the retaining wall on the northeast side.

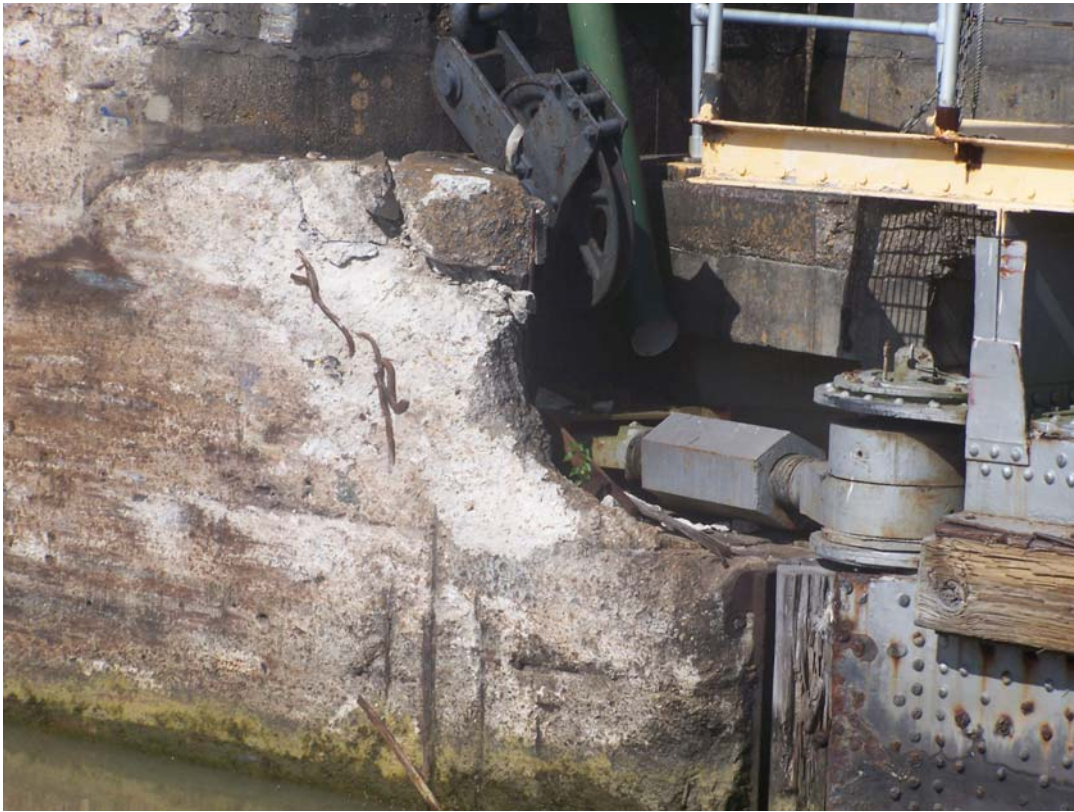
**Photo 187**     Damaged concrete at the northwest reverse head gate hinge.

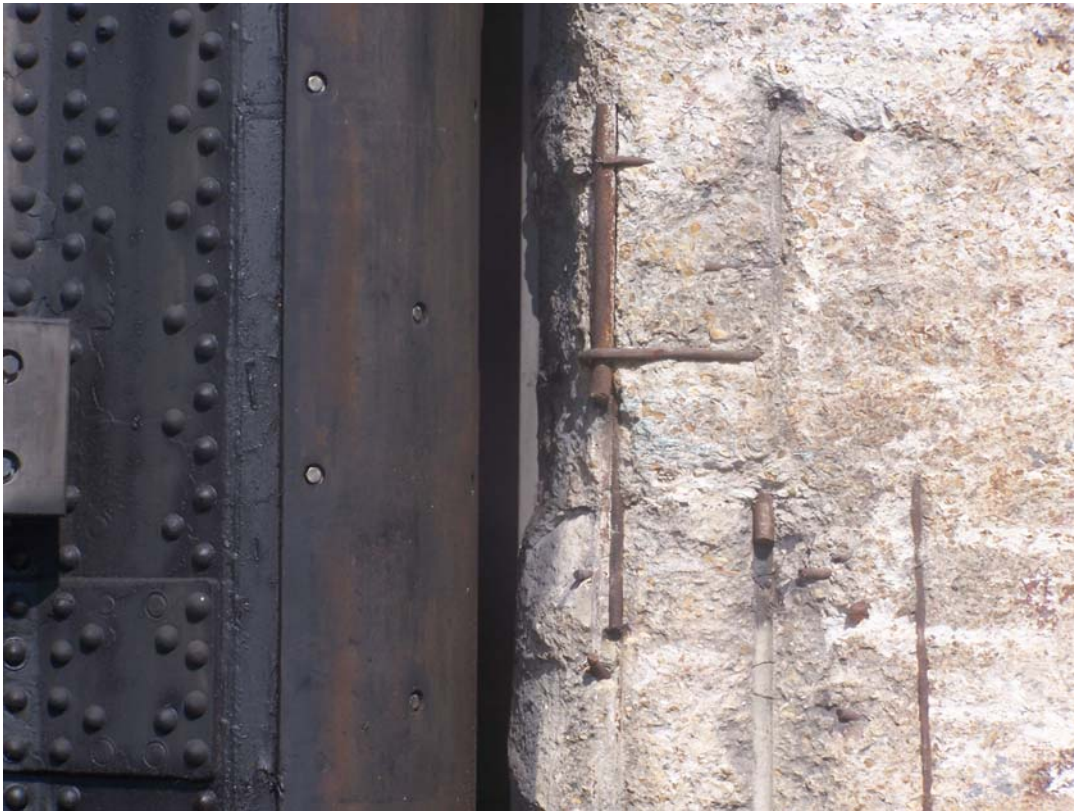
**Photo 189** Spalled corner with exposed steel near the hinge for the southwest gate.

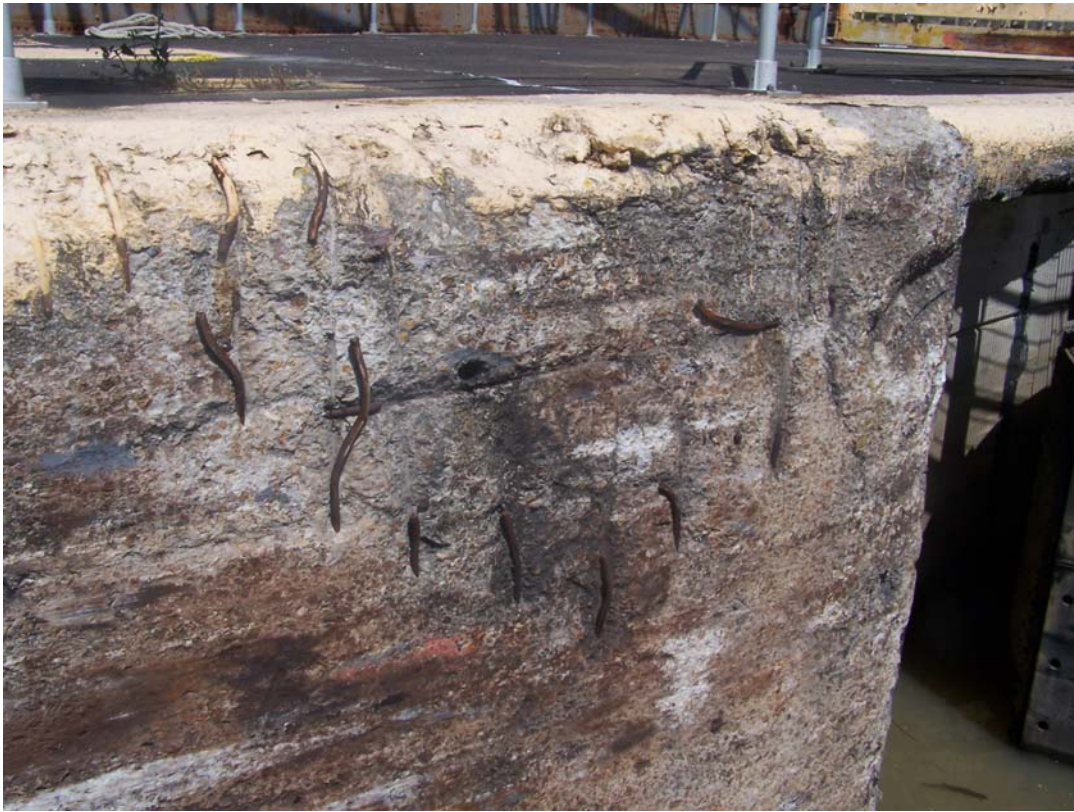
**Photo 201** Spalls and exposed steel in chamber walls.
