# LAKE PONTCHARTRAIN AND VICINITY HURRICANE PROTECTION PROJECT LONDON AVENUE CANAL **ORLEANS PARISH, LOUISIANA**

# **MOWL for London Avenue Canal**

> **Revised Final** March, 2011

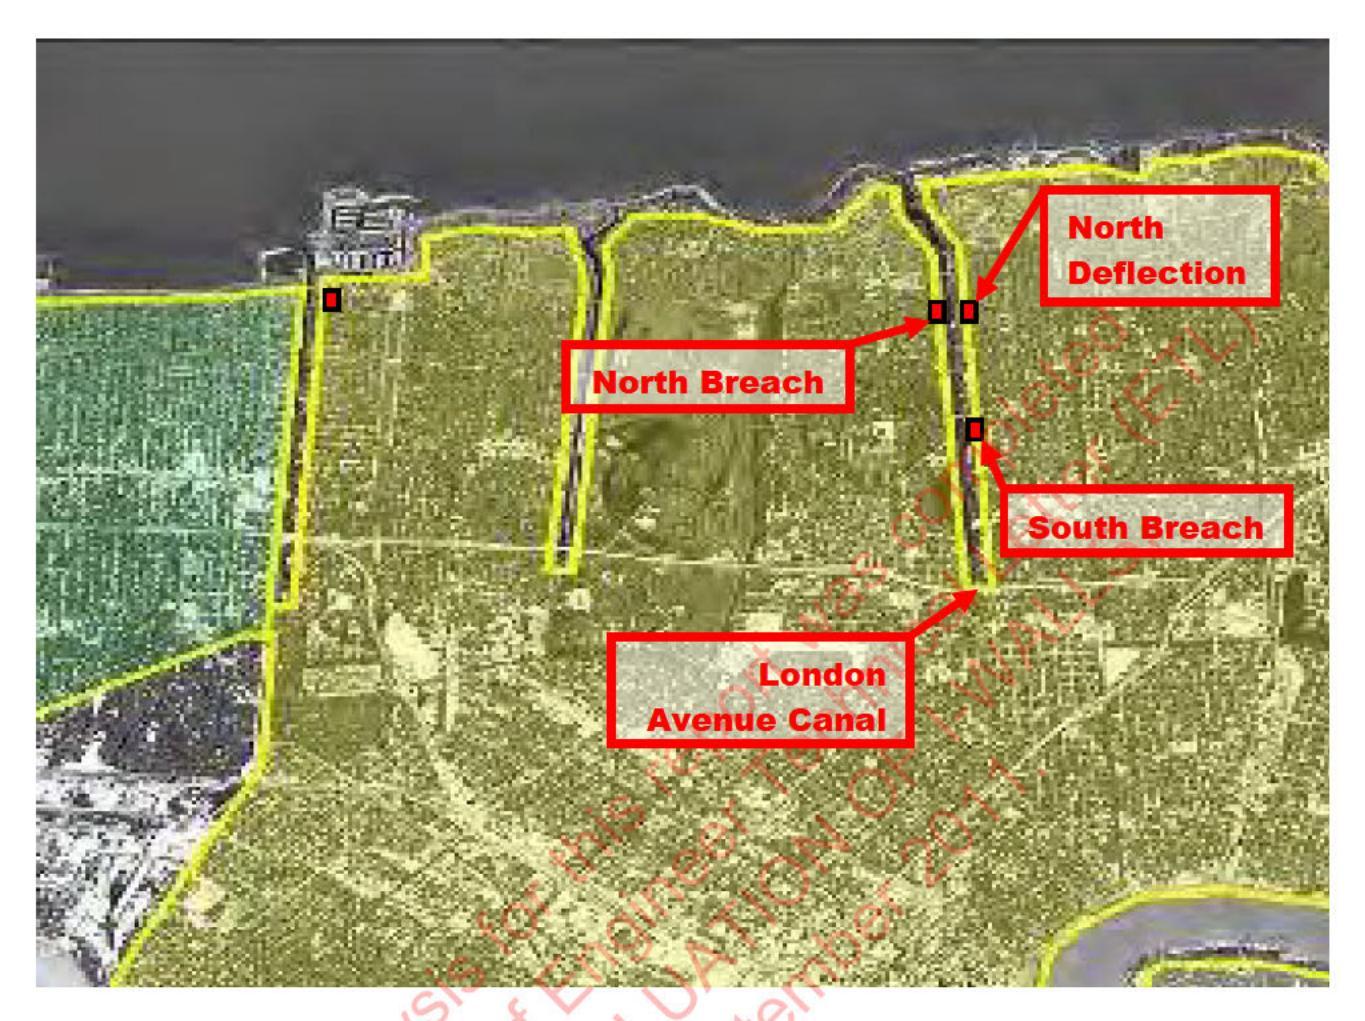
# FIGURE 3-1 LOCATIONS OF LONDON AVENUE OUTFALL CANAL FAILURES

The London Avenue Canal failed in two locations between 6 and 8 AM on August 29, 2005. The first failure occurred between 6 and 7 AM along the east I-wall north of Mirabeau Avenue and has been designated the south breach. This breach was about 60 feet long, but the I-wall deflected outward over a length of about 210 feet between Stations 70+40 and 72+50. Based on estimates of the storm surge, the water level in the canal was rising during the failure and ranged from about EL7 NAVD88 initially to about EL8 NAVD88 when this failure was complete. The second failure occurred between about 7 and 8 AM south of Robert E. Lee Avenue along the west I-wall and was designated the north breach. This breach was about 410 feet long and occurred between Stations 114+00 and 118+10. Based on estimates of the storm surge, the water level was at about El 8 NAVD88 when this failure initiated and was at about El 95 NAVD88 when the failure was complete. The east I-wall opposite the north breach tilted significantly but did not breach between about Stations 116+50 and 119+00. It is believed that these failures were also caused by the formation of a gap along the flood side of the sheet pile walls. The tips of the sheet pile walls along the London Avenue Canal are underlain by a sand layer. When the gap extended to the sand layer the water pressure from the canal caused uplift failure in the marsh layer overlying the sand layer beyond the levee and catastrophic failure ensued.

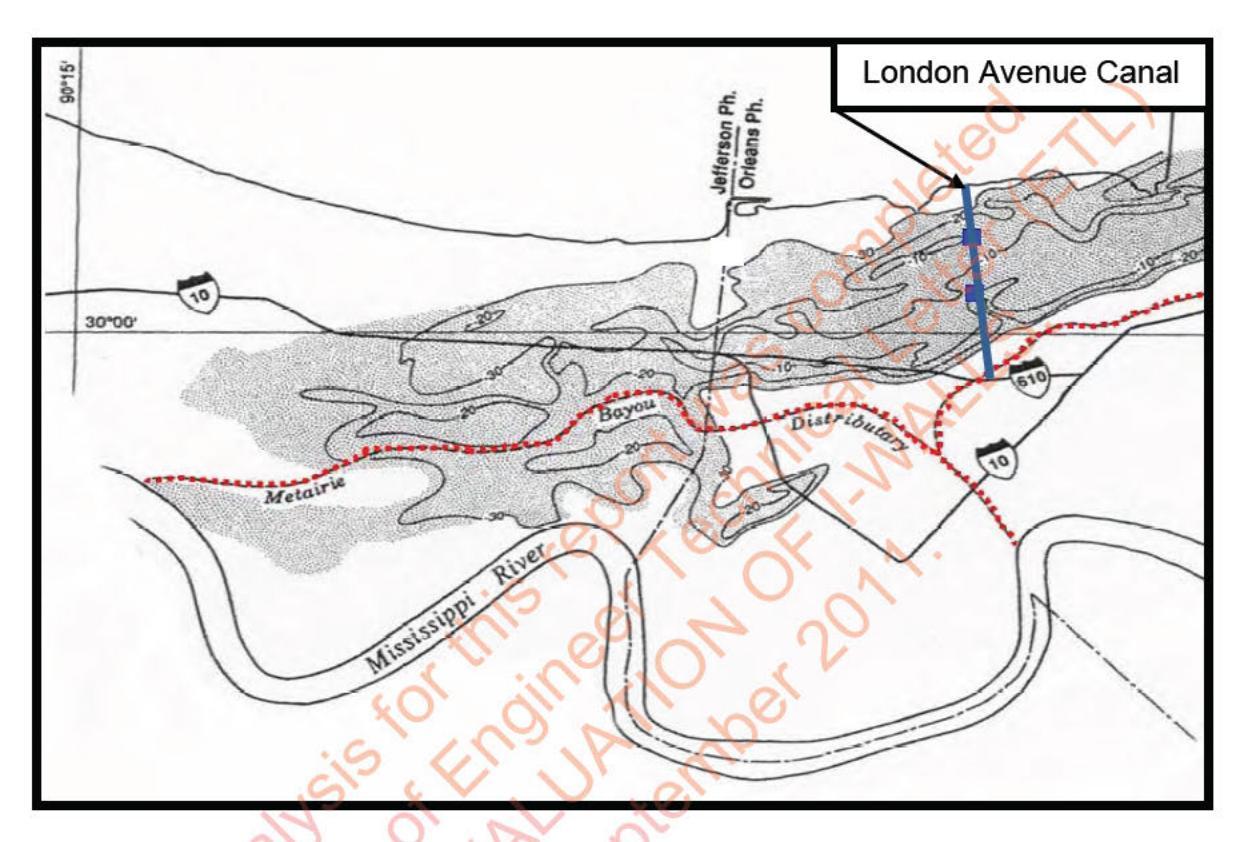
FIGURE 5-1 PINE ISLAND BARRIER BEACH AND BAYOU SAUVAGE (METAIRIE) DISTRIBUTARY CHANNEL WITH LONDON AVENUE CANAL FAILURE AREAS SHOWN AS BLUE BOXES [1]
