U.S. Army Corps of Engineers - New Orleans District
Louisiana State University - Coastal Studies Institute

BENEFICIAL USE OF DREDGED MATERIAL MONITORING PROGRAM 1996 ANNUAL REPORT

Part 7: Results of Monitoring the Beneficial Use of Dredged Material at the Houma Navigation Canal, Louisiana - Terrebonne Bay Reach

Base Year 1990 through Fiscal Year 1996

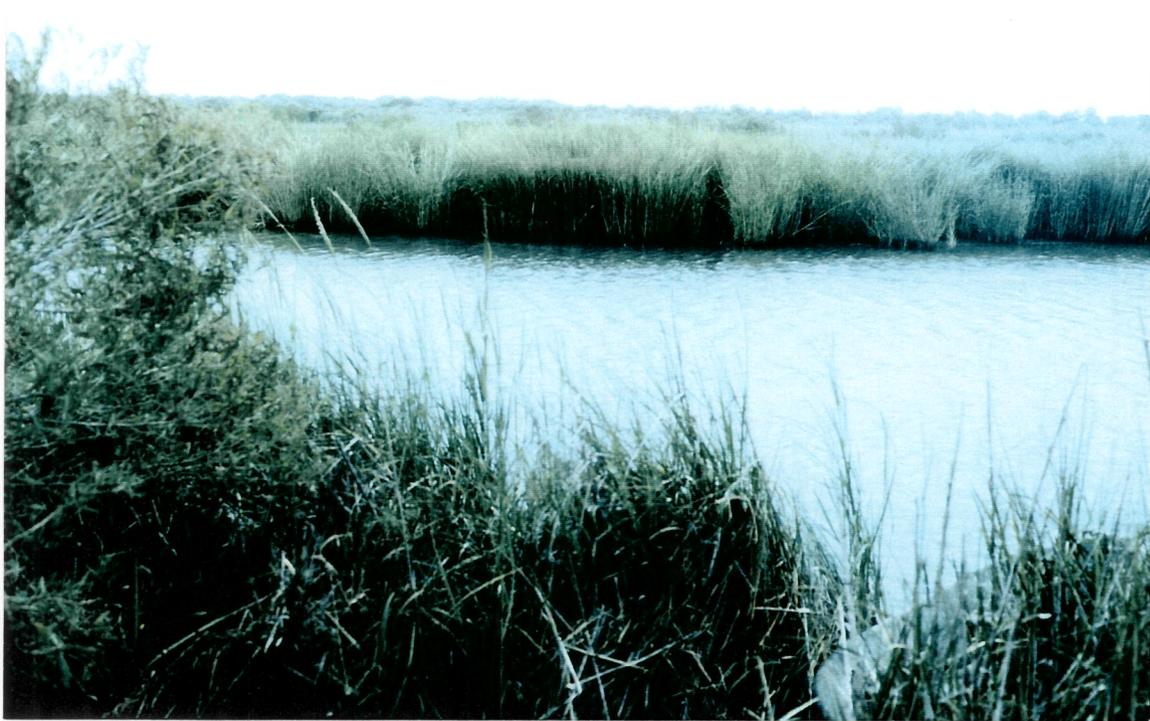
The Terrebonne Bay Reach site at Mile 11.3 is located just south of the LUMCON facility at Cocodrie along the northeast side of Houma Navigation (Figure 4). It consists of an encircling dike that is open to tidal action at the southwest side, an adjacent encircling, shallow to intertidal lagoon, and central colonizing saltmarsh (Figure 5).

Figure 5. Photograph of the Houma Navigation Canal - Terrebonne Bay Reach Mile 11.3 BUMP study site in September 1996. This view is from the channel side dike, looking across the shallow lagoon to the semi-confined saltmarsh.

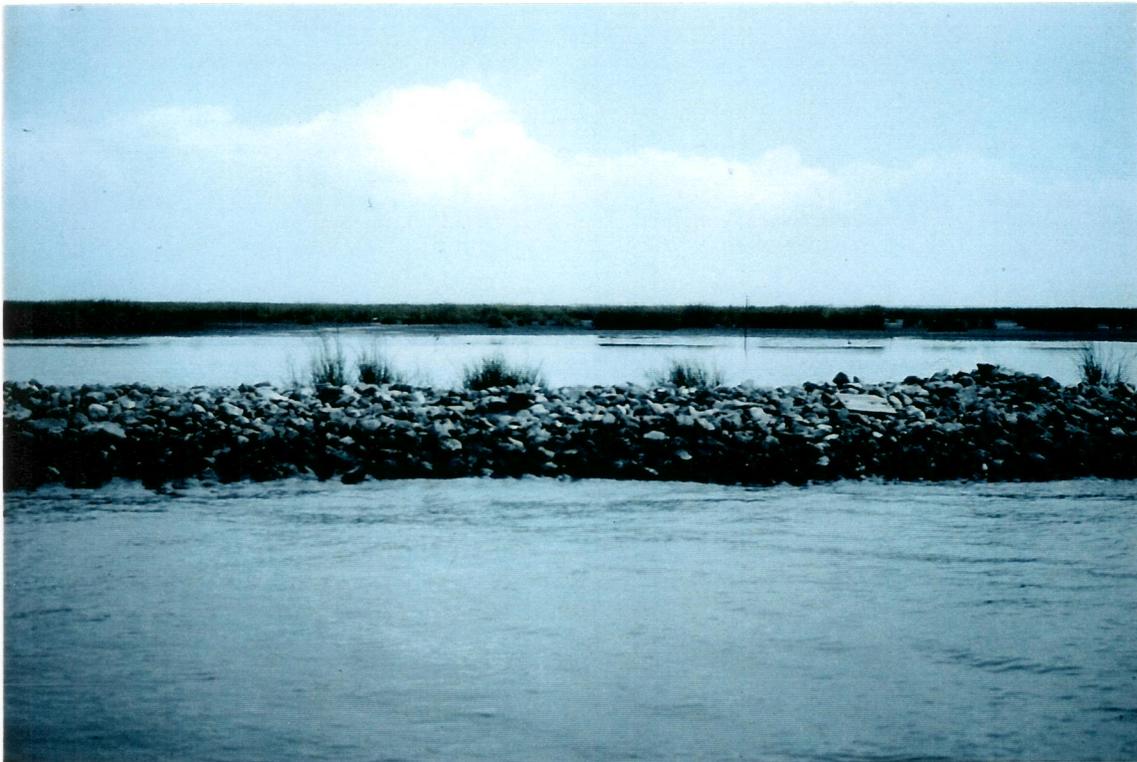
The site at Mile 7.1-8.0 is located along the northeast side of the Houma Navigation Canal as it passes through Bay Welsh near Lake Pelto (Figure 5). A dike was constructed around existing saltmarsh (Figure 7) and material was filled in around the marsh during the FY1993 and FY1995 maintenance events. However, the dike is incomplete in at least two places allowing tidal flow and wave action to remove much of the placed material.

Figure 7. Photograph of the Bay Chaland Mile 7.1-8.0 BUMP study site taken in September 1996, showing the rock dike that partially encloses the existing natural marsh.

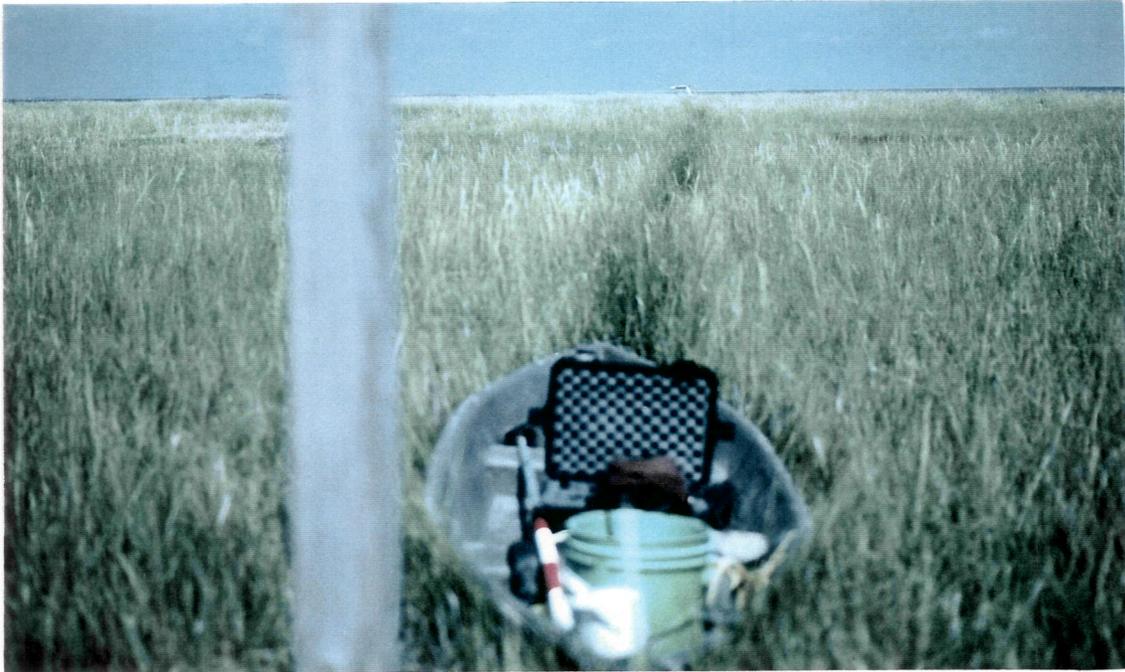
The transect was delineated by one stake set in the rock levee on the northeast side of the site, and was aligned due south along the series of survey stakes placed within the existing marsh by the dredging survey crews (Figure 8).

Figure 8. Photograph of the Bay Chaland Mile 7.1-8.0 BUMP study site taken in September 1996, showing the transect line that is in line with survey markers left by a previous crew.
