**Atchafalaya River and Bayous Chene, Boeuf, and Black, LA  
Disposal Area I Inspection**

**CEMVN-OD-T  
August 2011**

**Overview** – The CEMVN conducted an inspection of Disposal Area I on 4-August-2011 to investigate habitat development and type, and gauge overall habitat quality. Observations made during this inspection are intended to improve the District’s understanding of the maturation of beneficial use disposal areas within the Atchafalaya Basin. Findings will also help direct future disposal practices.

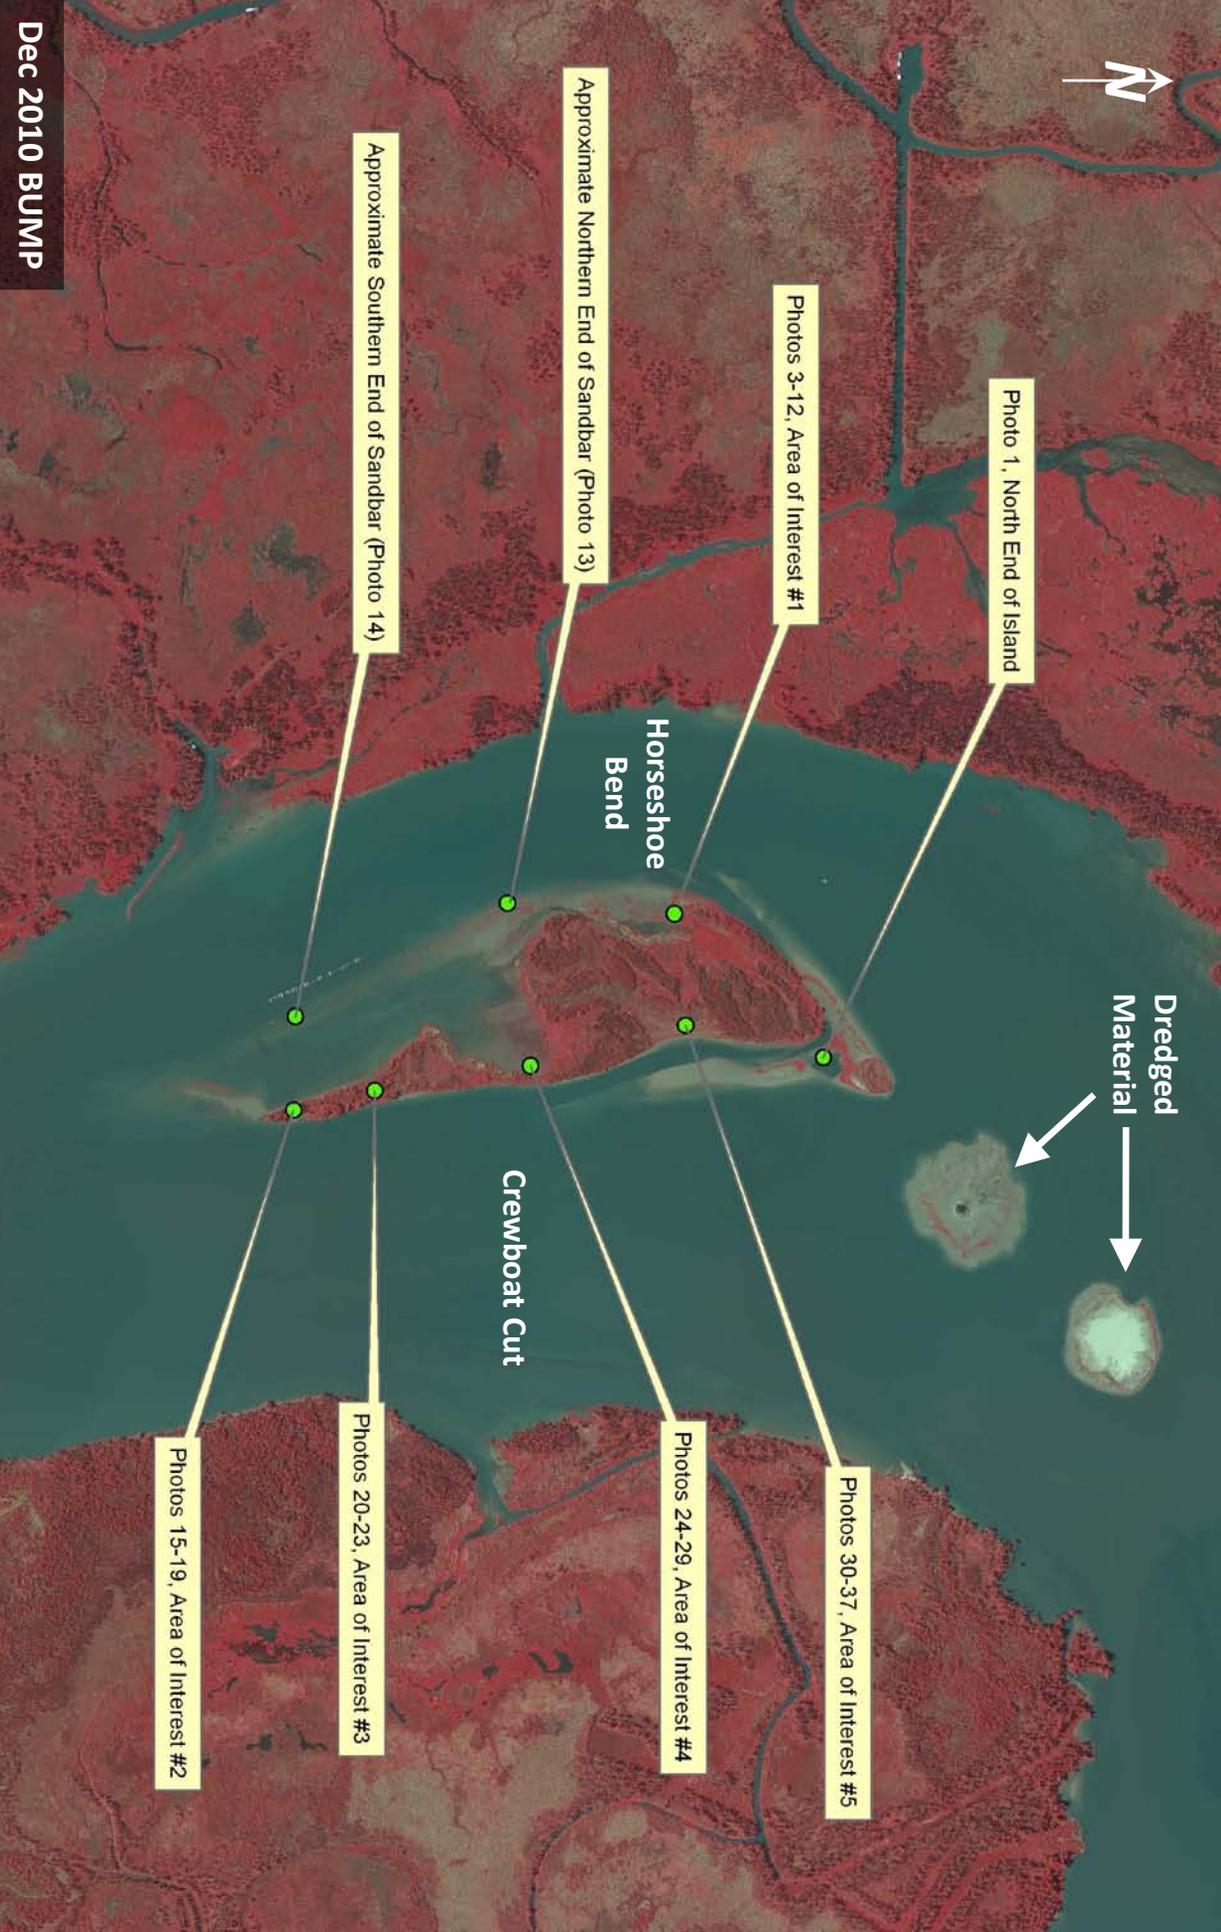
**Dec 2010 BUMP**

Figure 2. December 2010 extent of Disposal Area 1. Green dots serve as match-points in thumbnails of prior aerial reconnaissance shown in Figure 3. Each match-point is also labeled for reference to photographs contained in this report.

Note that dredged material mounds were placed upriver of the disposal area during Fiscal Year (FY) 2009 channel maintenance. Mounds are dispersed by currents and drift into the disposal area – as opposed to direct placement on the disposal area.

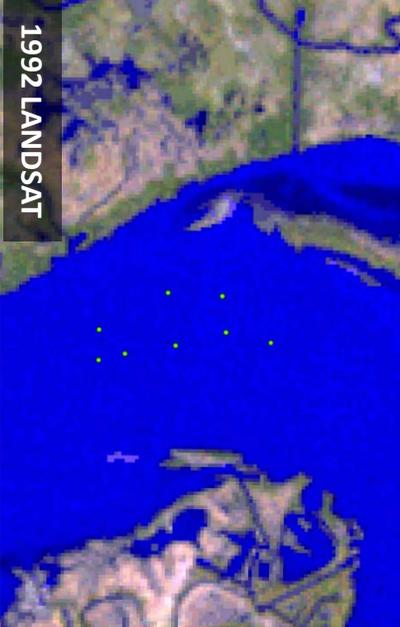
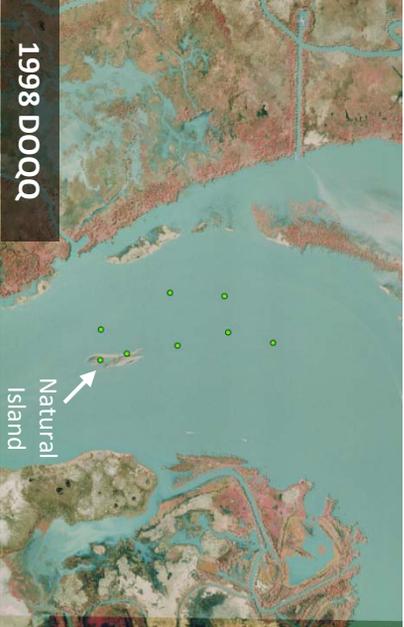
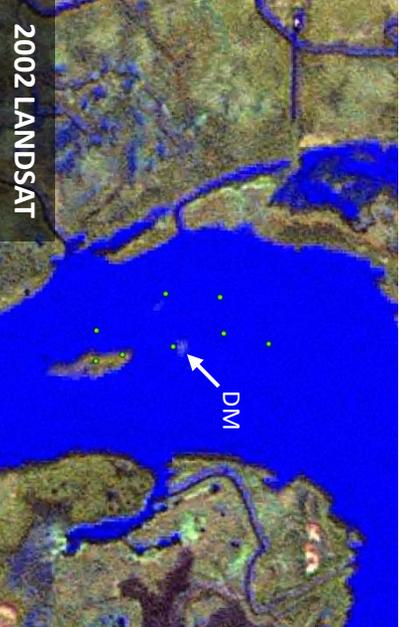
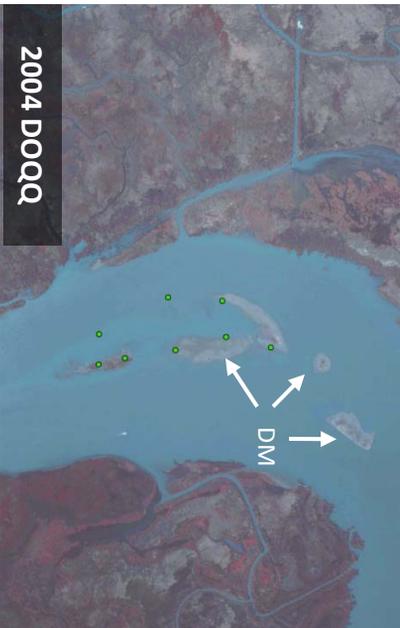
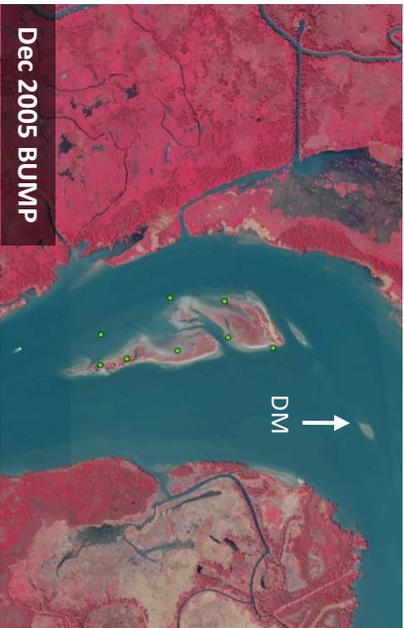
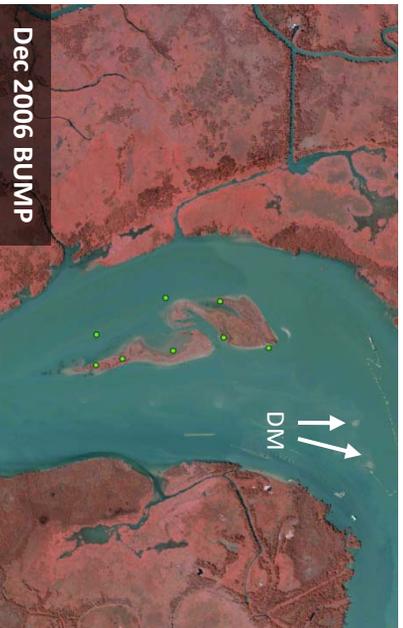
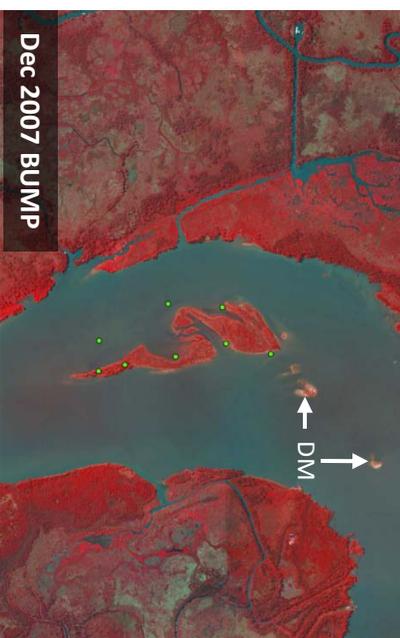
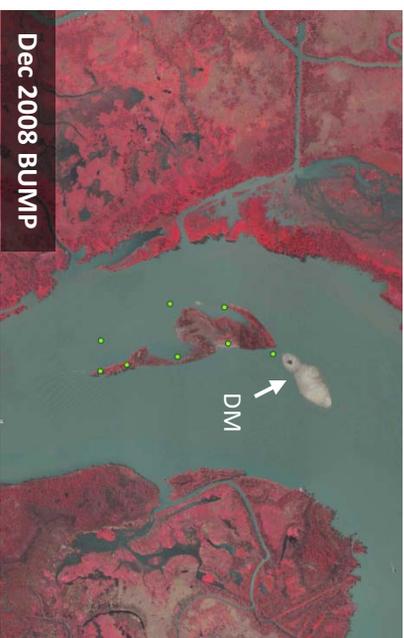
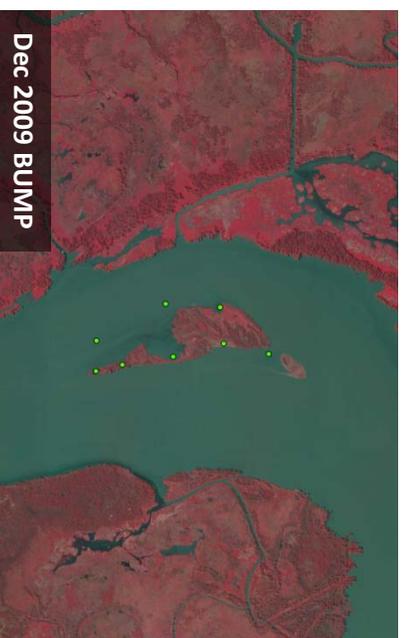
Figure 3. Natural formation of an island at Horseshoe Bend (1992-1998). Placement of dredged material mounds (labeled "DM" in above images) upriver of the island began in FY 2002. Migration of material from the mounds and natural accretion bridged the gap with the island during FY 2004. Dredged material mounds were placed upriver of the island / Disposal Area I complex during all subsequent channel maintenance events.

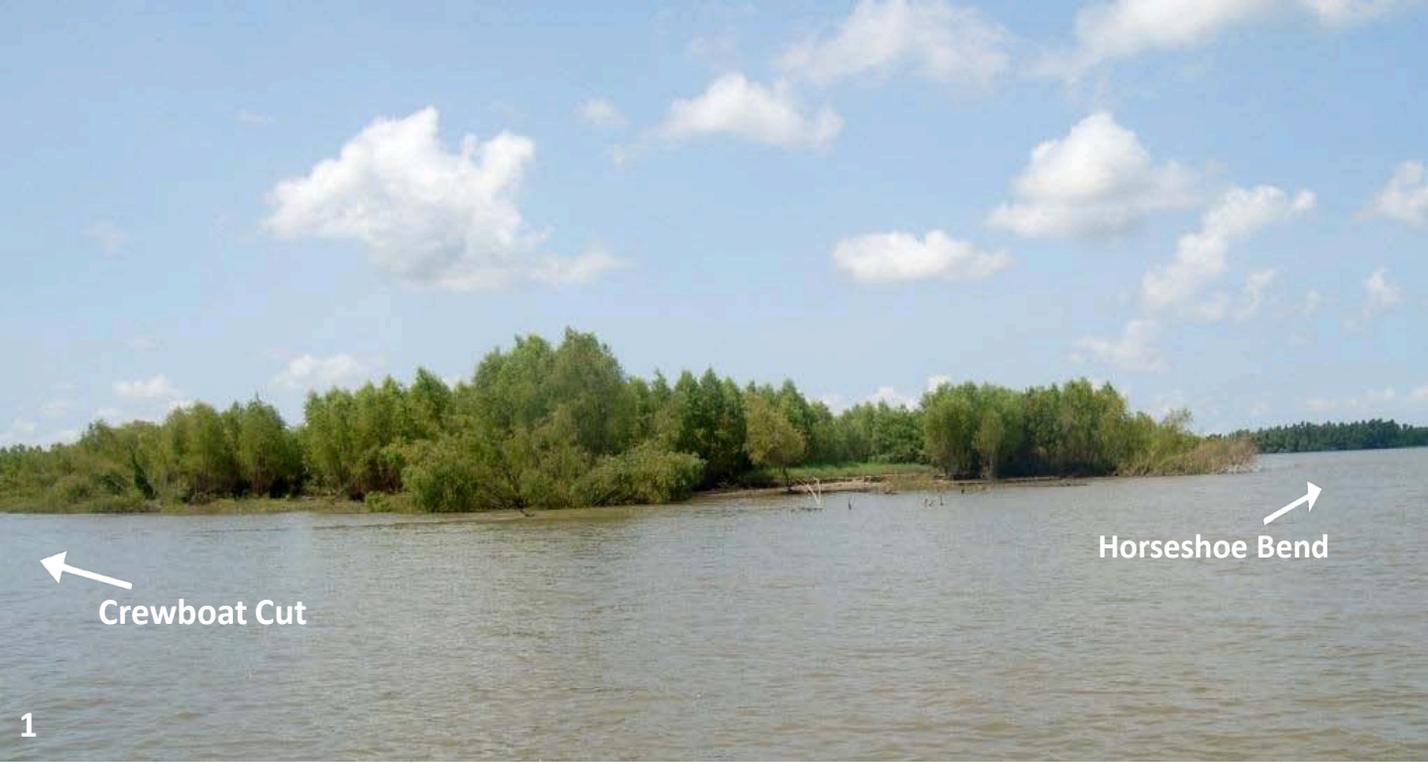
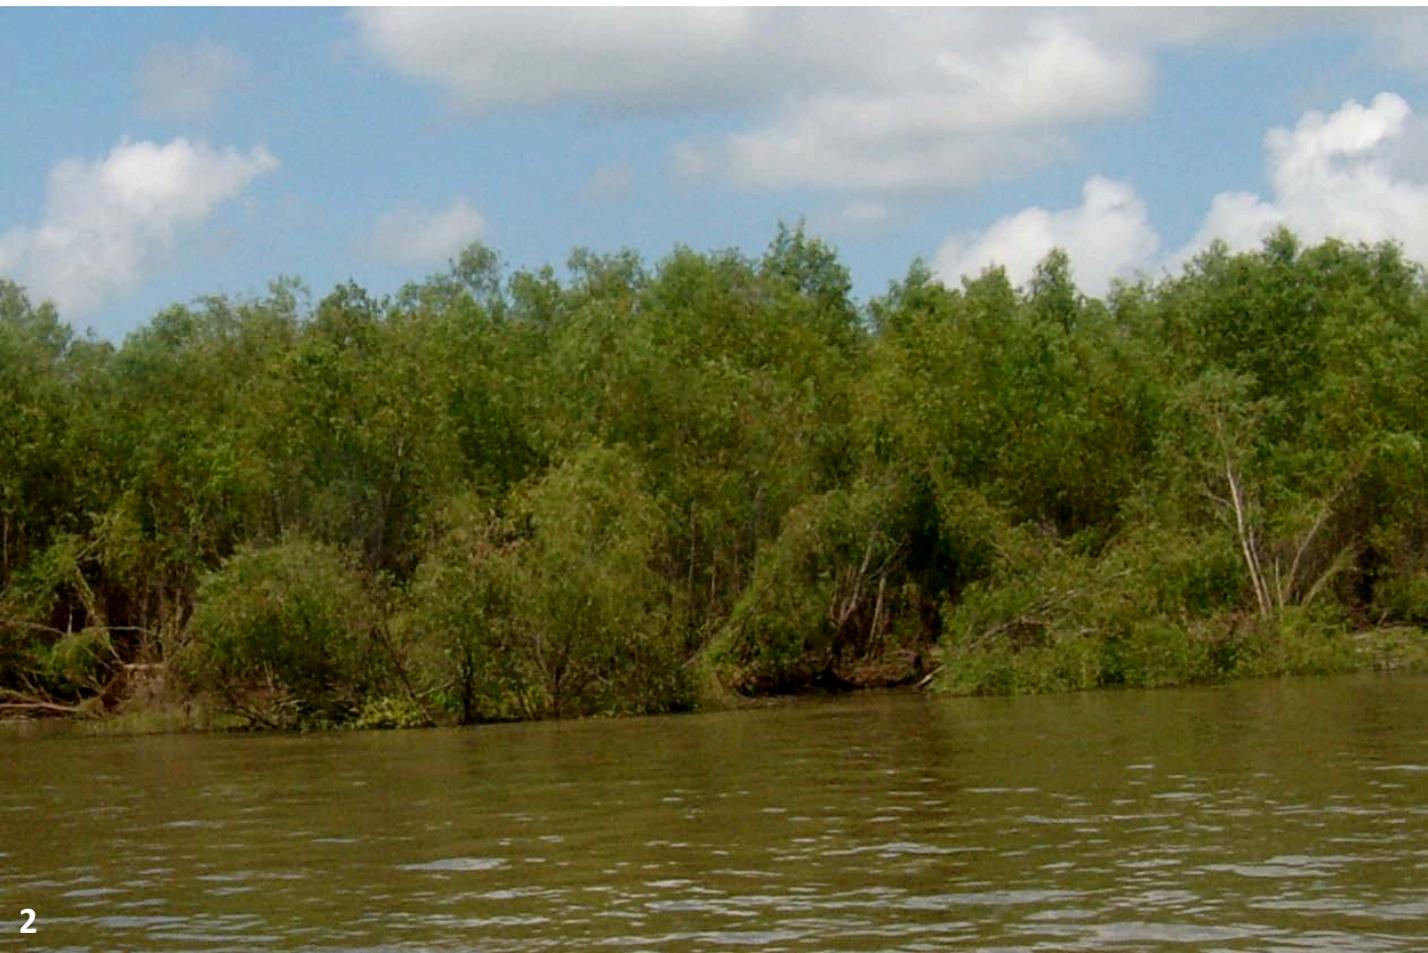
**Pictures 1 & 2.** Northern end of Disposal Area I (above), and black willow (*Salix nigra*) along the outer margins of Disposal Area I (below). Note that the two dredged material mounds and the v-shaped sandbar north of Disposal Area I visible in the December 2010 aerial photograph (Figure 2) were not visible above the waterline during this inspection.

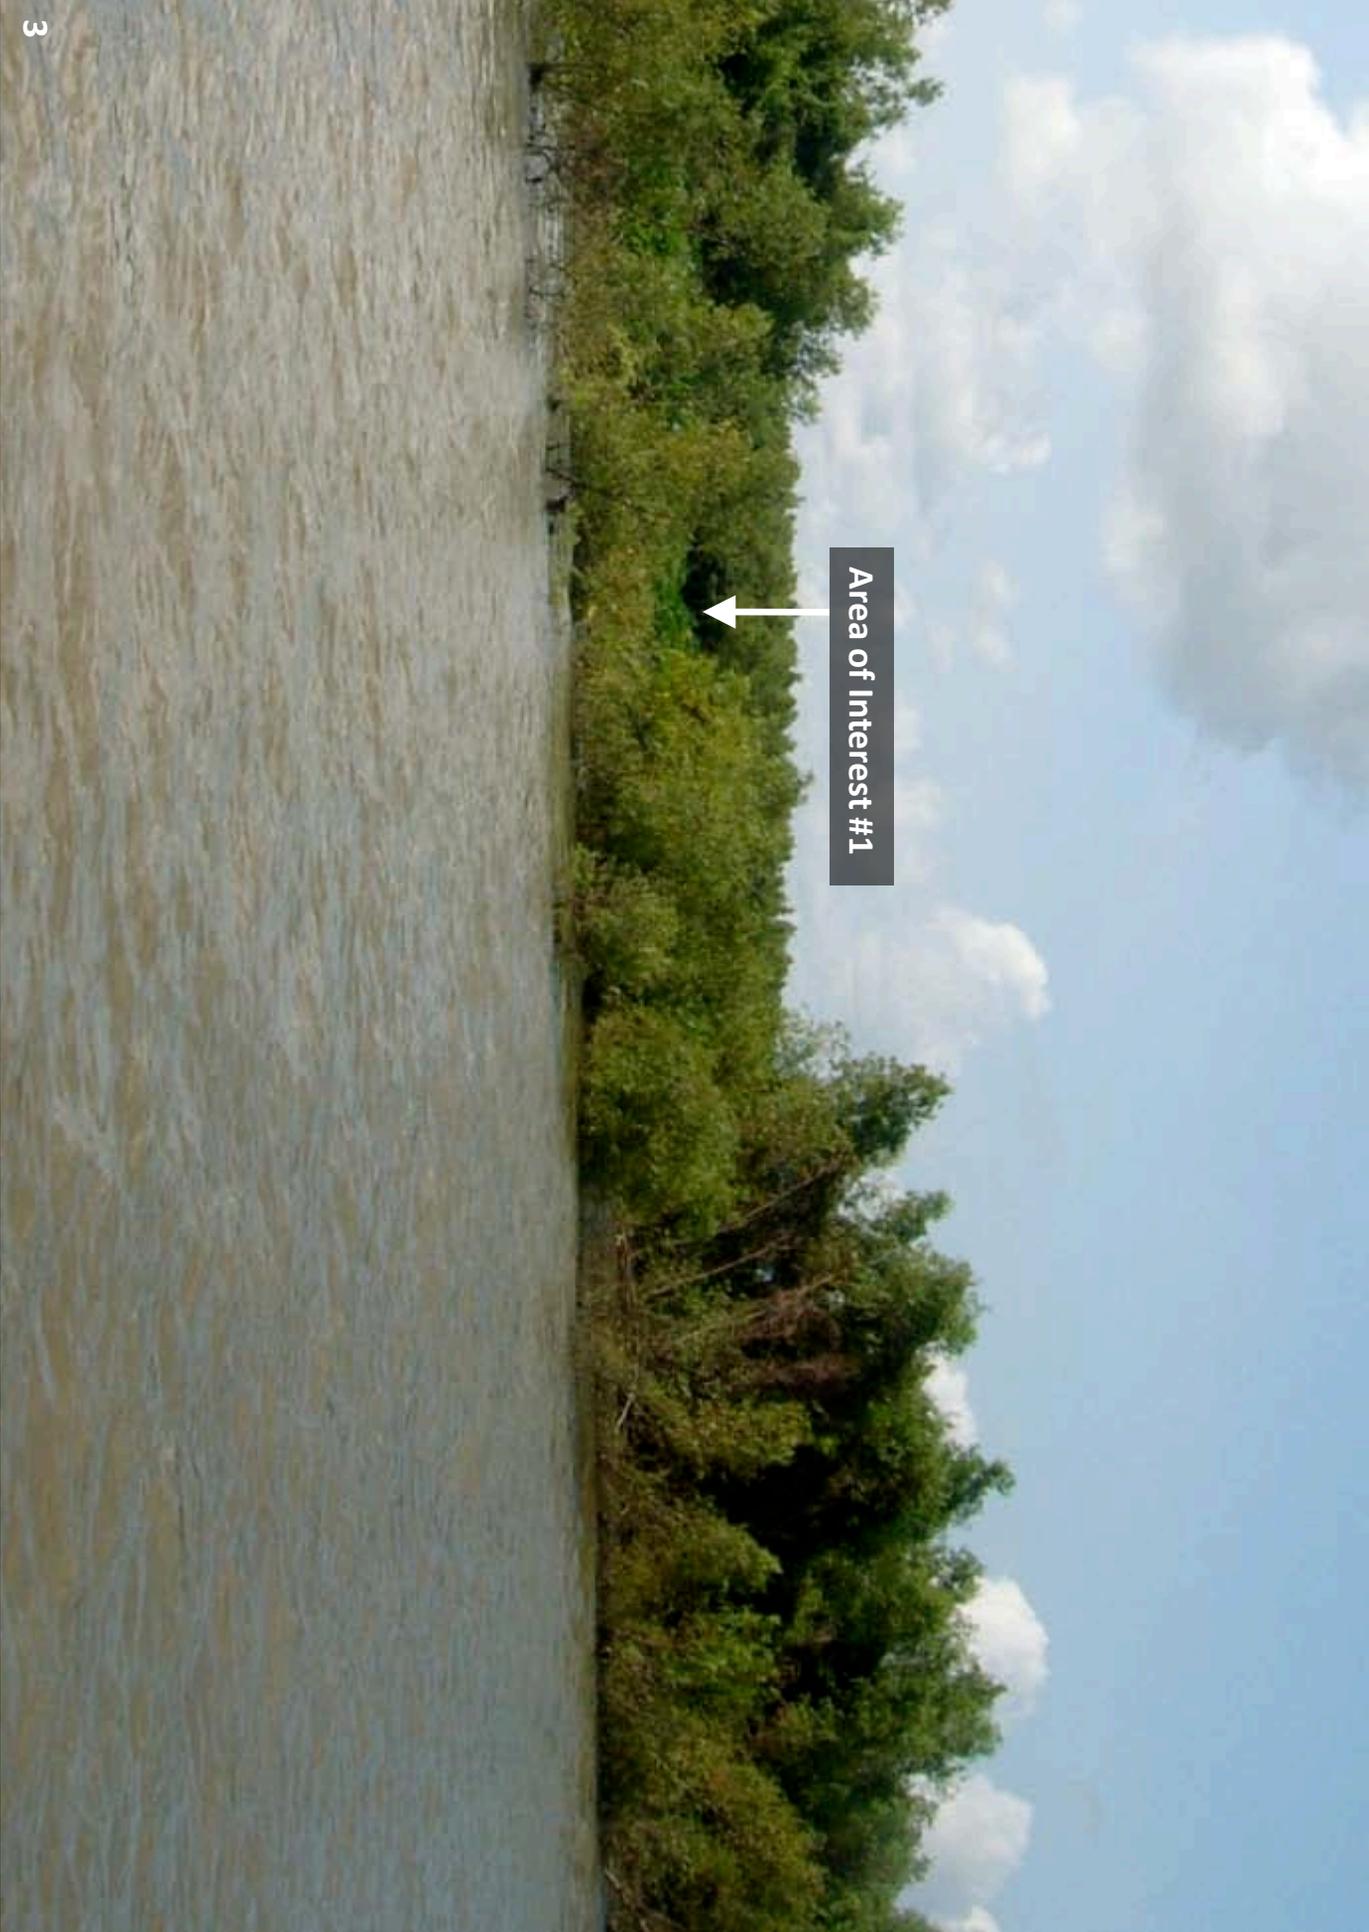
**Picture 3.** Area of interest #1. Interior of Disposal Area I visible through a break in outer margin of black willow,

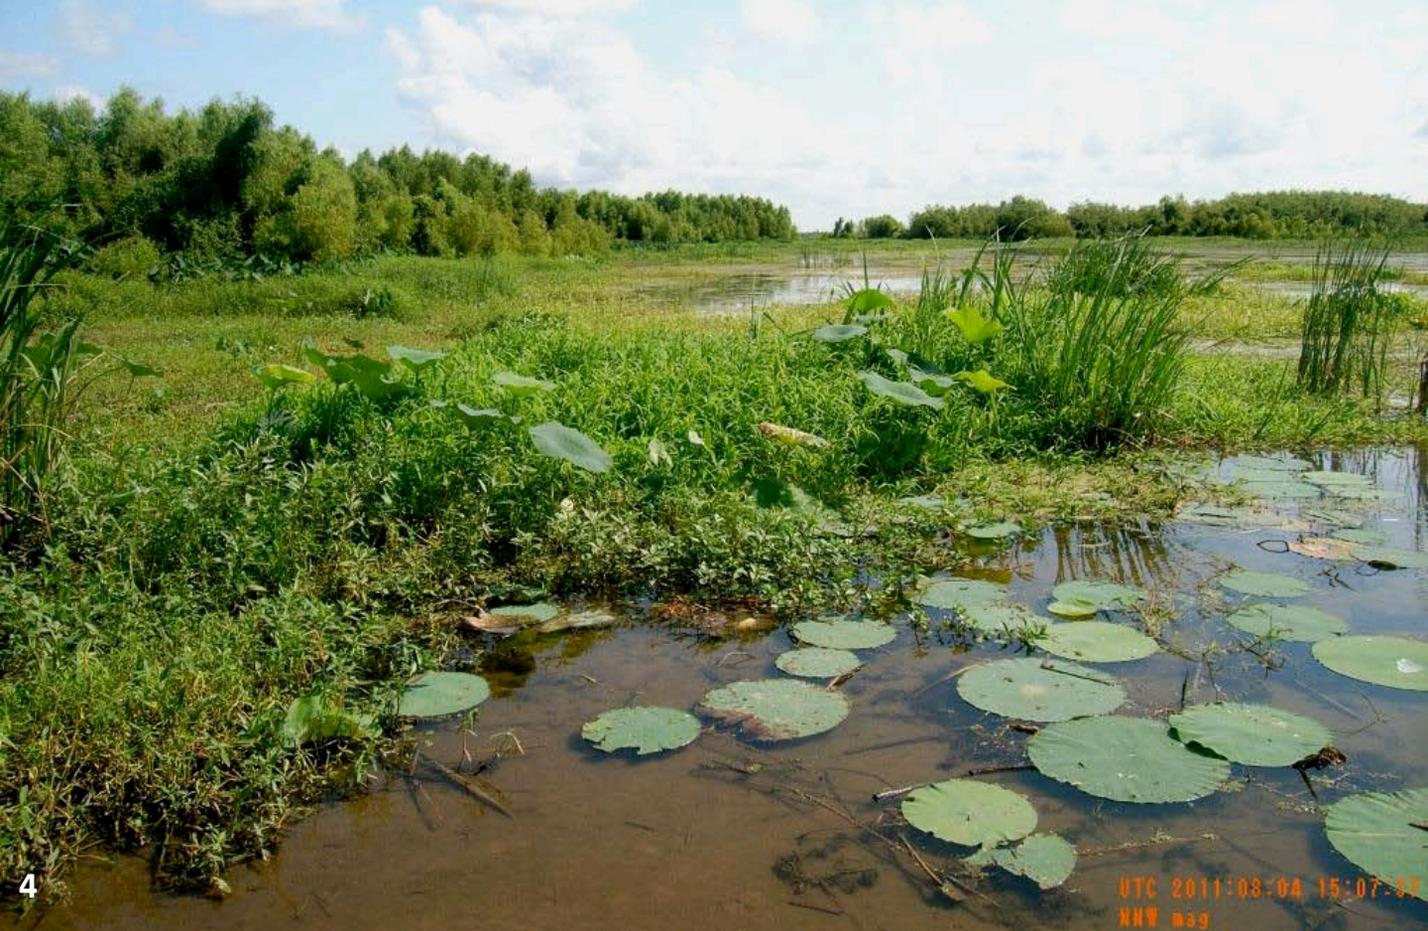
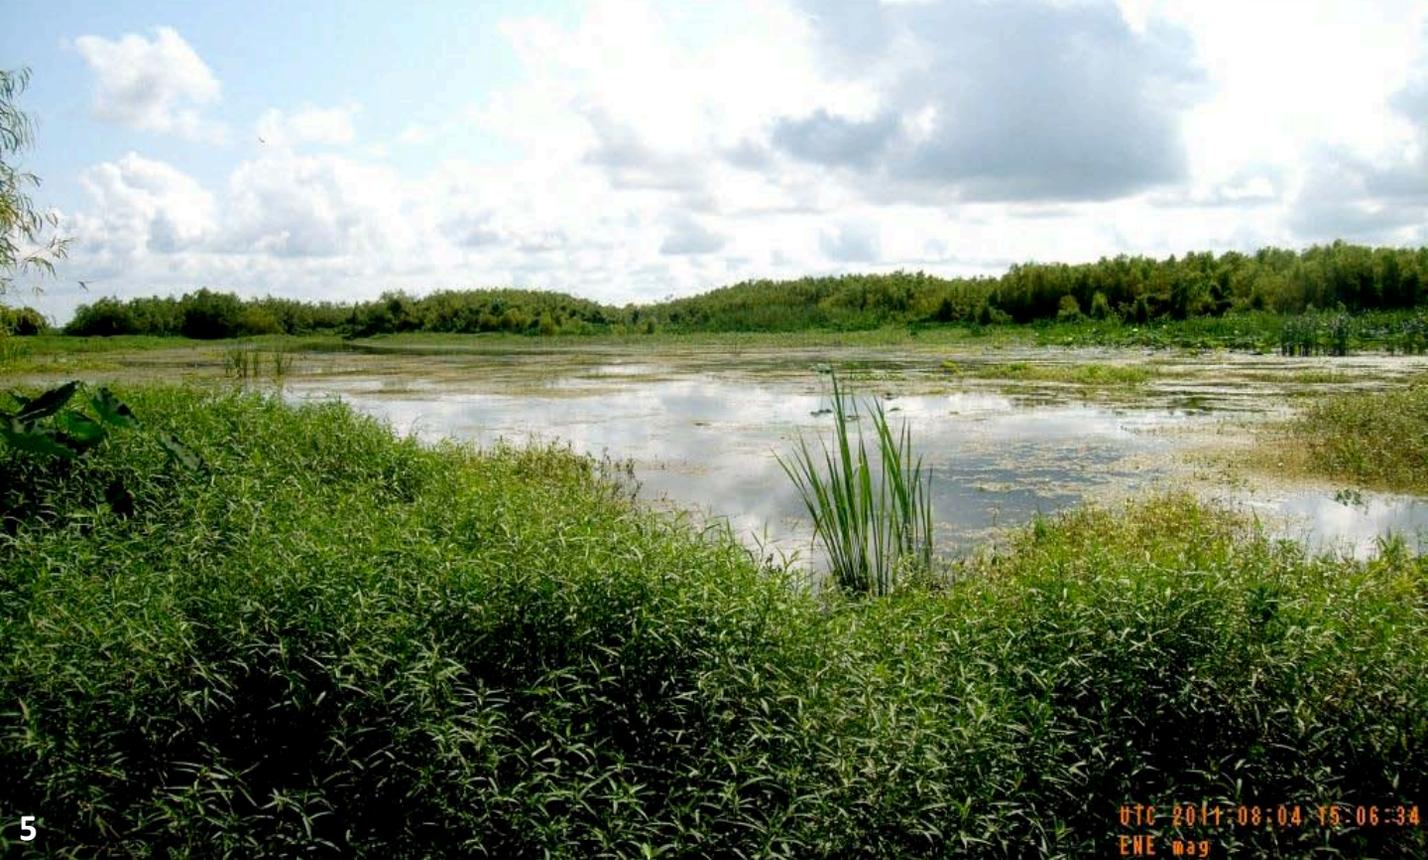
Pictures 4 & 5. Area of interest #1 looking northwest (above) and northeast (below). Poned area and fringe vegetation encompassed about 15 acres. Plant species included alligatorweed (*Alternanthera philoxeroides*), American lotus (*Nelumbo lutea*), smartweed (*Polygonum* sp), cattail (*Typha latifolia*) and giant cutgrass (*Zizaniopsis miliacea*).

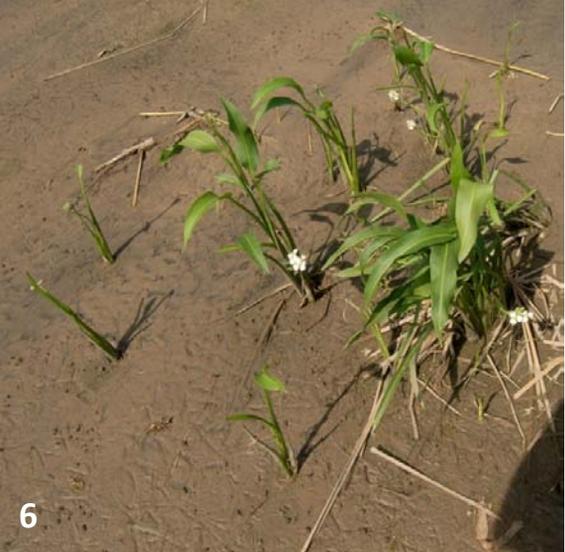
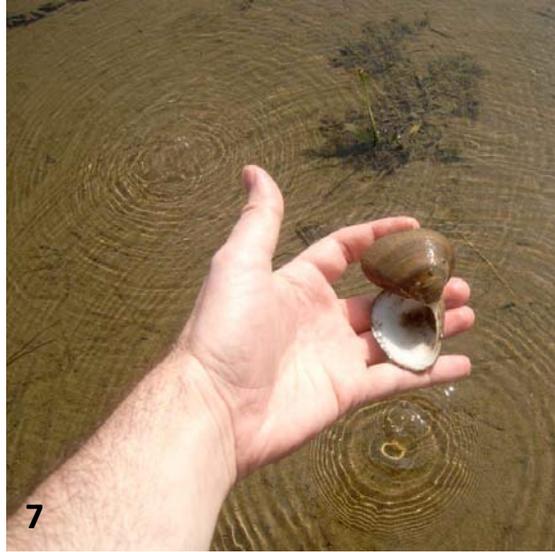
Pictures 6 & 7. Bulltongue (*Sagittaria lancifolia*) and bird tracks (far left); freshwater mussel shells were scattered throughout the ponded area (left). Great blue heron (*Ardea Herodias*), great egret (*Ardea alba*), and American coot (*Fulica americana*) were sighted in the area.

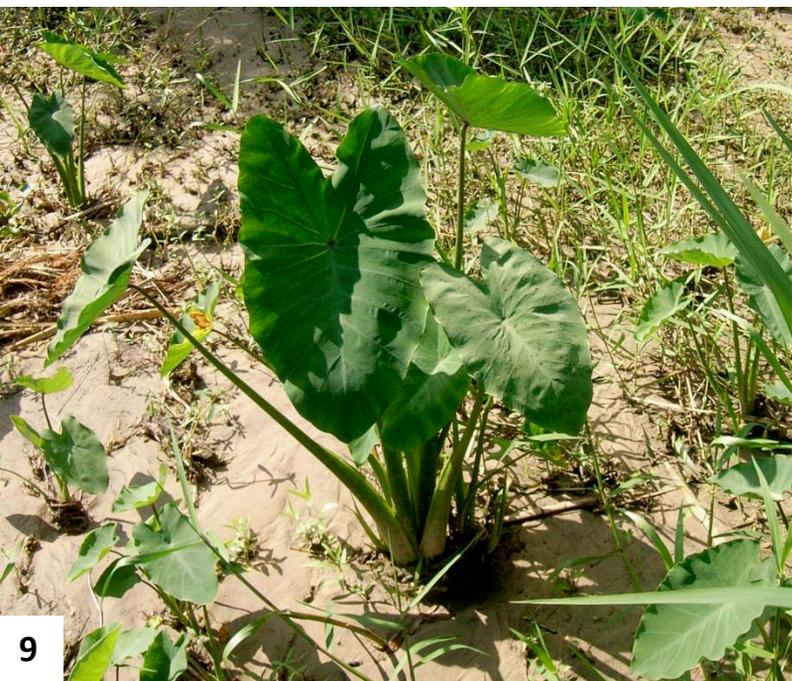
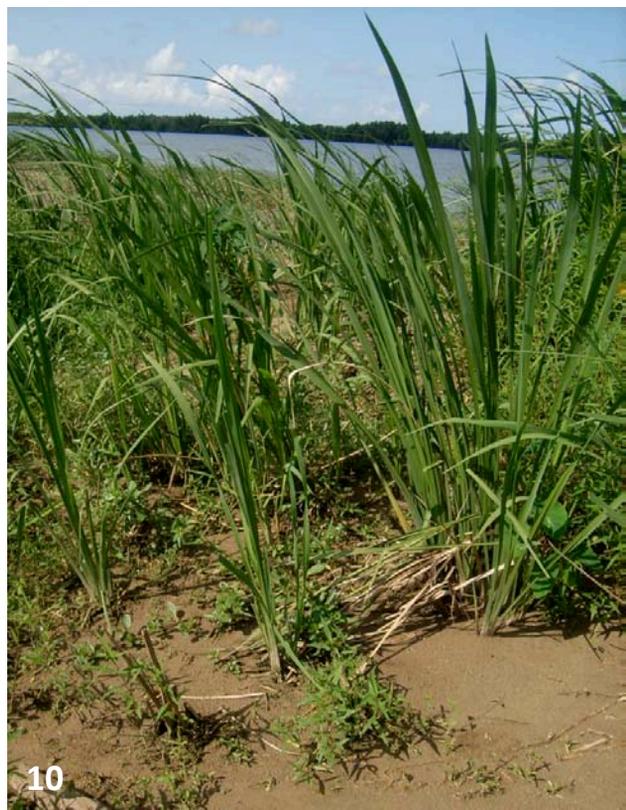
Pictures 9 & 10. Elephant's ear (*Colocasia esculenta*) and giant cutgrass (lower left and right) becoming established on recently deposited sand within area of interest #1.

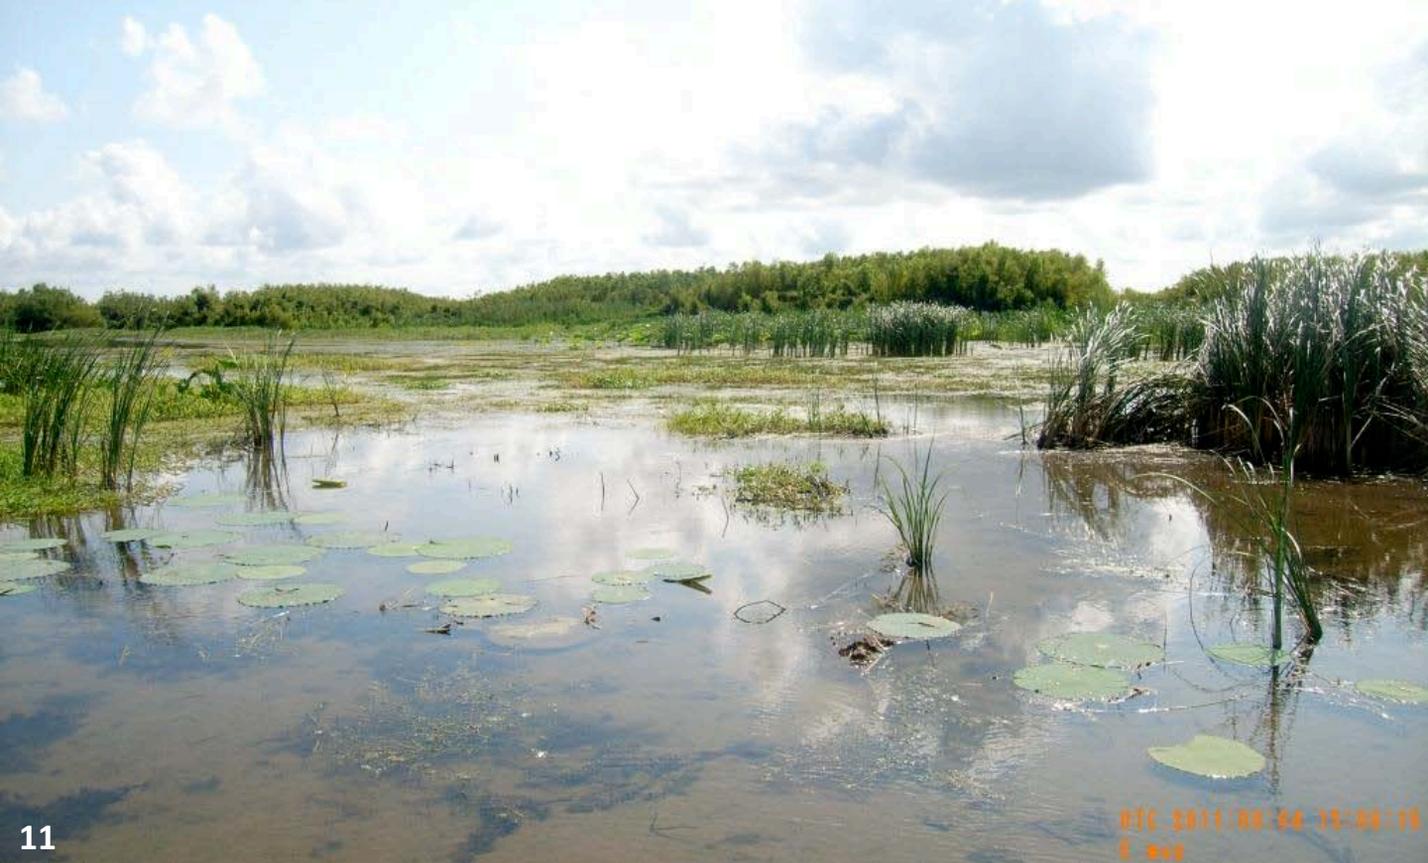
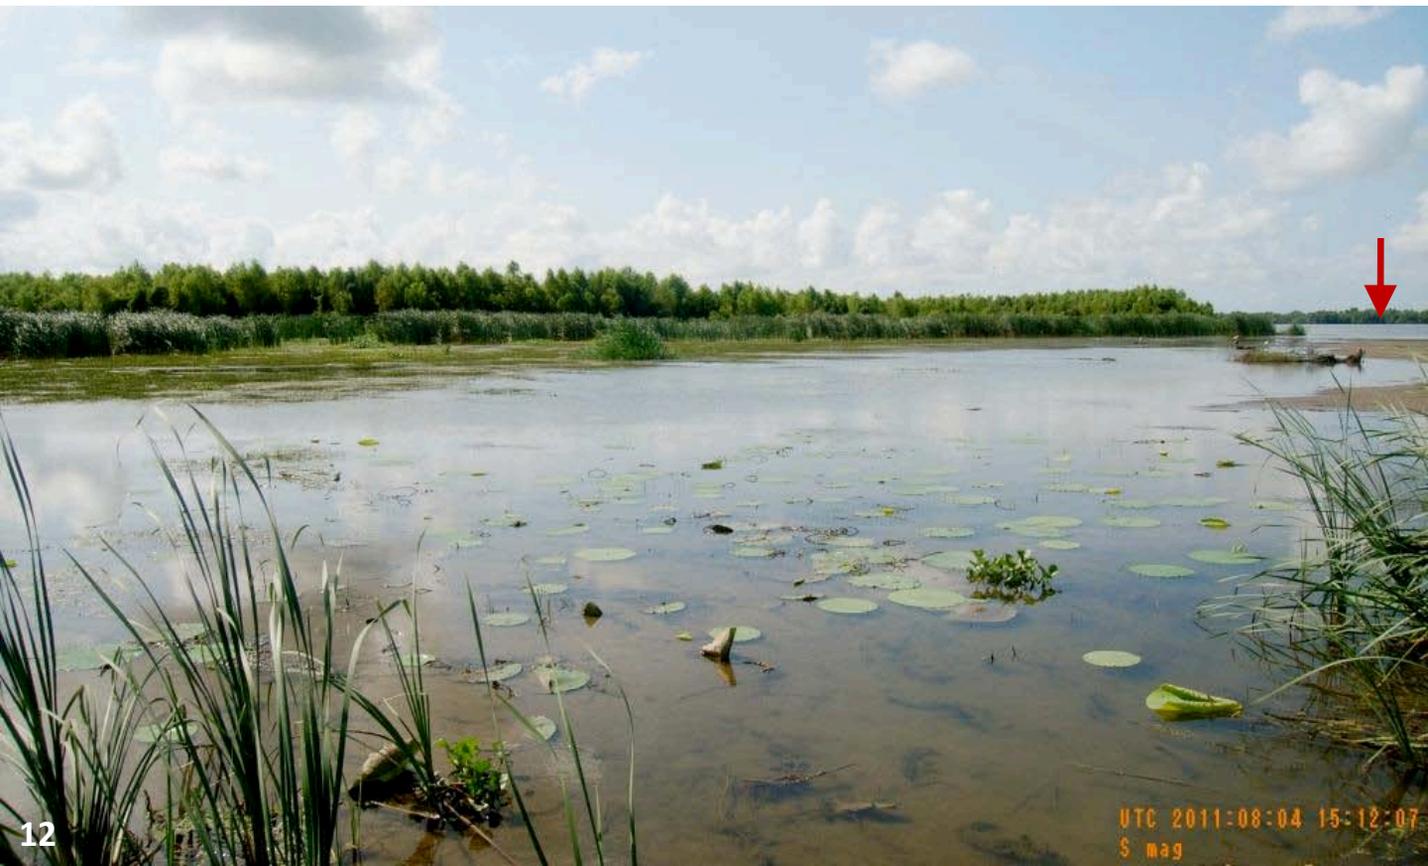
**Pictures 11 & 12.** Area of interest #1 looking east (above) and south (below). Note beginning of outer sandbar to the east (red arrow). Willet (*Tringa semipalmata*) and white ibis (*Eudocimus albus*) were present within the transition between the ponded area and outer sandbar.

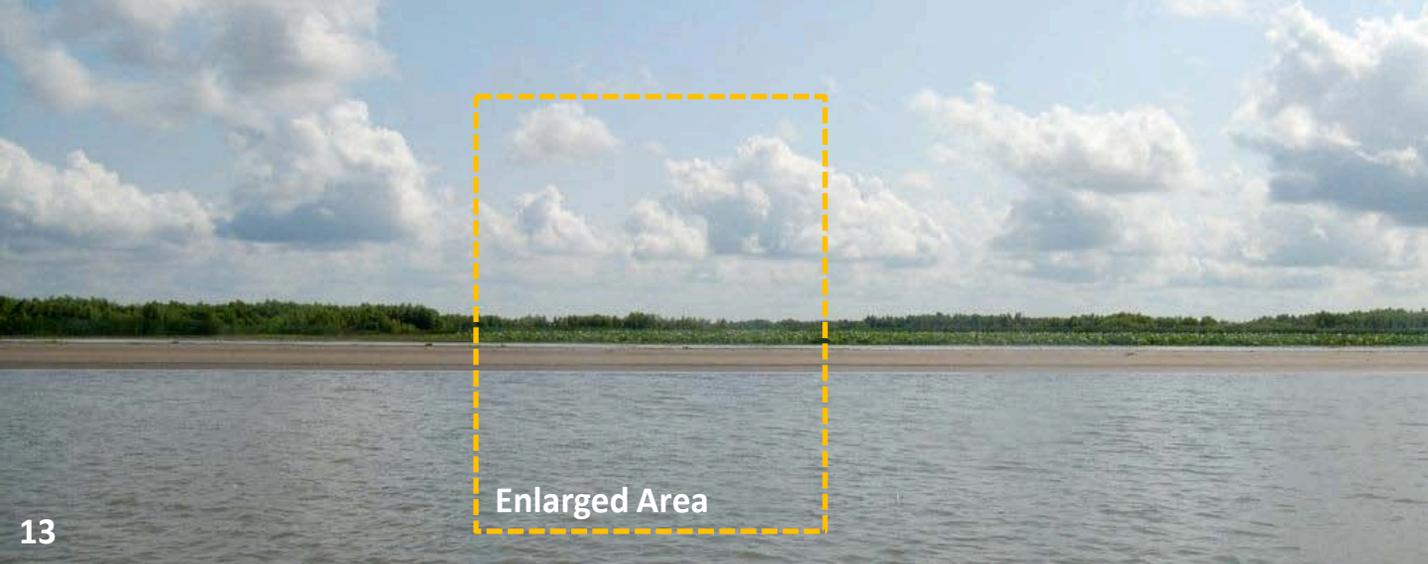
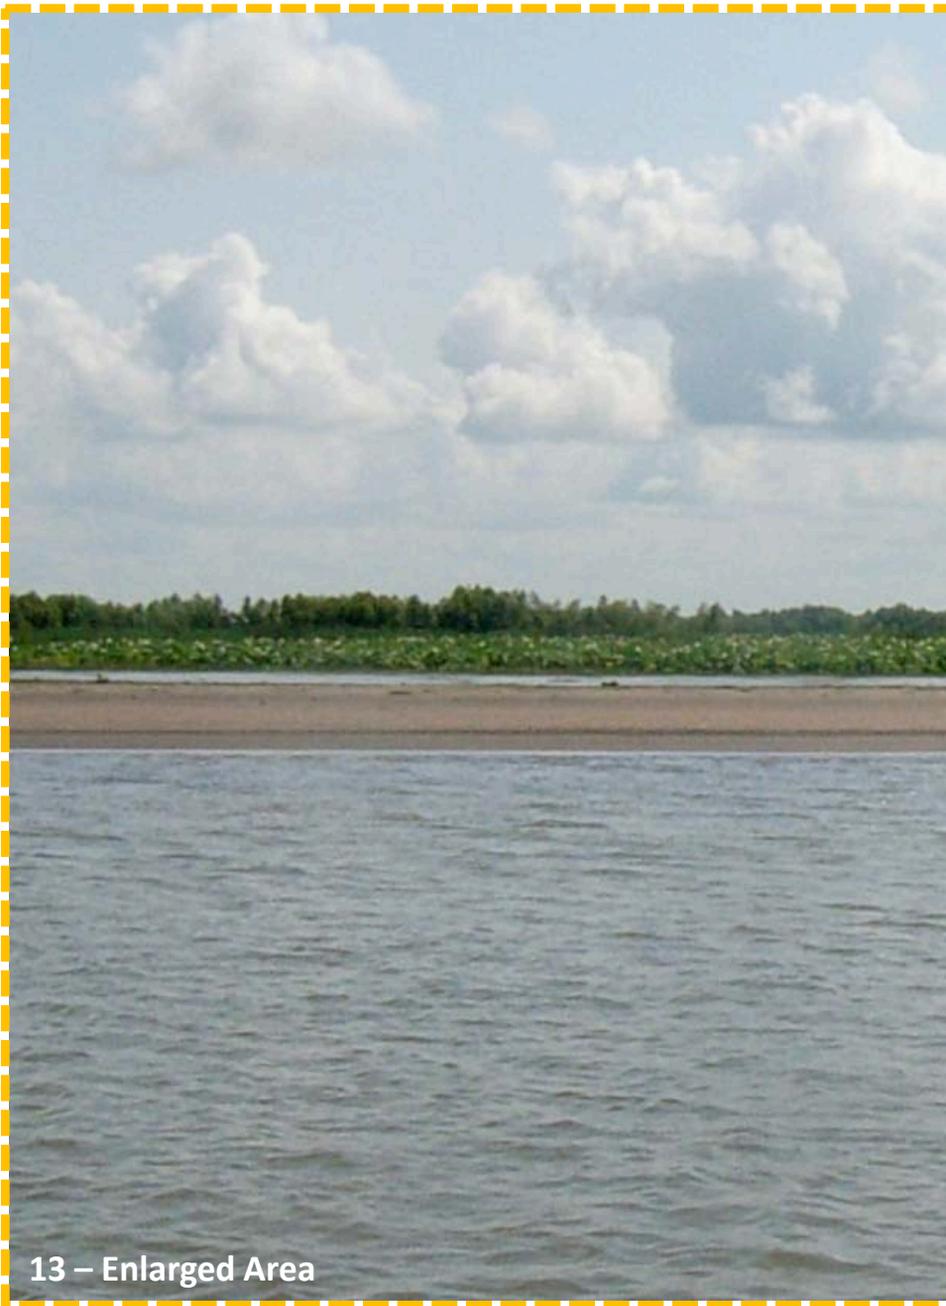
13

**Picture 13.** Sandbar separating Horseshoe Bend from the eastern edge of Disposal Area I (Above). Sandbar extended about 1,800 feet along the western edge of Disposal Area I and was backed by an additional 3 acre American lotus stand (visible in the enlarged photo at right). Both areas were separated from each other and the disposal area by shallow open-water.

Roseate spoonbills (*Platalea ajaja*), Laughing gulls (*Leucophaeus atricilla*), plovers (*Charadrius spp.*), and caspian terns (*Hydroprogne caspia*) were sighted loafing on the sandbar and foraging in the shallow open-water.

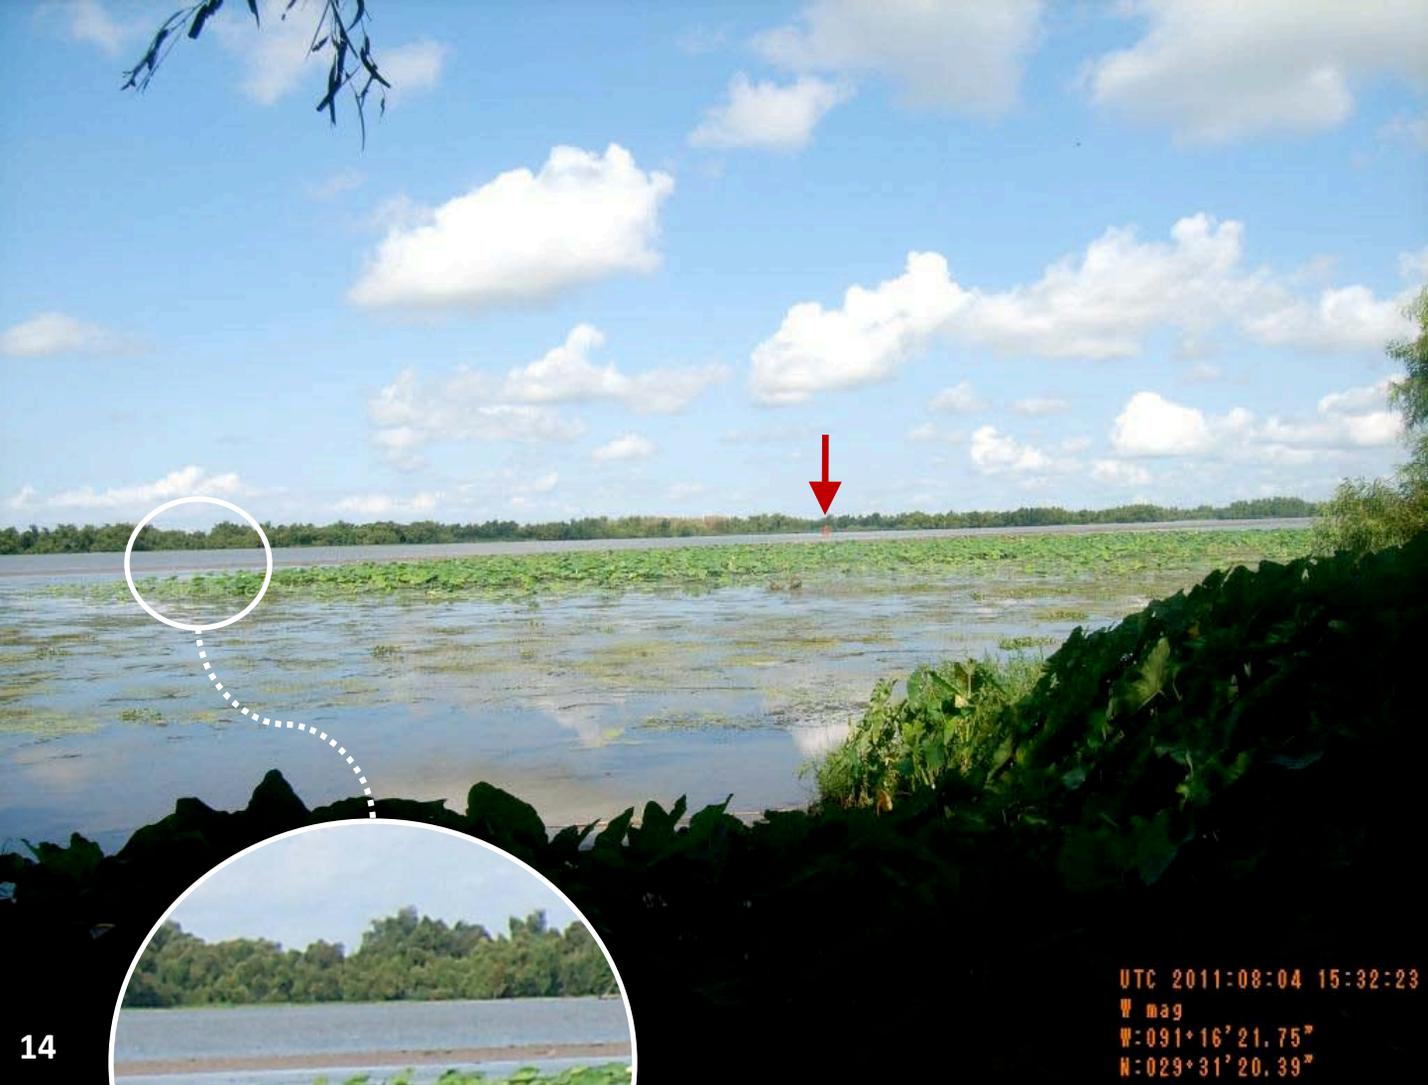
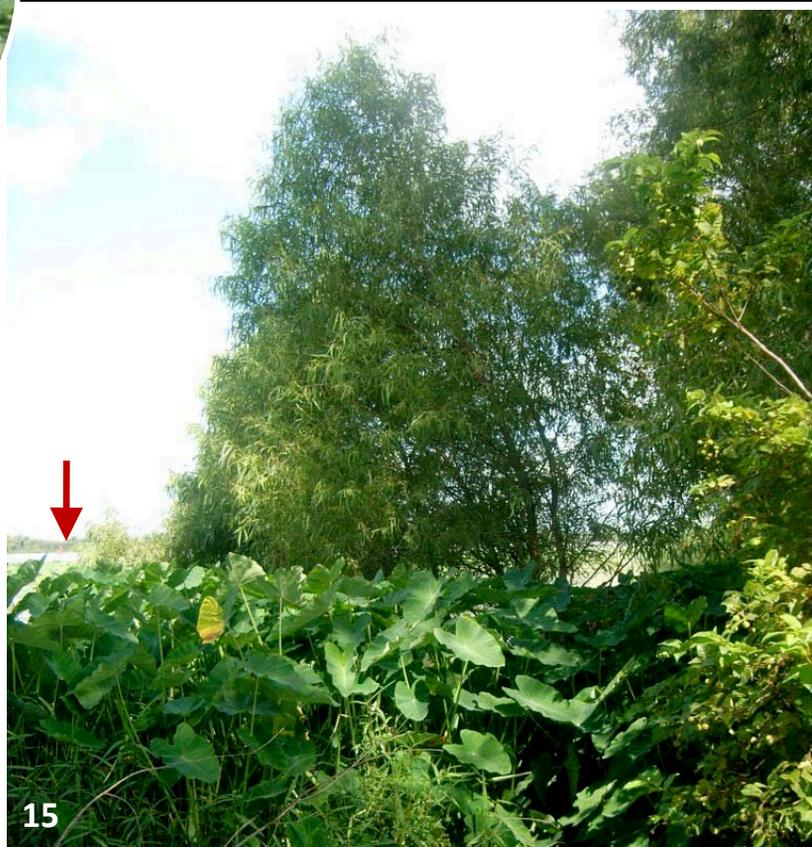
**Pictures 14 & 15.** Area of Interest #2 within the natural island footprint. Sandbar and American lotus stand visible from the southern end of Disposal Area I (above). Elephant's ear and black willow were well established on the southern end of the disposal area (right). Note channel marker for Horeshoe Bend is visible in both photos (red arrow).
