**Atchafalaya River and Bayous Chene, Boeuf, and Black, LA  
Disposal Area I Inspection**

**CEMVN-OD-T  
August 2011**

**Overview** – The CEMVN conducted an inspection of Disposal Area I on 4-August-2011 to investigate habitat development and type, and gauge overall habitat quality. Observations made during this inspection are intended to improve the District’s understanding of the maturation of beneficial use disposal areas within the Atchafalaya Basin. Findings will also help direct future disposal practices.

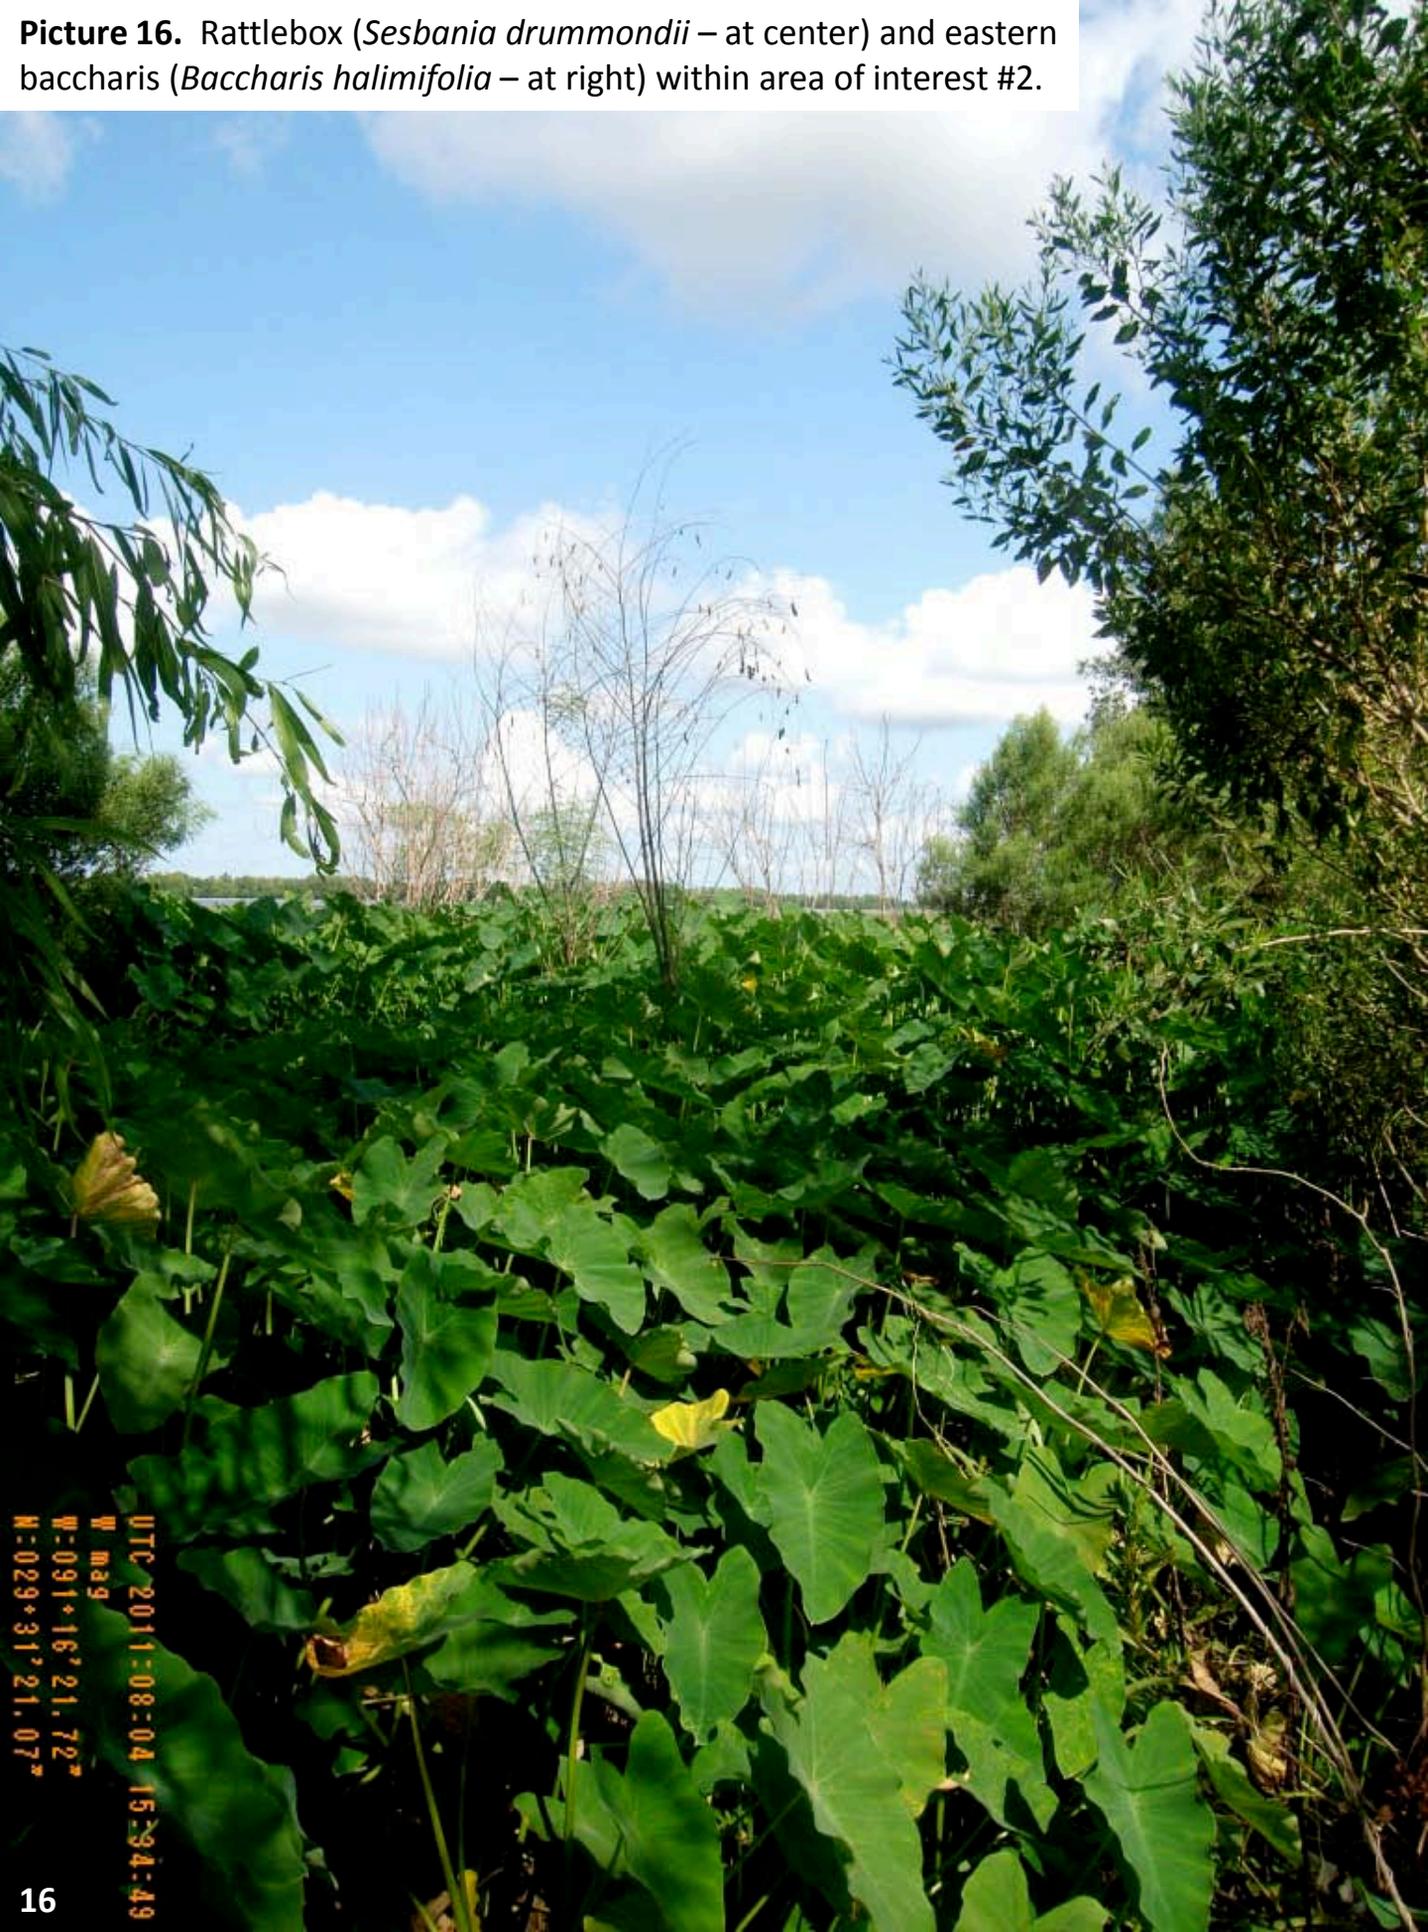
**Picture 16.** Rattlebox (*Sesbania drummondii* – at center) and eastern baccharis (*Baccharis halimifolia* – at right) within area of interest #2.

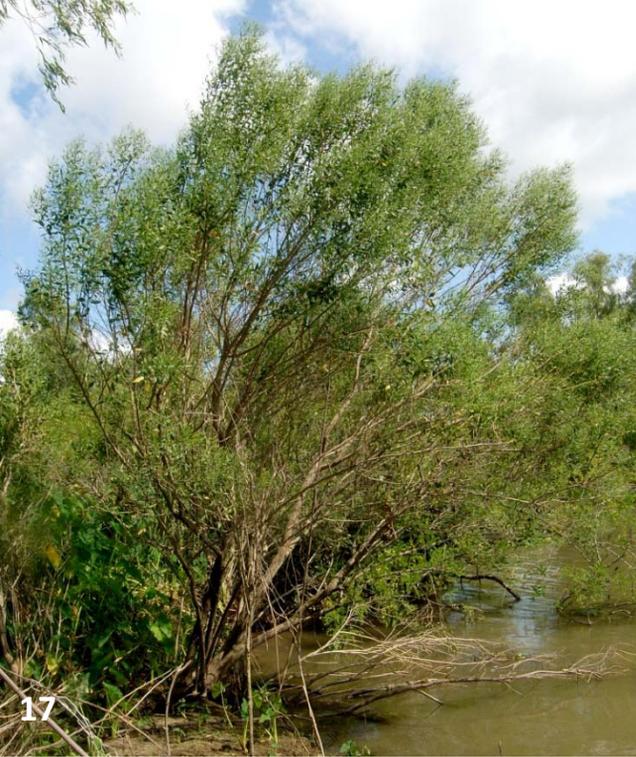
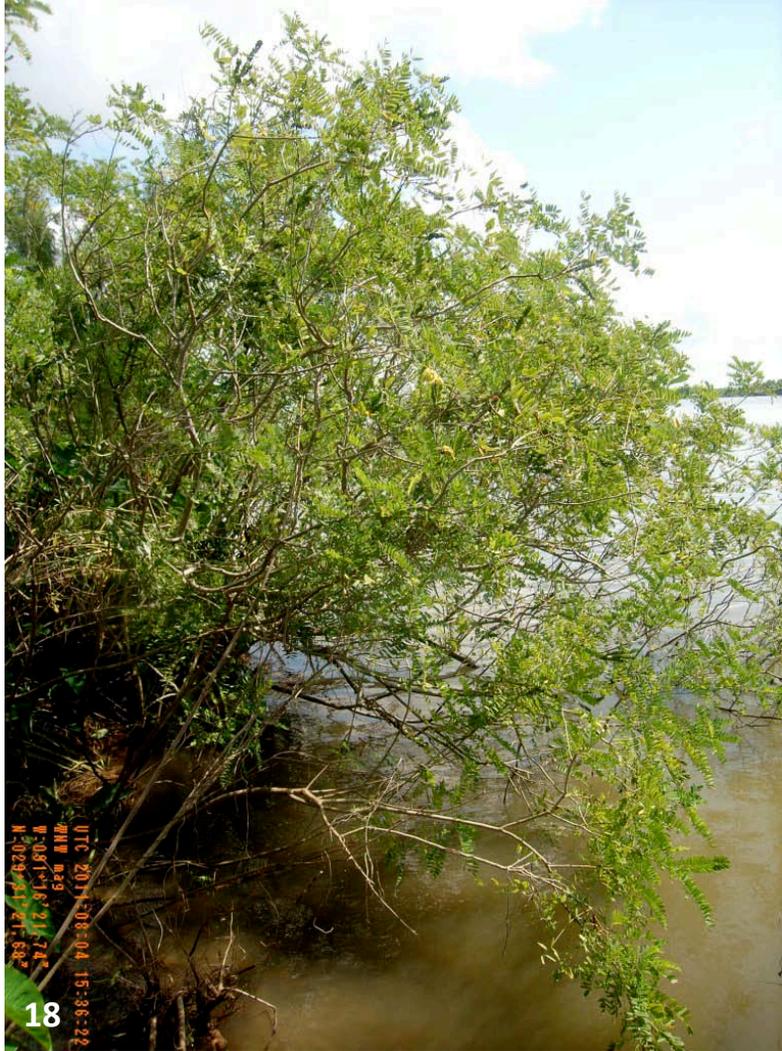
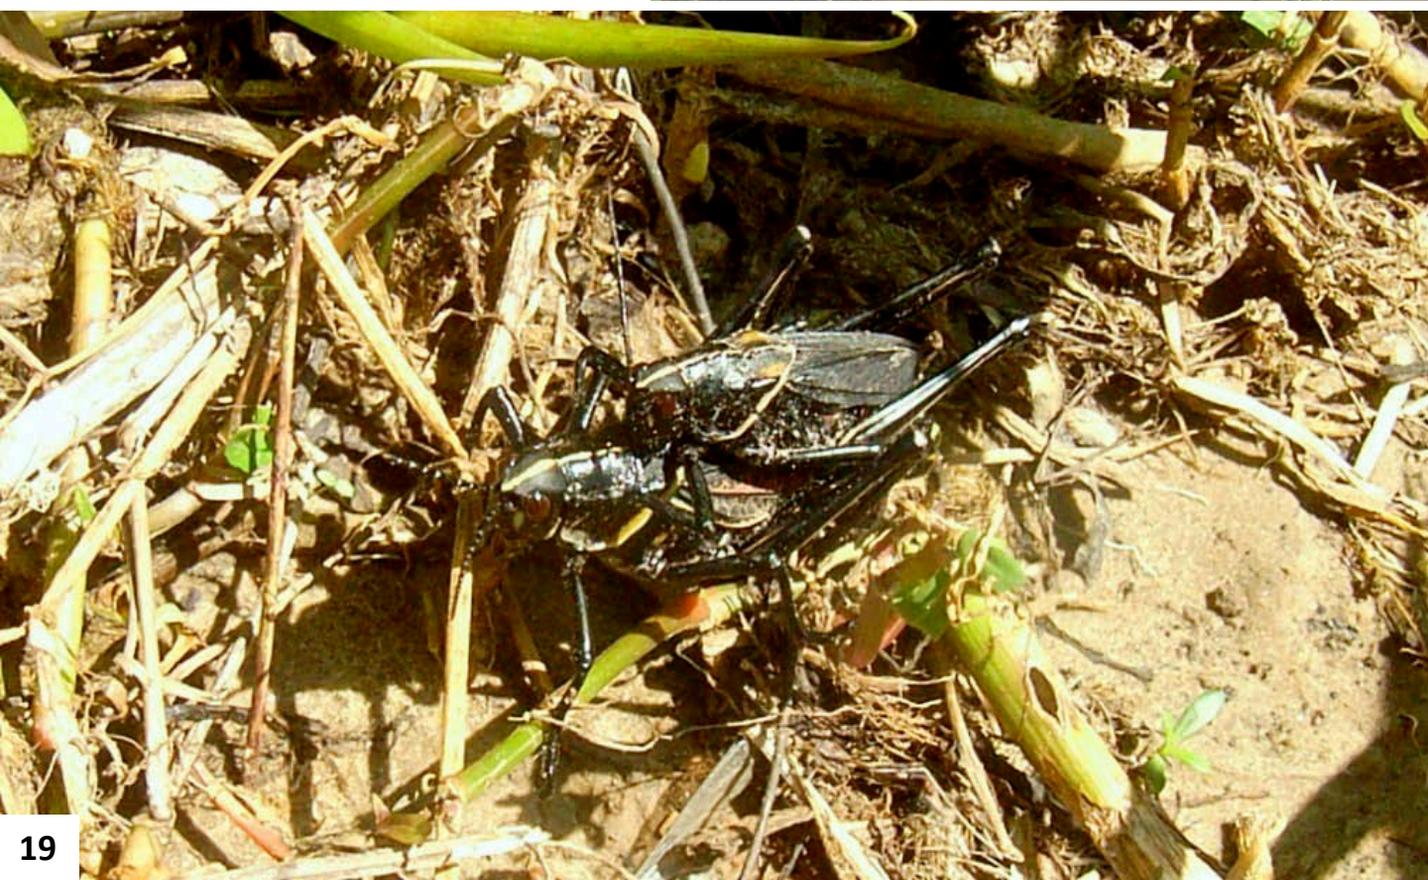
**Pictures 17 - 19.** Eastern baccharis (above) and false indigo (*Amorpha fruticosa* - at right).

Locust and fiddler crabs were abundant along the shoreline of area of interest #2 (below).

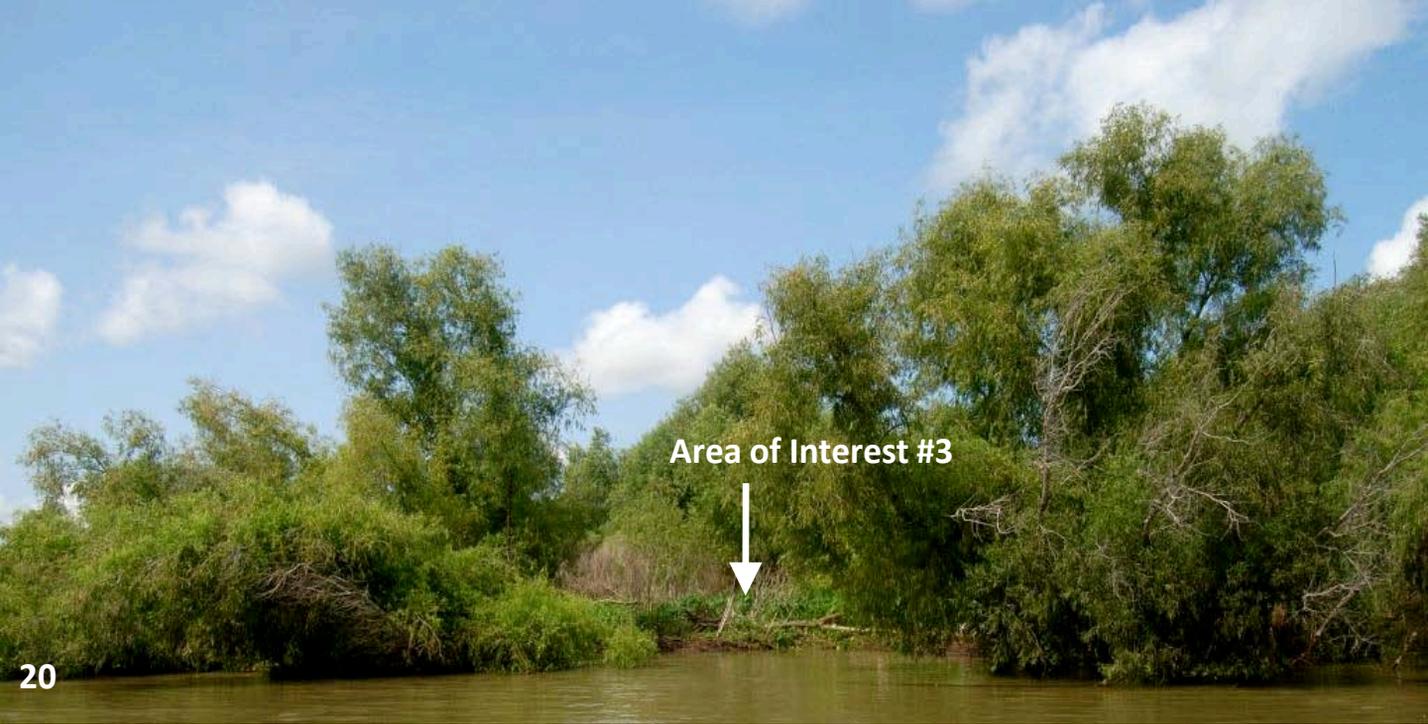
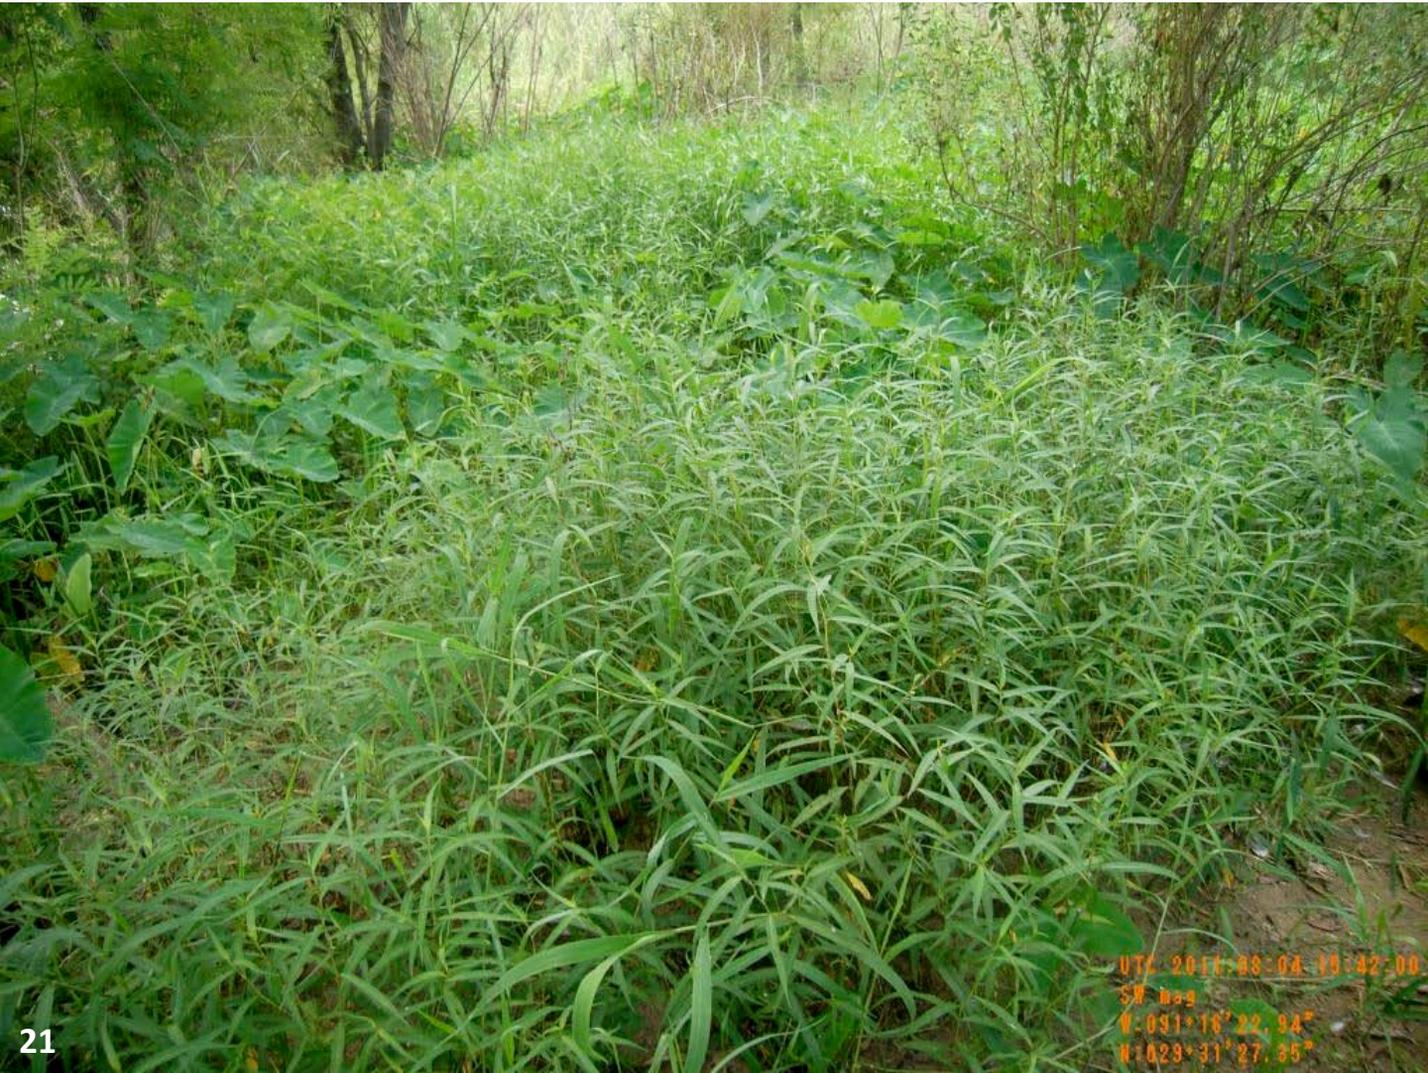
**Pictures 20 & 21.** Area of interest #3, also within the natural island footprint, as viewed from Crewboat Cut through a shoreline break in black willow (above). Unknown grasses and elephant's ear below hidden below the tree canopy (below).

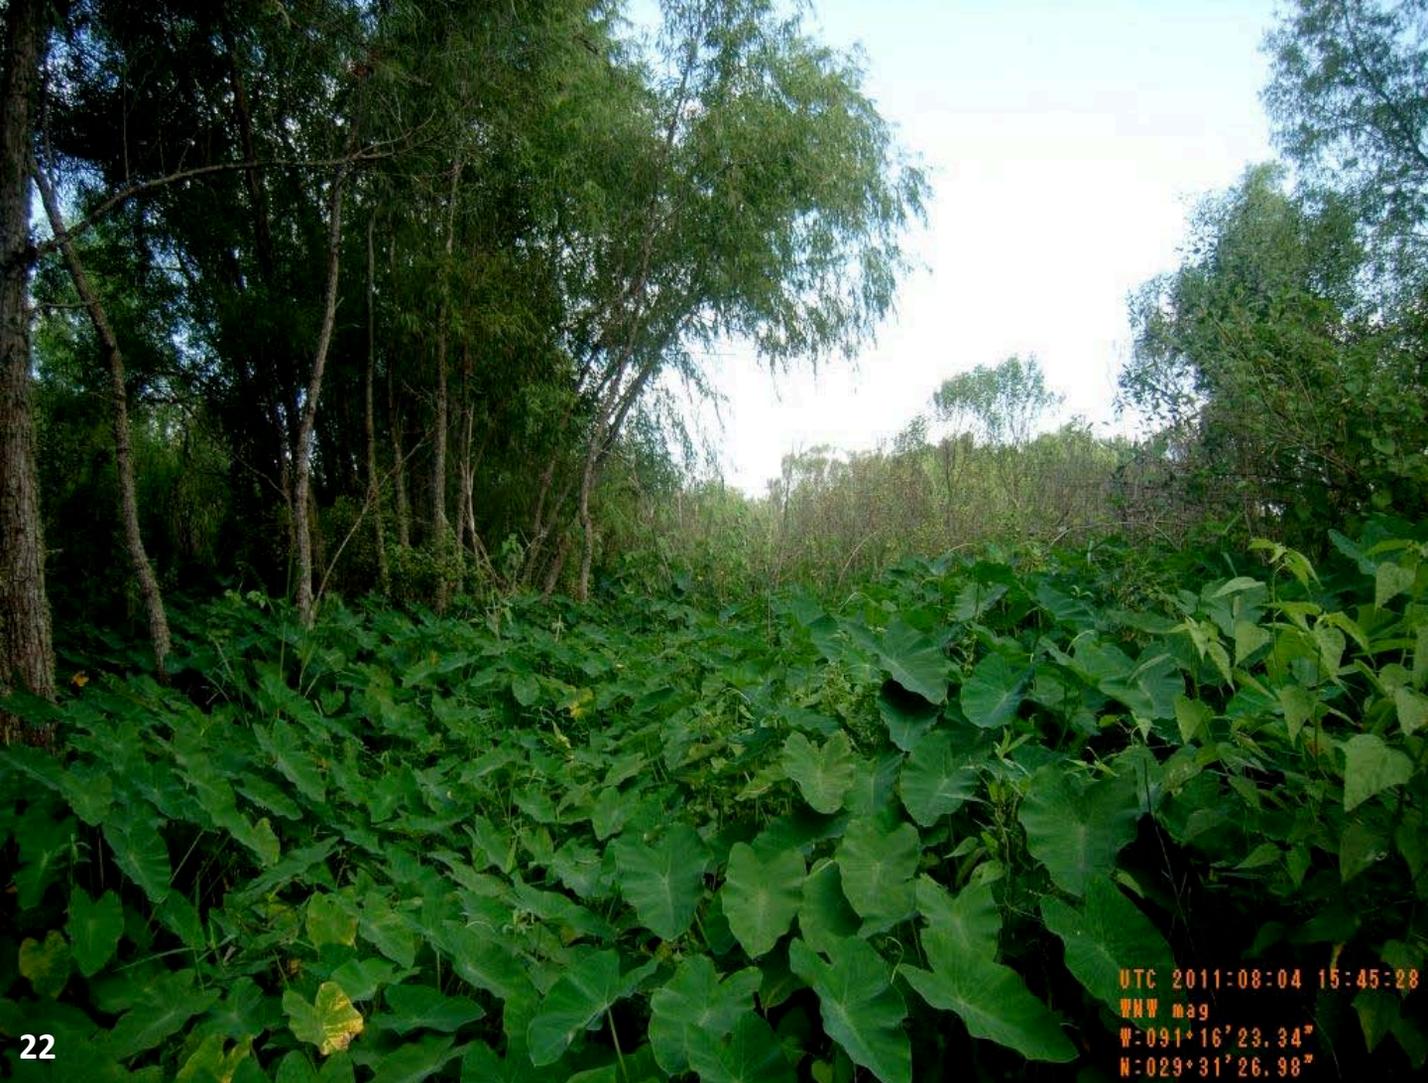
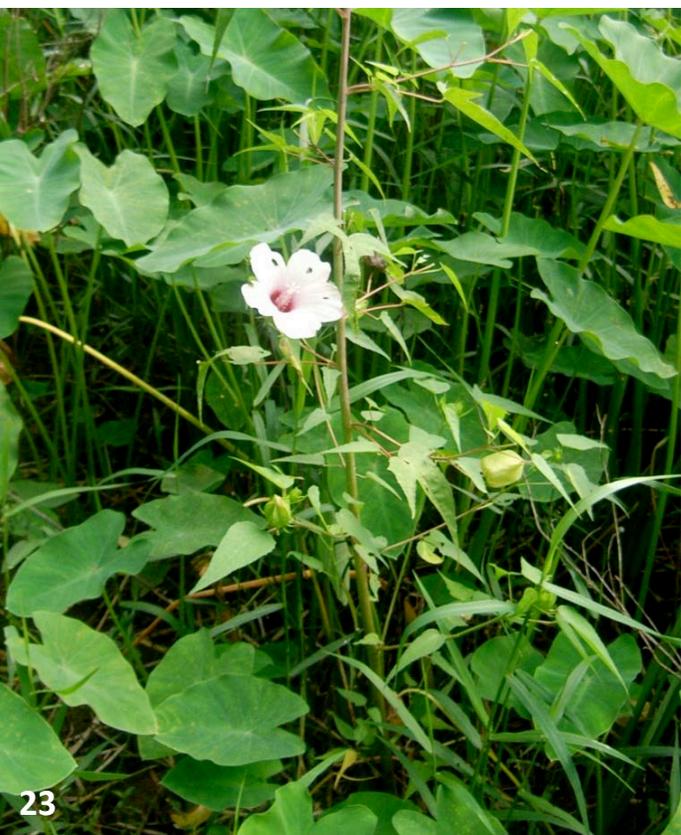
**Pictures 22 & 23.** Elephant's ear and *Hibiscus laevis* (above and left) below the willow canopy in area of interest #3.

Areas #2 and #3 combined encompassed about 4 acres within the boundaries of the natural sandbar island that began forming prior to dredged material disposal operations.

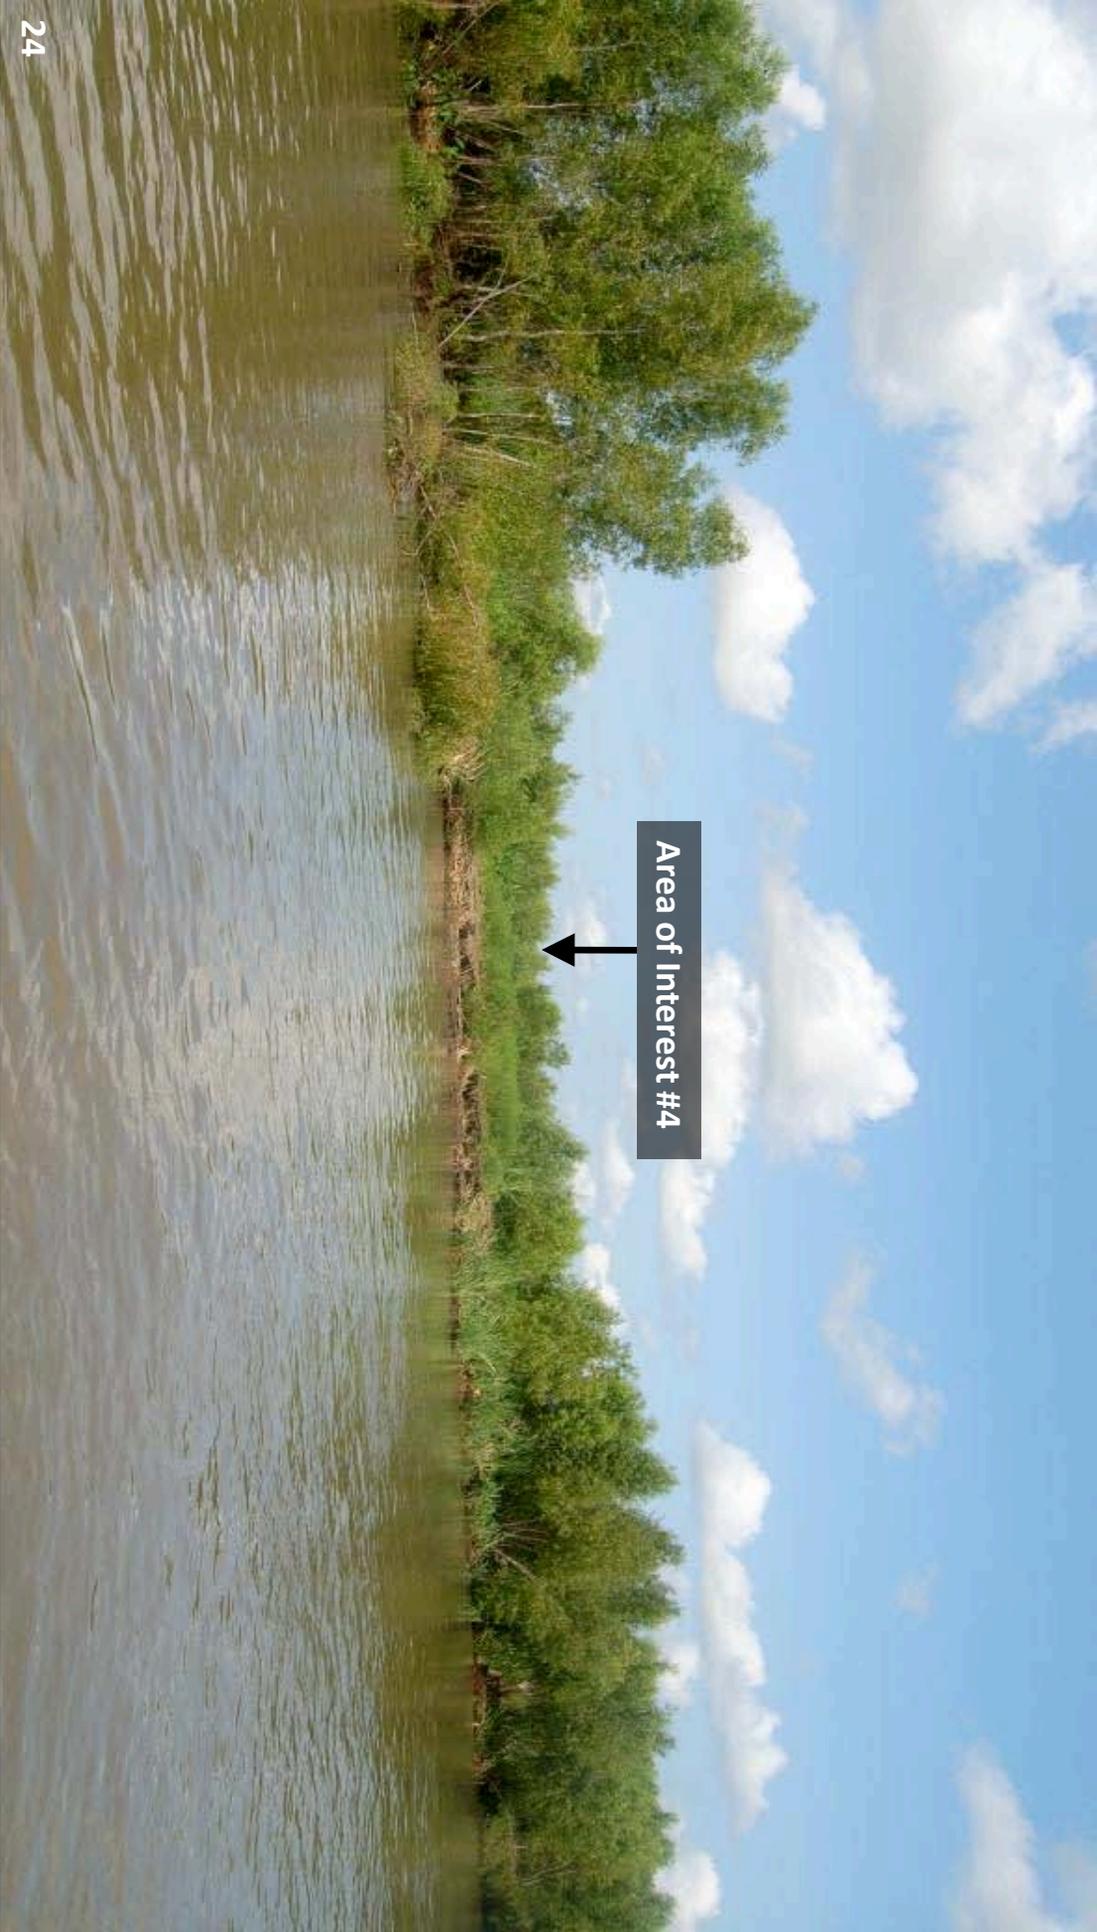
24

**Picture 24.** Area of interest #4, as viewed from Crewboat Cut through a shoreline break.

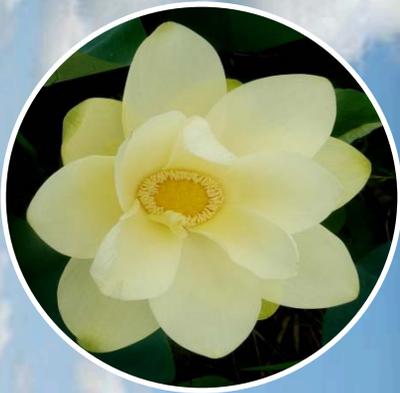
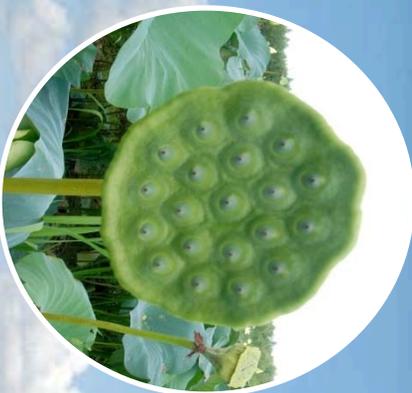
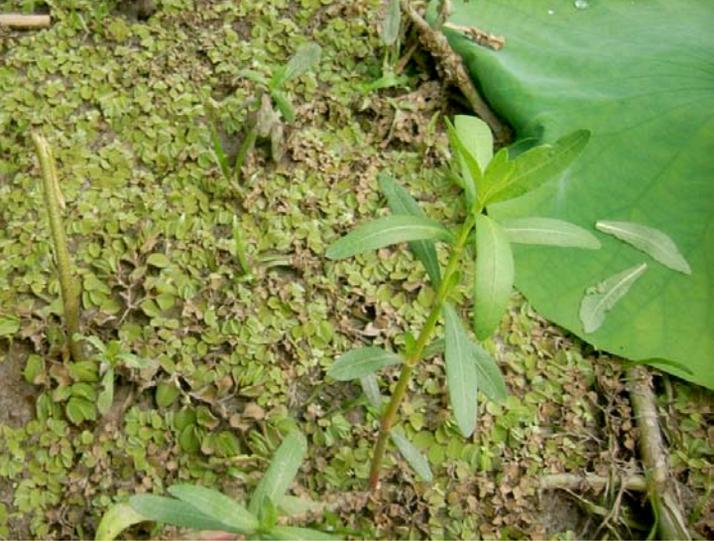
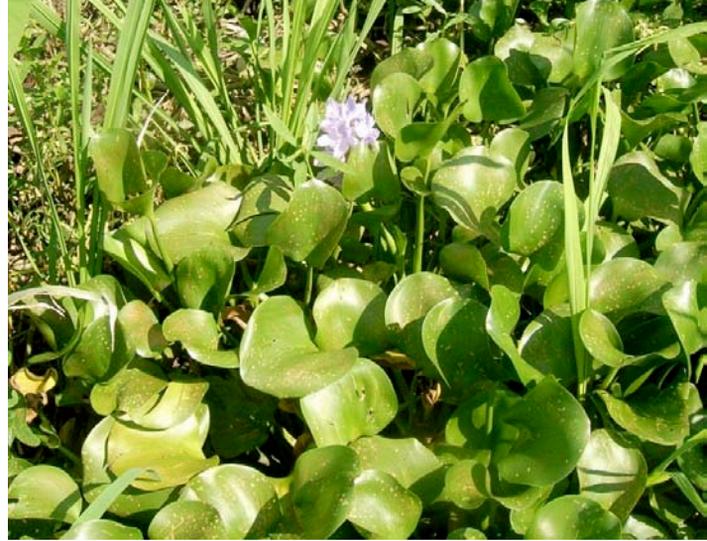
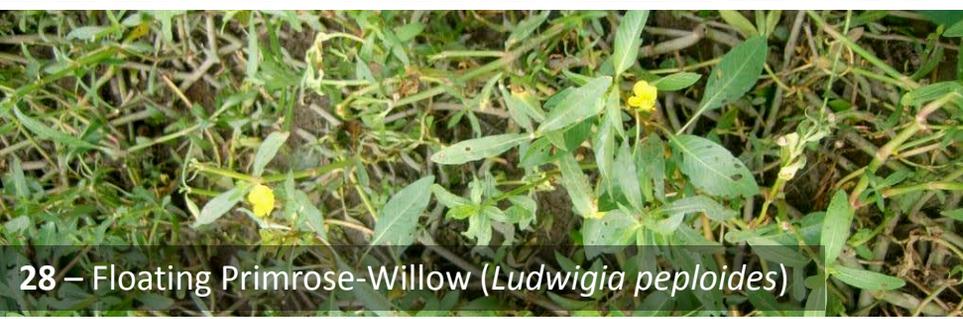
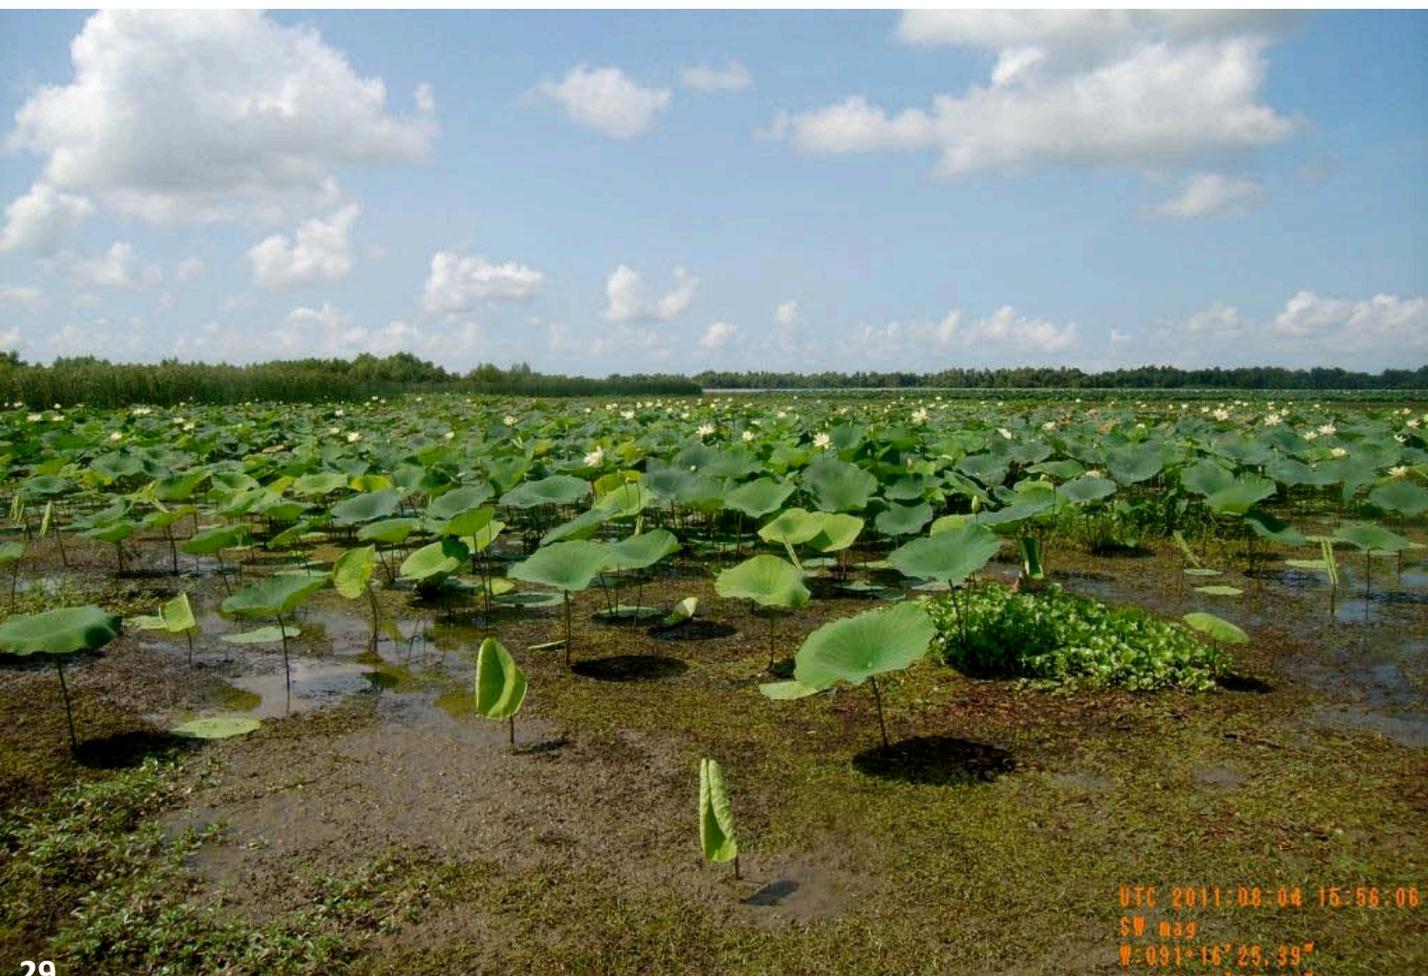
Pictures 26 - 29. Lotus field looking southwest towards Horeshoe Bend (below). Floating plants trapped among the lotus field by receding water in area of interest #4. The lotus field and fringe vegetation extended out about 15 acres.

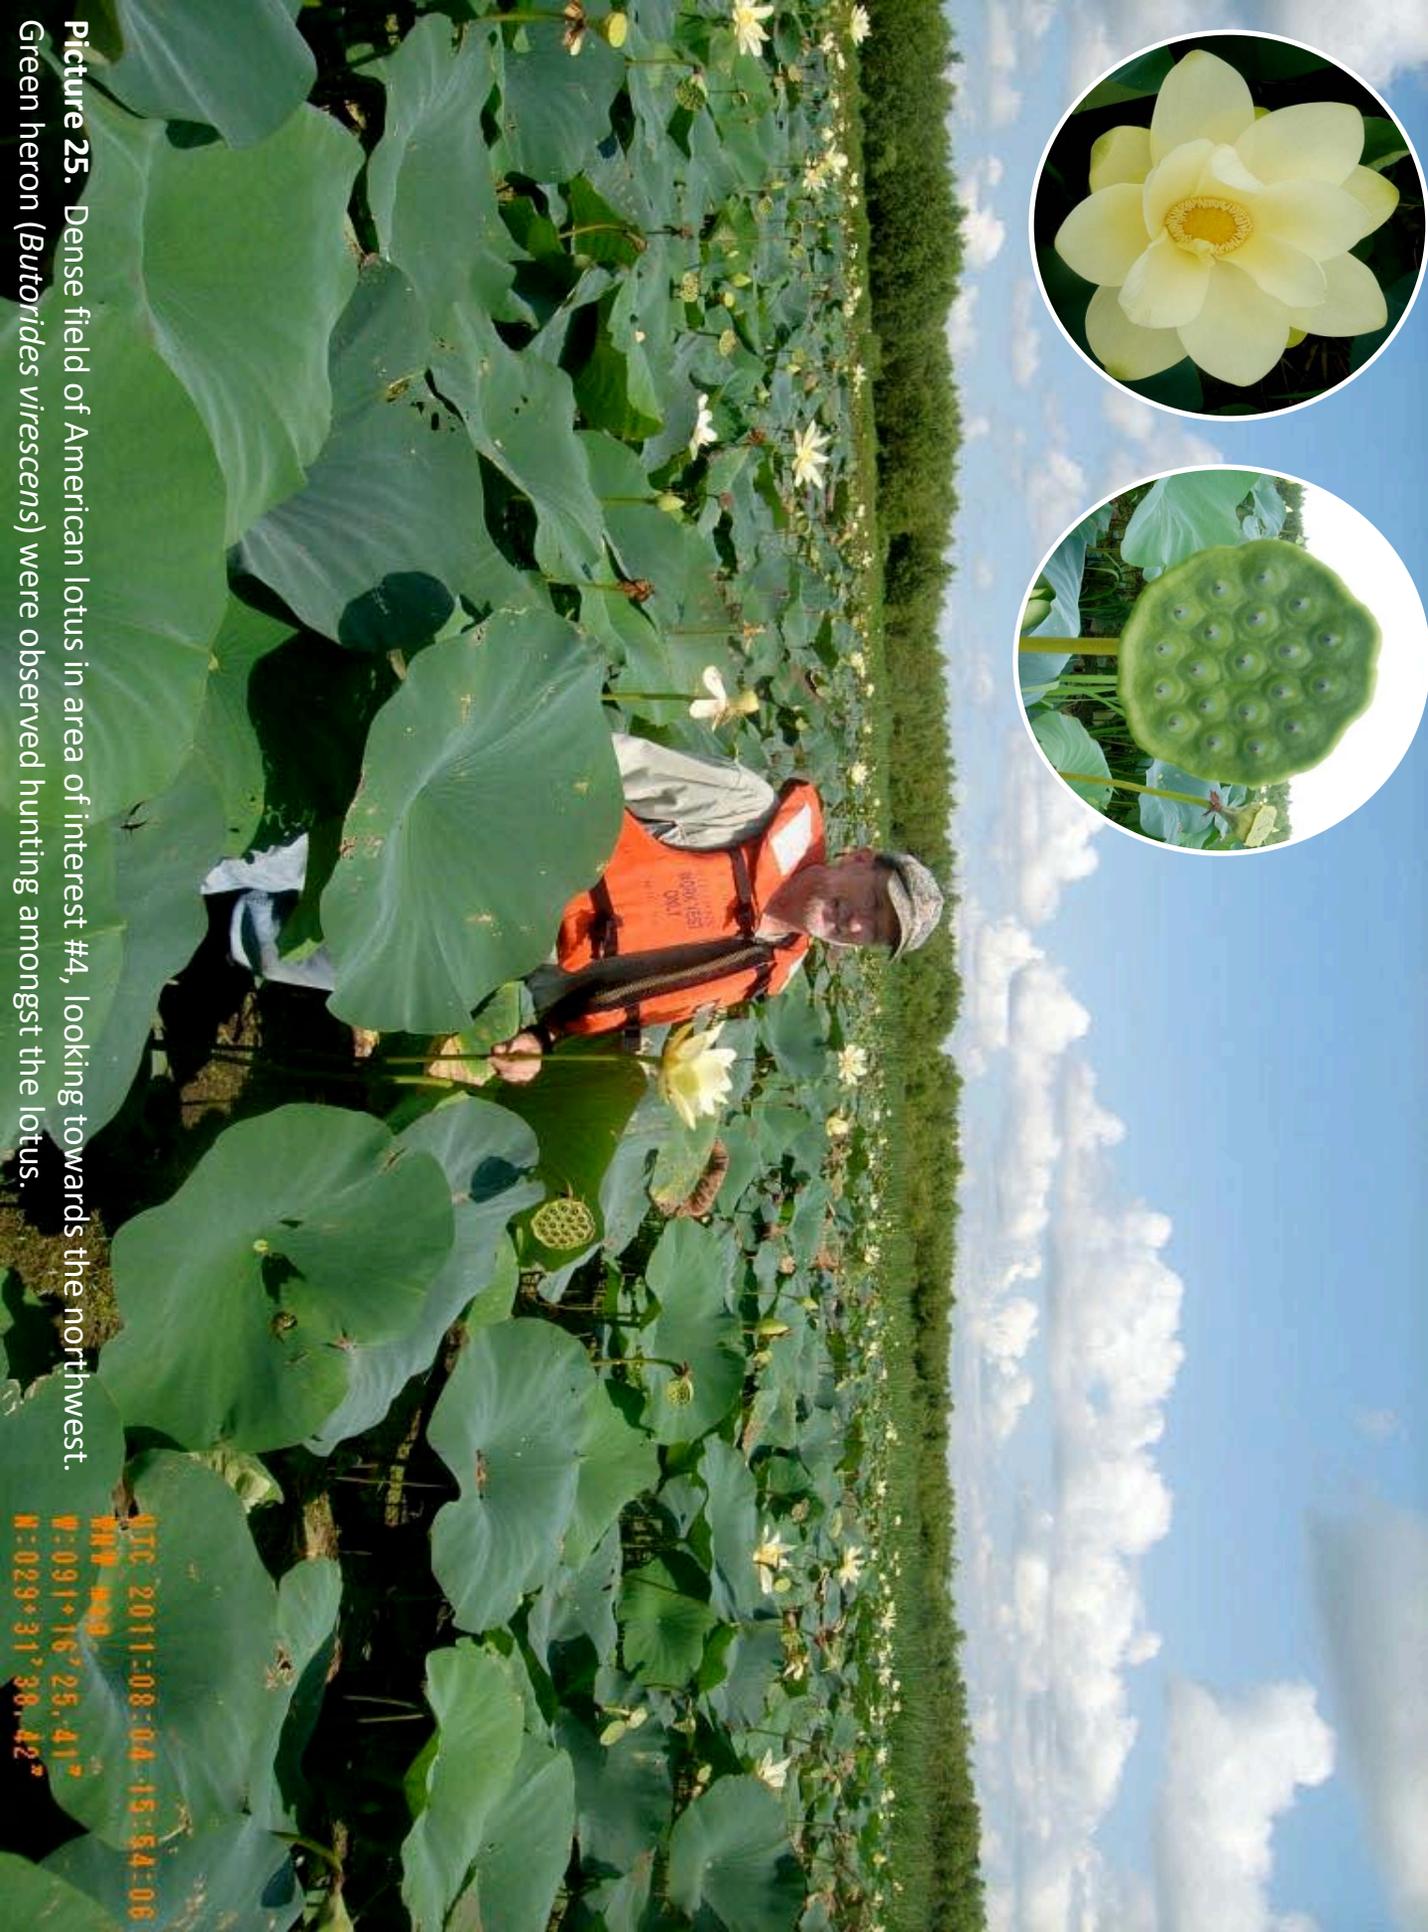
Picture 25. Dense field of American lotus in area of interest #4, looking towards the northwest. Green heron (*Butorides virescens*) were observed hunting amongst the lotus.

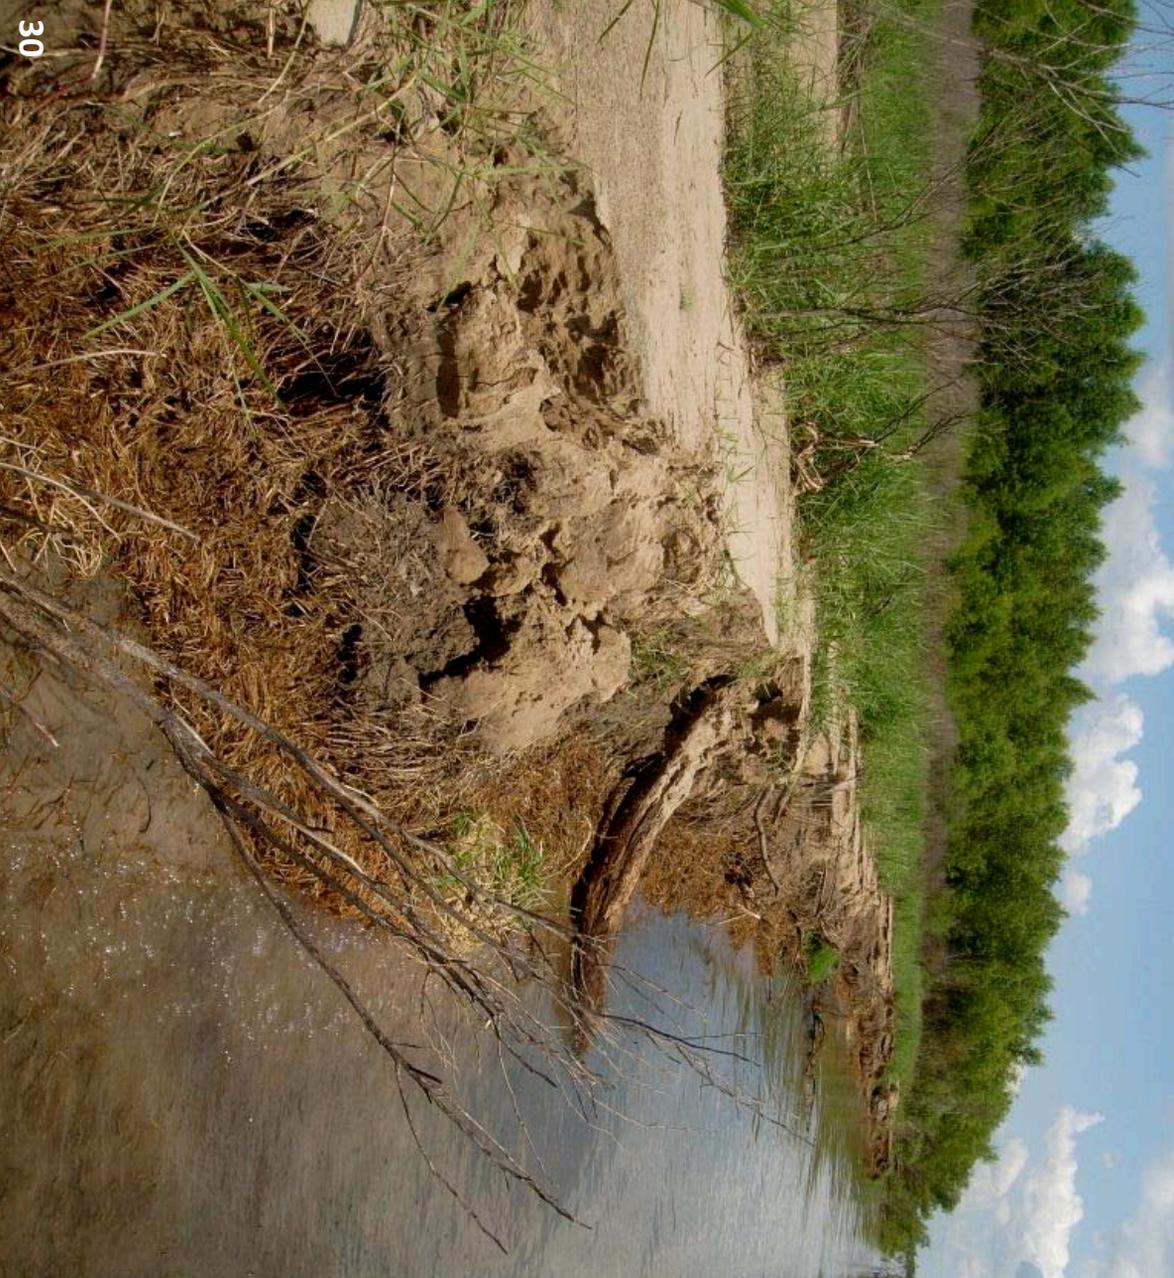
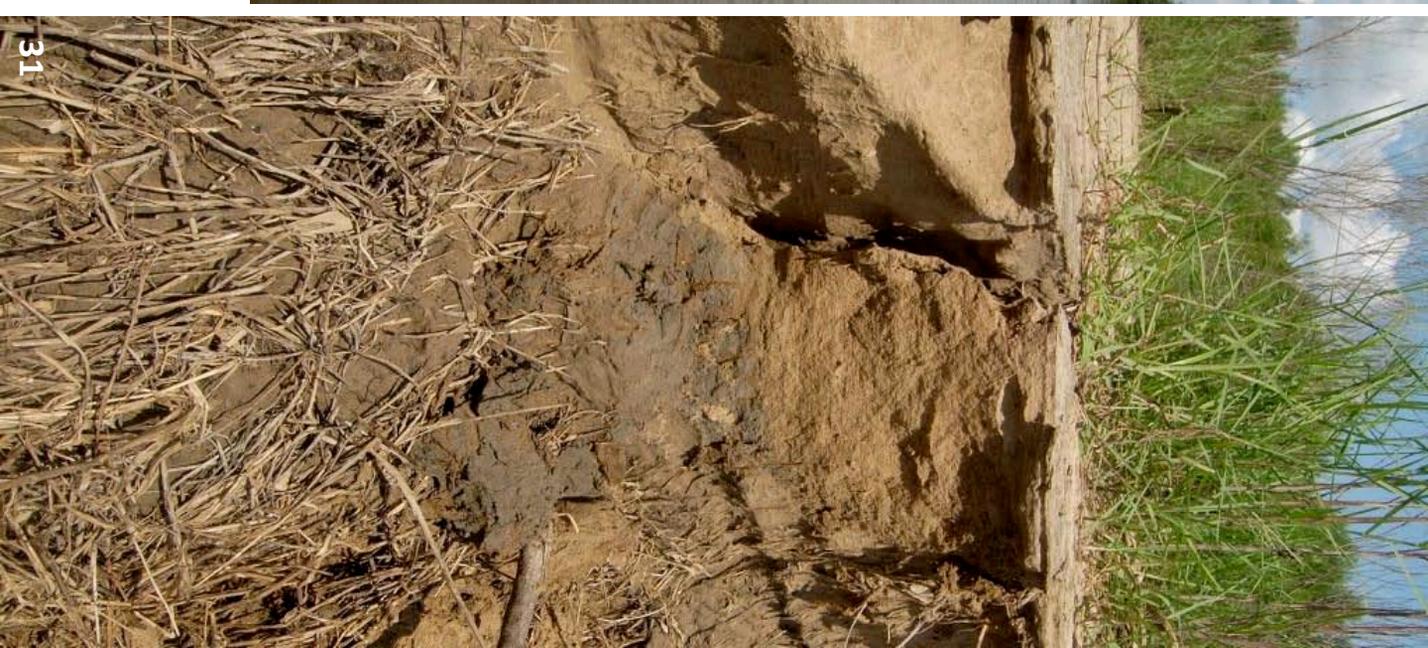
**Pictures 30 & 31.** Area of interest #5. Cut bank bordering Crewboat Cut. An abrupt face formed from the deposition of sand on top of the existing embankment, presumably from the 2011 spring flood.

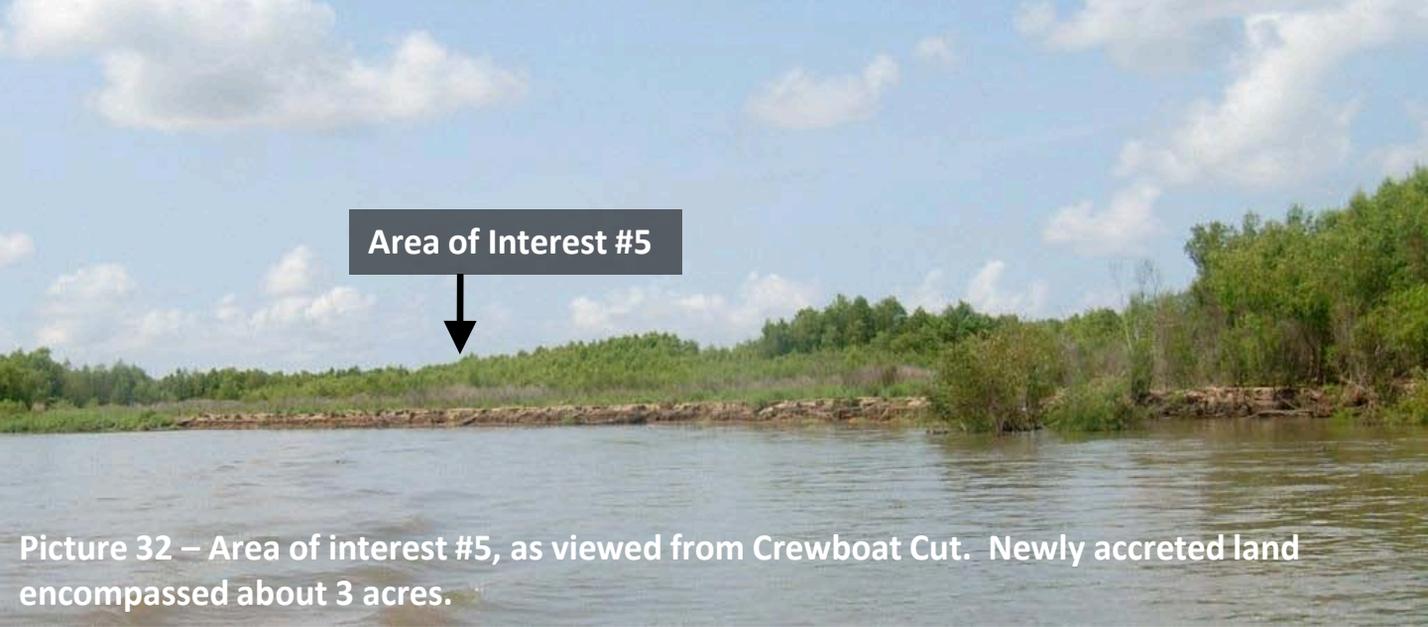
Area of Interest #5

Picture 32 – Area of interest #5, as viewed from Crewboat Cut. Newly accreted land encompassed about 3 acres.

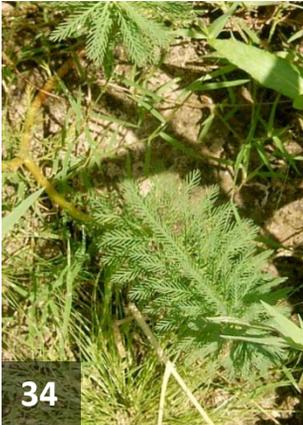
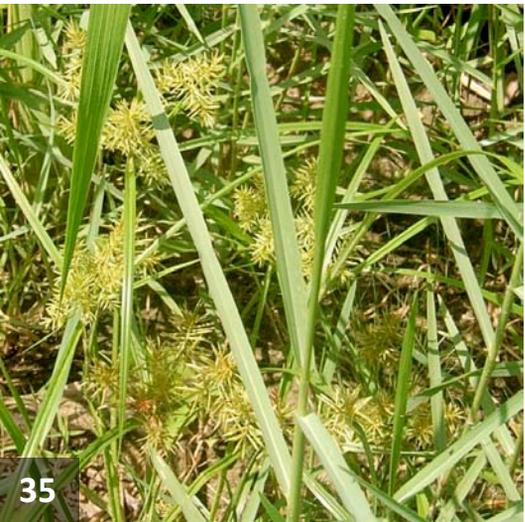
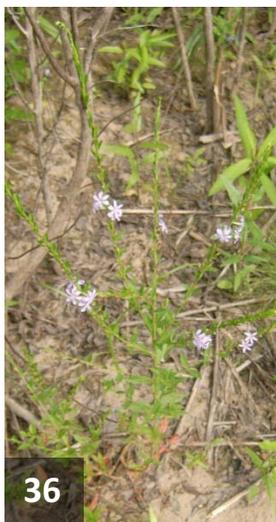
Pictures 34 - 36. Diverse assemblage of plants was found in area of interest #5 (in picture numerical order, parrot's feather, *Cyperus odoratus*, and *Lythrum lineare*).
