PROPOSED PARISH LINE MITIGATION BANK IN LAFOUCHE AND TERREBONNE PARISHES

PARISH LINE MITIGATION BANK

FINAL PROSPECTUS

Located In Lafourche and Terrebonne Parishes, Louisiana

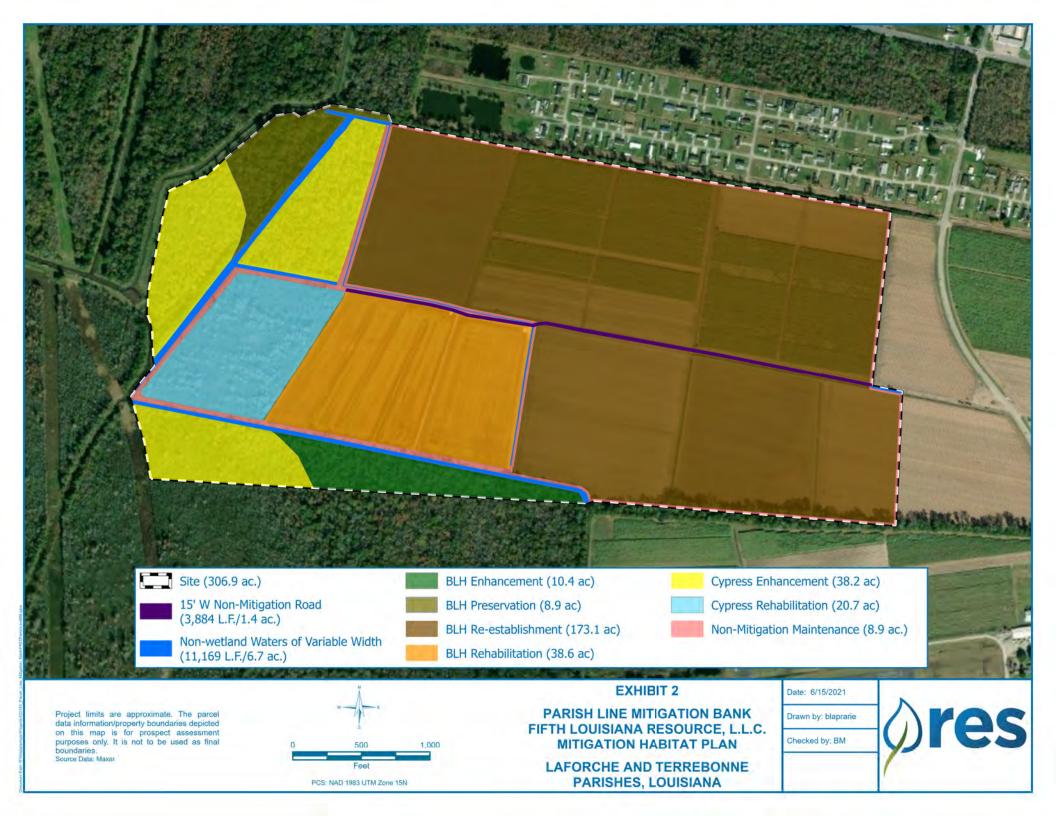
EXHIBIT 2

Mitigation Habitat Plan

The proposed preservation, enhancement, rehabilitation, and re-establishment of BLH and CYP habitats is approximately 289.9 acres. Specifically, the Bank shall preserve 8.9 acres, enhance 10.4 acres, rehabilitate 38.6 acres, and re-establish 173.1 acres of BLH, and enhance 38.2 acres, and rehabilitate 20.7 acres of CYP. The Bank will also include approximately 17.0 acres of non-mitigation features composed of critical drainage features, maintenance areas, and an existing access road (**Exhibit 2**), totaling a 306.9-acre Bank.

The Bank is proposed to preserve 8.9 acres, enhance 10.4 acres, rehabilitate 38.6 acres, and re-establish 173.1 acres of BLH, and enhance 38.2 acres, and rehabilitate 20.7 acres of CYP (**Exhibit 2**). Approximately 17.0 acres of existing access road, maintenance areas, and multiple critical drainage features shall be maintained as non-mitigation acreage. The Bank shall provide additional BLH and CYP functions and values not currently recognized under existing conditions and land use, as well as enhance these values in portions of the Bank where these habitats currently exist. Current functions and values not currently recognized under existing conditions are as follows:

Proposed Bank habitats were derived using the historical land use, current land cover, soils, elevations, and the current vegetation data gathered during a wetland delineation and baseline survey within the Bank. The Bank is proposed to preserve, enhance, rehabilitate, and re-establish 231.0 acres of BLH as well as enhance and rehabilitate 58.9 acres of CYP with 17.0 acres of non-mitigation features composed of an existing access road, maintenance areas, and multiple drainage features, totaling a 306.9-acre Bank (**Table 1** and **Exhibit 2**).

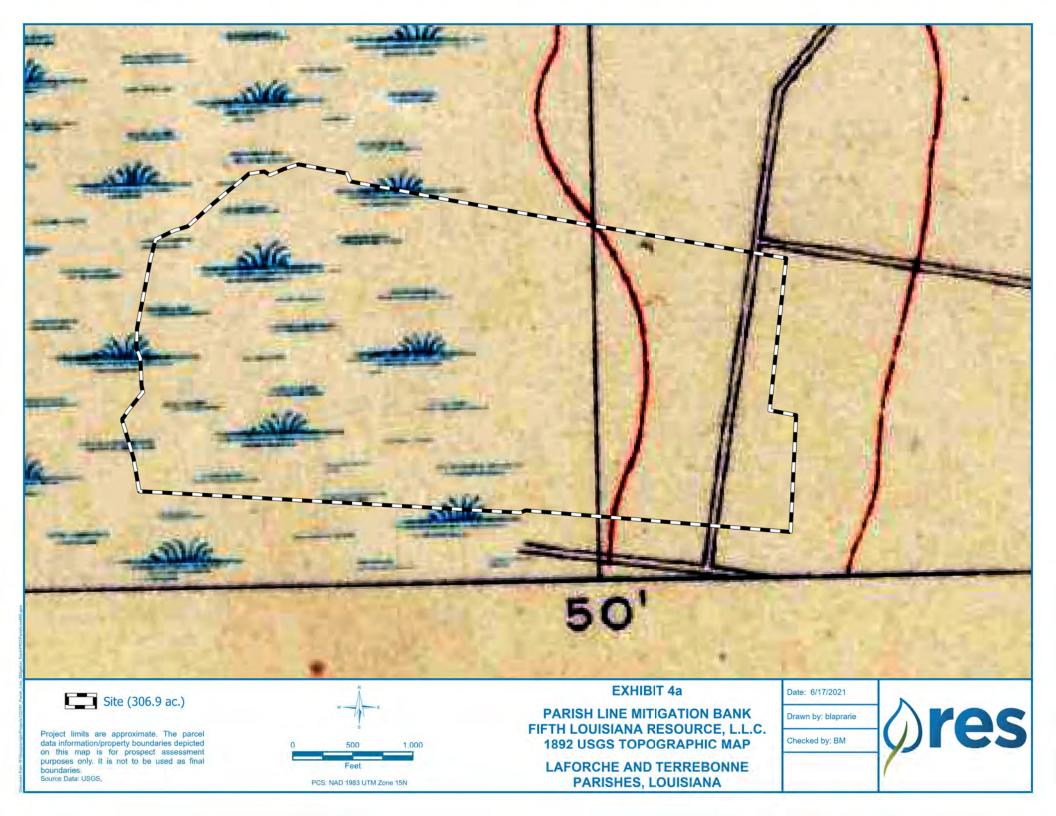
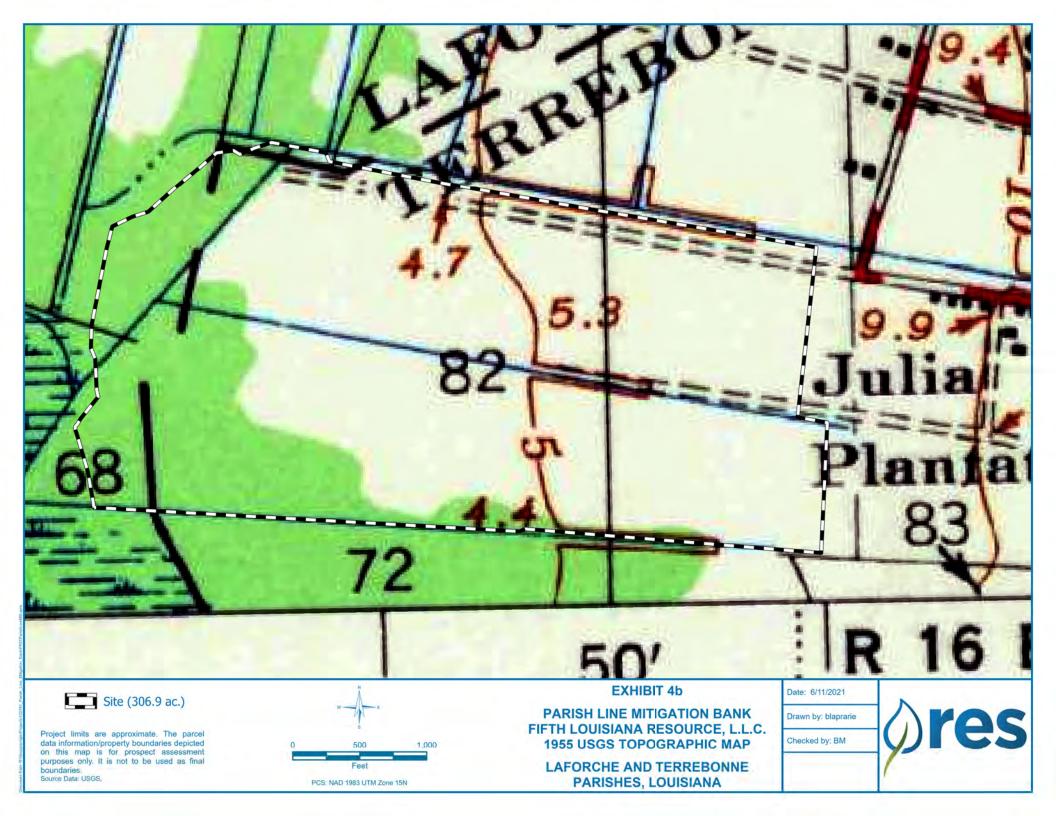
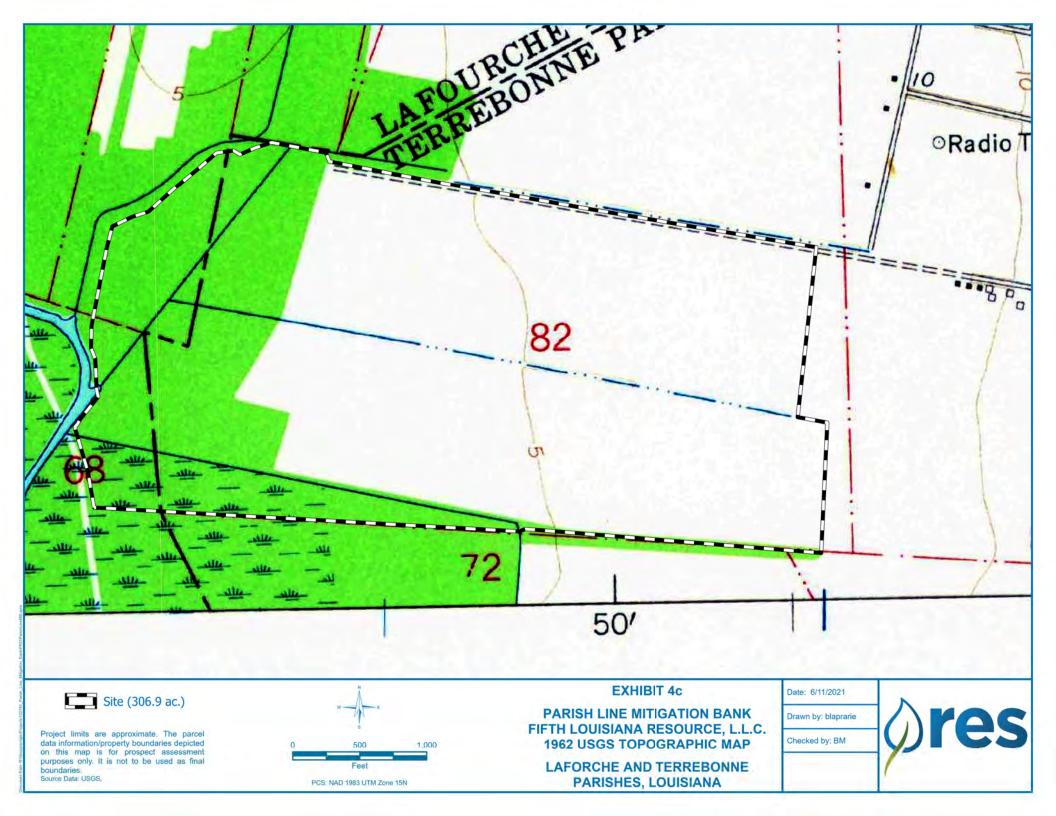
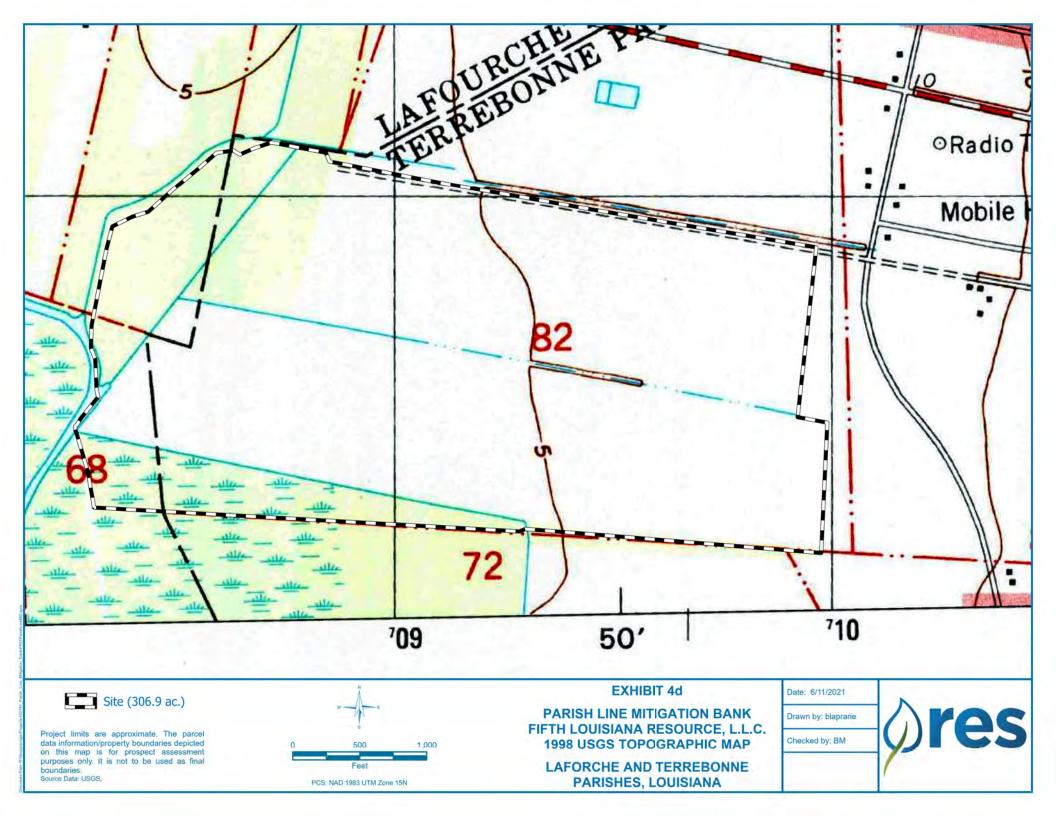
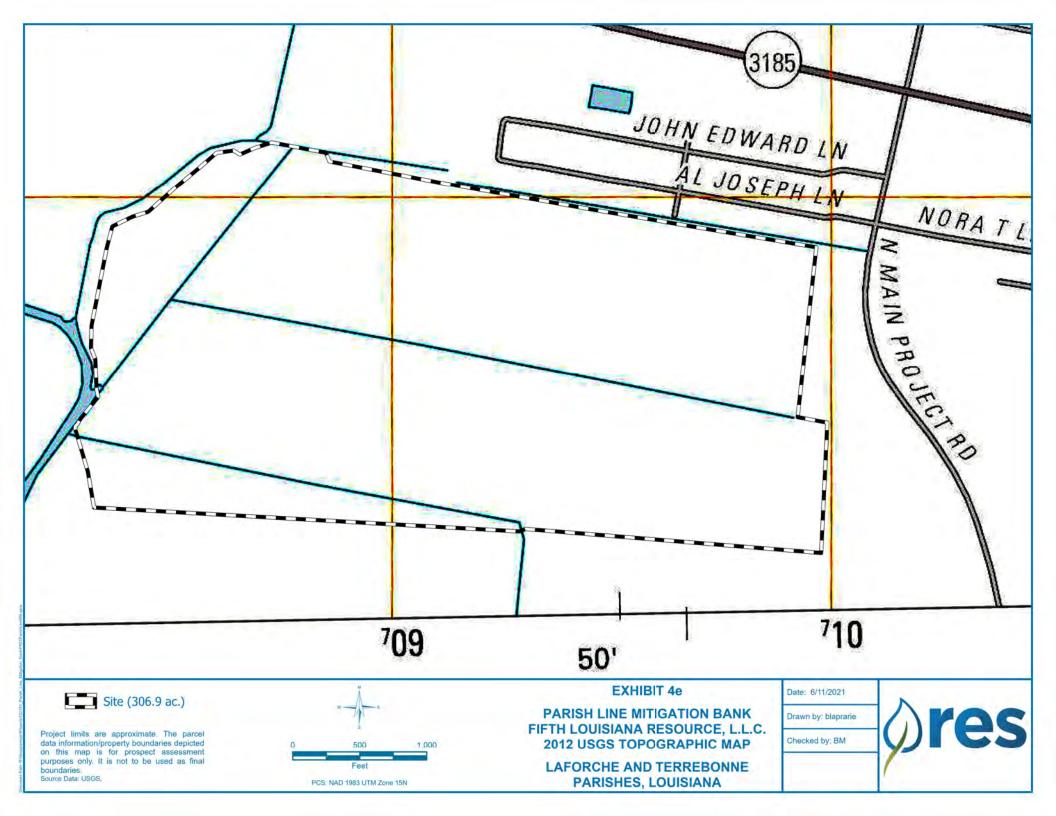
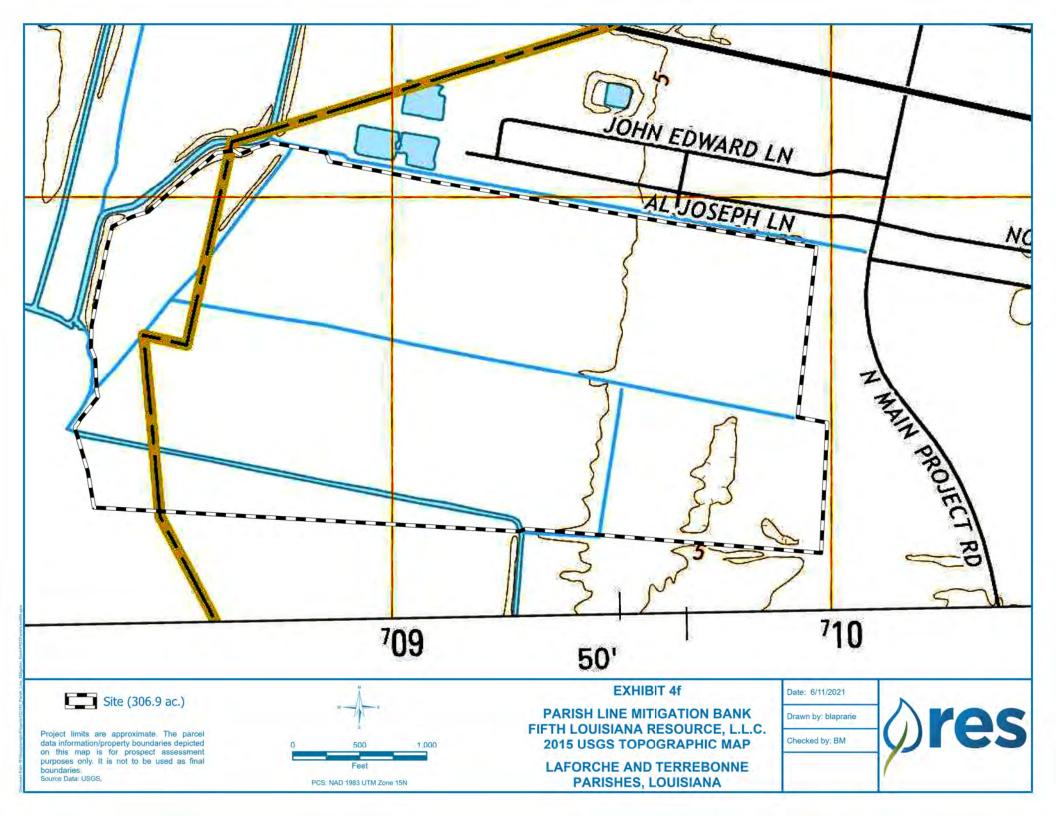
EXHIBITS 4a-4g

Topographic Maps Package

Based on historical topographical quadrangle maps (**Exhibits 4a–4g**) and aerial photographs (**Exhibits 5a–5i**), the Bank site historically contained BLH and/or CYP forested habitats on most of the Bank. Topographic maps and aerial photographs reveal that sometime, prior to 1955, the eastern side of the Bank was cleared for agricultural use; however, some areas were left forested (**Exhibits 4b** and **5a**). Around 1978, some mature forests were cleared again to create aquaculture ponds for crawfish production. Significant anthropogenic alteration of the Bank associated with agricultural production has continued until present day. **Tables 2** and **3** detail the changes on the land from when it was minimally impacted until today.

USGS quadrangle maps were reviewed as a supplement to the historical aerial photographs and to determine the prior use or occupancy of the subject properties. Copies of these USGS quadrangle excerpts are presented in **Exhibits 4a – 4g** along with a written observation in **Table 2**.

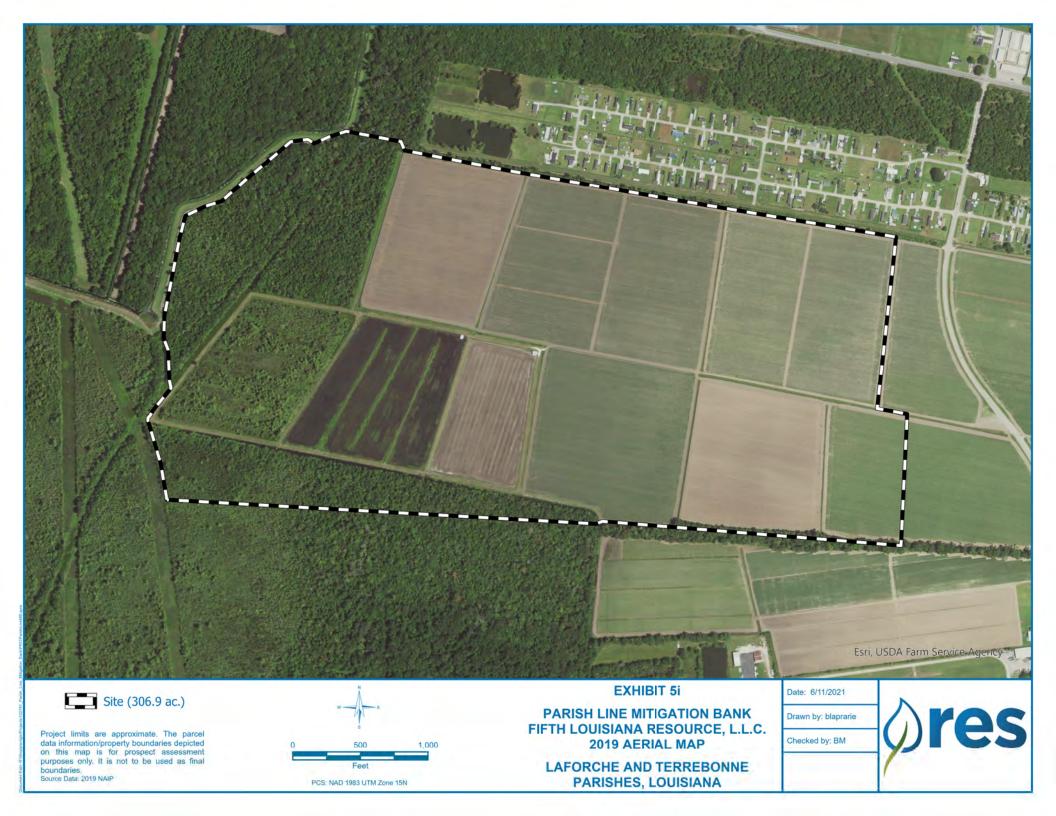
Land Use and Land Cover Within Bank

HORIZONTAL DATUM IS NAD83 UTM ZONE 15N. LAND USE TYPES BASED ON HABITATS OBSERVED DURING WETLAND SURVEYS CONDUCTED 09/28/2020 - 10/14/2020. BASE MAP FROM ESRI WORLD IMAGERY.

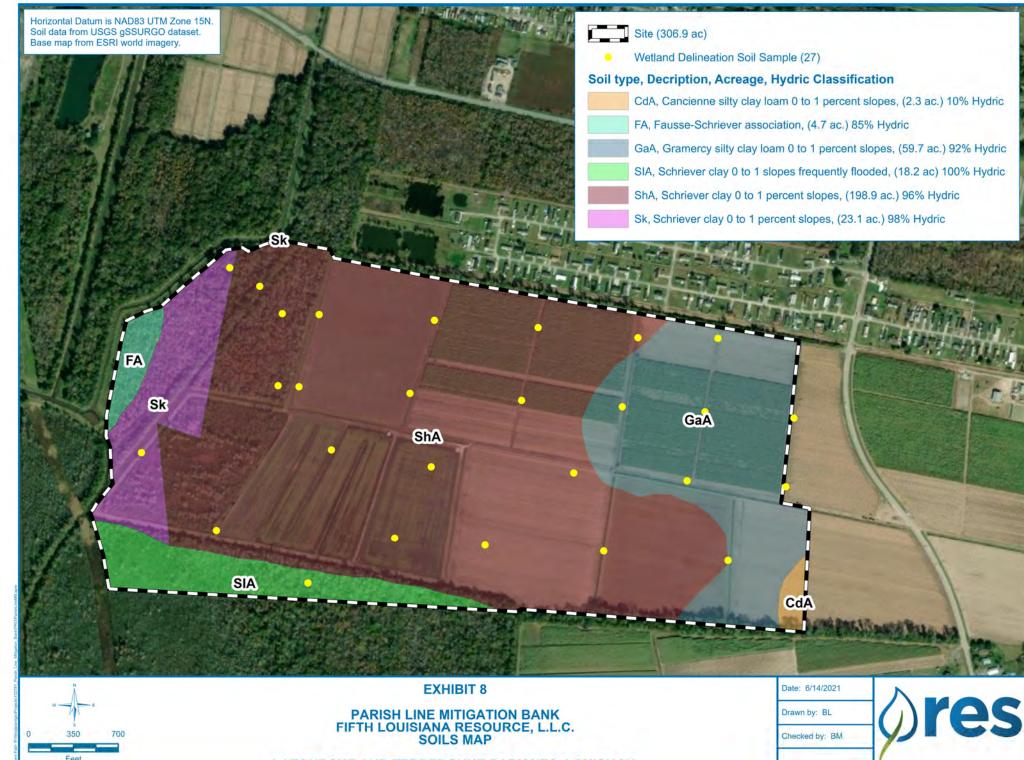
Soils Map

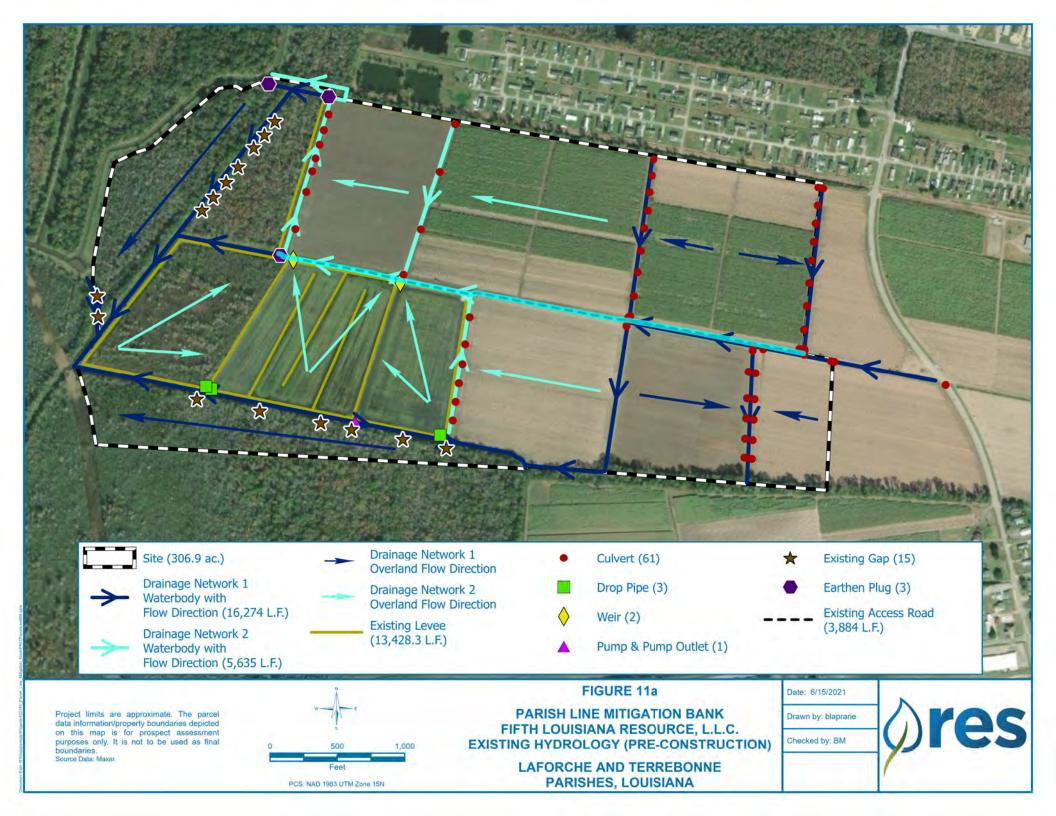
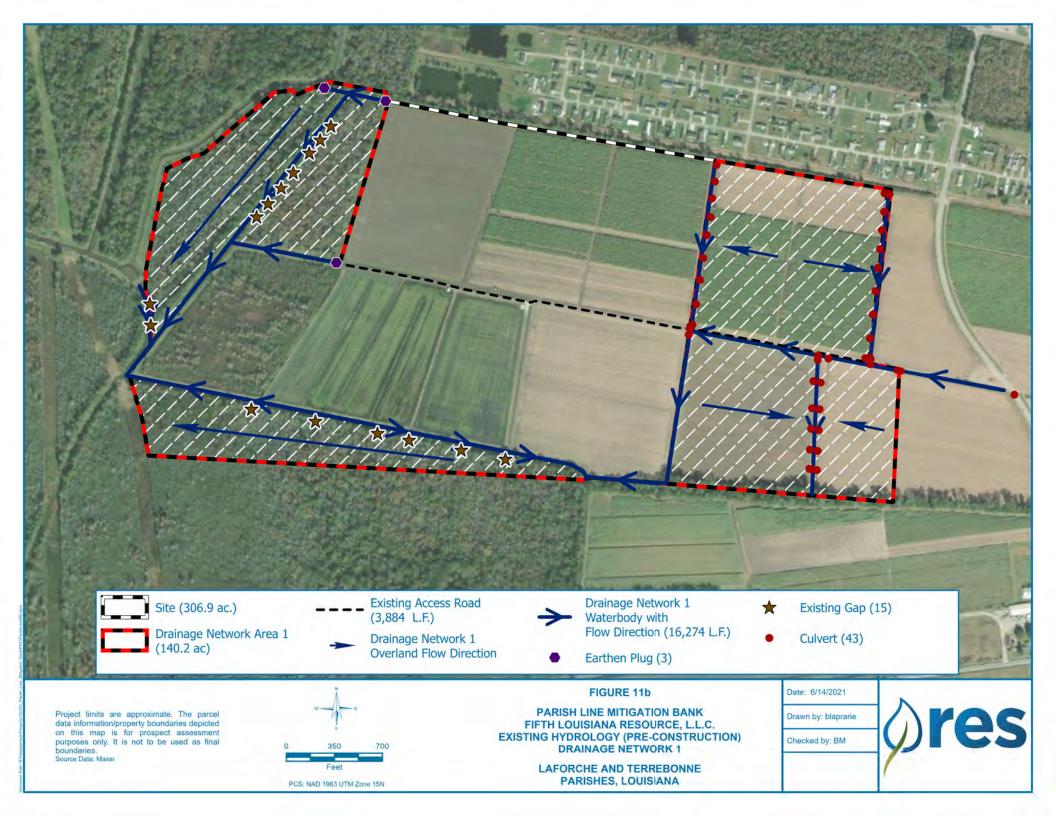
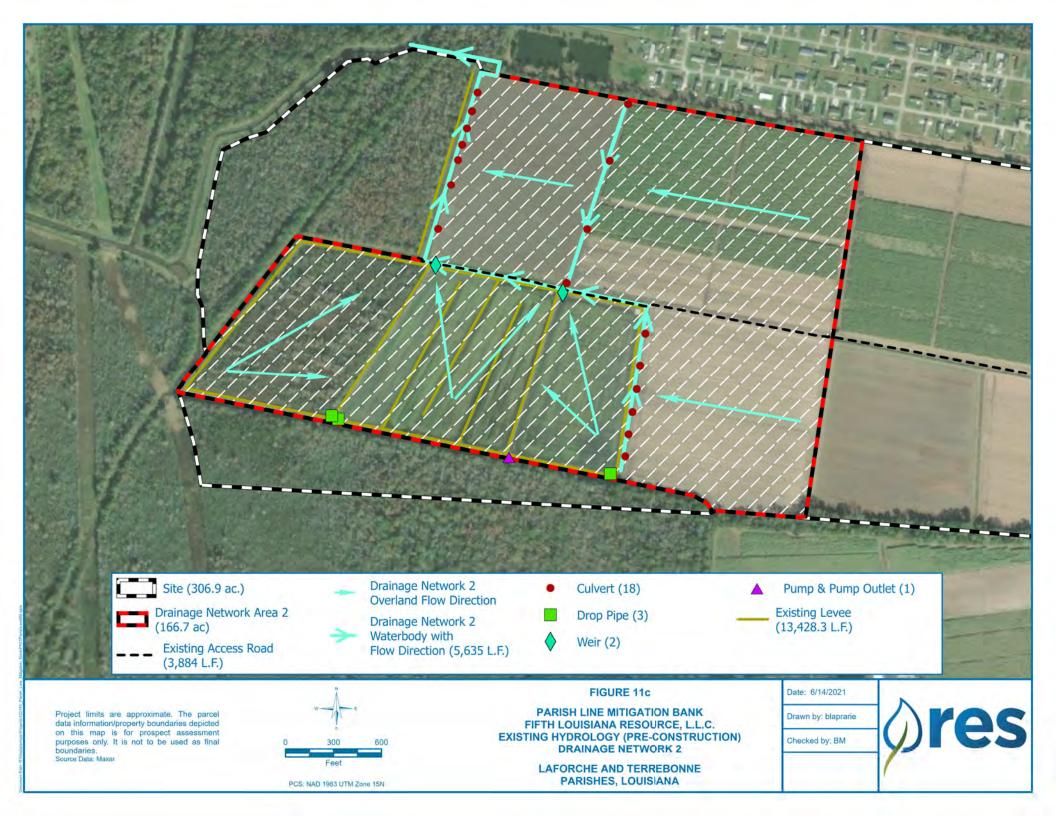
EXHIBITS 11a-11c

Existing Hydrology (Pre-Construction)

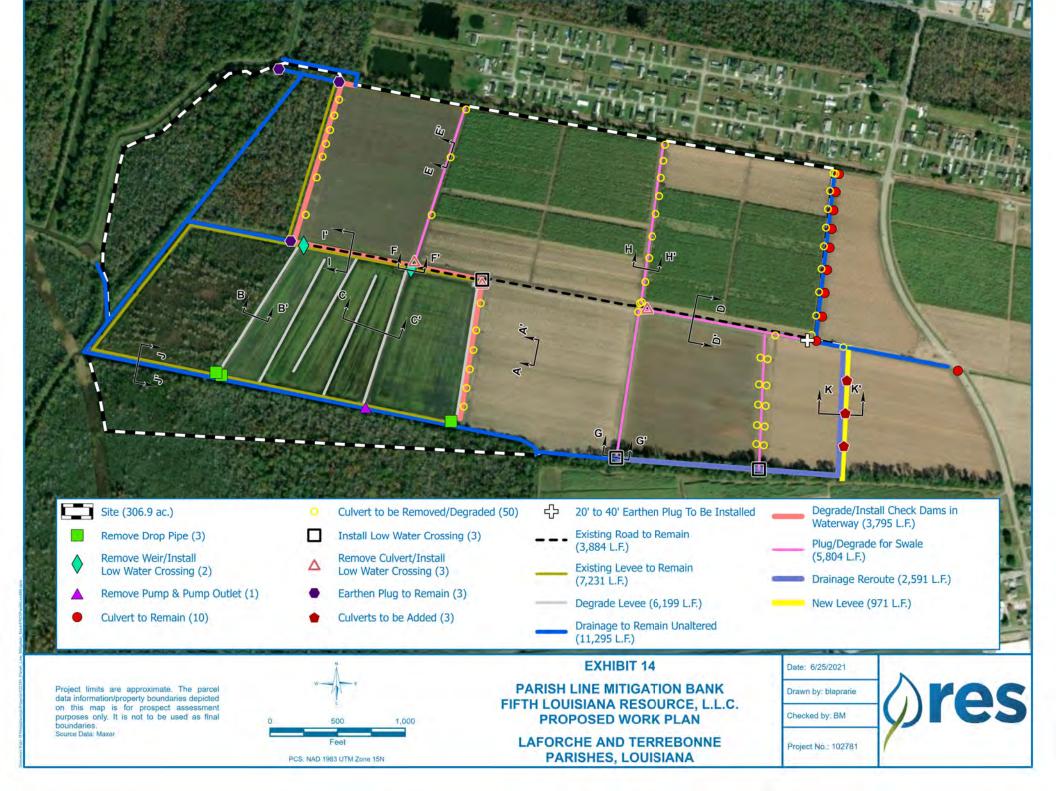
EXHIBIT 14

Proposed Work Plan

- 1. Fifty (50) agricultural field culverts shall be removed and/or degraded (rendered ineffective) to restore overland flow (**Exhibits 14 and 15e**);
- 2. Three (3) drop pipes shall be removed and/or rendered ineffective (Exhibit 15f);
- 3. Three (3) culverts shall be removed and replaced by low water crossings (LWCs) (Exhibit 15f);
- 4. Two (2) weirs shall be removed and replaced by LWCs (Exhibit 15f);
- 5. Three (3) LWCs will be installed to create additional hydrologic connectivity and will be used to traverse the site for monitoring, assessment, and maintenance activities (**Exhibits 15g**);
- 6. Approximately 5,804 L.F. of agricultural field drains shall be partially backfilled with in-situ earthen material to create shallowly swaled, microtopographic drainage features (**Exhibit 15h**);

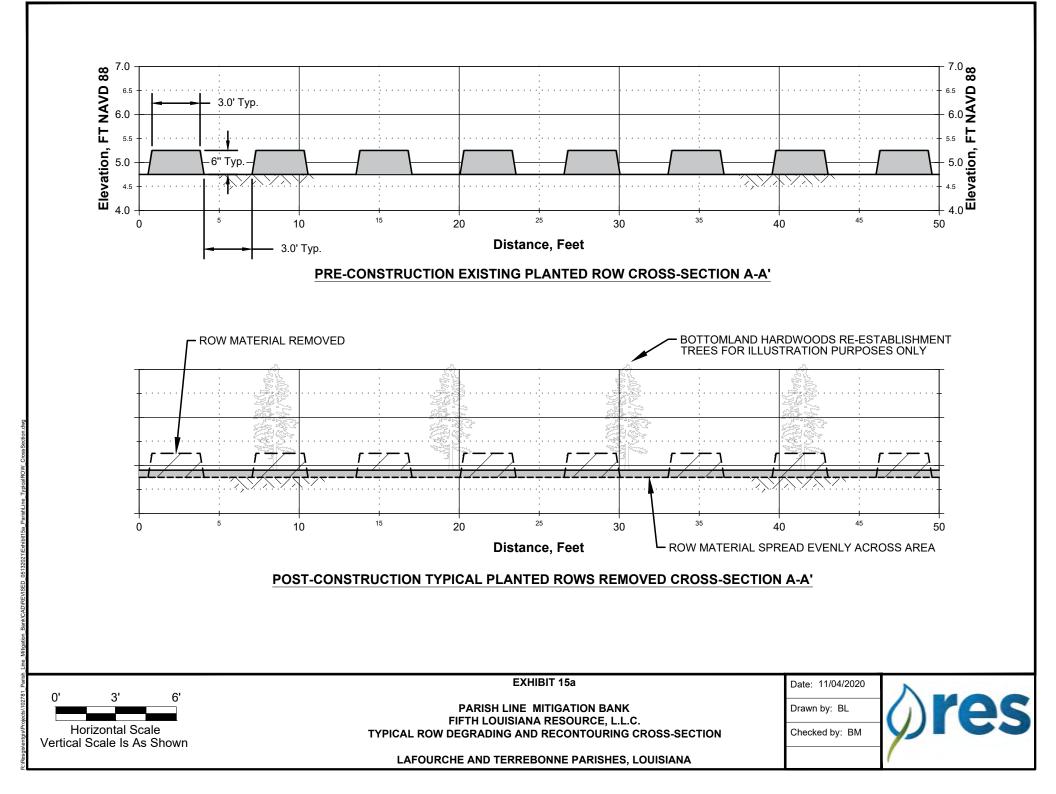
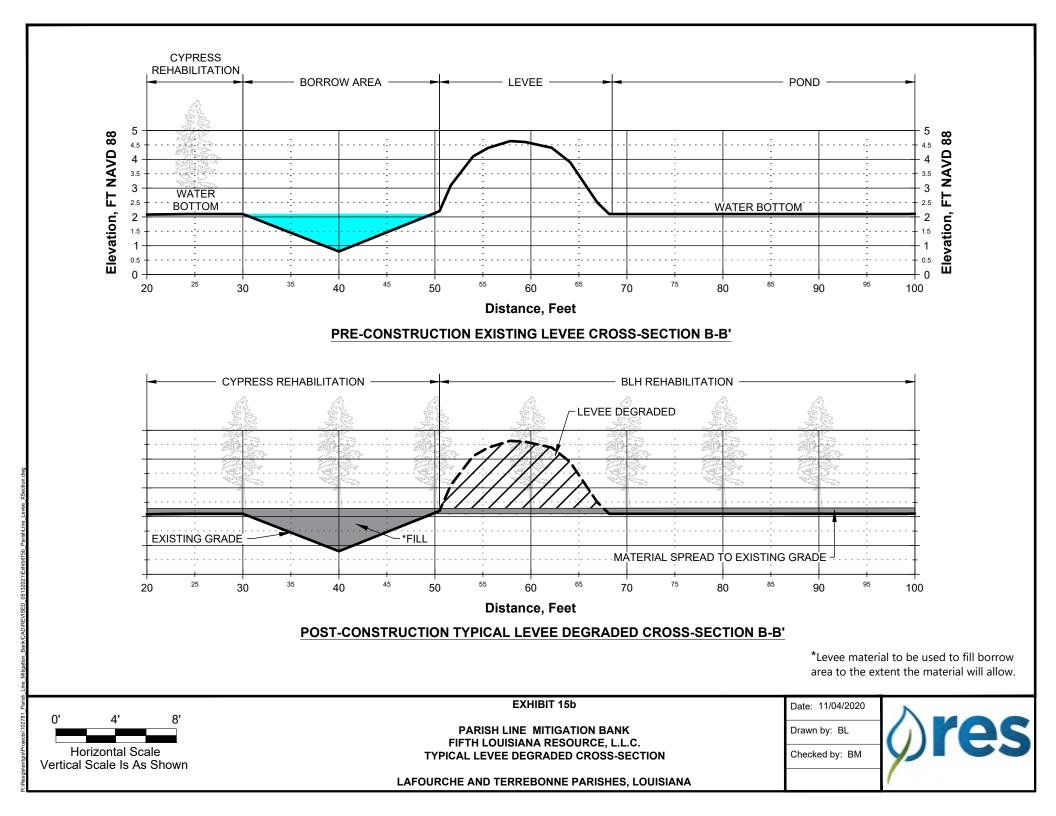
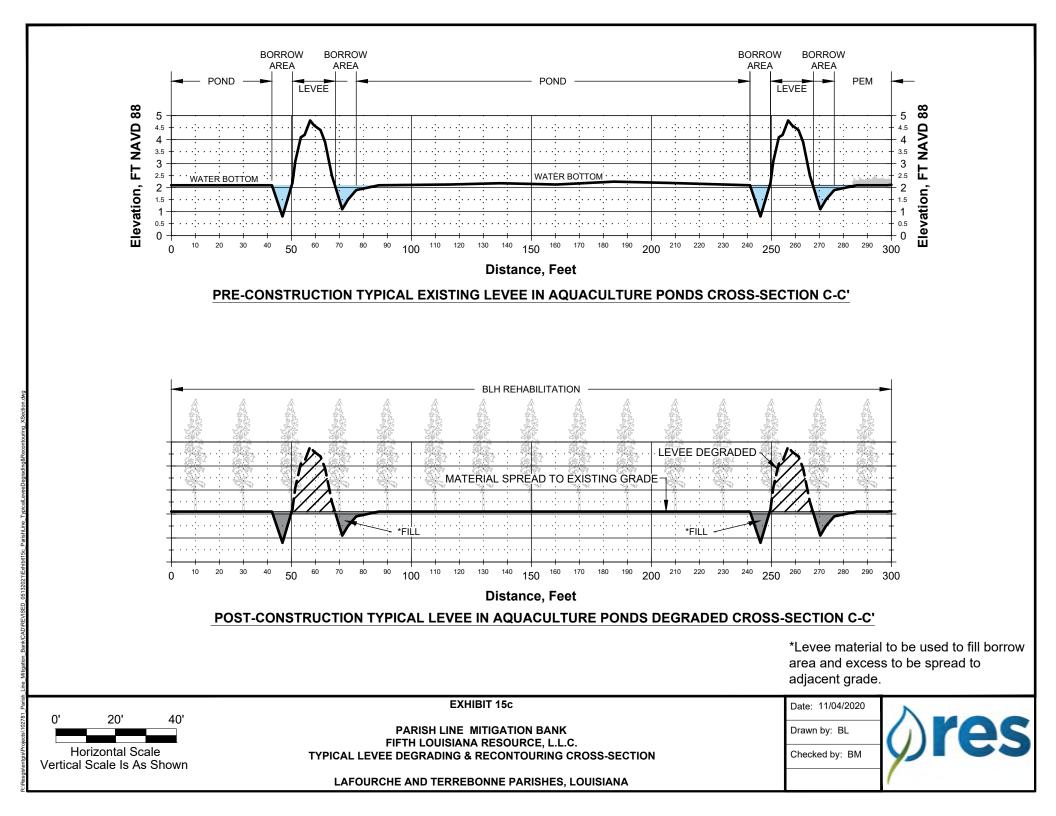
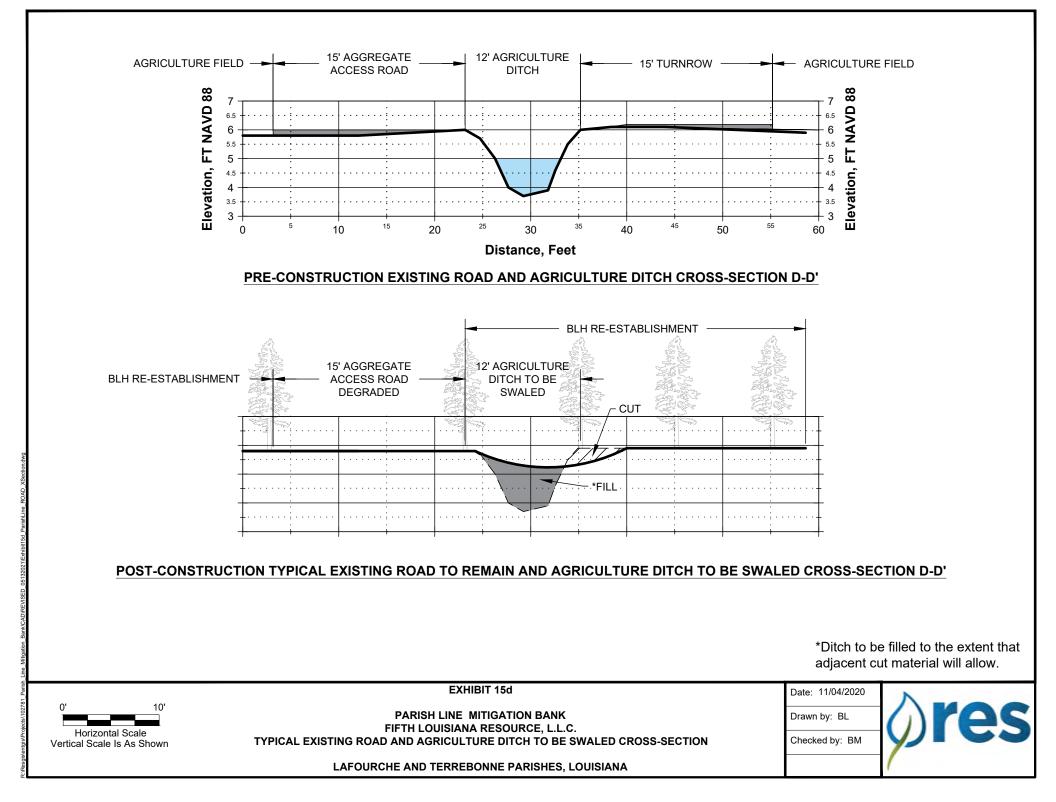
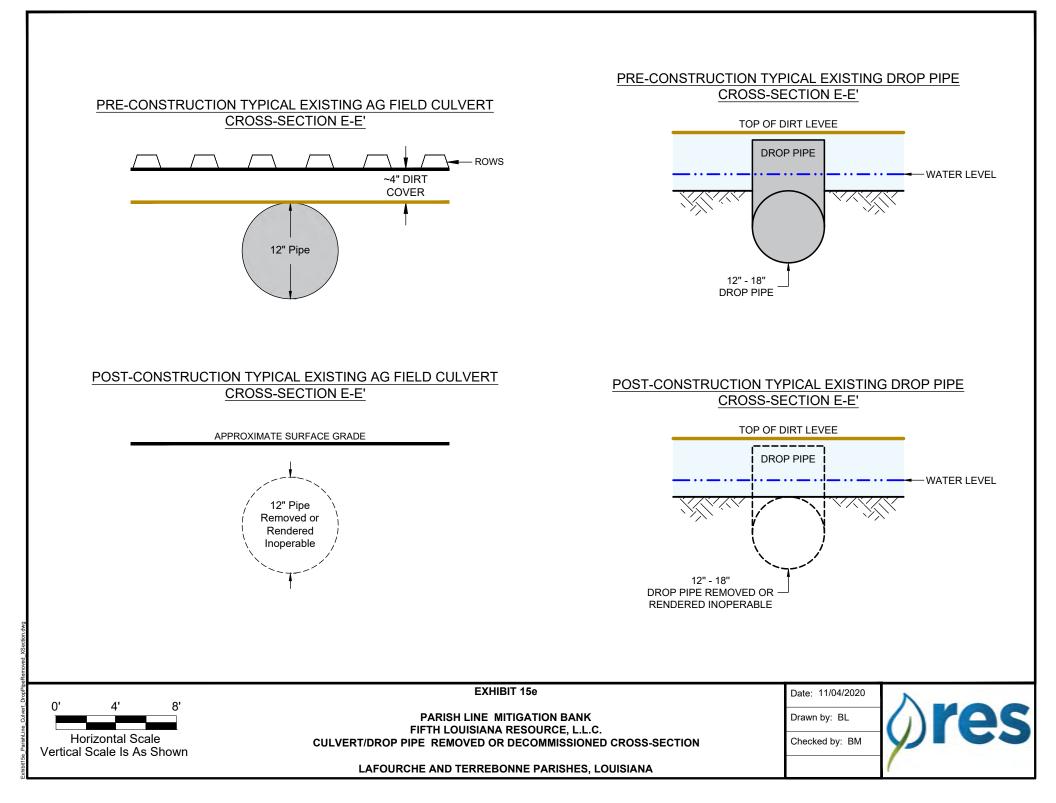
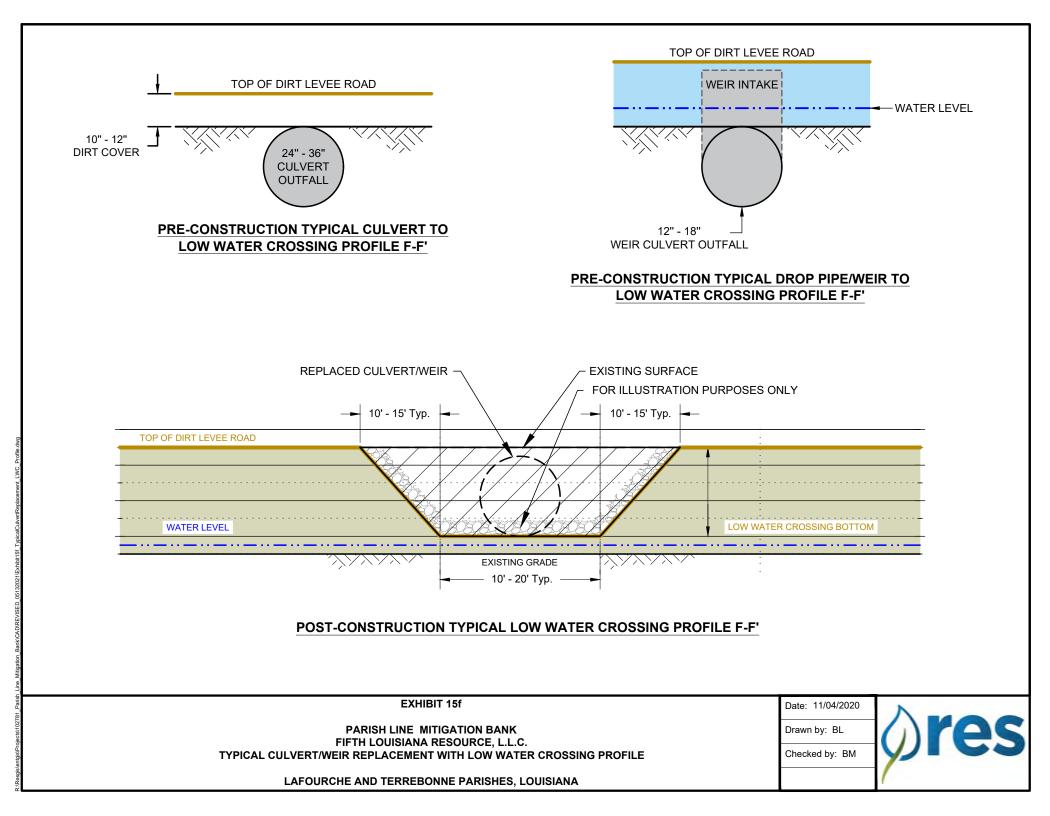
EXHIBITS 15a-15l

Construction Work Plan Cross-Sections

Similarly, approximately 40.1 acres of the aquaculture areas shall be recontoured to the maximum extent practical with in-situ earthen material, including spoil material obtained from degrading approximately 6,199.0 linear feet (L.F.) of levees. Spoil from levee degradation will be returned to the adjacent borrow areas the material was taken from originally (**Exhibits 15b** and **15c**).

- 7. Approximately 3,795 L.F. of drainages will be recontoured to become a stream-like feature containing armored check dams which will aid in reducing water velocity and allow for increased temporary ponding and sediment deposition that may, over time, elevate the water bottom to allow for overbank flooding. Under low-flow conditions, the check dams will allow water to pond and then slowly drain off-site, infiltrate the soil, or evaporate. Sediment will also begin to accumulate behind the check dams. Under high-flow conditions, ponding will occur in the areas between check dams faster than water can drain and creating overbank flooding into the adjacent Bank habitats. The goal of this feature is to reduce the surface hydro period while maintaining the subsurface hydrology (**Exhibits 15i 15j**).

- 8. As stated in **Section 4.1.1.1**, approximately 6,199 L.F. of levees in/or surrounding the aquaculture ponds and CYP forest area shall be degraded and pushed into the borrow areas or used as in-situ material to swale drainage features (**Exhibits 15b, 15c,** and **15j**) to restore hydrology in these areas;
