**BENEFICIAL USE OF DREDGED MATERIAL  
MONITORING PROGRAM  
1998 ANNUAL REPORT**

**Part 1: Results of Monitoring the Beneficial Use of Dredged Material at the  
Barataria Bay Waterway, Louisiana -  
Barataria Bay and Bar Channel Reaches**

**Base Year 1985 through Fiscal Year 1997**

Prepared by:  
University of New Orleans  
Department of Geology and Geophysics  
New Orleans, LA 70148

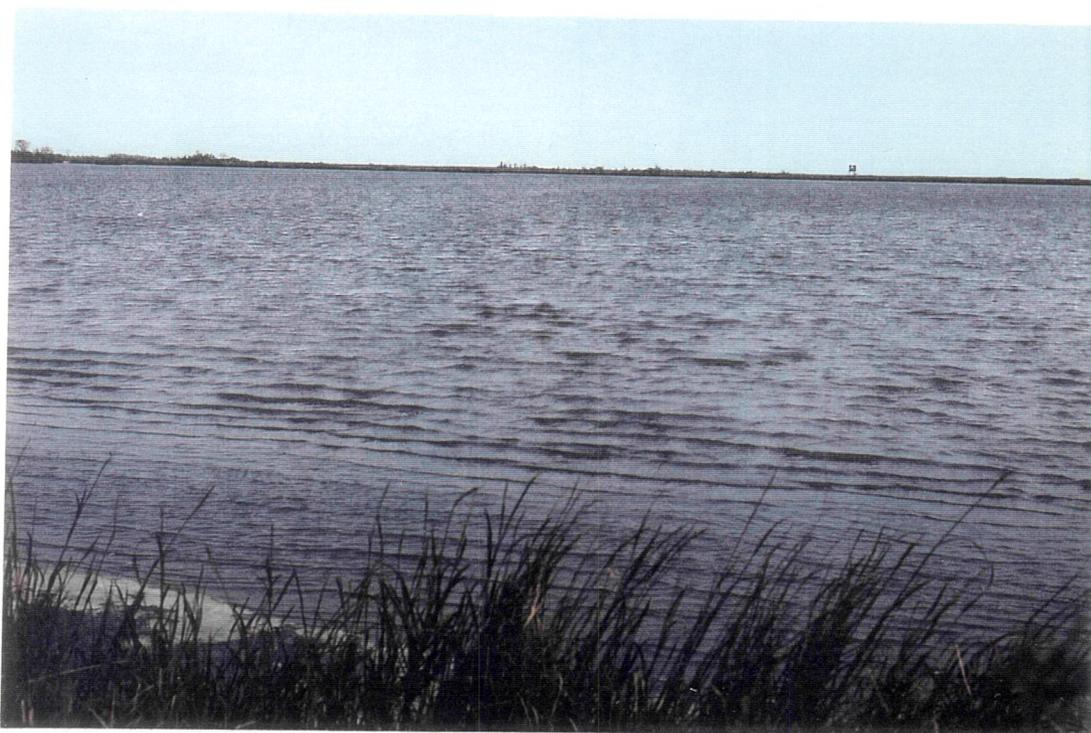
Figure 7. Photograph of the disposal site at the Barataria Bay Waterway - Barataria Bay Reach Vicinity Mile 14 BUMP study site on November 12, 1998. This view is from the west side looking across the disposal site to the pre-existing saltmarsh.

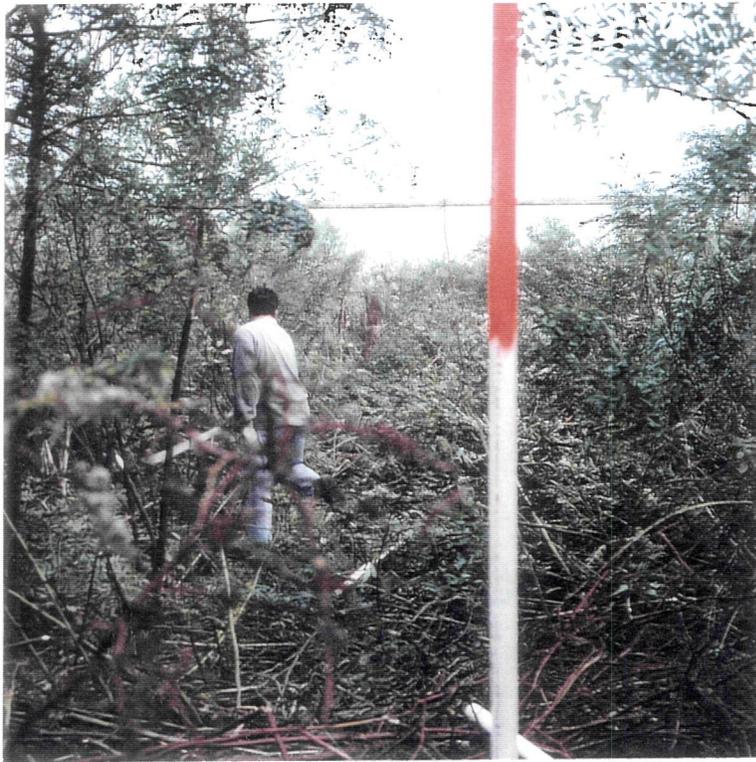
Figure 8. Photograph taken on November 12, 1998 along the transect (BB1-BB1') and across the disposal site from the stake on the ridge at the Barataria Bay Reach Vicinity Mile 14 BUMP study site.

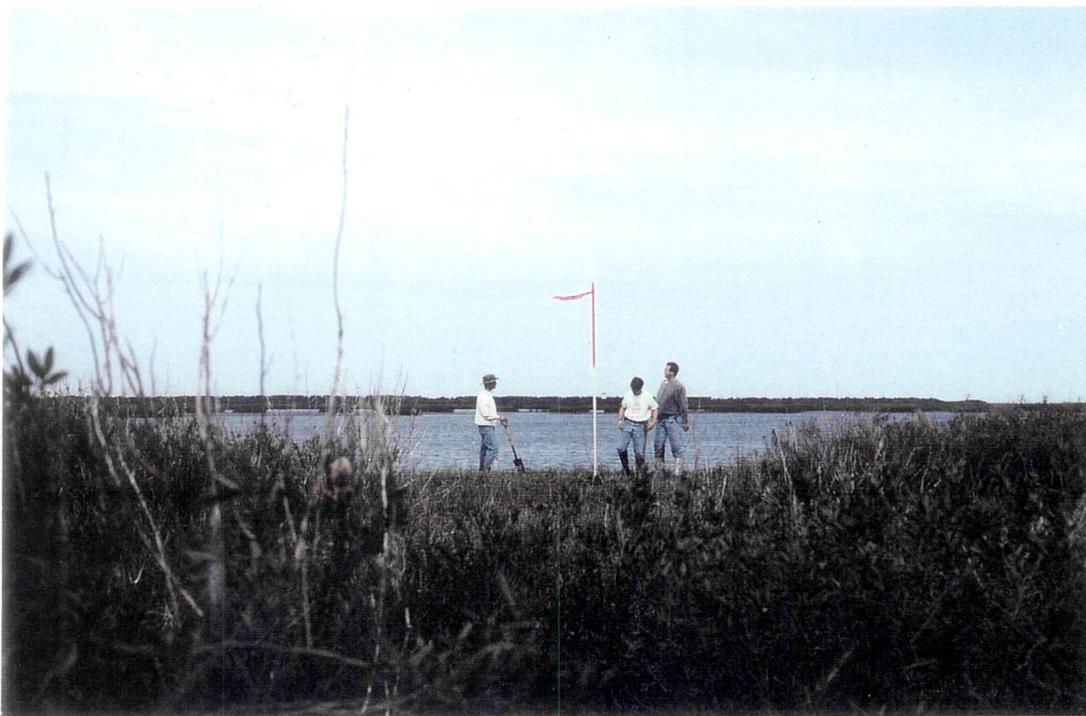
Figure 11. Photograph of the Barataria Bay Waterway - Barataria Bay Reach Vicinity Mile 6.5 BUMP study site taken on November 12, 1998, looking along the transect (BB2-BB2') into the shrub thicket where the first stake was placed.

The stakes were placed on the marsh island at the south end of the site. The transect BB2 was delineated by one stake set within a shrub thicket at the base of the ridge along the channel on the southwest side of the site (Figure 11), the second was set along the southern edge of the disposal site and was aligned with a pipeline marker across the disposal site to the north (Figure 12). The material within the disposal site was extremely fine, soft mud. Wind and wave action prevented the use of a pirogue within the disposal site and the substrate was too soft to traverse. Therefore, no elevation profile was obtained at this site.

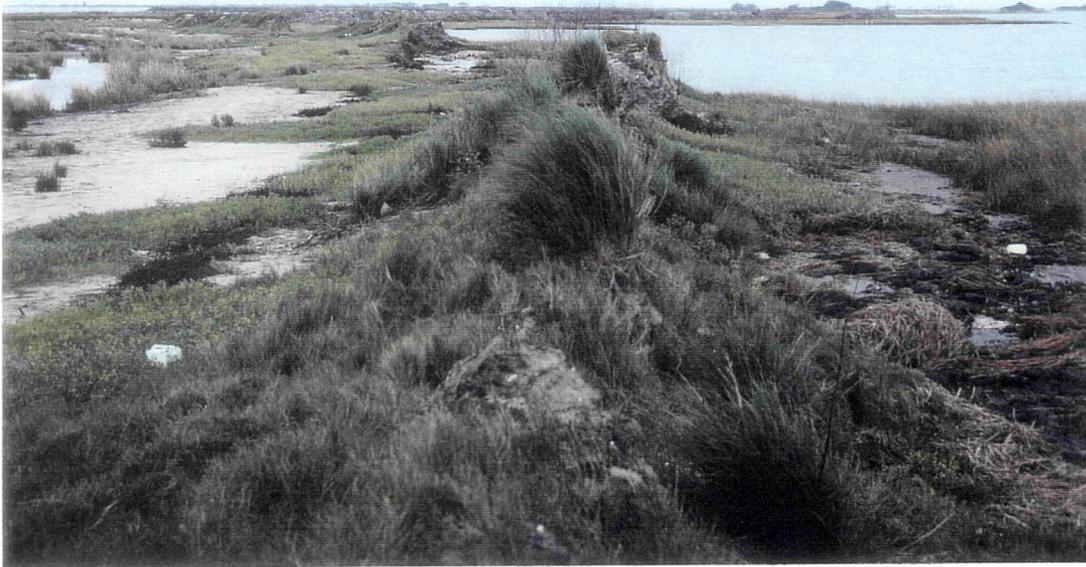
Figure 22a. Photograph of the north dike, looking southwest, on the west transect (GT1-GT1') at the Grand Terre Island BUMP study site in November 1998.

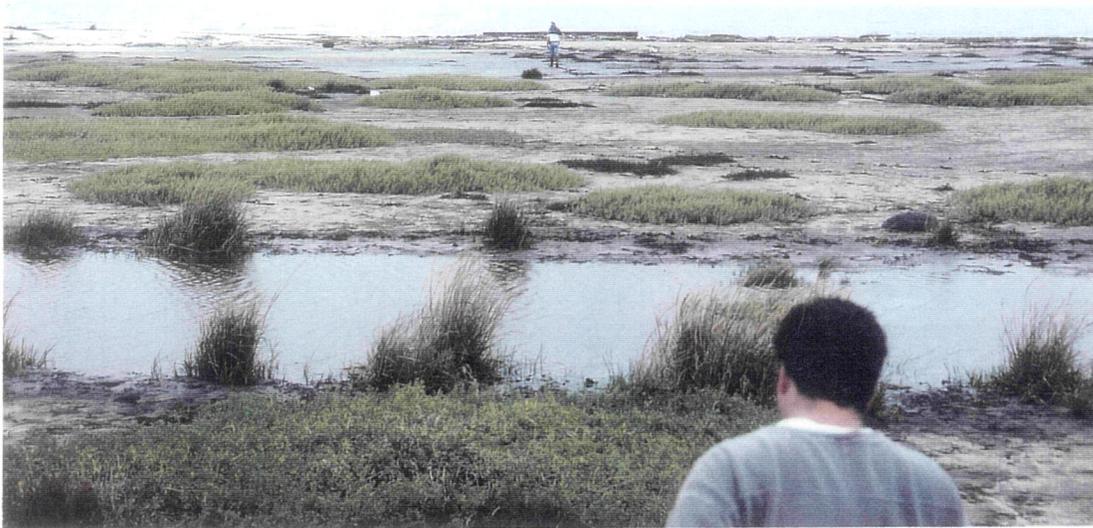
Figure 23a. Photograph of the borrow ditch and partially vegetated sand flat, looking south from the first stake of the central transect (GT2-GT2') at the Grand Terre Island BUMP study site in November 1998.

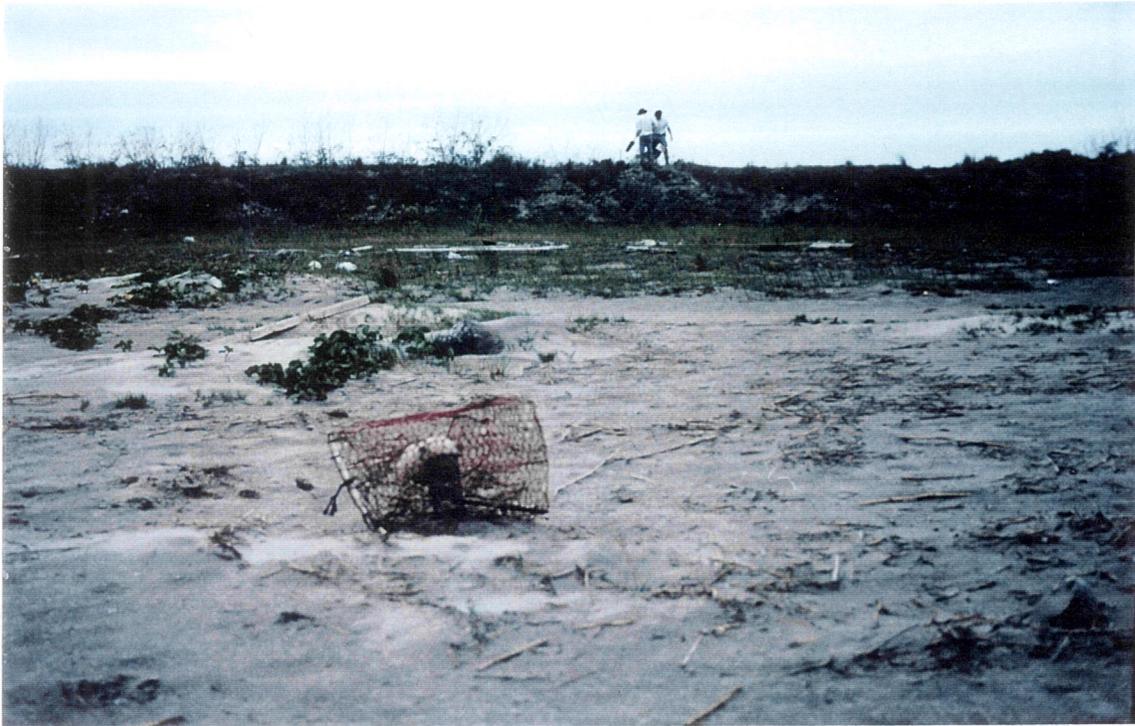
Figure 24a. Photograph of the Gulf side of the south dike along the East transect (GT3-GT3') at the Grand Terre Island BUMP study site in November 1998.
