**BENEFICIAL USE OF DREDGED MATERIAL
MONITORING PROGRAM
2001 ANNUAL REPORT
(Base year through FY2000)**

Results of Monitoring the Beneficial Use of Dredged Material at the
Mississippi River, Baton Rouge to the Gulf of Mexico, Louisiana -
Southwest Pass
Base Year 1985 thru Fiscal Year 2000

U.S. Army Corps of Engineers
New Orleans District

Prepared by:
Coastal Research Laboratory
University of New Orleans
New Orleans, Louisiana

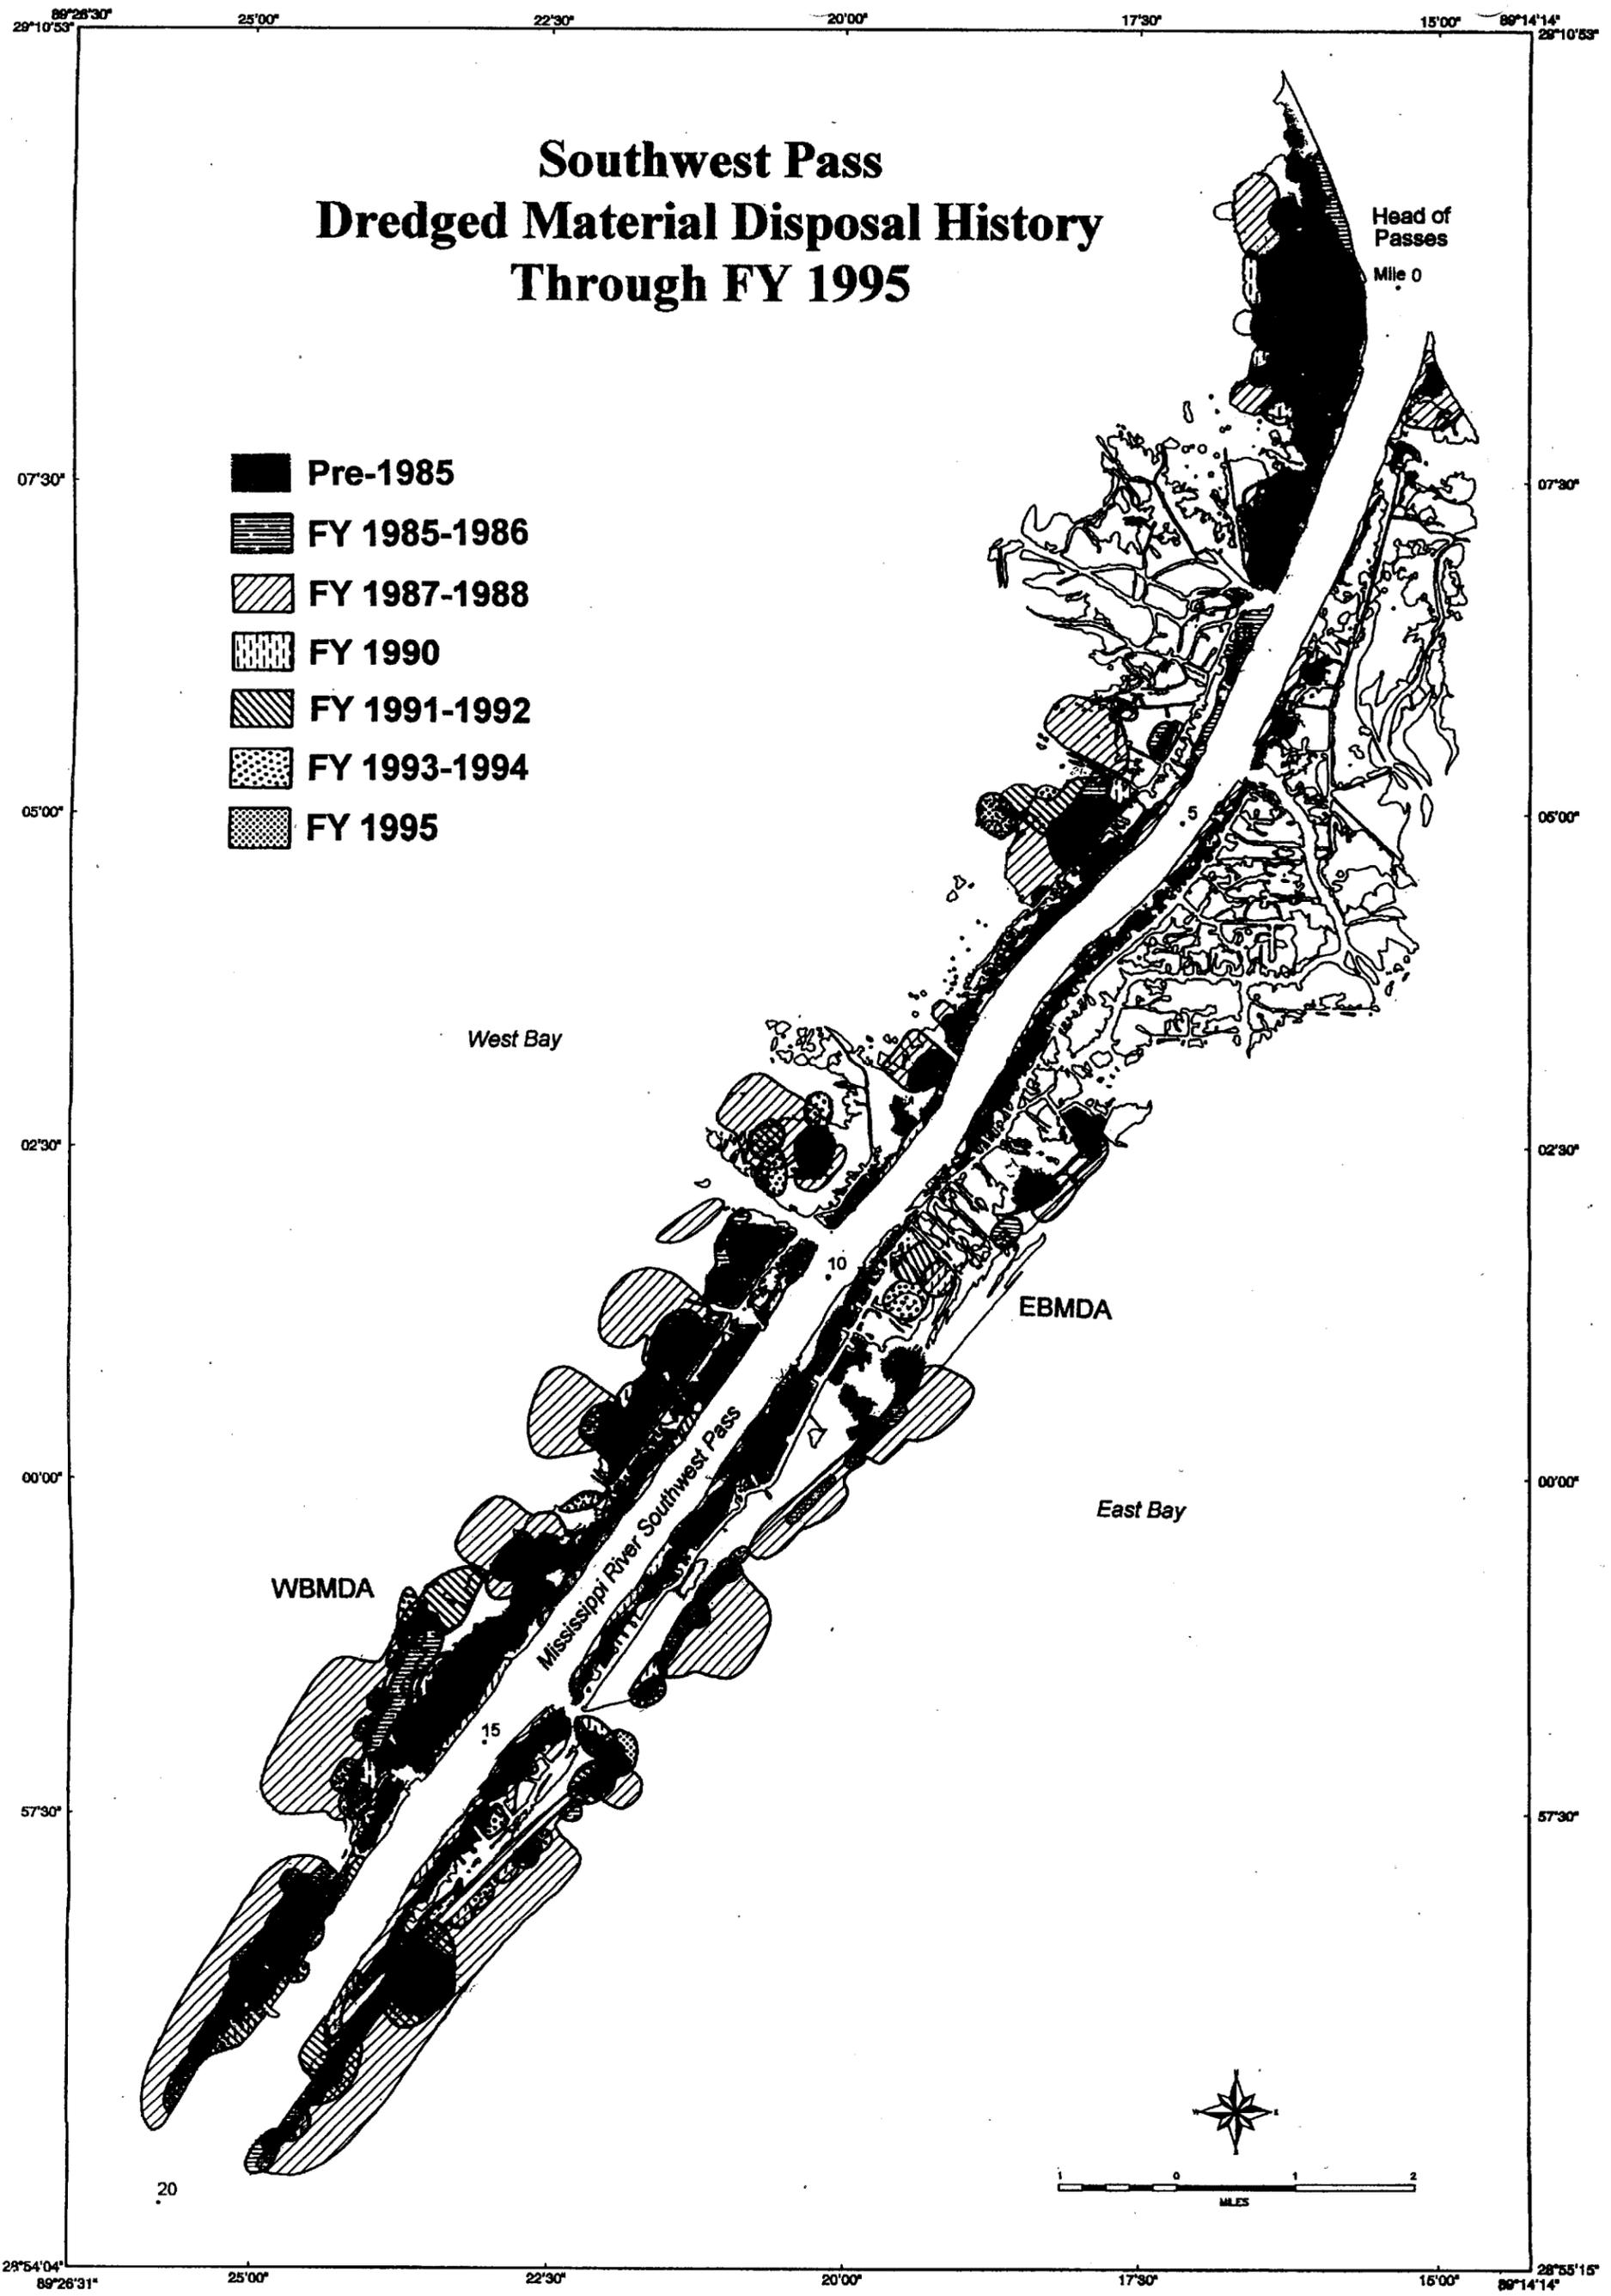
Figure 4A. The dredged material disposal history for the Mississippi River - Southwest Pass BUMP study area, showing FY 1985 through FY 1995 disposal in detail

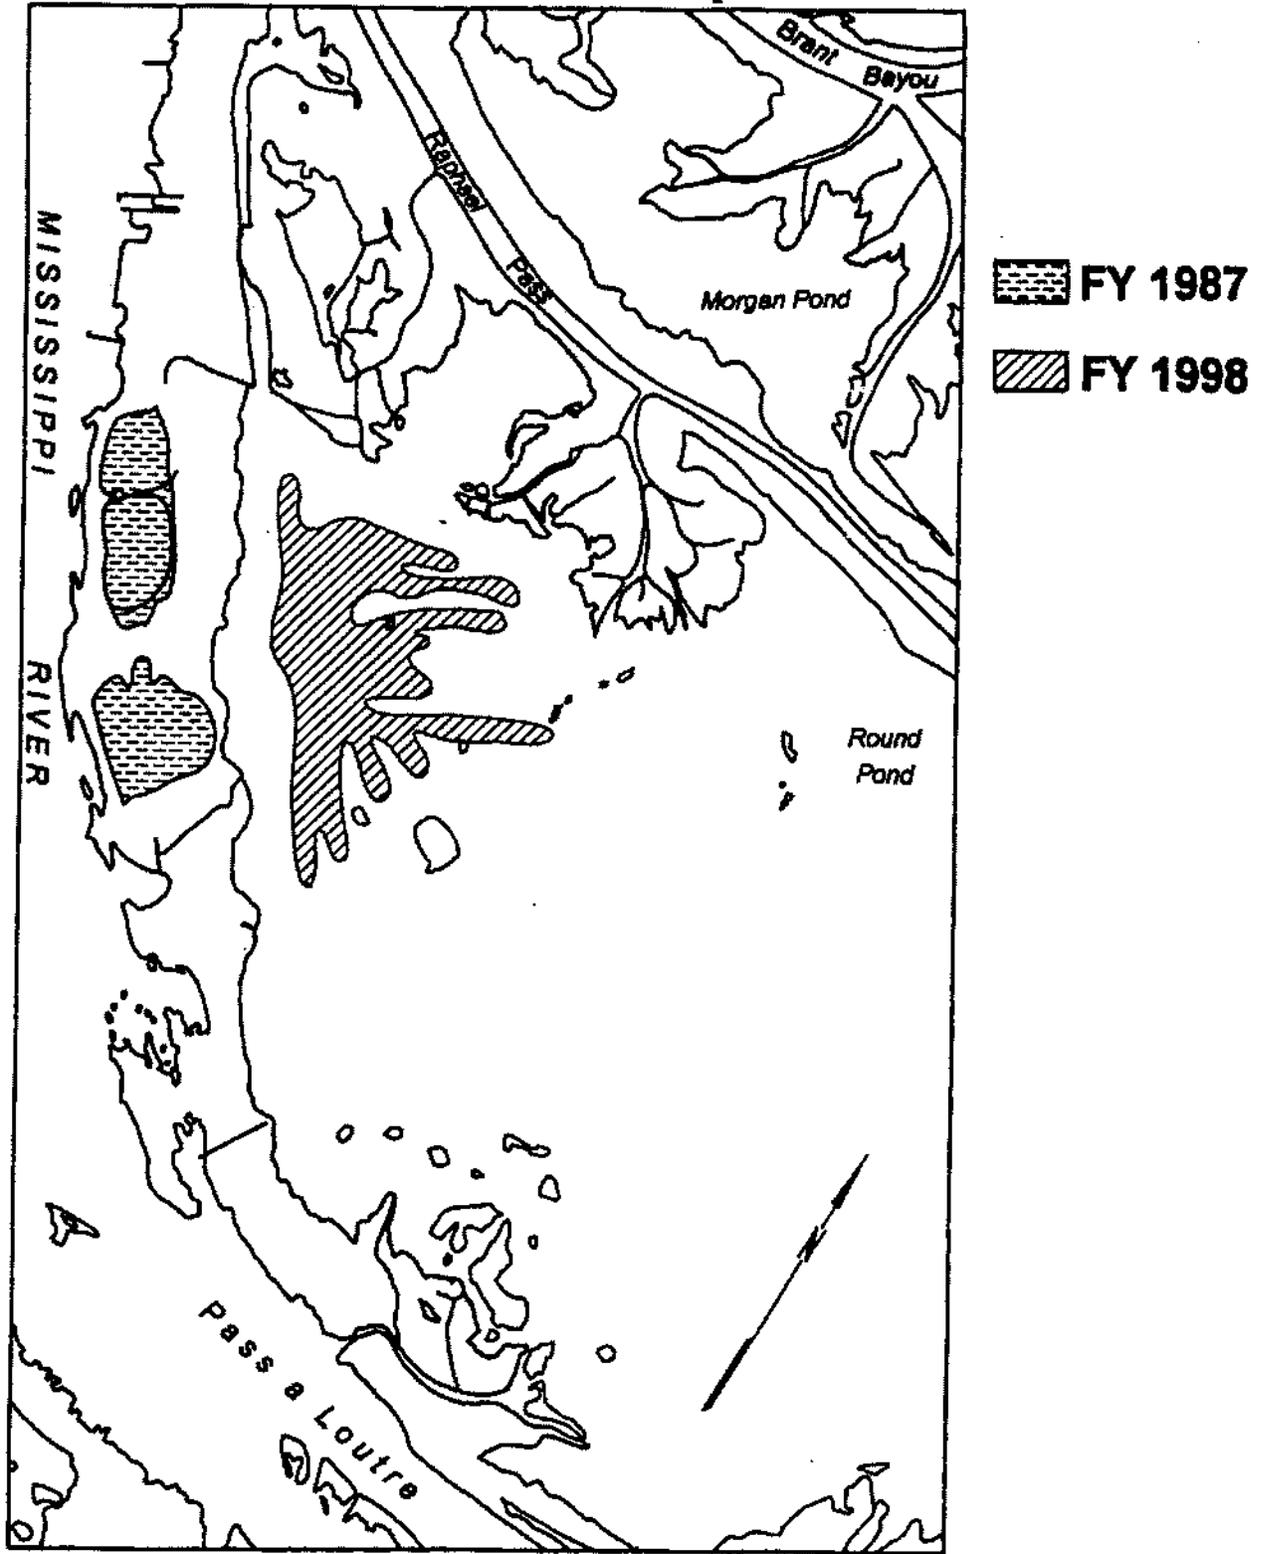
Figure 4C. The dredged material disposal history for the Pass a Loutre BUMP study area showing disposal through FY2000. The last disposal in this area was FY1998.

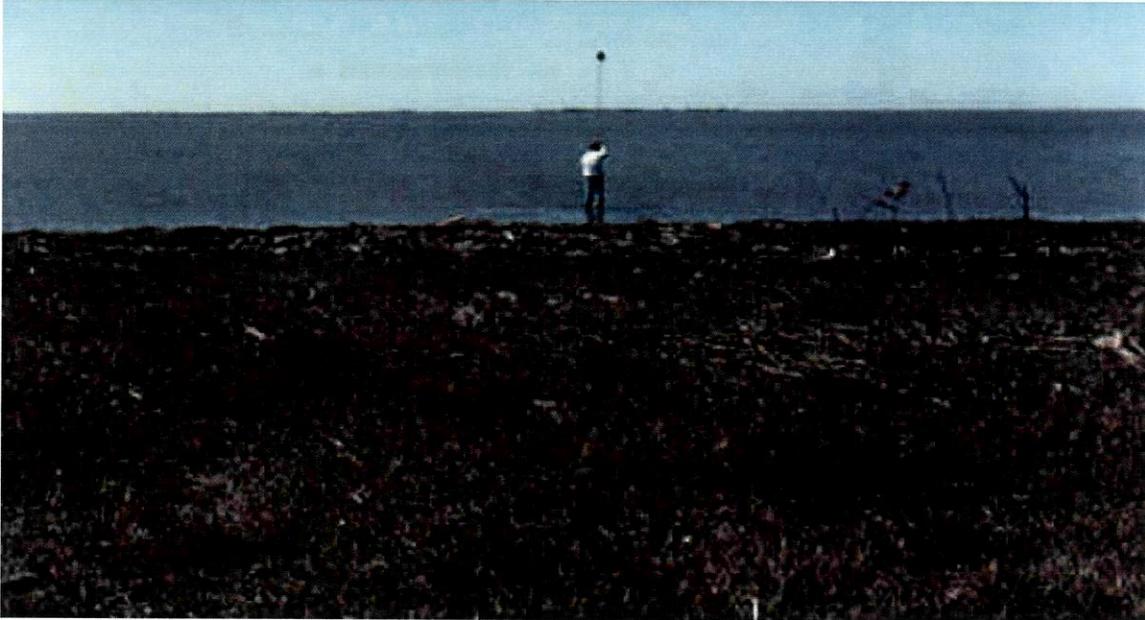
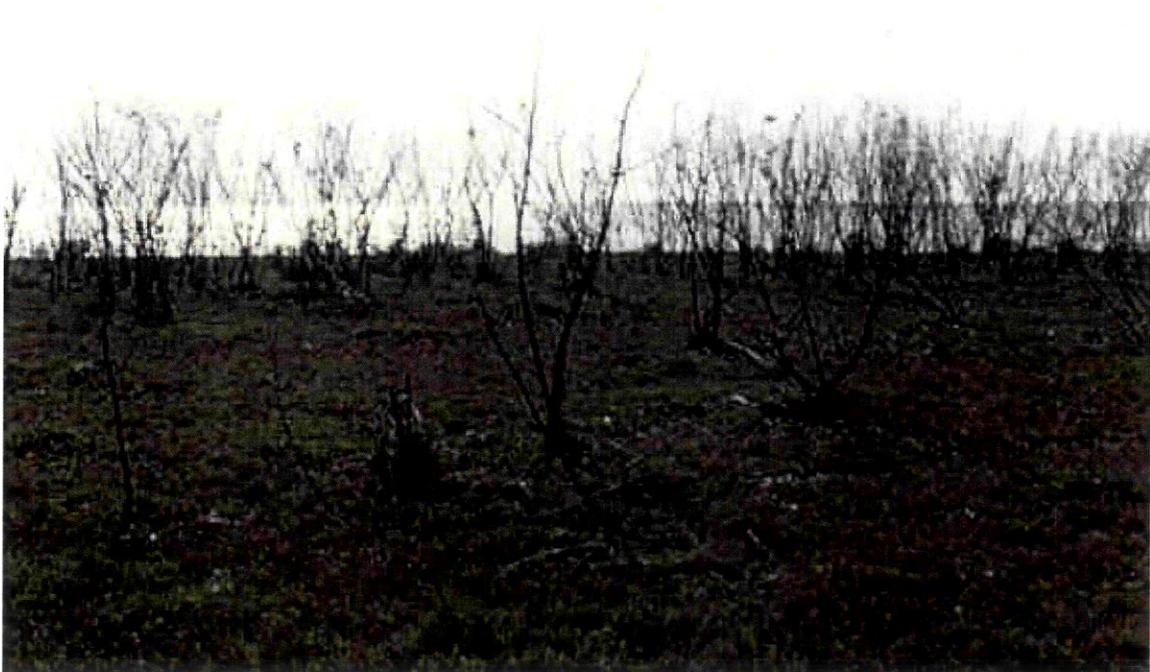
Figure 8. A) Photograph taken on February 24, 1999 at the end of transect SW1 at the Southwest Pass - Head of Passes BUMP study site. B) Same shot taken April 6, 2001, showing the difference that can occur because of short-term, opportunistic vegetation.

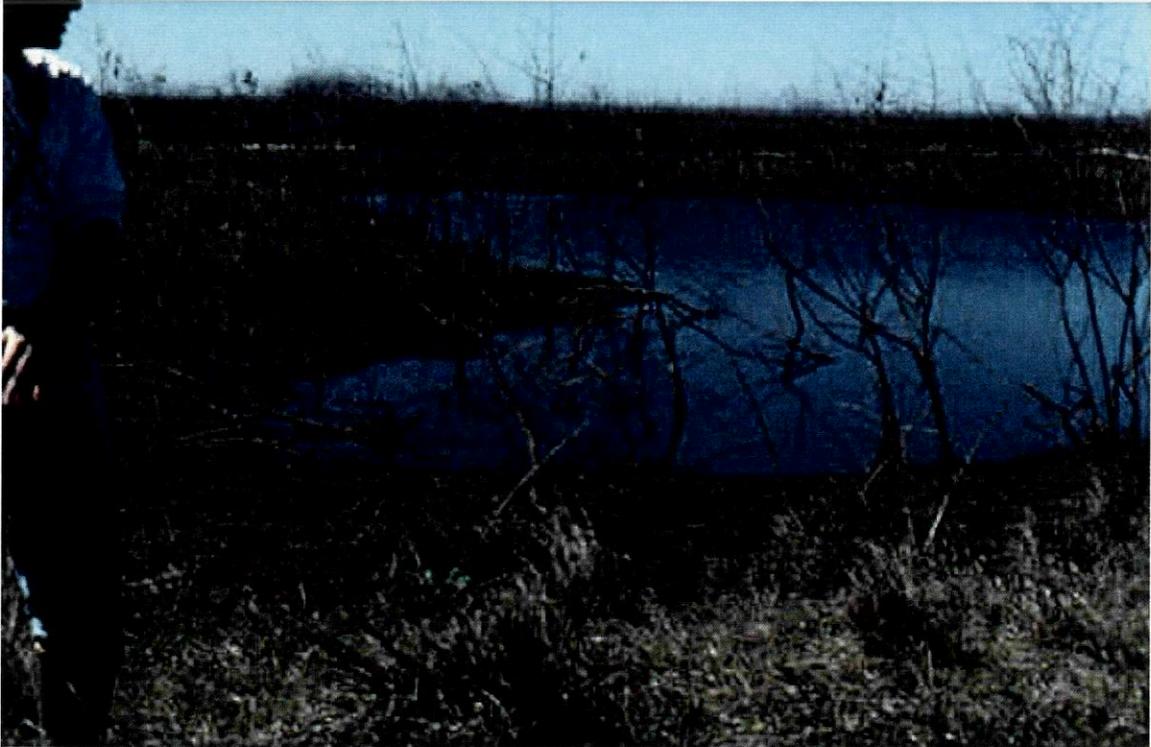
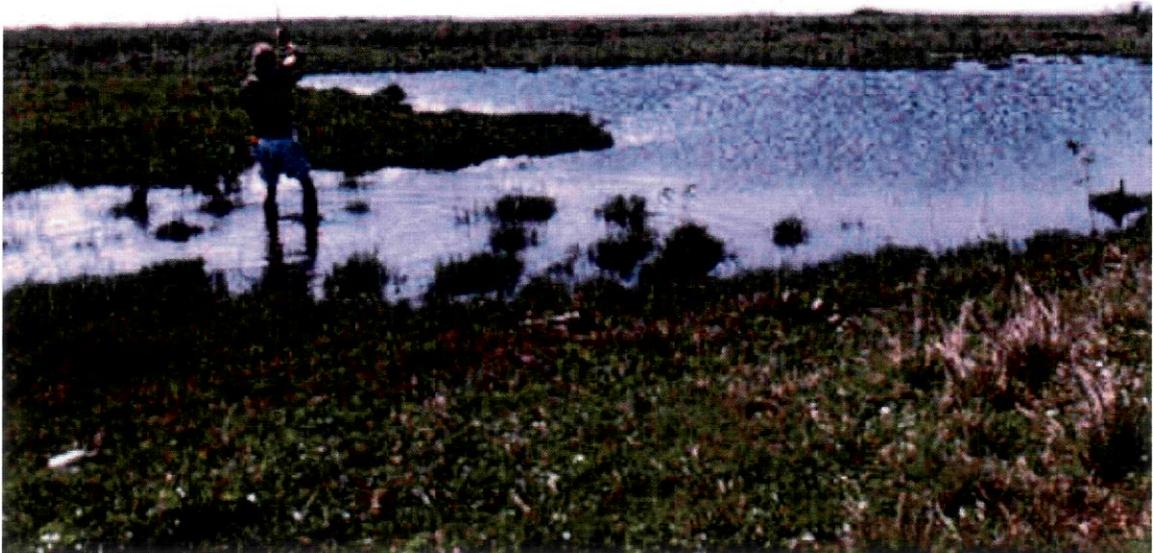
Figure 9. A) Photograph taken on February 24, 1999 along transect SW1 at the Southwest Pass - Head of Passes BUMP study site showing a pond with associated marsh vegetation. B) Same shot taken April 6, 2001, showing the difference that can occur because of short-term, opportunistic vegetation.

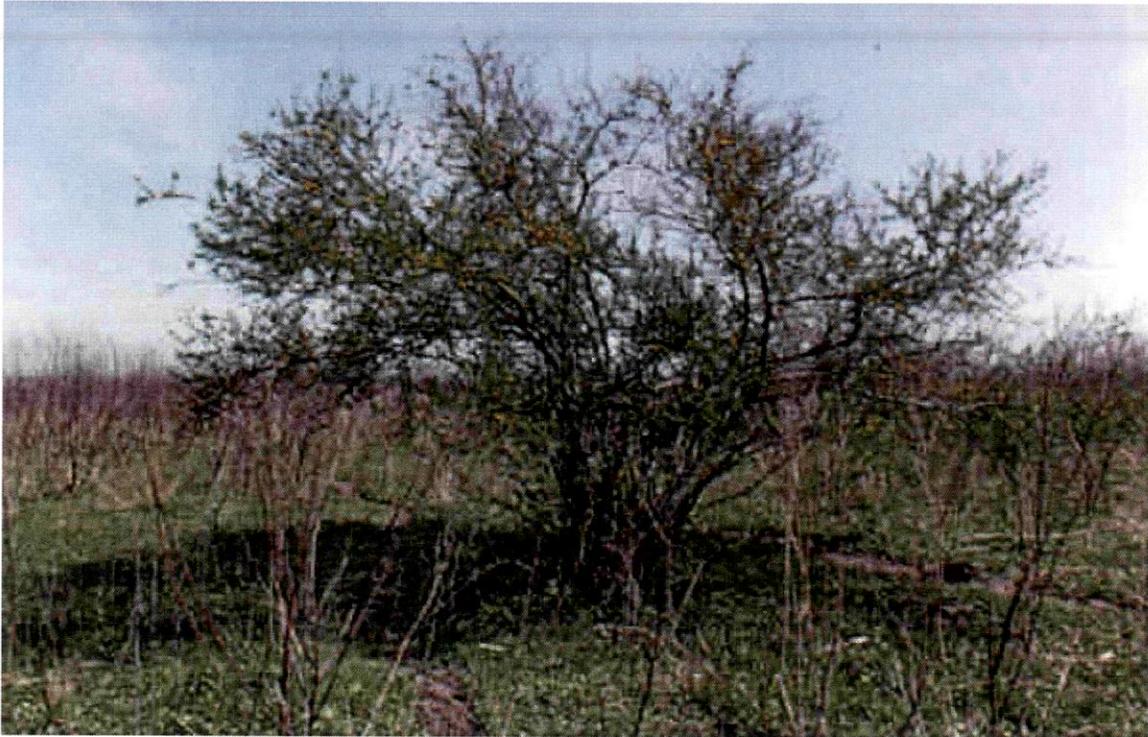
Figure 10. Photograph taken on April 6, 2001 near transect SW1 at the Southwest Pass - Head of Passes BUMP study site, showing grassland and small acacia tree.

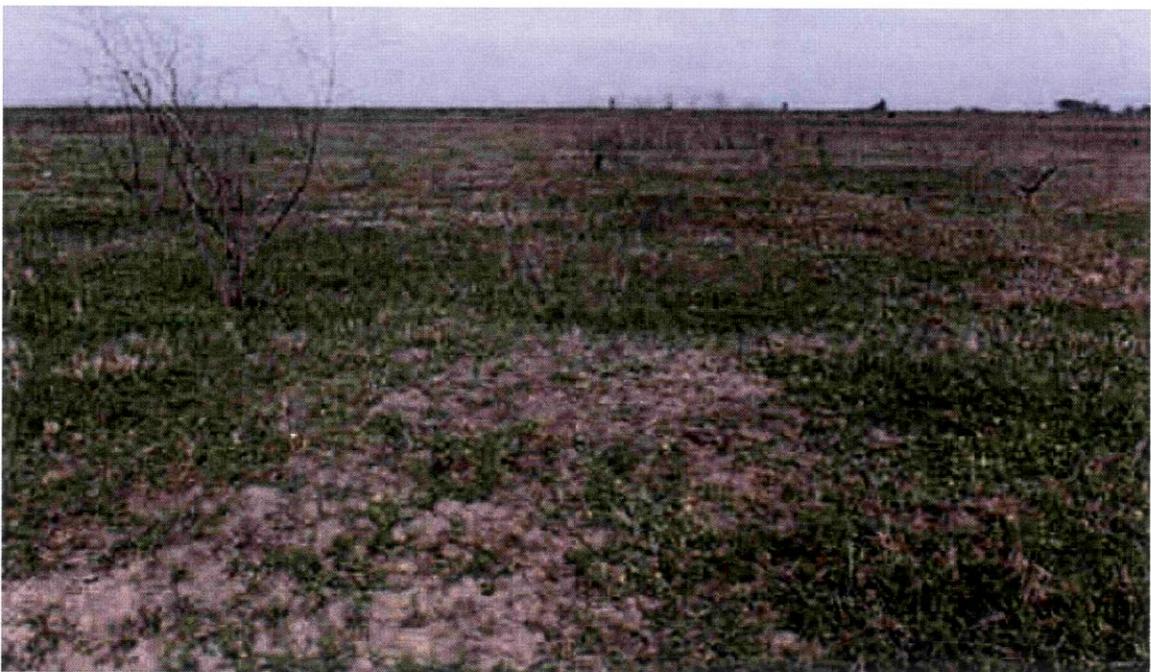
Figure 11. Photograph taken on April 6, 2001 along transect SW1 at the Southwest Pass - Head of Passes BUMP study site showing extensive grasslands used for grazing cattle.

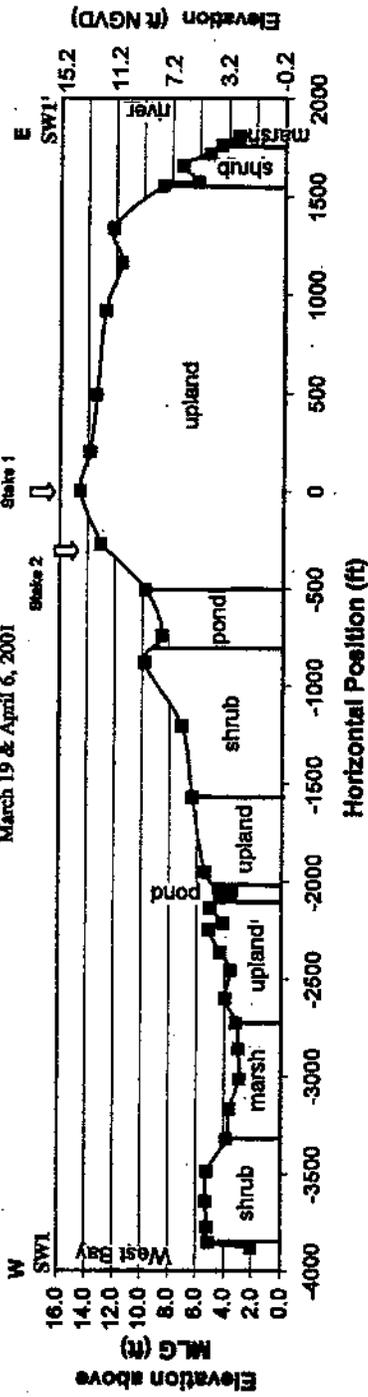
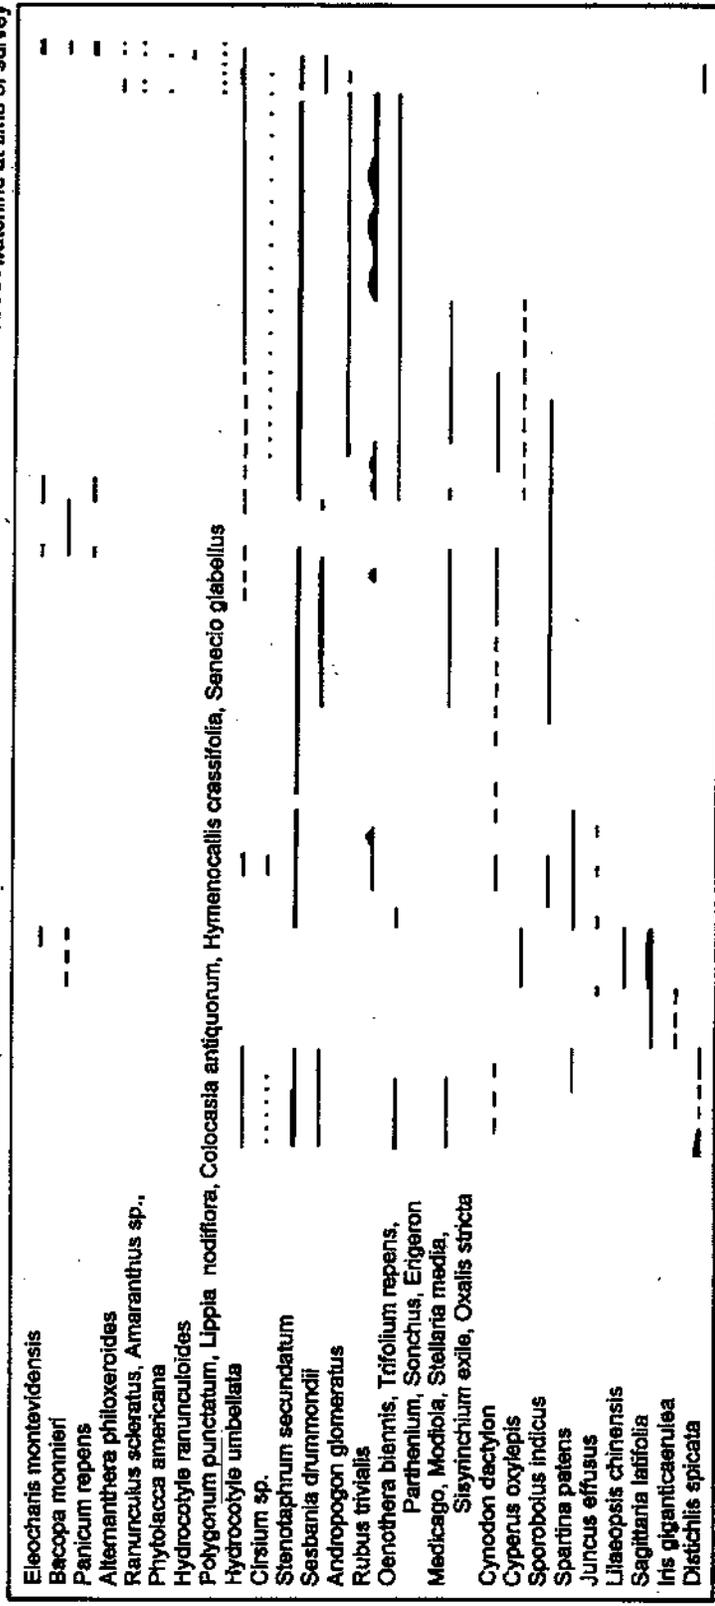
Figure 13. Elevation profile SW1 at the of the Southwest Pass - Head of Passes BUMP study site with vegetation data illustrated.

The profile was over a mile long and had a length of 5691 ft (Figure 13). The maximum relief along the axis was 14.5 ft MLG (13.7 NGVD), at the location of stake 1, with an average relief of 6.6 ft MLG (5.8 NGVD). The published tidal range for Southwest Pass is 1.3 ft.

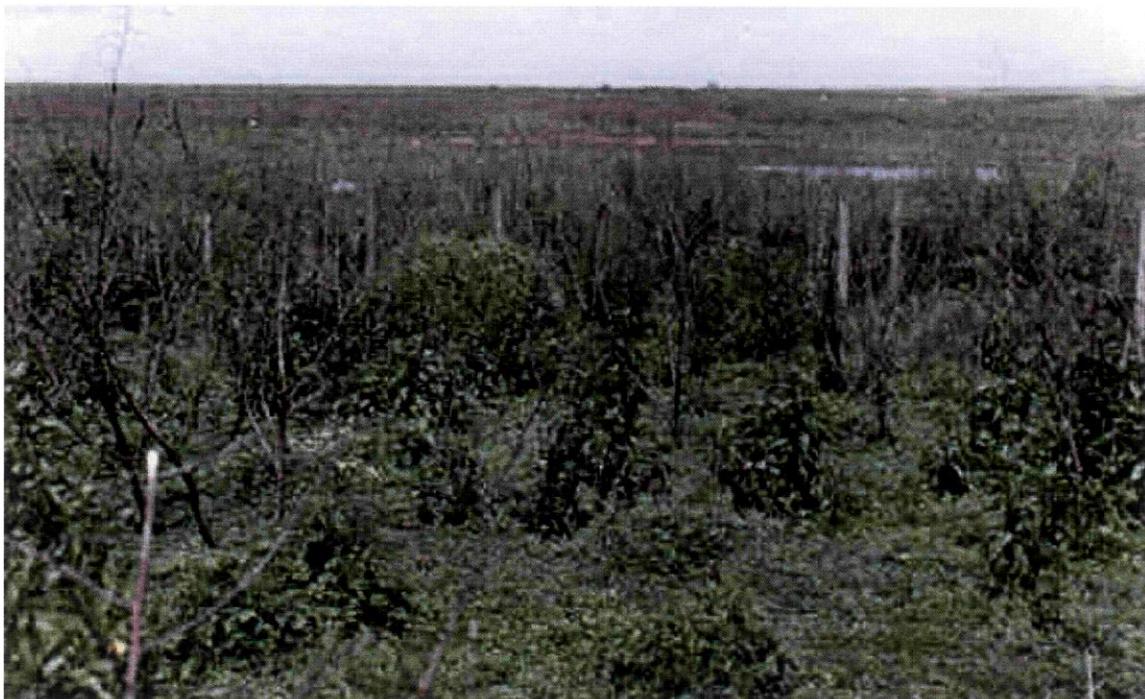
Figure 15. Photograph taken on April 5, 2001 along transect SW2 - Central West Bay showing shrub, upland, and fresh marsh habitats and a pond. This view is in line with the transect toward West Bay, from the instrument placed over stake 1 on the ridge.

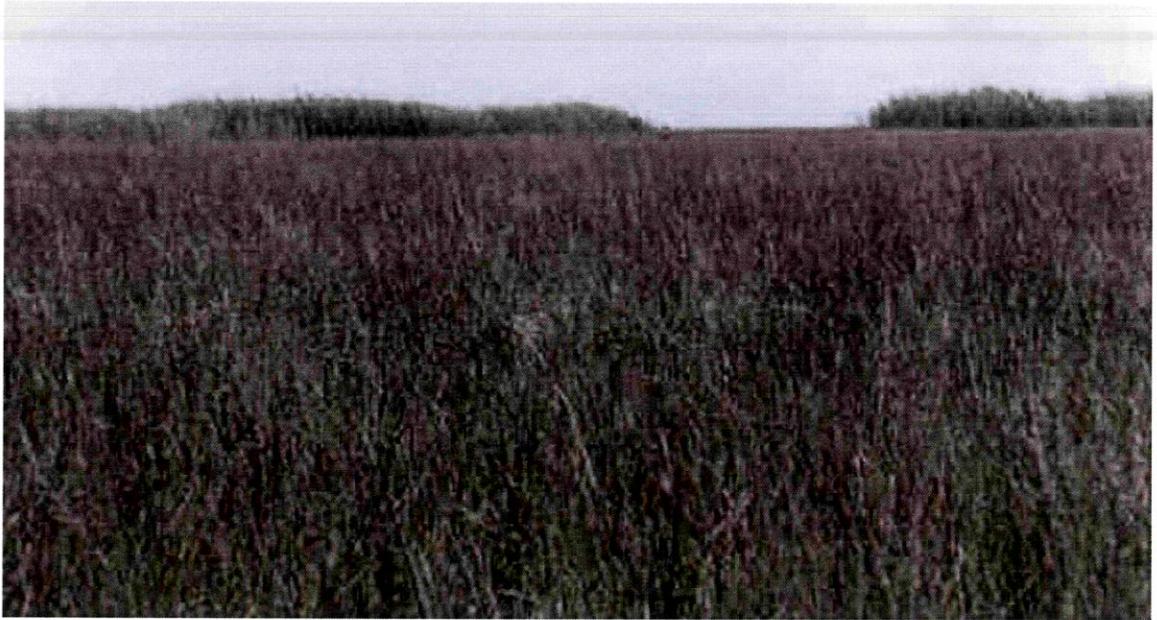
Figure 16. Photograph taken April 5, 2001 along transect SW2 - Central West Bay, showing wide area of *Spartina alterniflora* toward the end of the transect, looking toward West Bay.

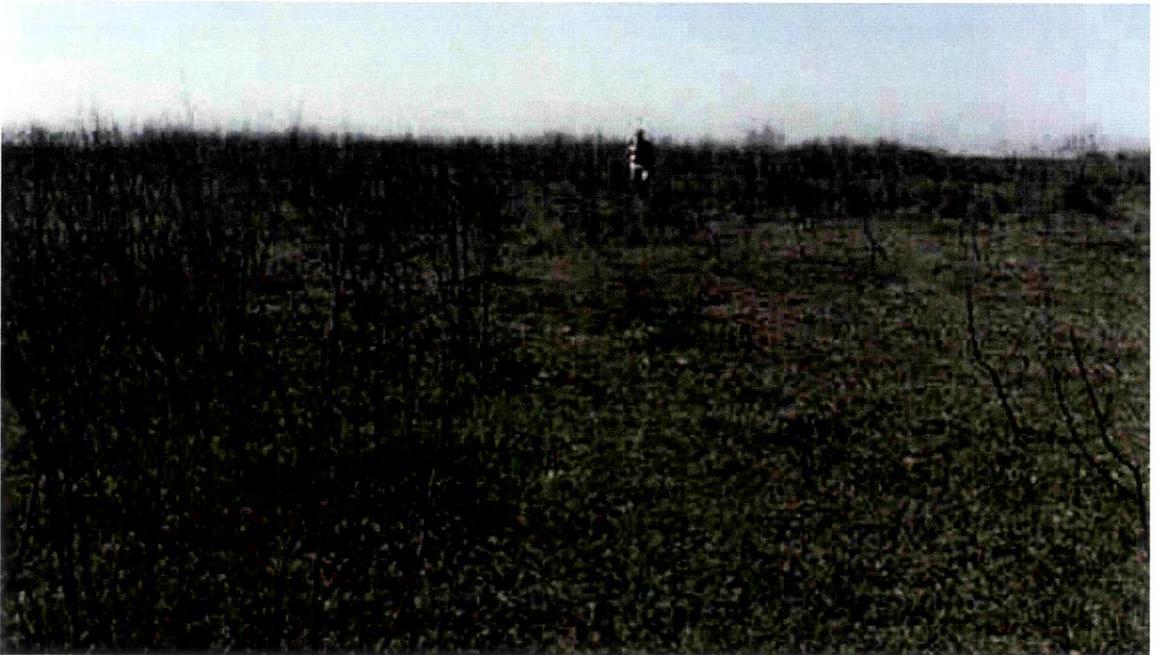
Figure 17. Photograph taken April 5, 2001 along the central part of transect SW2 - Central West Bay, showing the extensive grassland with old Sesbania shrubs.

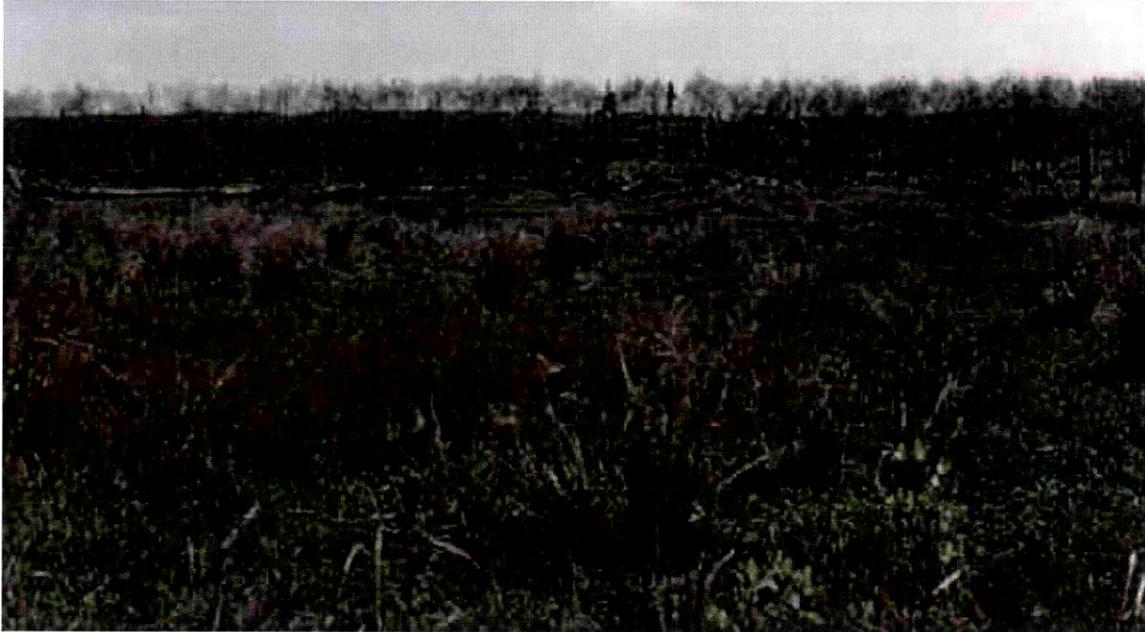
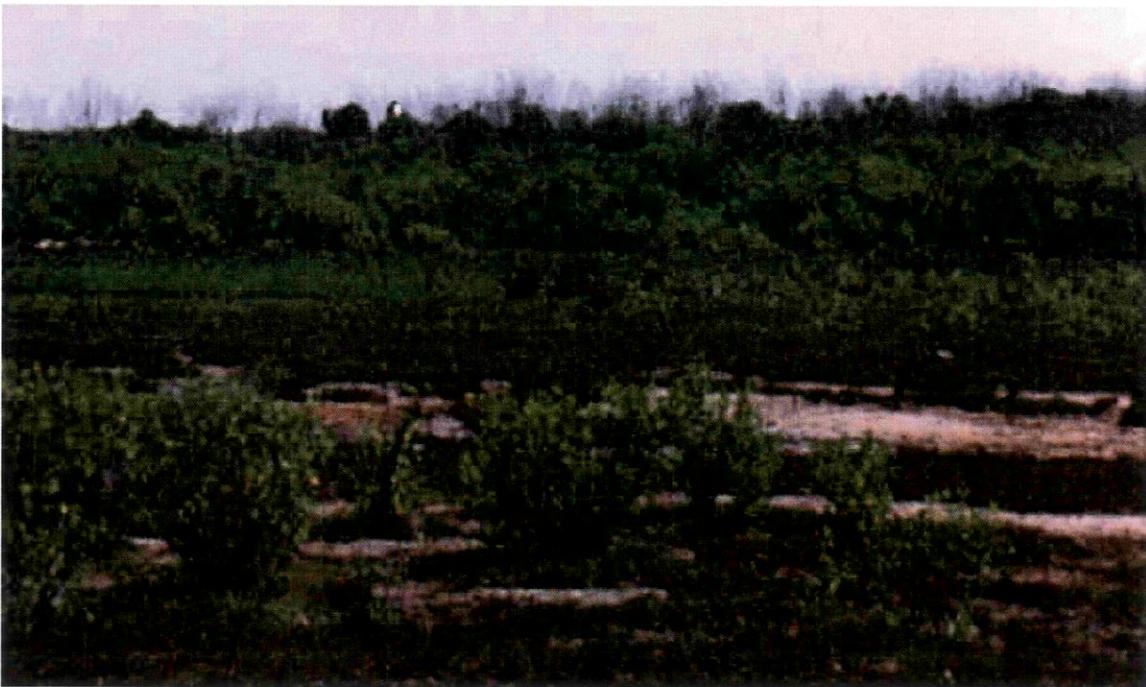
Figure 18. Photographs taken along transect SW2 - Central West Bay, looking past the former location of stake 2 to the instrument placed over stake 1 on the ridge next to the access canal. Notice the log on the left side of the picture for reference, and the difference in vegetative cover and the shrub thicket that now appears in front of the fence line. A) December 15, 1998. B) April 5, 2001.

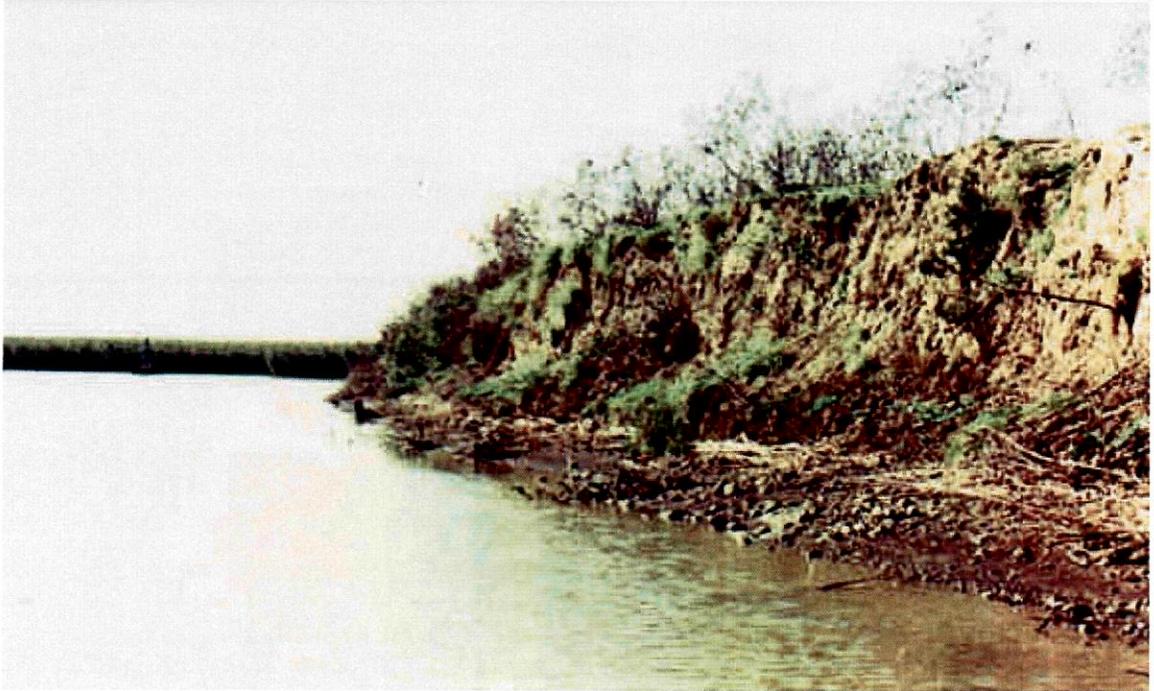
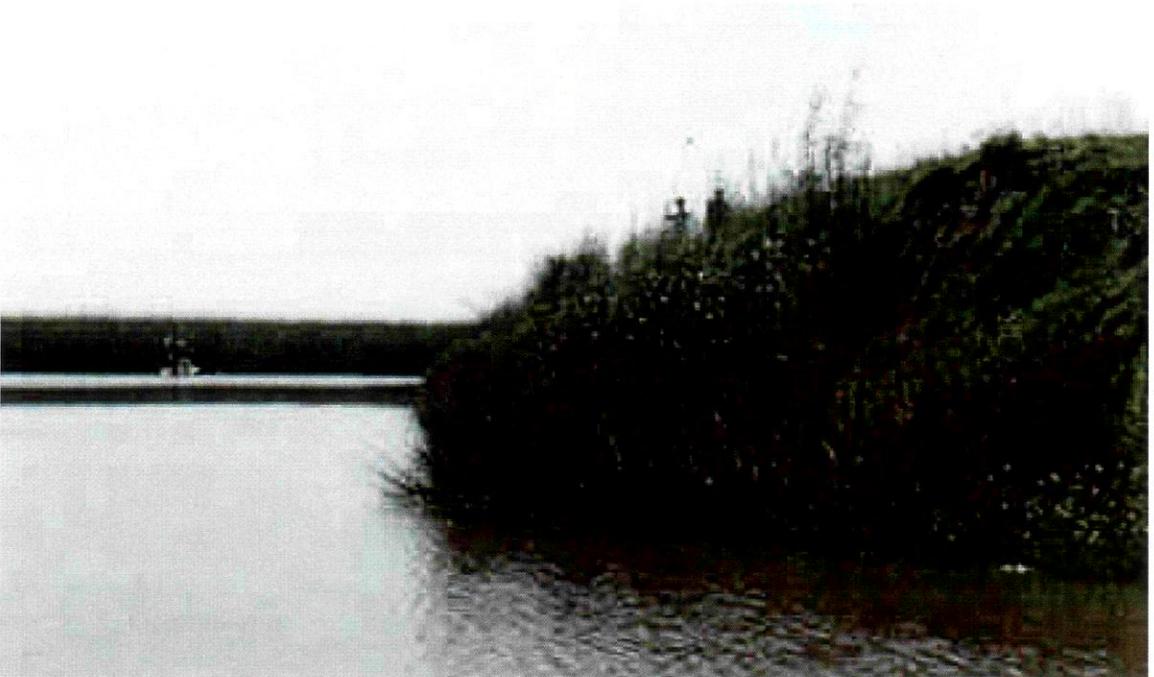
Figure 19. Photographs taken of the cliff at the instrument end of transect SW2 - Central West Bay. A) December 15, 1998. B) April 5, 2001.

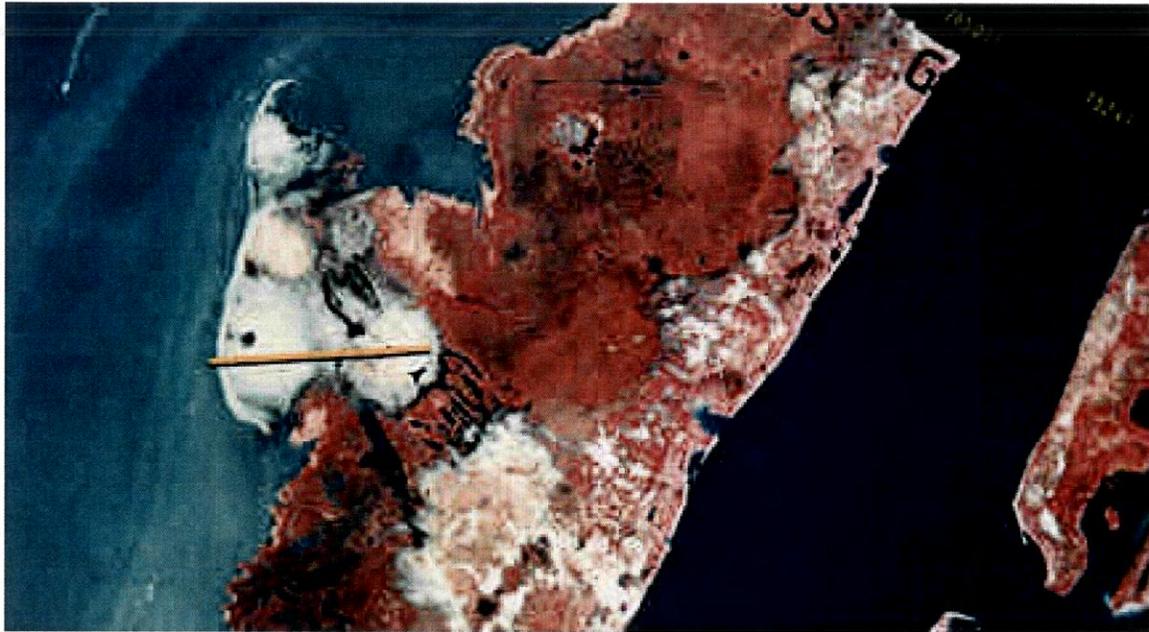
Figure 21. Vertical aerial photograph taken on October 16, 1997 of the area containing the SW3 transect (black line) at the Southwest Pass - Southern West Bay BUMP study site. The old lighthouse can be seen as a dot indicated by the arrow.

The initial elevation and vegetation data was acquired February 24, 1999, and was revisited for new data on March 19, 2001. Access to the area was by helicopter. The transect SW3 was oriented to cross the most recent disposal in the area. The transect crossed the width of land between the lighthouse and West Bay (Figure 21 & 22). The transect was delineated by 1 stake north of the old lighthouse, and a second stake set 149 ft away toward the west (Figure 23).

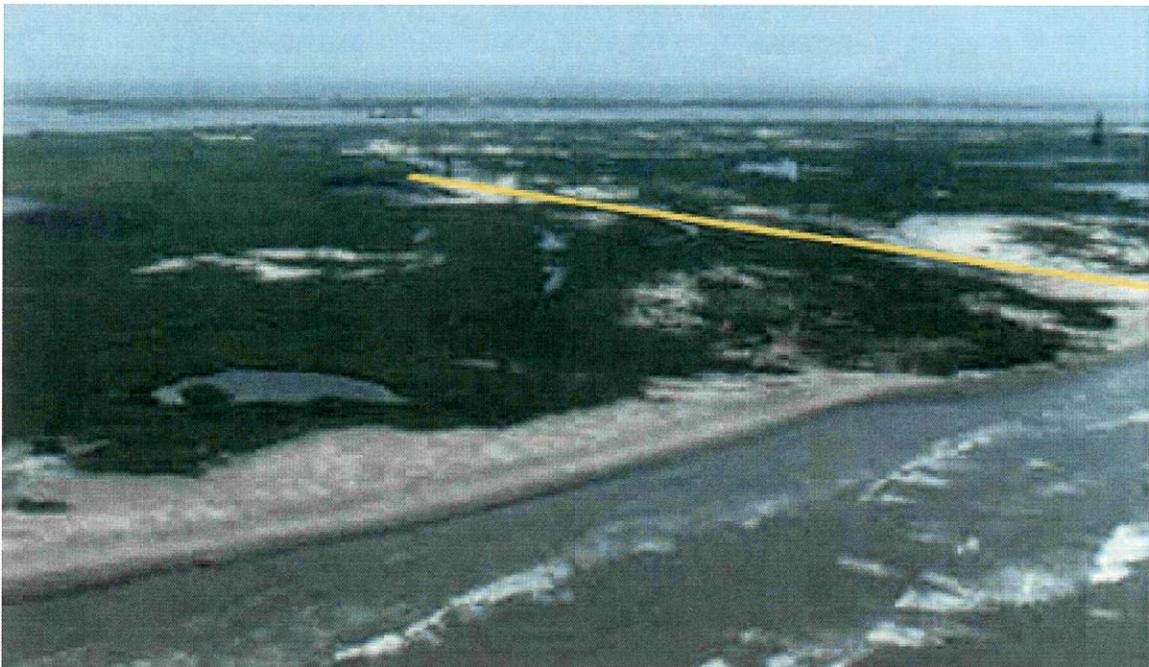
Figure 22. Oblique photograph taken in June 2001 of the area containing the SW3 transect (approximately represented by the yellow line). From the *Aerial Videotape Survey of Coastal Louisiana -- 2001*, LSU Aerial Videotape Survey Program.

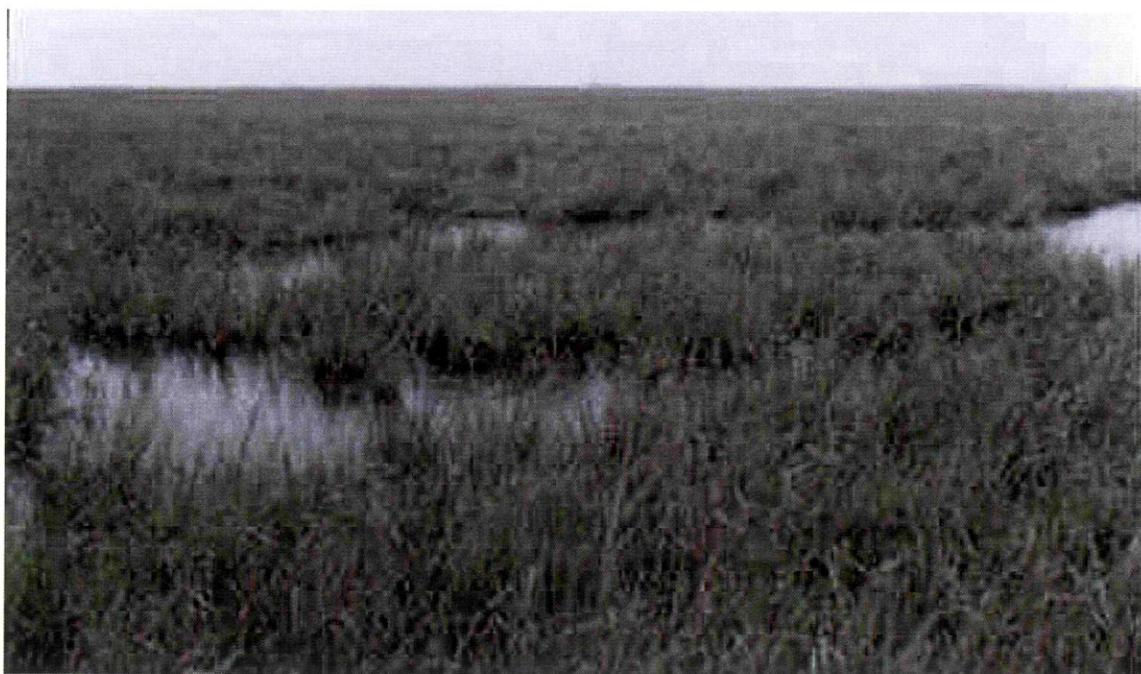
Figure 24. Photograph of transect SW3 at the Southwest Pass - Southern West Bay BUMP study site on March 19, 2001. The transect began in the well established salt marsh east of the lighthouse. The view is looking southeast toward the Mississippi River.

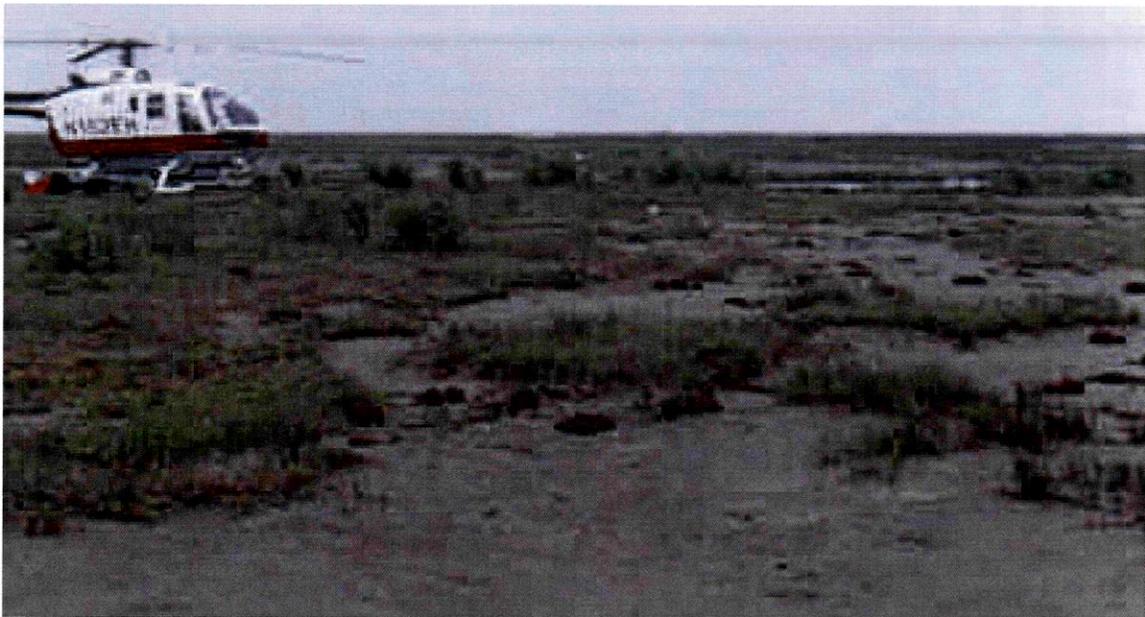
Figure 25. Photograph taken on March 19, 2001 along transect SW3 at the Southwest Pass - Southern West Bay BUMP study site. The newer deposits were only sparsely vegetated with Bermuda grass on the slightly higher areas and *Spartina* on the lower.

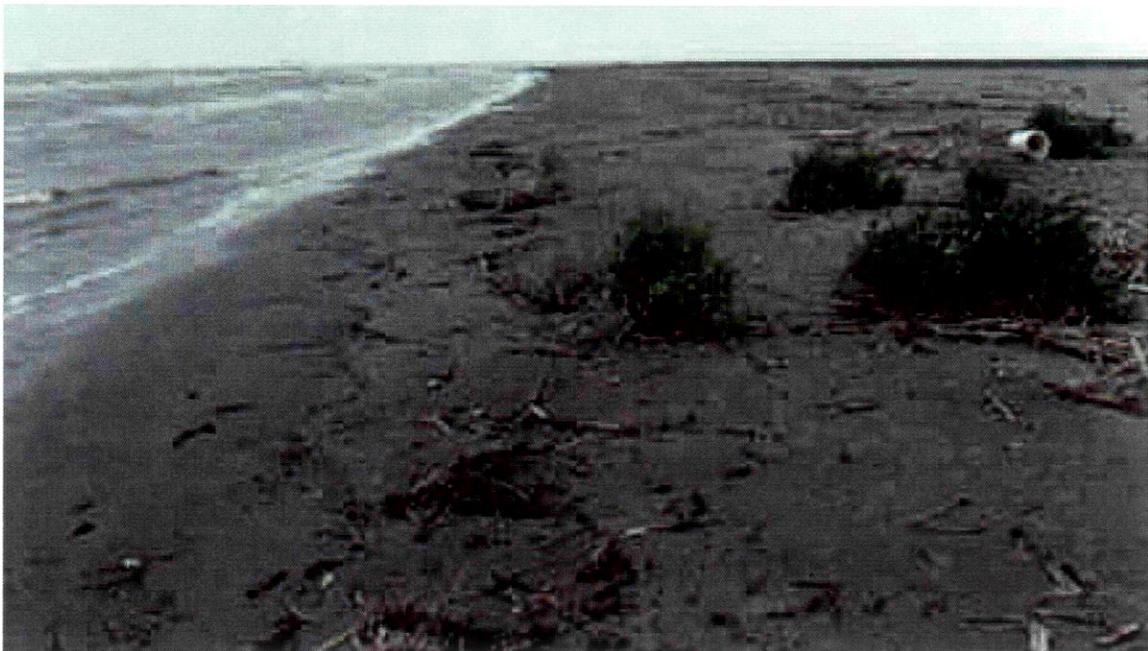
Figure 26. Photograph taken on March 19, 2001 at the western end of transect SW3 at the Southwest Pass - Southern West Bay BUMP study site. Washover flat now occupies what was once a dune habitat.
