**BENEFICIAL USE OF DREDGED MATERIAL
MONITORING PROGRAM
2001 ANNUAL REPORT
(Base year through FY2000)**

Results of Monitoring the Beneficial Use of Dredged Material at the
Mississippi River, Baton Rouge to the Gulf of Mexico, Louisiana -
Southwest Pass
Base Year 1985 thru Fiscal Year 2000

U.S. Army Corps of Engineers
New Orleans District

Prepared by:
Coastal Research Laboratory
University of New Orleans
New Orleans, Louisiana

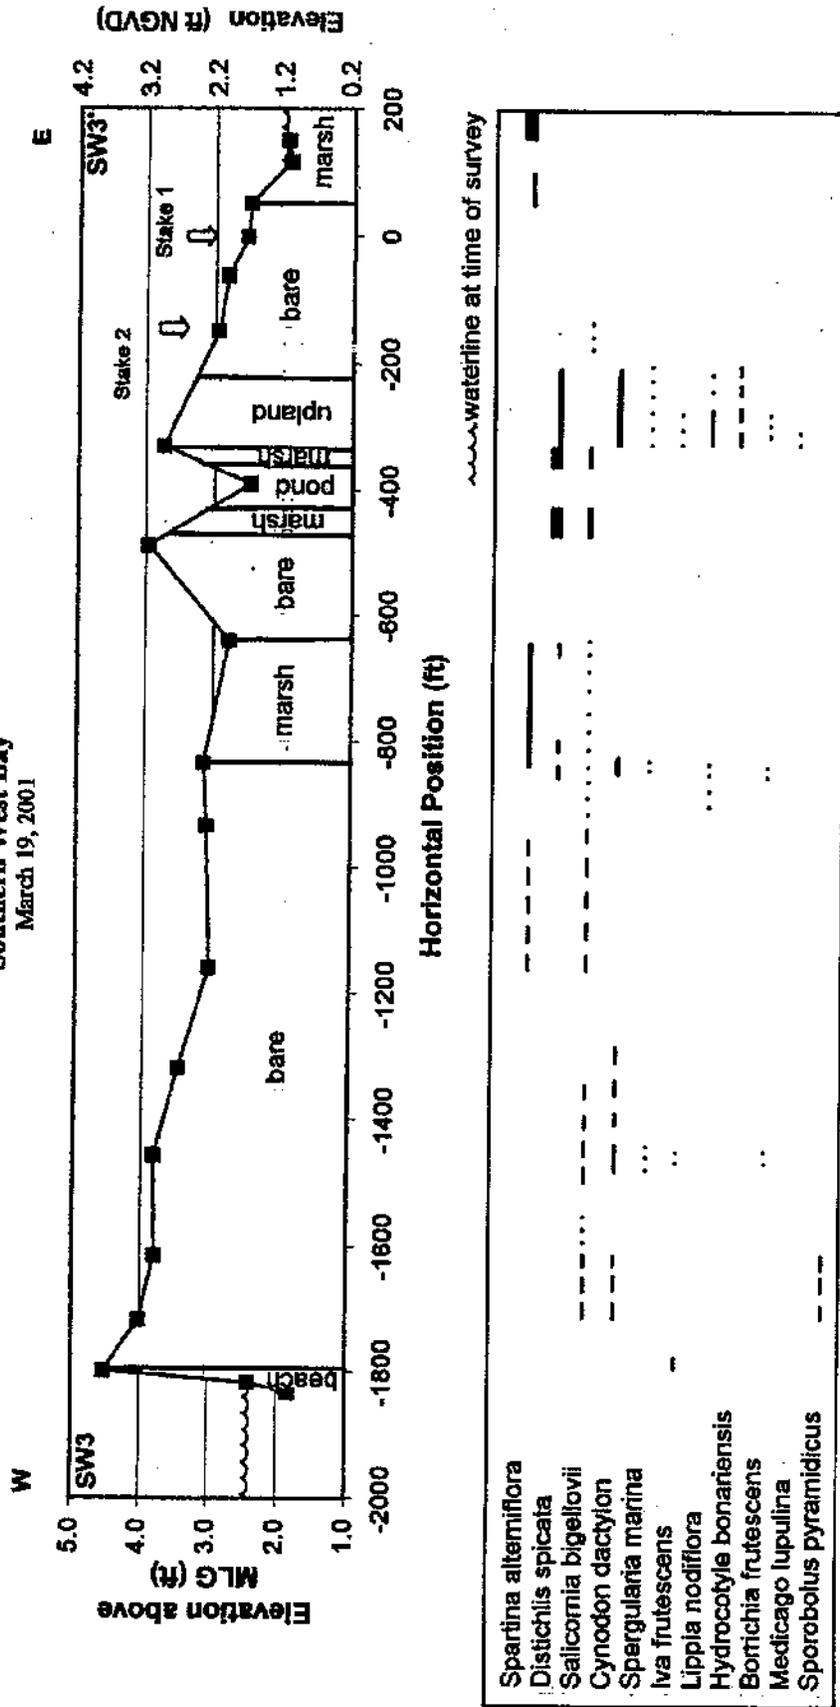
Figure 27. Elevation profile SW3 - Southern West Bay of the Southwest Pass BUMP study site with vegetation data illustrated. This site received dredged material in FY96 and FY97 and was only sparsely vegetated.

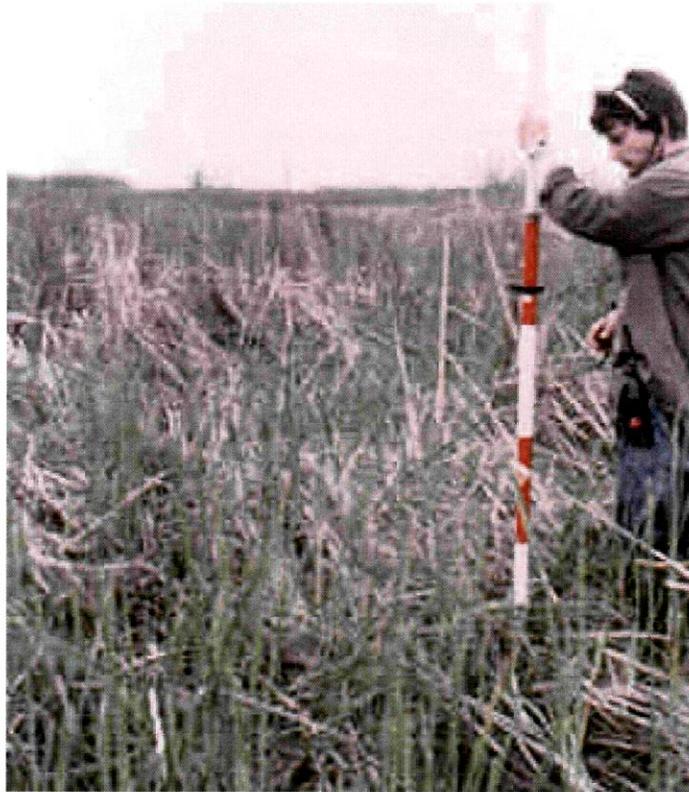
Figure 29. Photograph taken March 19, 2001 of transect SW4 - East Bay at the Southwest Pass BUMP study site. This view is of the well-established mixed marsh on the southern side of the south lobe.

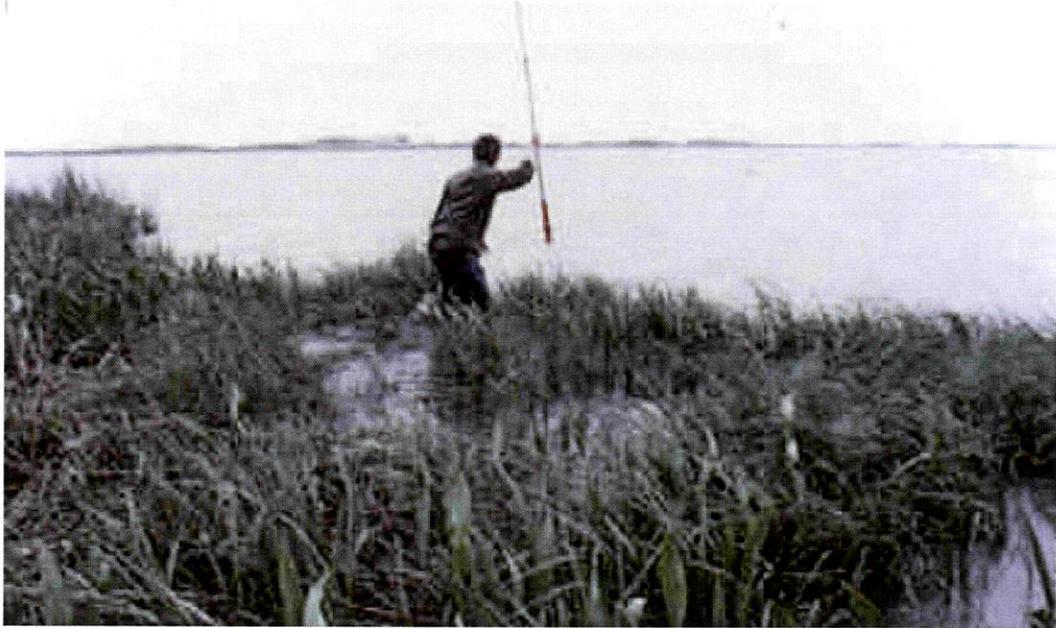
Figure 31. Photograph taken on March 19, 2001 along transect SW4 - East Bay at the Southwest Pass BUMP study site, showing the mixed *Spartina* and *Sagittaria* marsh along the south shore of the north lobe. The south lobe is visible in the distance.

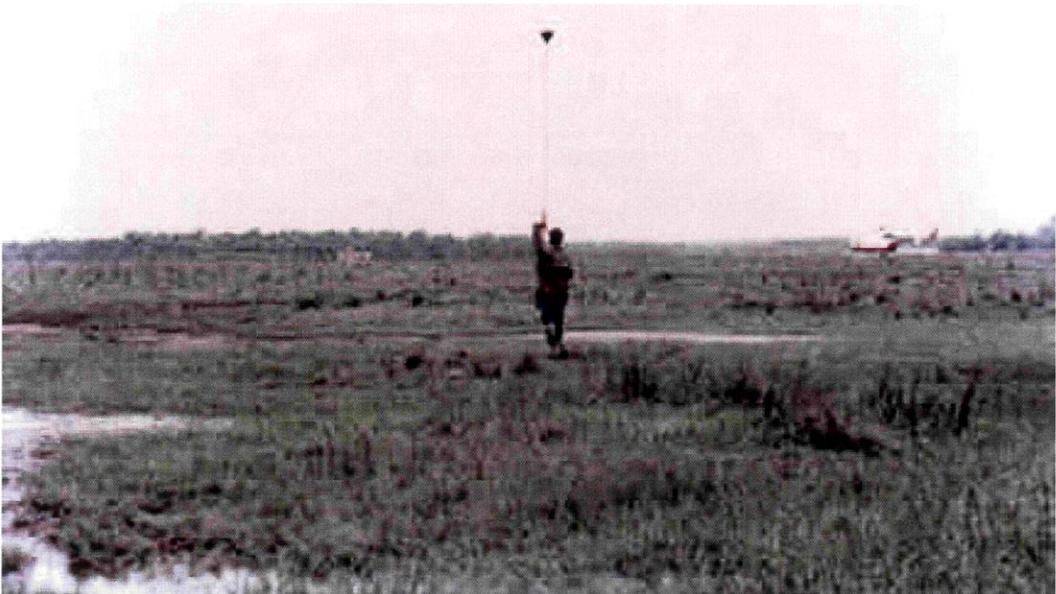
Figure 32. Photograph taken on March 19, 2001 along transect SW4 - East Bay at the Southwest Pass BUMP study site. This view is of fresh marsh approaching the instrument and other stake on the northern lobe of the transect.

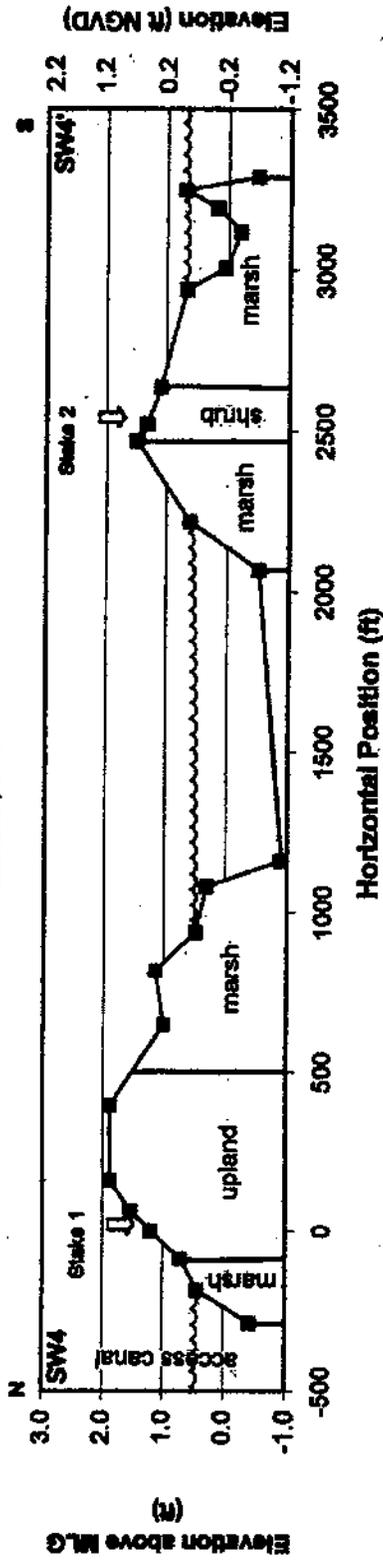
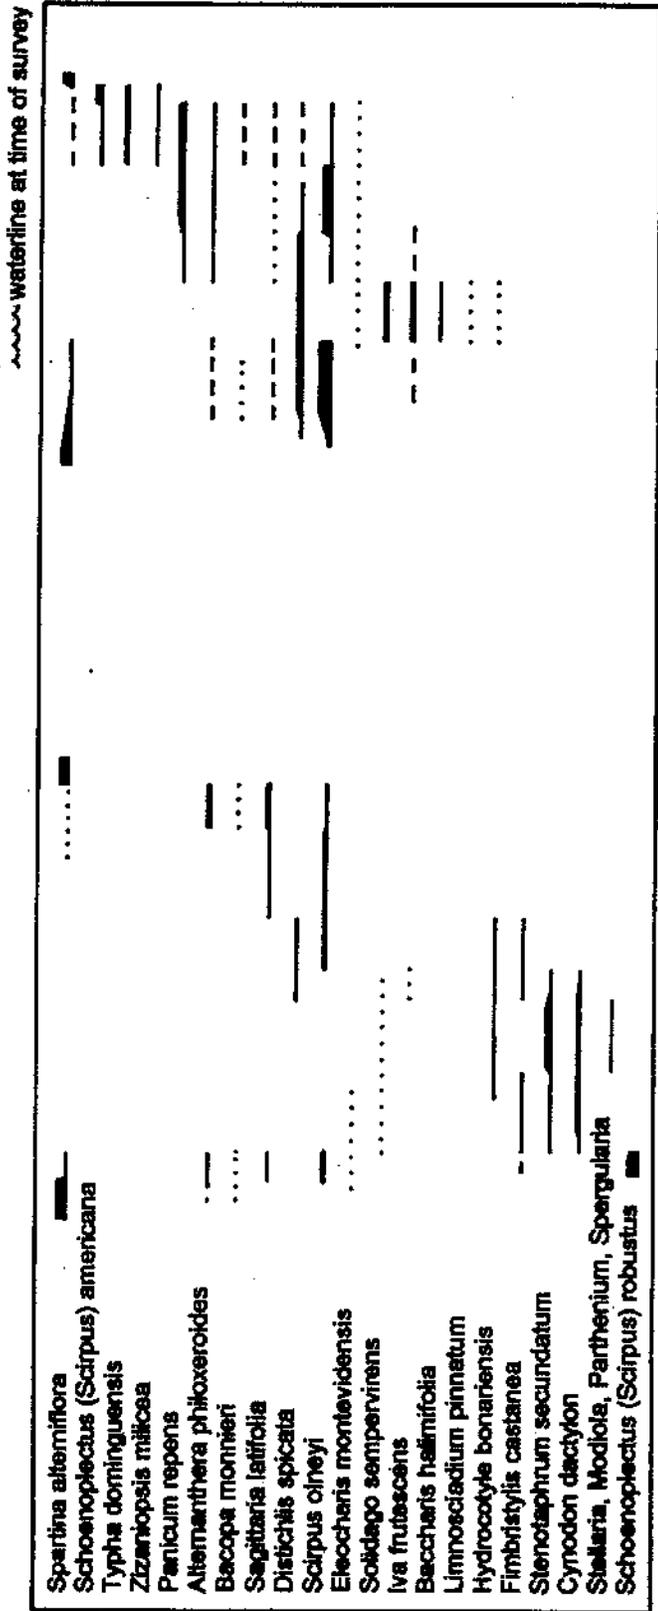
Figure 33. Elevation profile SW4 - East Bay of the Southwest Pass BUMP study site with vegetation data illustrated.

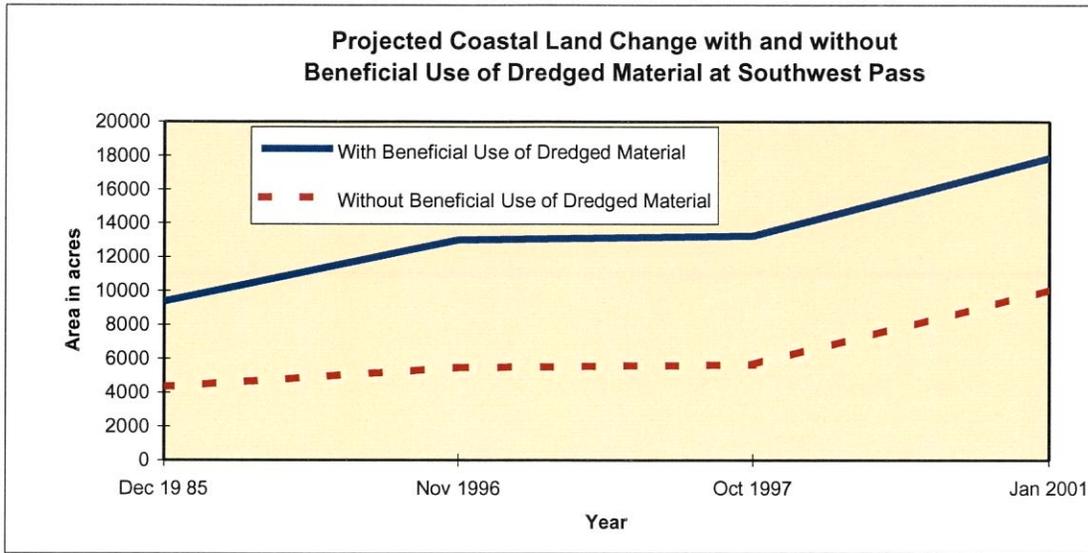
Figure 34. Graph of the area of the Mississippi River - Southwest Pass BUMP study area over time, showing the contribution of the beneficial use of dredged material.

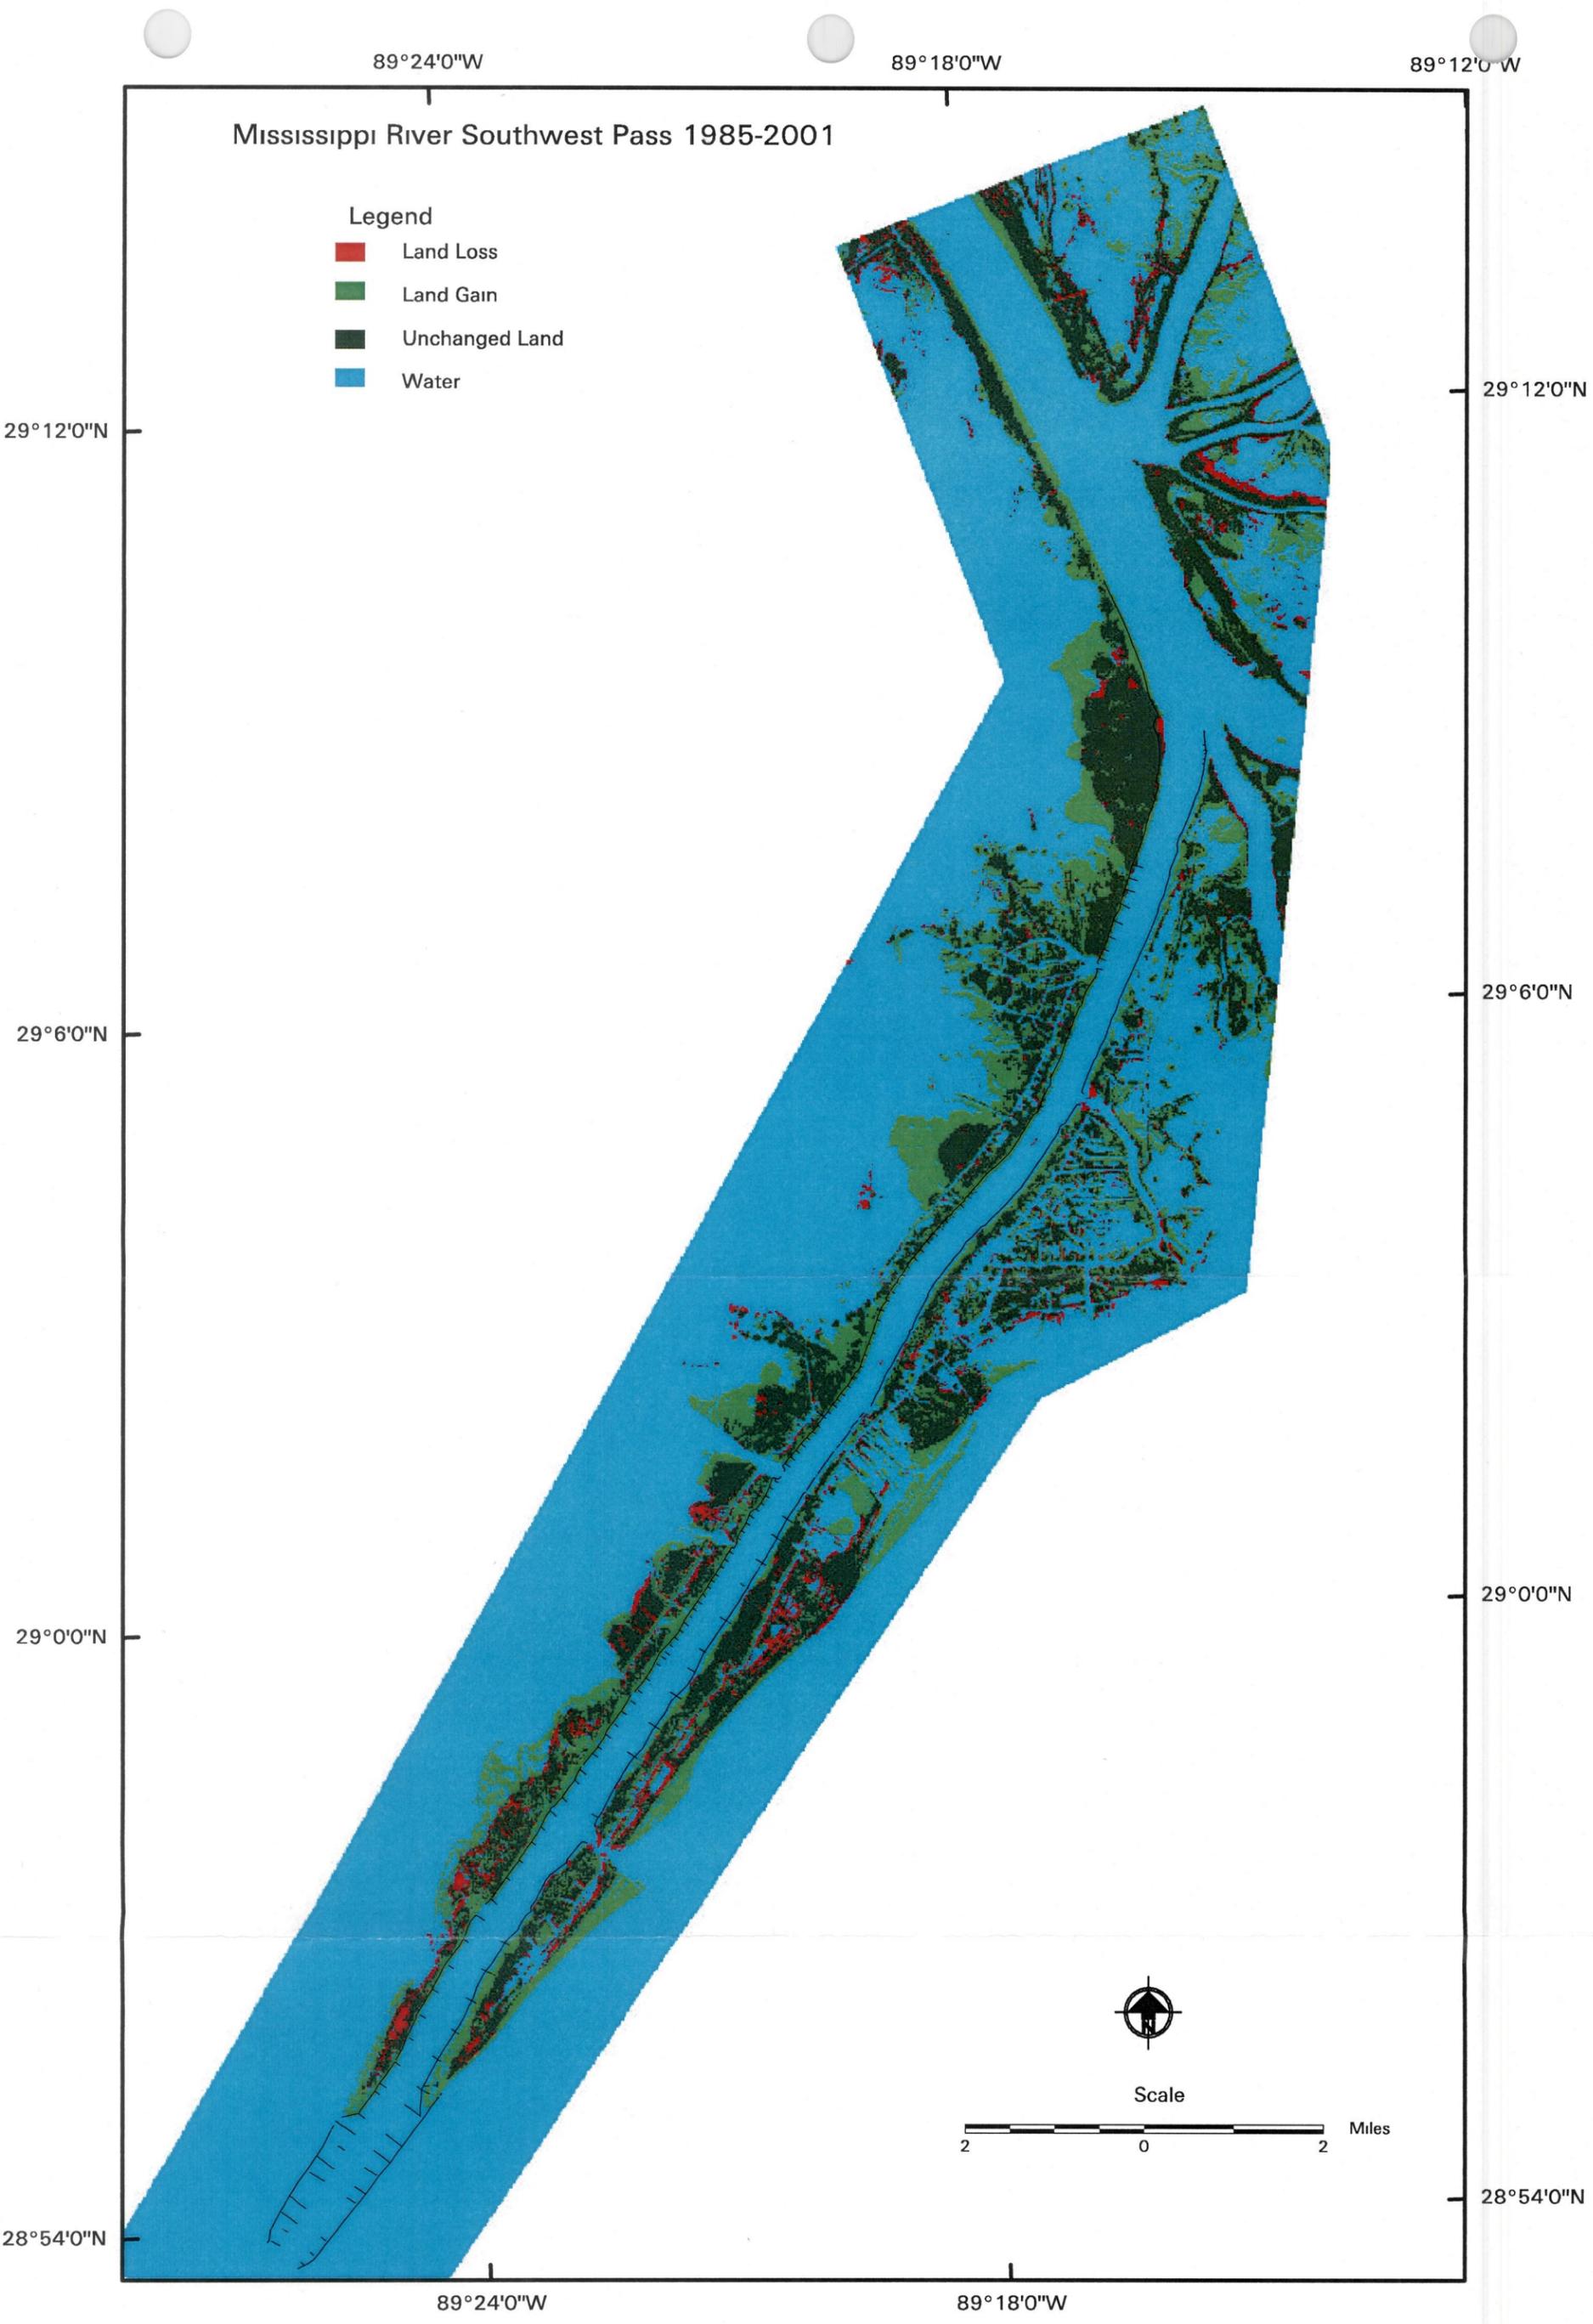
Figure 35 Shoreline changes of the Mississippi River- Southwest Pass BUMP study area between December 1985 and January 2001

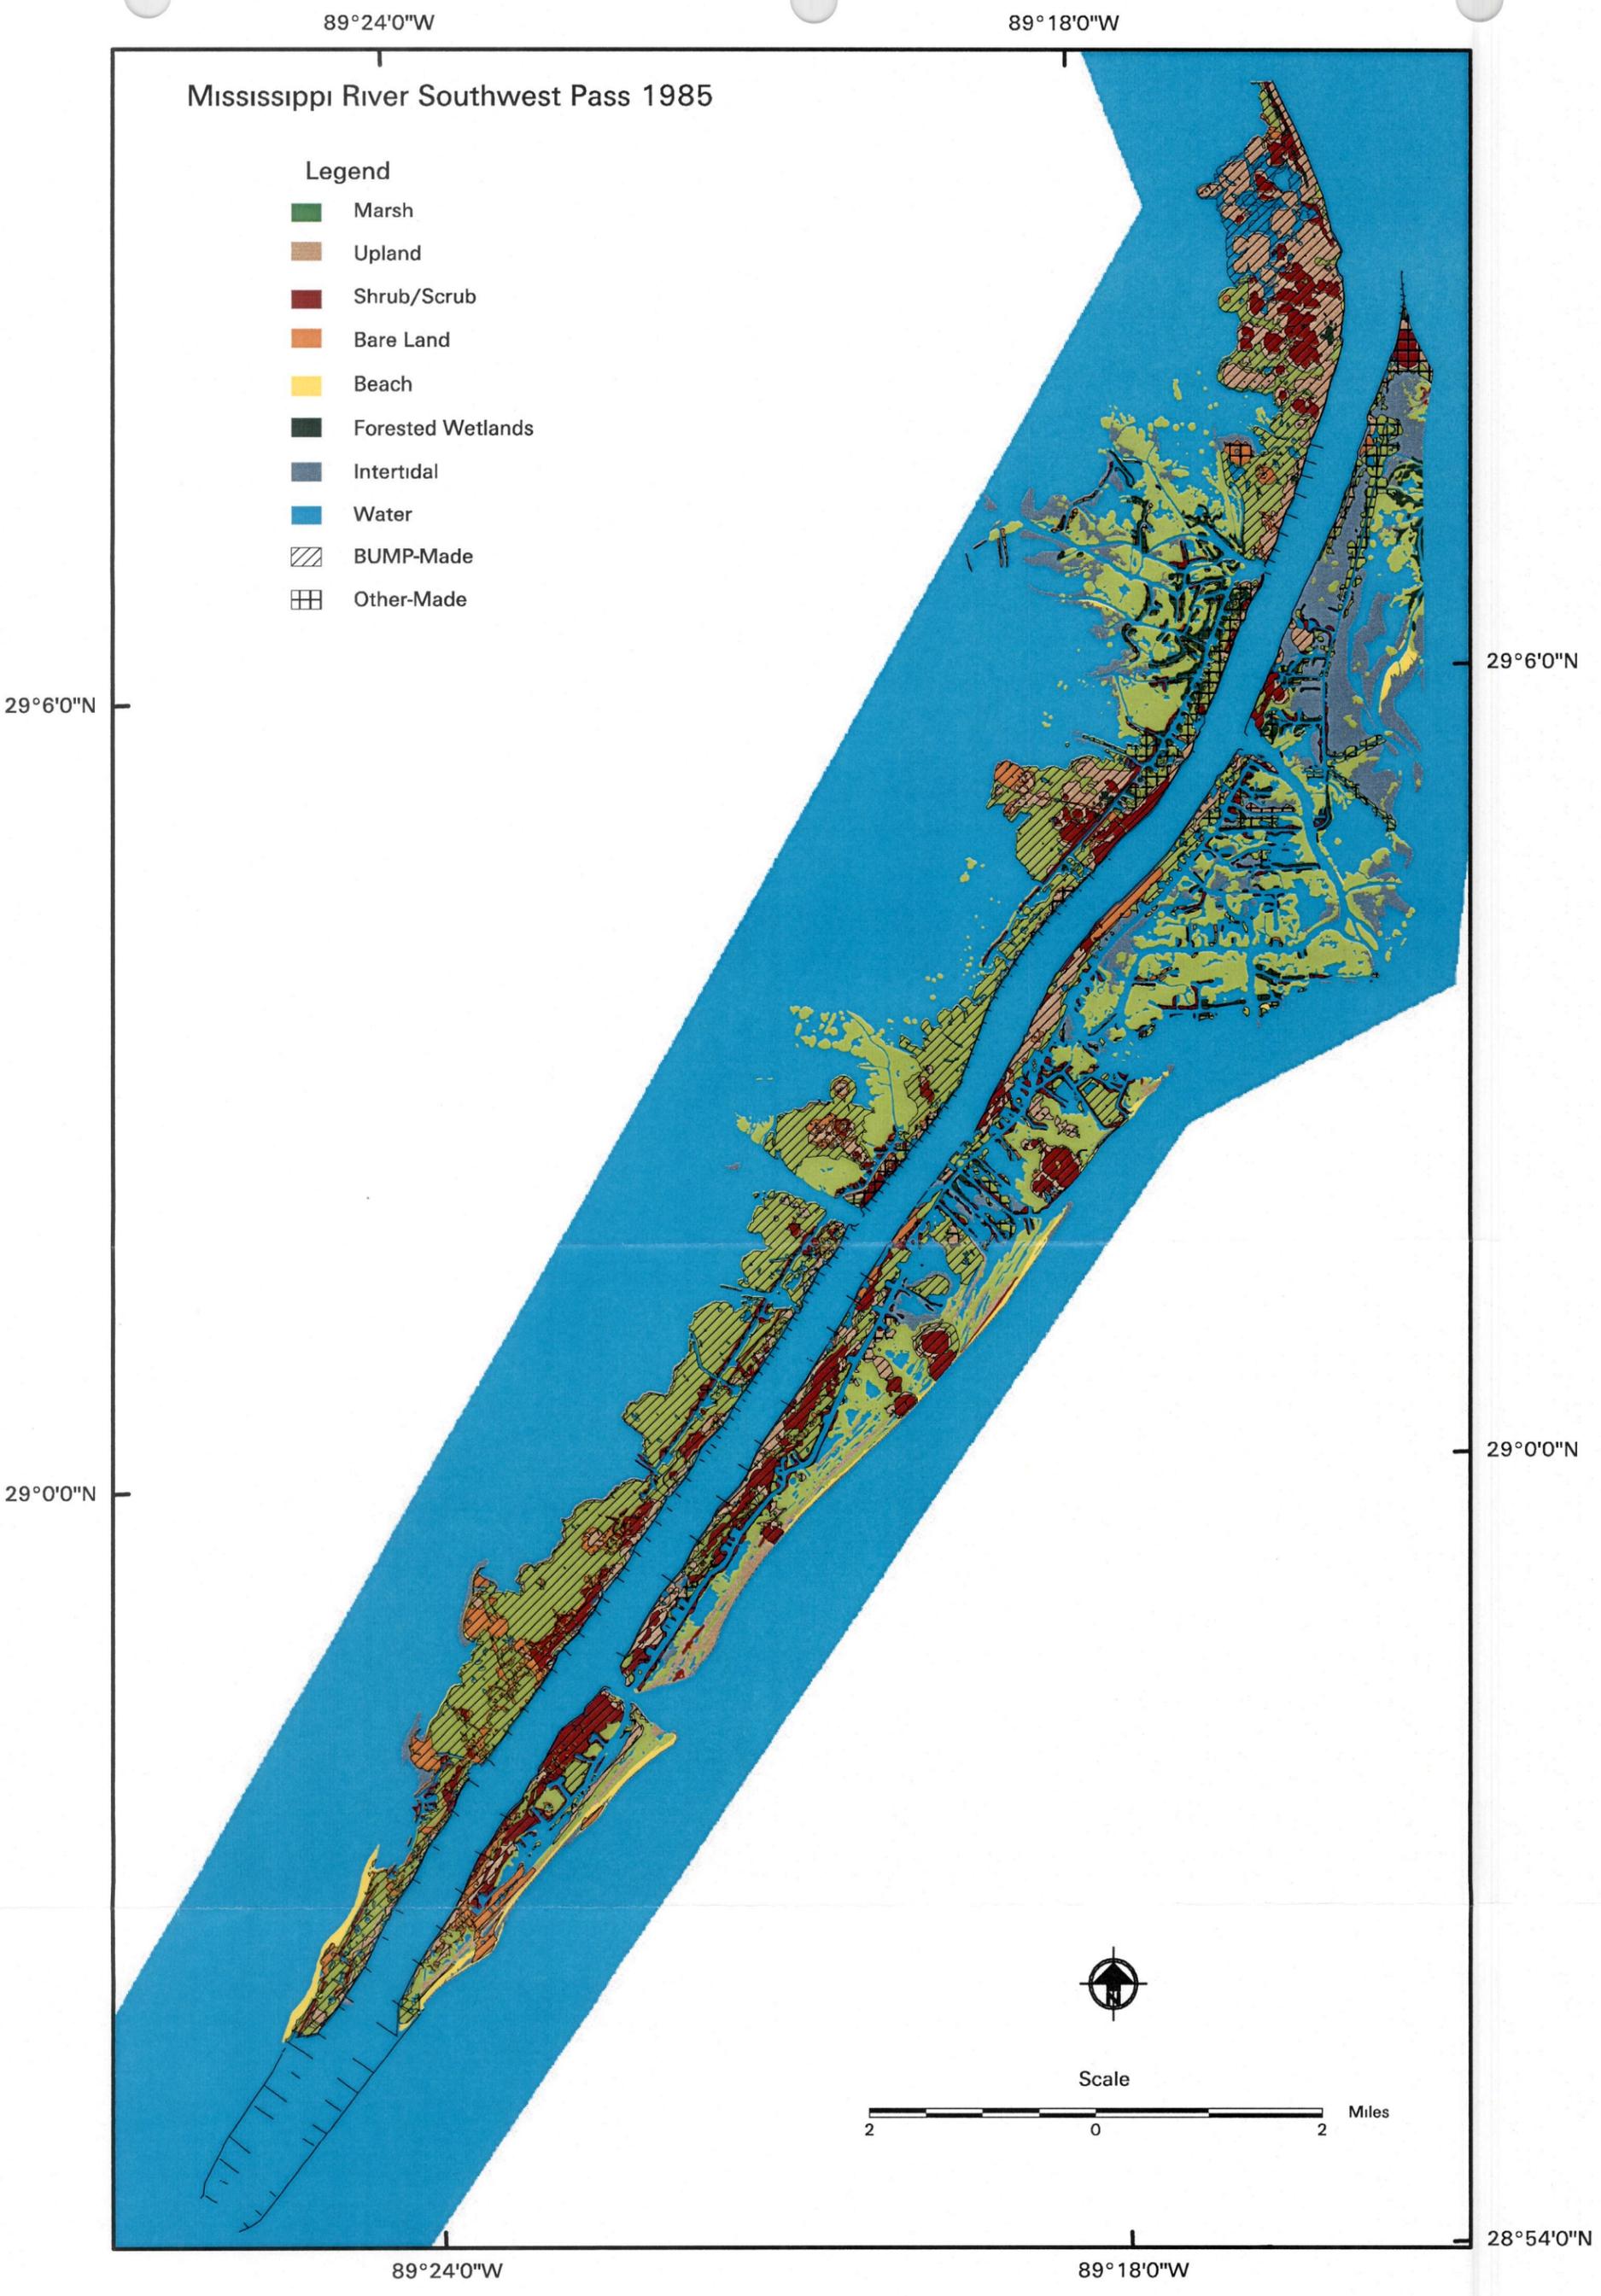
Table 2 lists the areas of the six habitat types found in the Mississippi River - Southwest Pass BUMP study area in December 1985. The location and arrangement of these habitats is presented in figure 36. The total area of the Southwest Pass study site was 9,389.5 acres. Of this total, 3,327.5 acres were natural and 6,062.0 acres were man-made including 5,060.7 acres of BUMP-made and 1,001.3 acres of other-made. Habitats within the BUMP study site were 35.4 percent natural, 53.9 percent BUMP-made and 10.7 percent other-made.

In order of decreasing size and importance, the largest habitats found were natural marsh (2,964.2 acres) and BUMP-made marsh (2,049.7 acres), followed by BUMP-made upland (1,636.6 acres), BUMP-made bare land (1,250.5 acres), other-made marsh (417.0 acres), and other-made shrub/scrub (326.6 acres). In terms of habitat totals, marsh (5,430.9 acres or 57.8%) dominated the Mississippi River - Southwest Pass landscape.

Figure 36 Habitat inventory of the Mississippi River- Southwest Pass BUMP study area in December 1985

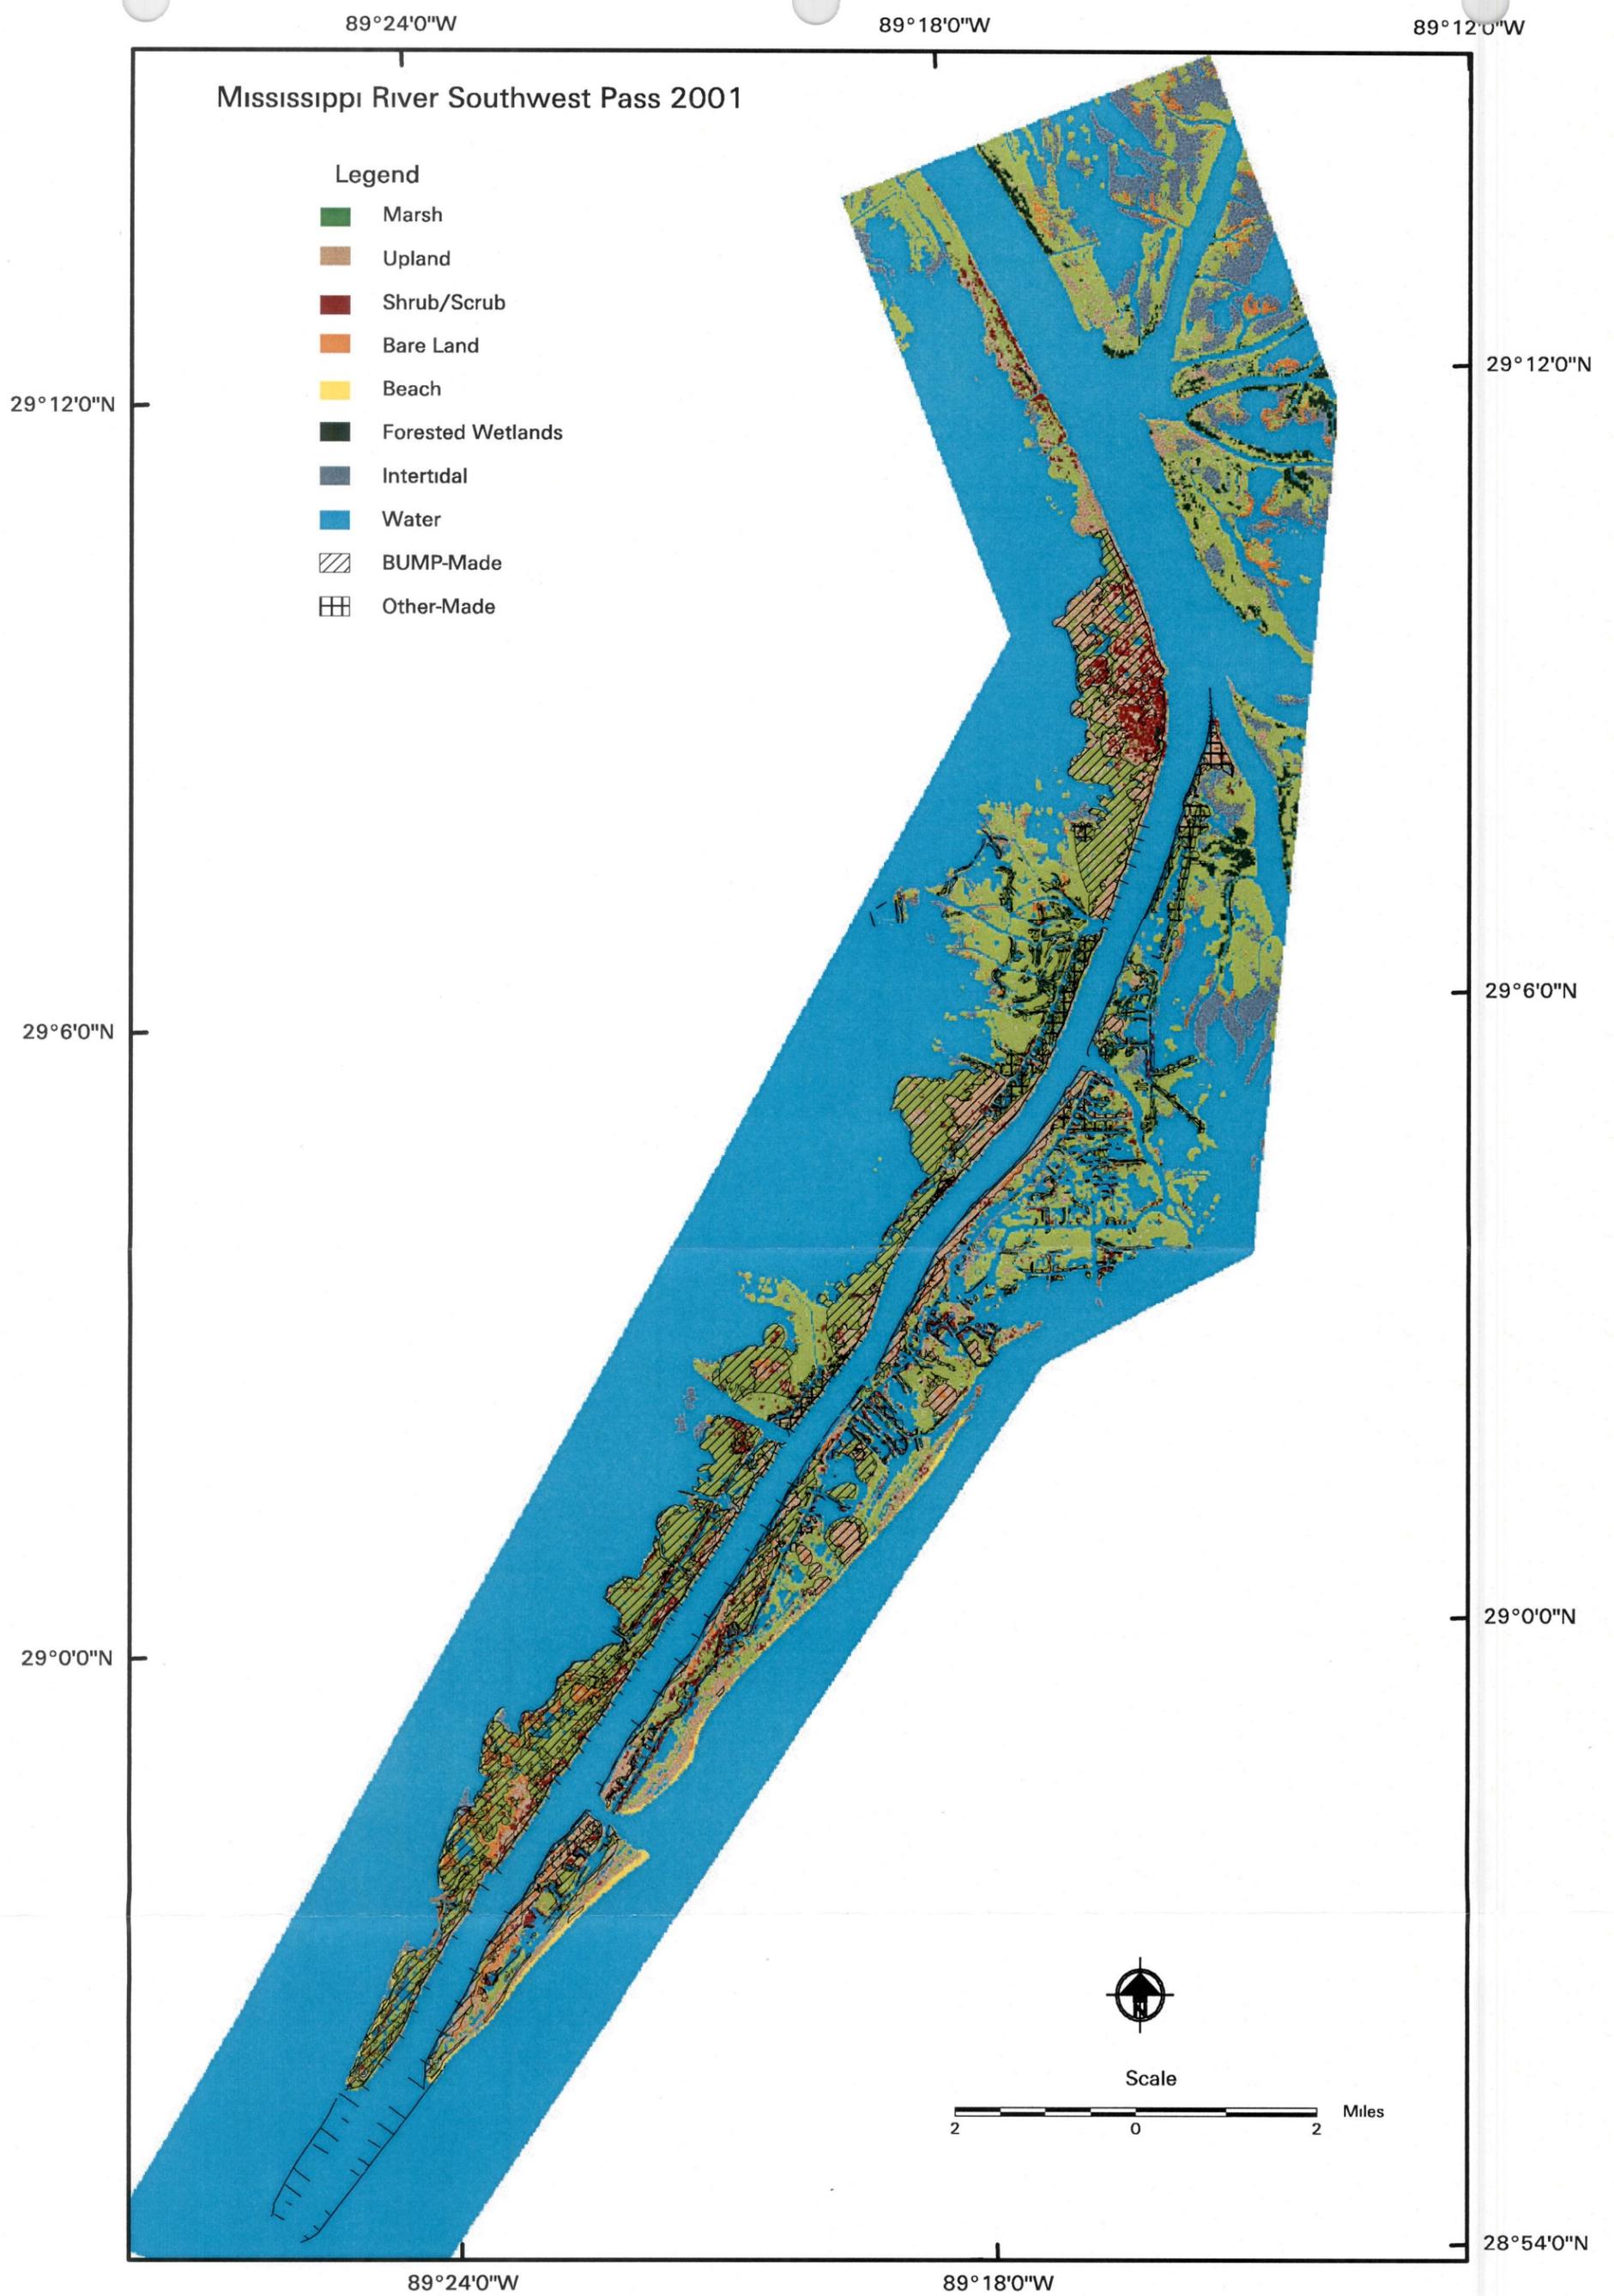
Table 3 lists the areas of the six habitats found in the Mississippi River - Southwest Pass BUMP study area in January 2001. The location and arrangement of these habitats is presented in figure 37. In 2001, the total area of the Mississippi River - Southwest Pass BUMP study area was calculated at 19,967.5 acres. Of this total, 10,680.2 acres were natural and 9,287.3 acres were man-made including 7,771.7 acres BUMP-made and 1,515.6 acres other-made. Habitats were 53.5 percent natural, 38.9 percent BUMP-made and 7.6 percent other-made.

In order of decreasing size and importance, the largest habitats found were natural marsh (7,852.1 acres) followed by BUMP-made marsh (3,691.1 acres), BUMP-made upland (2,793.3 acres), natural upland (1,179.6 acres), and BUMP-made shrub/scrub (735.8 acres).

Figure 37 Habitat inventory of the Mississippi River- Southwest Pass BUMP study area in January 2001

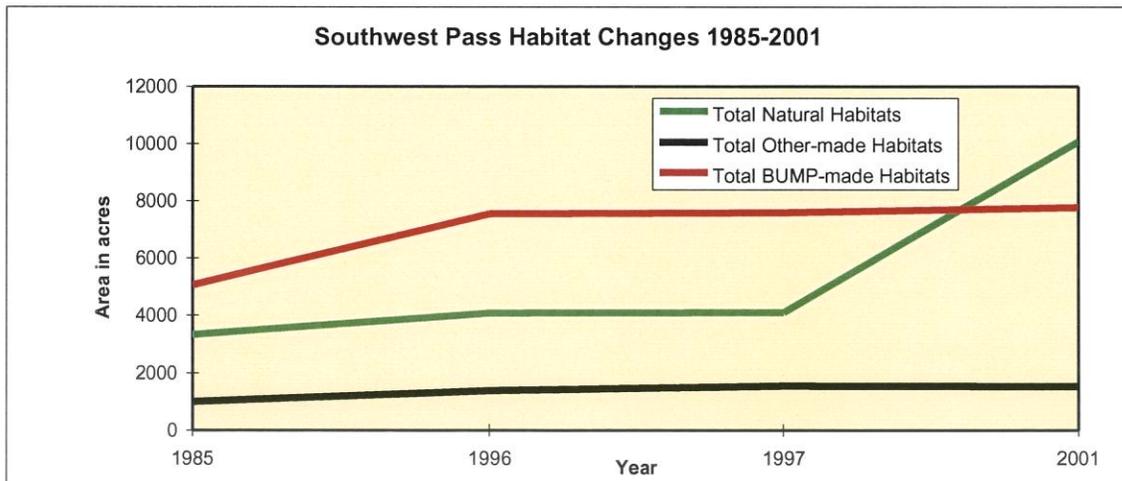
Figure 38. Graph showing the relative change in total area of the major habitat categories: natural, other-made, and BUMP-made, between 1985 and 2001.

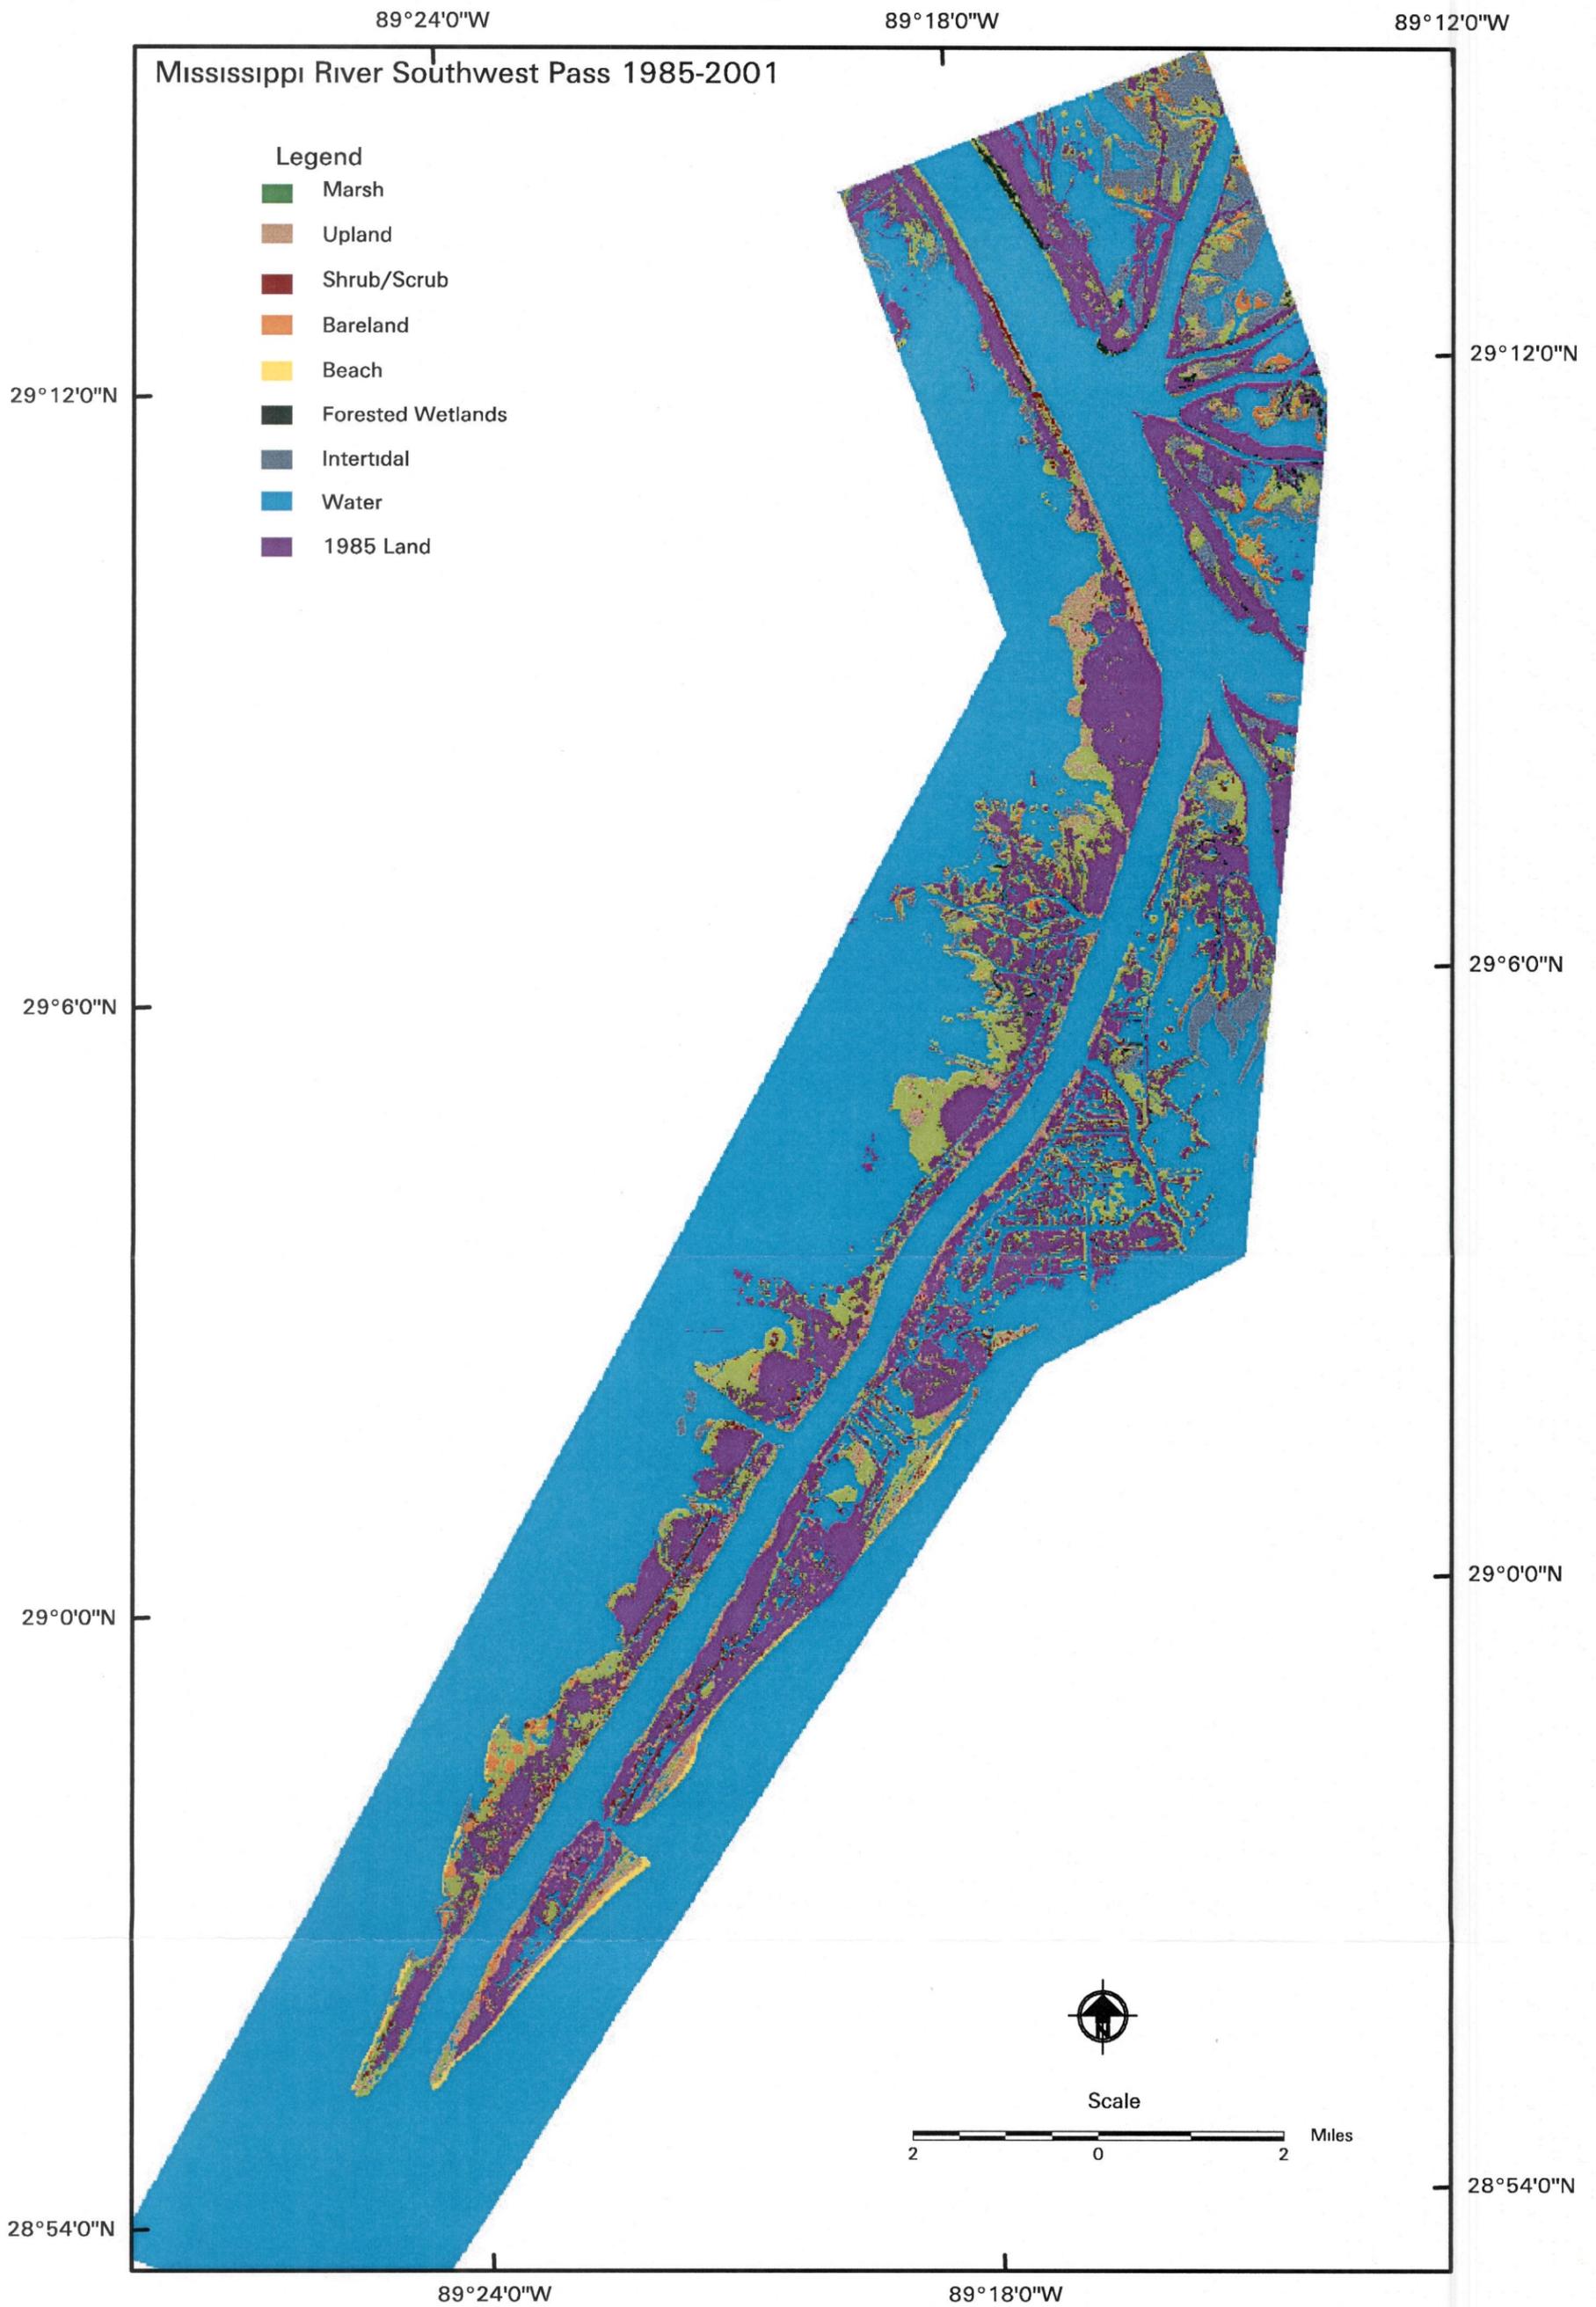
Figure 39 New habitats of the Mississippi River- Southwest Pass BUMP study area between December 1985 and January 2001
