**BENEFICIAL USE OF DREDGED MATERIAL
MONITORING PROGRAM
2001 ANNUAL REPORT
(Base year through FY2000)**

Results of Monitoring the Beneficial Use of Dredged Material at the
Mississippi River, Baton Rouge to the Gulf of Mexico, Louisiana -
Southwest Pass
Base Year 1985 thru Fiscal Year 2000

U.S. Army Corps of Engineers
New Orleans District

Prepared by:
Coastal Research Laboratory
University of New Orleans
New Orleans, Louisiana

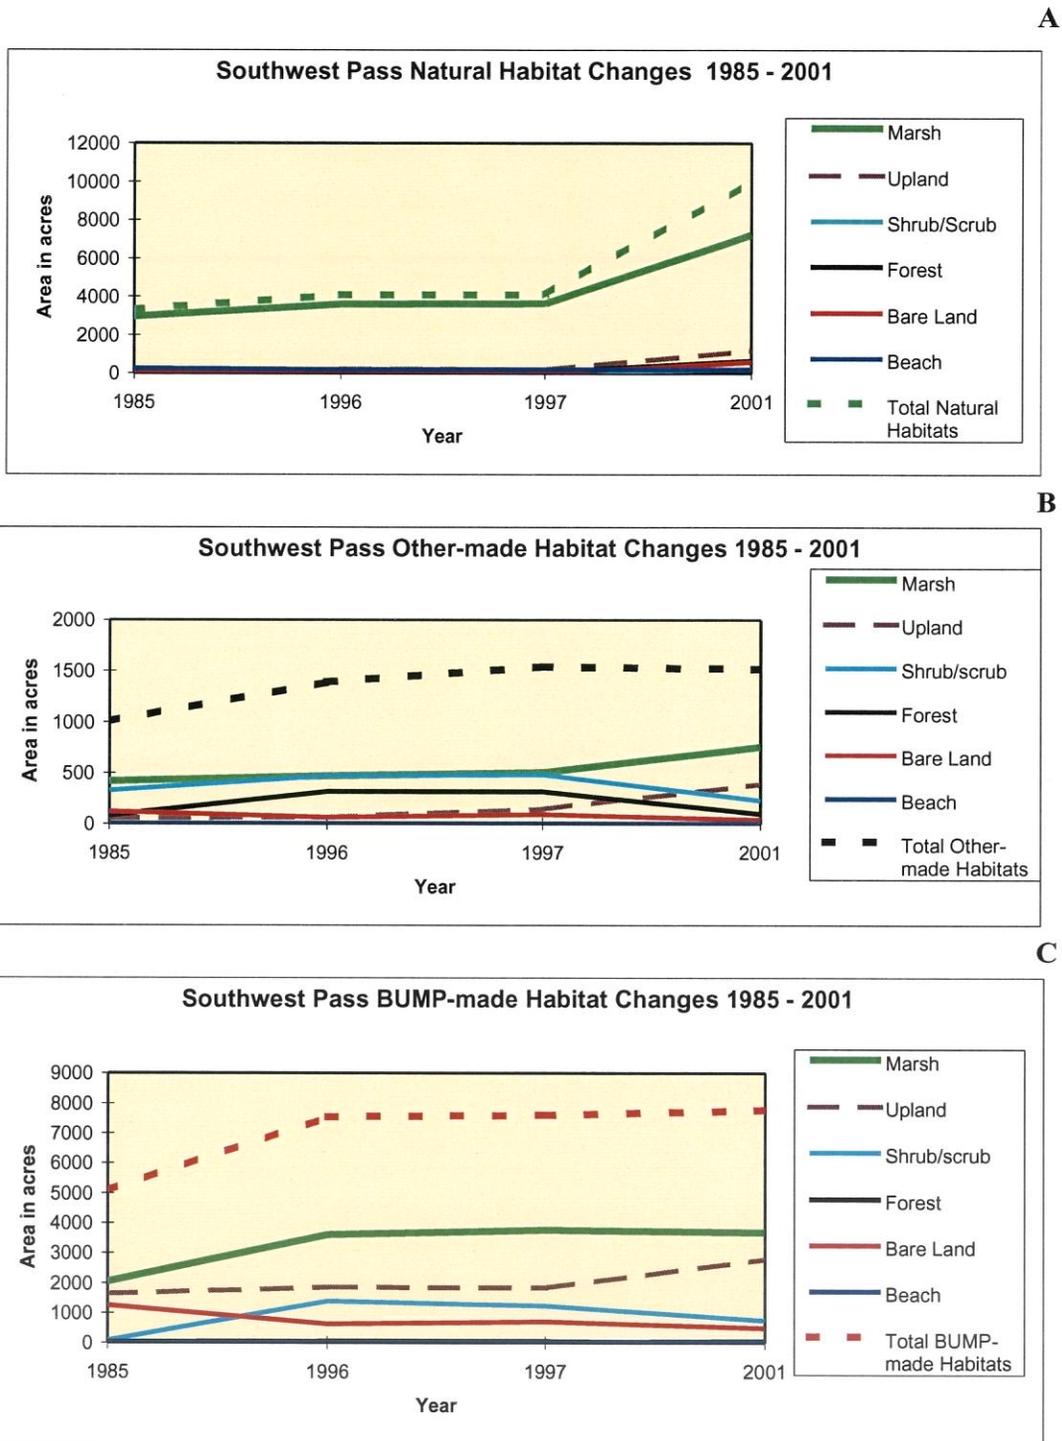
Figure 40. Time series showing the changes in total area of each habitat in the Mississippi River - Southwest Pass BUMP study area between December 1985 and January 2001. A) natural habitat changes. B) Other-made habitat changes. C) BUMP-made habitat changes.

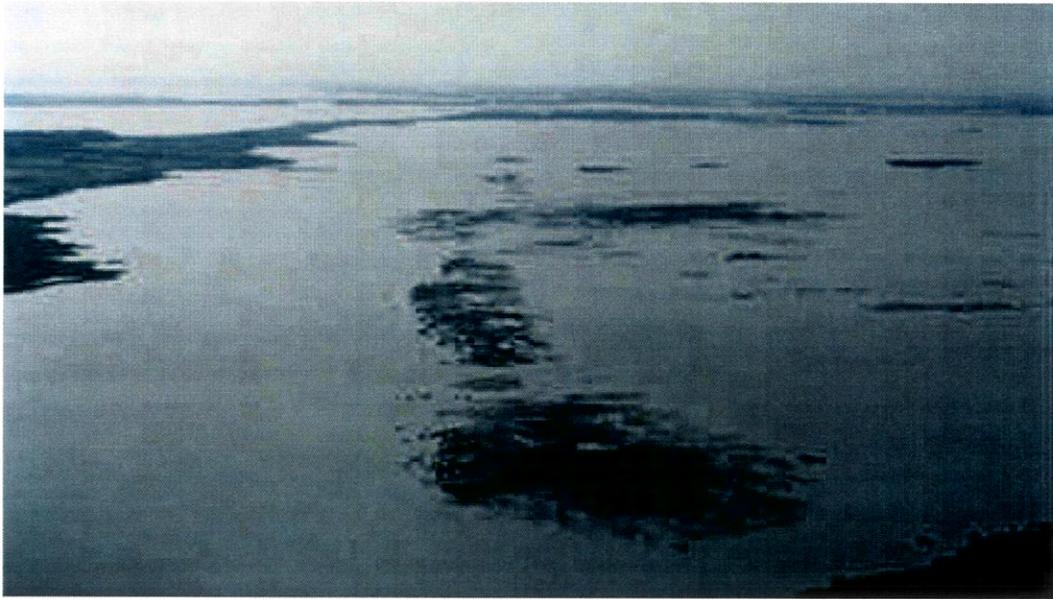
Figure 42. Oblique aerial photography taken on November 19, 1998 of the Pass a Loutre BUMP study site showing the low relief of the newly placed bare land.

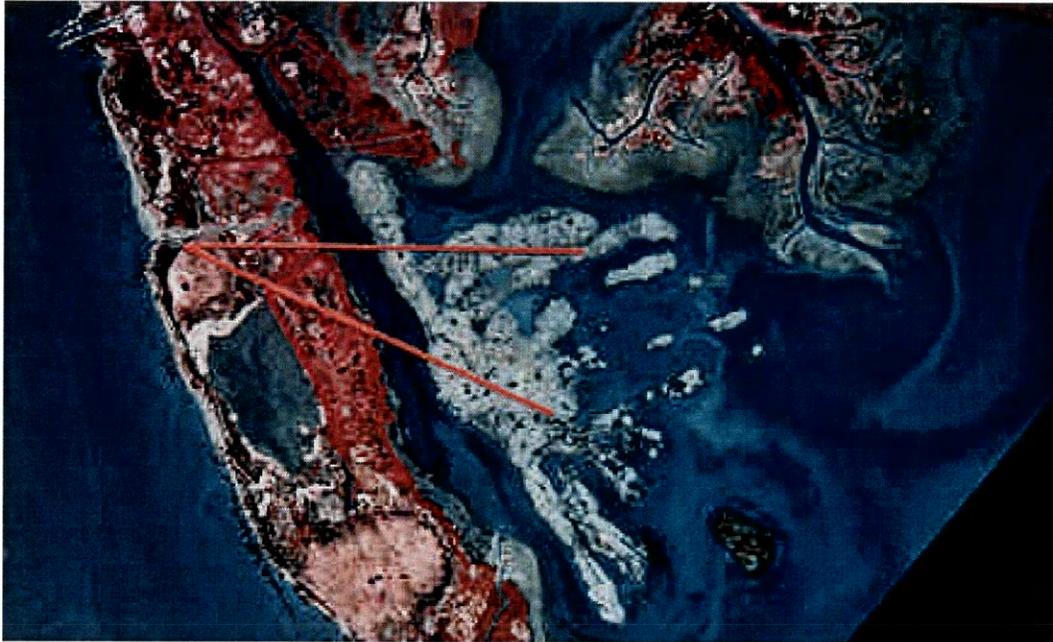
Figure 43. Vertical aerial photography taken on January 11, 1999 of the Pass a Loutre BUMP study site. The approximate locations of the transects are represented by the orange lines.

The profiles were established in 1999 with one metal pole (stake) partially buried and anchored with concrete, and extending 2-3 feet from the sediment surface. The two transects converged at the site of the survey instrument which was placed on a navigation marker platform near the Mississippi River navigational channel at mile 1.4 AHP, just south-east of Pilottown (Figure 43). The platform provided the best vantage-point for surveying the area (Figure 44). The area along the navigational channel has been used for disposal during maintenance dredging for many years prior to 1985. The last disposal within the Pass a Loutre disposal area was in FY98 (Figure 6).

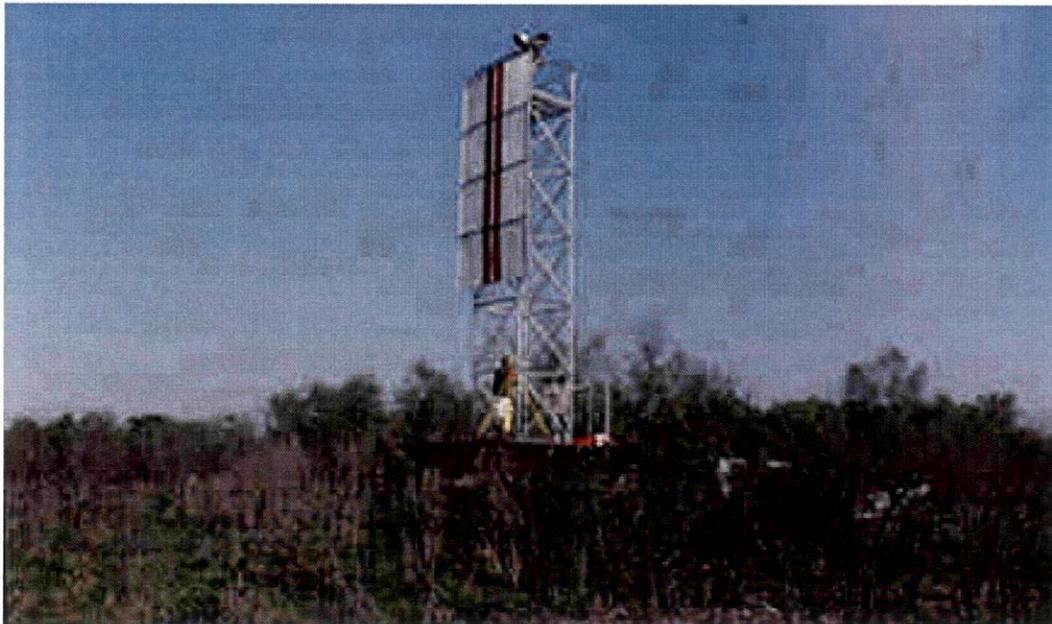
Figure 44. Photograph taken on April 6, 2001 along transect A-A' at the Pass a Loutre BUMP study site, showing the platform within the upland/shrub habitat where the survey instrument was placed.

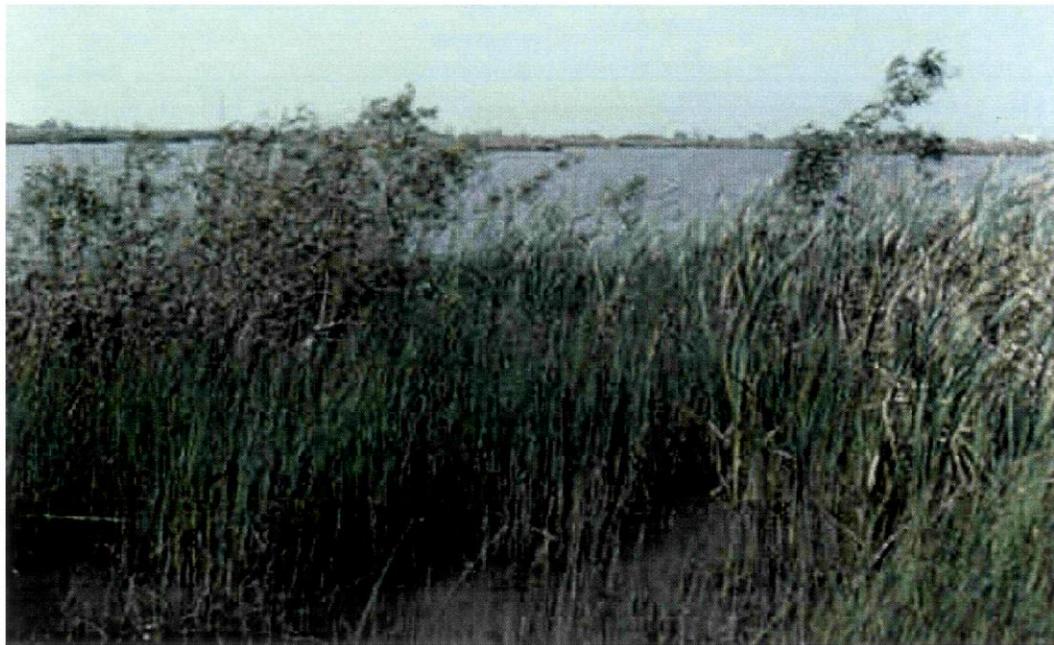
Figure 46. Photograph taken on April 6, 2001 toward the eastern extent of transect A-A' at the Pass a Loutre BUMP study site showing the colonizing fresh marsh of bulrush, cattails and willow trees. The view is along the transect looking west toward the instrument.

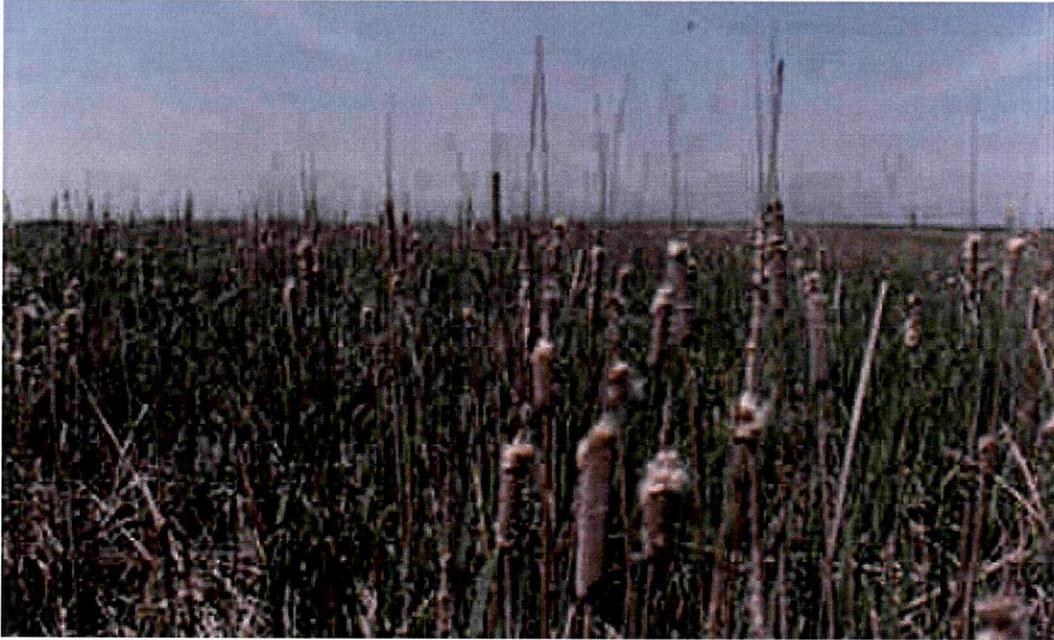
Figure 47. Photograph taken on April 6, 2001 along transect B-B' at the Pass a Loutre BUMP study site, showing fresh marsh of almost solid cattails.

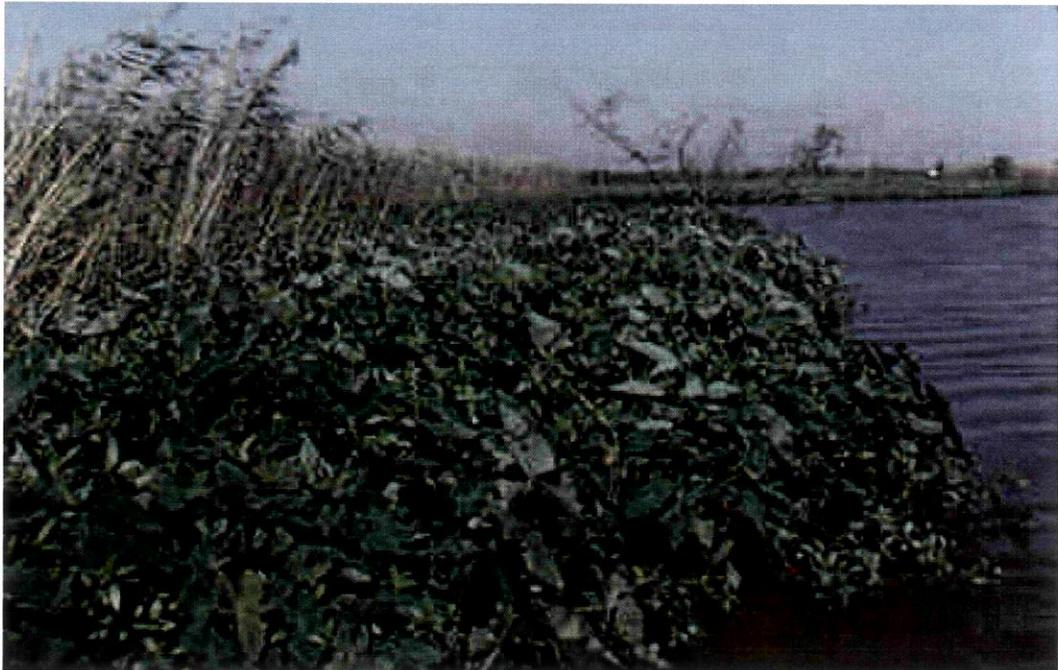
Figure 48. Photograph taken on April 6, 2001 along transect A-A' at the Pass a Loutre BUMP study site, showing the dense fringe of elephant ears that lines the older shoreline. The view is to the north of the transect.

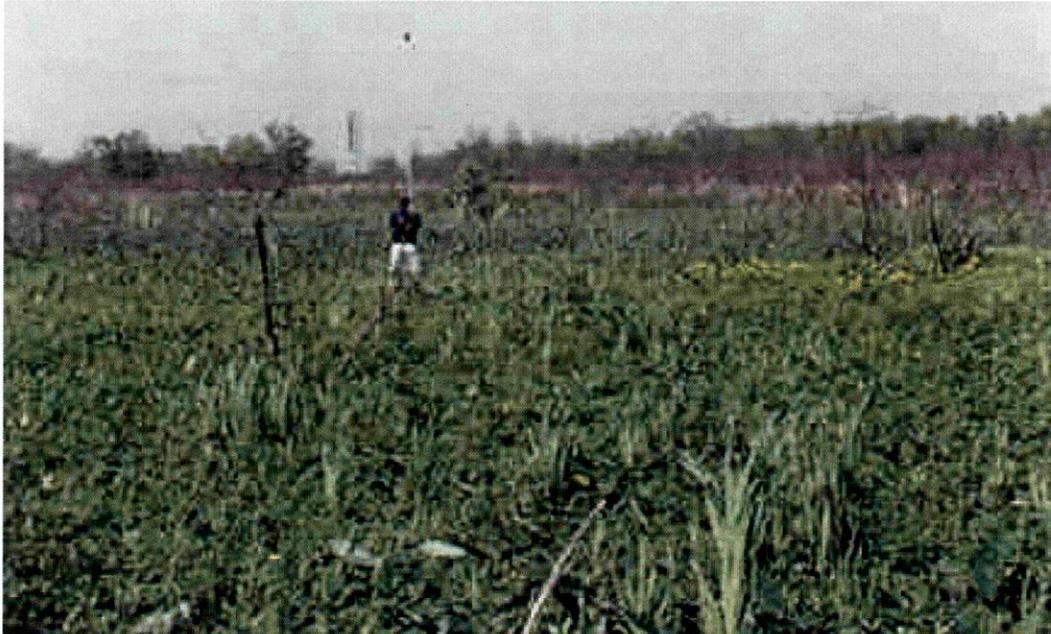
Figure 49. Photograph taken on April 6, 2001 along transect A-A' at the Pass a Loutre BUMP study site, showing the complex fresh marsh covering the older sediment.

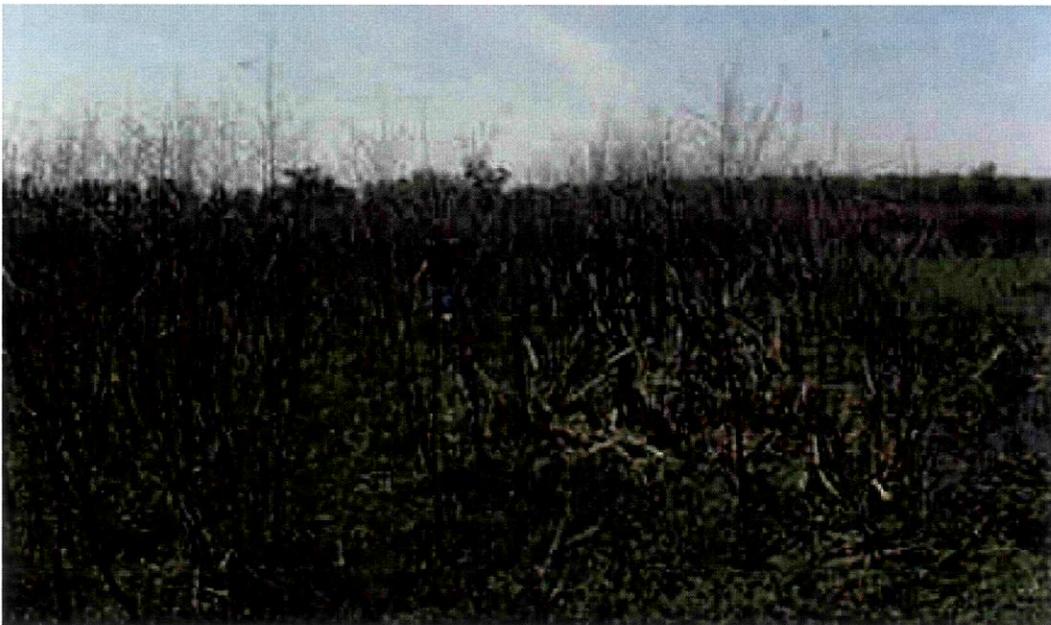
Figure 50. Photograph taken on April 6, 2001 along transect B-B' at the Pass a Loutre BUMP study site, showing the rattlebox canopy over upland grass and composites. The view is along the transect approaching the platform and instrument. Willow trees in the background are beyond the end of the transect.

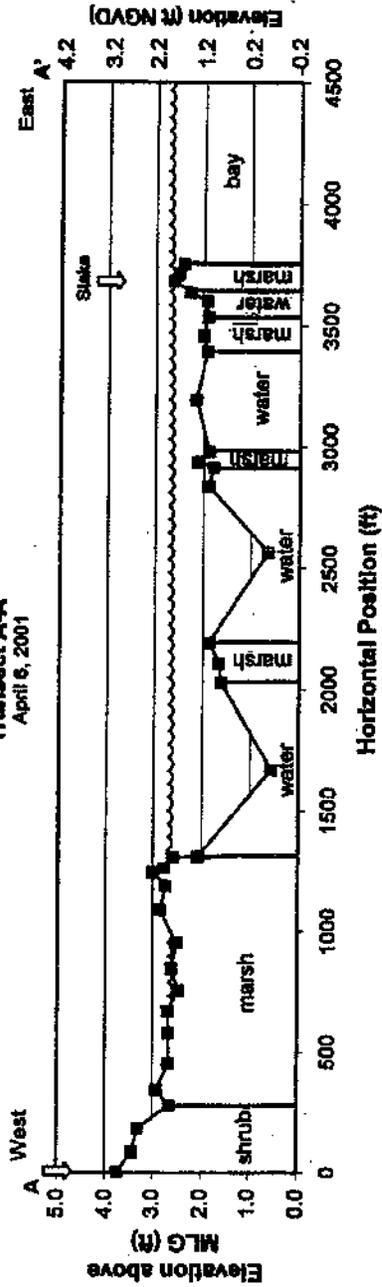
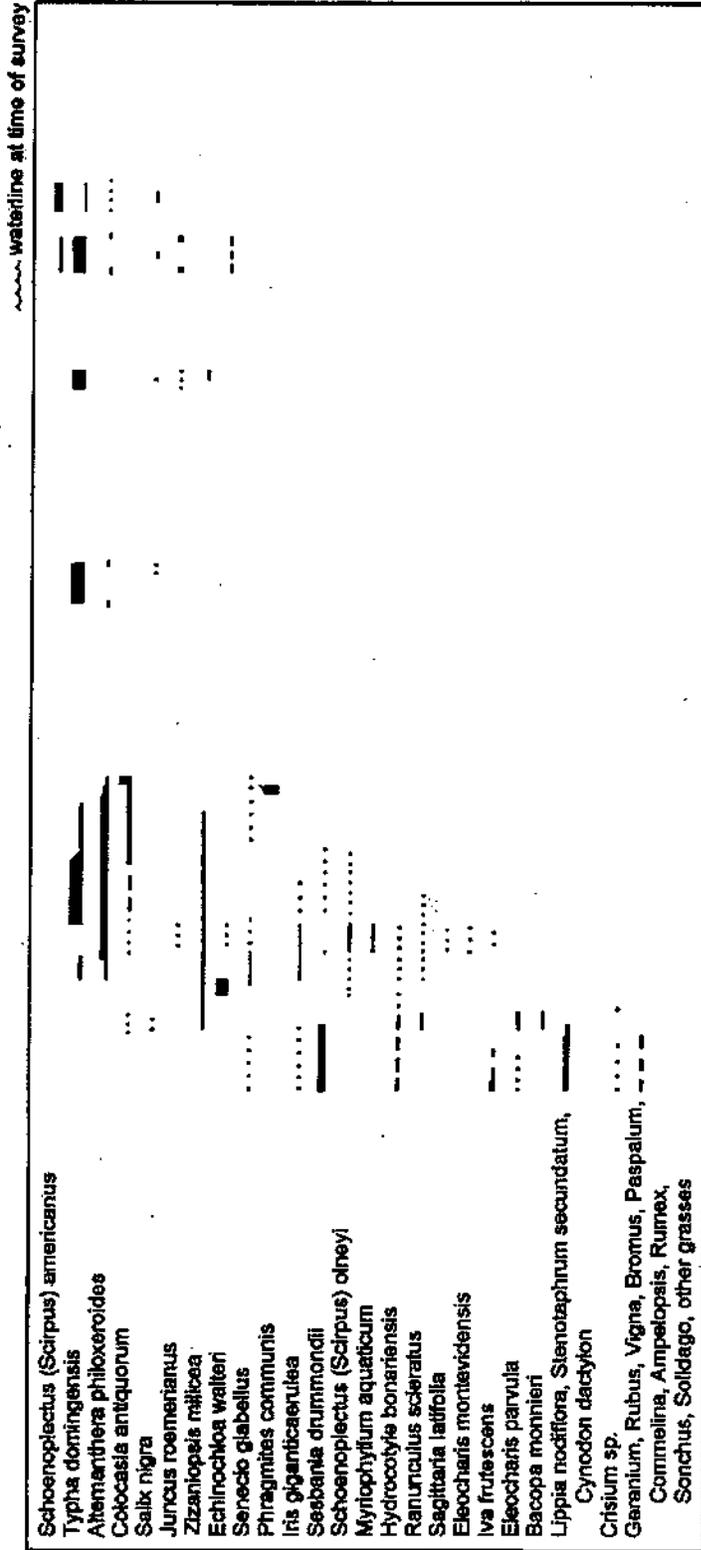
Figure 51. Elevation profile A-A' at the of the Pass a Loure BUMP study site with vegetation data illustrated.

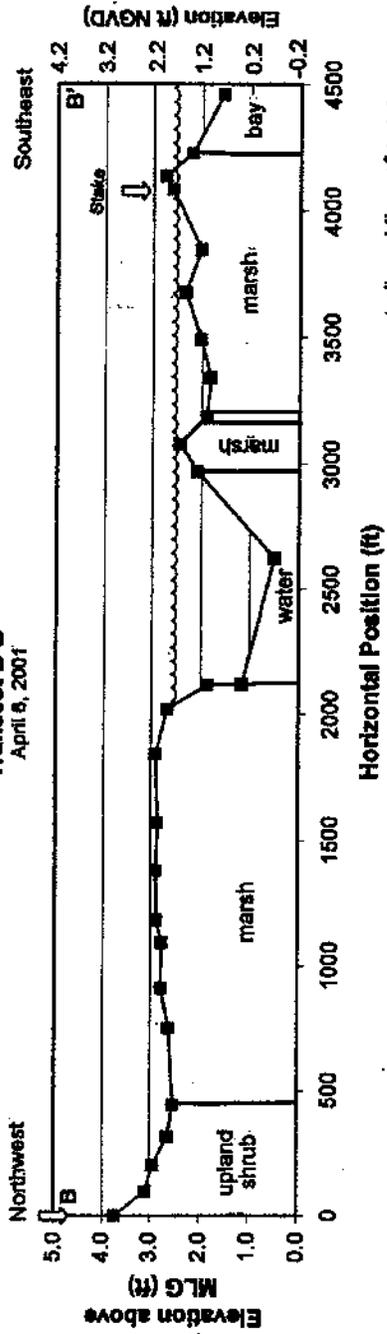
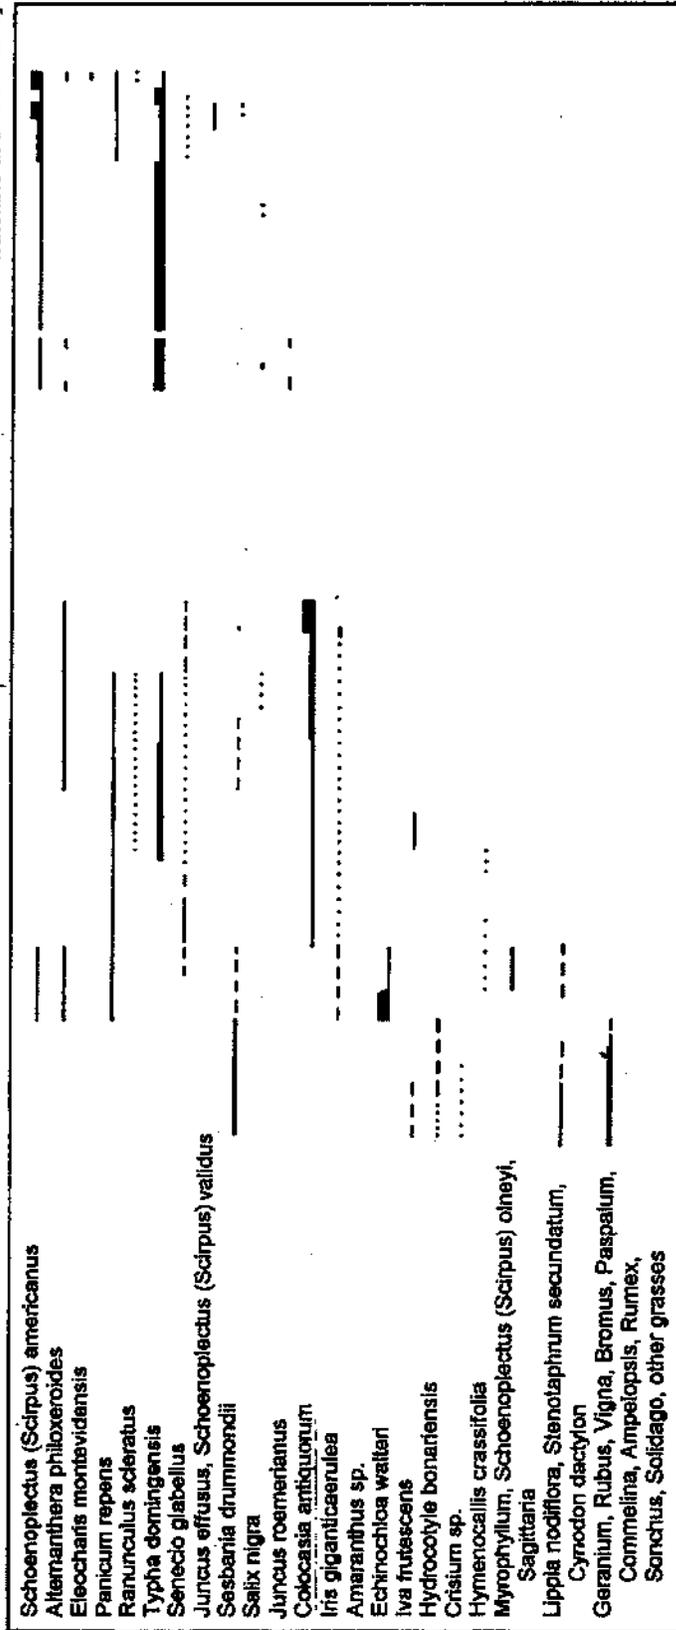
Figure 52. Elevation profile B-B' at the of the Pass a Loutre BUMP study site with vegetation data illustrated.

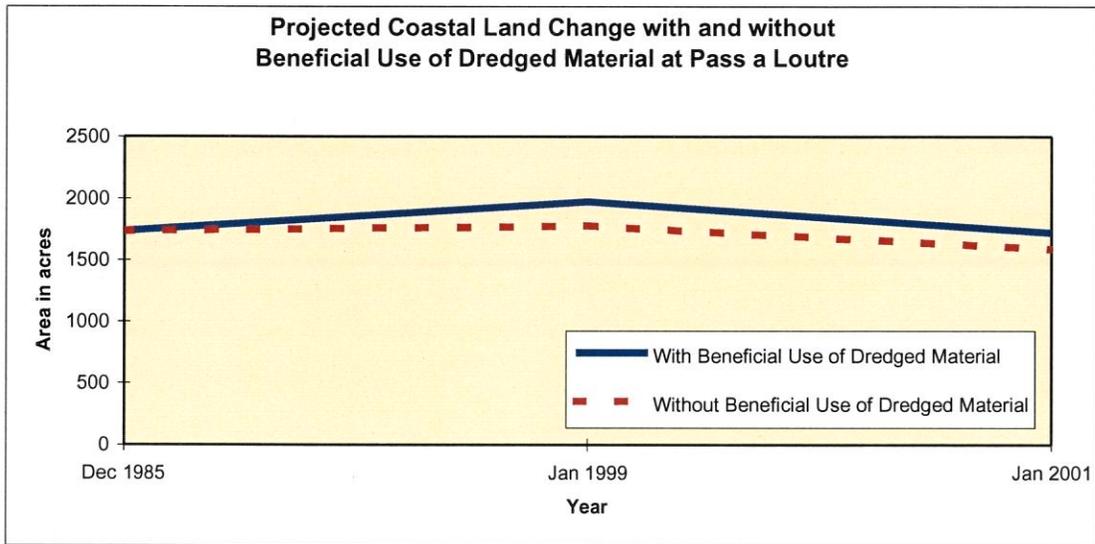
Figure 53. Graph of the area of the Pass a Loutre BUMP study area over time, showing the contribution of the beneficial use of dredged material.

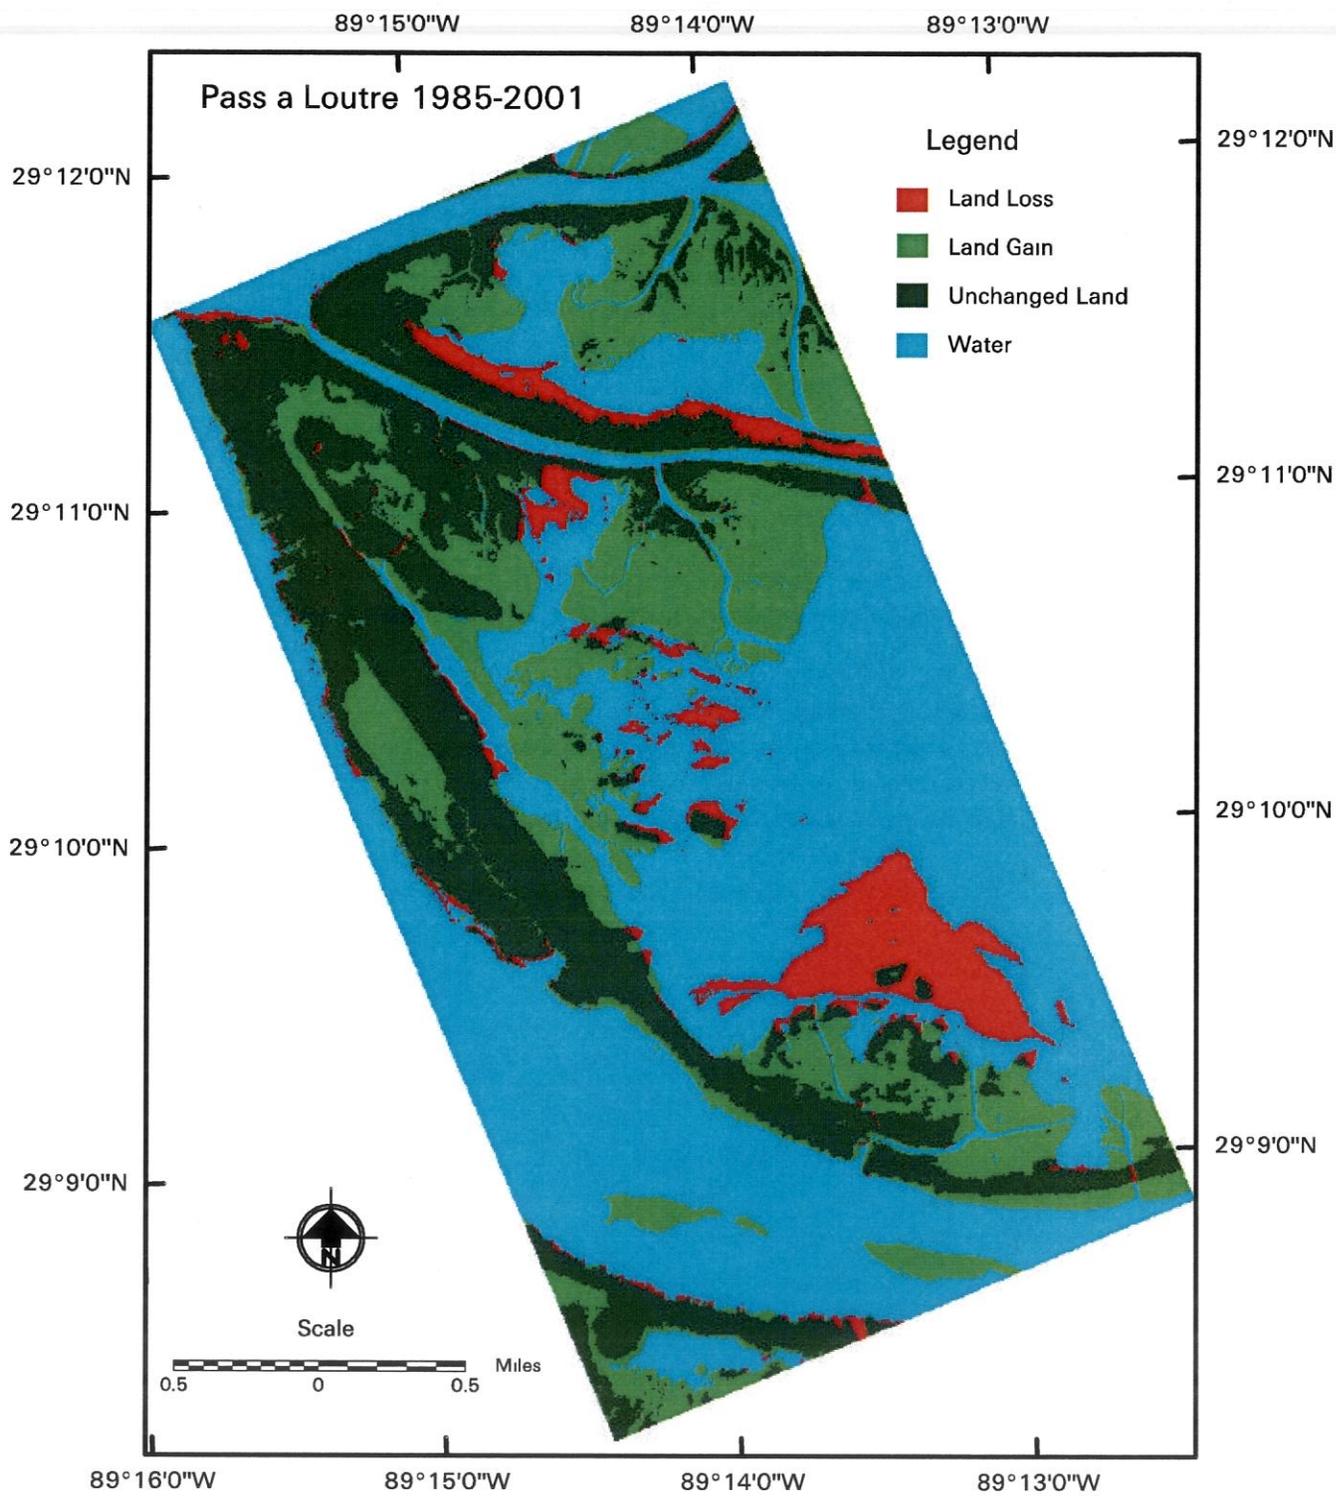
Figure 54 Shoreline Changes of the Pass a Loutre Bump study area between December 1985 and January 2001

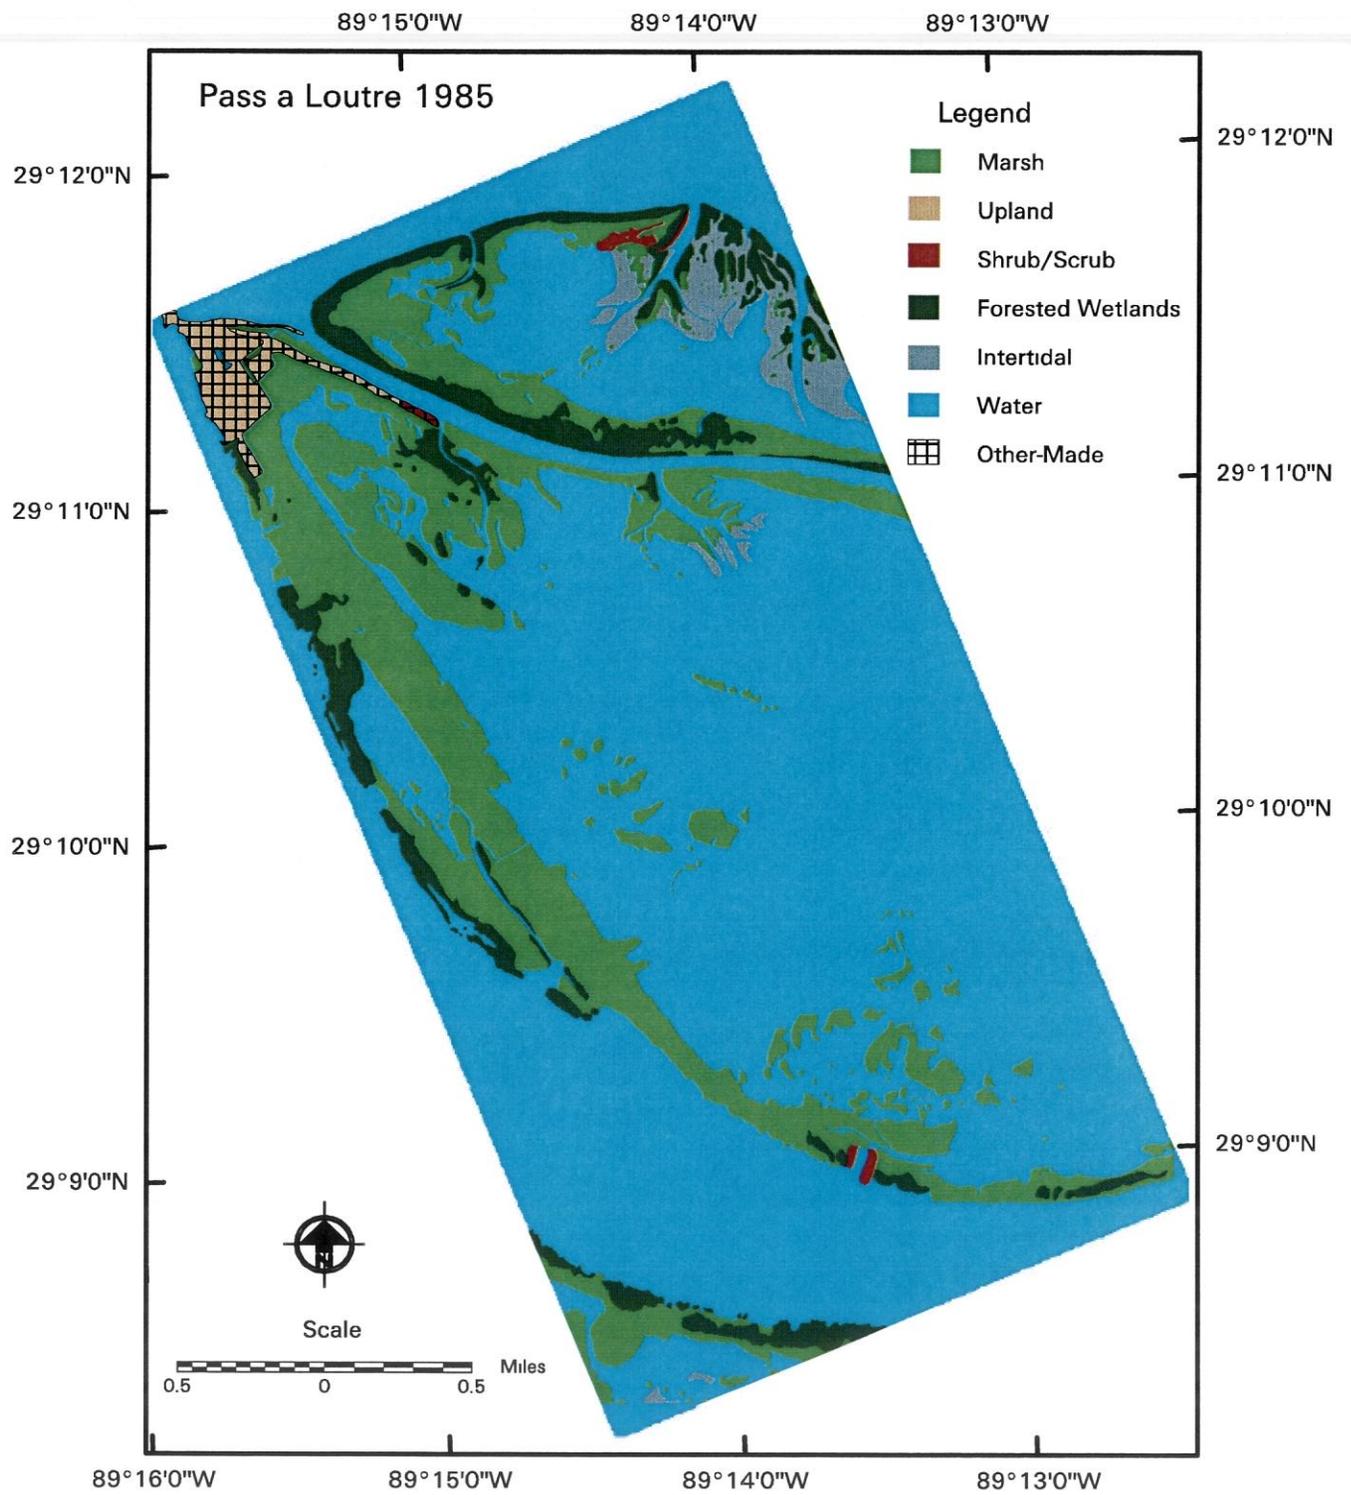
Table 6 lists the areas of the six habitat types found in the PAL BUMP study area in December 1985. The location and arrangement of these habitats is presented in figure 55. The total area of the PAL BUMP study site was 1735.9 acres. Of this total, 1661.7 acres were natural and 74.2 acres were man-made with 0 acres of BUMP-made; or 95.7 percent were natural, 0 percent were BUMP-made and 4.3 percent were other-made.

In order of decreasing size and importance, the largest habitats found were natural marsh (1208.7 acres), natural forested wetland (453.0 acres), other-made upland (67.8 acres), and other-made shrub/scrub (6.4 acres).

Figure 55 Habitat of the Pass a Loutre Bump study area in December 1985

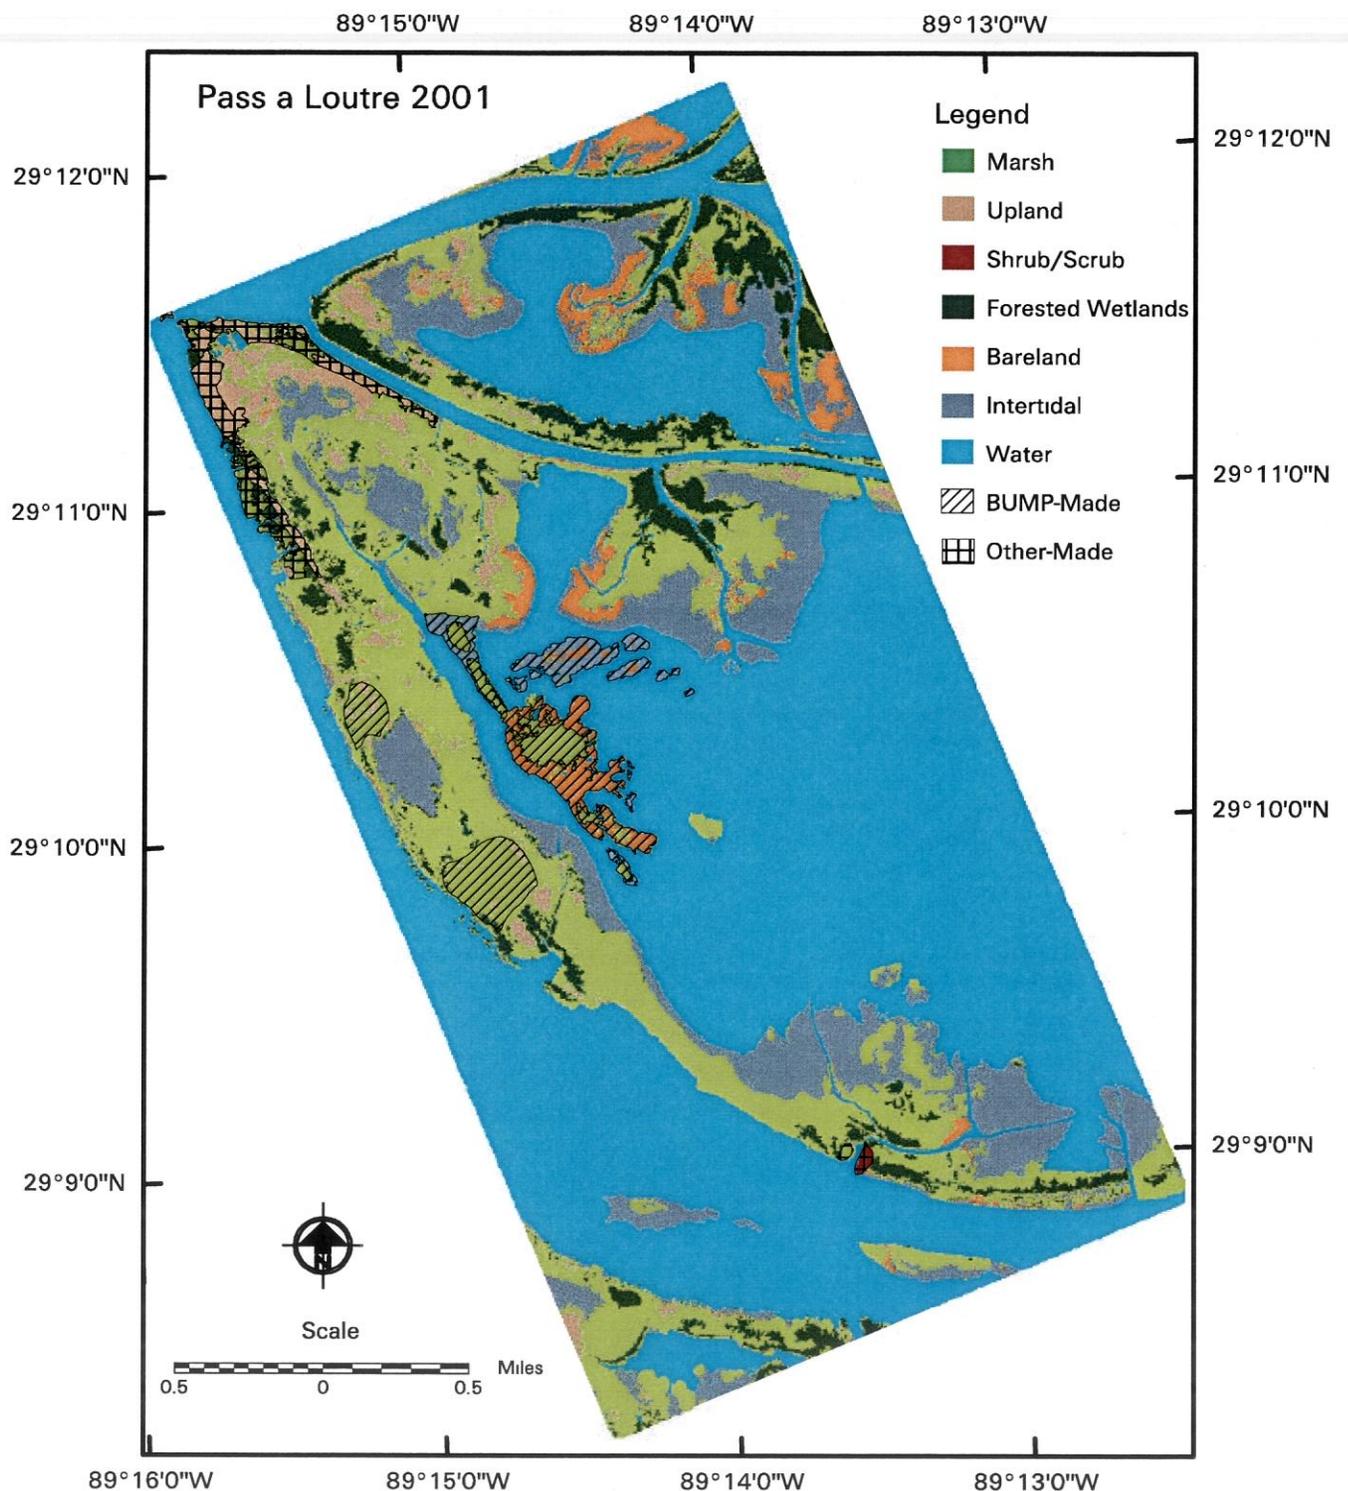
Table 7 lists the areas of the six habitats found in the PAL BUMP study area in January 2001. The location and arrangement of these habitats is presented in figure 56. In 2001, the total area of the PAL BUMP study area was calculated as 1,801.8 acres. Of this total, 1,589.4 acres were natural and 212.4 acres were man-made including 135.2 acres BUMP-made and 77.2 acres other-made, or 88.2 percent was natural, 7.5 percent was BUMP-made and 4.3 percent was other-made.

In order of decreasing size and importance, the largest habitats found were natural marsh (1,032.1 acres), natural forested wetland (317.5 acres), natural upland (131.1 acres), natural bare land (108.7 acres), BUMP-made marsh (82.1 acres), and BUMP-made bare land (44.9 acres).

Figure 56 Habitat of the Pass a Loutre Bump study area in January 2001

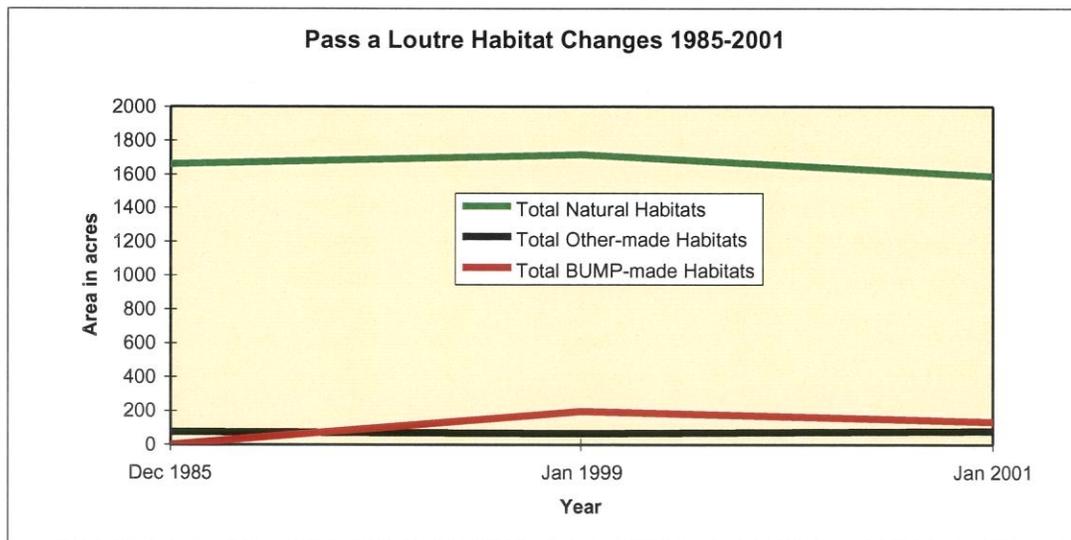
Figure 57. Graph showing the relative change in total area of the major habitat categories: natural, other-made, and BUMP-made, between 1985 and 2001.

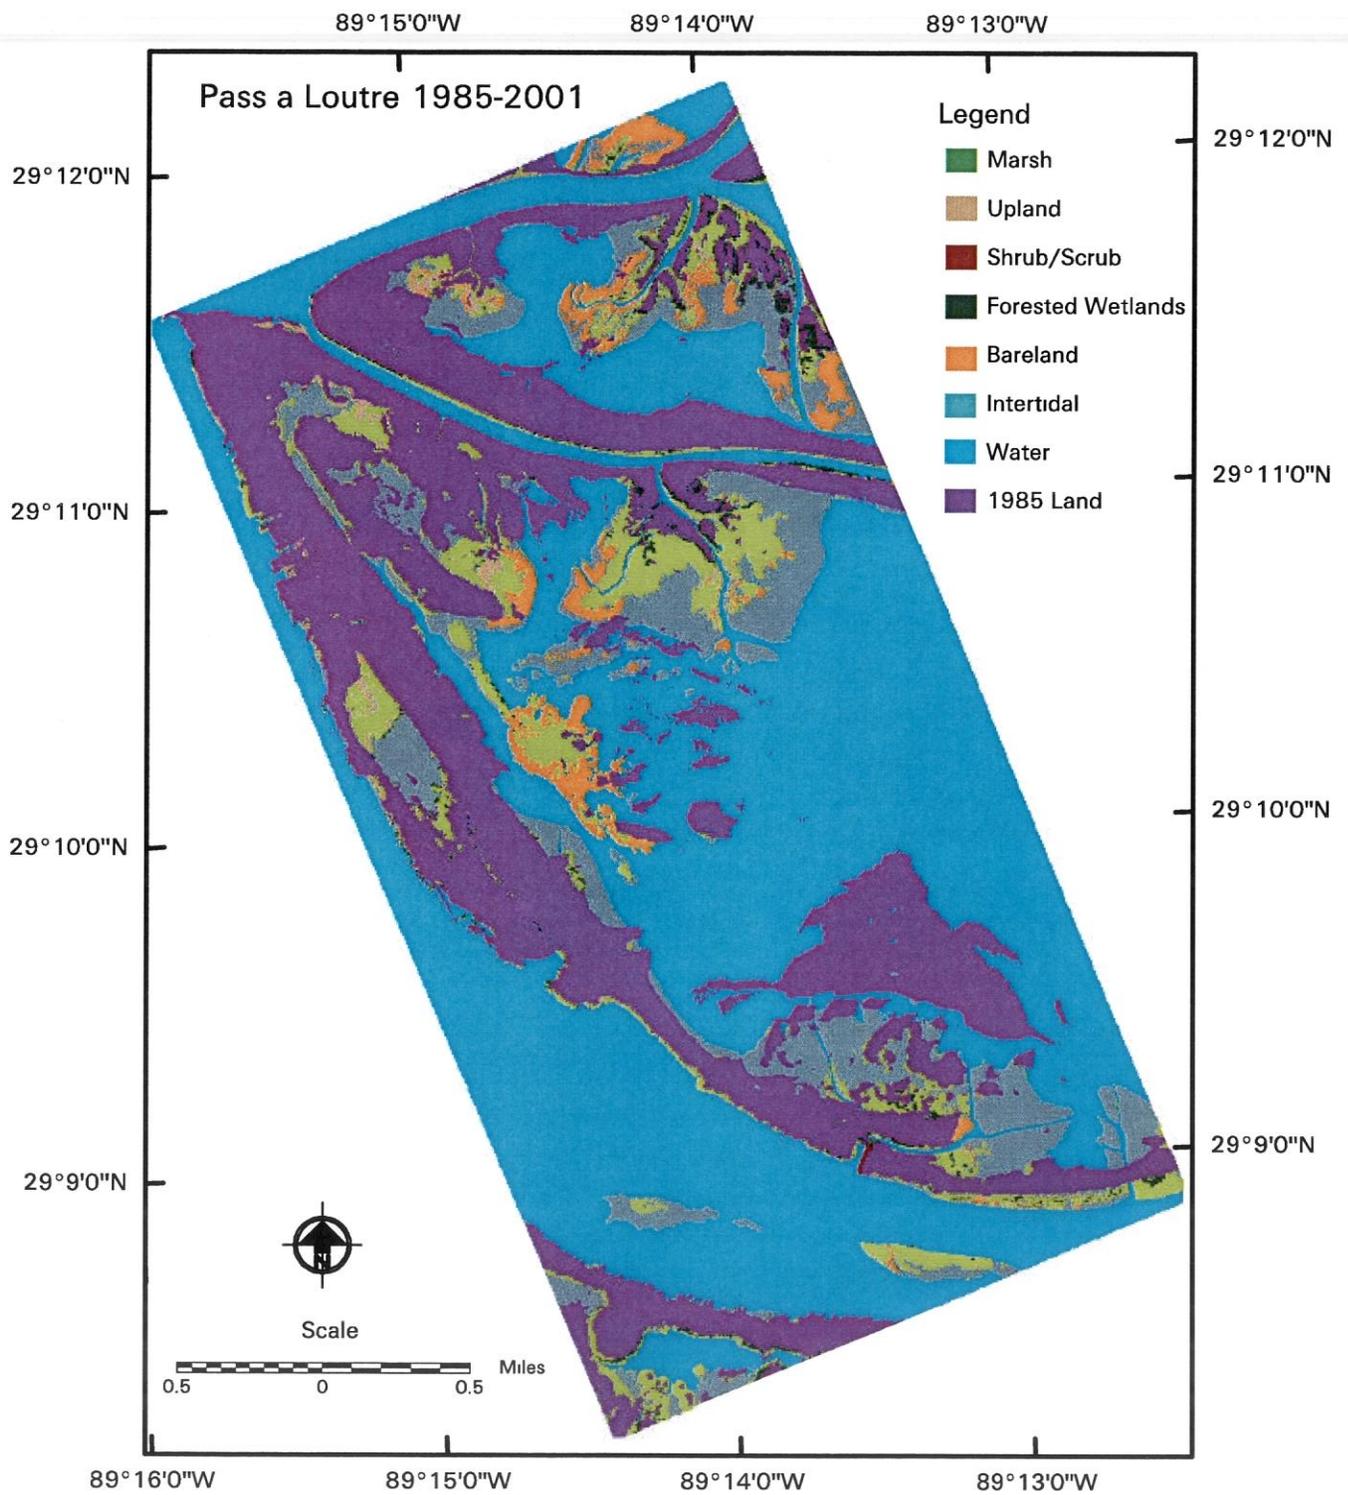
Figure 58 New habitats of the Pass a Loutre Bump study area between December 1985 and January 2001

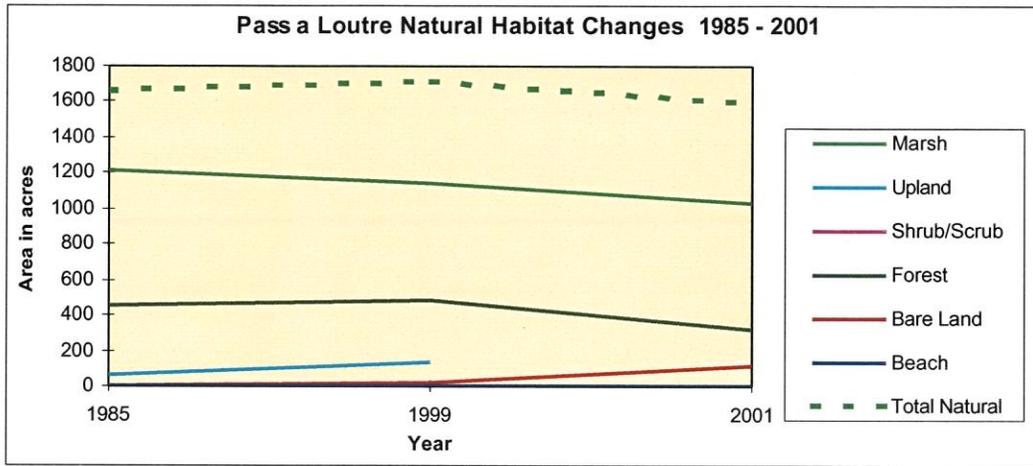
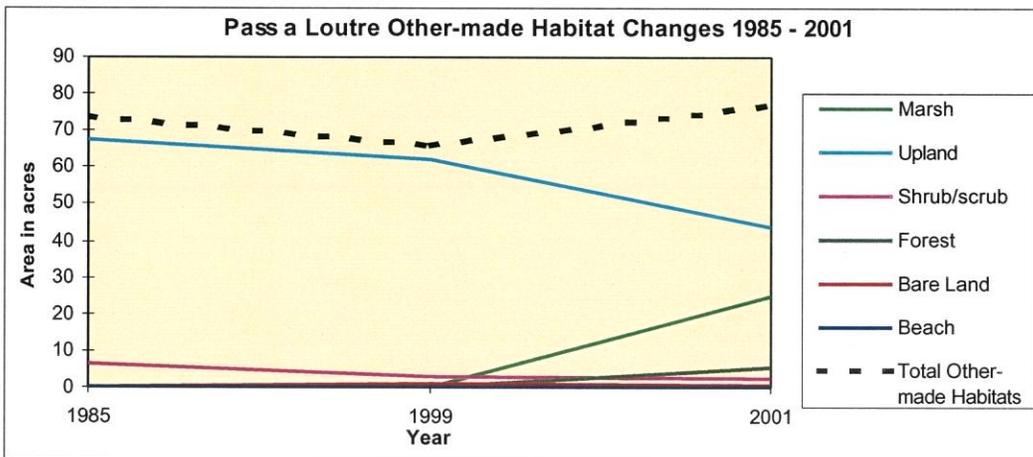
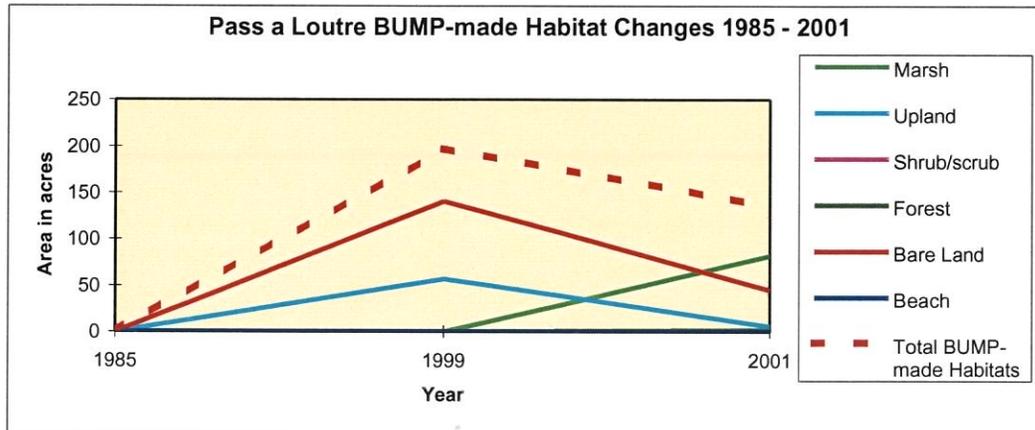
Figure 59. Time series showing the changes in total area of each habitat in the Pass a Loutre BUMP study area between December 1985 and January 2001. A) natural habitat changes. B) Other-made habitat changes. (continued on next page)
