# LAKE PONTCHARTRAIN AND VICINITY HURRICANE PROTECTION PROJECT ORLEANS AVENUE CANAL ORLEANS PARISH, LOUISIANA

## MOWL for Orleans Avenue Canal

**Revised Final  
March, 2011**

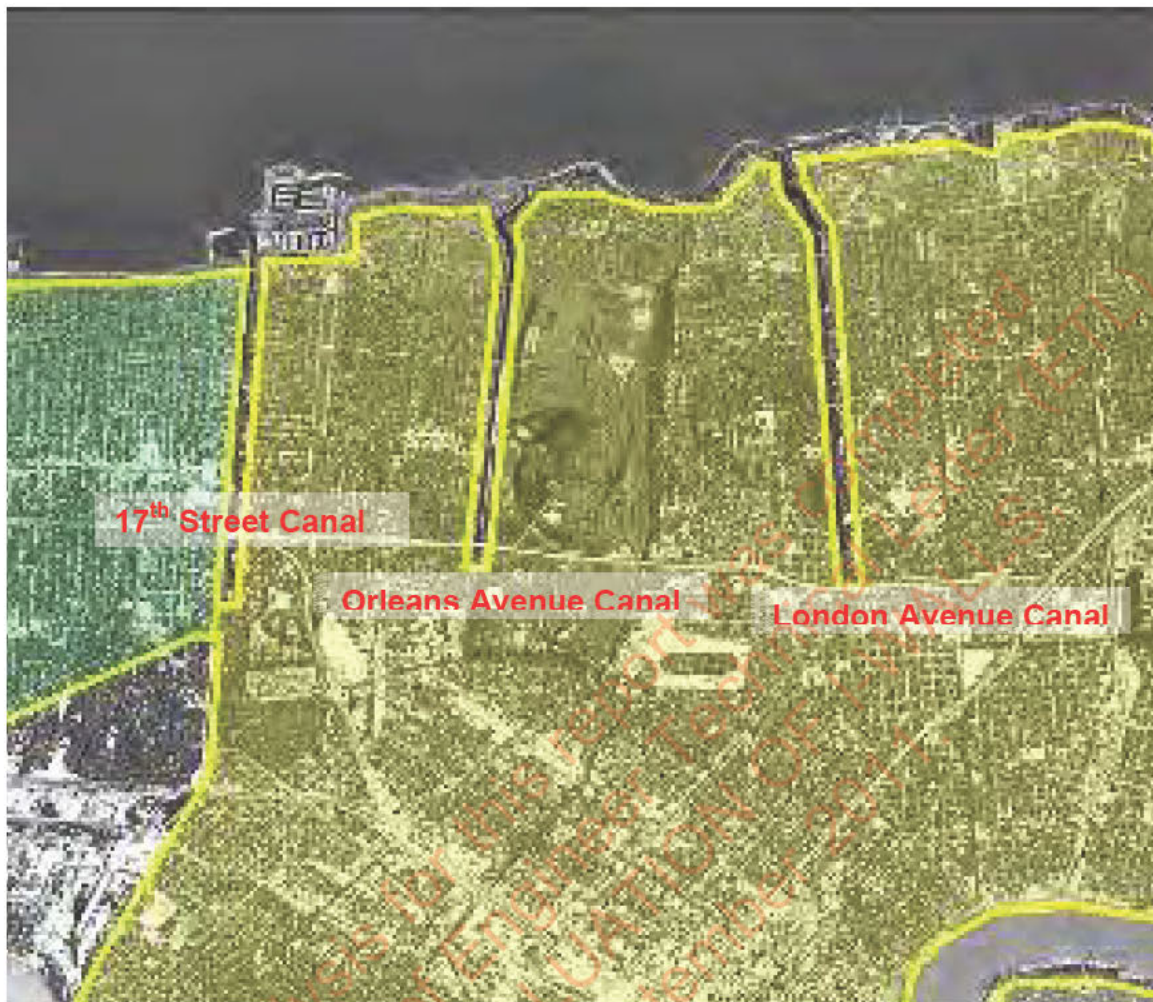
**FIGURE 2-1  
LOCATION OF OUTFALL CANALS [1]**

Three outfall canals, the London Avenue Canal, the 17<sup>th</sup> Street Canal, and the Orleans Avenue Canal, provide discharge of surface water collected from the City storm-runoff systems. The City has been subsiding for many years and continues to subside due to: 1) confinement of the Mississippi River by levees, thus eliminating river sedimentation during high river flows; and 2) pumping of ground water. Since much of the City is now located below sea level, precipitation that falls on the City must be pumped up into the canals for discharge to the Lake. Flow of water from the City is initiated towards the Lake by gravity as the pumping causes the hydraulic grade line to rise. The canals were designed as open canals at the north end along the Lake at the time Katrina occurred. Because of the increase in Lake water level during Katrina, the fact that the canals were open allowed the storm surge to flow into the canals, causing the water levels to rise to levels that had not previously been experienced. The locations of the three outfall canals are shown on Figure 2-1. A general description of the outfall canals follows.

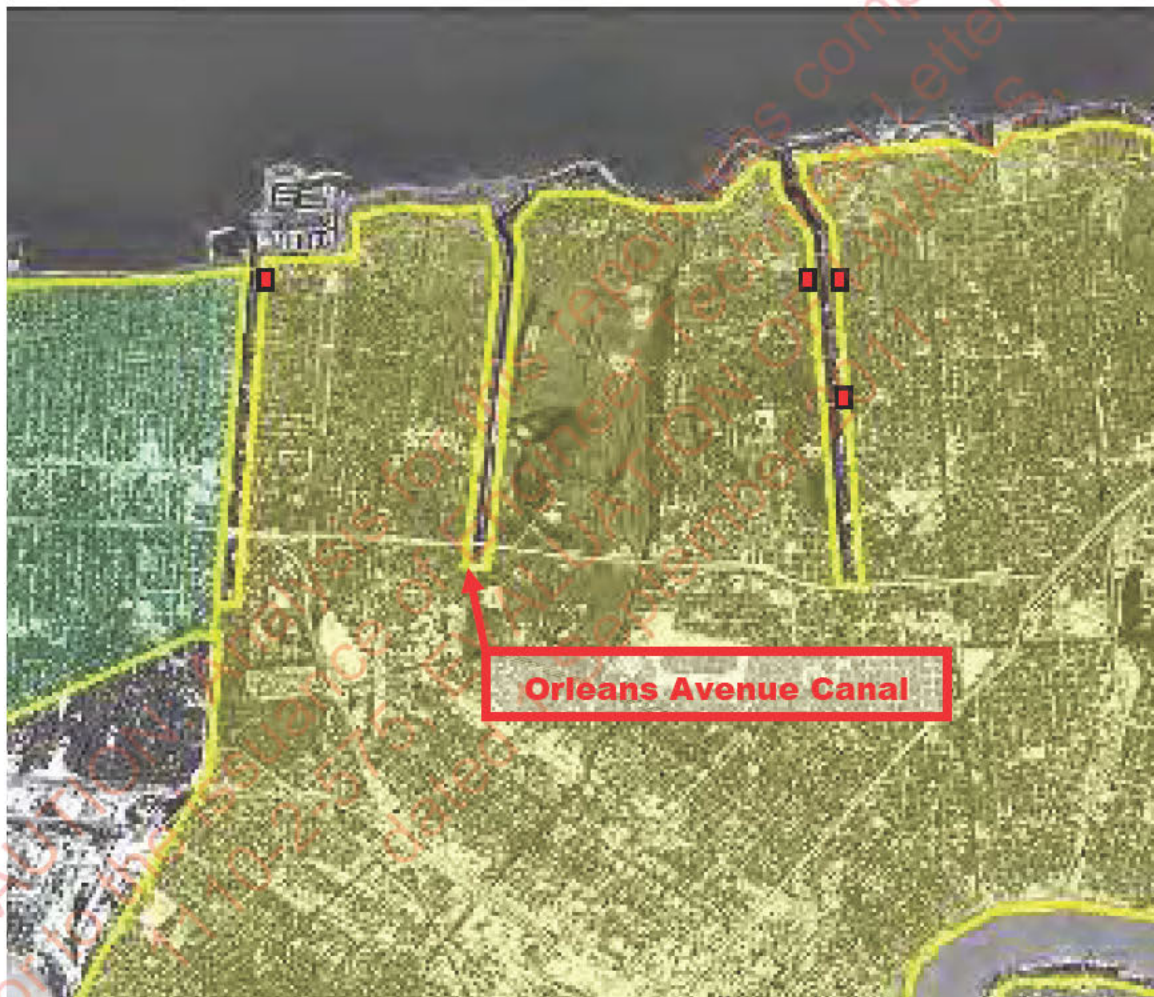
**FIGURE 3-1  
LOCATIONS OF ORLEANS AVENUE OUTFALL CANAL**

The storm surge from Katrina caused one failure along the 17th Street Canal and two failures along the London Avenue Canal. Figure 3-1 illustrates the locations of the outfall canal failures. The Orleans Avenue Canal levees and flood walls did not fail. The 17th Street Canal failed south of the Old Hammond Road Bridge near the north end of the canal between about 6:00 and 9:00 AM on August 29, 2005 [1]. A 400-ft long section of the east I-wall failed between Stations 560+50 and 564+50 when the water level in the canal was at about El 7 NAVD88, or about 5.5 feet below the top of the I-wall at the time of failure. The water level in the canal prior to Katrina was about El 3.0 NAVD88 and it ultimately rose to a maximum level of about El 9 NAVD88 during Katrina. It is believed that the failure occurred when a gap formed between the sheet pile wall, supporting the I-wall, and levee soil on the flood side of the I-wall. This gap allowed canal water to fill the space between the sheet pile and the levee soil down to the tip of the sheet pile. Ultimately, a shear failure developed below the tip of the I-wall in the soft clay foundation soils. Figure 3-1 illustrates the locations of the outfall canal failures.
