**BENEFICIAL USE OF DREDGED MATERIAL DISPOSAL HISTORY
MISSISSIPPI RIVER, BATON ROUGE TO THE GULF OF MEXICO, LA
HEAD OF PASSES
HOPPER DREDGE DISPOSAL AREA**

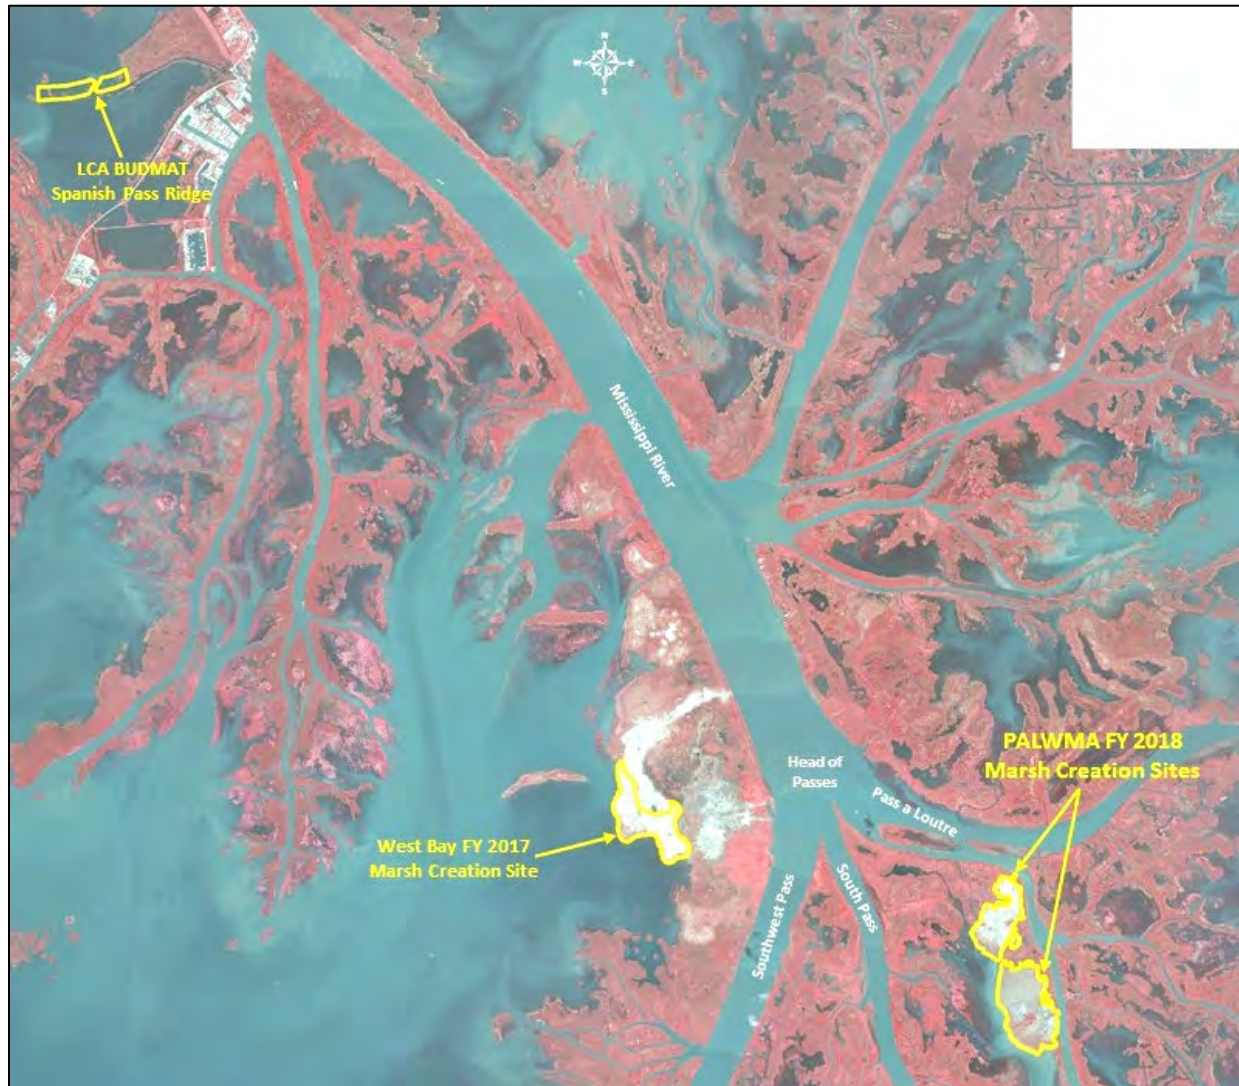
FY 2017-2018 Southwest Pass & HDDA Placement Sites

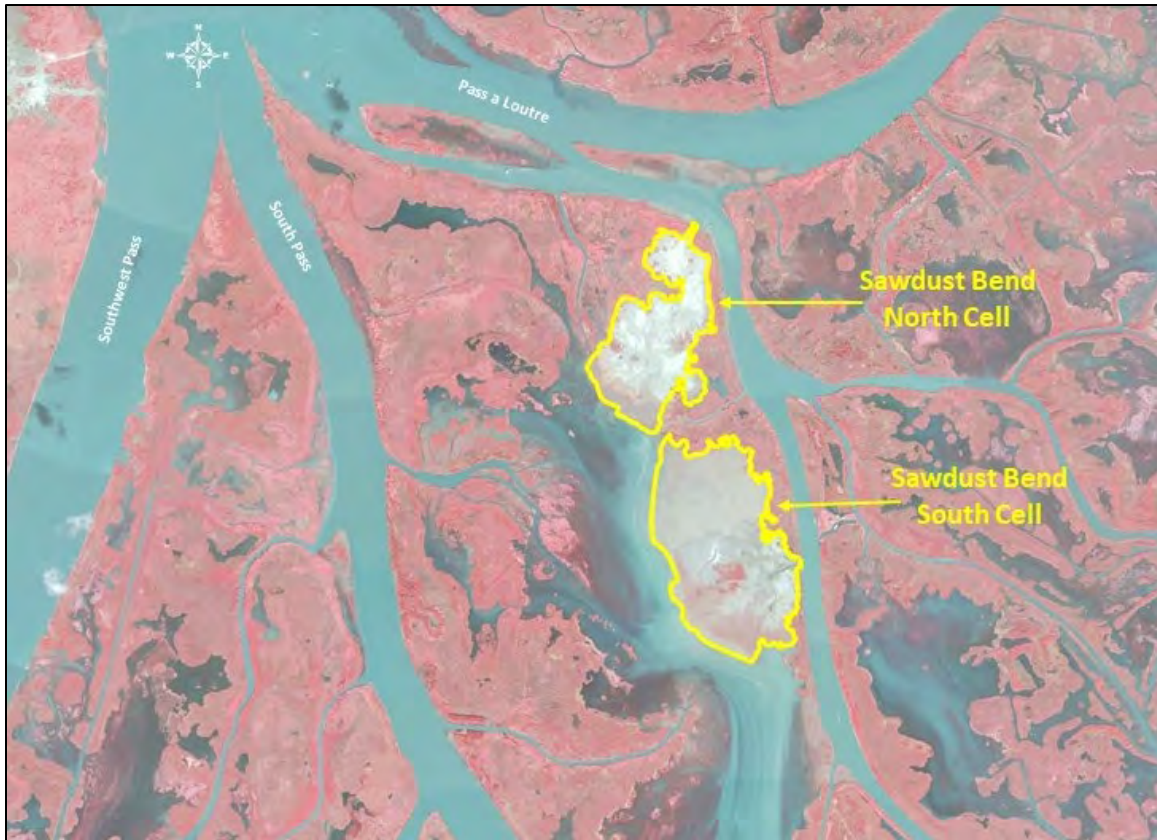
FY 2017 PALWMA Sawdust Bend Placement Site

Dredged material was placed at two PALWMA disposal sites (Sawdust Bend North and Sawdust Bend South) and was limited to a maximum initial elevation of approximately +8.0 feet MLG. While dredged material was not allowed to be discharged directly upon existing wetlands, a maximum of about 1-foot of dredged material was allowed to overflow adjacent existing marsh. It was anticipated that the final settled elevation of the dredged material would be approximately +5.0 to +6.0 feet MLG, an elevation conducive to the development of high marsh.

1. Sawdust Bend North: Approximately 1,711,770 CY of dredged material was placed unconfined at the Sawdust Bend North site and resulted in the creation of about 178 acres of marsh habitat.
2. Sawdust Bend South: Approximately 2,596,039 CY of dredged material was placed unconfined at the Sawdust Bend North site and resulted in the creation of about 291 acres of marsh habitat.

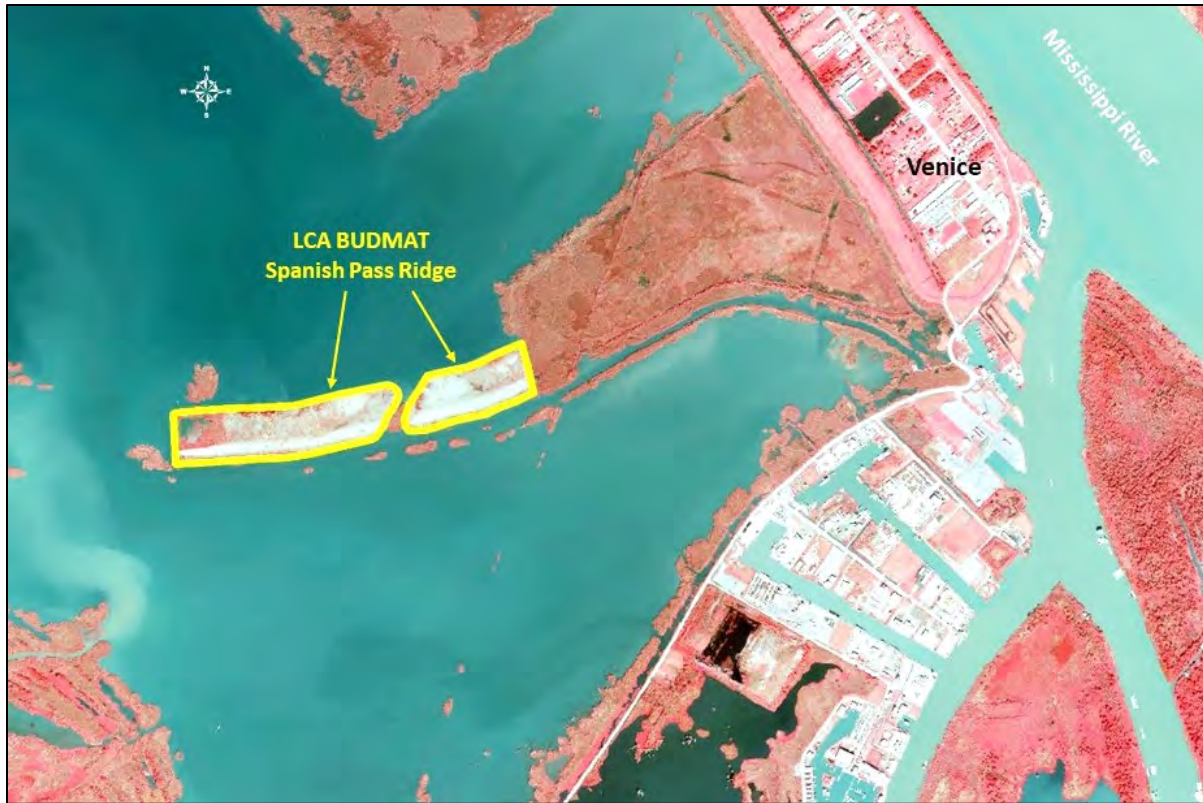
FY 2018 LCA BUDMAT SPANISH PASS RIDGE SITE

A ridge feature was constructed along the southern boundaries of both placement cells. An approximately 2,800-foot long ridge was constructed in the western cell, and an approximately 1,700-foot long ridge was constructed in the eastern cell. Ridges were constructed to a maximum initial elevation of about +7.5 feet NAVD88, with an expectation that it would settle to an elevation of about +6.0 feet NAVD88 within 1-2 years following completion of construction activities. Ridges were constructed with a crown width of about 80 feet and side slopes of about 1V on 20H.

A marsh platform was constructed along the north side of the ridge feature in both cells. The marsh platform was constructed to a maximum initial elevation of about +4.0 feet NAVD88, with an expectation that it would settle to an elevation of about +1.5 to +2.0 feet NAVD88 with about 10 years following completion of construction activities.

Earthen perimeter dikes were constructed around each cell to an elevation of about +5.0 feet NAVD88, a crown width of 5-feet, and with side slopes no steeper than 1V on 4H. The dikes constructed along the south side of the ridge also included a 25-foot wide stability berm, constructed to elevation 0.0 feet NAVD88, and with slopes no steeper than 1V on 4H.

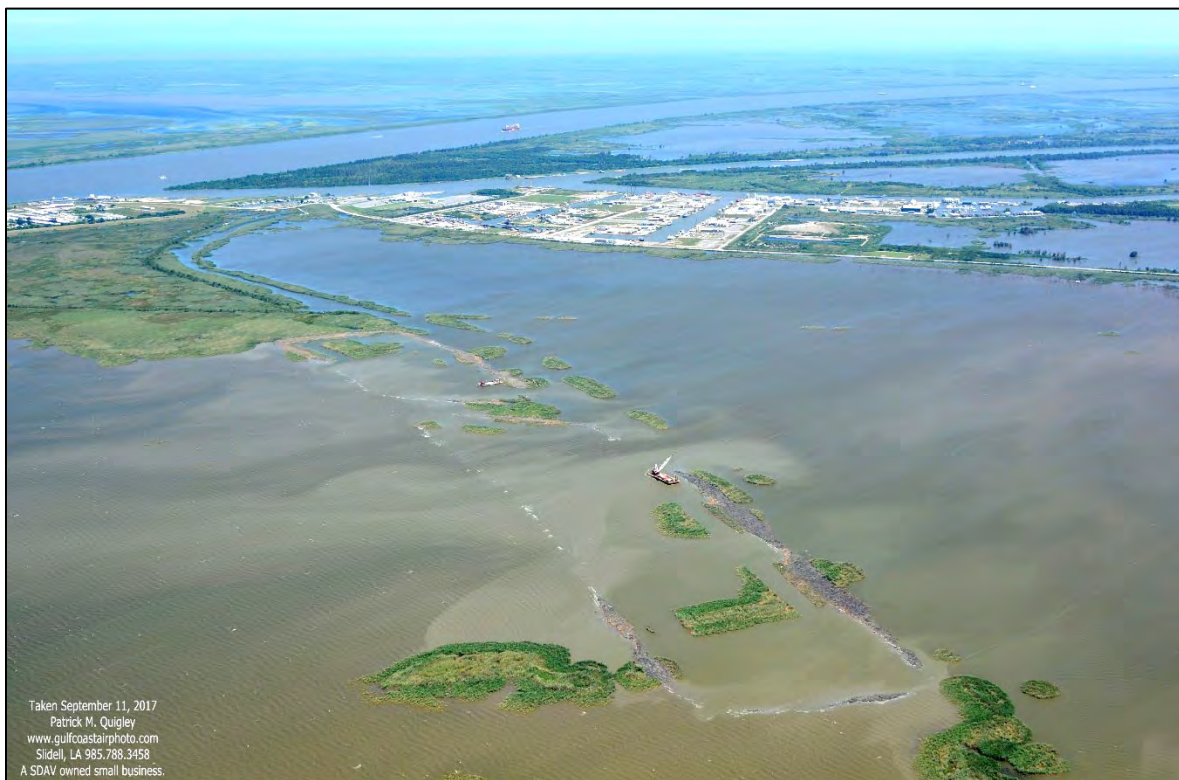
FY 2018 LCA BUDMAT Spanish Pass Ridge Construction (13 September 2017)
