# Bonnet Carré Spillway

The Bonnet Carré Spillway is a vital element of the comprehensive plan for flood damage risk management in the Lower Mississippi Valley. This multi-state plan, called the Mississippi River and Tributaries Project (MR&T), provides flood damage risk management for the alluvial valley between Cape Girardeau, Missouri, and the mouth of the river. Due to the wide expanse of the project and the complex problems involved, the plan contains an array of features. The MR&T provides for levees to contain flood flows, floodways such as the Bonnet Carré to redirect excess flows away from the Mississippi River, plus features such as channel improvement and stabilization for efficient navigation and risk reductions of the levee system. It also involves reservoirs and pumping plants for flood drainage.

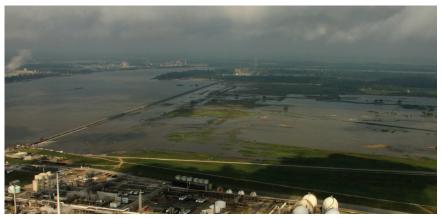
High altitude view of the spillway (center) stretching from the Mississippi River to Lake Pontchartrain, looking upriver. This photo was taken just after the first bays were opened during the flood of 2011.

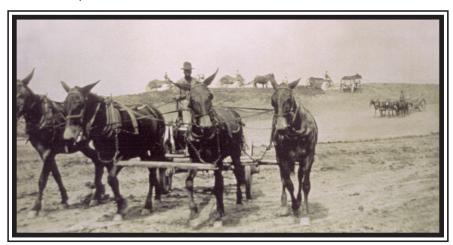
Early levee construction

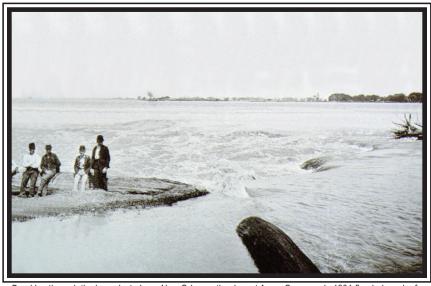
Breaking through the levee just above New Orleans, the river at Ames Crevasse in 1891 flooded much of western Jefferson Parish.

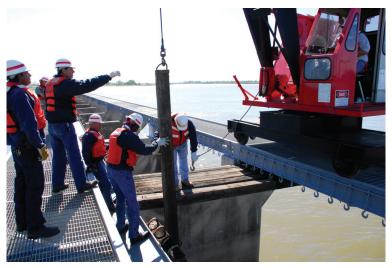
In opening the spillway, each timber is individually lifted and placed atop the structure.

Once the decision is made, actual operation of the structure is relatively simple. Two cranes, which move along tracks atop the structure, are used to individually lift each timber from the required number of bays. The timbers are raised from their vertical position across the weir opening (where together they serve as a dam against the high water) and are laid horizontally on top of the structure for later use in its closing. A complete opening of all 350 bays requires about 36 hours to lift the 7,000 wooden timbers in the structure. If a quicker opening of the structure is ever required, emergency procedures can release 20 timbers at a time and reduce the opening to three hours.

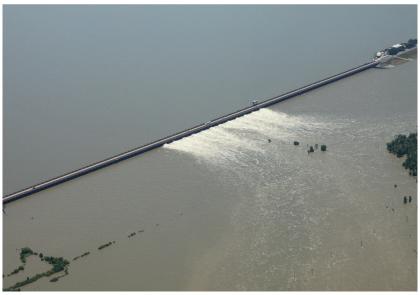
The Corps operated the Morganza Floodway for only the second time ever (and the first time for its intended purpose) in 2011 to divert excess Mississippi River water to the Atchafalaya River Basin and relieve pressure on the mainline Mississippi River levees.
