**FINDING OF NO SIGNIFICANT IMPACT
(FONSI)**

**CONTINUING AUTHORITY PROGRAM, SECTION 14
EMERGENCY STREAMBANK PROTECTION
LOUISIANA HIGHWAY 77 AT BAYOU PLAQUEMINE
IBERVILLE PARISH, LOUISIANA**

EA #587

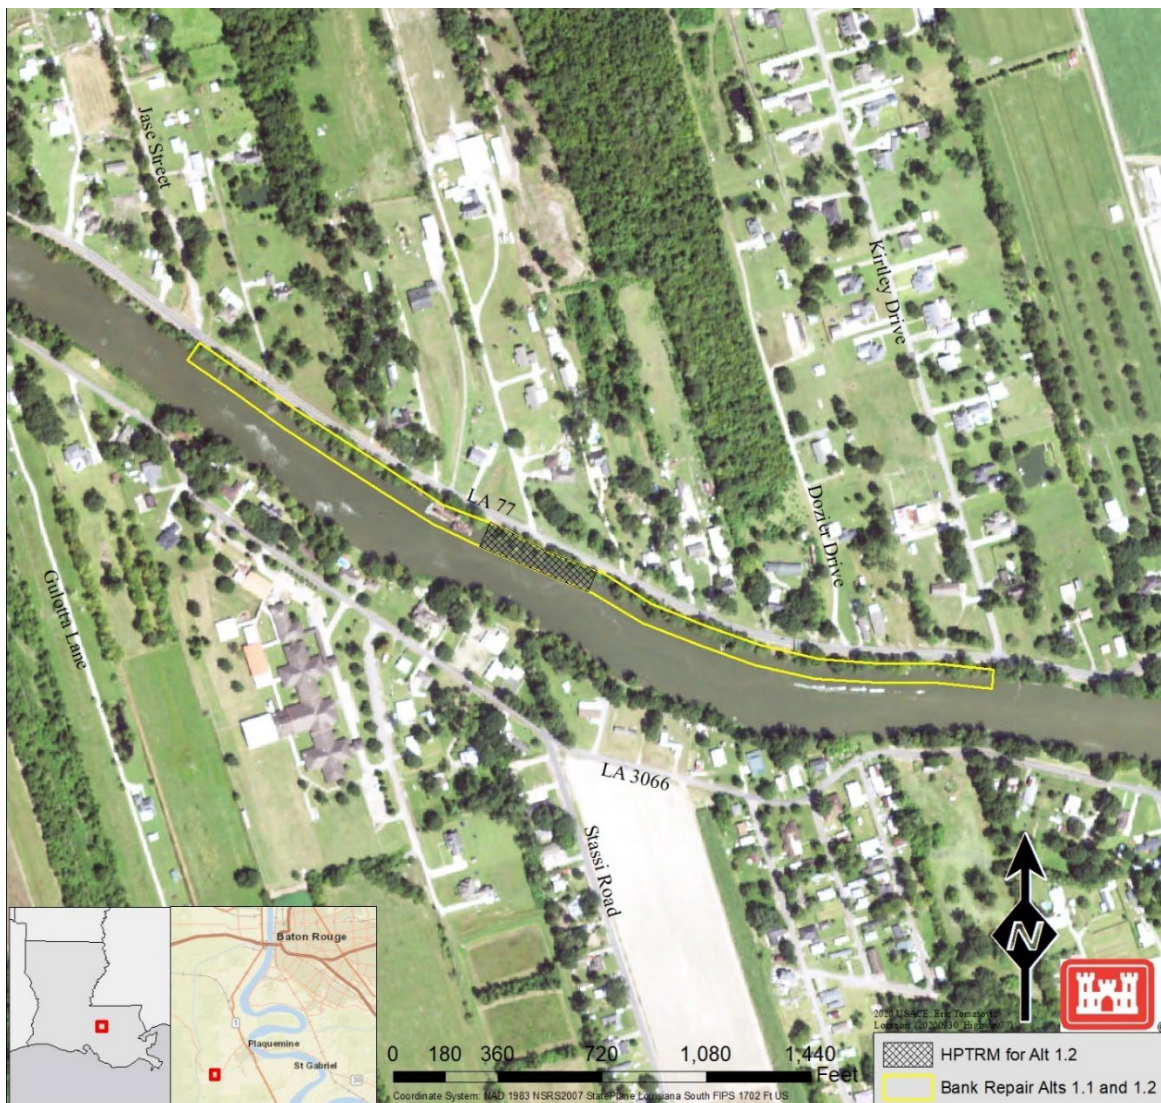
Figure 1: Proposed repair reach and Alternative Design Options 1.1 and 1.2

The proposed action and project location is along LA Highway 77 east of Jase Street within Bayou Plaquemines, approximately 4.5 miles southwest of the intersection of LA Highway 77 and LA Highway 1 south of the city of Plaquemines in Iberville Parish, LA. The streambank failure location is northeast of the Bayou Sorrel Lock and southwest of the Port Allen Lock along Bayou Plaquemine which parallels LA Highway 77 (Figure 1).

Design Option 1.1: Relocate Pipeline. The pipeline would be relocated at the pipeline owners' expense and 3,000 feet of bank line would be reinforced using the typical repair (Section 2.3, Figure 3).

Design Option 1.2: Alternate Design at the Pipeline Crossing. A High-performance turf reinforcement mat (HPTRM) will be used for approximately 400 feet of the repair, centered on the buried pipeline to avoid accidental damage to the pipeline. The remaining 2,600 feet will be constructed using the typical repair as described in Section 2.3 and illustrated in Figure 3.

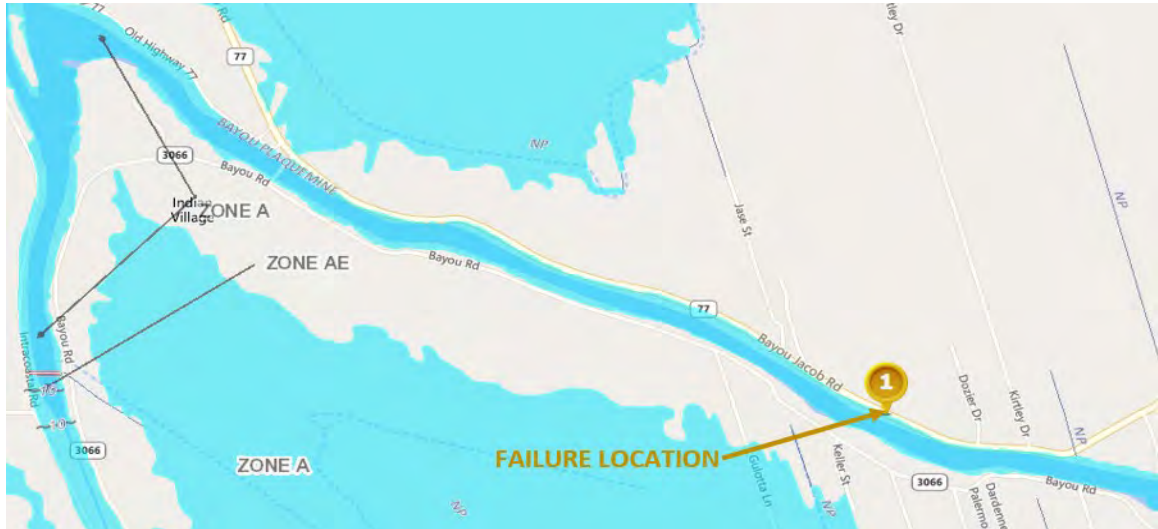
Figure A:2-6. FEMA FIRM Panels

The floodplain maps were also reviewed to determine the base flood elevation in Bayou Plaquemines at the failure location. The bayou is located within a Zone A floodplain. It was determined that the associated 100-year floodplain elevation is approximately 10 ft as approximated on the effective Federal Emergency Management Agency (FEMA) flood rate insurance map (FIRM) panels 22047C0195D and 22047C0310D.

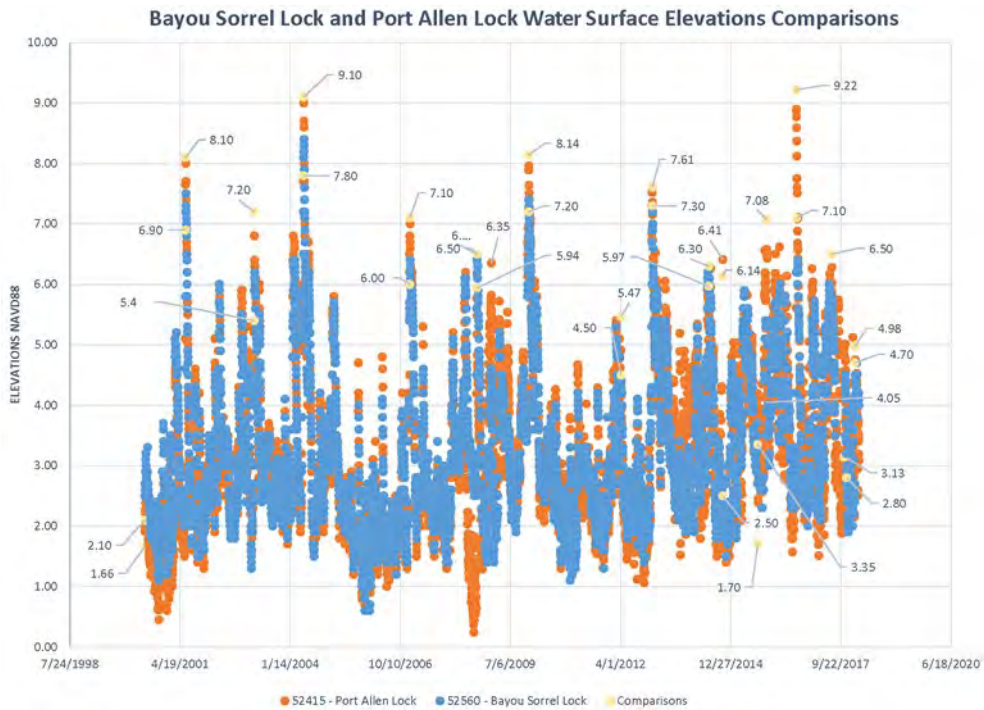
Figure A:2-8. Bayou Sorrel Lock Versus Port Allen Lock Stages

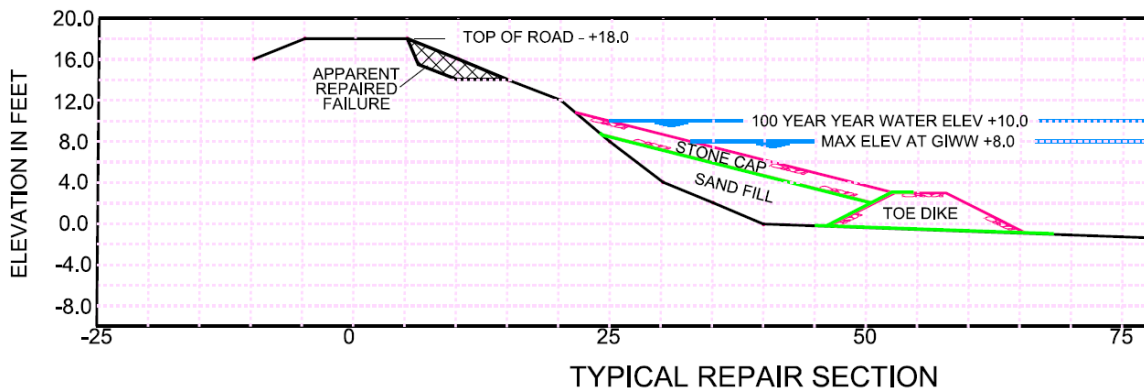
Figure A:2-9. 2017 Survey Cross Sections

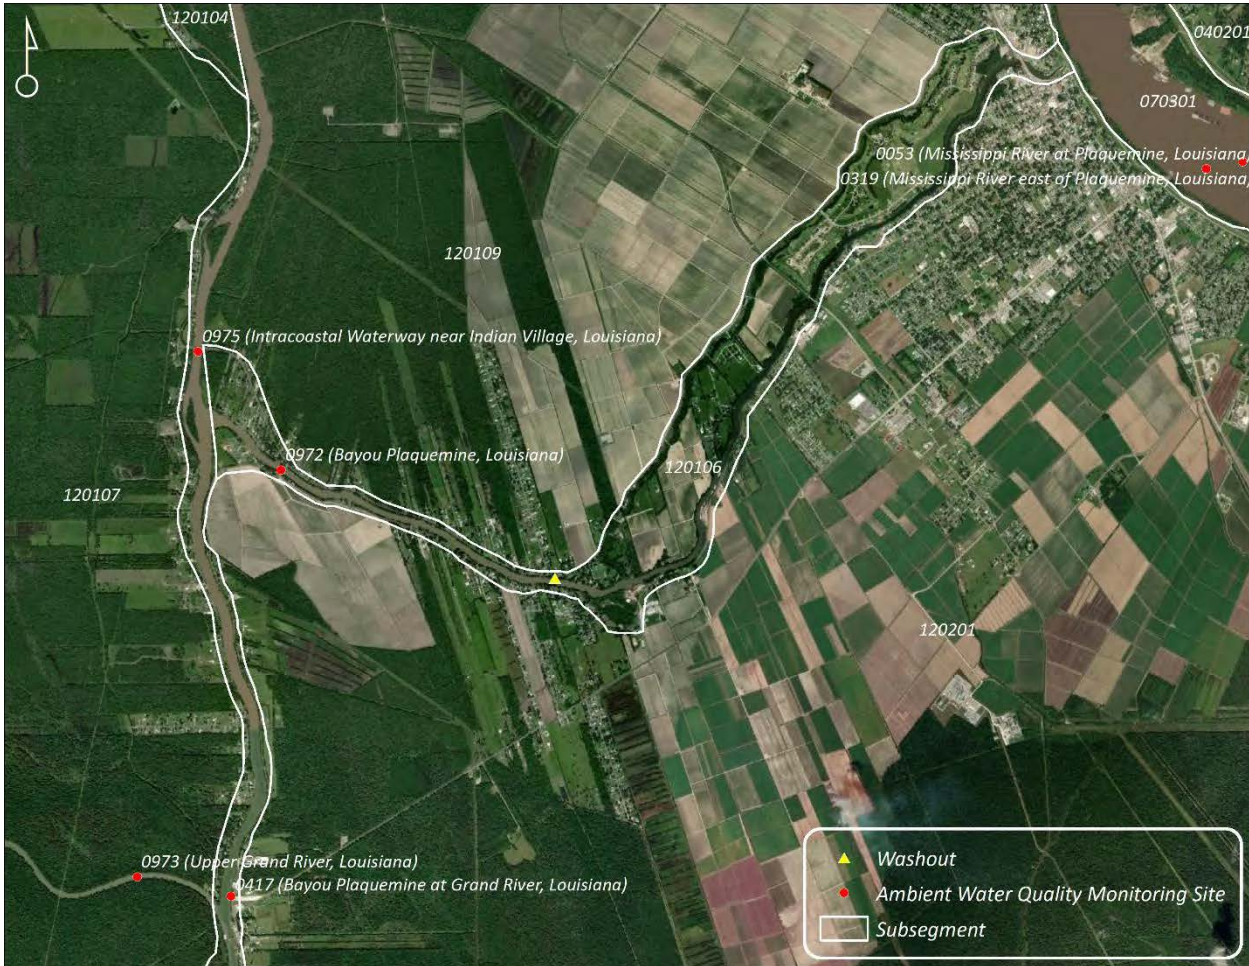
Figure A:2-10. Project area with washout location, waterbody subsegments, and ambient water quality monitoring sites.

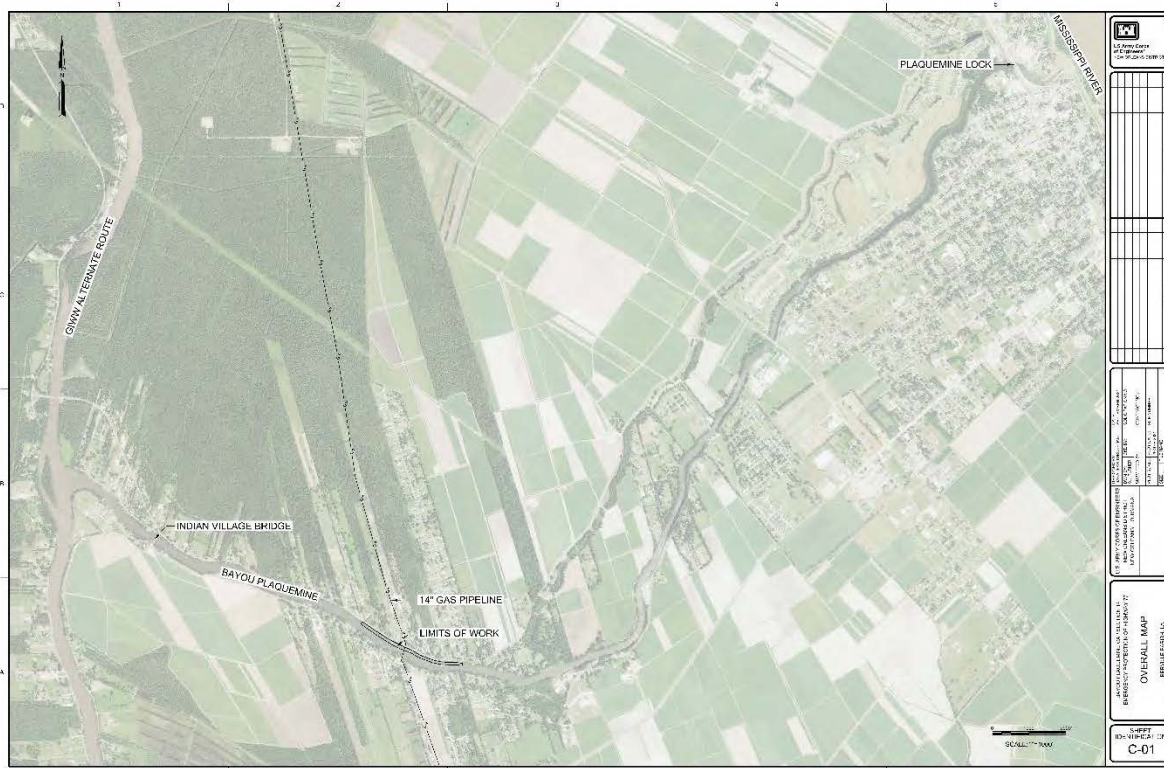
Figure A:4-1. Location Map

Bayou Plaquemine, Figure A:4-1, is a federally authorized waterway. However, the channel is no longer maintained, because of the closure of Plaquemine Lock. The Indian Village Bridge is located at the entrance of Bayou Plaquemine from the Gulf Intracoastal Waterway (GIWW) Alternate Route. The swing span bridge is used for local boat and barge traffic. Bayou Plaquemine is mostly used for personal recreation. Bayou Plaquemine parallels LA Hwy 77 near the city of Plaquemine, LA in Iberville Parish, LA. Hwy 77 is the primary route from the city of Plaquemine to agricultural areas along the GIWW Alternate Route. A segment of the Bayou Plaquemine bank line has experienced erosion. The erosion jeopardizes the integrity of Hwy 77, as the bank is a component of the base of the highway. For this study, design alternatives were looked at to stabilize the bank and protect the highway. These alternatives are as follows: 1) Construct emergency repair of the entire proposed reach with alternate design placing high-performance turf reinforcement mat (HPTRM) over the pipeline, and 2) Construct emergency repair of entire reach. Two additional alternatives were evaluated to determine federal interest in the project. These are referred to as the Future Without Project (FWoP) alternatives. The FWoP alternatives are as follows: 1) Construct a local bypass road, and 2) Relocate Hwy 77.

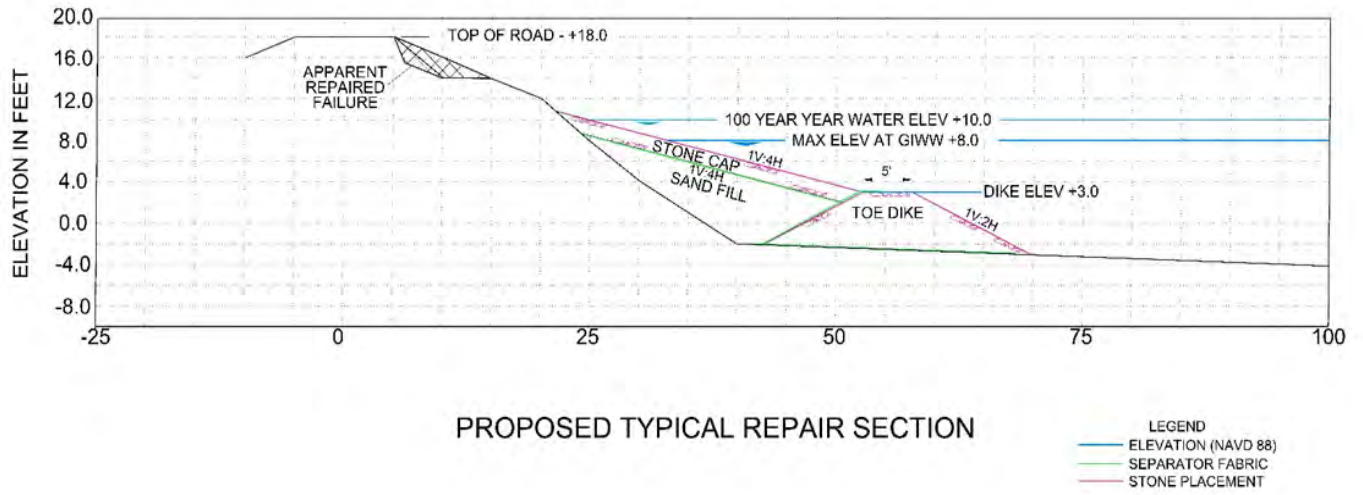
Figure A:4-4. Proposed Typical Repair Section

be blanketed by geotextile fabric, to be pinned on the rock dike crown. A 9 ft width of fabric should cover the entire face and provide adequate laps. The earthen backfill would require some sandy content (silty sand) to allow for compaction in open water. The sand backfill would initiate at approximately 1 foot below the toe dike crown elevation and proceed landward on an approximate 1:4 slope. This should achieve an inshore elevation of approximately 8.5 ft or 10.0 ft, such that the final rock armor is in the general range of normal high-water elevation. This should eliminate shoreline erosion resulting from stage differentials or localized wave wash. This rock should also be underlain with geotextile fabric. Standard 200# top size stone gradation was assumed to be used for the construction of the stone armor, Figure A: 4-7. The final layer of stone armor should be placed on the earthen fill 16 inches thick. All rock gradations and geotextile strengths will be finalized during the design phase.

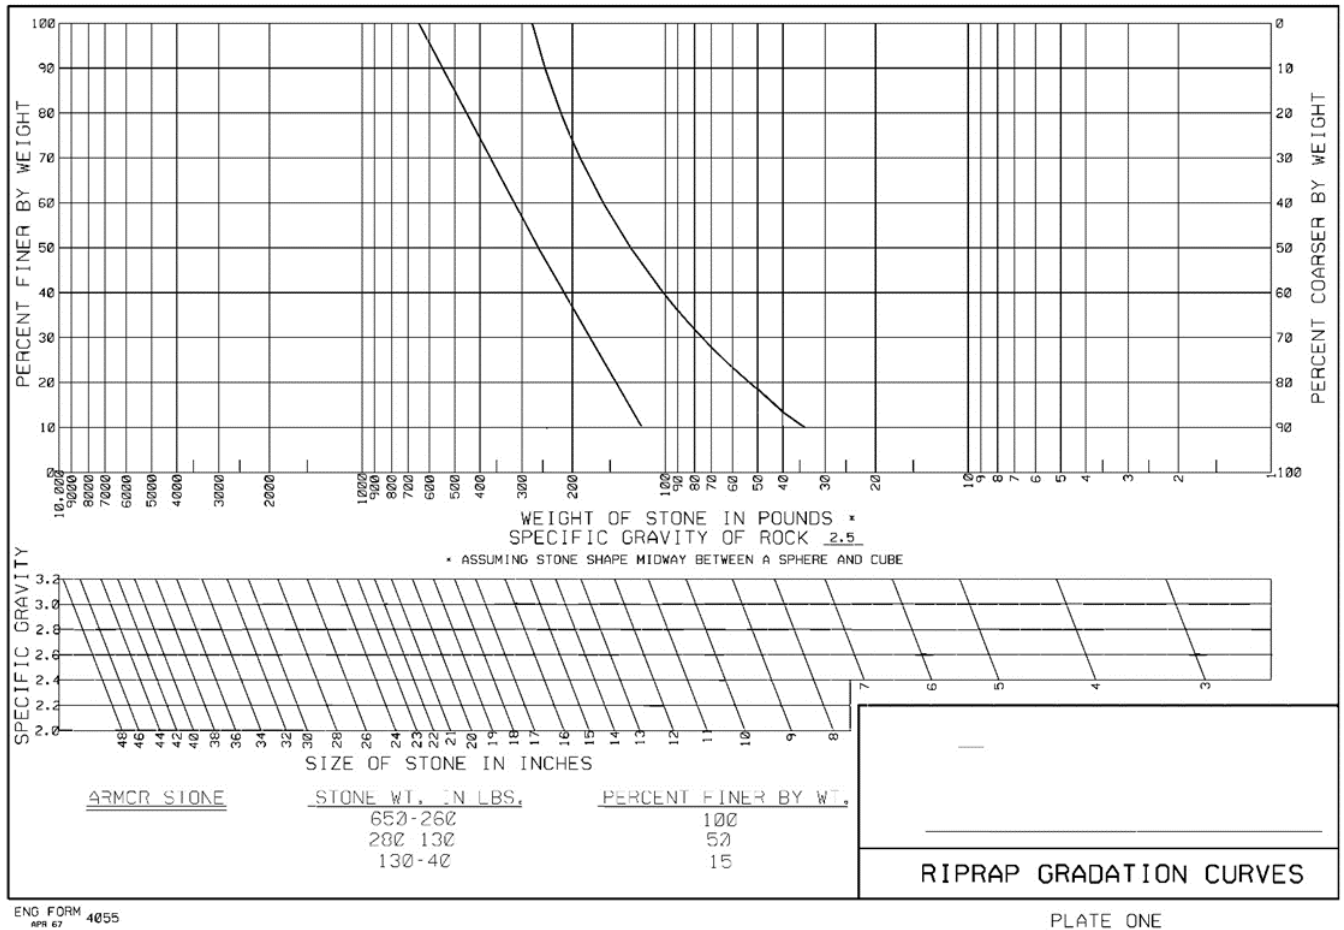
Figure A:4-6. Proposed Rock Dike Gradation Curve

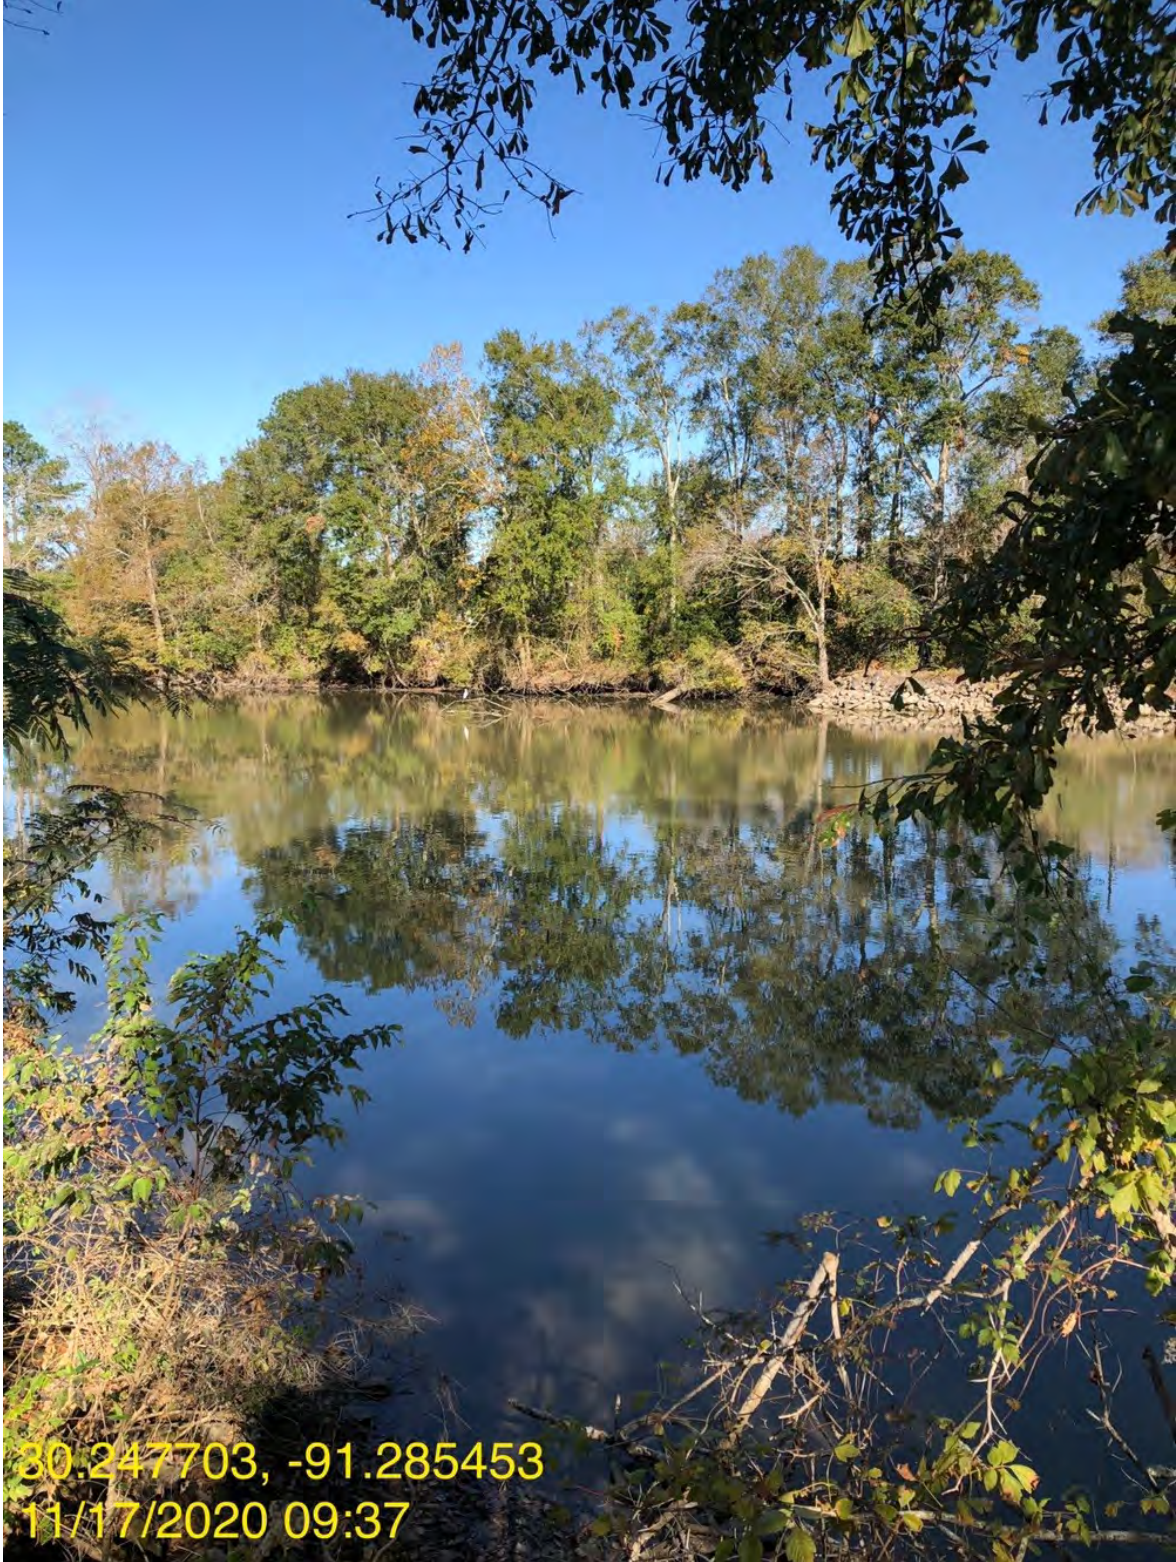
Photograph 1. Facing north. Photograph taken on the southern portion of Bayou Plaquemine (Left descending bank) located on the most eastern portion of the ROW.

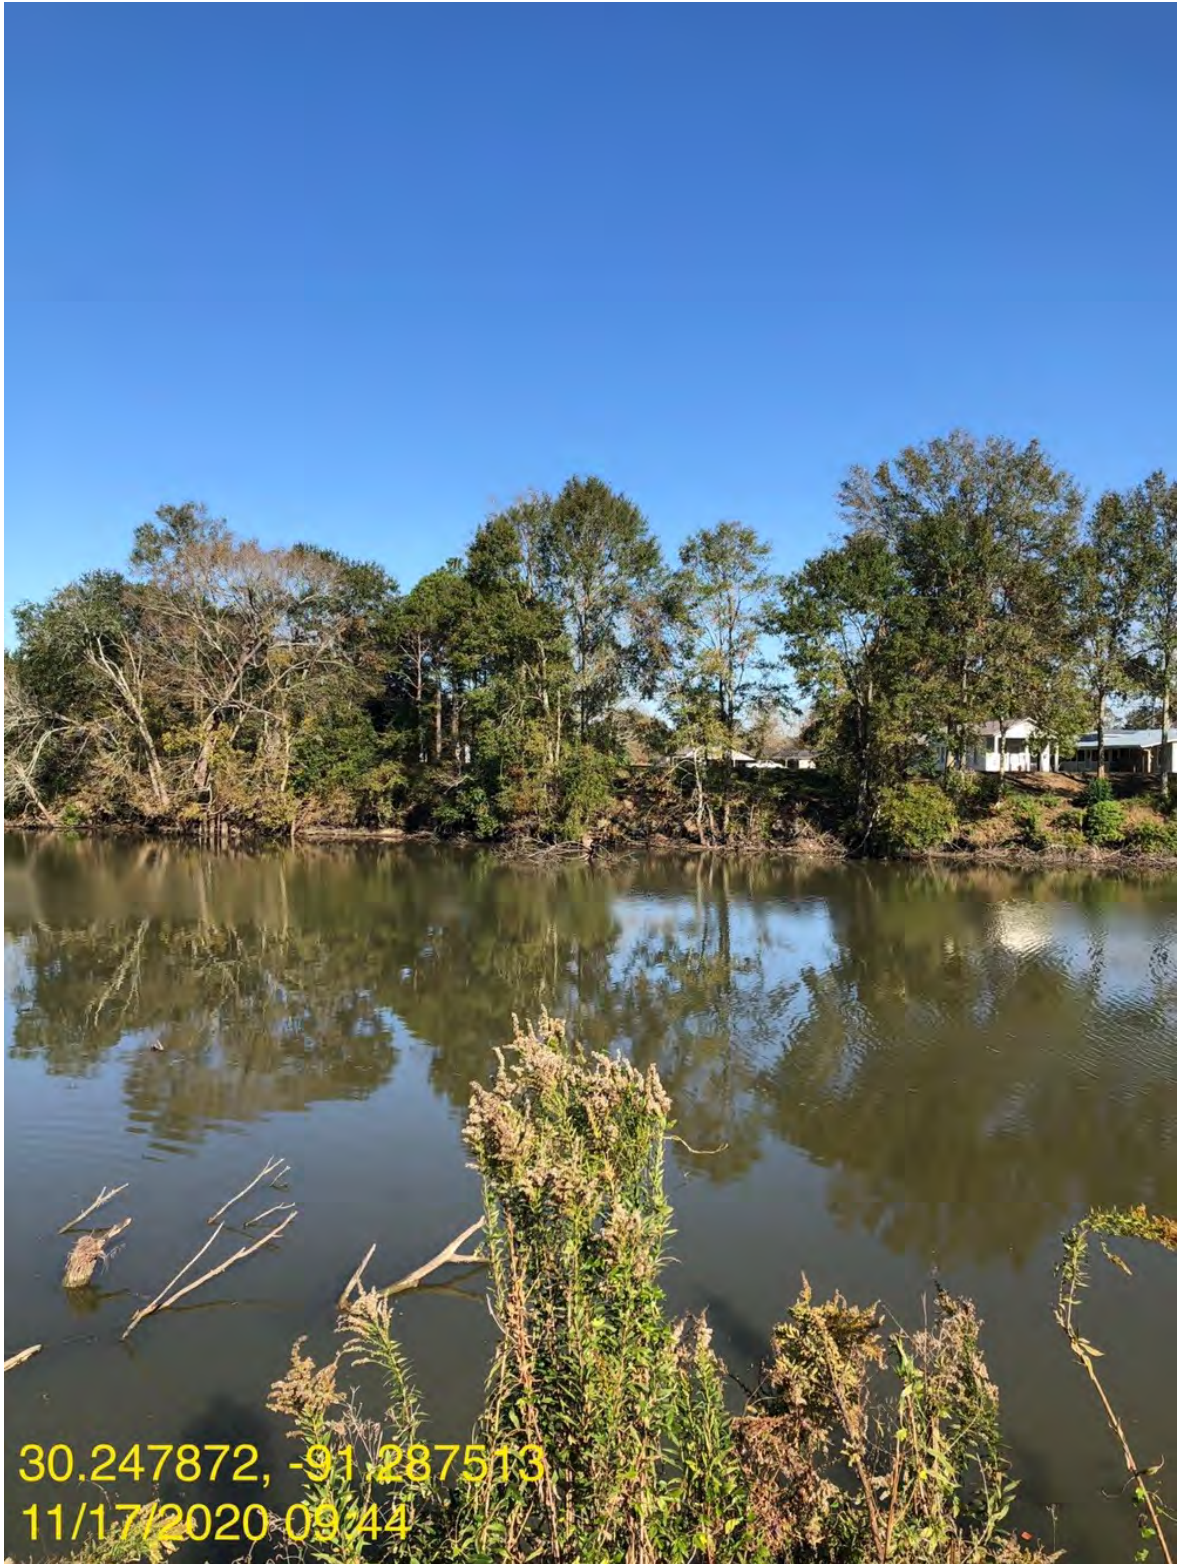
Photograph 2. Facing north. Photograph taken on the southern portion of Bayou Plaquemine (Left descending bank) located on the most eastern portion of the ROW.

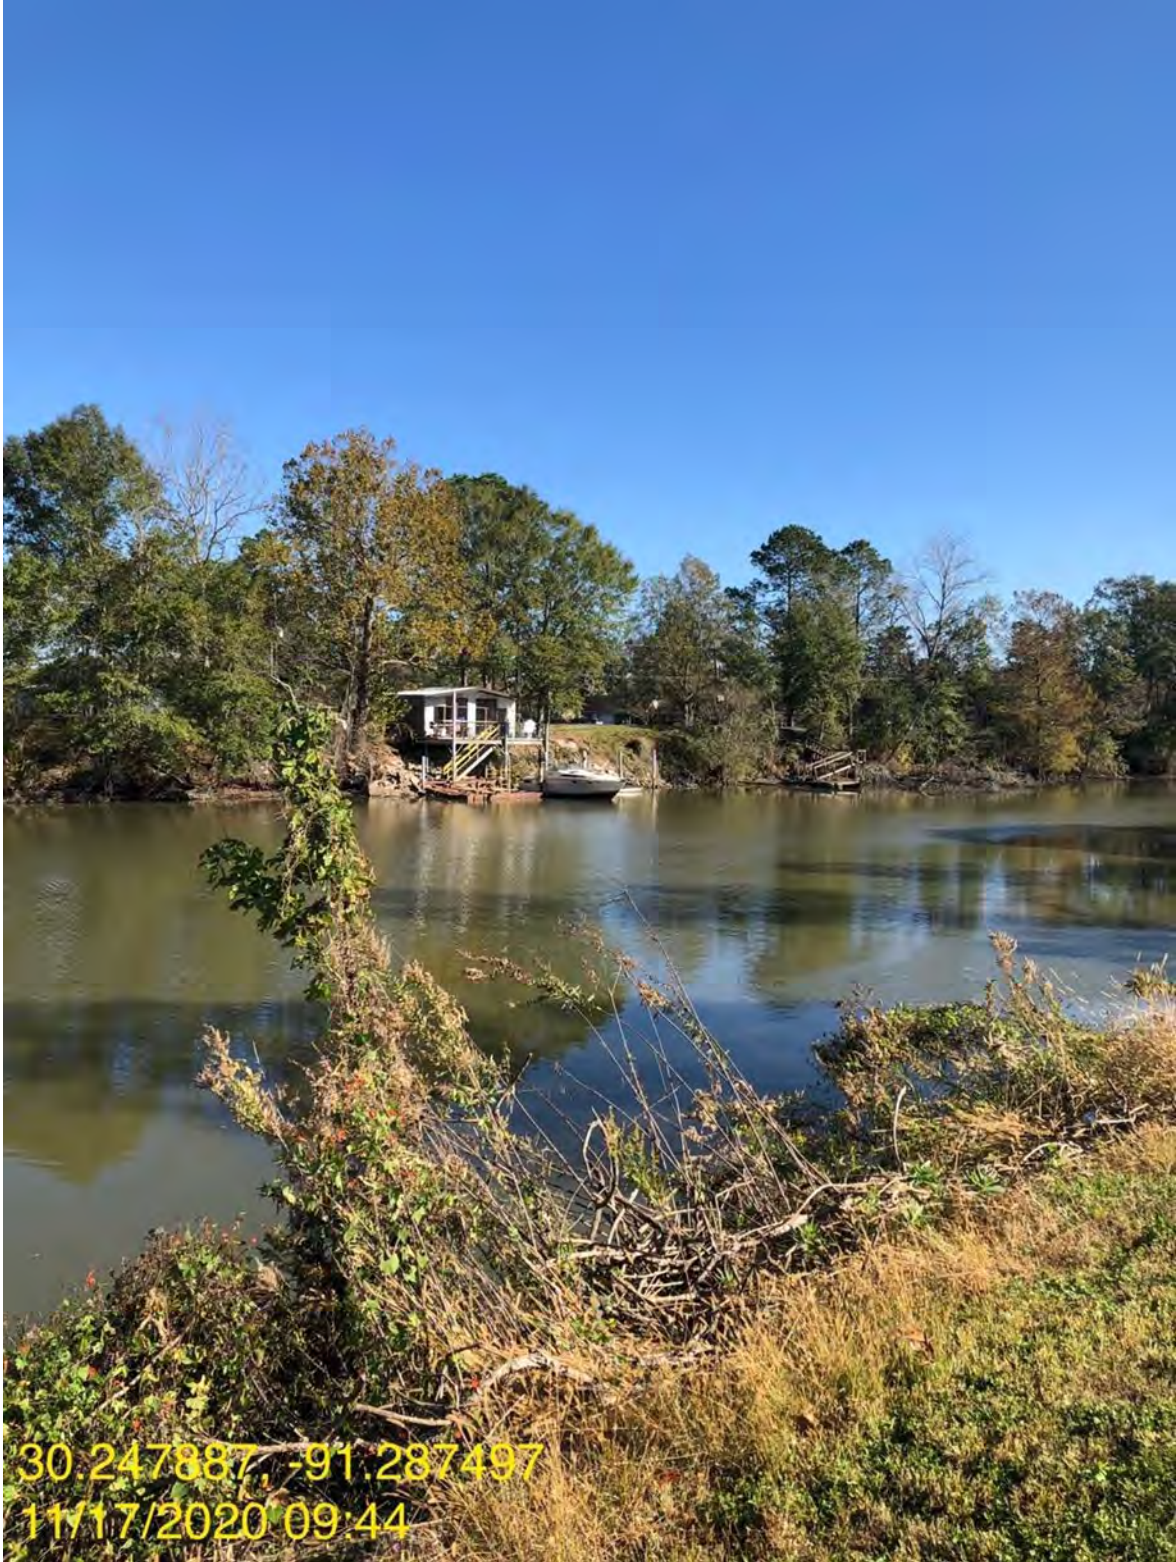
Photograph 3. Facing northeast. Photograph taken on the southern portion of Bayou Plaquemine (Left descending bank) located on the most eastern portion of the ROW.

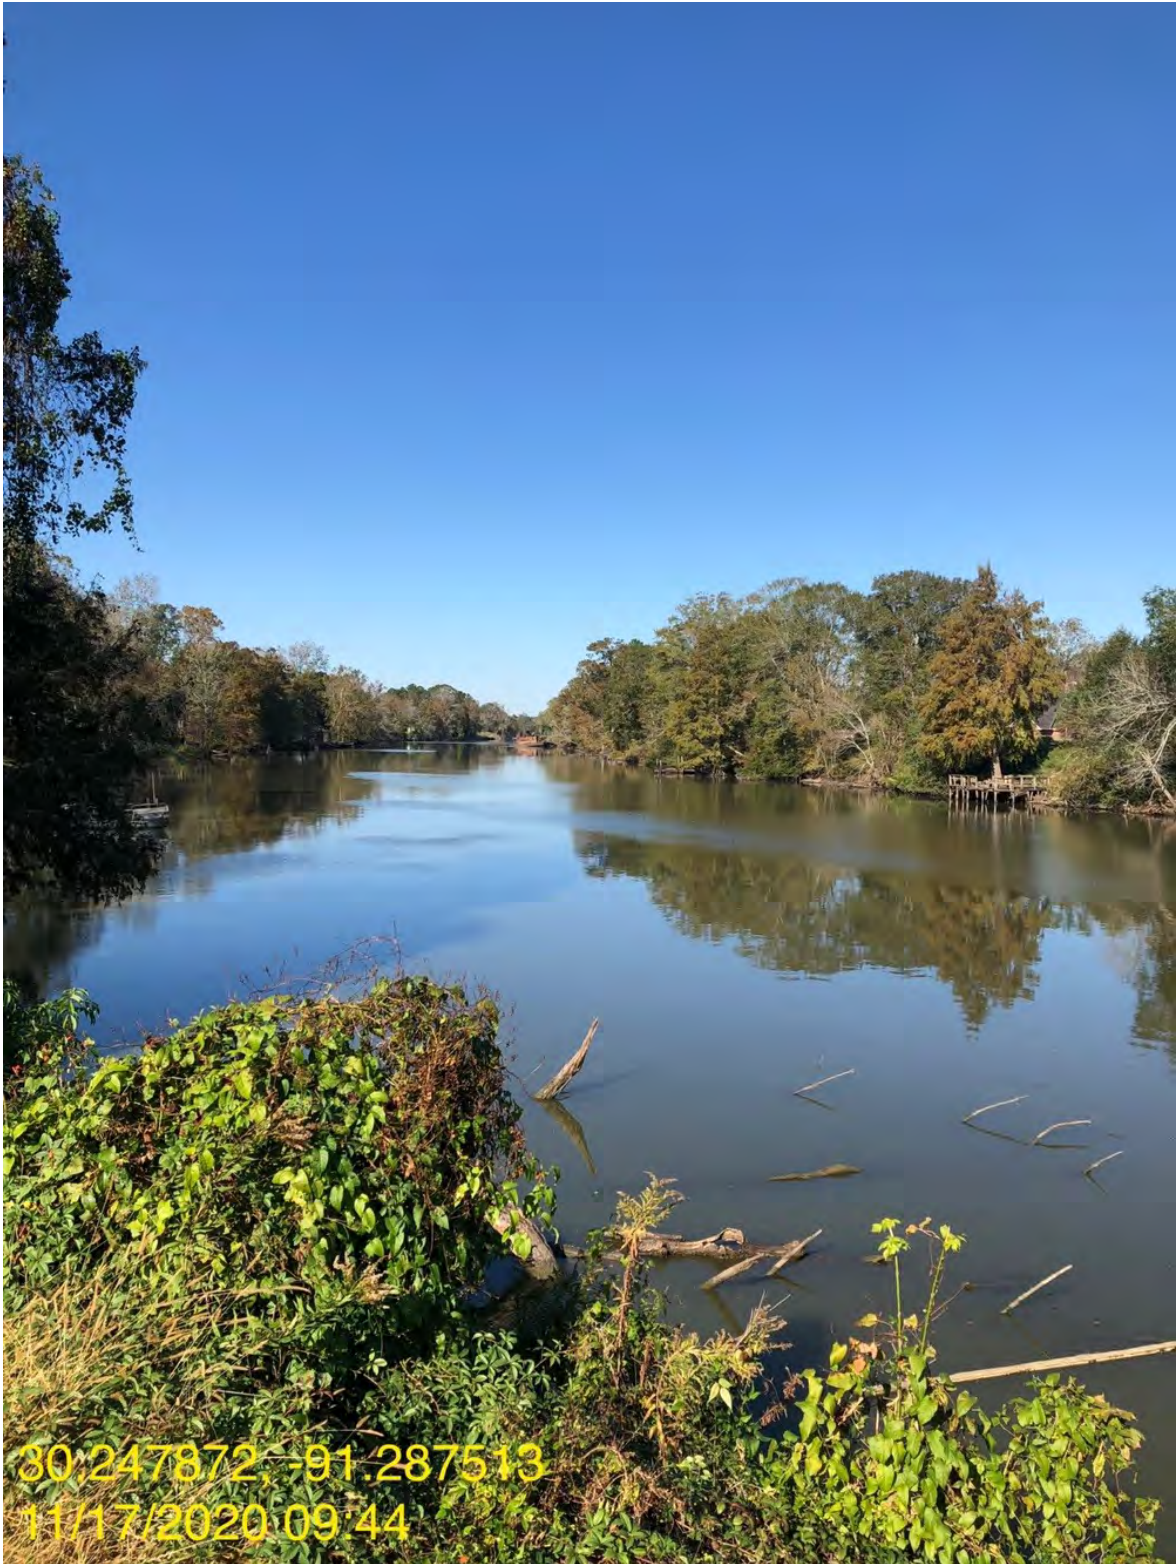
Photograph 4. Facing northwest. Photograph taken on the southern portion of Bayou Plaquemine (Left descending bank) located on the most eastern portion of the ROW. The dilapidated barge can be seen within the middle of the photograph.

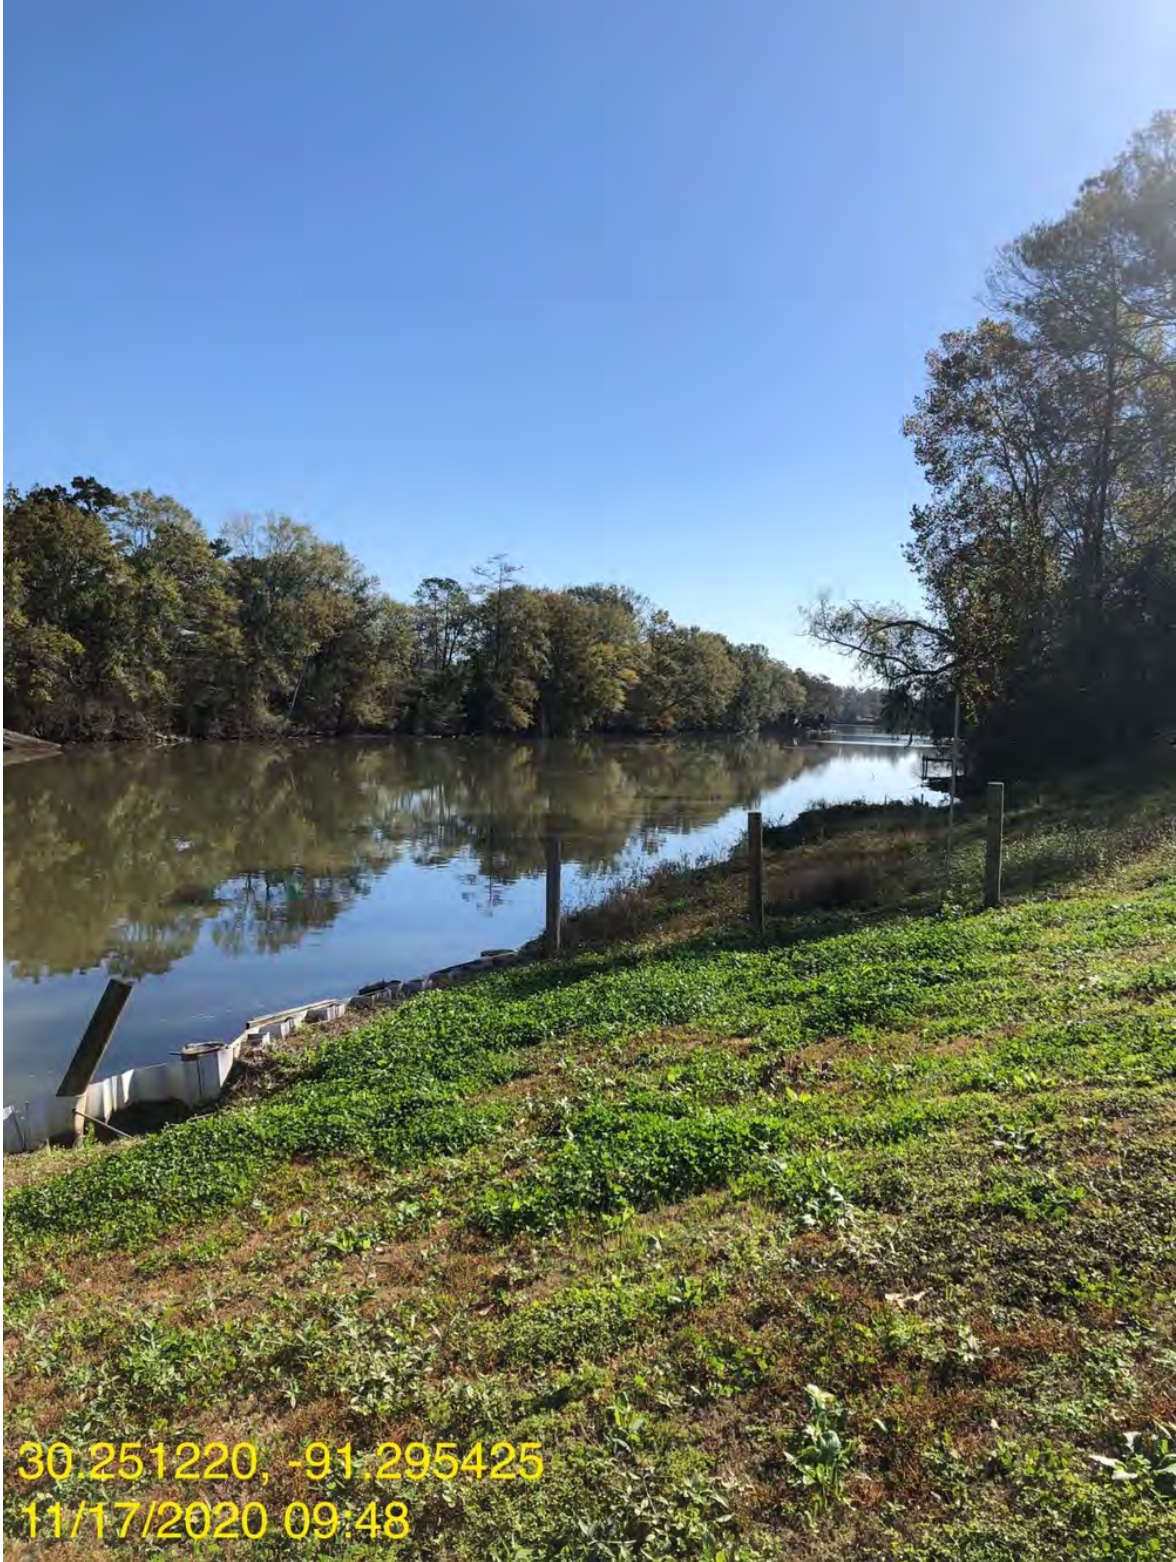
Photograph 5. Facing northeast. Photograph taken on the southern portion of Bayou Plaquemine (Left descending bank) located on the most western portion of the ROW. The dilapidated barge can be seen within the middle of the photograph.

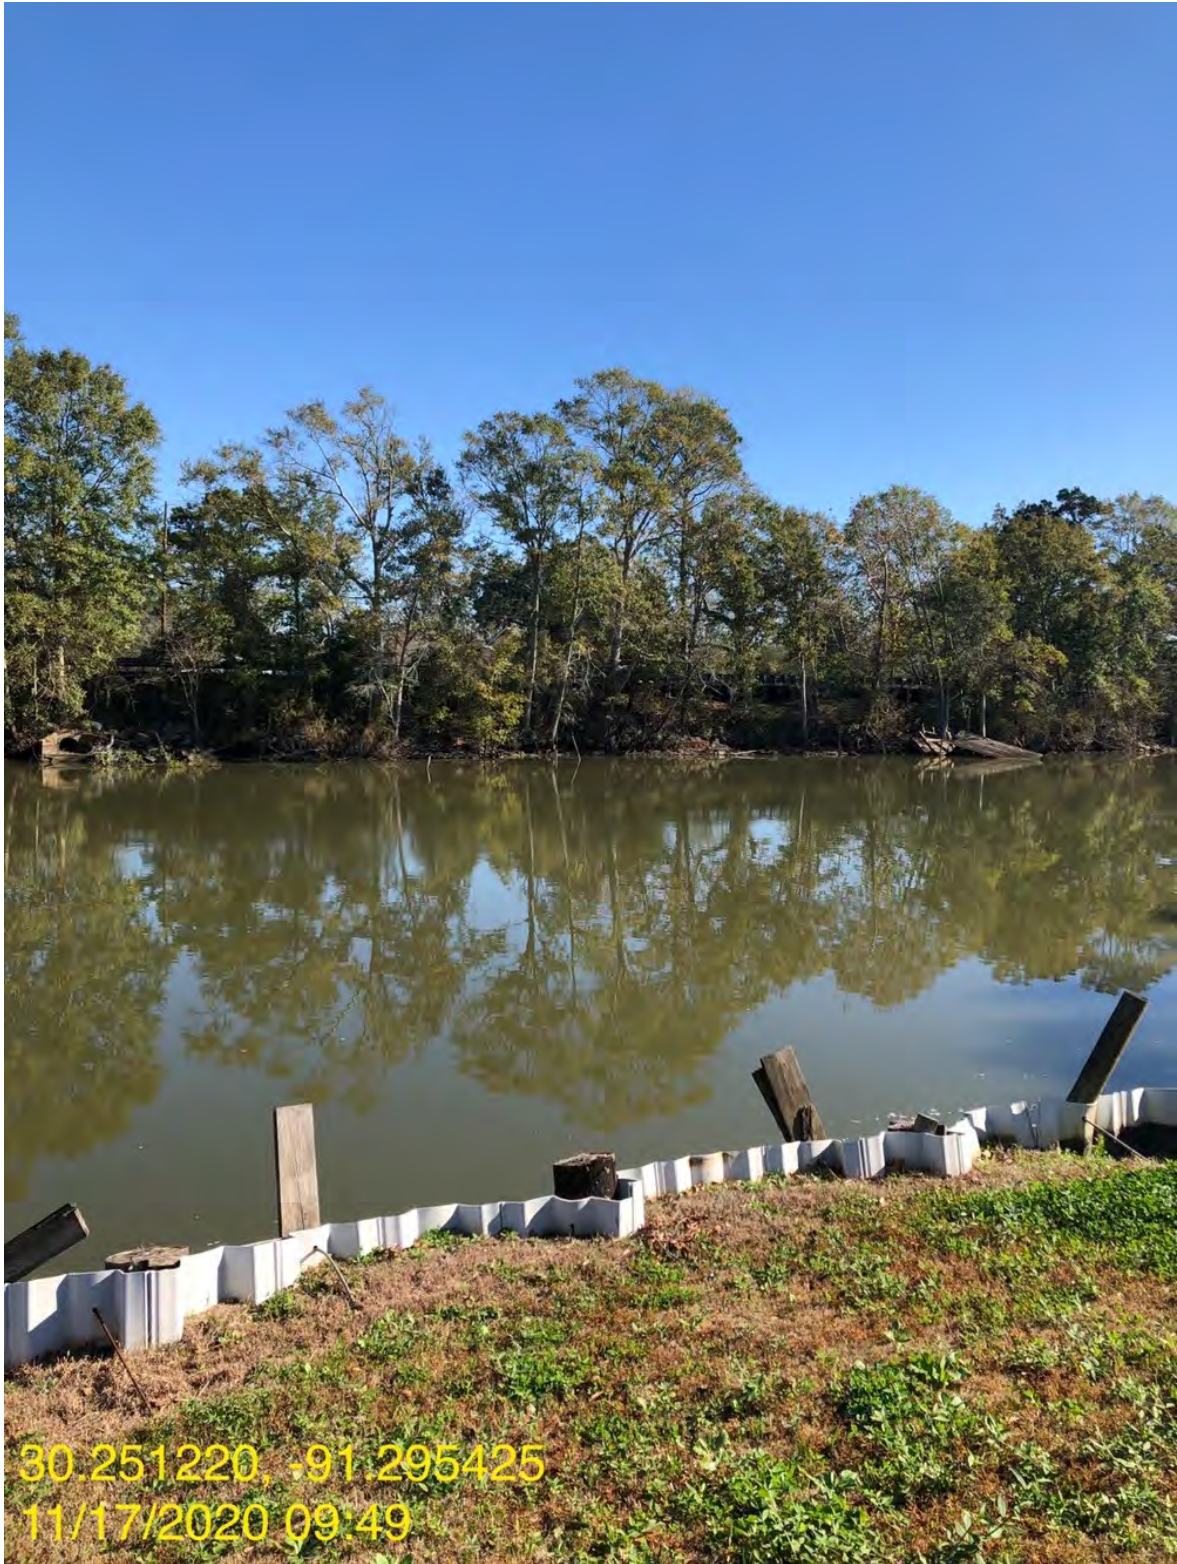
Photograph 6. Facing northeast. Photograph taken on the southern portion of Bayou Plaquemine (Left descending bank) located on the most western portion of the ROW.

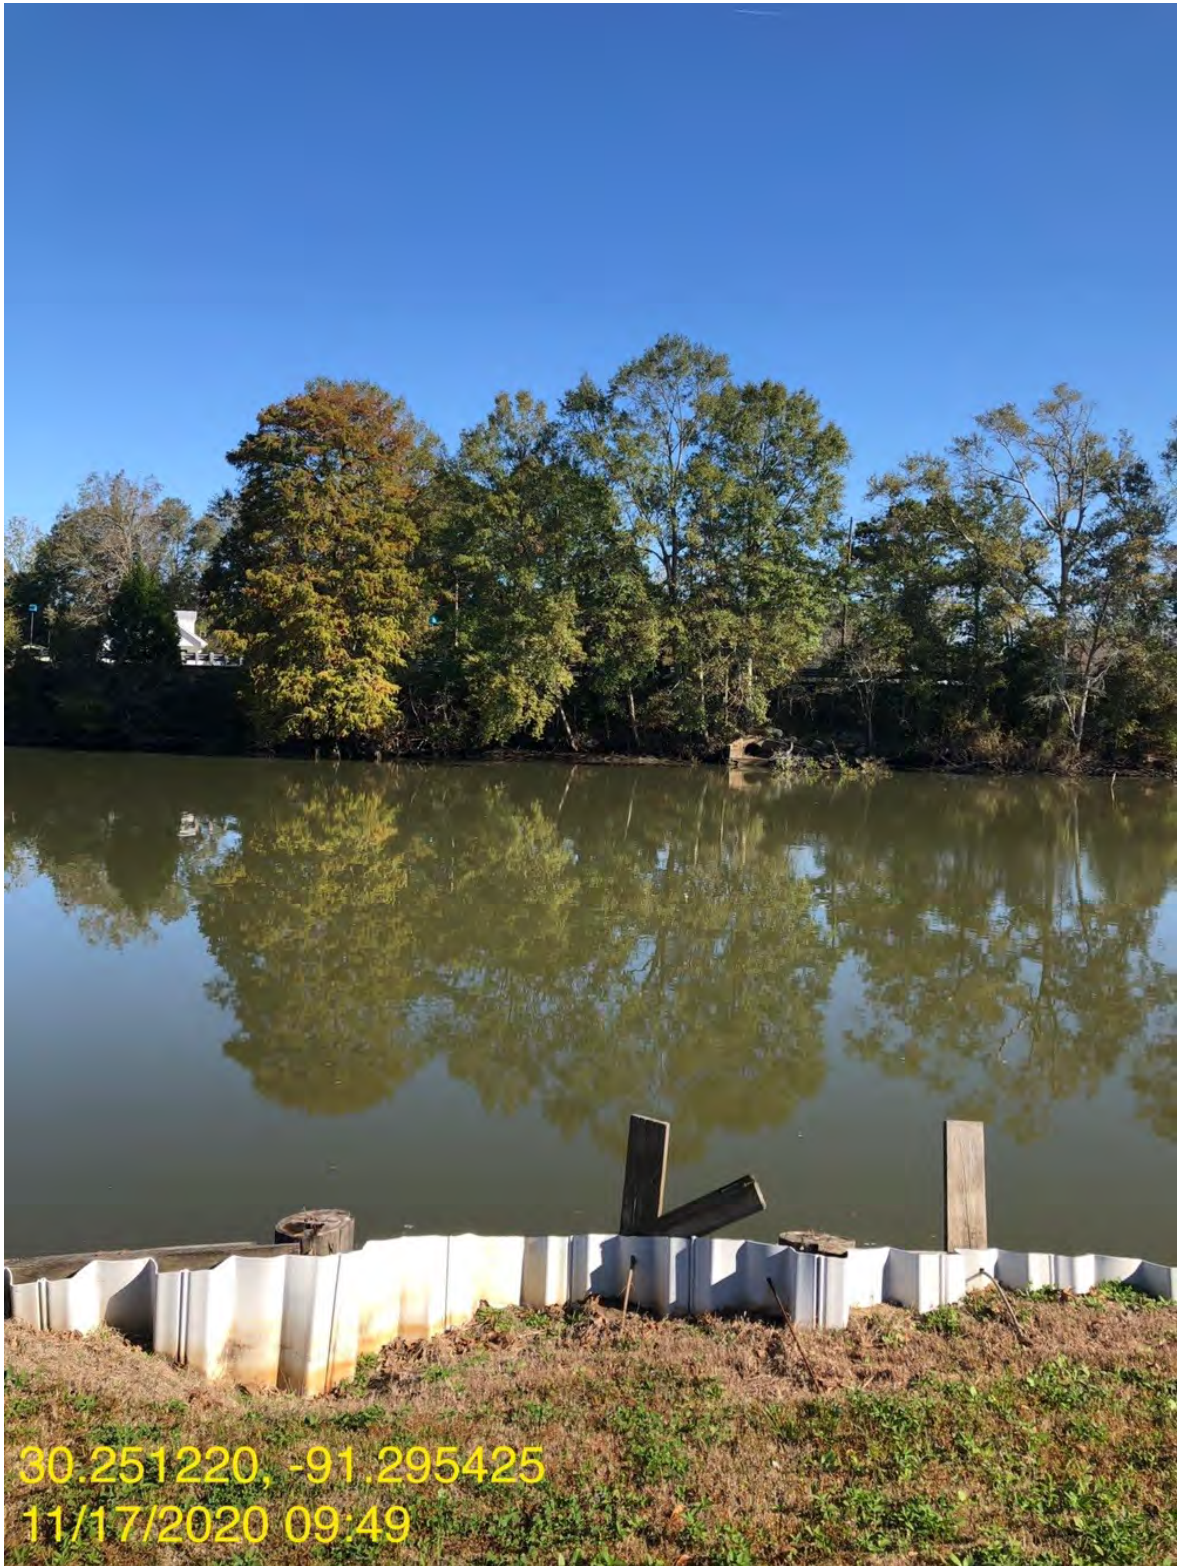
Photograph 7. Facing north. Photograph taken on the southern portion of Bayou Plaquemine (Left descending bank) located on the most western portion of the ROW.
