**FINDING OF NO SIGNIFICANT IMPACT
(FONSI)**

**CONTINUING AUTHORITY PROGRAM, SECTION 14
EMERGENCY STREAMBANK PROTECTION
LOUISIANA HIGHWAY 77 AT BAYOU PLAQUEMINE
IBERVILLE PARISH, LOUISIANA**

EA #587

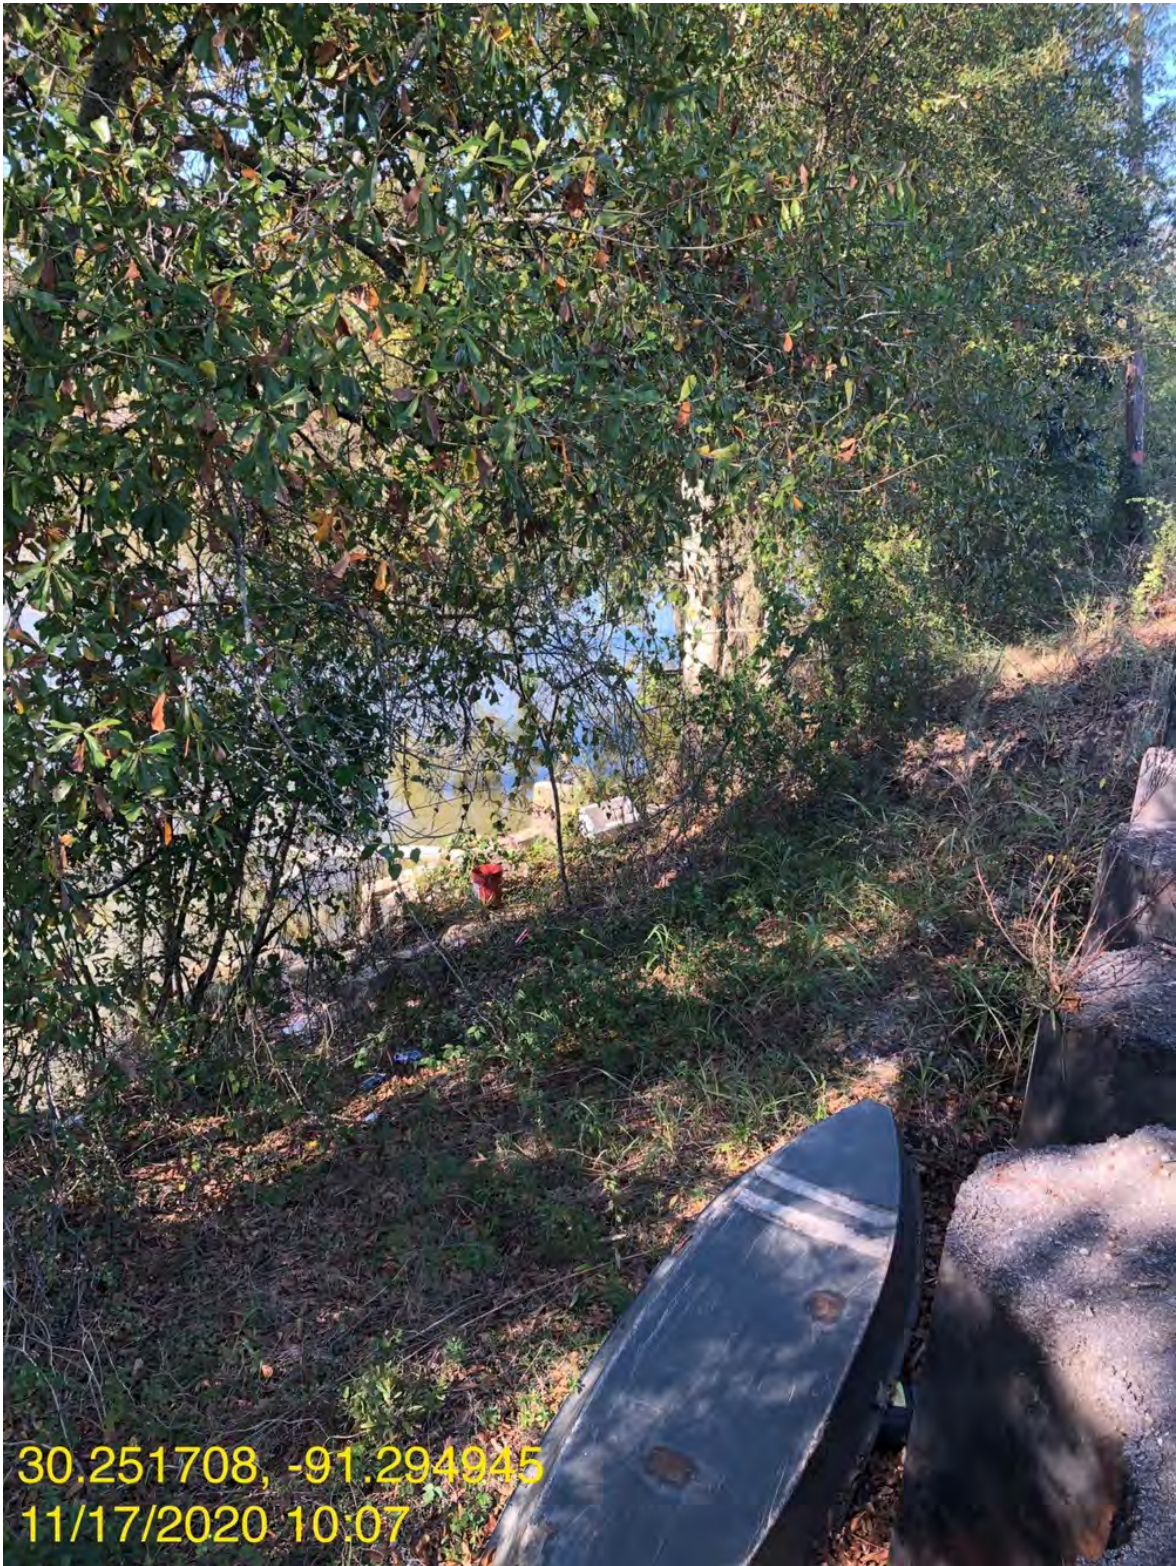
Photograph 8. Facing southwest. Photograph taken on the northern portion of Bayou Plaquemine (right descending bank) located on the most western portion of the ROW.

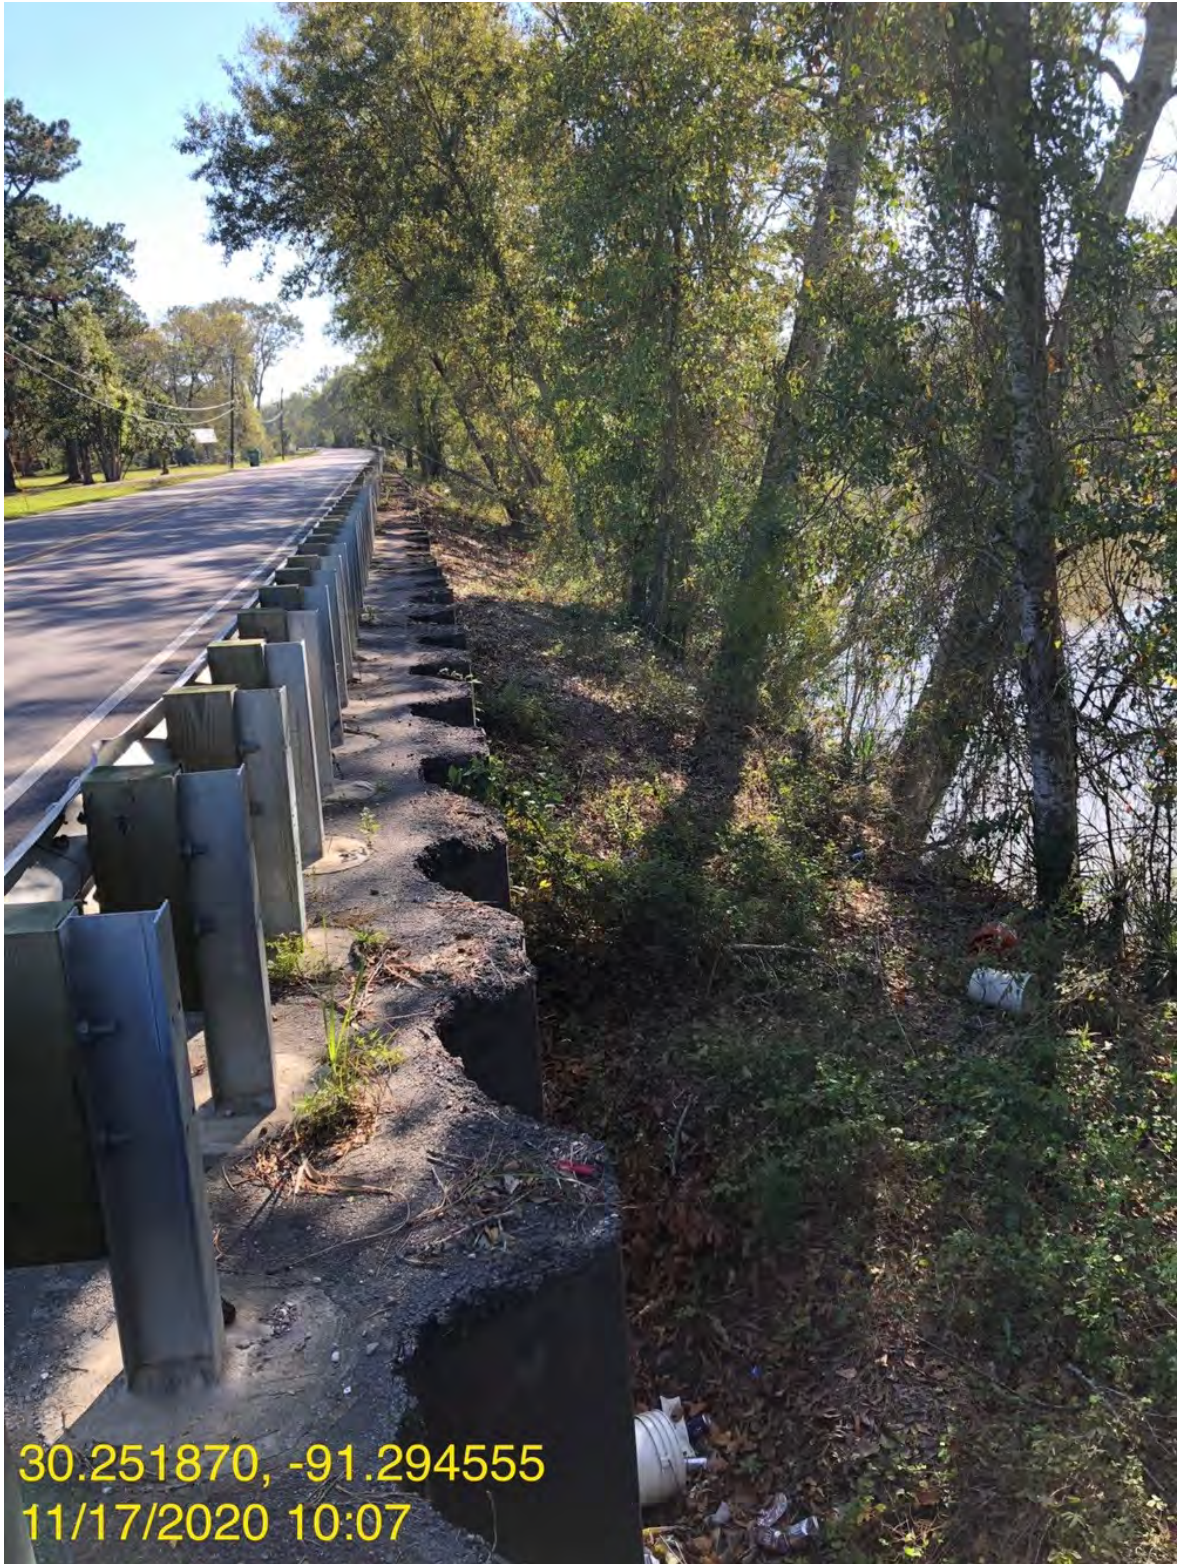
Photograph 9. Facing east. Photograph taken on the northern portion of Bayou Plaquemine (right descending bank) located on the most western portion of the ROW.

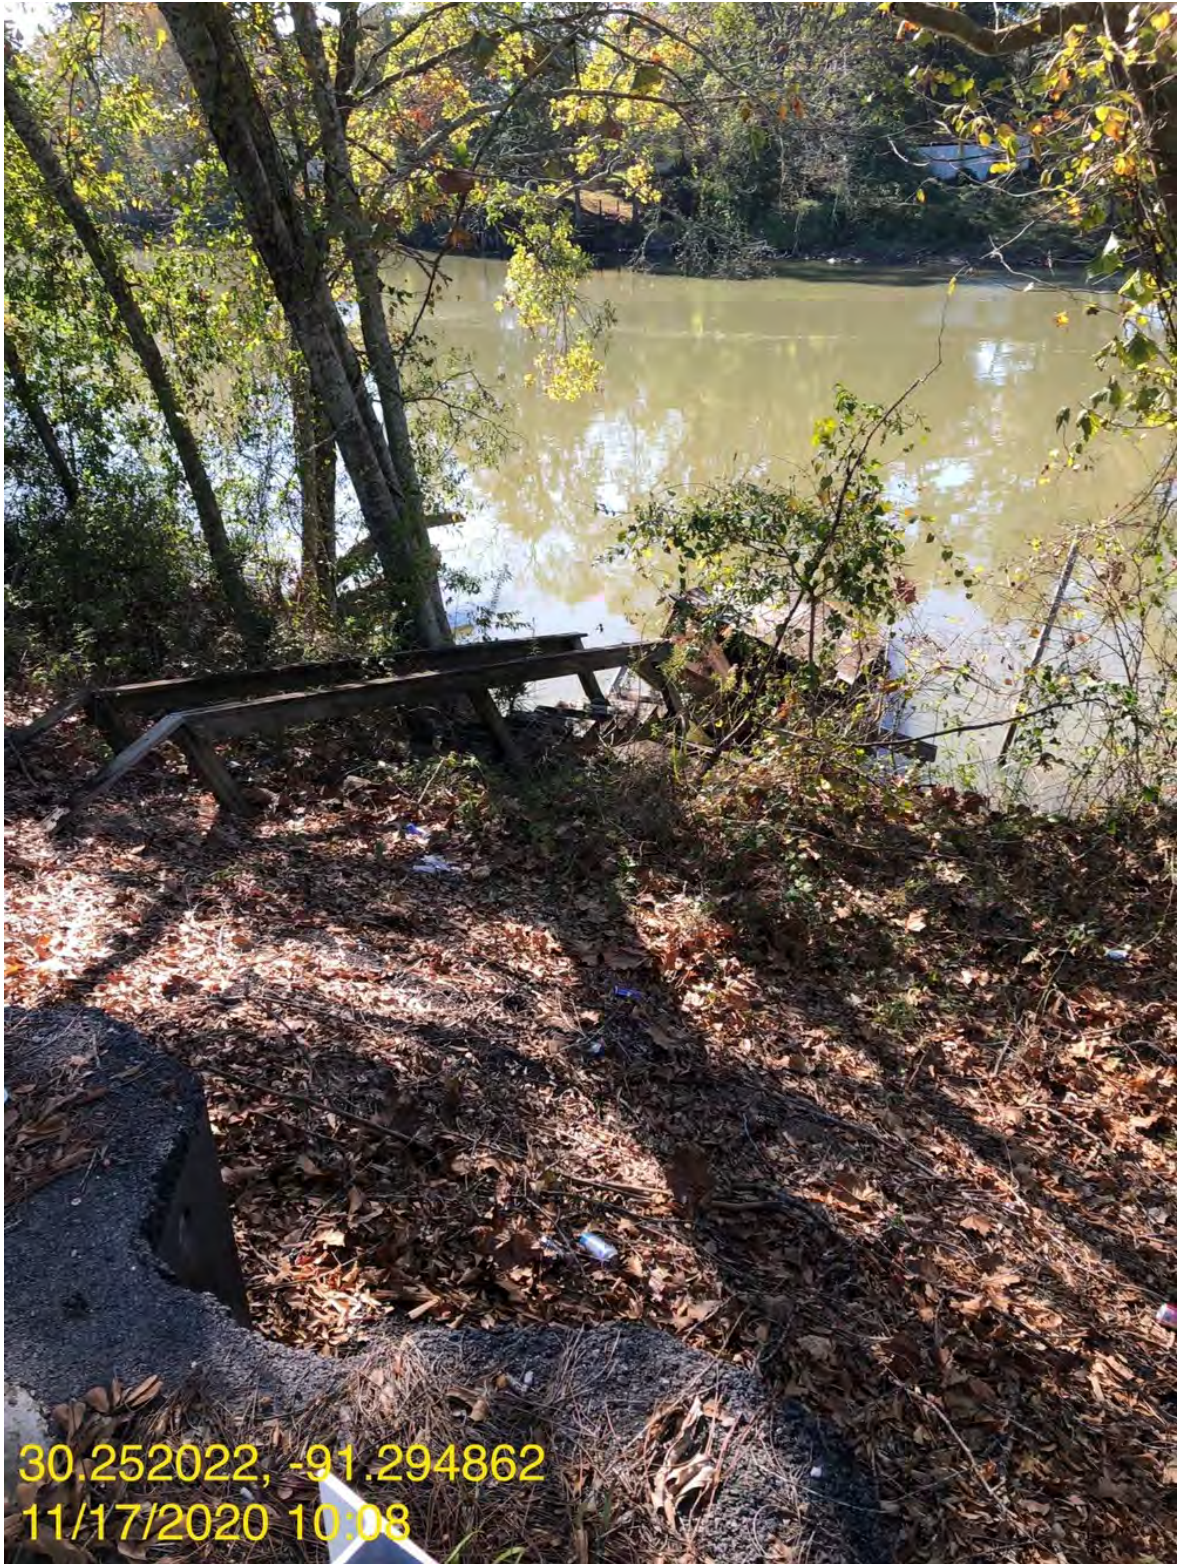
Photograph 10. Facing southeast. Photograph taken on the northern portion of Bayou Plaquemine (right descending bank).

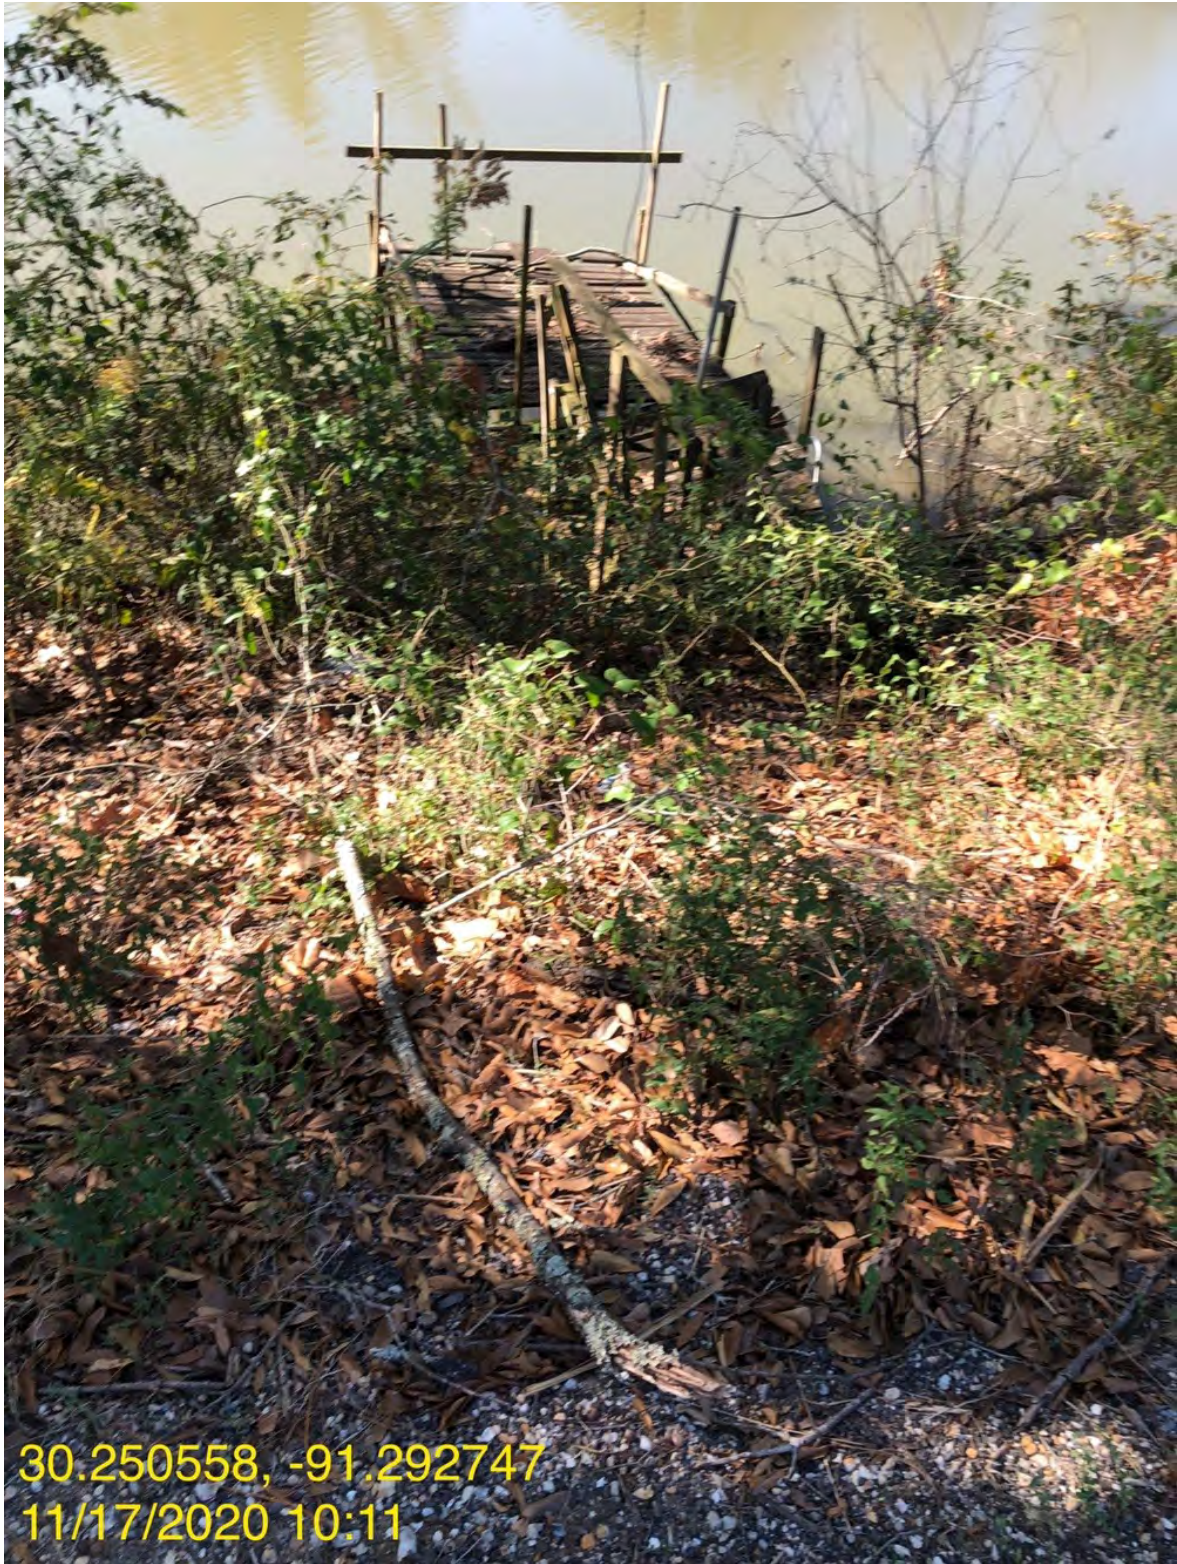
Photograph 11. Facing south. Photograph taken on the northern portion of Bayou Plaquemine (right descending bank).

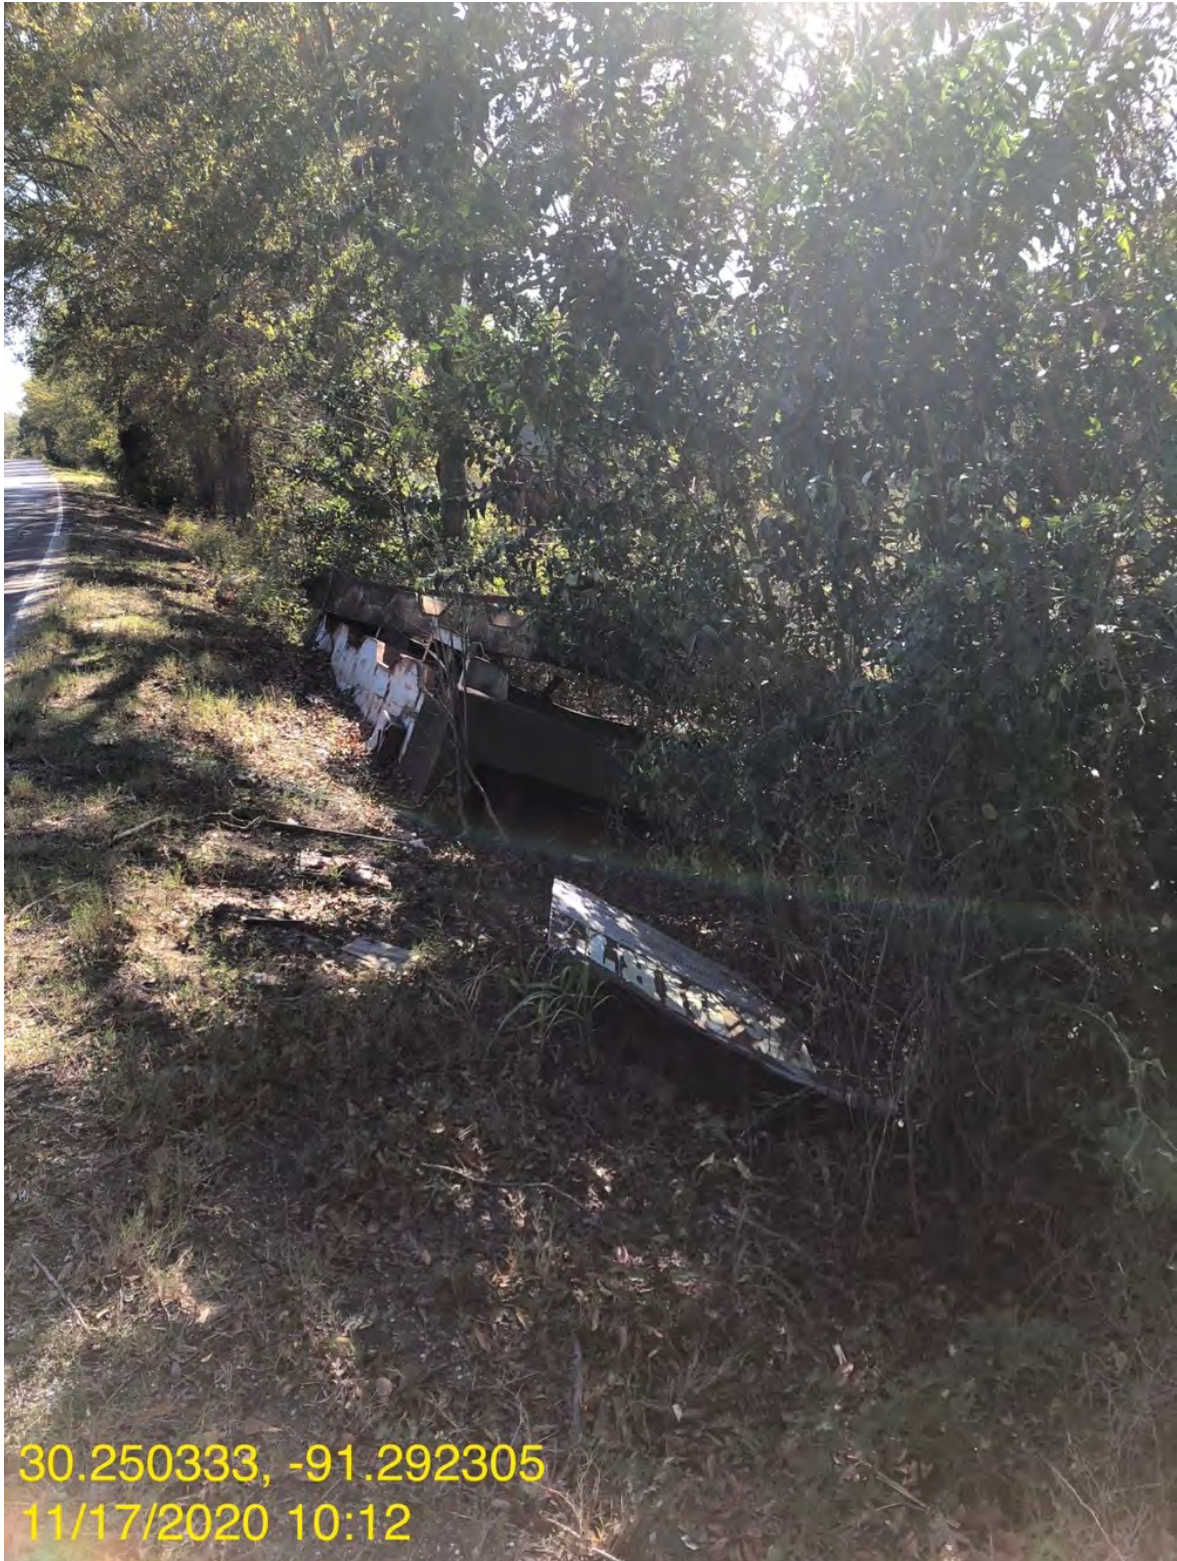
Photograph 12. Facing southeast. Photograph taken on the northern portion of Bayou Plaquemine (right descending bank). Metal support pieces for the dilapidated barge located between Bayou Jacob Road and Bayou Plaquemine.

Personnel from CEMVN-PDC-C performed a field inspection on 17 November 2020 in the proposed work areas within the Bayou Plaquemine area. The area was inspected for the presence of pipes, containers, tanks or drums, ponds or lagoons, car bodies, tires, refrigerators, trash dumps, electrical equipment, oil drilling equipment, gas or oil wells, discoloration of vegetation or soils, water sheens, out-of-place dirt mounds or depressions in the landscape, evidence of fire, stressed soils with lack of vegetation, animal remains, unusual animal behavior, biota indicative of a disturbed environment, and odors indicative of poor water quality or chemical presence. During the site visit, a pipeline was discovered within Bayou Plaquemine on the right descending bank (Photograph 1). In addition to the pipeline, a dilapidated barge (Photographs 16-18) and a sunken structure (Photograph 19) were located on the right descending bank of Bayou Plaquemine. On the dilapidated barge, a 55-gallon steel drum was located and a 55-gallon propylene drum was located between the barge and Bayou Jacob Road (Photograph 16-18). No other indicators above were found during the site visit.

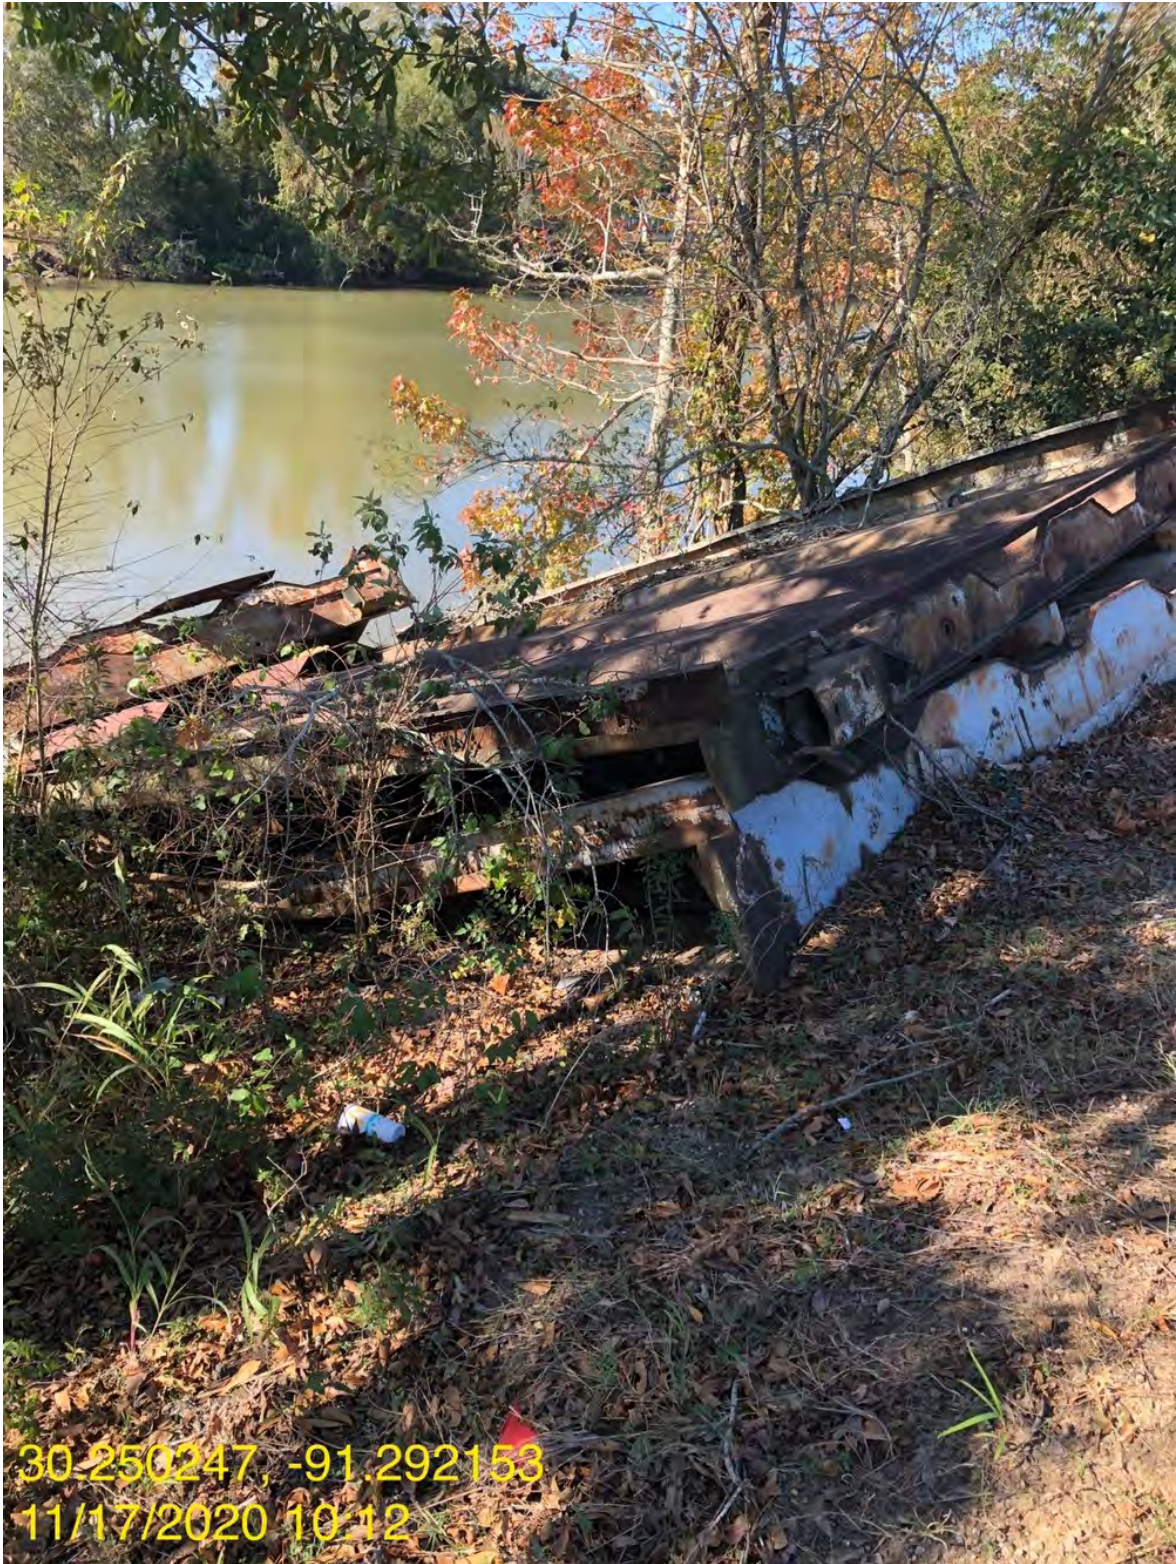
Photograph 13. Facing southwest. Photograph taken on the northern portion of Bayou Plaquemine (right descending bank). Metal support pieces for the dilapidated barge located between Bayou Jacob Road and Bayou Plaquemine.

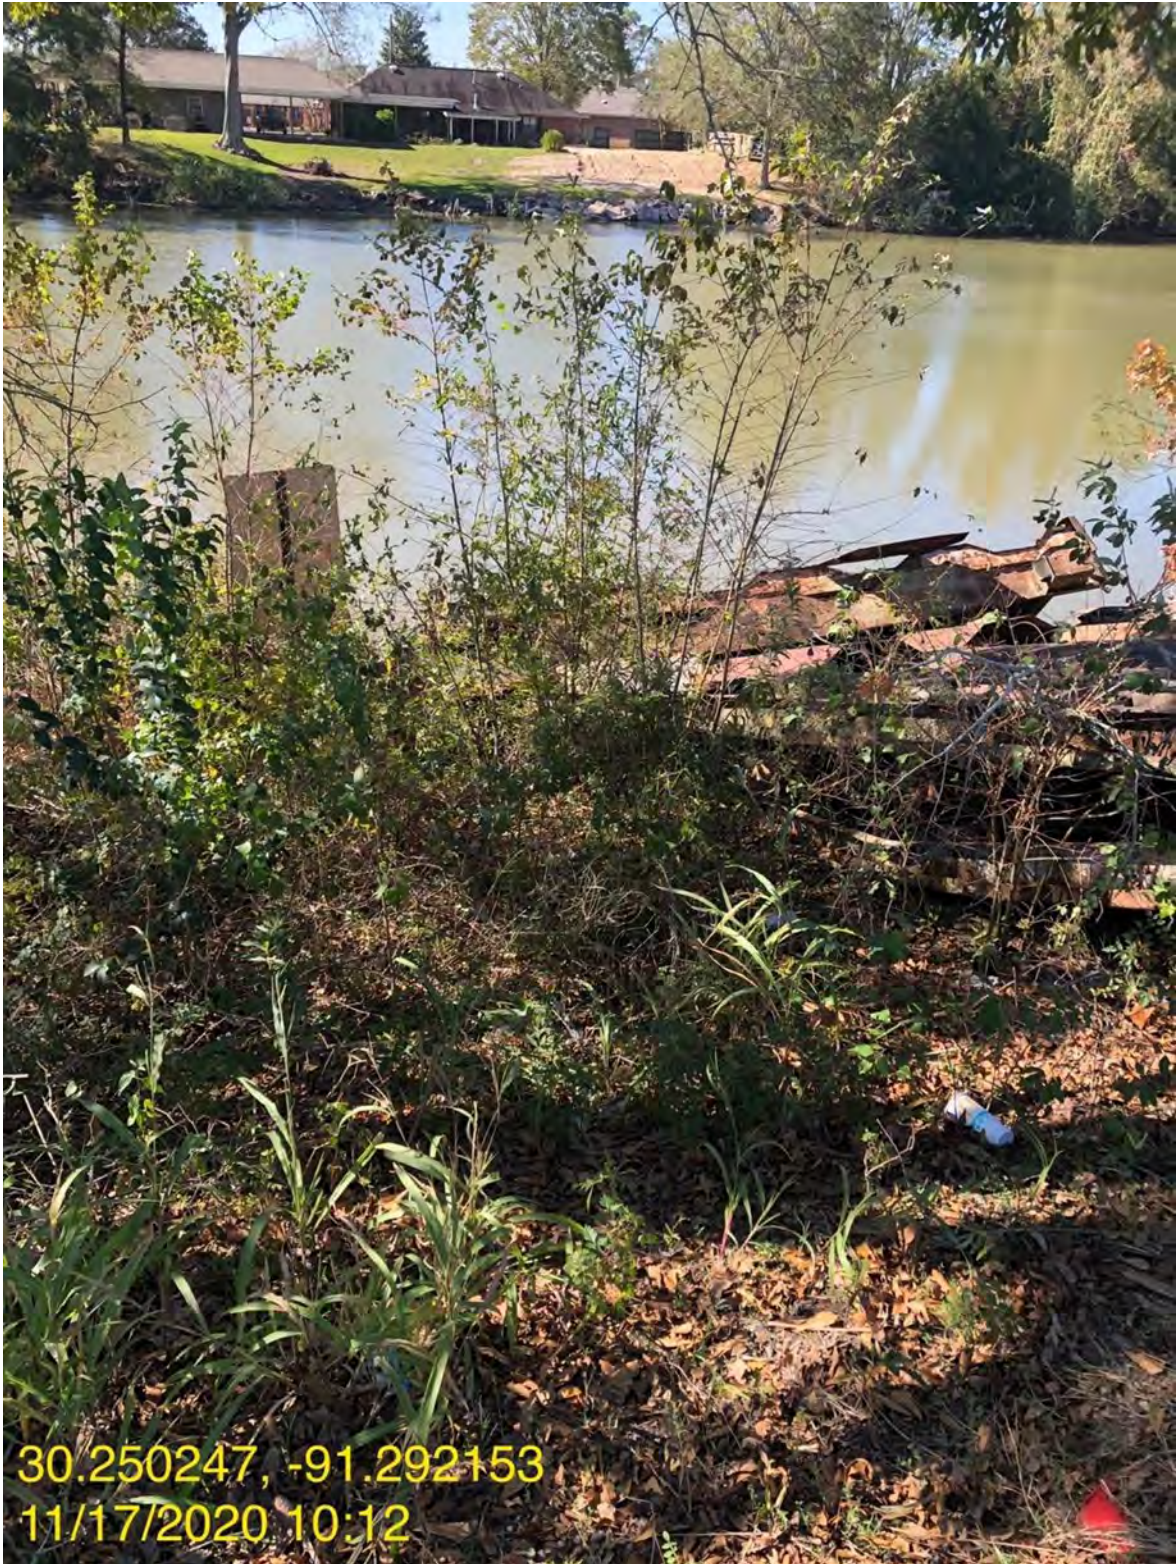
Photograph 14. Facing southwest. Photograph taken on the northern portion of Bayou Plaquemin (right descending bank). Metal support pieces for the dilapidated barge located between Bayou Jacob Road and Bayou Plaquemin.

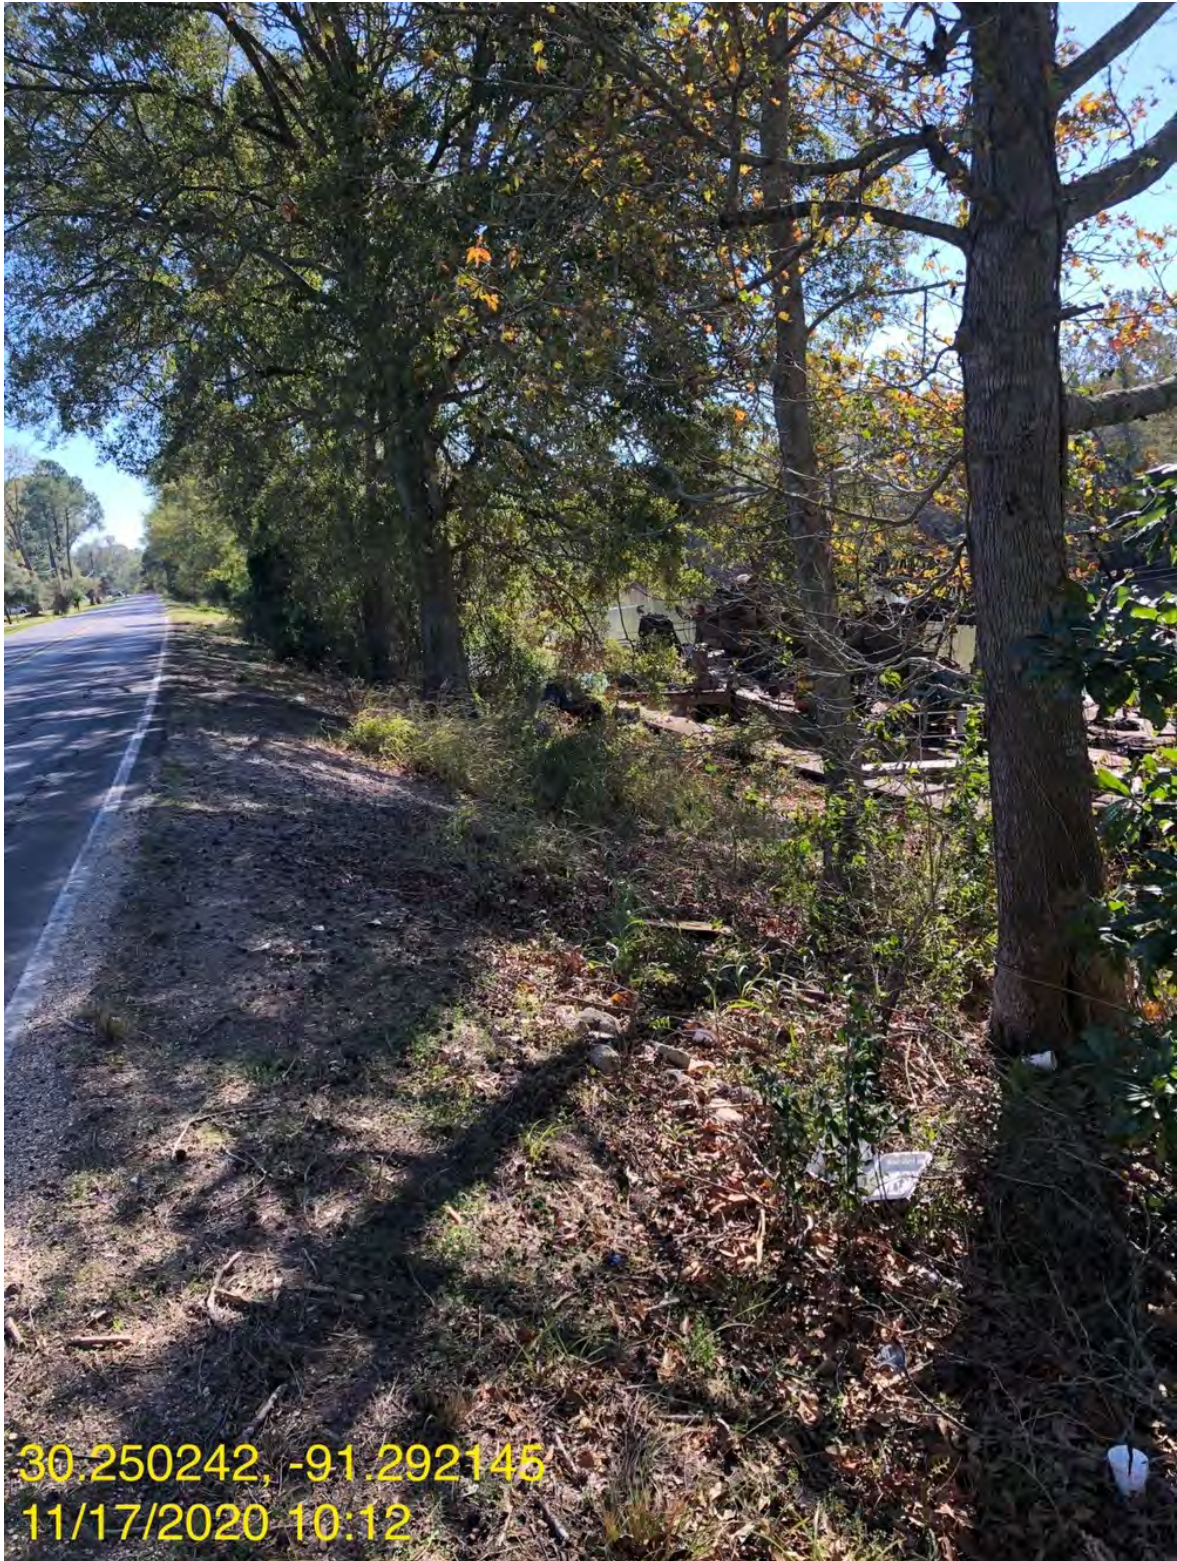
Photograph 15. Facing southeast. Photograph taken on the northern portion of Bayou Plaquemine (right descending bank). Metal support pieces for the dilapidated barge located between Bayou Jacob Road and Bayou Plaquemine. The dilapidated barge can be seen within the right side of this photograph.

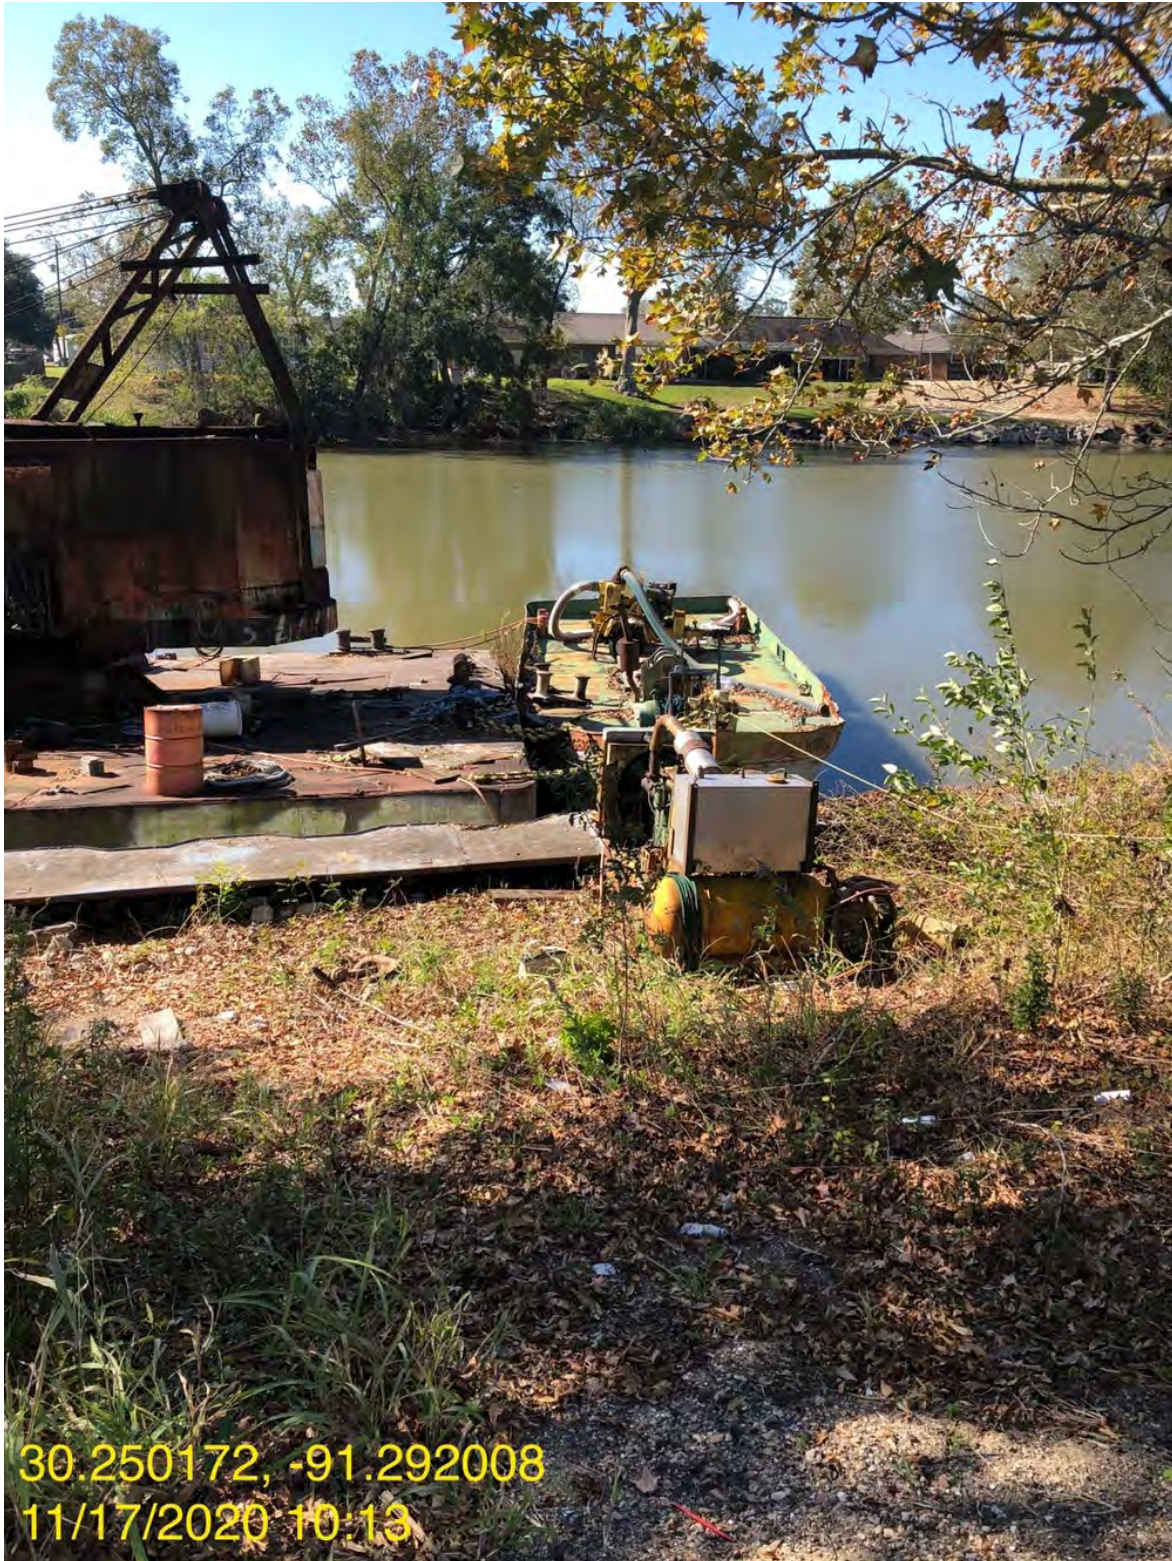
Photograph 16. Facing south. Photograph taken on the northern portion of Bayou Plaquemine (right descending bank). Dilapidated barge located within Bayou Plaquemine. A 55-gallon steel drum and other canisters can be seen on the barge. Machinery can be seen on the bank as well.

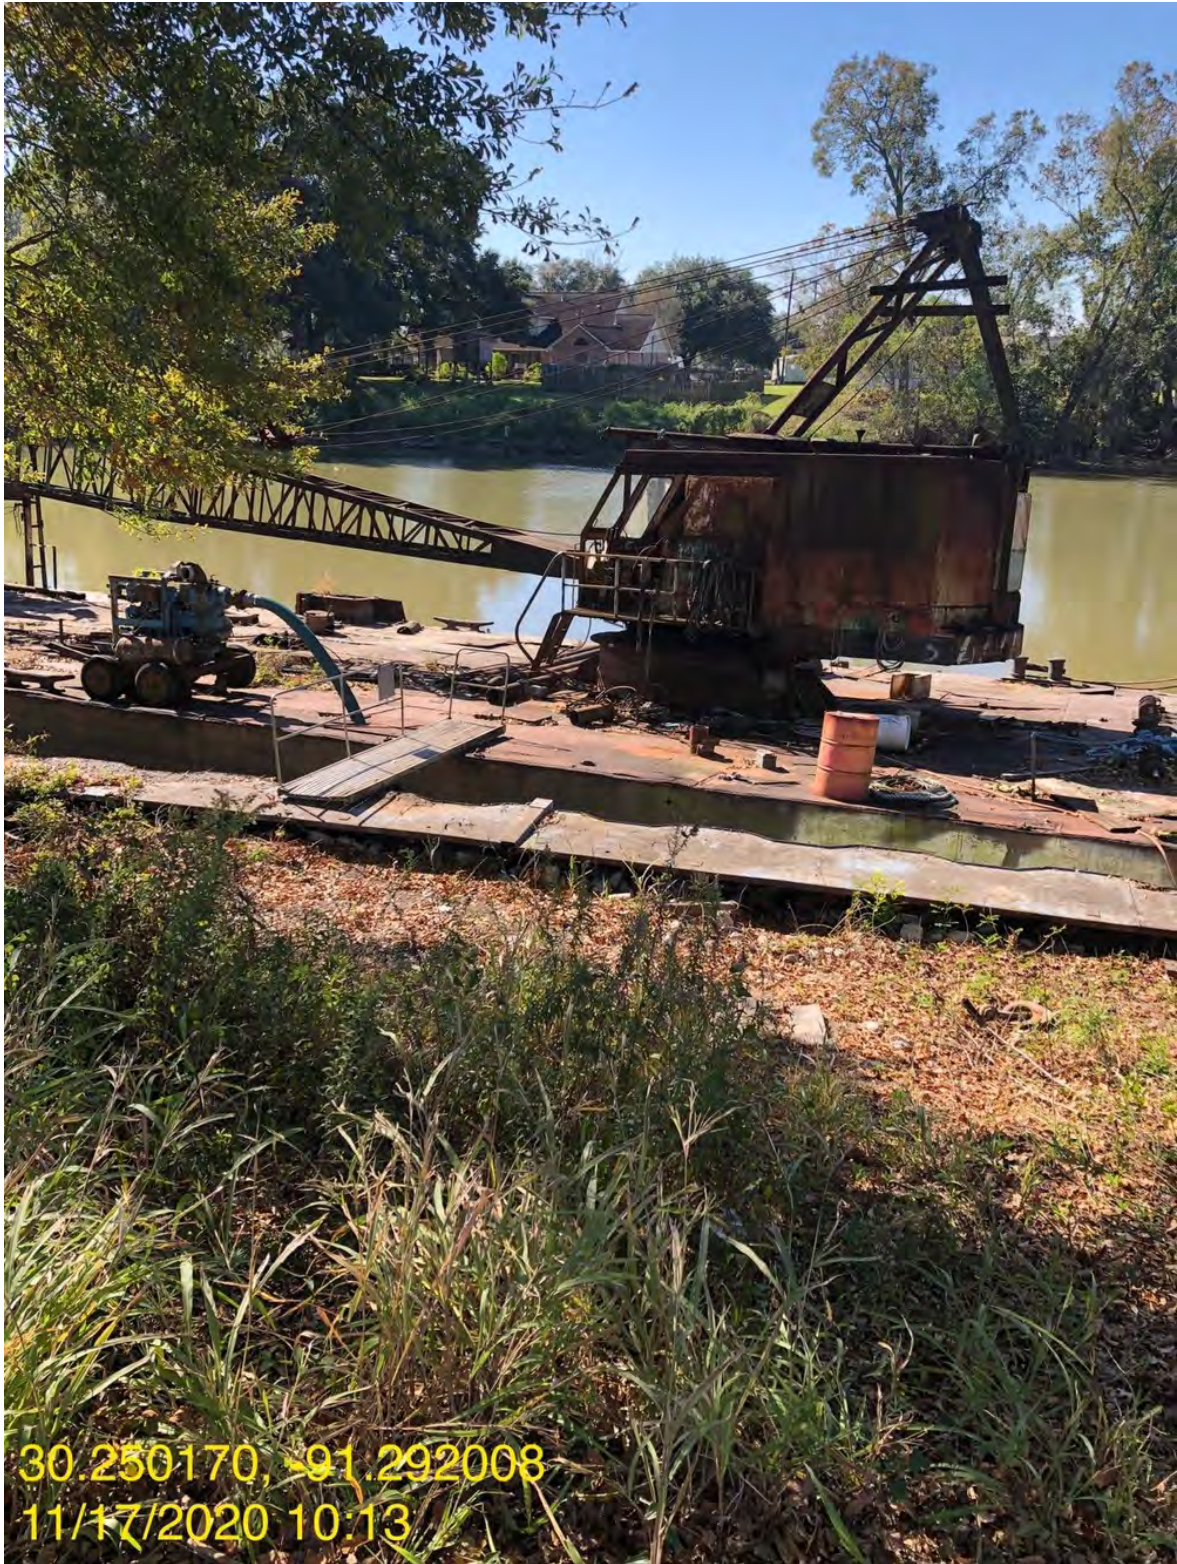
Photograph 17. Facing south. Photograph taken on the northern portion of Bayou Plaquemine (right descending bank). Dilapidated barge located within Bayou Plaquemine. A 55-gallon steel drum and other canisters can be seen on the barge.

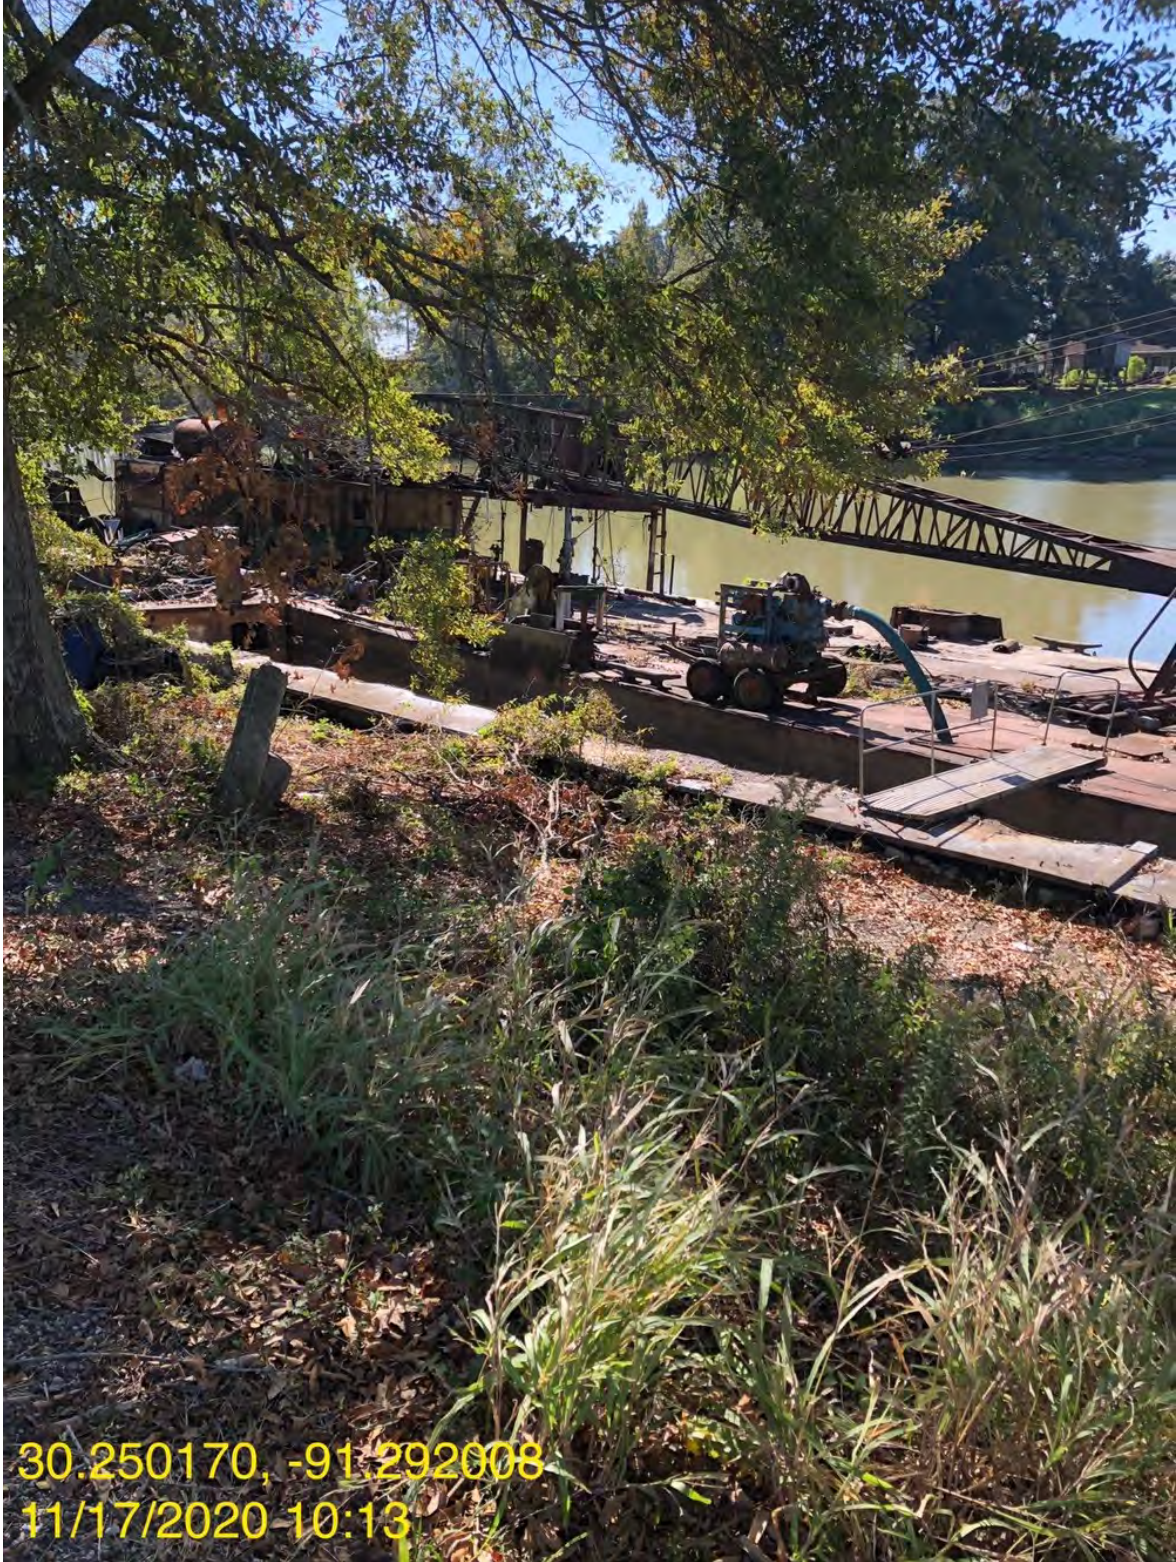
Photograph 18. Facing southeast. Photograph taken on the northern portion of Bayou Plaquemine (right descending bank). Dilapidated barge located within Bayou Plaquemine. A 55-gallon propylene drum and other canisters can be seen on the barge and on land.

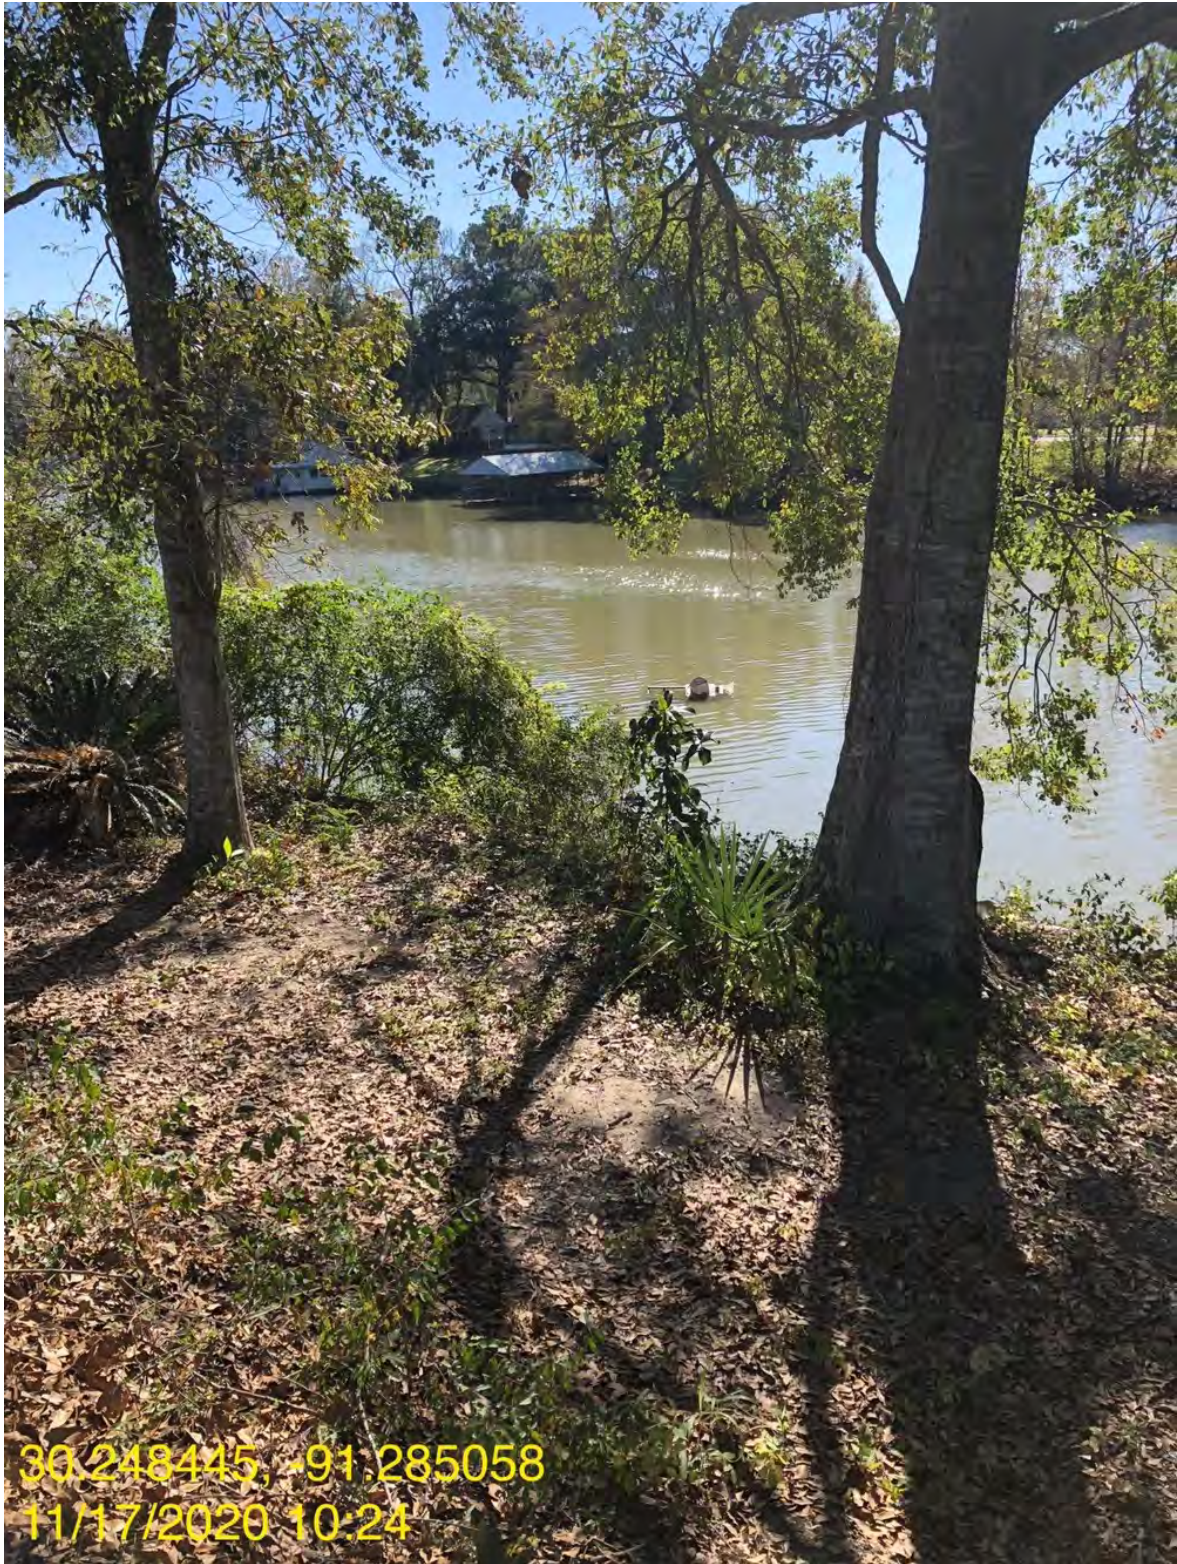
Photograph 19. Facing southeast. Photograph taken on the northern portion of Bayou Plaquemine (right descending bank) located on the most eastern portion of the ROW. Unknown metal structure within Bayou Plaquemine.
