St. Tammany Parish, Louisiana Feasibility Study

Appendix C – Annex F - ESA Phase I Report

**PHASE I
ENVIRONMENTAL SITE ASSESSMENT**

**St. Tammany Parish Louisiana Feasibility Study,
St. Tammany Parish, Louisiana
March 2023**

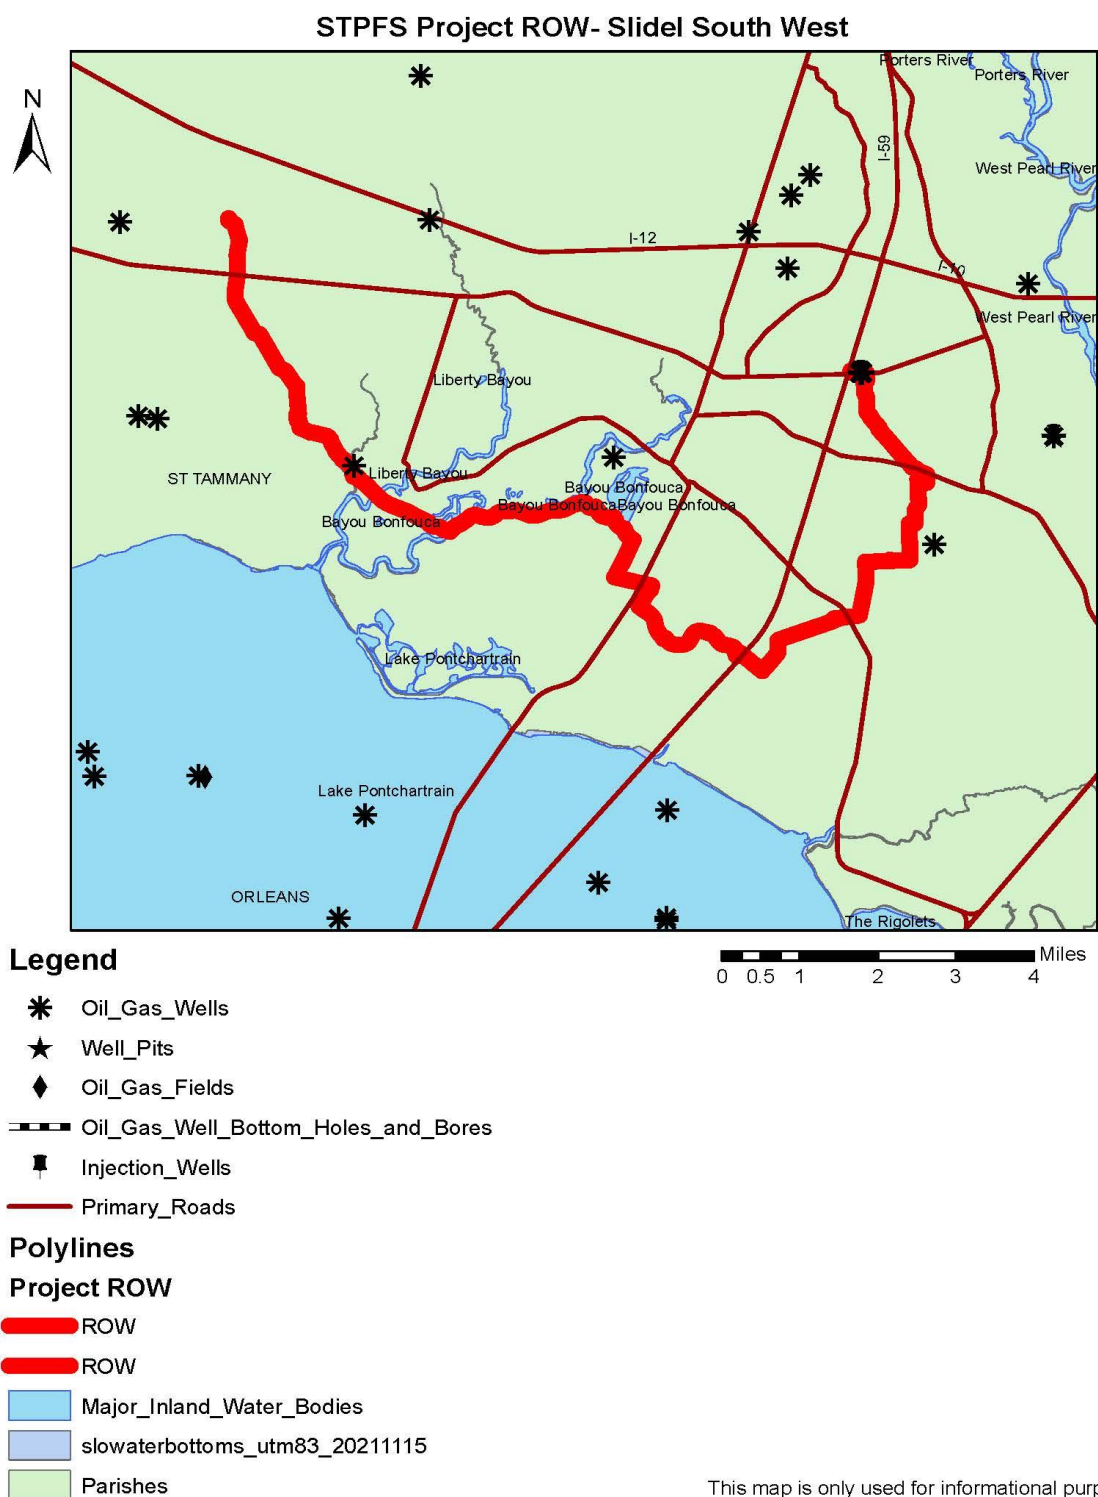
Figure 8: St. Tammany Parish Louisiana Feasibility Study South and West Slidell: Oil and Gas

Several pipelines and oil and gas wells (i.e., petroleum and natural gas) were noted to be in the Project area. Pipelines and oil and gas wells should be avoided if encountered during construction of the project. Oil and Gas wells were found within a one-mile radius of the project area. (Figures 1-7). One oil and gas well titled “A A MAYER ETAL”, well serial number 73323, located at Latitude 30.269801 and Longitude -89.856274 was found 65 meters east of the Slidell ROW near Liberty Bayou. This oil & gas well is labeled as inactive with no reported releases. One oil and gas well titled “BONNIE JEAN PERSCHALL ET AL”, well serial number 189047, located at Latitude 30.251563 and Longitude -89.732318 was found 506 meters east of the Slidell ROW. This oil & gas well is labeled as plugged and abandoned with no reported releases. Ten oil and gas wells were found 12 meters from the most northern portion of the Slidell ROW located at Latitude 30.285191 and Longitude -89.746984. The well serial number for each oil gas are 974356, 974359, 974364, 974357, 974358, 974360, 974362, 974363, 974365, 974361. Each well is listed under RaceTrac Petroleum, Inc and are labeled as plugged and abandoned. One oil and gas well titled “R S RUSS ETAL”, well serial number 620111, located at 30°15'59.58"N, 89°34'36.26"W was found south of the Mississippi borrow location: 30°16'12.59"N, 89°34'42.73"W. Though oil and gas wells were found within close proximity of the ROW, the desktop search found that these areas of concerns pose a low probability of HTRW.

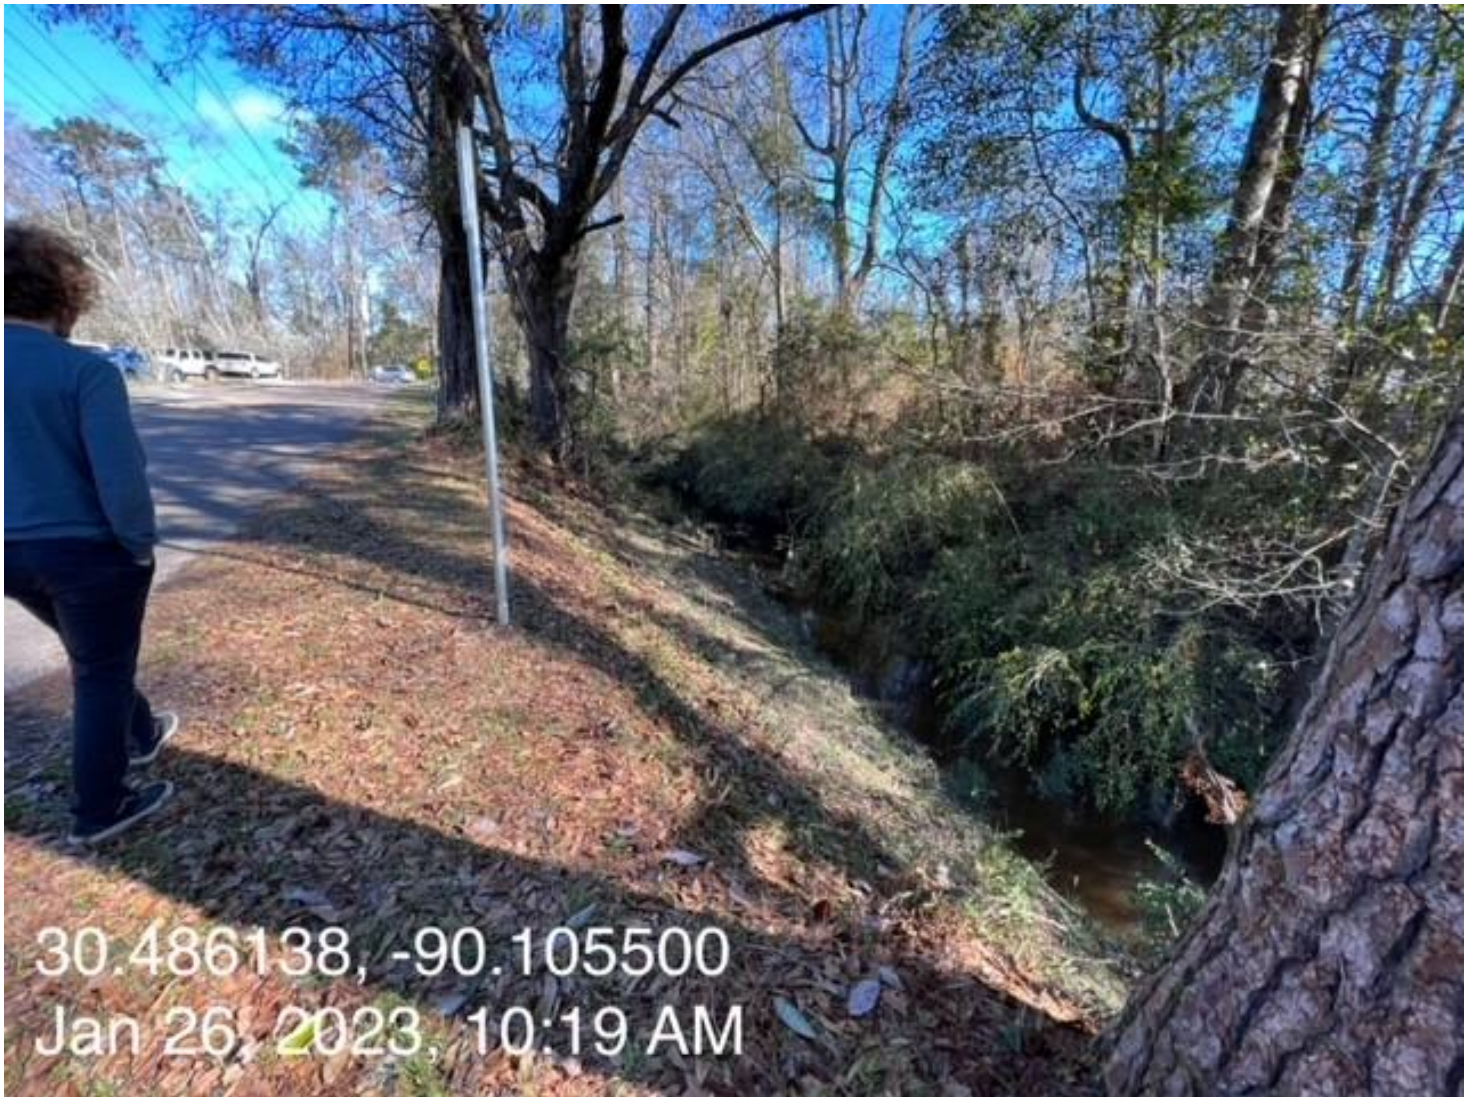
Photograph 17: Facing Northeast. Photo take from Mile Branch ROW. Two containment booms and 55-gallon drum within waterway.

Within Mile Branch, two oil containment booms were found within the water way on January 26, 2023 located at 30.486420, -90.105369 (Appendix B, Photos 15-22). In addition to the two oil containment booms, waste tires and a rusted 55 gallon drum was found within the water way. Louisiana Department of Environmental Quality (LDEQ) was informed of the findings on January 27, 2023. LDEQ informed USACE on February 14, 2023, that the oil containment booms are trash booms installed by the city and the 55-gallon drum found within the waterway contained no product prior to any construction, a site evaluation will need to be done due to lack of ROE for the project

This assessment revealed one REC in connection with the proposed ROW. Two oil containment booms and a 55-gallon drum were located within Mile Branch waterway during a site visit on January 26, 2023. LDEQ was notified on January 27, 2023 of the discovery. LDEQ informed USACE on February 14, 2023, that the oil containment booms are trash booms installed by the city and the 55-gallon drum found within the waterway contained no product. (Appendix B, Photos 15-22).

Two containment booms and a rusted 55-gallon drum were found within the waterway (Appendix B, Photos 15-22). Per LDEQ, the containment booms were placed by the city of Covington to prevent trash from traveling into the waterway. The 55-gallon drum was found to contain no products of concern per LDEQ.

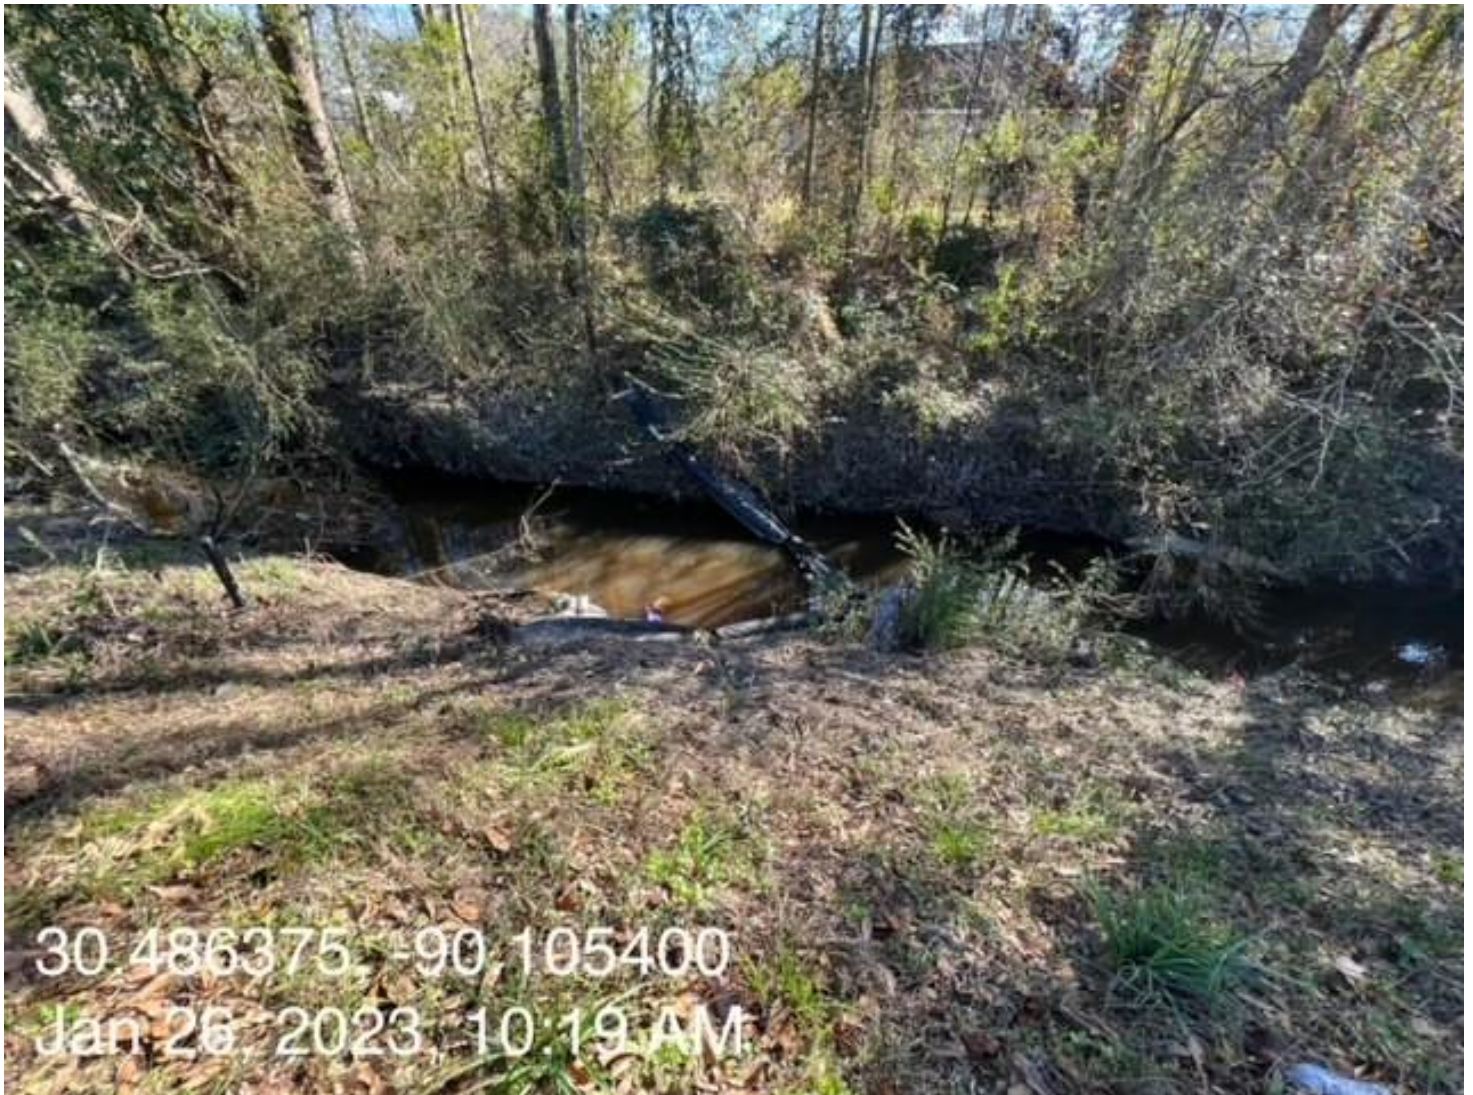
Photograph 19: Facing East. Photo take from Mile Branch ROW. Two containment booms and 55-gallon drum within waterway.

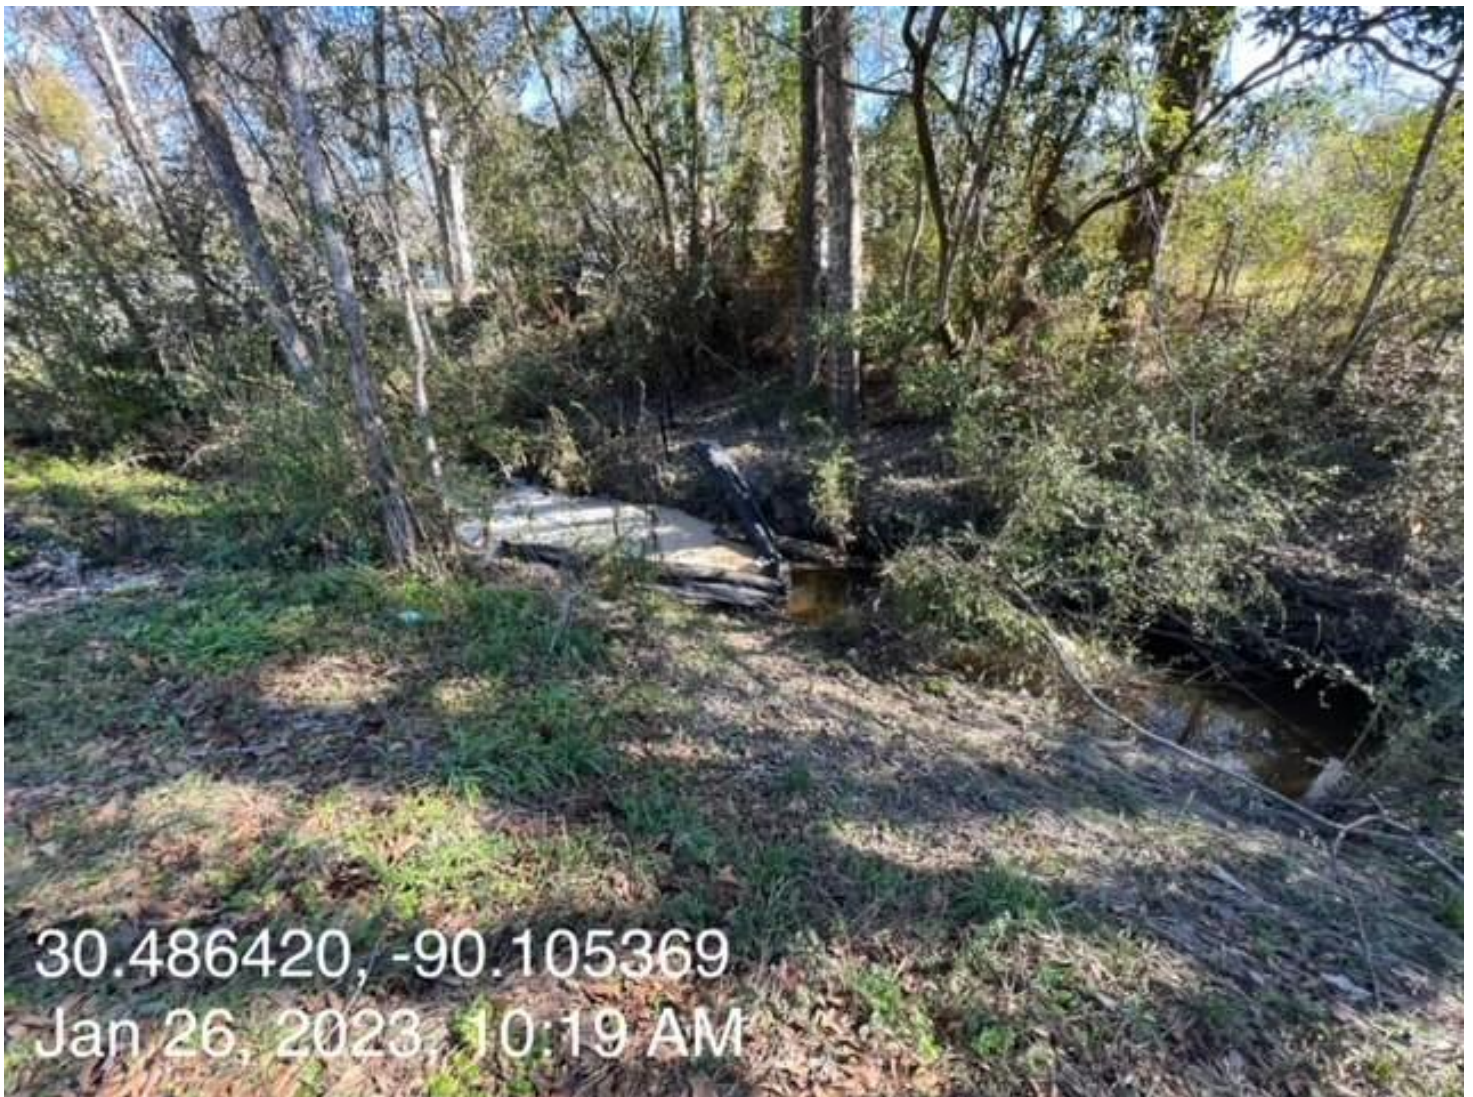
Photograph 20: Facing Northeast. Photo take from Mile Branch ROW. Two containment booms and 55-gallon drum within waterway.

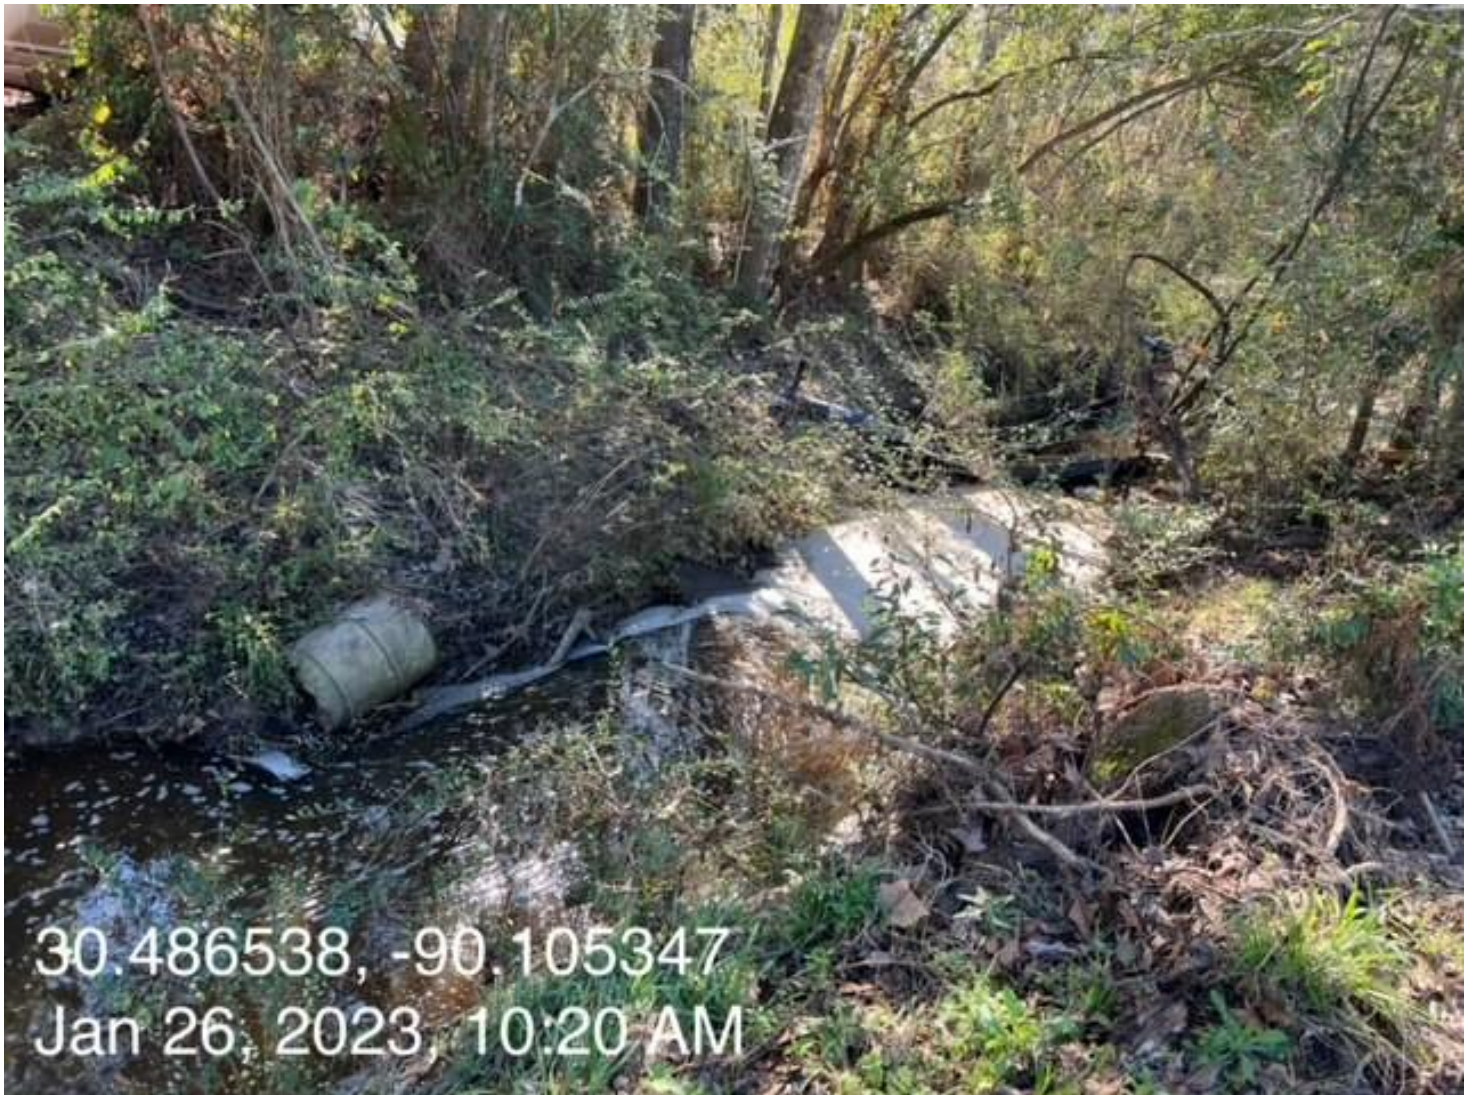
30.486538, -90.105347
Jan 26, 2023, 10:20 AM

Photograph 22: Facing Southeast. Photo take from Mile Branch ROW. Two containment booms and 55-gallon drum within waterway.
