PROPOSED RE-AUTHORIZATION OF MITIGATION BANK
IN ASCENSION PARISH

Prospectus for the Proposed
St. Gabriel Wildlife Refuge and Mitigation Bank, LLC

MITIGATION BANKING INSTRUMENT

St. Gabriel Wildlife Refuge and Mitigation Bank

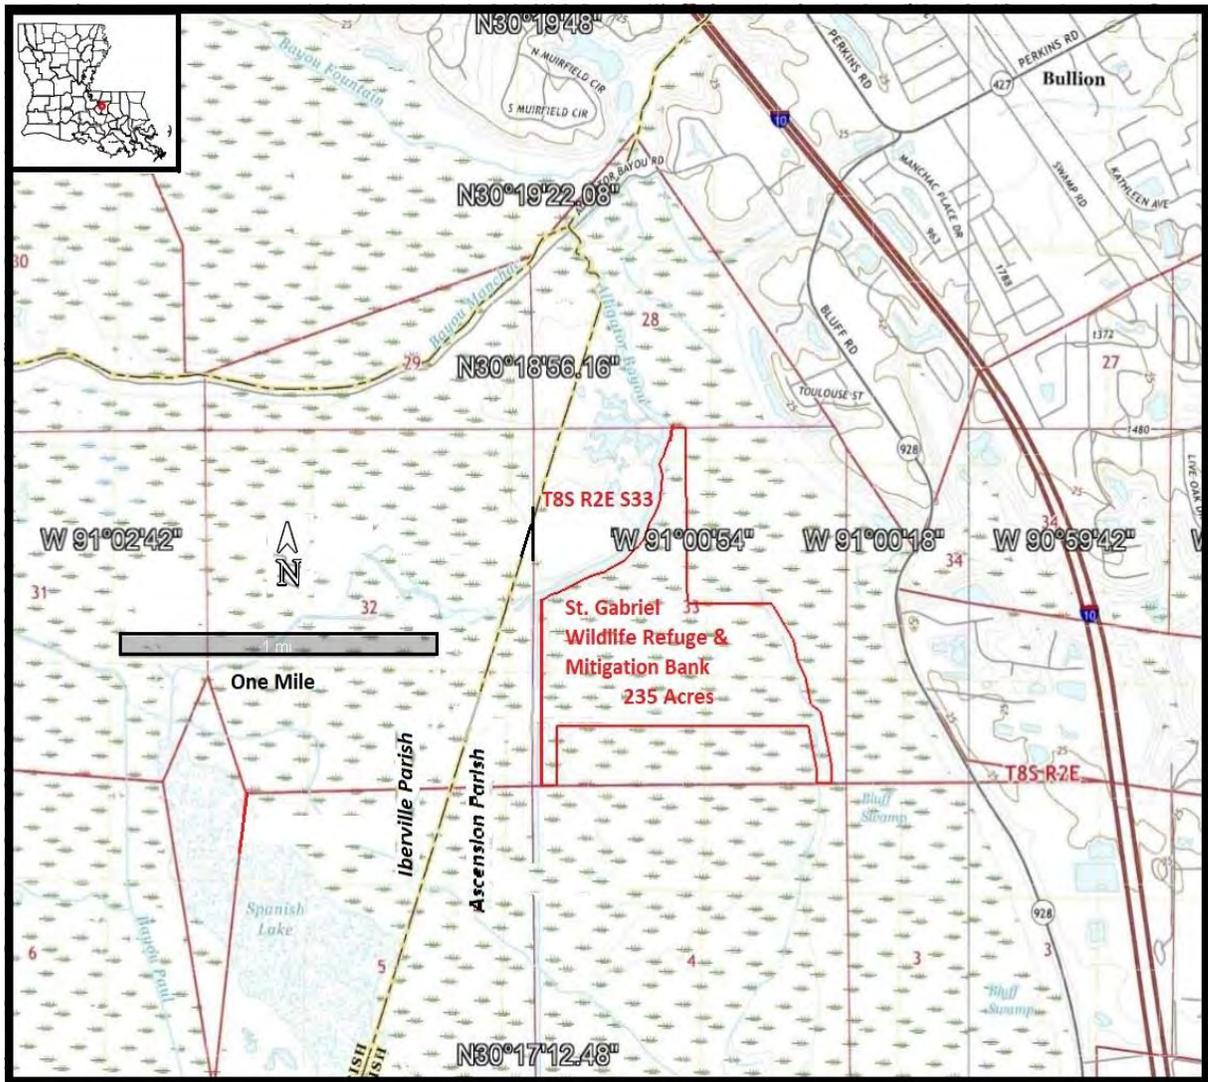
Figure C1. Location, Vicinity and Boundary of St. Gabriel Wildlife Refuge and Mitigation Bank shown on merge of 1:24,000 USGS St. Gabriel and Prairieville Quadrangles (2012).

The Property is located at latitude 30°18.139' N and longitude 91°01.004' W (approximate center point) in Ascension Parish, Louisiana (Figure C1), near the Iberville Parish line on the west side, and East Baton Rouge Parish to the north. It includes 235.09 acres more or less of jurisdictional wetlands on a portion of the Western half and Southeast quarter of Section 33, T8S, R2E. The Bank property is reached from Baton Rouge by following Highland Road (LA 42) south under Interstate 10 (I-10) to a right turn on Old Perkins Road (LA 427) toward Prairieville. A second right is made after 2 miles at the first traffic light onto Bluff Road. This road crosses the I-10 again. A third right turn is made at bottom of overpass onto Alligator Bayou Road (Figure C1). This road winds for about a mile down off a higher terrace onto a causeway (levee) built along the south bank of Bayou Manchac, passing over the existing Frog Bayou Sluice Gate and the future site of the newly permitted Fish Bayou Sluice (Figure C7). Water access with a boat - pass the Alligator Bayou Tour Center and cross Alligator Bayou and turn left into the Alligator Bayou Boat Launch (30°19'15"N, 91°1'16"W) continue down Alligator Bayou to the private pier approximately 3700 feet on east side of Alligator Bayou (30°18'41"N, 91°1'15"W). Vehicle access - turn left into a private gravel parking lot with a wooden building (former Alligator Bayou Tour Center) (30°19'18"N, 91°11'2"W) just before reaching the recently rebuilt Alligator Bayou Locks, which also pass under the road. In a 4WD or ATV, the owner will convey visitors on the levee road south along the east bank of

Alligator Bayou for 3,700 feet through the Spanish Lake Wildlife Refuge and Botanical Gardens to reach the northernmost point of the Bank at the Section line where three gated 42-inch pipes, collectively known as the “EPA Locks,” pass through the levee. The west boundary road meanders southwest from the EPA Locks atop the Alligator Bayou levee for approximately 3,783 feet, and then continues to follow the levee due south along the Braud Canal an additional 2,777 feet (Figure C1).

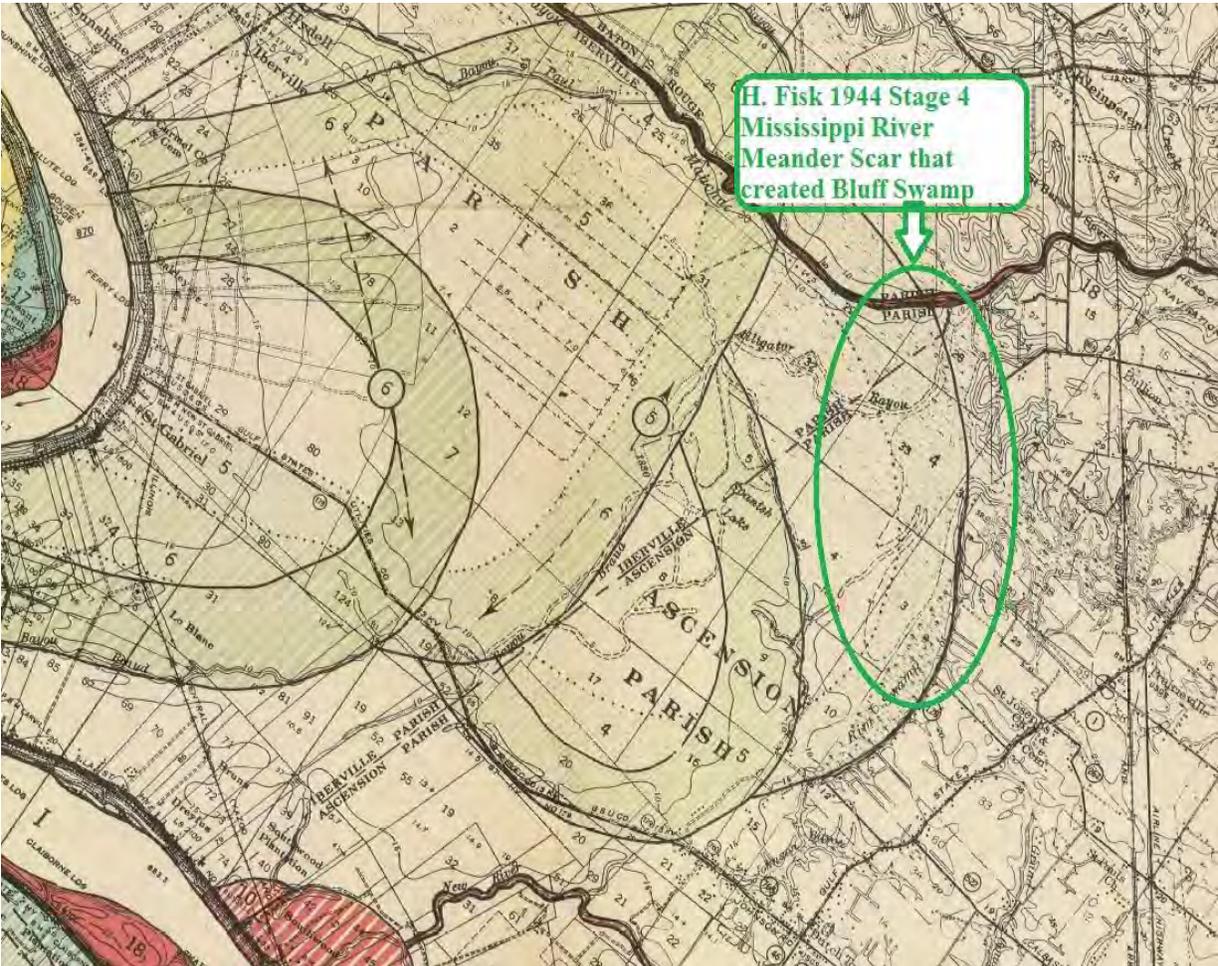
Figure C2. Excerpt from Fisk (1944, Plate 22, Sheet 15) showing location of Mississippi River channel at its easternmost position in the Bluff Swamp area, as well as locations of younger meanders occupied by the river as it moved west toward its current location 7 miles to the west.

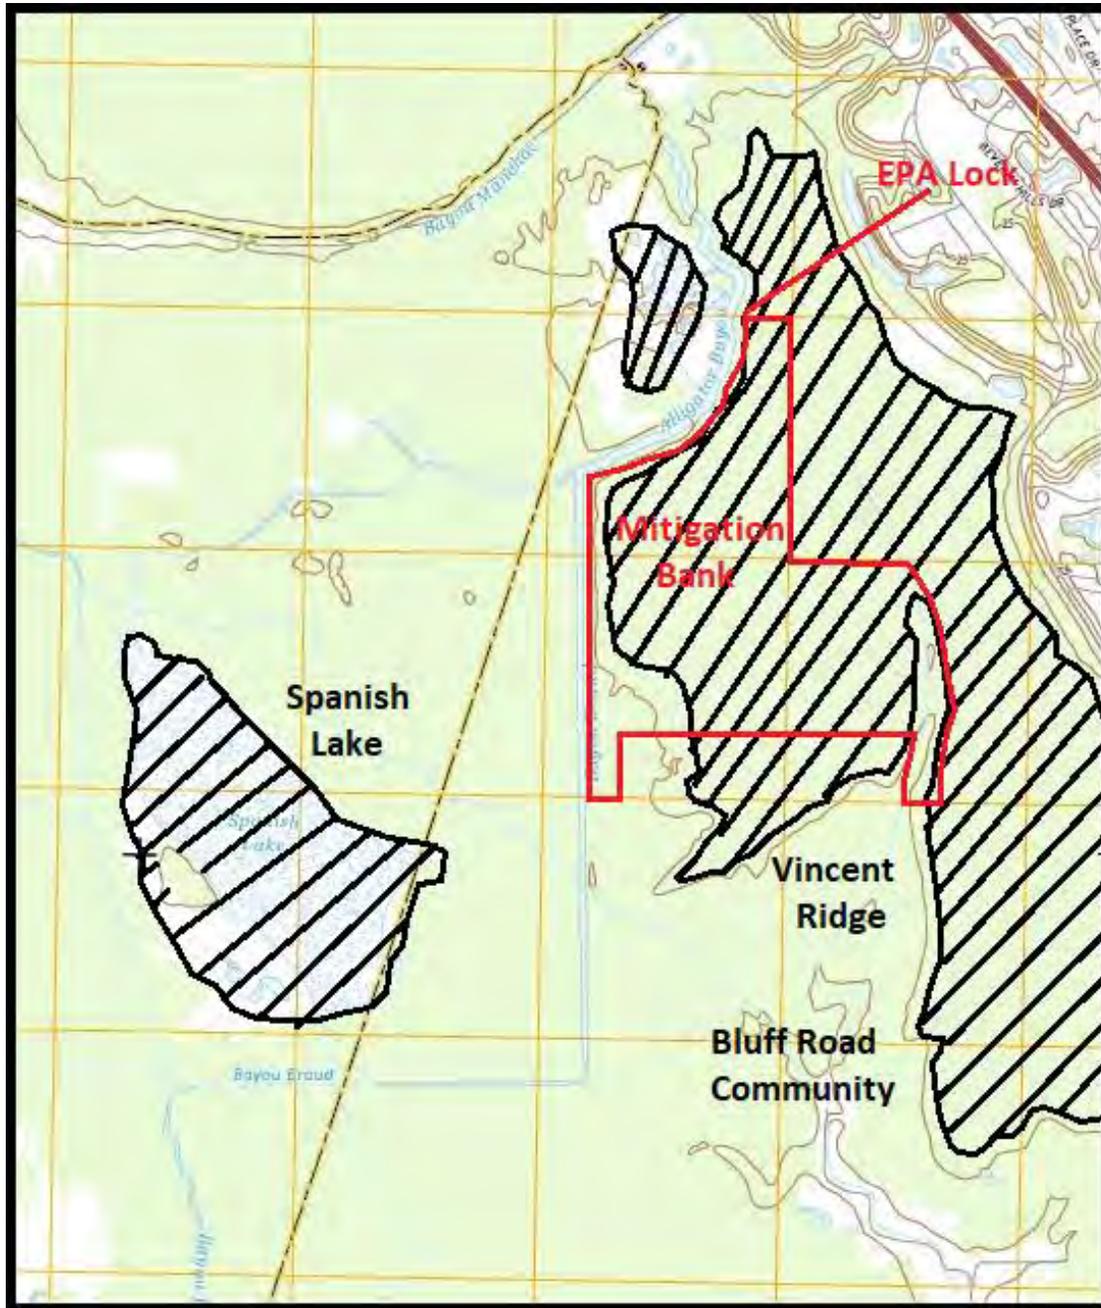
Figure C3. The only wetlands in the Spanish Lake Basin – other than those around Spanish Lake itself -- that are below 4-feet are in the Bluff Swamp (hatched area). The Vincent Ridge is barely over 5-feet where it extends north into the Bank. The EPA Lock is located in the lowest part of the Bluff Swamp.

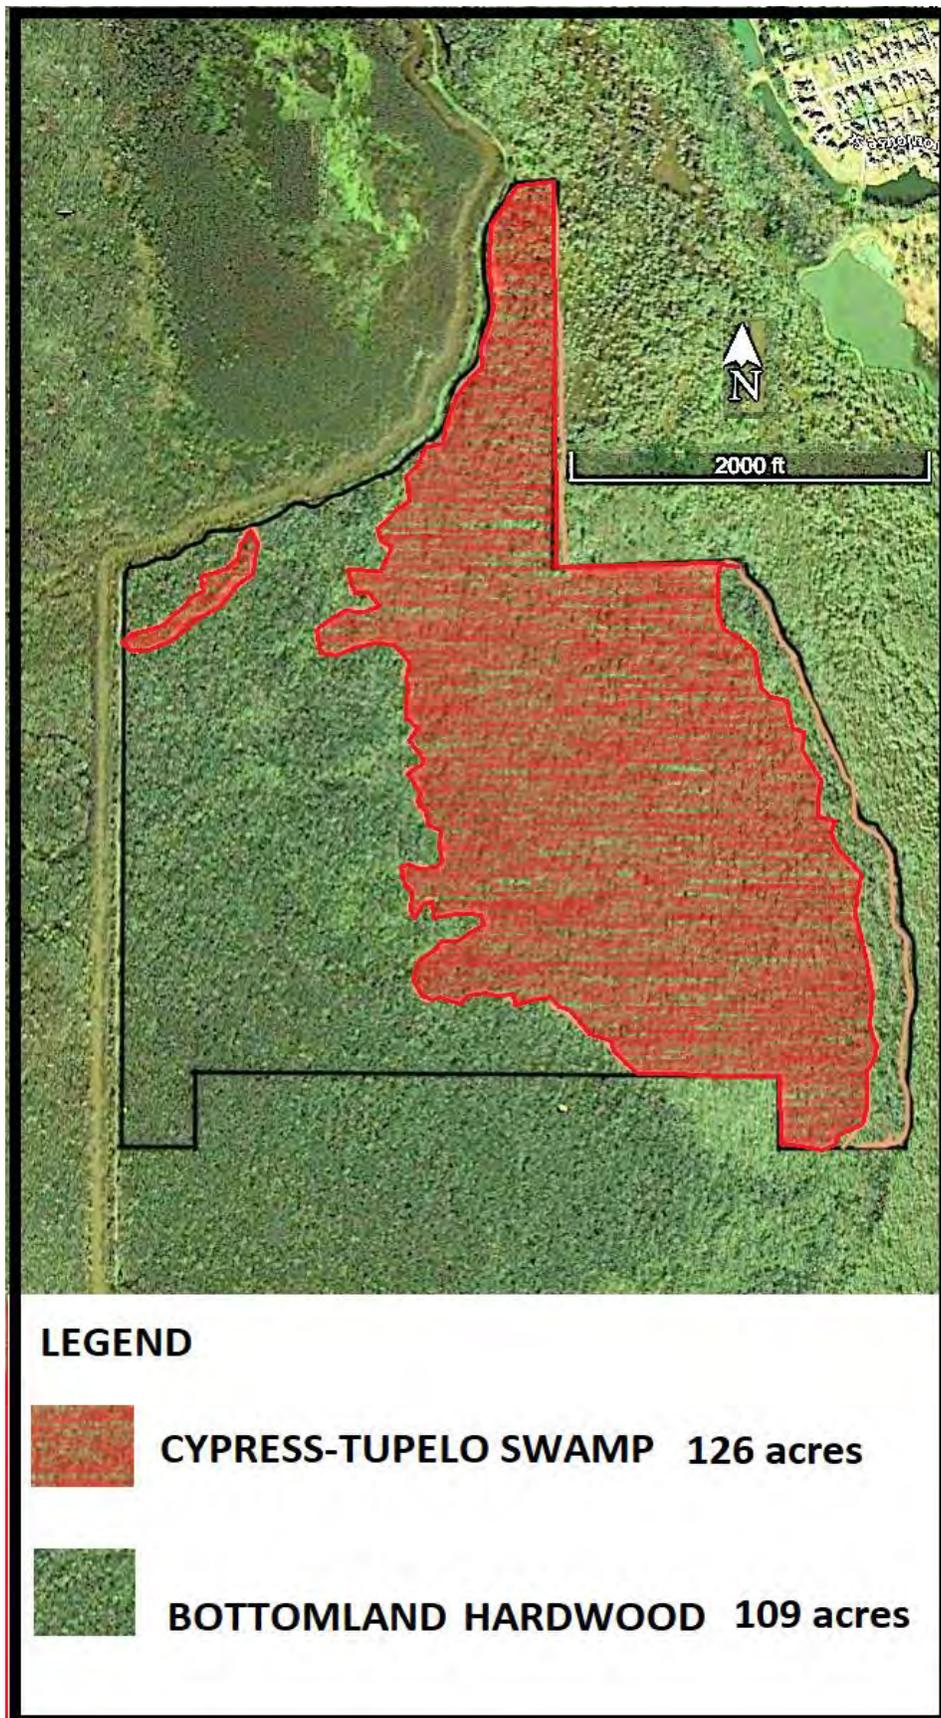
Figure C4. Jurisdictional wetlands in the St. Gabriel Wildlife Refuge and Mitigation Bank

The Bank lies between the northern extension of the Vincent Ridge (including Vincent Ridge) and up to the base of the Alligator Bayou/Braud Canal Levee (Figure C4). The only relief is provided by low natural levees on either side of small sloughs. Runoff enters the swamp through incised streams on the Prairieville terrace to the east that collect into a low central wetland area (Figure C7). Water also drains to a lesser degree from the crevasse ridge deposit on the south that is home to the Bluff Road community. This is where the people live who are most vulnerable to flooding, and this happens whenever the water level in the swamp rises above 8-feet (NAVD88) on the Frog Bayou gauge.

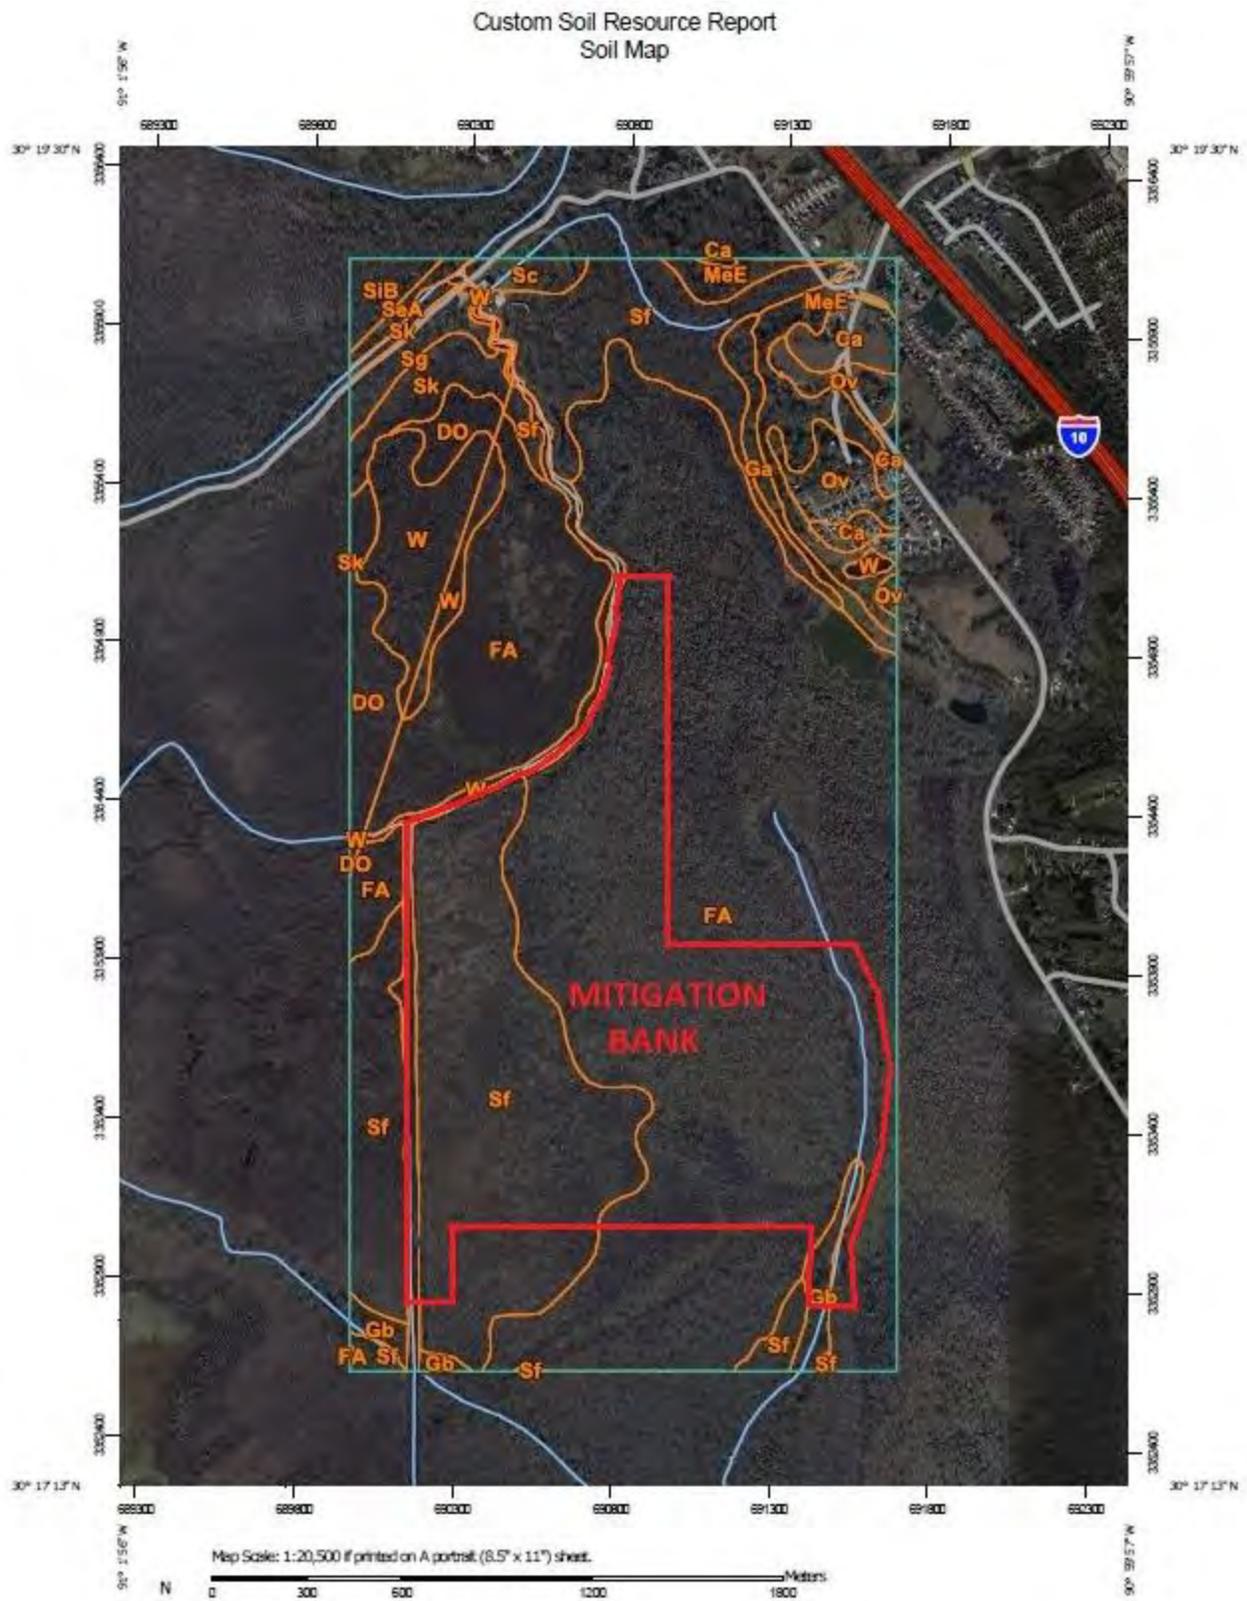
Figure C5. Soil types in the Bank: Fausse Association (FA), Sharkey Clay (Sc), Galvez Silty Clay Loam (Gb).

The soil types present at the proposed Bank, as identified in the Ascension Parish Soil Survey vary slightly throughout the Bluff Swamp (Figure C5). Generally, Galvez (Gb) silty clay loam soil is shown along the natural “oak/swamp privet” ridges which are present in portions of the basin. Galvez (Gb) soil has a woodland classification of 2W5. Fause (FA) association soils are found in large areas throughout. This association is described as 75% Fause. The remaining 25% consists mostly of Sharkey (Sf) and Barbary. The description of a representative Fause clay profile found in the Ascension Parish Soil Survey was taken from the Bluff Swamp. Sharkey clay (Sf - frequently flooded) is found across the broad bottom areas interspersed with the Fause association. Both Sharkey and the Fause association are in woodland classification 3W6. These are all wetland soils with the exception of Galvez soil on the ridge crests, which occasionally flood. Field investigations and a wetland delineation conducted in 1995 and 2019 confirmed these soil types, along with hydric indicators.

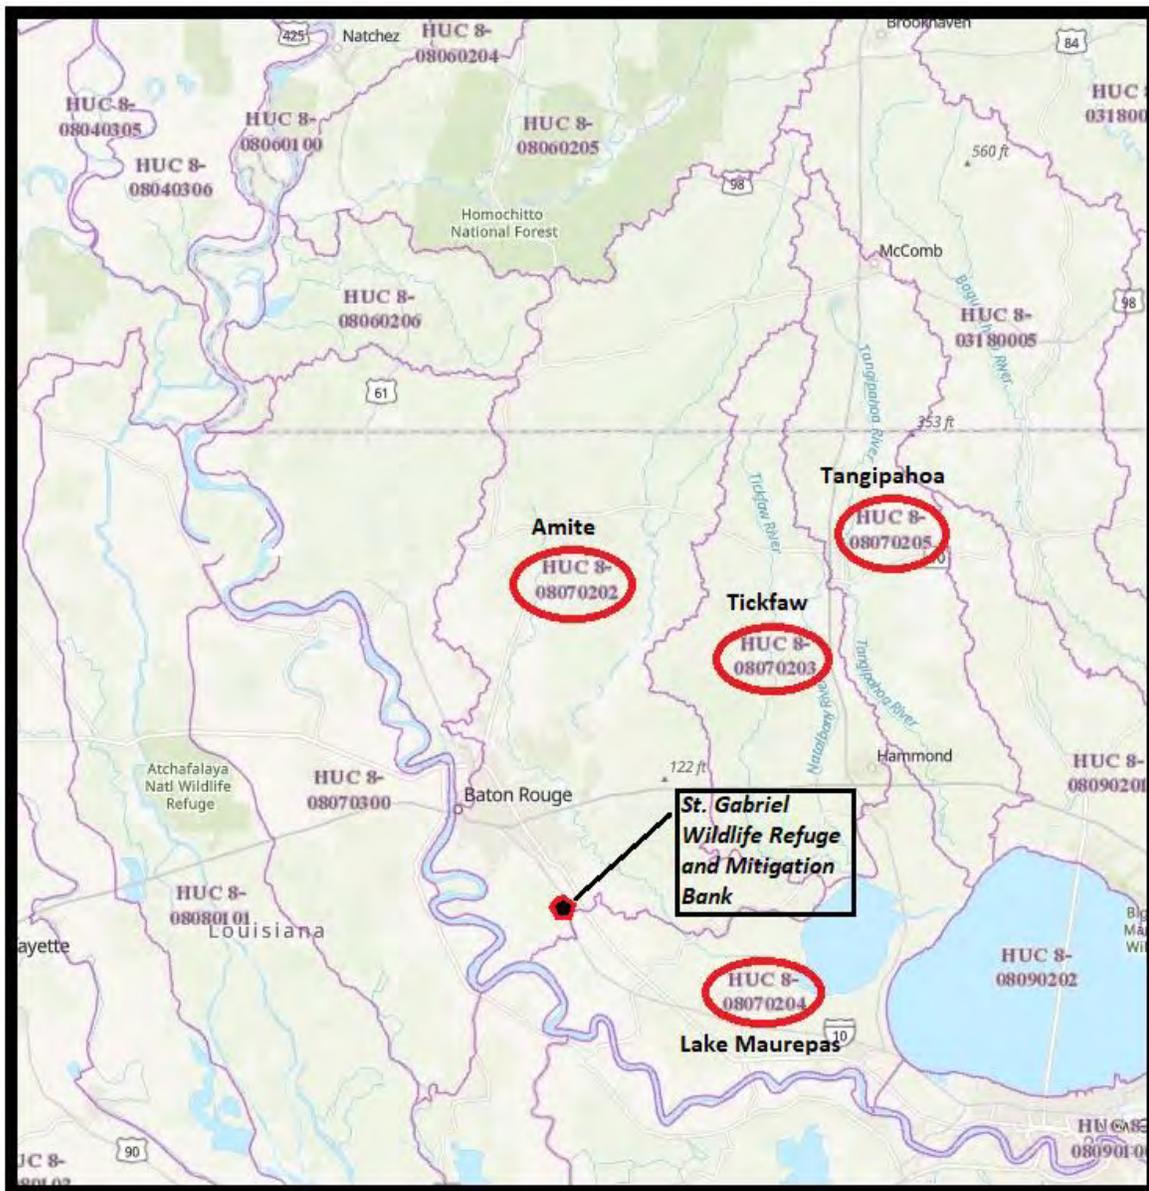
Figure C6. The St. Gabriel Wildlife Refuge and Mitigation Bank is within the ‘Amite’ USGS HUC 8 (8-digit: 08070203) Watershed near its southern boundary. The service area of the Bank includes:

- 08070202: Amite River
- 08070203: Tickfaw River
- 08070204: Lake Maurepas
- 08070205: Tangipahoa River
- 08090201: Liberty Bayou-Tchefuncta River
- 08090202: Lake Pontchartrain
- 08090203: Eastern Louisiana Coastal

The Bank is near the southern margin of the 'Amite' USGS HUC 8 (8-digit: 08070203) Watershed near its southern boundary (Figure C6). The entire Spanish Lake Basin and the natural levee of the Mississippi River is included in the 'Braud and Alligator Bayou Sub-watershed' (HUC 14) but the Bluff Swamp and the small portion of the terrace that it drains in the Prairieville area amount to only 5,285 acres. The 3,062 acres of terrace provides runoff via small streams into the 2,960 acres that make up Bluff Swamp (Figure C7). So, the upland watershed is roughly the same size as the receiving wetland basin. The St. Gabriel Wildlife Refuge and Mitigation Bank takes up about 10 percent of the area of Bluff Swamp, but is surrounded by other protected land.

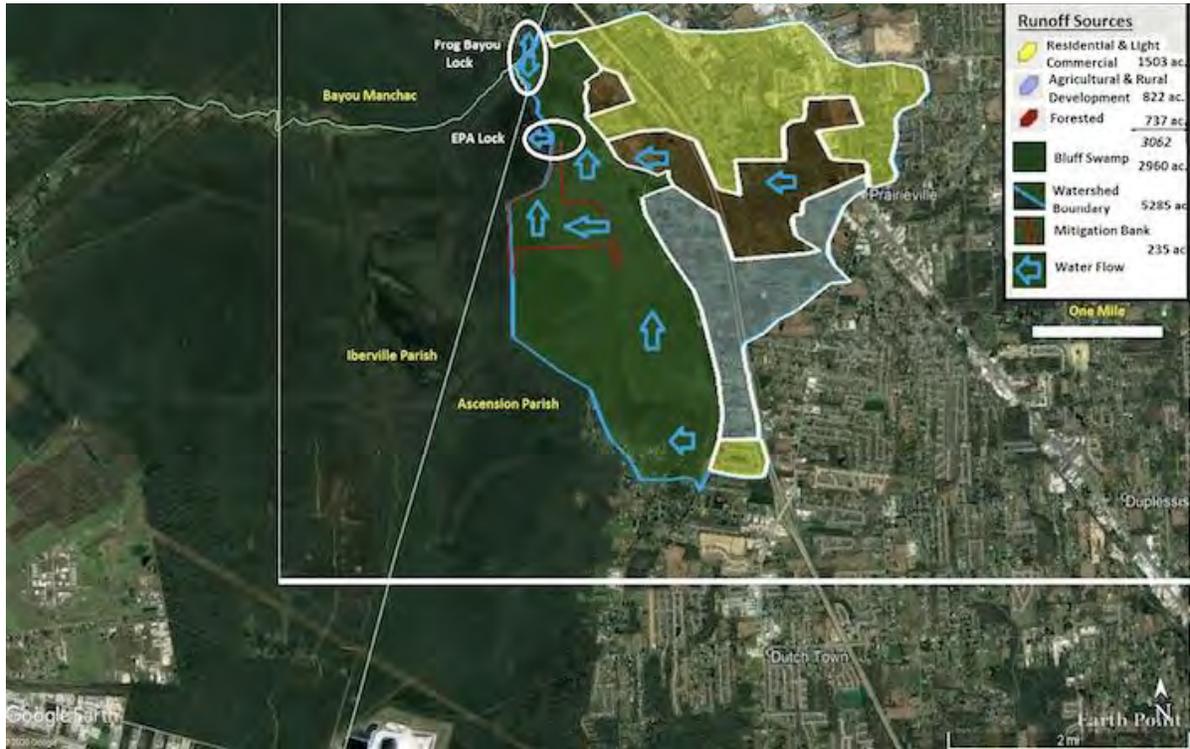
Figure C7. Current hydrologic conditions. An estimated 3,062 acres of Pleistocene terrace drain into a similar area (2960 acres) of Bluff Swamp. The Bluff Swamp watershed westwardly drains into Alligator Bayou through the EPA Locks. Exchange with Bayou Manchac takes place at the Frog Bayou Lock.

Development of land within one mile of the Bank is residential, light-commercial and rural on the Pleistocene uplands around Prairieville (Figure C7). This is about a half-mile from the eastern boundary. The Bluff Road community on the Vincent Ridge is about 1.5 miles from the southern Bank boundary. Cypress-tupelo swamp constitutes most of the buffer area between developed land and the Bank.

There was a proposal to clear-cut a majority of the acreage, but purchase of the property (1130+ acres) in 1994 and its incorporation into a mitigation bank ensured that it was not timbered. Approximately 901 acres were used to satisfy a Consent Decree between EPA and the Parish of Ascension. However, the remainder of credits associated with the total acreage were neither sold nor made available to the public. The (EPA), the U.S. Army Corps of Engineers (Corps), the U.S. Fish and Wildlife Service (FWS), the Louisiana Department of Wildlife and Fisheries (LDWF) and the Louisiana Department of Forestry (LDF) have inspected the site. LDWF and LDF have done preliminary studies on the site and have established potential guidelines for habitat improvements. LDWF and LDF have done preliminary studies on the site and have established potential guidelines for habitat improvements. Adjacent wetland use is for mitigation banks, while adjacent uplands are residential and commercial (Figure C7).

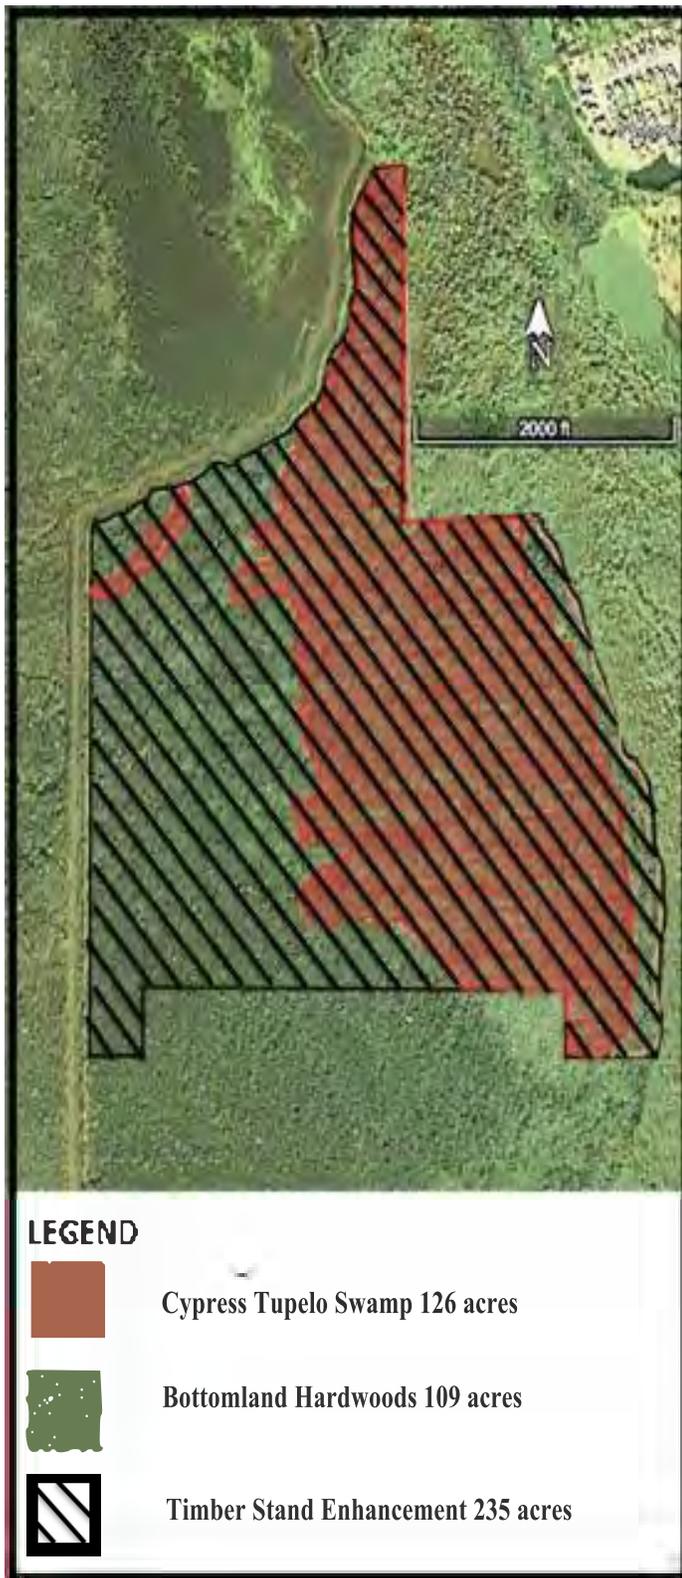
Figure C8. Work to be performed.

A. Habitat Enhancement Procedures

1. Timber stand enhancement using chemical and/or mechanical techniques

Reduce the number of undesirable tree species in the overstory through chemical and/or mechanical techniques. The overabundance of species such as sugar berry, willow and tallow will be treated as scheduled above to release the tree species which support wildlife.

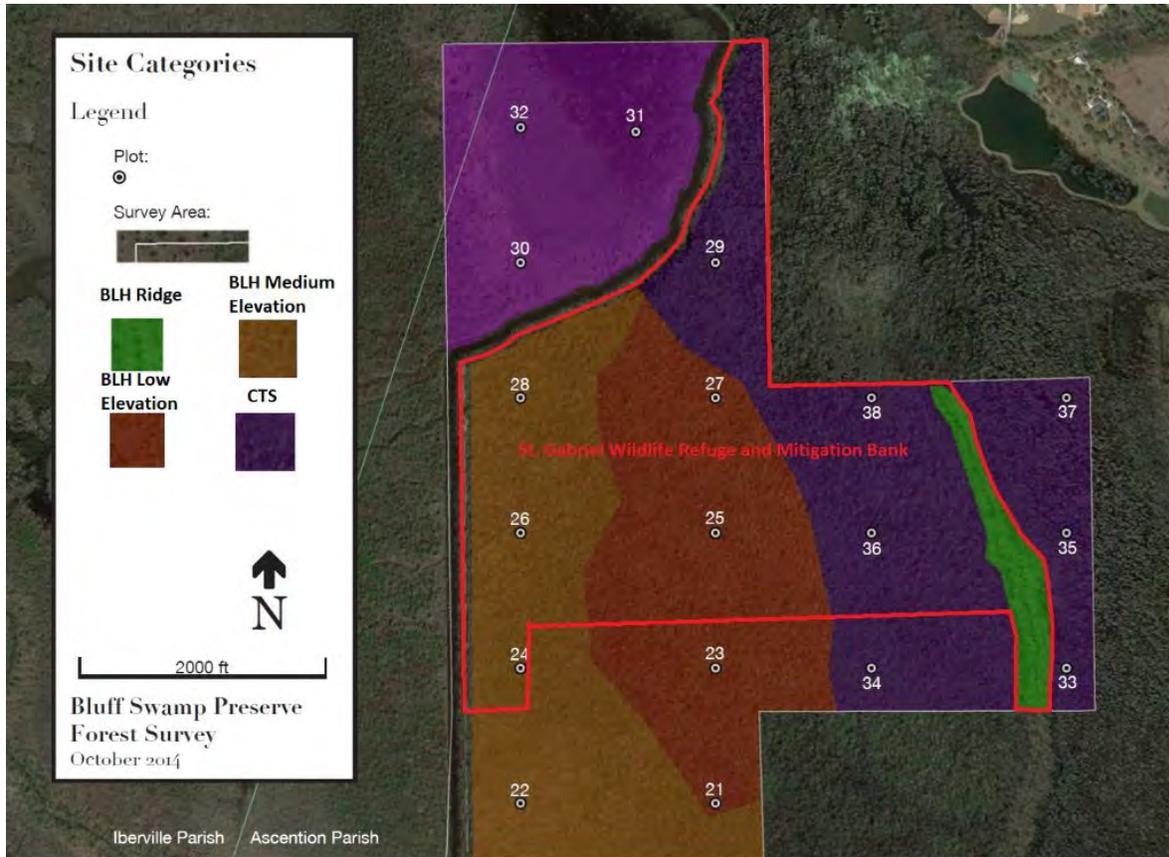
Figure C9. Forest Inventory Plot Locations and Types. Orr et al. (2014).

The second forest type identified by Orr (2014) is a medium elevation BLH (Figure C9). It is flooded seasonally but is dry for extended periods when rainfall is low. The soil is a heavy clay. The presence of large old-growth baldcypress is evidence that this area was once a cypress swamp that has received significant influxes of sediments that have raised the overall elevation. The area is dominated by overcup oak and hackberry. Nuttall oak (***Quercus nuttallii***) is present but in much smaller numbers than overcup oak. Other co-dominant trees include green ash, baldcypress, bitter pecan, red maple (***Acer rubra var. drummondii***), American elm, honey locust (***Gleditsia triacanthos***) and water oak. The canopy is mostly closed and dense with scattered openings caused by blow-downs. The oaks are growing slowly. The average diameter of the overcup oaks is 16-inches DBH, but these are mature trees. The understory includes seedlings and saplings of hackberry, baldcypress, nuttall oak, red maple, elm and tallow tree. Palmetto, swamp privet (***Forestiera acuminata***) and water elm (***Planera aquatica***) are also present in the understory. The understory is pretty open but with thickets of swamp privet and water elm covering approximately 20 percent of the area. Forage for wildlife is fair as acorns from the overcup oaks are abundant.

Orr (2014) also described as a third type a low-elevation BLH that could also be described as a marginal cypress swamp (Figure C9). The land is flooded up to four feet deep for extended periods. The soil is a heavy clay muck. This zone has a number of old-growth baldcypress scattered throughout with second-growth baldcypress also numerous. The dominant stand is green ash and black willow. Overcup oak, hackberry, Nuttall oak and American elm are also present in the overstory, but the overstory is not closed. Instead, thickets of swamp privet and water elm cover about 40 percent of the area. Growth of the relatively sparse oaks was moderate to slow, and conditions seem better for baldcypress and tupelo gum (***Nyssa aquatica***) than for BLH species. The understory has a few seedlings and saplings of green ash, hackberry and tallow tree. Water locust (***Gleditsia aquatica***) and buttonbush (***Cephalanthus occidentalis***) are present in some open areas.

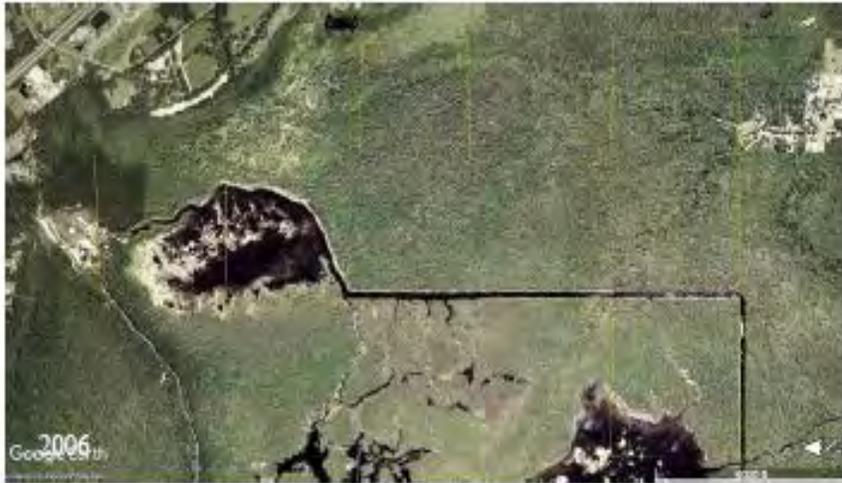
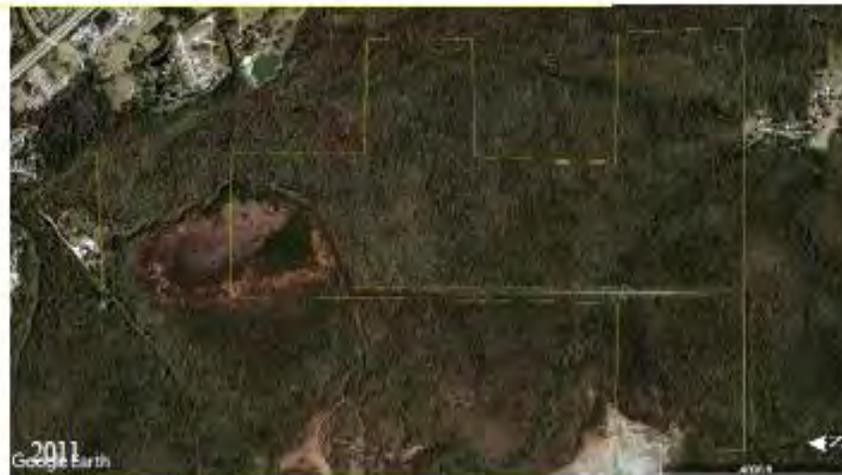
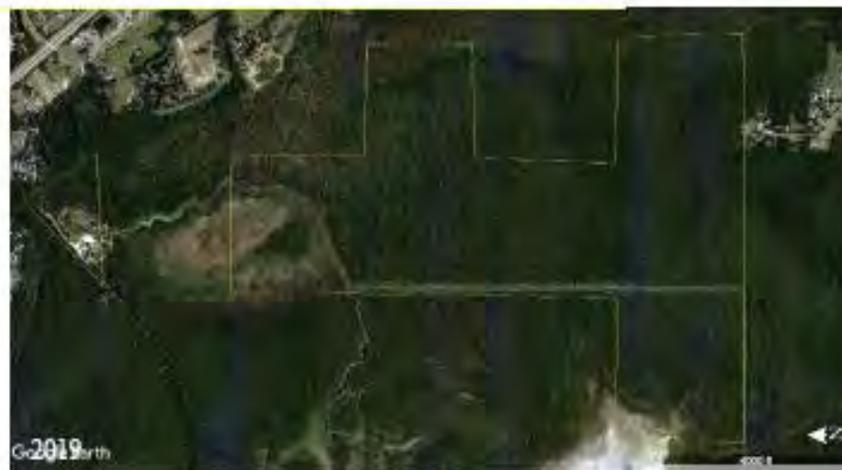
Photo 1 - Satellite photos of the mitigation bank property. Orr (2019) states, “This surveyor believes that evidence abounds to support the premise that hydrologic improvements to the proposed mitigation area since 2008 have greatly enhanced the forest vegetation of the area. Forest stand conditions will continue to improve as time goes on.”

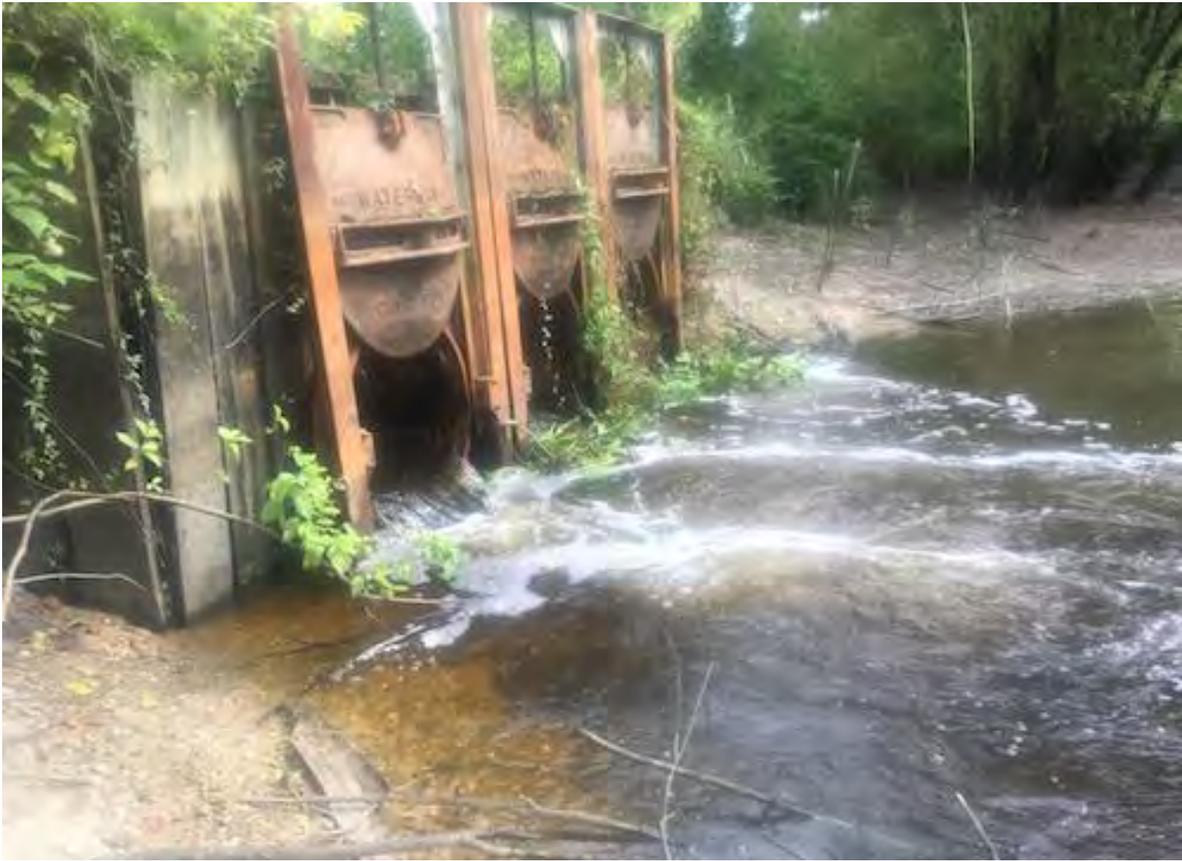
Photo 6 – The EPA water-control structure in the Alligator Bayou levee between the Bluff Swamp Watershed and the Spanish Lake Watershed.

a. The Parish of Ascension manages the hydrology of the Bluff Swamp watershed via two water-control structures (Frog Bayou structure and the three 42” EPA water control structures (MVN 2007-877 CZ) in the Bluff Swamp watershed). These structures are meant to help ensure that the bottomland hardwood forest is not inundated at key seasonal stages. A third water-control structure, the Fish Bayou Lock, has received a DA permit (MVN 2018-0135-CQ) and is awaiting construction by Ascension Parish Government. The Ascension Parish Government is responsible for maintenance and operation of all three water-control structures. The property owner/agents advocated for installation of a recording water level gauge on their property by the U.S. Geological Survey (USGS) in the swamp near the Frog Bayou water-control structure. This gauge has made it possible to operate the Frog Bayou water-control structure for both drainage and ecological purposes.

b. Hydrologic enhancement with the EPA three 42” water control structure (MVN 2007-877 CZ) in the Alligator Bayou levee is used to control passage of Bluff Swamp water which drains west into Alligator Bayou, when the high water level of Bayou Manchac restricts the outflow of the Bluff Swamp watershed. The agents permitted and assisted with installation of the three 42" gated pipes installed through the Alligator Bayou levee, placed at the lowest point of the Bluff Swamp, enhancing the BLH (108.66 acres) and TC (126.43 acres) in the SGWRMB (Attachment D, photo 6). This point where the water-control structure is located is at the northern boundary of the Bank (Figure C7). Orr (2019) notes hydrologic improvement that occurred after the additional structures were installed in 2008. Orr (2019) notes that seedlings, saplings, and understory vegetation are denser than in the past.
