MEMORANDUM FOR Chief, Regional and Environmental Planning Division-South
(CEMVN-REPD/Troy Constance)

SUBJECT: IHNC Lock Replacement General Re-evaluation Report, Engineering
Assessment of the Existing Lock Structure

Enclosure 1 – Pictures of Structural Deficiencies

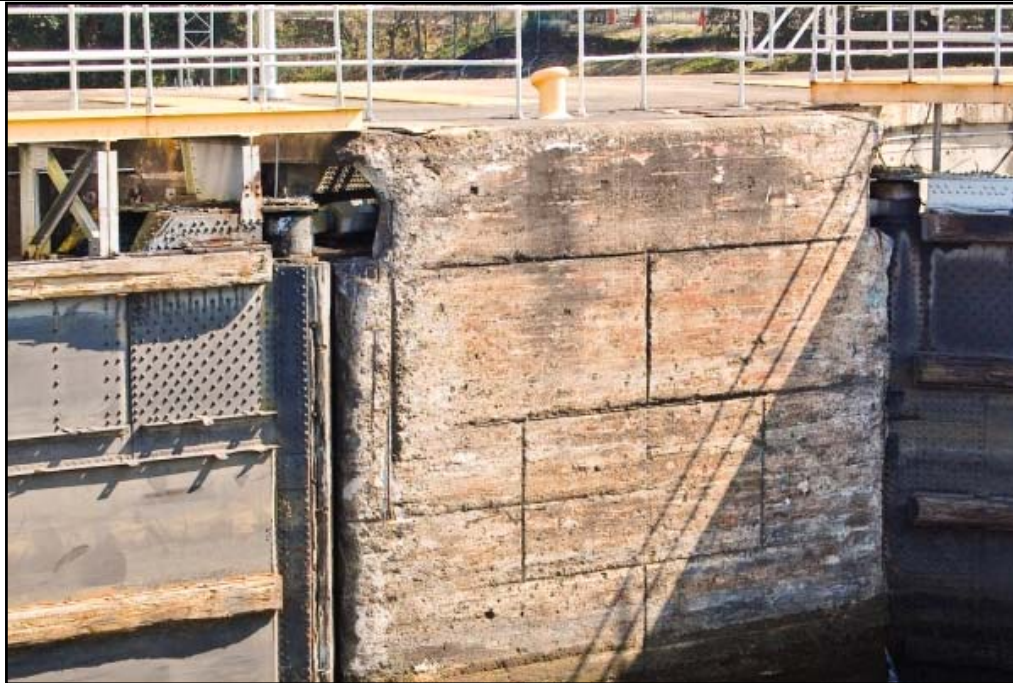
Spalding concrete and exposed rebar on corners of gate bays and top edge of lock wall deck, image is of east wall gate recesses but is typical of all eight gate recesses.

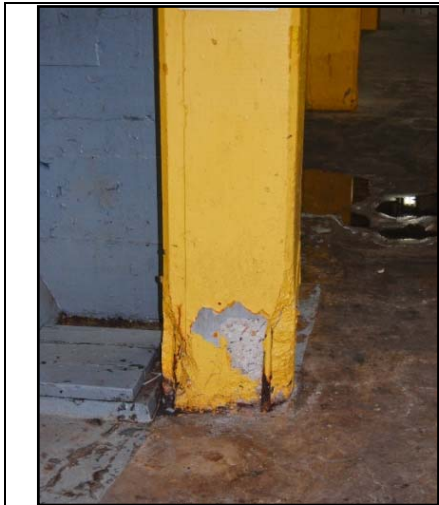
Deck support column in NW machinery room.

Columns and beams in each of the machinery rooms exhibit severe spalling of concrete to point of exposing rebar. The steel reinforcing is severely corroded exhibiting significant section loss and some locations the rebar is completely corroded and missing. Additionally, spalling and corrosion is also present in walls, floor and ceilings of the tunnels and machinery rooms.

The component exhibits a clear mode of failure: Reinforcing steel in columns and beams is severely corroded exhibiting significant section loss and some locations the rebar is completely corroded and missing. As a result, the capacity of these components is reduced. If the columns or beams were to fail, the result would be damage to the operating machinery causing a shutdown of the lock. Due to the reduced capacity, operational restrictions have been put into effect at the lock to prevent significant live loading above the machinery rooms.

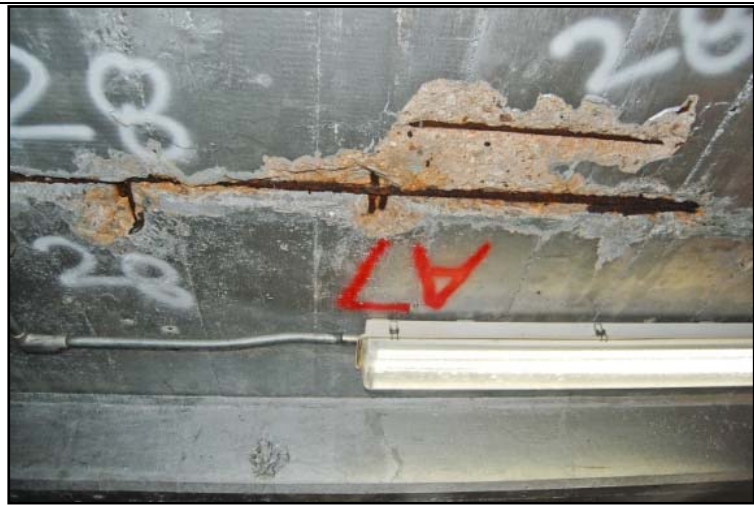
Underside of concrete deck in a machinery room in the west wall.

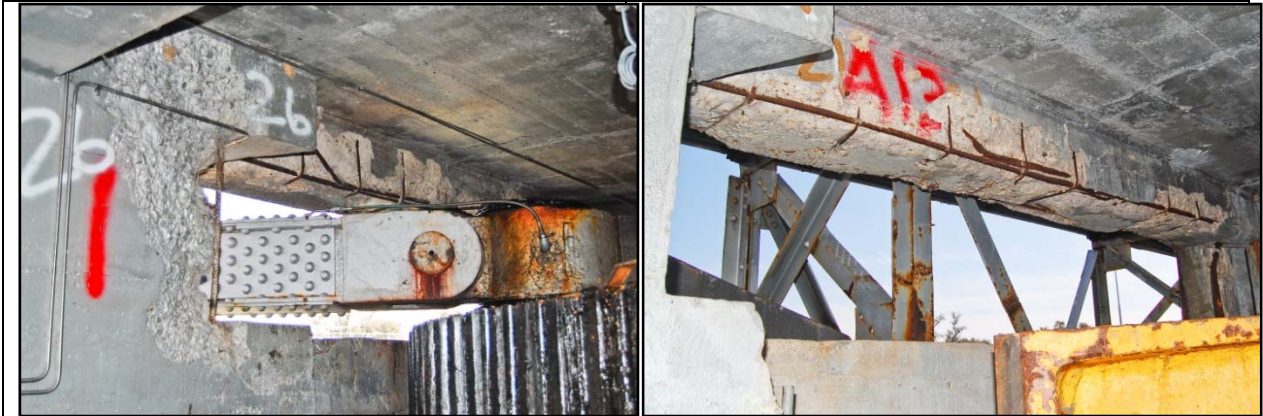
Pictured are main gate and reverse head gate strut arm openings on NW side of chamber that support the edge of the lock wall deck. These two pictures are typical for all eight machinery room/strut arm openings and show severe spalling exposing the rebar support system.

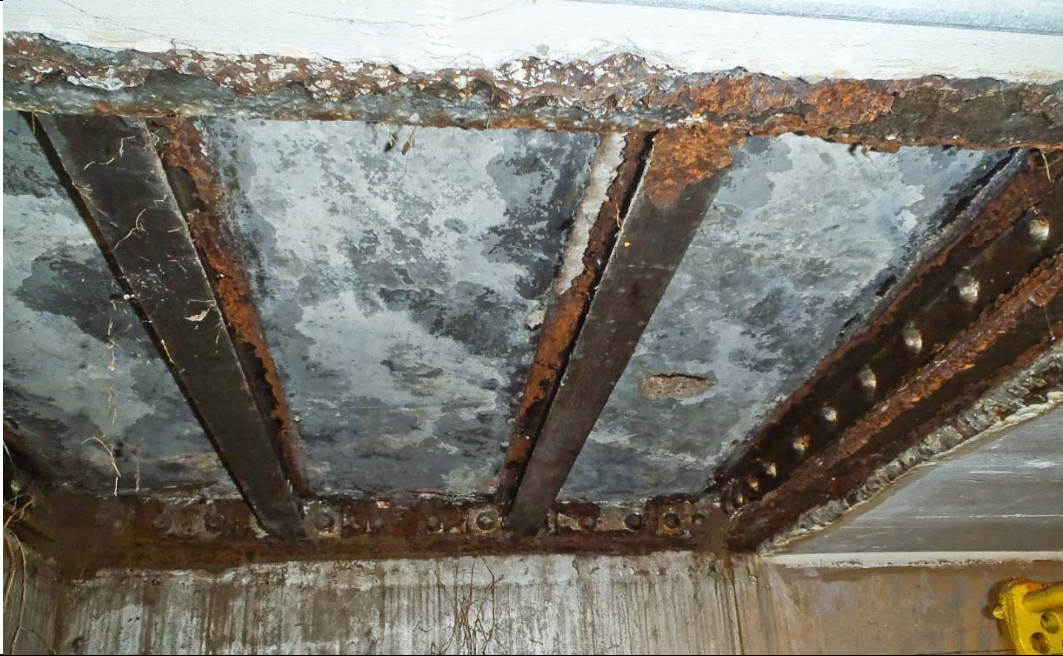
Corroding I-beams supporting hatch cover also showing section loss of beams and hatch recess steel frame. IHNC Lock Photo 04-23-2014No Structure020-1.jpg

Cracked and spalled concrete hatch covers, rusted out steel frames with significant and missing section loss.

The component exhibits a clear mode of failure: The cracked covers and leaking frames is leading to increased section loss of frames and increasing risk of cave-in.

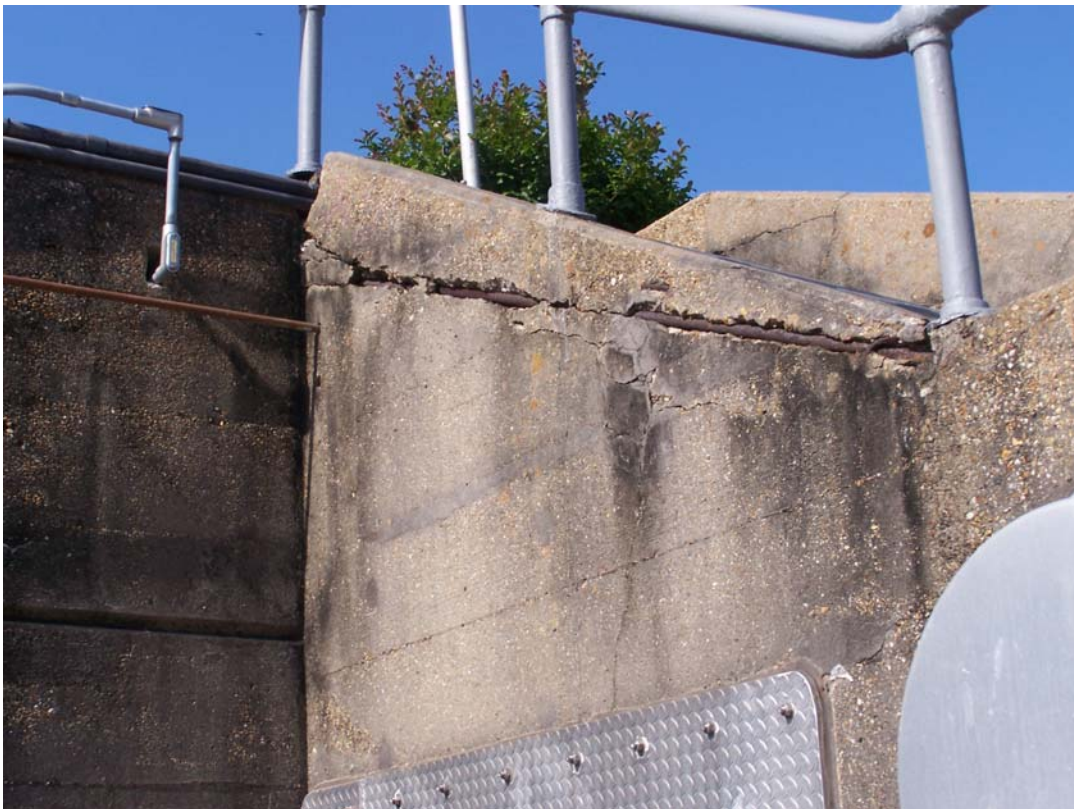
Photo 4 Spalling and exposed steel in the wall below stairs between gates 7 and 9 on northwest side of lock.

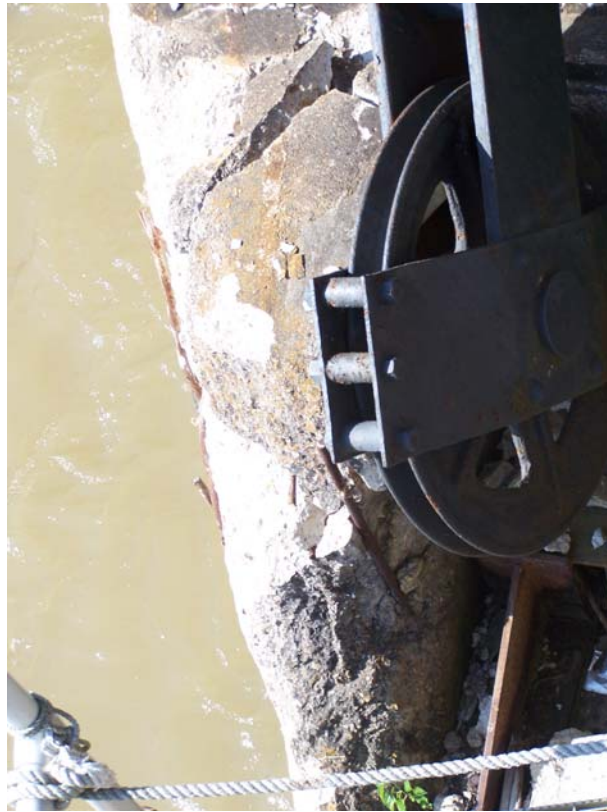
Photo 5 Large spalls and cracked concrete with exposed steel on the northwest side near hinge for gate 9.

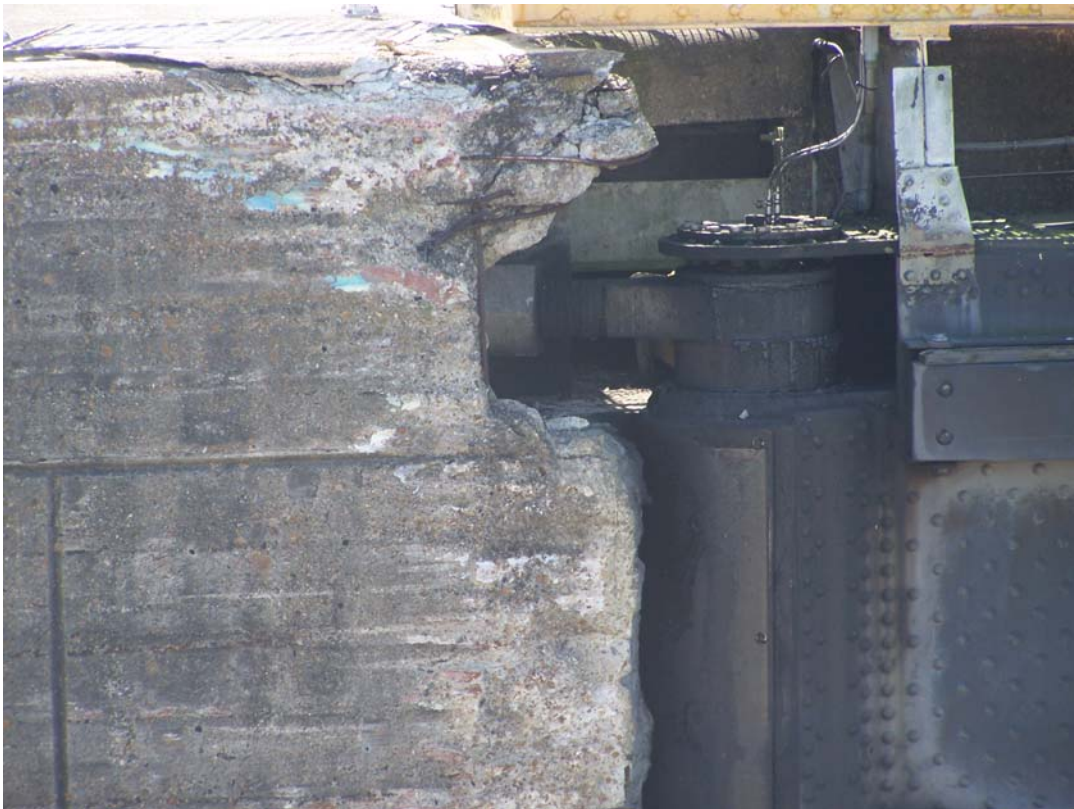
Photo 10 Spalling with exposed steel in the northeast gatebay near the hinge

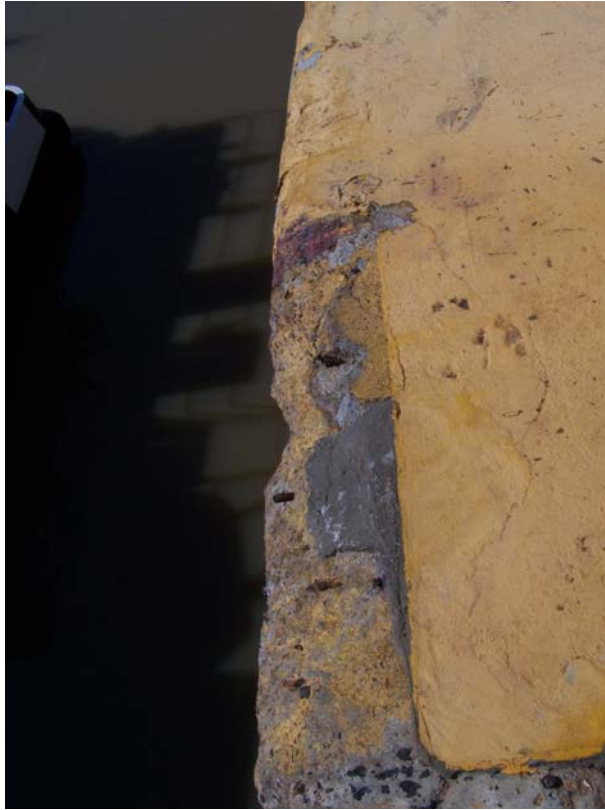
Photo 11 Spalls in top of the west chamber wall near control house.

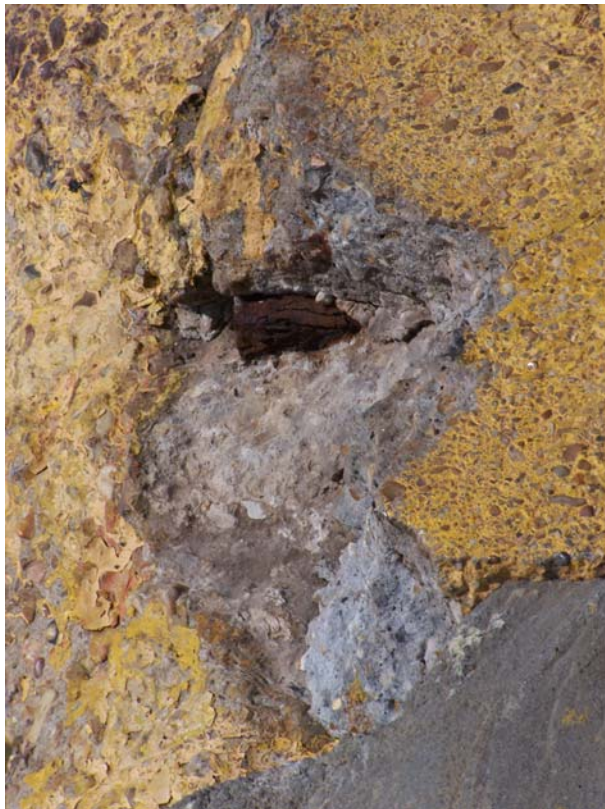
Photo 12 Spalls in top of the west chamber wall near control house.

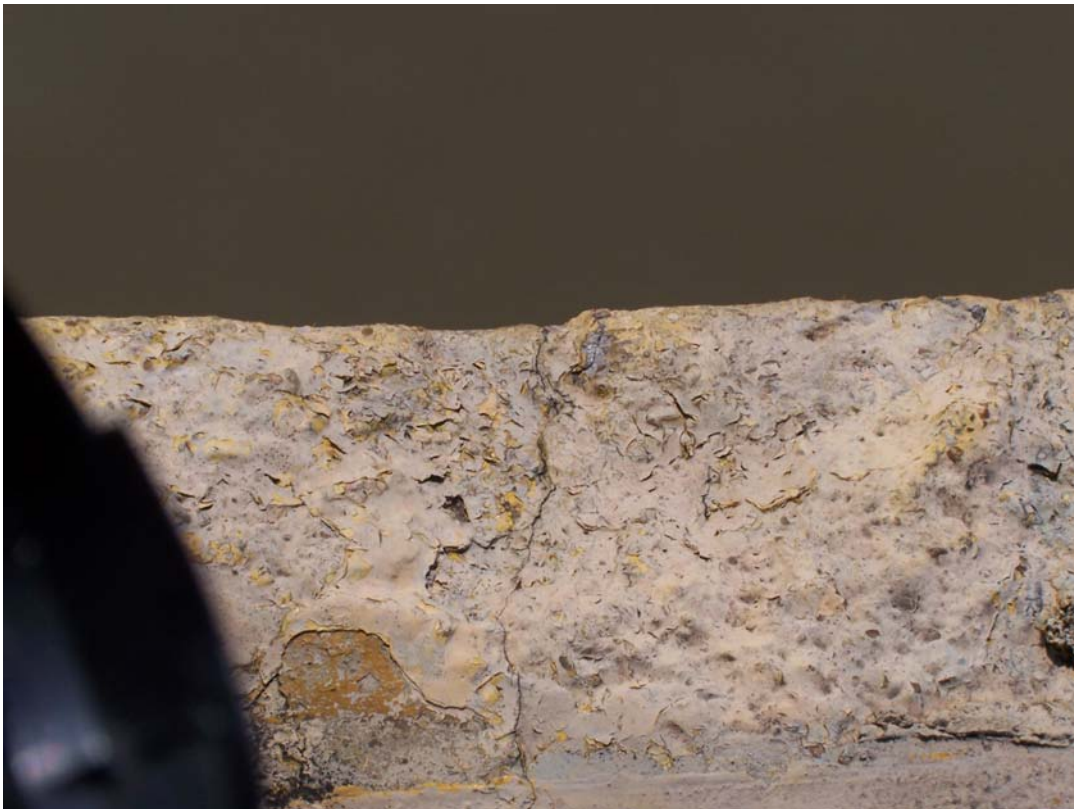
Photo 16 Spall in top of west chamber wall near light pole number 9.

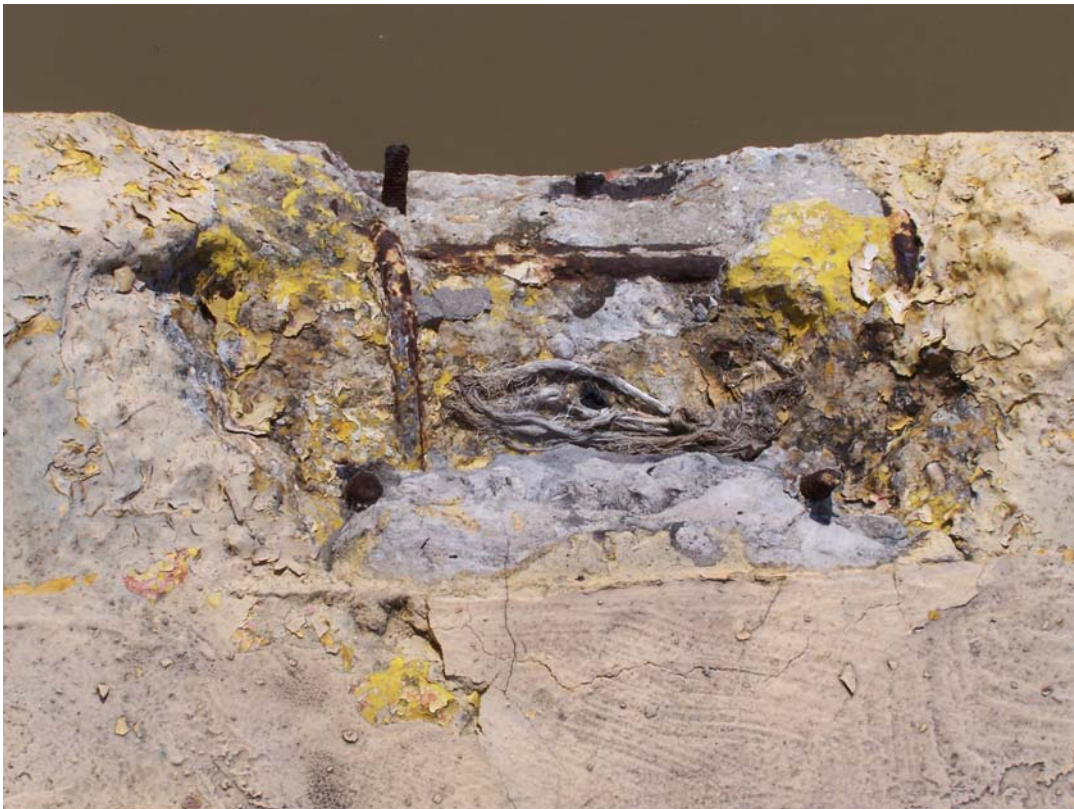
Photo 22 Large spall with corroded steel on top west chamber wall.

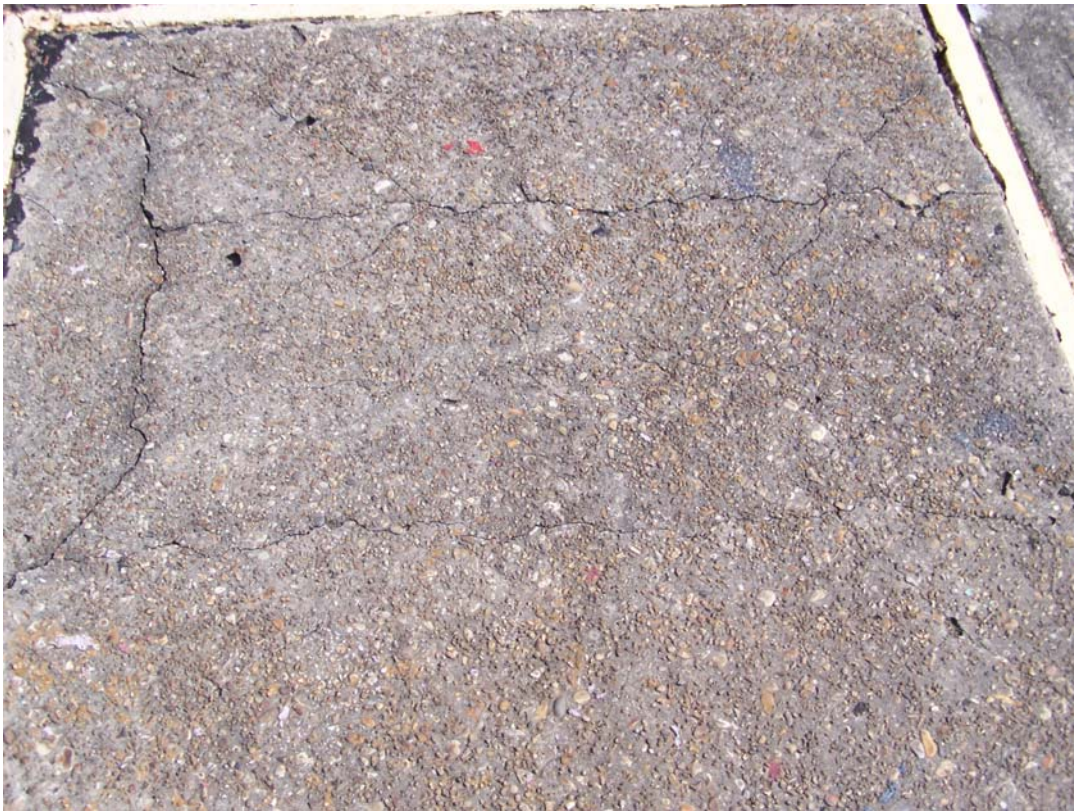
Photo 24 Hatch cover behind the west chamber wall near reference marker 8W.

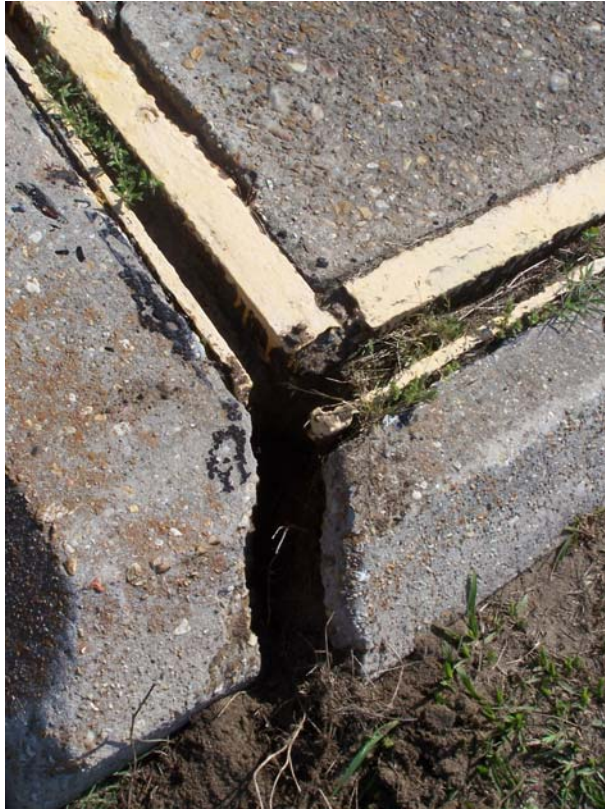
Photo 25 Hatch cover behind the west chamber wall near reference marker 8W.

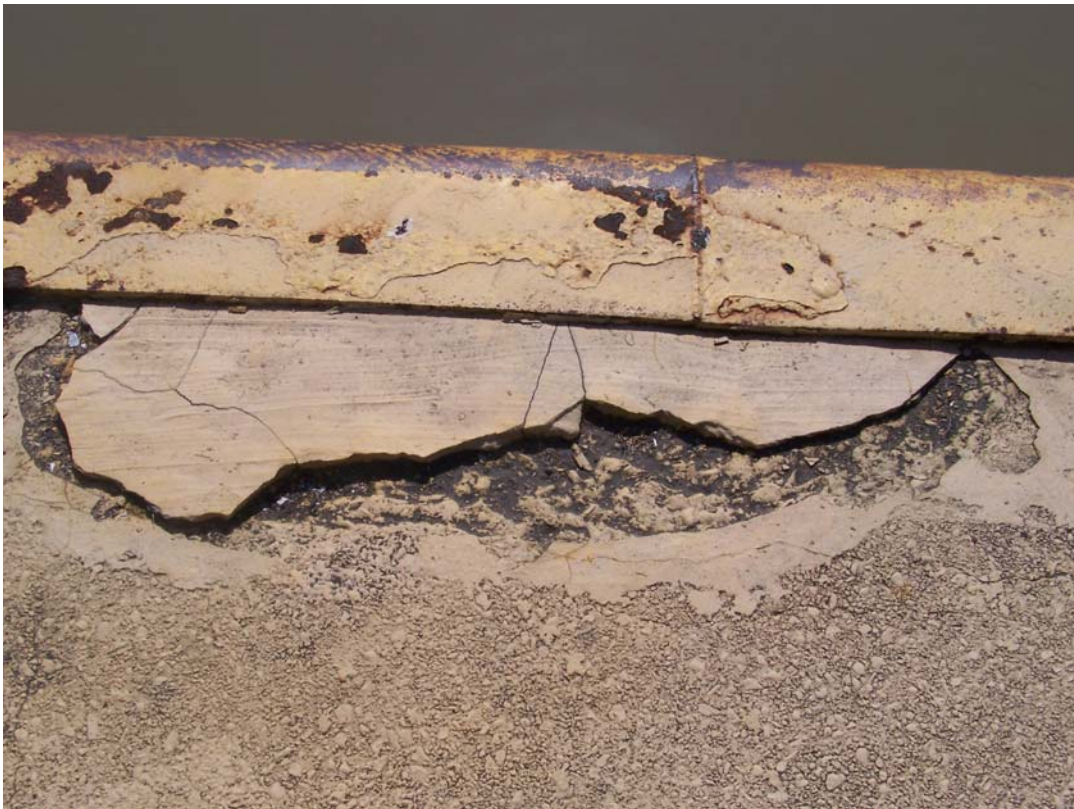
Photo 26 Large shallow spall with a failing patch in top of west chamber wall.

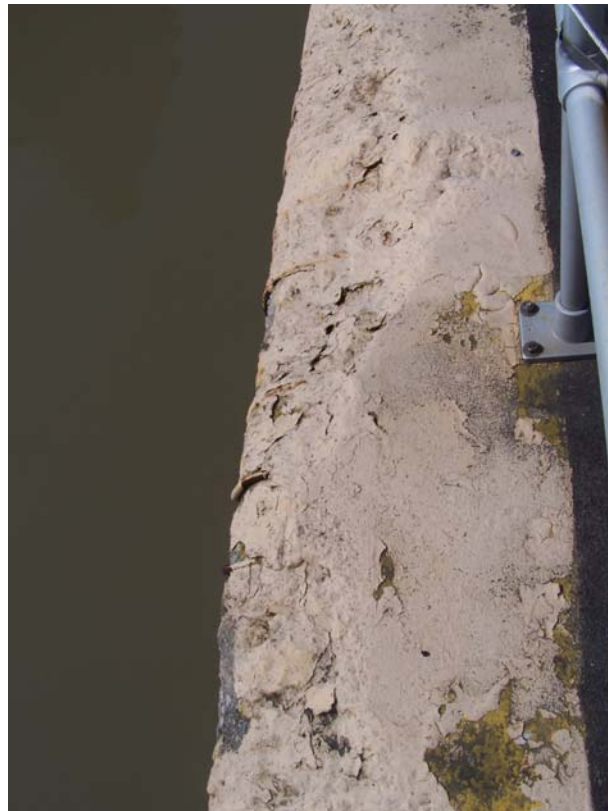
Photo 32 Spalls in west river side gatebay.

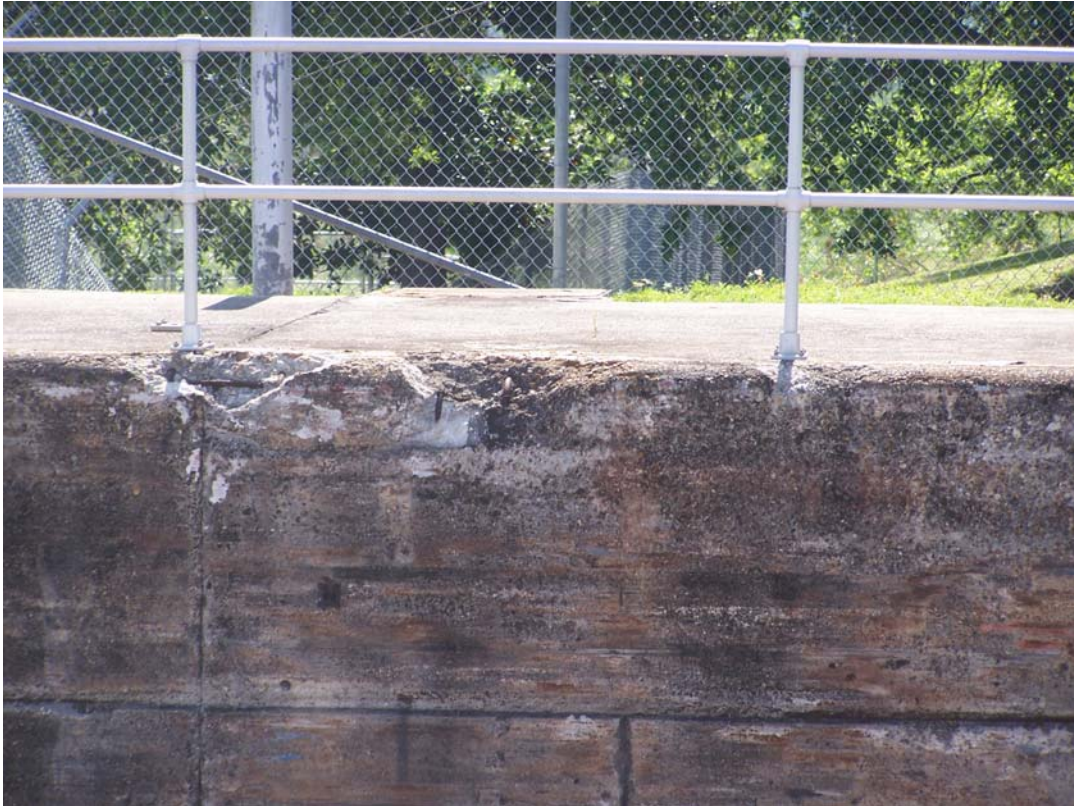
Photo 34 Spalls with exposed steel on the east wall on river side near the gate for the bridge.

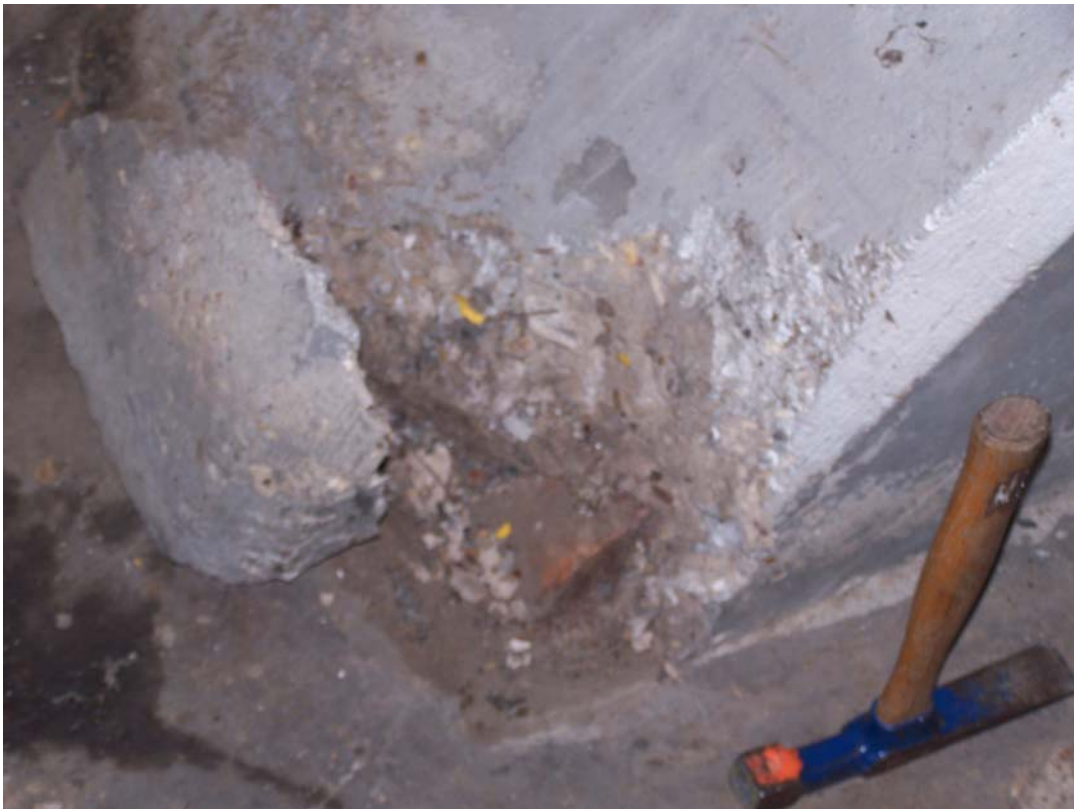
Photo 38 Large spall with exposed steel near the hinge for Gate 3.

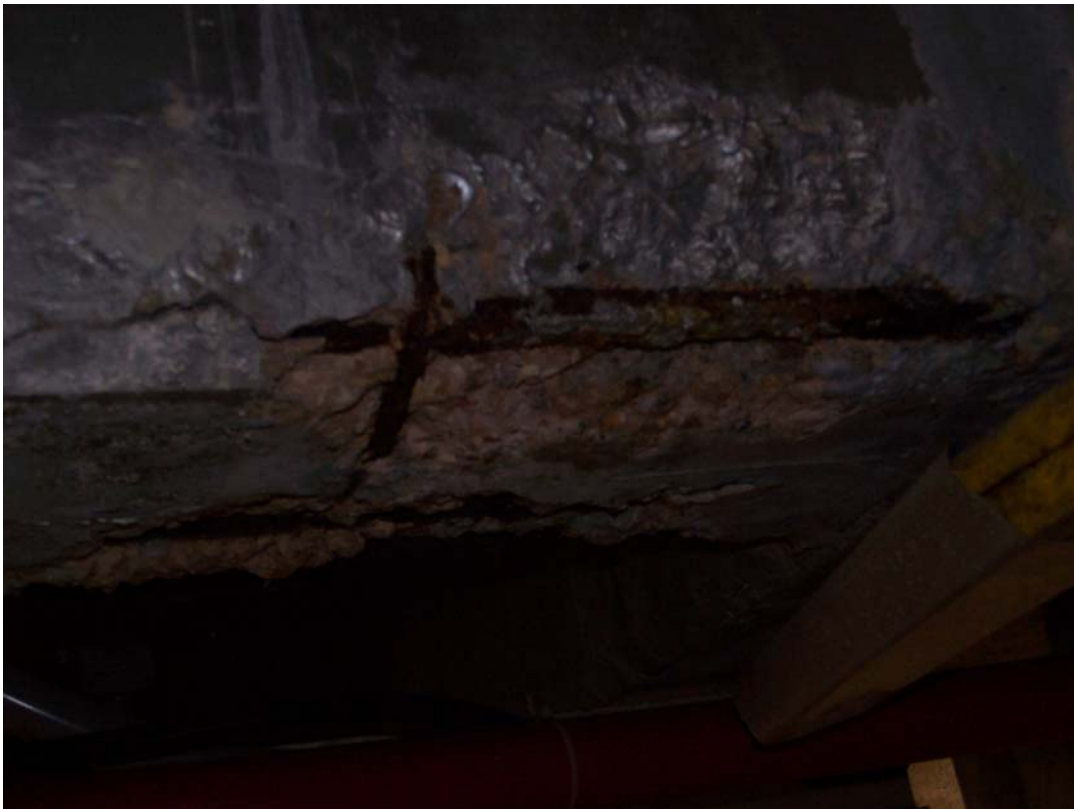
Photo 40 Spalled beam near valve 11. Bottom steel and spiral wire severely corroded.

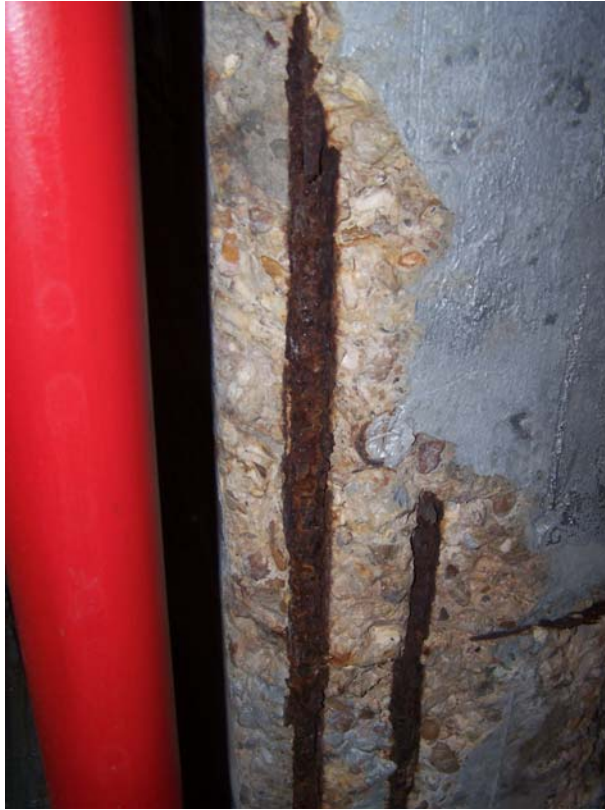
Photo 41 Spalled beam near valve 11. Bottom steel and spiral wire severely corroded.

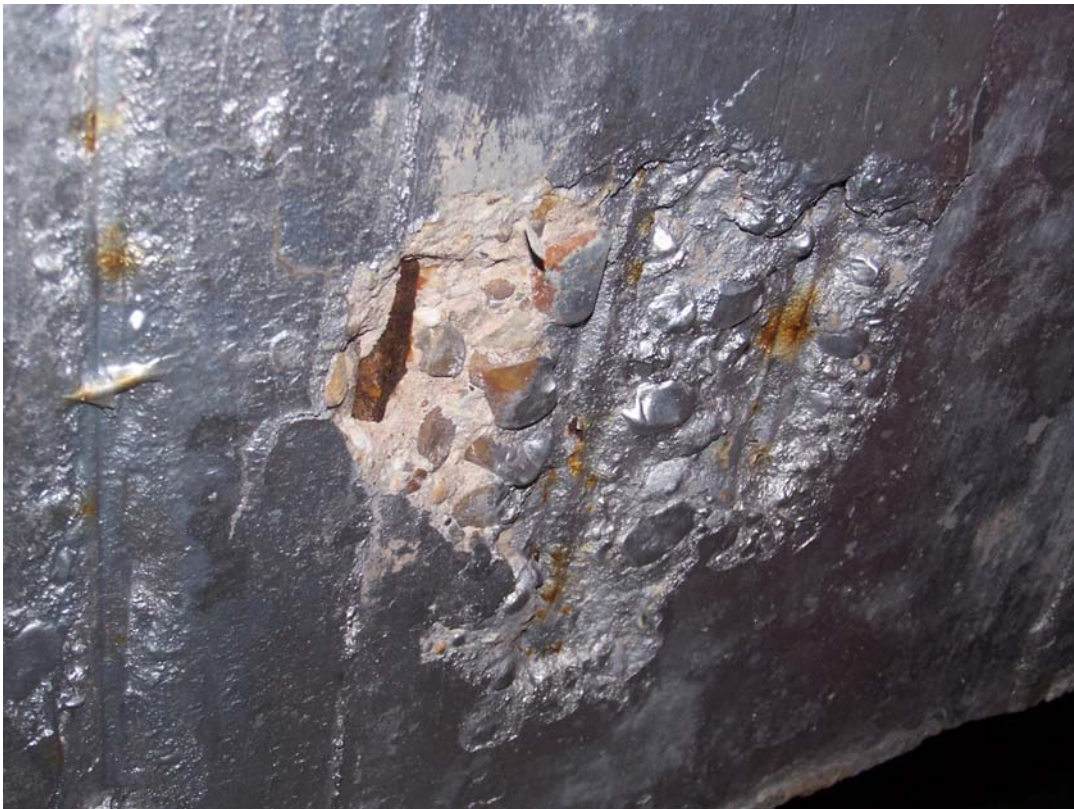
Photo 42 Popout in beam near valve 11 caused by corroding steel.

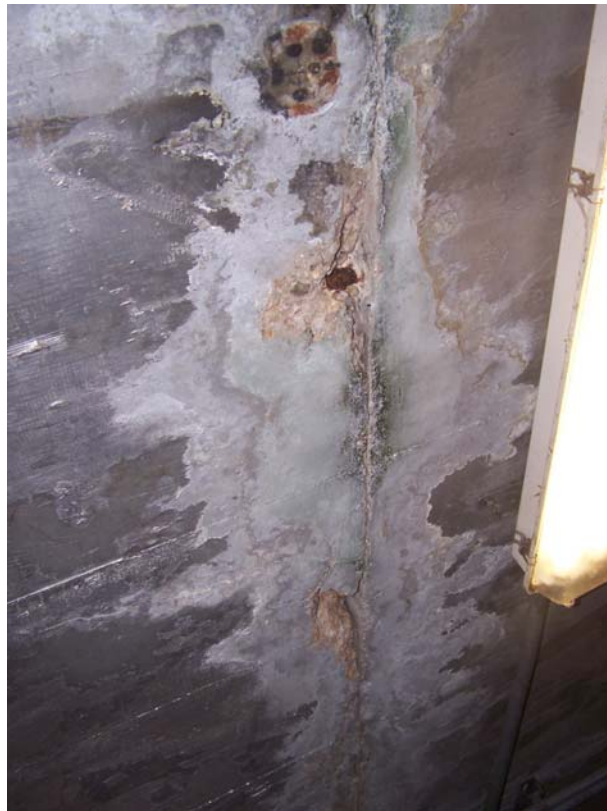
Photo 44 Spalls in ceiling near valve 11 caused by corroding steel

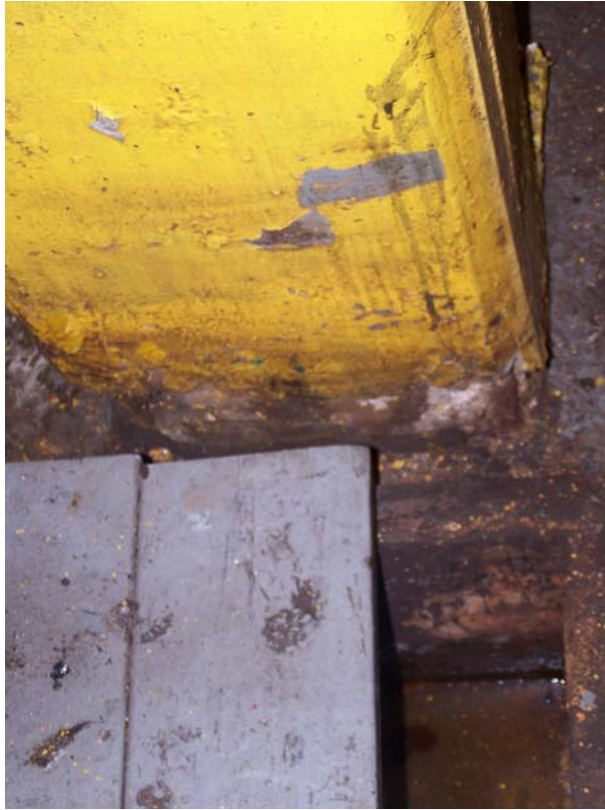
Photo 47 Spalls and delaminations at bottom of columns on both sides of hinge for gate 1.

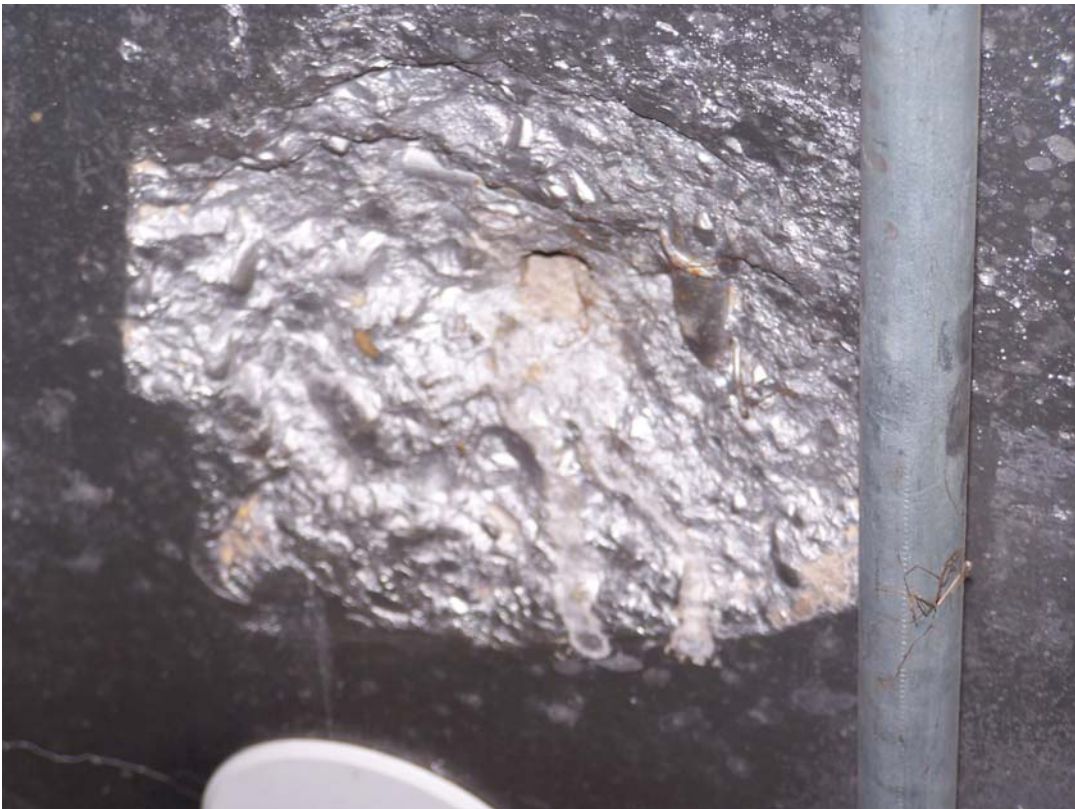
Photo 52 Popout in beam over gate 1 machinery.

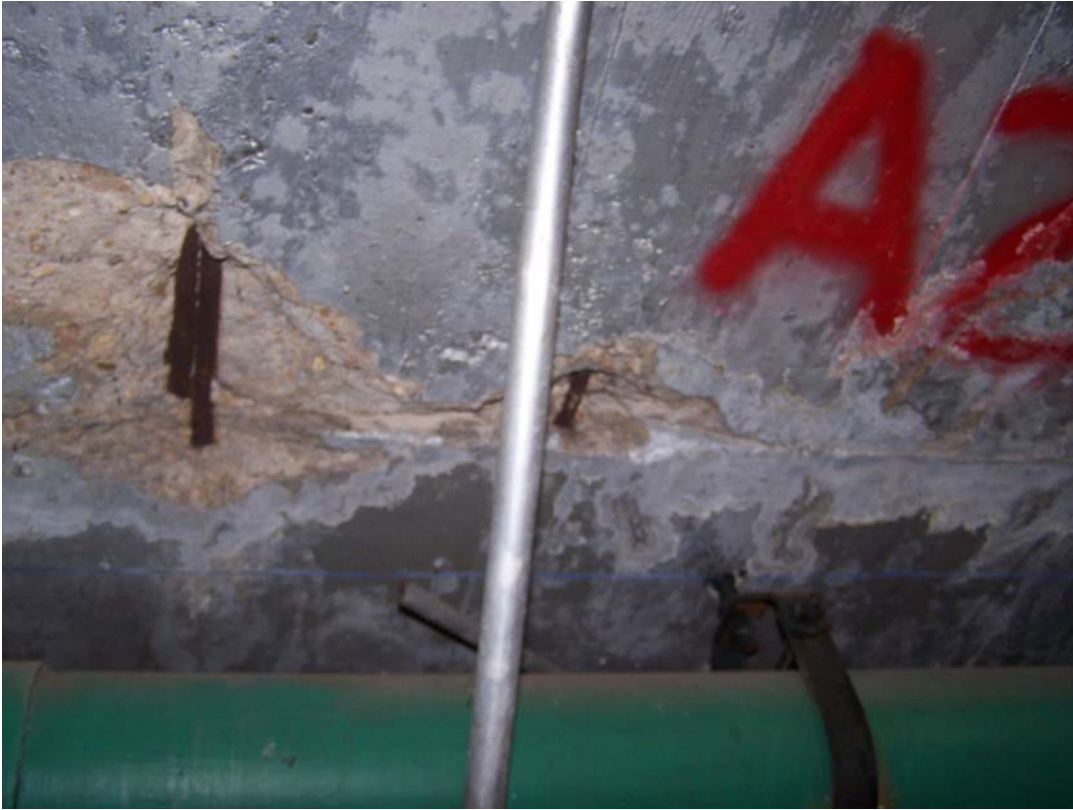
Photo 55 Spalling with corroded steel in ceiling over gate 3 machinery.

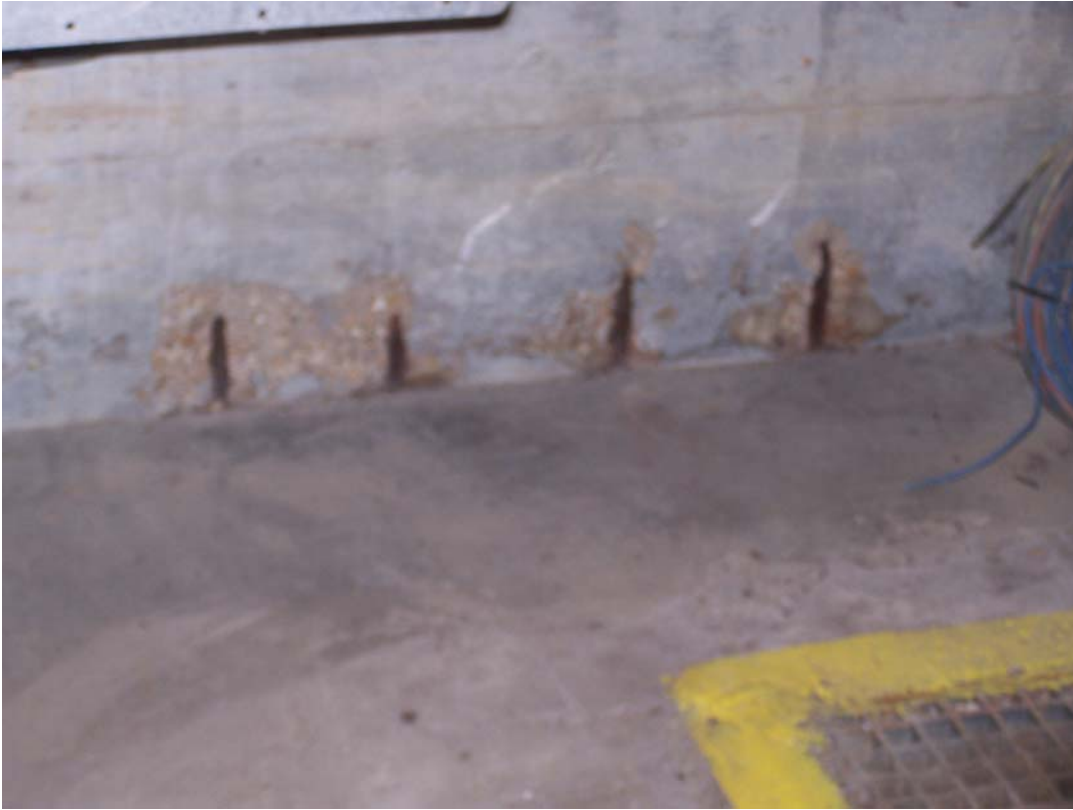
Photo 57 Spalls caused by corrosion of steel at the bottom of the wall in room 3.

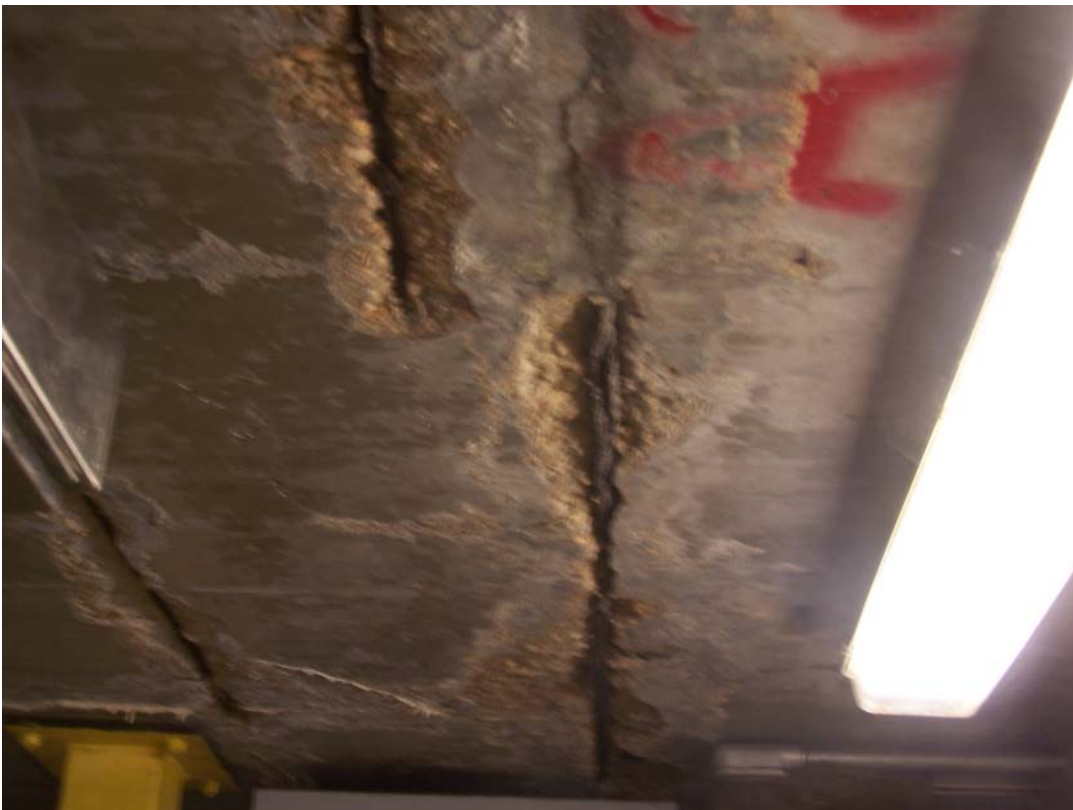
Photo 58 Spalls and popouts in the ceiling of room 3.

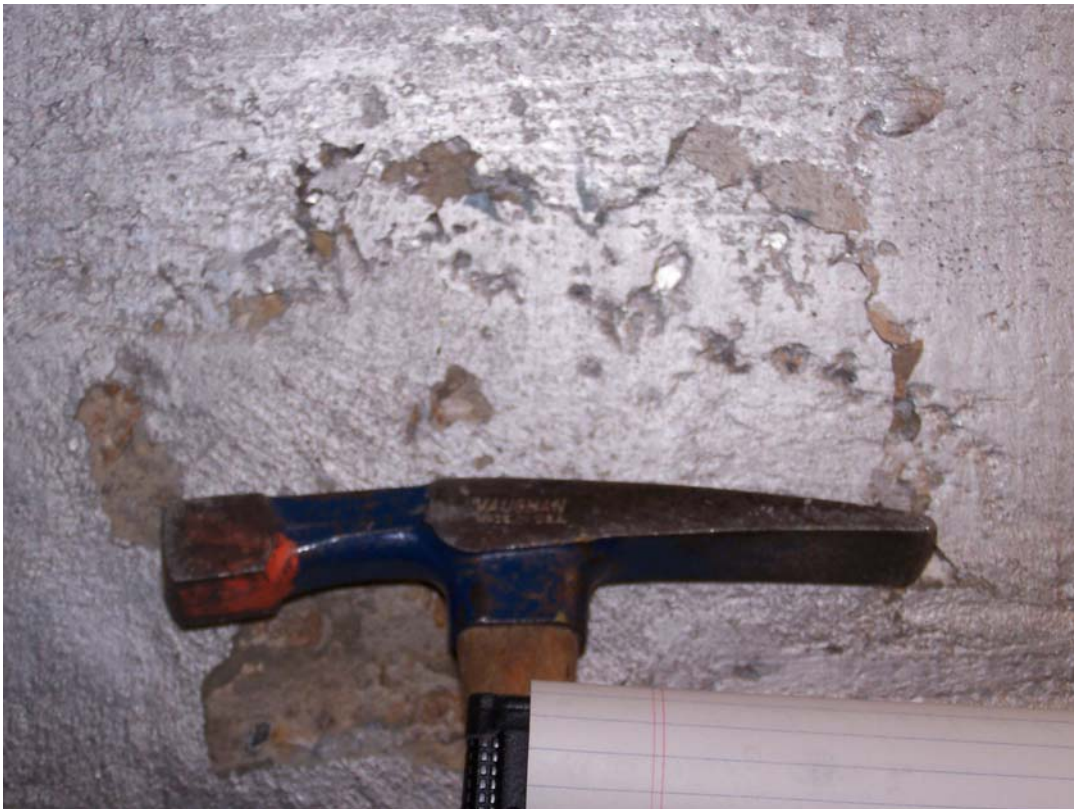
Photo 66 Small shallow delamination in the West tunnel wall.

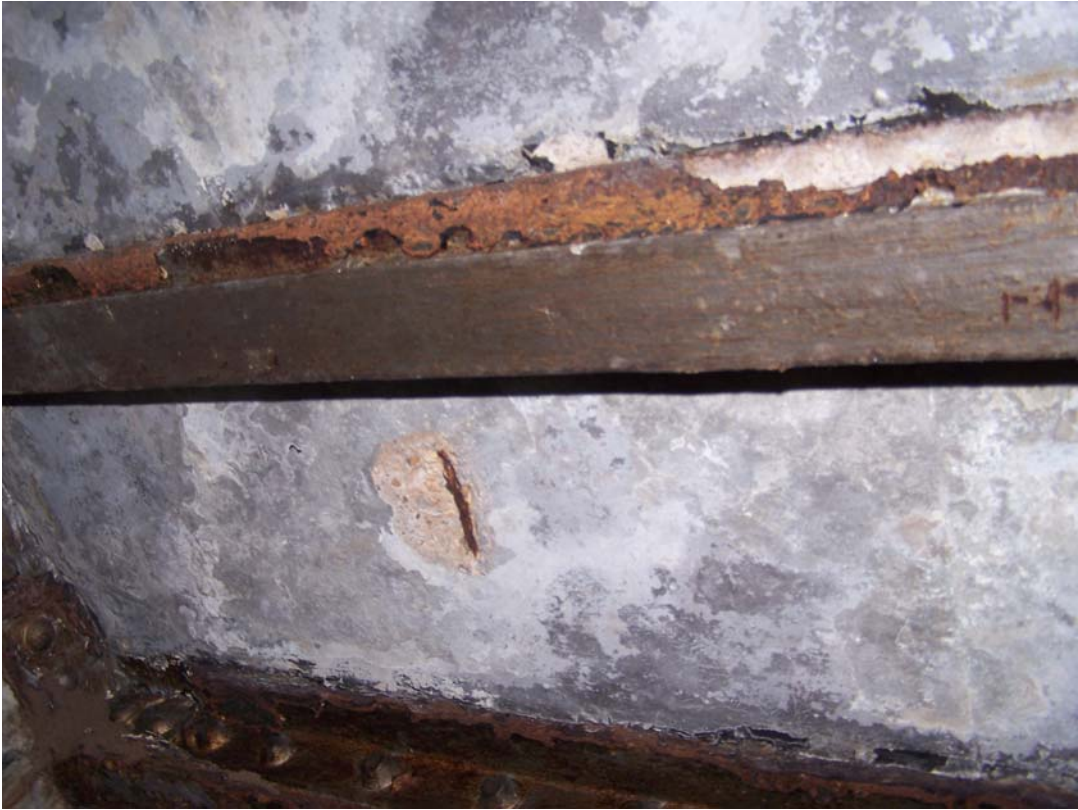
Photo 69 Bottom of hatch cover in west tunnel.

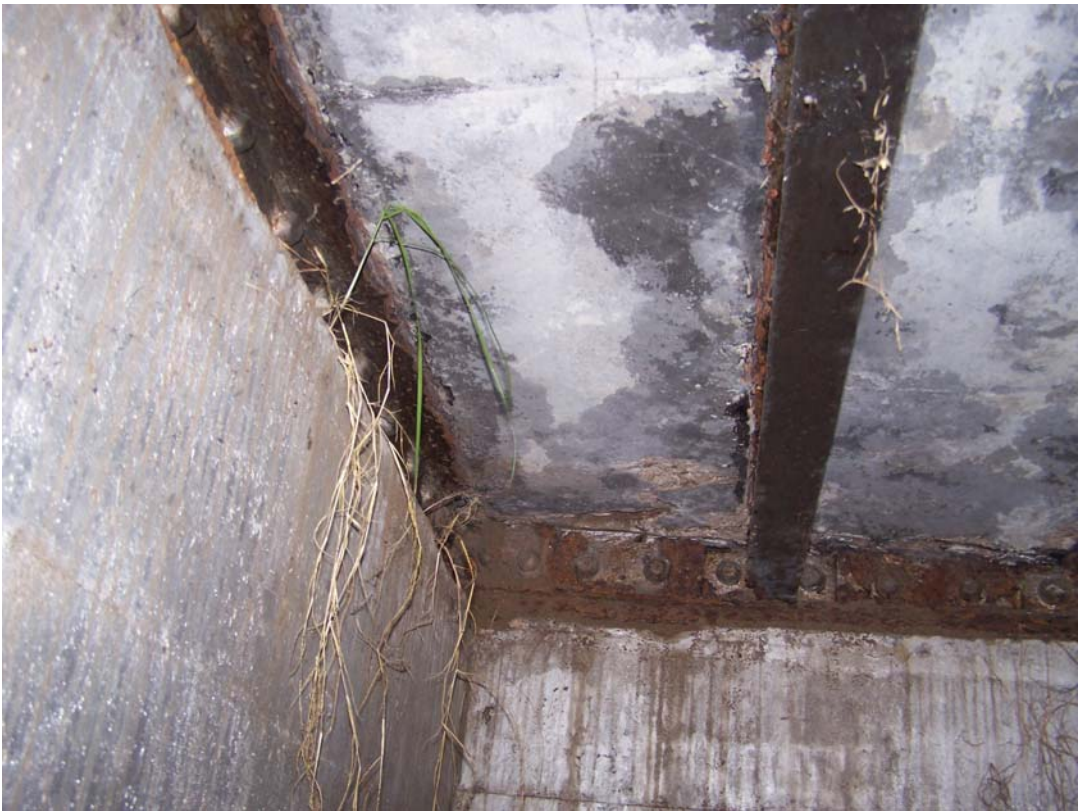
Photo 70 Bottom of hatch cover in west tunnel.

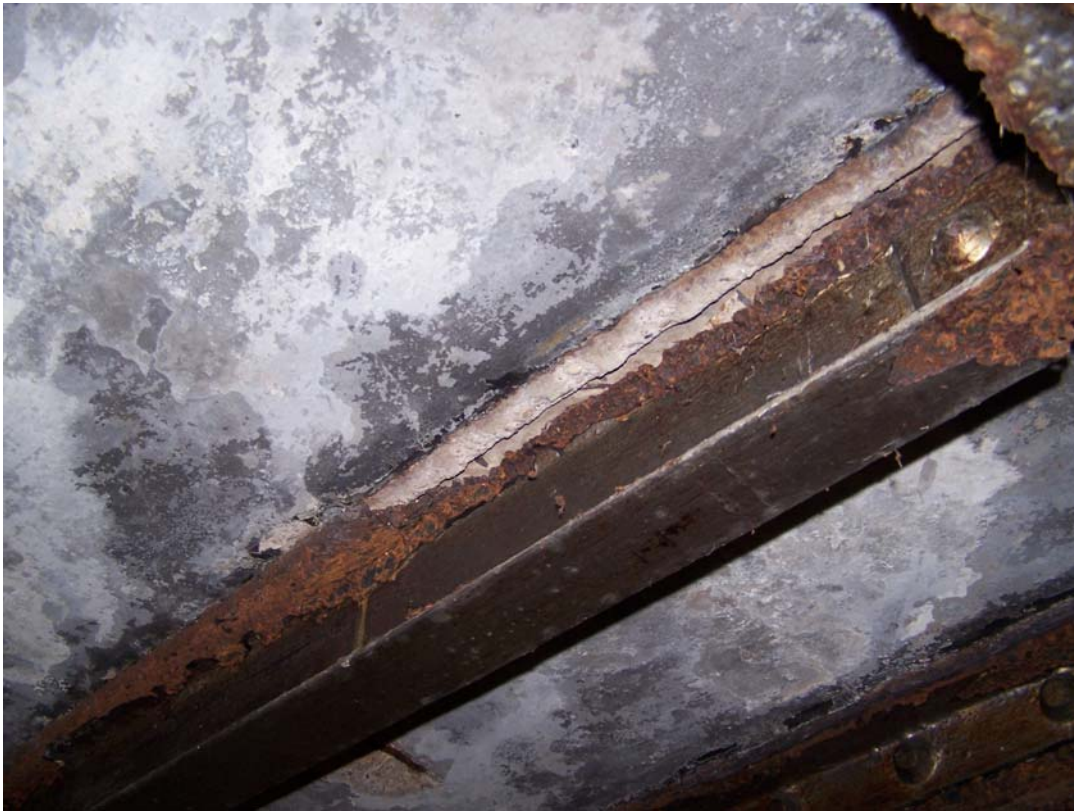
Photo 71 Bottom of hatch cover in west tunnel.
