MEMORANDUM FOR Chief, Regional and Environmental Planning Division-South
(CEMVN-REPD/Troy Constance)

SUBJECT: IHNC Lock Replacement General Re-evaluation Report, Engineering
Assessment of the Existing Lock Structure

Enclosure 1 – Pictures of Structural Deficiencies

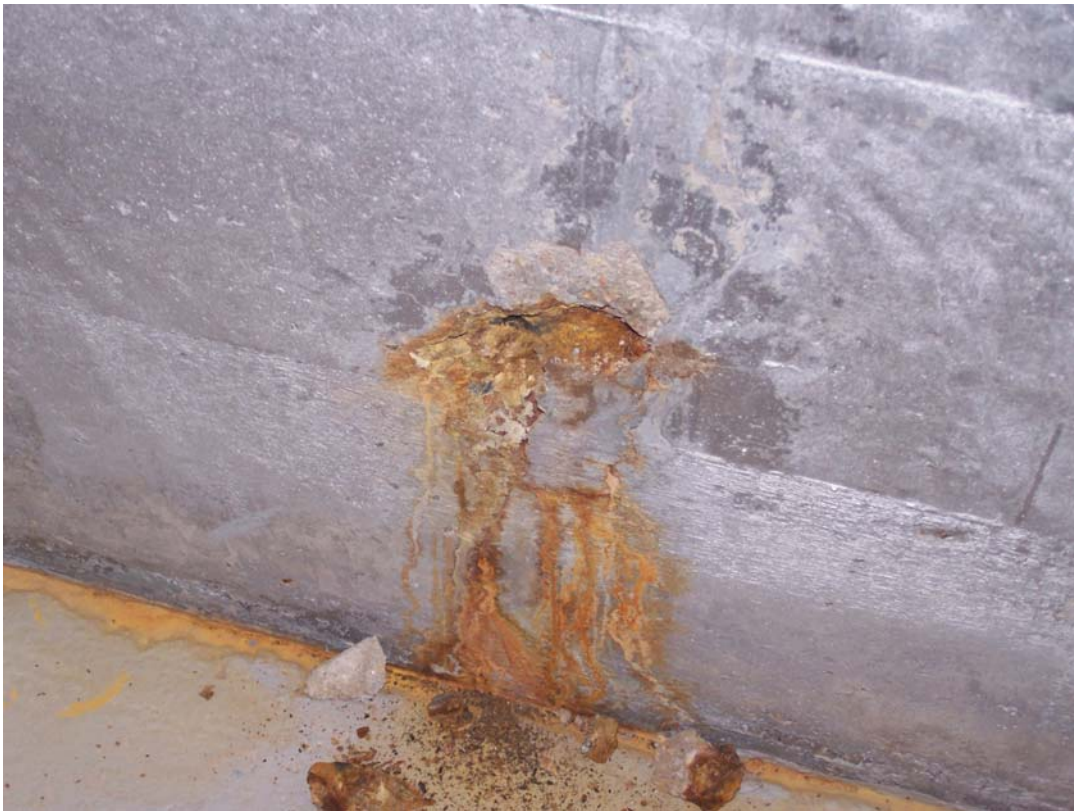
Photo 72 Popout in the bottom of west tunnel wall.

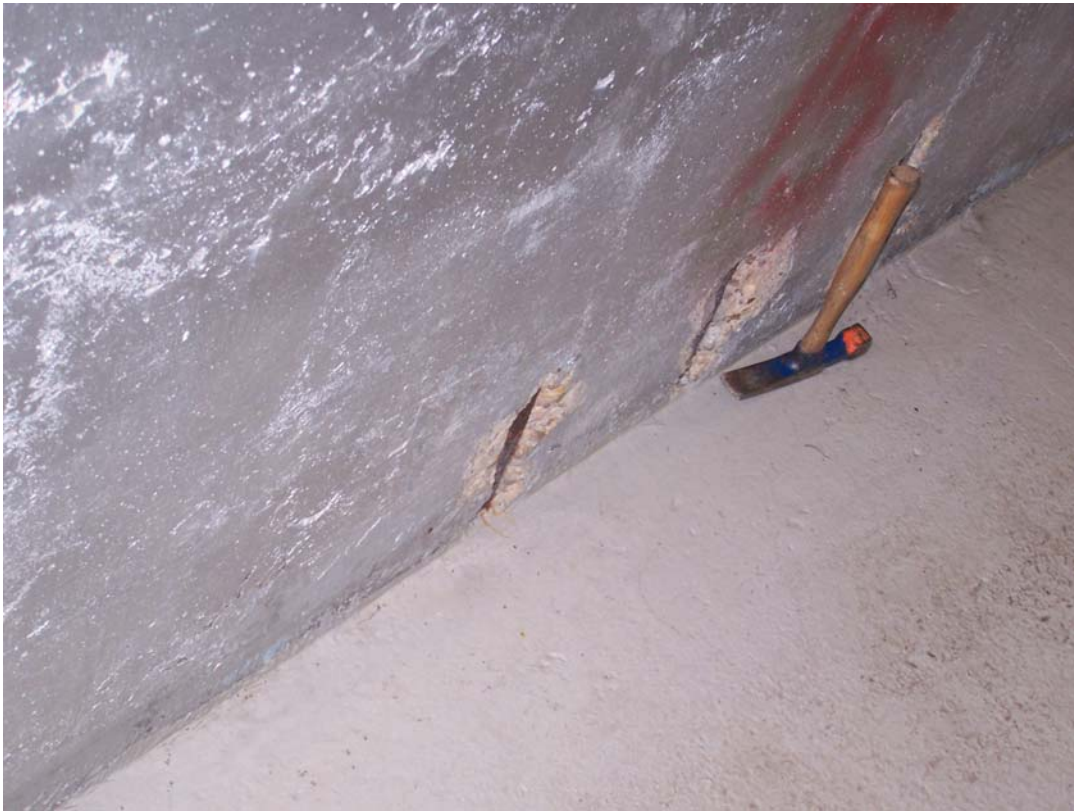
Photo 73 Popout in the bottom of west tunnel wall.

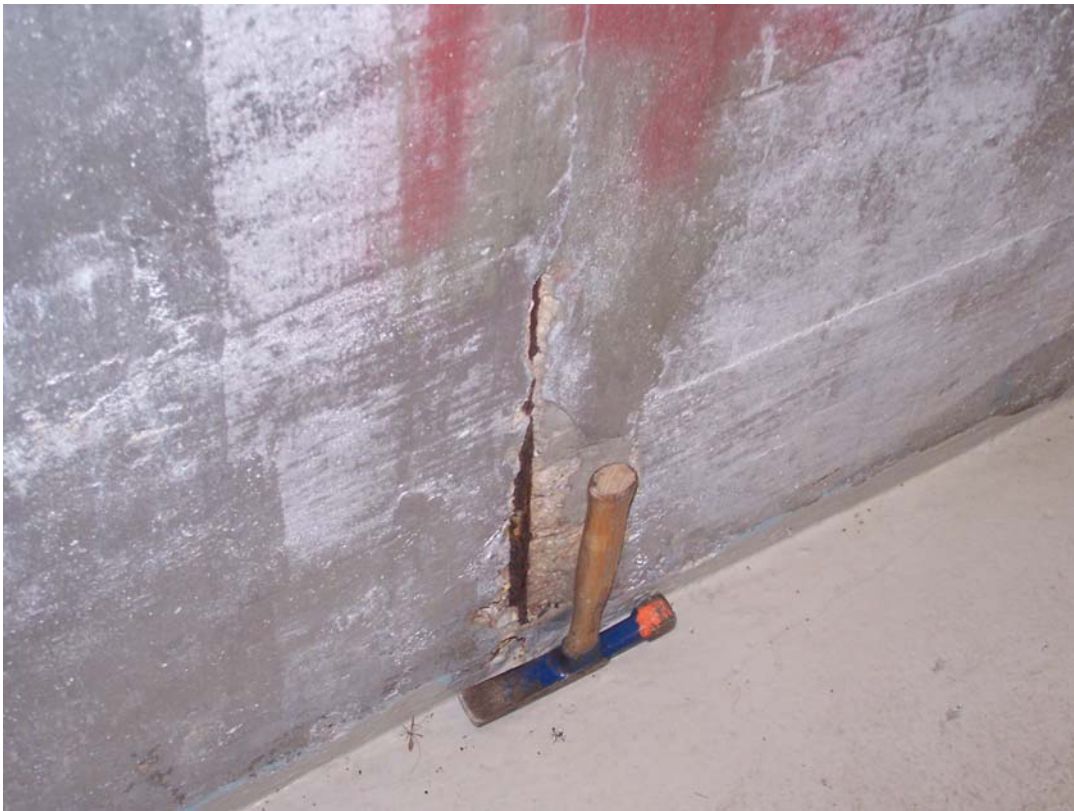
Photo 74 Popout in the bottom of west tunnel wall.

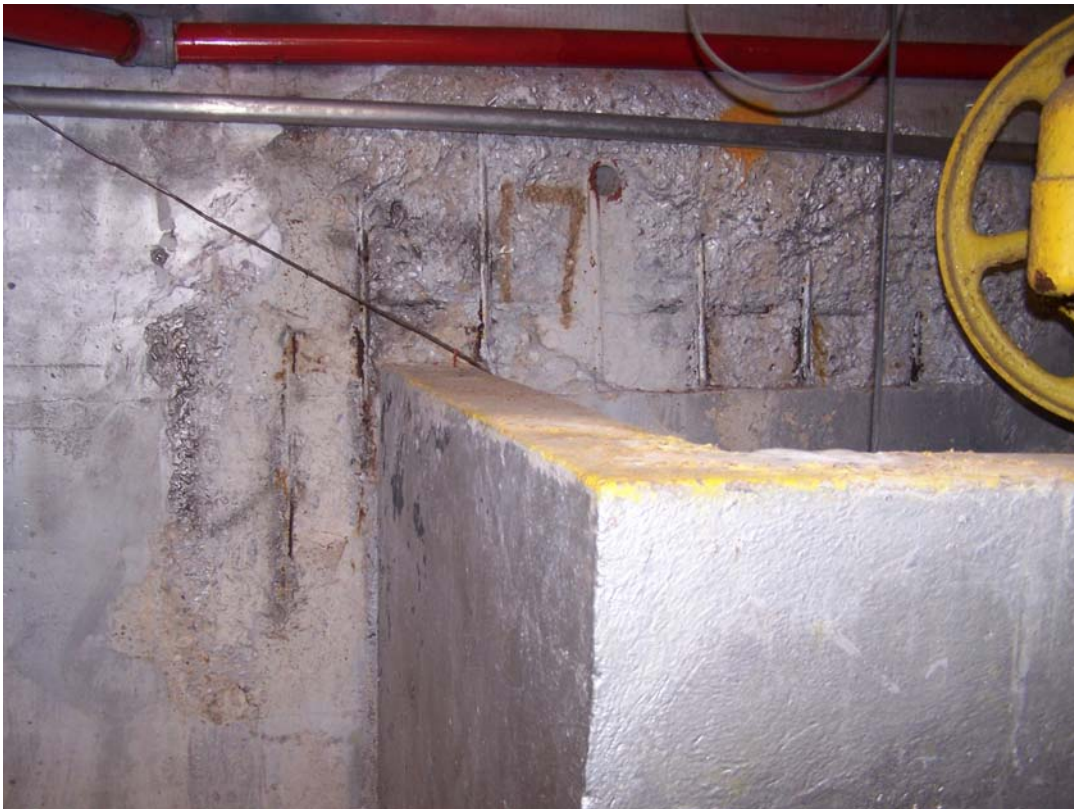
Photo 83 Cracks in top of wall around sump pump in room 5.

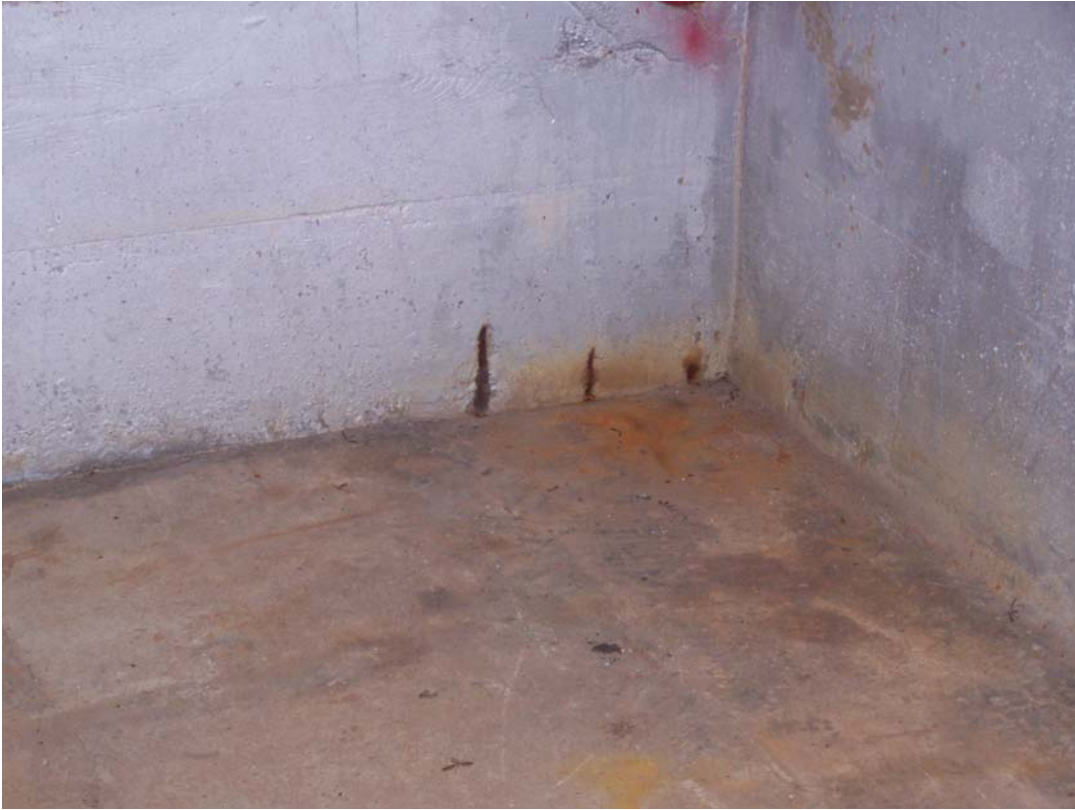
Photo 86 Popouts at the bottom of the wall in room 5.

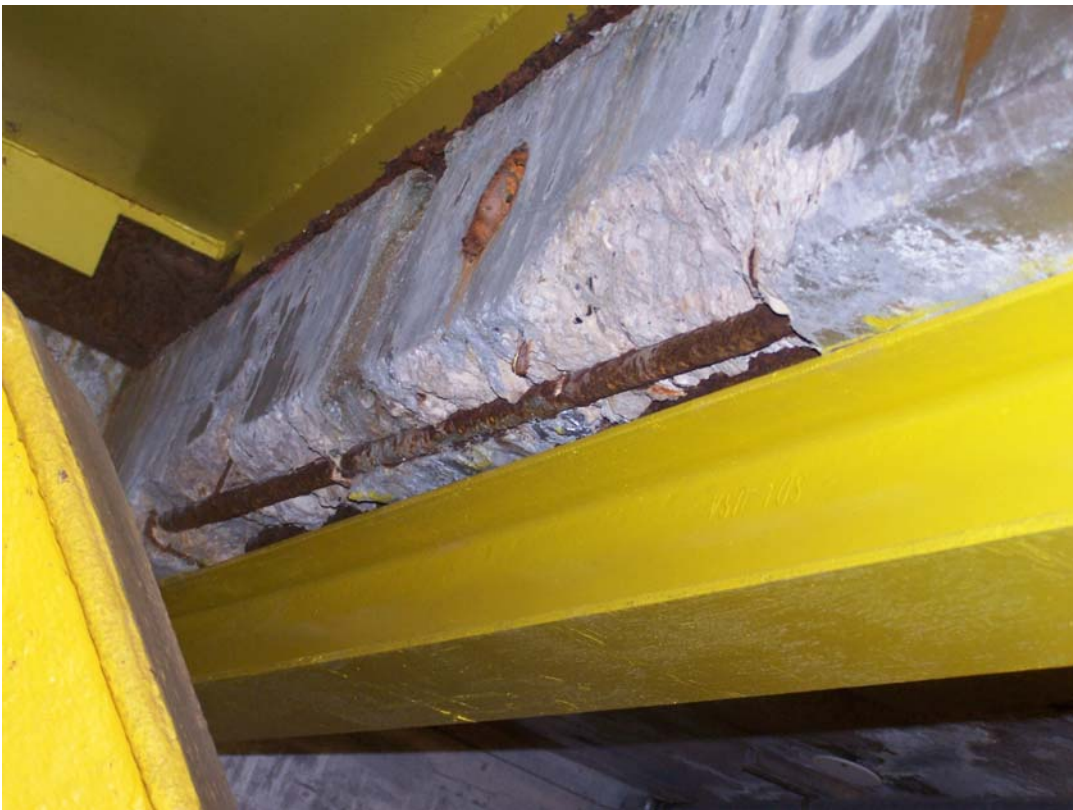
Photo 93 Spalls and corroded steel in beams over machinery in room 5. Note steel beam and columns added to support these beams.

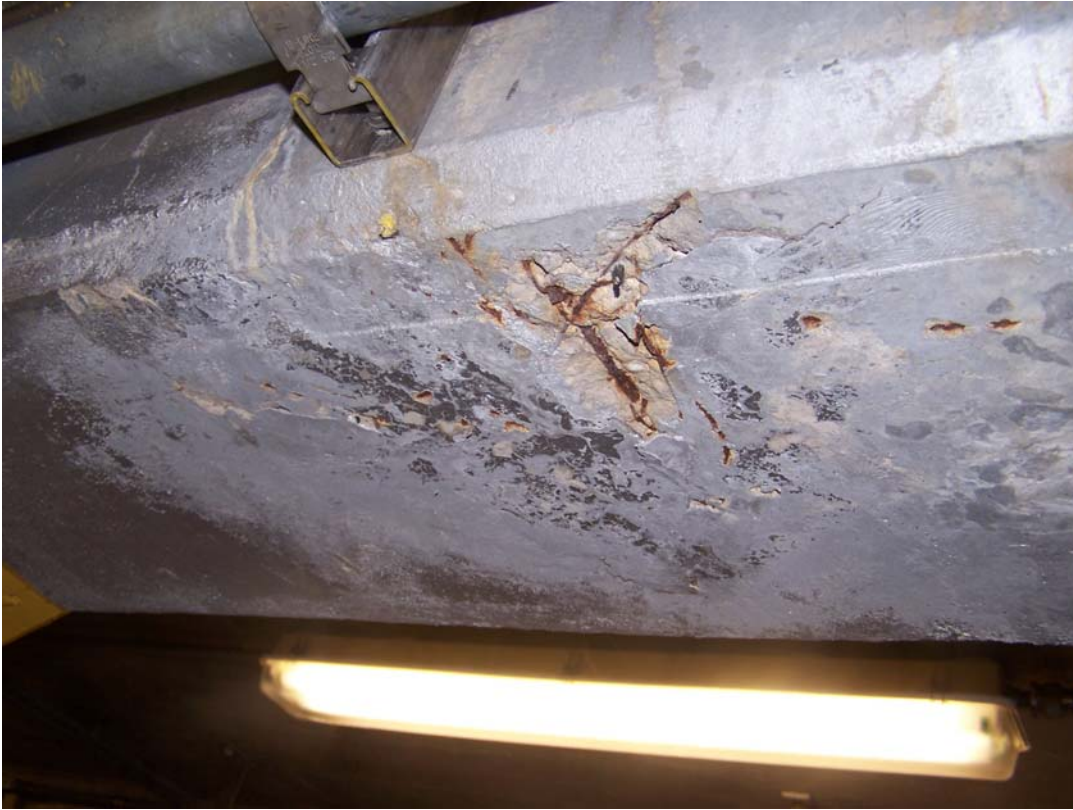
Photo 100 Spalled beam with corroded reinforcing over opening for gate 7.

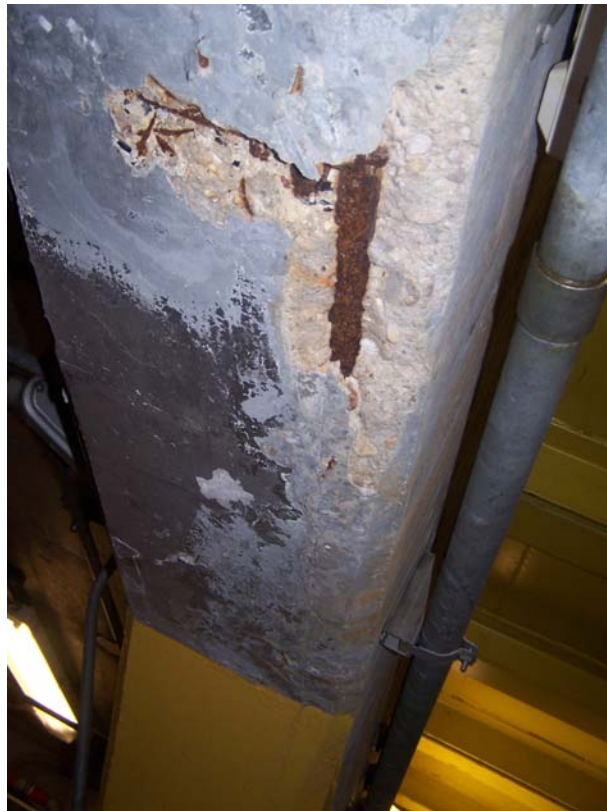
Photo 103 Crack and spall in the bottom of beam in room 7.

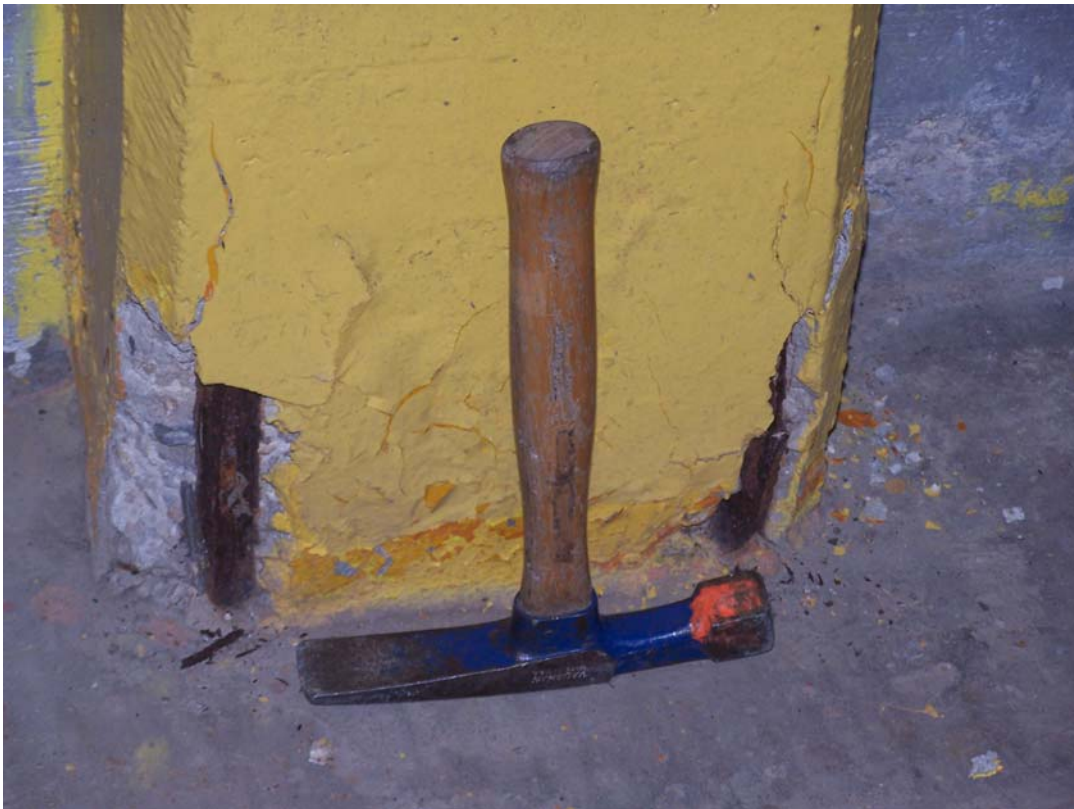
Photo 105 Bottom of column in the wall in room 5. Delamination continues up the column.

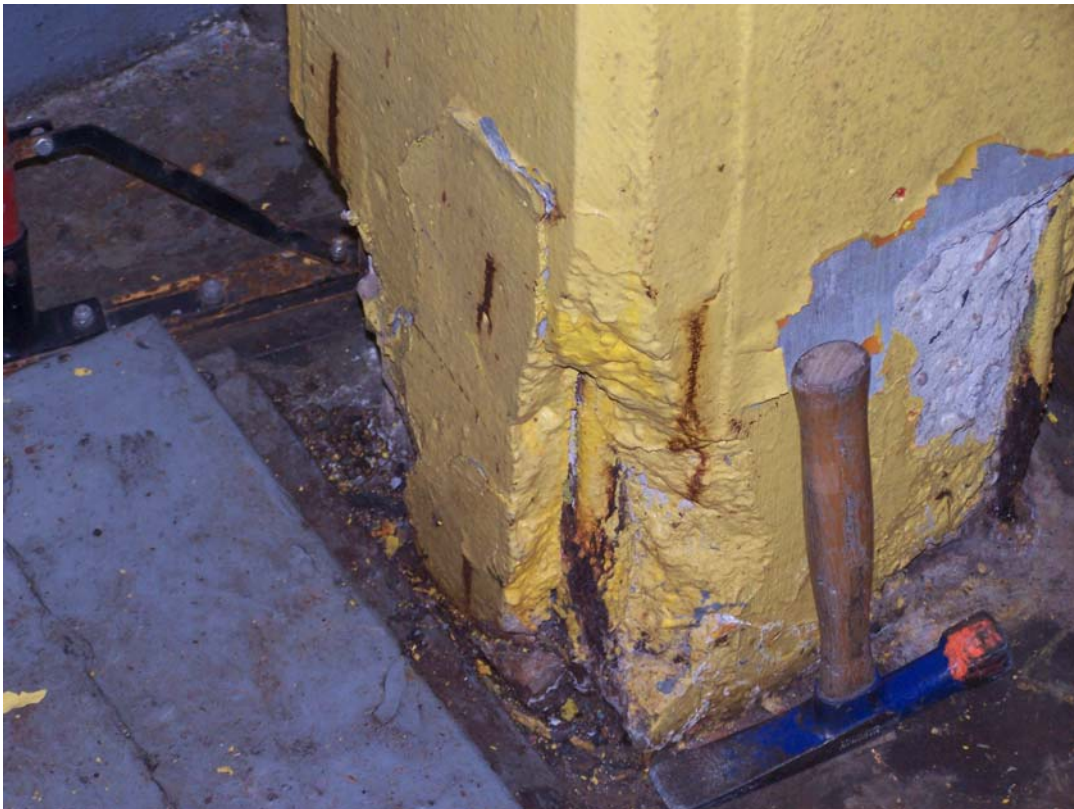
Photo 109 Spall at the bottom of the column by the gate under the stairway.

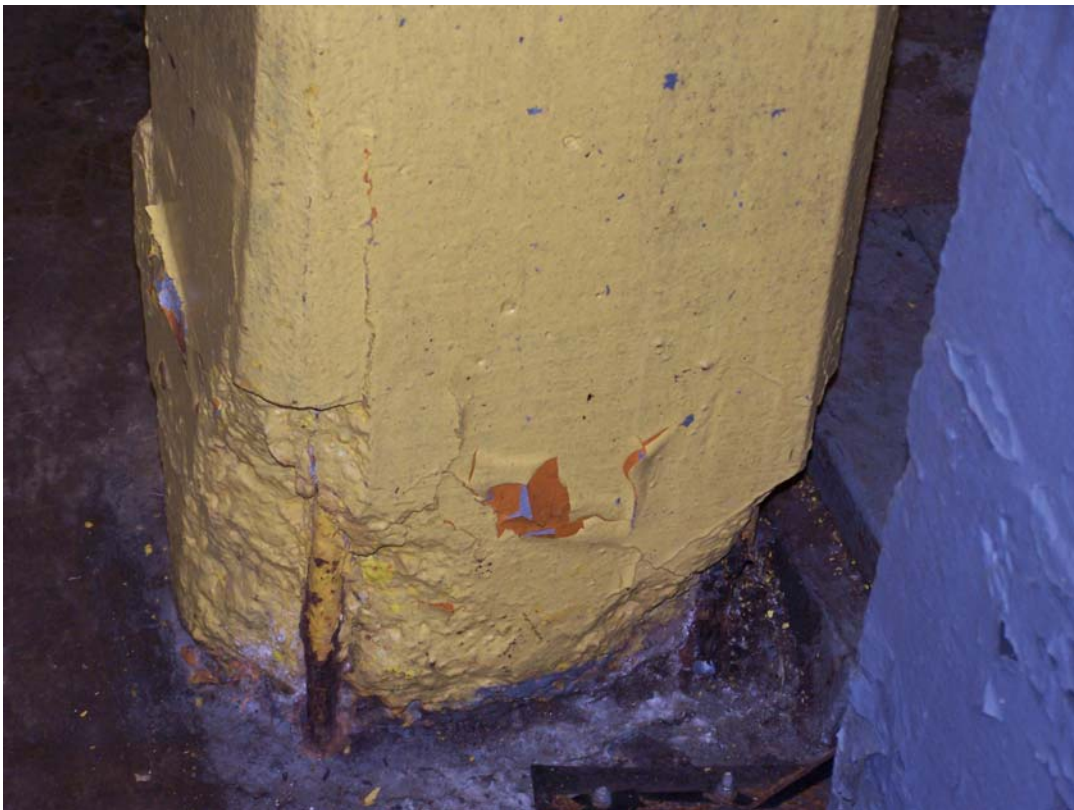
Photo 111 Spalling and corroded steel at the bottom of the column near the louvers by the hinge of gate 5. Damage to about 20" up from floor.

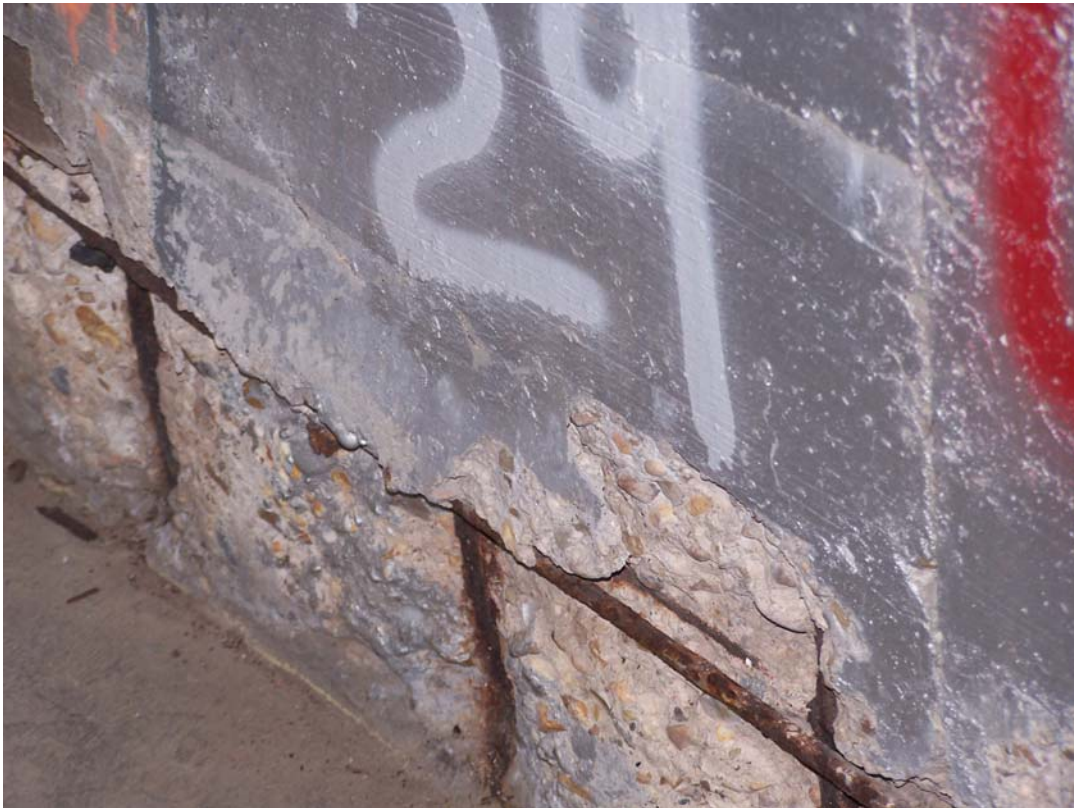
Photo 115 Popouts/spalling along the bottom of the wall near valves 15 and 16.

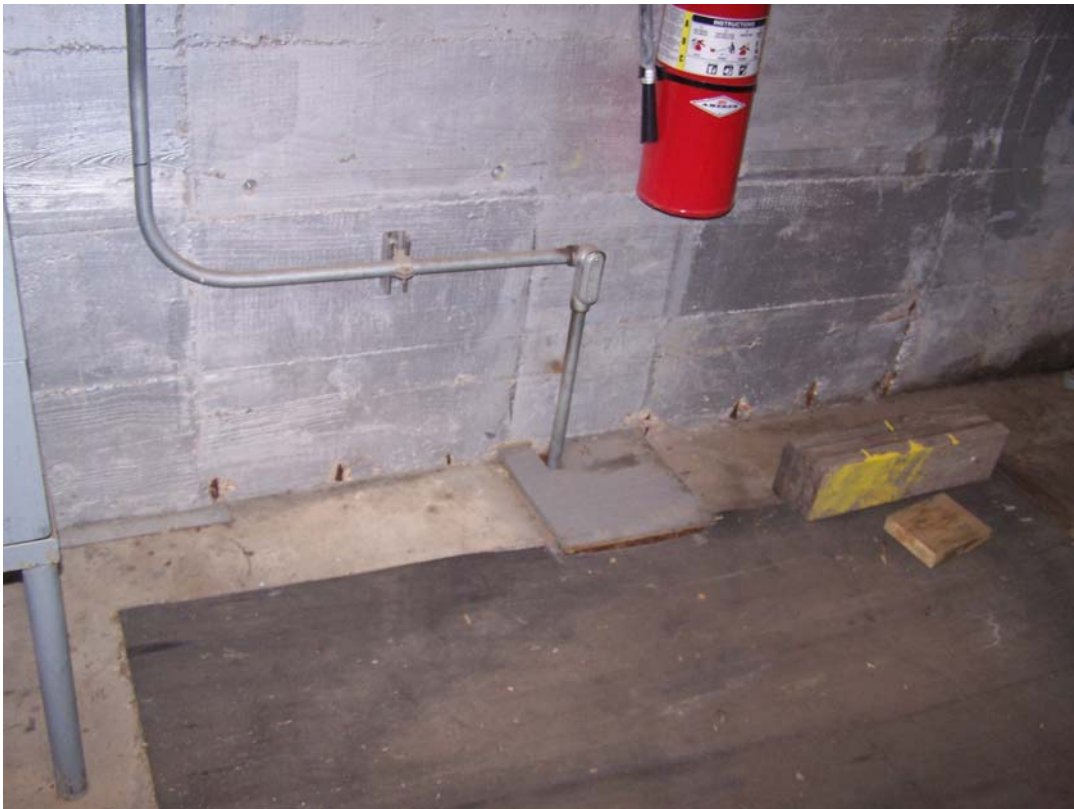
Photo 117 Popouts along the bottom of the wall near valves 15 and 16.

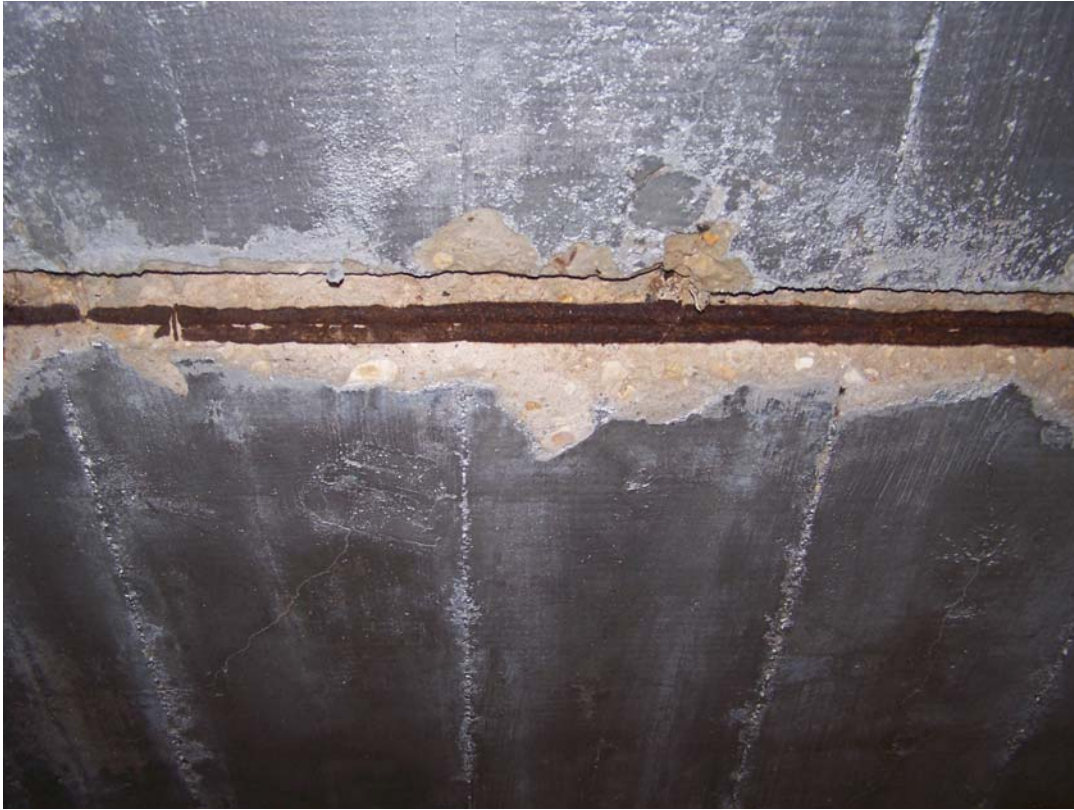
Photo 118 Popouts along the bottom of the wall near valves 15 and 16.

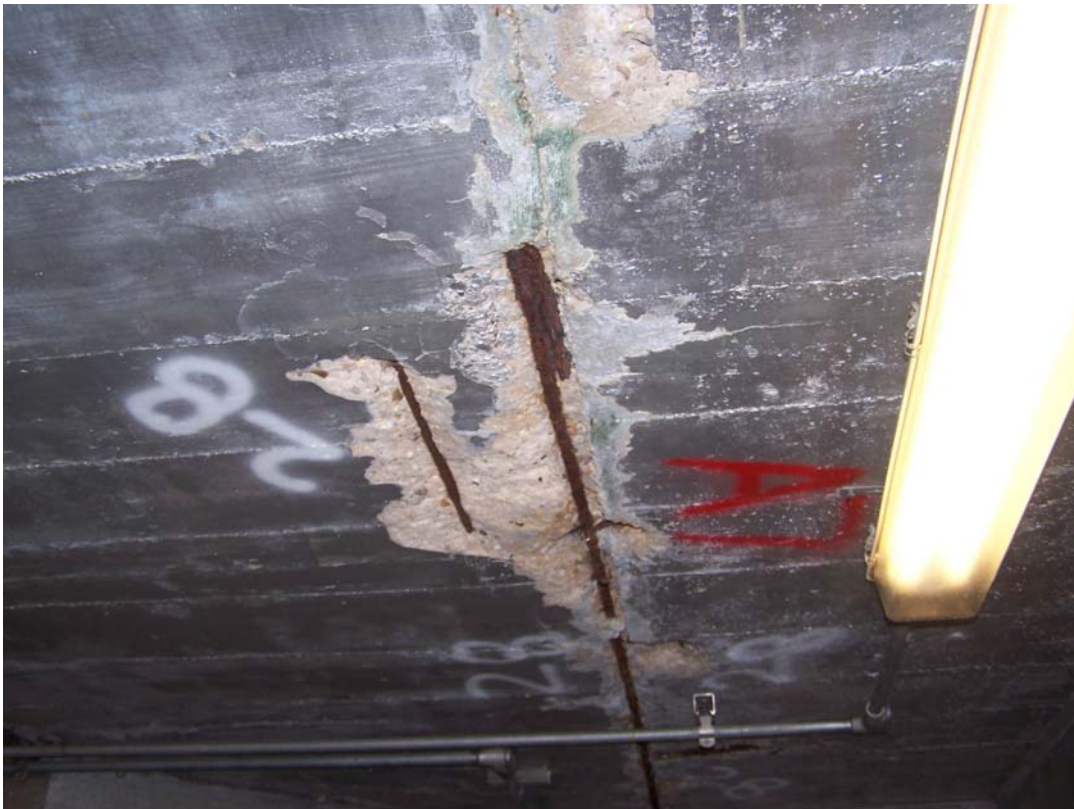
Photo 119 Spalls in ceiling near gate 5.

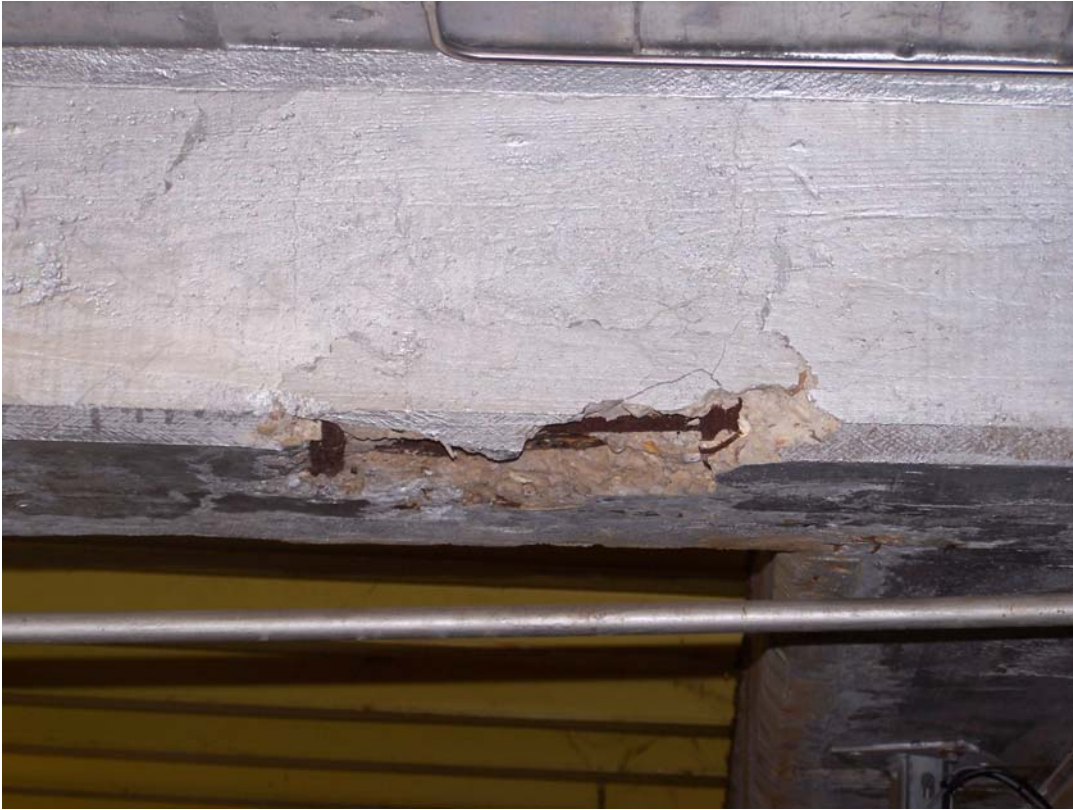
Photo 120 Spalls in ceiling near gate 5.

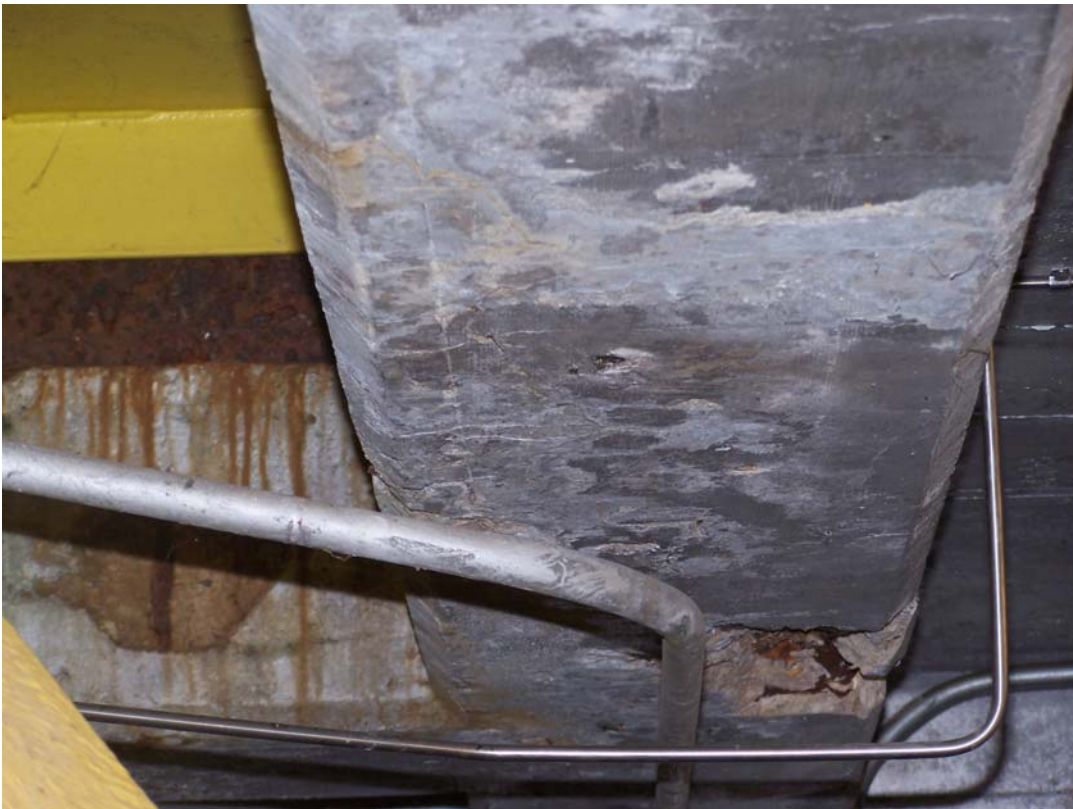
Photo 121 Spall and corroded steel in beam over gate 5 machinery.

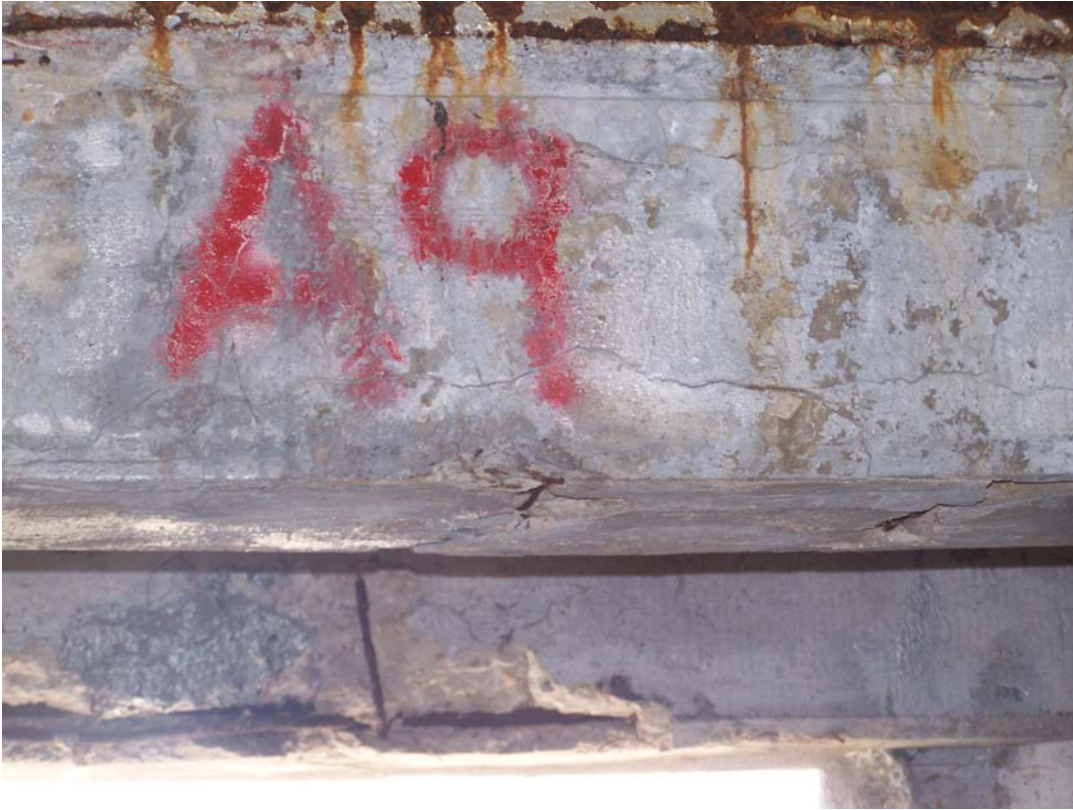
Photo 122 Spall and corroded steel in beam over gate 5 machinery.

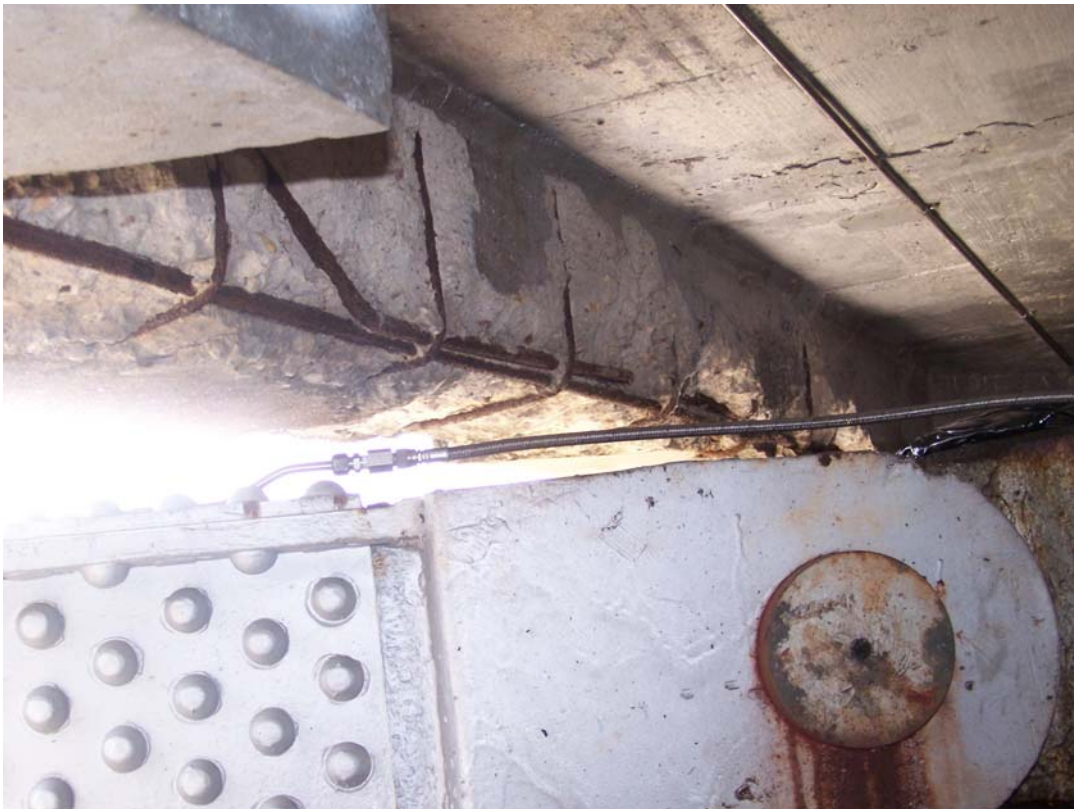
Photo 127 Spalls in beam over Gate 5 machinery. About mid span of beam.

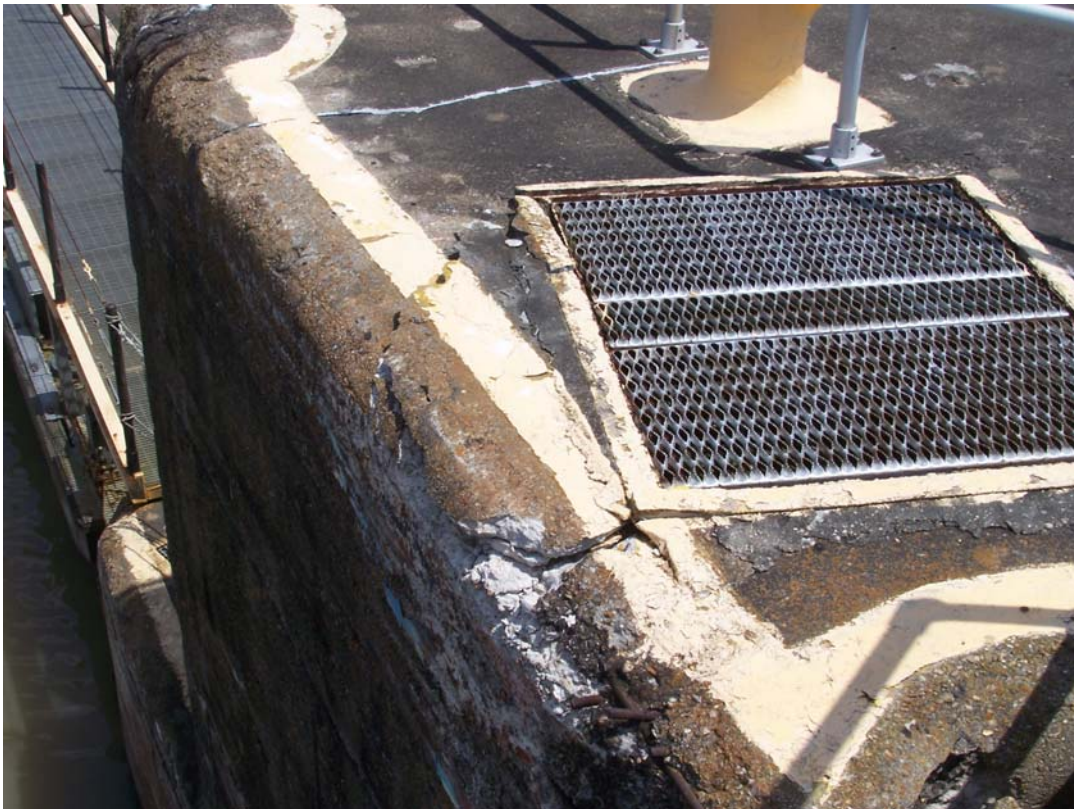
Photo 133 Spalled concrete and exposed steel near hinge of northeast gatebay.

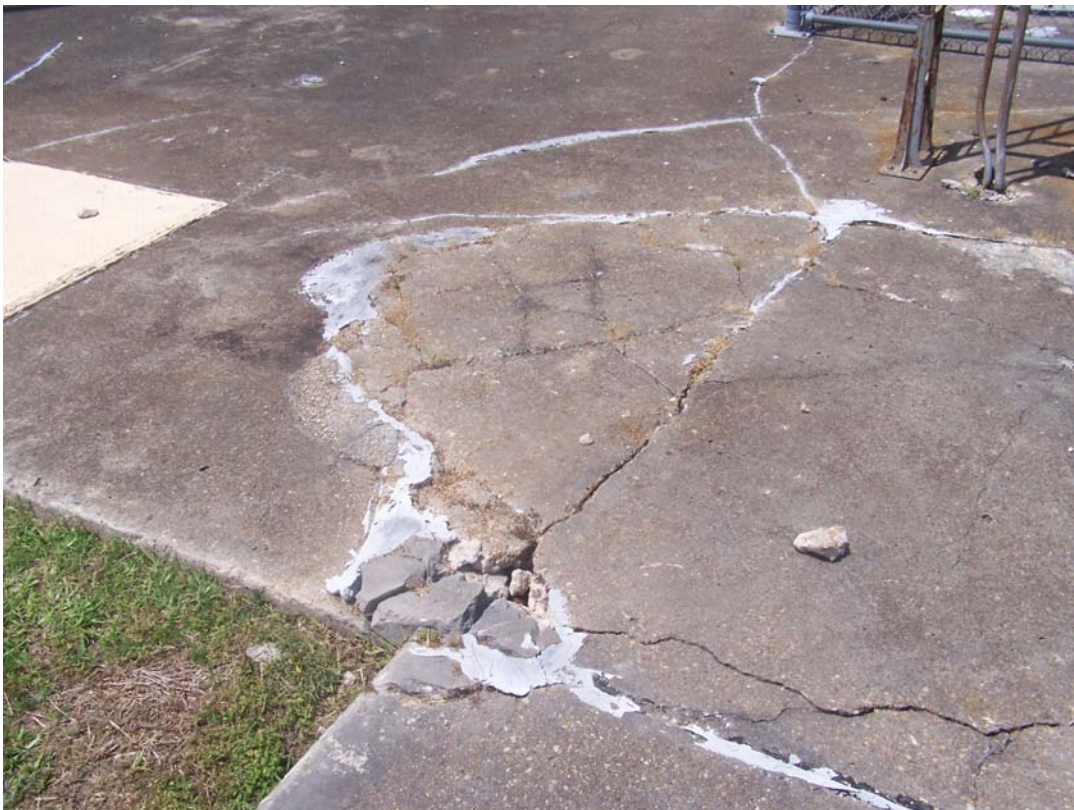
Photo 143 Large area of cracked and spalling concrete behind northeast retaining wall. The whole area sounded hollow underneath.

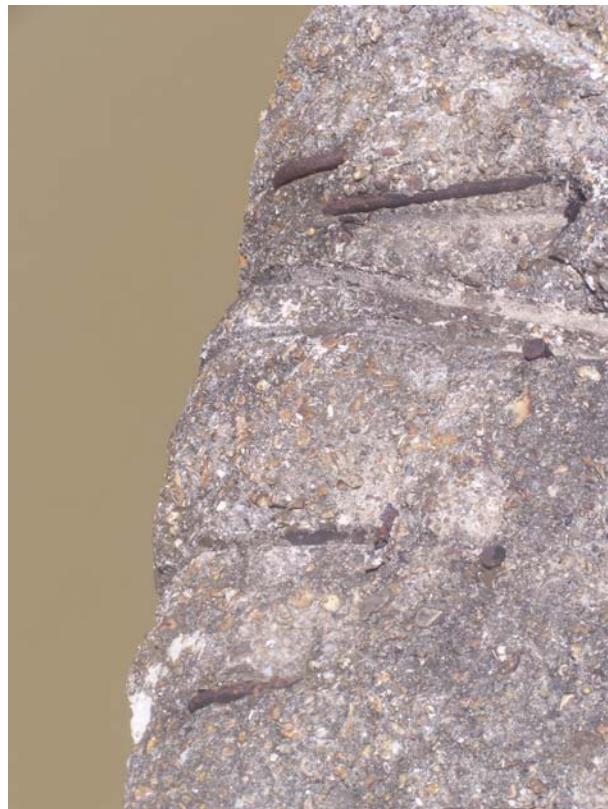
Photo 145 Spalls in north gatebay.

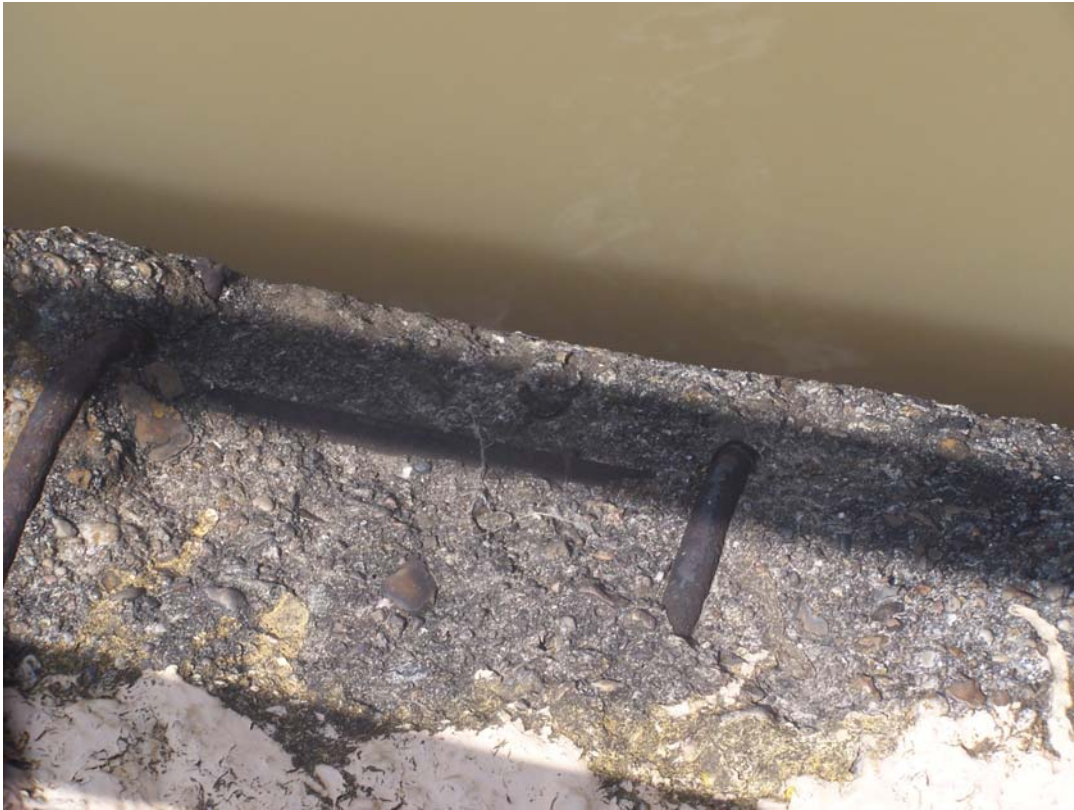
Photo 146 Spalls in north gatebay.

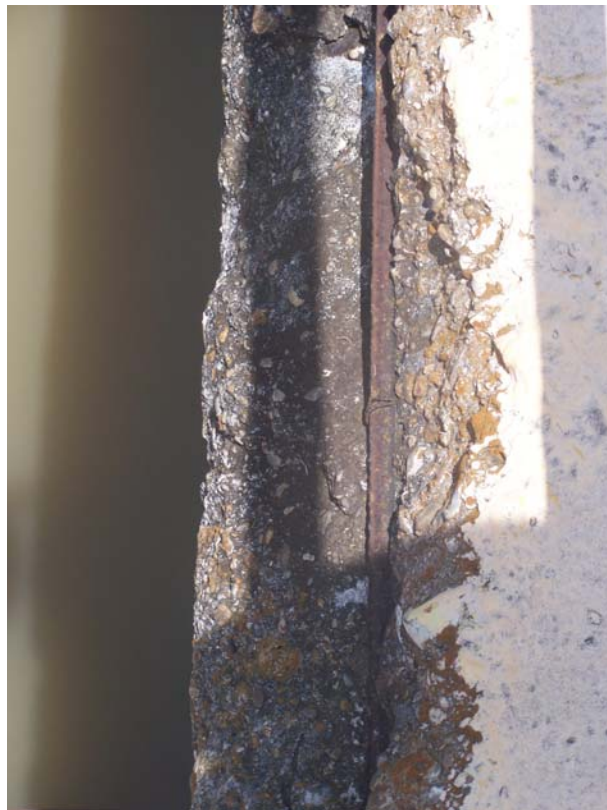
Photo 147 Spalls in east lock chamber wall. (Typical).

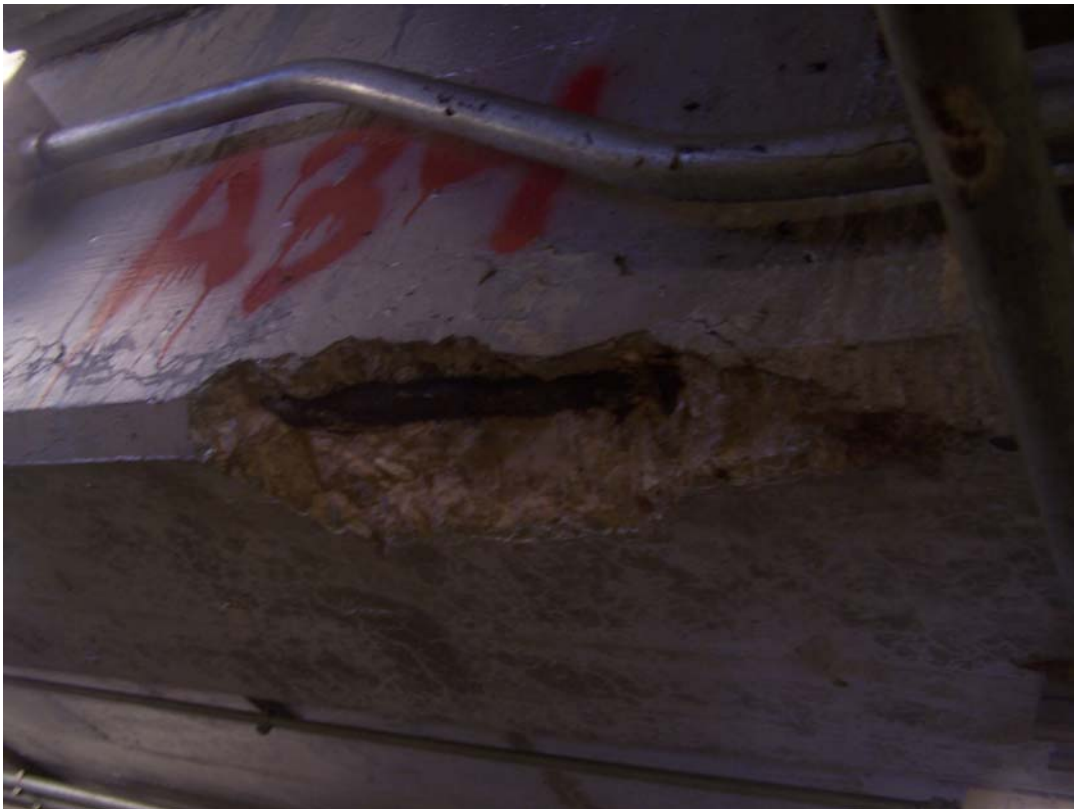
Photo 153 Popouts in Room 2 caused by corroding steel.

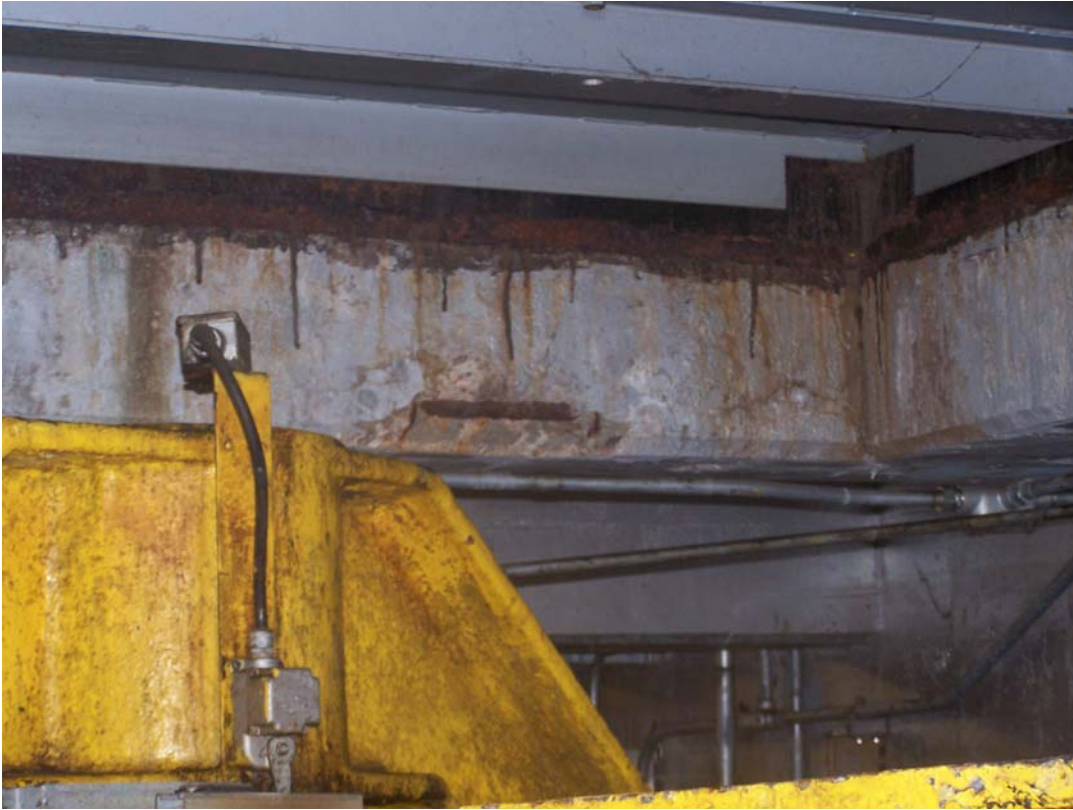
Photo 154 Spall with corroded steel in beam in Room 2.

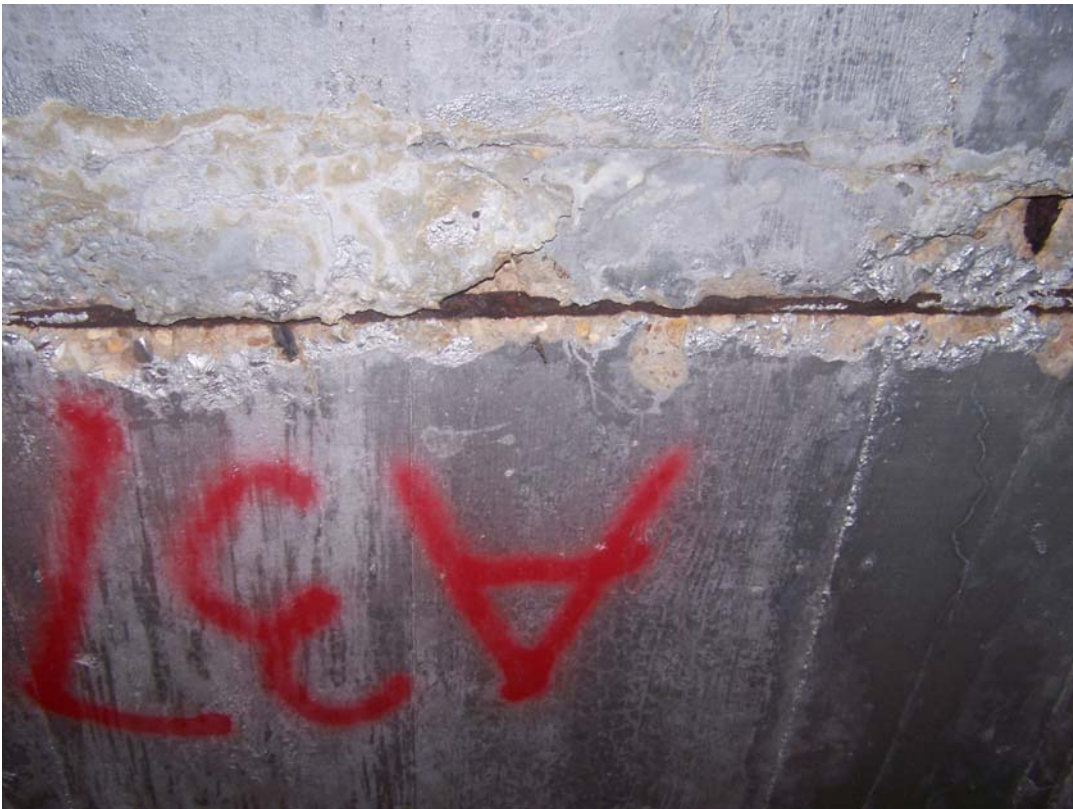
Photo 155 Spall with corroded steel in beam in over machinery for Gate 2.
