MEMORANDUM FOR Chief, Regional and Environmental Planning Division-South
(CEMVN-REPD/Troy Constance)

SUBJECT: IHNC Lock Replacement General Re-evaluation Report, Engineering
Assessment of the Existing Lock Structure

Enclosure 1 – Pictures of Structural Deficiencies

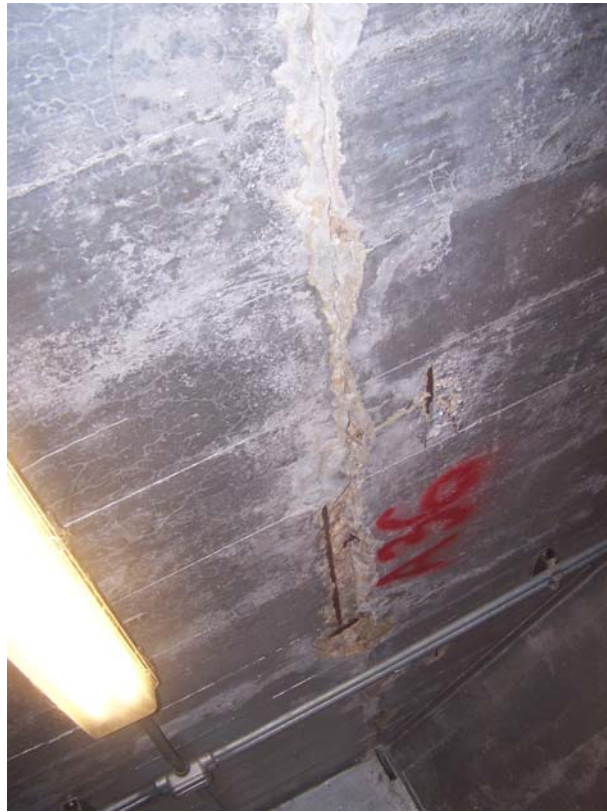
Photo 156 Spalls and popouts with corroded steel in ceiling of Room 2.

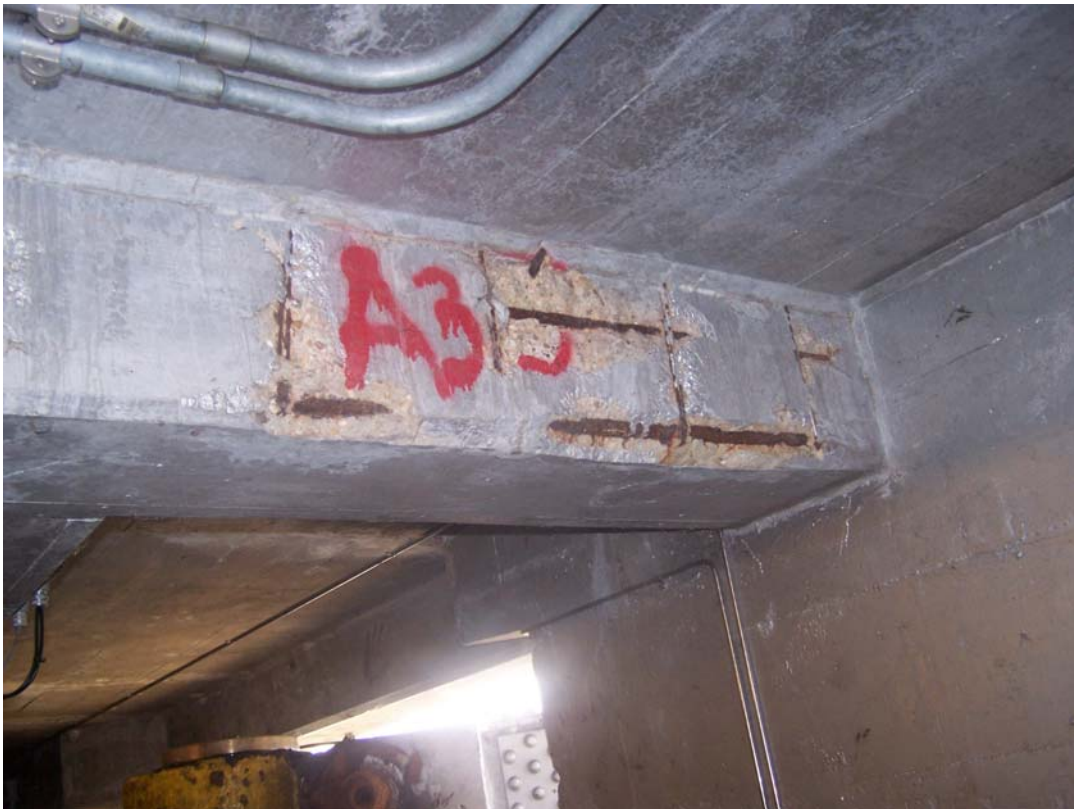
Photo 157 Spalls and popouts with corroded steel in ceiling of Room 2.

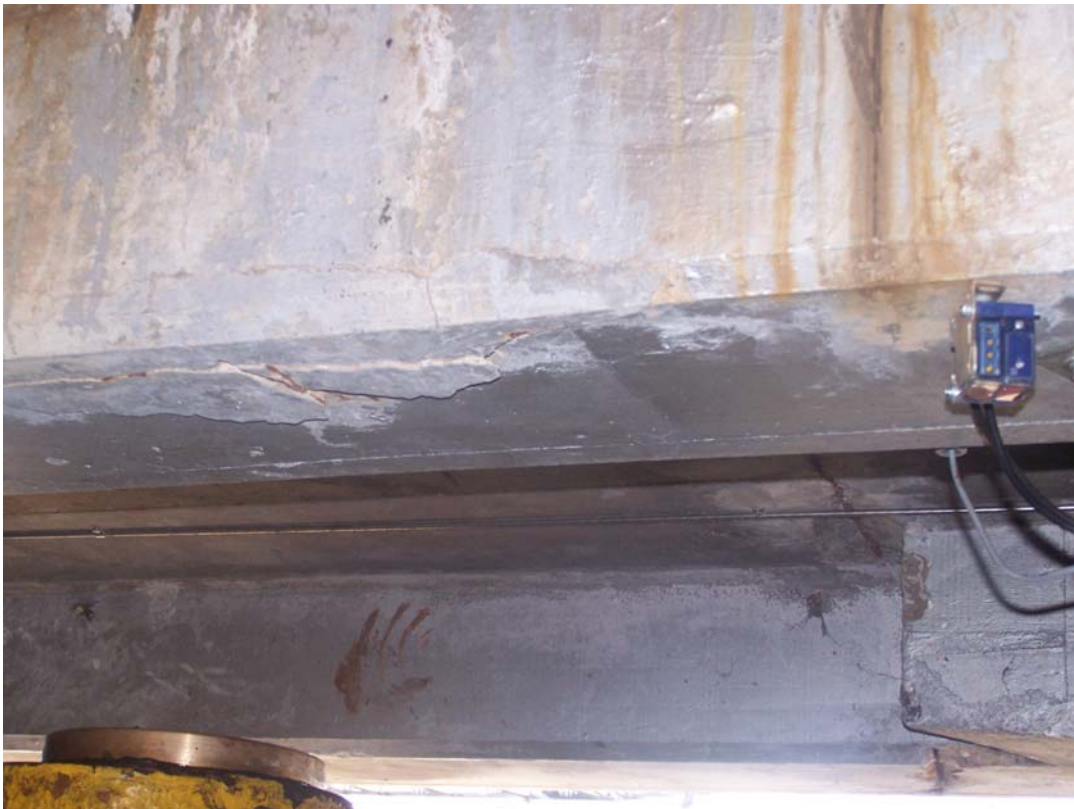
Photo 159 Spalling and corroding steel in beam in Room 2.

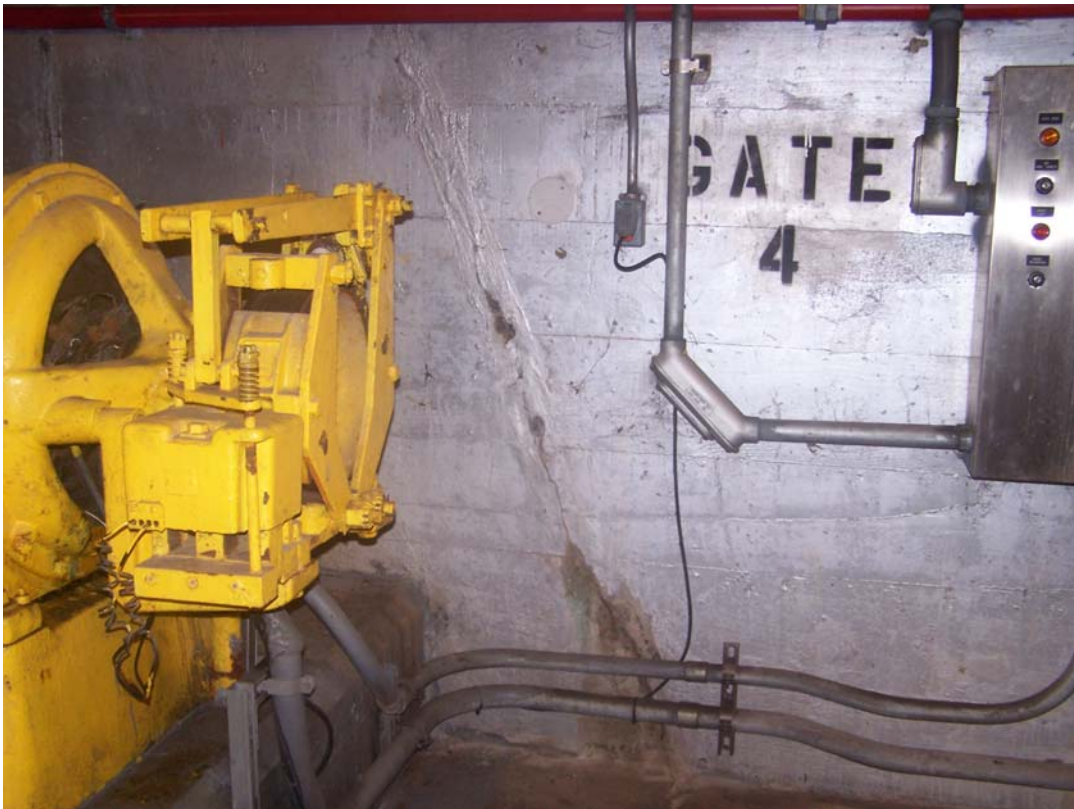
Photo 163 Spall with corroded steel and crack in beam over gate 4.

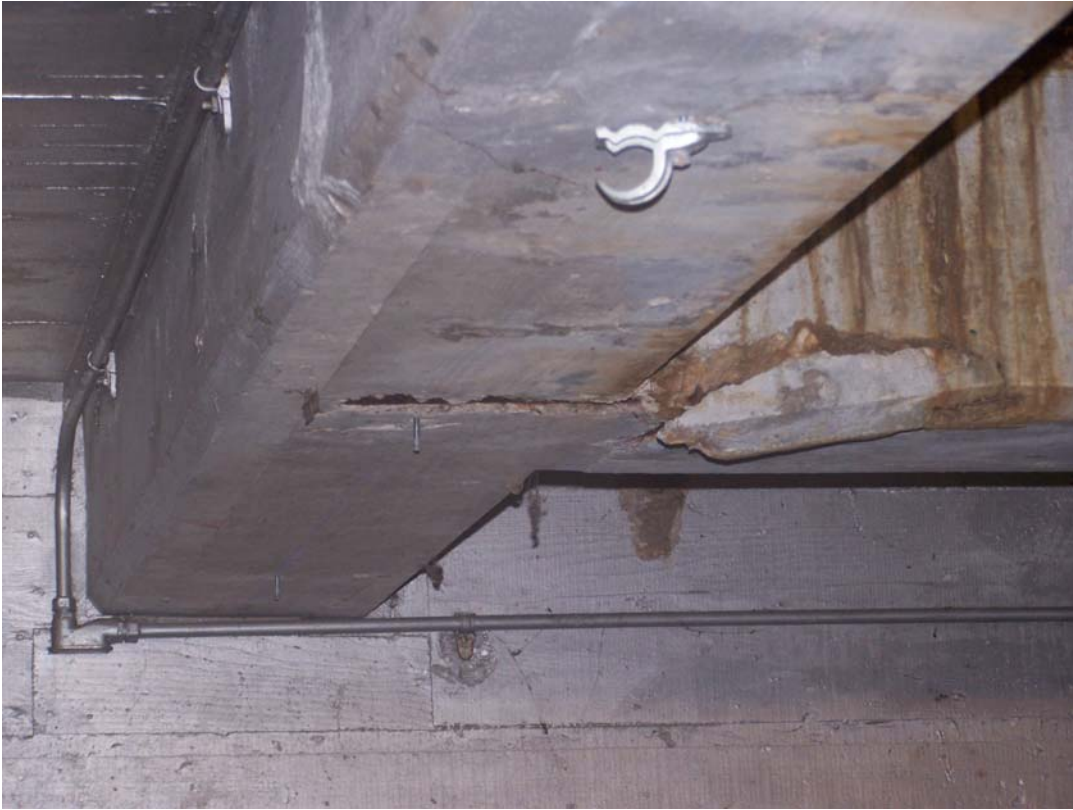
Photo 172 Painted spall in ceiling of room 6.

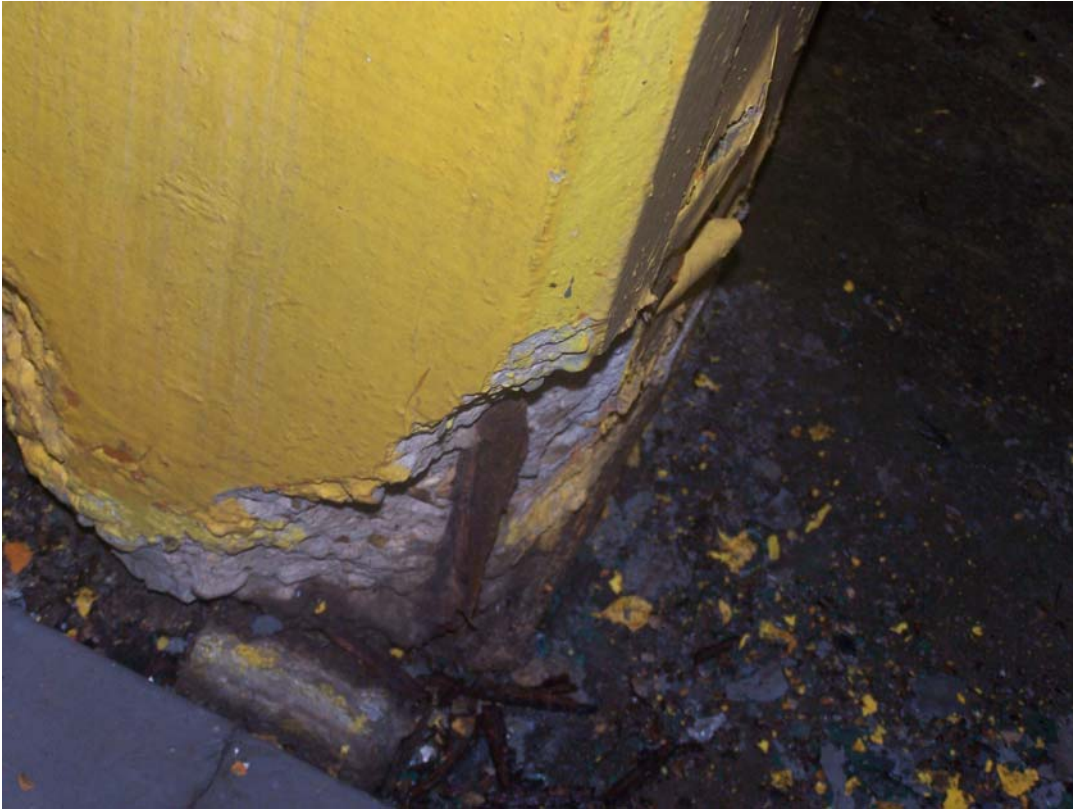
Photo 174 Large spalls with corroded steel in the bottom of the column near the hinge in room 6.

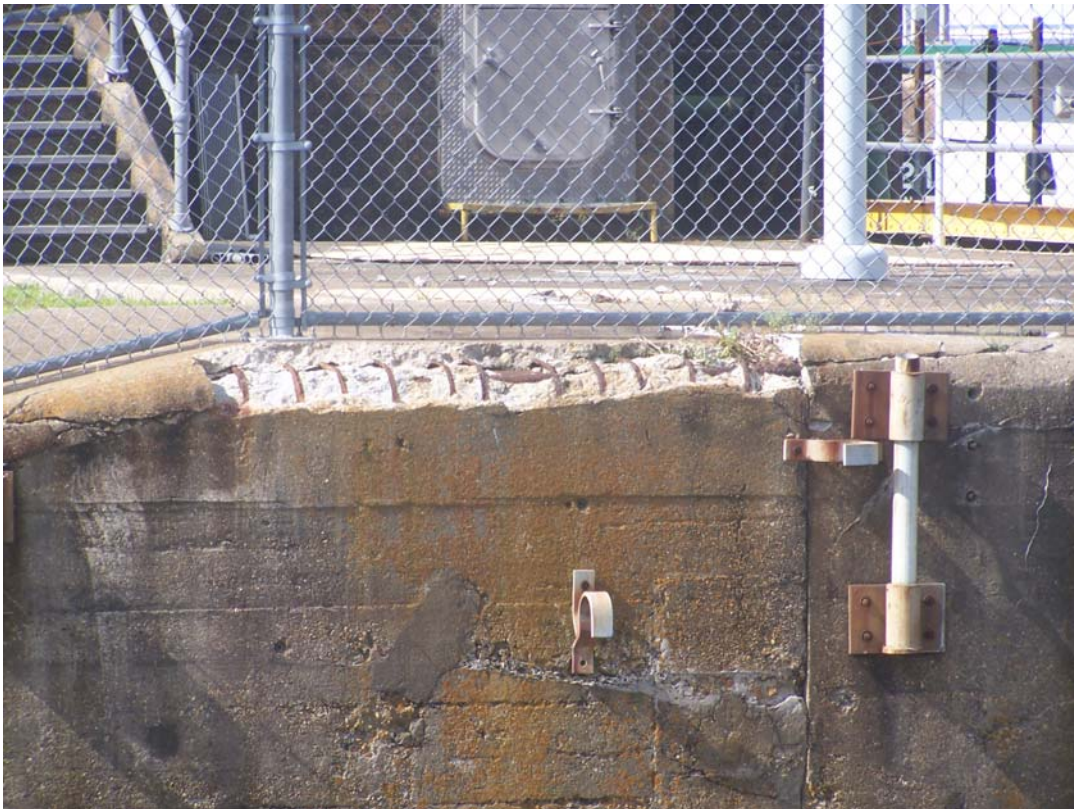
Photo 184 Cracks and spalling in the retaining wall on the northeast side.

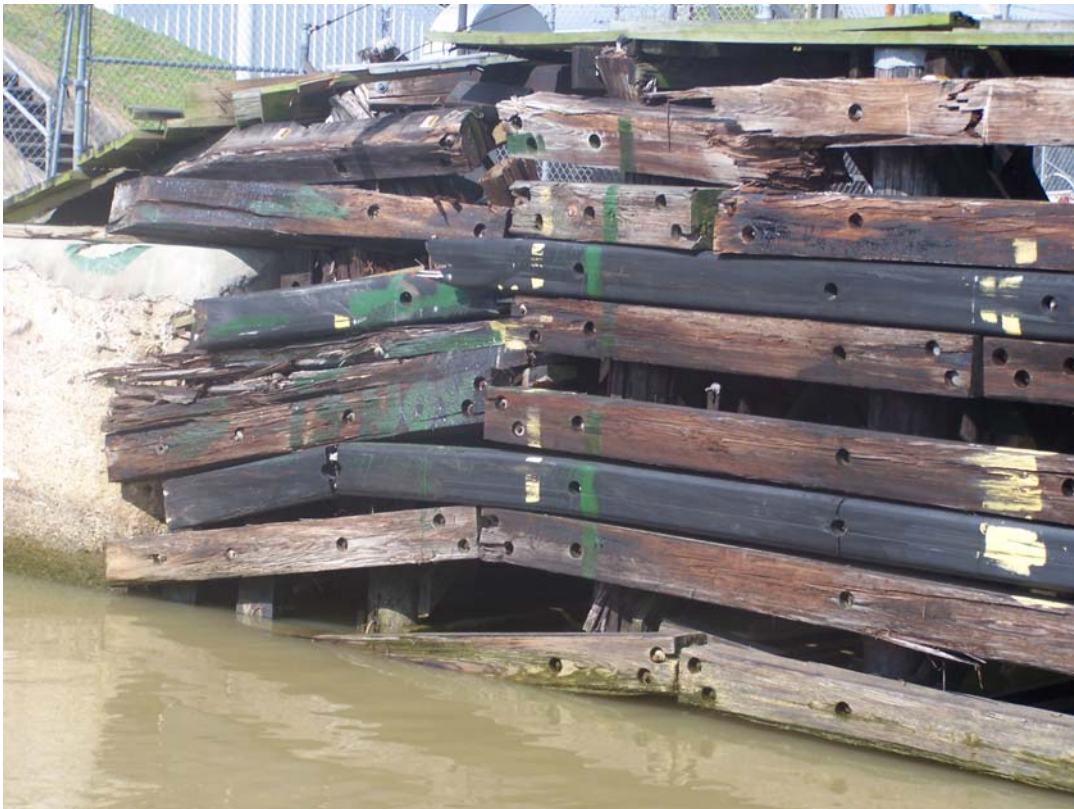
Photo 186 Damage to south end of the northwest guidewall.

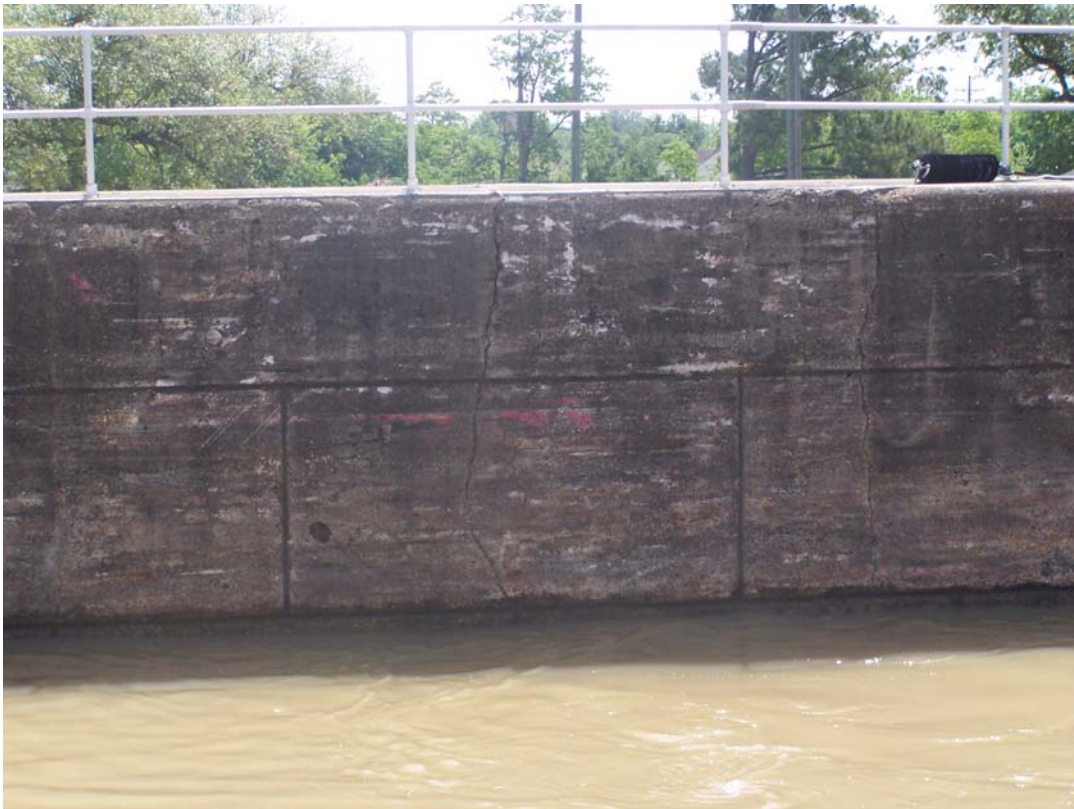
Photo 202 Crack in east chamber wall. (Typical of cracks in chamber walls).
