## NON CONCURRENCE STATEMENT

- Tiger Team members have diligently worked for many months to complete their mission of investigating, evaluating, then reporting their activities regarding construction of the WBV-14c.2 levee in Jefferson Parish, Louisiana
- In an effort to complete and otherwise finalize, then publish the report of its mission the Tiger Team members have been in almost continuous conference for several weeks
- Unfortunately, several serious differences in the opinion and findings of the members remain and now appear irreconcilable
- Following deep and honest discussion of these differences the Tiger Team has concluded our best course of action is to allow the report to be issued but, containing statements of non-concurrence in those chapters of the report remaining unresolved

## **Tiger Team Update for SLFPA-W Technical, Operations and Maintenance (TOM) Committee:**

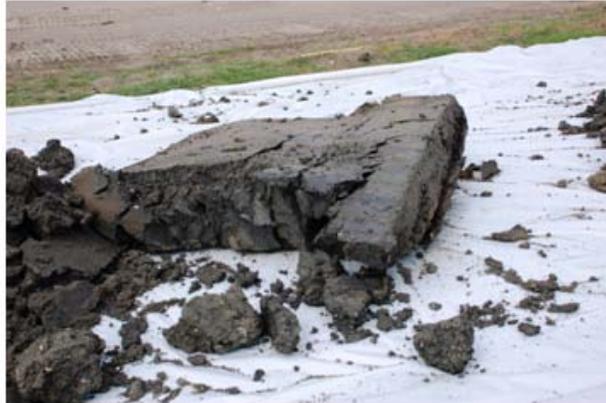
### 108 + 18 PS 60

machine dropped a bucket full of material similar to stiff modeling clay and the unyielding material fell as a single block (as happened, for example, at a trench named **108 + 18 PS 60** and located 18 feet east of Station Marker 108 along the levee reach and 60 feet off the crown on the protected side).

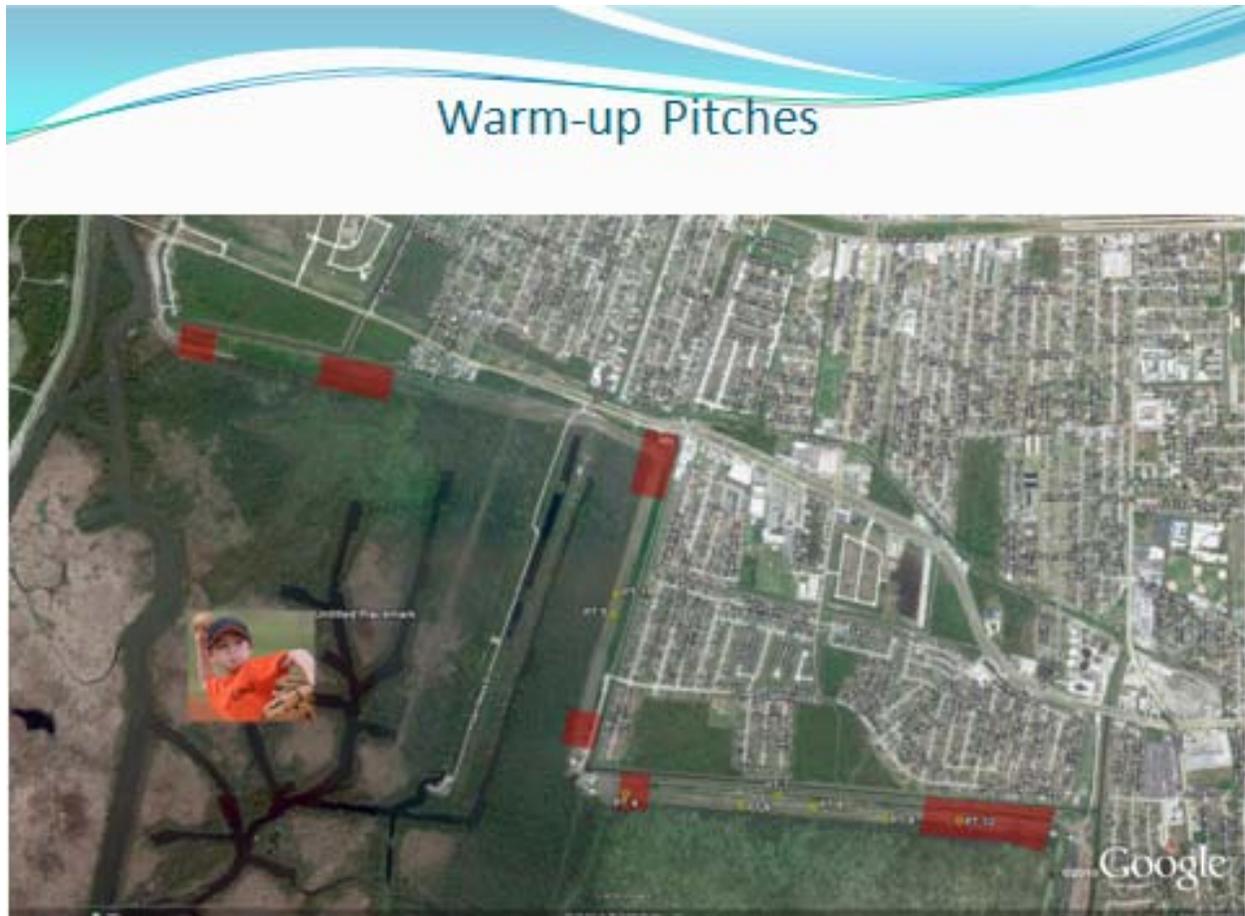
virtually all SLFPA-W areas of concern for excessive wood debris. One particular slide in the exhibit was created on an air photo by plotting (1) the planned trench sites and (2) the wood cluttered areas originally noted by inspectors. At a glance it was obvious almost all attempts missed the targets. Merritt summarized his concerns for the impromptu trenches by calling them “practice pitches”.

total wood in the levee. Again, this effort was almost exclusively confined to known “clean” areas where the wood observed being placed during construction would not be encountered by the “practice trenches” dug in September. This was tantamount to shooting to avoid the target as shown on the map above by comparing proposed trench locations with high debris areas during construction.

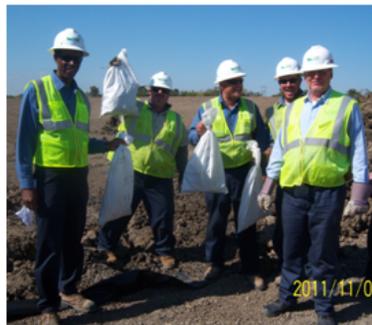
#### **SLFPA-W crew picks trash out of “new clay” fill at trench 27+25 FS 80**

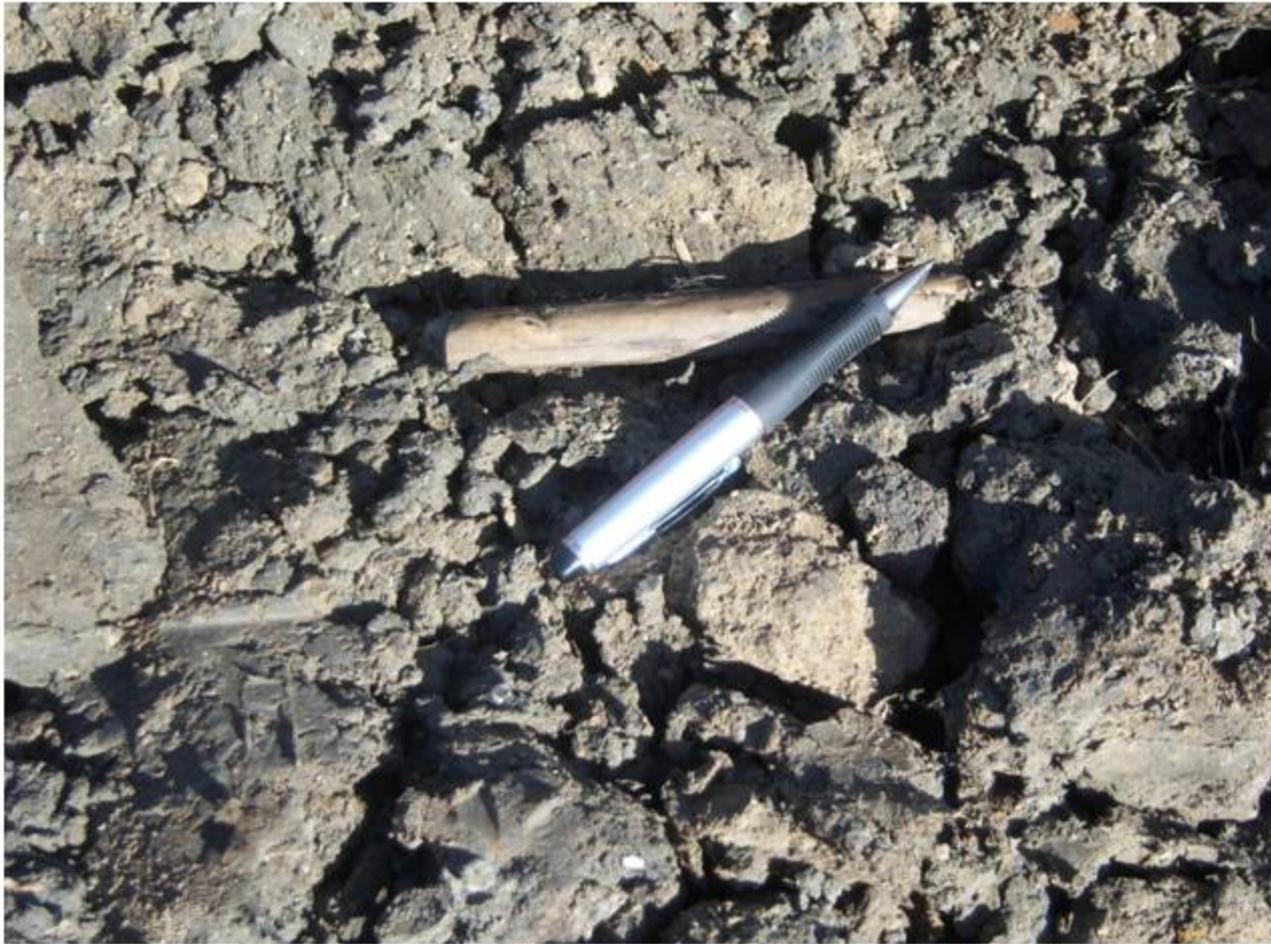
# 21+95 CL

**shows how long branches were not picked up but were sliced into smaller pieces and left in place**

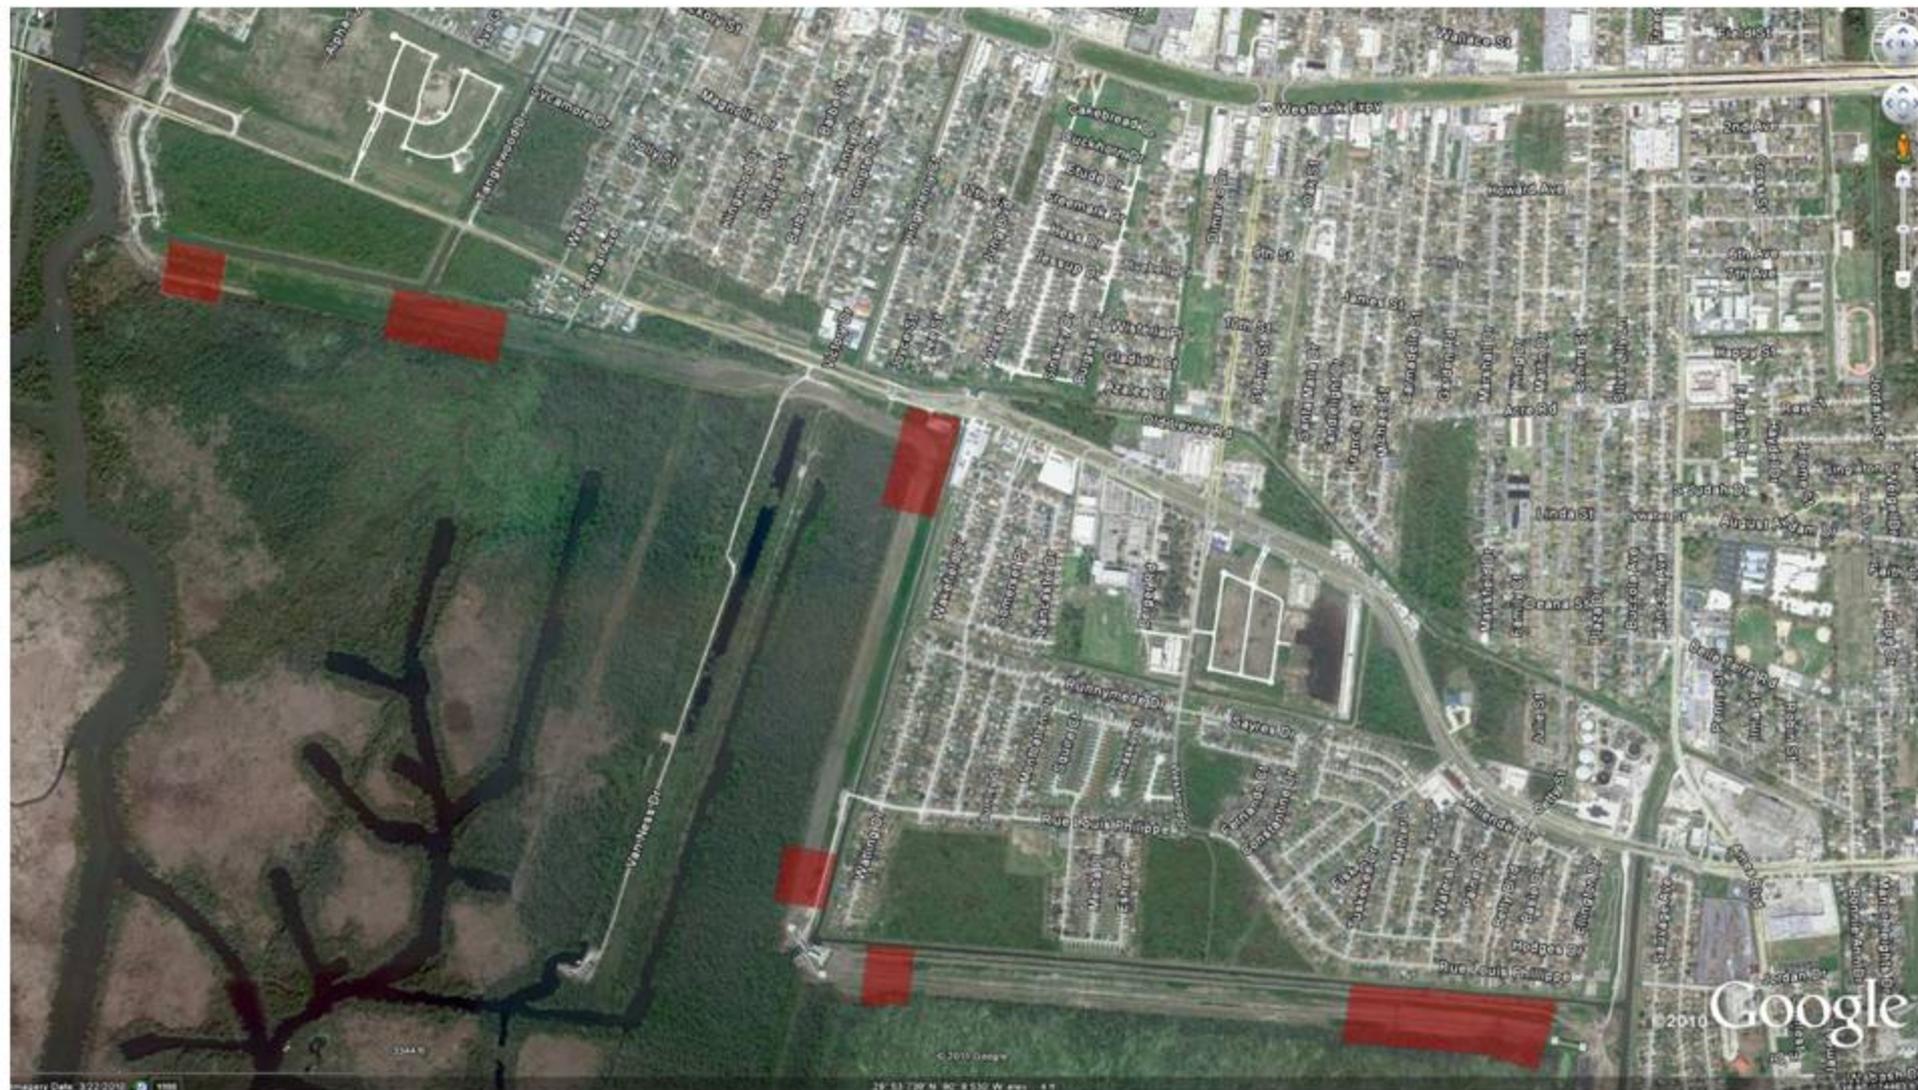
# 6 Areas of Concern

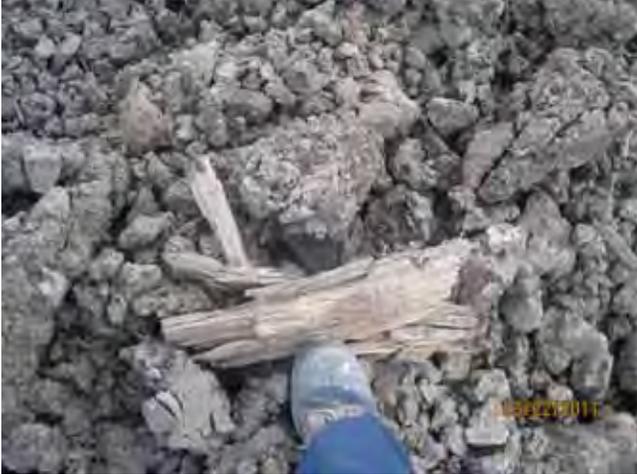
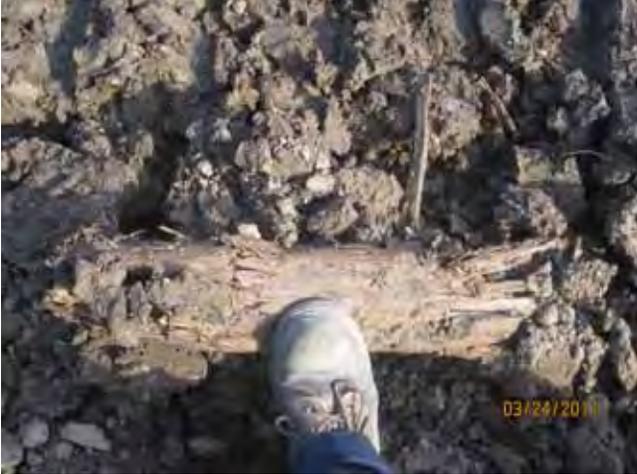
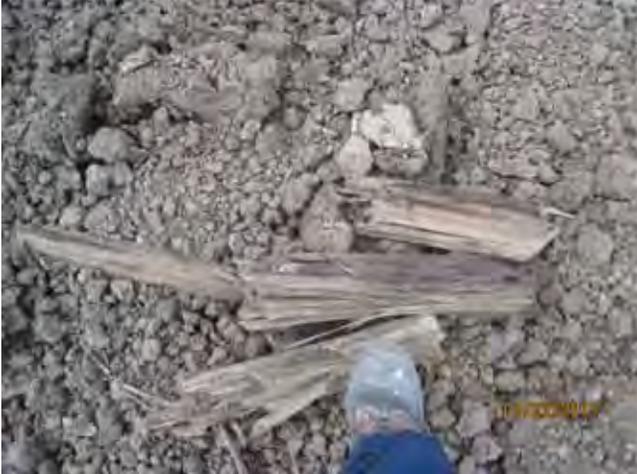
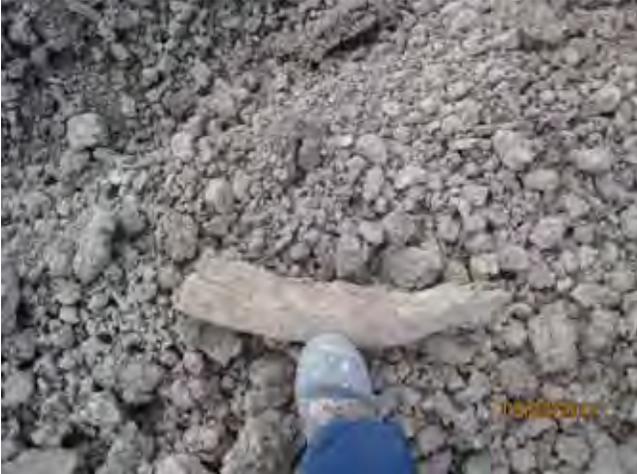
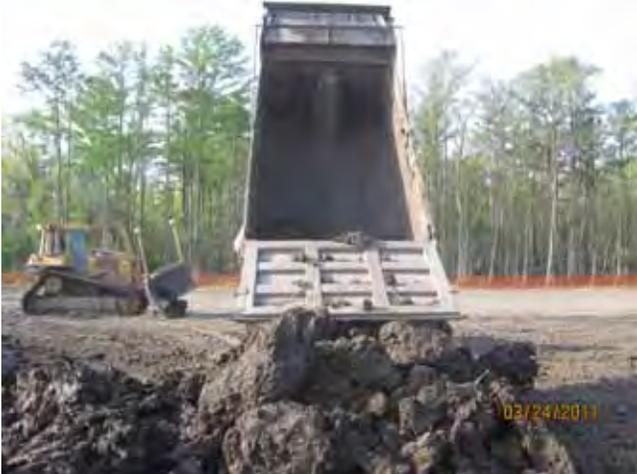
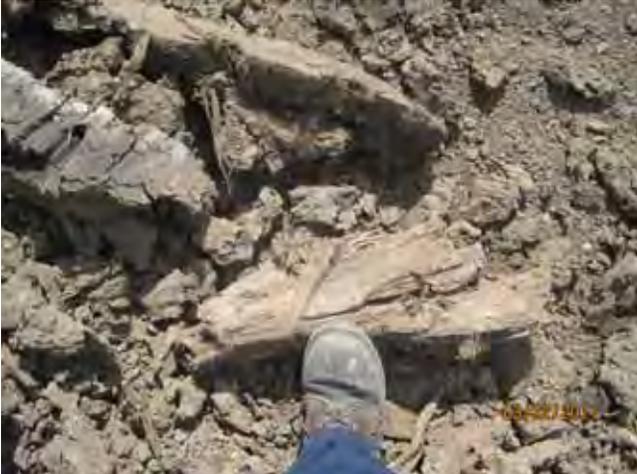
2. Debris in the material that is being hauled in from Sta.55+00 to Sta.45+00.

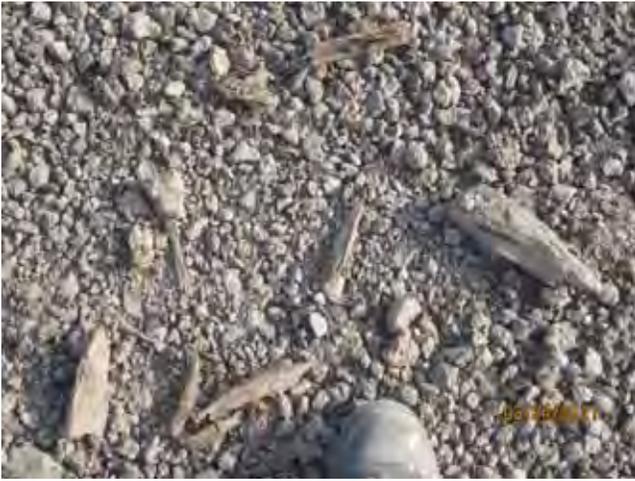
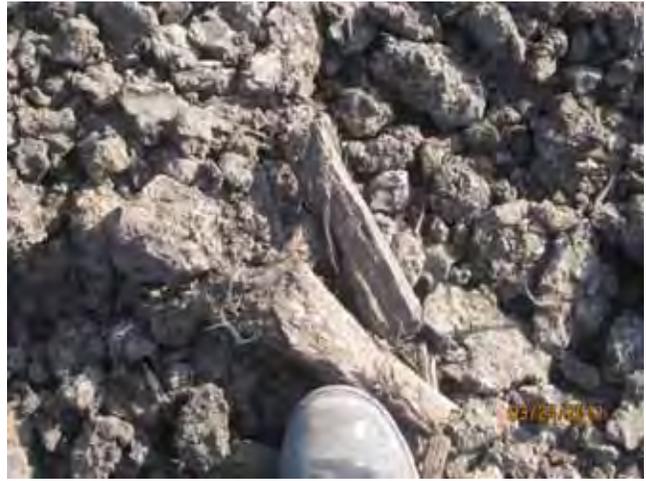
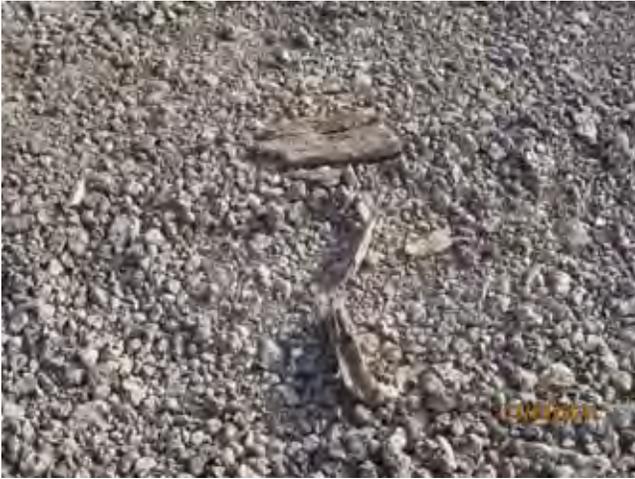
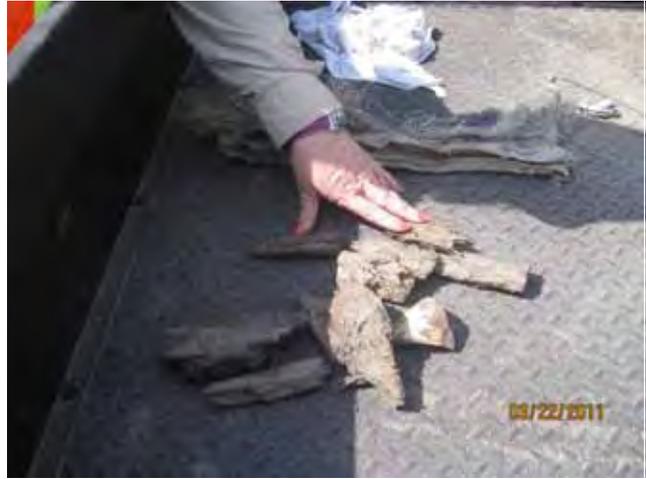
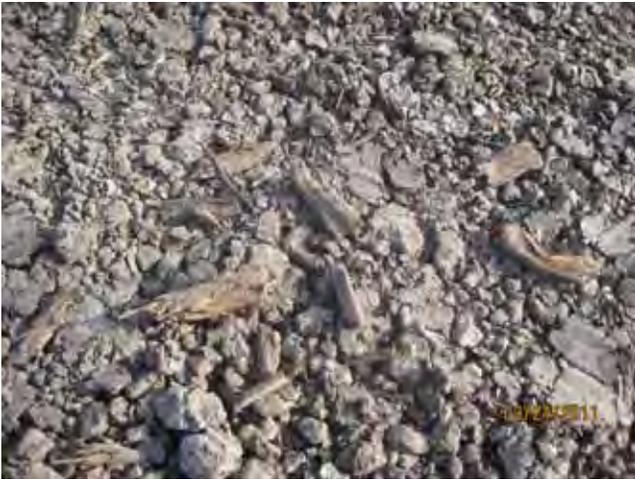
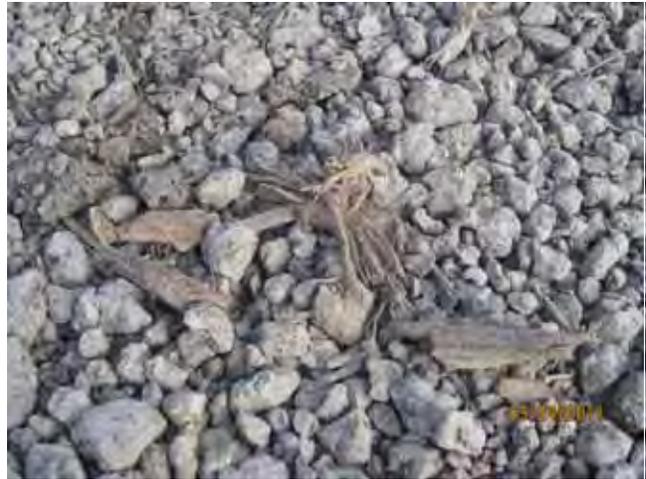
- 
3. An abundant amount of small wood chips (within spec size) are being found in the levee section from Sta.55+00 to Sta.25+00. SLFPAW representatives are concerned that the amount of wood chips in this area would be beyond the 1% of organics allowed in the material, but would like USACE Geotech to determine this. SLFPAW representatives met with Wade Wright (USACE) at the WBV-14e.2 site visit later that day. He informed SLFPAW that he will be making a visit to the WBV-14c.2 jobsite today (3/24/2011), and also to the River Birch pit to investigate the debris problem. GPS Coord: N29 53" 20.82" W090 09' 14.90"

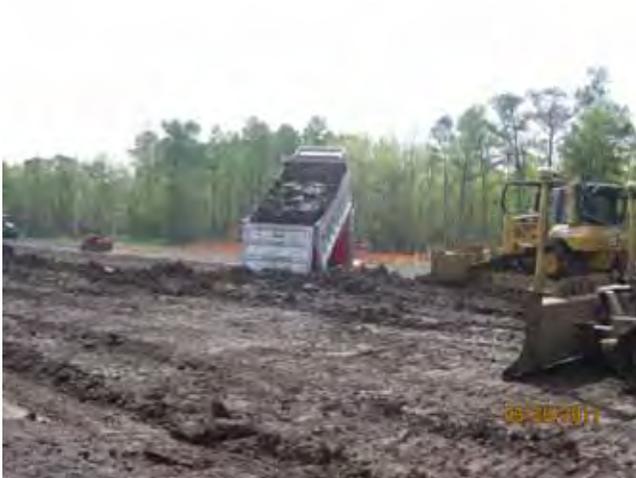
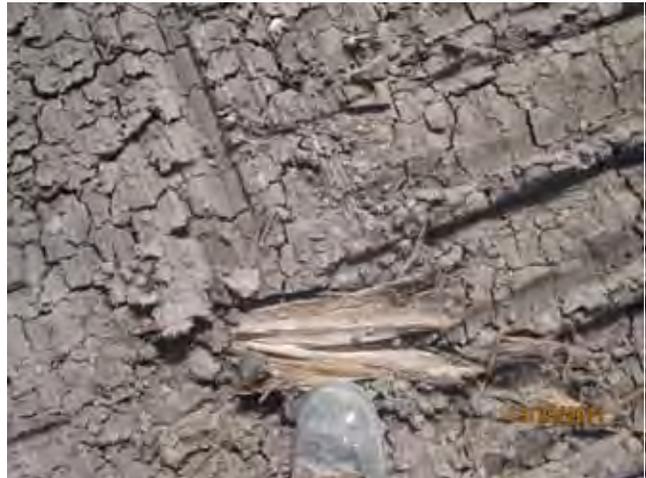
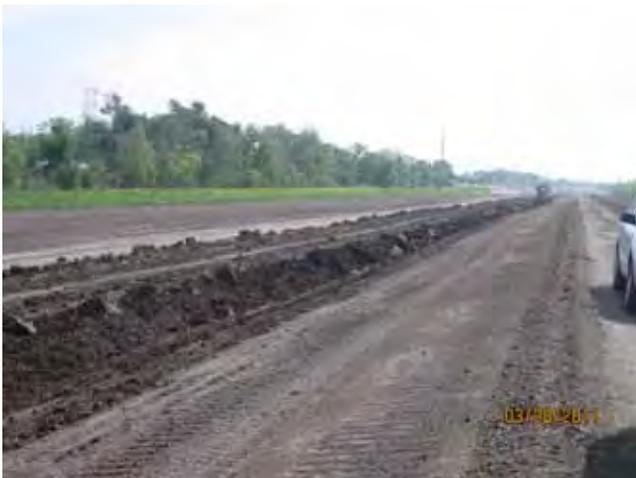
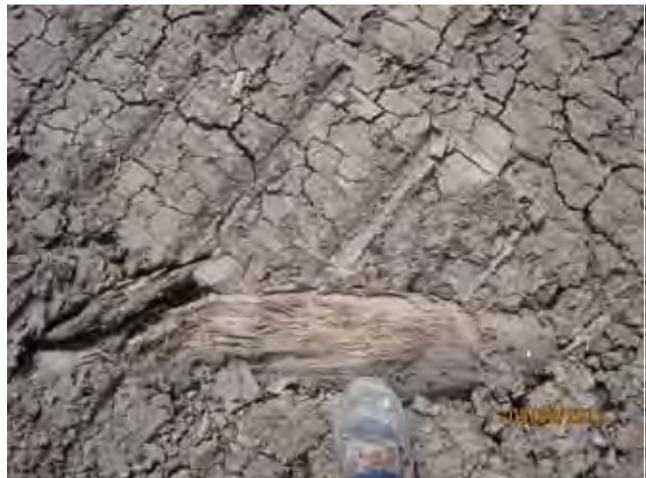
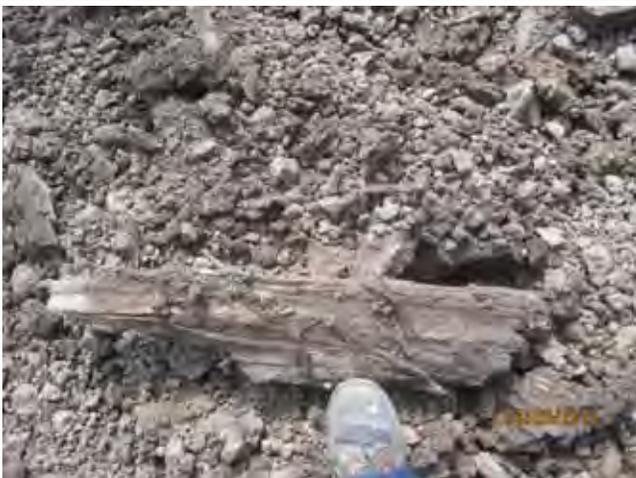
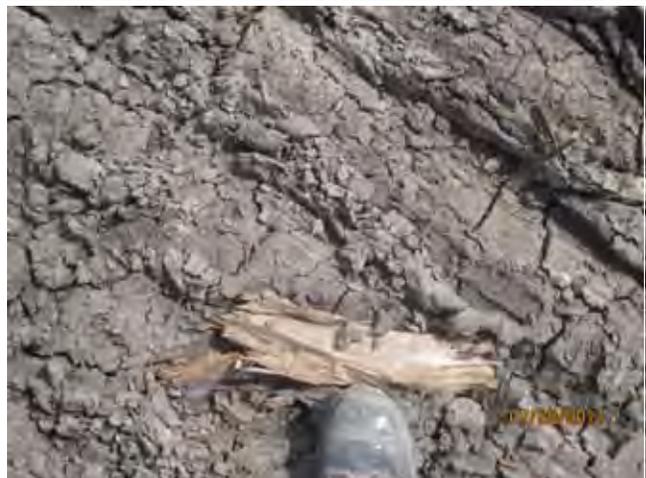
2. Debris in the material that is being hauled in from Sta.55+00 to Sta.25+00. Area has not been picked yet but USACE assured SLFPAW representatives that this area would be picked before the next levee lift was placed. Levee accessibility was an issue later on in the week due to extreme ground saturation from inclement weather. GPS Coord: N29 53' 13.19" W090 08' 41.57"

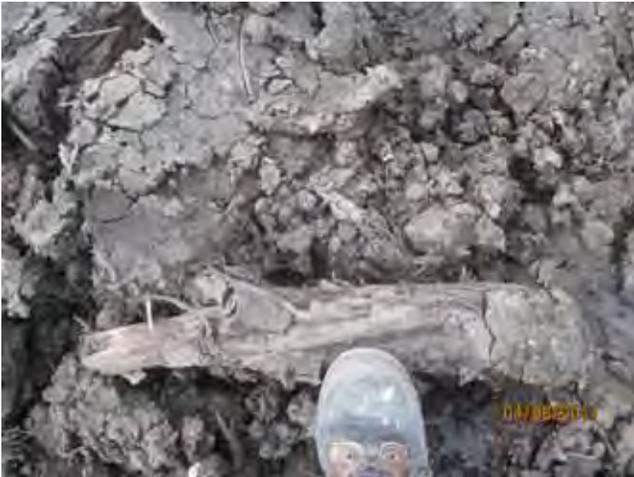
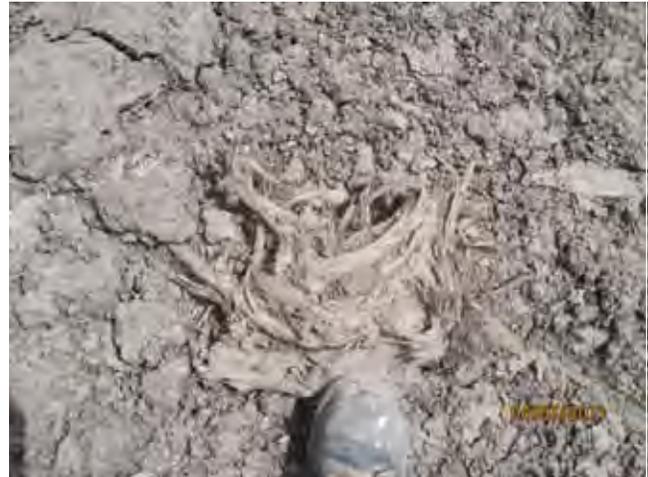
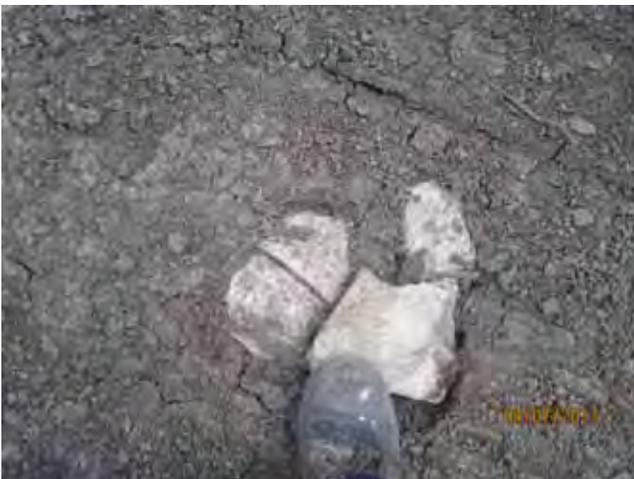
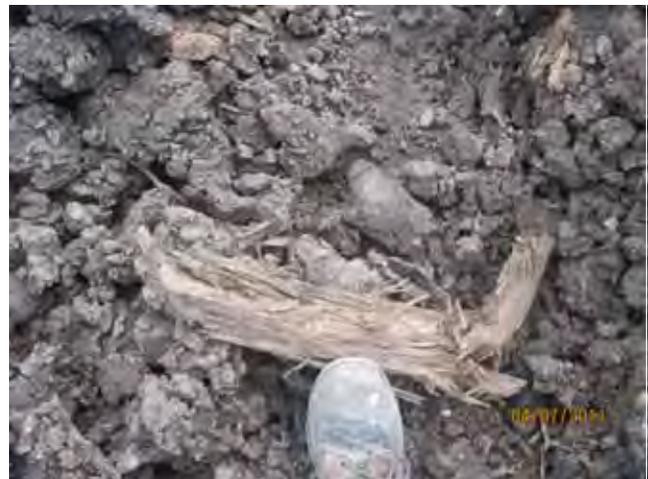
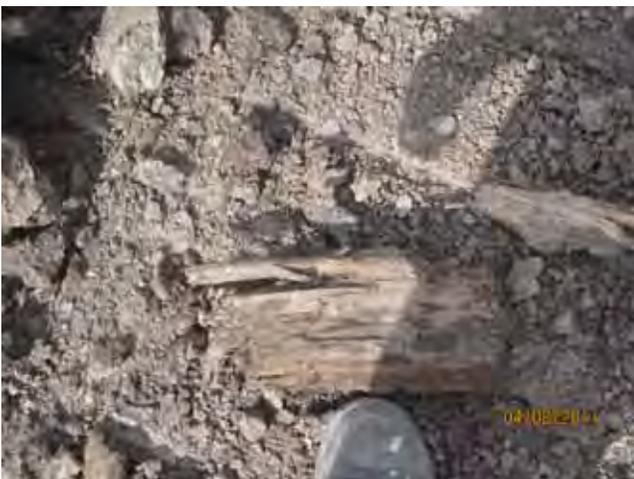
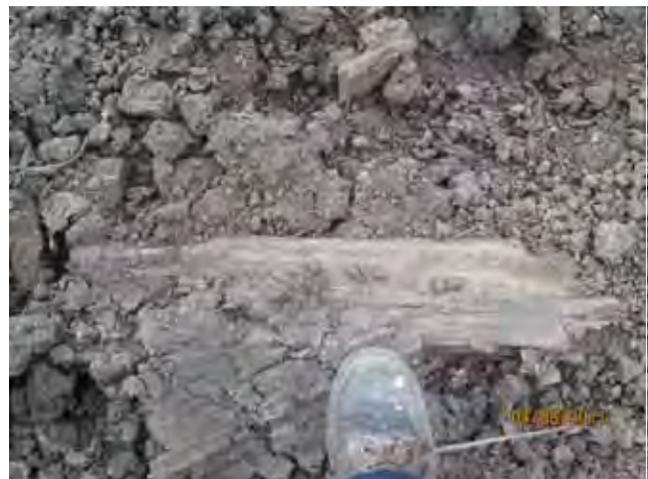
- The material that was being hauled in contains a considerable amount of debris and is being picked out.
- Pickers were at approx. Sta.15+00 during site visit.
- This area is currently at elev.+8.0'.

. GPS Coord: N29 53" 20.82" W090 09' 14.90"

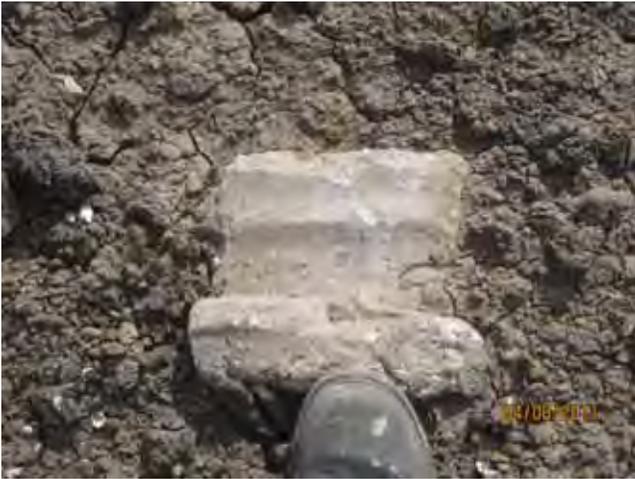
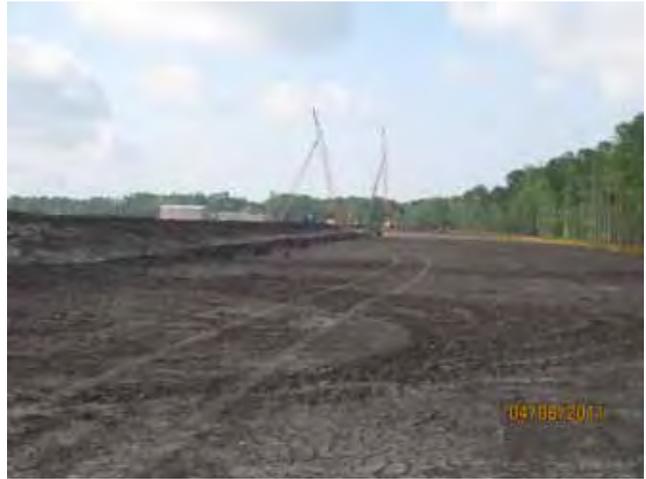
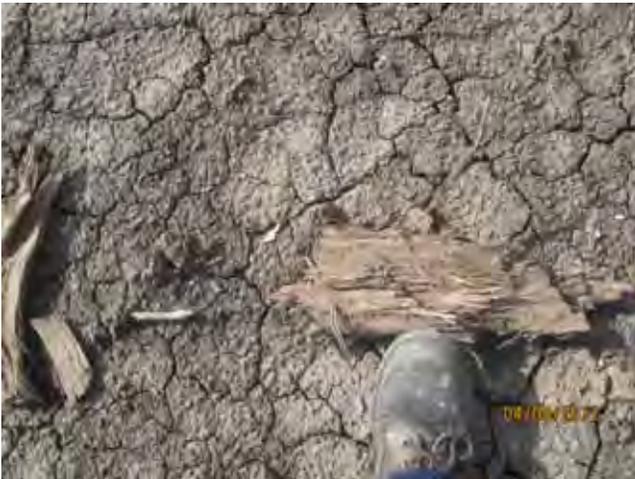
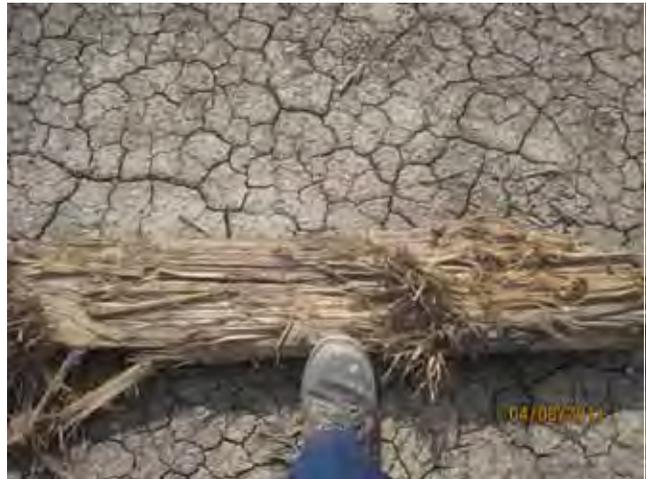
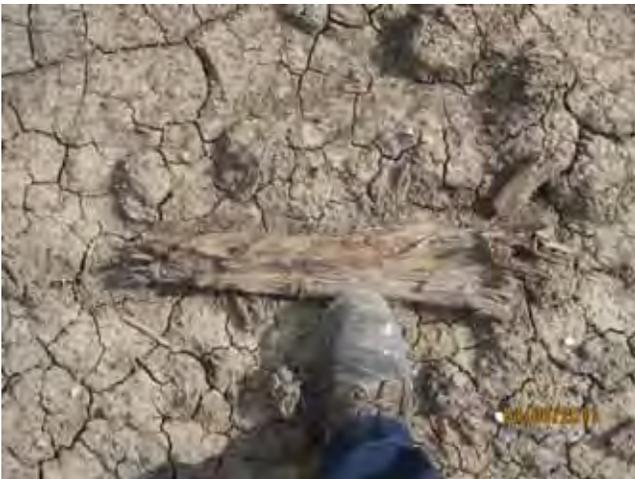
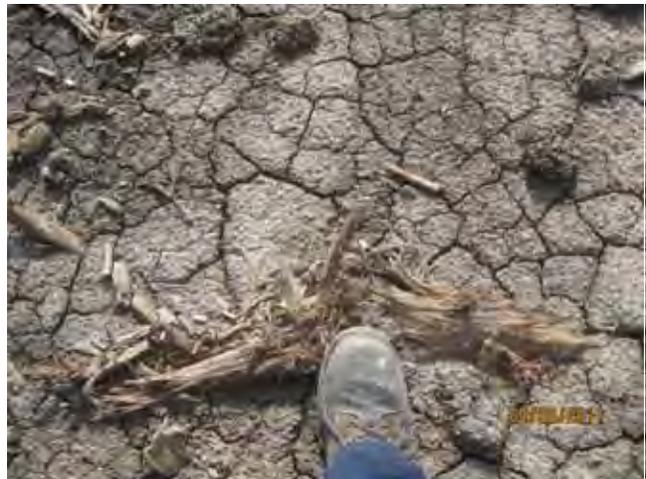
- 
3. Sta.65+00 to 107+00 (floodside).  
- No active work was going on during time of site visit but some debris was found and noted.  
- Area is currently at elev.+13.0'. GPS Coord: N29 53' 13.19" W090 08' 41.57"

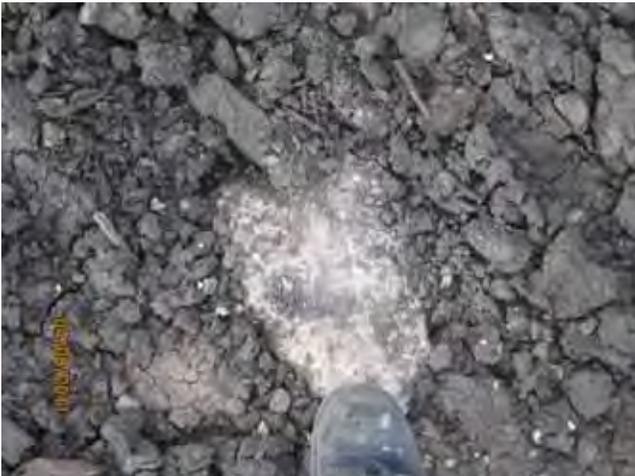
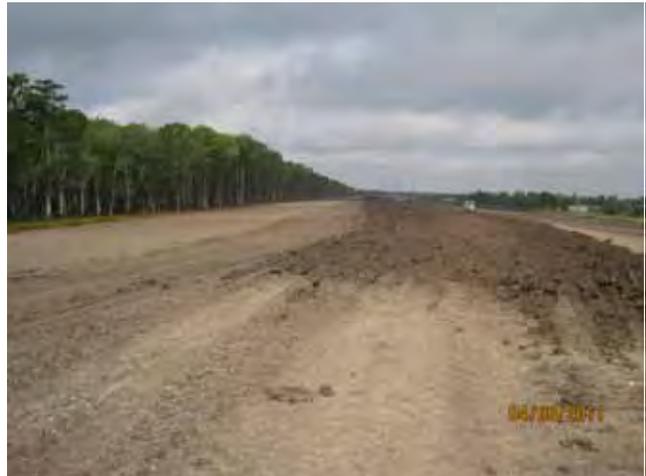
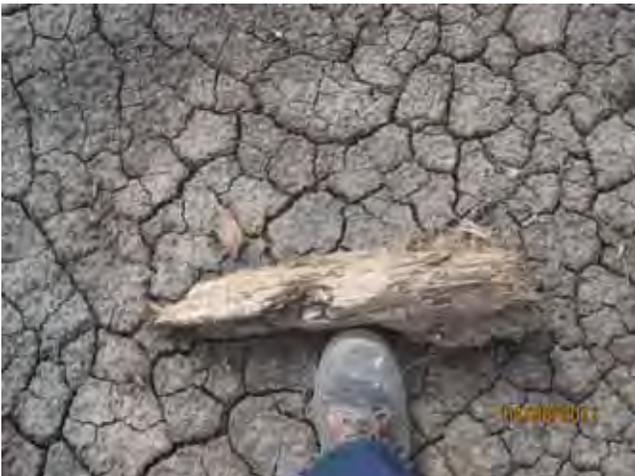
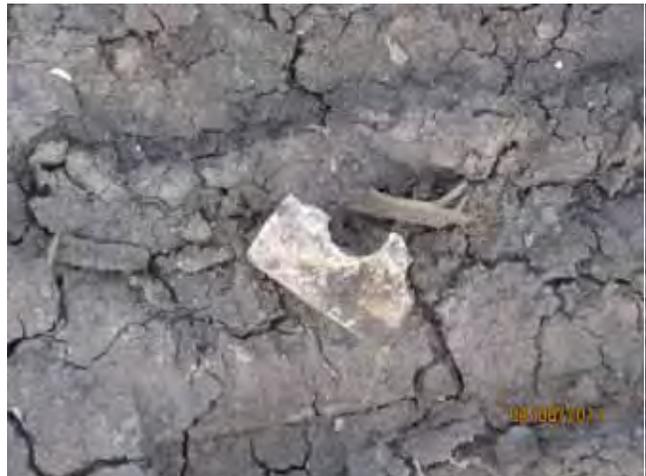
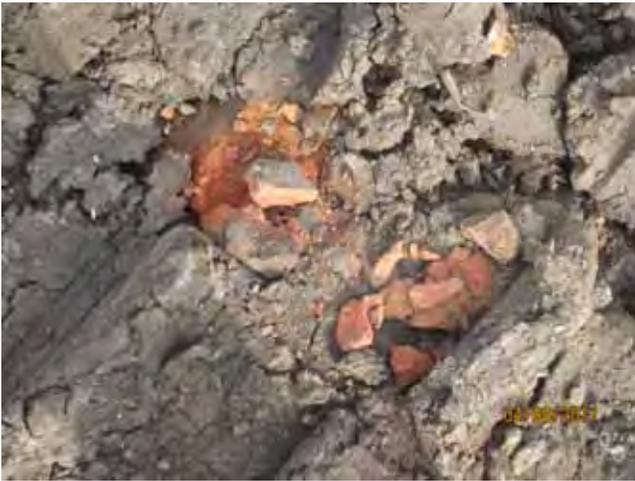
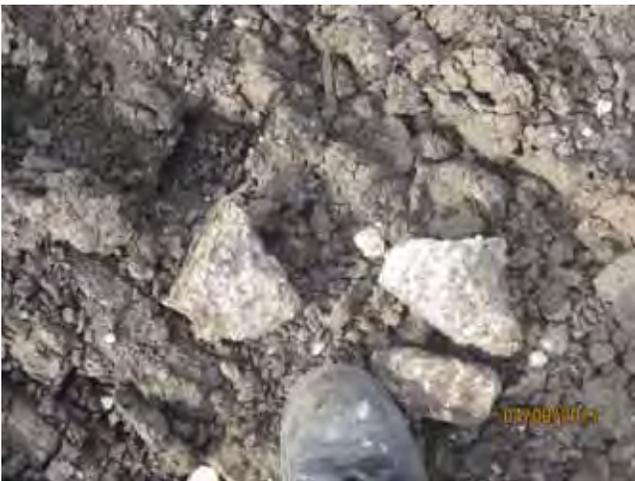
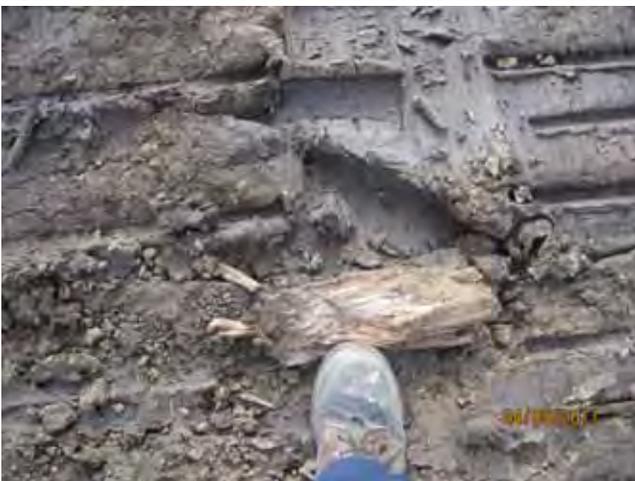
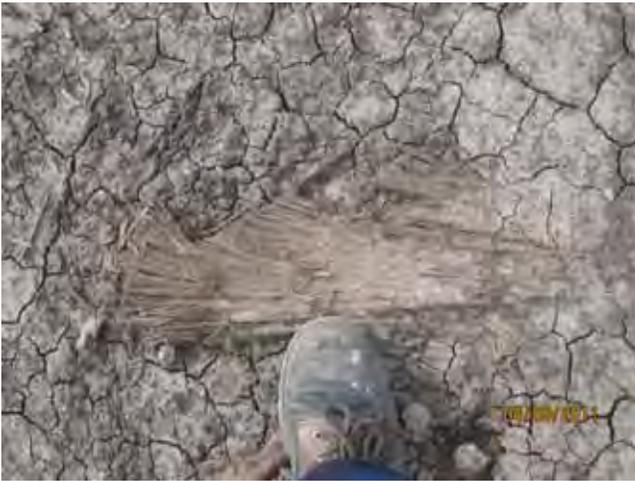
- Material contains some debris and needs to be disced and picked out. Pickers were on the other end of the job site during site visit.

- Area where material is being placed is currently at elev.+10.0'. GPS Coord: N29 52' 34.73" W090 08' 17.09"

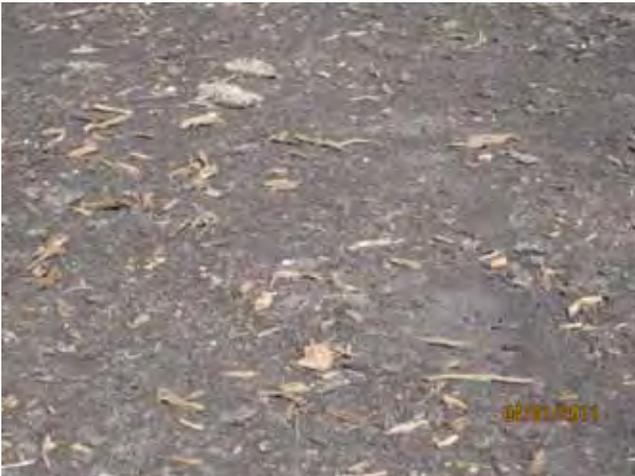
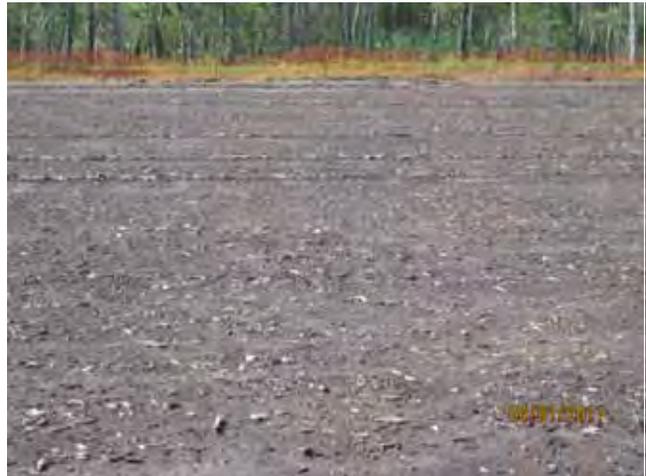
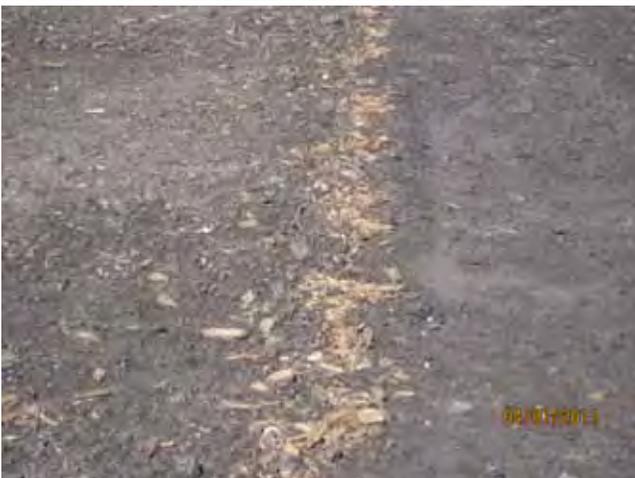
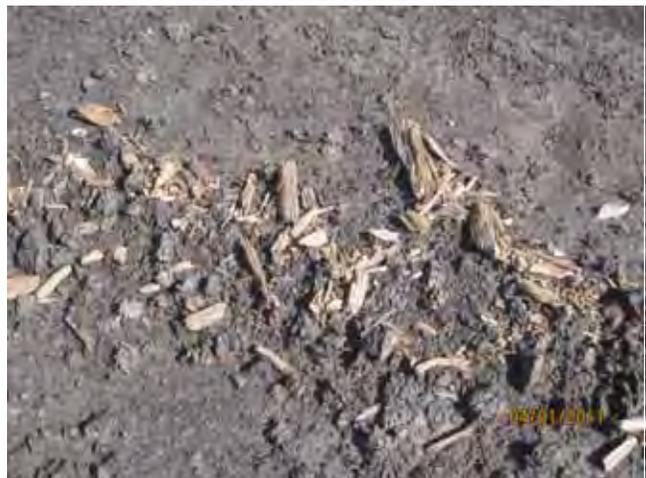
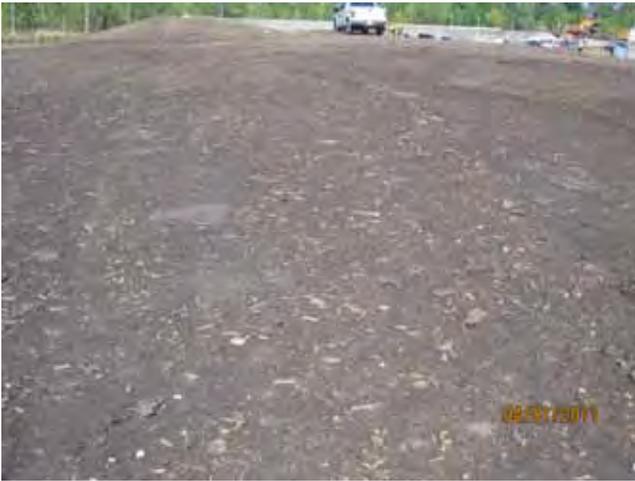
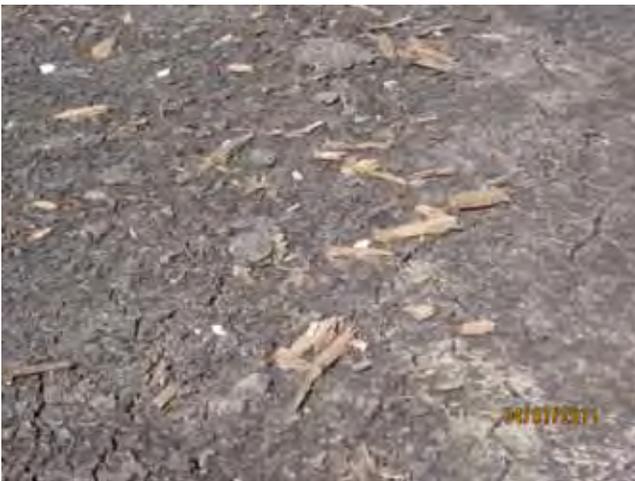
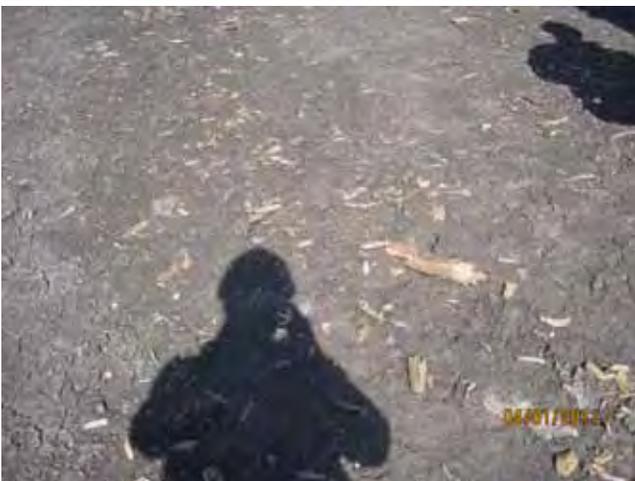
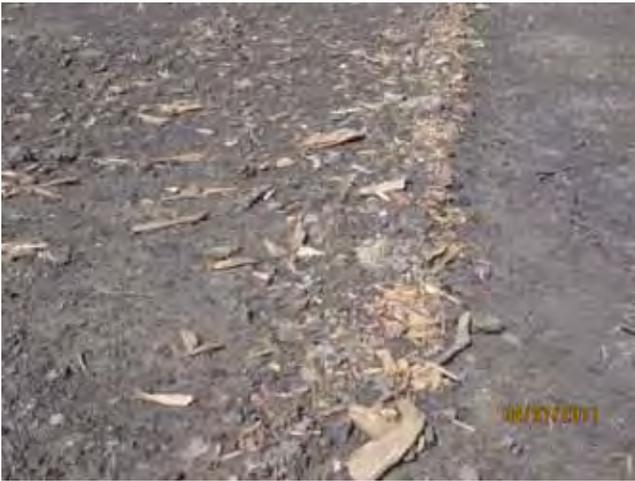
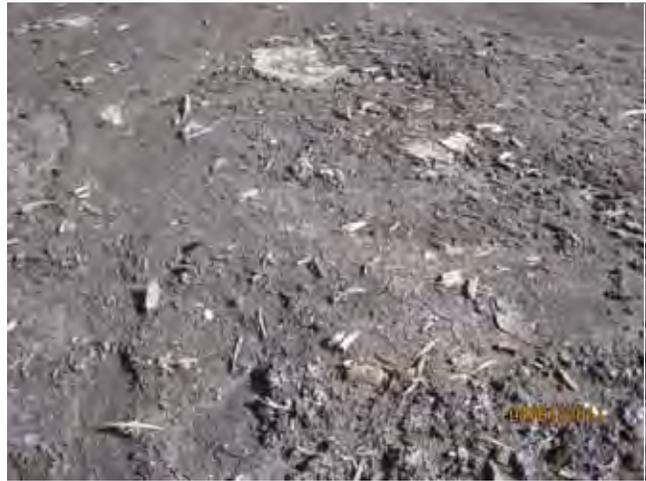
5. An abundant amount of small wood chips (within spec size) is being found in the levee section from Sta.0+44 to Sta.55+00. USACE stopped hauling of material from Sta.0+44 to Sta.55+00 to investigate problem with wood chips and smaller debris. Levee lifts were being placed on top of these wood chips. GPS Coord: N29 53" 20.82" W090 09' 14.90"
