## NON CONCURRENCE STATEMENT

- Tiger Team members have diligently worked for many months to complete their mission of investigating, evaluating, then reporting their activities regarding construction of the WBV-14c.2 levee in Jefferson Parish, Louisiana
- In an effort to complete and otherwise finalize, then publish the report of its mission the Tiger Team members have been in almost continuous conference for several weeks
- Unfortunately, several serious differences in the opinion and findings of the members remain and now appear irreconcilable
- Following deep and honest discussion of these differences the Tiger Team has concluded our best course of action is to allow the report to be issued but, containing statements of non-concurrence in those chapters of the report remaining unresolved

## **Tiger Team Update for SLFPA-W Technical, Operations and Maintenance (TOM) Committee:**

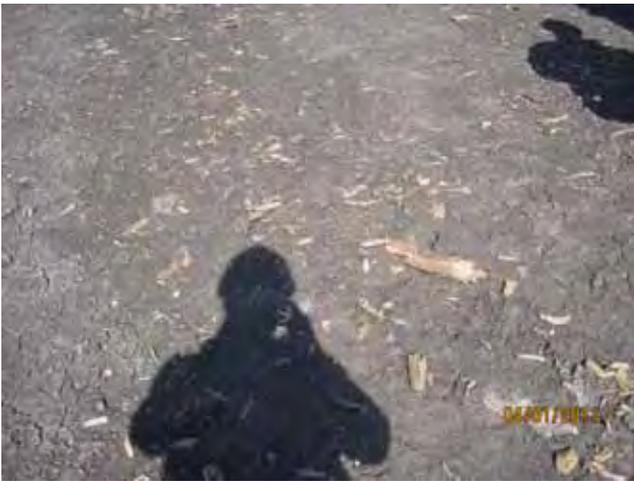
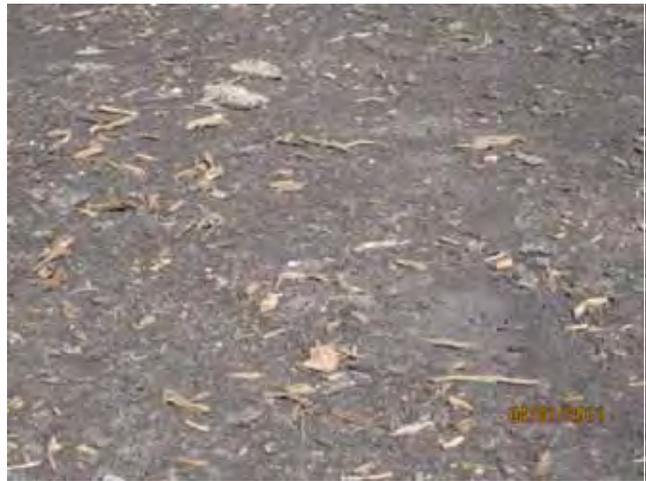
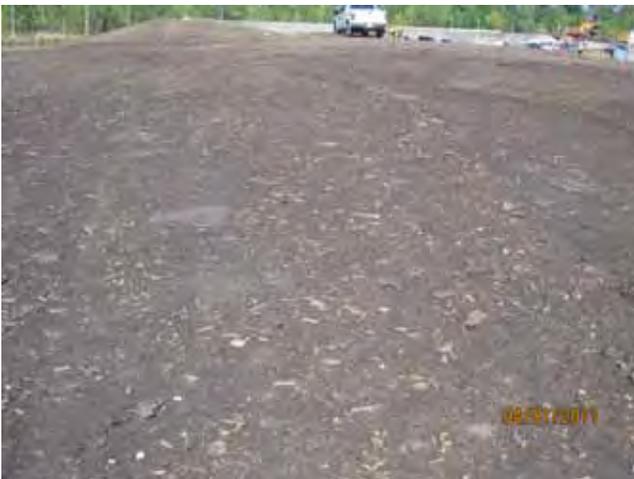
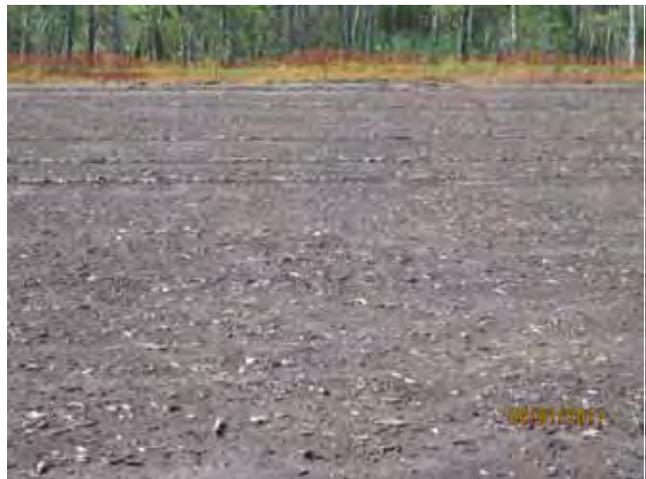
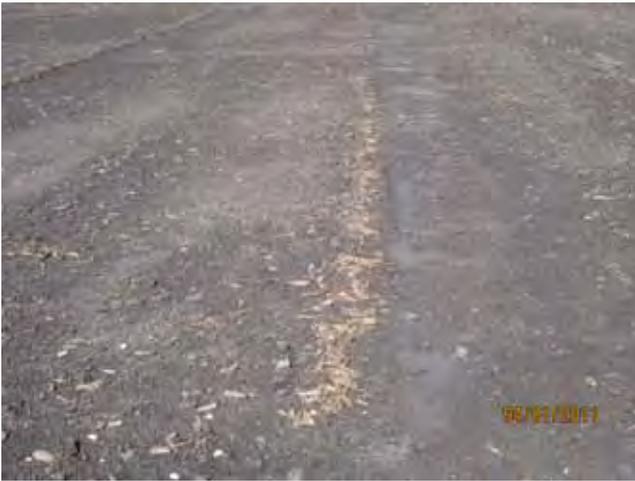
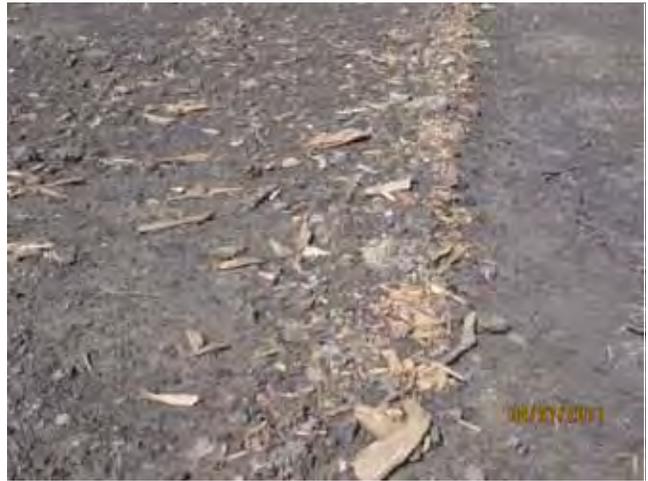
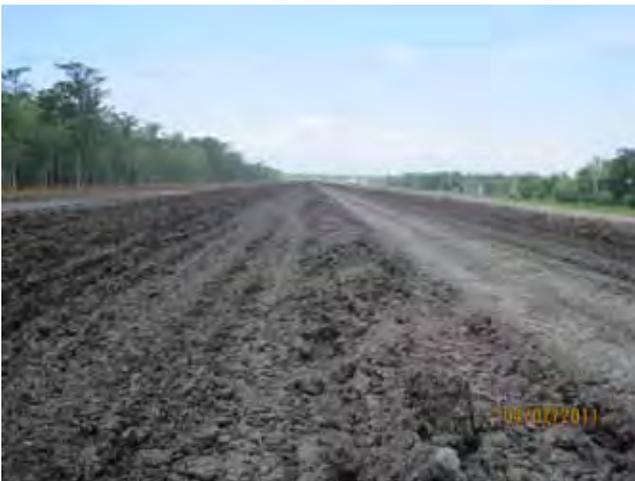
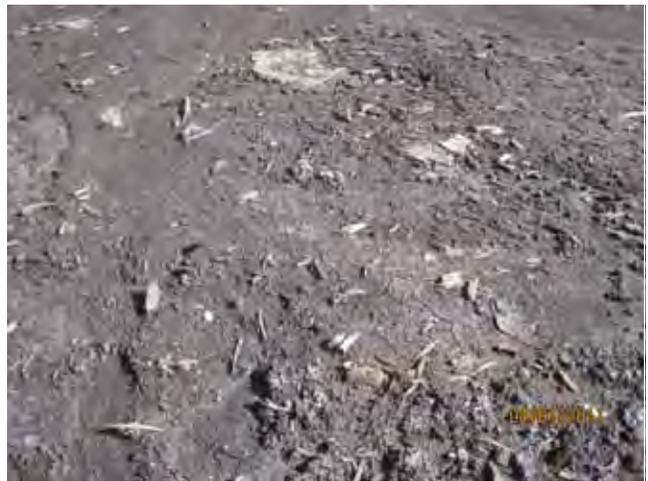
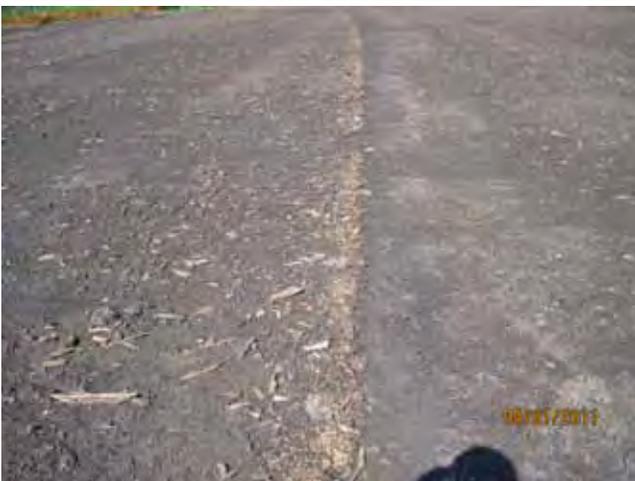
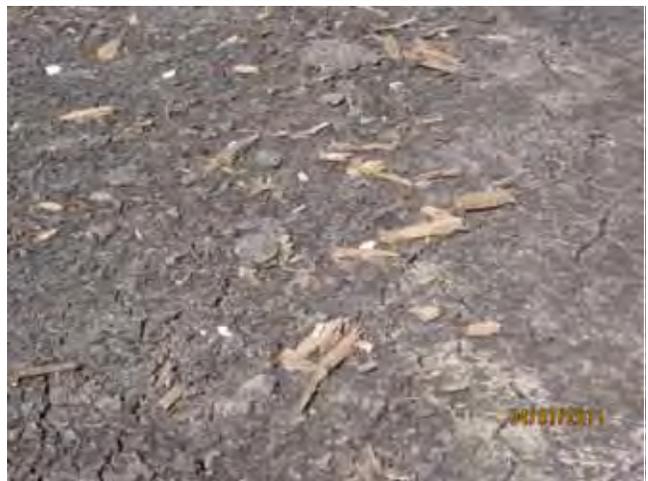
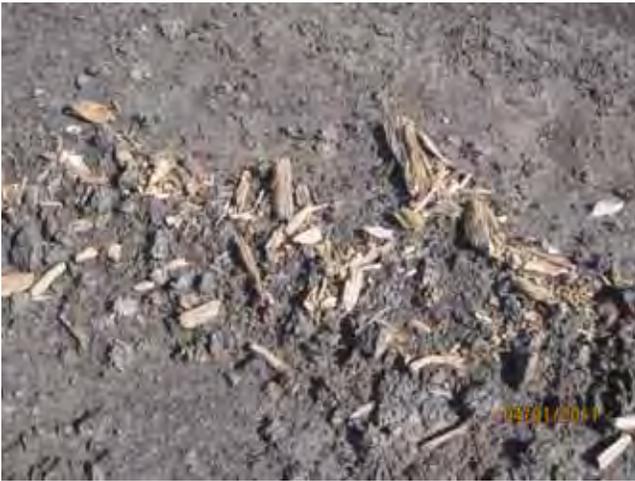
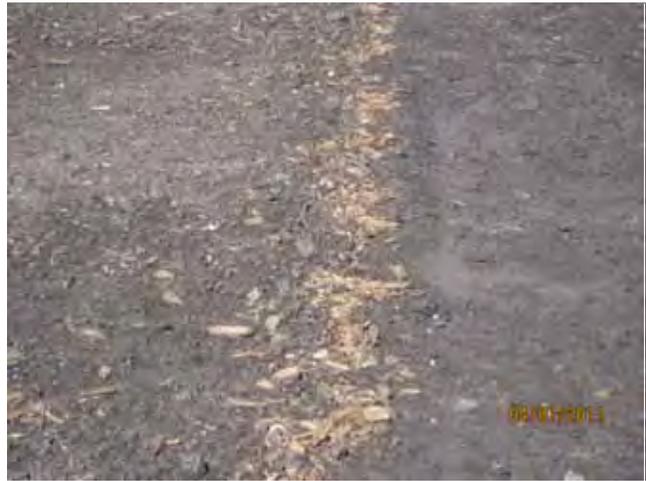
2. ISSUE: Sta.0+44 to Sta.55+00.

- Work remains on hold to investigate smaller debris problem.
- . GPS Coord: N29 53" 20.82" W090 09' 14.90"

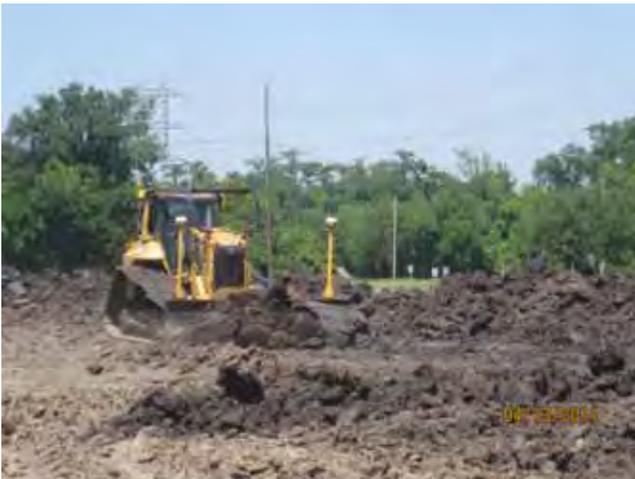
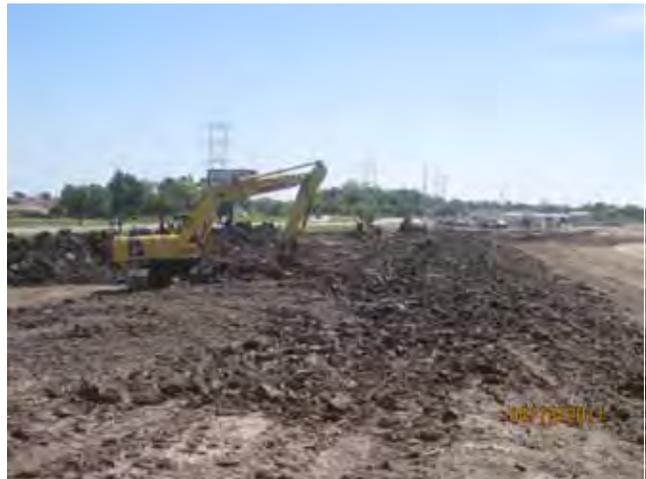
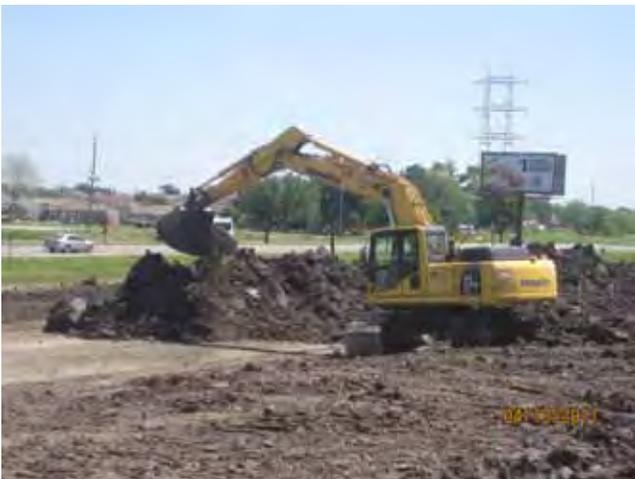
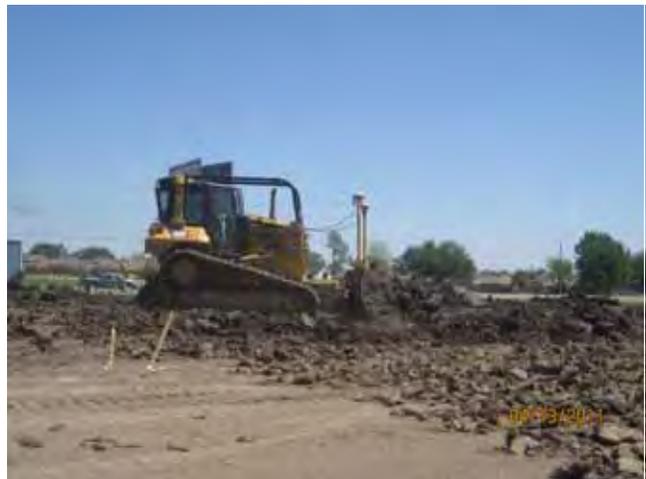
3. Sta.55+00 to Sta.60+51

- Levee is currently being degraded to elevation +3.0'. Geotextile will be installed at this elevation. 200 ft of existing vinyl sheet pile will be cut to elevation -1.0'.
- . GPS Coord: N29 53' 13.19" W090 08' 41.57"

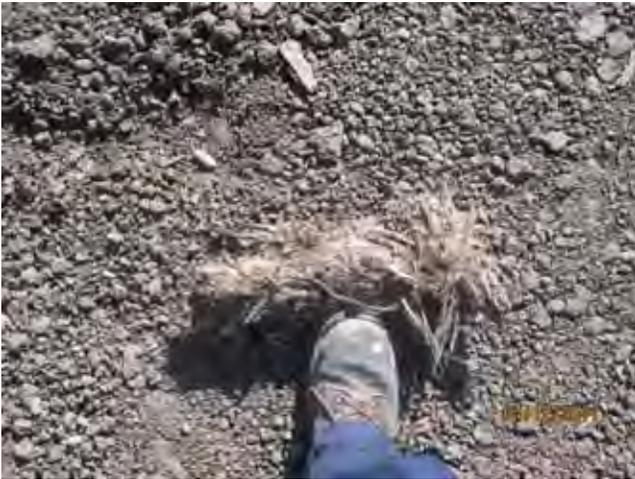
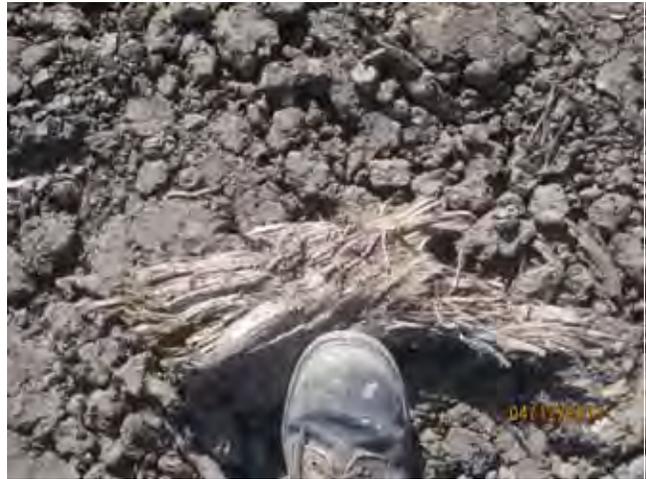
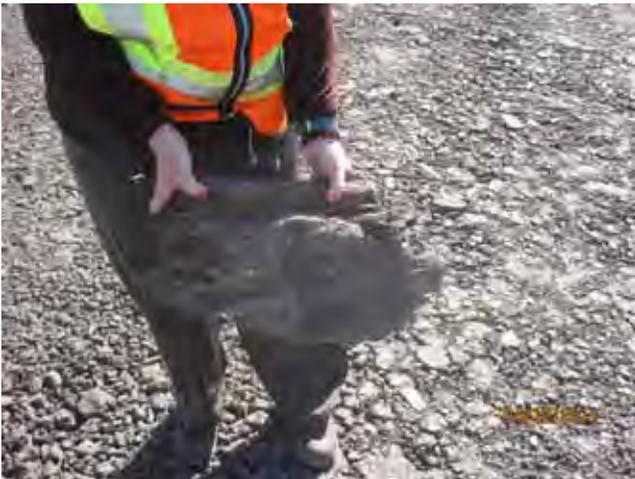
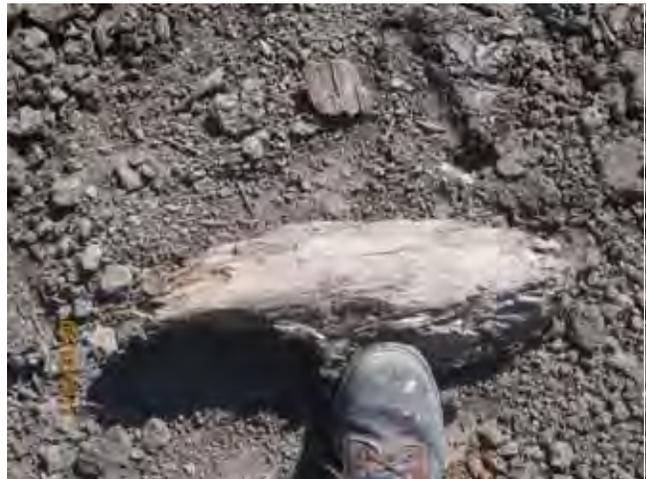
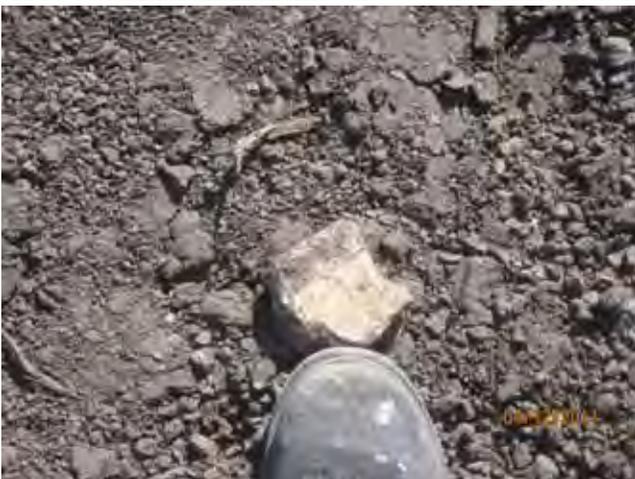
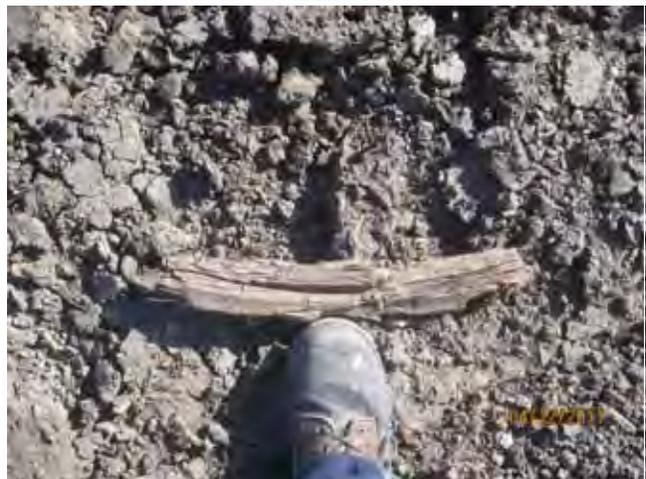
4. ISSUE: Sta.119+00 to Sta.182+00

- A considerable amount of large debris, stones, and smaller wood chips was found in the levee section in this area (not berms). Contractor informed SLFPAW reps that the area had been sealed due to expecting rains earlier in the week. This area needs to be picked before more material is placed. GPS Coord: N29 52' 34.73" W090 08' 17.09"

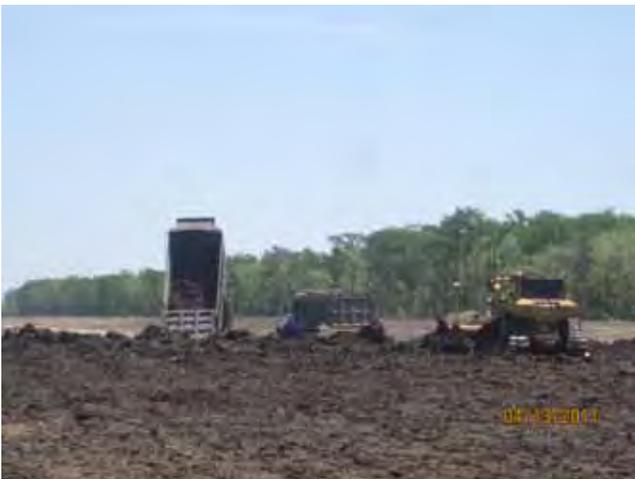
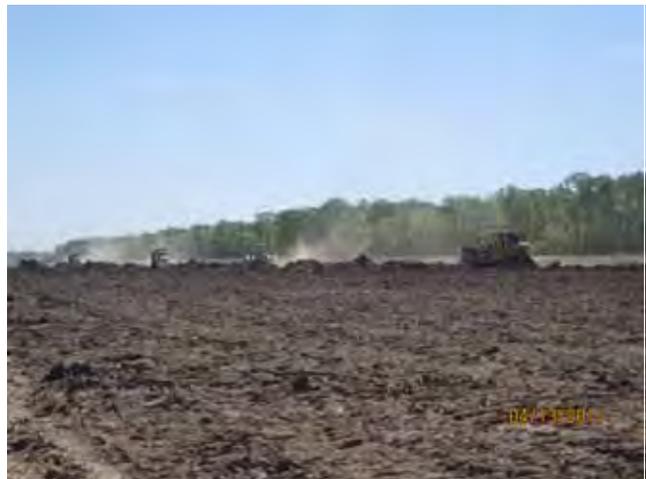
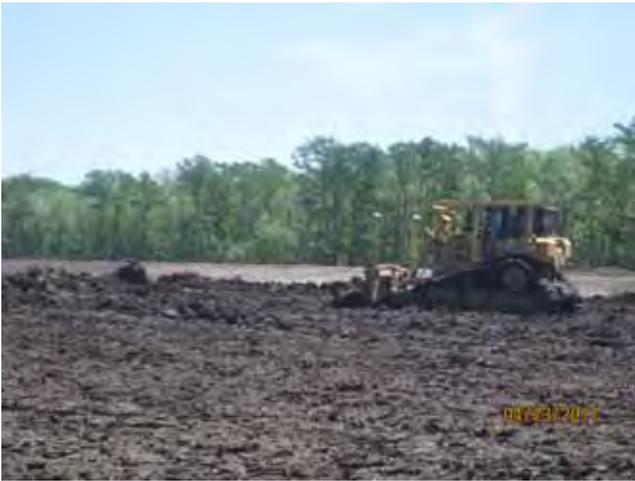
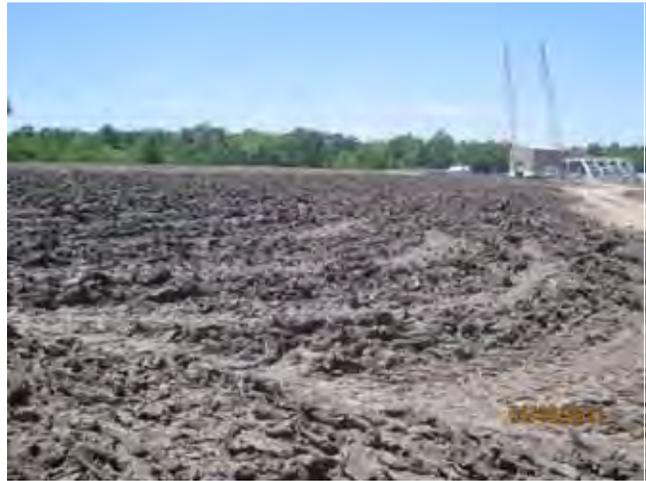
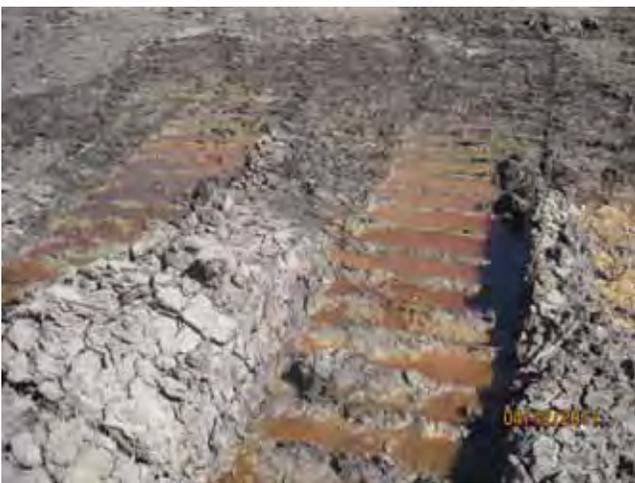
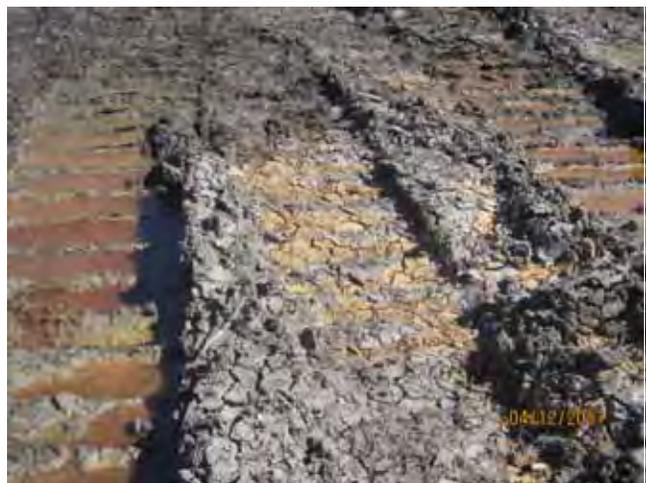
5. Sta.119+00 to Sta.182+00

- Work continues on enlarging and filling in the protected side berm in accordance with the contract modification to eliminate seepage problems. GPS Coord: N29 52' 34.73" W090 08' 17.09"

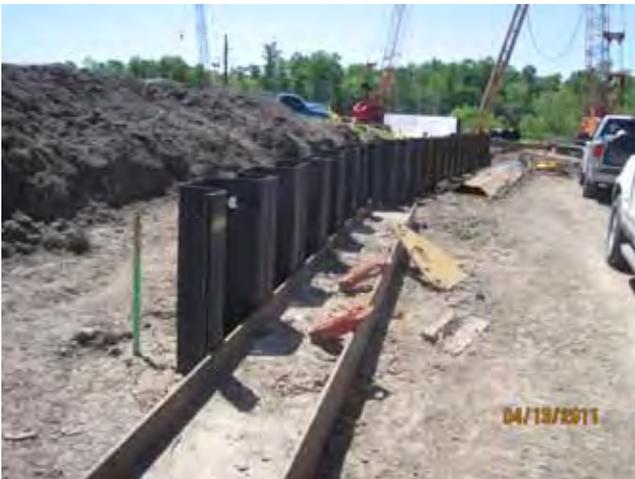
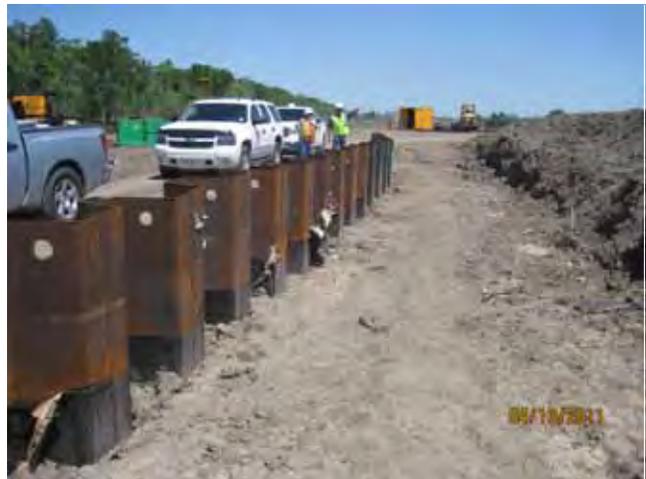
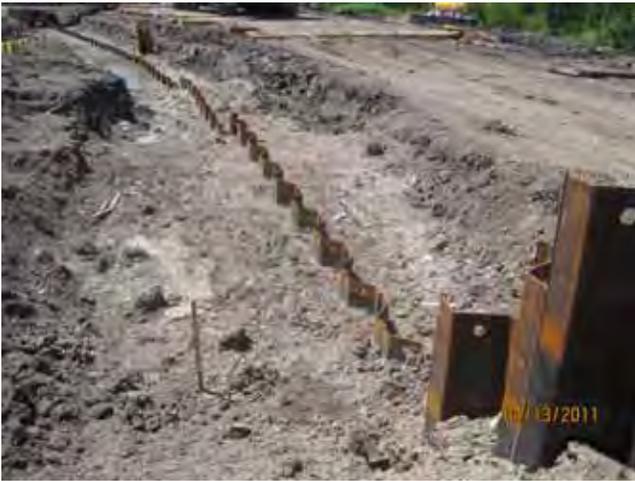
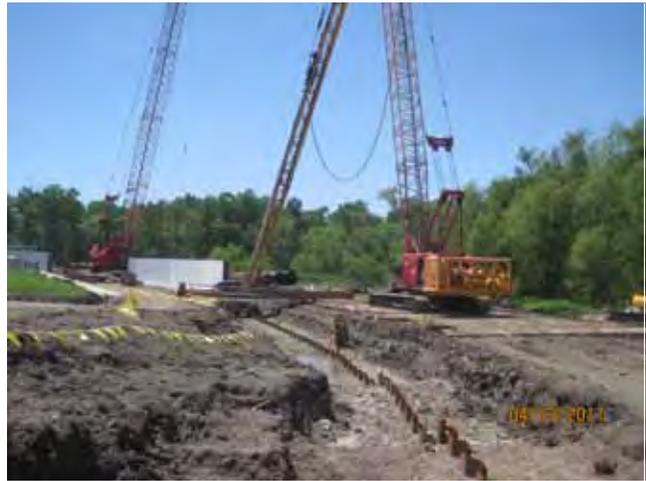
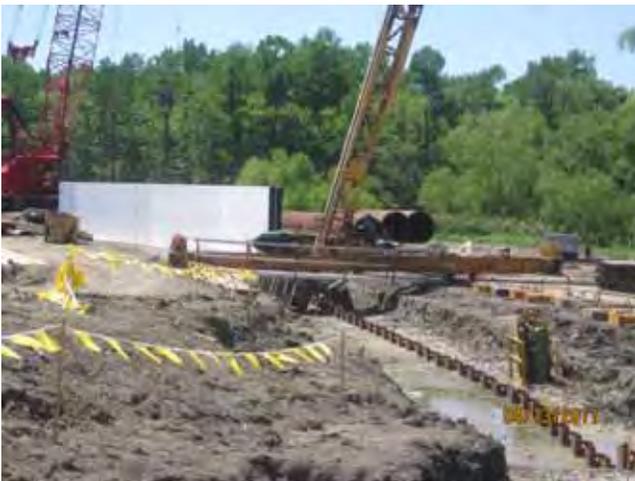
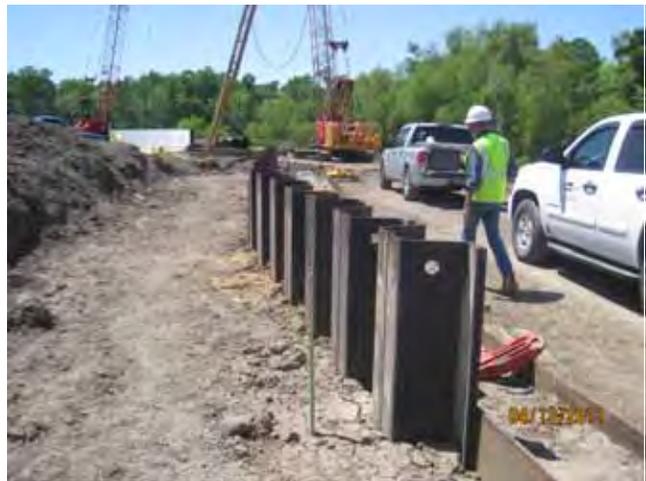
6. All sheet piling on the west side of Westminster Pump Station have been driven. H piles for monolith C were complete and H piles for monolith D were being started.  
GPS Coord: N29 52' 34.73" W090 08' 17.09"

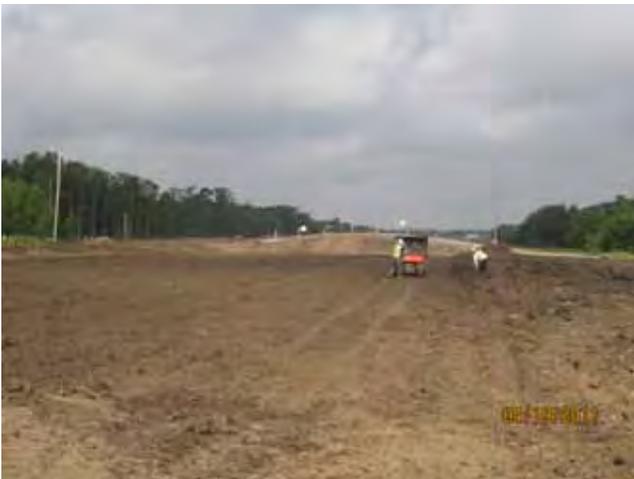
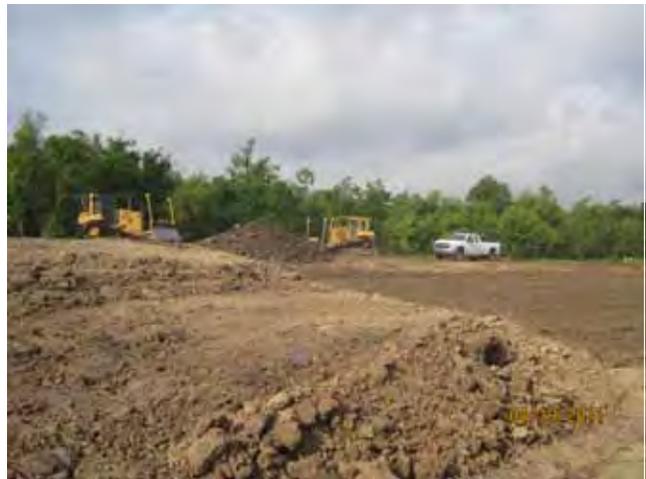
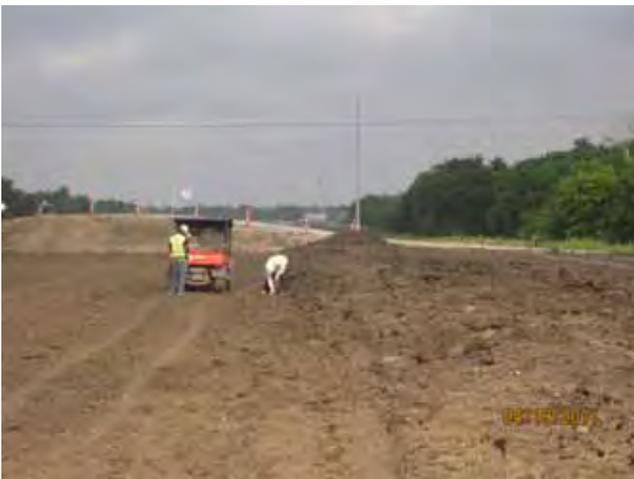
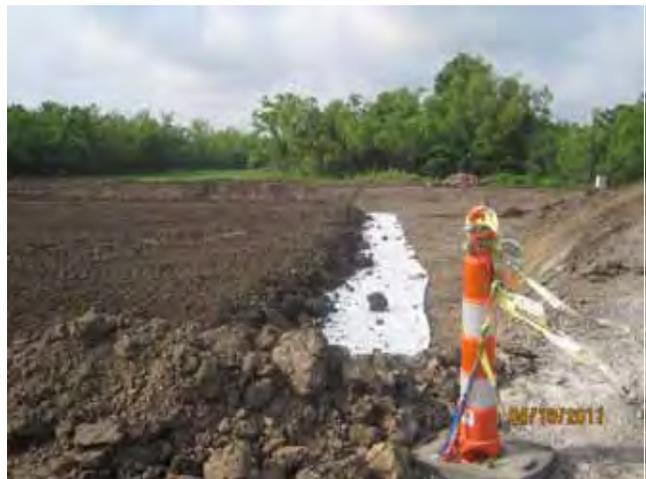
2. Between Sta.55+00 and Sta.60+51, the levee has been degraded to elevation +3.0'. Geotextile has been completely installed at this elevation and the first lift is being placed on top.

. GPS Coord: N29 53' 13.19" W090 08' 41.57"

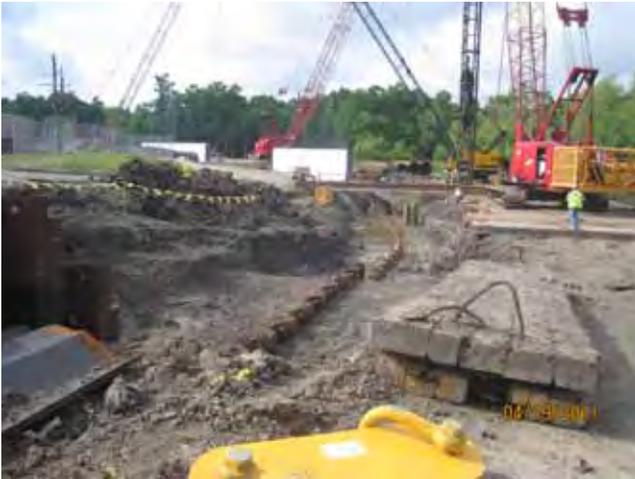
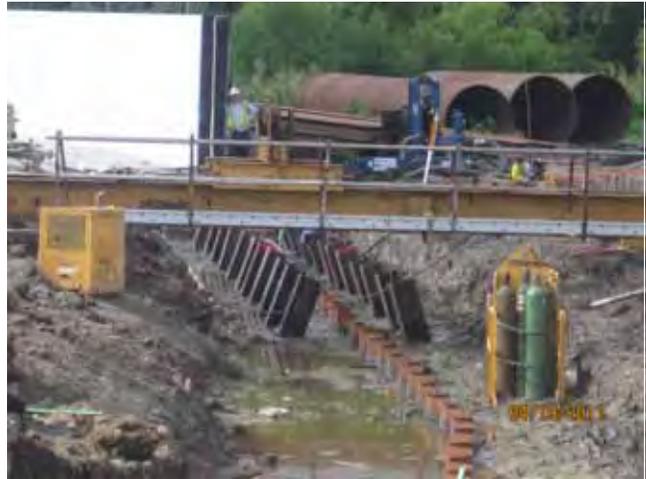
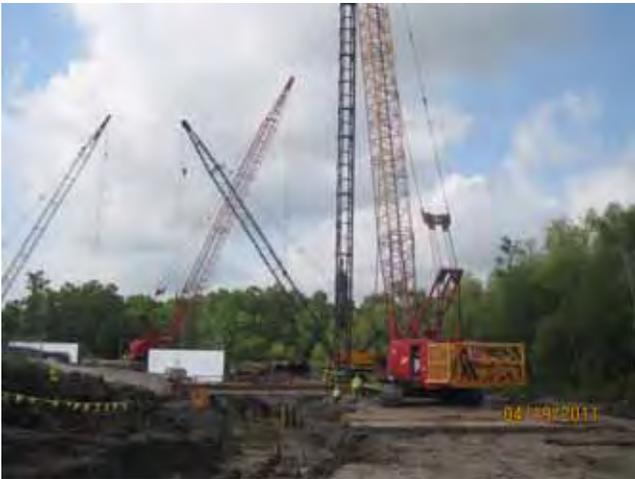
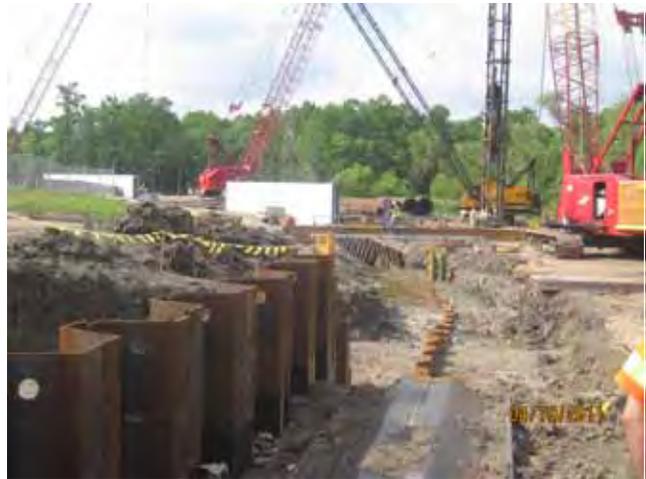
3. All sheet piling on the west side of Westminster Pump Station has been driven. H piles for monolith D were complete and H piles for monolith E were starting to be driven. GPS Coord: N29 52' 34.73" W090 08' 17.09"

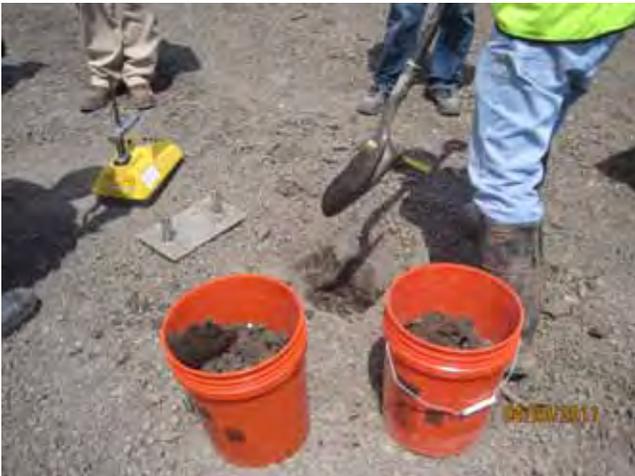
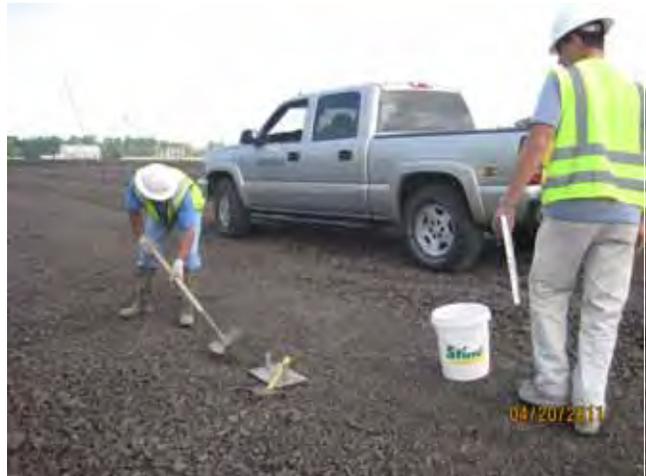
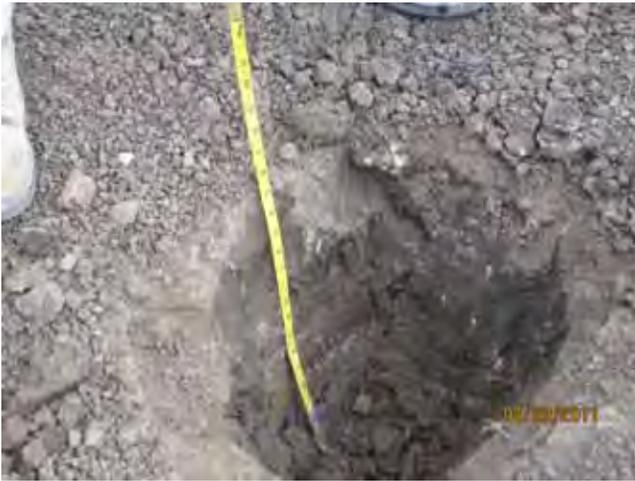
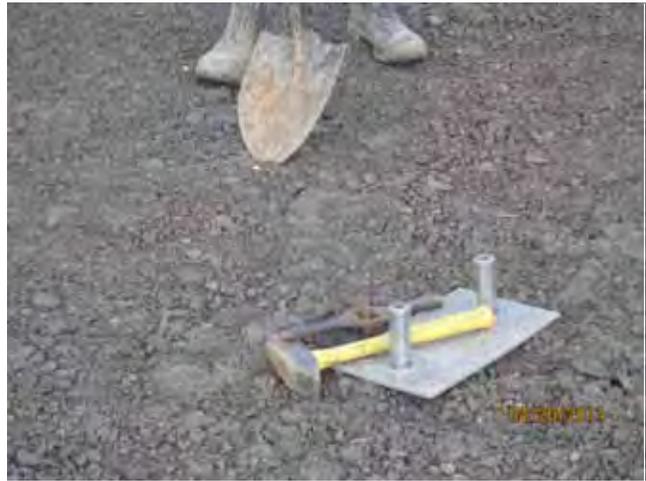
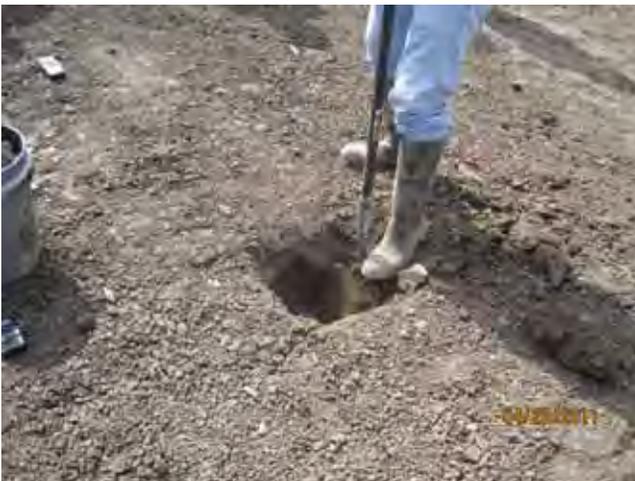
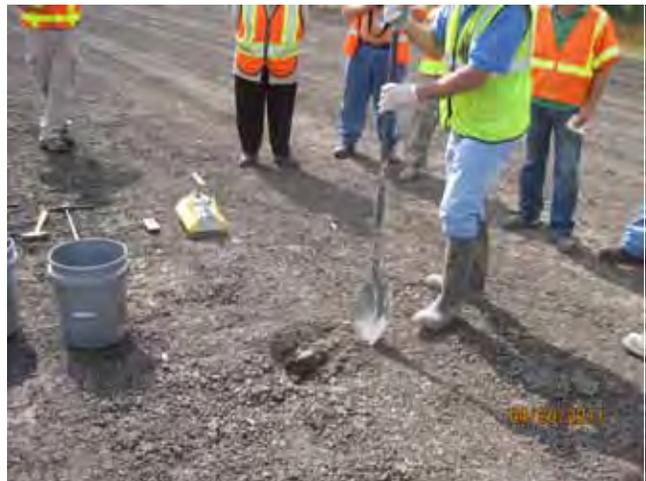
4. On 4/20/2011 a geotech evaluation of unsuitable material by volume was held. Samples were taken from 6 areas ranging from the floodside berm to the crown of the levee. (3 from Westwego levee, 3 from Westminster East/West Levee) Results of the test will be available after 1 and a half weeks. GPS Coord: N29 53' 20.82" W090 09' 14.90"

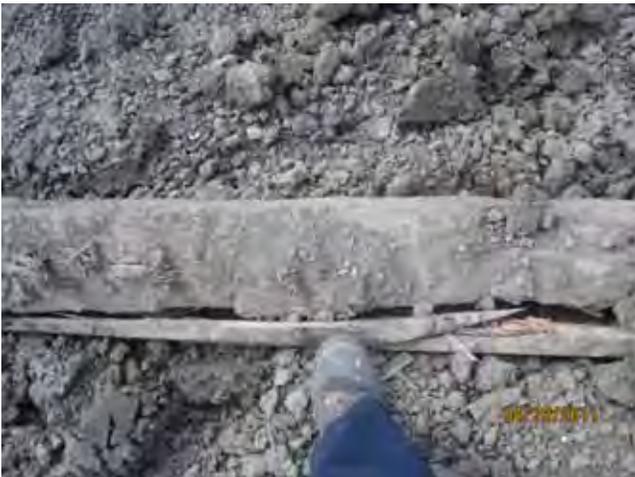
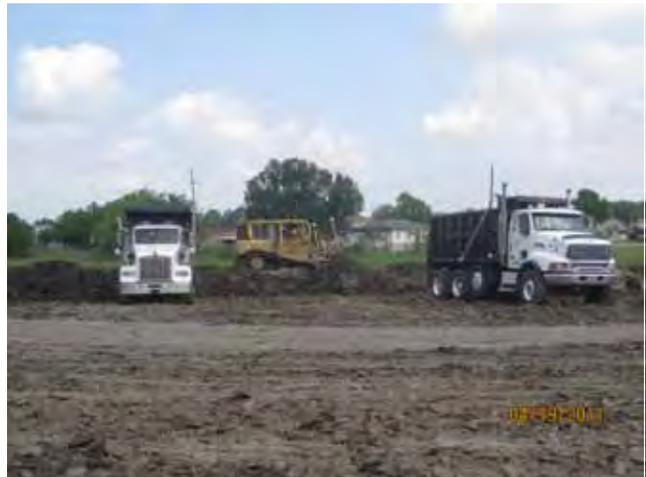
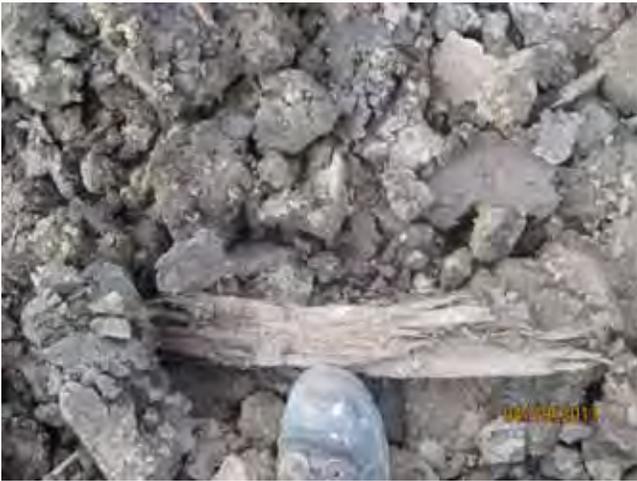
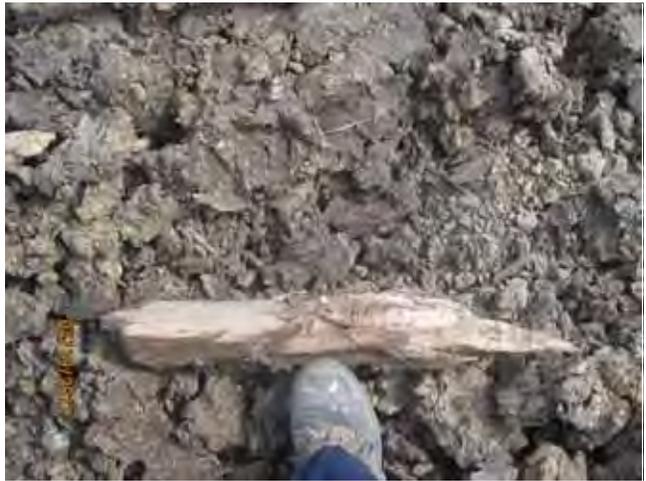
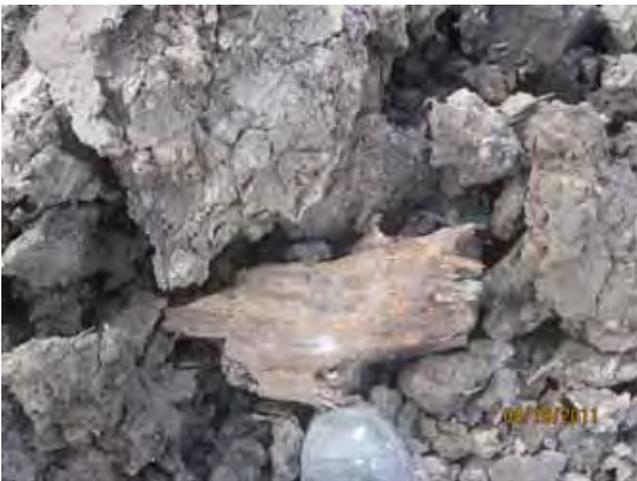
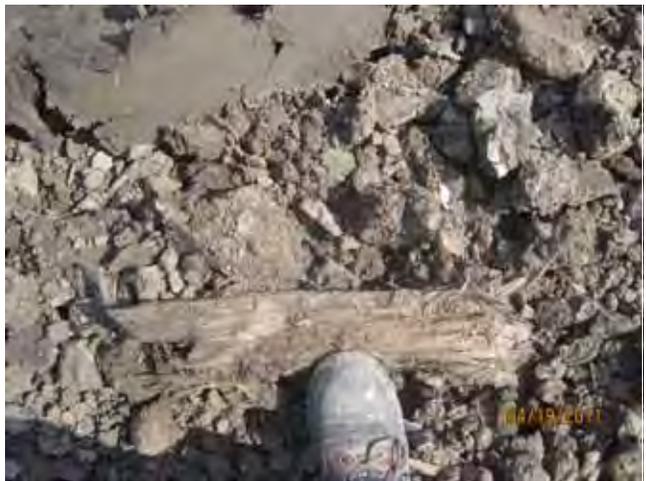
5. ISSUE: On the east end of the job (Sta.119+00 to Sta.182+00) work continues on enlarging and filling in the protected side berm in accordance with the contract modification to eliminate seepage problems. A considerable amount of large debris, stones, and smaller wood chips was found in this area. Pickers were at approx. Sta.120+00 during the site visit, picking the levee and the flood side berm. GPS Coord: N29 52' 34.73" W090 08' 17.09"

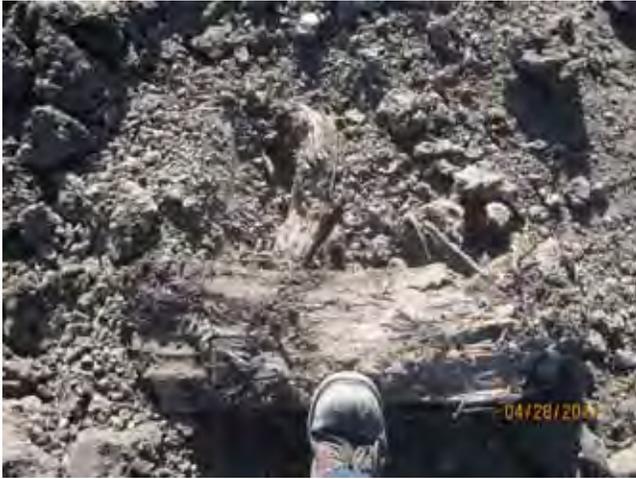
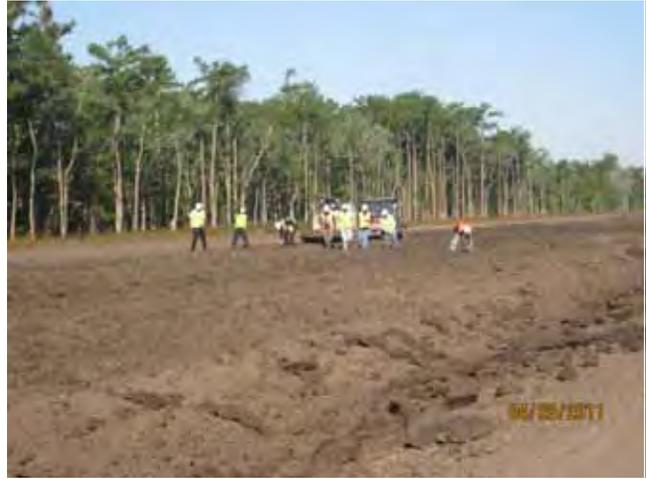
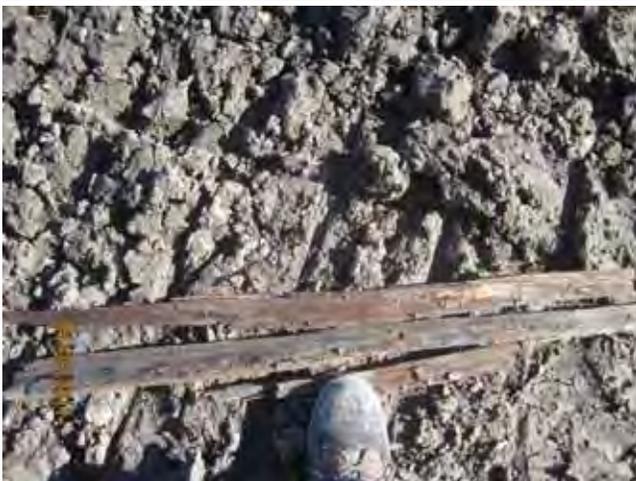
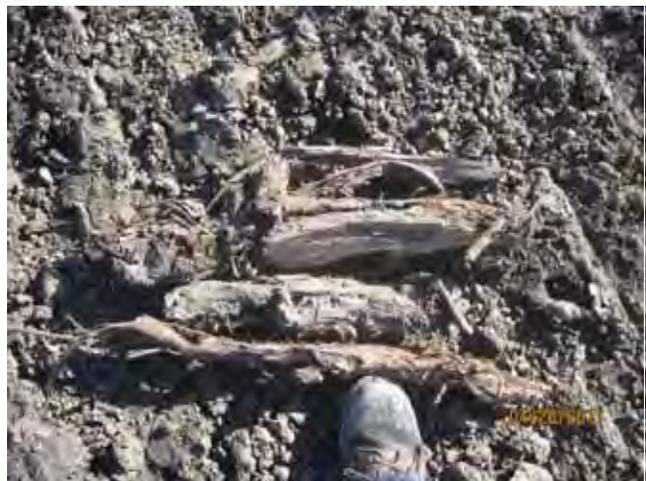
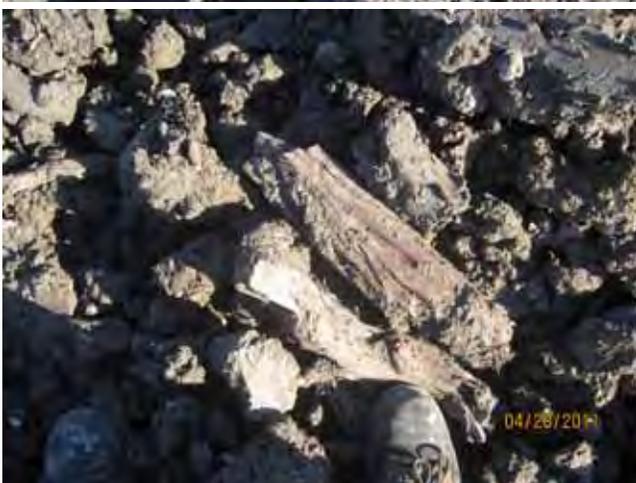
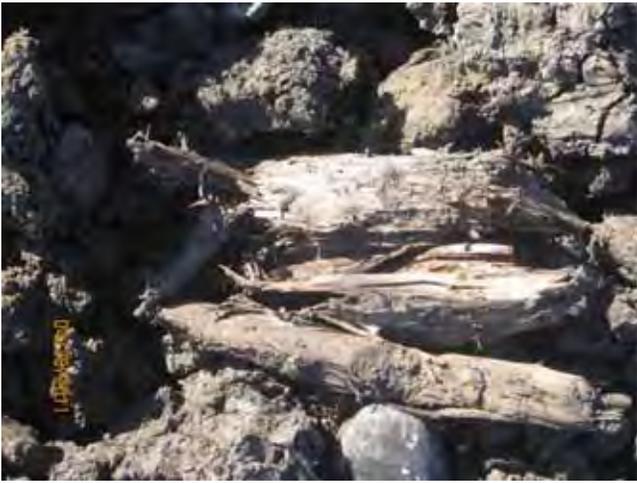
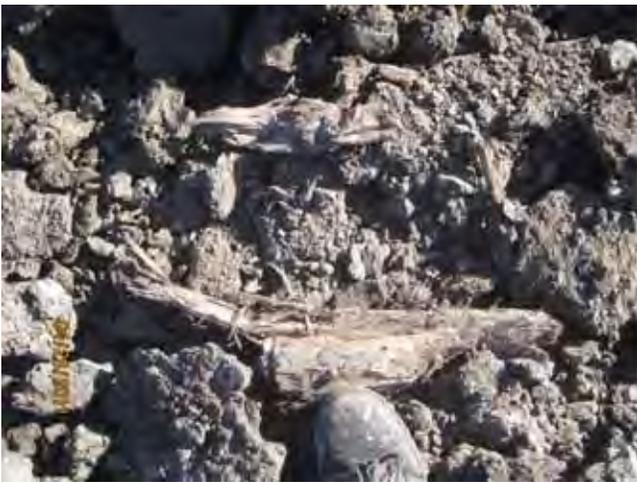
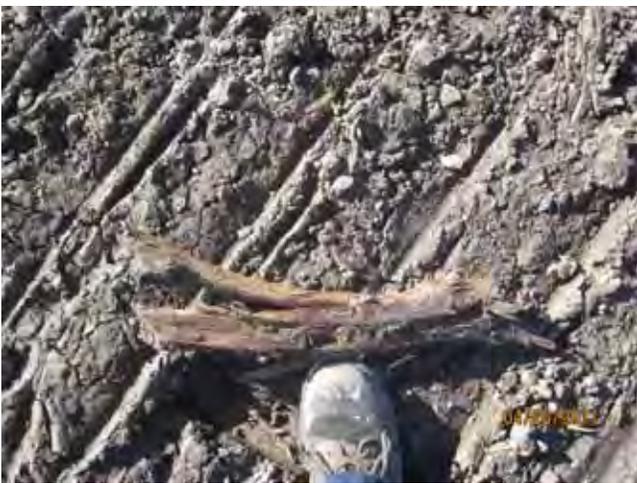
2. Sta.0+44 to Sta.55+00.

- Material has been hauled in to this area earlier in the week. A considerable amount of large debris, stones, and smaller wood chips was found in this area. Pickers were at approx Sta.45+00 during site visit. GPS Coord: N29 53" 20.82" W090 09' 14.90"
