## NON CONCURRENCE STATEMENT

- Tiger Team members have diligently worked for many months to complete their mission of investigating, evaluating, then reporting their activities regarding construction of the WBV-14c.2 levee in Jefferson Parish, Louisiana
- In an effort to complete and otherwise finalize, then publish the report of its mission the Tiger Team members have been in almost continuous conference for several weeks
- Unfortunately, several serious differences in the opinion and findings of the members remain and now appear irreconcilable
- Following deep and honest discussion of these differences the Tiger Team has concluded our best course of action is to allow the report to be issued but, containing statements of non-concurrence in those chapters of the report remaining unresolved

## **Tiger Team Update for SLFPA-W Technical, Operations and Maintenance (TOM) Committee:**

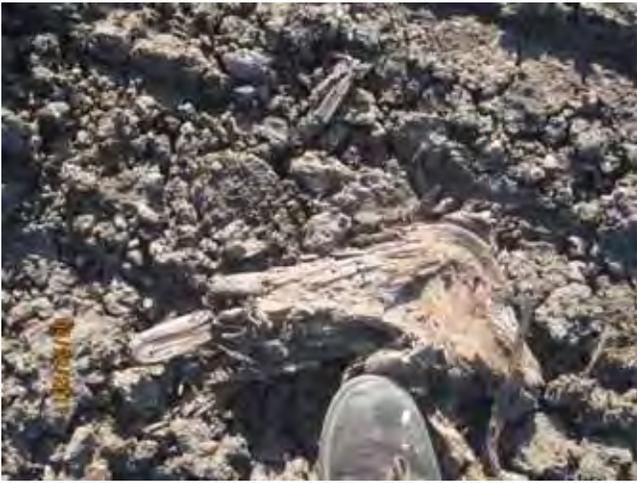
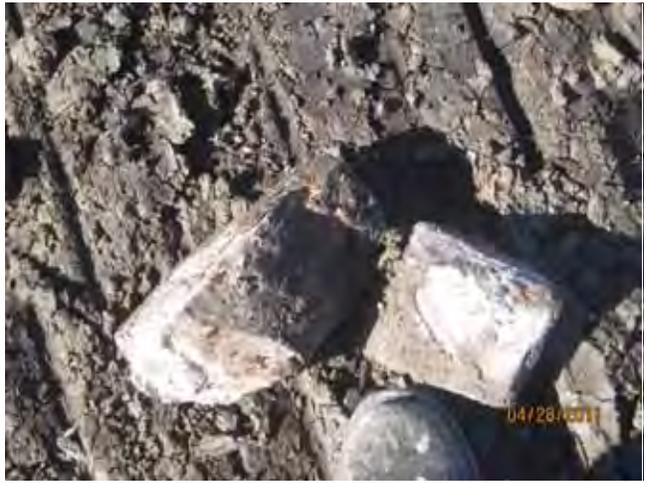
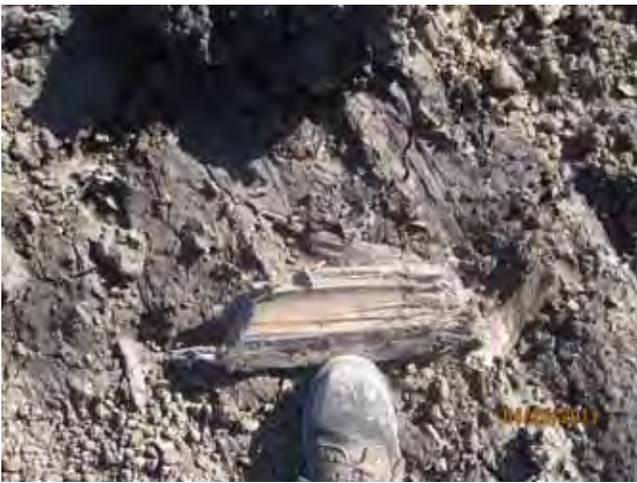
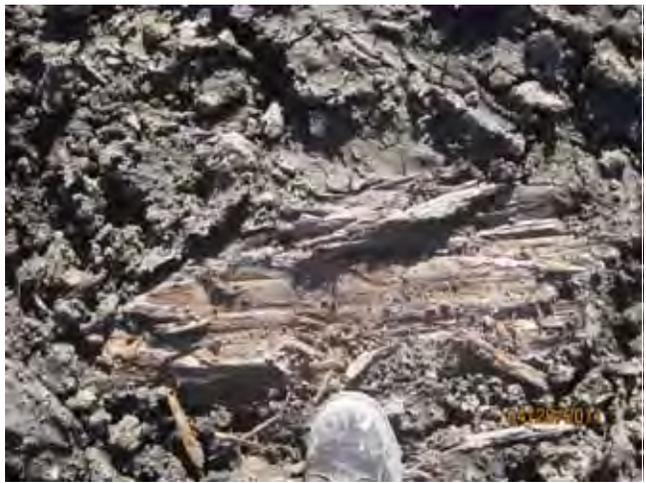
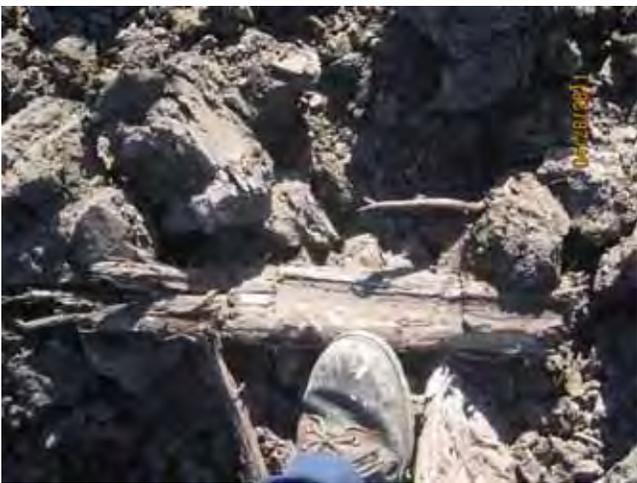
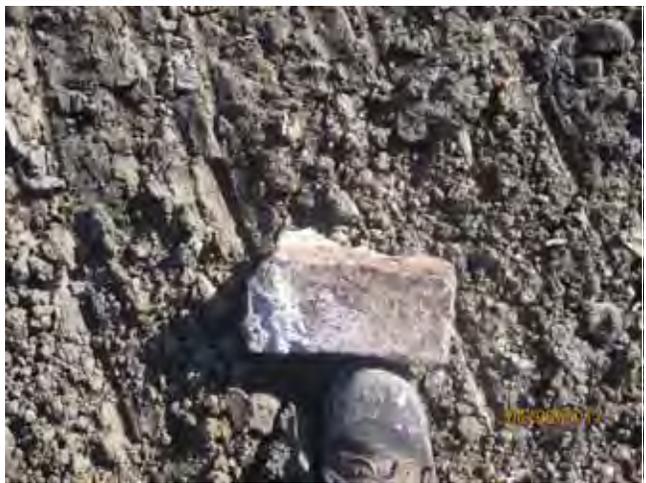
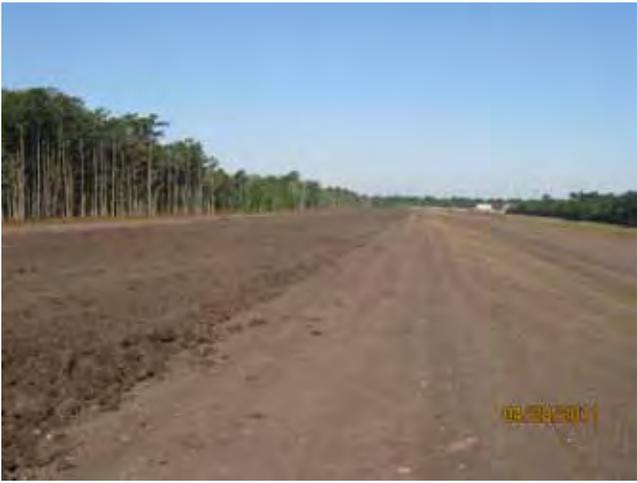
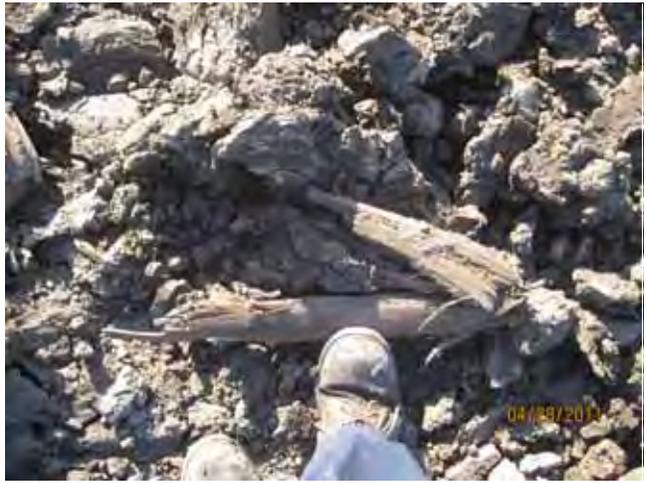
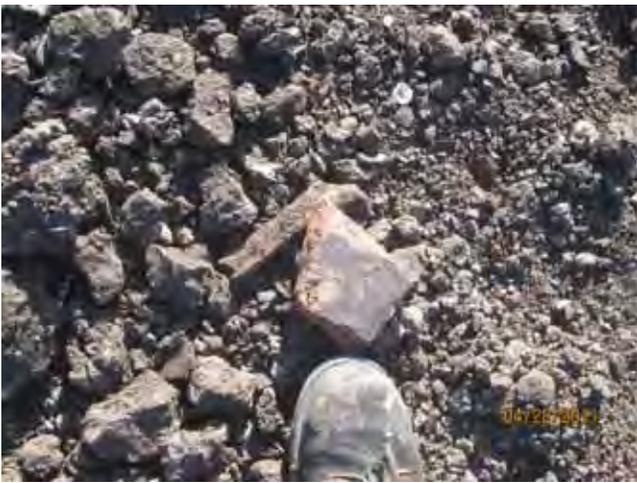
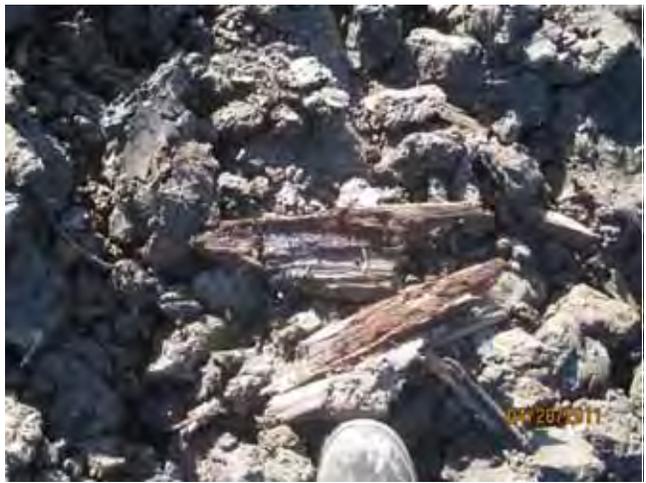
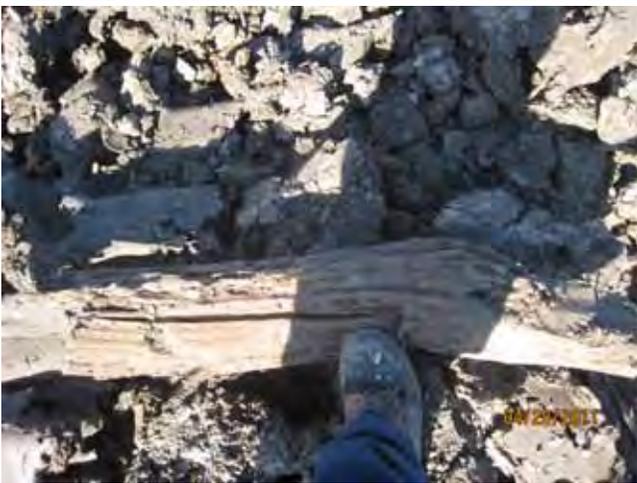
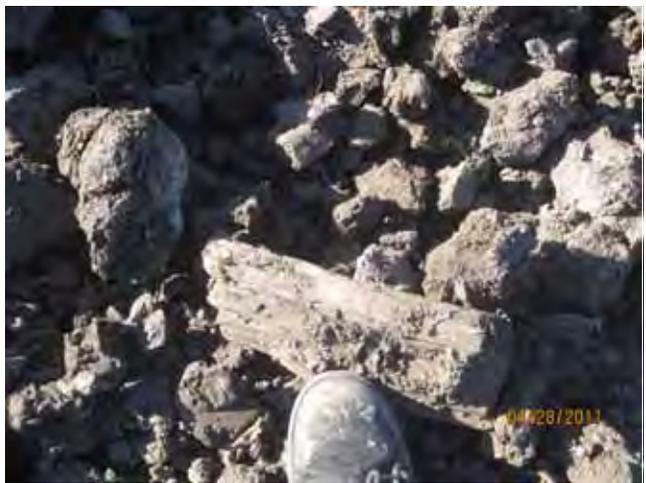
- 
3. At approx Sta.55+00, the levee is being degraded to elevation +3.0' where geotextile will be installed. GPS Coord: N29 53' 13.19" W090 08' 41.57"

- 
4. A considerable amount of debris is being found from Sta.68+00 to Sta.112+00 (north/south levee). Material is being added to the protected side berm in this area at approx. Sta.110+00, debris is also being found in this material. GPS Coord: N29 52' 34.73" W090 08' 17.09"

6. On the east end of the job (Sta.119+00 to Sta.182+00) debris is being found within the levee section and on the protected side berm. GPS Coord: N29 52' 34.73" W090 08' 17.09"

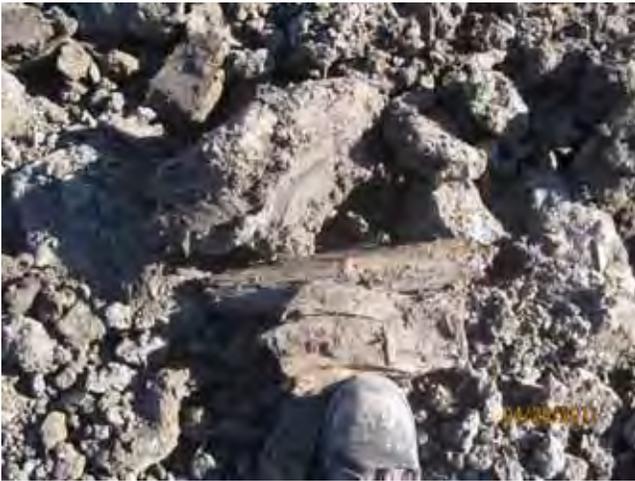
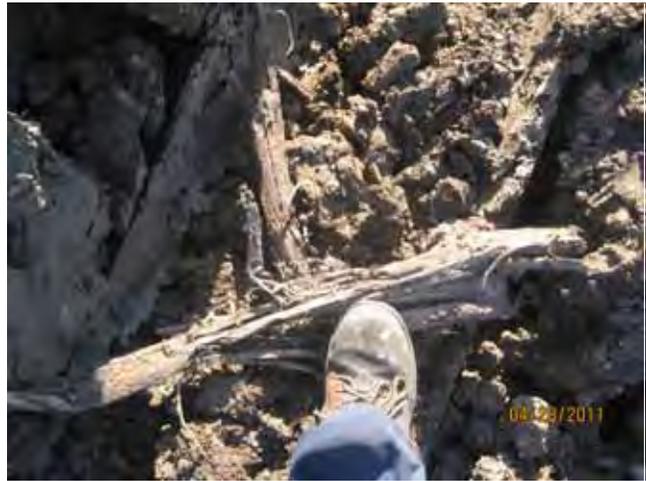
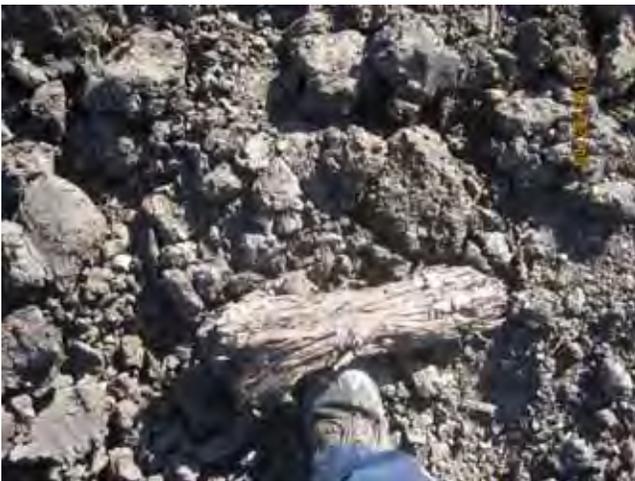
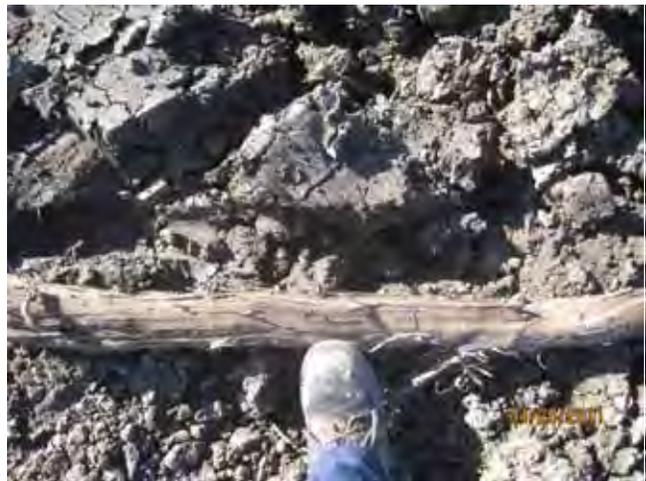
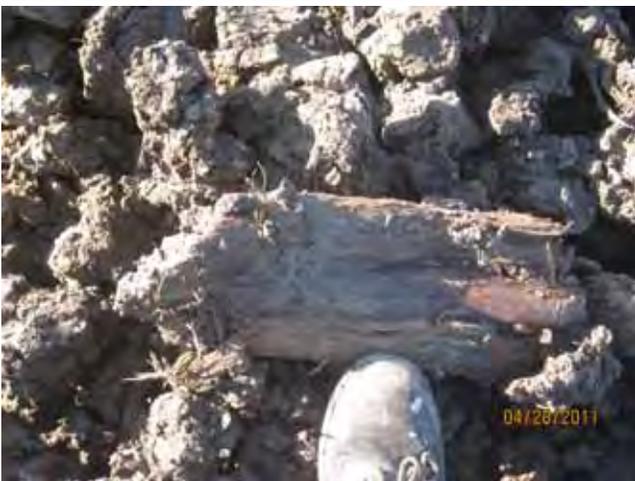
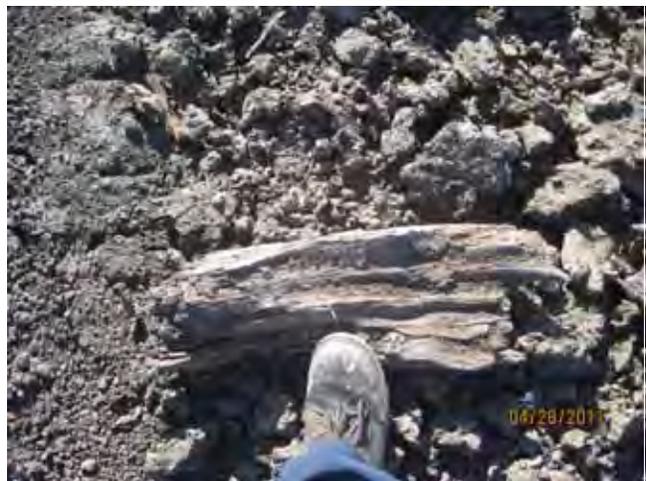
- Material has been hauled in to this area earlier in the week. A considerable amount of large debris, stones, and smaller wood chips was found in this area. Pickers were at approx Sta.45+00 during site visit. GPS Coord: N29 53" 20.82" W090 09' 14.90"

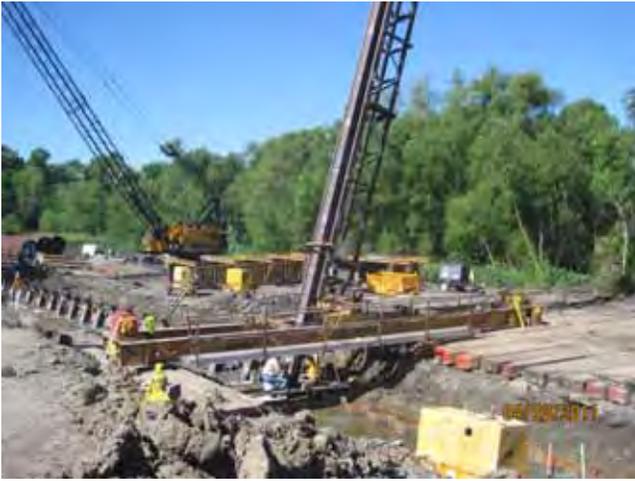
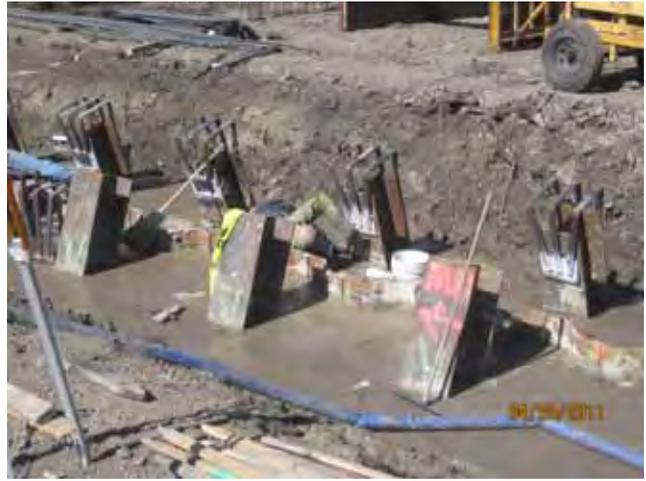
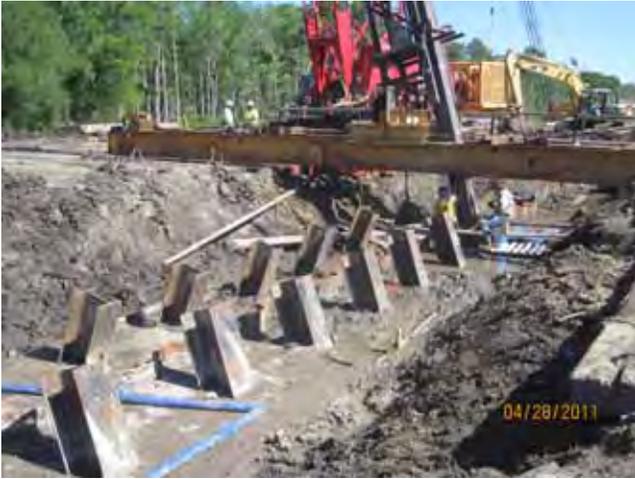
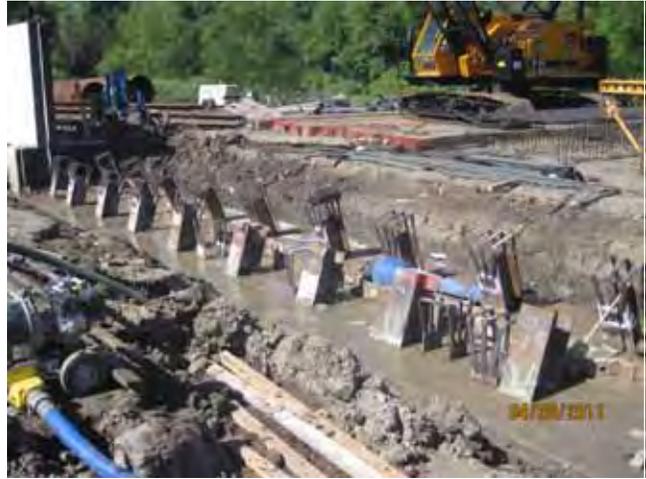
- 
5. All sheet piling on the west side of Westminster Pump Station has been driven. H-piles are currently being driven at monolith F. GPS Coord: N29 52' 34.73" W090 08' 17.09"

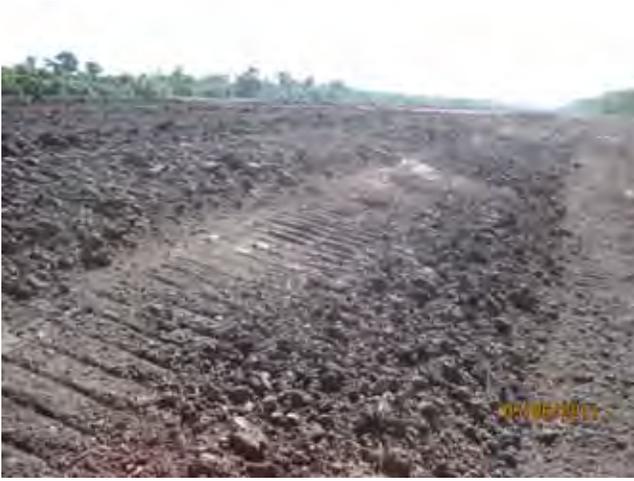
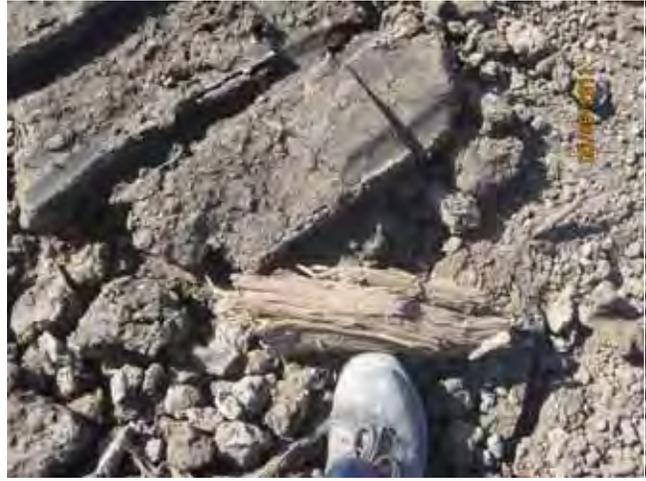
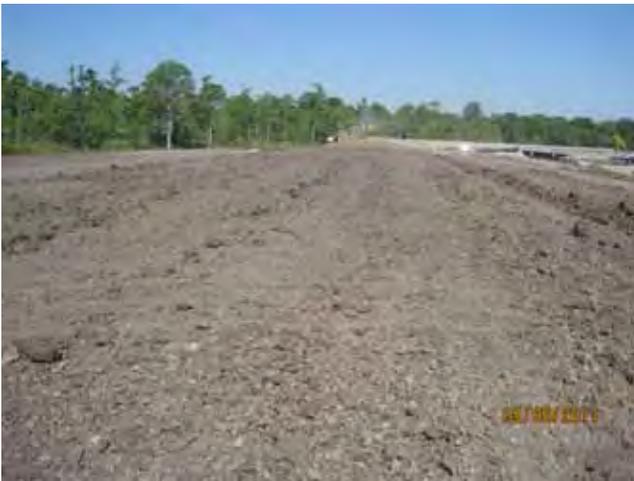
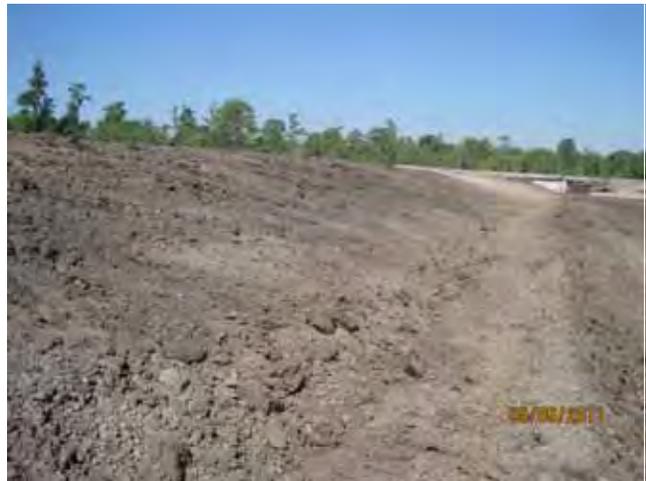
2. West end of job (Sta.0+44 to Sta.55+00). No material was being hauled into area during time of inspection. Area is up to elev. +10'. Degrade of existing levee is scheduled to begin next week. Much less debris is being found in the levee section. GPS Coord: N29 53" 20.82" W090 09' 14.90"

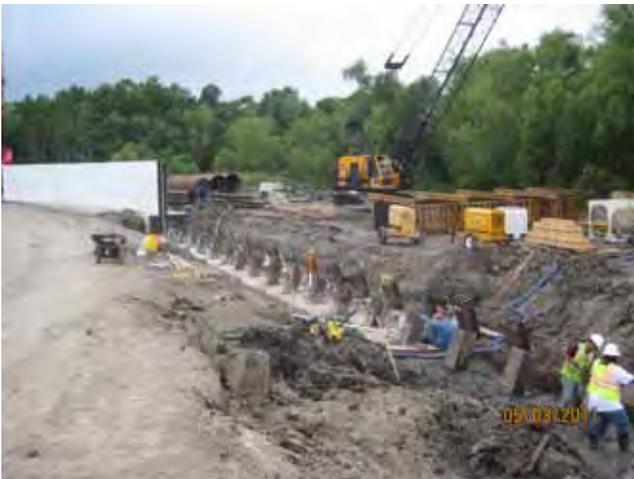
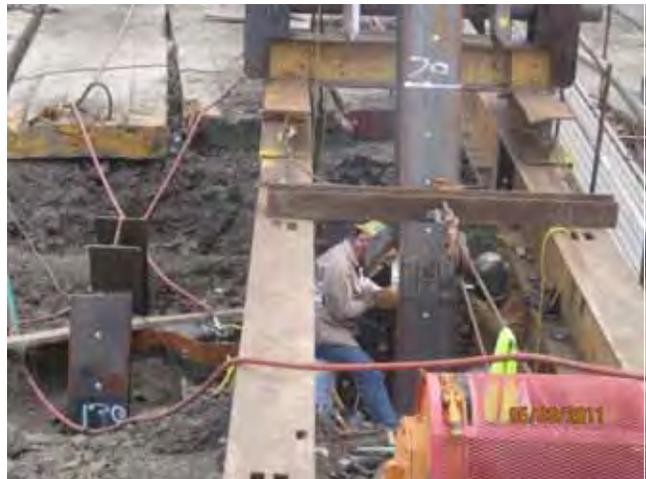
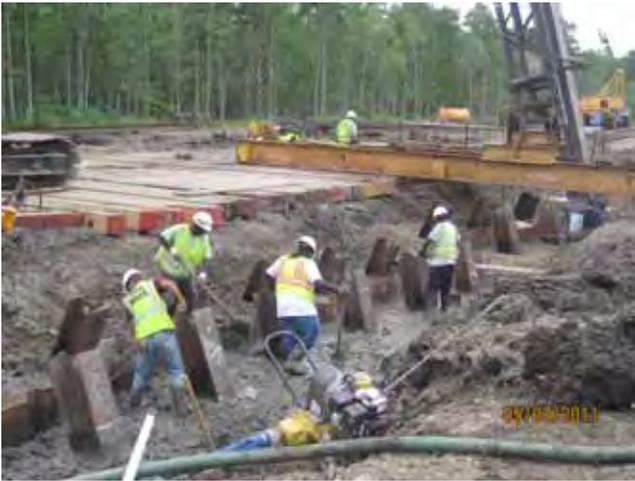
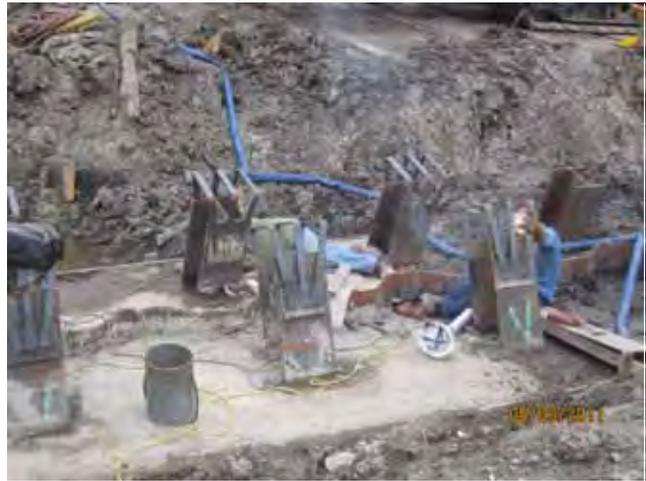
3. All sheet piling on the west side of Westminster Pump Station has been driven. H-piles are currently being driven at monolith G. GPS Coord: N29 52' 34.73" W090 08' 17.09"

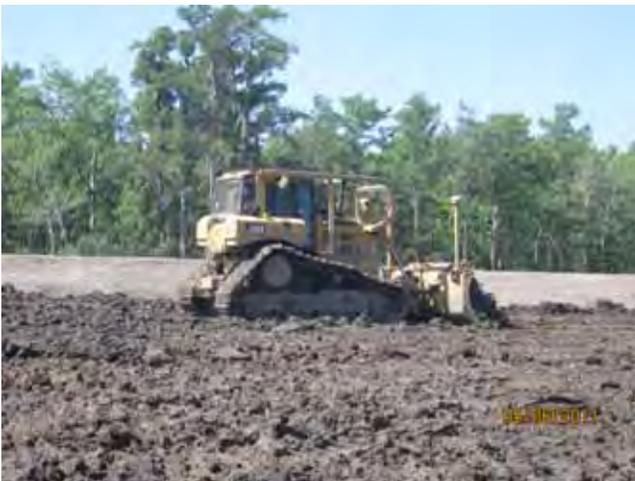
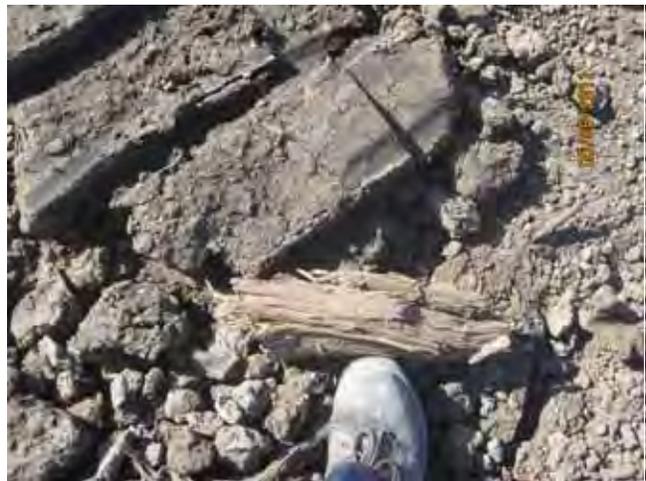
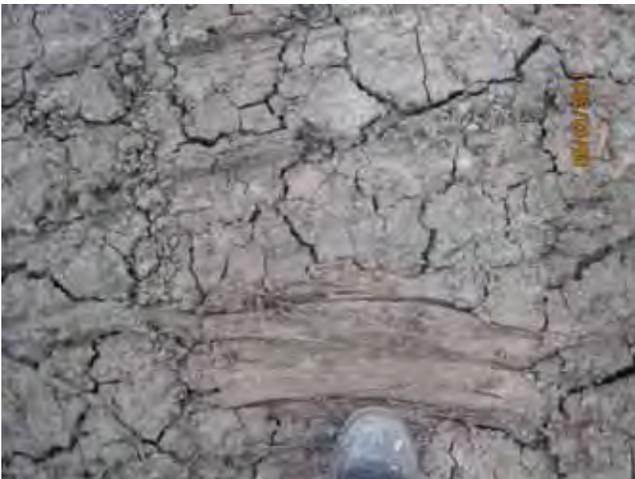
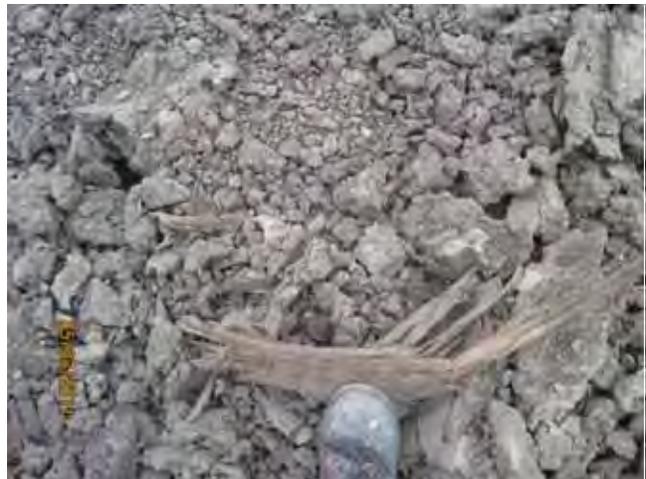
4. On the east end of the job (Sta.119+00 to Sta.182+00) material is being hauled in to fill the protected side berm. Some debris is being found on the surface in this area.  
GPS Coord: N29 52' 34.73" W090 08' 17.09"

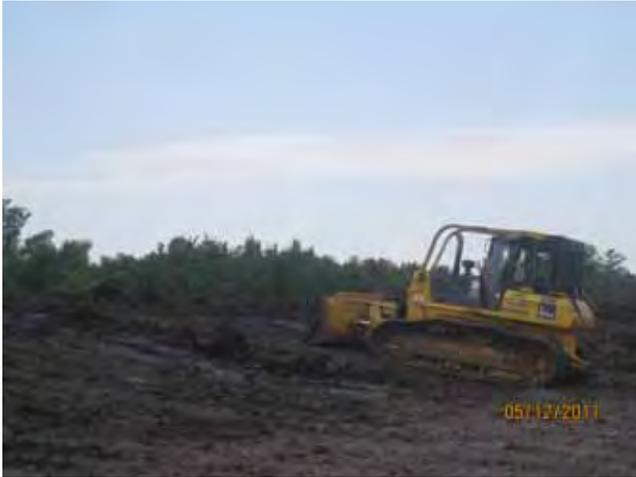
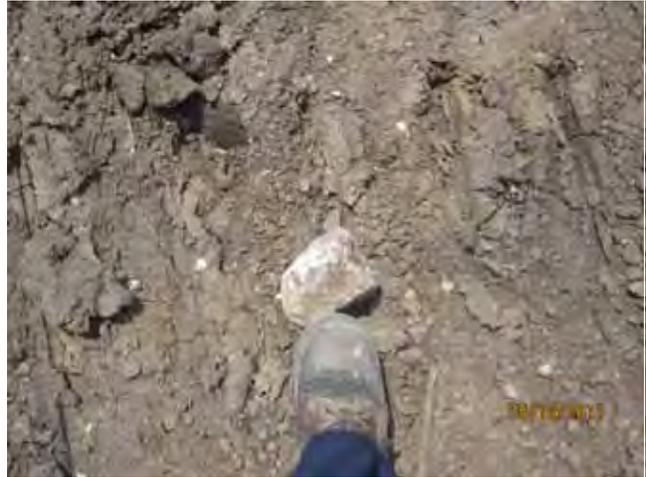
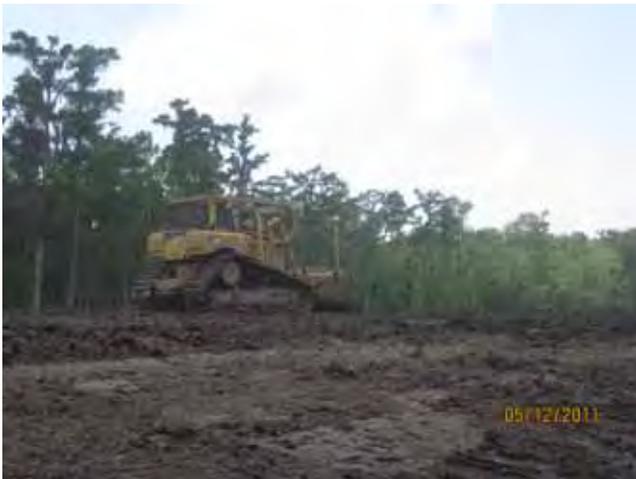
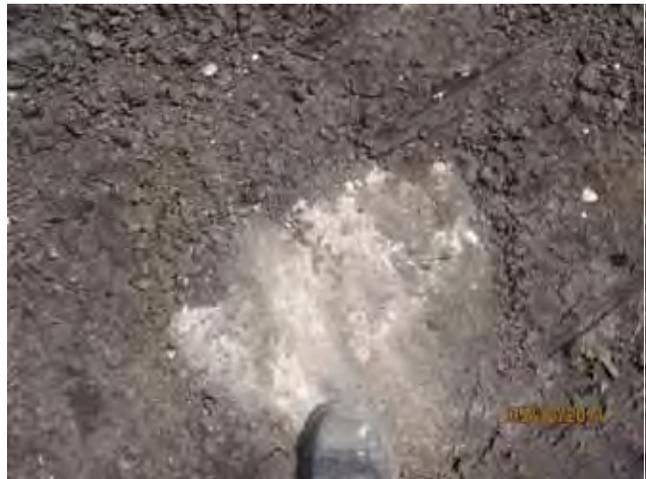
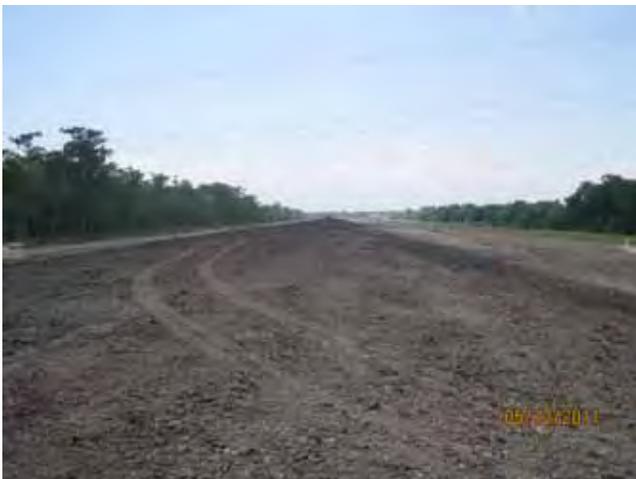
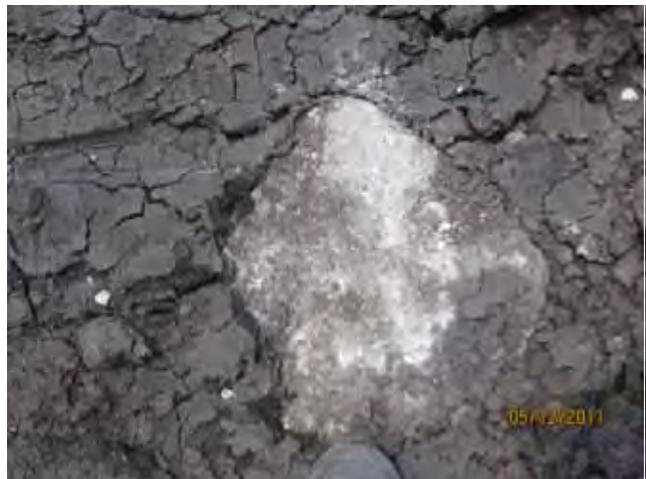
- SLFPA-W reps expressed their concerns to Jeremy George (USACE) about the concrete being found in the existing levee that is being degraded (approx. Sta.0+44 to Sta.55+00). Debris throughout the levee system remains to be an issue, although the material being hauled in is cleaner than previous material.

2. West end of job (Sta.0+44 to Sta.55+00). The new levee is up to elevation 10 in this area and the degrade of the existing levee is in progress. A large amount of concrete rocks is being found in the existing levee. Contractor will need to go through this area and pick out unsuitables. GPS Coord: N29 53" 20.82" W090 09' 14.90"

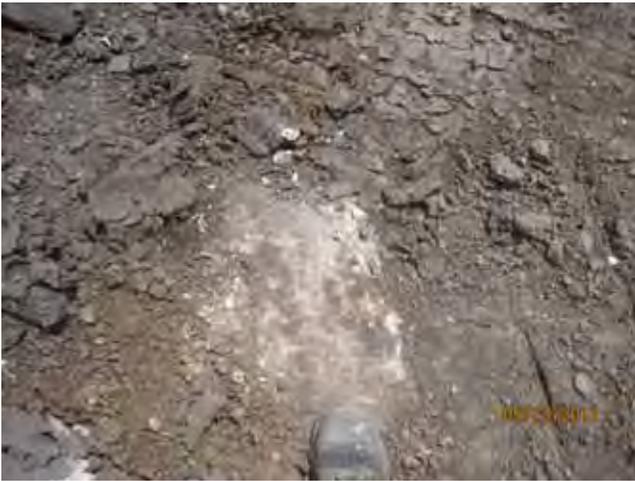
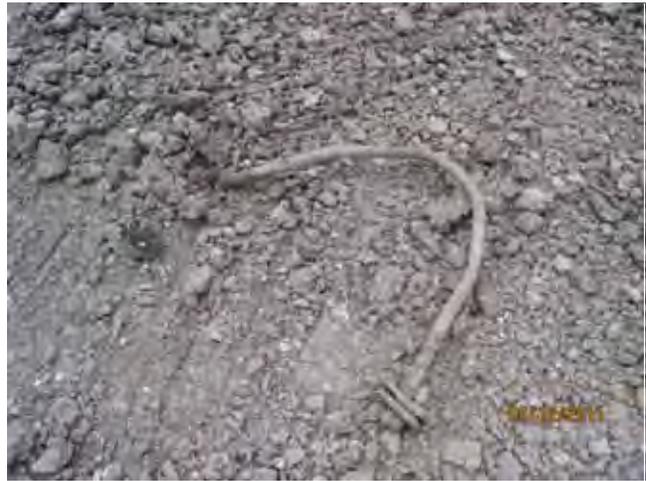
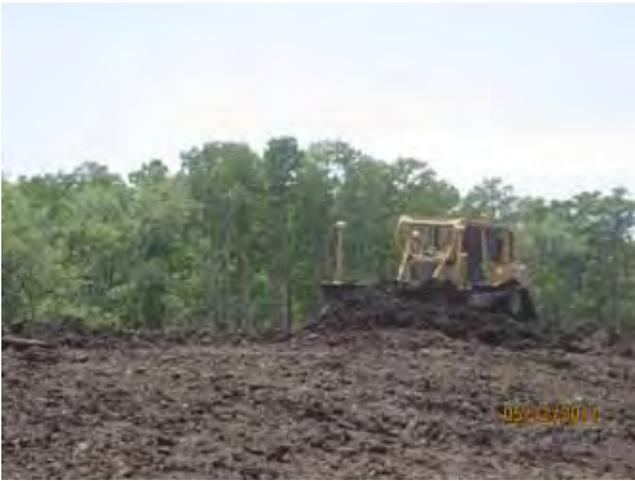
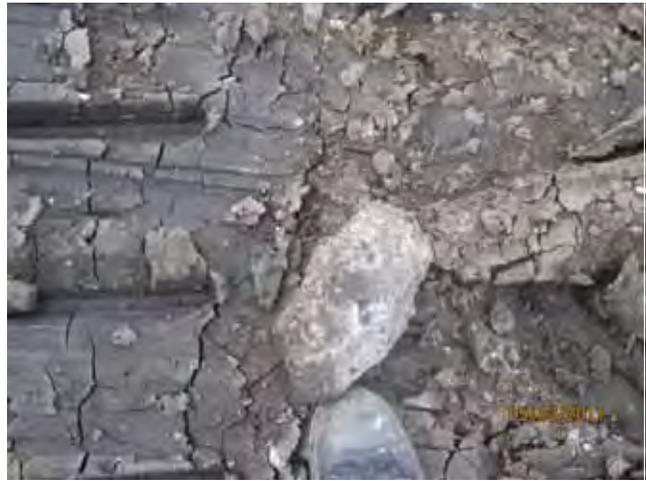
- West end of job (Sta.0+44 to Sta.55+00). The new levee is up to elevation 10 in this area and the degrade of the existing levee is in progress. A large amount of concrete rocks is being found in the existing levee. Contractor will need to go through this area and pick out unsuitables.

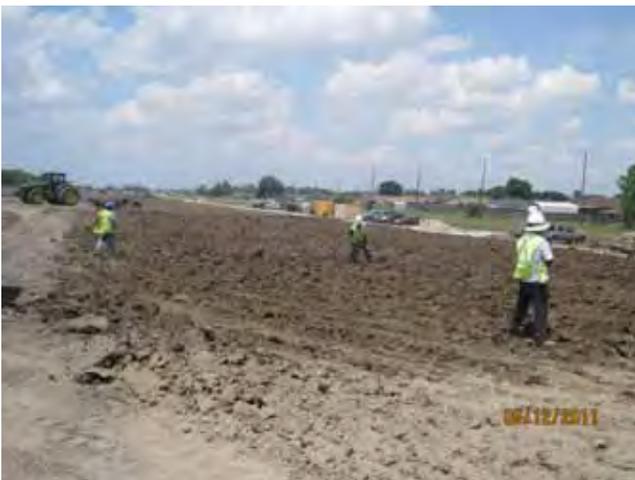
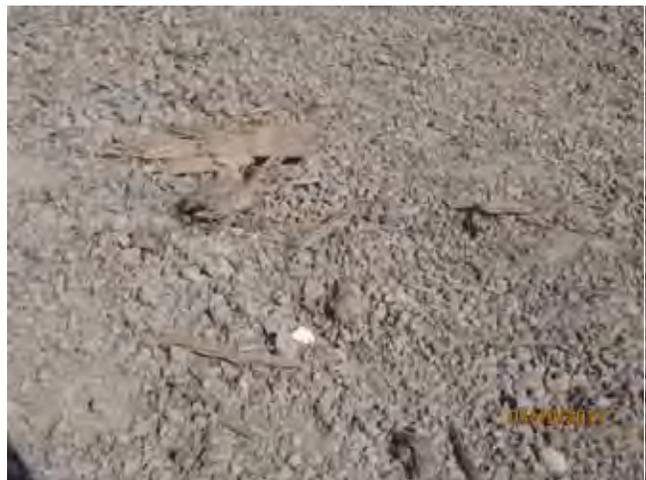
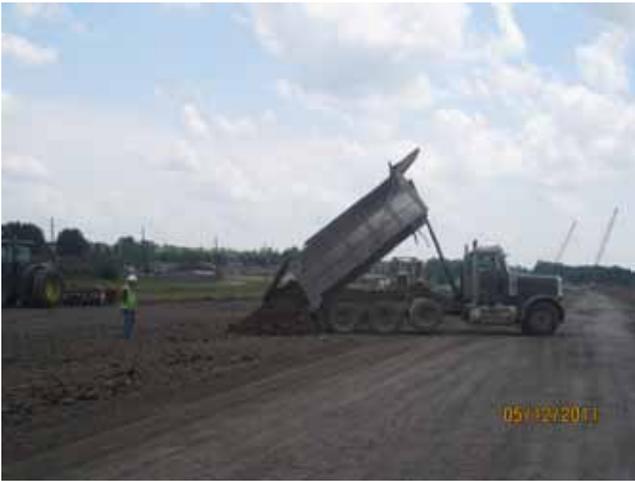
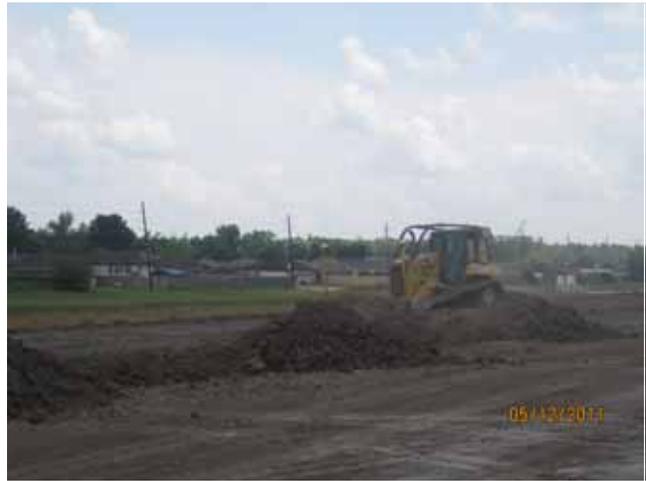
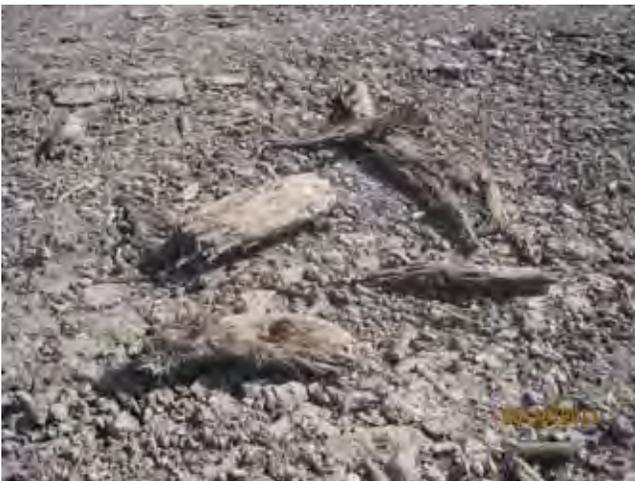
3. North/South levee (Sta.68+00 to Sta.112+00). Contractor was hauling in material to the protected side berm during site visit (approx. Sta.95+00). Material is much cleaner than previous material that had been hauled into job site but the area will still need to be picked. Pickers were at approx. Sta.105+00 during site visit. GPS Coord: N29 52' 34.73" W090 08' 17.09"

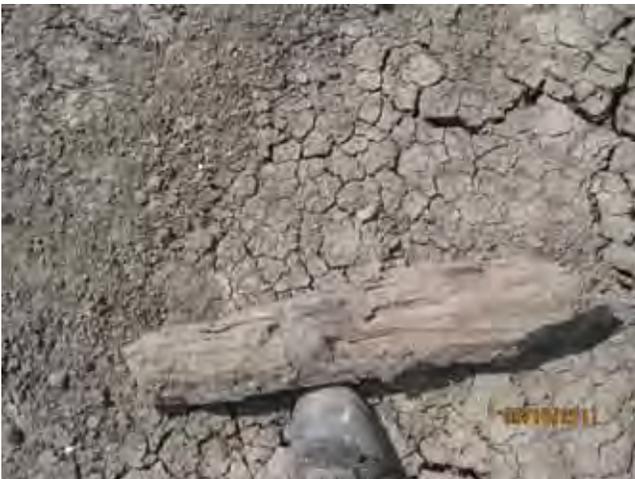
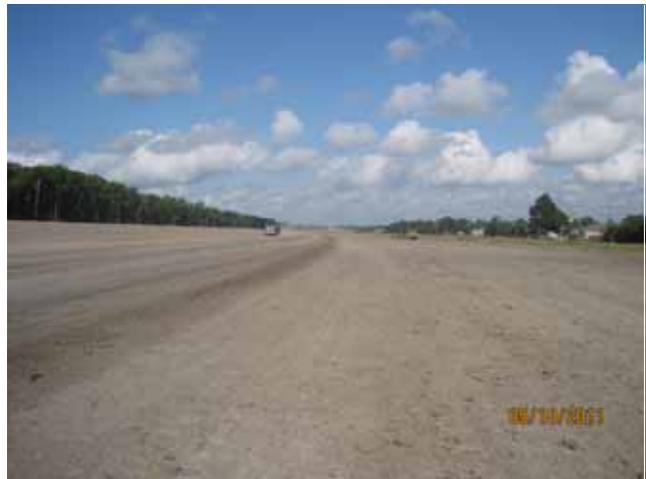
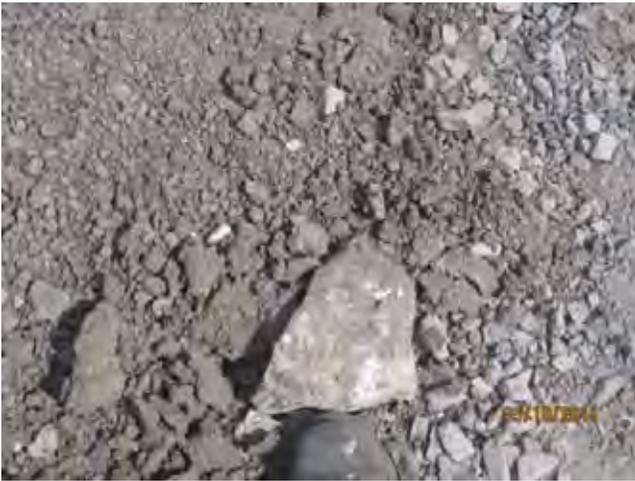
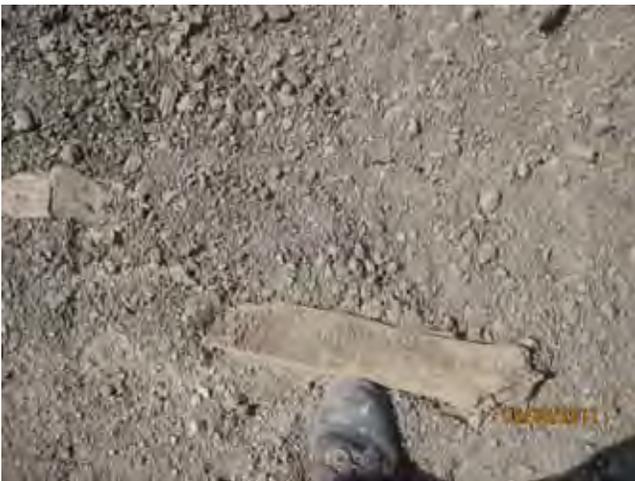
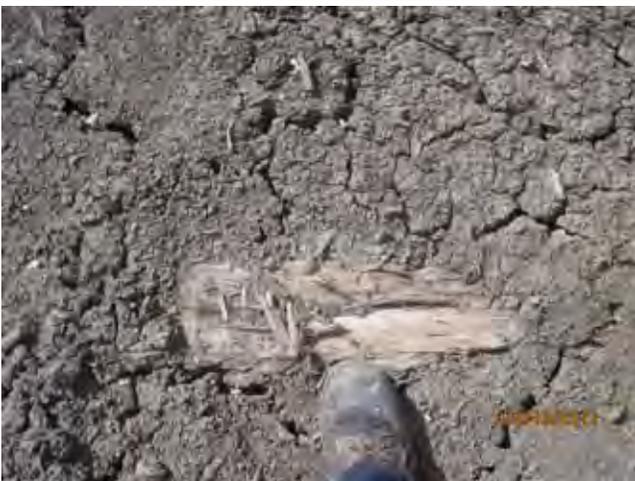
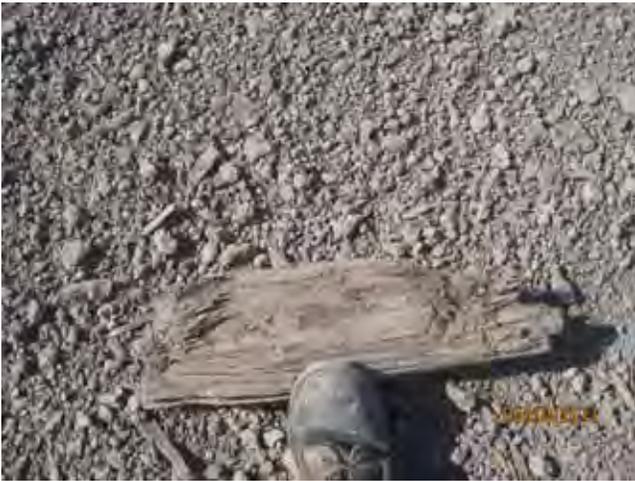
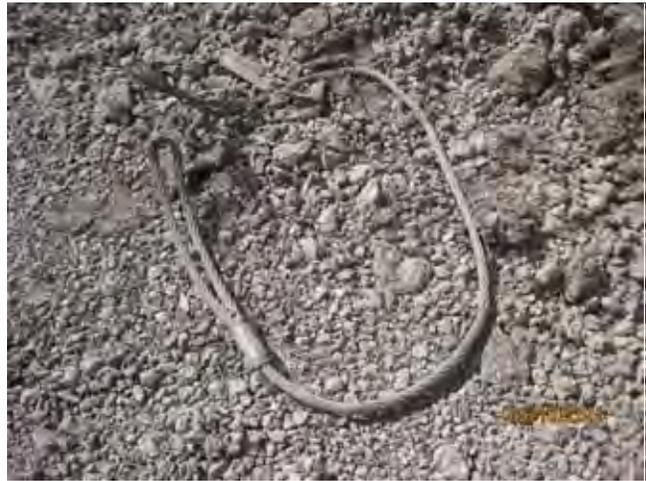
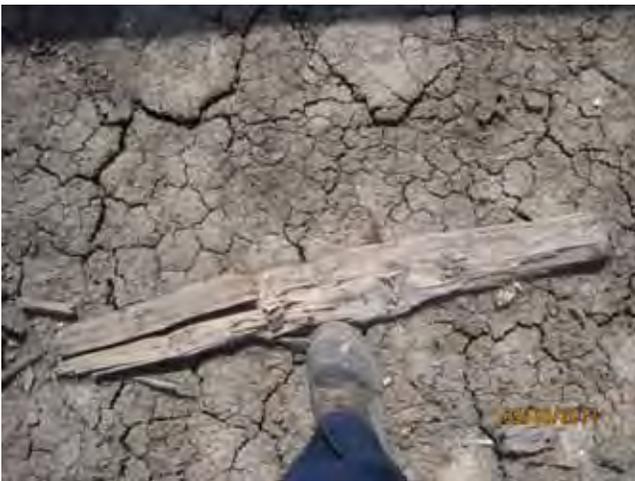
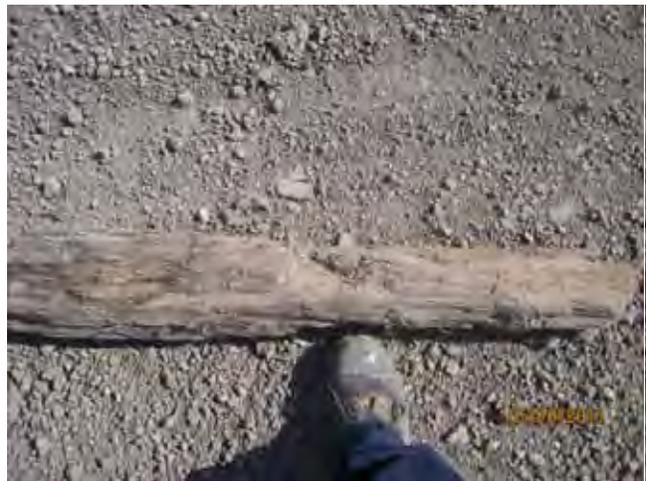
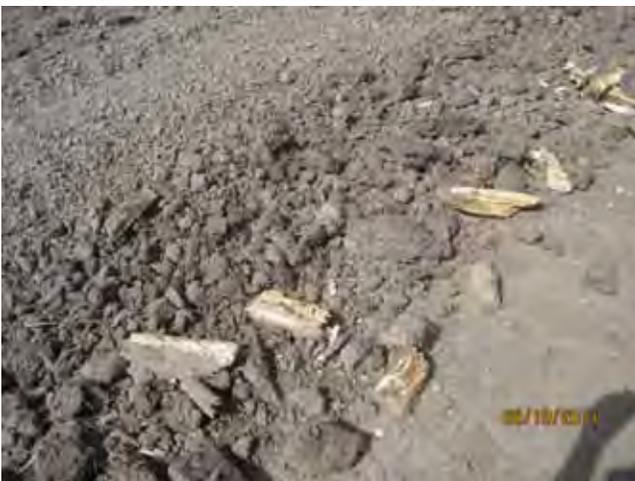
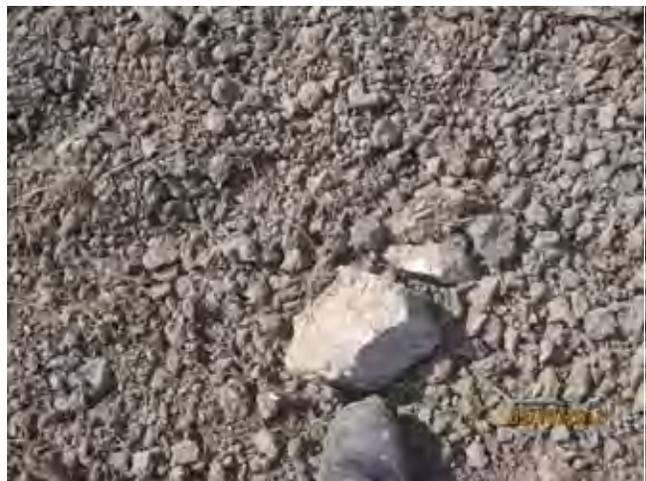
- East end of the job (Sta.119+00 to Sta.182+00). No active work was being performed on this end of the job, but some unsuitables were found on the protected side berm.

- 
4. East end of the job (Sta.119+00 to Sta.182+00). No active work was being performed on this end of the job, but some unsuitables were found on the protected side berm. GPS Coord: N29 52' 34.73" W090 08' 17.09"

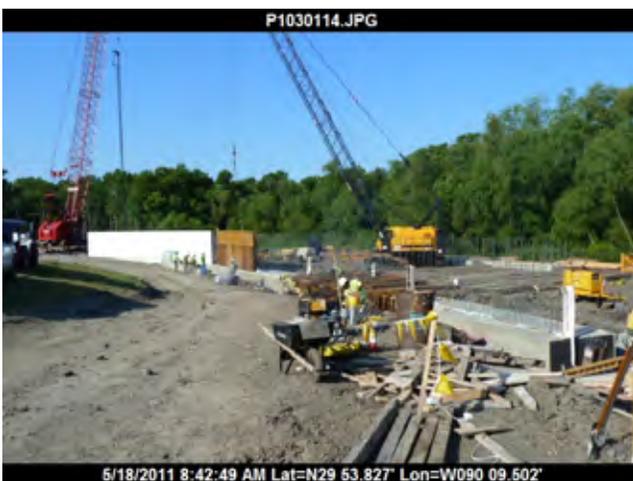
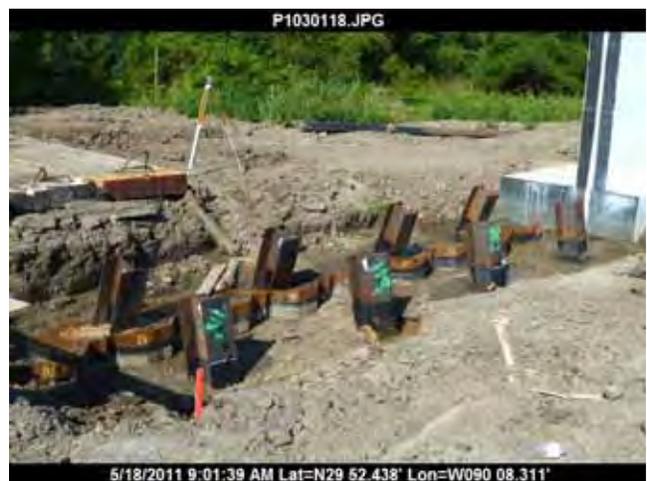
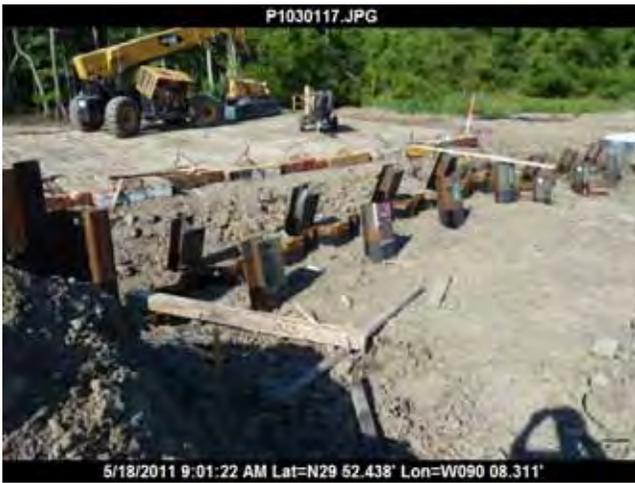
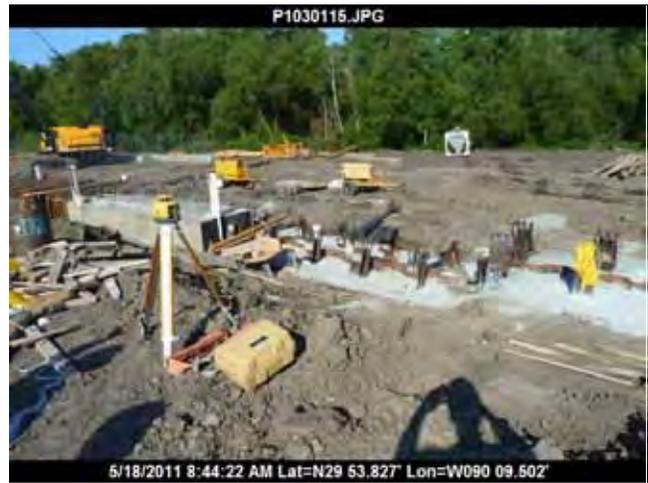
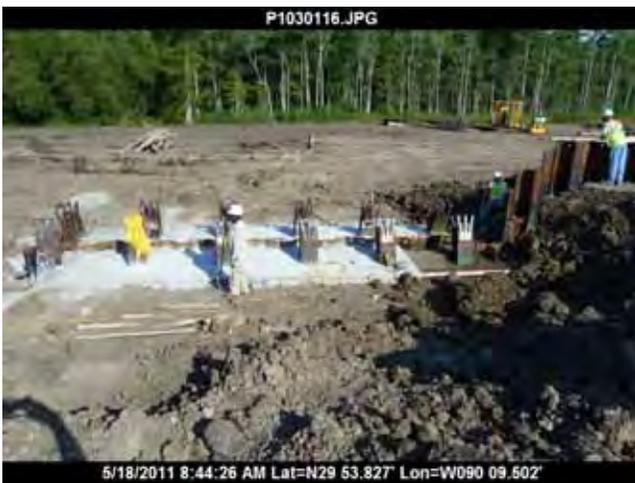
- Contractor placing concrete at base slab for monolith E today. GPS Coord: N29 53.827' W090 09.502'

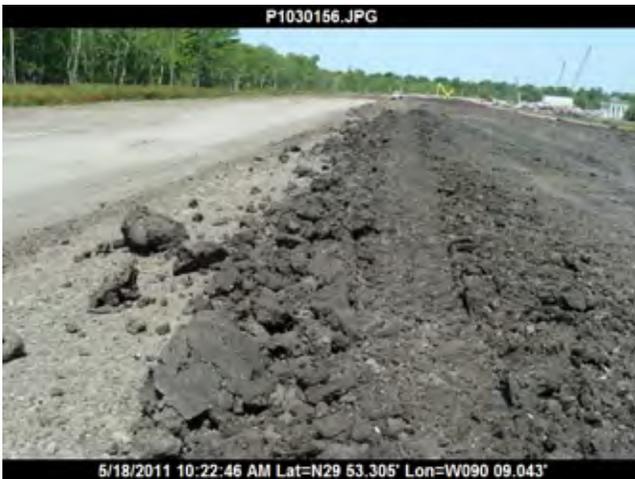
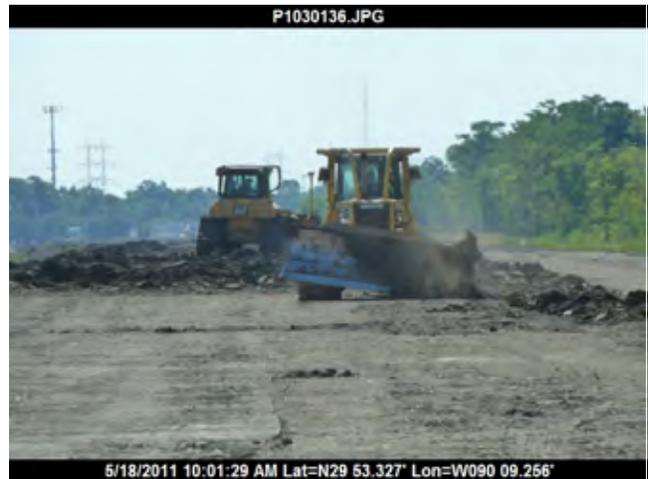
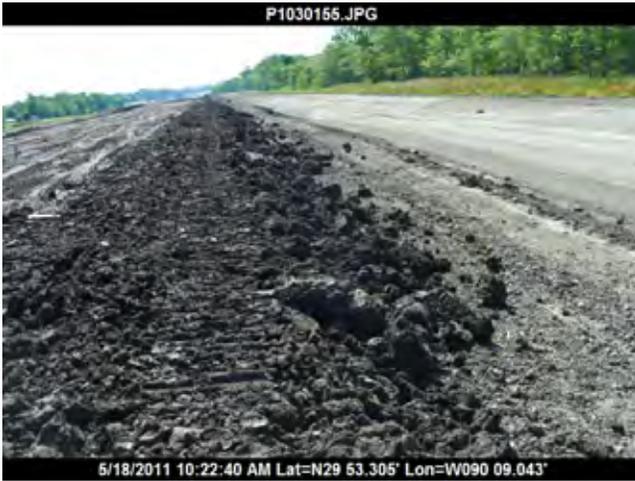
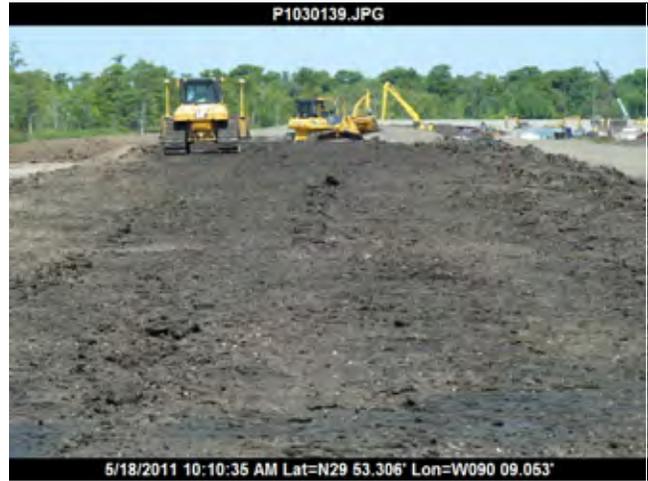
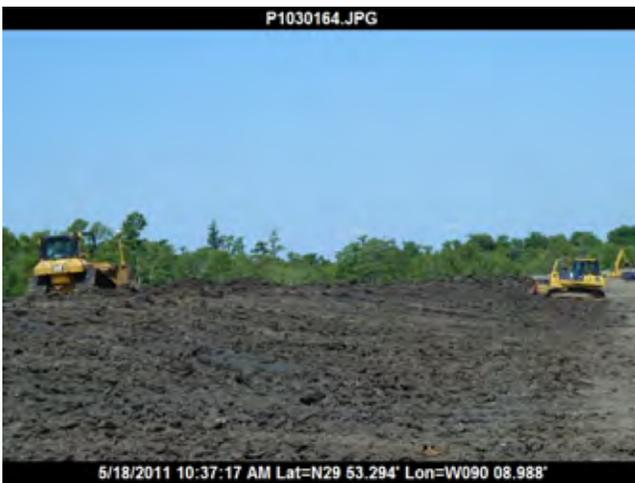
3. Levee, West end of project (Sta.0+44 to Sta.55+00):
- The new levee is up to elevation 10.0' in this area.
  - Degrading of the existing levee is in progress. GPS Coord: N29 53.306' W090 09.053'
