## NON CONCURRENCE STATEMENT

- Tiger Team members have diligently worked for many months to complete their mission of investigating, evaluating, then reporting their activities regarding construction of the WBV-14c.2 levee in Jefferson Parish, Louisiana
- In an effort to complete and otherwise finalize, then publish the report of its mission the Tiger Team members have been in almost continuous conference for several weeks
- Unfortunately, several serious differences in the opinion and findings of the members remain and now appear irreconcilable
- Following deep and honest discussion of these differences the Tiger Team has concluded our best course of action is to allow the report to be issued but, containing statements of non-concurrence in those chapters of the report remaining unresolved

## **Tiger Team Update for SLFPA-W Technical, Operations and Maintenance (TOM) Committee:**

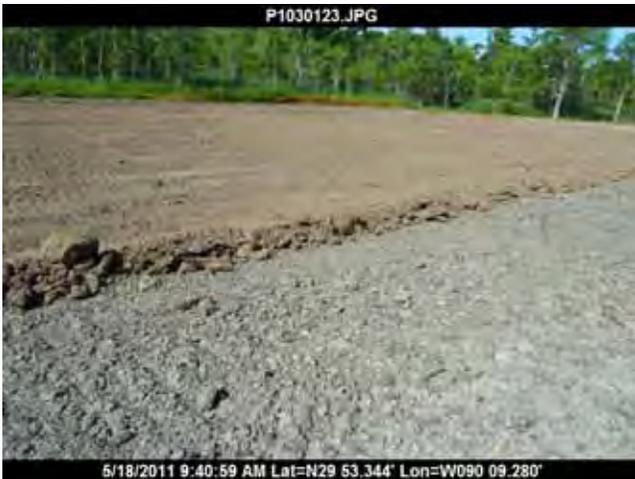
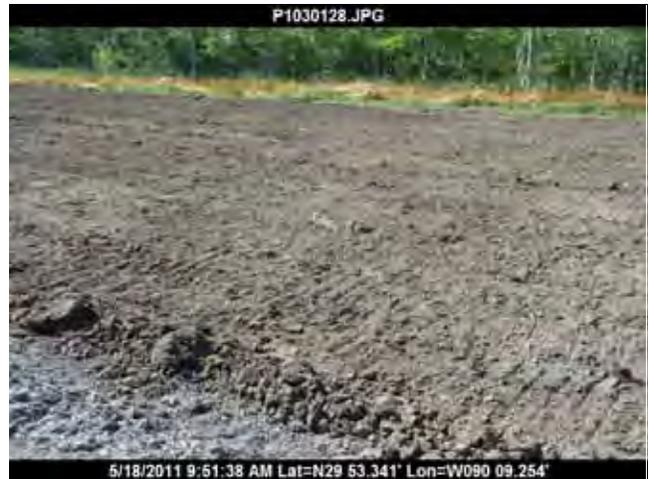
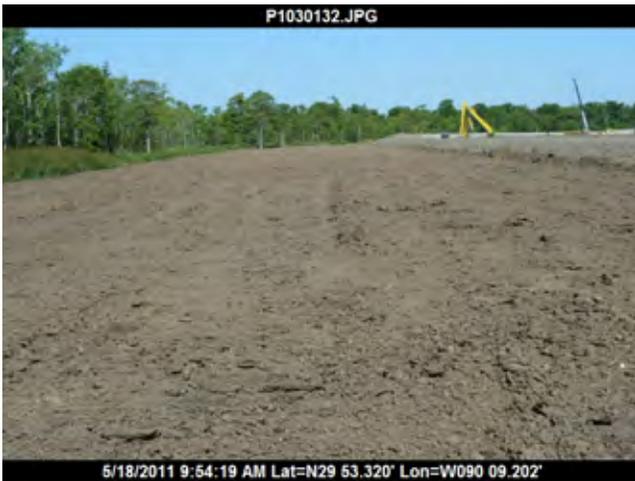
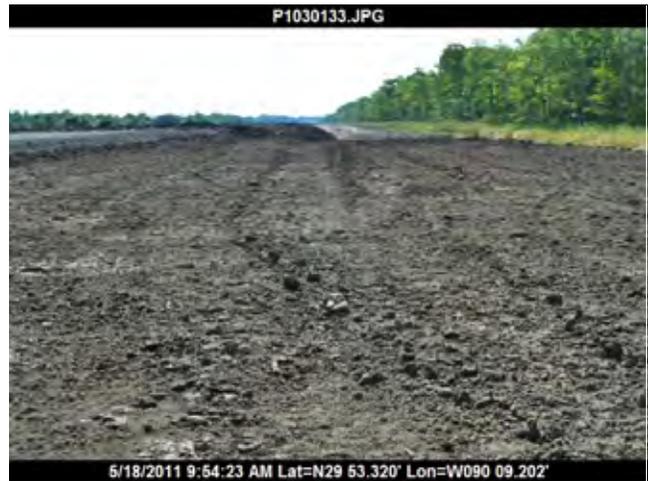
- 
4. West end of project (Sta.0+44 to Sta.55+00):  
Approximately a 1' lift has been placed on the flood side berm between approximate stations 0+44 and 10+00. GPS Coord: N29 53.320' W090 09.202'

Approximately a 1' lift has been placed on the flood side berm between approximate stations 0+44 and 10+00. Material appears not to have been disked, cleaned of debris or graded to final grade; contains debris. GPS Coord: Noted on photos

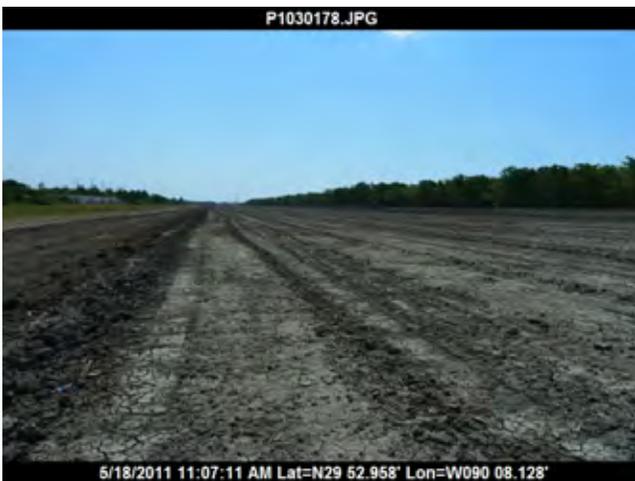
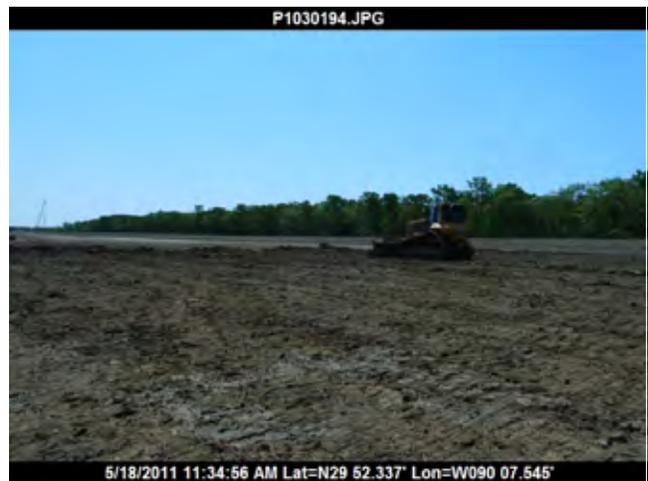
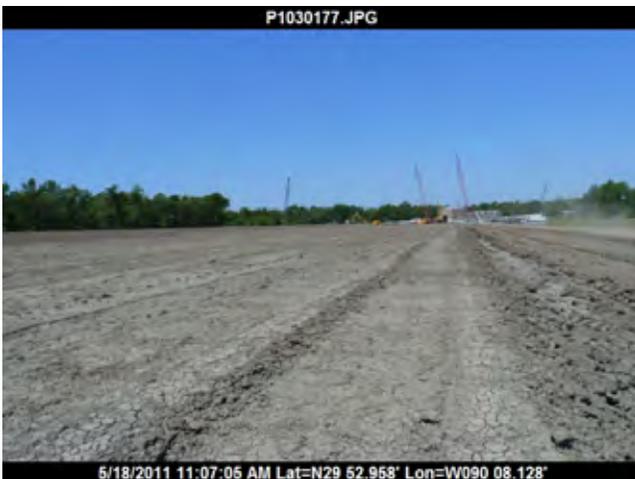
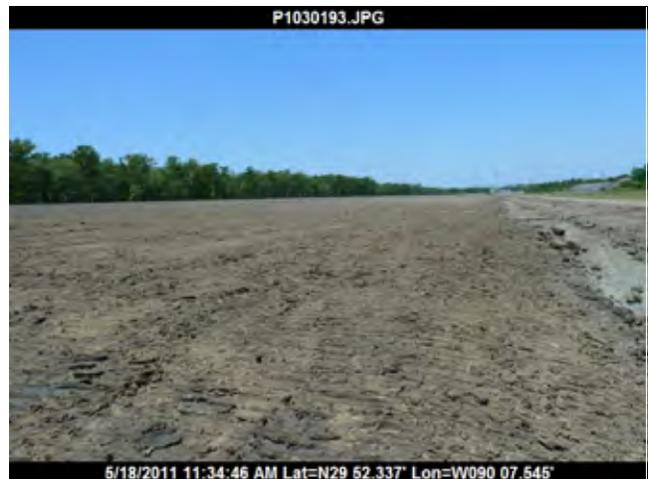
5. - East end of the project (Sta.119+00 to Sta.182+00):  
 Contractor placing material along the protected side berm. GPS Coord: Noted on photos

Contractor placing material along the protected side berm. SLFPA-W reviewed several areas and noted that the debris found was large in size but not as abundant as previous material. USACE inspector stated that debris will be removed during diking operation before final grading. GPS Coord: Noted on photos

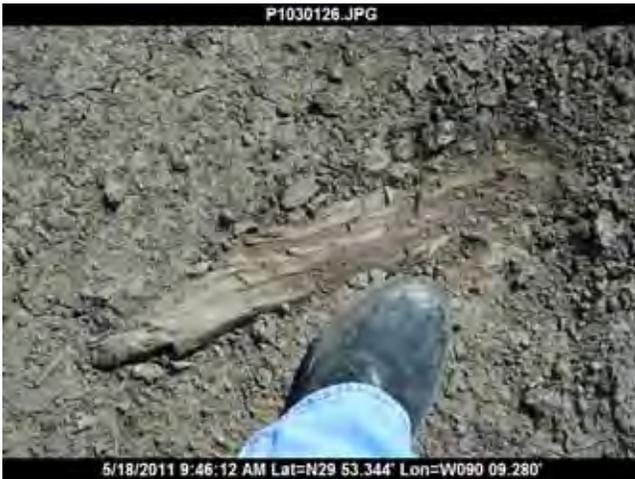
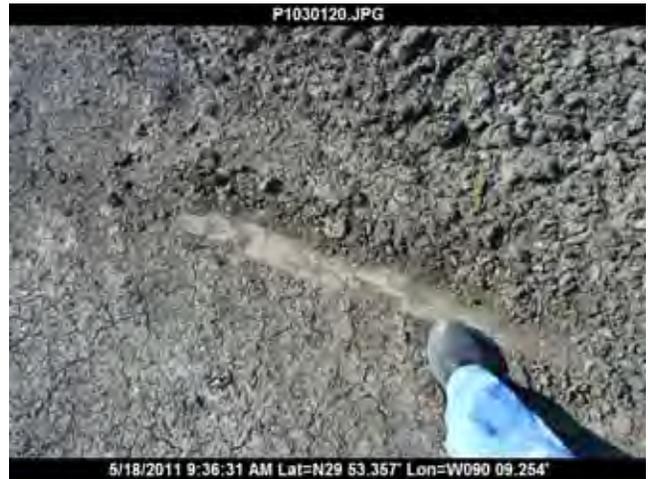
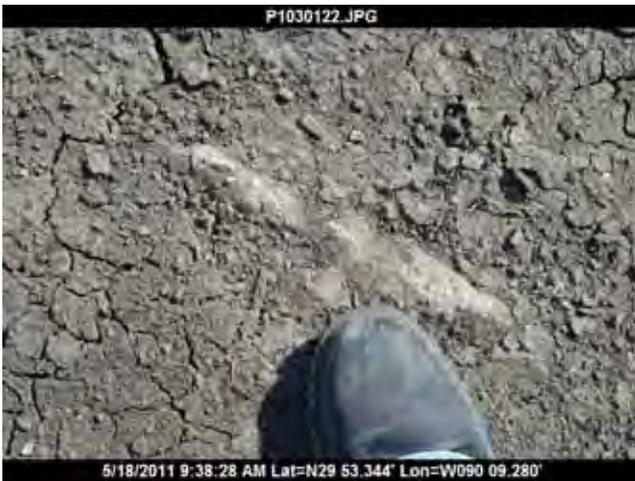
6. Issue:  
 West end of project (Sta.0+44 to Sta.55+00):  
 SLFPA-W reviewed top of new levee ahead of placement operation and noted some debris. GPS Coord: Noted on photos

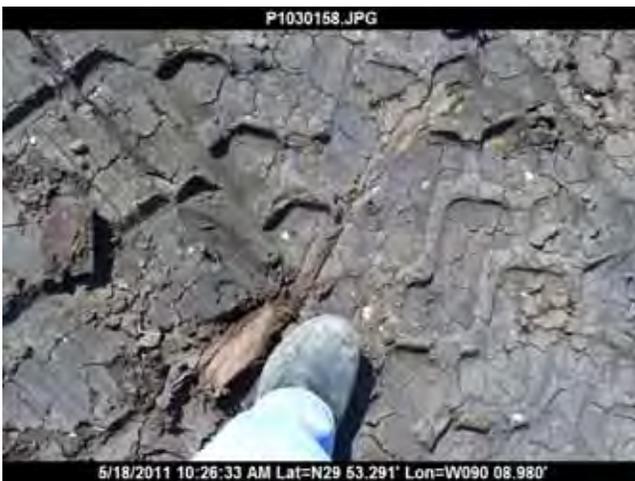
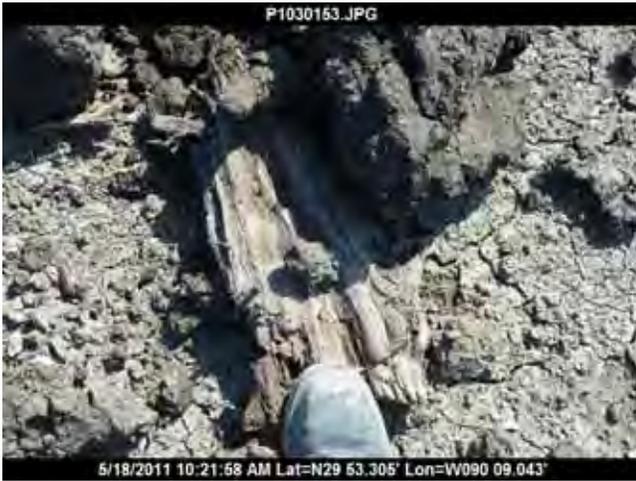
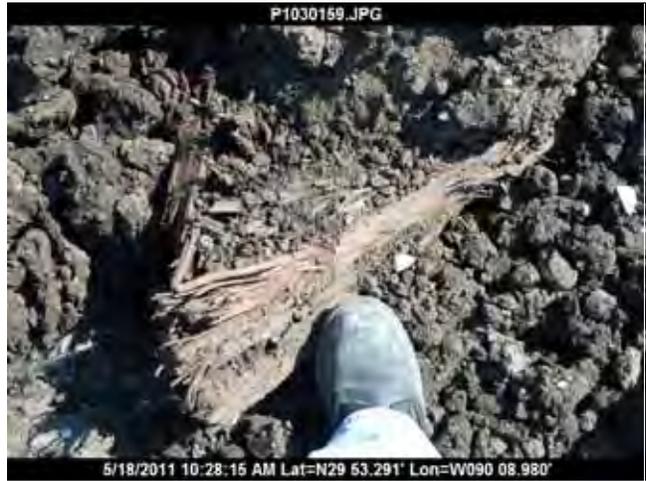
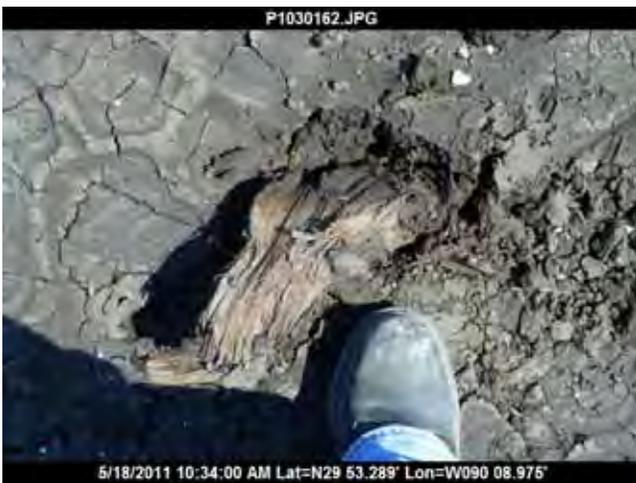
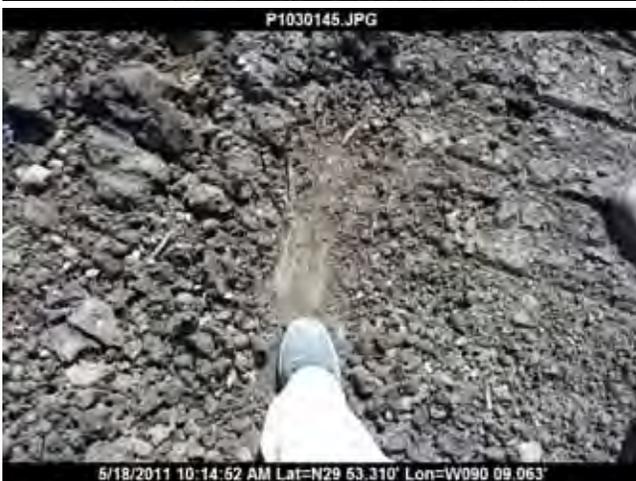
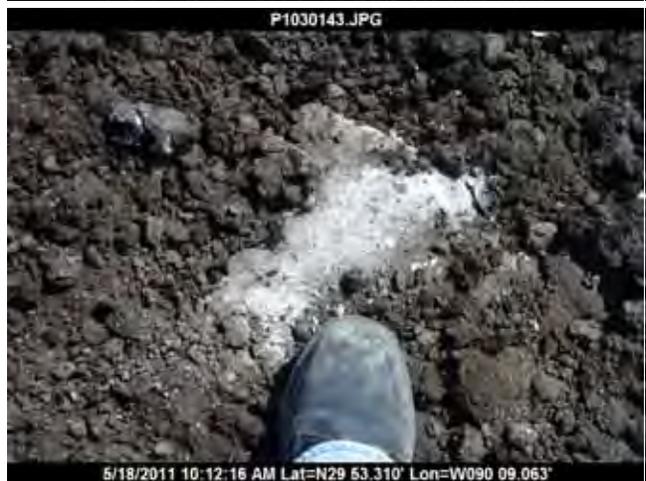
West end of project (Sta.0+44 to Sta.55+00):

Material from degraded levee contains concrete, bricks and wood debris. Material is to be disked and debris removed before next lift (see previous issue). GPS Coord:

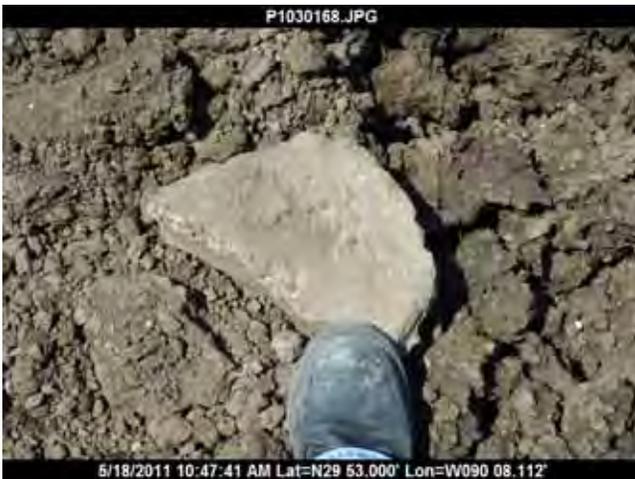
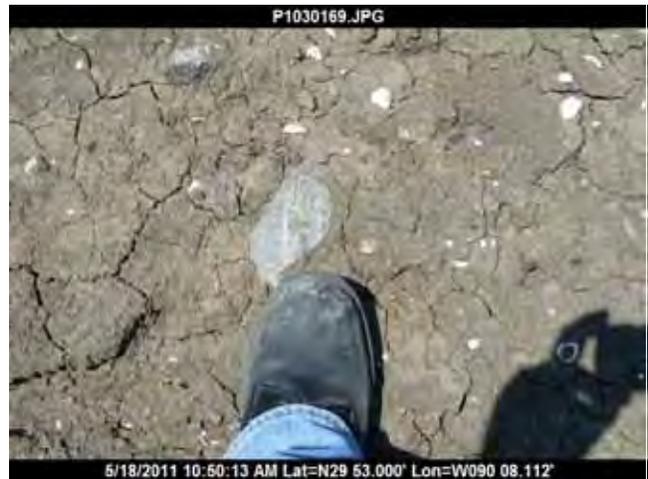
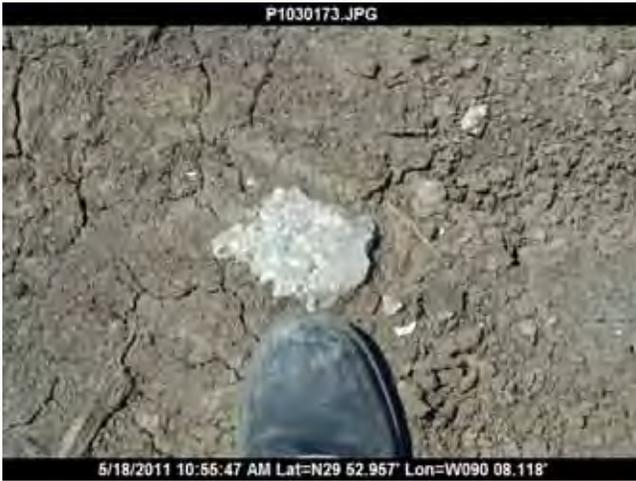
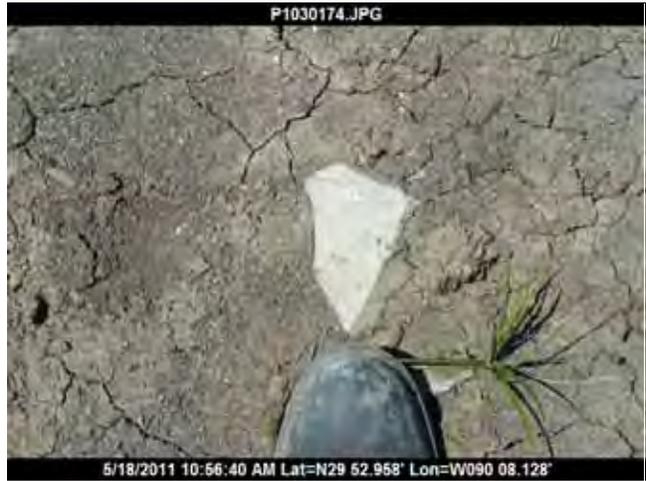
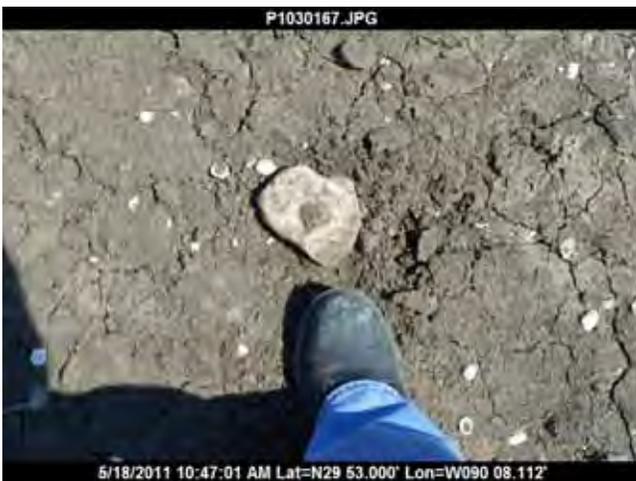
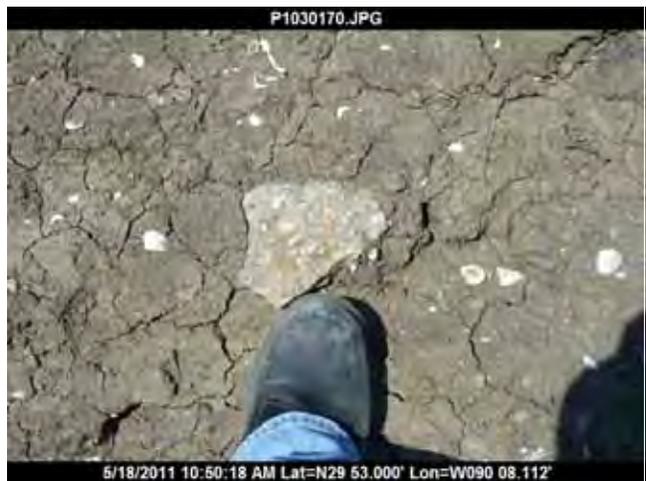
North/South levee (Sta.68+00 to Sta.112+00):

SLFPA-W noted concrete debris in crown and slope (protected side) of levee. GPS

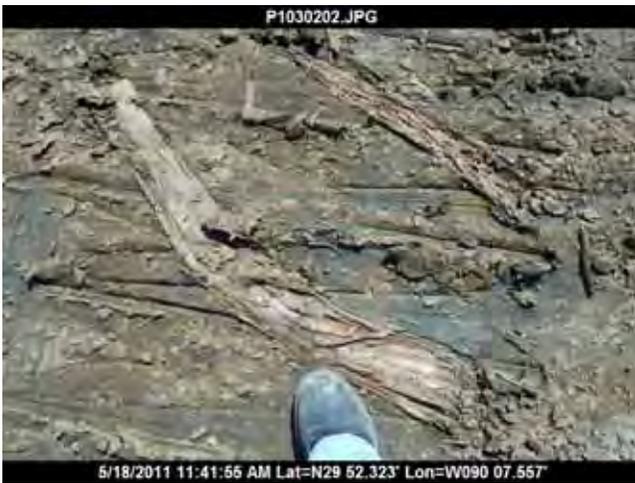
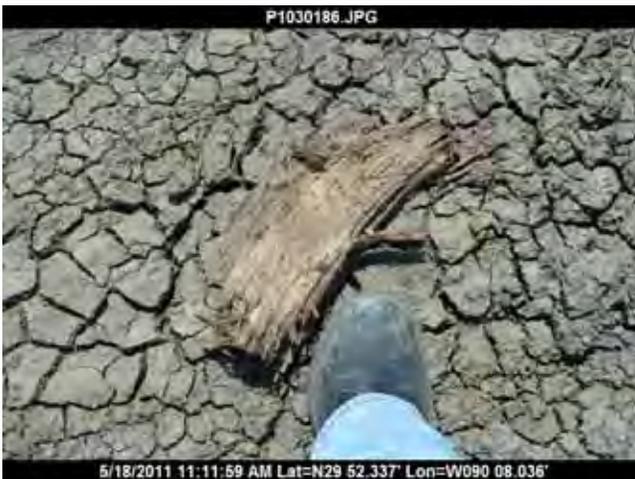
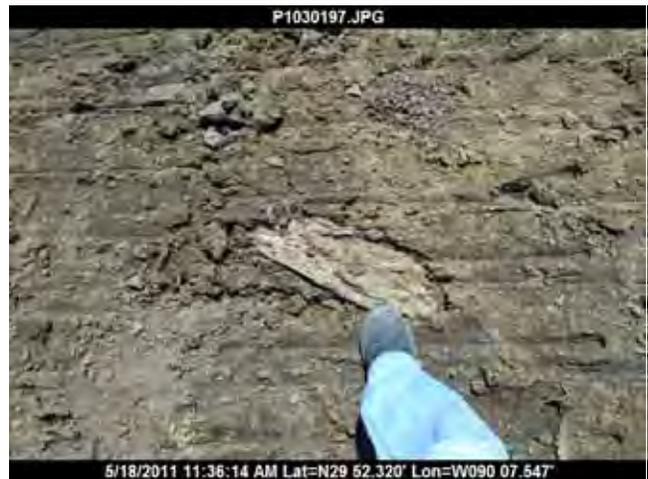
East end of the project (Sta.119+00 to Sta.182+00):

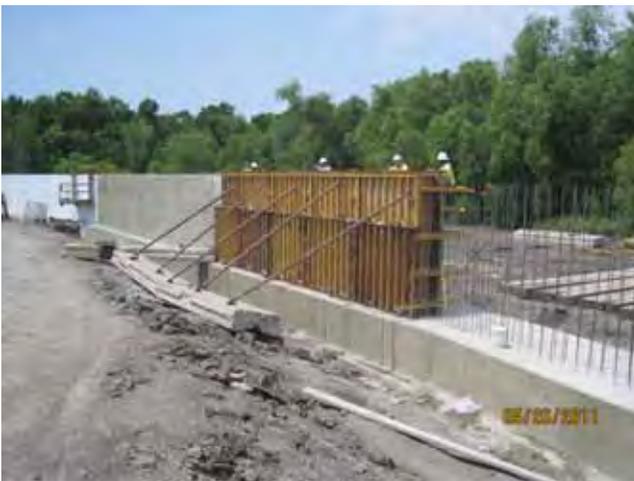
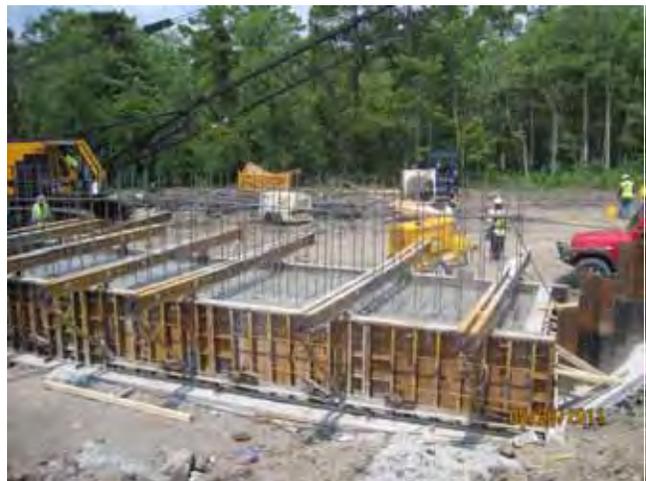
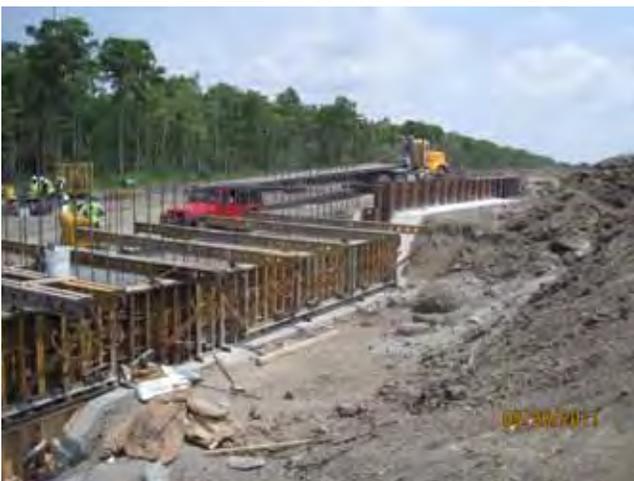
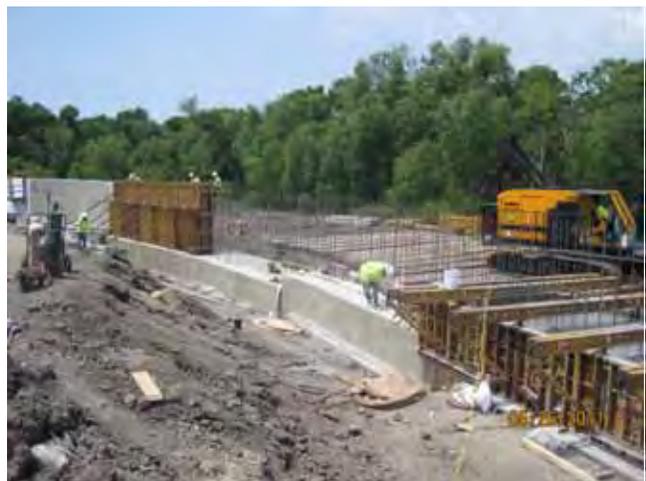
## 2. Floodwalls:

-Contractor has completed driving of all H-pile and cut off sheet pile. Concrete has been placed for base slabs F and G. Base slab H was being placed during site visit.  
GPS Coord: N29 53.827' W090 09.502'

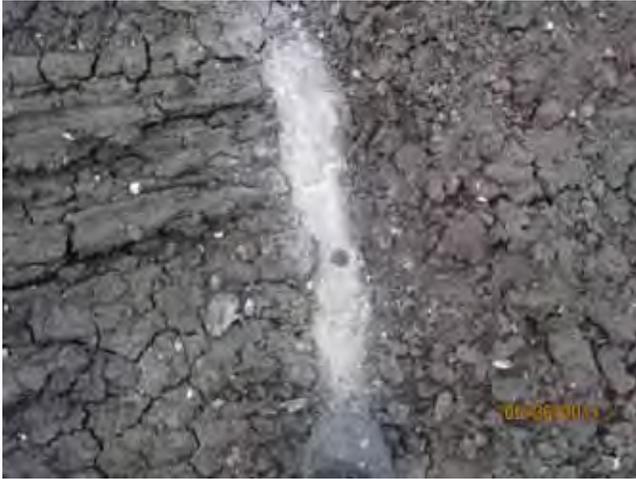
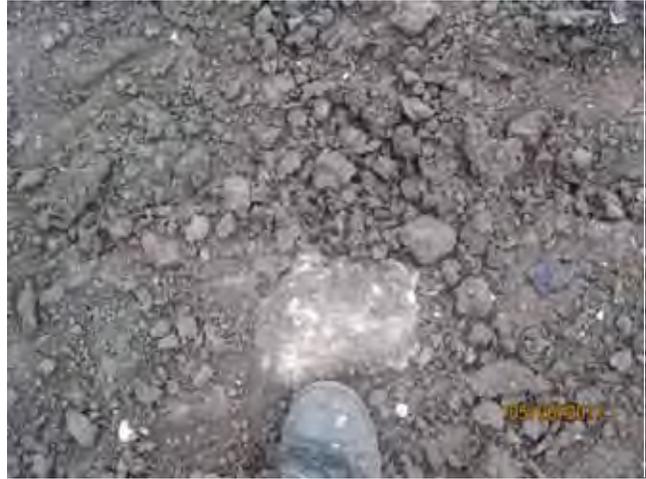
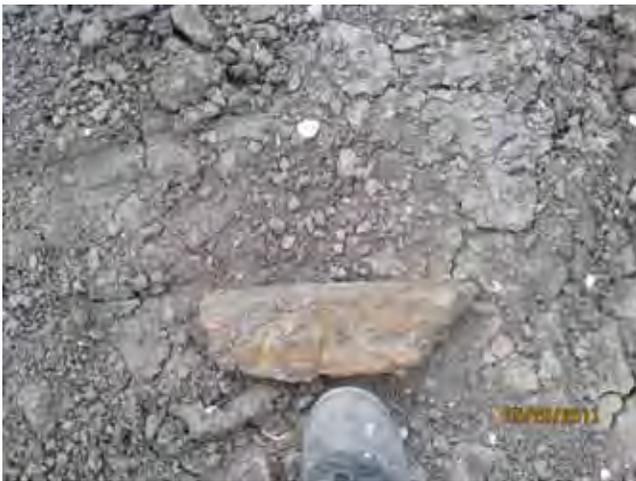
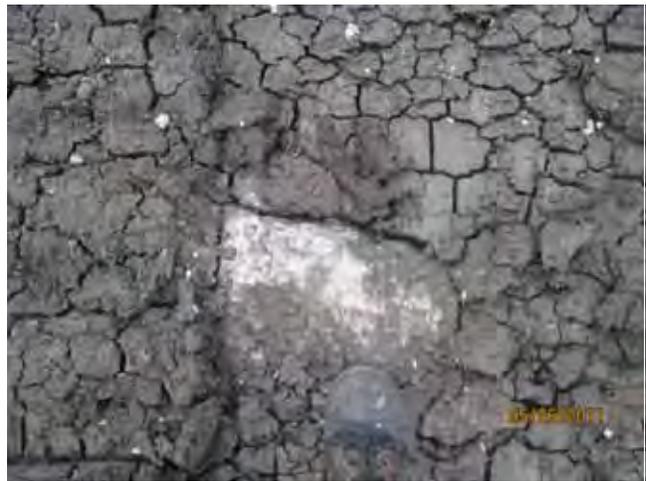
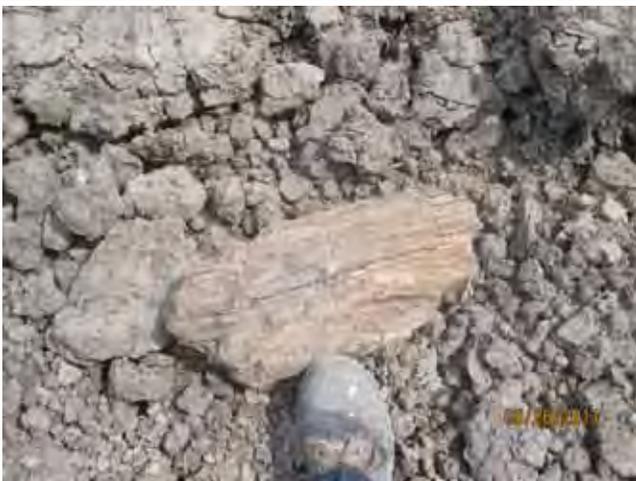
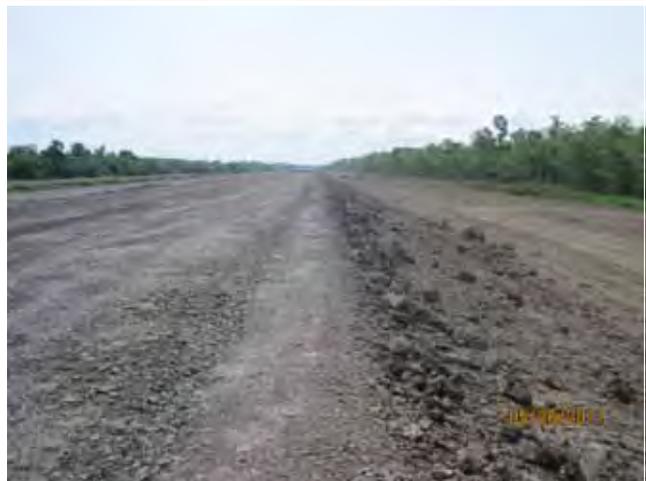
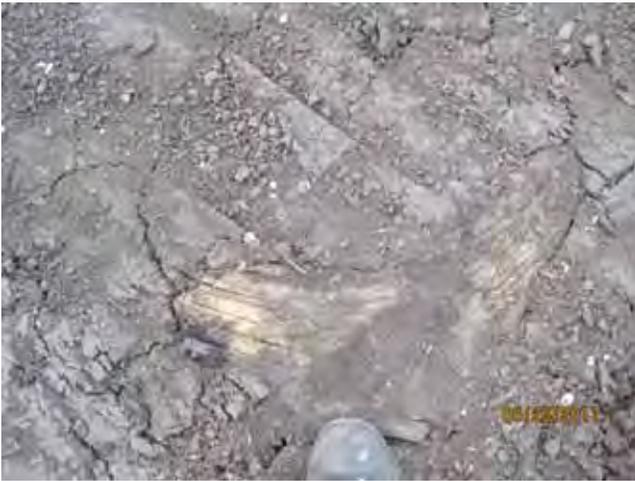
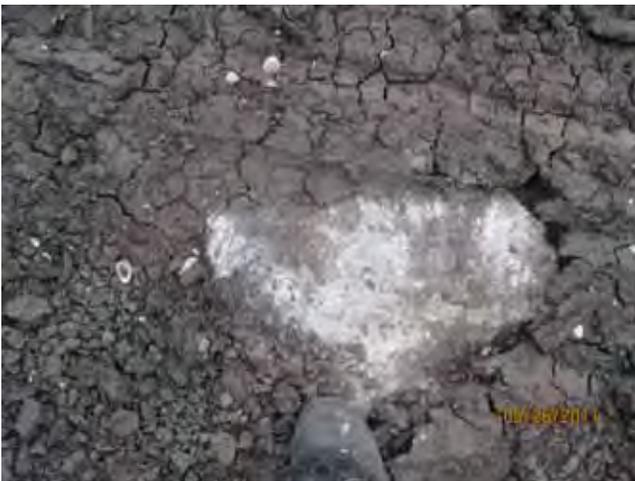
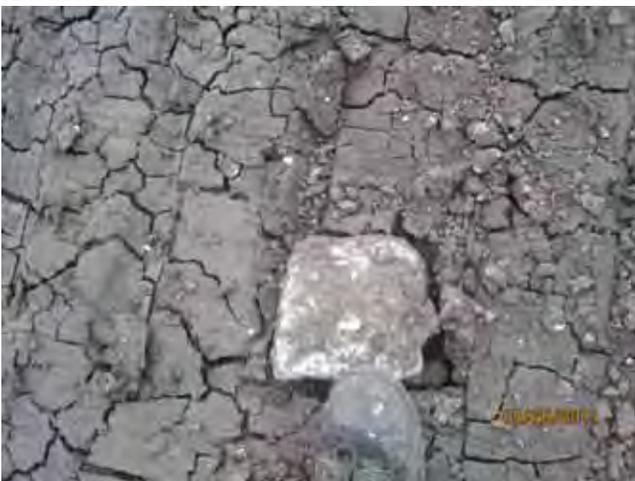
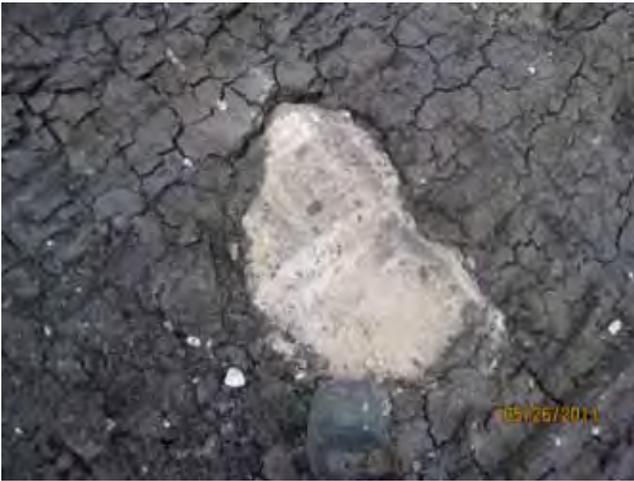
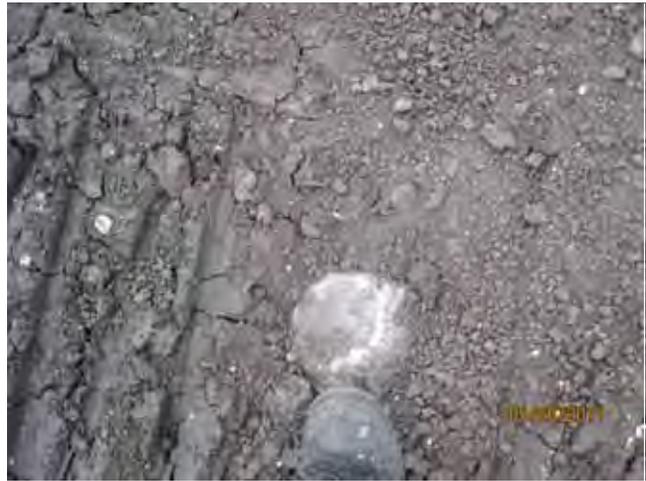
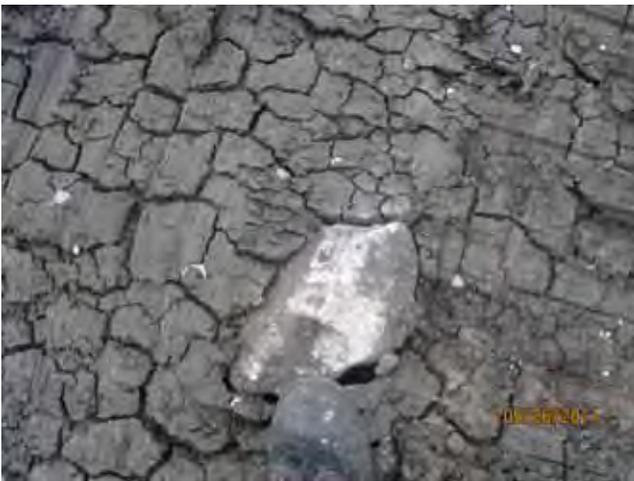
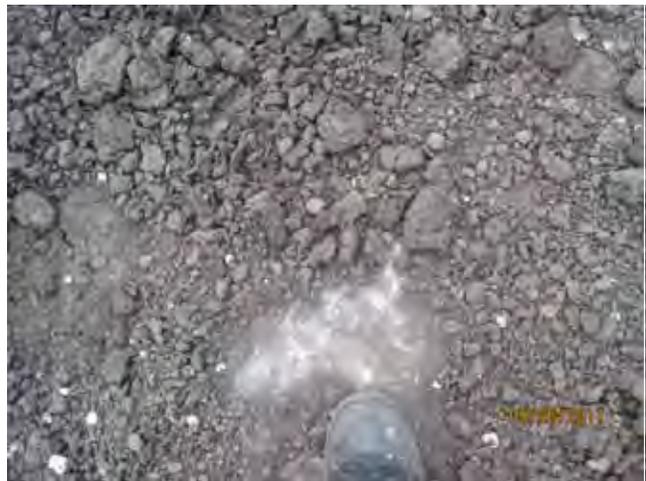
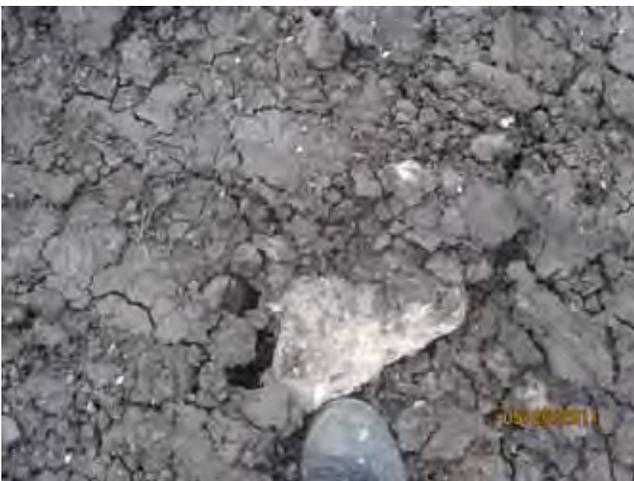
3. West end of project (Sta.0+44 to Sta.55+00):

The new levee is up to elevation 11.0' in this area and the degrading of the existing levee is complete. Material from degraded levee contains concrete, bricks, and wood debris. Material needs to be disked and picked before another lift is placed in this area. GPS Coord: N29 53.306' W090 09.053'

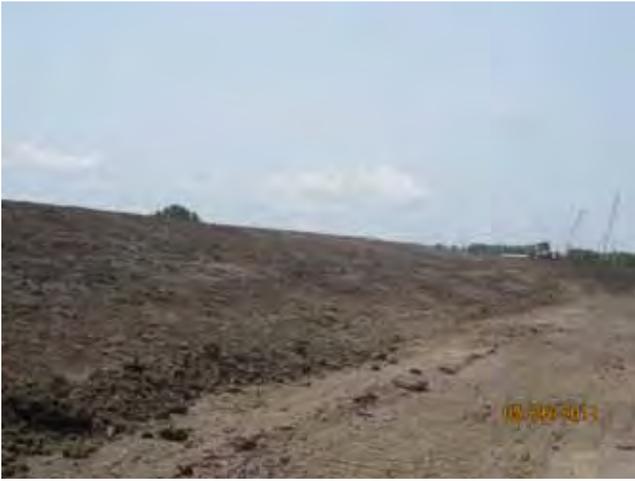
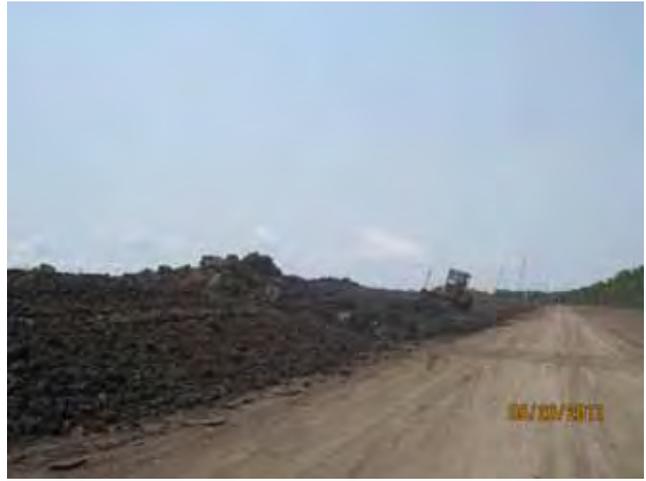
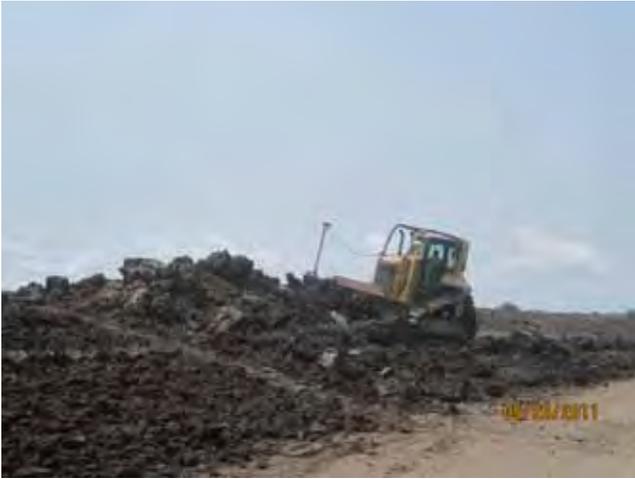
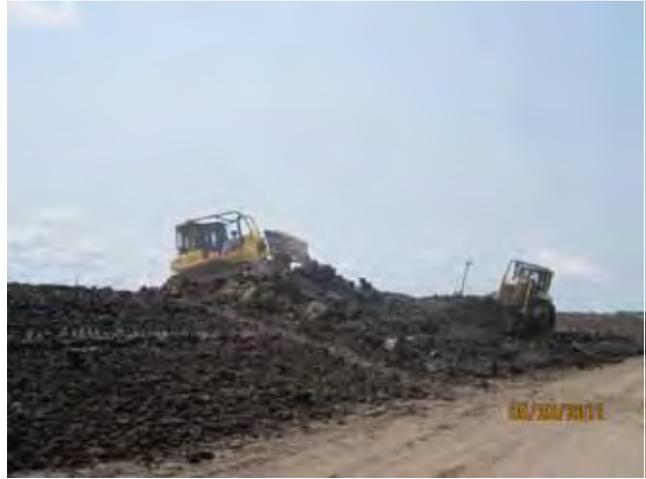
- 
4. North/South levee (Sta.68+00 to Sta.112+00):  
Final 6" lift is being installed in this area. Pickers have picked the entire north/south levee this week. Contractor plans to seed this levee within the next few weeks. SLFPAW will be notified before the seeding of this levee for a final inspection. GPS Coord: N29 53.320' W090 09.202'

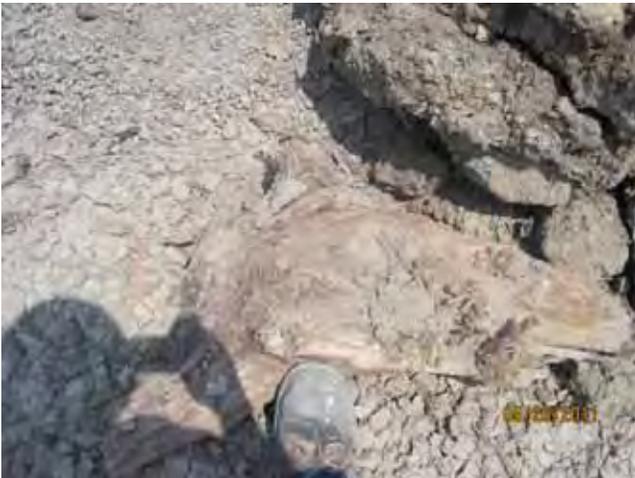
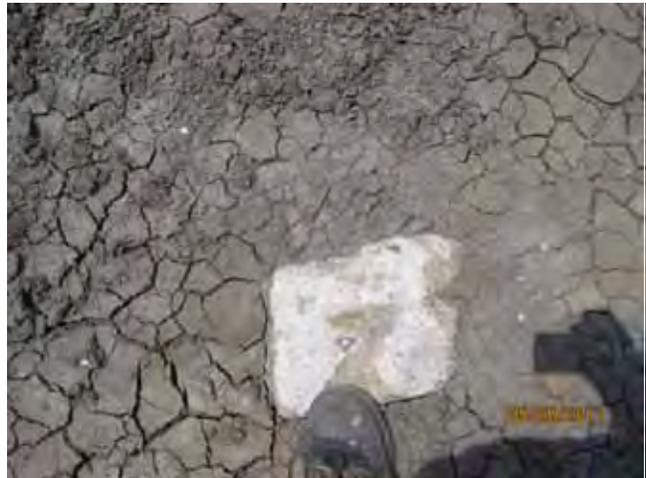
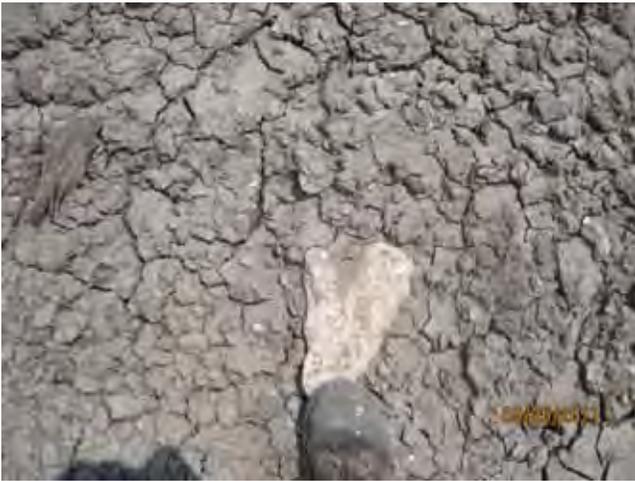
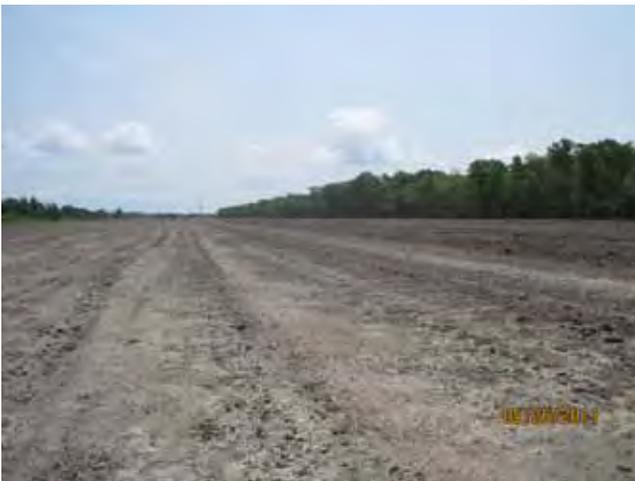
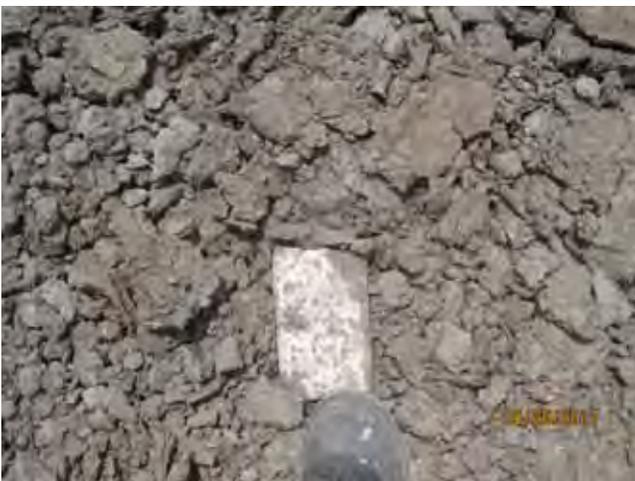
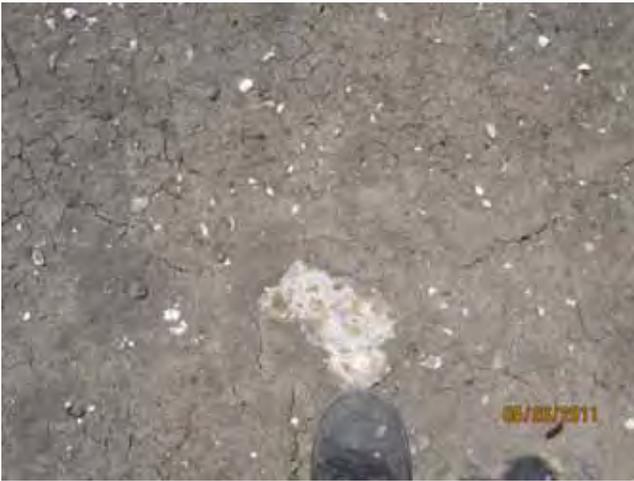
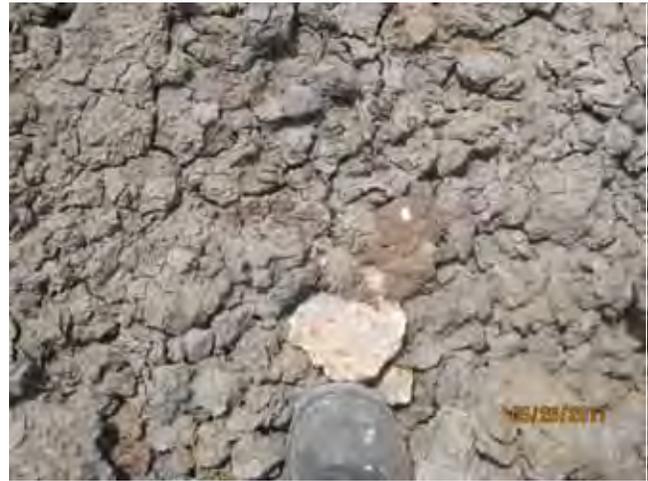
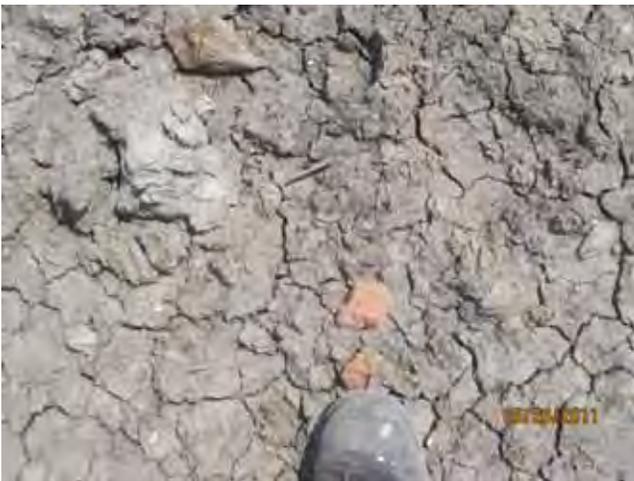
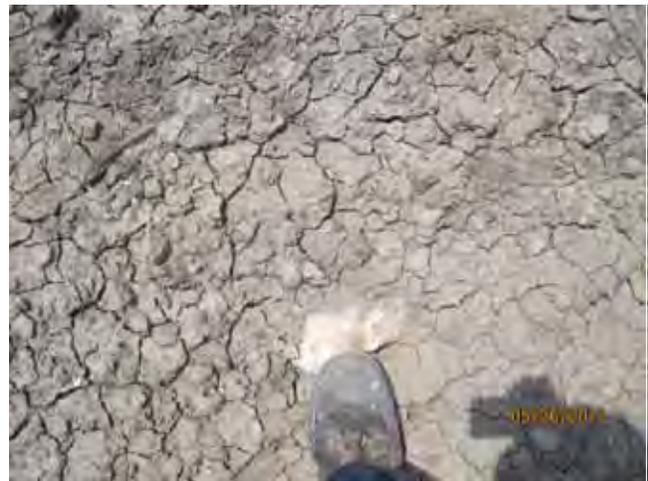
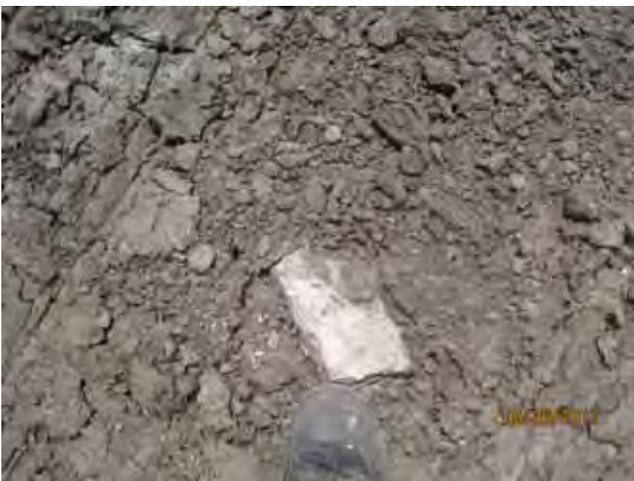
- 
5. East end of the project (Sta.119+00 to Sta.182+00):  
Contractor is placing material along the protected side berm at approx Sta.170+00.  
Throughout the levee and berm of this area concrete and wood debris was found.  
GPS Coord: N29 53.320' W090 09.202'

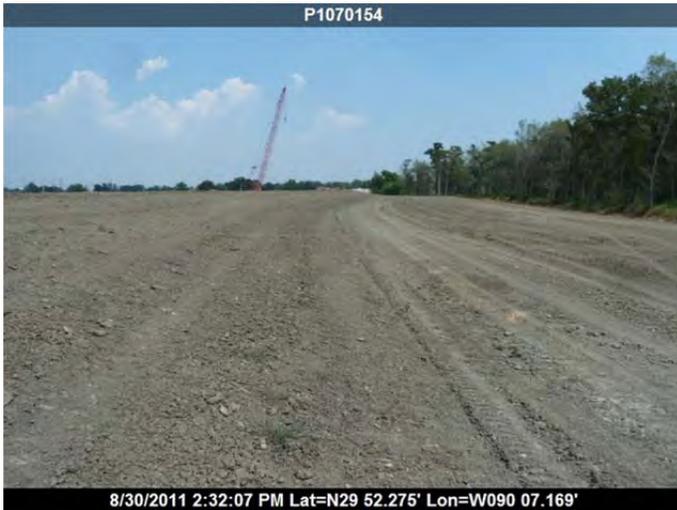
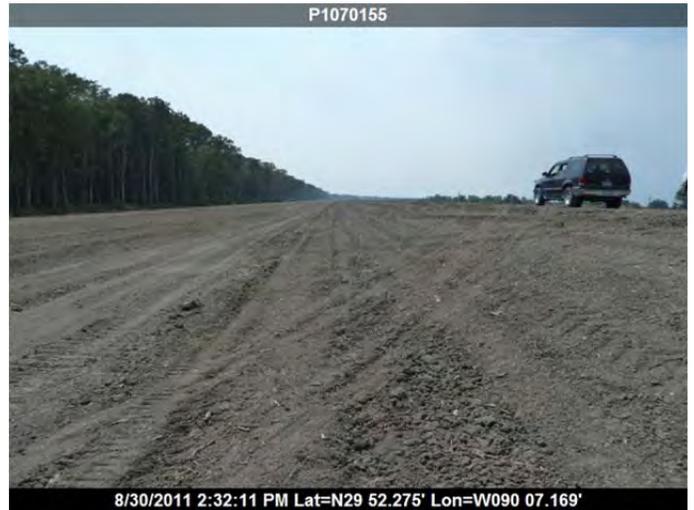
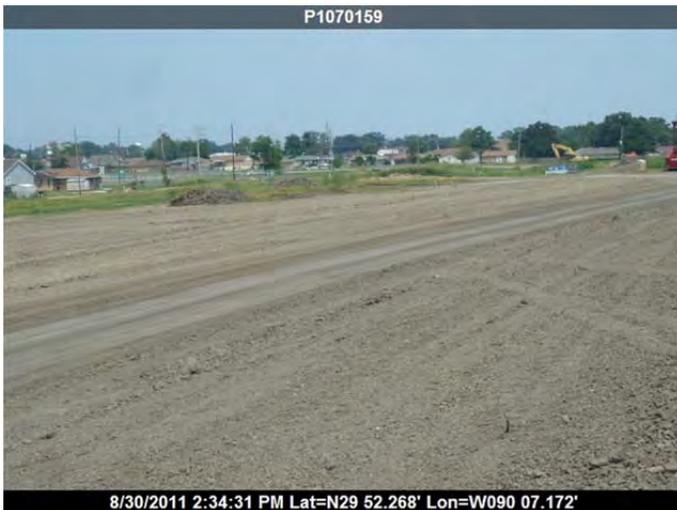
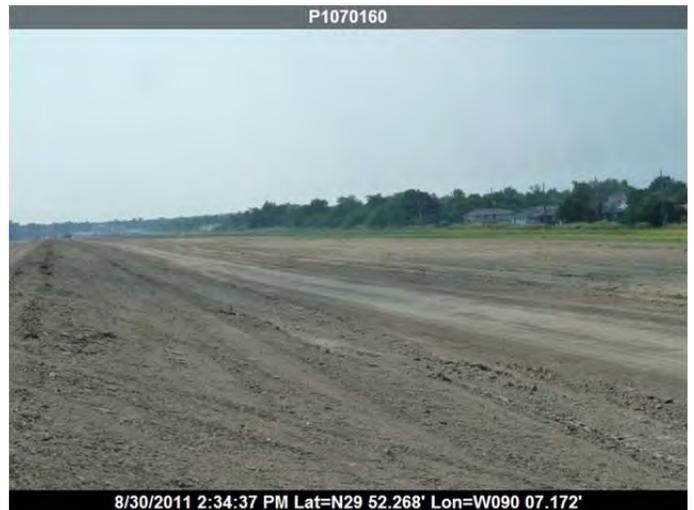
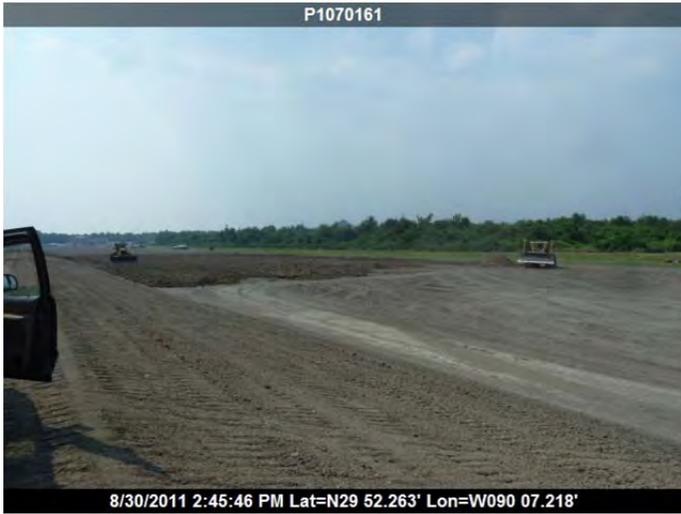
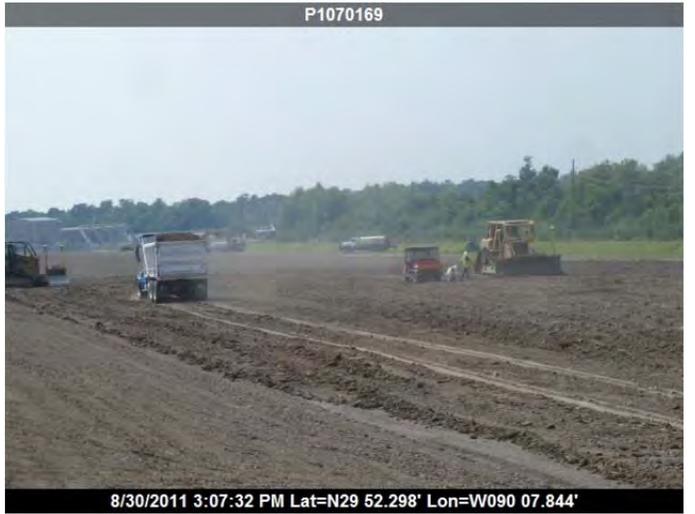
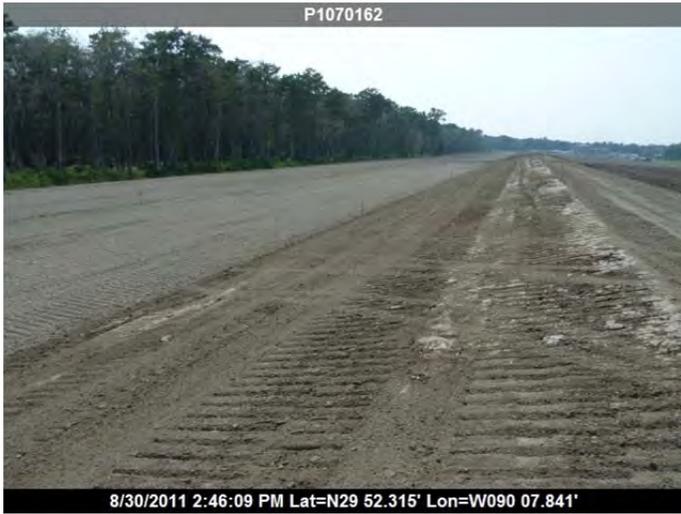
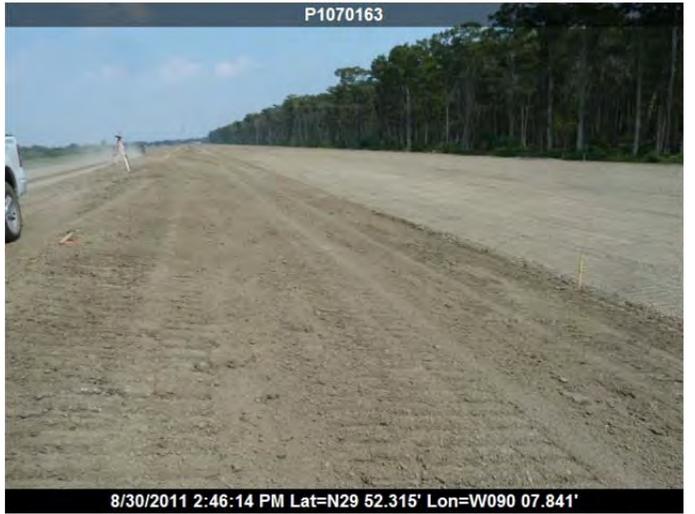
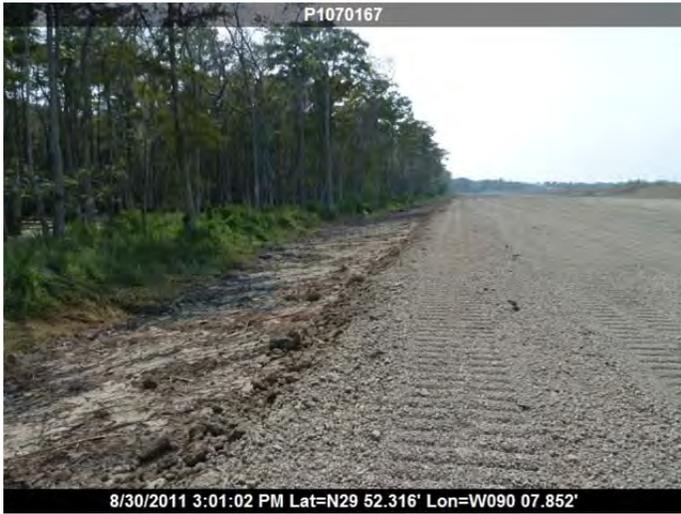
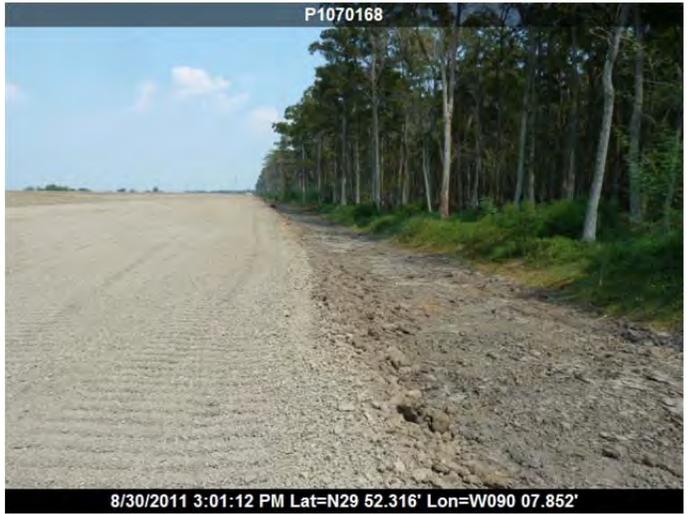
The protected side berm is constructed to grade less final grading in some areas.

Contractor is placing fill along the protected side berm at approximate station 138+00, this material will be pushed into the levee and the flood side berm for final grading.
