## NON CONCURRENCE STATEMENT

- Tiger Team members have diligently worked for many months to complete their mission of investigating, evaluating, then reporting their activities regarding construction of the WBV-14c.2 levee in Jefferson Parish, Louisiana
- In an effort to complete and otherwise finalize, then publish the report of its mission the Tiger Team members have been in almost continuous conference for several weeks
- Unfortunately, several serious differences in the opinion and findings of the members remain and now appear irreconcilable
- Following deep and honest discussion of these differences the Tiger Team has concluded our best course of action is to allow the report to be issued but, containing statements of non-concurrence in those chapters of the report remaining unresolved

## **Tiger Team Update for SLFPA-W Technical, Operations and Maintenance (TOM) Committee:**

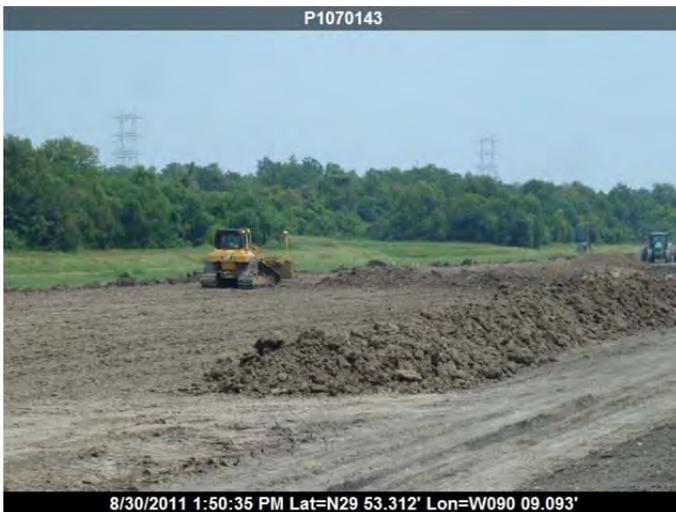
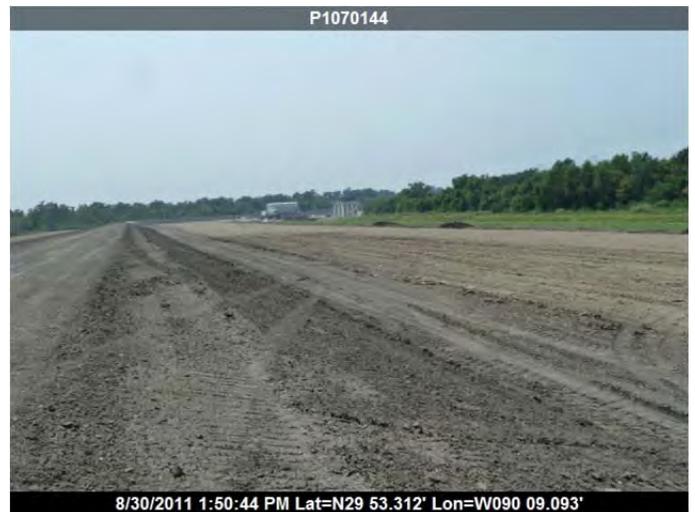
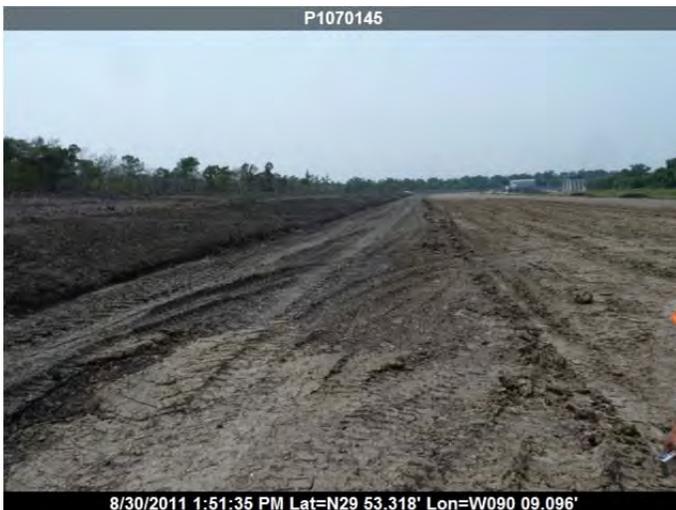
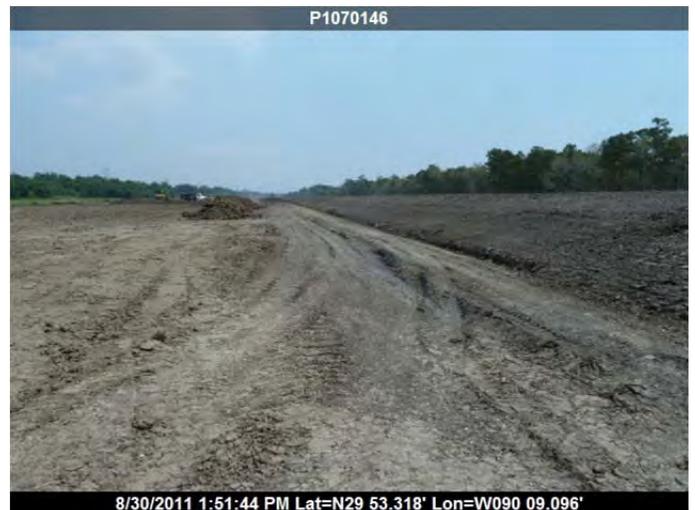
4. West end of project (Sta.55+00 to Sta.0+00):  
4<sup>th</sup> lift of material is being placed along the protected side berm at approximate station 17+00. Material is very clean and no debris was noted.  
Contractor is degrading and hauling off of the existing levee (protected side) at approximate station 30+00. The existing levee will be degraded to elevation 5.5'. Some of this material has been pushed to the flood side which the contractor has begun to pile up to remove.

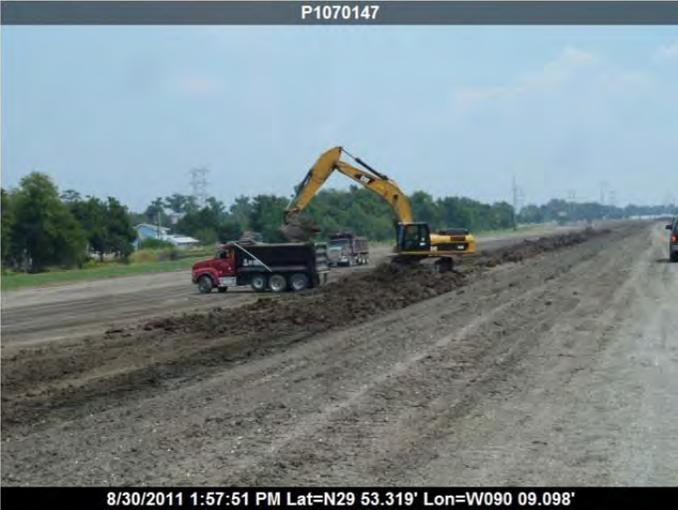
P1070147

5. Issue: Debris

SLFPA-W noted the USACE QAR and CPRA flagging debris during site visit. Debris was noted along the west end levee section (crown).

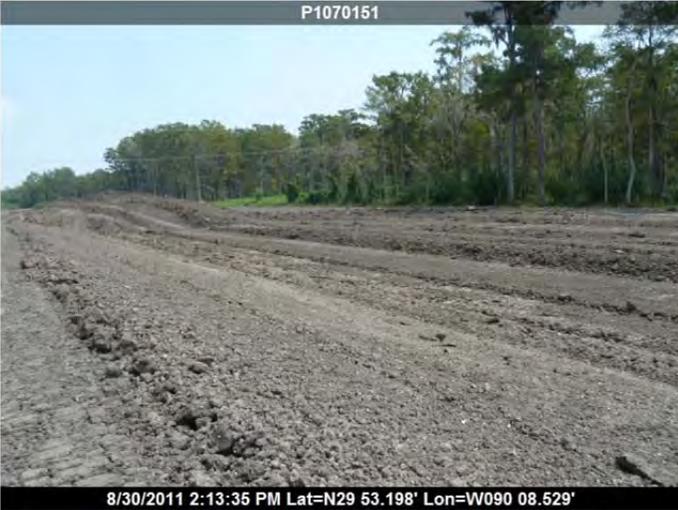
P1070151

Debris noted along the east end levee section was a lot of small pieces of wood in the approximate last 1,000 ft.
