New Orleans District

Fiscal Year 2013 Maintenance Dredging Locations

MVN Beneficial Use of Dredged Material

NEW ORLEANS DISTRICT
Beneficial Use of Dredged material
1976-2013

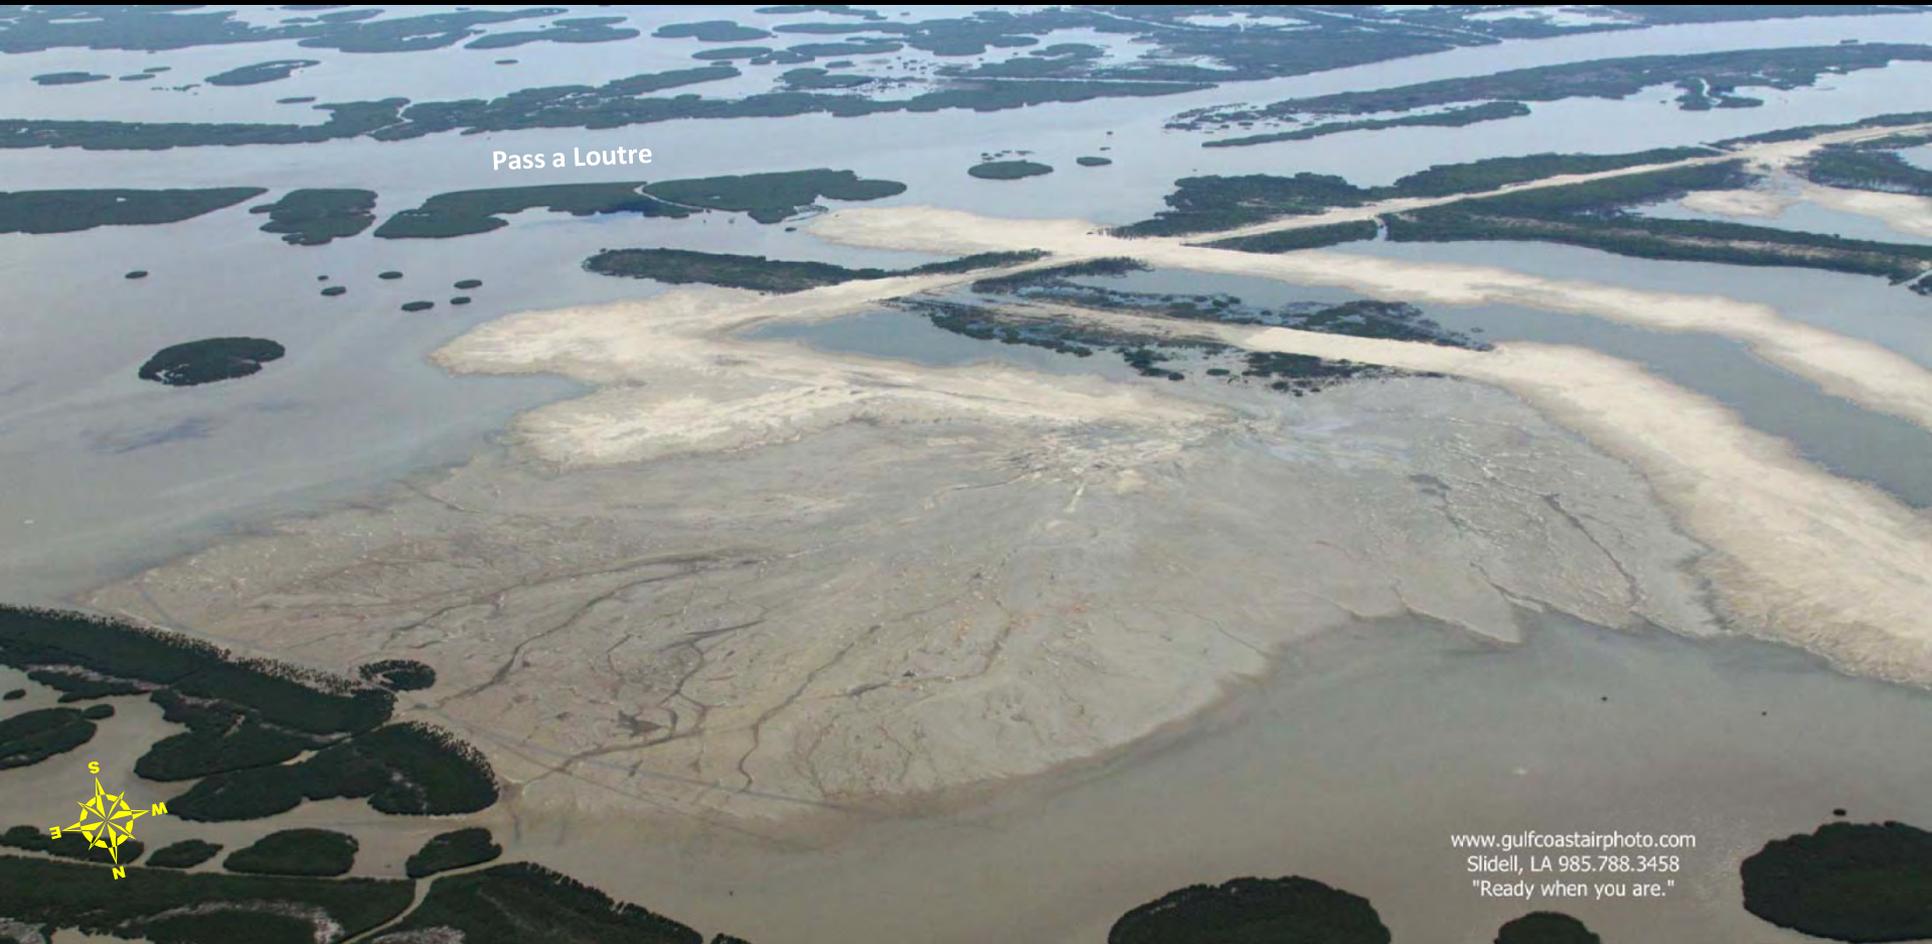
Delta National Wildlife Refuge (1 April 2013)

Placement of HDDA Dredged Material

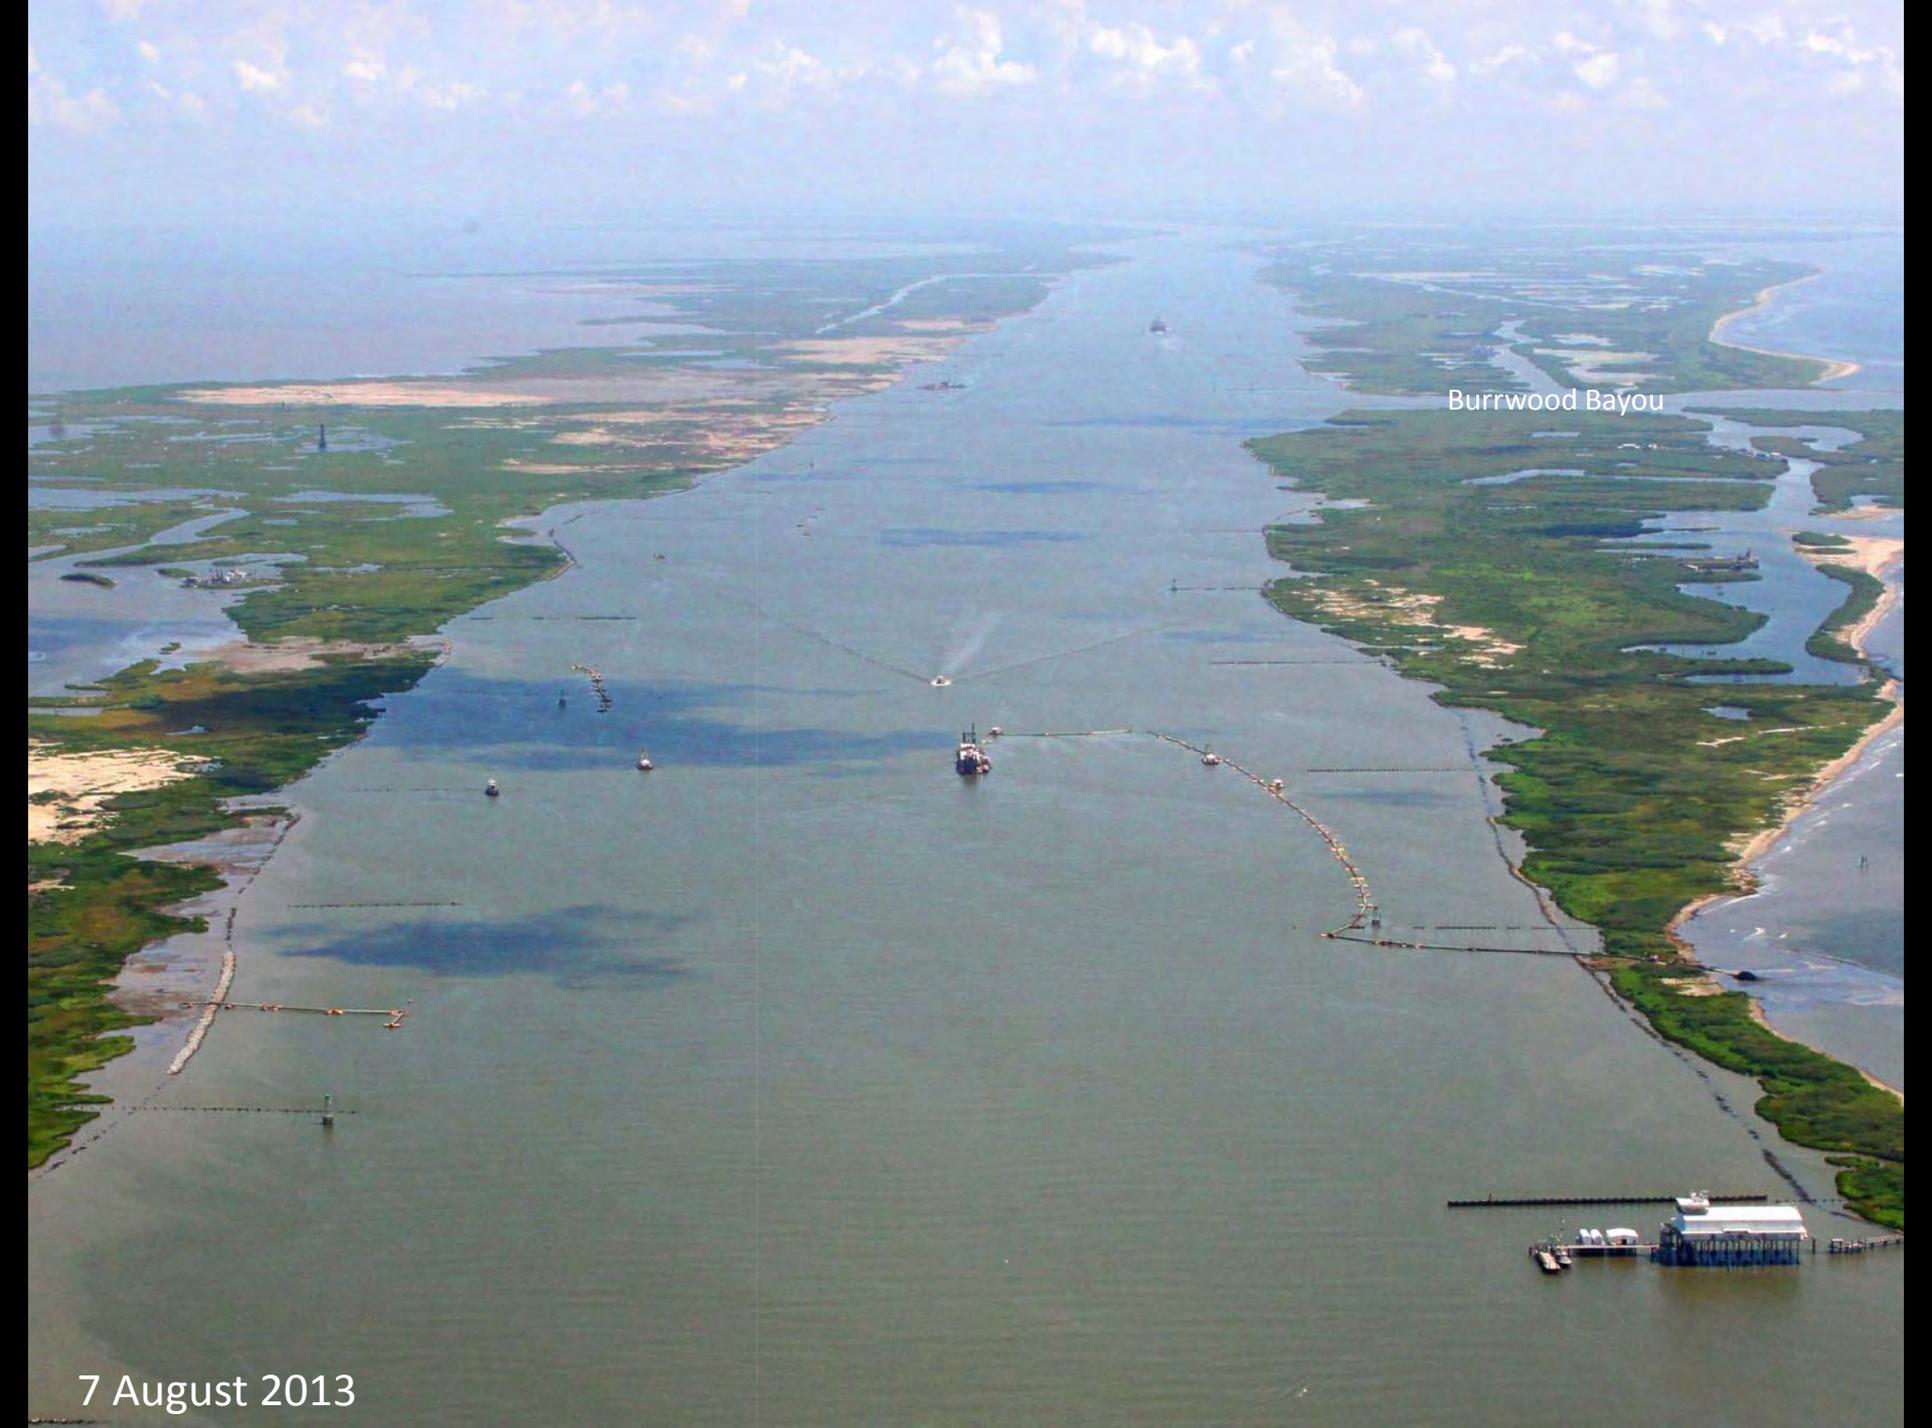
Burrwood Bayou

An aerial photograph of Burrwood Bayou, a large waterway with extensive green marshland on both sides. A large-scale dredging operation is underway in the center of the bayou. A central tugboat is connected to a long, curved line of barges. A smaller tugboat is positioned further up the bayou, also connected to a line of barges. Several other smaller boats are scattered throughout the water. In the bottom right corner, there is a large, white, rectangular structure on a wooden pier. The sky is blue with scattered white clouds.
