Bonnet Carré Spillway

**US Army Corps
of Engineers®**
New Orleans District

October 2014

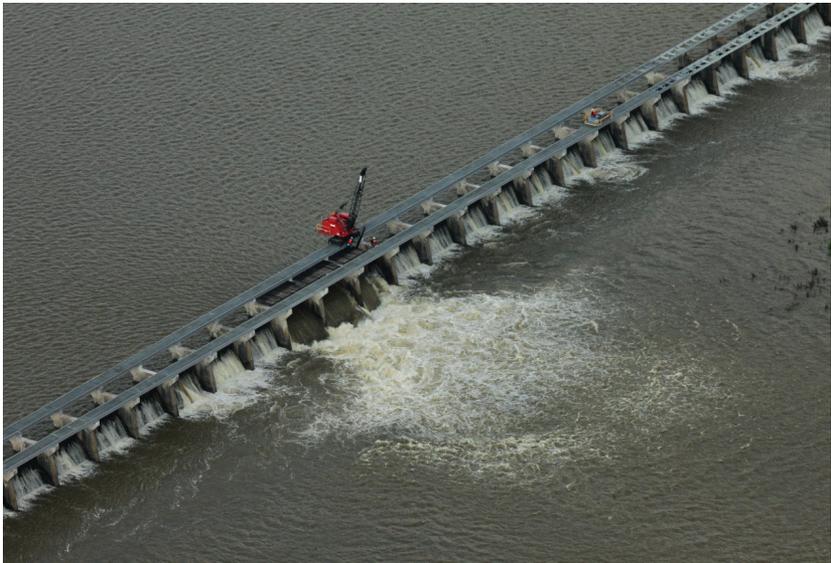
Map of Bonnet Carré Spillway (top), and aerial of the spillway in operation during the flood of 2011 (bottom).

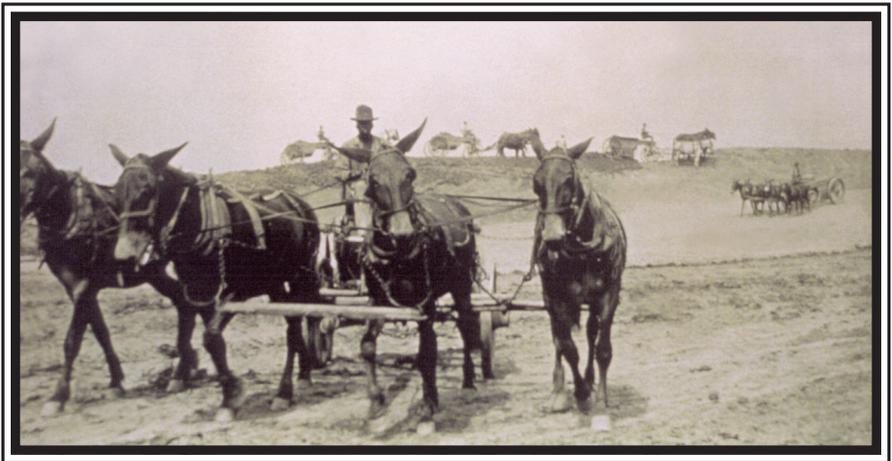
Early levee construction

Early inhabitants began constructing earthen embankments (called levees) along the river's banks to contain the flow and protect residents and developed property. Levees were built to reduce risk for New Orleans as early as 1718. At the turn of the nineteenth century, a crude system of levees extended for 100 miles upriver of New Orleans, with individual landowners constructing and maintaining the levees.

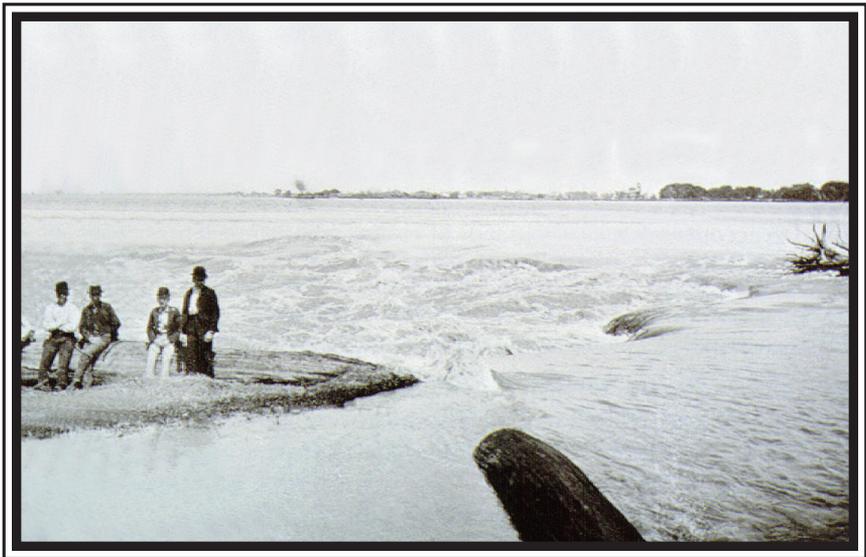
Breaking through the levee just above New Orleans, the river at Ames Crevasse in 1891 flooded much of western Jefferson Parish.

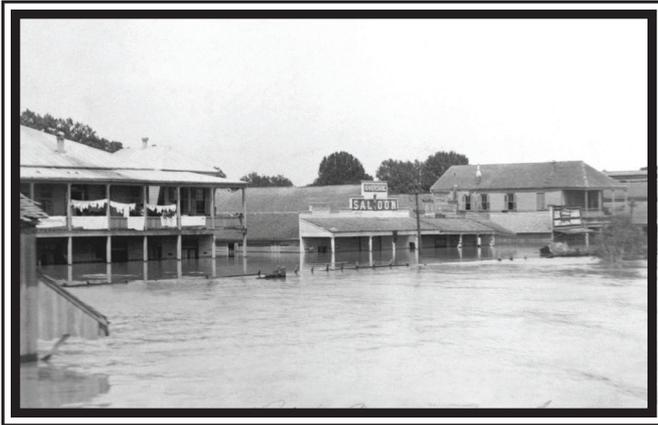
Even with improved levees in 1912, flooding continued to plague communities along the river.

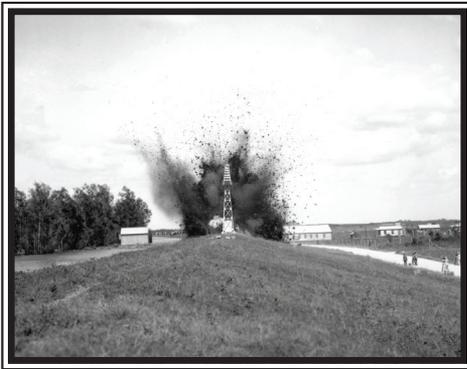
With MRC approval, Gov. Simpson gave the "go ahead" to dynamite the Caemarvon levee below New Orleans to create an artificial crevasse during the 1927 flood. The effort not only saved the city, it also blew away the "levees only" policy of the MRC.

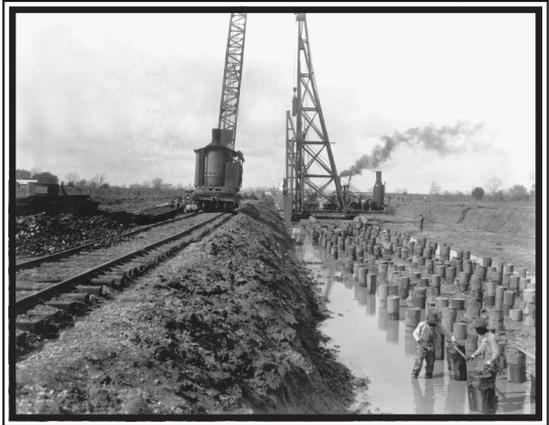
Thousands of wooden pilings were driven to provide a reliable foundation for the spillway structure.

A series of preliminary investigations were conducted to address the design concerns and ensure an effective and high quality construction project. Three separate studies were performed on-site. The first of these were site and foundation studies to determine the properties of the soil. Piling tests were undertaken to compare the qualities of wooden and concrete pilings. The tests indicated that long timber piles, in the range of 70 feet, would be adequate if sufficient numbers were driven under the structure.

Untreated piles were selected after examining the Robert E. Lee Monument foundation in New Orleans, which showed that such piles last indefinitely as long as they are kept below the water table. A temporary hydraulics laboratory was constructed on-site to determine the best shape of the weirs and to test various designs for dissipating the energy of water coming over the weir.

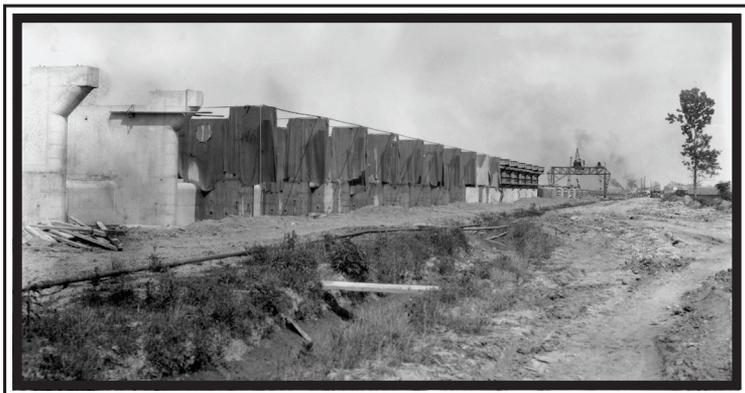
High strength concrete used in the spillway was an engineering advancement.

Because of the large quantity of concrete involved in the structure (135,000 cubic yards), it was essential that the concrete mixture produce strong, durable and economical concrete. The Corps established a concrete laboratory to determine optimal mixes of sand, gravel, cement and water quality for the spillway. Tests from the lab proved critical, resulting in a very high strength concrete in the neighborhood of 5,000 pounds per square inch. This was a significant advancement for the time, as typical concrete in the 1930s provided only 2,500 to 3,000 pounds per square inch compressive strength.

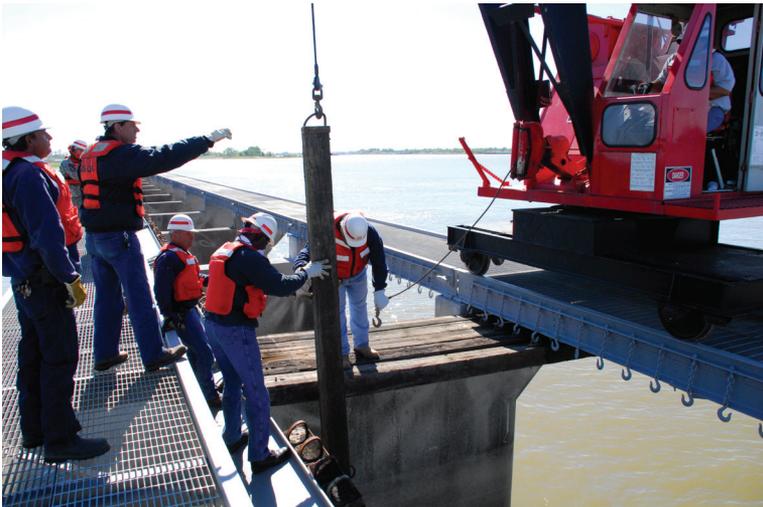
In opening the spillway, each timber is individually lifted and placed atop the structure.

Once the decision is made, actual operation of the structure is relatively simple. Two cranes, which move along tracks atop the structure, are used to individually lift each timber from the required number of bays. The timbers are raised from their vertical position across the weir opening (where together they serve as a dam against the high water) and are laid horizontally on top of the structure for later use in its closing. A complete opening of all 350 bays requires about 36 hours to lift the 7,000 wooden timbers in the structure. If a quicker opening of the structure is ever required, emergency procedures can release 20 timbers at a time and reduce the opening to three hours.

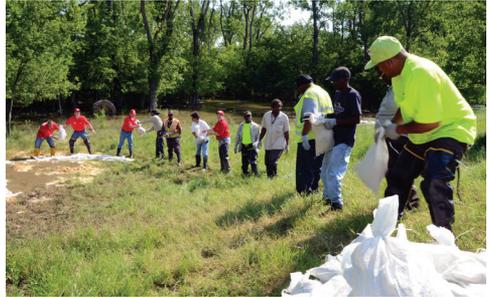
Workers place sandbags near a developing sand boil during the high water event of 2011.

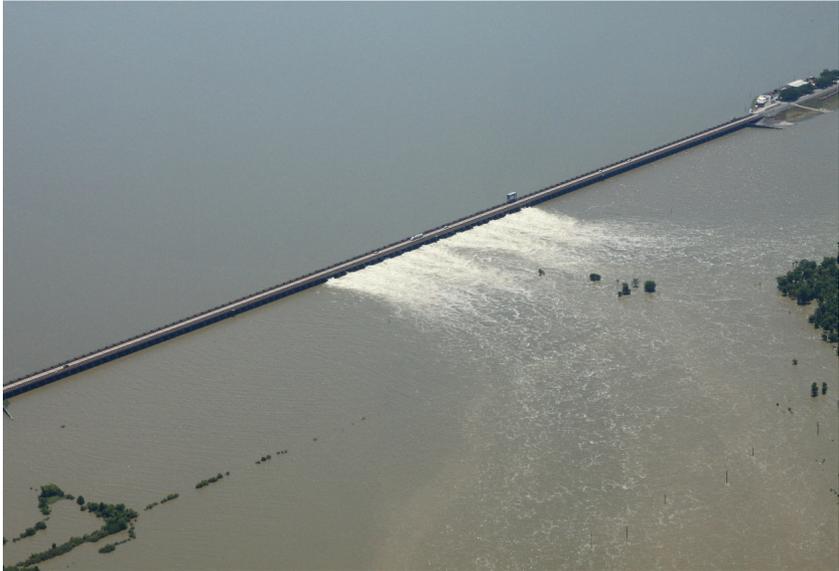
The Corps operated the Morganza Floodway for only the second time ever (and the first time for its intended purpose) in 2011 to divert excess Mississippi River water to the Atchafalaya River Basin and relieve pressure on the mainline Mississippi River levees.

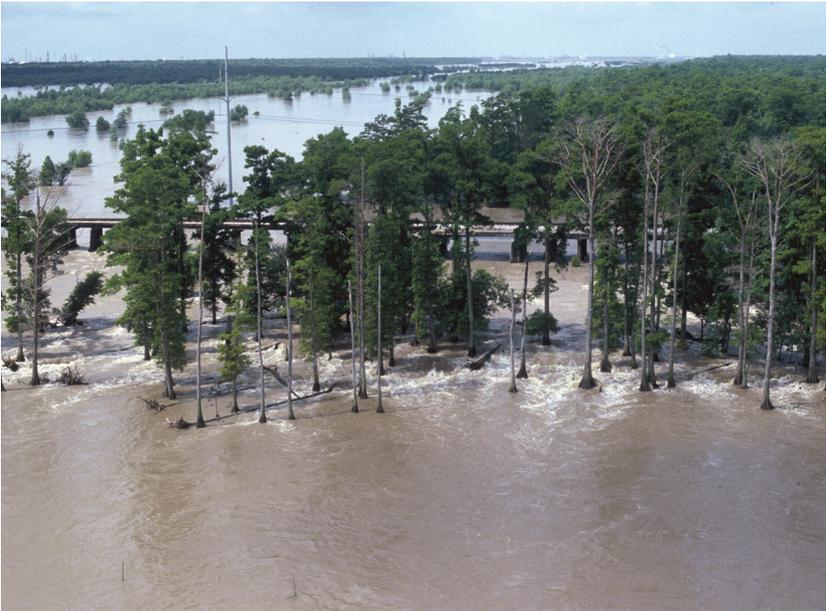
Diverted flood waters enter Lake Pontchartrain, providing valuable nutrients to the ecosystem.
