Lake Pontchartrain & Vicinity GRR Appendix E– Structural Engineering

U.S. Army Corps of Engineers,
New Orleans District

Non-Federal Sponsor: Coastal
Protection and Restoration Authority
Board

12/04/2019

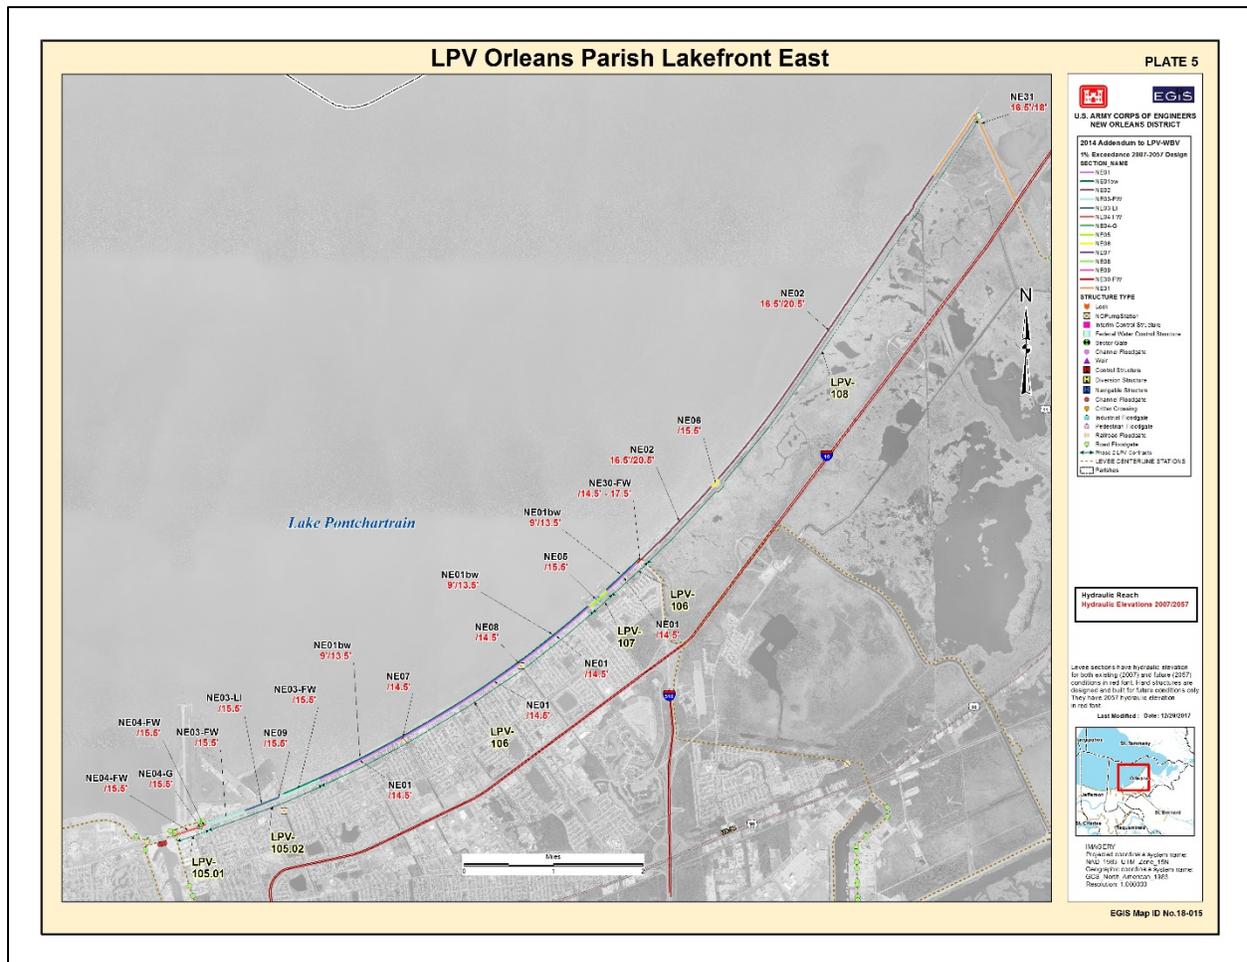
Figure 1-4. Orleans Parish Lakefront East

The Orleans Parish Lakefront East portion of the LPV system covers the New Orleans East lakefront from the IHNC to South Point. This segment includes three pumping stations, one pipeline crossing, and sections of floodwalls at the New Orleans Lakefront Airport, along the Citrus Lakefront Levee, at Lincoln Beach, and a transition section at South Point. Figure 1-4 shows the Orleans Parish Lakefront East segment. Table 1-4 lists the sections and their corresponding descriptions.

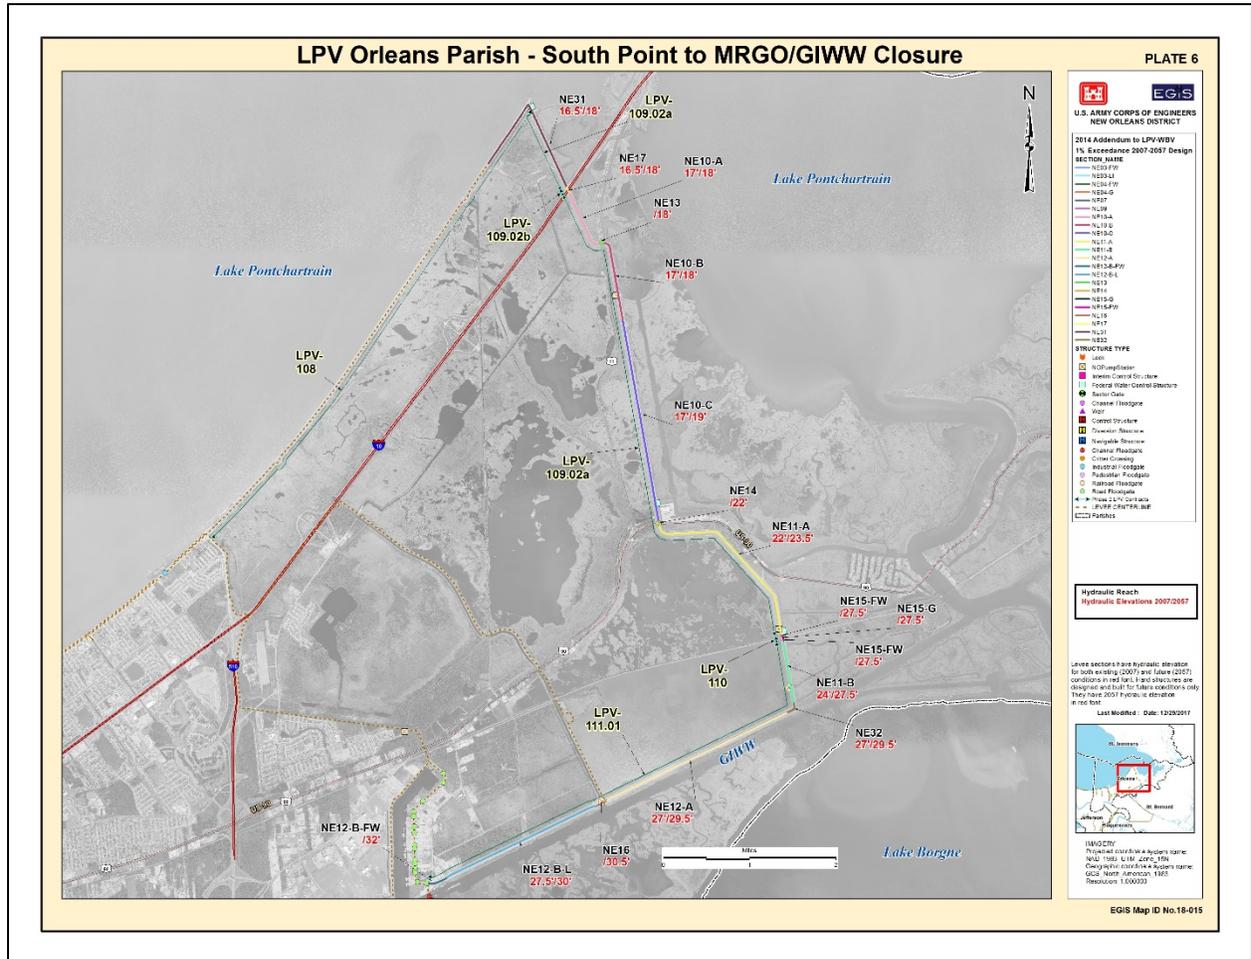
Figure 1-5. South Point to MRGO/GIWW Closure

The South Point to MRGO/GIWW Closure portion of the LPV system covers the segment from South Point to the Lake Borgne Surge Barrier. This segment includes one section of floodwall at the end of the New Orleans Back Levee closest to the Lake Borgne Surge Barrier, one pumping station and three floodgates: two at highway crossings and one at a railroad crossing. Figure 1-5 shows the South Point to MRGO/GIWW Closure segment. Table 1-5 lists the sections and their corresponding descriptions.

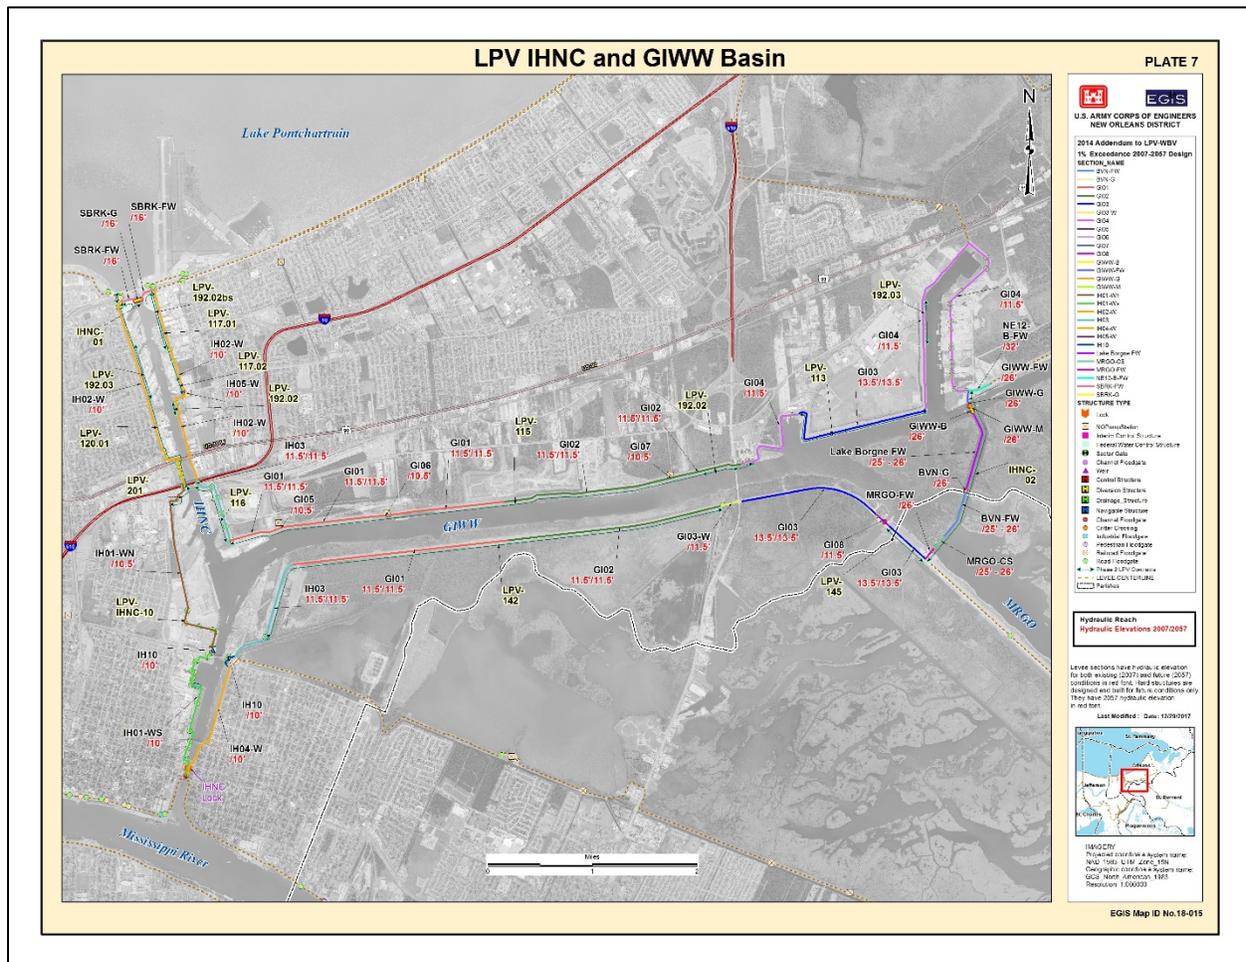
Figure 1-6. IHNC and GIWW Basin

The IHNC and GIWW Basin portion of the LPV system consists of the levees and floodwalls encompassing the Inner Harbor Navigation Canal (IHNC), Gulf Intracoastal Waterway (GIWW) and a portion of the Mississippi River Gulf Outlet (MRGO) where it joins the GIWW. This segment includes the Lake Borgne Surge Barrier, IHNC Lock, Bayou Bienvenue Floodgate and Seabrook Closure Complex; six pumping stations; and floodwall sections under the Paris Rd. Bridge, along the IHNC and at the Michoud Canal and Slip. Figure 1-6 shows the IHNC and GIWW Basin segment. Table 1-6 lists the sections and their corresponding descriptions. This analysis only includes perimeter floodwalls; therefore only the Seabrook Closure Complex, GIWW, Lake Borgne Surge Barrier, Bayou Bienvenue Floodgate, and MRGO Closure floodwalls were analyzed.

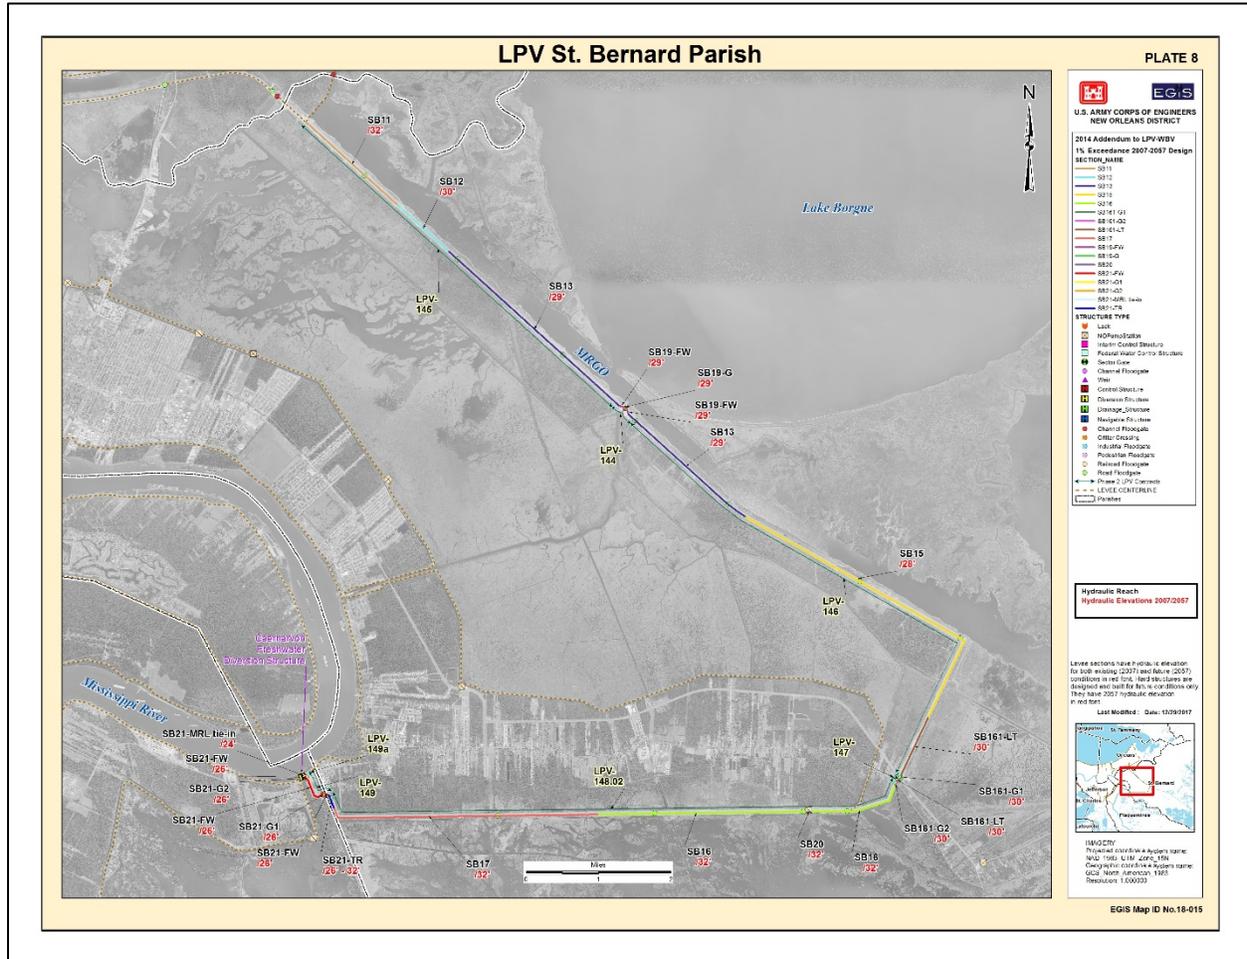
Figure 1-7. St. Bernard Parish

The St. Bernard Parish portion of the LPV system extends from the Lake Borgne Surge Barrier to the Caernarvon Freshwater Diversion Structure. This segment includes one pumping station, the Bayou Dupre Control Structure, the Caernarvon sector gate, three roadway floodgates, and either floodwall or levee and floodwall sections for the rest of the segment. Figure 1-7 shows the St. Bernard Parish segment. Table 1-7 lists the sections and their corresponding descriptions.

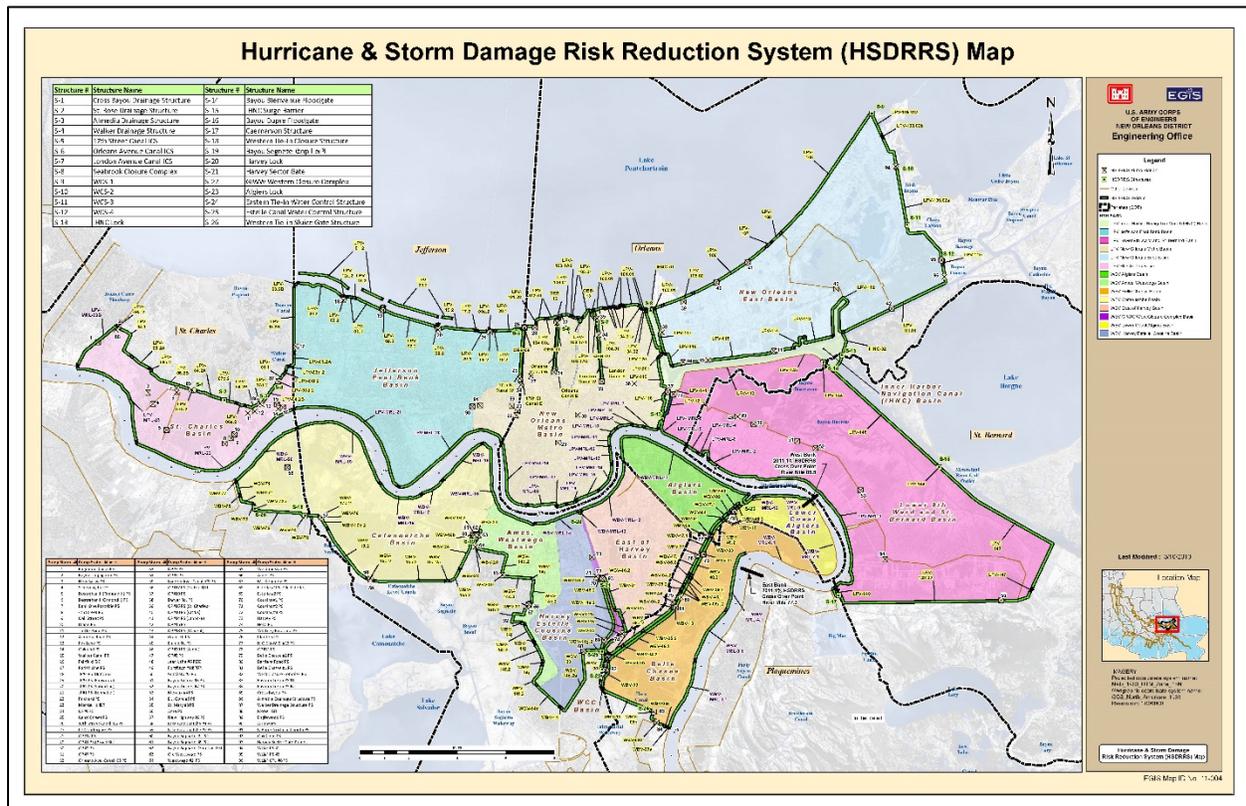
Figure 1-8. LPV-MRL

The LPV-MRL portion of the LPV system consists of the levees and floodwalls along the east bank of the Mississippi River. This segment includes numerous road and railroad floodgates. Figure 1-8 shows the LPV-MRL segment. Table 1-8 lists the sections and their corresponding descriptions.
