South Central Coast Louisiana

Appendix L – Wet Floodproofing Cost Development

June 2021

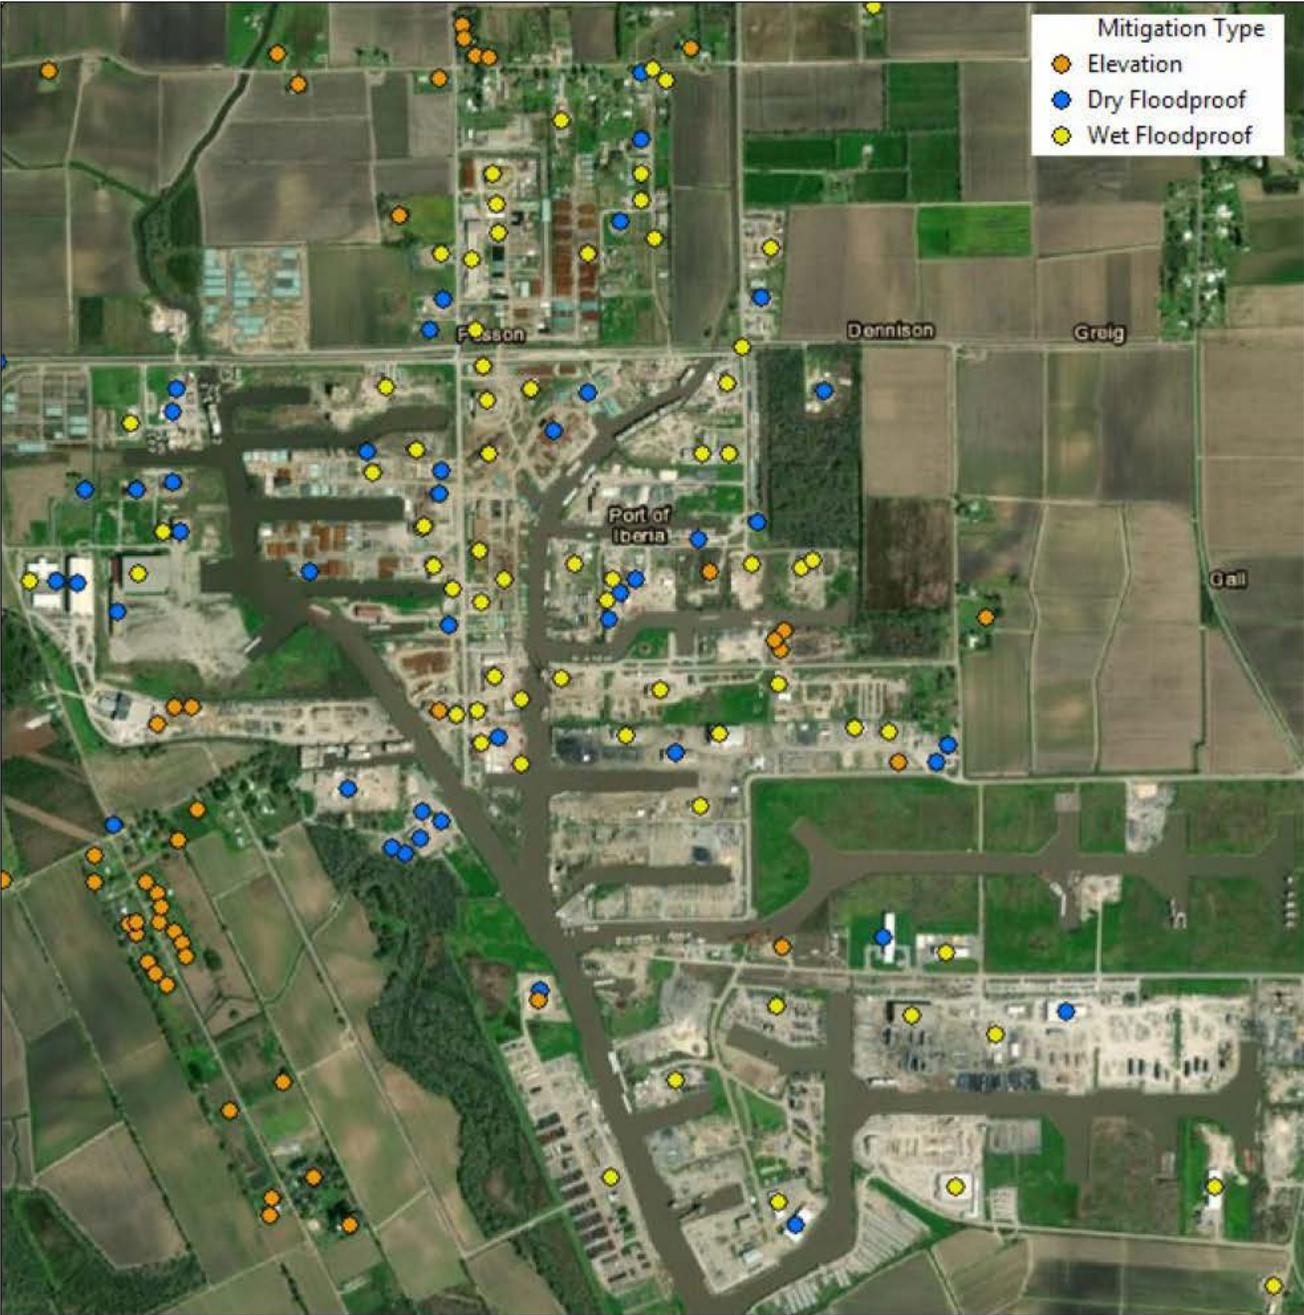
Figure L:1-1. Port of Iberia Recommended NED Plan Nonstructural Mitigation

The Port of Iberia was identified as a representative location, a highly industrial area with commercial structures often tied to oil and gas industry. Structures within the Port of Iberia were selected as a representative structural archetypes for refinement of assessed wet floodproofing methods. A template for the 185 structures identified within the Port of Iberia complex were utilized to assess the effectiveness of wet floodproofing warehouse relative to dry floodproofing. Figure L:1-1 shows locations and structural classification diversification of the Port of Iberia, residential structures were elevated, commercial structures were dry floodproofed, and industrial warehouse structures were identified as targets for potential wet floodproofing.

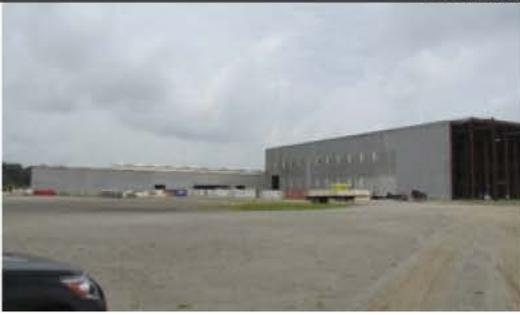
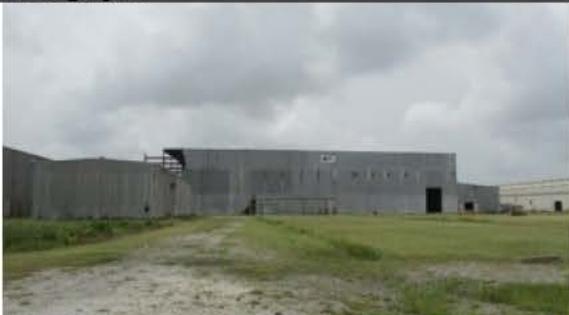
STRUCTURE ASSESSMENT SHEET	
Structure ID	Structure Address
#1	1216 Unifab Rd Bldg B
Structure Photographs

Front	Rear
Structure Characteristics	
Characteristic	Description
Occupancy -	Commercial – service and repair, being converted to storage.
Configuration -	One story with one wing 125,000 sq ft and the other 40,000 sq ft.
Construction -	Concrete slab foundation. Steel framing with steel siding and roof.
Condition -	Good
Other -	The east west main section of the building has a large opening at one end, which is scheduled to be closed in. There are no flood vents in the building walls
Site Visit Observations	
<p>General: The large site features the large 90' high main section and 60' high north south oriented building. A relatively smaller, second wing of the building is oriented north/south. The site is relatively flat and has 2 slips. The building is not occupied at this time, however a lease has been finalized. There are several other buildings on the site.</p> <p>Site: The structure is situated on an industrial port site and free standing on the property. The area around the structure is limestone. The grade at the front of the structure slopes slightly downward toward the access road. The grade at the sides of the structure slopes down from the building. The grade at the rear slopes down away from the structure.</p> <p>Structure: The building needs flood vents in order to be wet flood proofed. The former administration office spaces are going to be converted to conditioned storage. Some minor repairs are needed to the exterior steel siding. The building has a new tenant and is scheduled to have the open end closed in and a large door installed.</p> <p>Systems/Utilities: Systems and utilities are located below the DFE. Air conditioners need elevation to DFE. Electric service needs relocation to DFE. Toilet line needs back flow preventer.</p>

5.6 ft	5ft	n/a	AE-11	6.6ft	6ft	n/a
ABBREVIATIONS: FF – First Floor Elevation; LAG – Low Adjacent Grade Elevation; B – Basement Floor Elevation; CS – Crawl Space Ground Elevation; BFE – Base Flood Elevation; Δ – Delta (Elevation Difference); NA – Not Applicable; * - Estimated						
Flood Risk						
<p>Flood Risk: The first floor is approximately 6.6ft feet below the base flood elevation (BFE). The structure's construction, finishes, systems, utilities, storage and contents would incur substantial damage in a flood event. If wet flood proofed, the building would be subject to less damage due to letting the water in and out of the interior.</p>						
Recommendation						
<p>Based on the structure characteristics, site visit observations, structure / flood elevation data and the flood risk, the following mitigations are recommended:</p> <ol style="list-style-type: none"> 1. Relocate the building utilities / systems to upper level above the DFE if applicable. 2. Elevate the exterior HVAC equipment onto platform(s), above the BFE. 3. Remove water damagable construction material and finishes and replace with water resistant construction and finishes. 4. Wet flood proof the structure according to FEMA Technical Bulletin 7. Install engineered flood vents in the existing walls. 5. Plan for evacuation of moveable equipment and structure contents prior to flood event when adequate warning is given. 6. Evacuate the structure during a flood event to prevent loss of life. <p>Notes:</p> <ol style="list-style-type: none"> 1. The property owner indicated the structure experienced flooding on the first floor during past flood events. When a flood warning is given the property owner evacuates the structure contents and stores it off site. Interior finish materials need to be replaced with approved flood resistant construction materials 2. Loose equipment, containers and debris on the site will easily float away during a flood event, being lost or causing environmental hazard. <p>Note: The building qualifies as “functionally dependent” under CFR 59.1. FEMA/NFIP local ordinance requires a variance be provided for this work.</p>

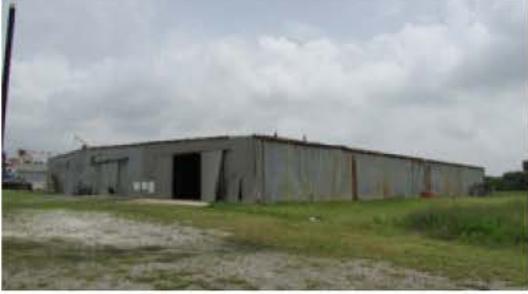
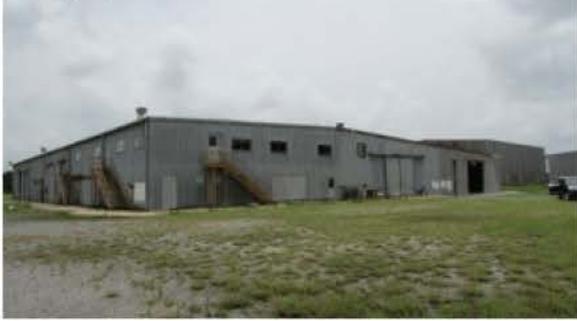
STRUCTURE ASSESSMENT SHEET	
Structure ID	Structure Address
#2	1216 Unifab Rd Building E
Structure Photographs

Front	Rear
Structure Characteristics	
Characteristic	Description
Occupancy -	Commercial storage.
Configuration -	The building measures 200' X 200' = 40,000 sq ft and 20' high. There is an elevated office space in the rear approximately 8ft above grade.
Construction -	Concrete slab foundation. Steel interior frame, steel siding and roof.
Condition -	Good. The building has a few loose steel panels. The roof above the office spaces is relatively new.
Other -	Structure sited above the level of the access road. There are multiple door openings in the sides of the building. There are no flood vents in the walls.
Site Visit Observations	
<p>General: The site is relatively flat. There is a slip just north of the building.</p> <p>Site: Industrial port site. The structure is situated on an industrial port site and free standing on the property. Interior finish materials need to be replaced with approved flood resistant construction materials. The grade at the front of the structure slopes slightly downward toward the access road. The grade at the sides of the structure slopes down from the building. The grade at the rear slopes down away from the structure.</p> <p>Structure: The building needs flood vents in order to be wet flood proofed. Some minor repairs are needed to the exterior steel siding.</p> <p>Systems/Utilities: Air conditioners for the upper level offices need to be elevated on stands to the DFE.</p>

5.6ft	5ft	n/a	AE-11	5.4ft	6ft	n/a
ABBREVIATIONS: FF – First Floor Elevation; LAG – Low Adjacent Grade Elevation; B – Basement Floor Elevation; CS – Crawl Space Ground Elevation; BFE – Base Flood Elevation; Δ – Delta (Elevation Difference); NA – Not Applicable; * - Estimated						
Flood Risk						
<p>Flood Risk: The first floor is approximately 5.4 feet below the base flood elevation (BFE). Structure's construction, finishes, systems, utilities, storage and contents/furnishings at the finished floor level (below the BFE) would incur substantial damage.</p>						
Recommendation						
<p>Based on the structure characteristics, site visit observations, structure / flood elevation data and the flood risk, the following mitigations are recommended:</p> <ol style="list-style-type: none"> 1. Relocate the building utilities / systems / storage to upper level above BFE if applicable. 2. Elevate the exterior HVAC equipment onto platform or onto the roof, above the BFE. 3. Remove water damagable construction material and finishes and replace with water resistant construction and finishes. 4. Wet flood proof the structure according to FEMA Technical Bulletin 7. Install engineered flood vents in the existing walls. 5. Plan for evacuation of moveable equipment and structure contents prior to flood event when adequate warning is given. 6. Evacuate the structure during a flood event to prevent loss of life. <p>Notes:</p> <ol style="list-style-type: none"> 7. The property owner indicated the structure experienced flooding on the first floor during past flood events and incurred extensive damages. When a flood warning is given the property owner evacuates the structure contents and stores it off site. Interior finish have been replace after previous flood event with easily removable water resistant construction in the showroom / office area. Some equipment is stored on mobile racks to facilitate evacuation. 8. Loose equipment, containers and debris on the site will easily float away during a flood event, being lost or causing environmental hazard. <p>Note: The building qualifies as "functionally dependent" under CFR 59.1. FEMA/NFIP local ordinance requires a variance be provided for this work.</p>

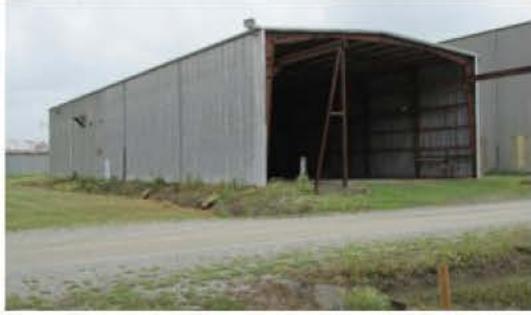
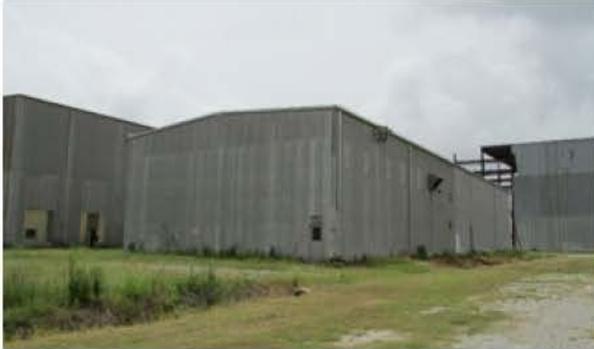
STRUCTURE ASSESSMENT SHEET	
Structure ID	Structure Address
#3	1216 Unifab Rd Building D
Structure Photographs

Front	Rear
Structure Characteristics	
Characteristic	Description
Occupancy -	Commercial – storage.
Configuration -	The building is a rectangular one story, gable roof that measures 180ft X 60ft = 10,800 sq ft. One end of the building is open.
Construction -	Concrete slab foundation. Roof and siding are steel.
Condition -	The siding and roof appear to be in good condition.
Other -	Structure sited above the level of the access road. There are 2 egress door openings in the sides of the building. There are no flood vents in the walls.
Site Visit Observations	
<p>General: The structure was viewed from the exterior and interior. The structure was not occupied and in good condition.</p> <p>Site: - Industrial port site. The structure is situated on an industrial port site and free standing on the property. The area around the structure is Limestone. The grade at the front of the structure slopes slightly downward toward the access road. The grade at the sides of the structure slopes down from the building. The grade at the rear slopes down away from the structure.</p> <p>Structure: The structure is steel framed with a steel siding and roof. The first floor is a concrete slab on grade. The exterior walls and roof have steel siding.</p> <p>Systems/Utilities: The utilities are located below BFE.</p>

5.6ft	5ft	n/a	AE-11	5.4ft	6ft	n/a
ABBREVIATIONS: FF – First Floor Elevation; LAG – Low Adjacent Grade Elevation; B – Basement Floor Elevation; CS – Crawl Space Ground Elevation; BFE – Base Flood Elevation; Δ – Delta (Elevation Difference); NA – Not Applicable; * - Estimated						
Flood Risk						
<p>Flood Risk: The first floor is approximately 5.4 feet below the base flood elevation (BFE). Structure's construction, finishes, systems, utilities, storage and contents/furnishings at the finished floor level (below the BFE) would incur substantial damage.</p>						
Recommendation						
<p>Based on the structure characteristics, site visit observations, structure / flood elevation data and the flood risk, the following mitigations are recommended:</p> <ol style="list-style-type: none"> 1. Relocate the building utilities / systems above BFE if applicable. 2. Elevate the exterior HVAC equipment onto platform or onto the roof, above the BFE. 3. Remove water damagable construction material and finishes and replace with water resistant construction and finishes. 4. Wet flood proof the structure according to FEMA Technical Bulletin 7. Install engineered flood vents in the existing walls. 5. Plan for evacuation of moveable equipment and structure contents prior to flood event when adequate warning is given. 6. Evacuate the structure during a flood event to prevent loss of life. <p>Notes:</p> <ol style="list-style-type: none"> 7. The property owner indicated the structure experienced flooding on the first floor during past flood events and incurred extensive damages. When a flood warning is given the property owner evacuates the structure contents and stores it off site. Interior finish have been replace after previous flood event with easily removable water resistant construction in the showroom / office area. Some equipment is stored on mobile racks to facilitate evacuation. 8. Loose equipment, containers and debris on the site will easily float away during a flood event, being lost or causing environmental hazard. <p>Note: The building qualifies as “functionally dependent” under CFR 59.1. FEMA/NFIP local ordinance requires a variance be provided for this work.</p>

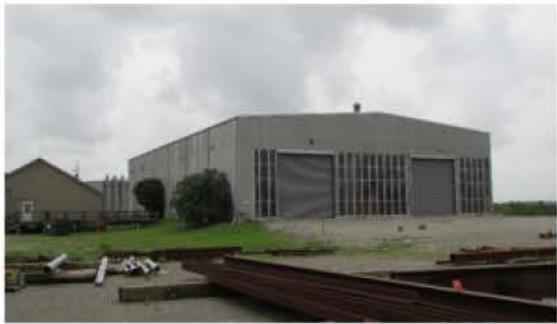
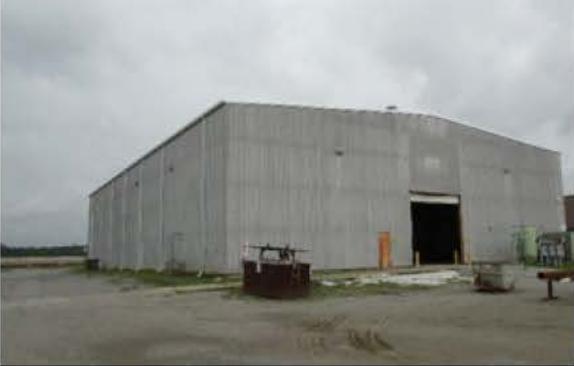
STRUCTURE ASSESSMENT SHEET	
Structure ID	Structure Address
#4	5314 C.P Voorhies Rd Building C
Structure Photographs

<p>Rear</p>
Structure Characteristics	
Characteristic	Description
Occupancy -	Commercial – storage.
Configuration -	One story, concrete slab on grade, gable end steel roof. 16,000 sq ft.
Construction –	Masonry exterior walls with metal framed roof. Wood framed interior.
Condition -	Good. Several steel siding panels on the front of the building have been replaced with clear acrylic panels.
Other -	Structure sited above the level of the access road. There are 2 egress door openings in the sides of the building. There are no flood vents in the walls.
Site Visit Observations	
<p>General: The structure was viewed from the exterior. The structure was not occupied and in good condition.</p> <p>Site: Industrial port site. The structure is situated on an industrial port site and free standing on the property. The area around the structure is sand and gravel. The grade at the front of the structure slopes downward toward the access road. The grade at the sides of the structure slopes down from the building. The grade at the rear slopes down away from the structure.</p> <p>Structure: The gable end structure is steel framed with a steel siding and roof. The first floor is a concrete slab on grade. The exterior walls and roof have steel siding.</p> <p>Systems/Utilities: The utilities and equipment is located at the rear and below DFE</p>

STRUCTURE DATA SHEET (CONTINUED)						
Structure ID	Structure Address					
#4	5314 C.P Voorhies Rd Building C					
Structure and Flood Elevations						
FF	LAG	B	BFE	Δ BFE-FF	Δ BFE-LAG	Δ BFE-B
7ft	6.5ft	n/a	AE-11	4ft	4.5ft	n/a
ABBREVIATIONS: FF – First Floor Elevation; LAG – Low Adjacent Grade Elevation; B – Basement Floor Elevation; CS – Crawl Space Ground Elevation; BFE – Base Flood Elevation; Δ – Delta (Elevation Difference); NA – Not Applicable; * - Estimated						
Flood Risk						
<p>Flood Risk: The first floor is approximately 4ft feet below the base flood elevation (BFE). The structure's construction, finishes, systems, utilities, storage and contents / furnishings at the first-floor elevation area are substantially below the BFE and will incur significant damage.</p>						
Recommendation						
<p>Based on the structure characteristics, site visit observations, structure / flood elevation data and the flood risk, the following mitigations are recommended:</p> <ol style="list-style-type: none"> 1. Relocate the building utilities / systems / storage to above DFE. 2. Remove water damagable construction material and finishes and replace with water resistant construction and finishes. 3. Wet flood proof the structure according to FEMA Technical Bulletin 7. Install engineered flood vents in the existing walls. 4. Plan for evacuation of moveable equipment and structure contents prior to flood event when adequate warning is given. 5. Evacuate the structure during a flood event to prevent loss of life. <p>Notes:</p> <ol style="list-style-type: none"> 6. The property owner indicated the structure experienced flooding on the first floor during past flood events and incurred extensive damages. When a flood warning is given the property owner evacuates the structure contents and stores it off site. 7. Loose equipment, containers and debris on the site will easily float away during a flood event, being lost or causing environmental hazard.

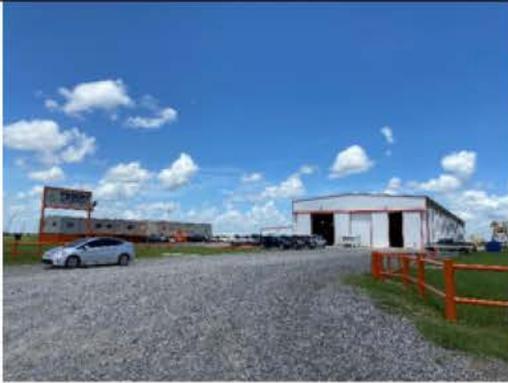
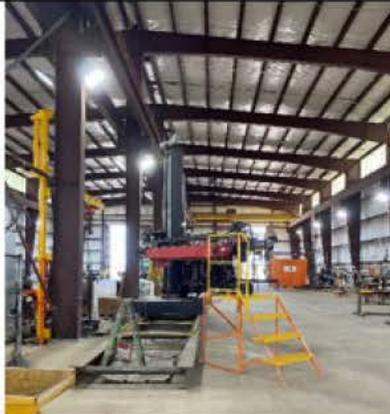
OCCUPIED STRUCTURE ASSESSMENT SHEET	
Structure ID	Structure Address
#5	3705 Earl B Wilson Dr, New Iberia, LA
Structure Photographs

Front	Interior
Structure Characteristics	
Characteristic	Description
Occupancy -	Commercial – Fabrication, service and repair
Configuration -	One story 35,700 sq ft
Construction -	Concrete slab foundation. Steel framing with steel siding and roof.
Condition -	Good
Other -	The building has 2 rolling door openings at either end. There are multiple non-engineered vents in the building walls. The building owner is gradually flood proofing the building. The electric transformer is at BFE. The interior electric needs elevating. The owner has an evac plan to get portable equipment into a shipping container and elevate with existing overhead crane.
Site Visit Observations	
<p>General: The large site features two double wide modular office modular buildings on an elevated structural steel frame. The fabrication building measures 357ft X 100ft X 50ft high.</p> <p>Site: The fabrication building is situated on an industrial port site and free standing on the property. The area around the structure is limestone. The grade at the front of the structure slopes slightly downward toward the access road. The grade at the sides of the structure slopes down from the building. The grade at the rear slopes down away from the structure.</p> <p>Structure: The building needs an engineered flood vent retro fit to be compliant with minimum square ft coverages required by FEMA/NFIP to be wet flood proofed. The administration office spaces are elevated to BFE +1FT. Some minor repairs are needed to the exterior steel siding.</p> <p>Systems/Utilities: The site power transformer is elevated to BFE+1ft. The power distribution system inside the building needs to be elevated. Sanitary waste line needs back flow preventer.</p>

5.9 ft	5ft	n/a	AE-11	6ft	7ft	n/a
ABBREVIATIONS: FF – First Floor Elevation; LAG – Low Adjacent Grade Elevation; B – Basement Floor Elevation; CS – Crawl Space Ground Elevation; BFE – Base Flood Elevation; Δ – Delta (Elevation Difference); NA – Not Applicable; * - Estimated						
Flood Risk						
<p>Flood Risk: The first floor is approximately 6ft feet below the base flood elevation (BFE). The structure’s construction, finishes, systems, utilities, storage and contents would incur substantial damage in a flood event. If wet flood proofed, the building would be subject to less damage due to letting the water in and out of the interior.</p>						
Recommendation						
<p>Based on the structure characteristics, site visit observations, structure / flood elevation data and the flood risk, the following mitigations are recommended:</p> <ol style="list-style-type: none"> 1. Relocate the building utilities / systems to upper level above the DFE if applicable. 2. Elevate the exterior HVAC equipment onto platform(s), above the BFE. 3. Remove water damagable construction material and finishes and replace with water resistant construction and finishes. 4. Wet flood proof the structure according to FEMA Technical Bulletin 7. Install engineered flood vents in the existing walls. 5. Plan for evacuation of moveable equipment and structure contents prior to flood event when adequate warning is given. 6. Evacuate the structure during a flood event to prevent loss of life. <p>Notes:</p> <ol style="list-style-type: none"> 1. The property owner indicated the structure experienced flooding on the first floor during past flood events. When a flood warning is given the property owner elevates the structure contents. Interior finish materials need to be replaced with approved flood resistant construction materials 2. Loose equipment, containers and debris on the site will easily float away during a flood event, being lost or causing environmental hazard. <p>Note: The building qualifies as “functionally dependent” under CFR 59.1. FEMA/NFIP local ordinance requires a variance be provided for this work.</p>

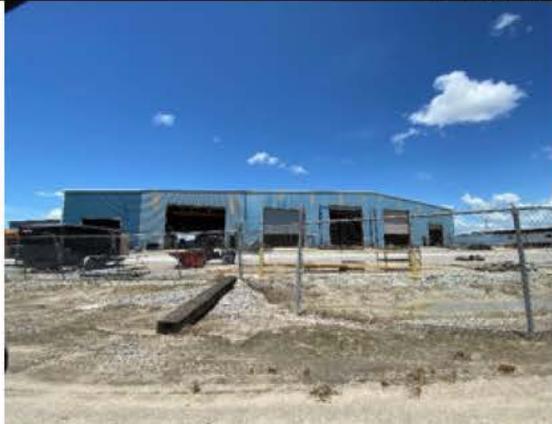
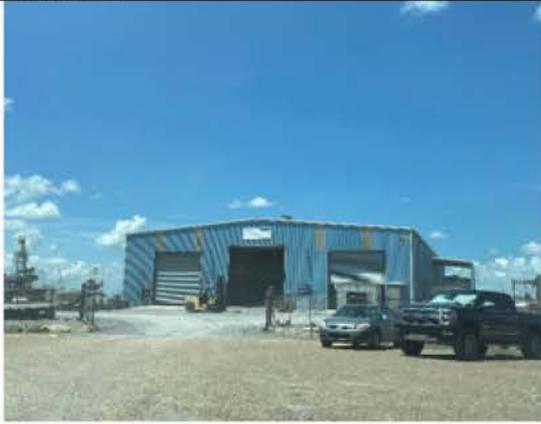
OCCUPIED STRUCTURE ASSESSMENT SHEET	
Structure ID	Structure Address
#6	3415 Earl B Wilson Dr, New Iberia, LA
Structure Photographs

"Main" shop	"Spool" shop
Structure Characteristics	
Characteristic	Description
Occupancy -	Fabrication.
Configuration -	The main shop building measures 280' X 250' = 70,000 sq ft and 50' high. Concrete slab foundation. Steel interior frame, steel siding and roof.
Construction -	Good.
Condition -	The main 2 buildings are sited above the level of the access road. There are multiple door openings in the sides of the building. There are non-engineered air vents in the walls. The site has multiple exterior power stations for overflow welding. There is an autoclave oven on grade that needs mitigating along with a small building power distribution that needs elevating. The site needs an elevated platform with ramp to park the crawler crane and two large fork lifts.
Other -

Site Visit Observations	
<p>General: The site is relatively flat. There is a slip on the north end of the site.</p> <p>Site: Industrial port site. The 2 main structures are situated on an industrial port site and free standing on the property. All but two of the office space modular buildings are at BFE+1ft. The grade at the front of the structure slopes slightly downward toward the access road. The grade at the sides of the structures slopes down from the building. The grade at the front and rear slopes down away from the structures.</p> <p>Structure: The building has existing non engineered air vents and needs engineered flood vents in order to be wet flood proofed.</p> <p>Systems/Utilities: Air conditioners for the upper level offices need to be elevated on stands to the DFE. All site electric utilities need to be elevated to BFE+1ft.</p>

OCCUPIED STRUCTURE DATA SHEET (CONTINUED)						
Structure ID	Structure Address					
#6	3415 Earl B Wilson Dr, New Iberia, LA					
Structure and Flood Elevations						
FF	LAG	B	BFE	Δ BFE-FF	Δ BFE-LAG	Δ BFE-B
6ft	5ft	n/a	AE-11	5ft	6ft	n/a
ABBREVIATIONS: FF – First Floor Elevation; LAG – Low Adjacent Grade Elevation; B – Basement Floor Elevation; CS – Crawl Space Ground Elevation; BFE – Base Flood Elevation; Δ – Delta (Elevation Difference); NA – Not Applicable; * - Estimated						
Flood Risk						
<p>Flood Risk: The first floor is approximately 5 feet below the base flood elevation (BFE). Structure's construction, finishes, systems, utilities, storage and contents/furnishings at the finished floor level (below the BFE) would incur substantial damage.</p>						
Recommendation						
<p>Based on the structure characteristics, site visit observations, structure / flood elevation data and the flood risk, the following mitigations are recommended:</p> <ol style="list-style-type: none"> 1. Relocate the building utilities / systems / storage to upper level above BFE if applicable. 2. Remove water damagable construction material and finishes and replace with water resistant construction and finishes. 3. Wet flood proof the structure according to FEMA Technical Bulletin 7. Install engineered flood vents in the existing walls. 4. Plan for evacuation of moveable equipment and structure contents prior to flood event when adequate warning is given. 5. Evacuate the structure during a flood event to prevent loss of life. <p>Notes:</p> <ol style="list-style-type: none"> 6. The property owner indicated the structure experienced flooding on the first floor during past flood events. When a flood warning is given the property owner elevates the structure contents. Interior finish materials need to be replaced with approved flood resistant construction materials 7. Loose equipment, containers and debris on the site will easily float away during a flood event, being lost or causing environmental hazard. <p>Note: The building qualifies as "functionally dependent" under CFR 59.1. FEMA/NFIP local ordinance requires a variance be provided for this work.</p>

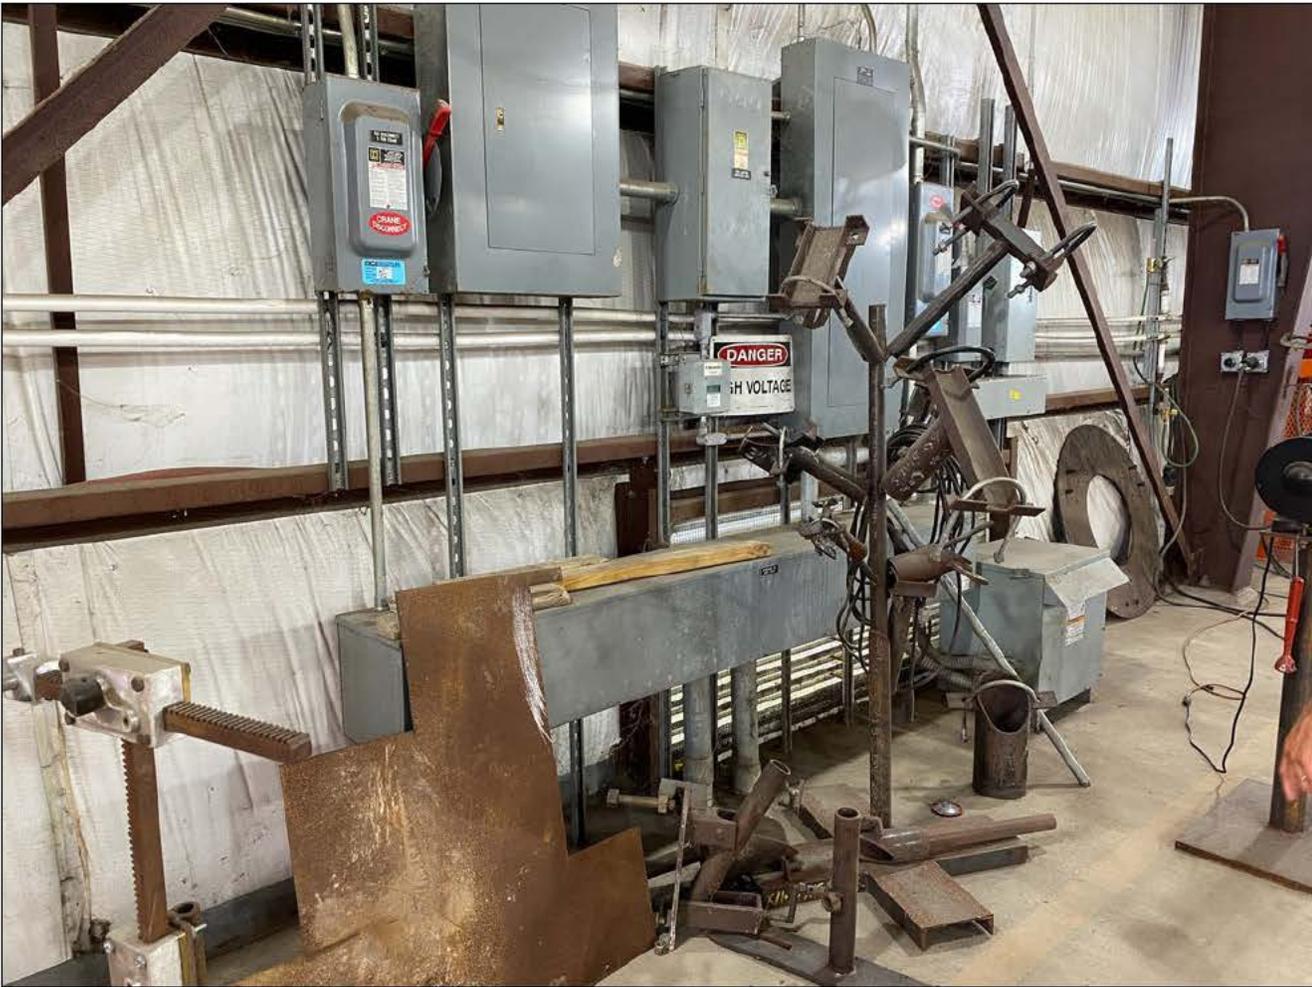
Figure L:2-1. Example of Significant Electrical Infrastructure Requiring Elevation

The PDT refined the wet floodproofing mitigation methods based on the types of structures and its associated operations that were surveyed within the Port of Iberia. Following screening of mitigation methods, structure were sorted into two types: general purpose warehouse structures and fabrication warehouses. The only significance difference as it relates to scope and cost of the cost estimate is that fabrication buildings require significantly more work to elevate as they tend to require large scale hoists and associated utilities as indicated in Figure L:2-1.

3. Risk Reduction of Utilities
 - Elevate electric service
 - Elevate HVAC condenser units
4. Conveying Flood Waters through the Structure
 - Flood vents installed to reduce hydrostatic pressures
5. Risk Reduction of Interior Office Operations
 - Construct elevated steel modular building exterior to the building footprint
