## APPENDIX B: FIGURES

**Figure B2. Proposed beach renourishment and Dune Restoration (Areas 1 and 2), proposed Caminada Pass Shoal borrow site, and proposed project construction staging area.**

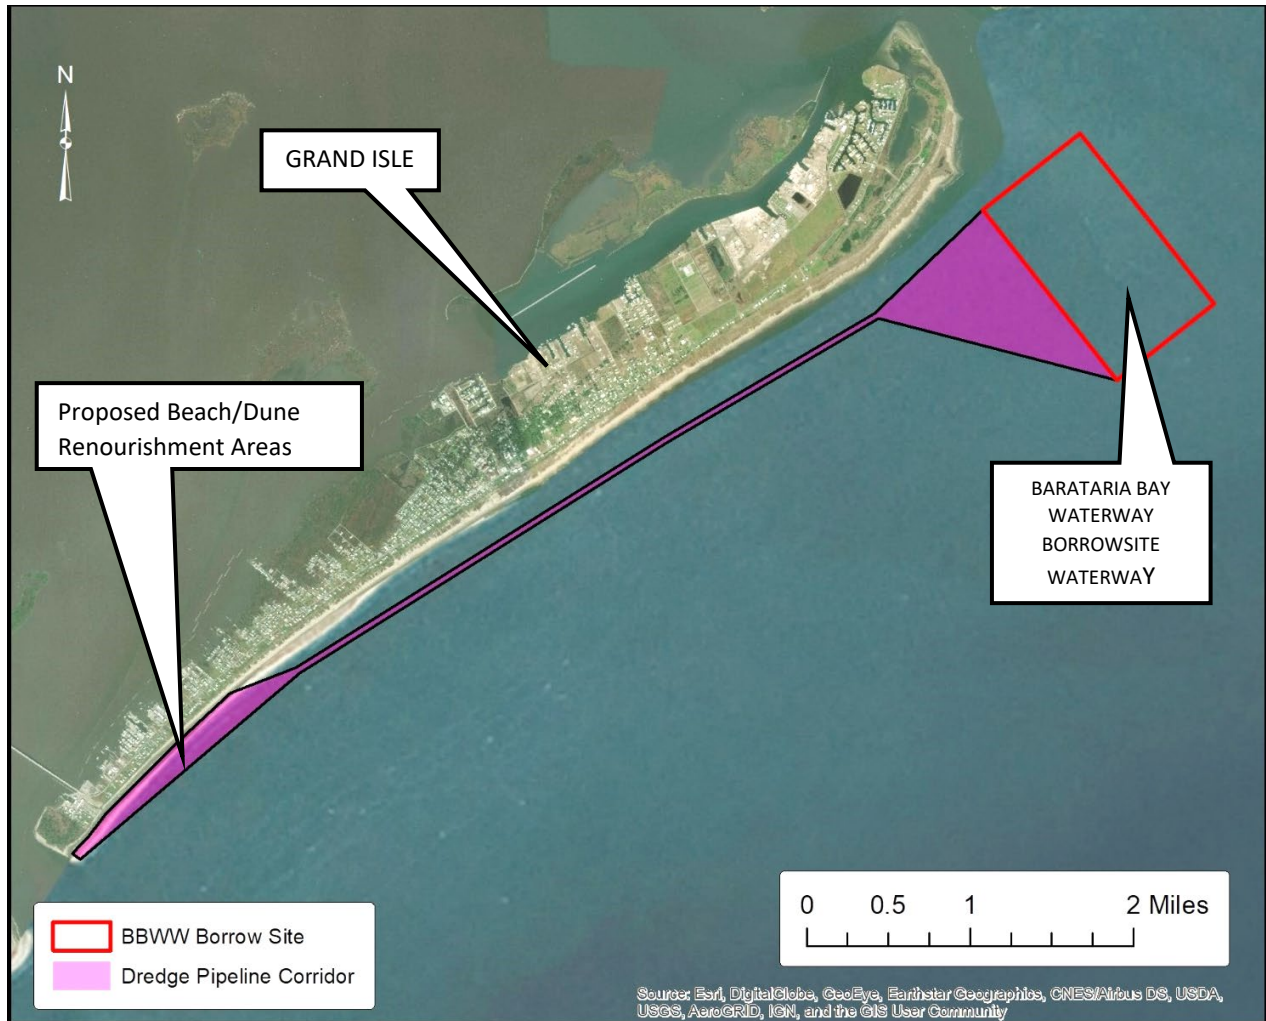
**Figure B3. Proposed Barataria Bay Waterway (BBWW) borrow site and the approximate limits of the corridor that would be used to pipe dredged sediments (sand) to the proposed beach renourishment and Dune Restoration areas.**

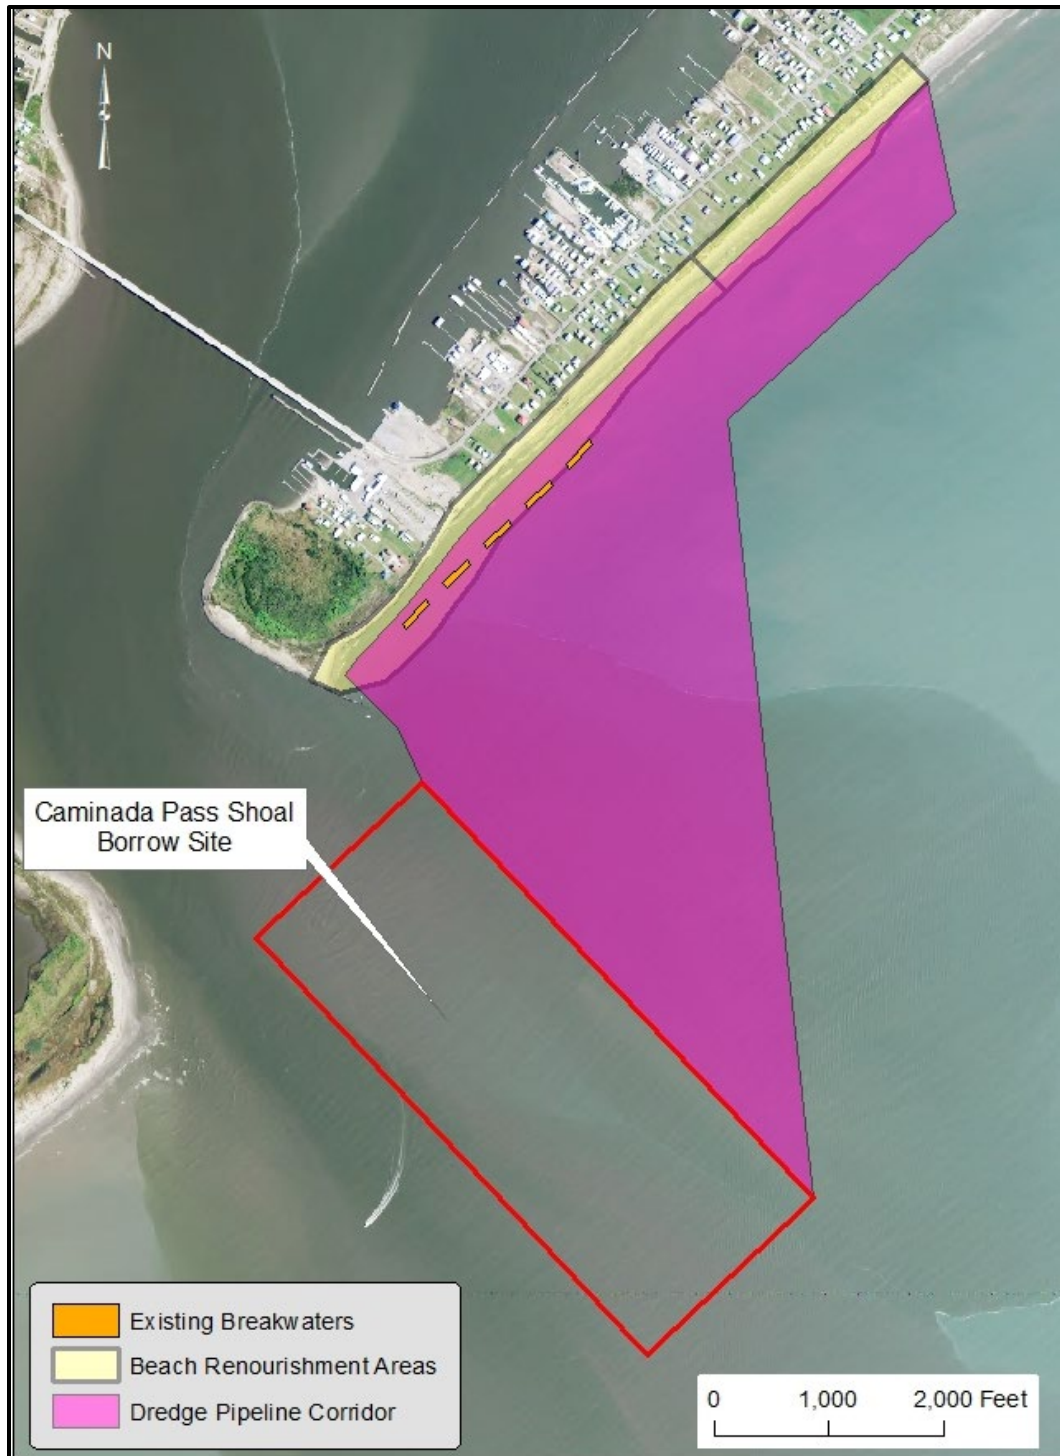
**Figure B4. Proposed dredge pipeline corridor extending from the proposed Caminada Pass Shoal borrow site to the proposed beach renourishment and Dune Restoration areas.**

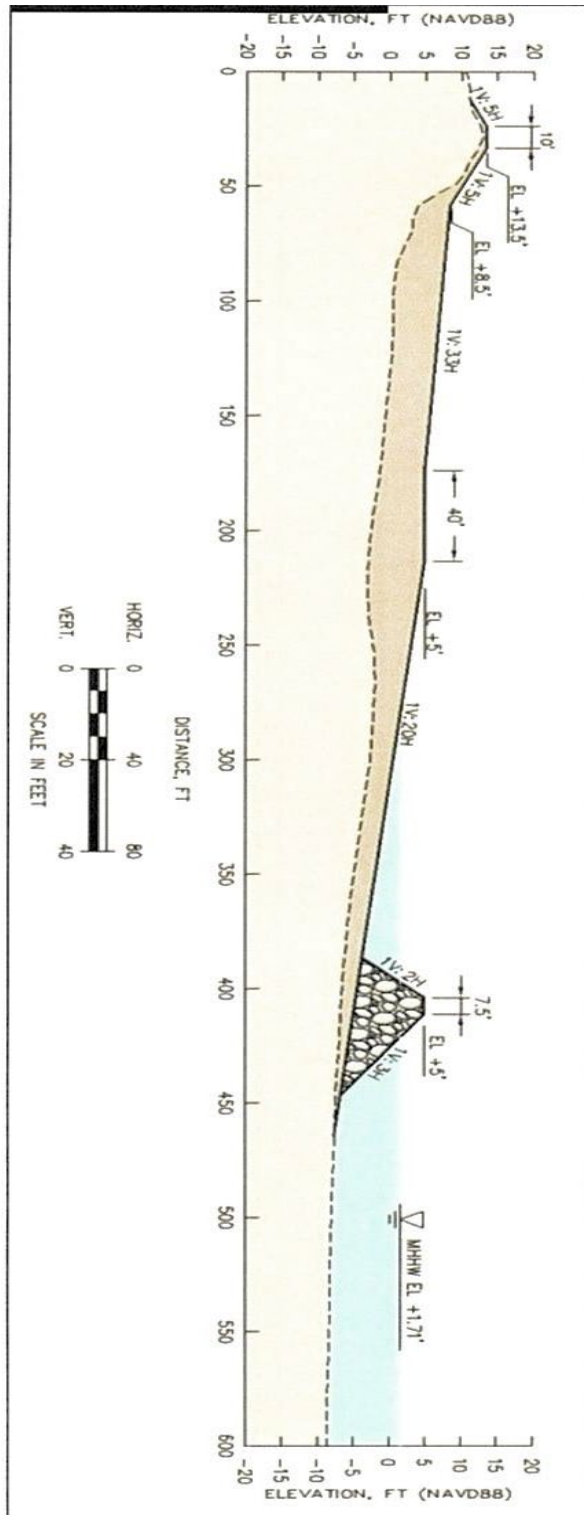
Figure B5. Typical cross-section through the proposed beach renourishment and Dune Restoration area and one of the previously constructed breakwater features. Darker brown shading indicates the sand that would be added for restoration/renourishment purposes.

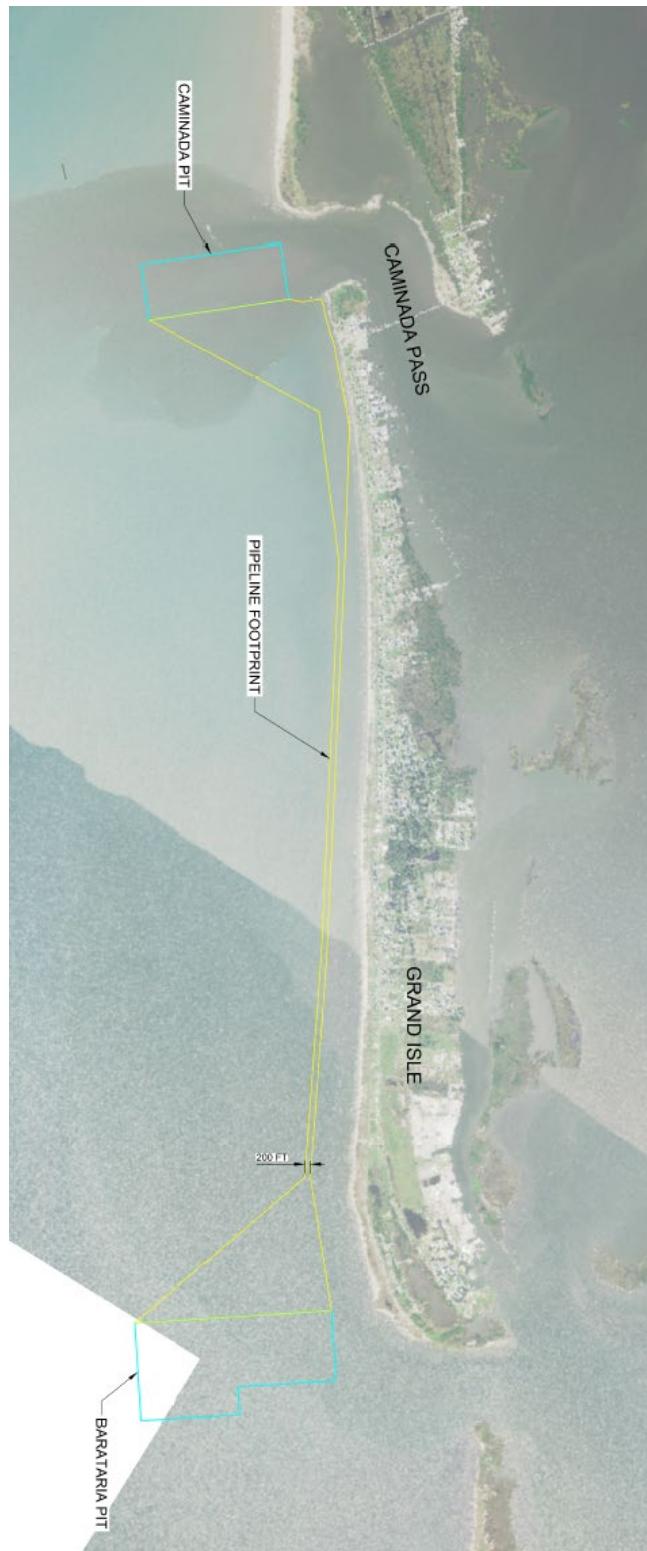
**Figure B2: Dredge Pipeline Pathway**

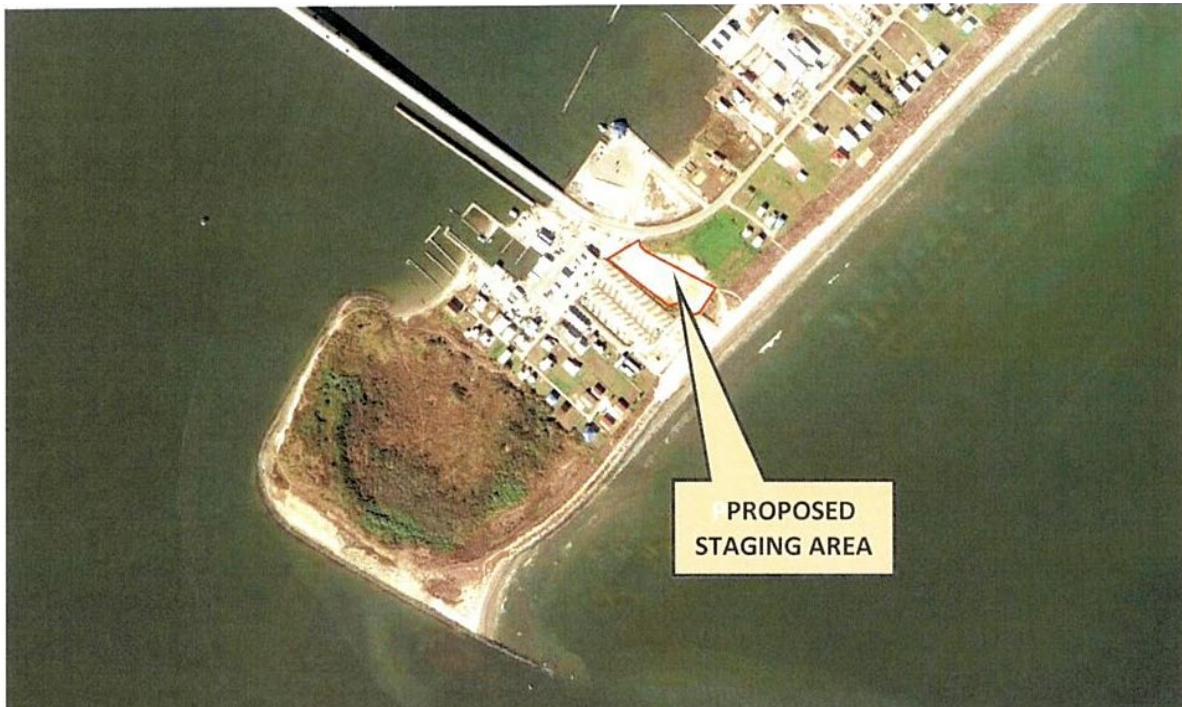
**Figure B3: Proposed Staging Area**

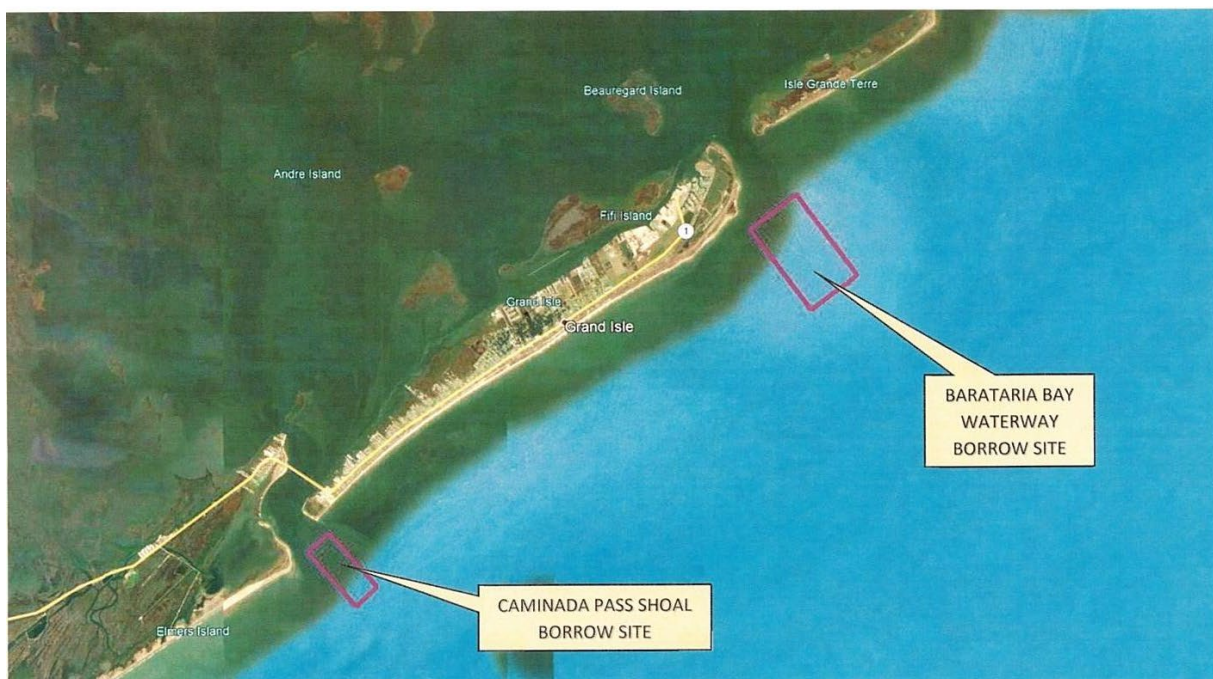
**Figure B4: Proposed Borrow Locations**

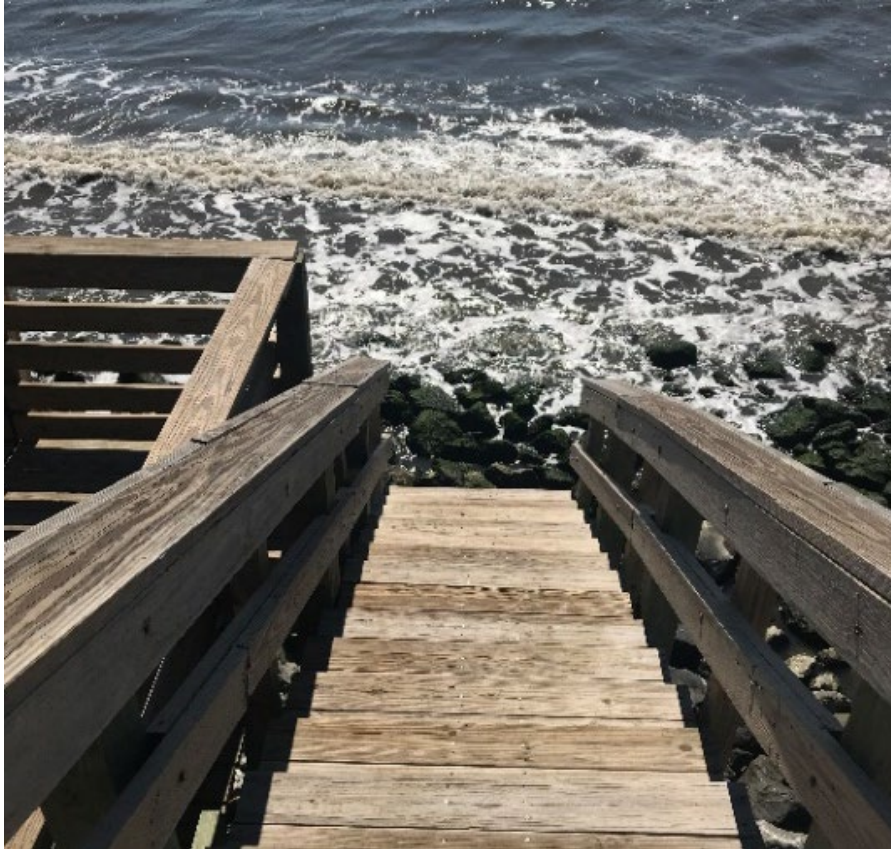
**Figure B7: Boardwalk Closed Due to Erosion**

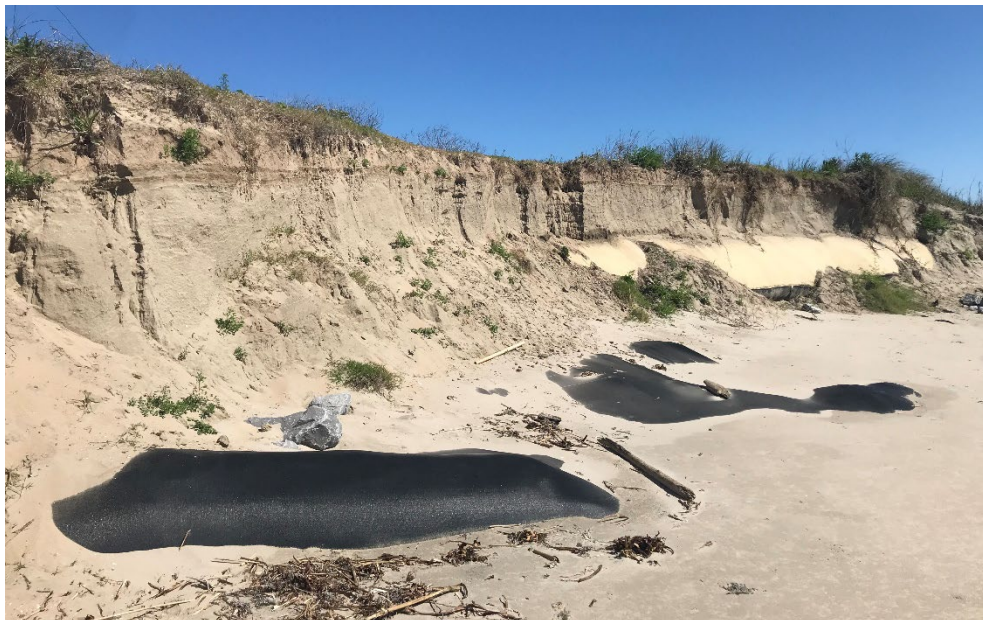
**Figure B8: Exposed Geotube**
