LAKE PONTCHARTRAIN AND VICINITY
LONDON AVENUE OUTFALL CANAL
EASTBANK TOE

SOIL AND GEOLOGIC PROFILE

U.S. ARMY ENGINEER DISTRICT, NEW ORLEANS
CORP OF ENGINEERS
NEW ORLEANS, LOUISIANA

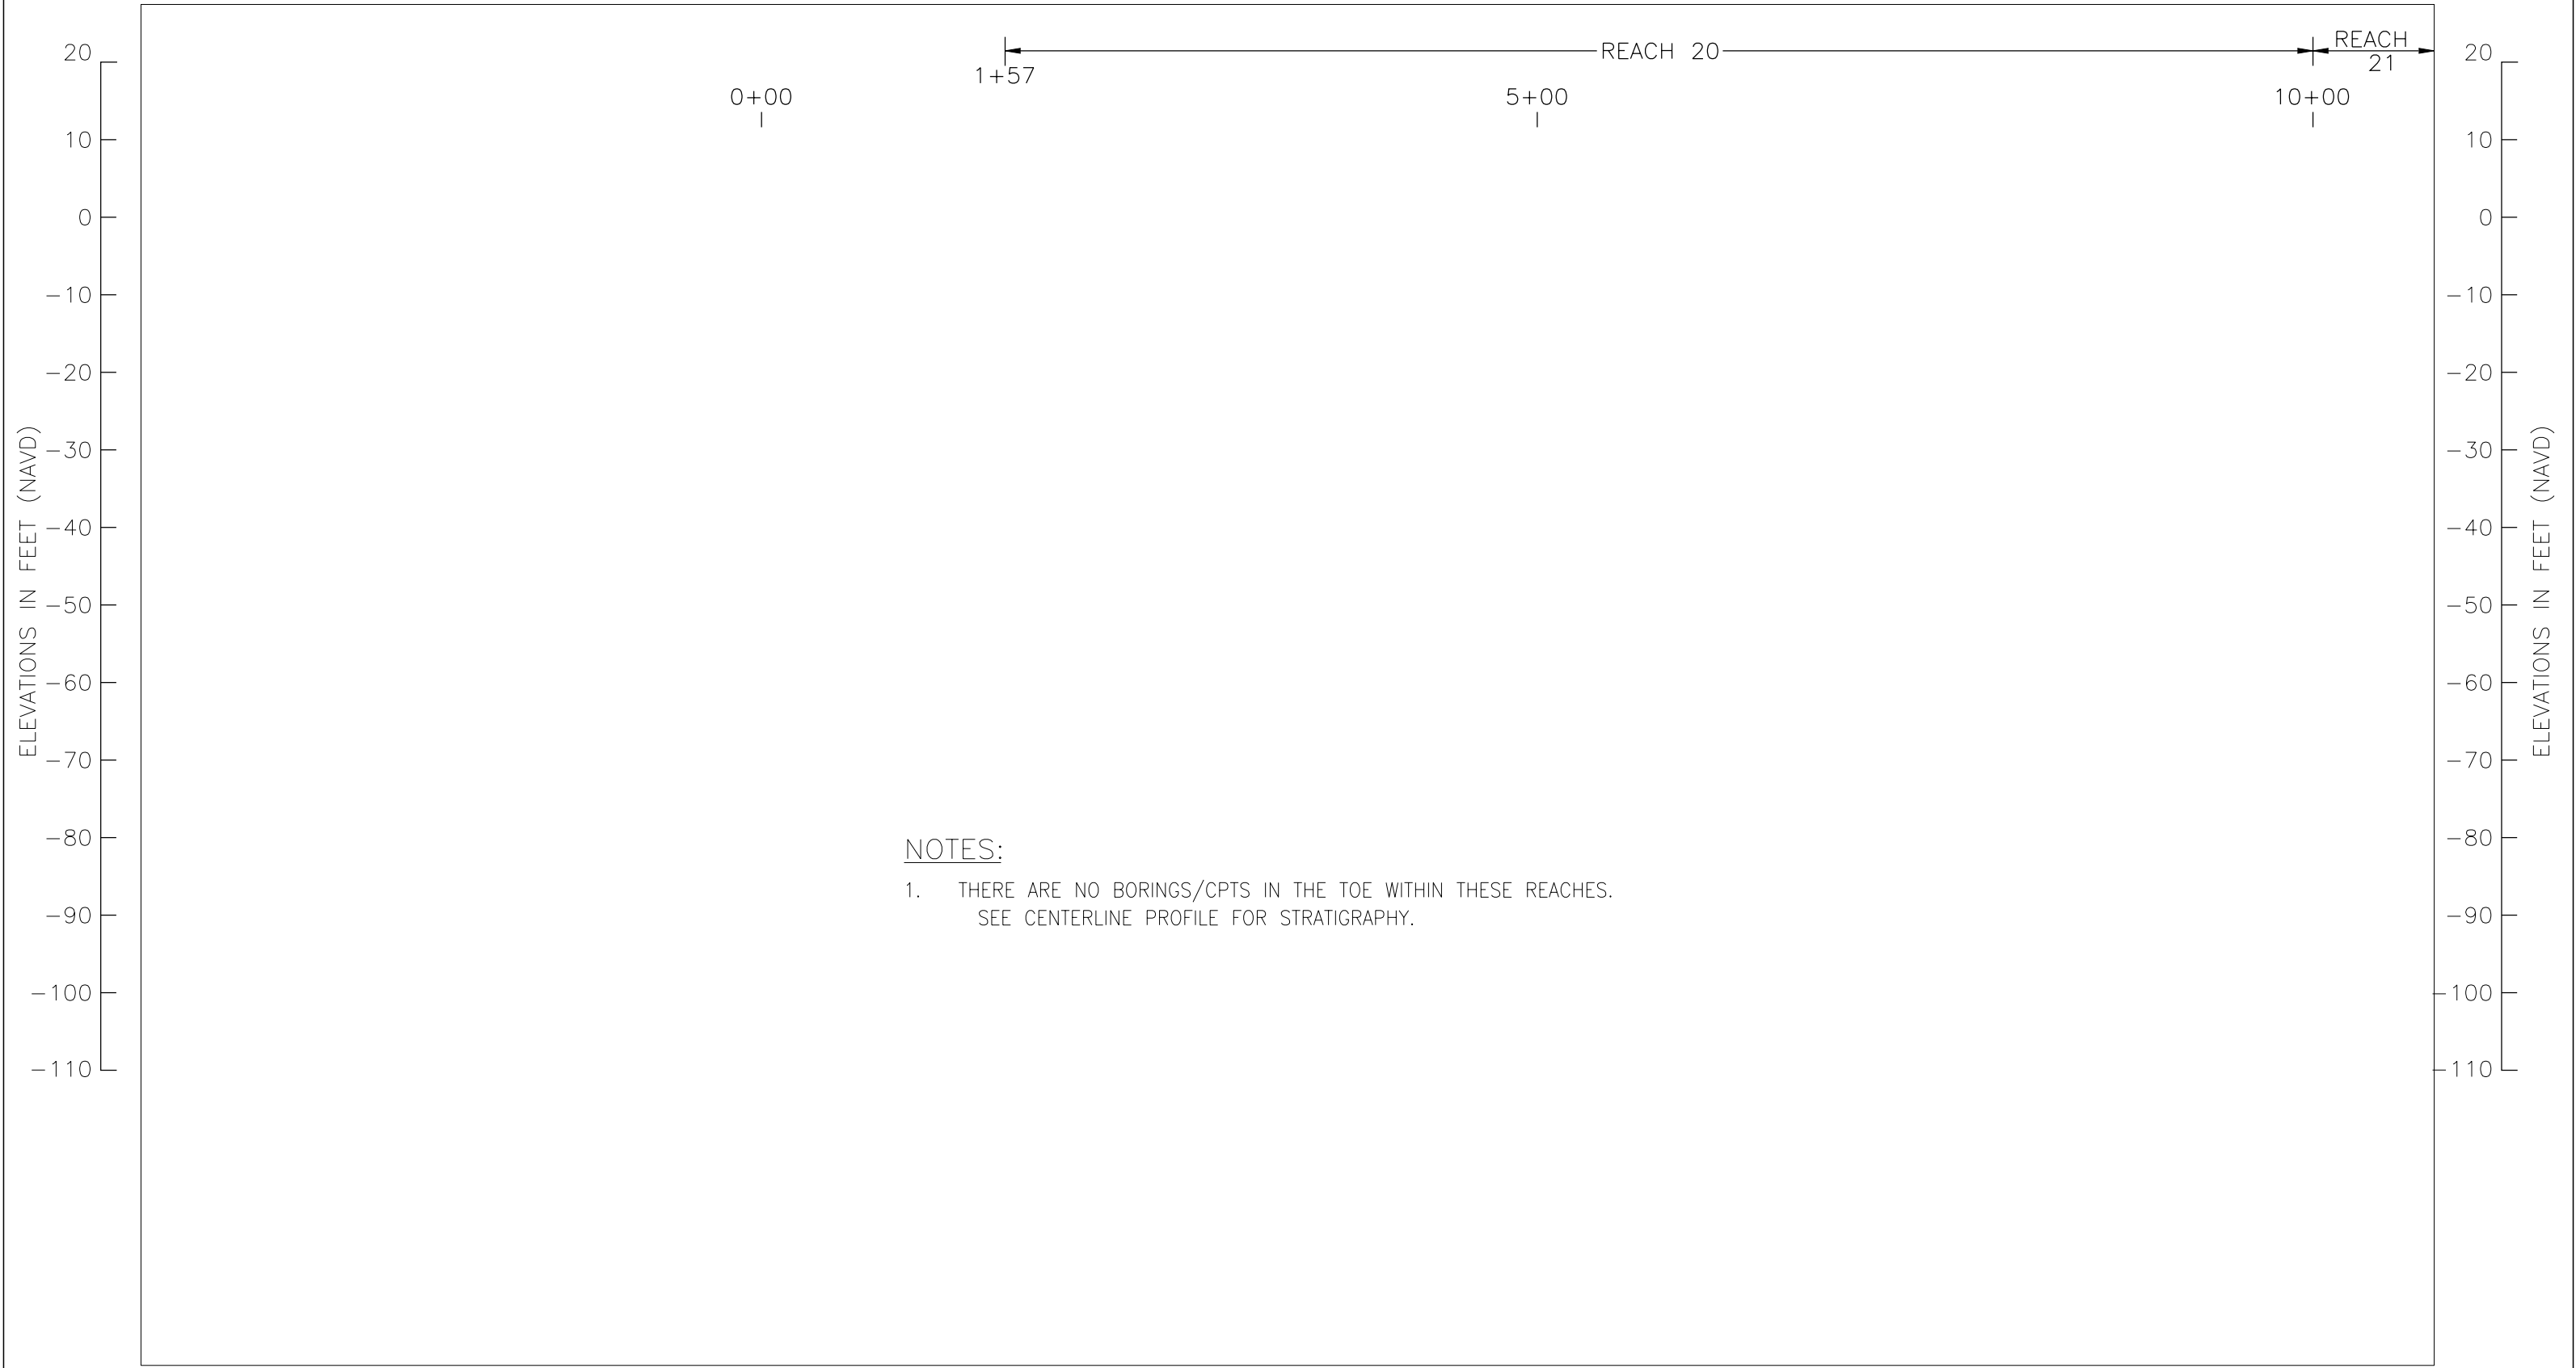
| PLOT SCALE: 1 : 1 | FILE NO. PLATE 21 |

1. THERE ARE NO BORINGS/CPTS IN THE TOE WITHIN THESE REACHES.
SEE CENTERLINE PROFILE FOR STRATIGRAPHY.
