PUBLIC NOTICE

COMITE RIVER MITIGATION BANK IN EAST FELICIANA PARISH

PROSPECTUS FOR THE PROPOSED
COMITE RIVER MITIGATION BANK
EAST FELICIANA PARISH, LOUISIANA

June 2022

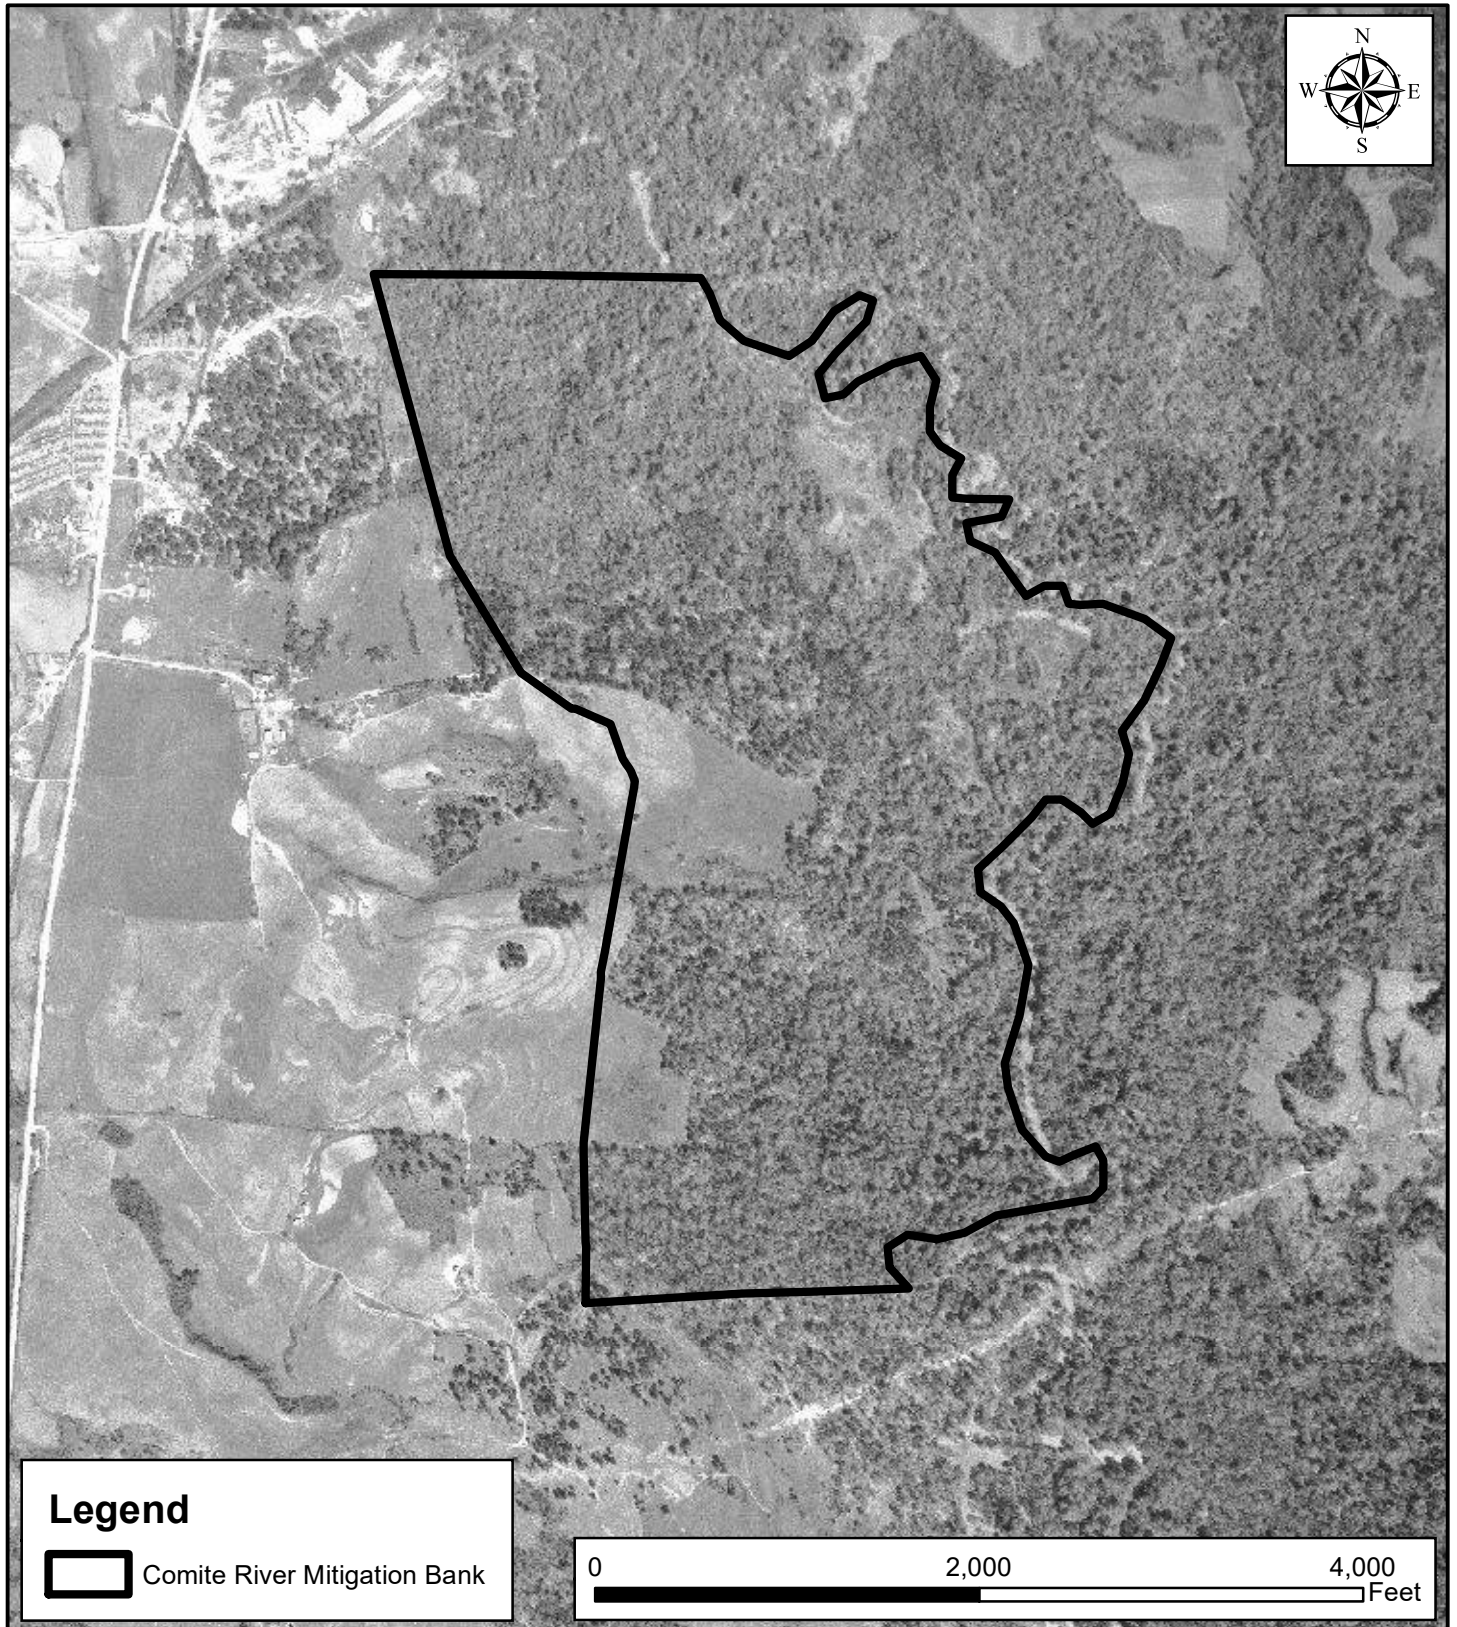
Figure 3. Historical Aerial Photograph (1952)

The Comite River Mitigation Bank historically encompassed upland hardwood and BLH forest communities. The floodplain along the Comite River supported a BLH forest community. A hardwood forest community existed on the higher elevations and ridges adjacent to the floodplain. Historical photos show the site conditions in and around the bank location between 1952 and 2015 (**Figures 3-8**).

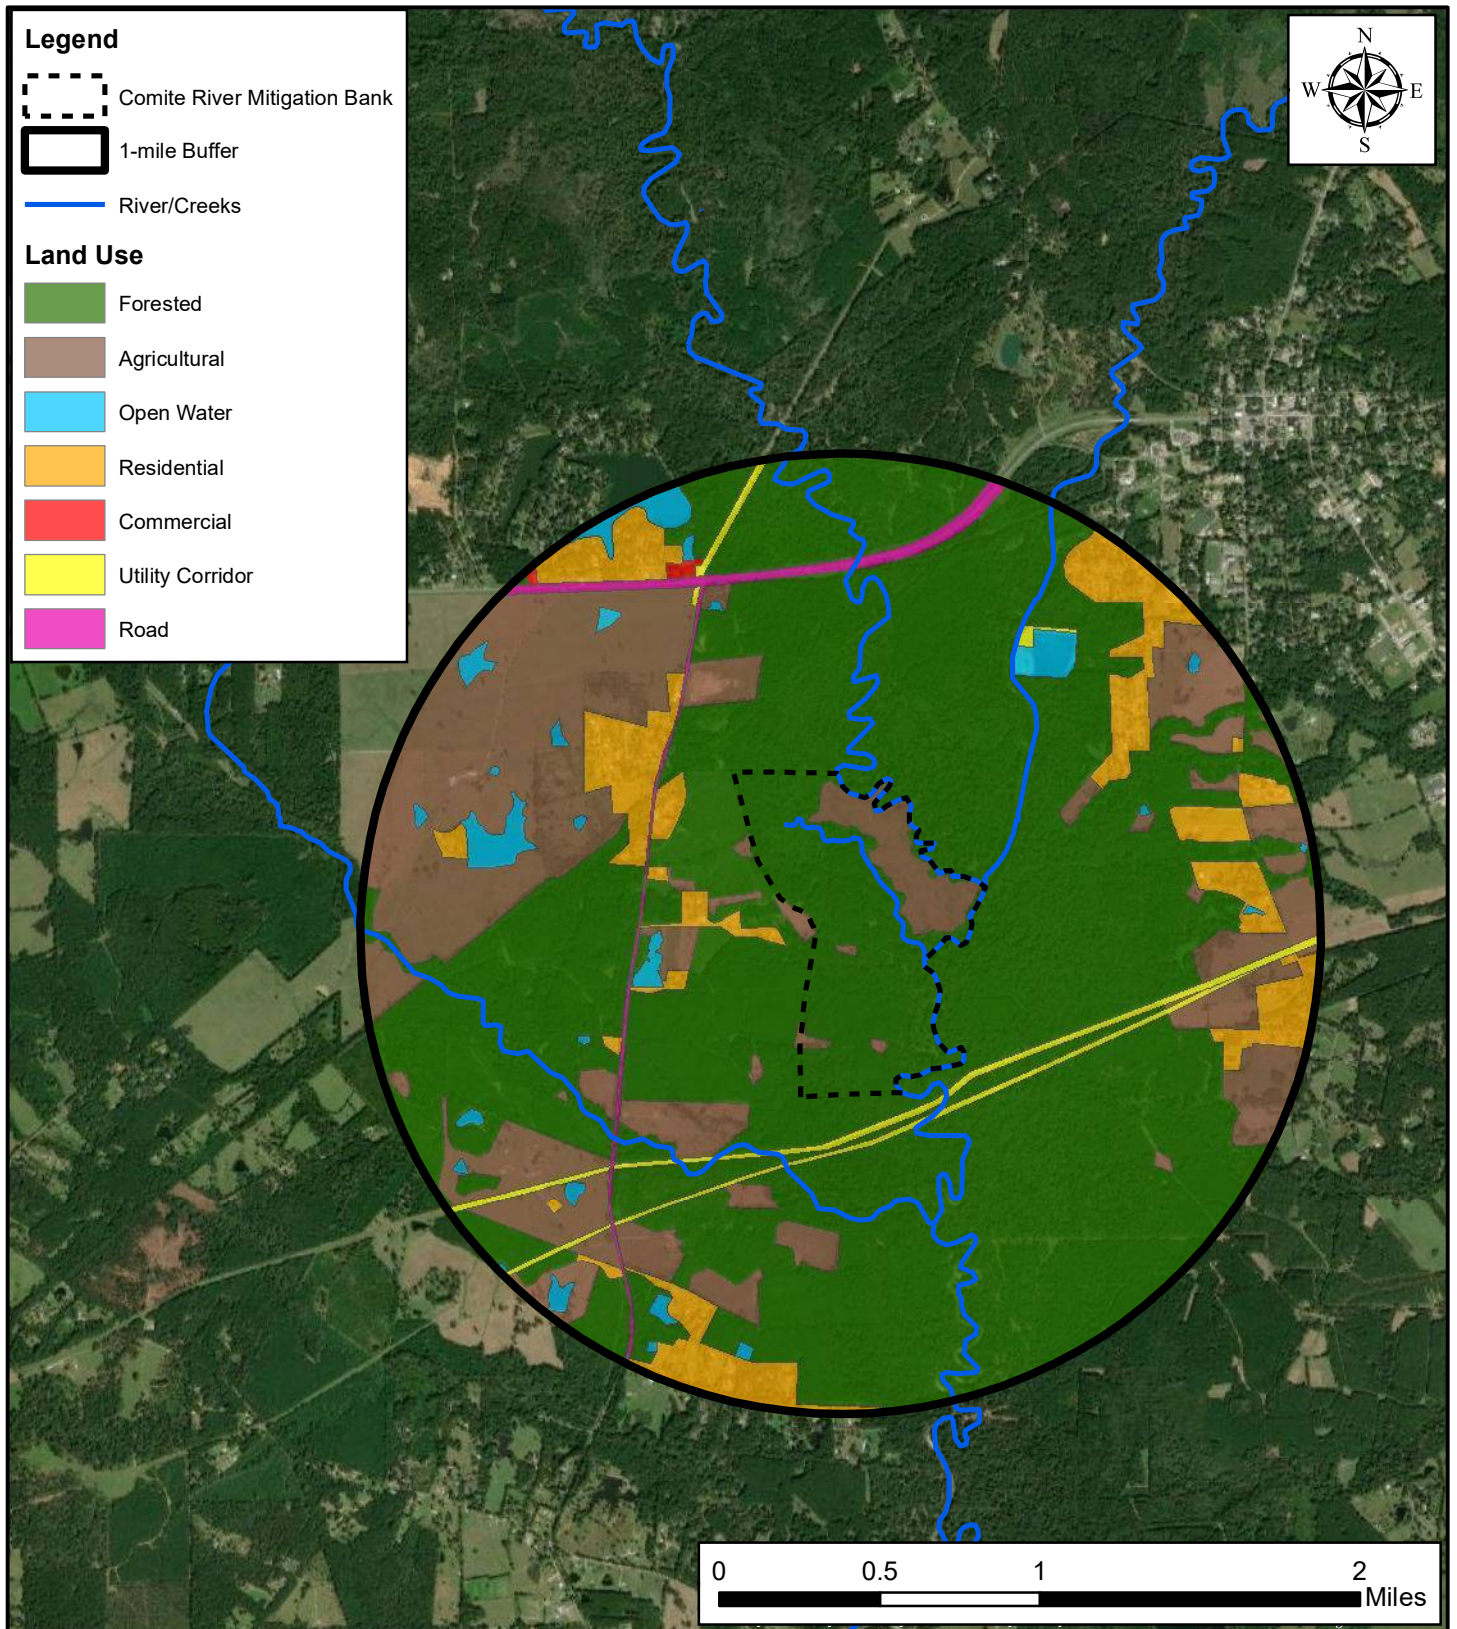
Figure 9. Land Use within 1 Mile of Comite River Mitigation Bank

Land use in the vicinity of the Comite River Mitigation Bank is mostly undeveloped forest land with scattered small residential developments (single family homes) and maintained pastures. Current aerial photography and field visits were used to determine the current land use on, and within a 1-mile radius of, the Bank (**Figure 9**). The property is currently used for agricultural (timber production) and recreational purposes.

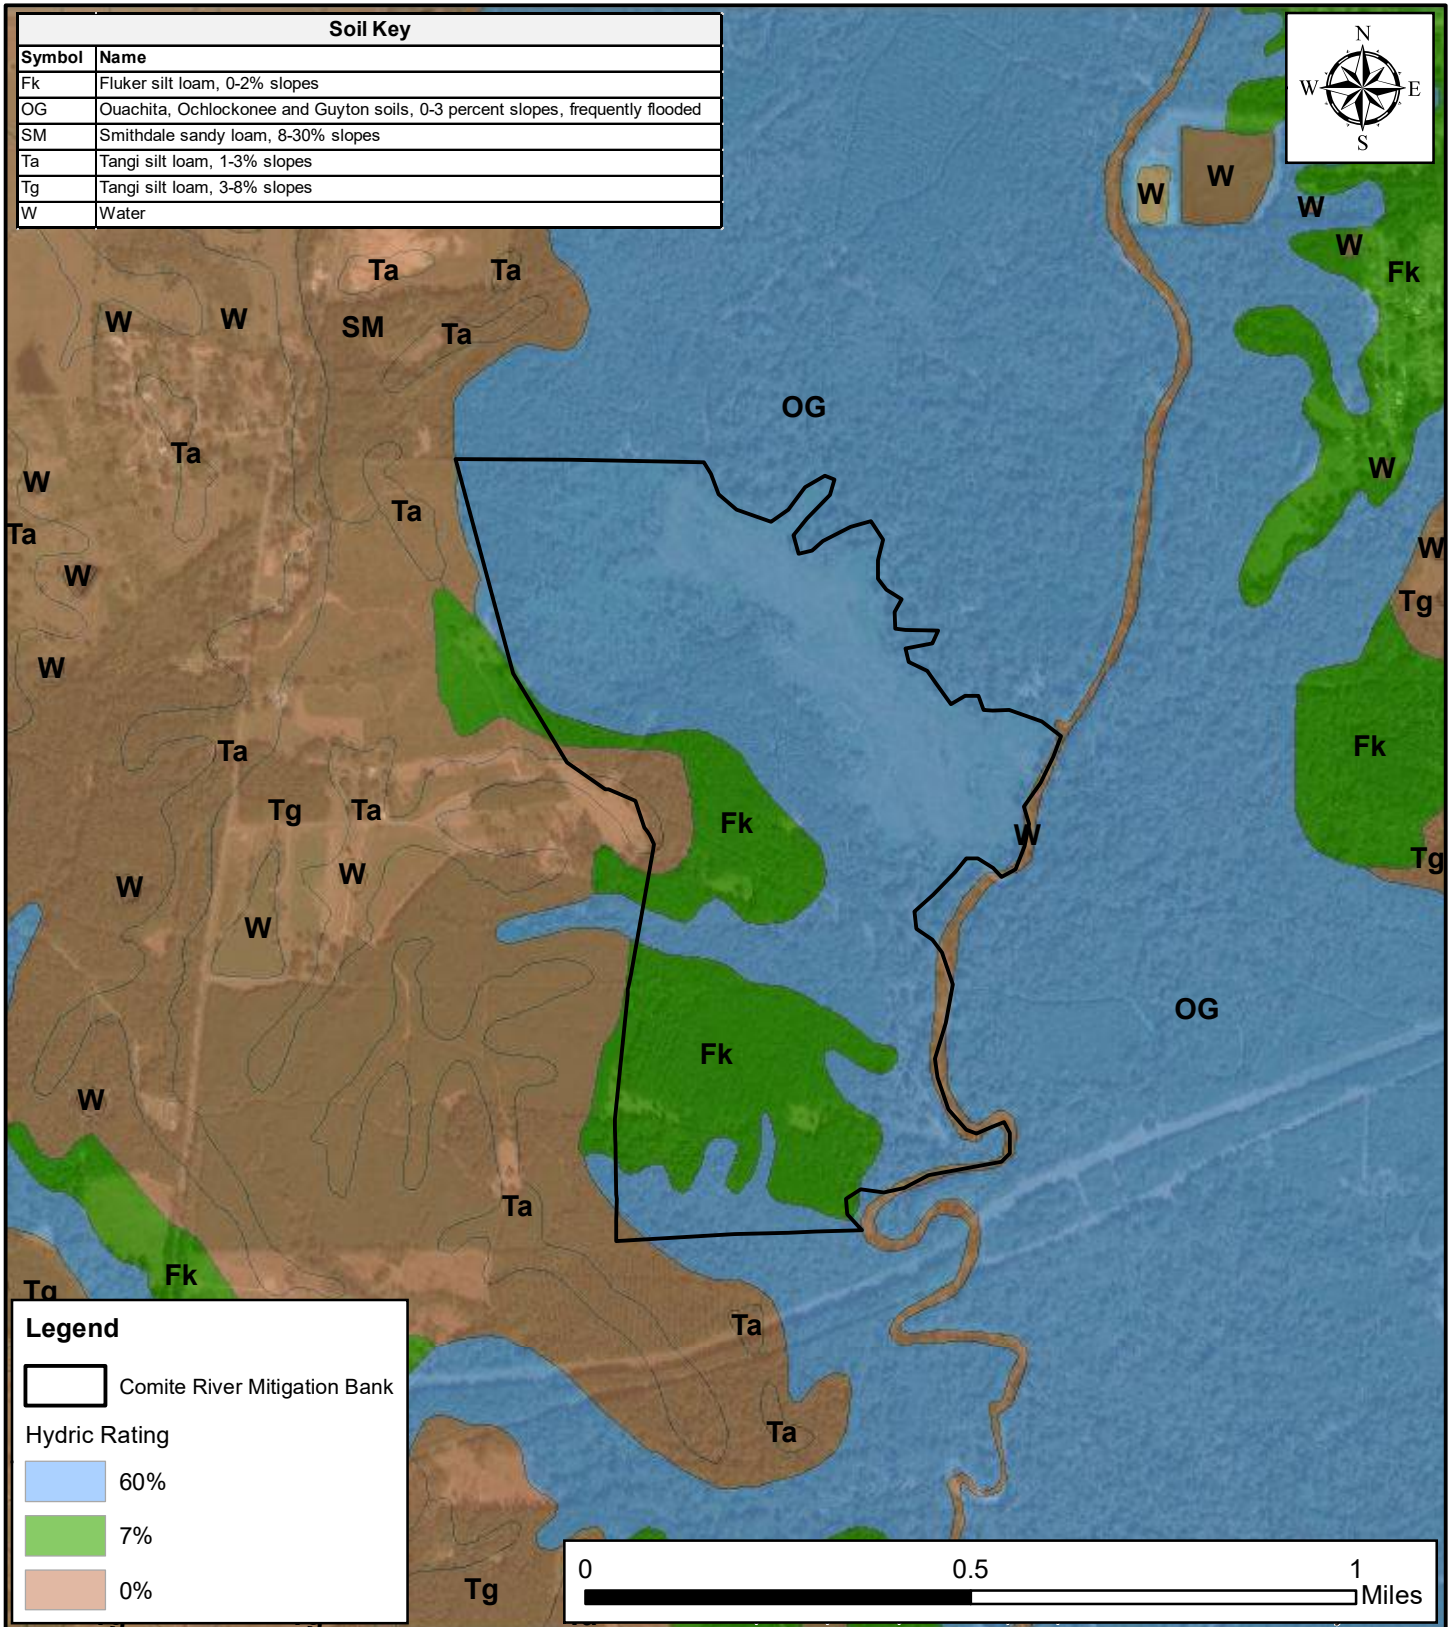
Figure 10. Soils Map

Soils within the proposed Comite River Mitigation Bank are determined in large part by topographic position in relation to the Comite River. In general, the property is level and very gently sloping poorly-drained to moderately well-drained loamy soils (USDA 2020). The majority of the soils within the proposed Comite River Mitigation Bank are mapped as Ouachita, Ochlockonee, Guyton Soils (OG). Smaller areas of Fluker silt loam (Fk) and Tangi silt loam (Ta and Tg) are also present (**Figure 10**).

Ouachita, Ochlockonee, Guyton soils are typical of floodplain areas and have a hydric rating of 60. Ouachita and Ochlockonee soils occur on low ridges, and Guyton soils are found in low positions between the ridges. These soils are subject to brief to long periods of flooding throughout the year. The Fluker soils are nearly level to gently sloping (0-2% slopes), somewhat poorly drained soils on broad, flat terraces. The Fluker soil has a hydric rating of 7. Tangi silt loam is a gently to strongly sloping (1-8% slopes), moderately well drained soil on narrow or broad ridgetops on uplands or on side slopes on uplands along drainageways. Tangi has a hydric rating of 0.

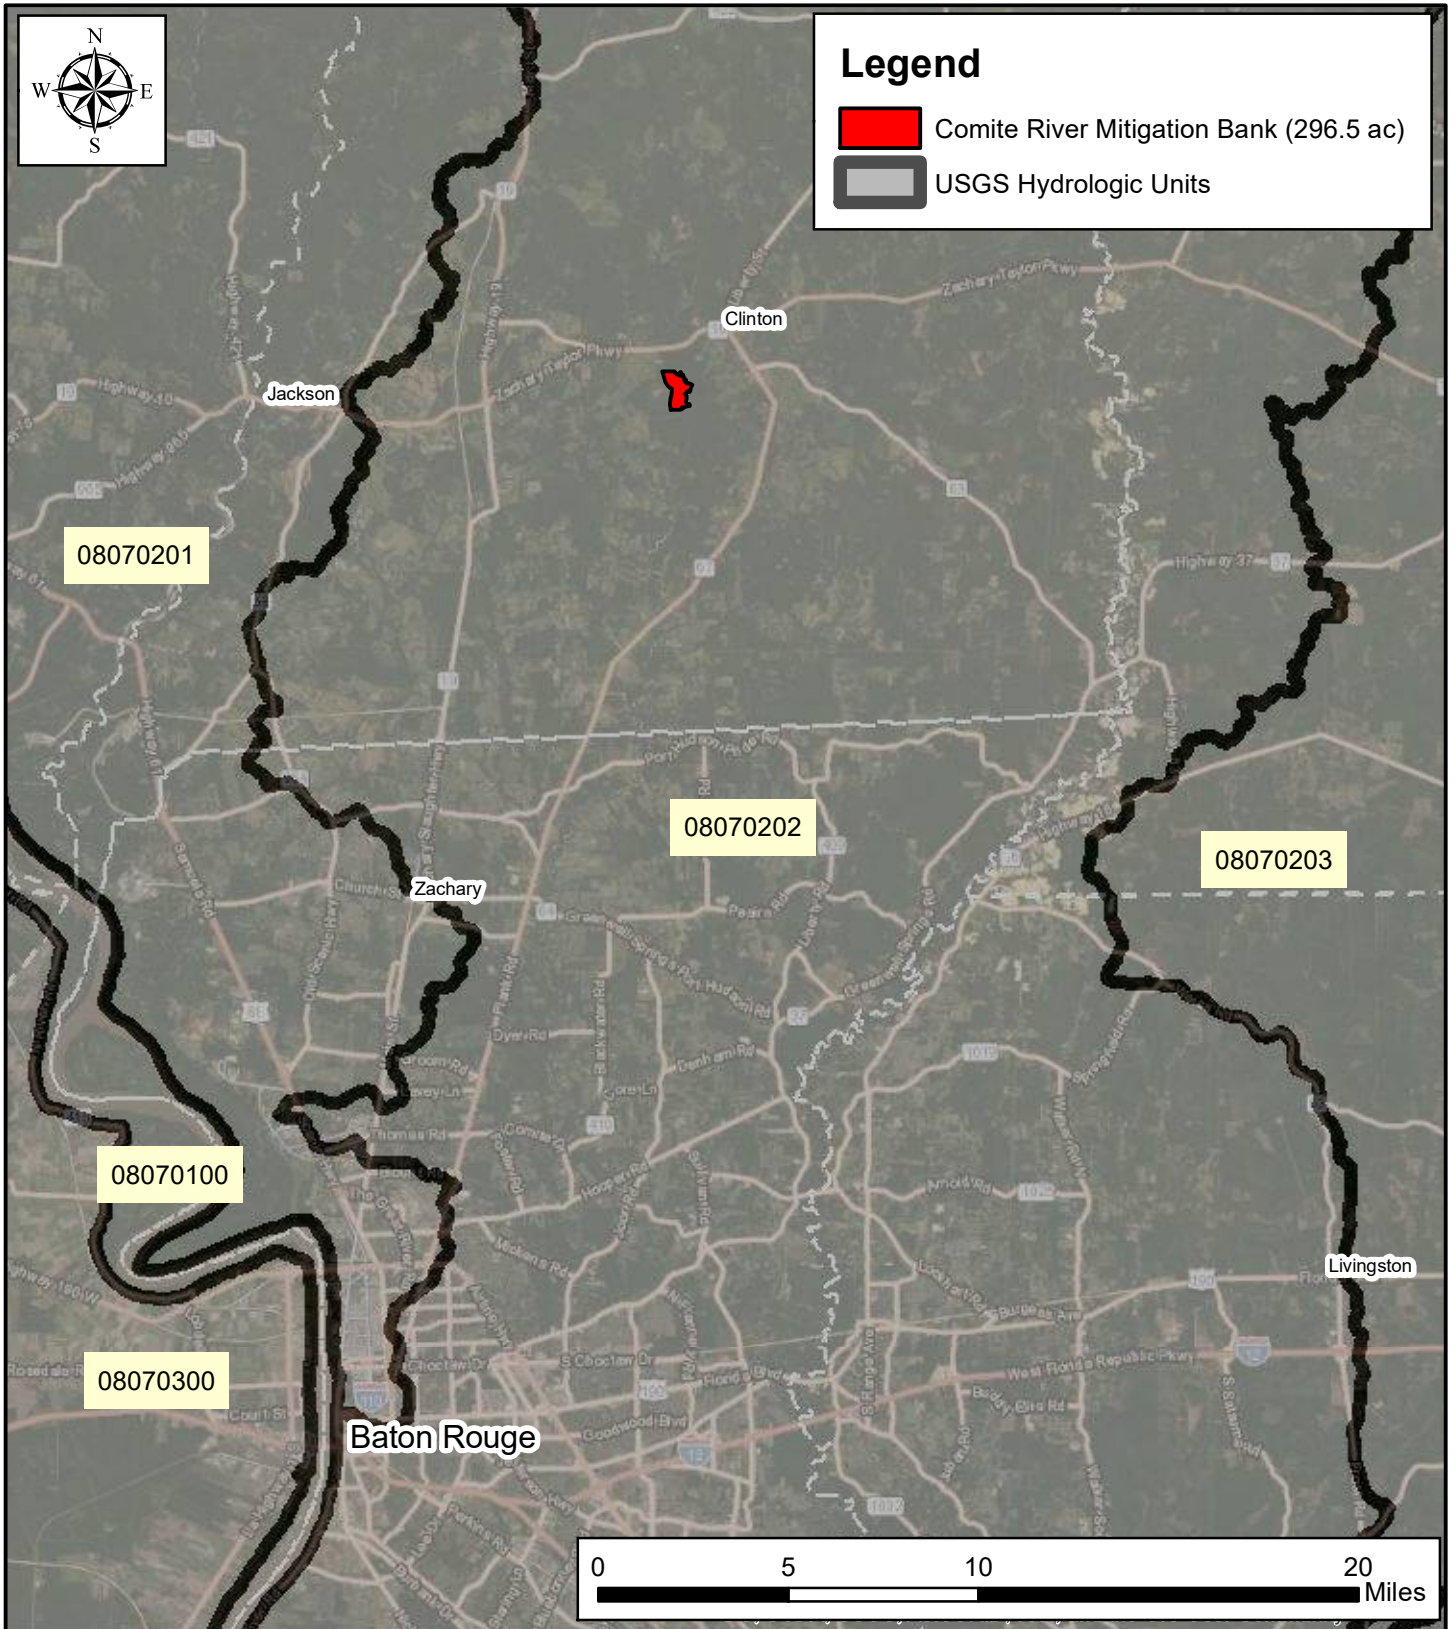
Figure 11. Hydrologic Units near the Comite River Mitigation Bank

The proposed Comite River Mitigation Bank is located within the Amite Basin encompassing 1,205,578 acres. The entire property lies within USGS Hydrologic Unit Code (HUC) 08070202 (**Figure 11**). The contributing drainage area associated with the proposed mitigation bank lies within the Pretty Creek (35,042 acres) and the Knighton Bayou-Comite River (33,098 acres) watersheds (**Figure 12**). The drainage area for the Comite River Mitigation Bank encompasses 35,277 acres (**Figure 13**).

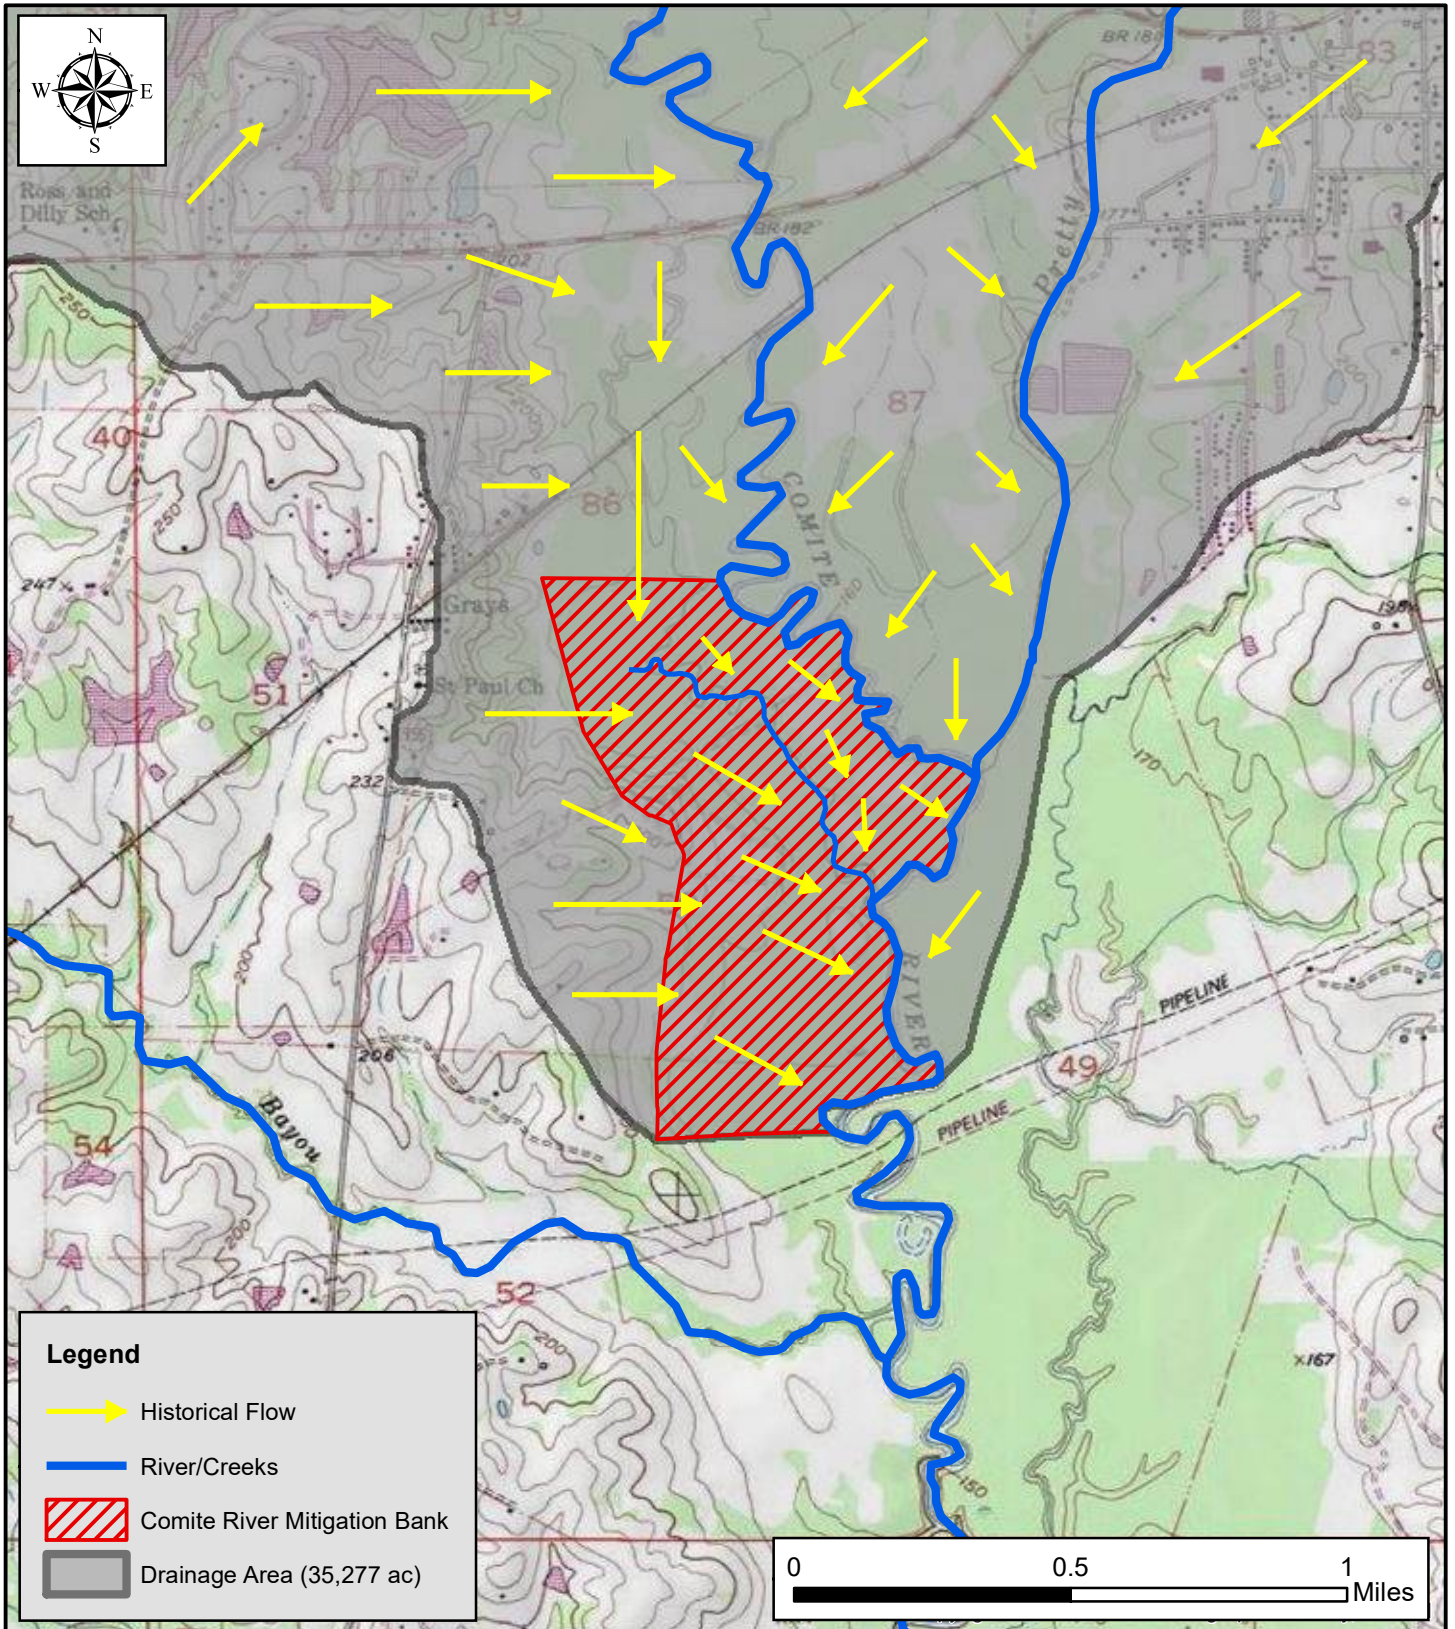
Figure 14. Historical Hydrology and Drainage Patterns

Historically, the area encompassing the proposed mitigation bank drained naturally via gravity into the Comite River (**Figure 14**). The Comite drains into the Amite River near Baton Rouge. The Amite River flows east into Lake Maurepas. Elevation on the proposed bank site ranges from 140 to 200 feet North American Vertical Datum (**Figure 15**).

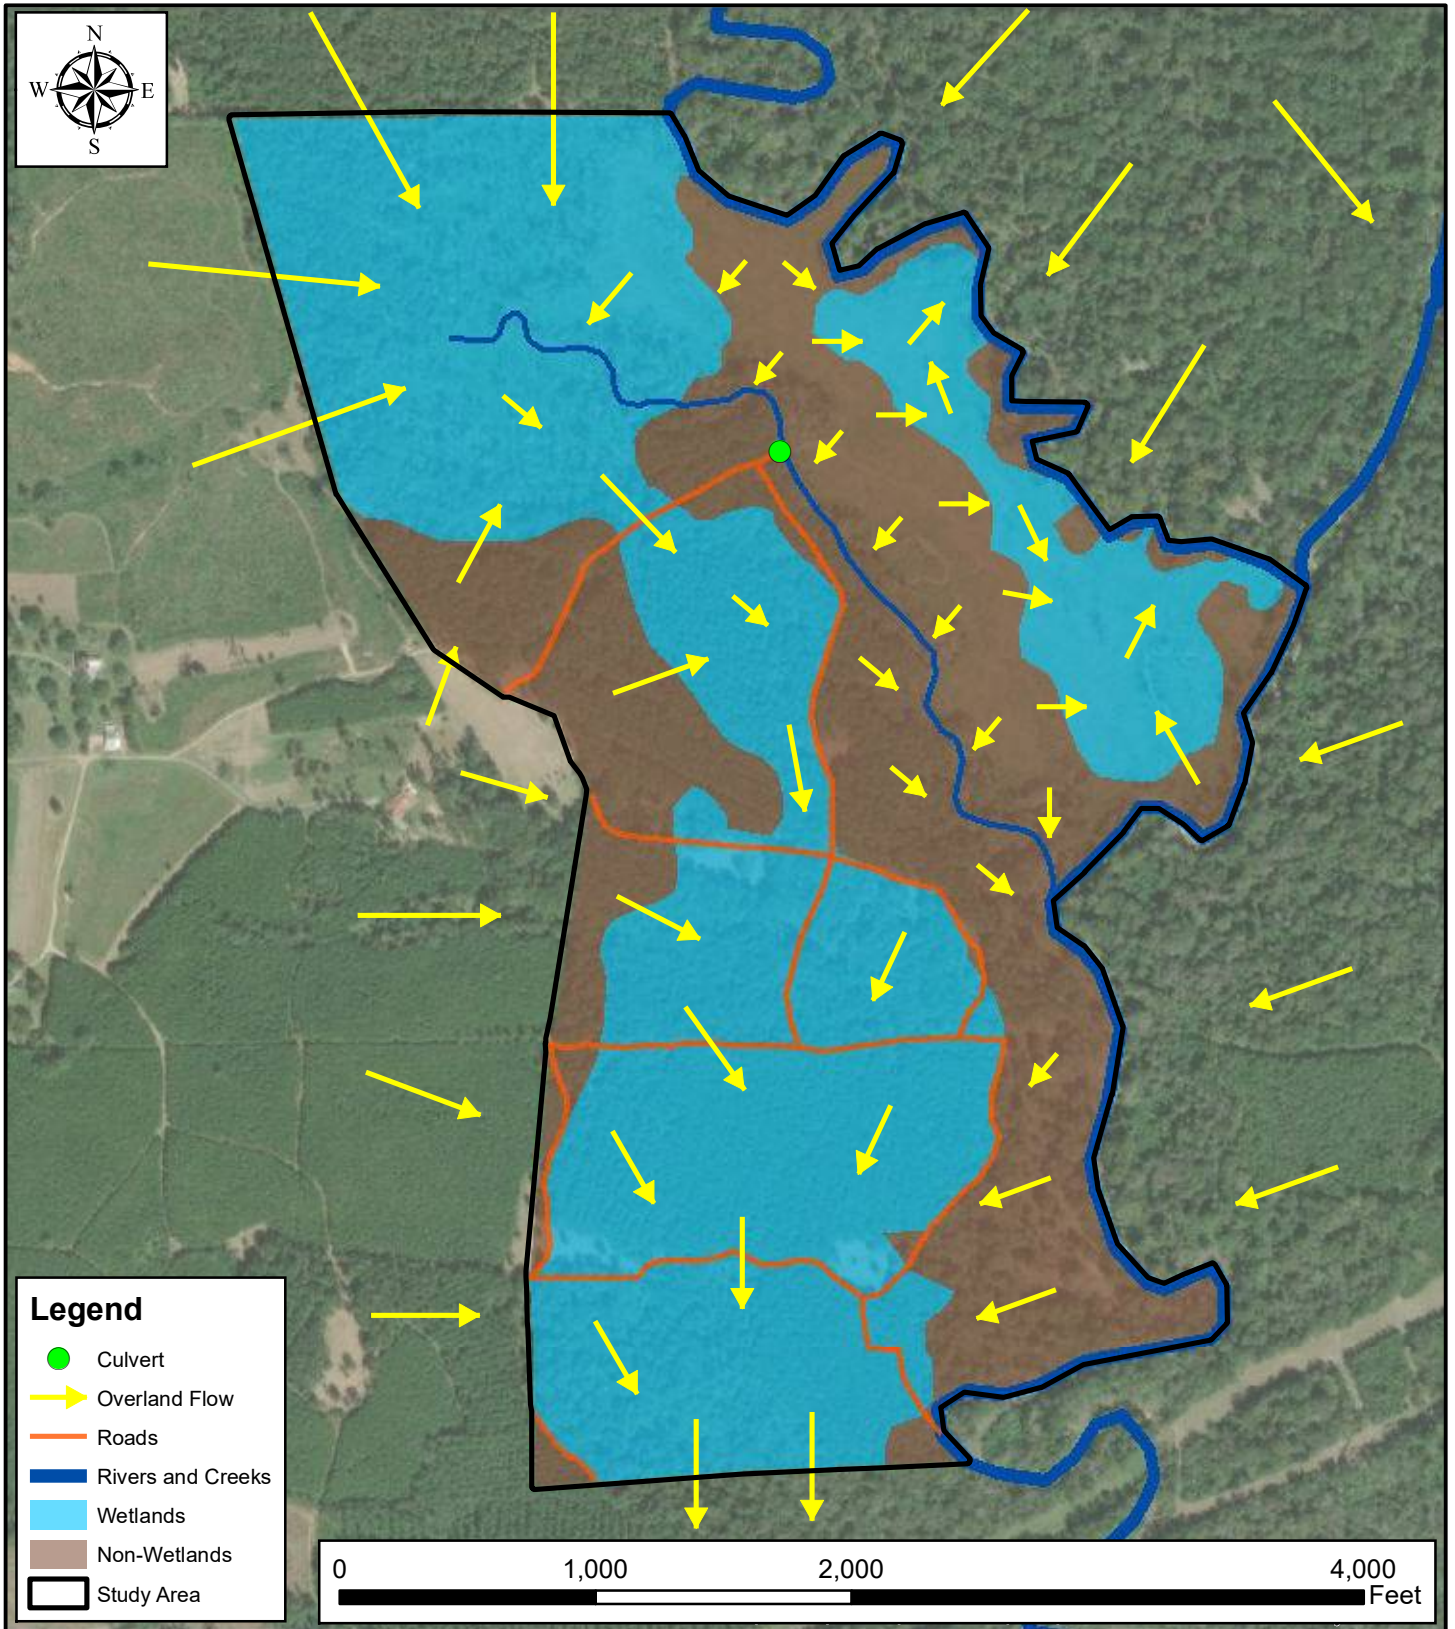
Figure 16. Existing Hydrology (Pre-Construction)

One small unnamed creek is located entirely within the proposed bank boundaries. The unnamed creek flows out of the existing wetland area in the northwest corner of the property and into the Comite River. There are no planting beds and the dirt roads and trails on the property are at grade and do not restrict hydrologic flow. The natural hydrology within the Comite River Mitigation Bank has not been altered (**Figure 16**).

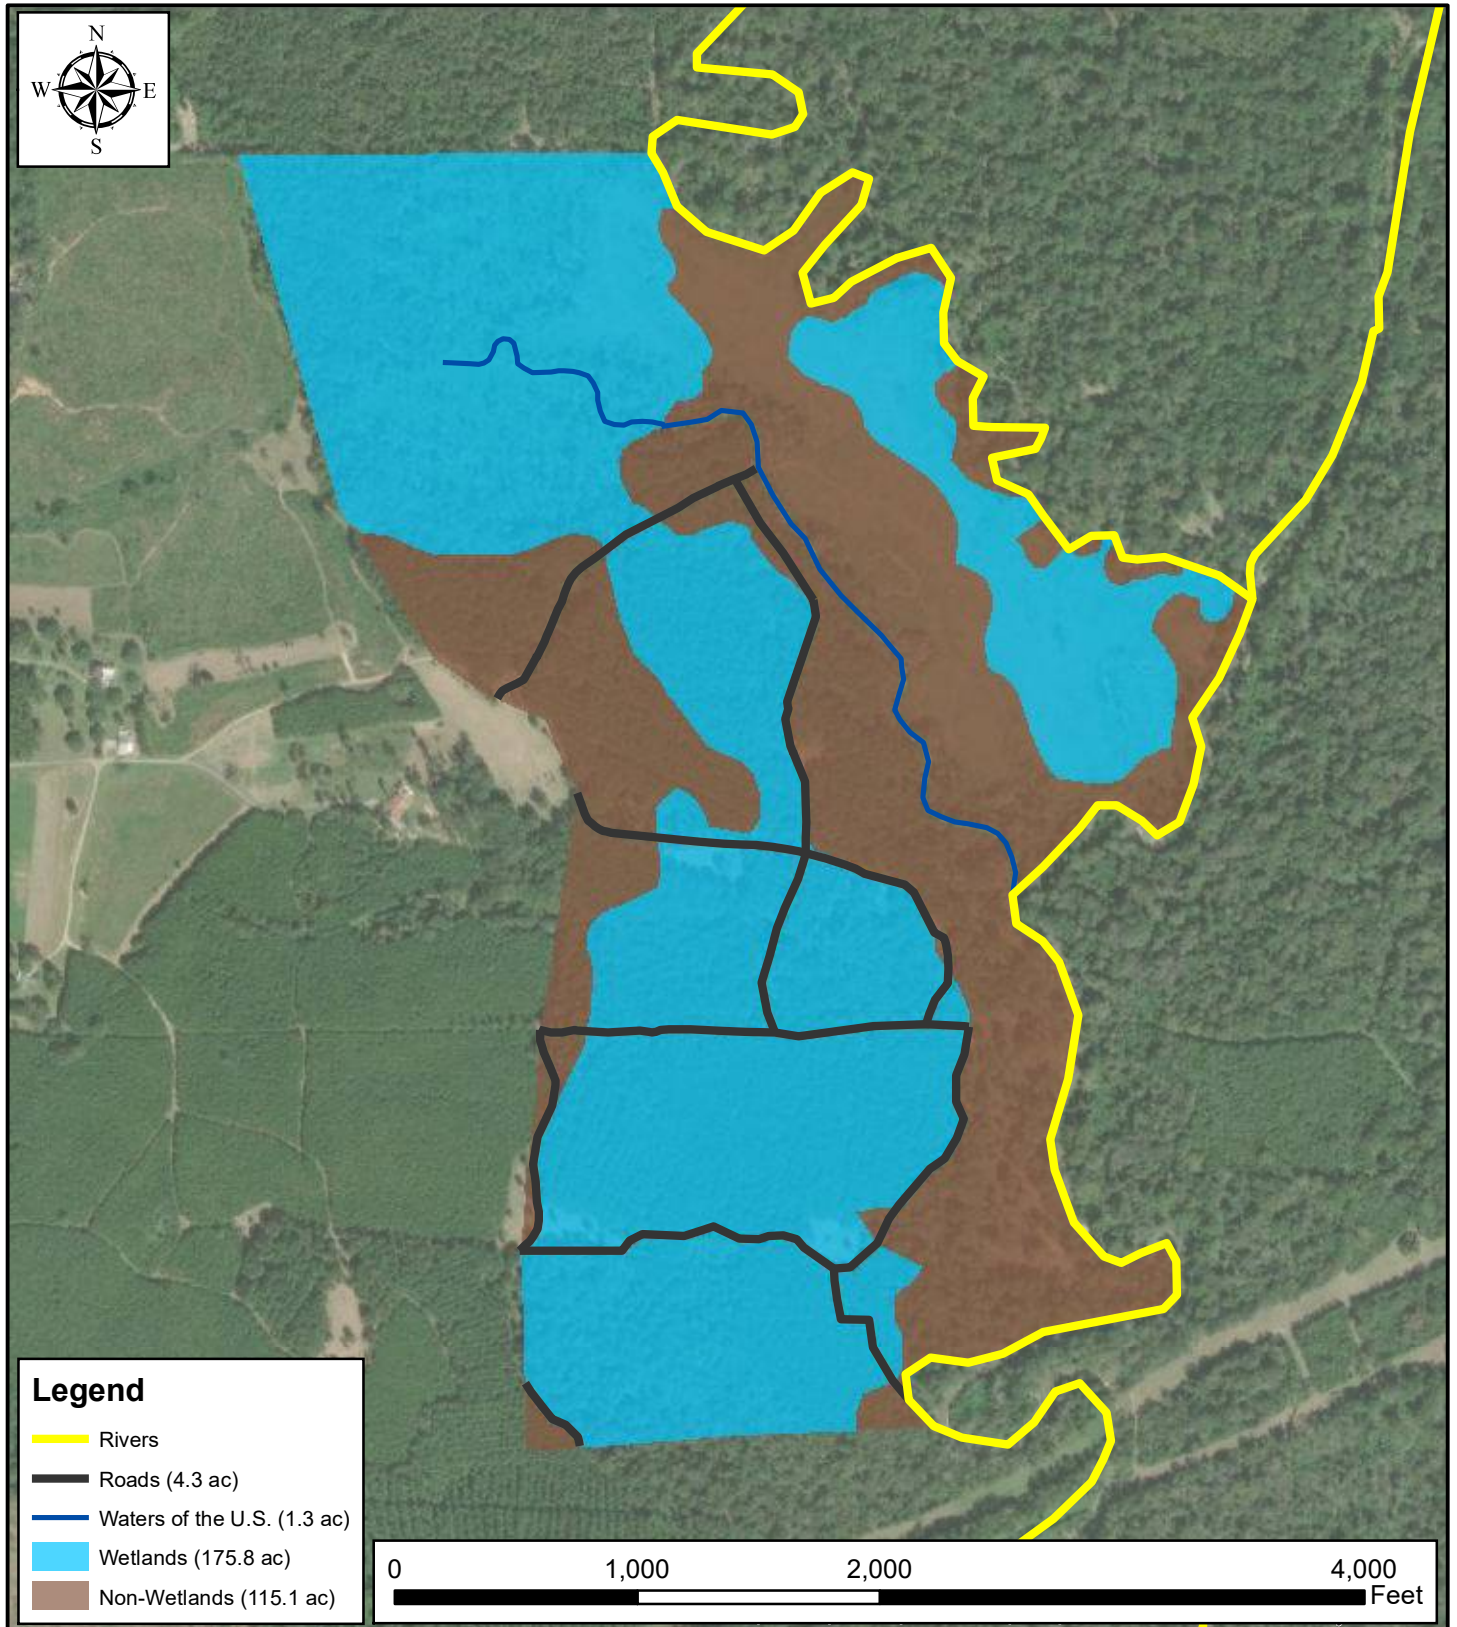
Figure 17. Wetlands within the Comite River Mitigation Bank

A wetland delineation of the property was prepared and submitted to the USACE, New Orleans District, Surveillance and Enforcement Section by Deep South Mitigation, LLC. A preliminary jurisdictional determination was issued on March 23, 2021 and is included in **Appendix A**. Based on these delineation efforts, it was determined that the proposed Comite River Mitigation Bank supports other waters of the U.S., including wetlands (**Figure 17**).

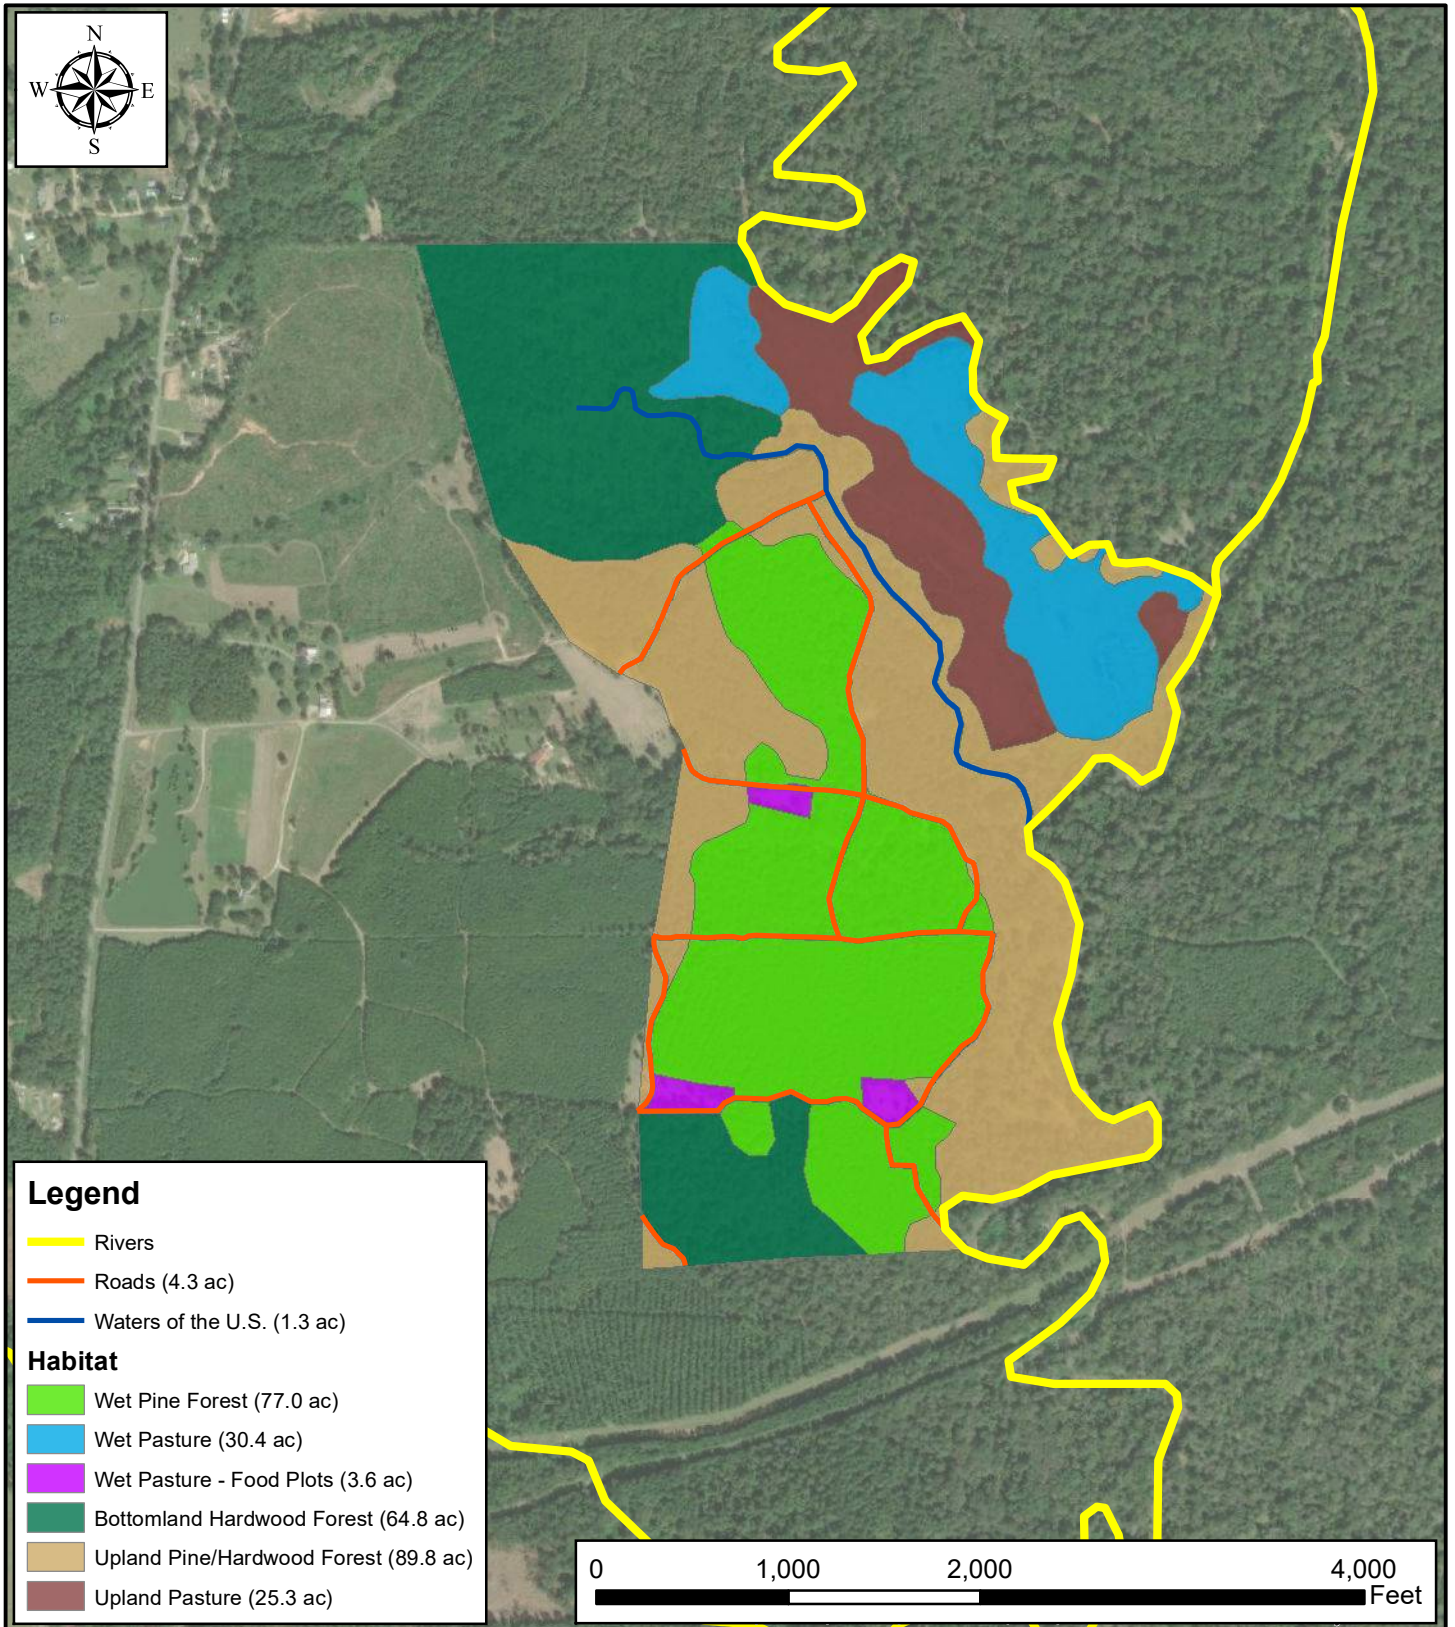
Figure 18. Existing Vegetation Communities

A mature Pine/Hardwood mixed forest occupies the majority of the site. Hardwood removal as part of past timber management efforts has shifted a large portion of the site from hardwood forest to a planted pine forest. Dominant species within the planted pine forests include slash pine (*Pinus elliottii*), water oak (*Quercus nigra*), sweet-gum (*Liquidambar styraciflua*), spruce pine (*Pinus glabra*), red maple (*Acer rubrum*), southern magnolia (*Magnolia grandiflora*), northern white oak (*Quercus alba*), swamp chestnut oak (*Quercus michauxii*), tuliptree (*Liriodendron tulipifera*), Chinese tallowtree (*Triadica sebifera*), slippery elm (*Ulmus rubra*), poison-bean (*Sesbania drummondii*), American beauty-berry (*Callicarpa americana*), Chinese privet (*Ligustrum sinense*), dwarf palmetto (*Sabal minor*), lizard's-tail (*Saururus cernuus*), eastern poison-ivy (*Toxicodendron radicans*), northern bracken fern (*Pteridium aquilinum*), Virginia-creeper (*Parthenocissus quinquefolia*), sedge (*Carex* sp.), lamp rush (*Juncus effuses*), muscadine (*Vitis rotundifolia*), panic grass (*Panicum* sp.), tall goldenrod (*Solidago altissima*), trumpet-creeper (*Campsis radicans*), Japanese climbing fern (*Lygodium japonicum*), and southern dewberry (*Rubus trivialis*). Vegetation stratification within this community is 80% overstory, 15% midstory, and 5% understory (**Table 2**).

Mature BLH and upland hardwoods comprised the majority of the remainder of the site. Dominant species include water oak, sweet-gum, willow oak (*Quercus phellos*), black tupelo (*Nyssa sylvatica*), swamp chestnut oak, northern white oak, water hickory (*Carya aquatica*), American beech (*Fagus grandifolia*), dwarf live oak (*Quercus minima*), tuliptree, red maple, Chinese tallowtree, American hornbeam (*Carpinus caroliniana*), Chinese privet, upland swamp privet (*Forestiera ligustrina*), broom-sedge (*Andropogon virginicus*), dog-fennel (*Eupatorium capillifolium*), red mulberry (*Morus rubra*), silver maple (*Acer saccharinum*), sedges, lizard's-tail, panic grass, lamp rush, southern dewberry, and dwarf palmetto (*Sabal minor*). Vegetation stratification within this community is 70% overstory, 20% midstory, and 10% understory (**Table 3**).
