PUBLIC NOTICE

COMITE RIVER MITIGATION BANK IN EAST FELICIANA PARISH

PROSPECTUS FOR THE PROPOSED
COMITE RIVER MITIGATION BANK
EAST FELICIANA PARISH, LOUISIANA

June 2022

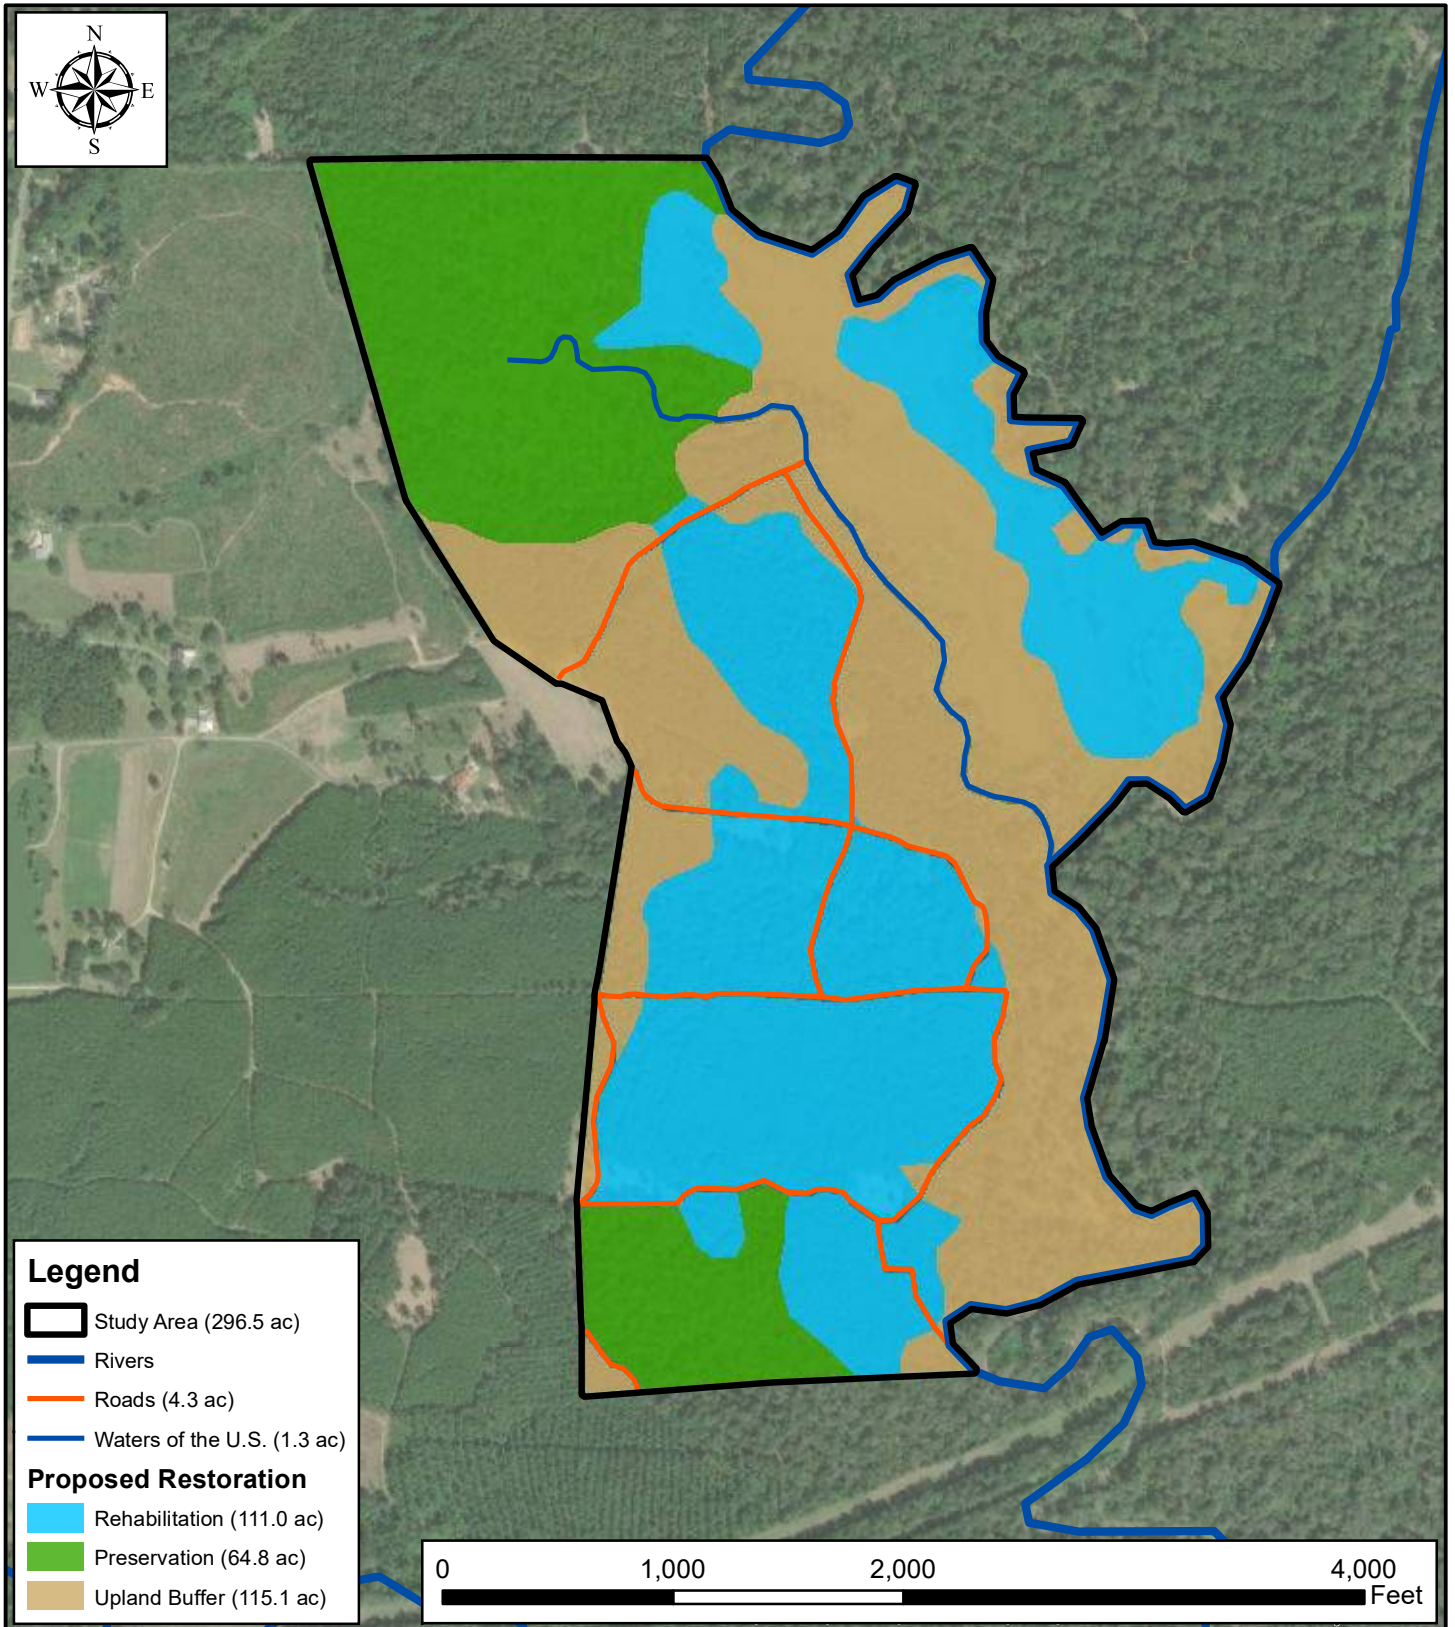
Figure 19. Site Restoration Plan

Pine species will be mechanically harvested with stumps remaining and the bottomland hardwood re-establishment and rehabilitation areas will be planted using a mixture of hard-mast (70%) and soft-mast (30%) producing species in the approximate percentages detailed in **Table 5**. A 70%-30% hard-mast to soft-mast mixture was chosen due to the high number of soft-mast volunteer species expected to be encountered at the site. Seedlings will be planted on 9-foot centers and with an average density of approximately 538 trees per acre. The goal is to achieve 60%-80% tree/seedling cover. An overview of the habitat restoration work was presented earlier in **Figure 19**.

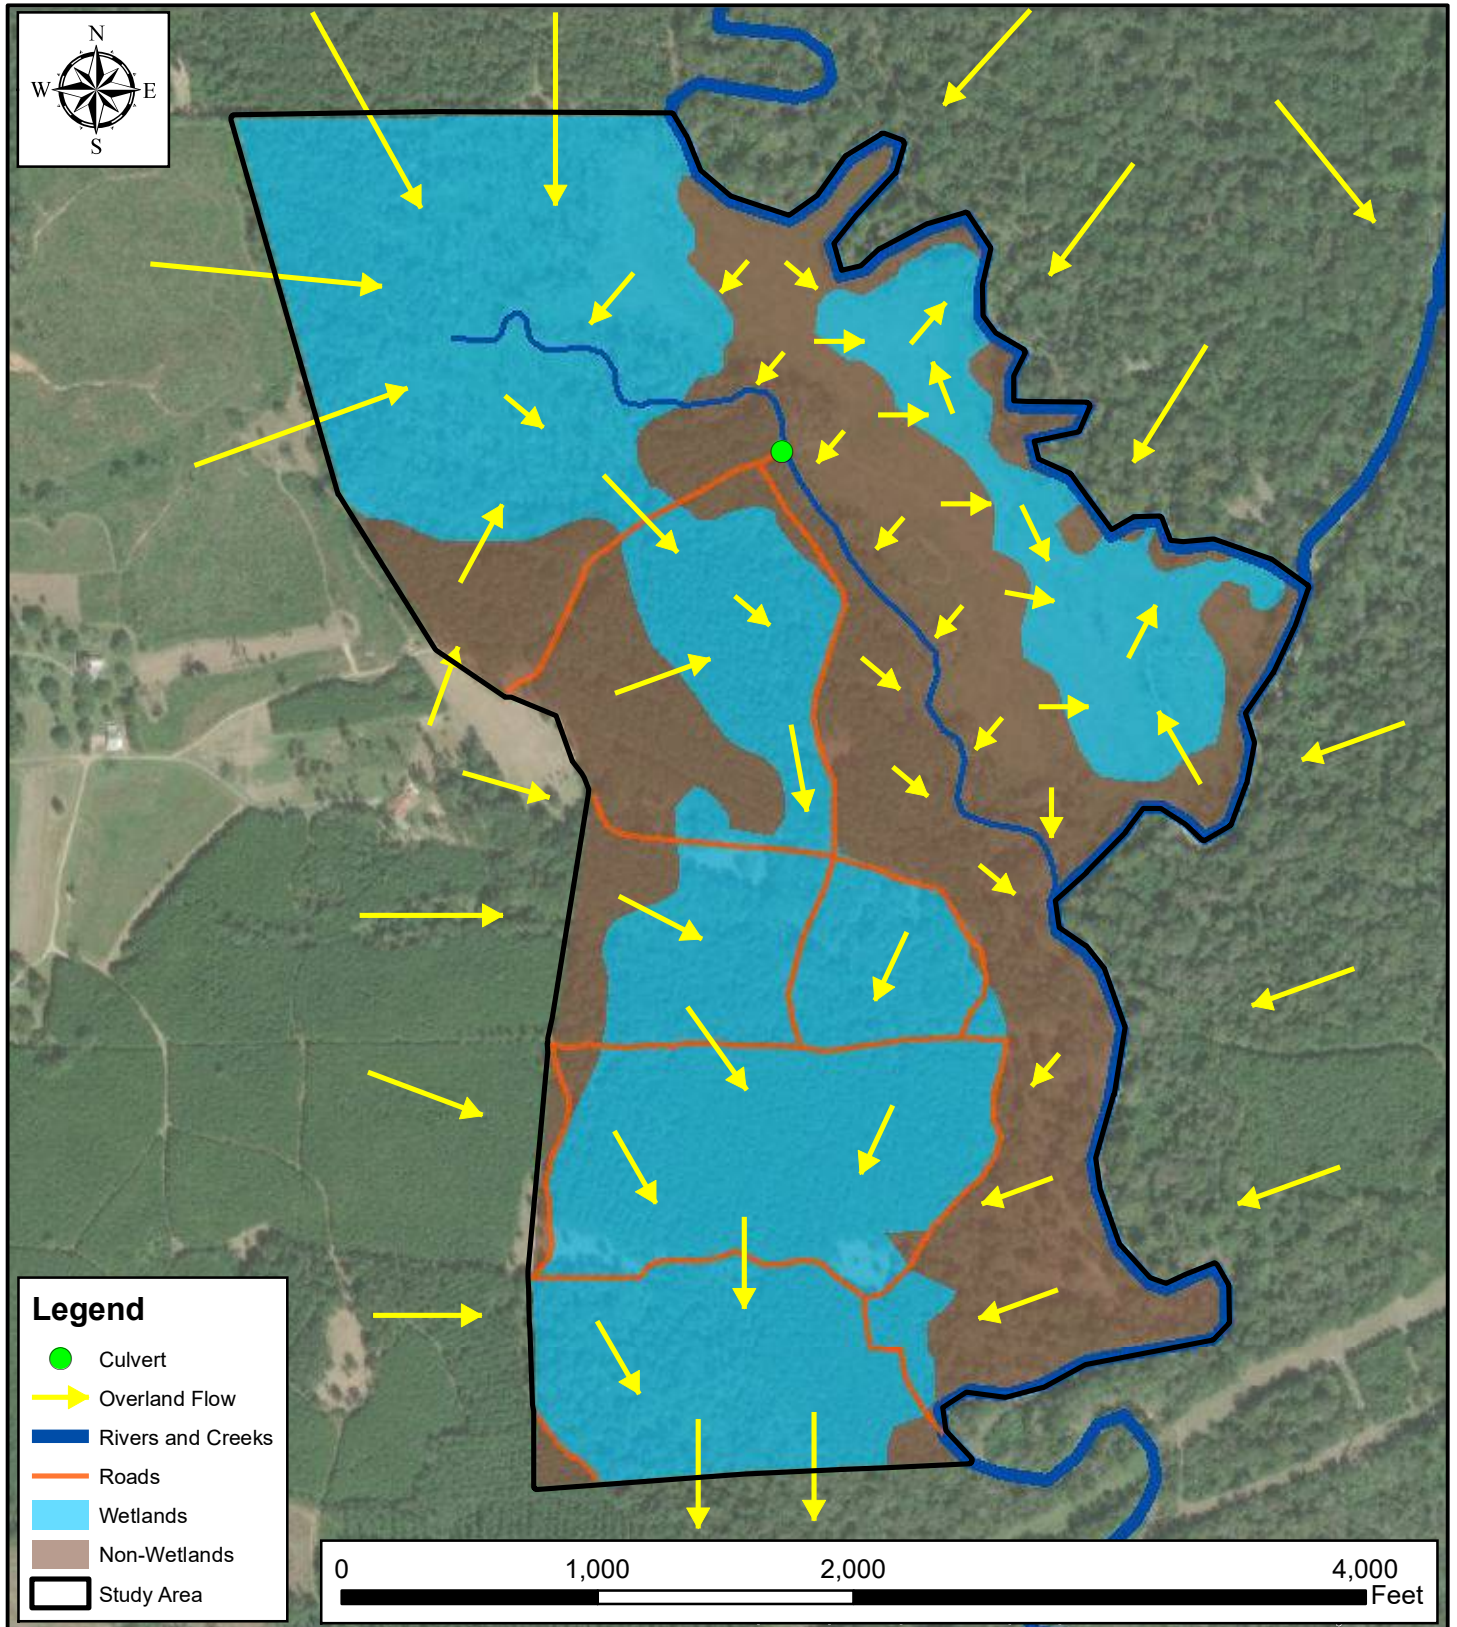
Figure 20. Proposed Hydrology Restoration (Post Construction)

The natural hydrology of the site has not been altered; therefore, no hydrologic or soils modifications are necessary (**Figure 20**). Profiles and cross-sections of the site are presented in **Figures 21-25**.

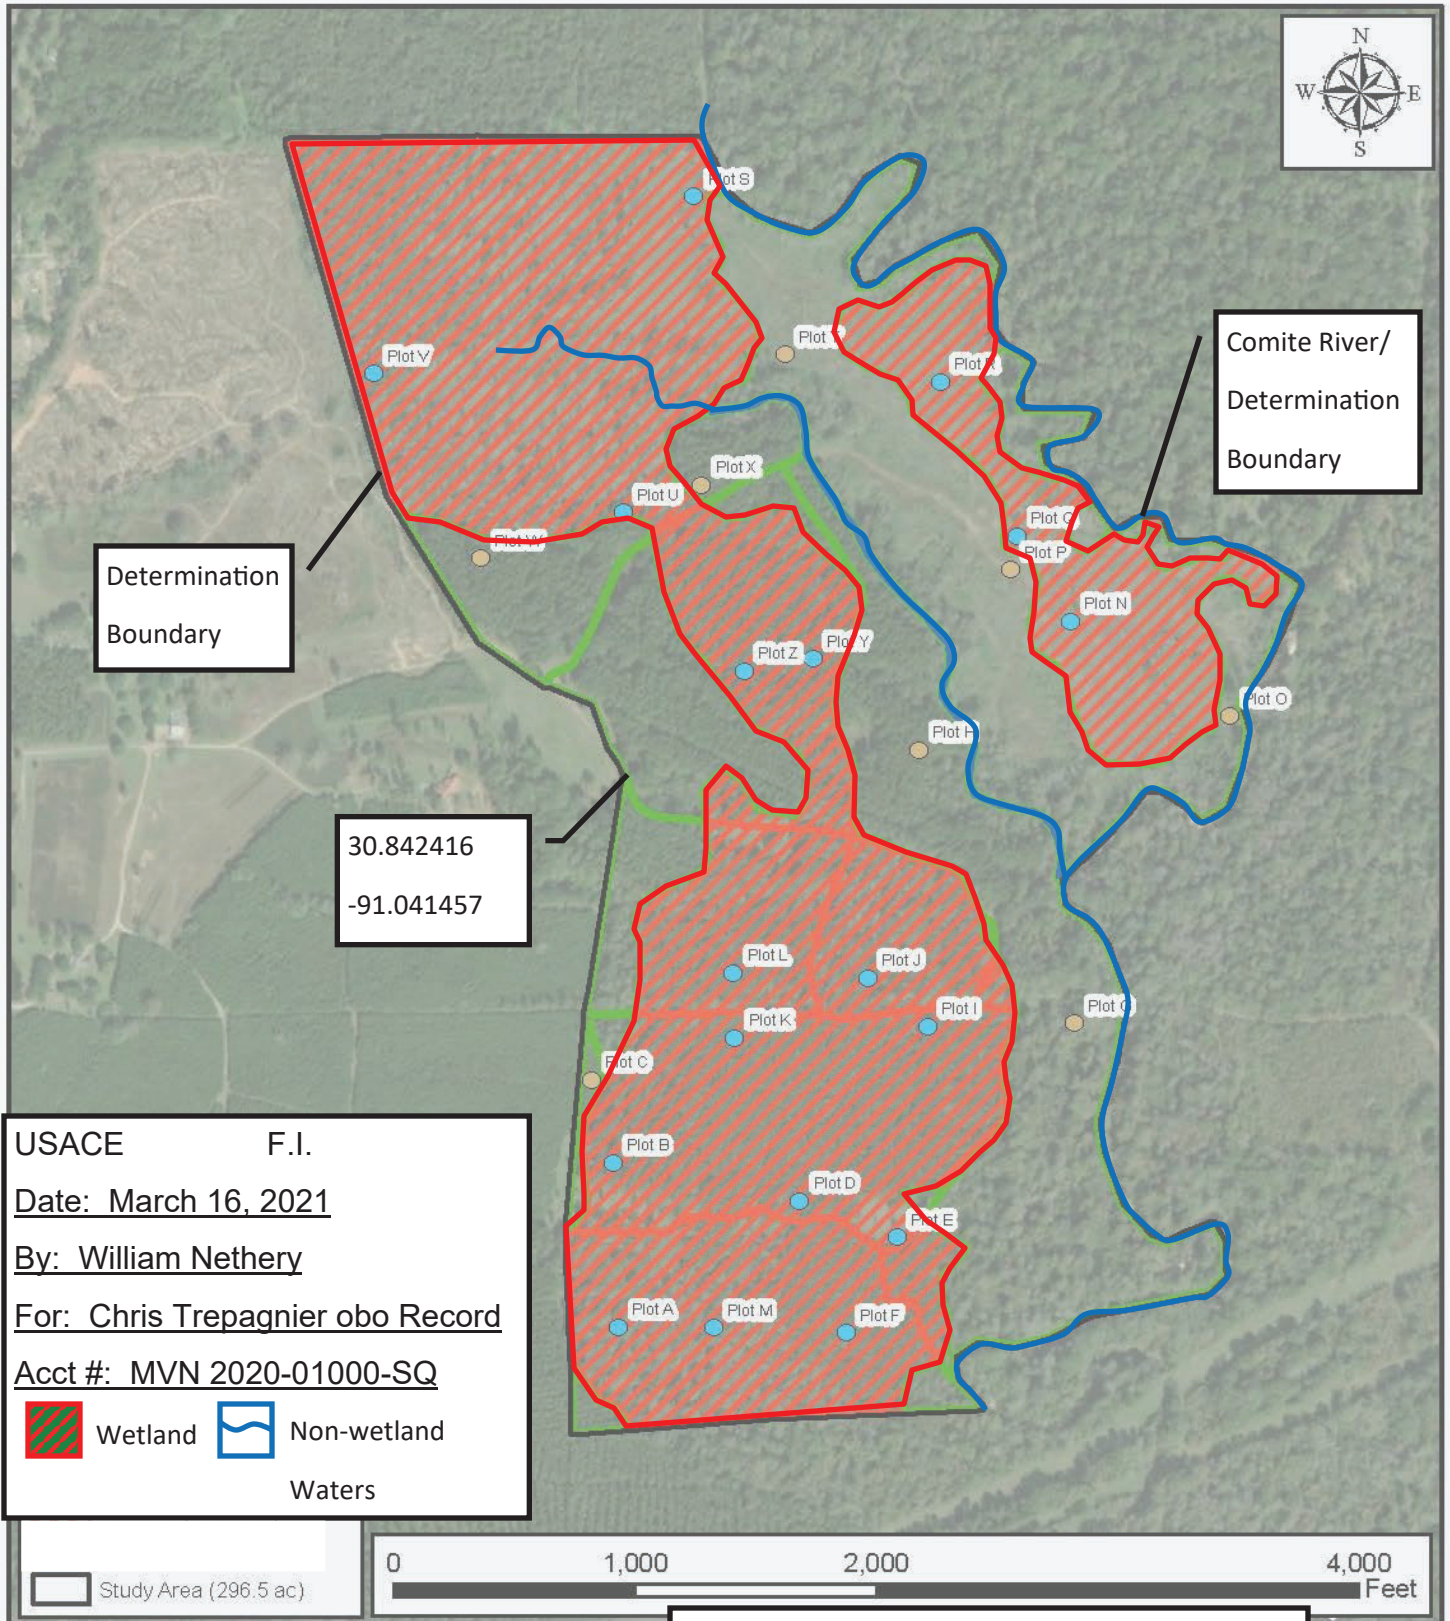
Figure 6. Wetland Delineation of the Study Area (Aerial Photo Background)

Wetland
 Non-wetland Waters
