SUBJECT: IHNC Lock Replacement General Re-evaluation Report, Engineering  
Assessment of the Existing Lock Structure

## **Enclosure 1 – Pictures of Structural Deficiencies**

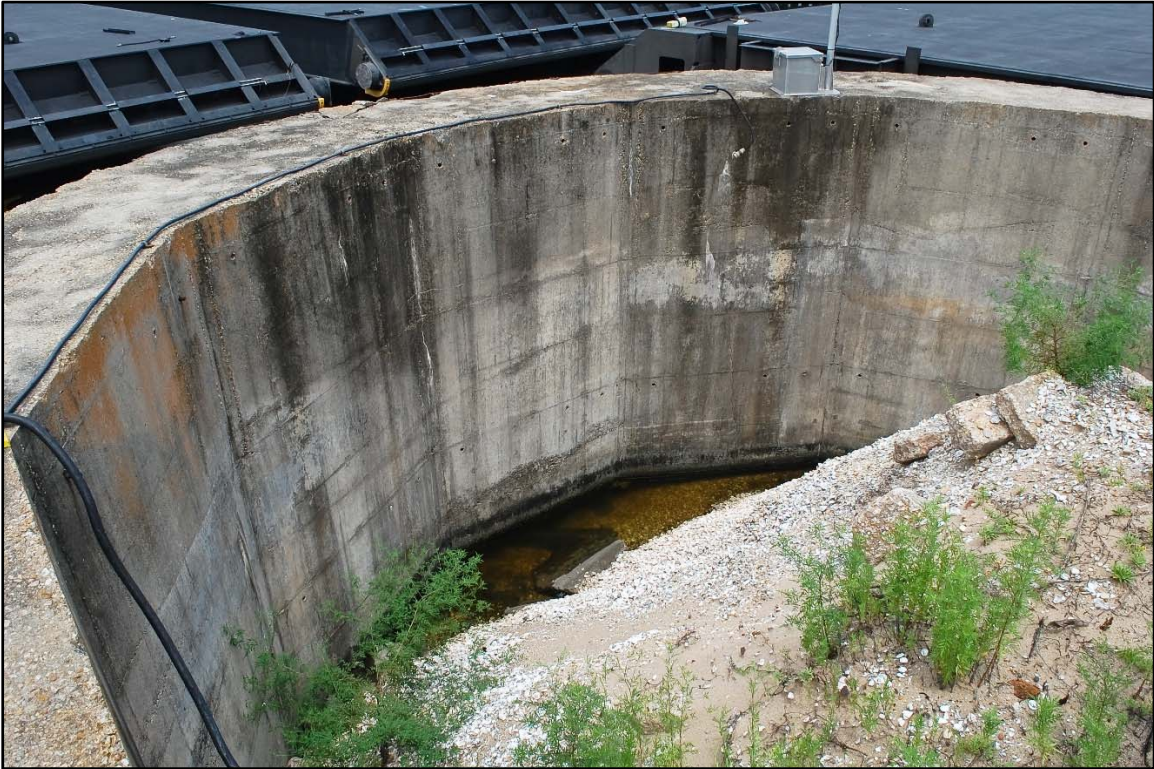
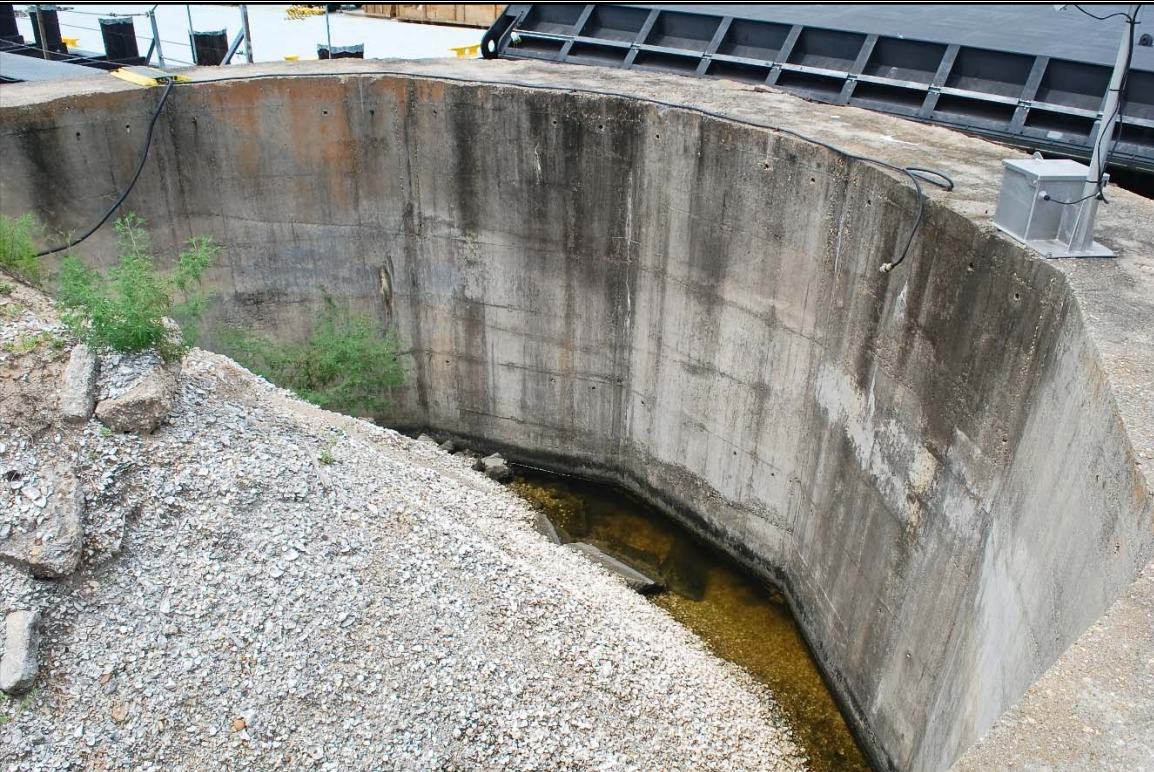
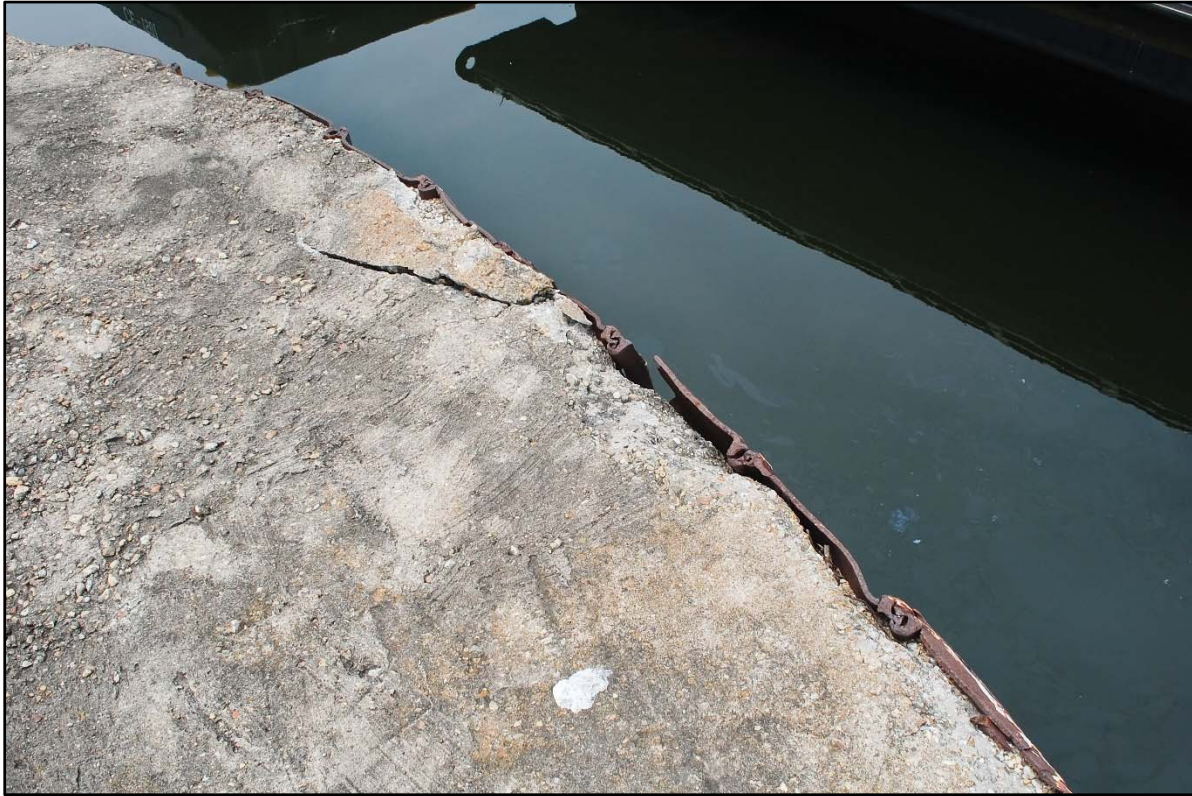
**The component exhibits a clear mode of failure:** The corroded sheet pile below the pile supported concrete inner wall is allowing the stability fill to spill out into the water. The result is loss of impact resistance.

The component has already failed. With the loss of stability fill through the corroded sheetpile, it will not sustain impact. If it sustains a vessel impact, it will fail and crumble into the channel. Failure of the nose pier will expose the guard wall to head on vessel impacts, which it is not designed for. Because of the narrow width of the lock chamber (74') and the maximum width of barge tows that travel through the lock (70'), it's highly likely a vessel impact will occur in the future.

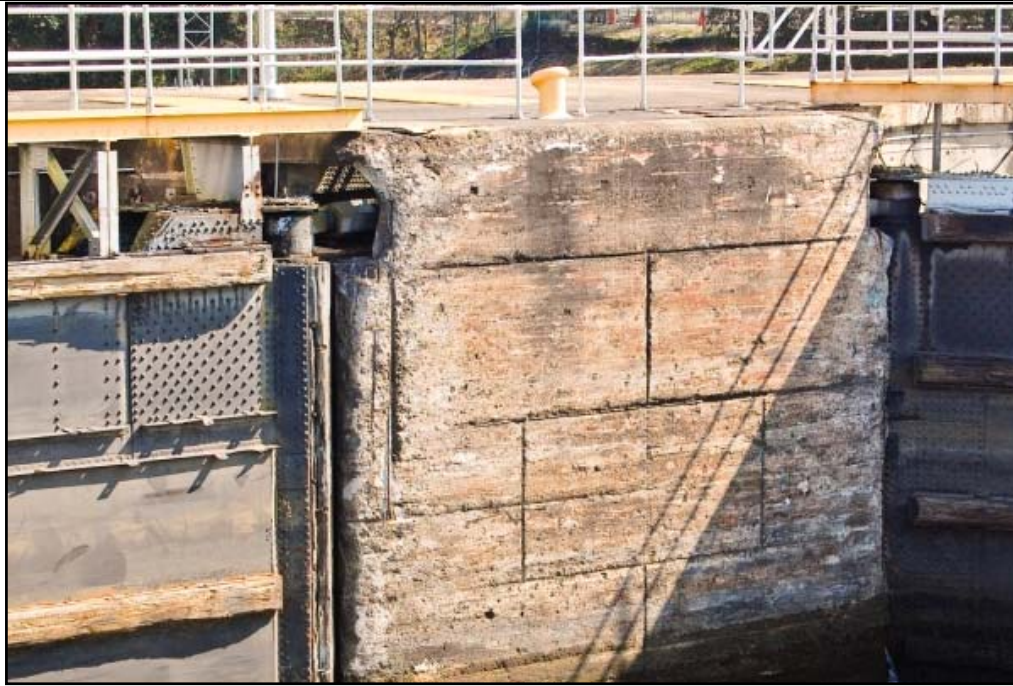
Spalding concrete and exposed rebar on corners of gate bays and top edge of lock wall deck, image is of east wall gate recesses but is typical of all eight gate recesses.

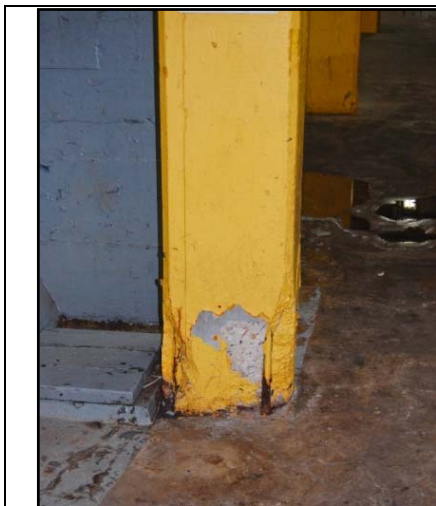
Deck support column in NW machinery room.

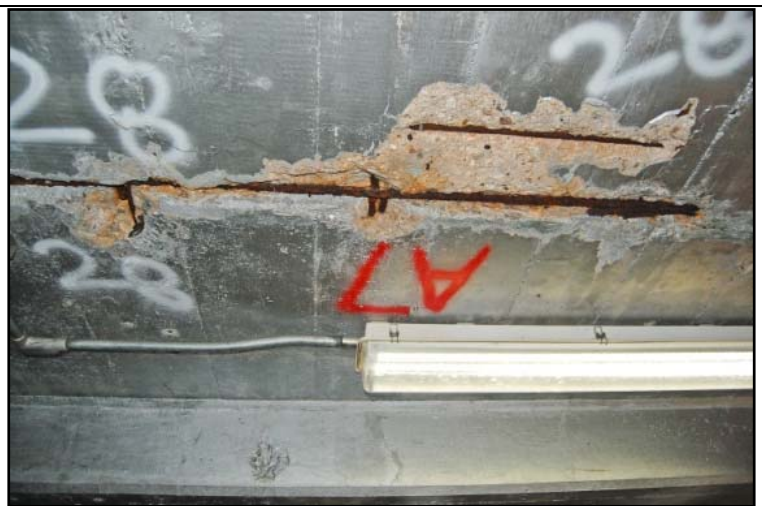
Underside of concrete deck in a machinery room in the west wall.

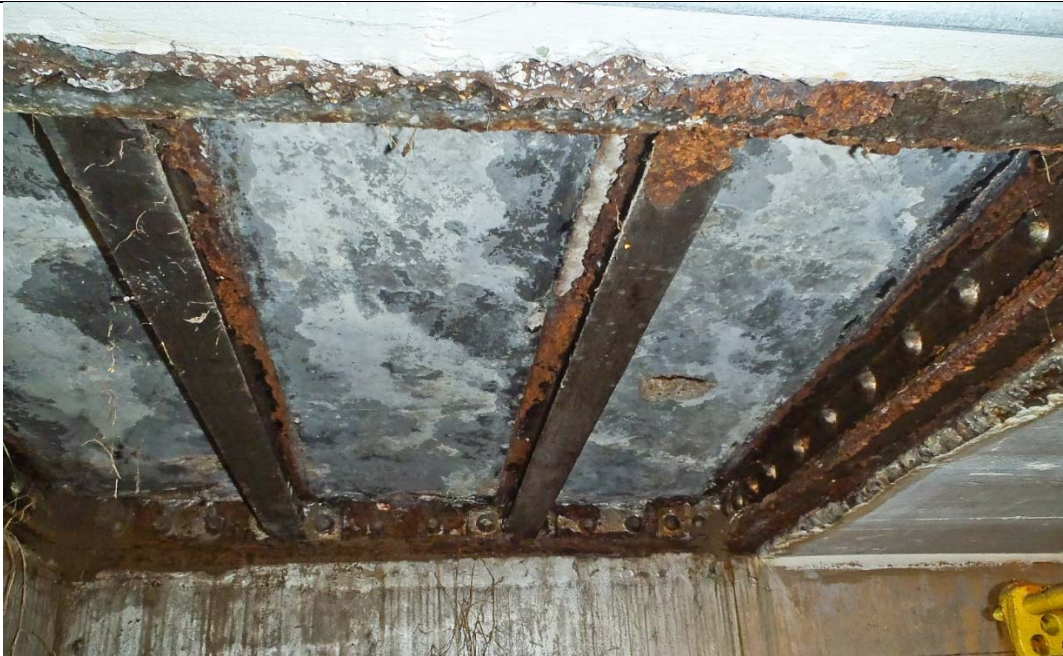
Corroding I-beams supporting hatch cover also showing section loss of beams and hatch recess steel frame. IHNC Lock Photo 04-23-2014No Structure020-1.jpg

Cracked and spalled concrete hatch covers, rusted out steel frames with significant and missing section loss.

**The component exhibits a clear mode of failure:** The cracked covers and leaking frames is leading to increased section loss of frames and increasing risk of cave-in.

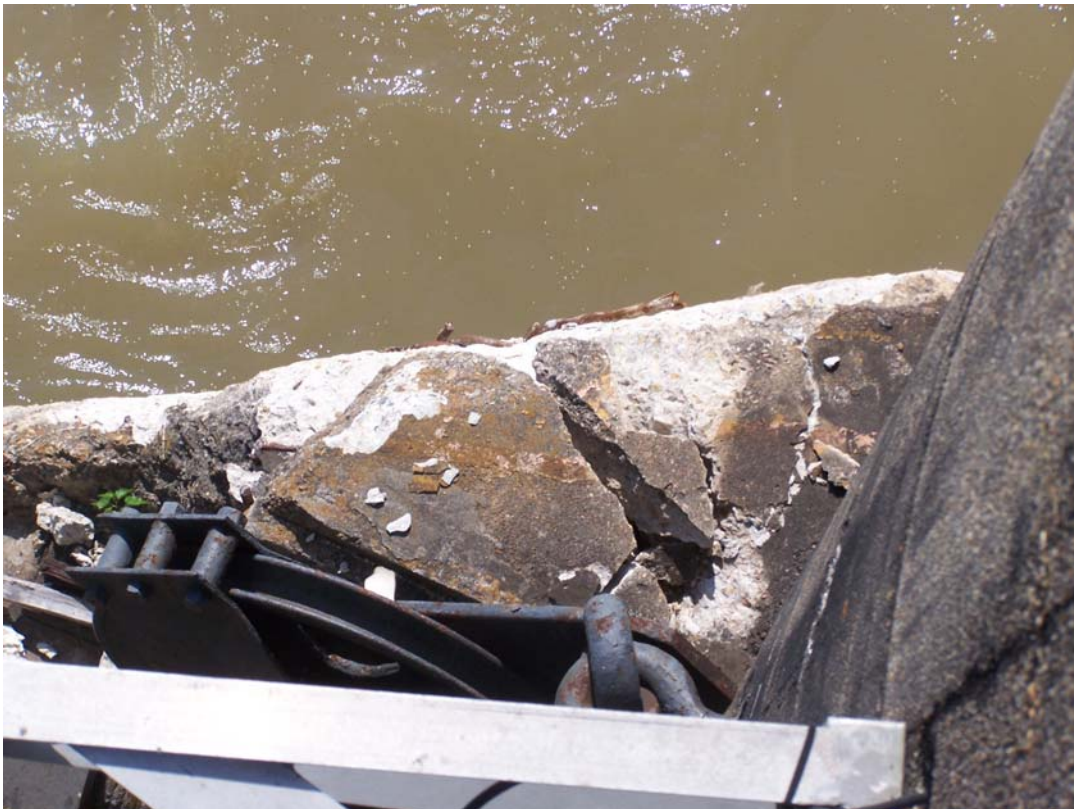
**Photo 6** Large spalls and cracked concrete with exposed steel on the northwest side near hinge for gate 9.

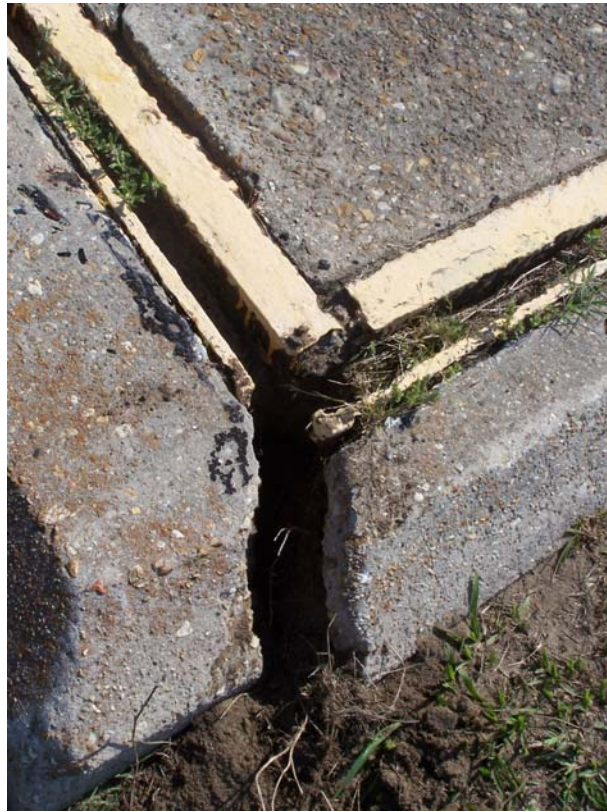
**Photo 25** Hatch cover behind the west chamber wall near reference marker 8W.

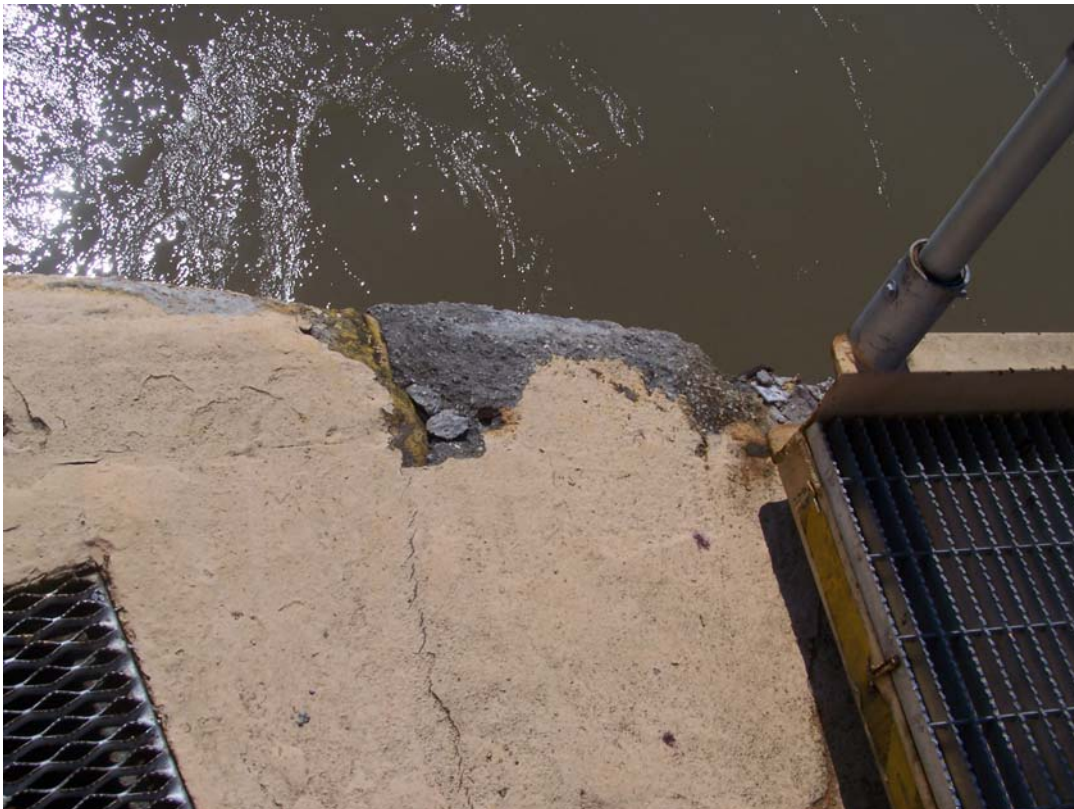
**Photo 28** Spall in top of west wall near the hinge for the river side gate.

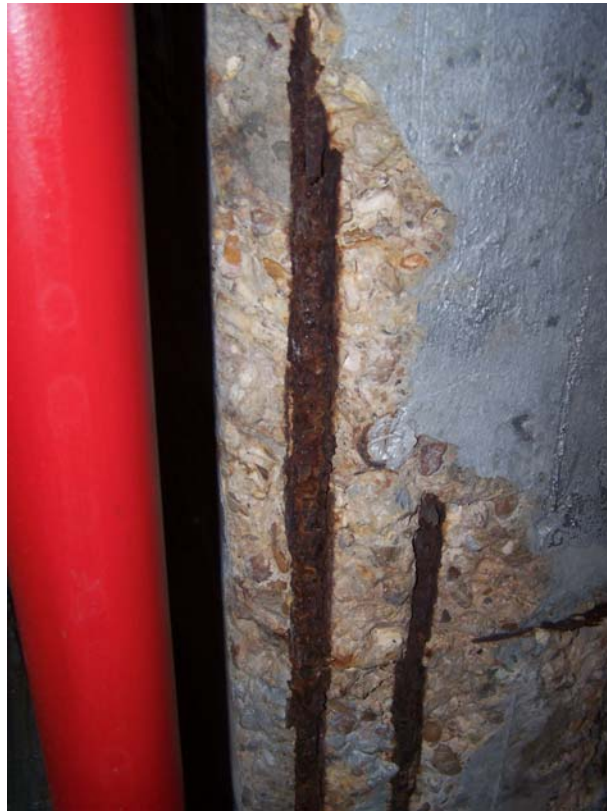
**Photo 41** Spalled beam near valve 11. Bottom steel and spiral wire severely corroded.

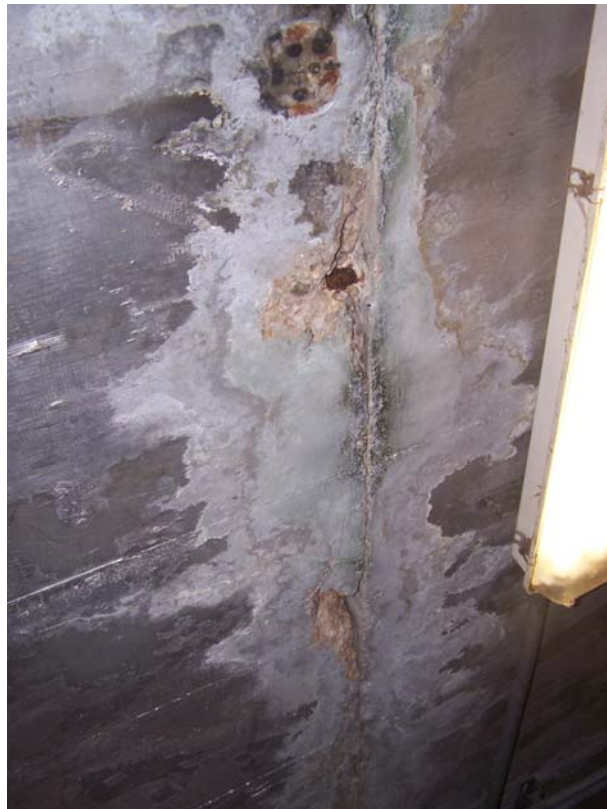
**Photo 44** Spalls in ceiling near valve 11 caused by corroding steel

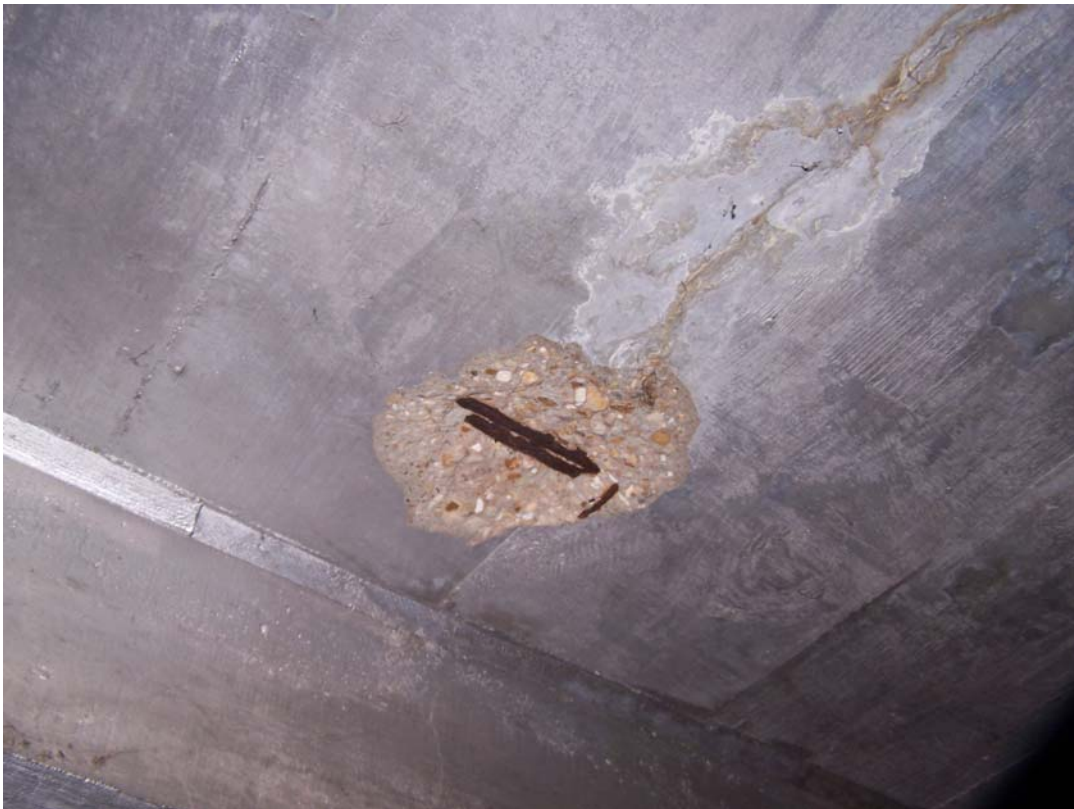
**Photo 46** Popout in ceiling near valve 11 caused by corroding steel.

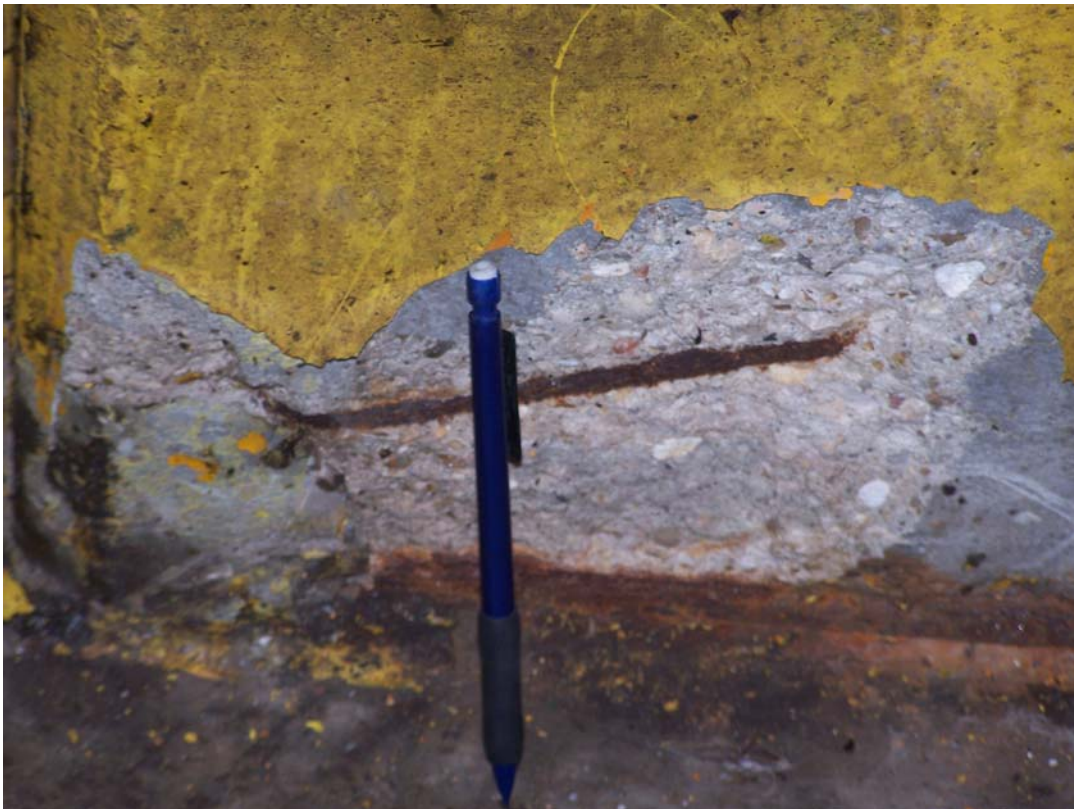
**Photo 50** Spalls and delaminations at bottom of columns on both sides of hinge for gate 1.

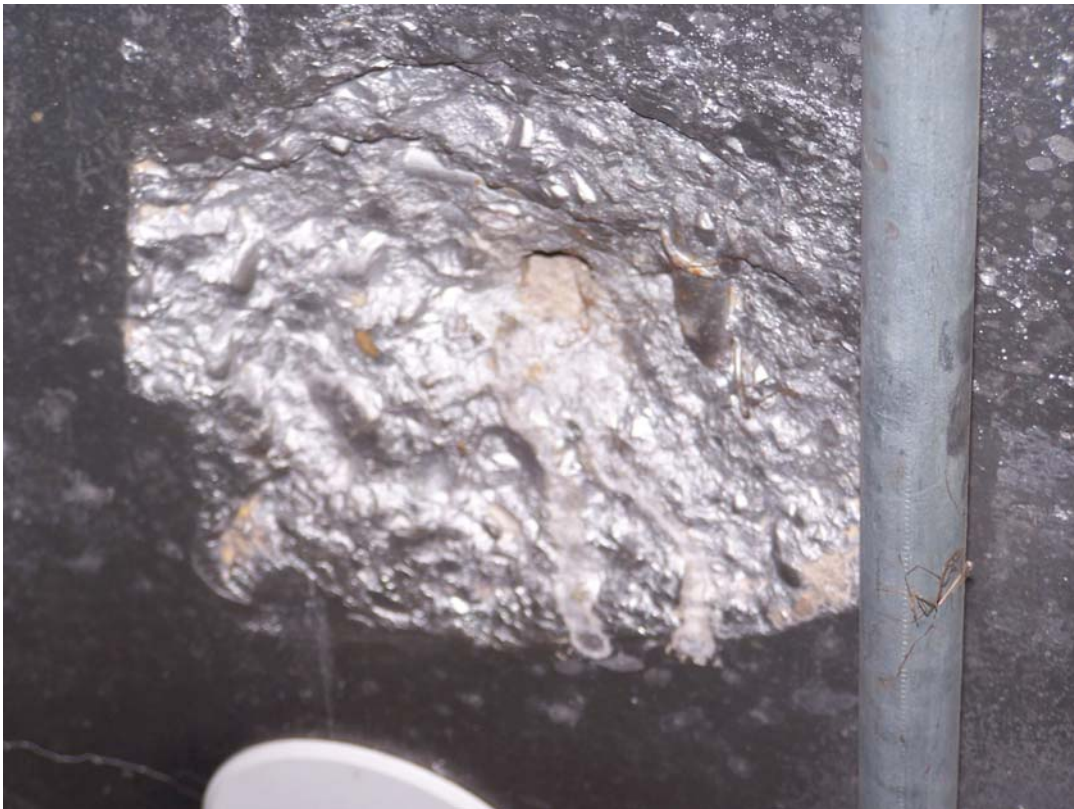
**Photo 52** Popout in beam over gate 1 machinery.

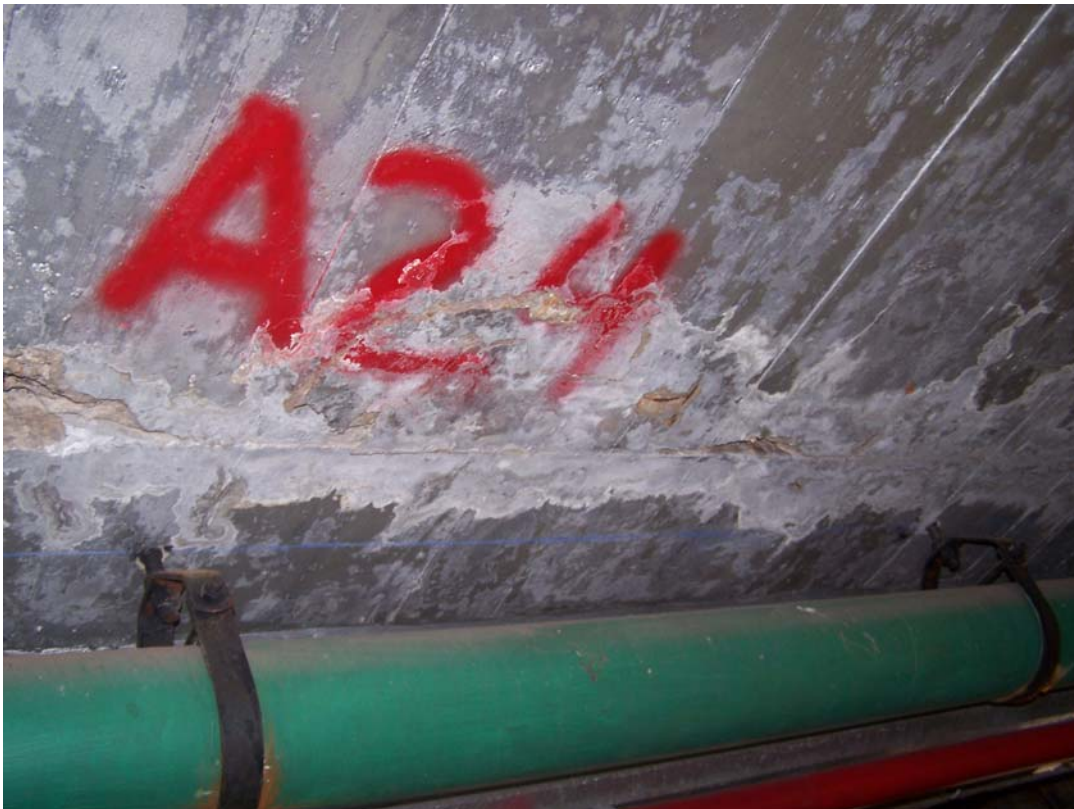
**Photo 56** Spalling with corroded steel in ceiling over gate 3 machinery.

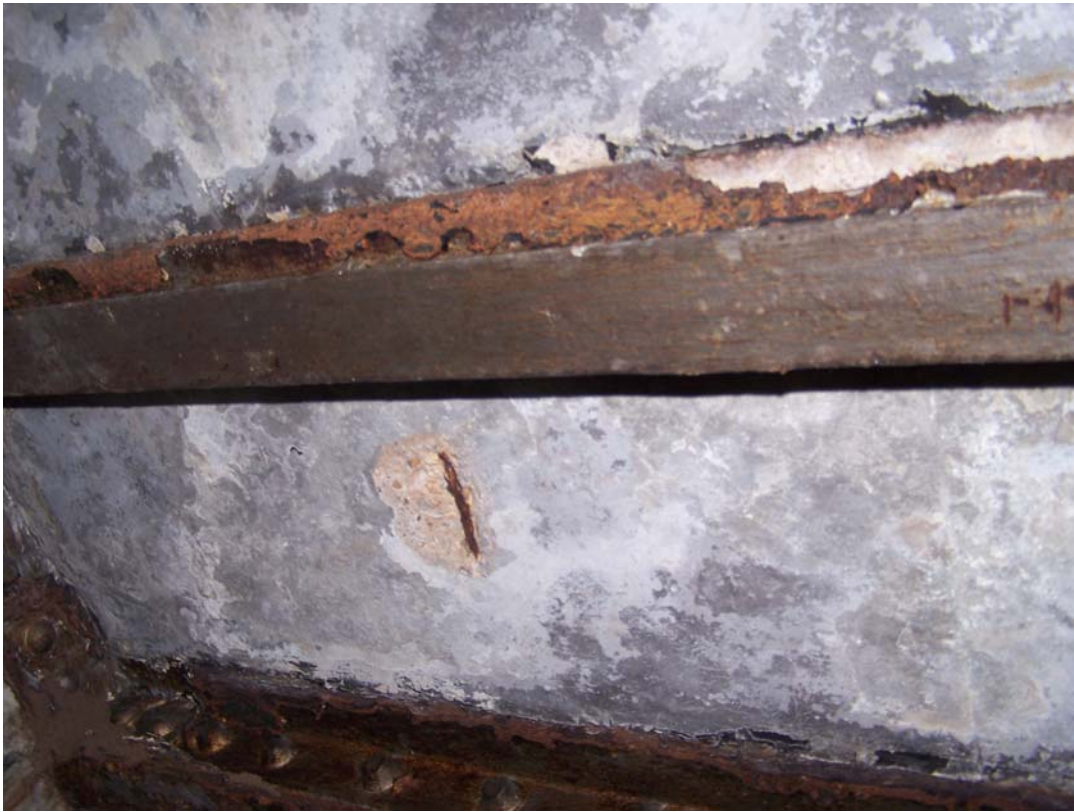
**Photo 69** Bottom of hatch cover in west tunnel.

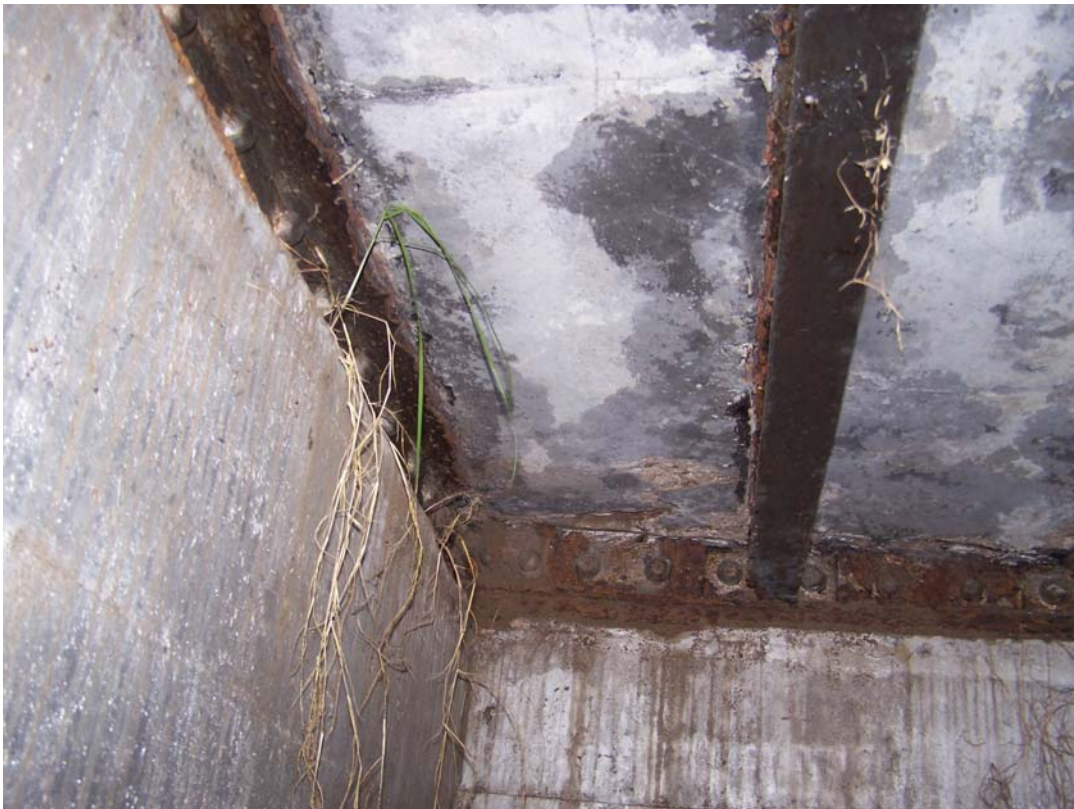
**Photo 70** Bottom of hatch cover in west tunnel.

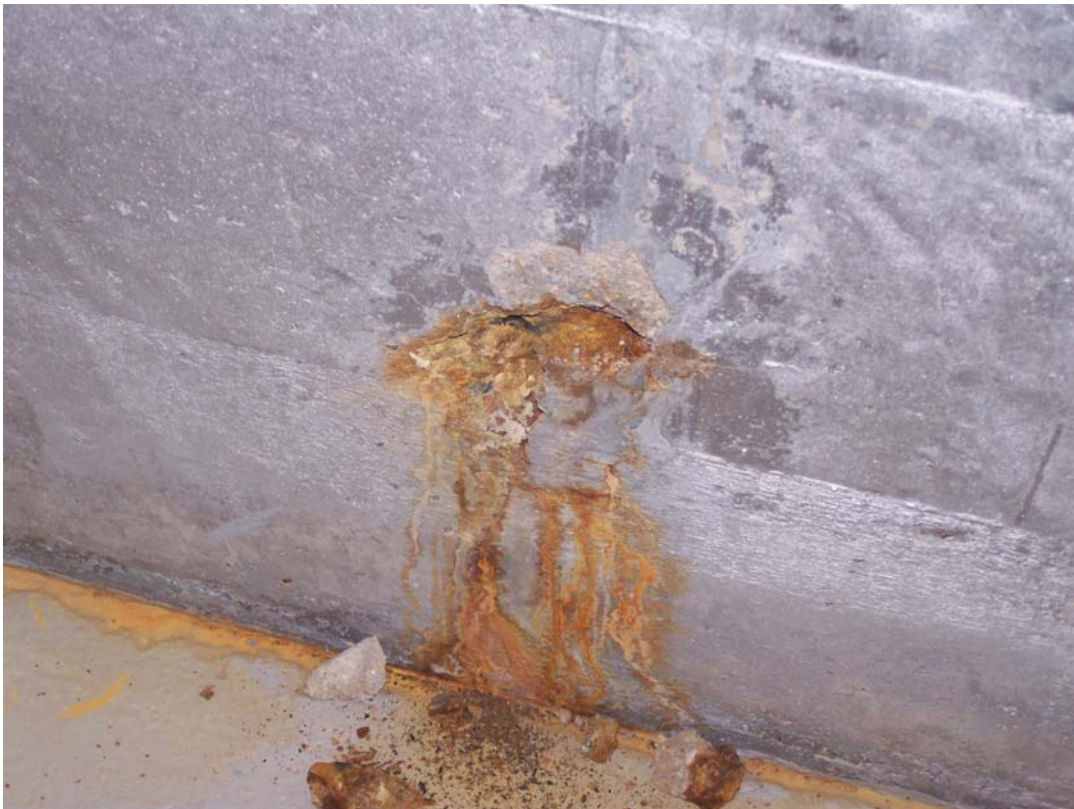
**Photo 72** Popout in the bottom of west tunnel wall.

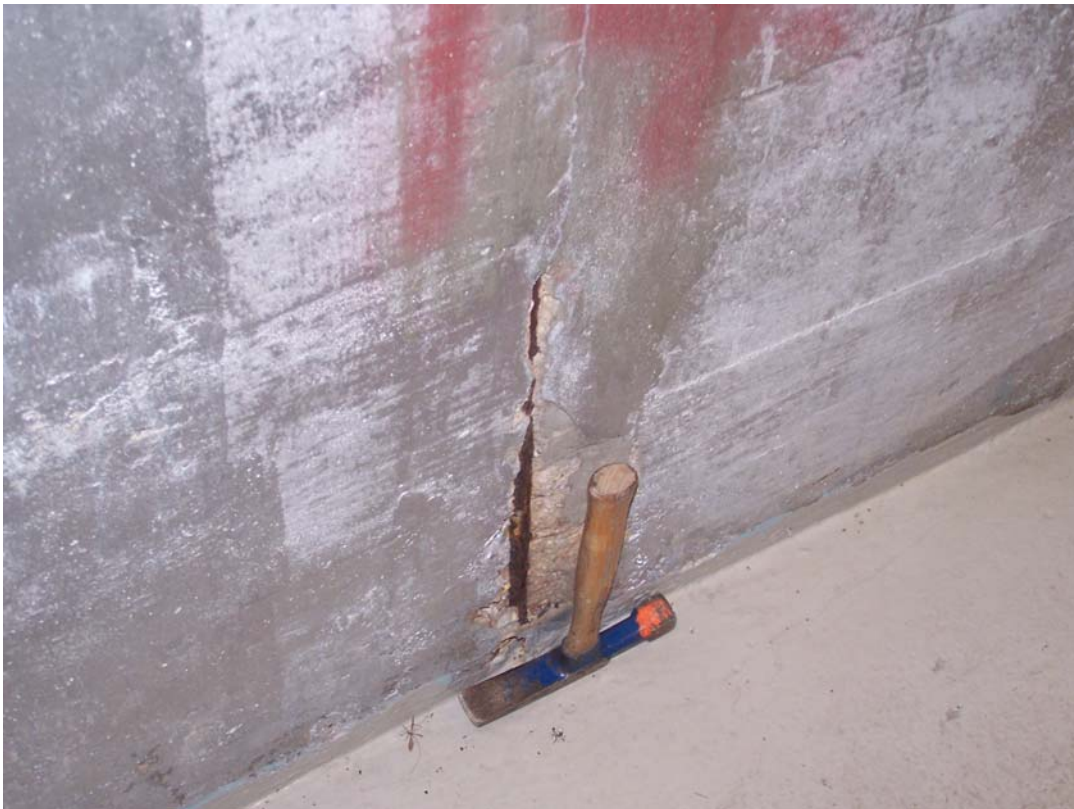
**Photo 74** Popout in the bottom of west tunnel wall.

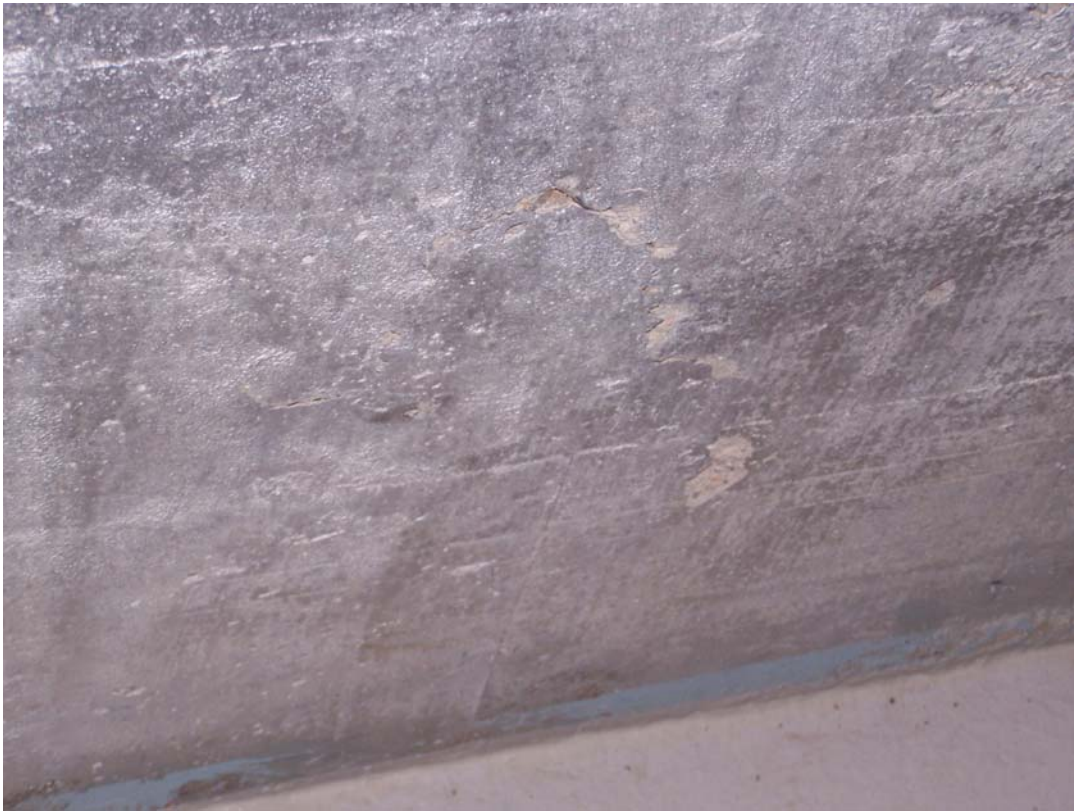
**Photo 77** 12" x 7" delamination in west tunnel wall.

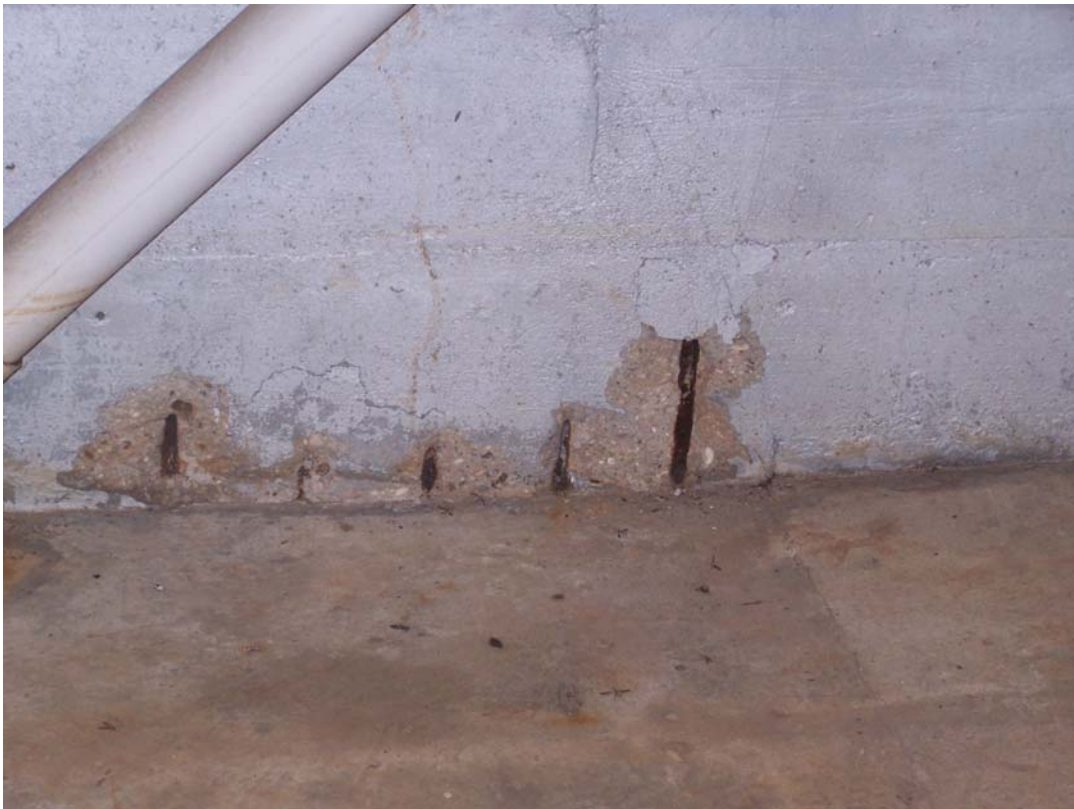
**Photo 86** Popouts at the bottom of the wall in room 5.

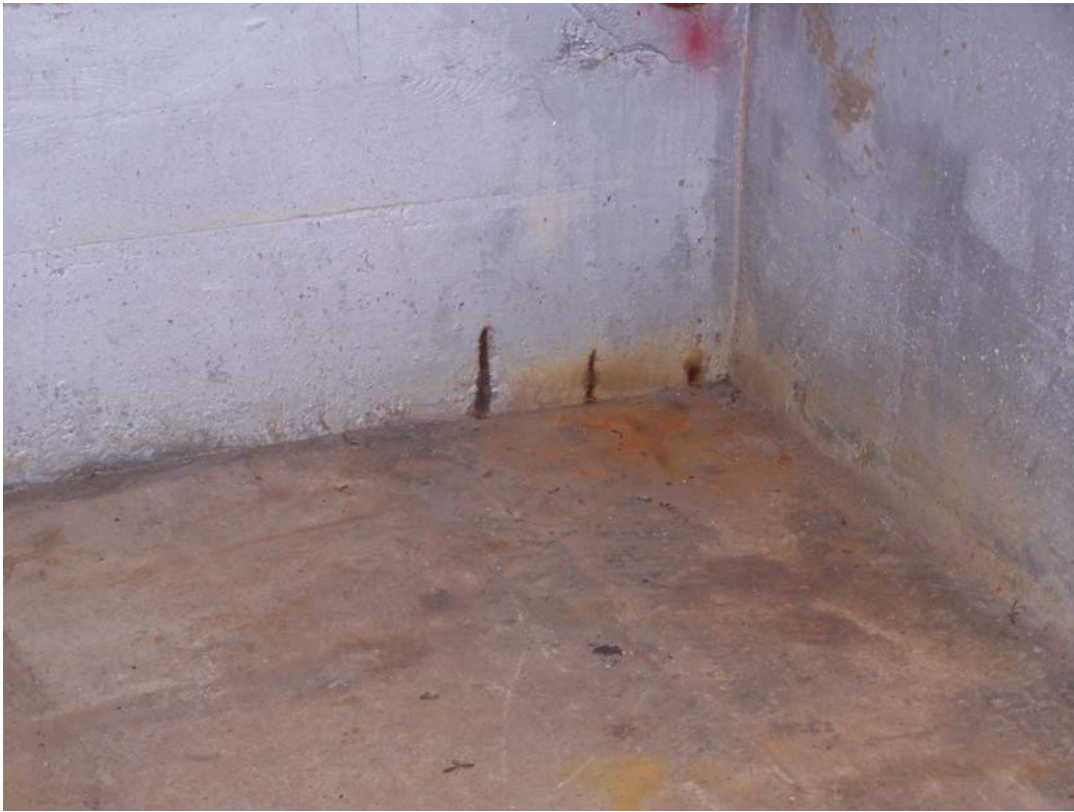
**Photo 87** Popouts at the bottom of the wall in room 5.

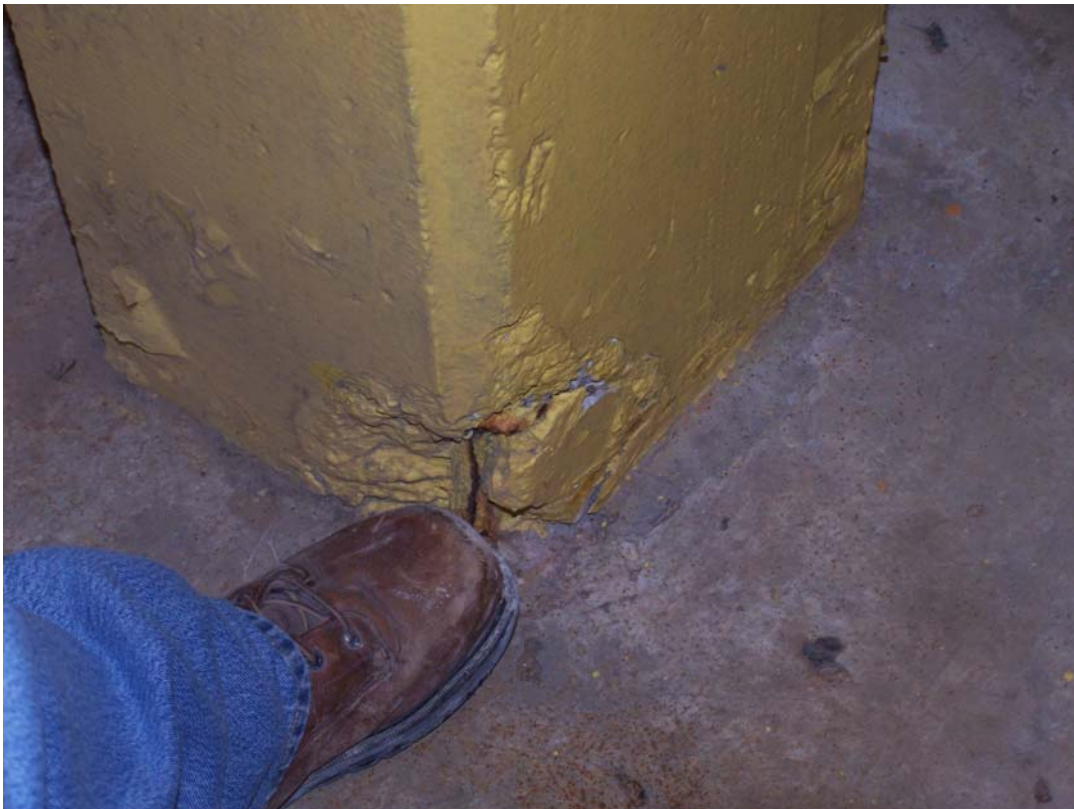
**Photo 88** Spall at the bottom of column in Room 5.

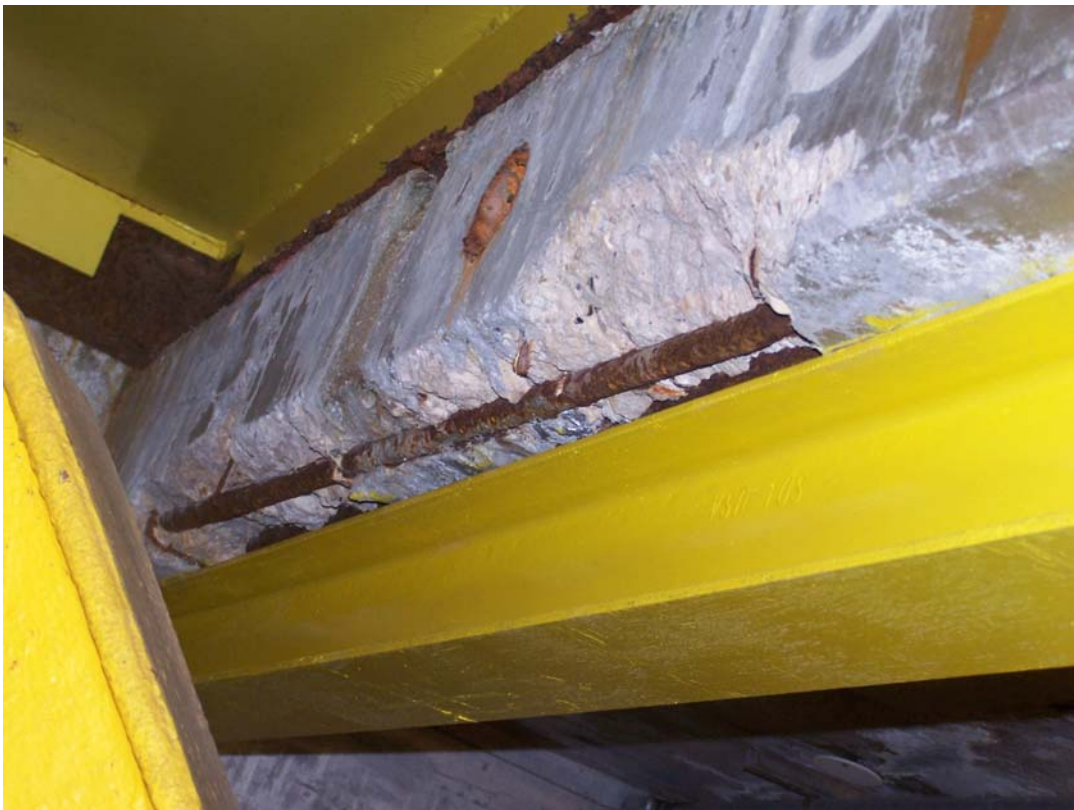
**Photo 94** Spalls and corroded steel in beams over machinery in room 5. Note steel beam and columns added to support these beams.

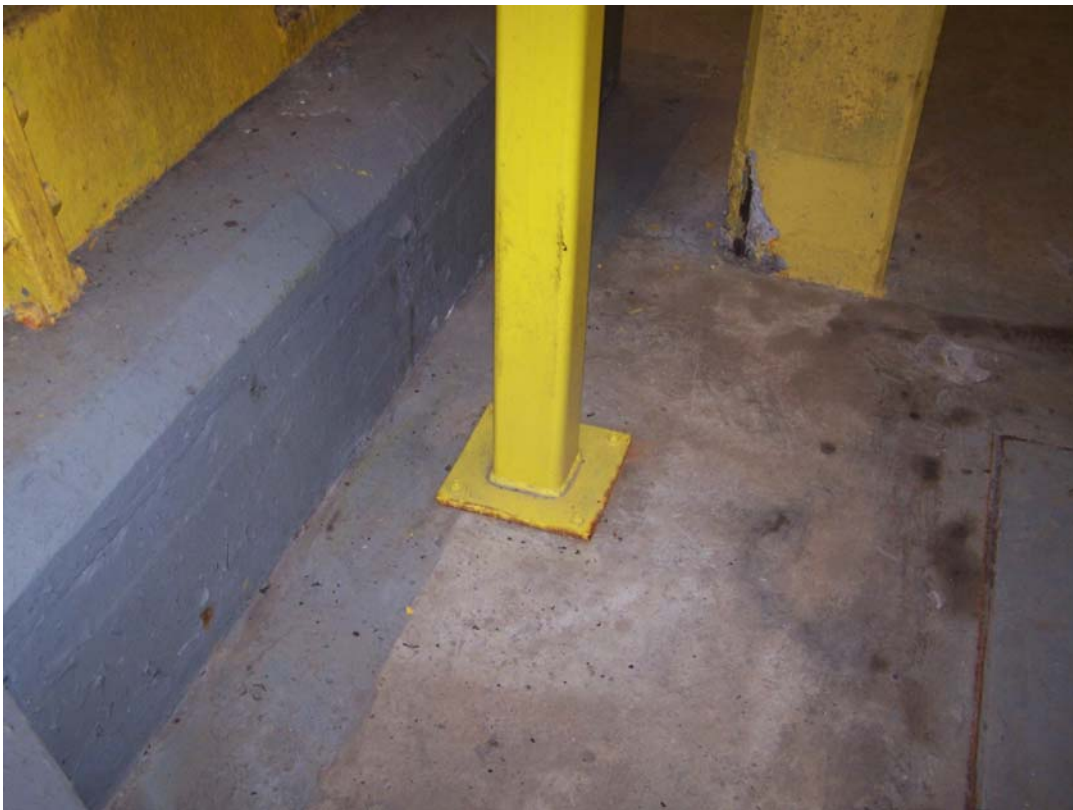
**Photo 96** Spall at bottom of column and steel column added to support deteriorated concrete beams and columns.

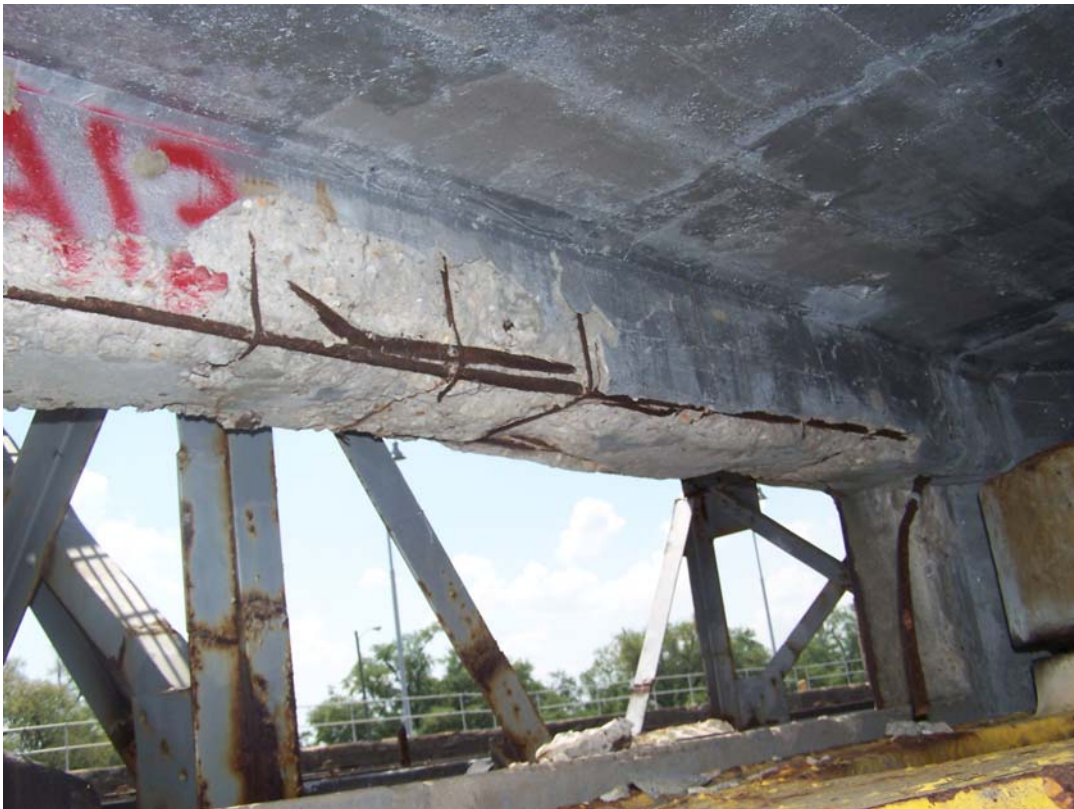
**Photo 100** Spalled beam with corroded reinforcing over opening for gate 7.

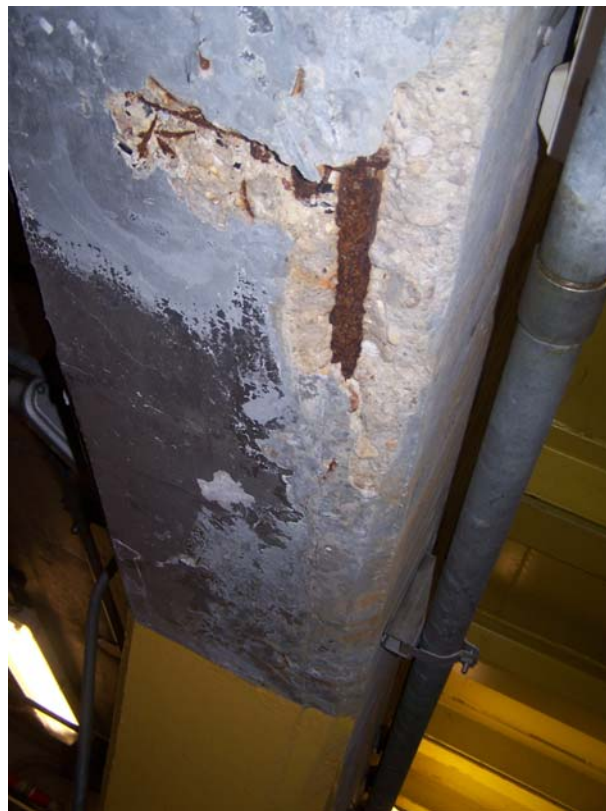
**Photo 104** Spall with corroded steel in bottom of beam in room 7.

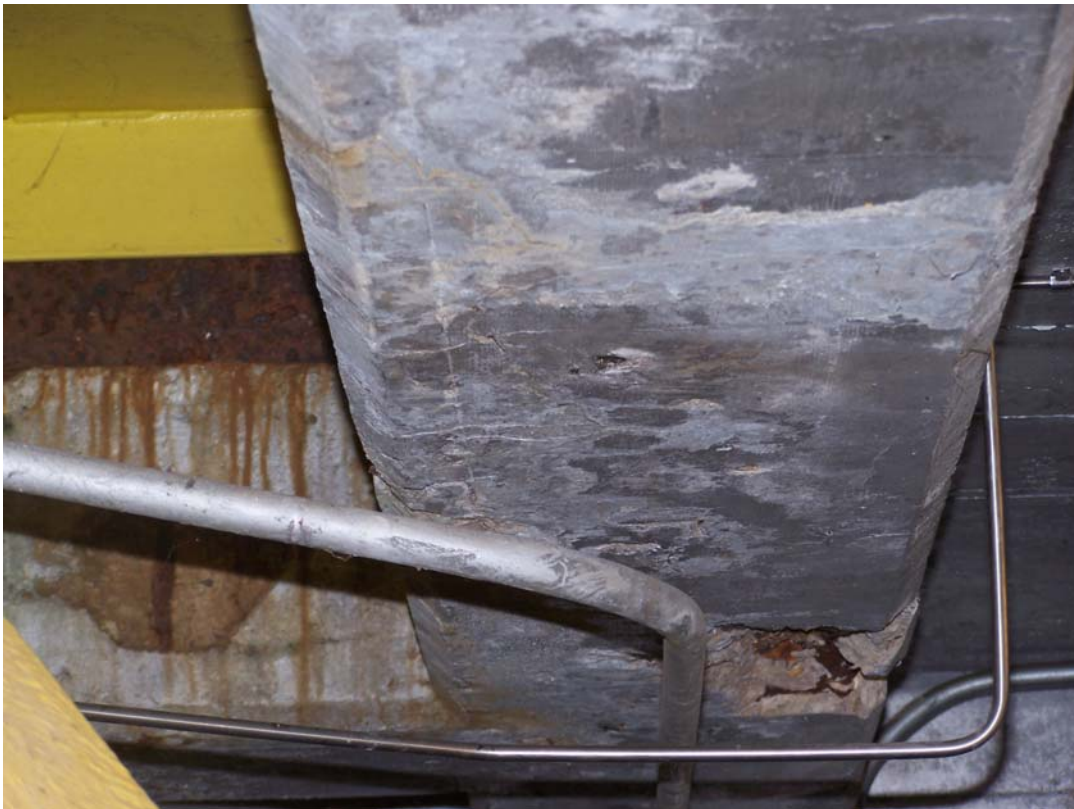
**Photo 122** Spall and corroded steel in beam over gate 5 machinery.
