SUBJECT: IHNC Lock Replacement General Re-evaluation Report, Engineering  
Assessment of the Existing Lock Structure

## **Enclosure 1 – Pictures of Structural Deficiencies**

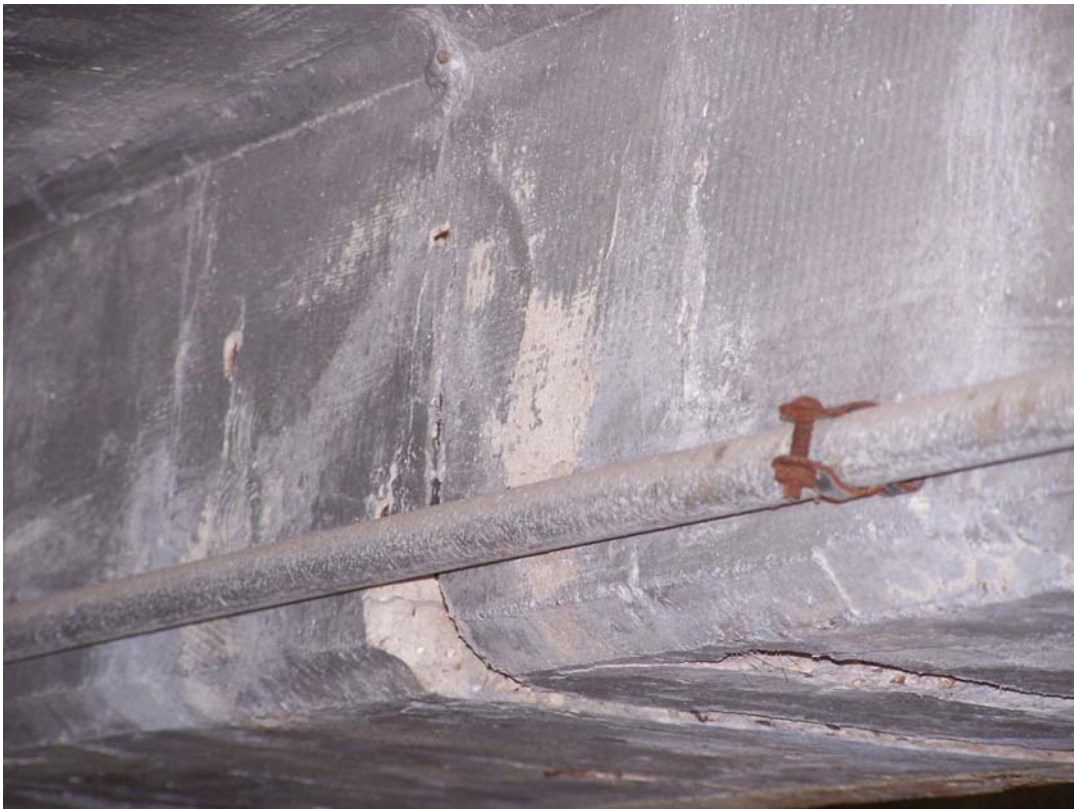
**Photo 126** Spalls in beam over Gate 5 machinery. About mid span of beam.

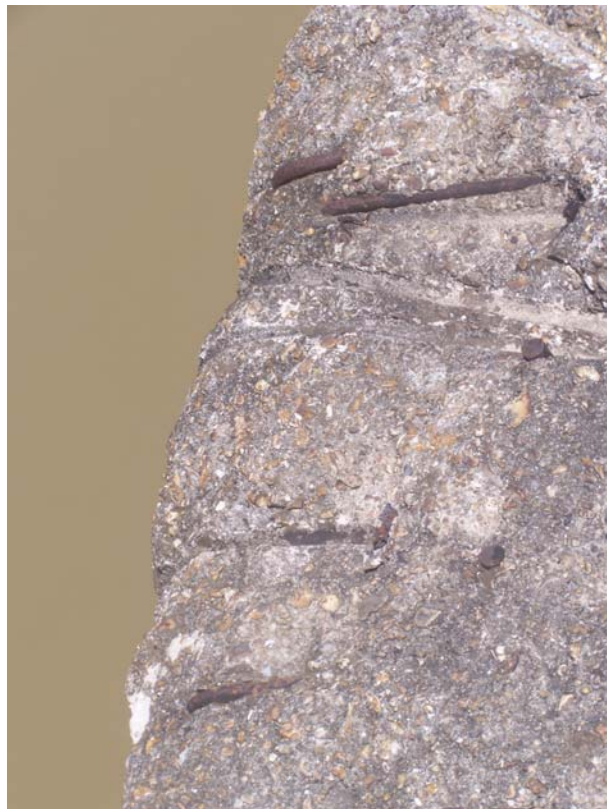
**Photo 146** Spalls in north gatebay.

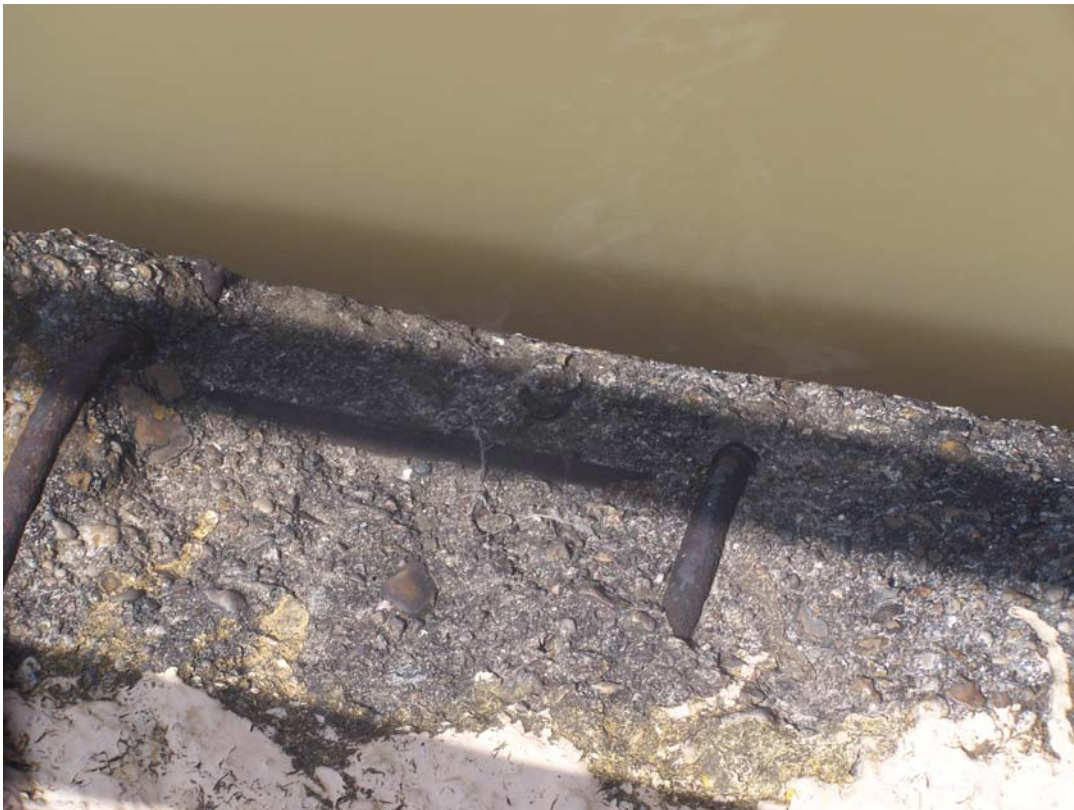
**Photo 147** Spalls in east lock chamber wall. (Typical).

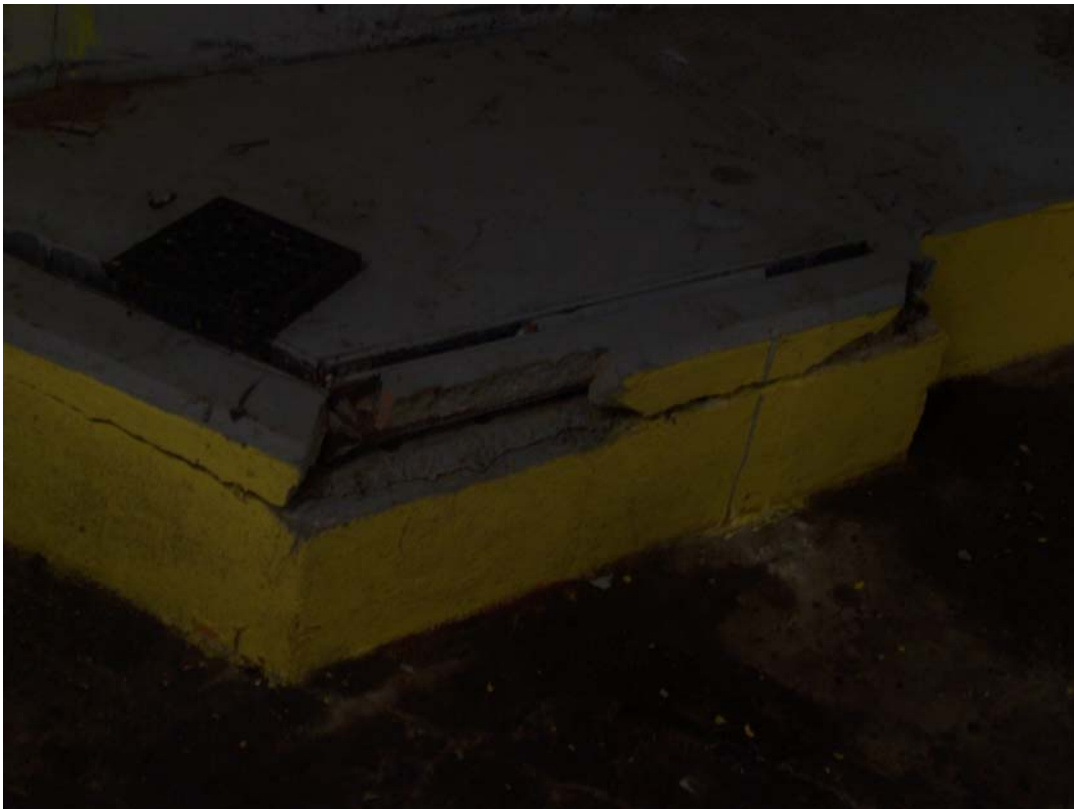
**Photo 152** Spalled/delaminated concrete in Room 2. Has increased since last inspection.

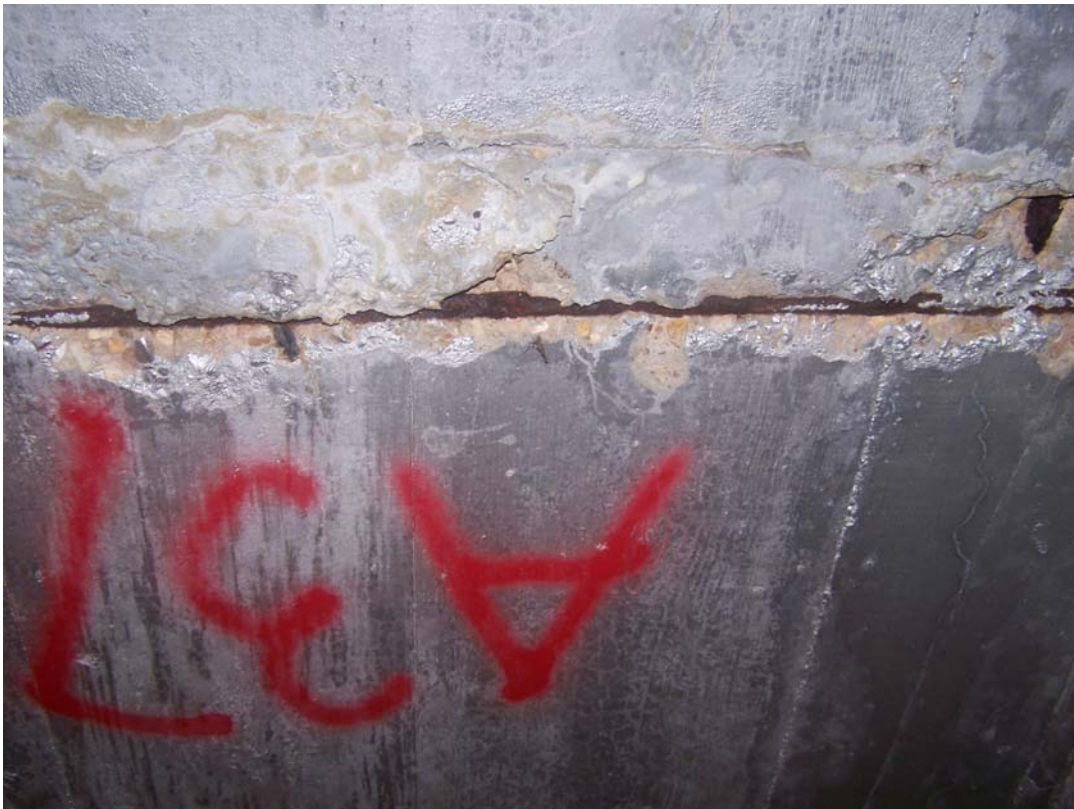
**Photo 156** Spalls and popouts with corroded steel in ceiling of Room 2.

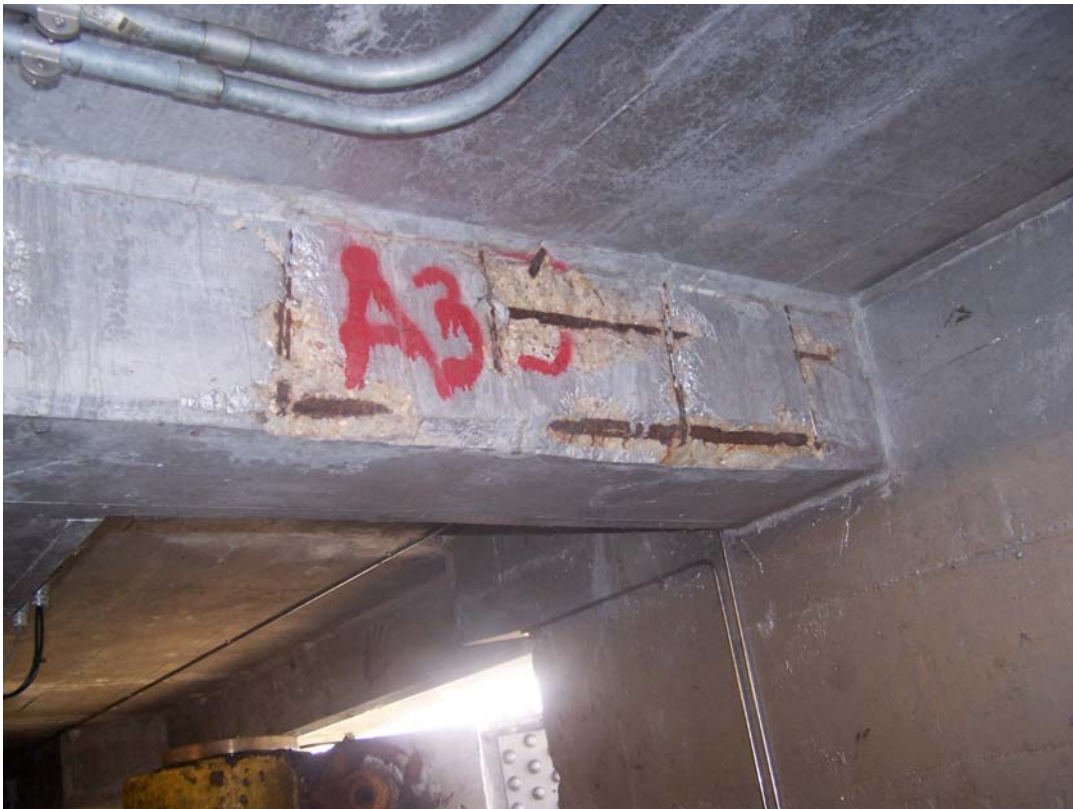
**Photo 158** Spalling and corroding steel in beam in Room 2. Further spalling has occurred since last inspection.

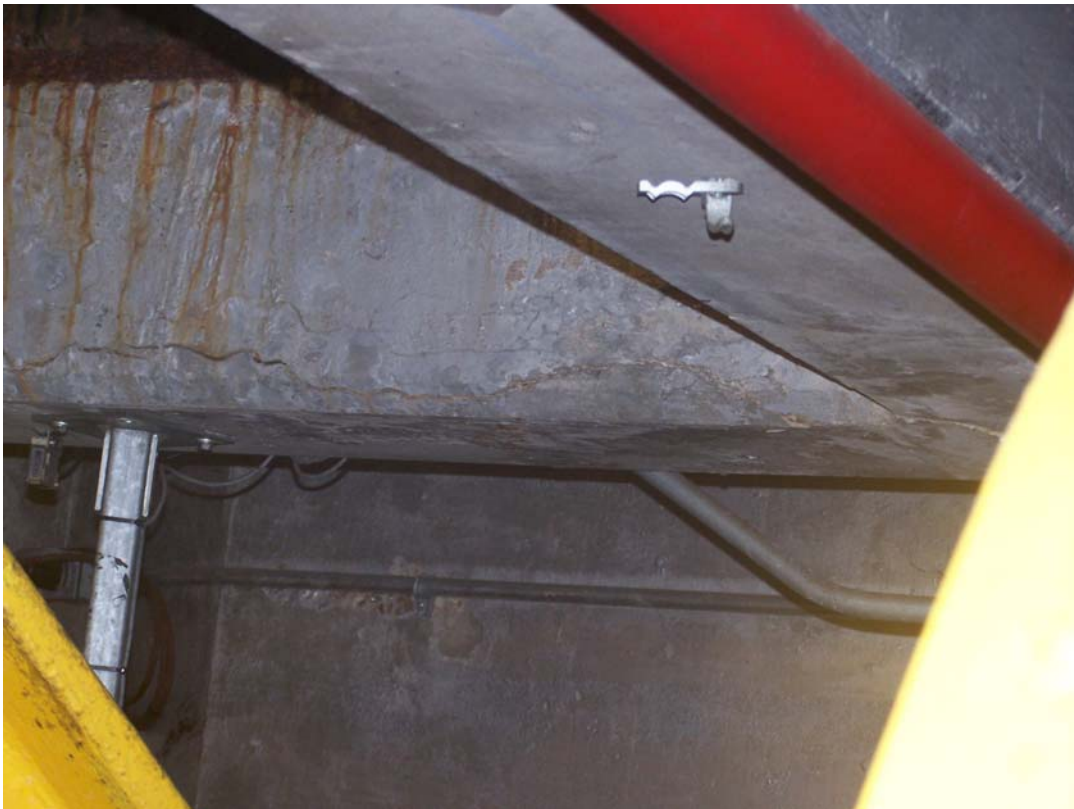
**Photo 162** Crack in beam over Gate 4.

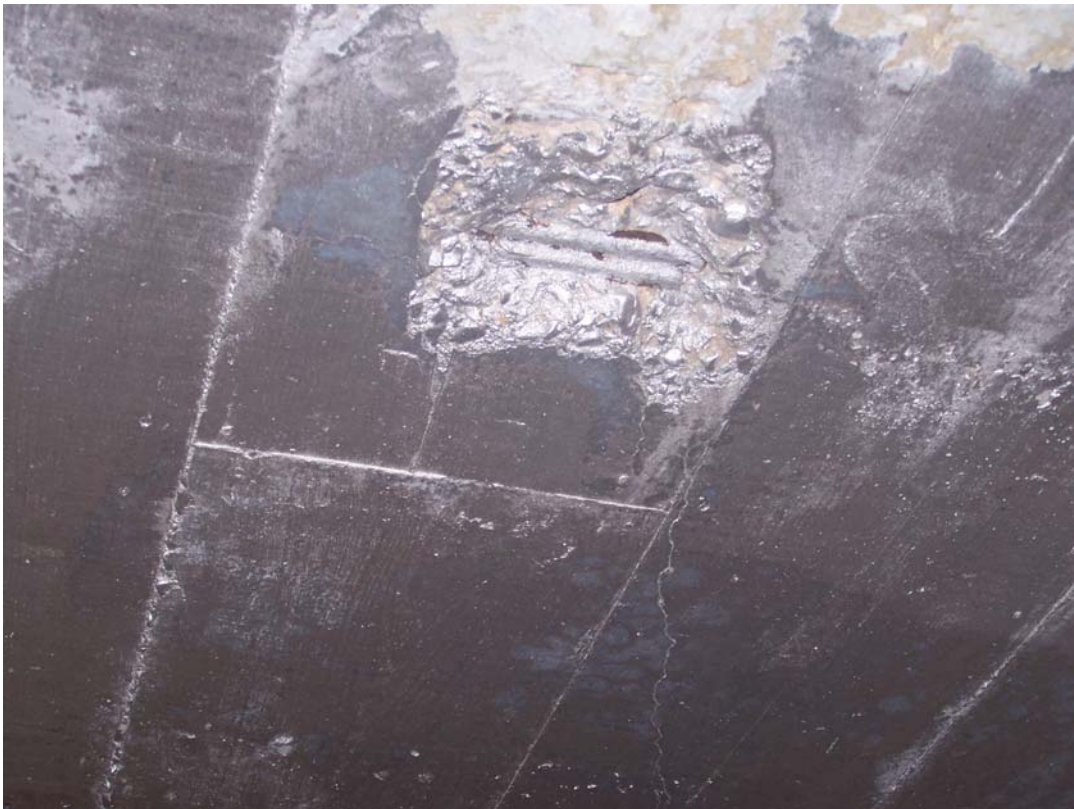
**Photo 172** Painted spall in ceiling of room 6.

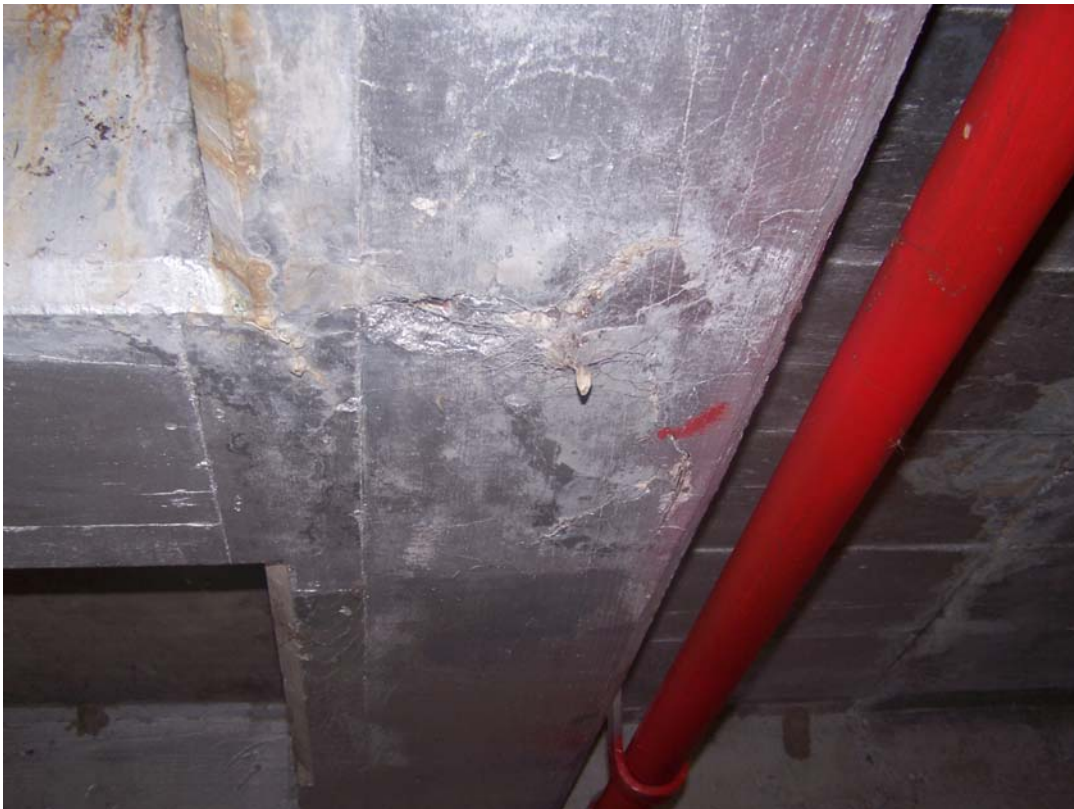
**Photo 176** Cracks in beams by hinge in Room 6.

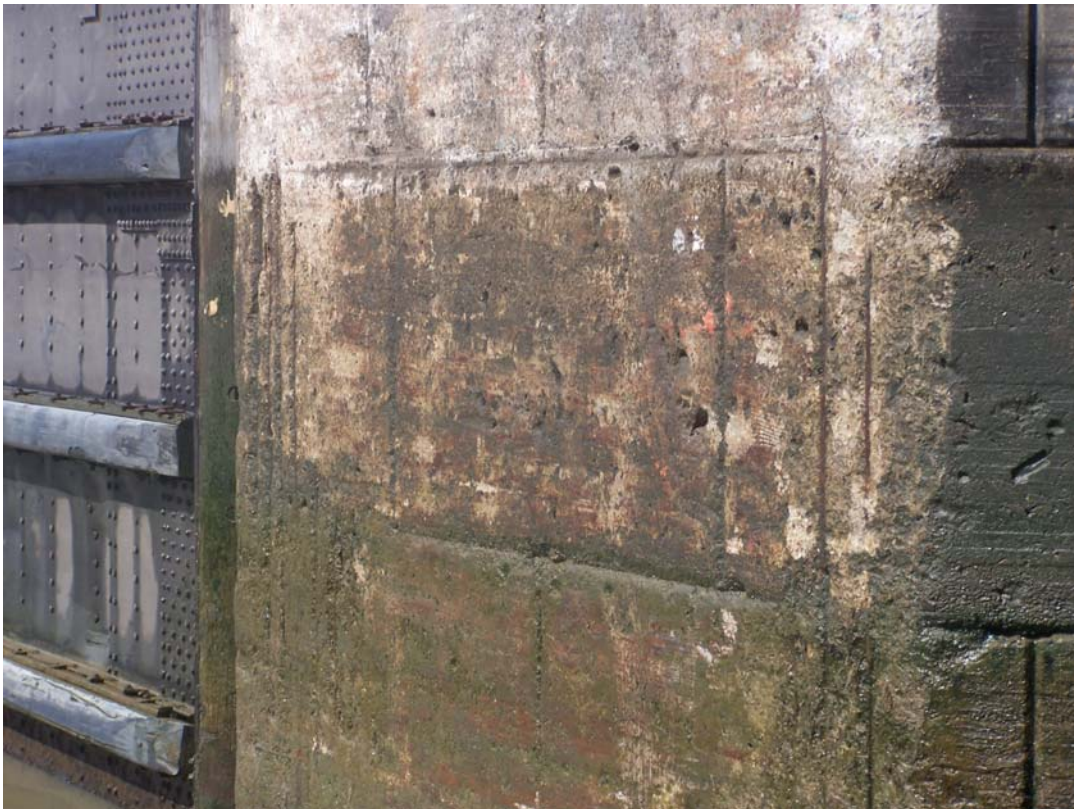
**Photo 188**     Northwest gatebay wall between the gates.

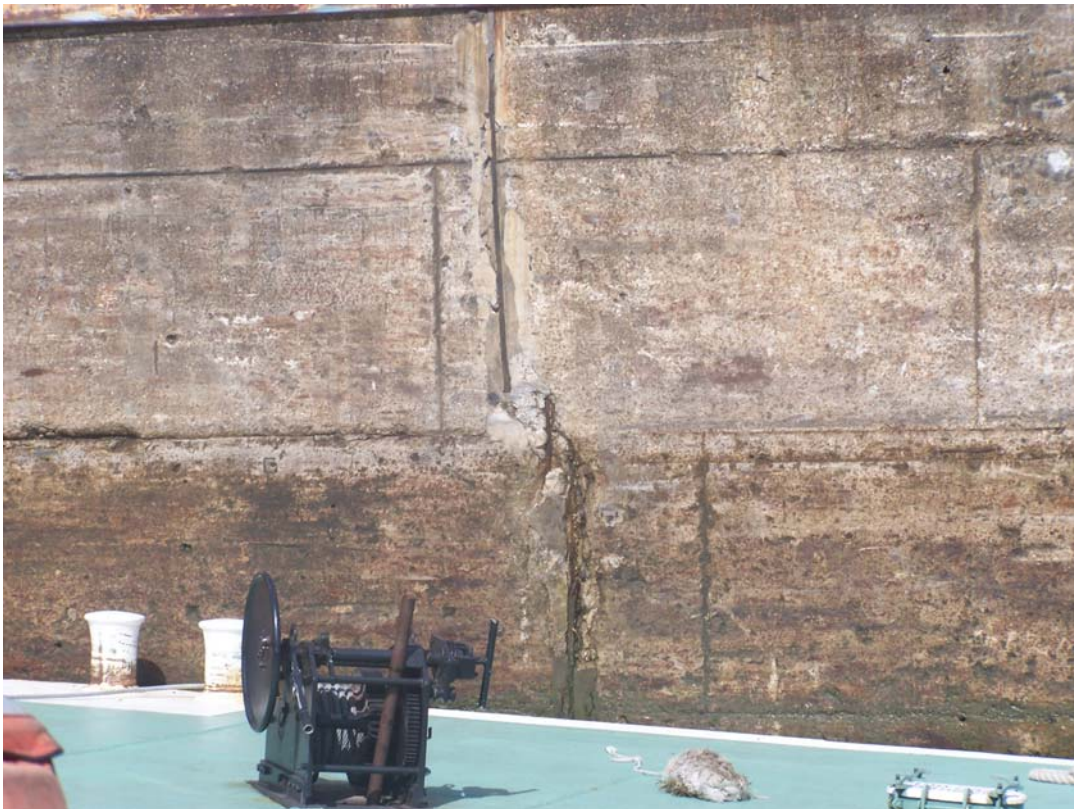
**Photo 190** Spalls with exposed steel in the west chamber wall on river side.
